# 2025 Annual Geochemistry Monitoring Report, Doris and Madrid

Hope Bay Mine, NU  
Agnico Eagle Mines Ltd.

SRK Consulting (Canada) Inc. ■ CAPR003761 ■ March 2026

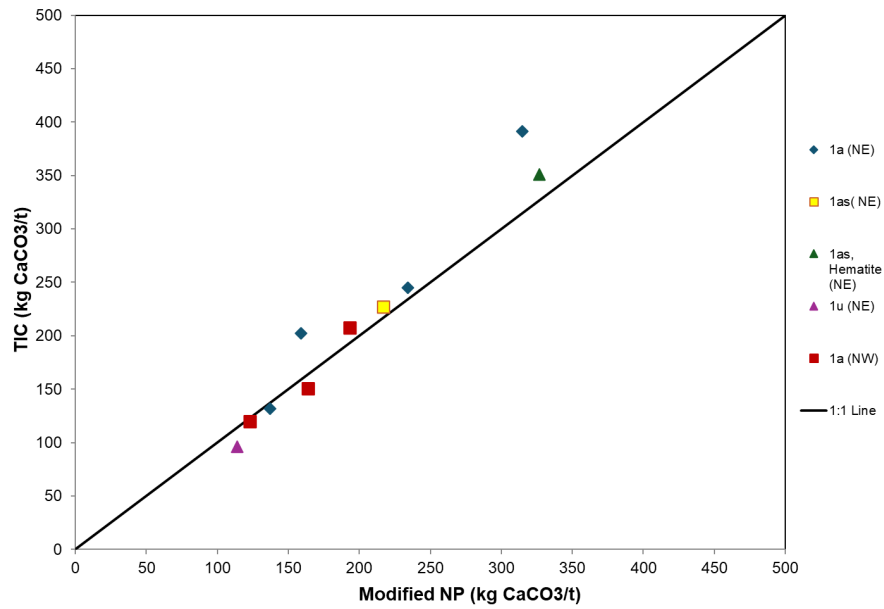
Figure 6-2: Comparison of Modified NP and TIC

Modified NP was between 110 and 330 kg CaCO<sub>3</sub>/t compared to TIC content between 96 to 390 kg CaCO<sub>3</sub>/t. For samples with TIC < 200 kg CaCO<sub>3</sub>/t, NP and TIC content was near equivalent. For samples with TIC > 200 kg CaCO<sub>3</sub>/t, TIC was greater than NP, indicating that TIC overestimates the amount of carbonate available for buffering due to the presence of NP-neutral iron and/or manganese carbonates. All samples were classified as non-PAG on the basis of TIC/AP and NP/AP.

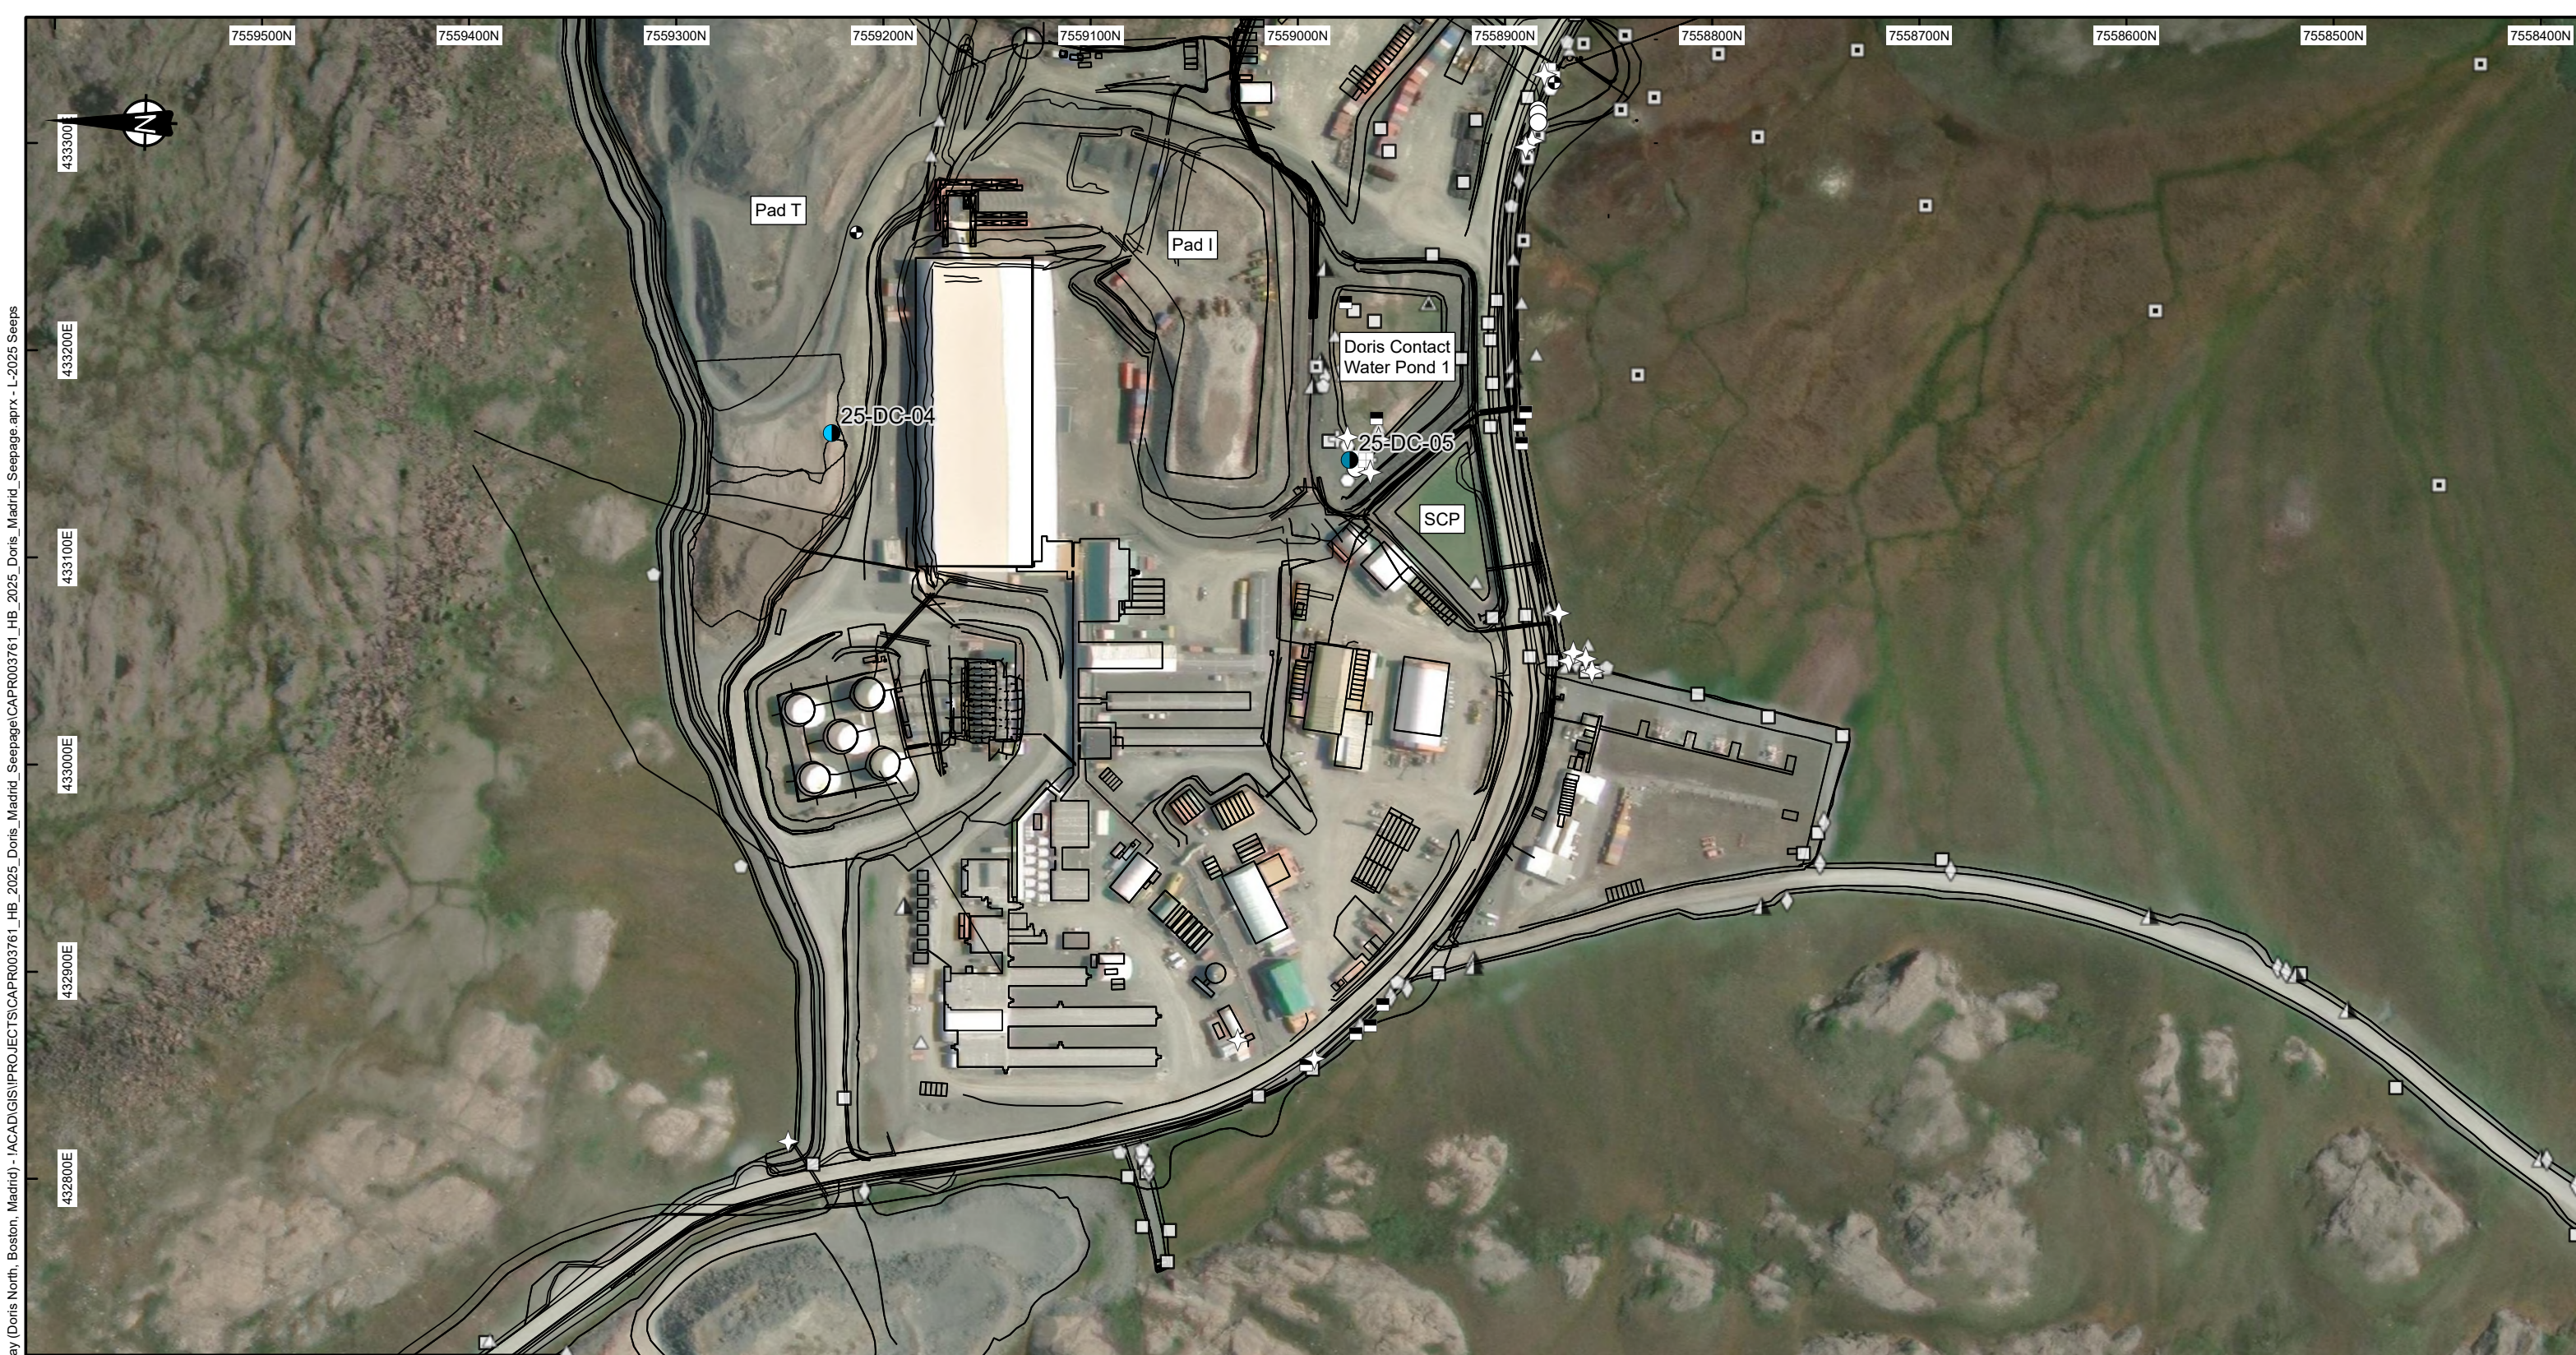
2025 Doris/Madrid Seepage Monitoring		
		Doris and Madrid Seepage Survey Overview		
SRK JOB NO.: CAPR003761 FILE NAME: CAPR003761_HB_2025_Doris_Madrid_Seepage	<b>Hope Bay Gold Project</b>	DATE: Feb 2026	APPROVED: BDD	FIGURE: 9-1

Table 9-1 inventories the construction rock and waste rock seepage samples collected in 2025. Agnico Eagle conducted the 2025 waste rock freshet seepage survey and construction rock seepage survey concurrently, from June 5 to 17, 2025, reference seep sampling on July 13, 2025, and monthly sampling of water in the Madrid North Waste Rock Storage Area (WRSA) Contact Water Pond (CWP) and Sumps on June 7, July 8, and August 5, 2025 (Figure 9-1 to Figure 9-10).

Figure 9-1 to Figure 9-10 present location maps of the seepage samples, surveyed areas, and of the as-built alignment of the Doris and Madrid mine areas. A complete set of field observations and measurements is provided in Appendix C1. Appendix C2 contains the laboratory water chemistry results.

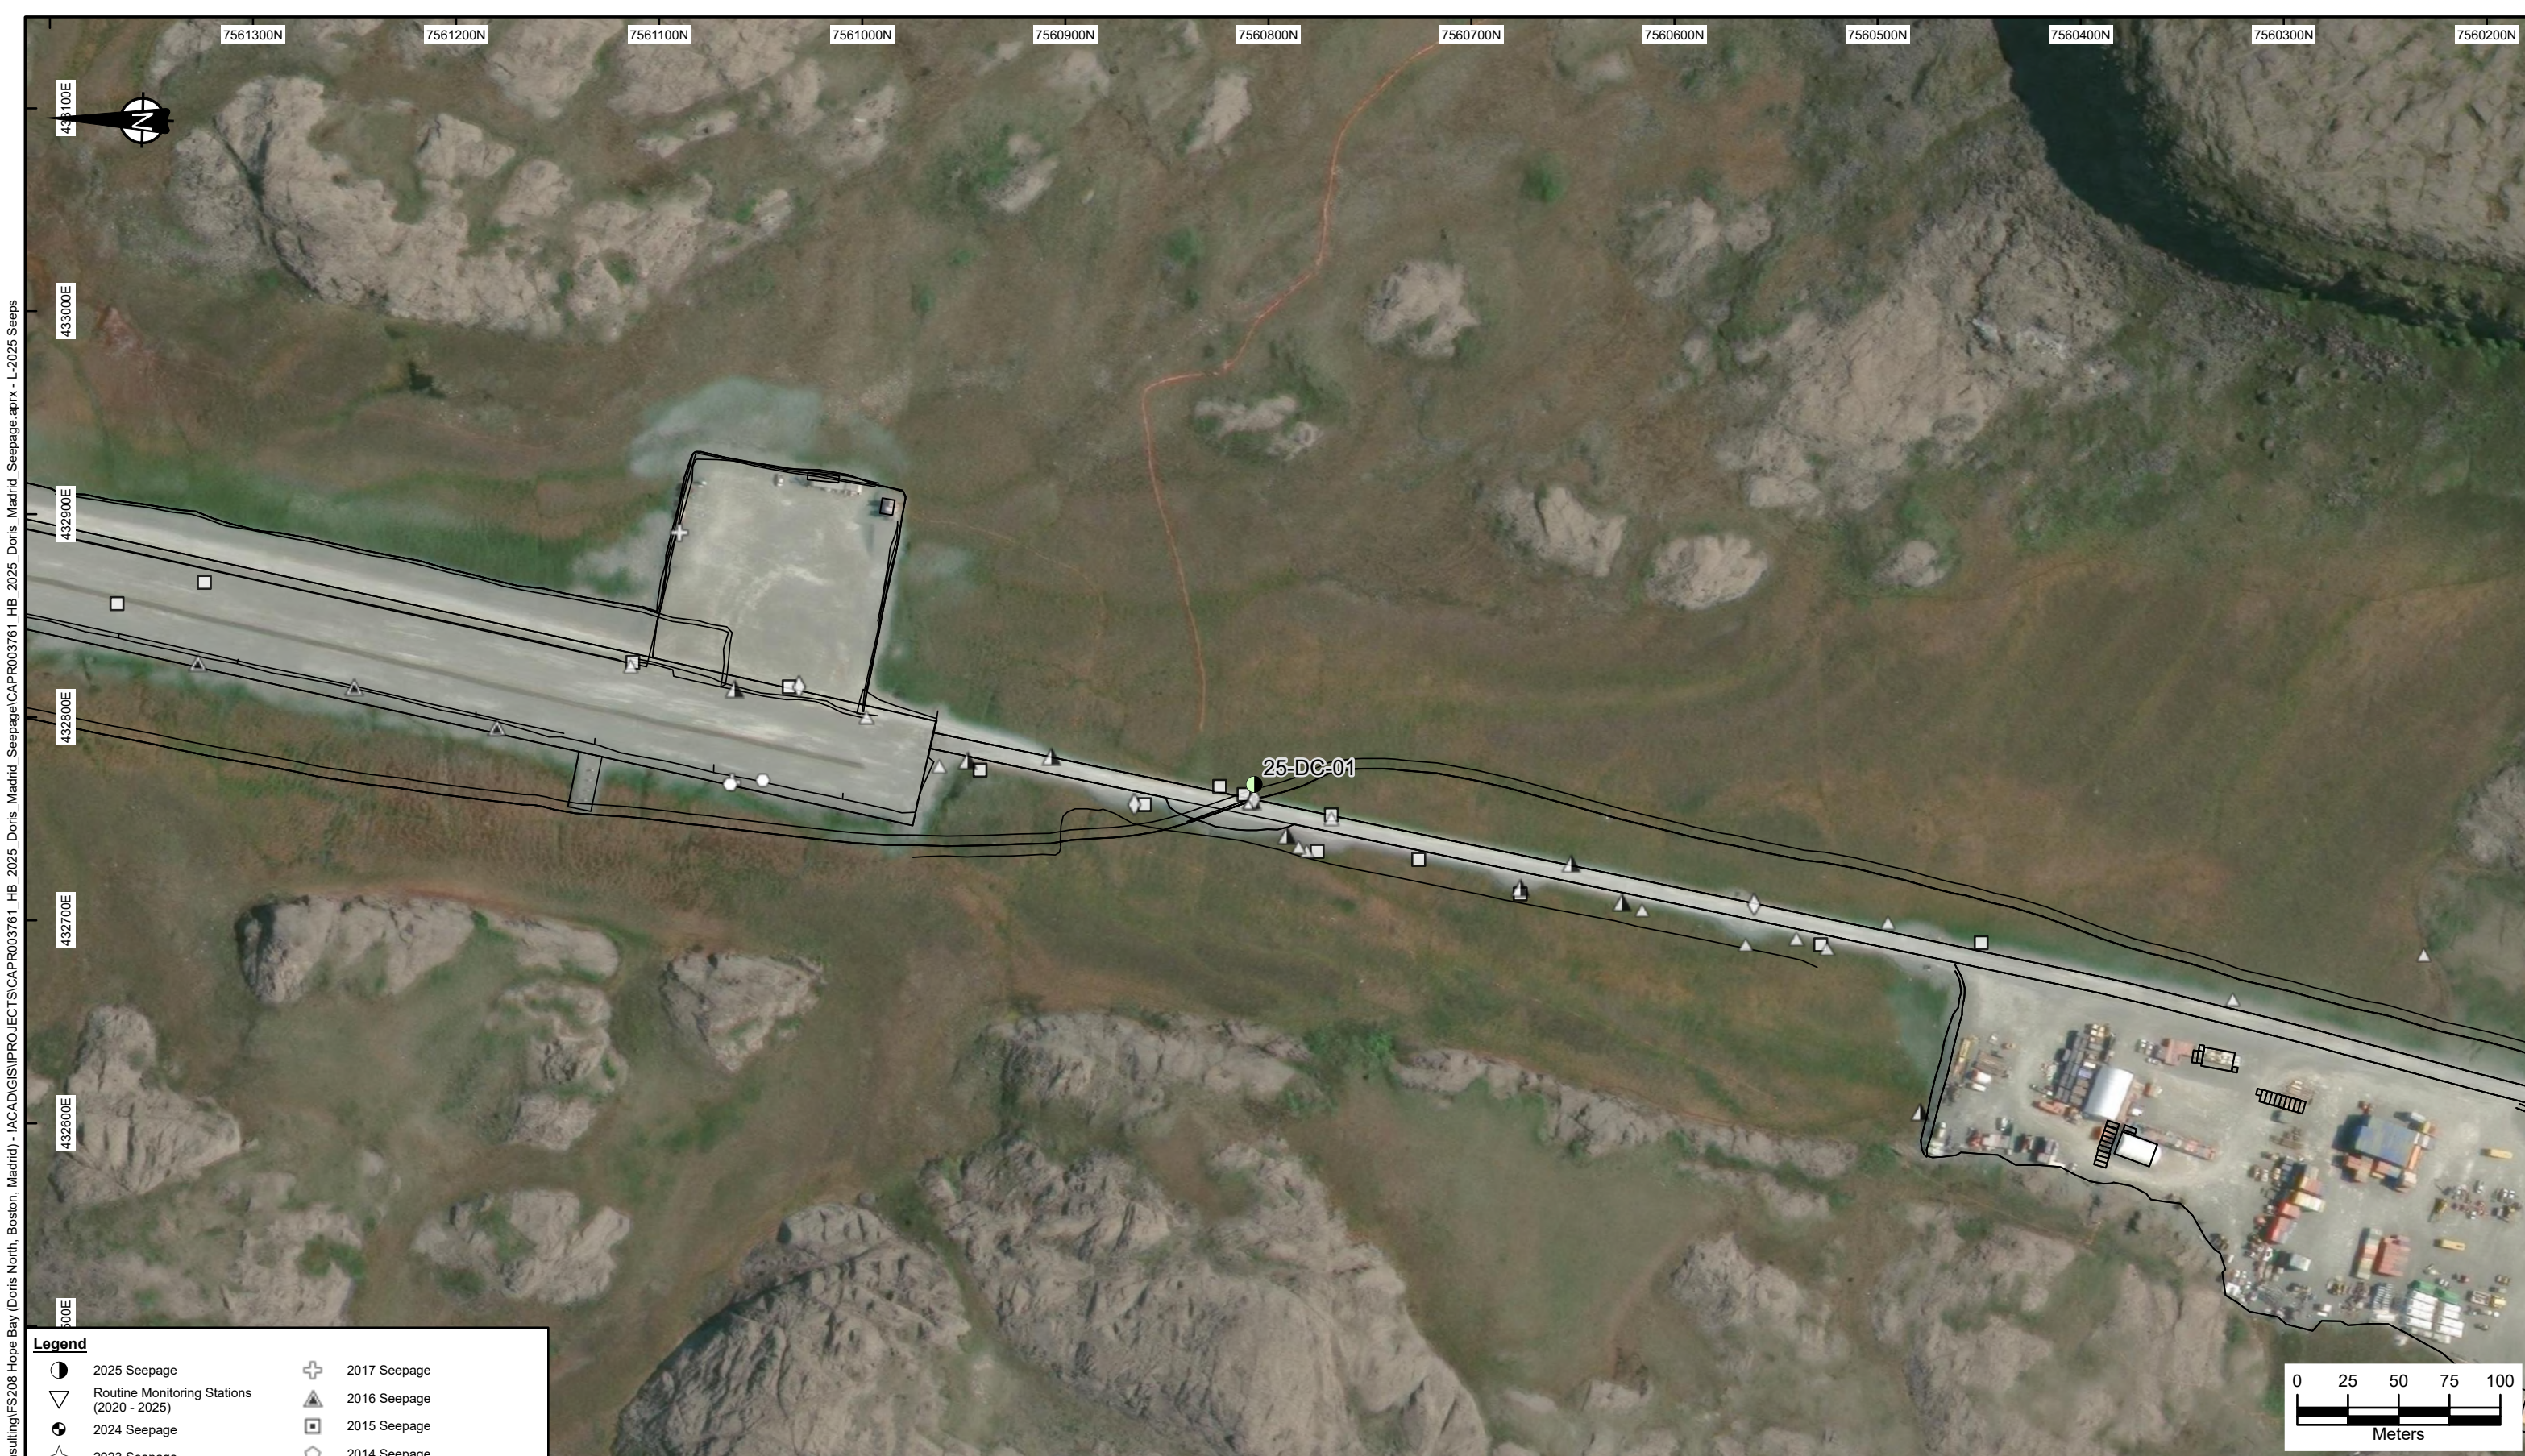
DATE: Feb 2026	APPROVED: BDD	FIGURE: 9-2
-------------------	------------------	----------------

Locations of seepage samples collected from the Doris Camp Pad are shown in Figure 9-2.

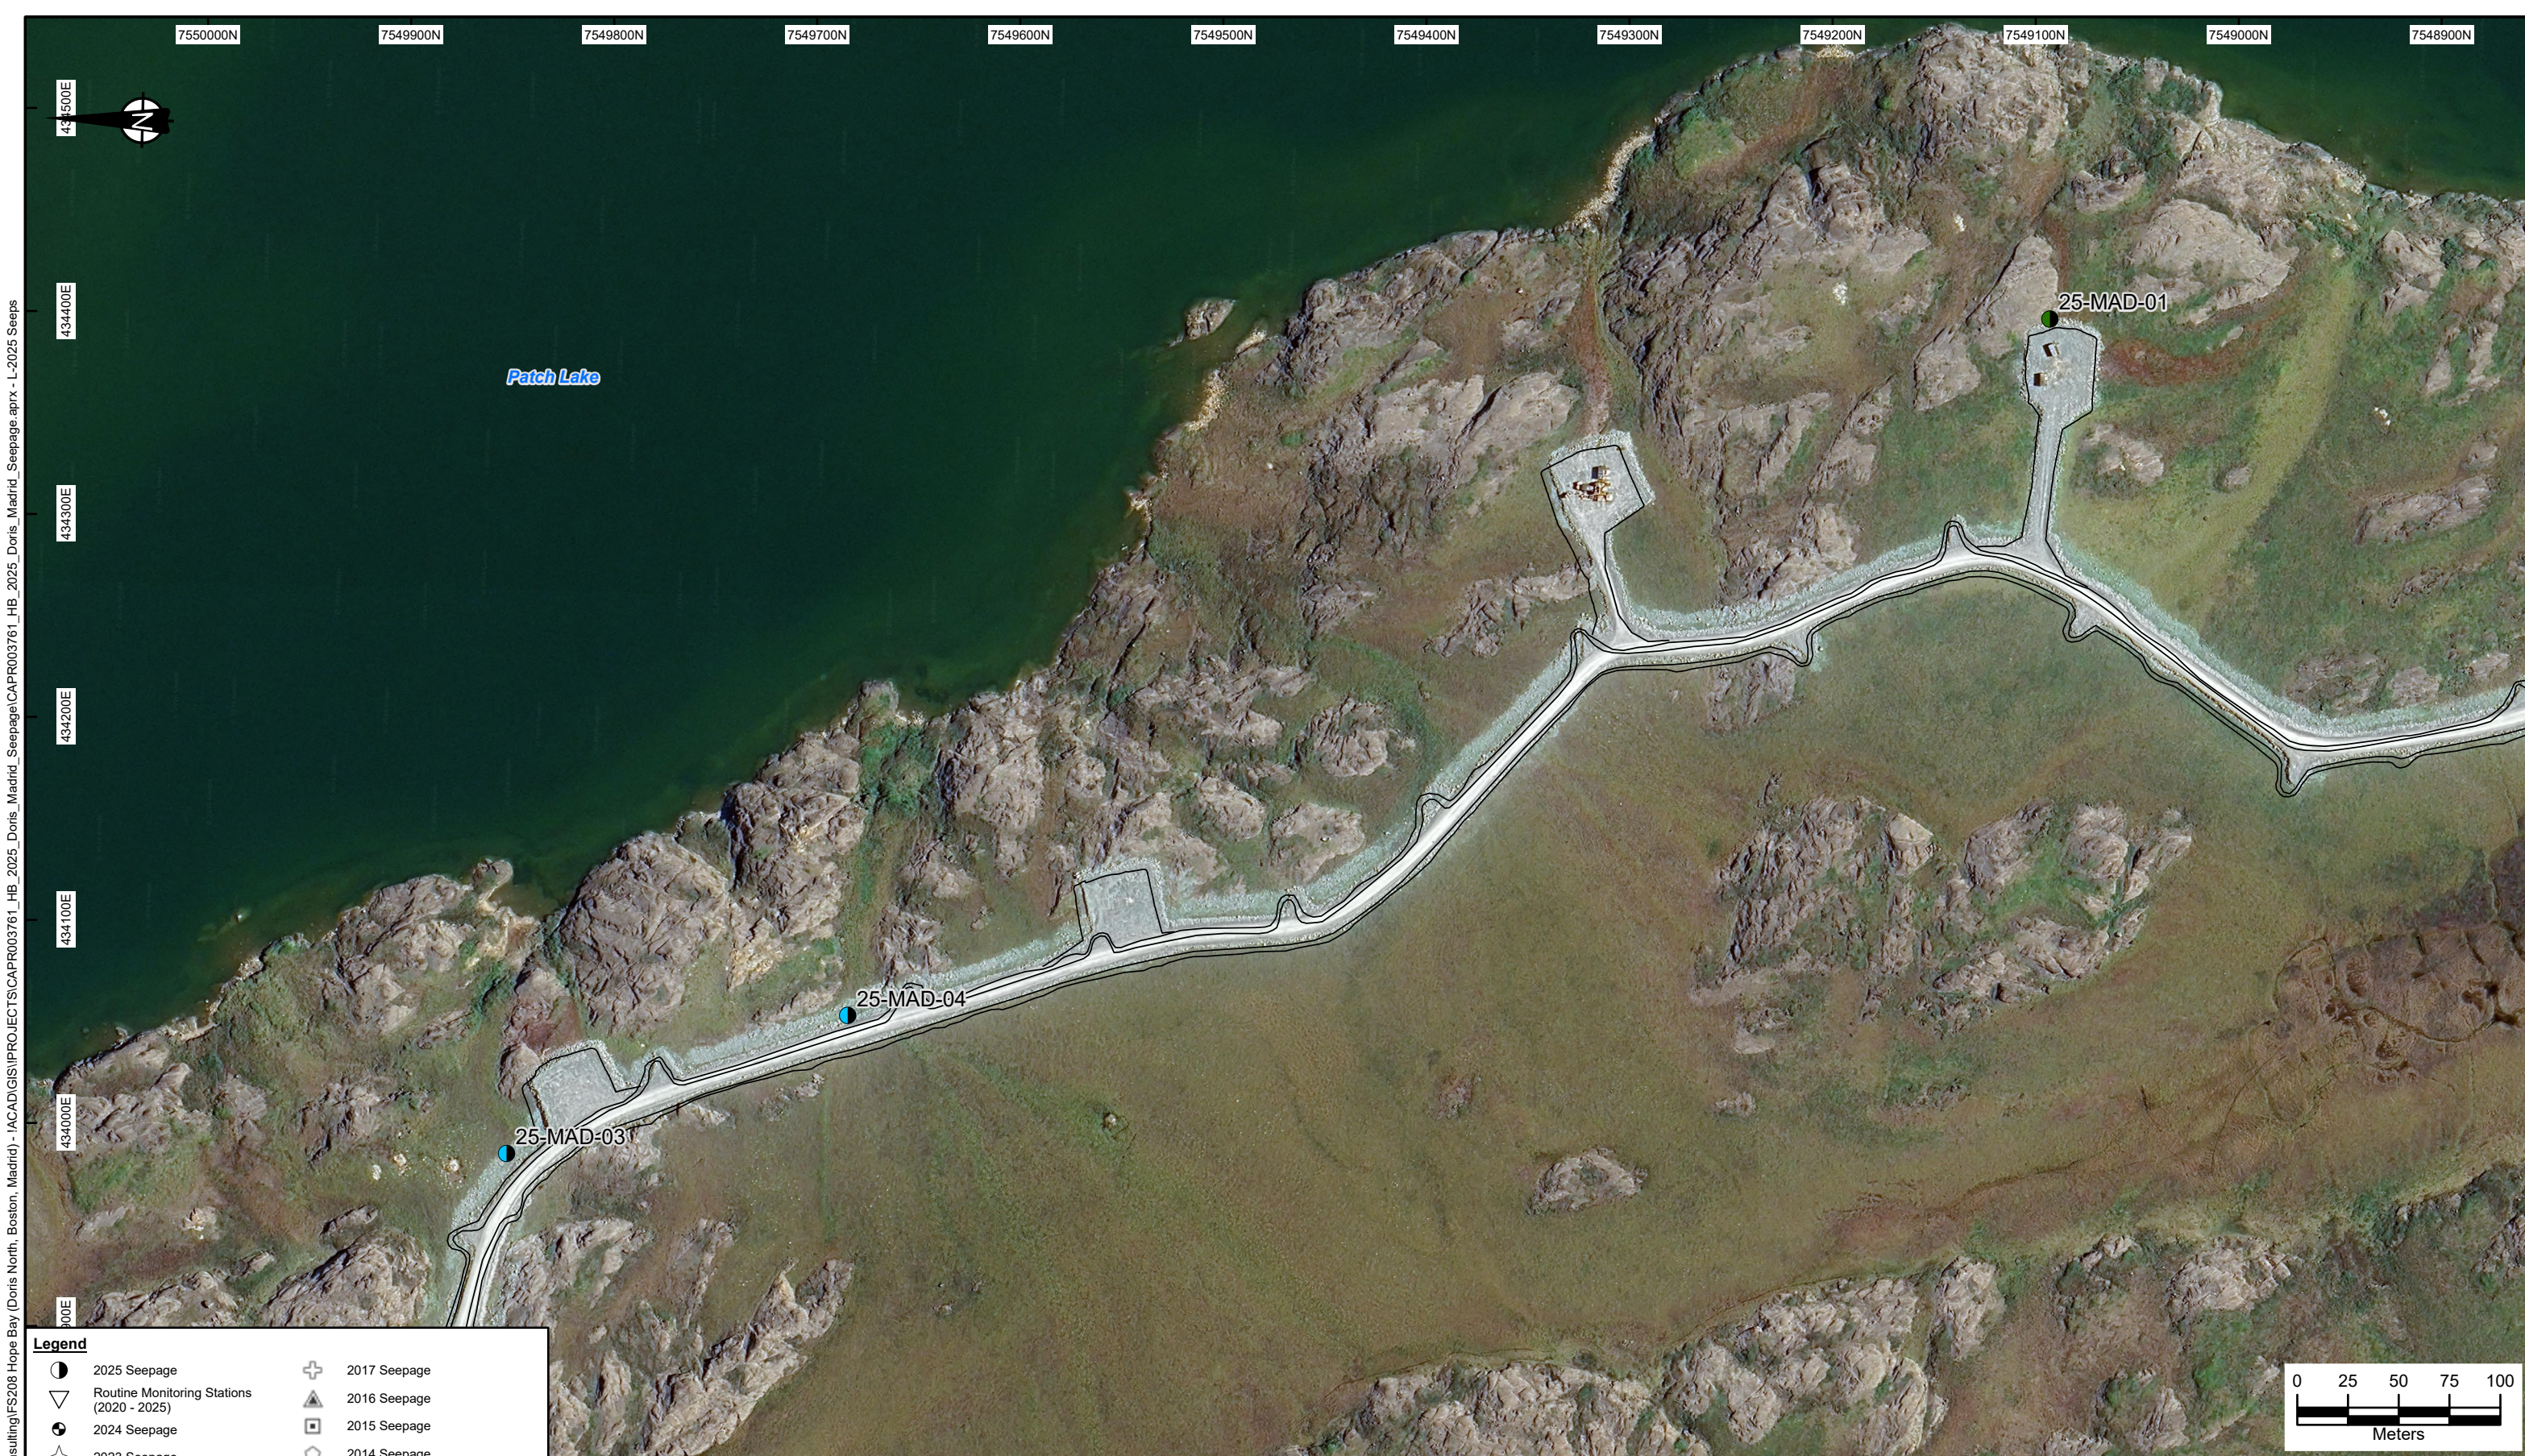
2025 Doris/Madrid Seepage Monitoring		
		TIA Road Seepage		
SRK JOB NO.: CAPR003761 FILE NAME: CAPR003761_HB_2025_Doris_Madrid_Seepage	<b>Hope Bay Gold Project</b>	DATE: Feb 2026	APPROVED: BDD	FIGURE: 9-4

One seepage sample each was collected from the reclaimed Madrid North Portal Pad and Overburden Stockpile Areas (Figure 9-6). Two seepage samples were collected along the Madrid to TIA Road (Figure 9-4) and the Windy Camp Access Road (Figure 9-7) and three seepage samples were collected along the Madrid Exploration Track and Pads adjacent to Patch Lake (Figure 9-5 and Figure 9-6).
