Meadowbank 2020 Annual Pit Slope Performance Review

2020 ANNUAL PIT SLOPE Performance Review

Meadowbank Mine, Nunavut

ISSUED FOR USE 704-ENG.ROCK03163-01

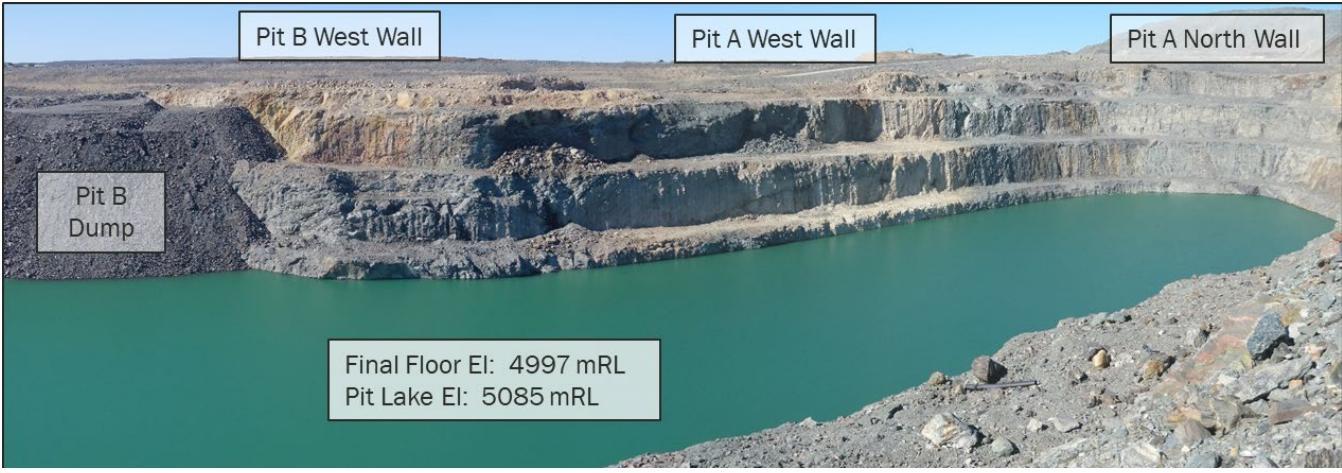
Photograph 4-1: Pits A and B looking west, from east crest (2020)

The inspection consisted primarily of observations made from the crest areas and from the base of the pit. The observations were made by comparing the current conditions with those previously observed, as well as comparing the current pit usage with risk assessments carried out as part of the assessment of the pits for use as tailings and water management areas (Tetra Tech 2018a and 2018b). Views of Pits A and B at the time of the site visit are shown in Photograph 4-1 and Photograph 4-2. For reference, the bench height in the photographs is 21 m.

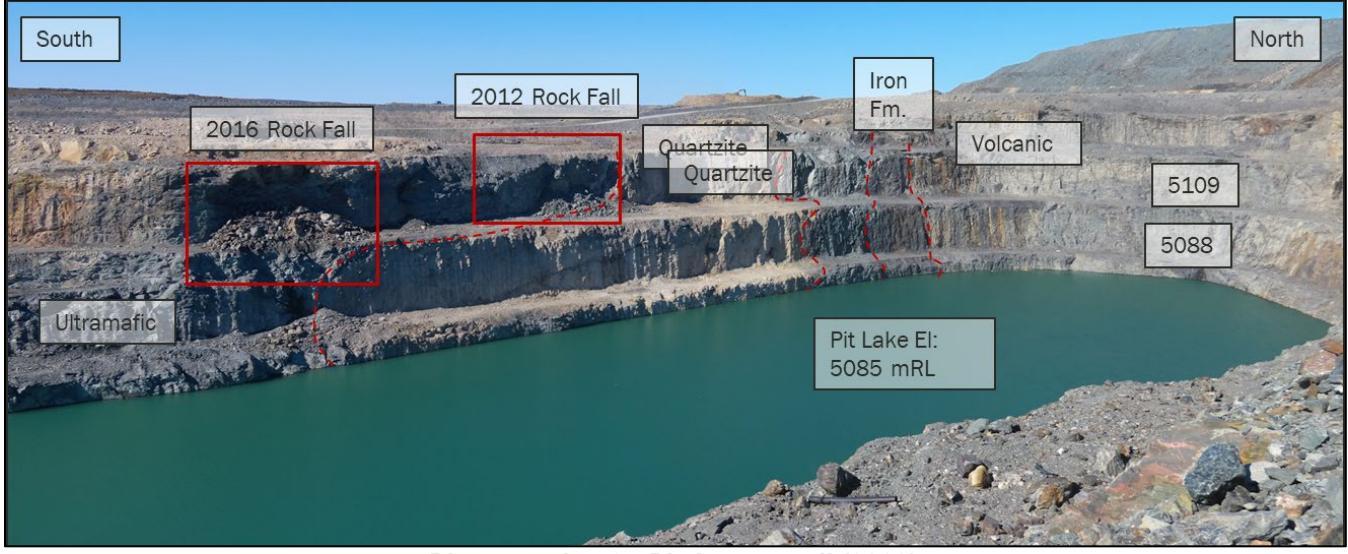
Photograph 4-3: Pit A west wall (2020)

The remaining walls exposed above the current lake elevation show no degradation since the 2019 inspection. The following actions are recommended:

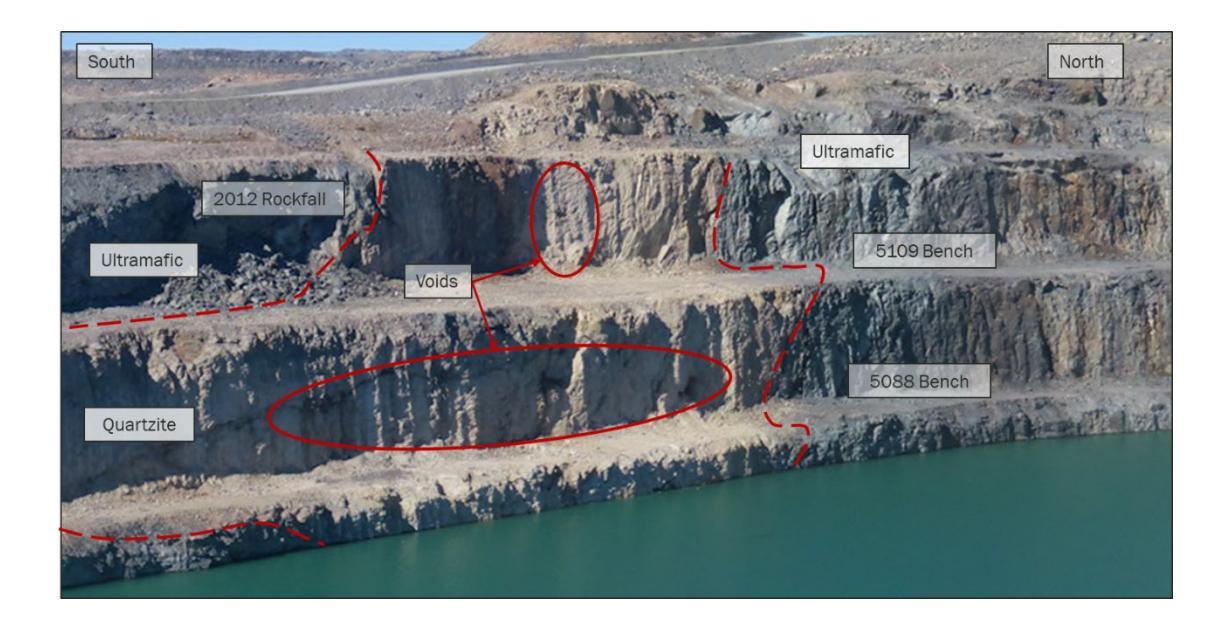
Photograph 4-4: Voids in quartzite above Pit A west ramp (2020)

The quartzite stratigraphy observed in the Pit A west wall contains several large voids identified during previous inspections. There has been no significant accumulation of material on the benches since the 2019 inspection. The condition of the Pit A West Wall Voids at the time of inspection are shown in Photograph 4-4.

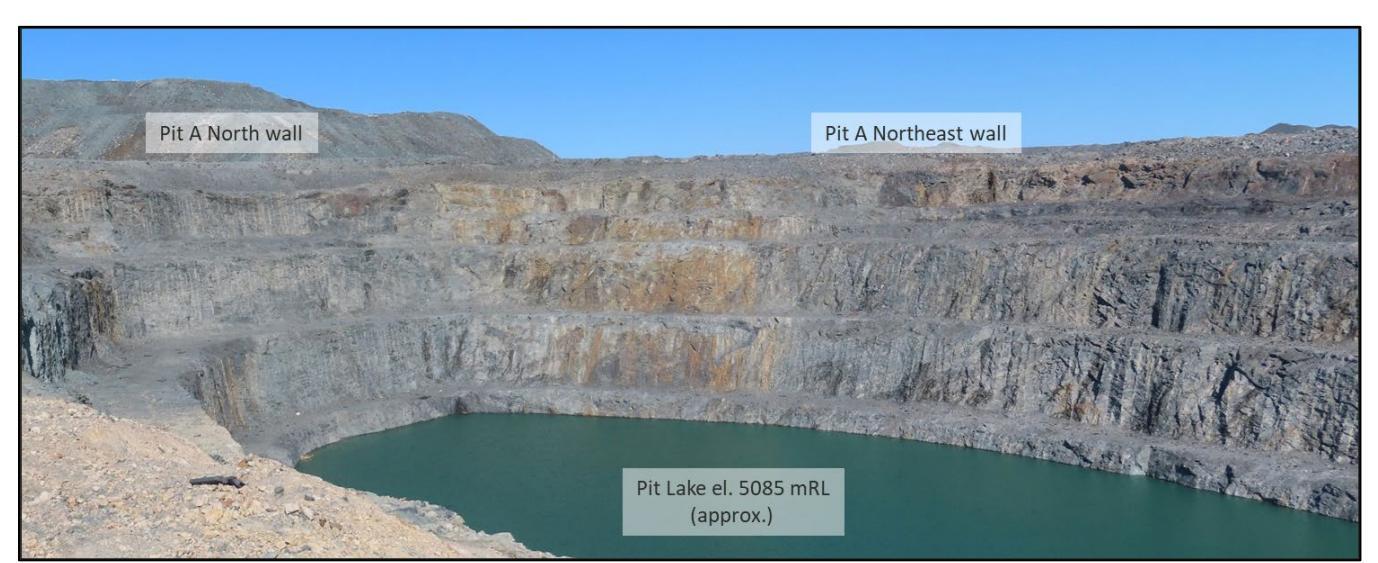
Photograph 4-5: Pit A north to northeast wall (2020)

The north through northeast walls of Pit A continue to perform well. There are no noticeable changes from 2019. No additional accumulation of loose or raveling material on the catch benches was noted during the site visit. The condition of the Pit A North to Northeast Wall at the time of inspection is shown in Photograph 4-5.

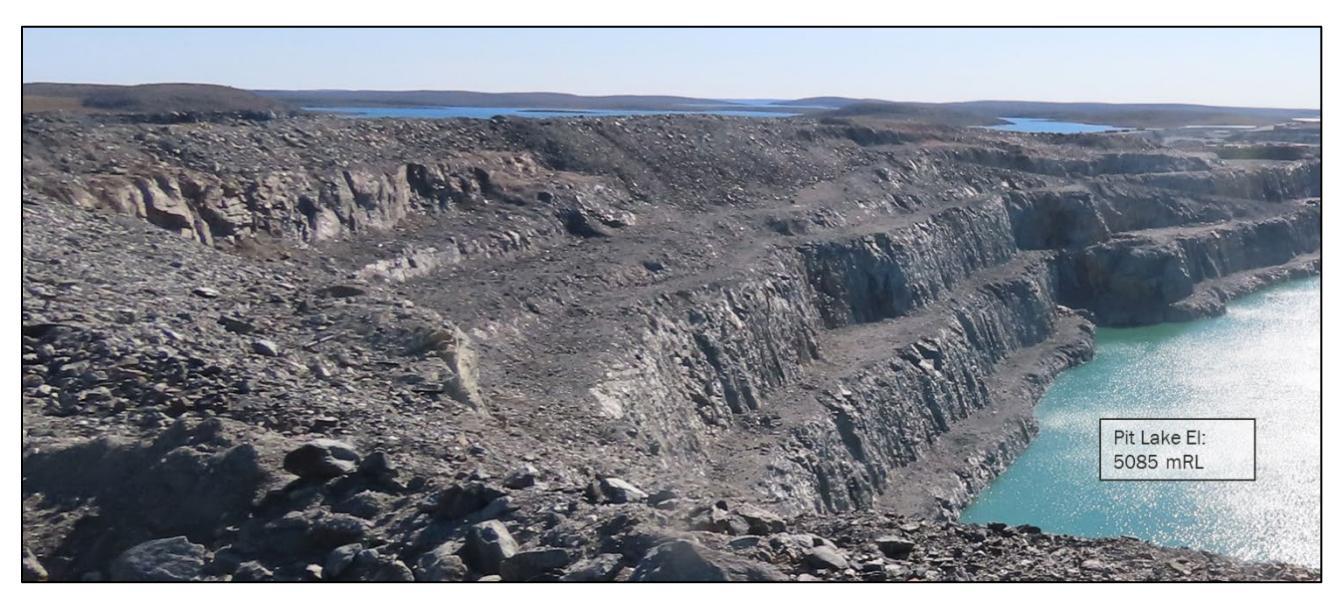
Photograph 4-6: Pit A East wall upper benches (2020)

The benches of the Pit A East Wall continue to perform well, as shown in Photograph 4-6. There are no noticeable changes from 2019.

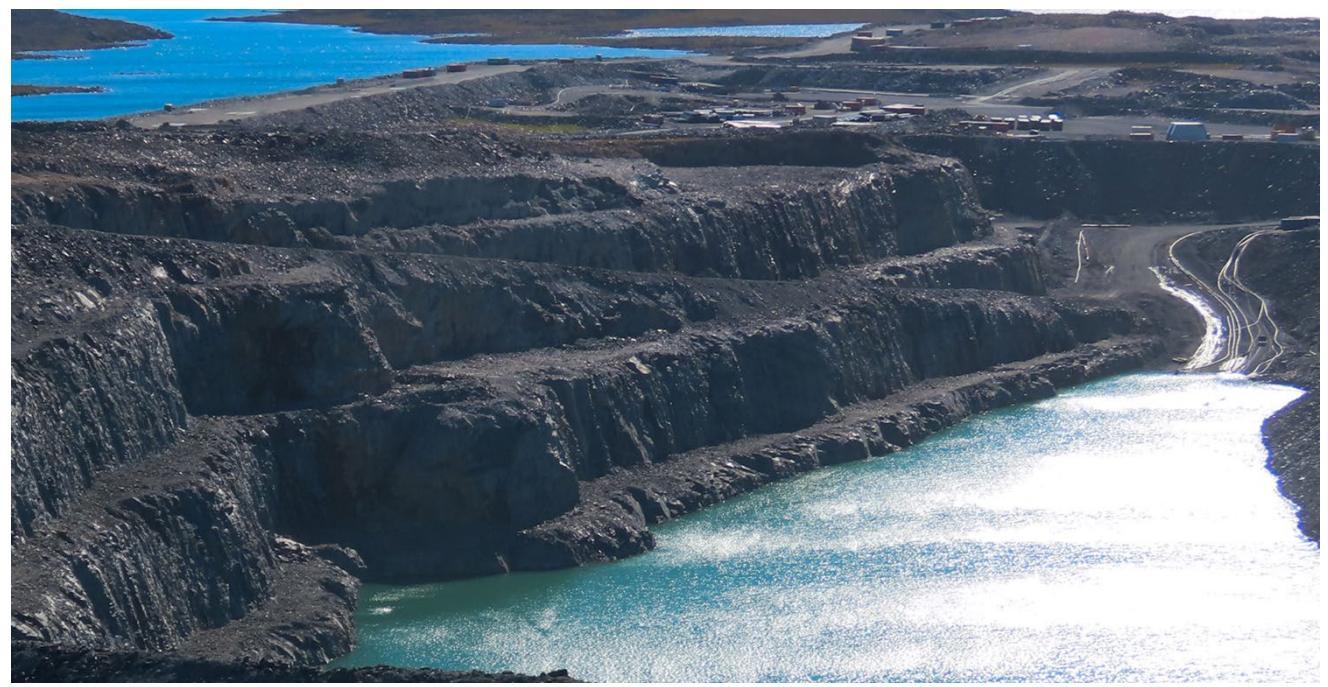
Photograph 4-8: Pit B east wall, looking south (2020)

The east wall of Pit B was inspected from several viewpoints as well as from within the pit. The wall continues to perform satisfactorily, and benches are generally clean with little accumulation of material. The condition of the Pit B East Wall at the time of inspection is shown in Photograph 4-8.

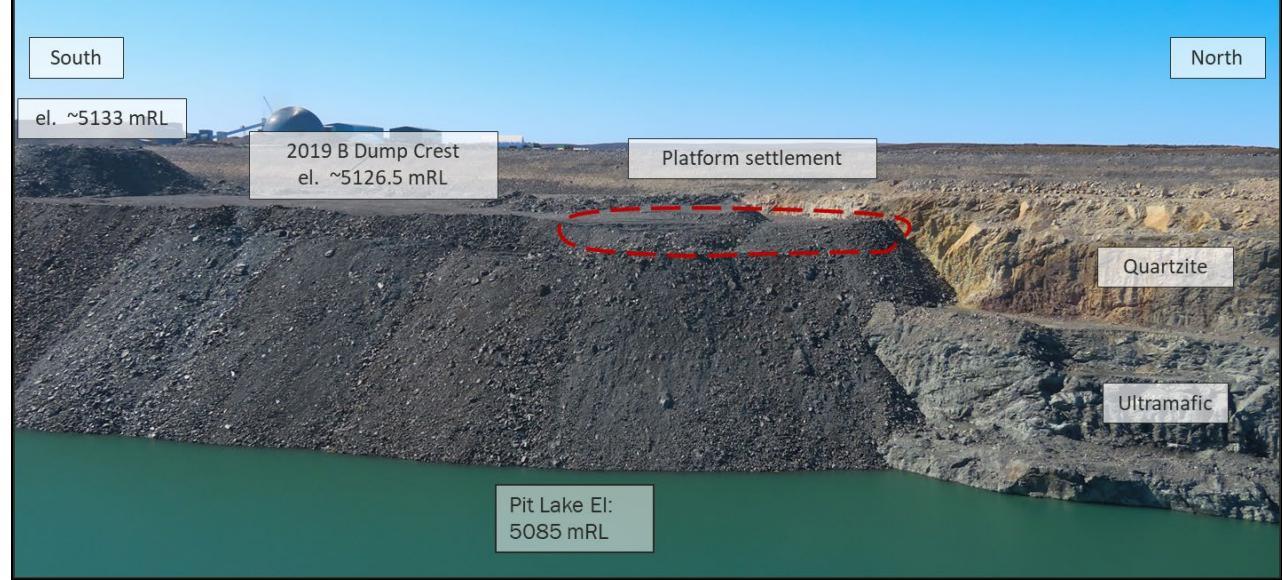
Photograph 4-9: B Dump looking southwest showing northward advance of dump face (2020)

The dump remains inactive and closed. No evidence of dump instability was noted on the dump face, such as bulging or shallow failures. However, as the pit water rises it is expected that shallow surface failures will occur.

Since personnel will continue to access the pumps at the base of the ramp below the south end of the dump, the dump performance should continue to be monitored as part of monthly geotechnical inspections.

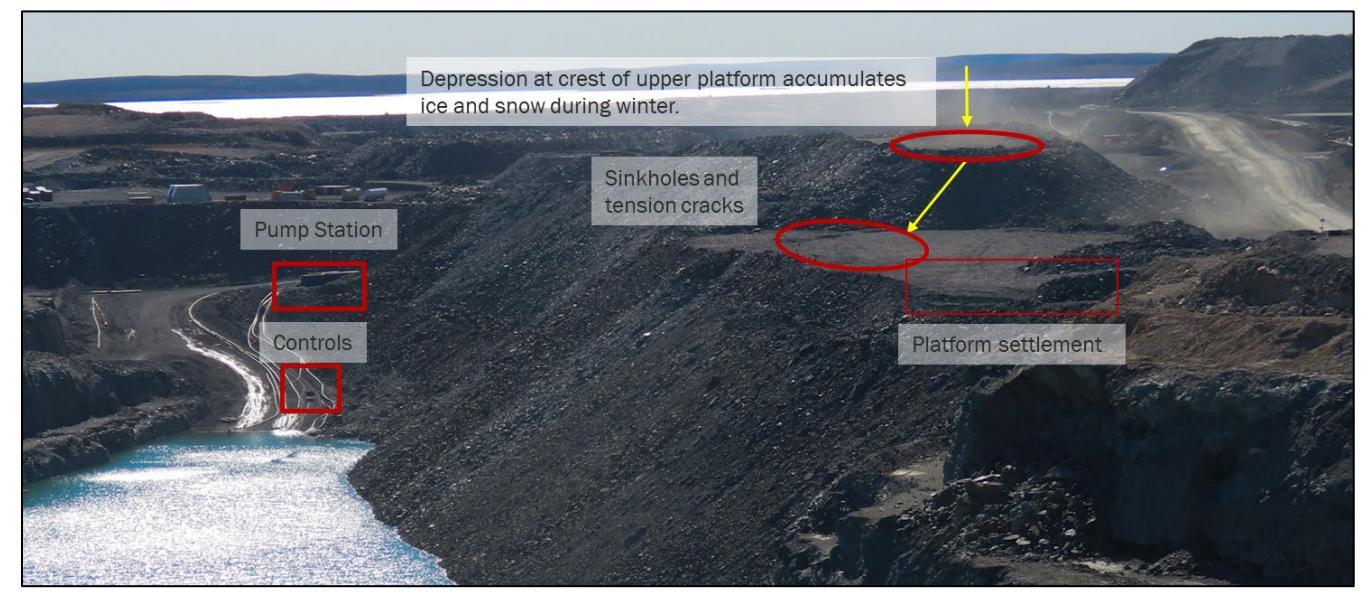
The B Dump platform has experienced significant settlement in the past. As the lake level continues to rise, ongoing settlement should be expected, and the dump platform should remain closed. During the inspection of the dump platform it was noted substantial sinkholes had developed. On further inspection, it was determined that a depression on the upper dump platform allowed ice and snow to accumulate during winter leading to outflow of large water volumes to the lower platform during freshet.

Photograph 4-10: B Dump showing settlement at north end of dump platform (2020)

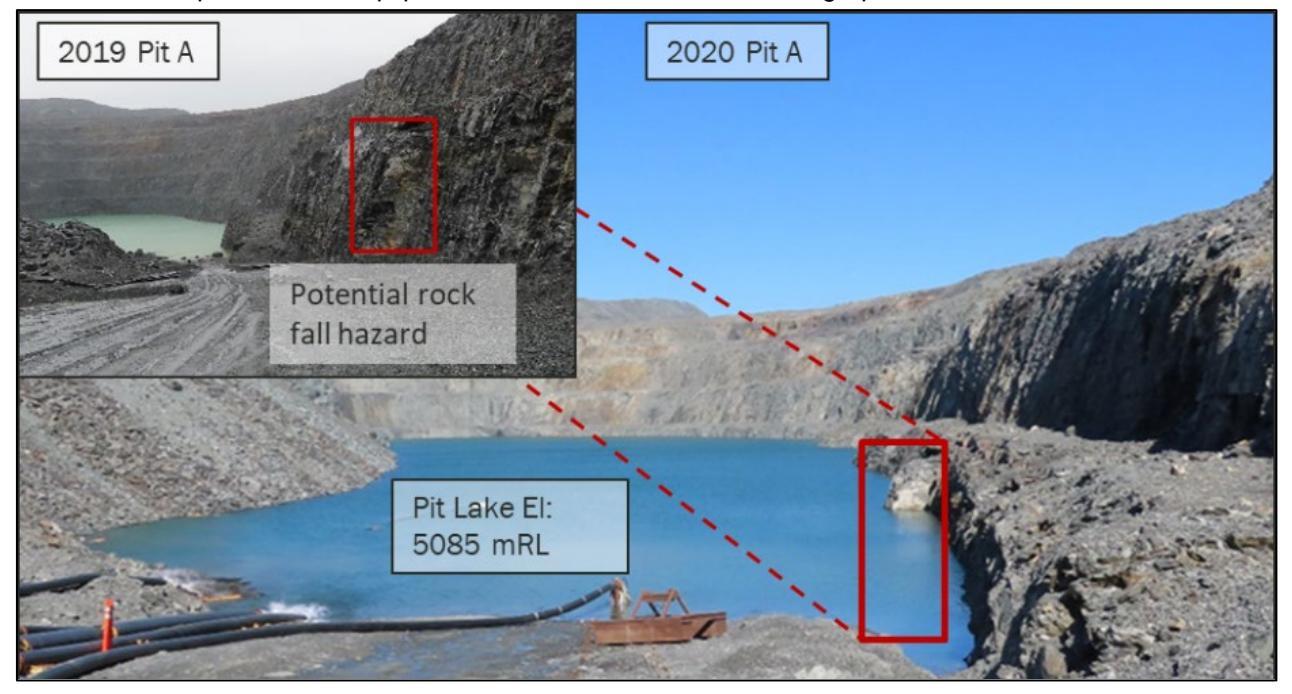
Photograph 4-11: Pit B ramp rockfall hazard (2020)

A previously identified geotechnical hazard on the lower ramp area of Pit B was visited. The lower ramp will continue to be used for water lines, pump controls and pump stations, and require access by personnel. The hazard was characterized by a potentially unstable portion of the bench face. The area is now below the pit lake, and no longer presents a risk to personnel or equipment. The area is shown in Photograph 4-11.

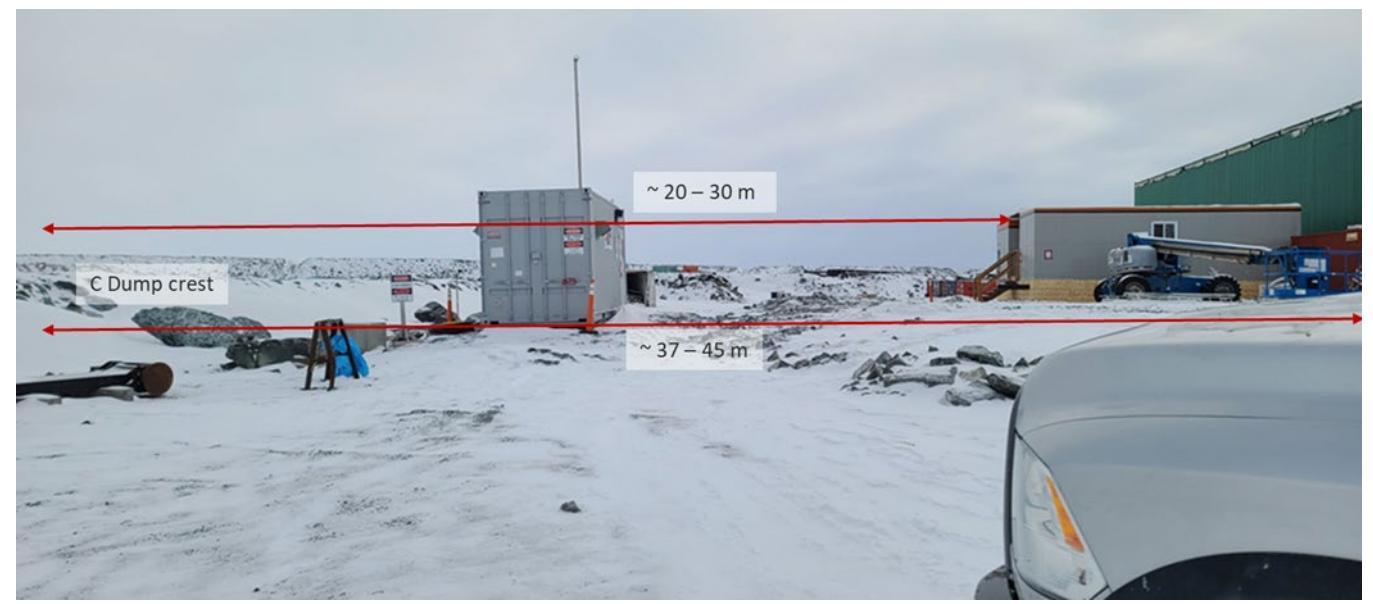
Photograph 4-13 shows the location of the garage slab during construction and the approximate setback distance of the slab from the C Dump crest. Photograph 4-14 shows the completed structure, with the addition of the entryway and dry area, which extend towards to the C Dump crest. A sea container is located directly adjacent to the crest.

Photograph 4-14: Completed ABF garage with entryway extending toward the C Dump crest (2020)

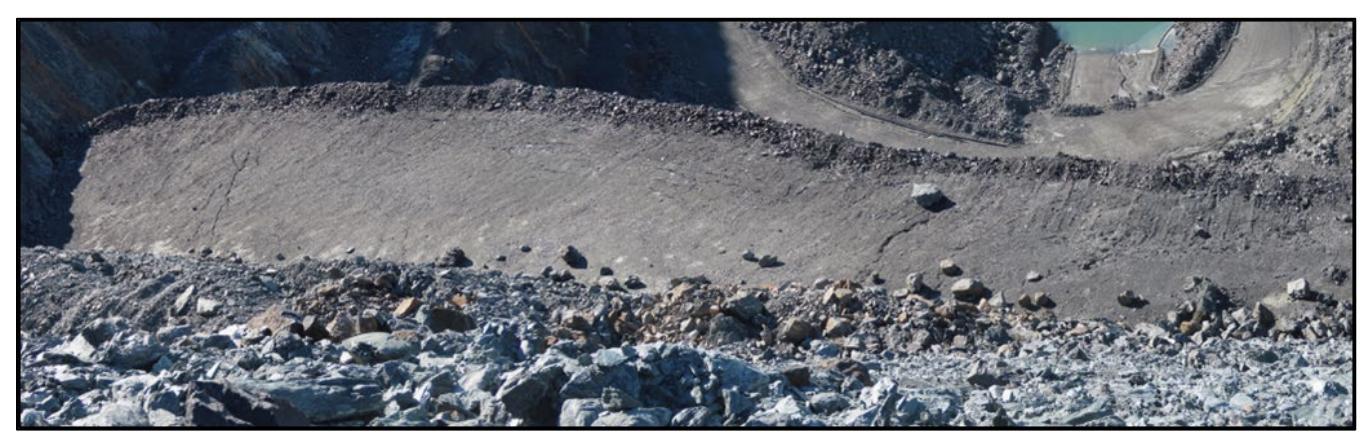
Photograph 4-18 is looking down the dump face at the 5088 mRL bench from the 5126 mRL platform. The tension cracks that are visible are the same as originally observed in 2016 and are dormant.

Photograph 4-18: Pit D Dump 5088 mRL platform and tension cracks (2020)

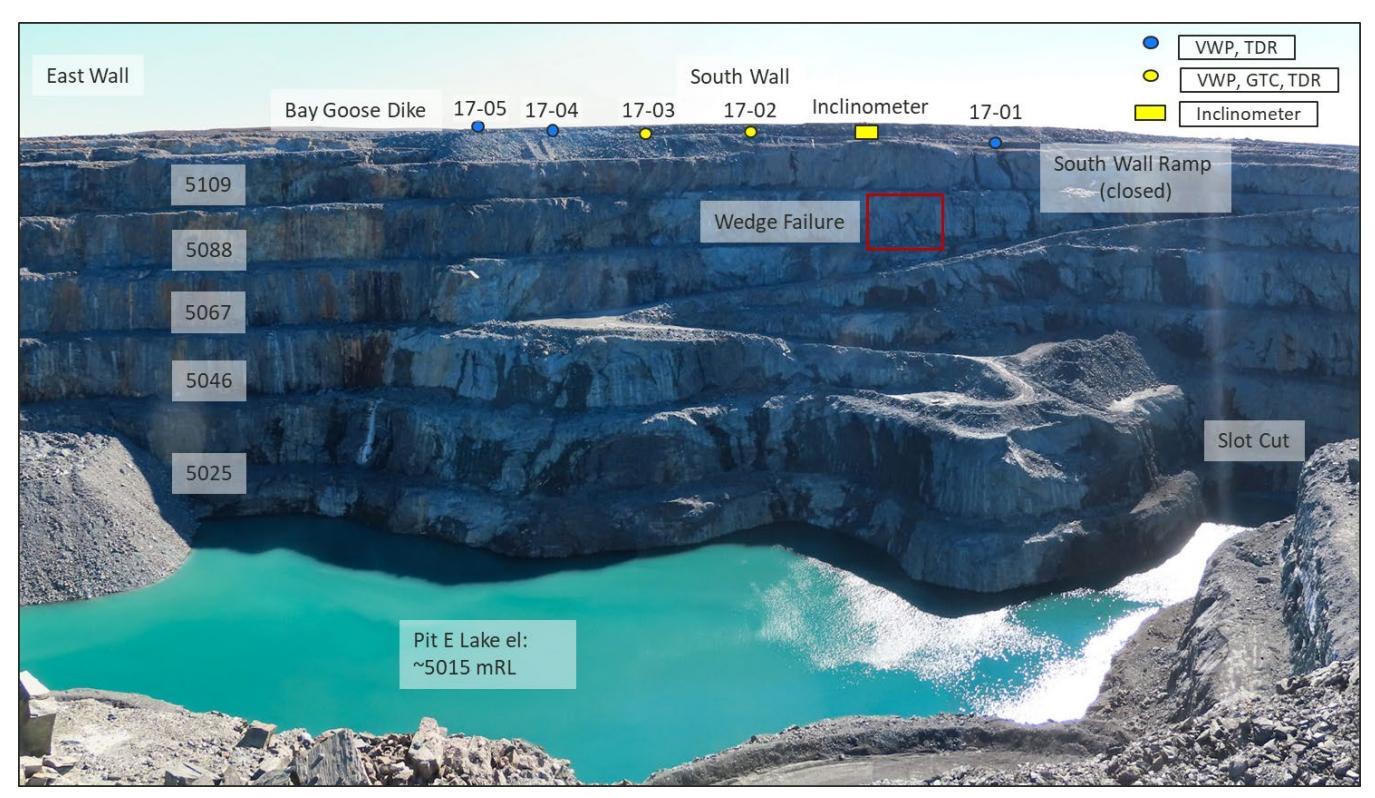
The west wall has localized bench-scale instability associated with the weaker ultramafic rock exposed at the base of the wall and adverse structure (shearing in the ultramafic rock) inclined into the walls and resulting in overhangs.

Photograph 5-2: Pit E viewing southeast showing current instrumentation (2020)

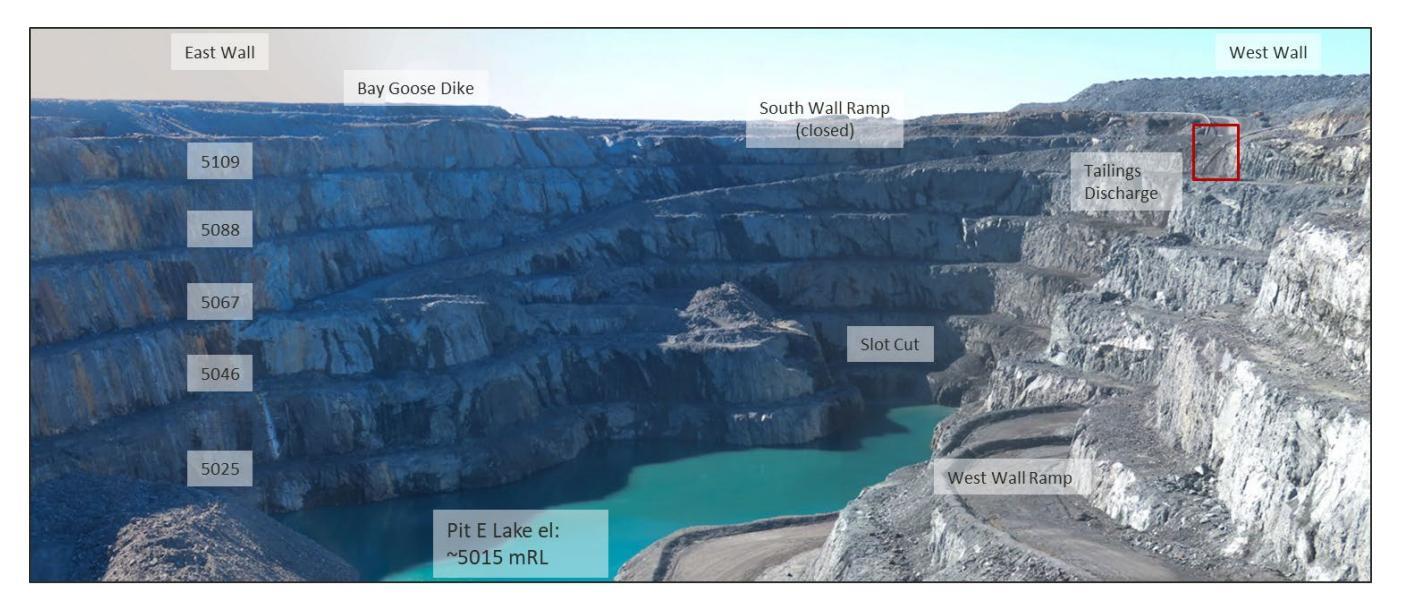
Photograph 5-4: Pit E south wall (2020)

Pit E south wall exposes primarily ultramafic rock with iron formation and volcanic rock on its eastern edge. The ultramafic rock is poor quality, and the south wall has had a history of poor bench and overall slope performance since 2015, as documented in previous site visit reports and referenced documents. Rockfalls are more common in the ultramafic rock and specifically in areas of the pit that were in talik. Where the ultramafic rock is frozen, wall performance is significantly improved, and in the iron formation and intermediate volcanic rock is enhanced. Significant faulting and folding have affected the south wall leading to the development of a strong shear fabric within the ultramafic rock which contributes to its poor performance, and to its ability to conduct groundwater flow.

The South Ramp is inactive and closed, and there are no plans to re-establish access from this area. Pit E was mined to completion with radar coverage of the south wall to monitor potential rock fall events. Now that mining has been completed, the radar has been removed. The instrumentation remains installed in the South Wall includes TDR cables, thermistors and vibrating wire piezometers, and a slope inclinometer. These data have been reviewed as part of this site inspection and are summarized later in this document. The condition of the Pit E South Wall at the time of inspection is shown in Photograph 5-4.

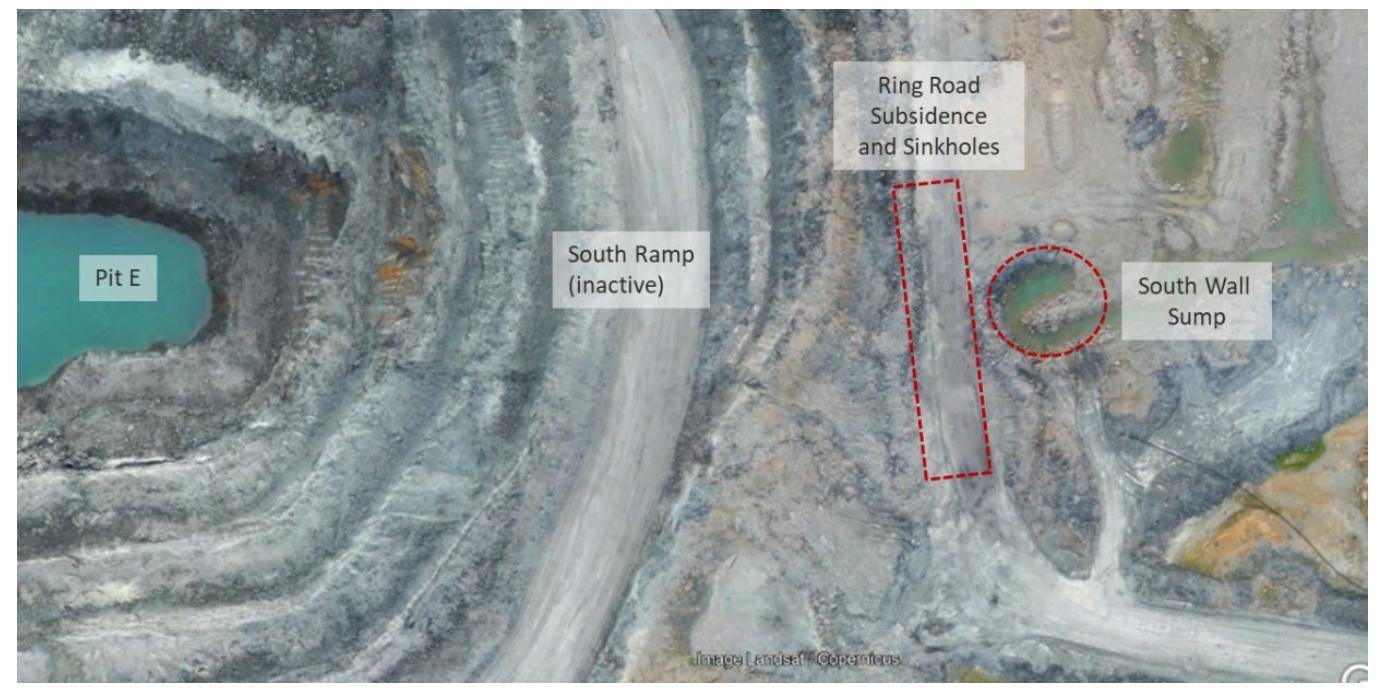
The sump at the crest of south pit wall continues to collect water as shown in Photograph 5-6. There was no pump at the sump at the time of the inspection. During the 2020 site visit it was observed that sinkholes and settlement of the ring road at the crest of the south wall of Pit E had developed. The area of subsidence is directly adjacent to the sump and is shown in Photograph 5-6.

Photograph 5-6: Sump at crest of Pit E south wall and area of ring road subsidence (2020)

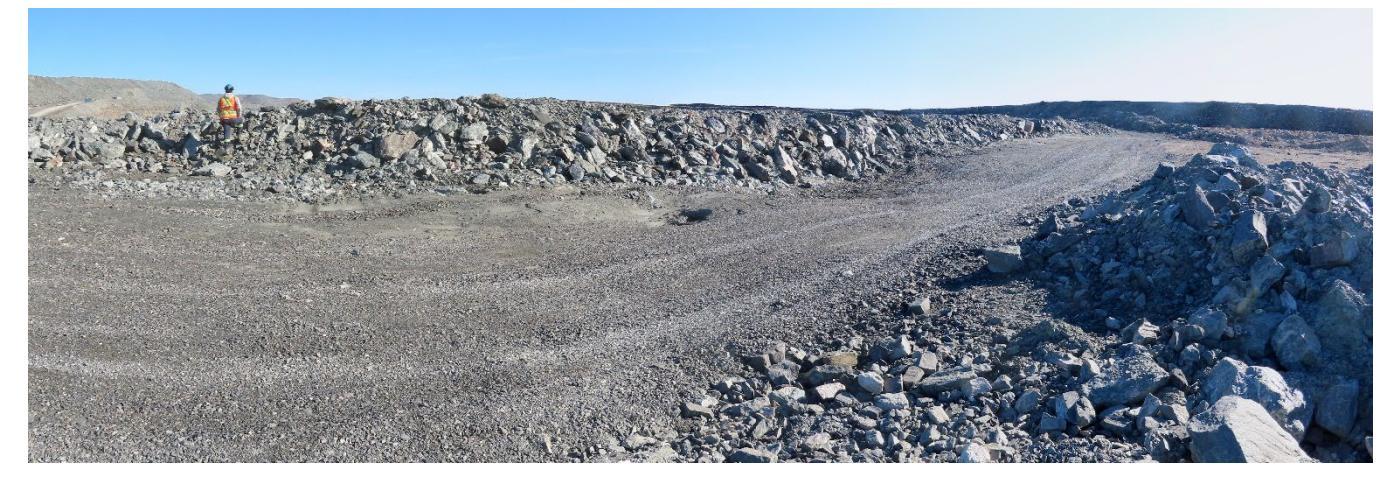
Subsidence and sinkholes were noted to have developed on the ring road at the crest of the south wall, adjacent to the location of the south wall sump. The access to the ring road from the west side is blocked to prevent access and an alternate entry to the instrumentation at the crest of the South Wall has been constructed from the east. If the South Wall sump is not pumped there may be additional erosion of the road prism; however, the South Ramp to Portage Pit E is also bermed, and there is no access for personnel near this area.

The settlement and sinkholes are shown in Photograph 5-7. The road is used to access the instrumentation that is installed between the pit crest and the Bay Goose Dike on the southeast side of the pit. Following the site visit and discussion with Agnico, the road has been closed and an alternative access to the instrumentation has been constructed on the east side.

Photograph 5-7: Subsidence and sinkhole formation in ring road at south wall crest and downstream of sump (2020)

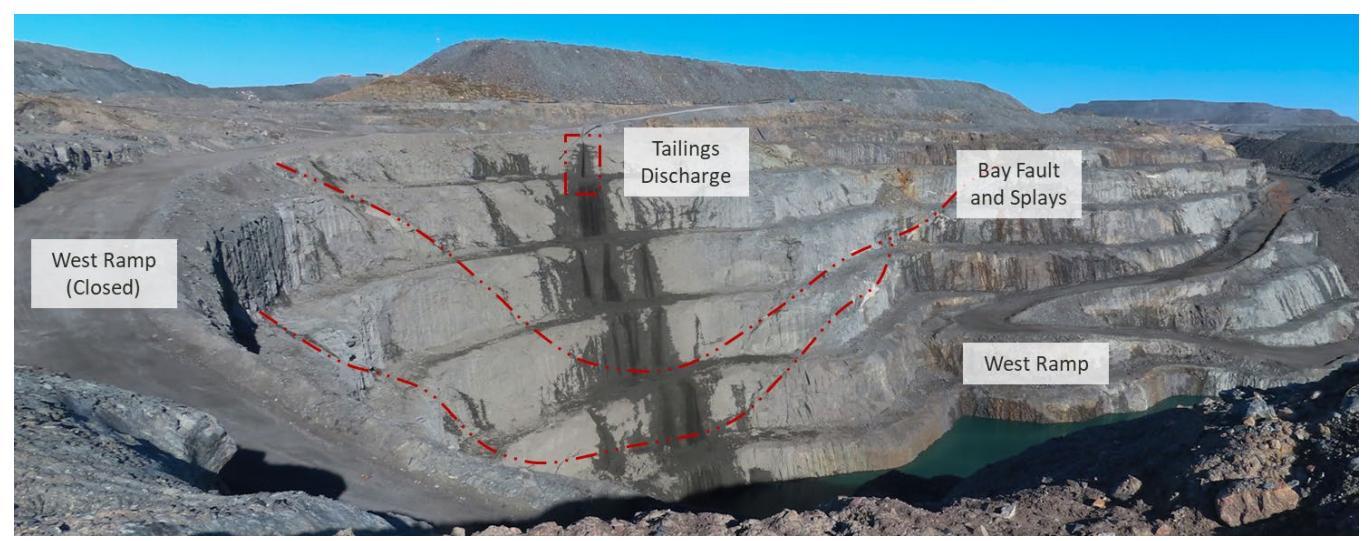
Tailings are currently being discharged from the crest of the south end of the West Wall, near the south ramp entry to the pit. The tailings are being discharged on to weak ultramafic rock. Agnico should monitor the crest area and pit wall closely for the possible development of tension cracks in the adjacent road surface, and any other signs of instability in the bench faces.

The Pit E west wall exposes predominantly quartzite, iron formation and intermediate volcanic rock in the upper benches of the wall, overlying ultramafic rock in the lower benches. Ultramafic rock is exposed along a substantial portion of the West Wall Ramp as it descends into the pit. The Bay Fault parallels the crest through the middle portion of the pit wall, and then is exposed in the lower benches through the southern portion of the wall. The condition of the Pit E West Wall, along with the tailings discharge point near the south end of the wall, is shown in Photograph 5-9.

Photograph 5-9: Pit E west wall showing Bay Fault and tailings discharge (2020)

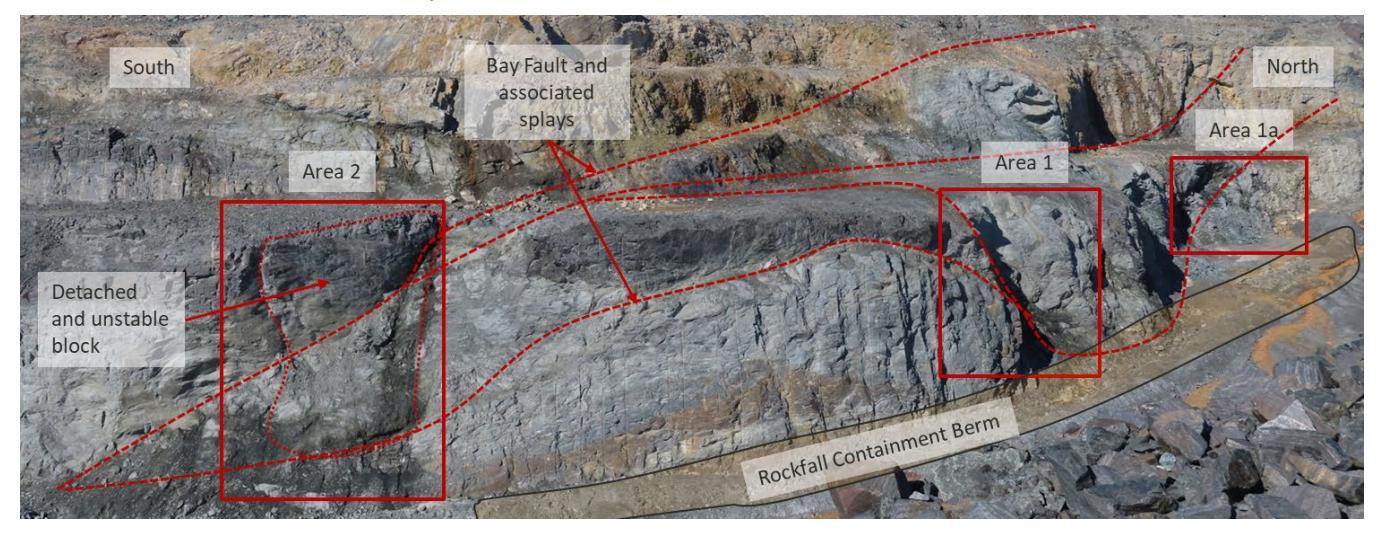
Photograph 5-11: Pit E west wall ramp Area 1 and Area 2 (2020)

corner leading to the local and on-going instability. The exposed fault varies in width from metre scale to several metres. The rock mass quality continues to degrade in response to exposure.

The rockfall containment berm along the inside shoulder of the ramp has been effective retaining local failures. A new, detached and potentially unstable block was noted during the 2020 site visit within Area 2 and shown in Photograph 5-11. It should be expected that this block will eventually fail but is expected to be retained by the rockfall berm. It is possible that the failed material might overtop the berm. If this occurs the berm should be cleaned, re-established, and reshaped.

The planned location of the pump station adjacent to this area should be reconsidered. The risk to personnel, equipment, and infrastructure of on-going instability is high, and the potential to over-top the containment berm exists. It is recommended the pump station be moved further up the ramp, clear of this area.

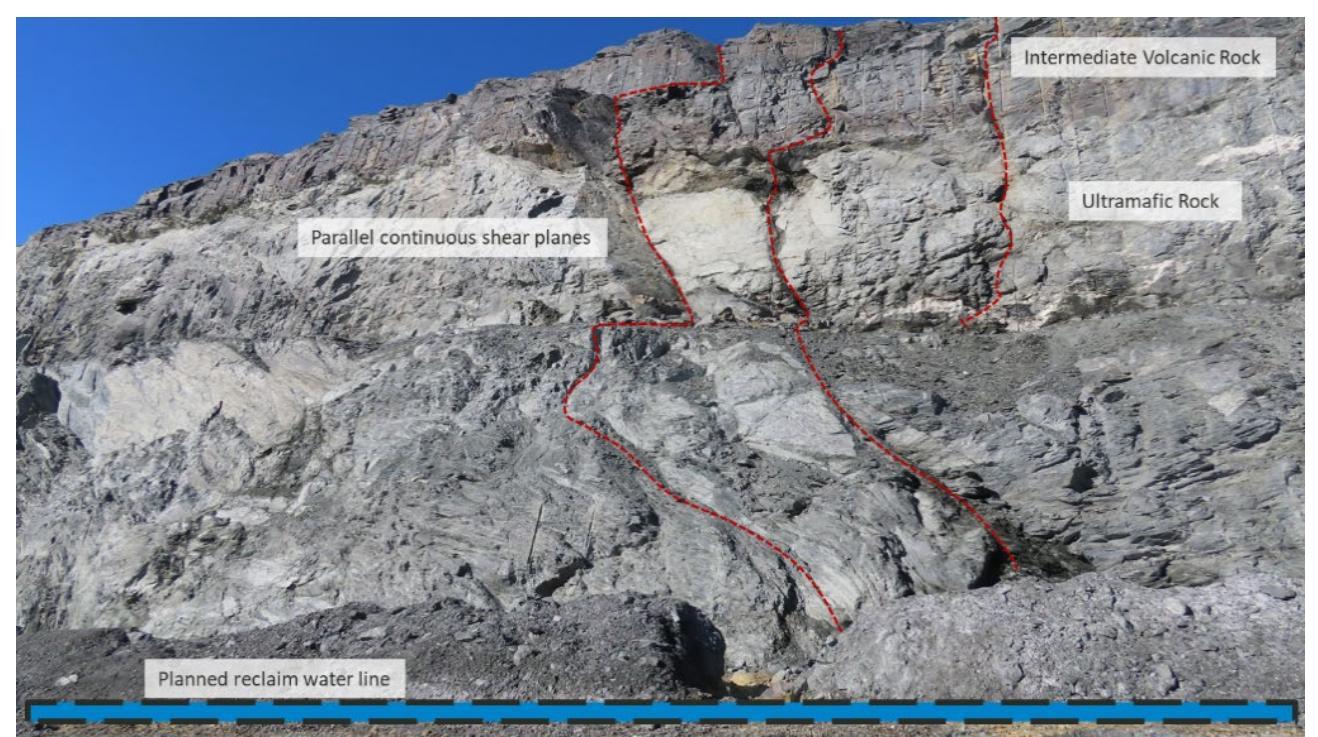
Photograph 5-12: Pit E Ramp Area 3 (2020)

The Ramp Area 3 is defined by a moderately to steeply north dipping continuous shear plane that strikes into the west wall of the pit above the ramp, and cross cuts the contact between the ultramafic rock and the overlying intermediate volcanic rock. At the contact, the combination of the continuous plane and associated open features, the west dipping contact, and vertically oriented jointing has resulted in historical rockfalls. A review of this area during the 2020 site visit shows no increase in accumulated material on the bench below. The condition of the Ramp Area 3 at the time of inspection is shown in Photograph 5-12.

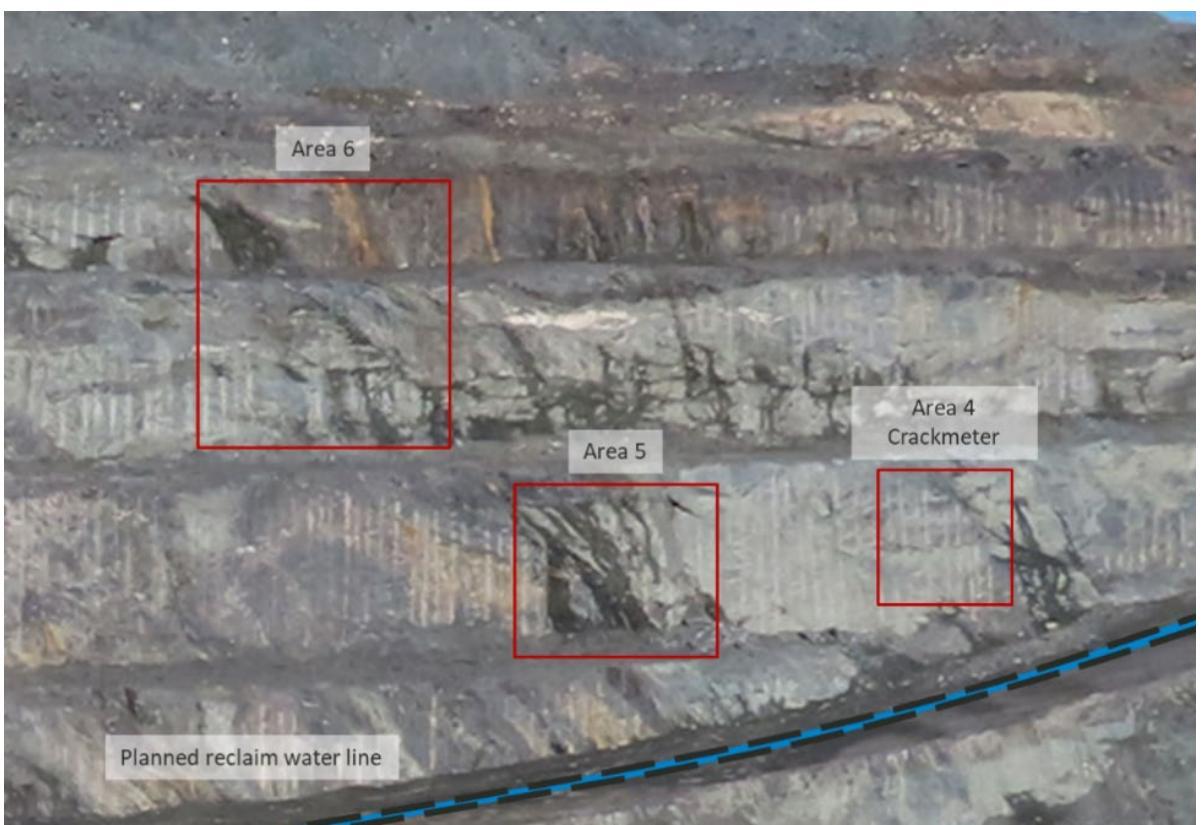
Photograph 5-14: Pit E Ramp Areas 4,5, and 6 (2020)

The planned reclaim water line will pass directly beneath this area of the wall. There is an on-going risk to personnel, equipment and infrastructure of rockfall instability. Agnico should consider relocating the planned reclaim water line to the outside edge of the ramp, rather than the inside edge. The current condition of Pit E Ramp Areas 4, 5, and 6 are shown in Photograph 5-14.

- Consider relocating the reclaim water line to the outside edge of the ramp, away from potential rockfall risk areas, if practical to do so.
- Maintain the rockfall containment berm along inside edge of ramp while Pit E is used for tailings and water management.
- Continue visual monitoring and recording of observations as part of monthly site geotechnical inspections.

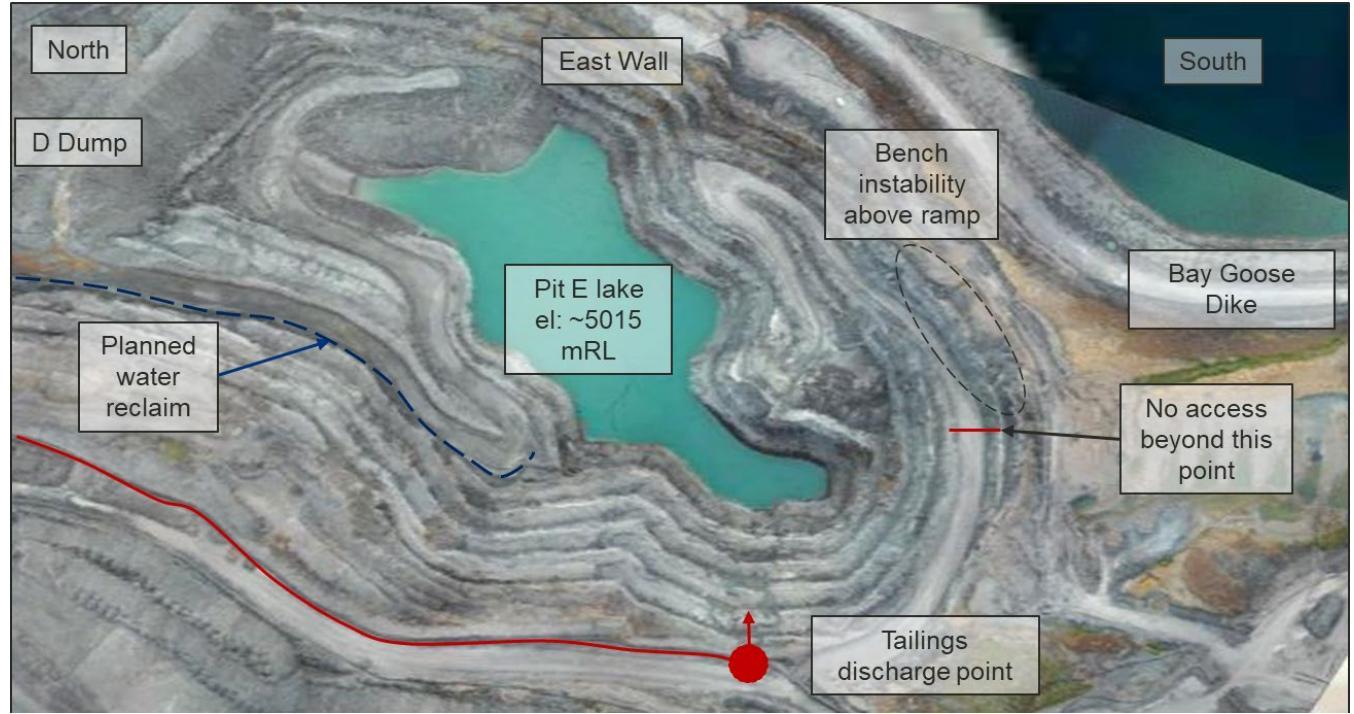
Photograph 5-16: Location of Pit E tailings discharge (2020)

The current discharge point is at the south end of the west wall which is approximately 110 to 120 m in height. The upper benches are ultramafic rock while the lower benches are intermediate volcanic rock. The slope is no longer being monitored by radar which would be viable due to the discharge of tailings in this area. There are no prisms installed on the wall. The location of the discharge point is shown in plan on Photograph 5-16.

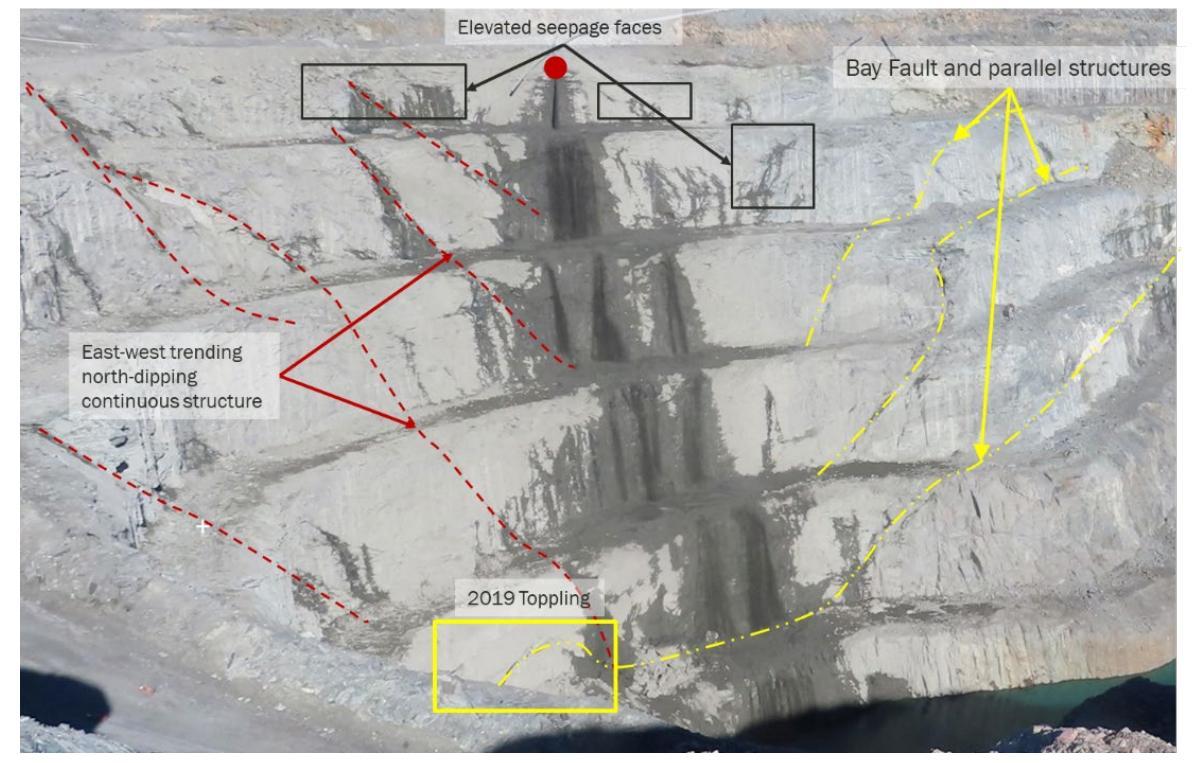
Several wall-height east-west trending and north dipping structures intersect the wall. These have led to bench scale wedge failures previously on the upper benches. The (approximately) north-south trending west dipping Bay Fault intersects the wall and led to a toppling failure on one of the lower benches in 2019 which was buttressed with rockfill before full toppling failure was mobilized. The pit wall at the location of the discharge is tightly curved (convex), which is inherently better for stability than a linear wall due to the development of confining stresses.

The intersection of the steep northeast dipping structure and the west dipping fault and parallel structures form a wedge(s); however, the plunge is to the northwest and is favourably oriented with respect to wall stability. These are shown in Photograph 5-17.

Photograph 5-177: Key observations of east-west trending structure and Bay Fault at Pit E discharge point (2020)

- The crest area of the pit at the tailings discharge point, and especially the road surface should be inspected on a bi-weekly basis (once every two weeks) and as part of other informal site inspections for the development of tension cracks or any indicators of slope instability such as settlement or sinkholes. If indications of instability are noted, the area should be closed and a geotechnical risk assessment undertaken to evaluate the risk of continuing from this location.
- If necessary, the road could be re-aligned further from the pit crest.

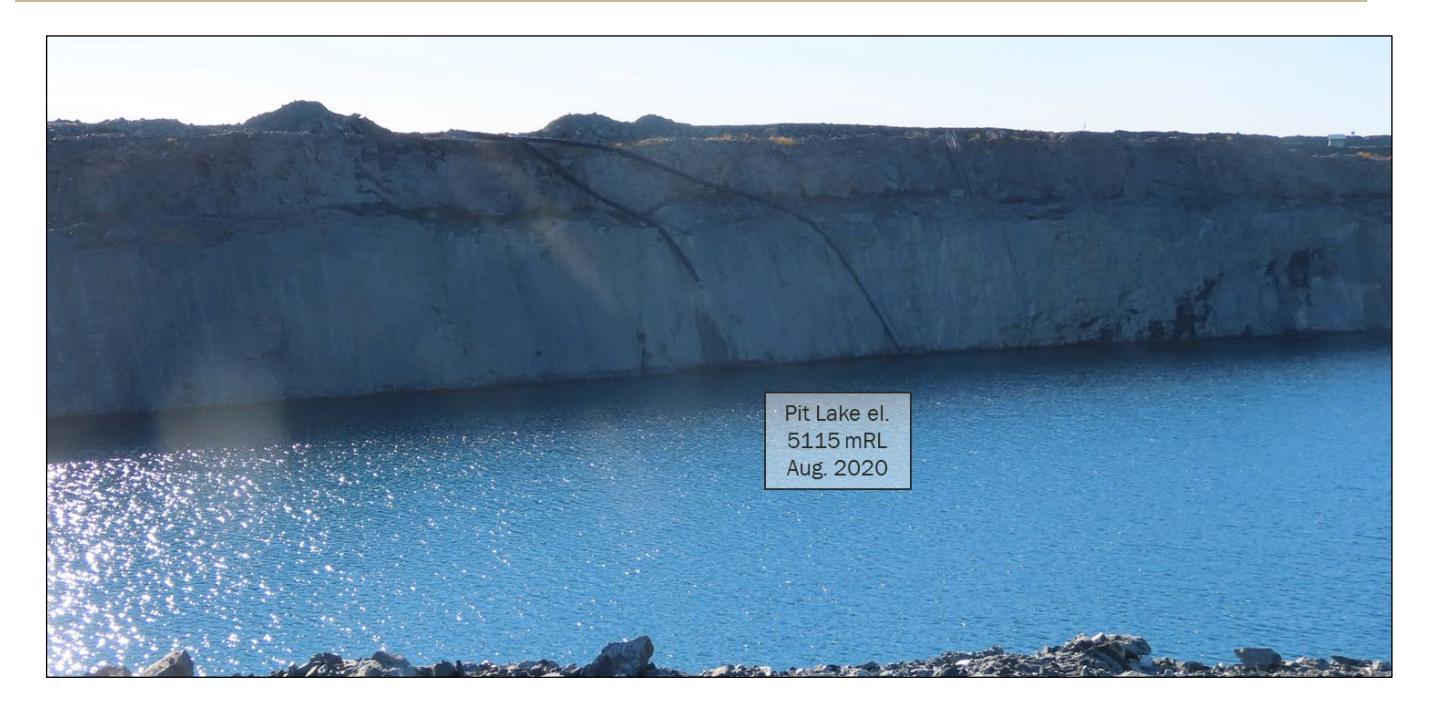
From 2018 to 2019 tailings were discharged from a spigot point at the north end of the east wall of the pit. The tailings were discharged on to competent and strong intermediate volcanic rock in permafrost. The discharge area was reviewed as part of the 2020 site visit for indications of scour or degradation of the rock mass quality, and none were observed. A photograph of the inactive discharge point and the wall beneath is shown in Photograph 6-2.

Photograph 6-2: Former tailings discharge point on east wall of Goose Pit (2020)
