Meadowbank 2020 Annual Pit Slope Performance Review

2020 ANNUAL PIT SLOPE Performance Review

Meadowbank Mine, Nunavut

ISSUED FOR USE 704-ENG.ROCK03163-01

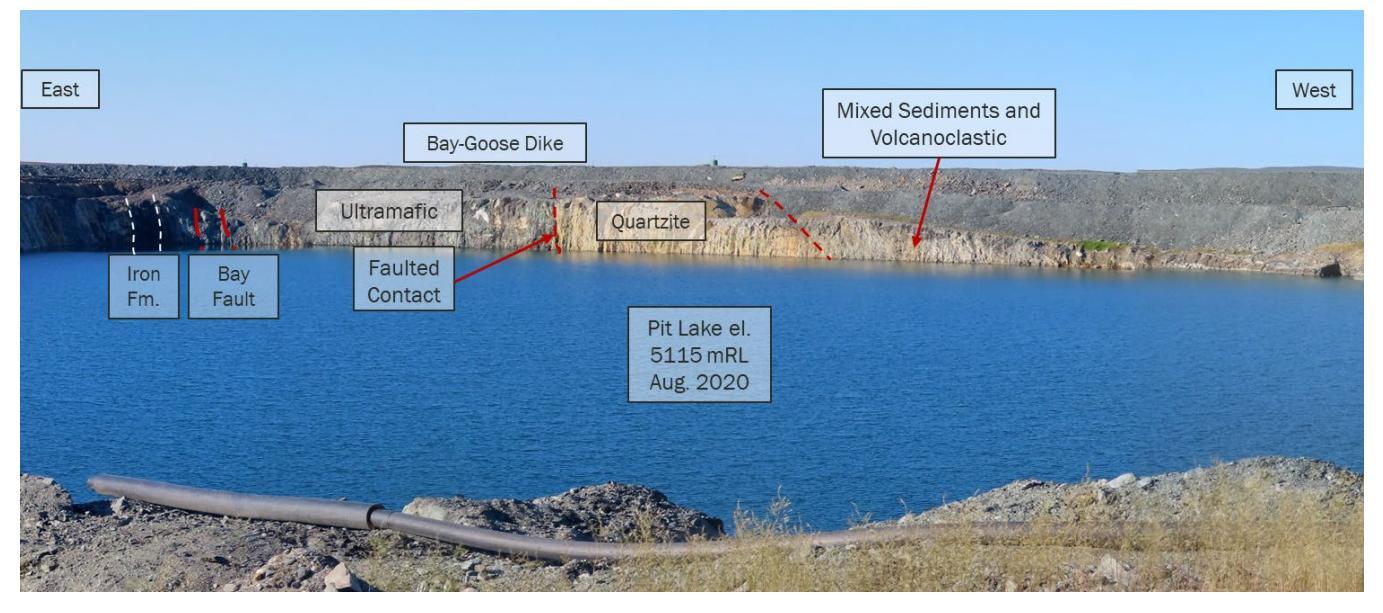
The south wall of the Goose pit comprises iron formation and intermediate volcanic rock in the east, transitioning through a sequence of iron formation, ultramafic rock, quartzite, and mixed volcaniclastic sediments in the west. The most prominent structural feature is the Bay Fault which intersects the south wall of the pit, within the ultramafic rock.

Photograph 6-3: Goose Pit south wall (2020)

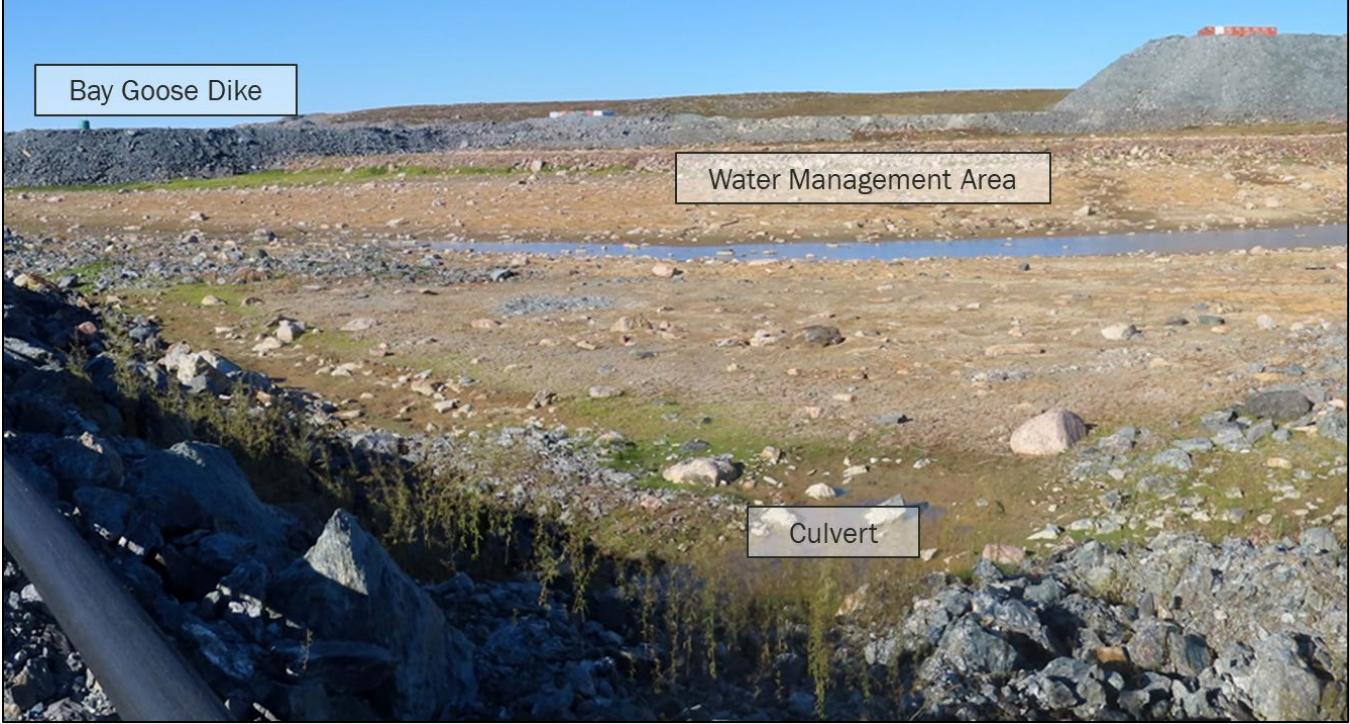
During the 2019 inspection water was being discharged from the southwest corner of the wall. The water management pond was filled in response to heavy rainfall events preceding the site visit. During 2020, the same water management pond was effectively dry as shown in Photograph 6-4. No water was being discharged to the pit as shown in Photograph 6-5.

Photograph 6-4: Water management area between ring road at south crest of Goose Pit (2020)

• Continue visual monitoring as part of regular monthly site geotechnical inspections.

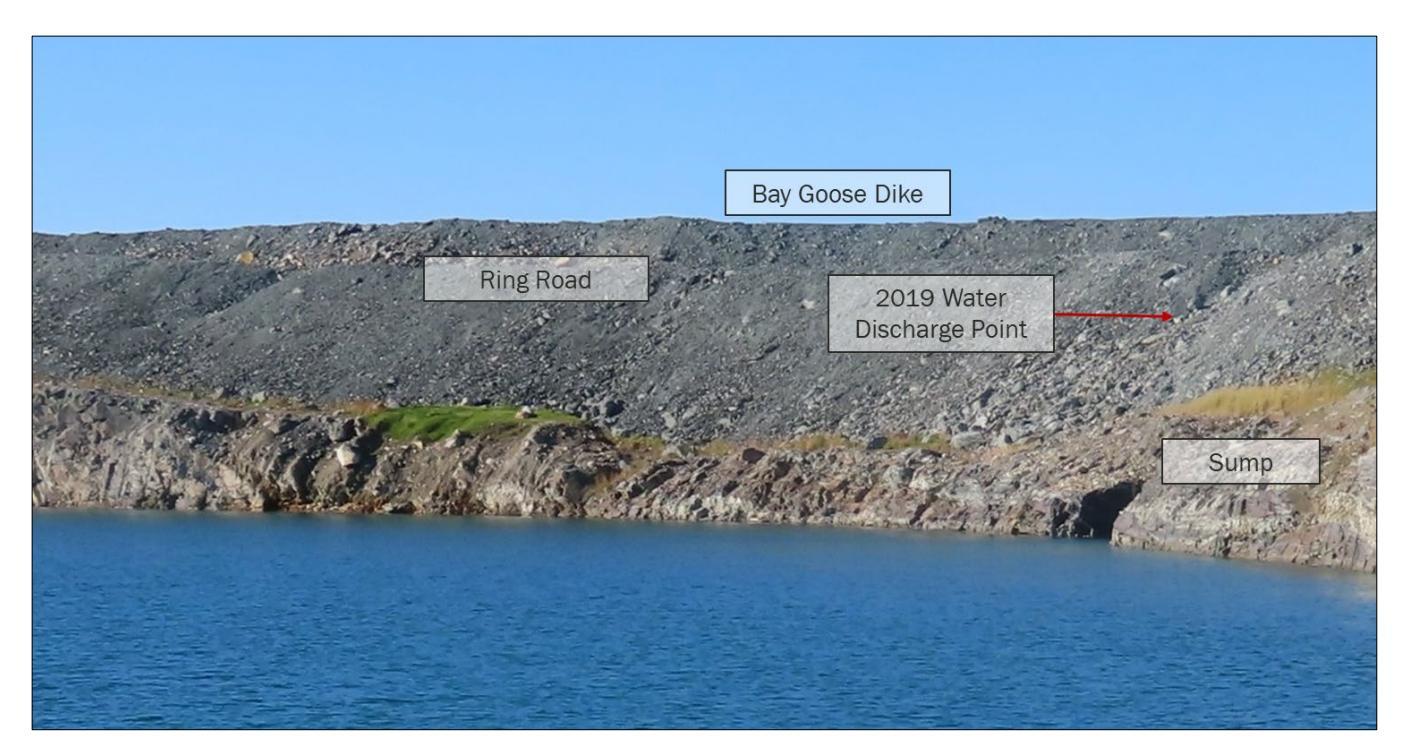
Photograph 6-5: Former water discharge point now dry (2020)

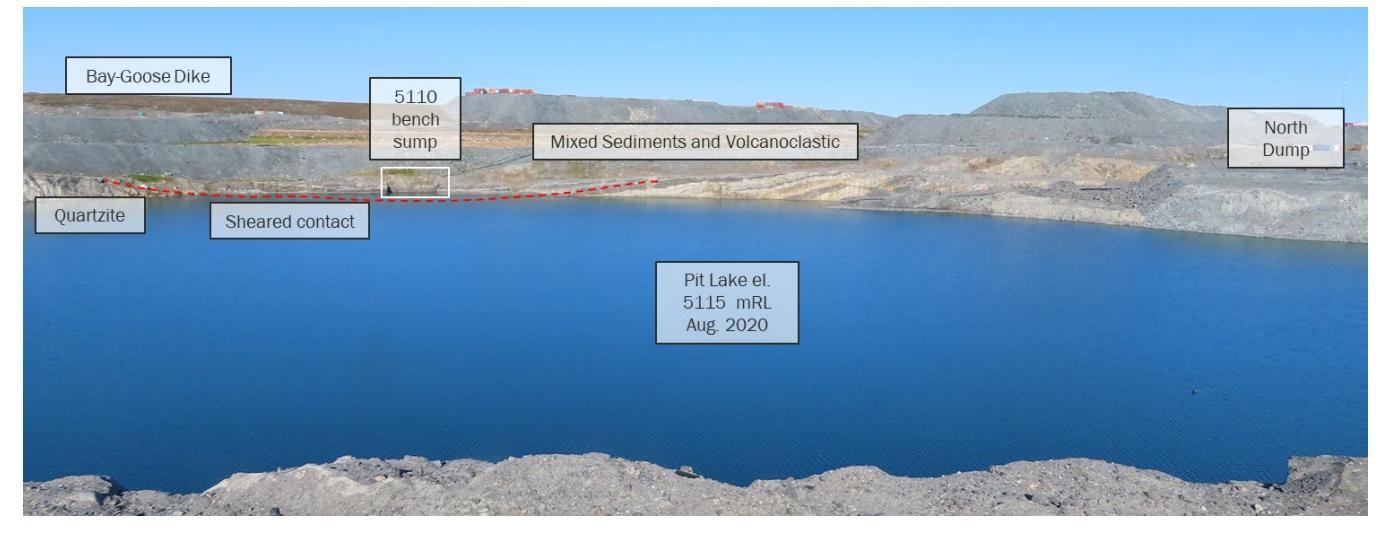
The west wall of the pit is no longer accessible due to the water level in the pit lake. The South Dump platform which was previously accessed from the west wall is below the water surface and no longer visible. Only the upper bench of the west wall remains exposed. The condition of the Goose Pit West Wall at the time of inspection is shown in Photograph 6-6.

There are no significant geotechnical concerns observed with the performance of the west pit wall of the Goose Pit.

Photograph 6-6: Goose Pit west wall (2020)

Continue visual monitoring as part of regular monthly site geotechnical inspections.

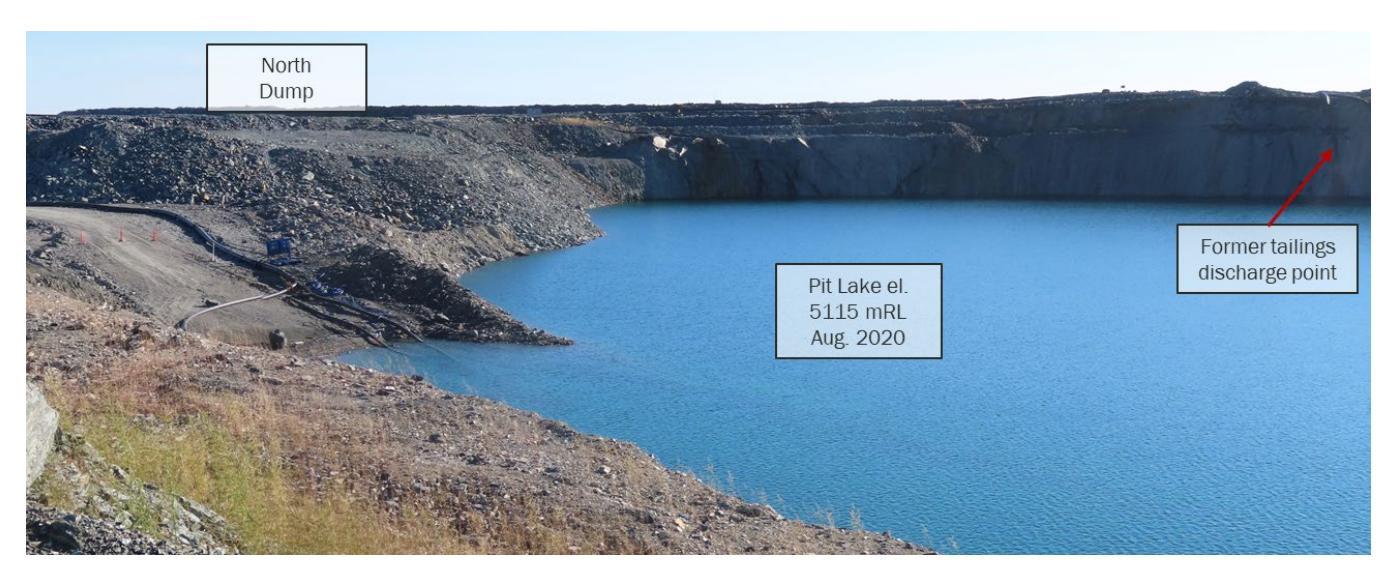
The northwest through northeast (north end-wall) walls of the Goose Pit exposed the stratigraphic sequence of the deposit, from ultramafic rock in the west, through iron formation, and then intermediate volcanic in the east. Only the upper bench remains exposed. The Bay Fault still is visible, and the large Northeast Wedge is still visible in the upper bench and remains stable. The condition of the Goose Pit Northwest through Northeast Walls at the time of inspection is shown in Photograph 6-7.

Photograph 6-7: Goose Pit northwest through northeast wall (north end wall 2020)

• Continue visual monitoring as part of regular monthly site geotechnical inspections.

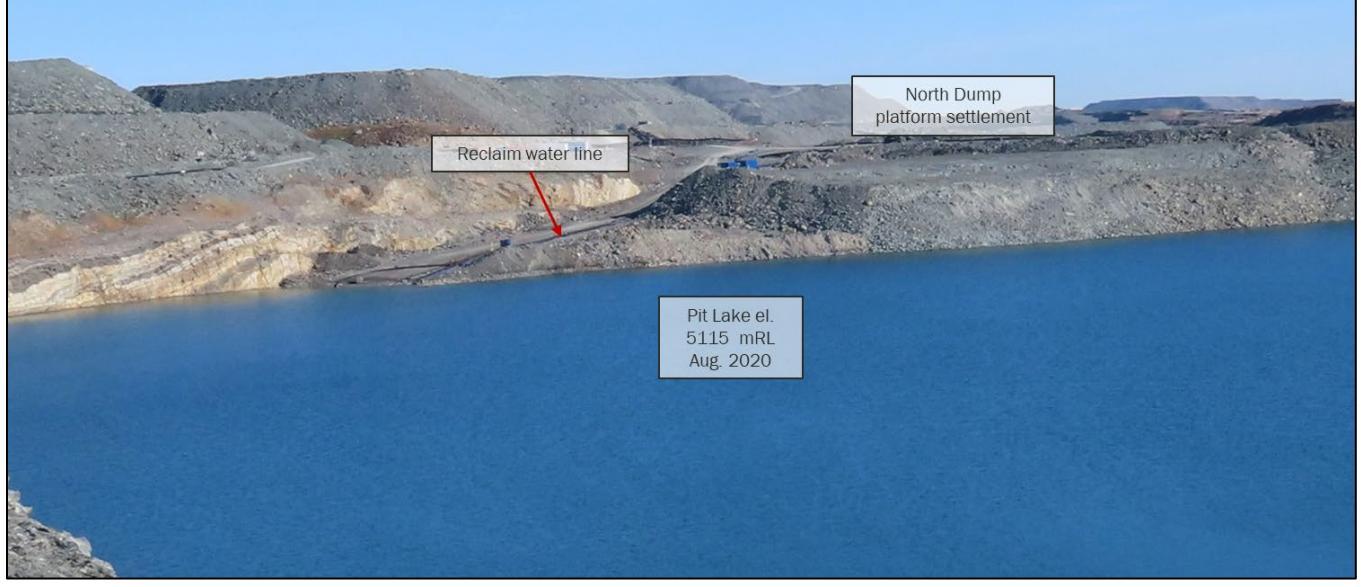
The in-pit waste rock dumps at the Goose Pit have been inactive since 2017. The toe of the dumps extends out into the Goose Pit Lake. The South Dump platform that was accessible during the 2019 inspection is no longer visible as it is beneath the lake surface. The condition of the Goose Pit Waste Rock Dumps at the time of inspection are shown in Photograph 6-8.

Photograph 6-8: Goose Pit waste rock dumps (2020)

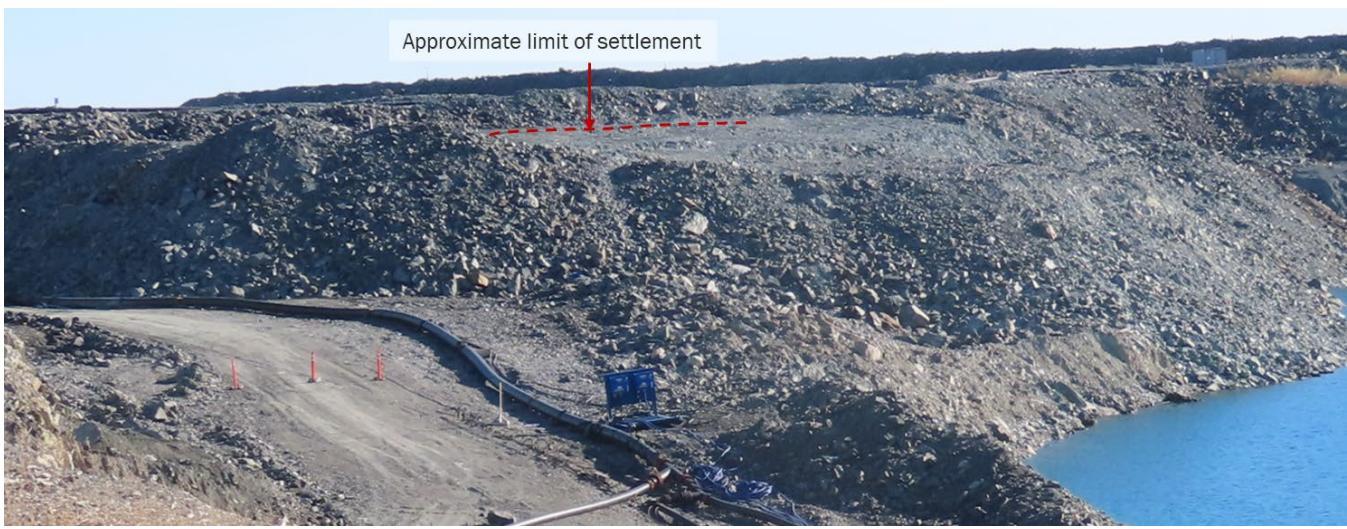
Tension cracks on the North Dump platform were first noted during the 2015 inspection. During the 2018 inspection additional shallow slumping of the South Dump face was noted, along with significant crest sag. Although no quantitative measurements of platform and crest settlement have been made, visual observations in 2020 suggest that additional settlement of the dump platform has occurred as shown in Photograph 6-9. This is most likely due

Photograph 6-9: Goose Pit North Dump platform (2020)

to the inundation of the dump material by water as the tailings management facility has been filled. The water infiltrated the void space within the dump, and any snow or ice that had accumulated within the dump during winter construction would have thawed. Furthermore, the introduction of water would also have thawed any frozen rock block contacts and combined with the increase in pore pressures within the dump these have likely led to on-going settlement. The extent of the affected area extends some 40 m behind the crest of the dump.

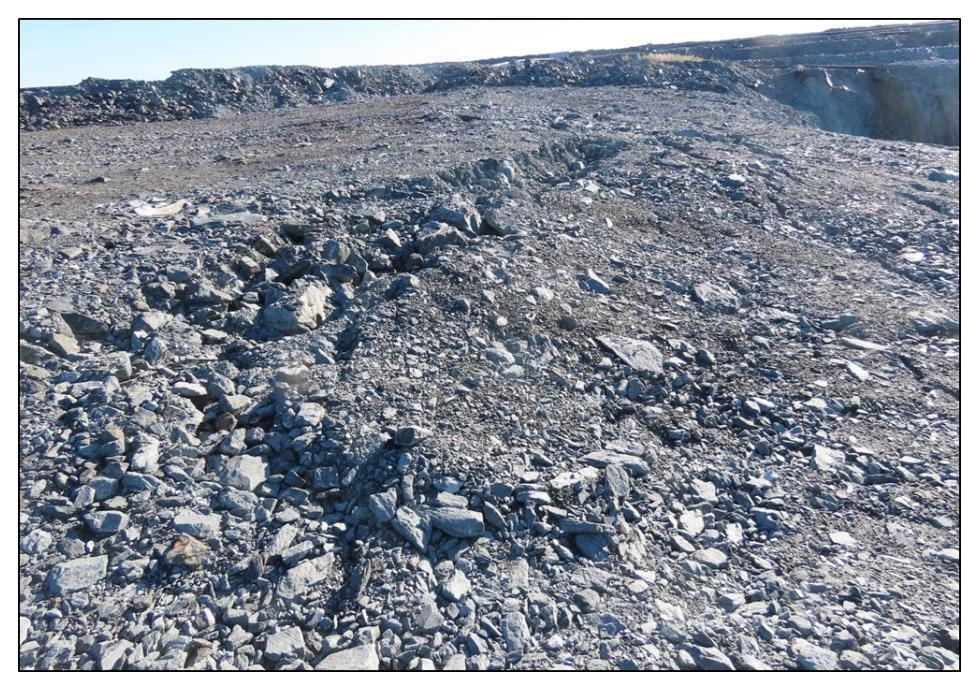
Tension cracks and crest sag continue to be evident on the North Dump crest (shown in Photograph 6-10). Currently, there is no active monitoring of the dump crest because the dumps are inactive. A pump station is located at the entry point to the North Dump platform and combined with a rockfill berm this effectively prevents entry by any vehicle traffic (see Photograph 6-11).

Photograph 6-10: Tension cracks and crest sag at Goose Pit North Dump (2020)

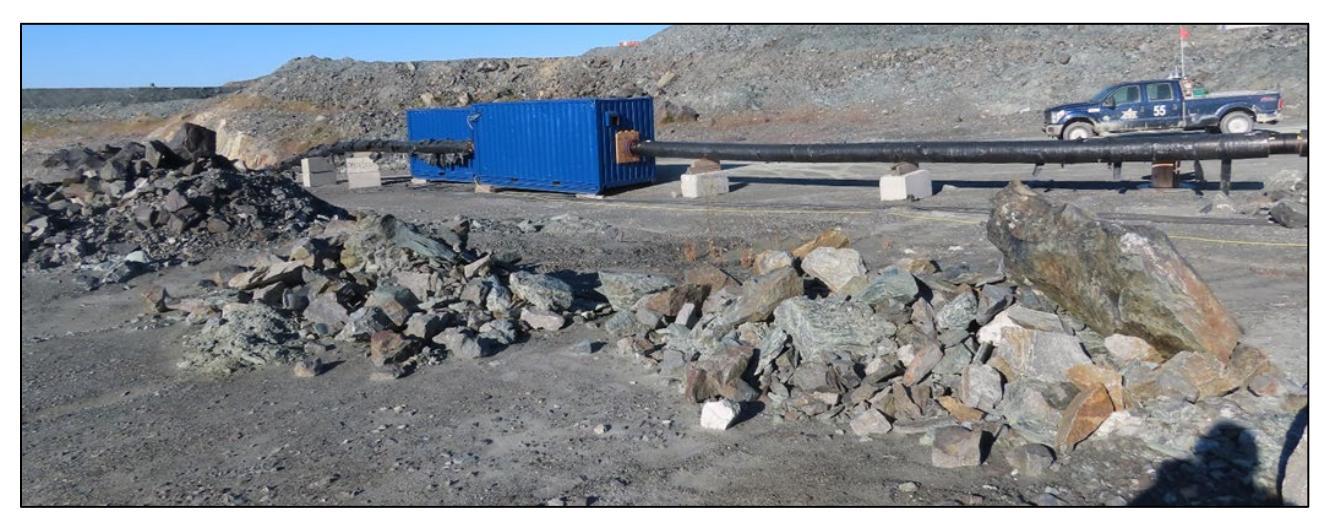
Photograph 6-11: Berm and pump station blocking vehicle entry to dump platform (2020)

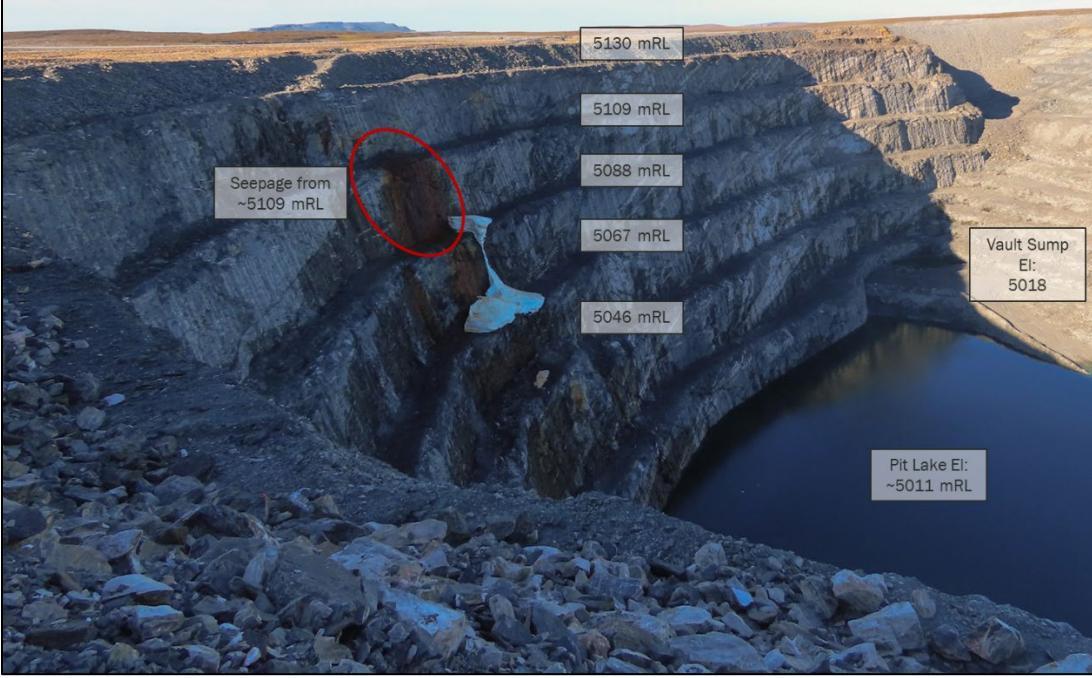
During the 2019 inspection it was noted that water from Pond D (the former Vault Lake) located behind the southeast pit wall crest was flowing at a high rate through the ring road at the crest and spilling over the pit crest. The 2019 site visit followed a period of heavy rainfall. During the 2020 inspection this flow had stopped, and seepage from the southeast wall of the pit was restricted again to seepage emanating from the 5109 mRL bench which has been the main source of water inflow to the pit since it was exposed (see Photograph 7-2). During operation of the pit, the water elevation in Pond D was pumped down to control the development of the ice wall from the 5109 mRL but is currently maintained at an elevation of about 5134 mRL (see Photograph 7-3).

Photograph 7-2: Vault Pit water inflow from Pond D (2020)

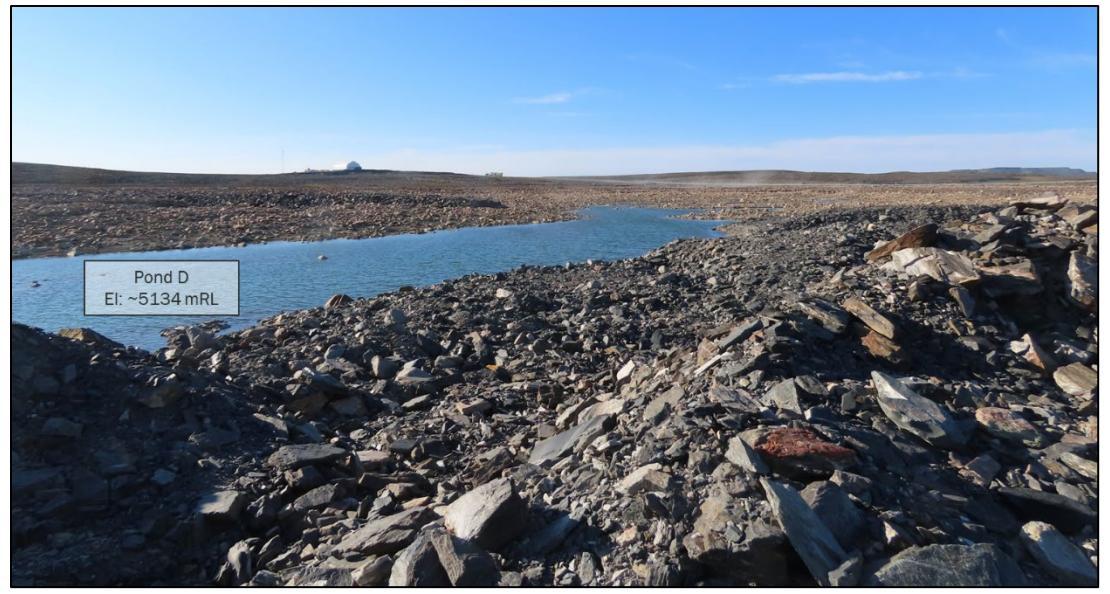
Photograph 7-3: Pond D attenuation storage (2020)

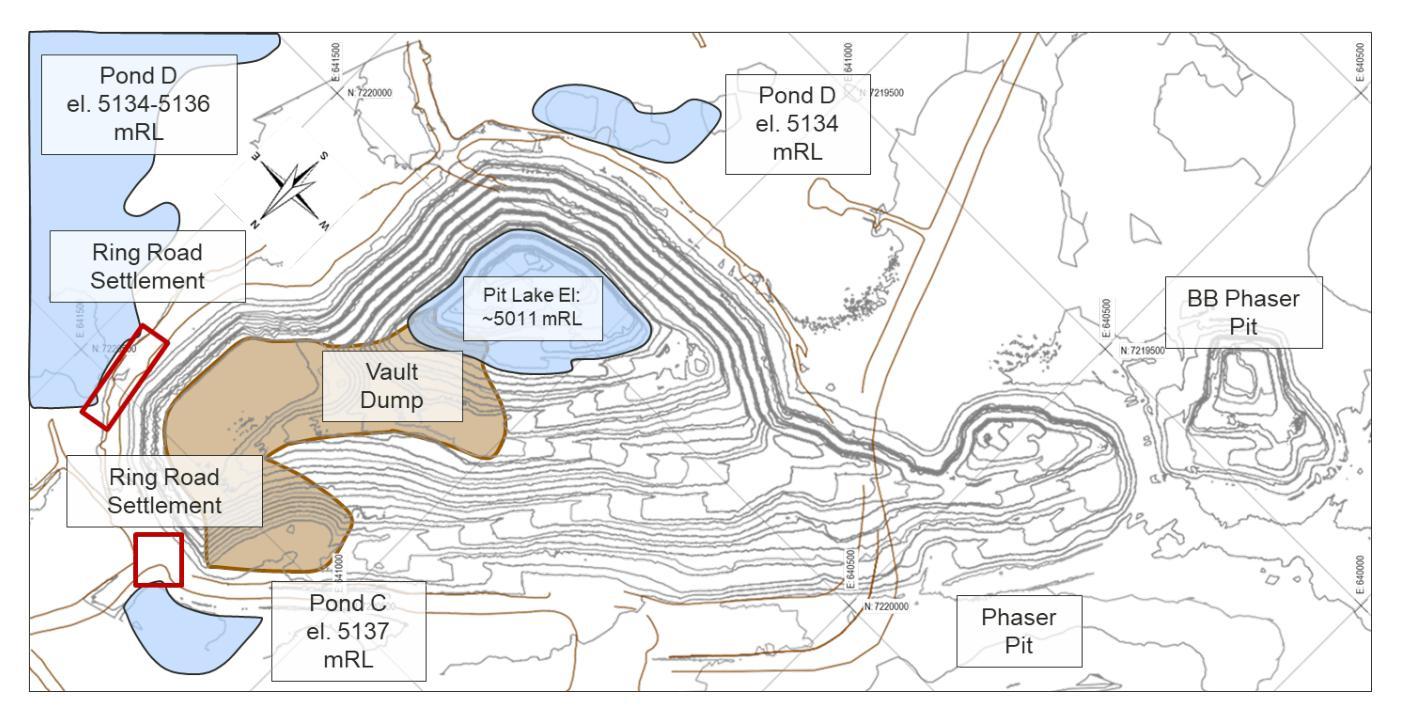
No additional indicators of settlement were noted in the south to southeast pit crest area above the annually forming ice wall which builds from flow from the 5109 mRL. However, significant settlement was noted in the ring road along the north side of the pit which was not present during the 2019 inspection. This included the development of road subsidence on the east (Pond D) side of the road, measured by pacing to be approximately 75 m in length

(parallel to the road axis) and approximately 20 m in width or more than half the road width. The location is shown on Figure 7-2.

Figure 7-2: Locations of ring road subsidence (2020)

- Berm off access to the ring road from the north end of the pit; the south end of the ring road is currently bermed to prevent access.
- Continue to monitor as part of monthly geotechnical inspections.
- Prior to any in-pit water sampling, it is recommended that in addition to the visual inspection of the pit by a
 geotechnical team member, a visual inspection of the ring road settlement area should also be undertaken to
 confirm no additional erosion has occurred.
- If in-pit sampling is required during freshet when Pond D will be at its highest elevation against the ring road, the visual inspection should identify if any under-flow (seepage) through the road base is occurring on the pitside of the road. If there is significant seepage noted through the road base on the pit-side then in-pit sampling should be deferred until following freshet when Pond D is lower.

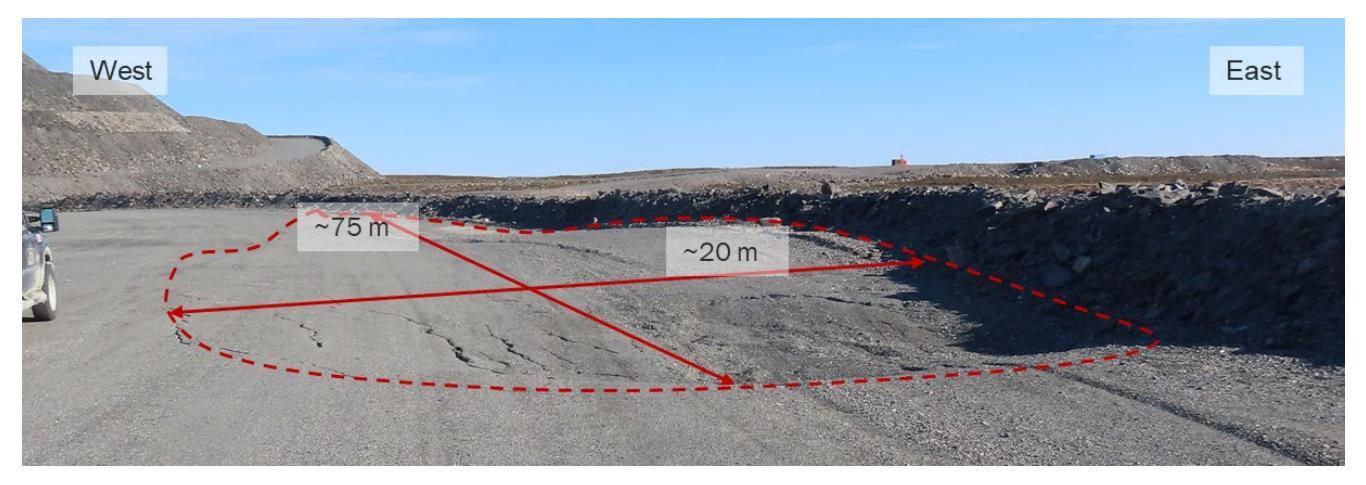
A photograph viewing north along the east side of the ring road is shown in Photograph 7-5 showing the estimated geometry of the impacted area.

Photograph 7-5: Ring road at north end of pit showing area impacted by road surface settlement

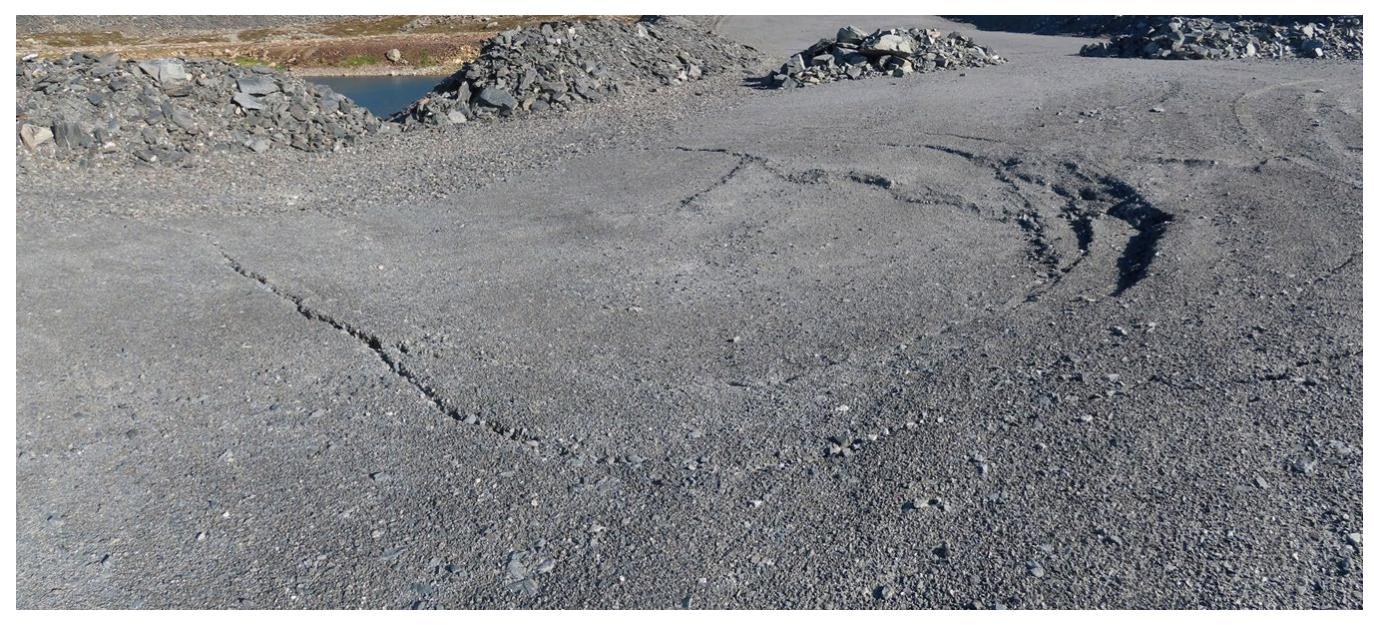
A similar indication of settlement was also observed in the road surface adjacent to Pond C, also associated with ponding of water against the road fill material (see Photograph 7-7).

Photograph 7-7: Ring road adjacent to Pond C where settlement cracks have developed which were not present in 2019

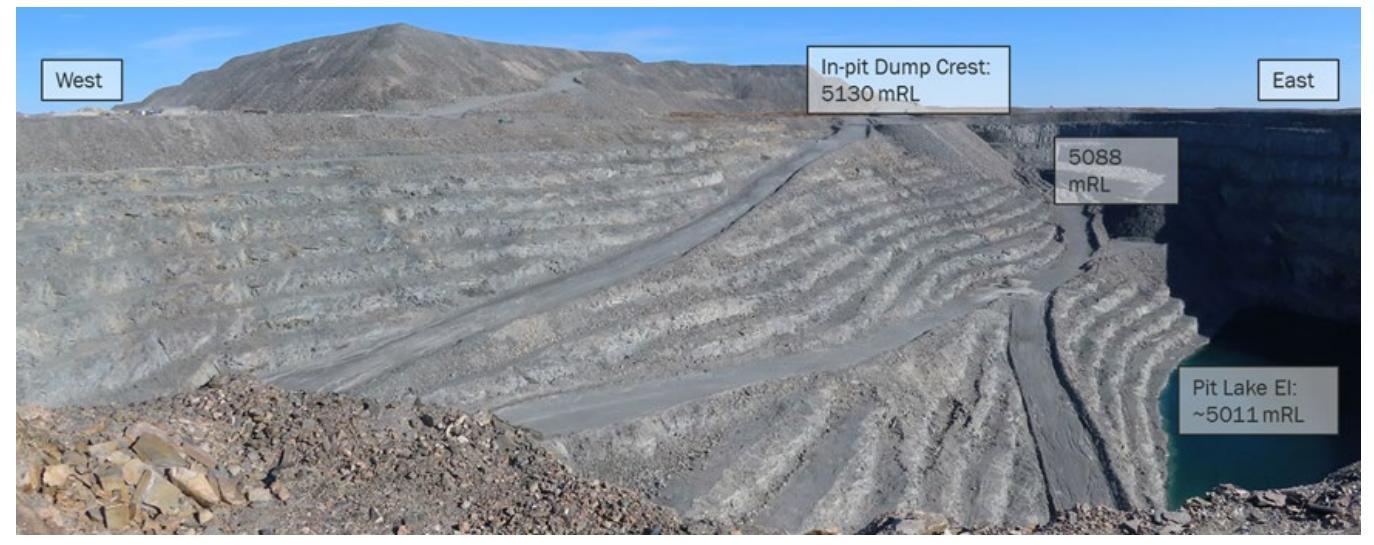
The west wall (grid west) of the Vault was mined as a series of single benches (7m high) to create a footwall slope (as shown in Photograph 7-8). The deposit dips at relatively shallow angles to the east (grid east), parallel to the foliation and stratigraphy. The average inclination is 22 degrees but ranges from as shallow as 10 degrees to as steep as 40 degrees.

Bench faces were not pre-sheared but were bulk blasted at steep angles, and generally broke back, or were scaled back, to the orientation of the foliation. Consequently, there are some benches with considerable loss of catchment which was anticipated during the design process. To account for the expected performance, the bench design heights were restricted to single-height to minimize failure volumes. The footwall slope has performed as expected through the life cycle of the pit and into its current inactive period, and no significant single or multiple bench instabilities were encountered.

Photograph 7-8: Vault Pit west wall looking north (2020)

There are no significant geotechnical concerns for the footwall slope.

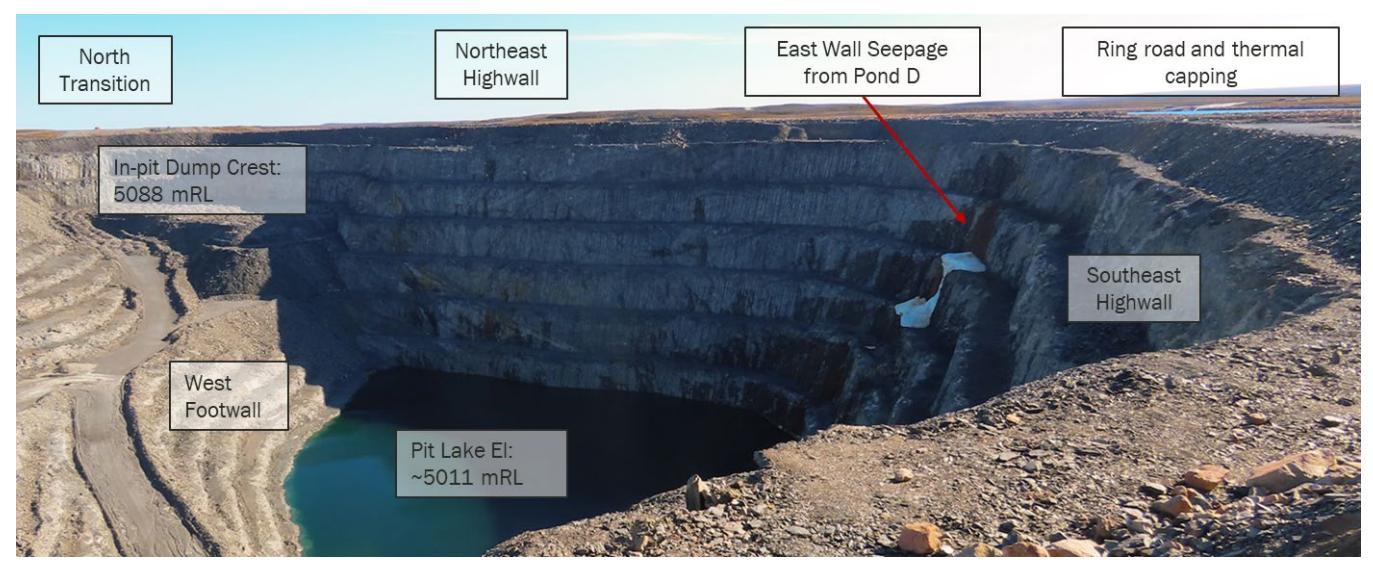
The southeast to northeast highwall is shown in Photograph 7-10. The catch benches developed for the highwall continue to perform well.

Photograph 7-10: Vault Pit southeast and northeast highwall (2020)

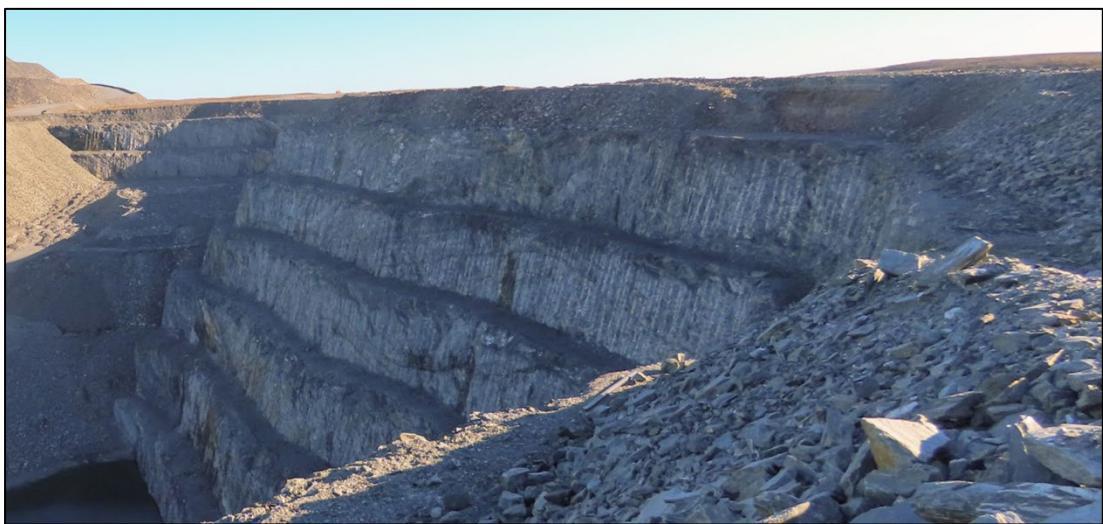
The benches are cleaned well, and there is no indication of significant raveling and no significant accumulation of material on the benches (as shown in Photograph 7-11 and Photograph 7-12). In general, the toe of the thermal capping material is greater than 2 m back from the pit crest.

Photograph 7-11: Vault Pit east-northeast highwall bench performance (2020)

- Since this area of the pit is no longer accessible it should be considered out of service and bi-weekly pit wall inspections and quarterly inspection summaries can be suspended.
- Visually inspect when opportunity presents.
- Complete a specific visual inspection prior to entry for water sampling.

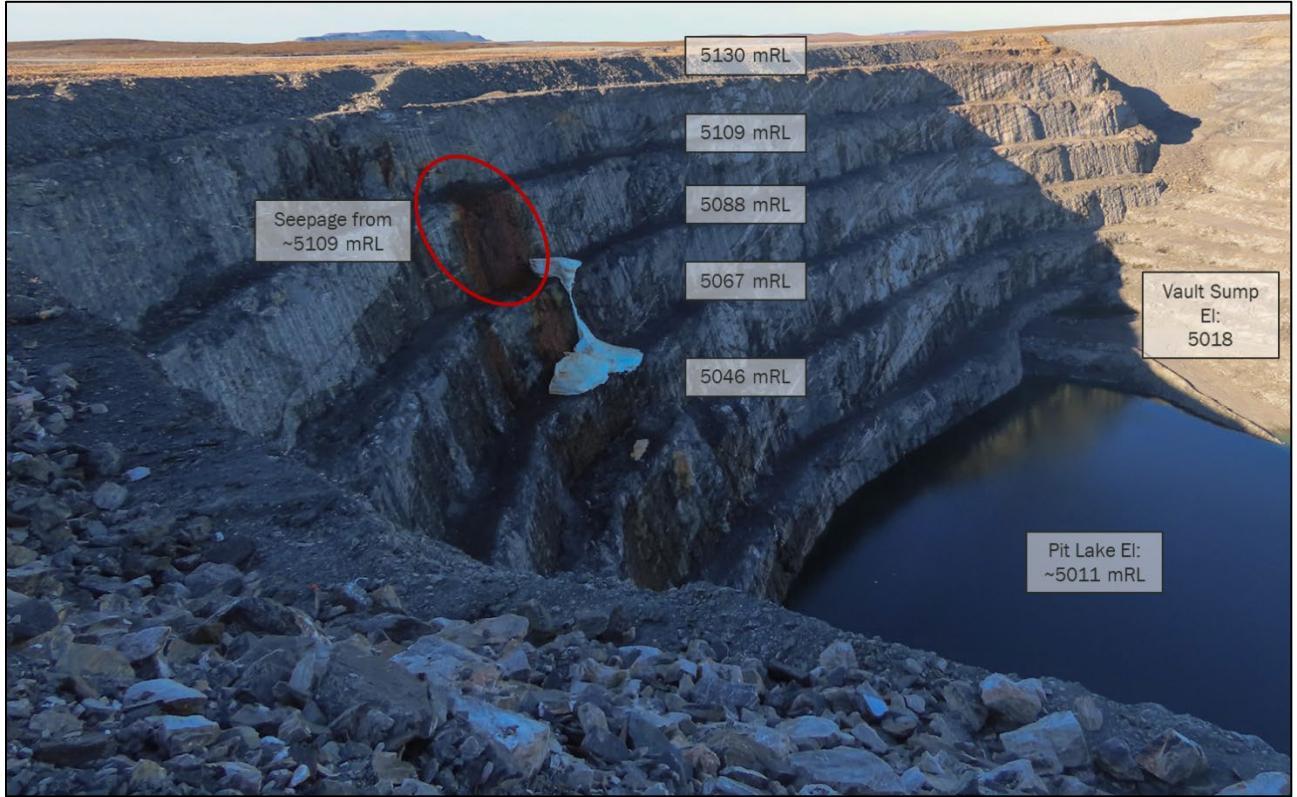
Photograph 7-12: Vault Pit southeast wall (2020)

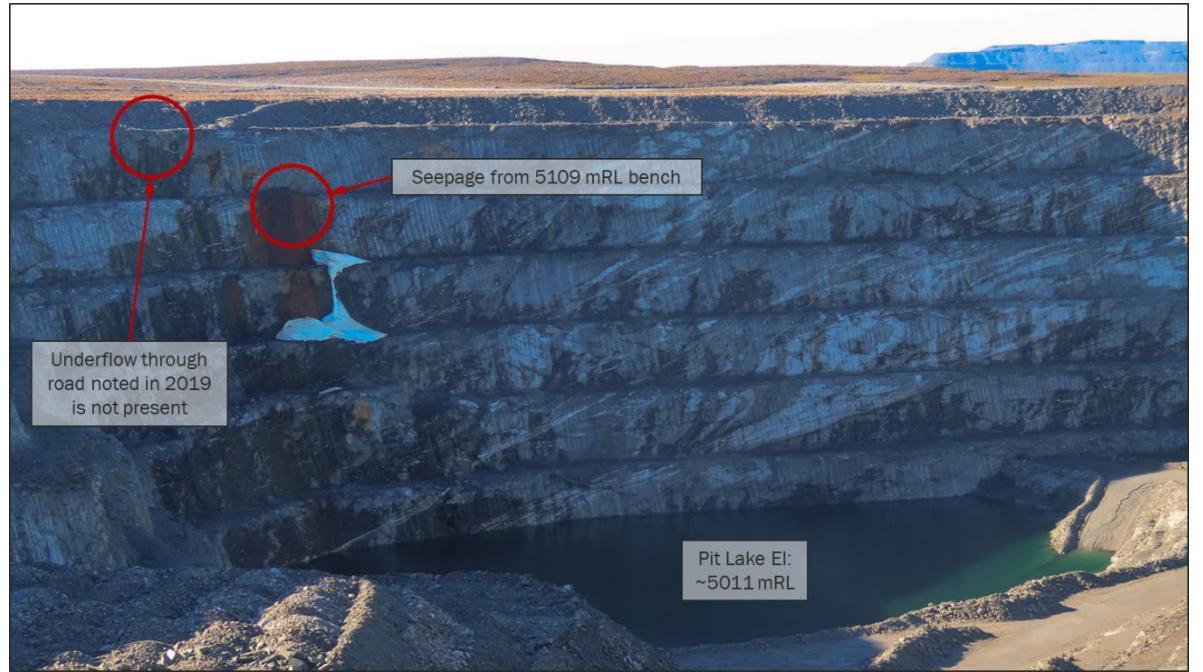
On the day of the site visit, very little ice remained on the southeast wall below the seepage source above the 5109 mRL bench. This seepage leads to the annual formation of the Vault ice wall (as shown in Photograph 7-13). Seepage still discharges from a fracture in the rock just above the 5109 mRL bench. The bench is heavily stained by iron oxidation. An area of high water inflows that was noted during the 2019 inspection and associated with underflow through road material from high water levels in Pond D was absent in 2020.

Photograph 7-13: Vault Pit seepage from southeast pit wall 5109 bench (2020)

It was recommended during the close out site visit meeting that the road be completely closed to use.

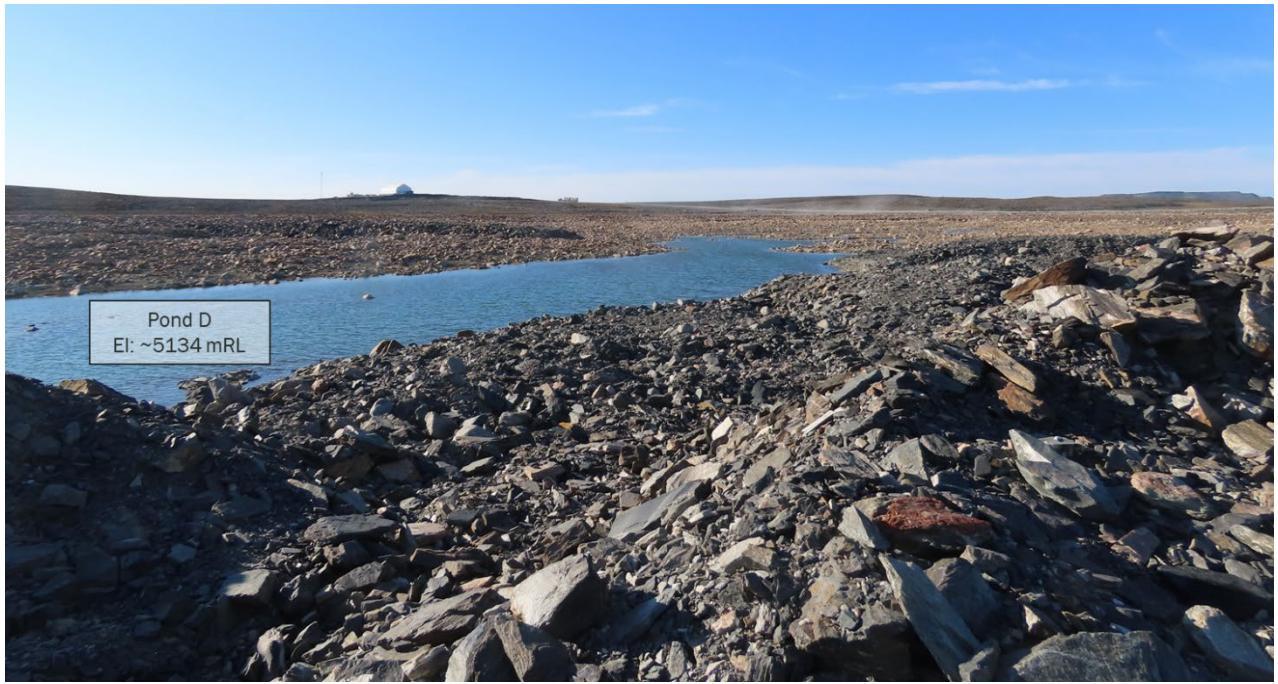
Photograph 7-14: Pond D water elevation 5134 mRL (2020)

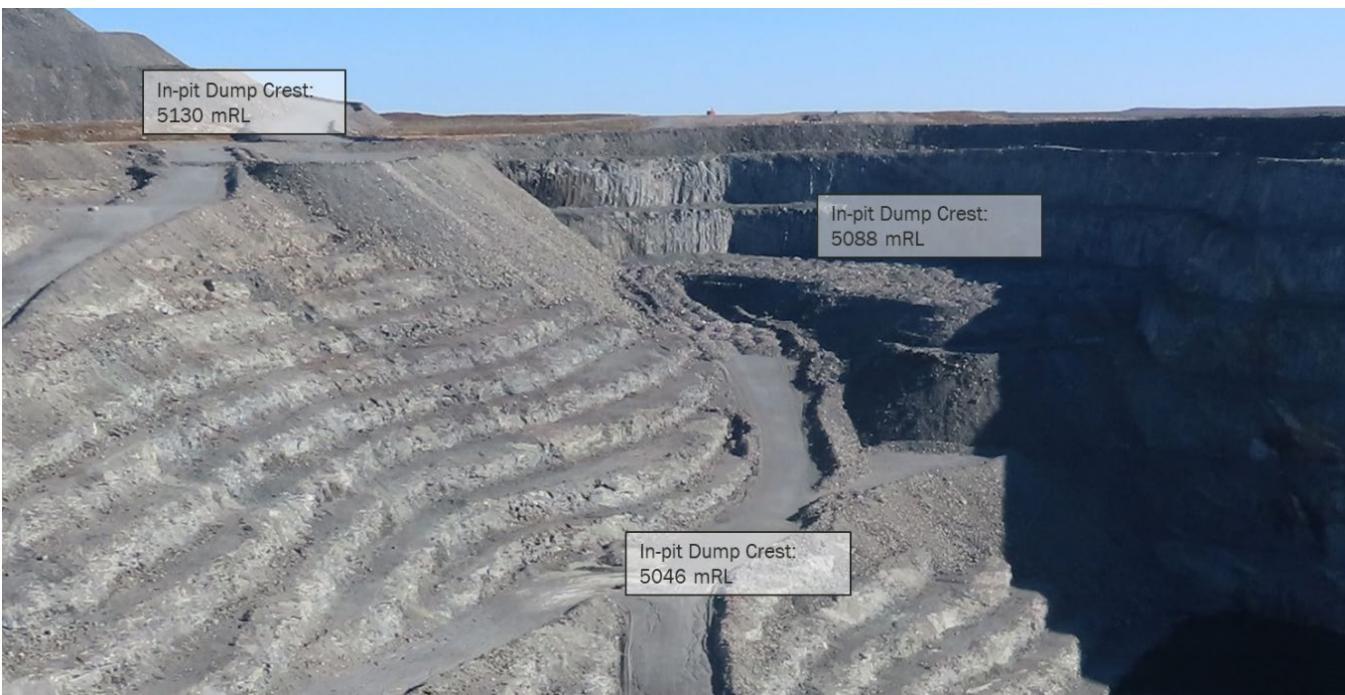
The north end of the Vault Pit has been used for in-pit disposal of waste rock (shown in Photograph 7-15). There are three main in-pit dumps with dump crests at three different elevations. The westernmost dump platform is at approximately 5130 mRL; the north through northeast platform is at approximately 5088 mRL; and, the southernmost platform is at approximately 5046 mRL.

Photograph 7-15: Vault In-Pit dumps (2020)

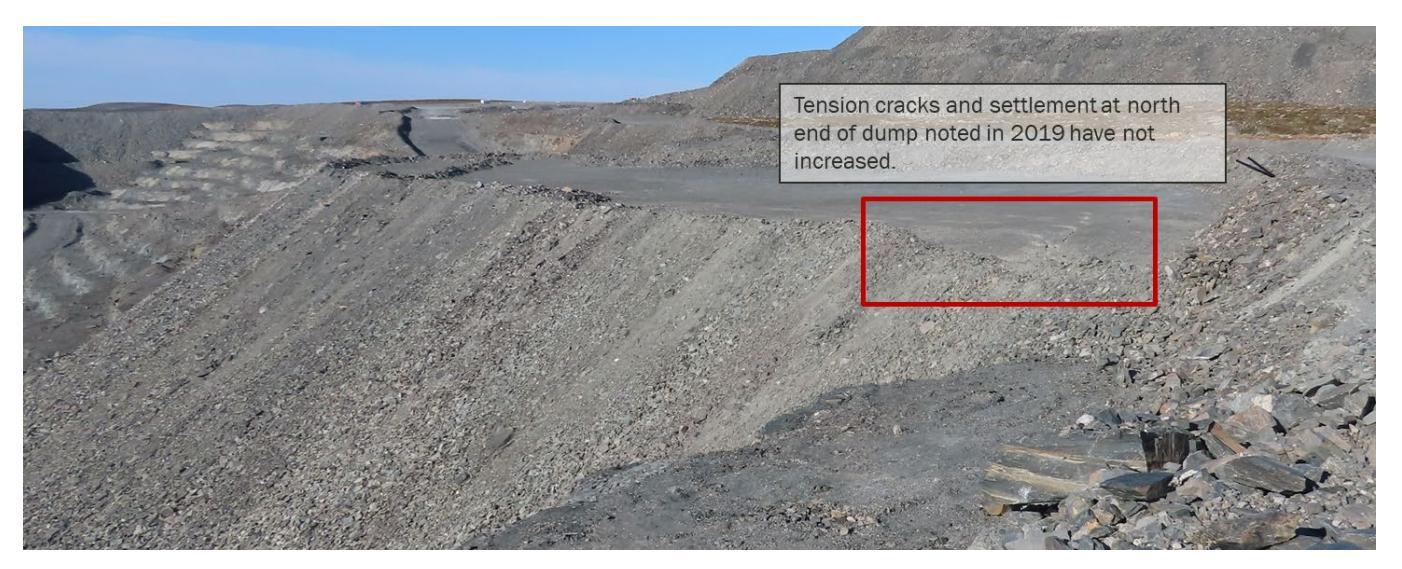
The dump crest areas were reviewed during the site inspection, along with the dump faces, for any indicators of potential instability such as tension cracks, subsidence, or over-steepening of the dump face. While some minor settlement and tension cracks were noted at the very north end of the westernmost dump platform, these are not considered significant to warrant monitoring other than observation during regular geotechnical inspections. The tension cracks have not grown since first observed in 2019 (see Photograph 7-16). Since the dumps are no longer active, access to the dump crest areas should be bermed off.

Photograph 7-16: Minor settlement of dump crest at north end (2020)

There do not appear to be any significant stability concerns with the Vault in-it dumps. Many of the geotechnical hazards identified during previous inspections no longer exist.

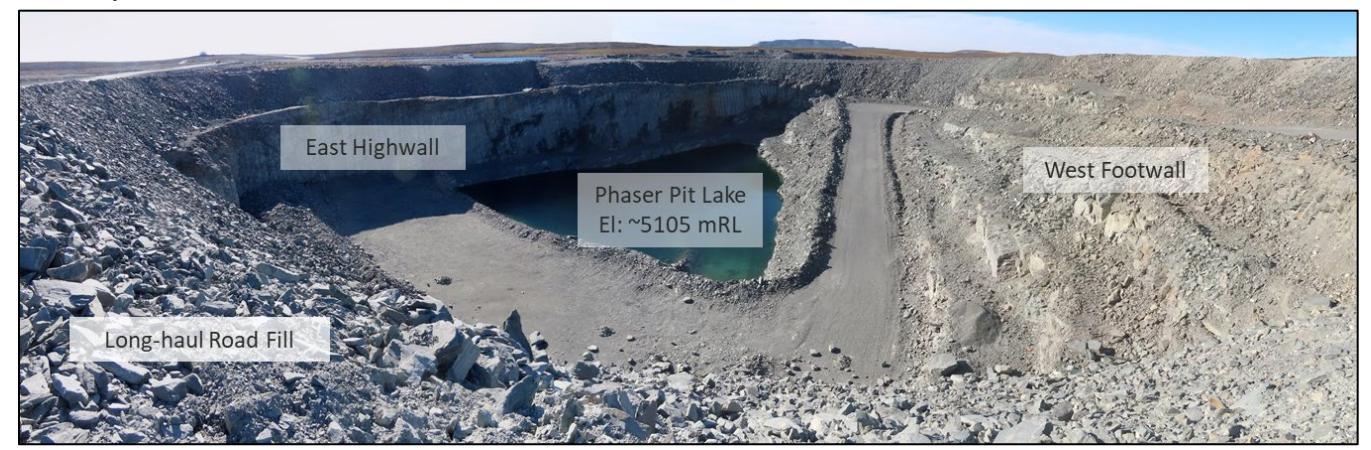
On the day of the site visit the Phaser Pit lake was at an elevation of approximately 5105 mRL (Photograph 7-17). Only one bench remains visible due to the pit lake. The pit walls continue to perform well and there are no signs of instability.

Photograph 7-17: Phaser Pit highwall (east wall) and footwall (west wall) performance (2020)

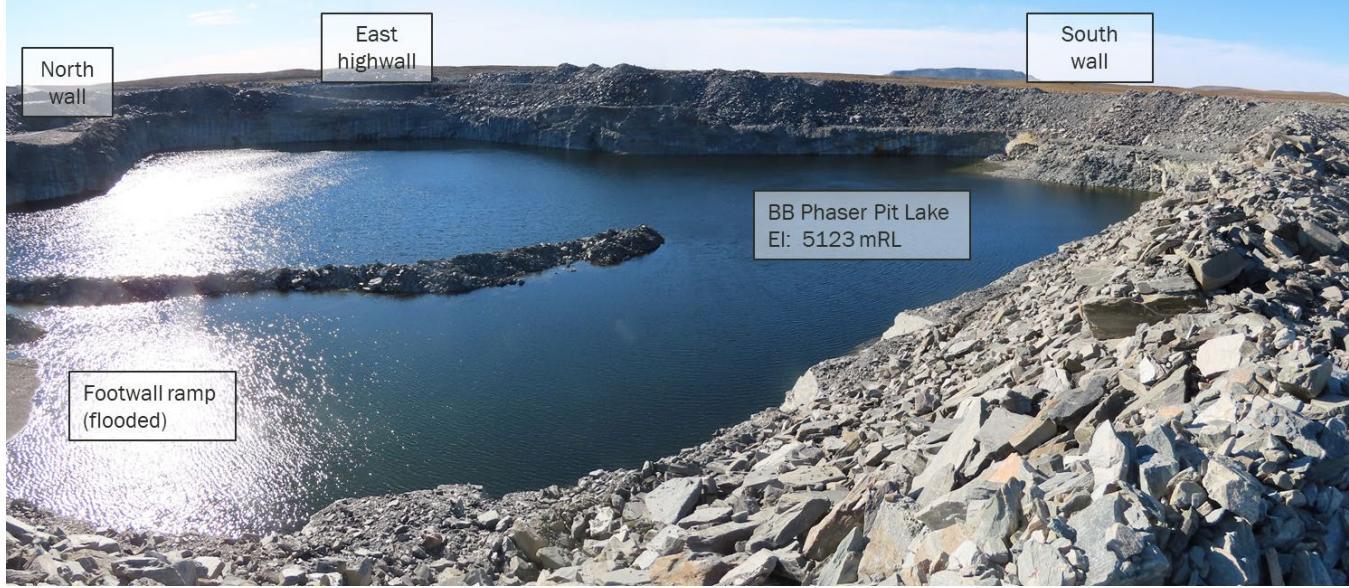
BB Phaser Pit is approximately 40 to 50 m south of the Phaser Pit. Mining was completed in Q3 of 2019 and the pit is inactive. The BB Phaser Pit stratigraphy is an extension of the Vault Pit/Phaser Pit stratigraphy and is inclined to the east to southeast at relatively shallow angles. The condition of the BB Phaser Pit at the time of inspection is shown in Photograph 7-18.

Photograph 7-18: BB Phaser Pit east highwall, endwalls and pit lake (2020)

Mining of BB Phaser Pit was completed in Q3 2019 to a final elevation of approximately 5088 mRL. On the day of the site visit the BB Phaser Pit lake was at an elevation of approximately 5123 mRL, and only the top 3 to 5 m of rock benches was visible above water level.
