Meadowbank 2020 Annual Pit Slope Performance Review

2020 ANNUAL PIT SLOPE Performance Review

Meadowbank Mine, Nunavut

ISSUED FOR USE 704-ENG.ROCK03163-01

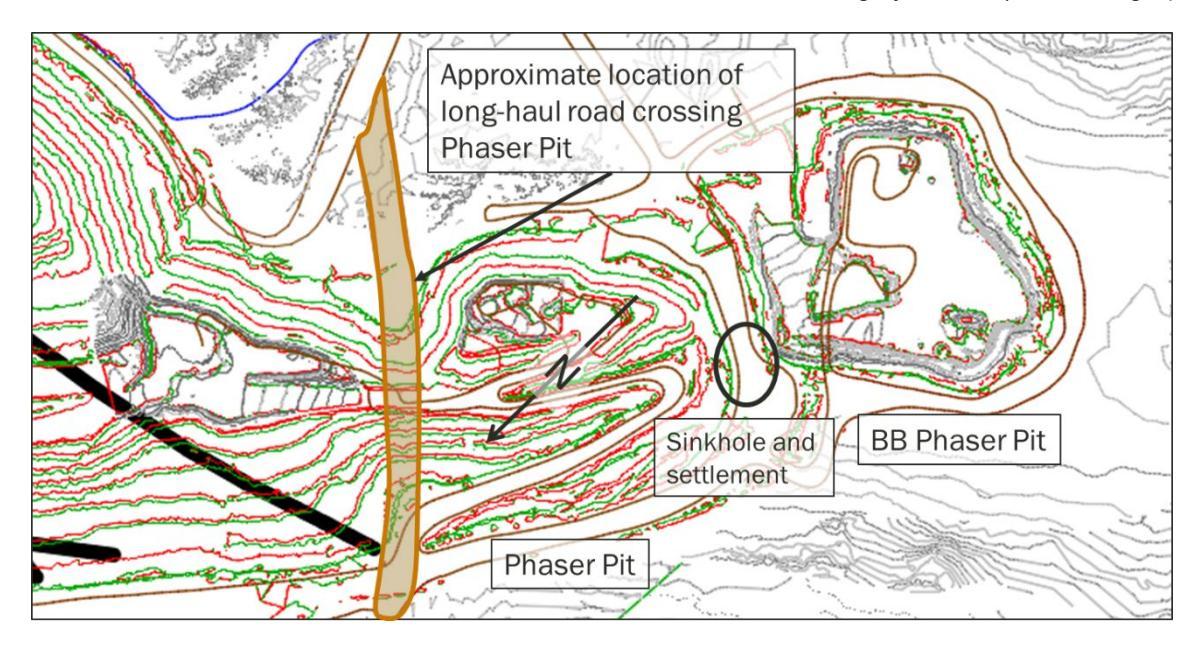
Figure 7-4: Location of sinkholes noted during 2019 inspection

During the 2019 inspection of BB Phaser Pit, sinkholes were noted on the access road that separates BB Phaser from Phaser pit. The general location of the sinkholes is shown in Figure 7-4. The area was inspected during the 2020 site visit, and the sinkholes and road settlement observed in 2019 was largely absent (see Photograph 7-19).

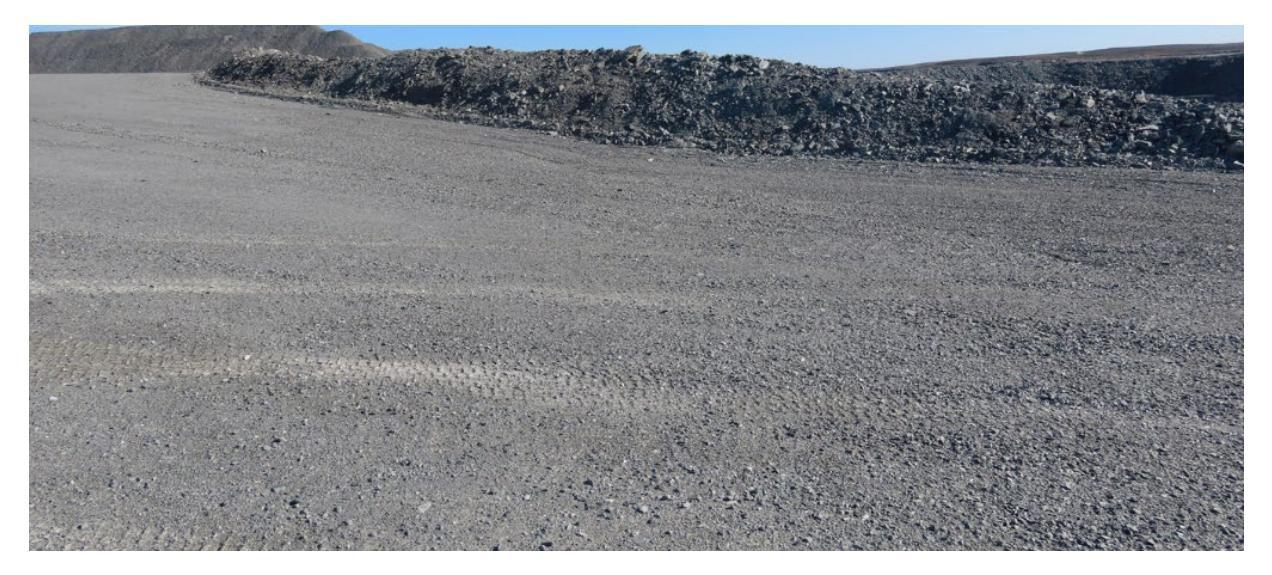
Photograph 7-19: Sinkholes and road settlement that was noted in 2019 are absent in 2020

Deactivate road and berm off to prevent use.

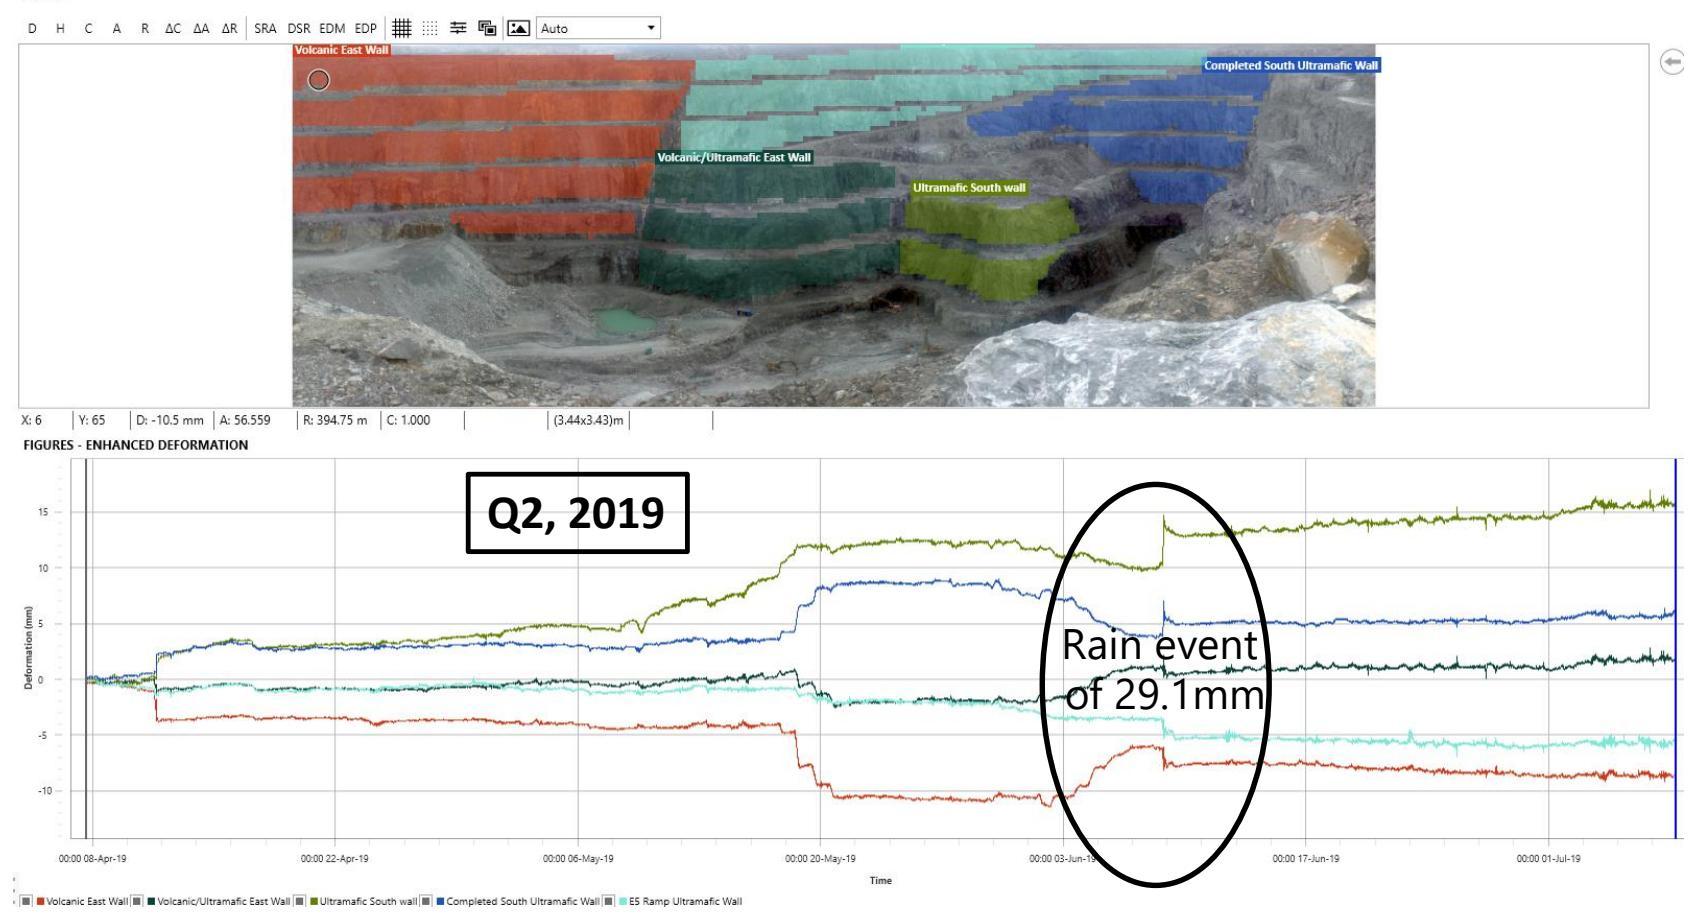
Enhanced deformation per sector (April 1st to June 30th) – Wall folder: SSR253_190407_Meadowbank_E5_South_Wall.

Comments: During the Q2 period, the deformation was relatively stable with some minor movement thru all the sections which is more indicative radar movement and not wall movement. There was a 100 tonne rock fall in the Ultramafic South Wall on May 8^{th} . The trend started approximately 1 hour prior to the rock fall.

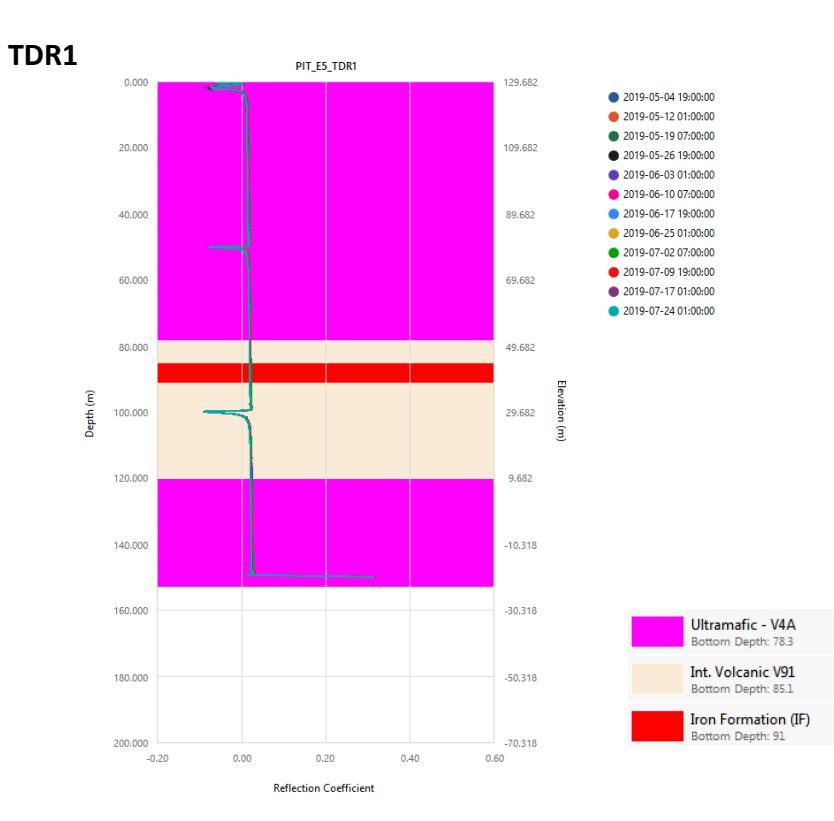
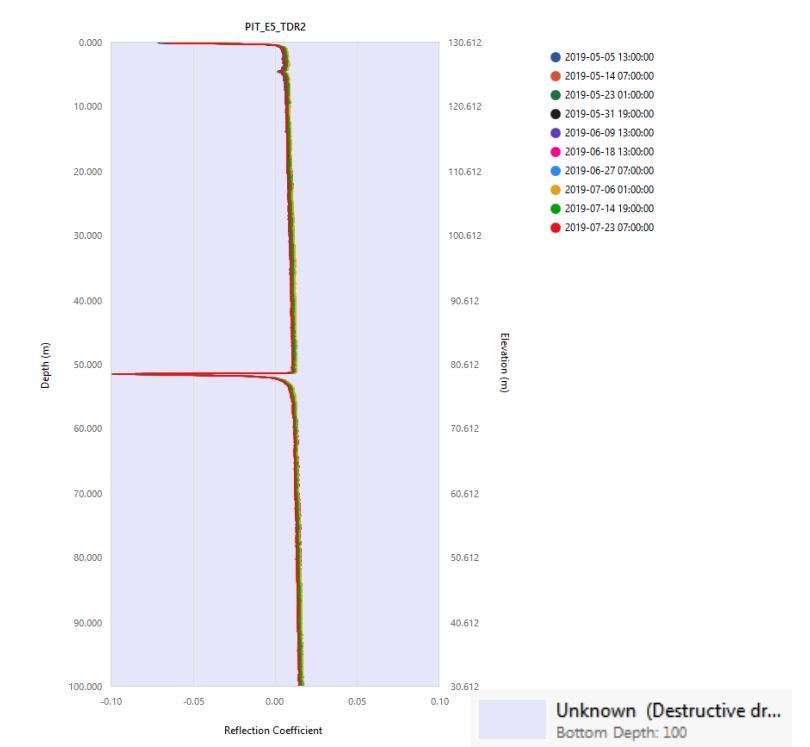
TDR2

- ➤ No sign of deformation observed in TDR1 & TDR2.
- \blacktriangleright No anomalies from the TDR logger were found in the graphs in Q2.

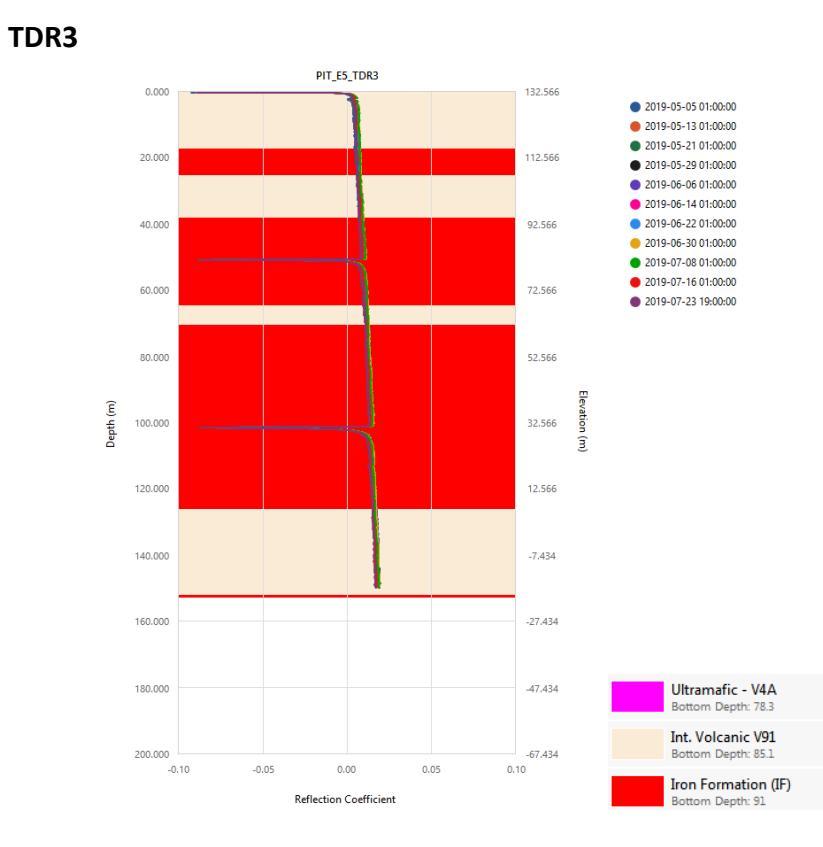
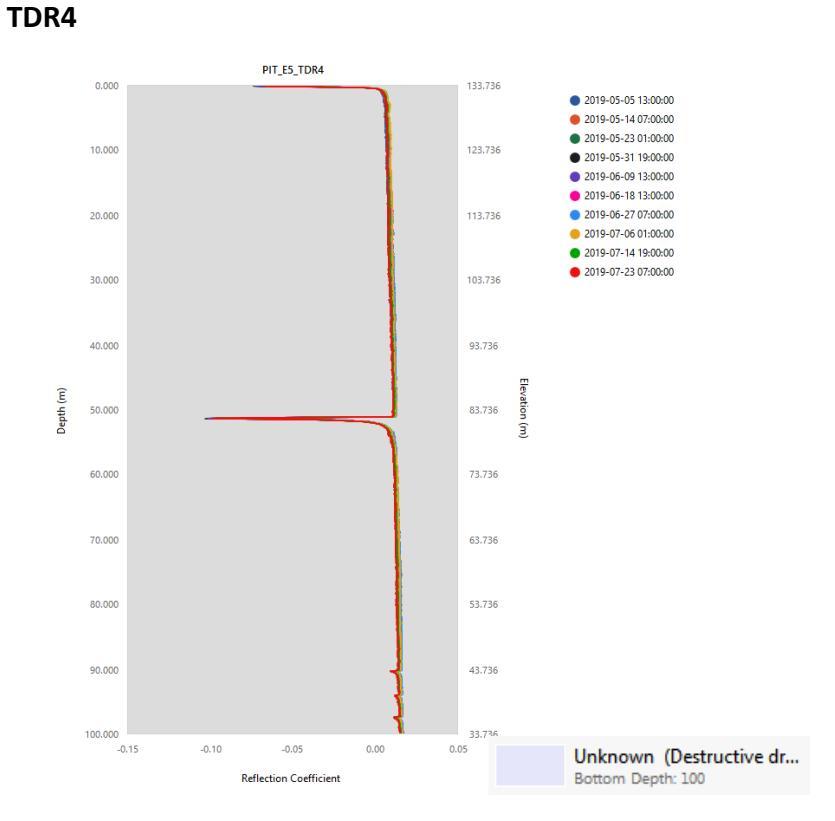
- > No sign of deformation observed in TDR3 and TDR4.
- \blacktriangleright No anomalies from the TDR logger were found in the graphs in Q2.

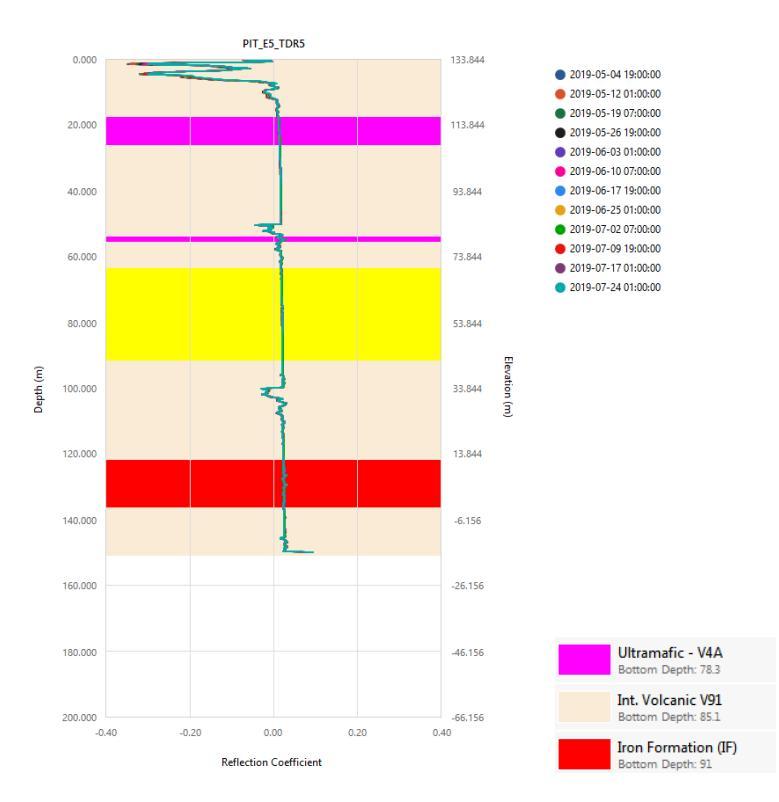
TDR5

- ➢ No sign of deformation observed in TDR5.
- \blacktriangleright No anomalies from the TDR logger were found in the graphs in Q2.

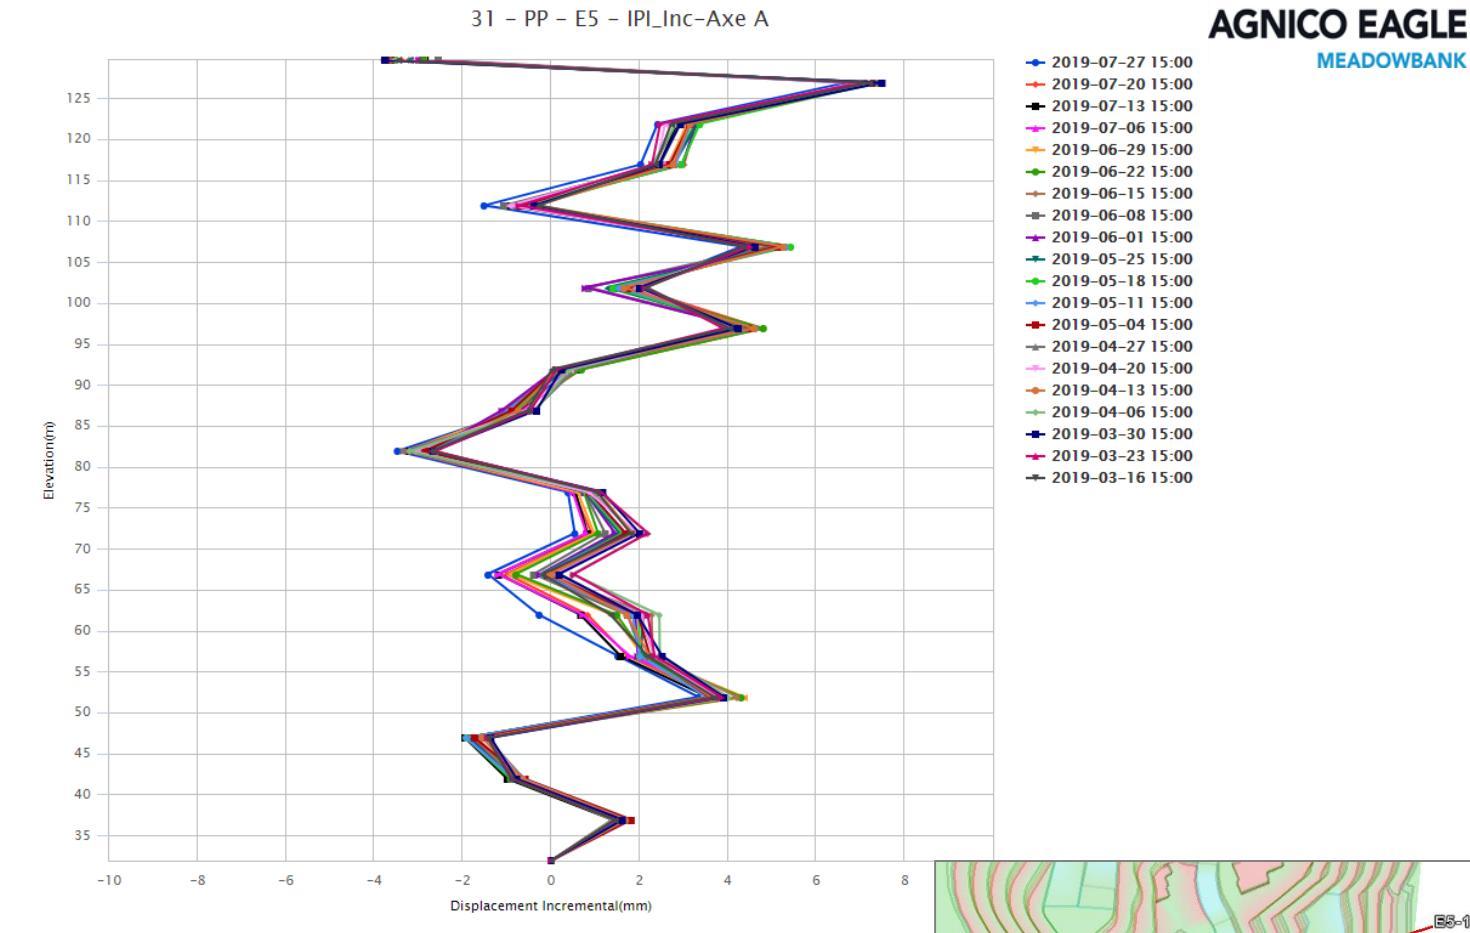
PP-E5-IPI

> Deformation are within the green level for the TARP for Pit E Pushback.

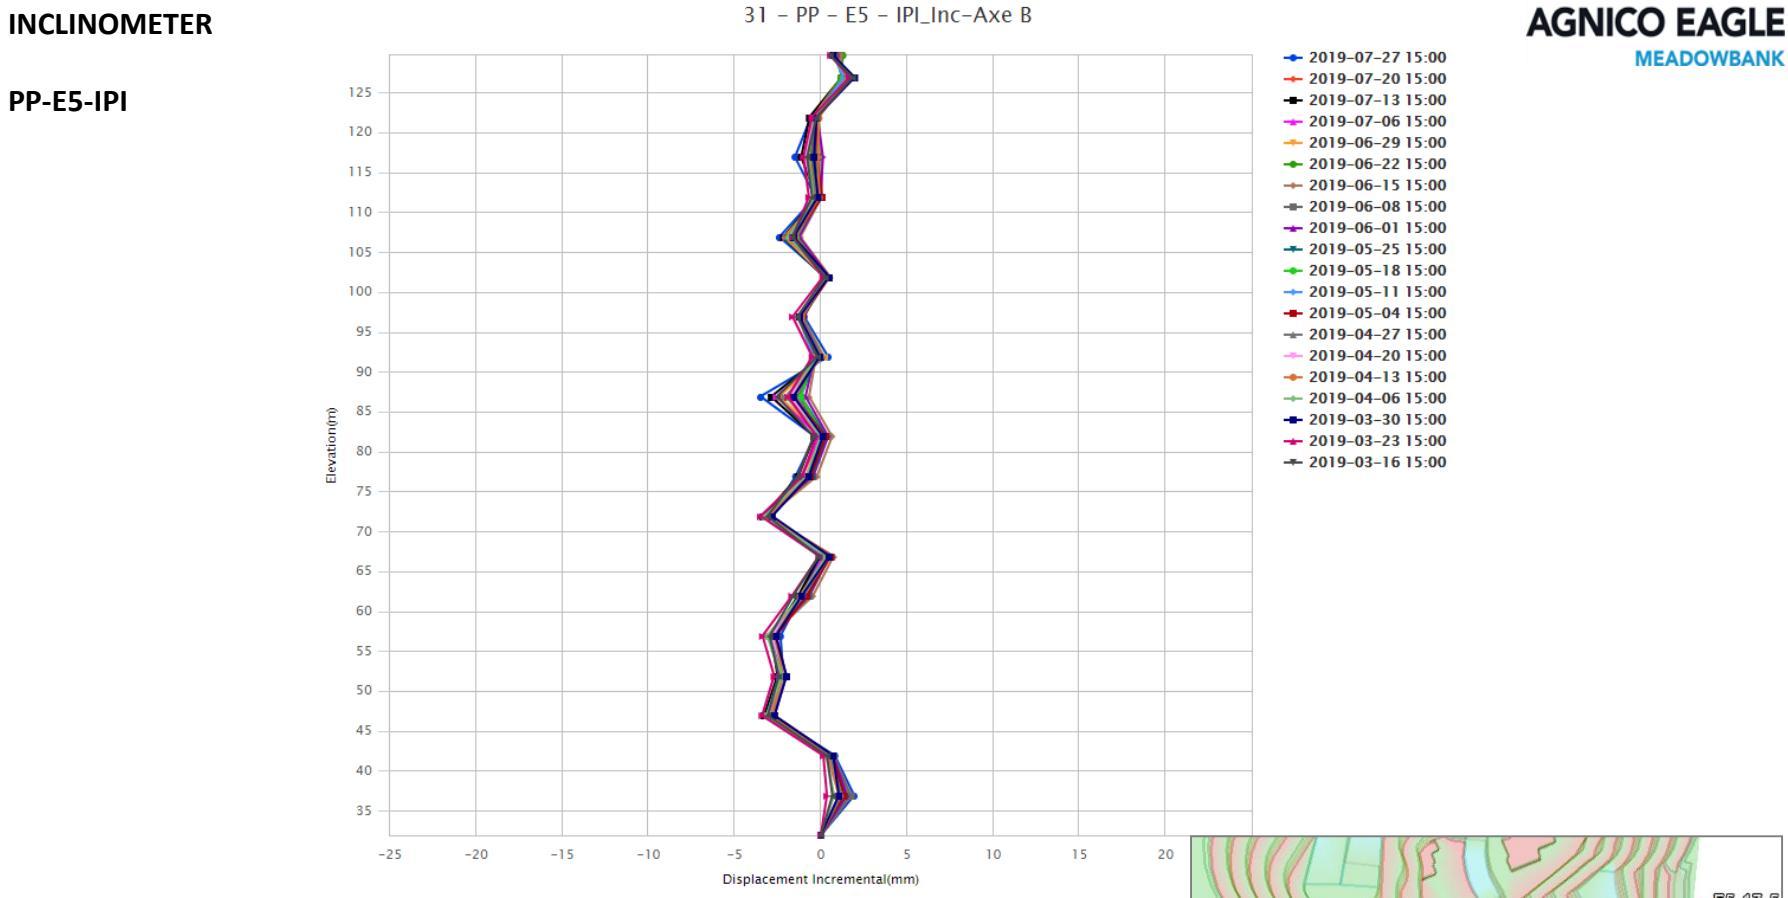
> The results fall within the Acceptable range for the TARP for Pit E Pushback.

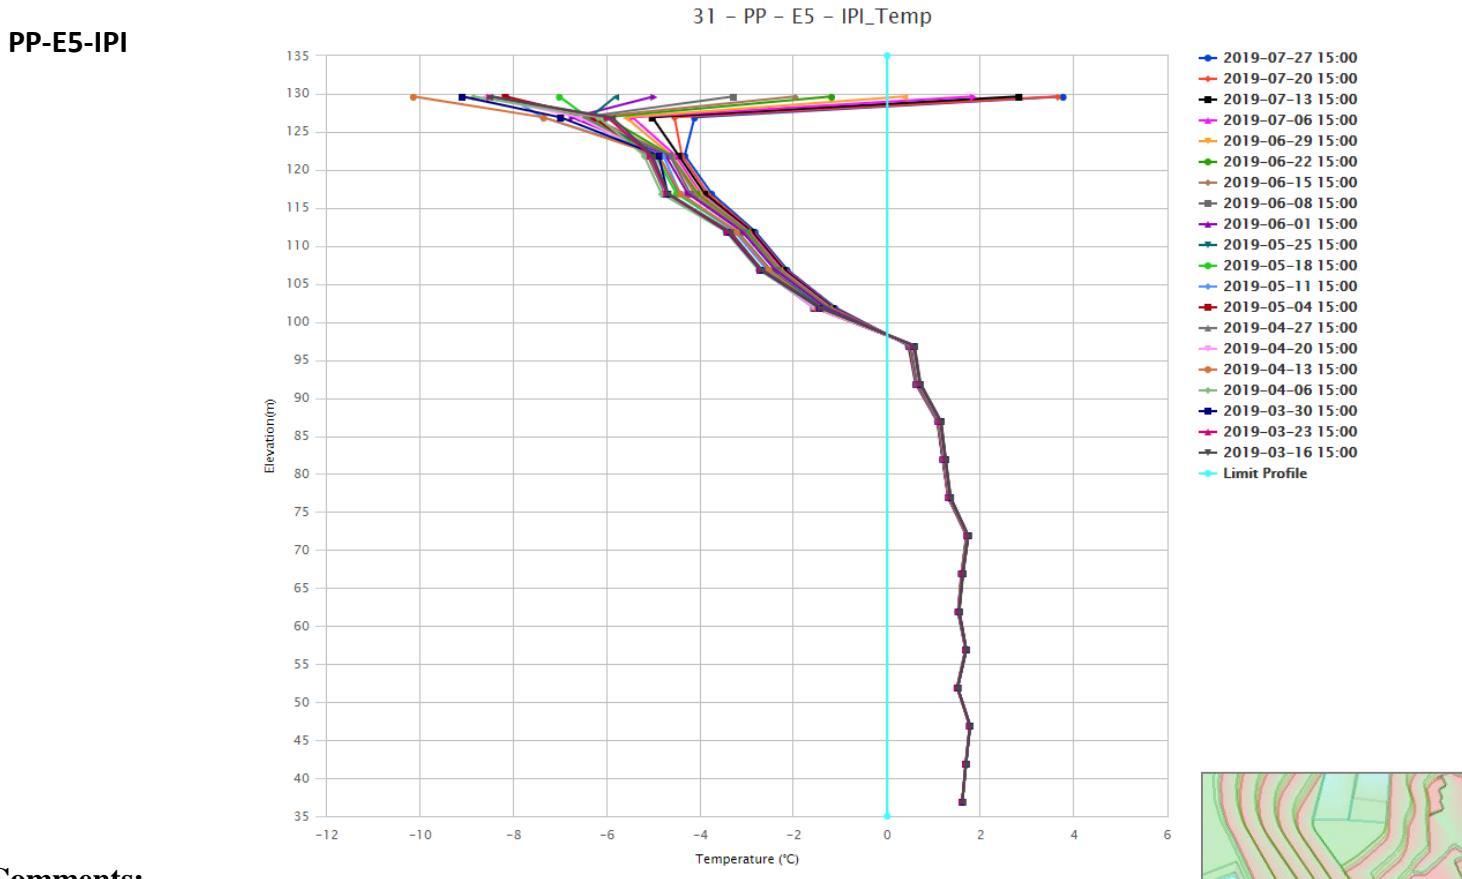
- > Unfrozen (Talik) condition under elevation 100 MASL.
- > There is a gradual warming trend in the active layer.

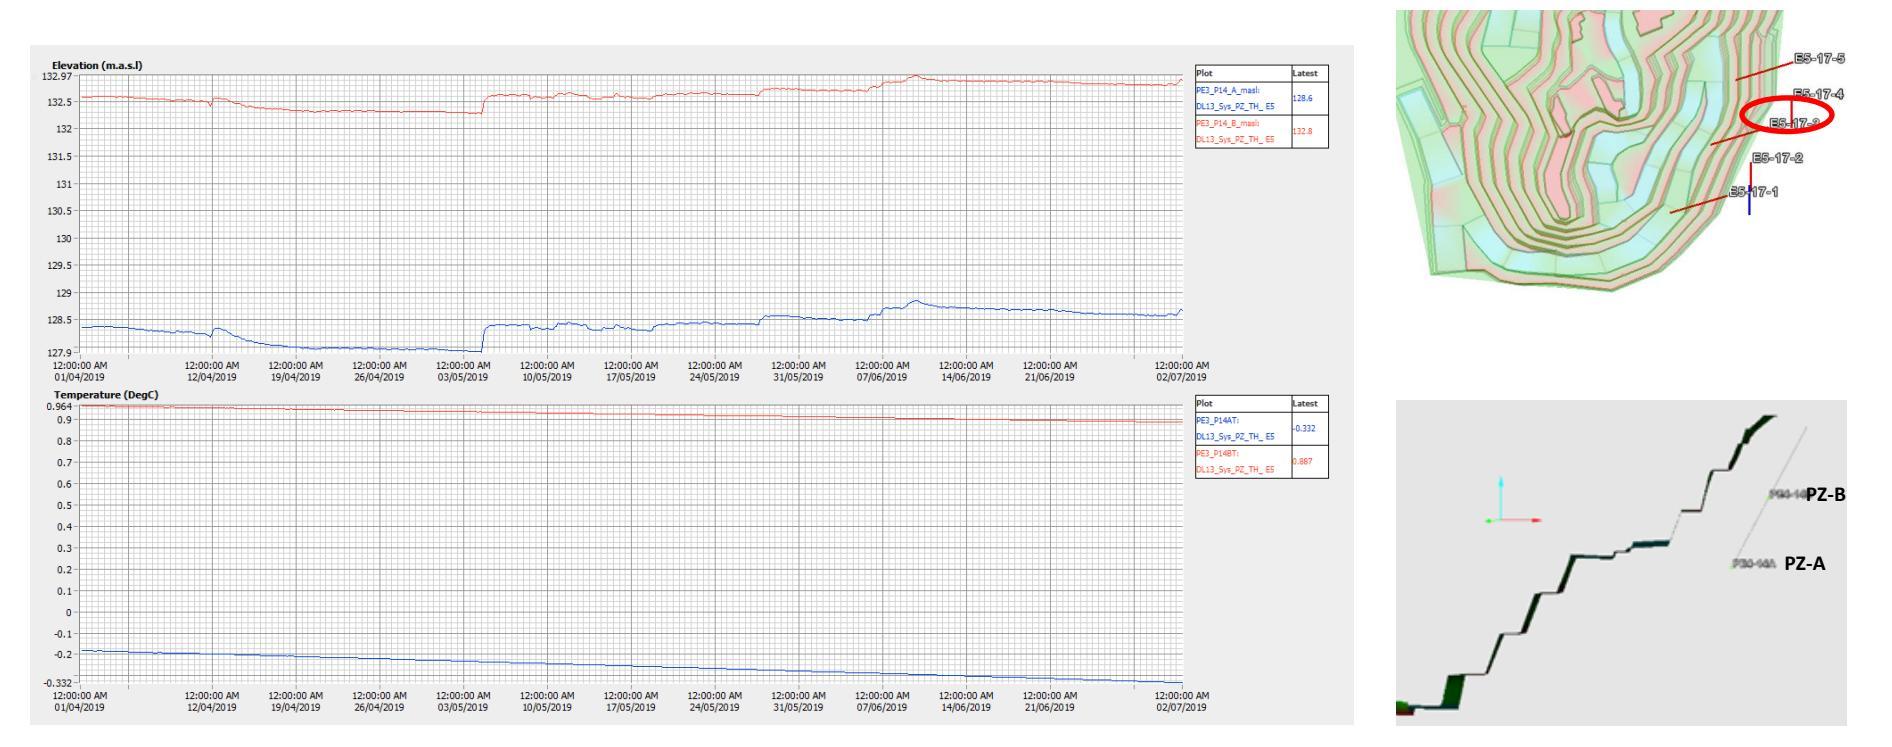
PE3-14 PZ-A,B

- > Minor variations in pore water pressure are related to mining activities (drilling/blasting) in Pit E5.
- > Overall downward trend for piezometer's temperature.
- ▶ PE3-14 PzA is close to be frozen. Latest temperature is -0.38 °C.

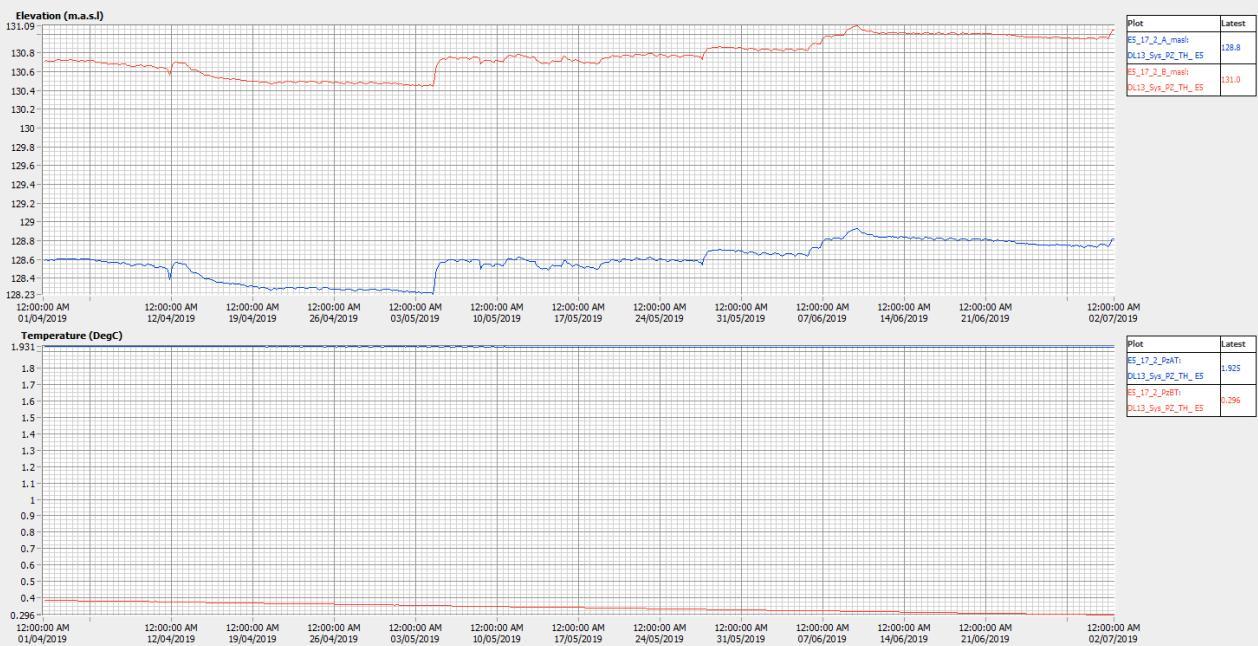
PE5-17-02 PZ-A,B

> Minor variations in pressure are related to mining activities (drilling/blasting) in Pit E5.

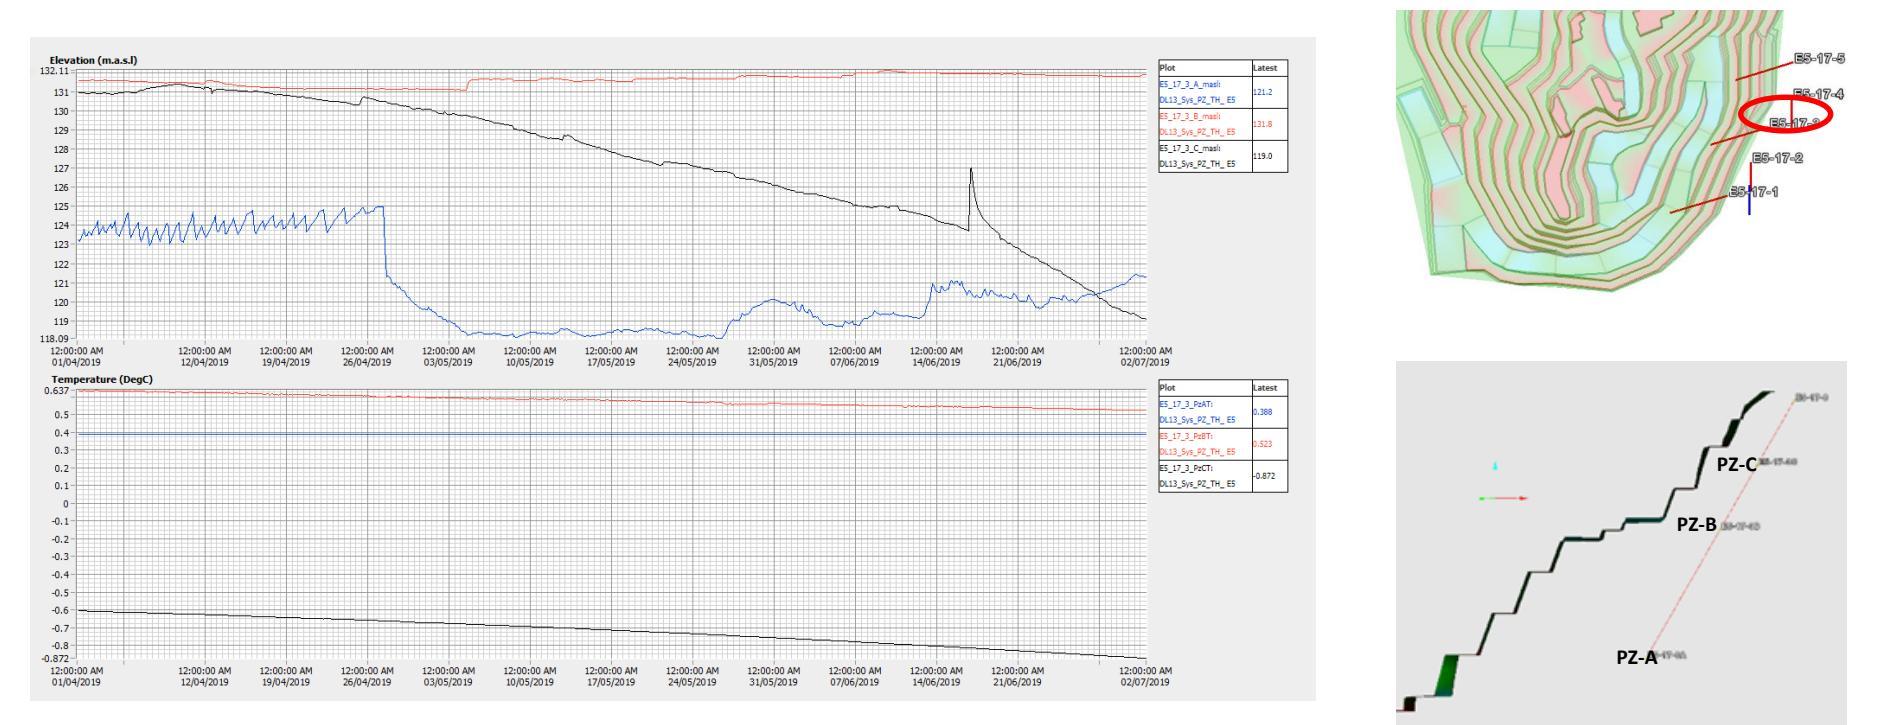
PE5-17-03 PZ-A,B,C

- Minor variations in pressure are related to mining activities (drilling/blasting) in Pit E5
- > The temperature for PzA is holding at a steady trend, meanwhile PzB and PzC are showing a cooling trend .
- > PzC is considered to frozen (-0.984°C) . Important diminution of the pressure level is attributed to that.

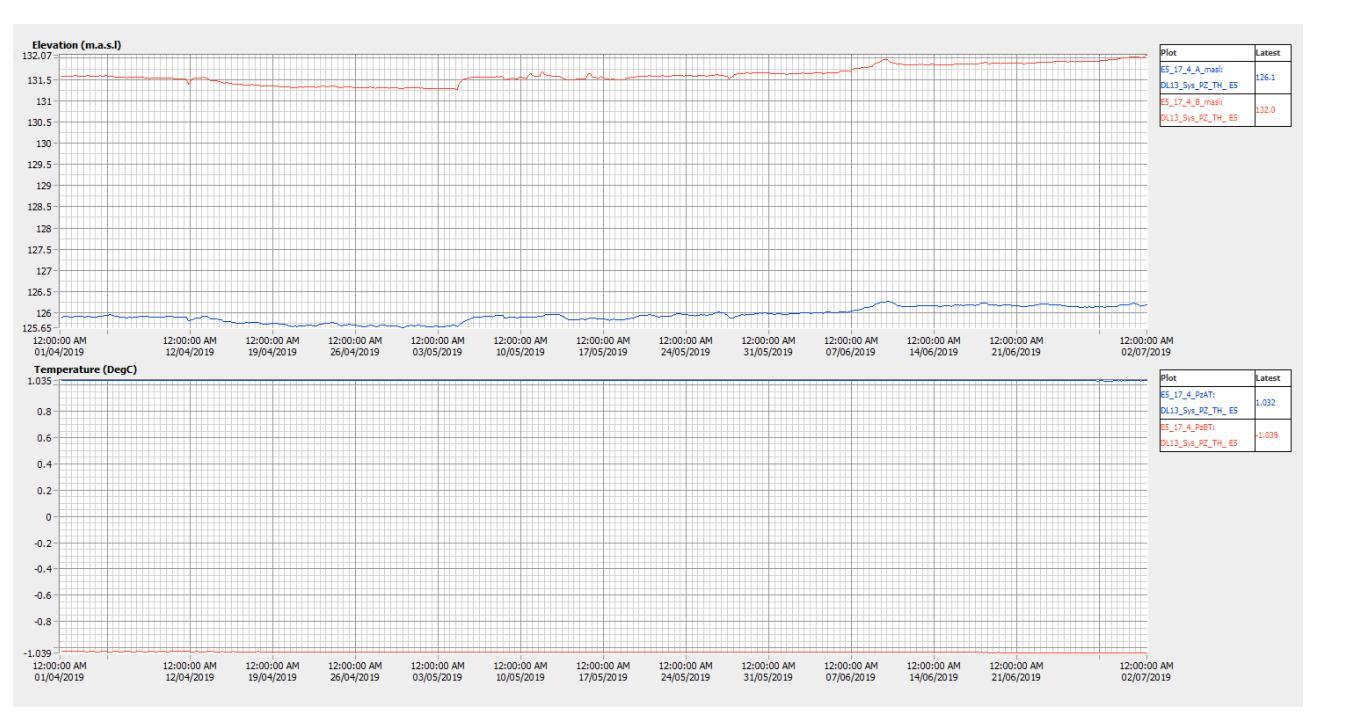
PE5-17-04 PZ-A,B

- > Minor variations in pressure are related to mining activities (drilling/blasting) in Pit E5.
- > Temperatures in PzA is on a constant trend, whilst temperature in PzB is showing a cooling trend.
- > PzB is considered to be frozen (-1.049°C) and diminution of the pressure level is attributed to that.

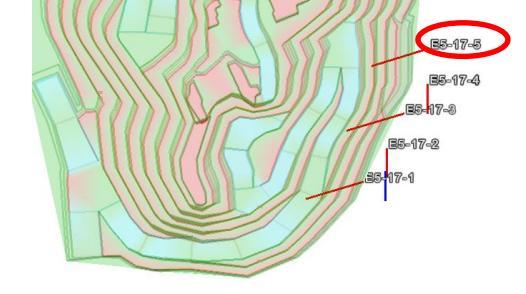
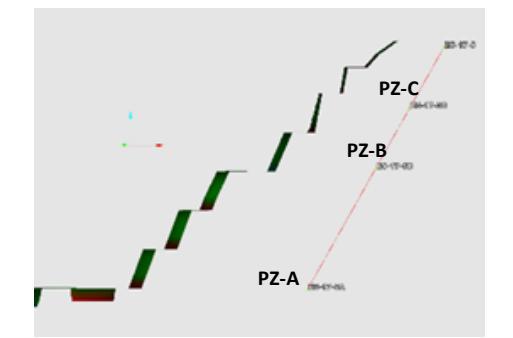
PE5-17-05 PZ-A,B,C

> PZ-A,B and C are considered to be frozen. The pressure measurements are considered unreliable.

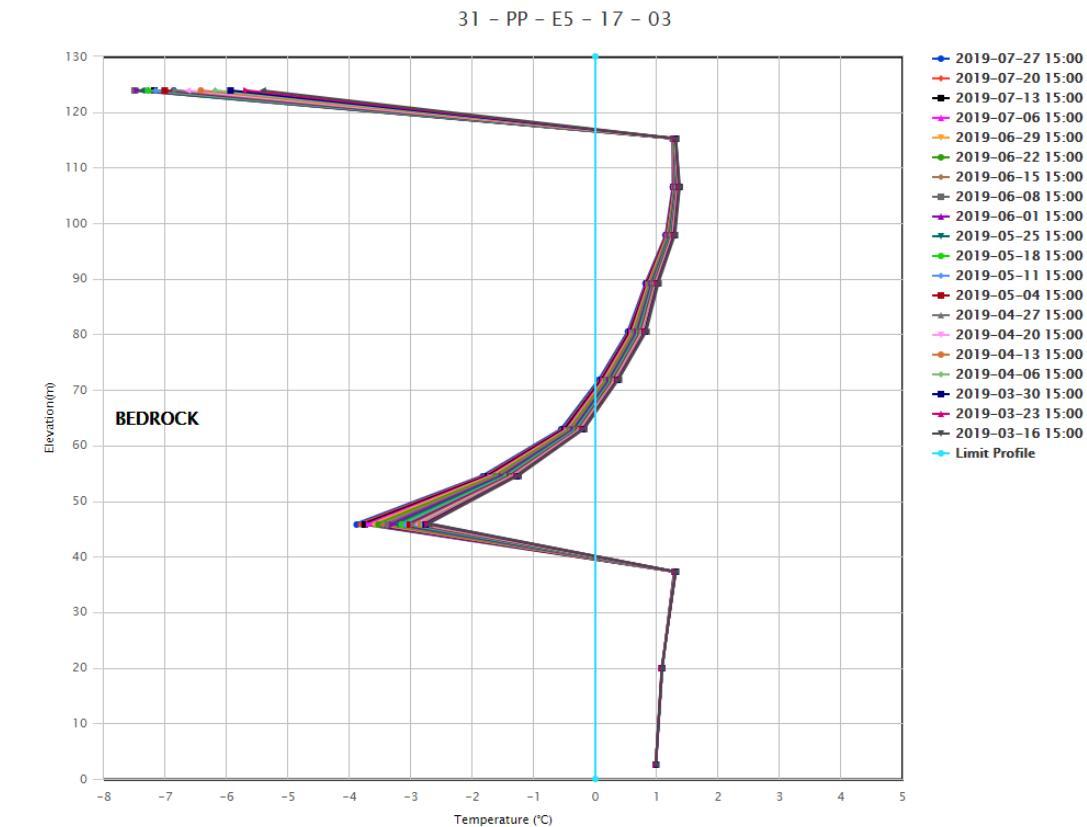
PP-E5-17-03

- > Only small variations of the thermistor occurred during Q2.
- > There is a unexplained permafrost layer between elevation 40 and 55 m.a.s.l.

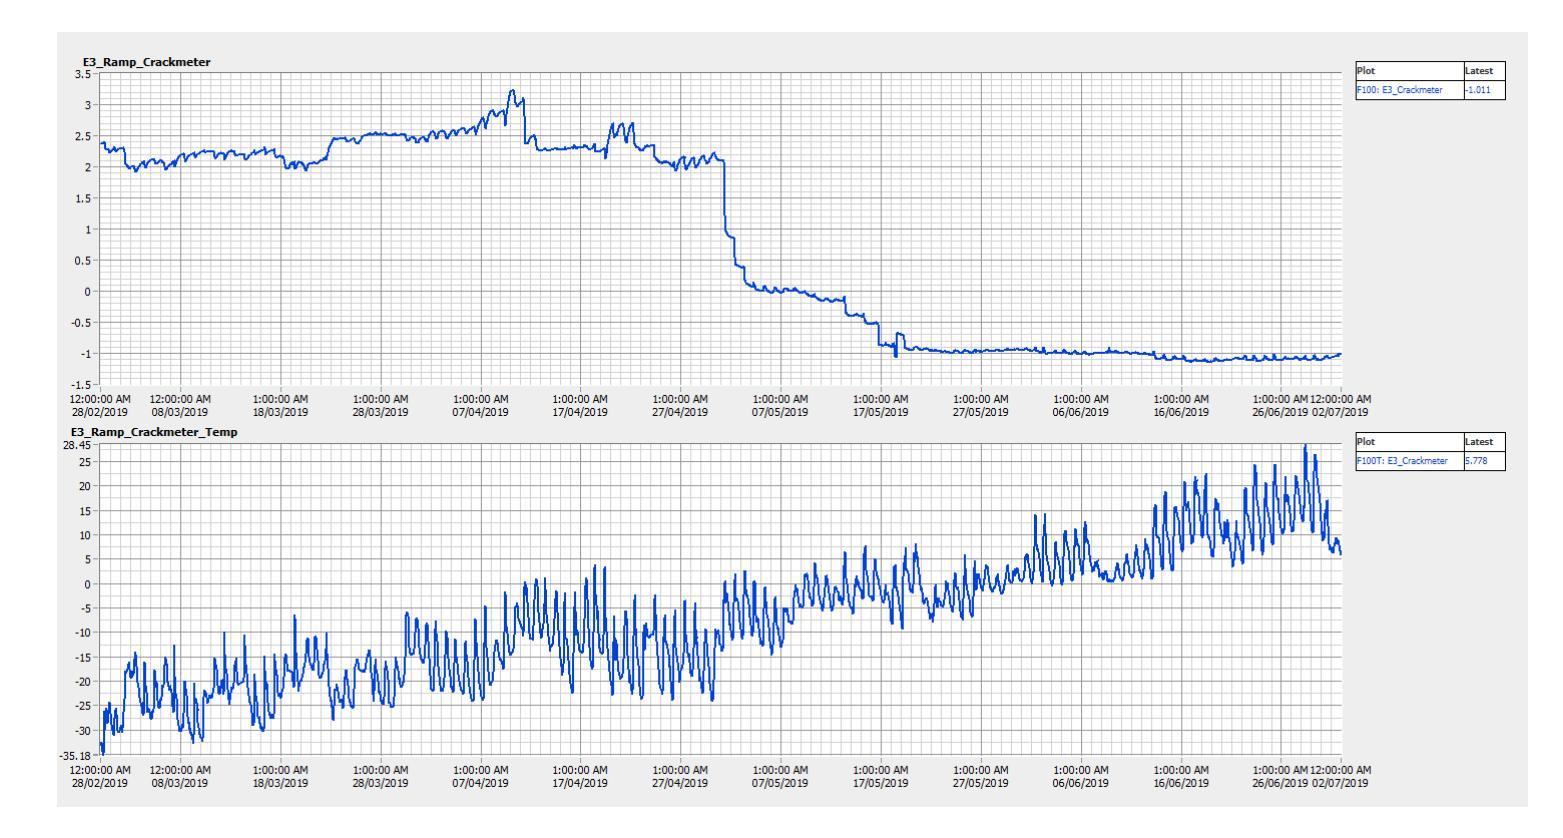
PE3_Crackmeter

Ice and snow melt during freshet is a contributing factor in the variations of the deformation. Situation is monitored closely. No observations noted in the field.

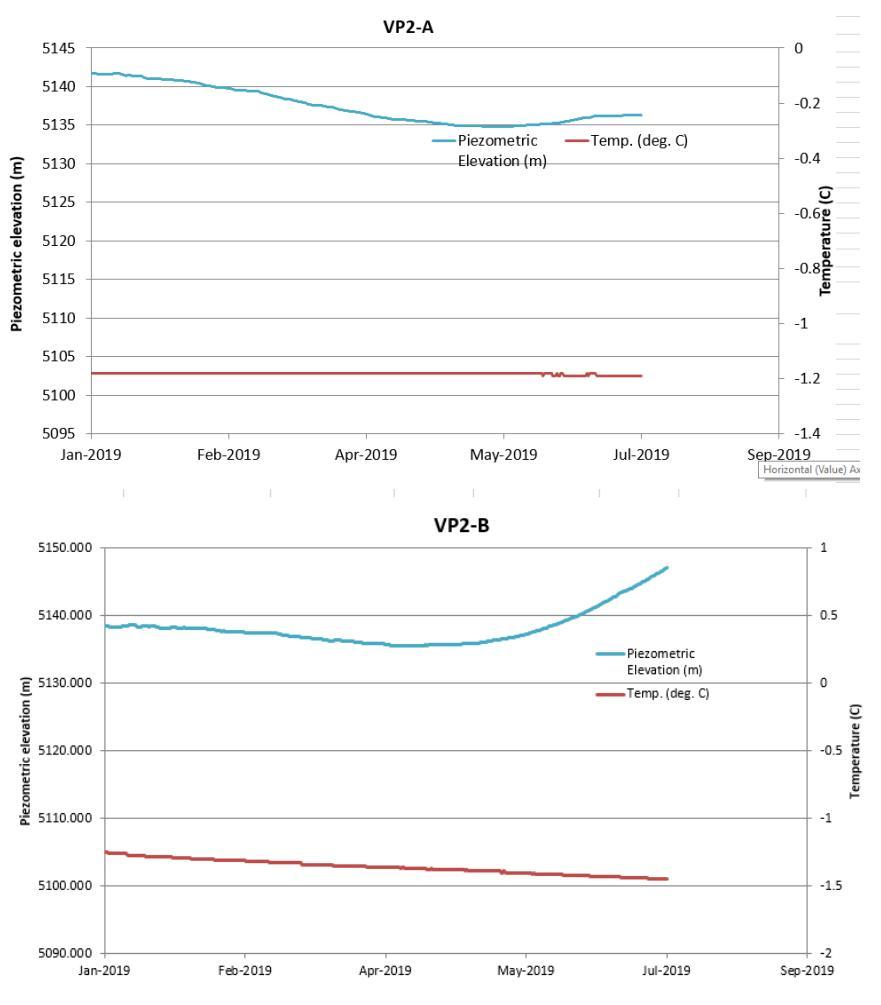
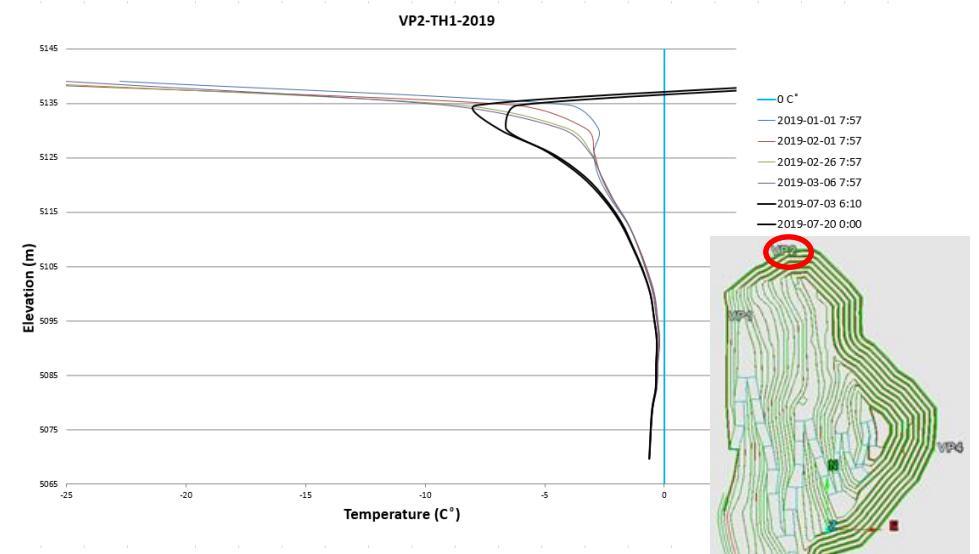
VP2-A, VP2-B, VP2-TH1

- PZ-A&B are below the freezing point since their installation and their data are considered unreliable.
- The section between 5105 and 5085 is close to the freezing but still below. Apart the top beads, minimal variations were recorded for the rest of the hole.

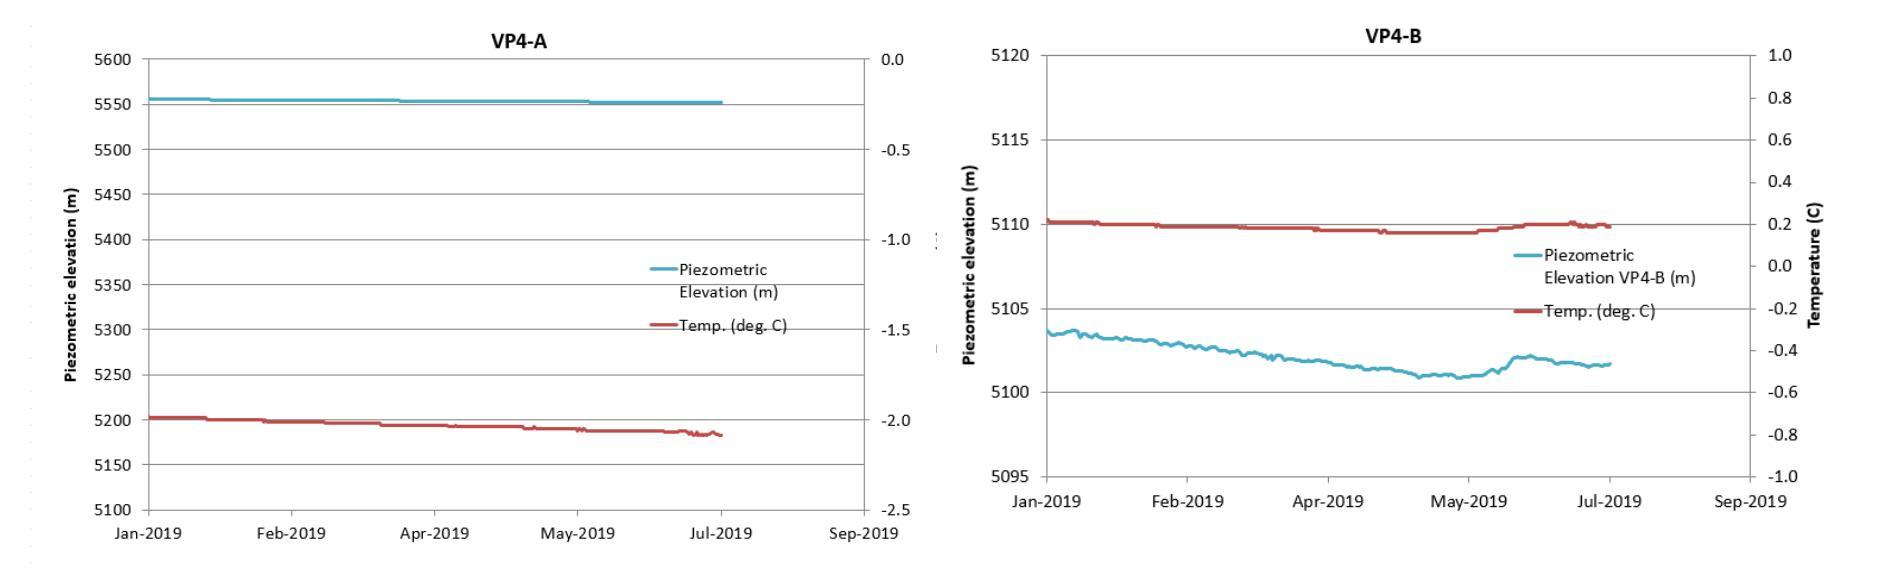
VP4-A, VP4-B

- > PZ-A is under the freezing point and considered unreliable.
- PZ-B shows minor variations. The instrument is installed in the confined layer of talik between 5105 and 5095 at the source of the seepage causing the major ice wall in the area.
- The temperature of PZ-B is on a downward trend suggesting a freeze back of the slope and aggradation of permafrost. It might now be frozen so data are not reliable.

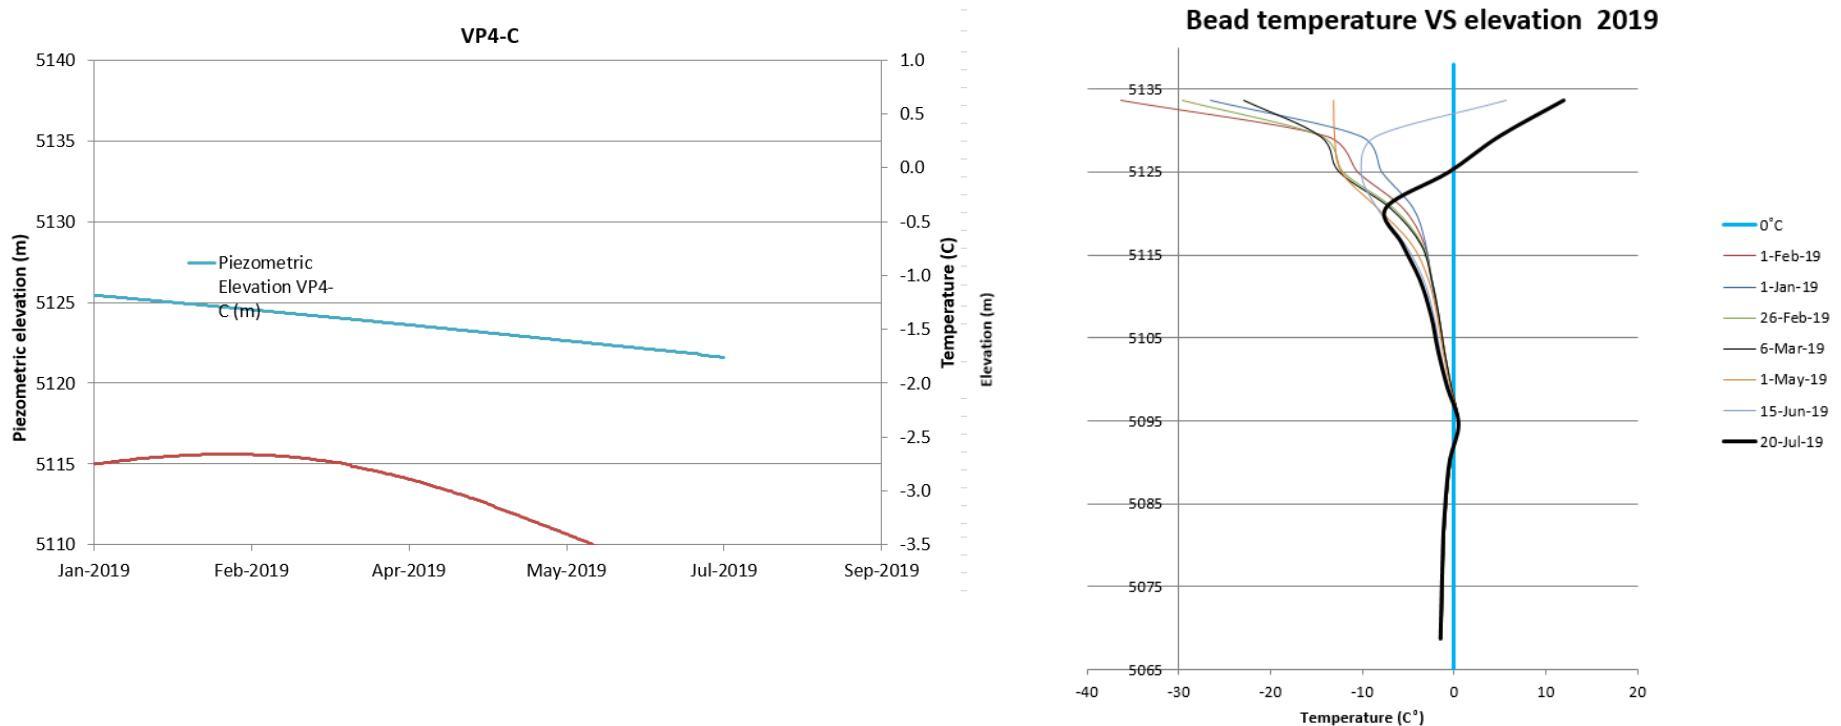
VP4-C, VP4-TH1

- > PZ-C is frozen and data is considered unreliable.
- The thermistor show that the hole is mainly in the permafrost at the exception of the section in between 5100 and 5090 (0.51°C). This zone causes the seepage and therefore the ice wall.
