Meadowbank 2020 Annual Pit Slope Performance Review

2020 ANNUAL PIT SLOPE Performance Review

Meadowbank Mine, Nunavut

ISSUED FOR USE 704-ENG.ROCK03163-01

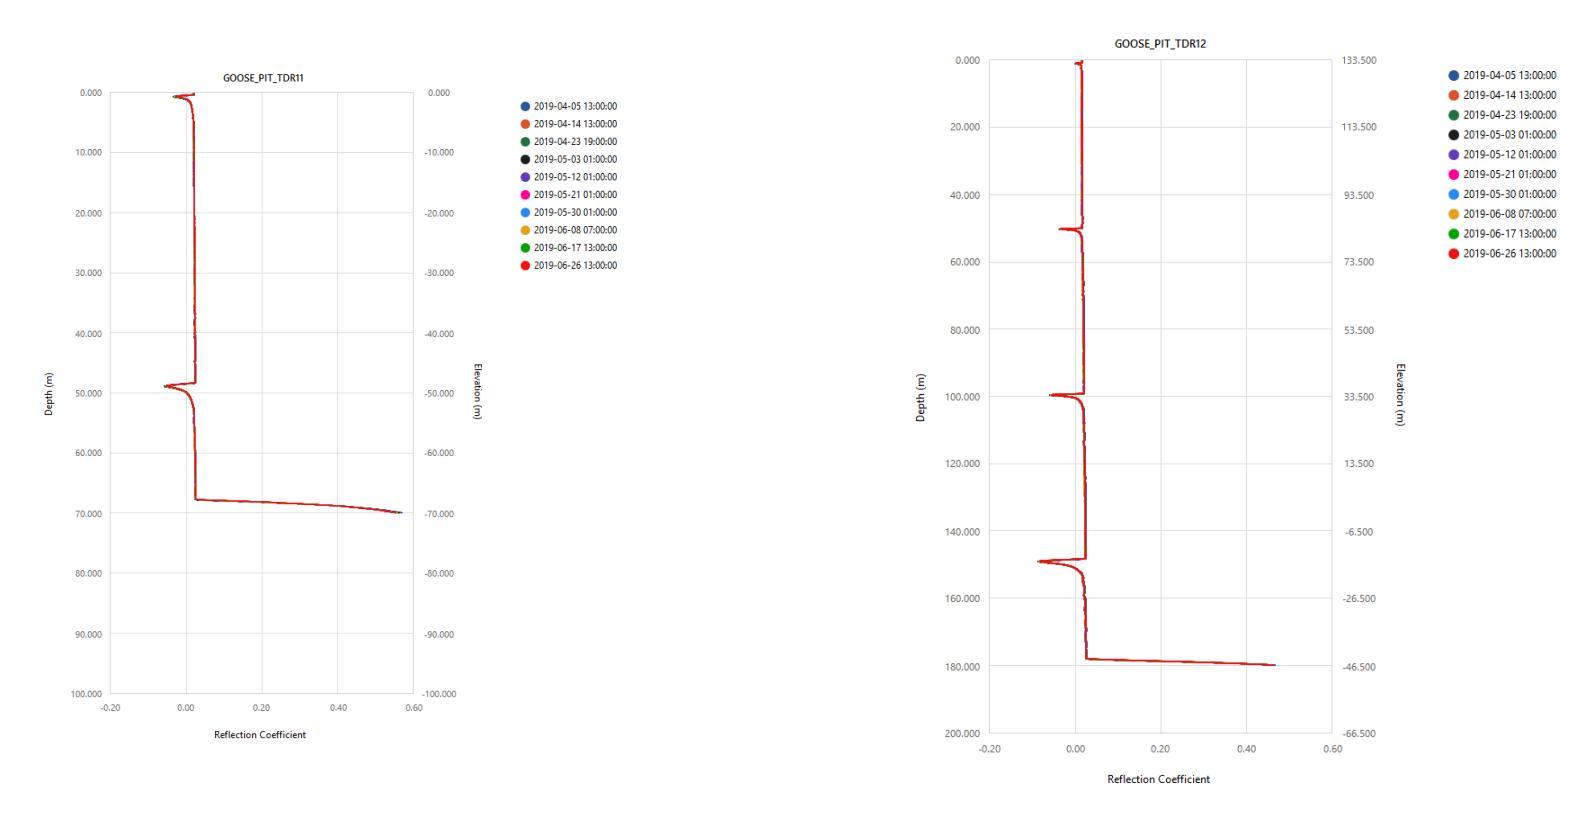
- No sign of deformation was observed in these TDRs. Anomalies from the TDR logger are still presents and were disregarded in the presented graphs. We are currently still trying to find a solution for this problem but it does not compromise the data integrity.
- TDR 14 was pinched at installation and therefore result might be compromise in the case of an event raising the reflection coefficient. This is why we are not showing it on the report anymore.

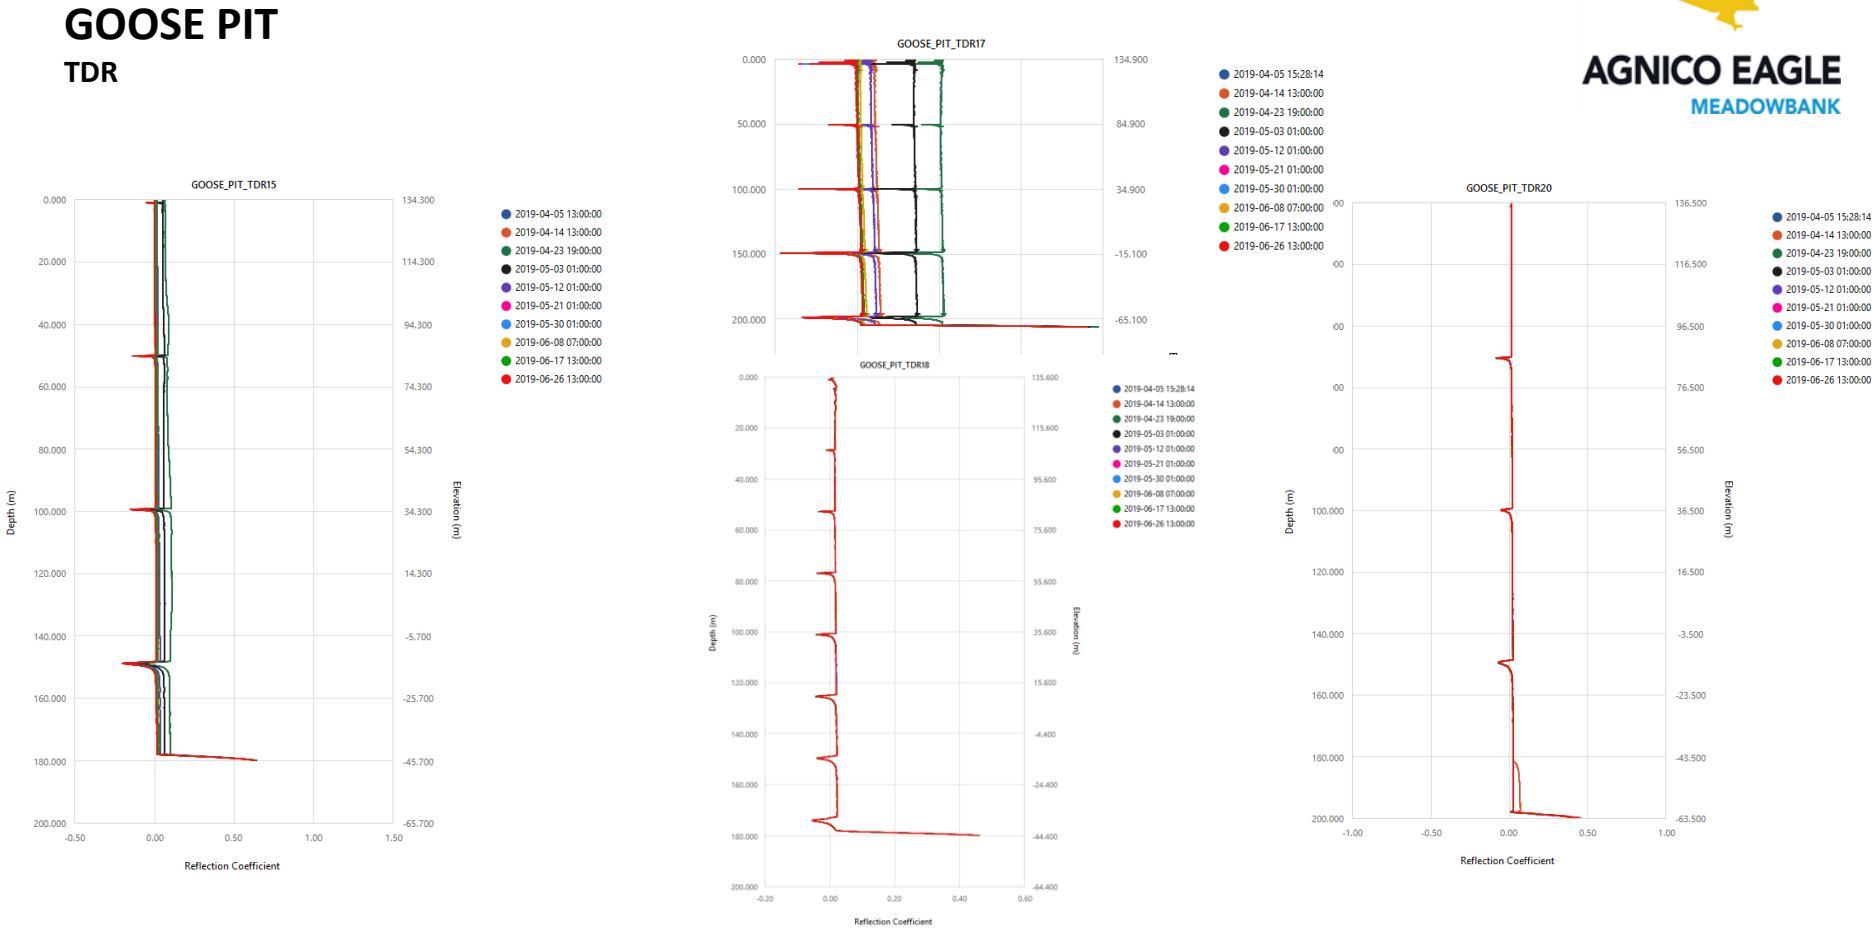
> No sign of deformation was observed in these TDRs. No sign of deformation was observed in these TDRs. Anomalies from the TDR logger are still presents and were disregarded in the presented graphs. We are currently still trying to find a solution for this problem but it does not compromise the data integrity.

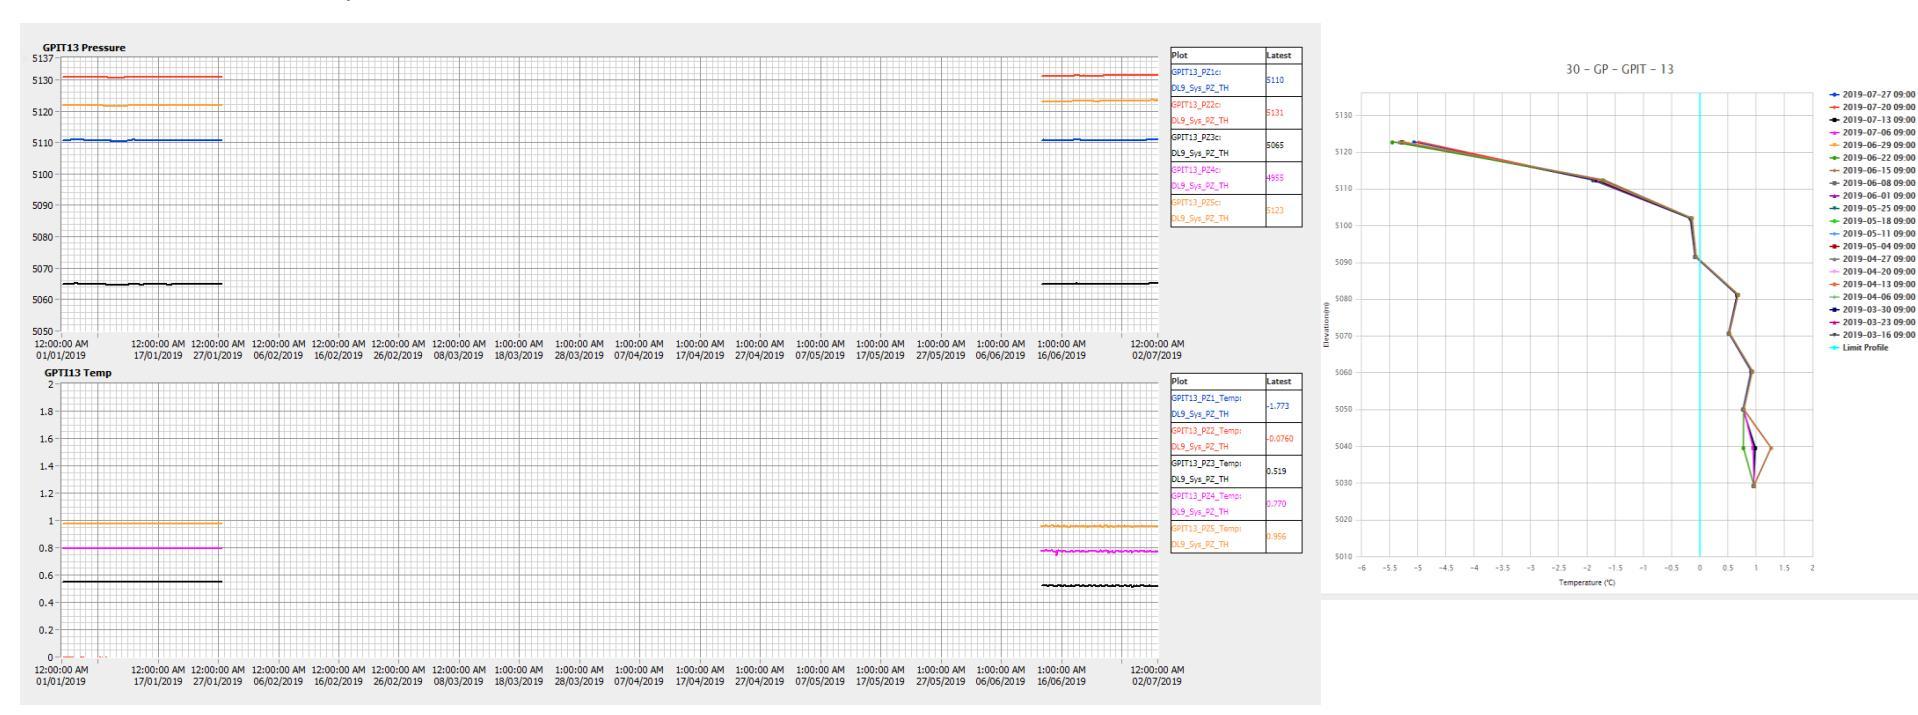
- Piezometers stopped recording data on January 27th but were fixed on June 14th. No anomalies in data observed.
- The beads of thermistor GPIT-13 are stable. The first bead temperature change is consistent with the cooling trend at this time of year. This is consistent with the previous years and with the thermal dynamics of the area.

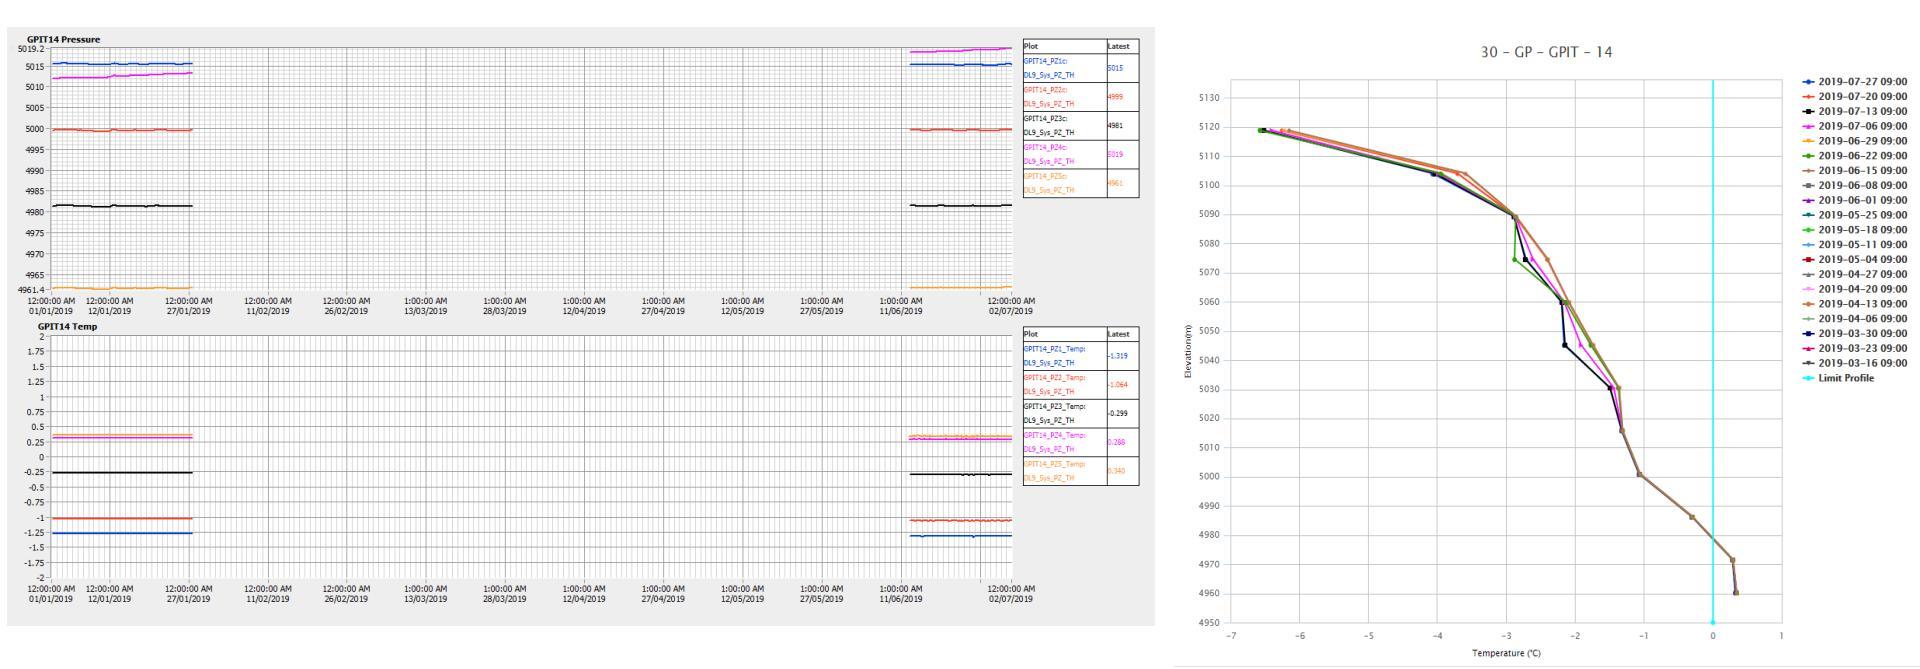
GPIT-14-PZ-1-2-3-4-5, GPIT-14-TH

- Piezometers stopped recording data on January 27thbut were fixed on June 14th. No anomalies in data observed.
- TH-GPIT-14 is in the permafrost from top at elevation 5120 to 4980. The last 20m of the hole is above the freezing line. The first bead temperature change is consistent with the cooling trend at this time of year. This is consistent with the previous years and with the thermal dynamics of the area.

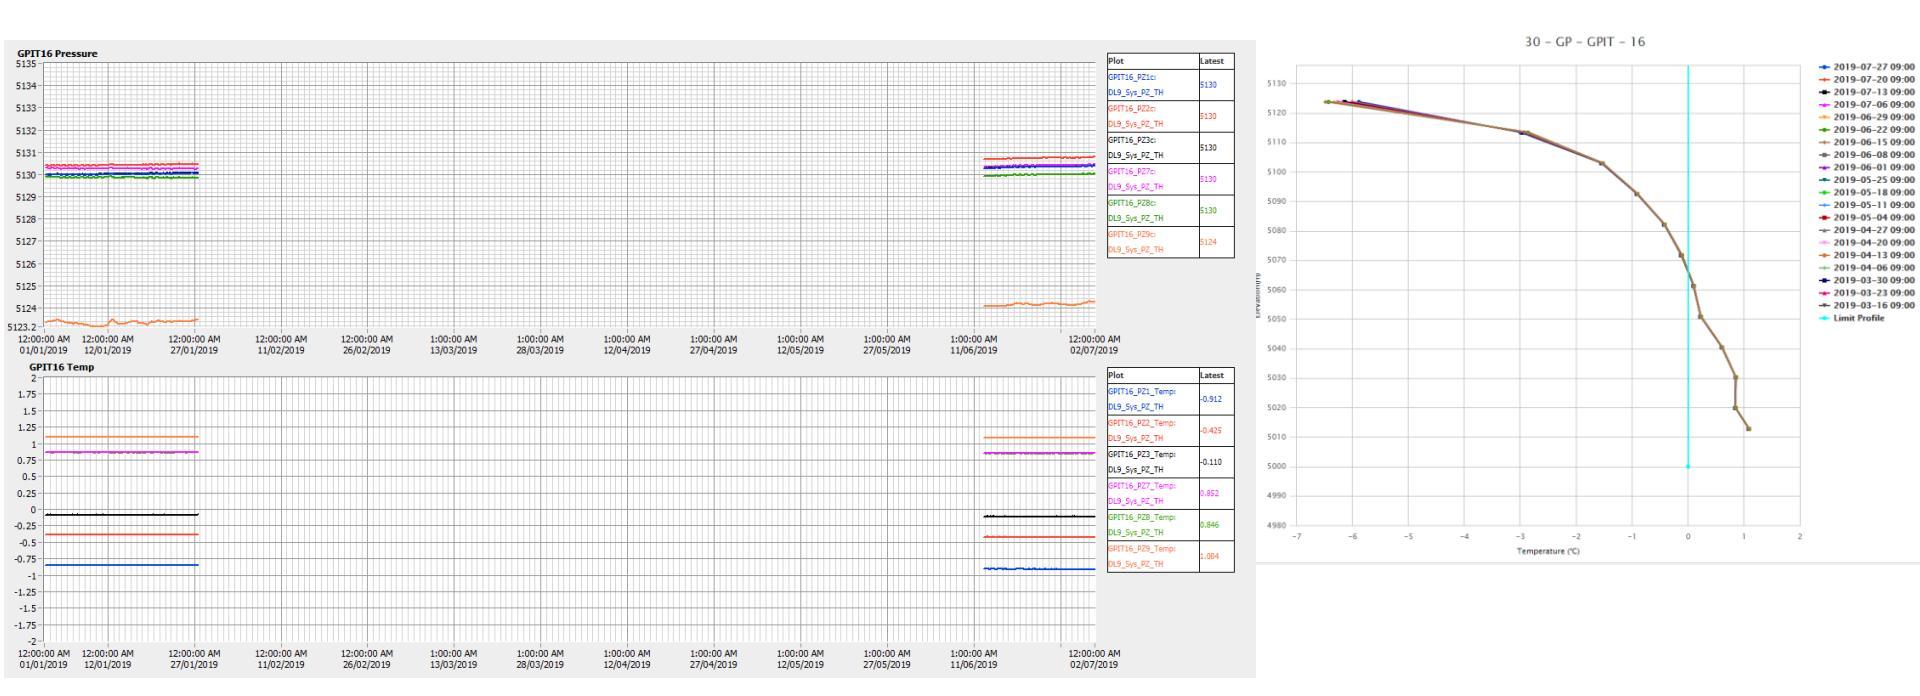
GPIT-16-PZ-1-2-3-7-8-9, GPIT-16-TH

- Piezometers stopped recording data on January 27th but were fixed on June 14th. No anomalies in data observed.
- TH-GPIT-16 is in the permafrost from top at elevation 5124 to 5068. The first bead temperature change is consistent with the cooling trend at this time of year. This is consistent with the previous years and with the thermal dynamics of the area.

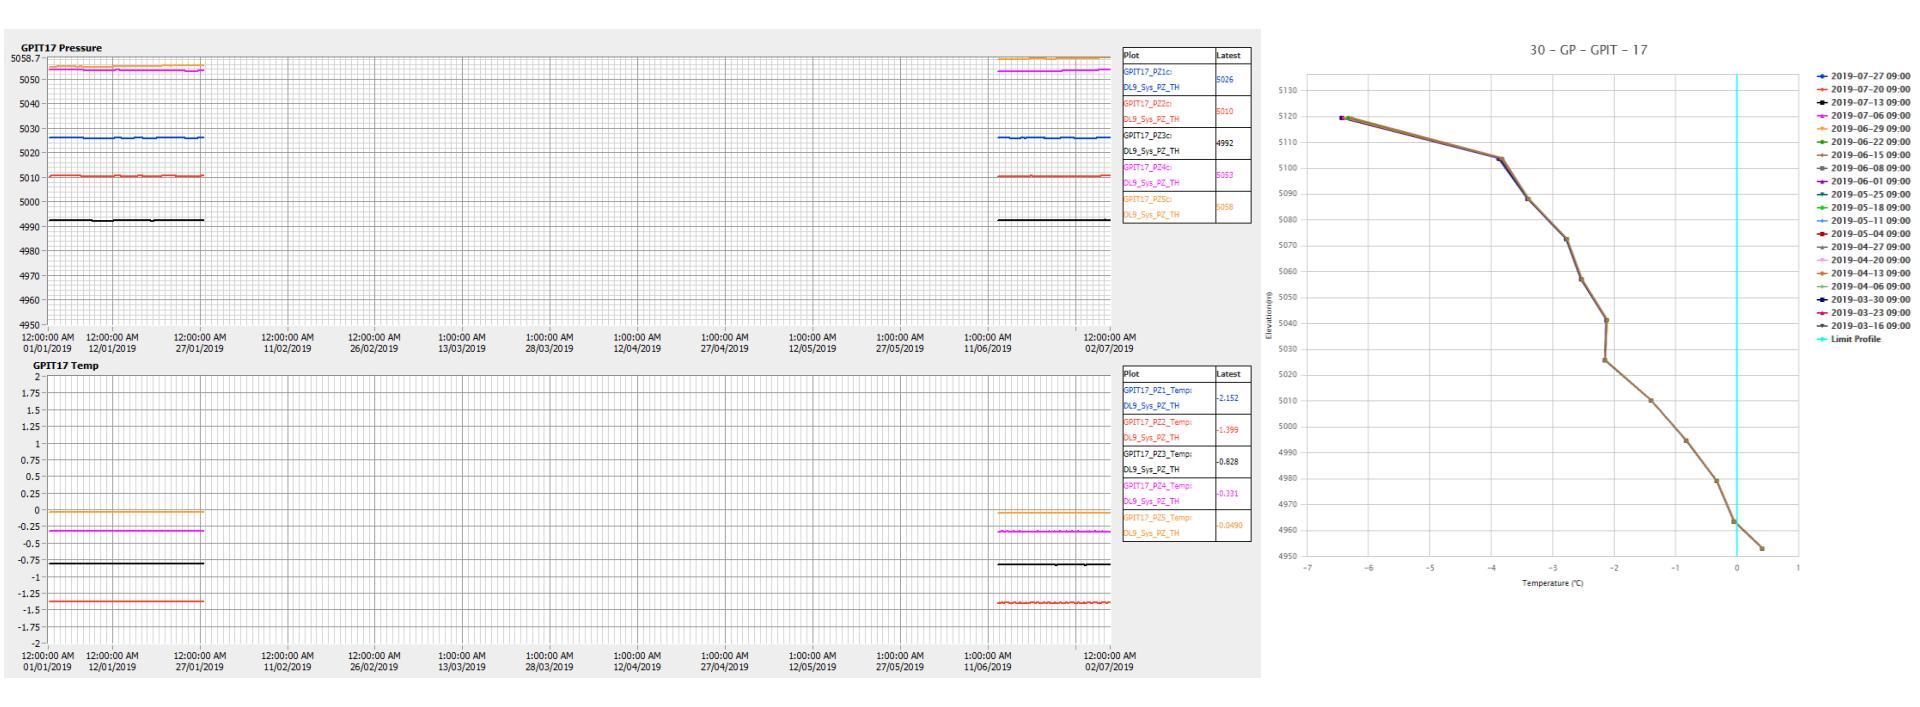
GPIT-17-PZ-1-2-3-4-5, GPIT-17-TH

- Piezometers stopped recording data on January 27th but were fixed on June 14th. No anomalies in data observed.
- TH-GPIT-17 is in the permafrost from top at elevation 5119 to 4962. The first bead temperature change is consistent with the cooling trend at this time of year. This is consistent with the previous years and with the thermal dynamics of the area.

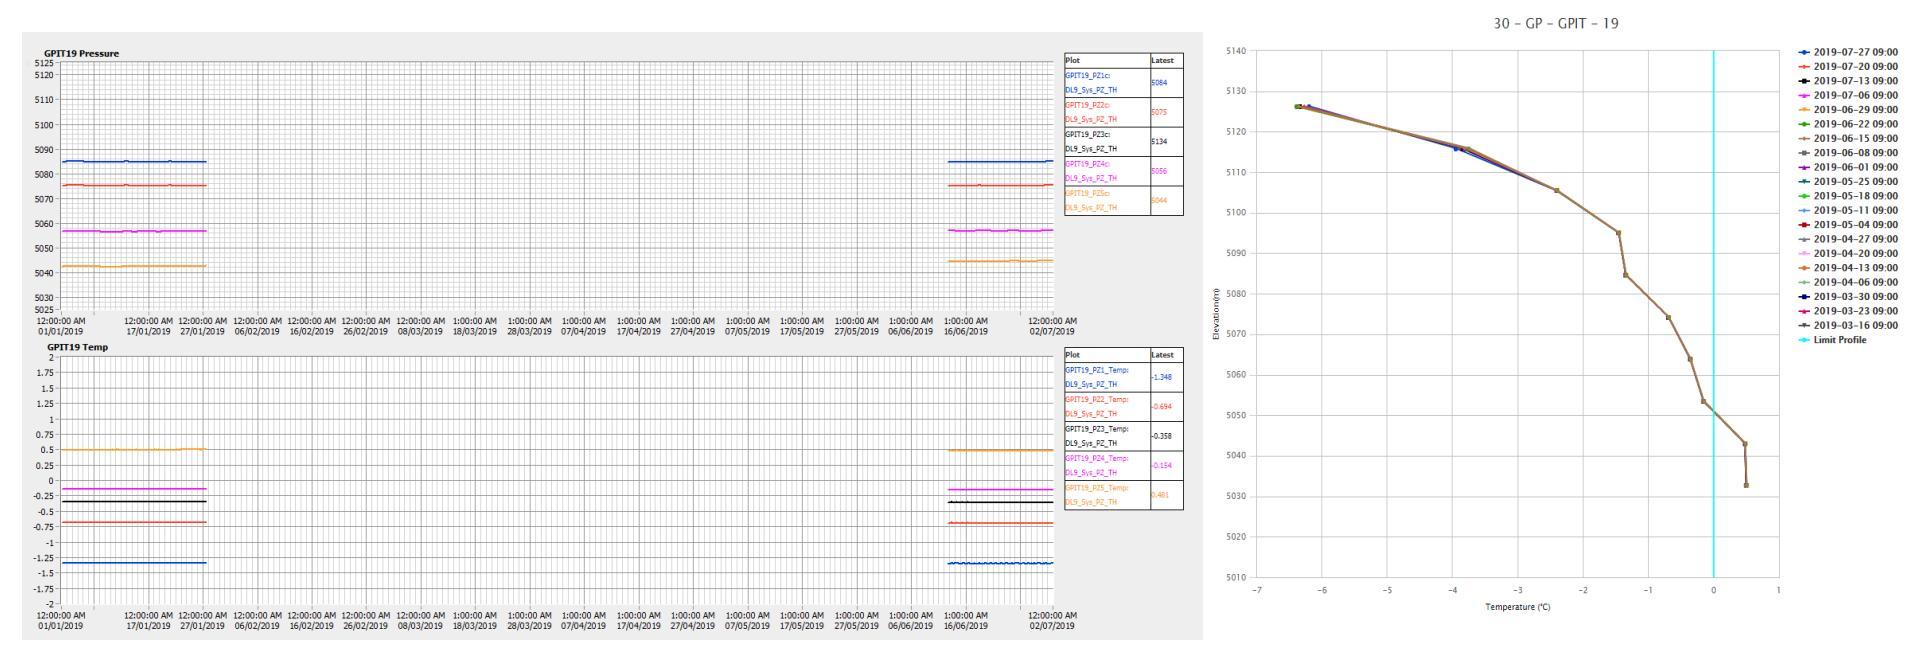
GPIT-19-PZ-1-2-3-4-5, GPIT-19-TH

- Piezometers stopped recording data on January 27th but were fixed on June 14th. No anomalies in data observed.
- TH-GPIT-19 is in the permafrost from top at elevation 5126 to 5051. The first bead temperature change is consistent with the cooling trend at this time of year. This is consistent with the previous years and with the thermal dynamics of the area.

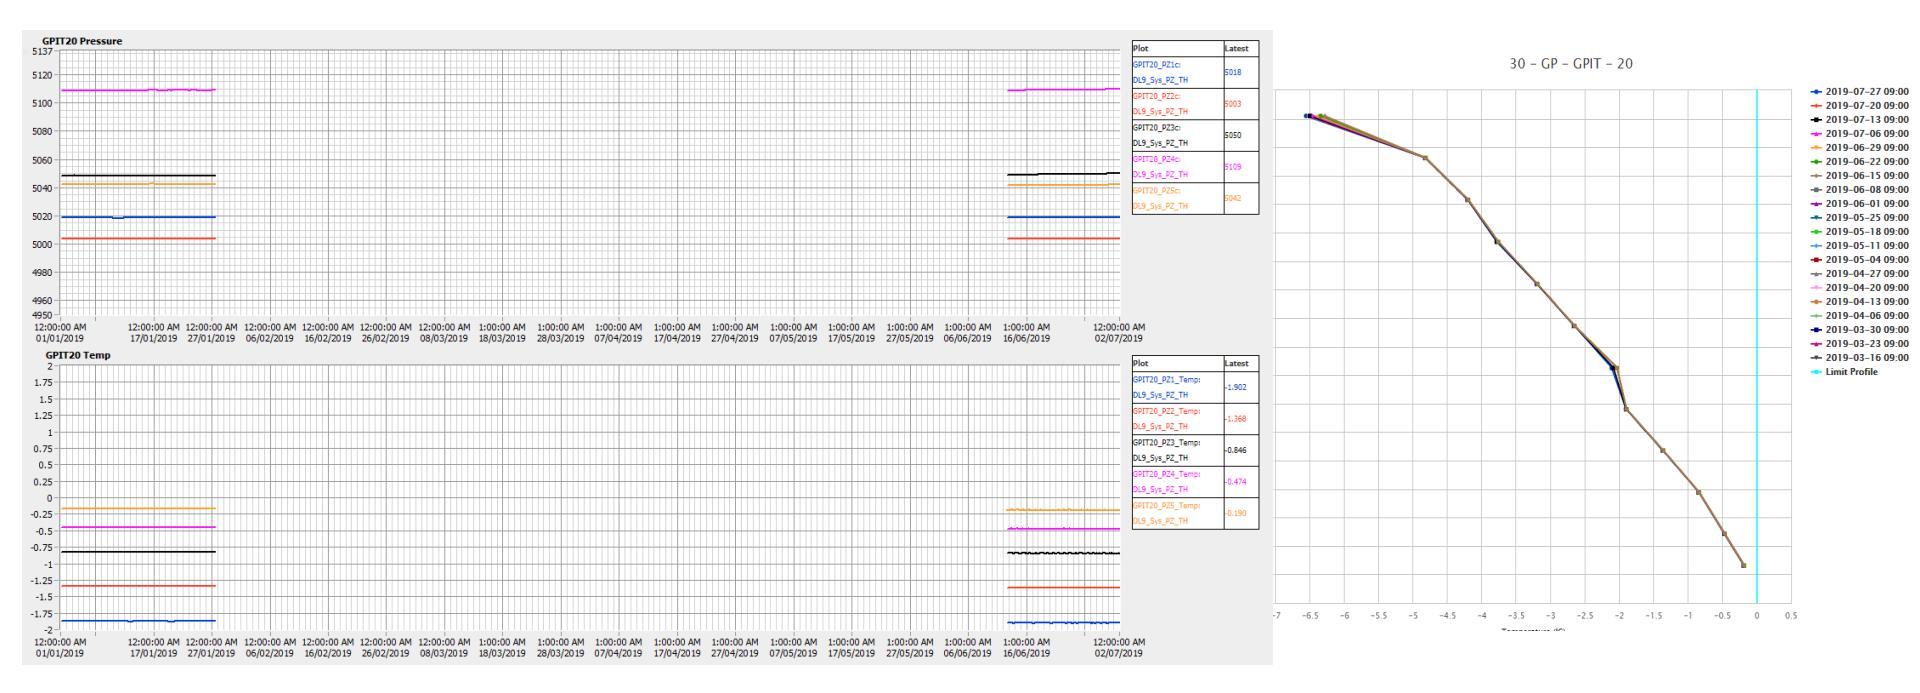
GPIT-20-PZ-1-2-3-4-5, GPIT-20-TH

- Piezometers stopped recording data on January 27th but were fixed on June 14th. No anomalies in data observed.
- TH-GPIT-20 is in the permafrost on its entire length from is top at elevation 5121 to the bottom at 4963. The first bead temperature change is consistent with the cooling trend at this time of year. This is consistent with the previous years and with the thermal dynamics of the area.

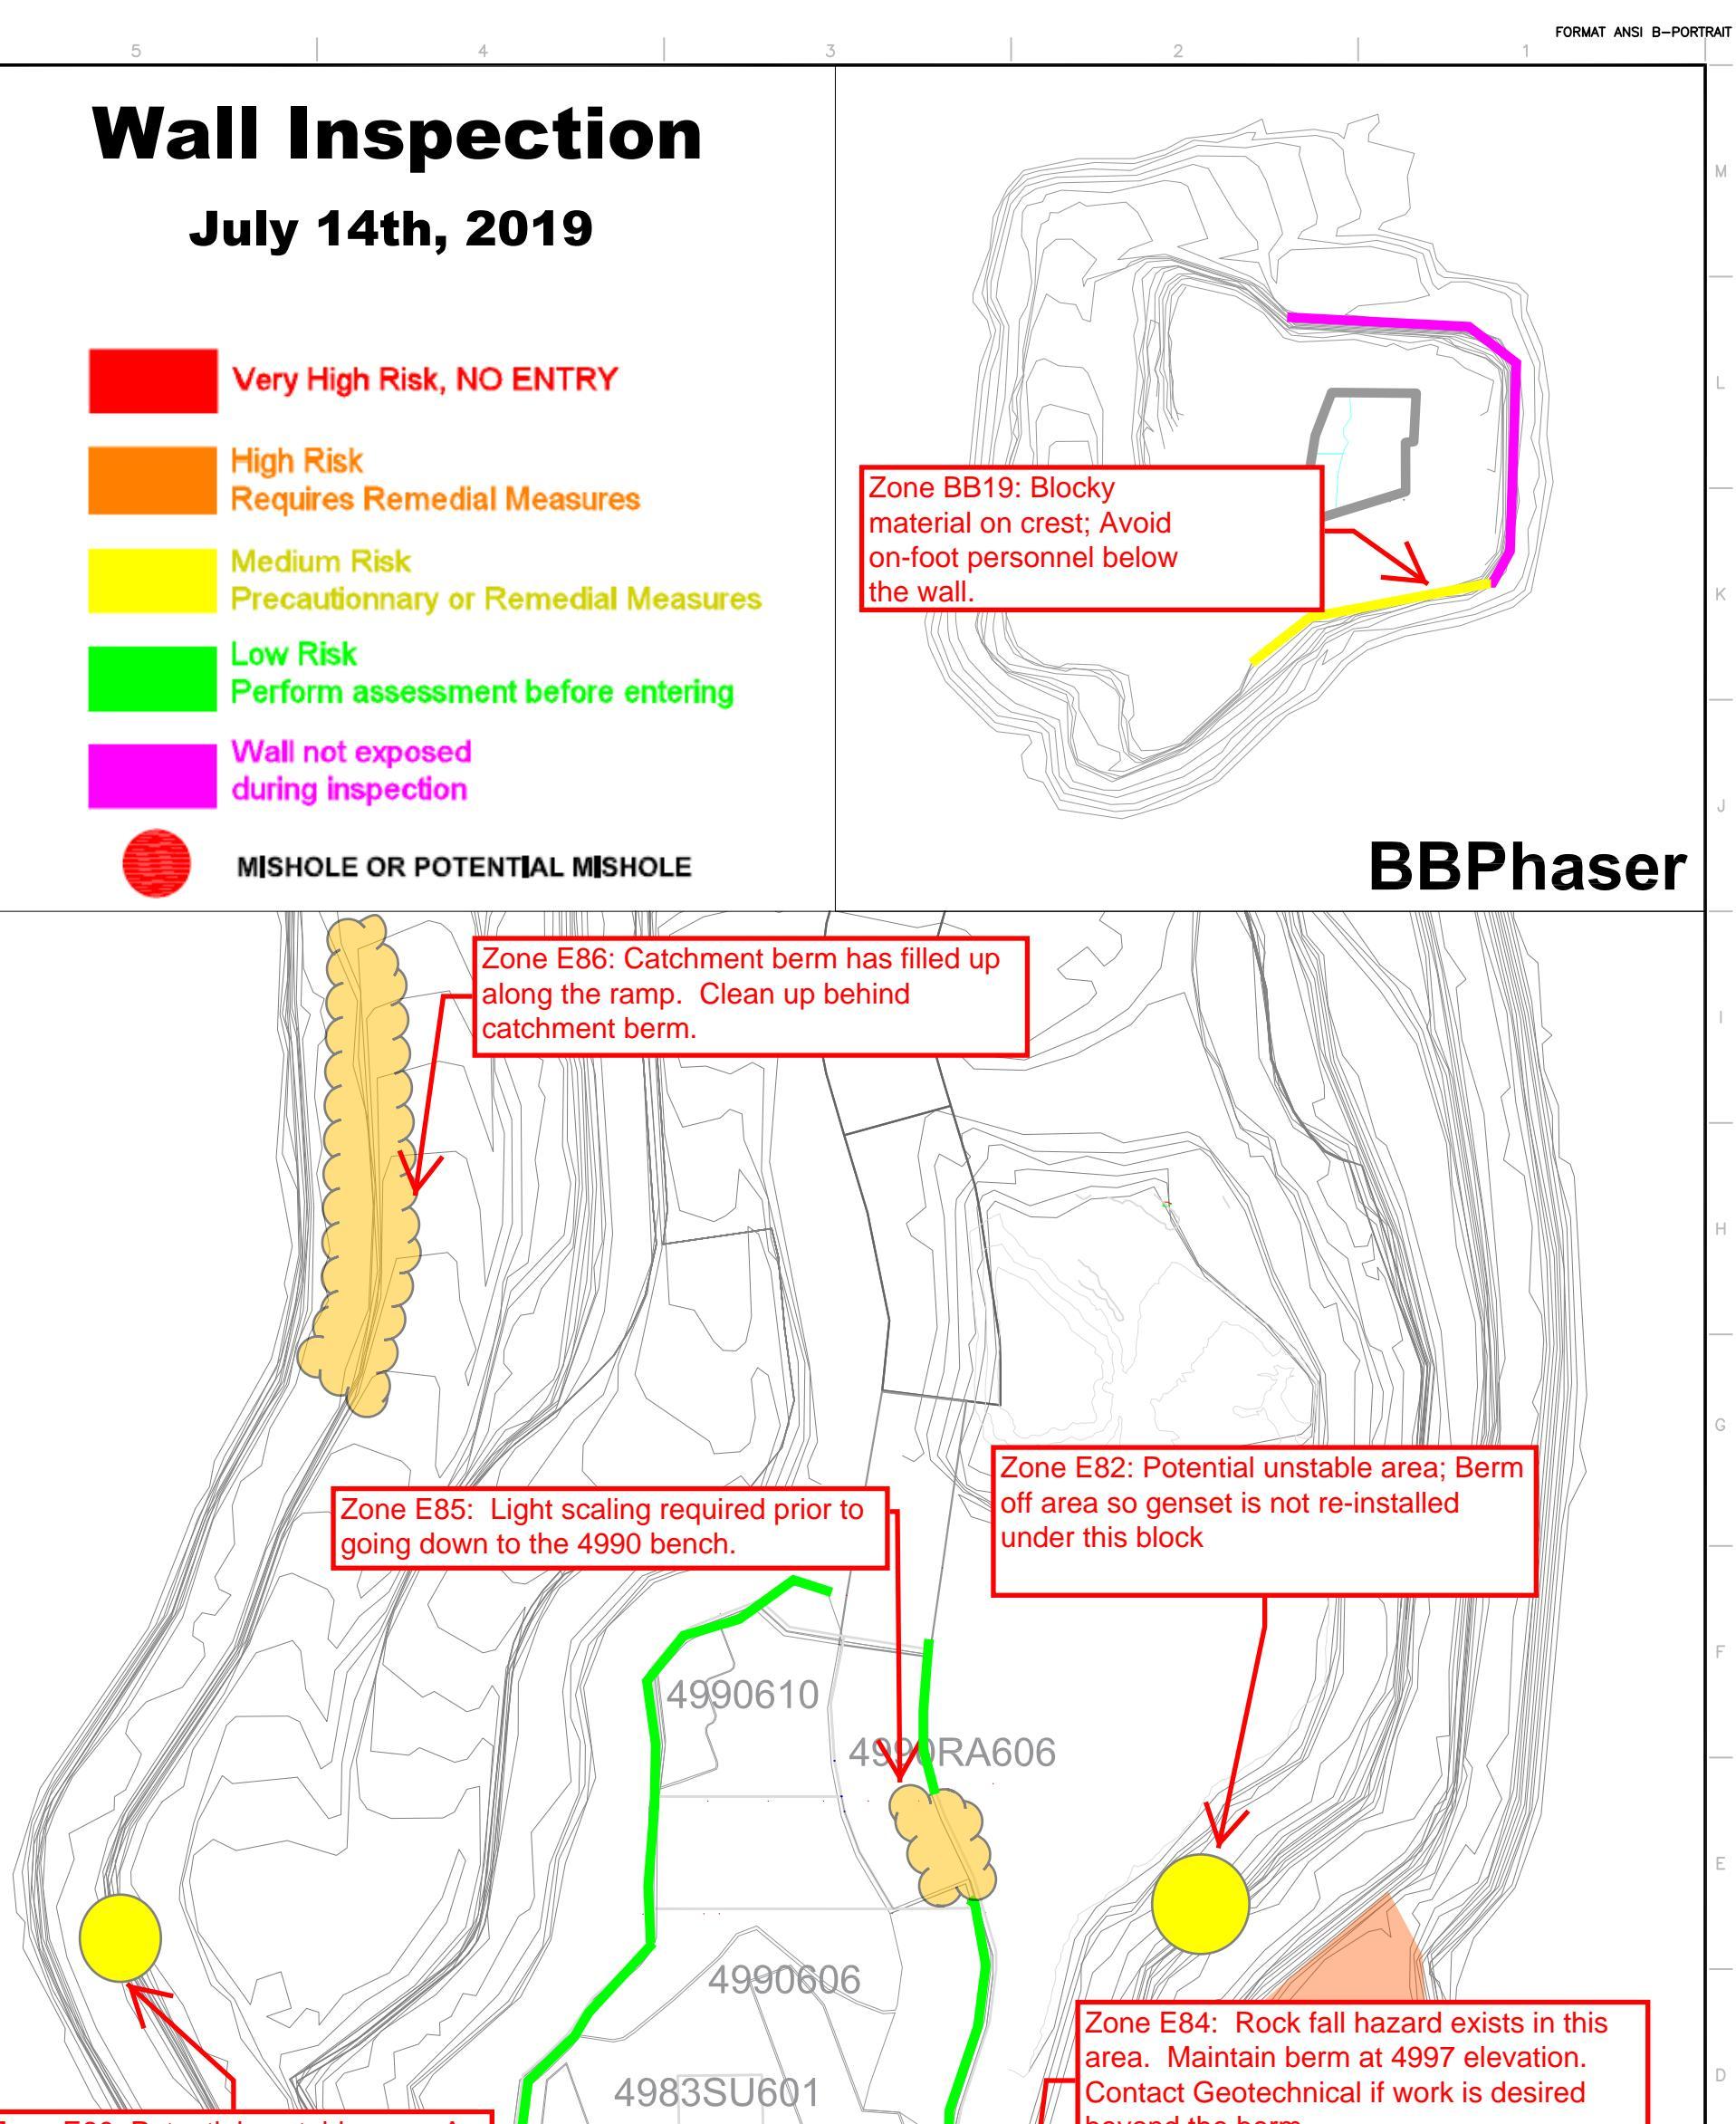
СВ	Zone E80: Potential unstable area; A rock fall occurred in this zone last year. Maintain the berm at the switchback, look for unusual debris ir the area, frequent visual monitoring.	Zone E71: B action for are monitoring.	erm and step-out at 50 ea. Monitored by rada Use caution when wor	beyon beyon 004 was reme ir and visual rking below at	d the berm. E5 Ram access edial rea at	p: Restricted for inspection Pit E	C
			SURVEY CHECK DATE	MODIFIED BY	DATE		v
A			GEOLOGY CHECK DATE			WALL INSPECTION	A
			ENGINEERING CHECK DATE			July 14th 2019	
	THE INFORMATION HERE ON IS THE PROPERTY OF ASING-FLOLE LTD, NO MIST BE RETURNED LIPON REQUEST.	ICO EAGLE					
	WHOUT WITTEN FERNISSION, ANY COPPING TRANSMITH, TO OTHERS AND ANY USE ELECT THAT FOR WHOLI IT IS LONGED ARE FROMHED. (C) Addred-Fare LID.	MEADOWBANK			sc	ALE NTS DATE FILE.DWG	G
	5	4	3		2	1

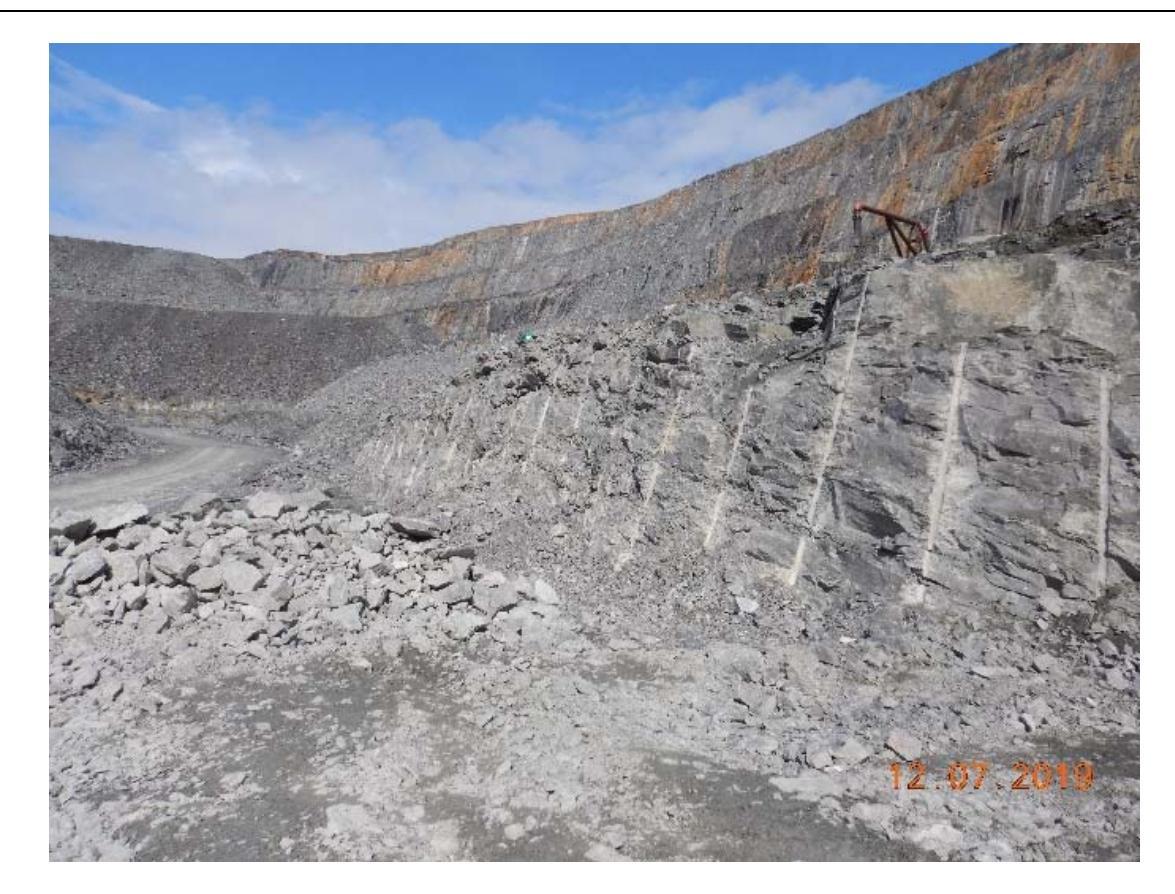
Zone E85: E5, 5004 Bench: Minor scaling prior to any work below these walls at 4990

Zone: E85 Pit: E5 Wall: East <u>Bench:</u> 5004	New: Loose rocks exist at the crest of the 5004 bench. This could present a rock fall hazard for future work at the 4990 bench.	UPDATE: Light scaling prior to working at the 4990 bench.	Prior to beginning work in this area on the 4990 bench	Completed July 14, 2019

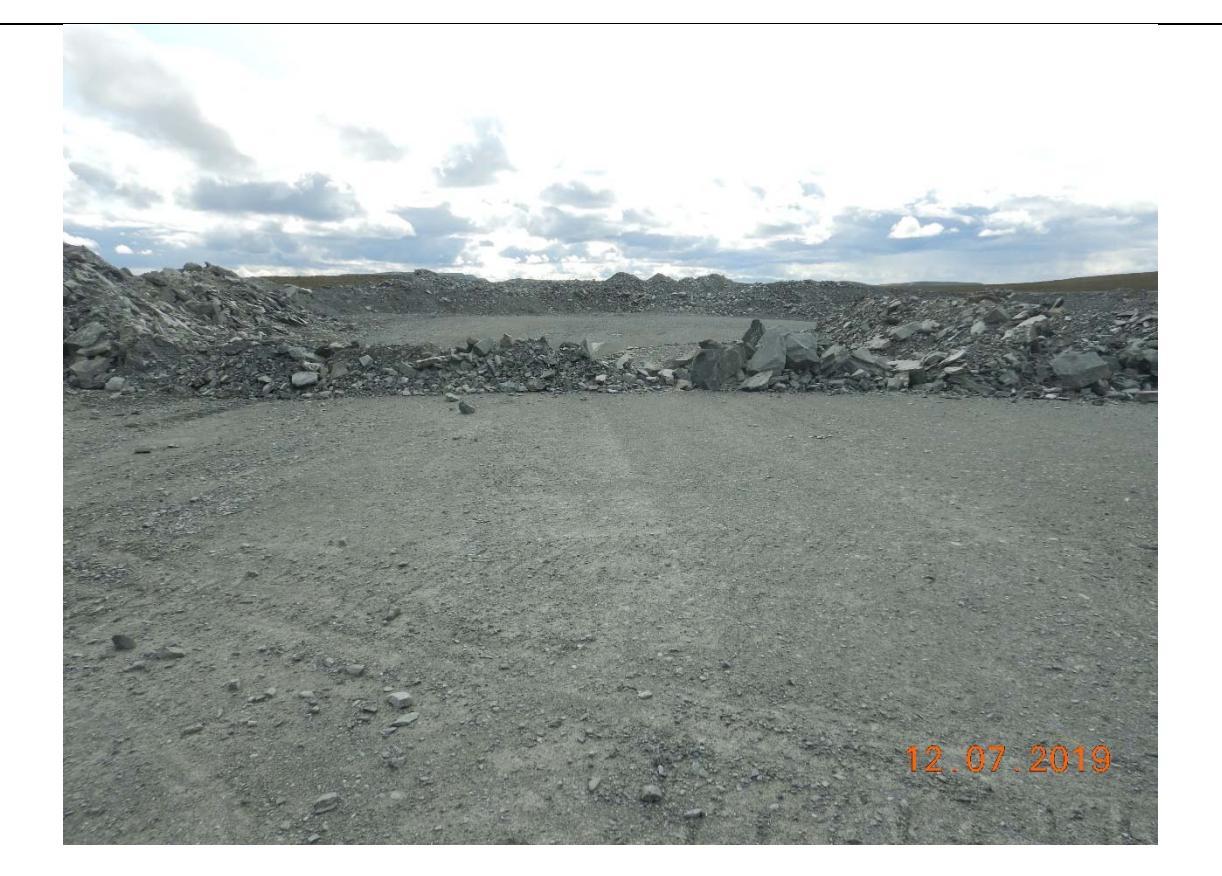
Zone BB19: BB Phaser, South Wall: BB Phaser bermed off at entrance. If re-opened bottom of the pit should be re-assessed.

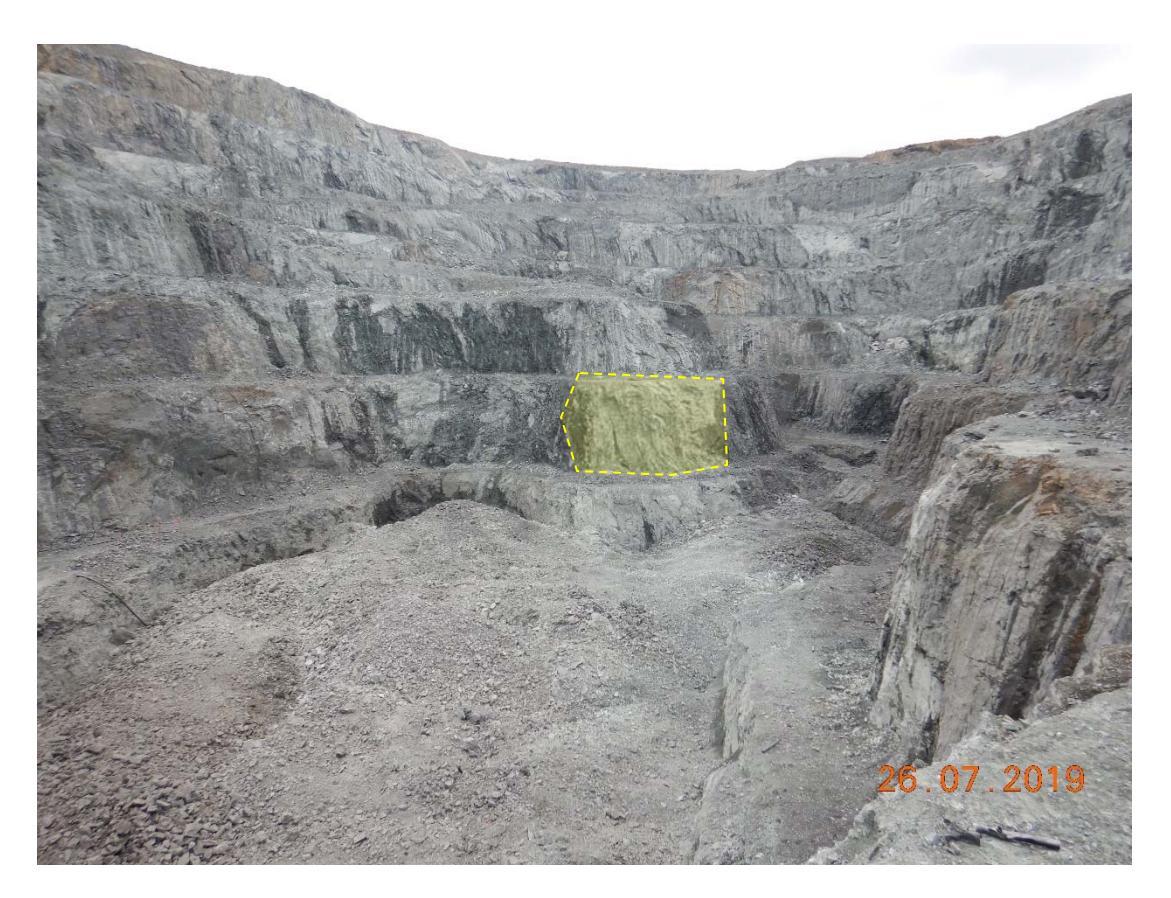
Zone E71: E5 South Wall: Potential wedge and cracks forming. Bumper in place.

Location	Observations	Recommendations	Due date	Date completed
Zone: E71 Pit: E5 Wall: South Bench: 5004	PREVIOUSLY: Ravelling was observed following the blast of the 4997663 pattern. This corner is made of ultramatic rocks slips dipping toward the east. However, the linear progression previously observed on the radar is not suggesting a trend anymore. UPDATE: Linear progression previously observed on the radar is not suggesting a trend anymore. Added rain fall could increase movement to this area, but nothing has been observed.	PREVIOUSLY Keep focusing on monitoring the zone and use caution when working below this area on the 4997 bench. UPDATE: Same as previous.	Ongoing	
Zone: E80 <u>Pit: E5</u> <u>Wall:</u> West <u>Bench:</u> 5067 Status:	PREVIOUSLY: There is no indication that additional rocks has fallen. UPDATE: Same as previous.	PREVIOUSLY: Maintain the bumper in place. Look for unusual debris in the area; continue frequent monitoring of the zone. UPDATE: Same as previous.	Ongoing

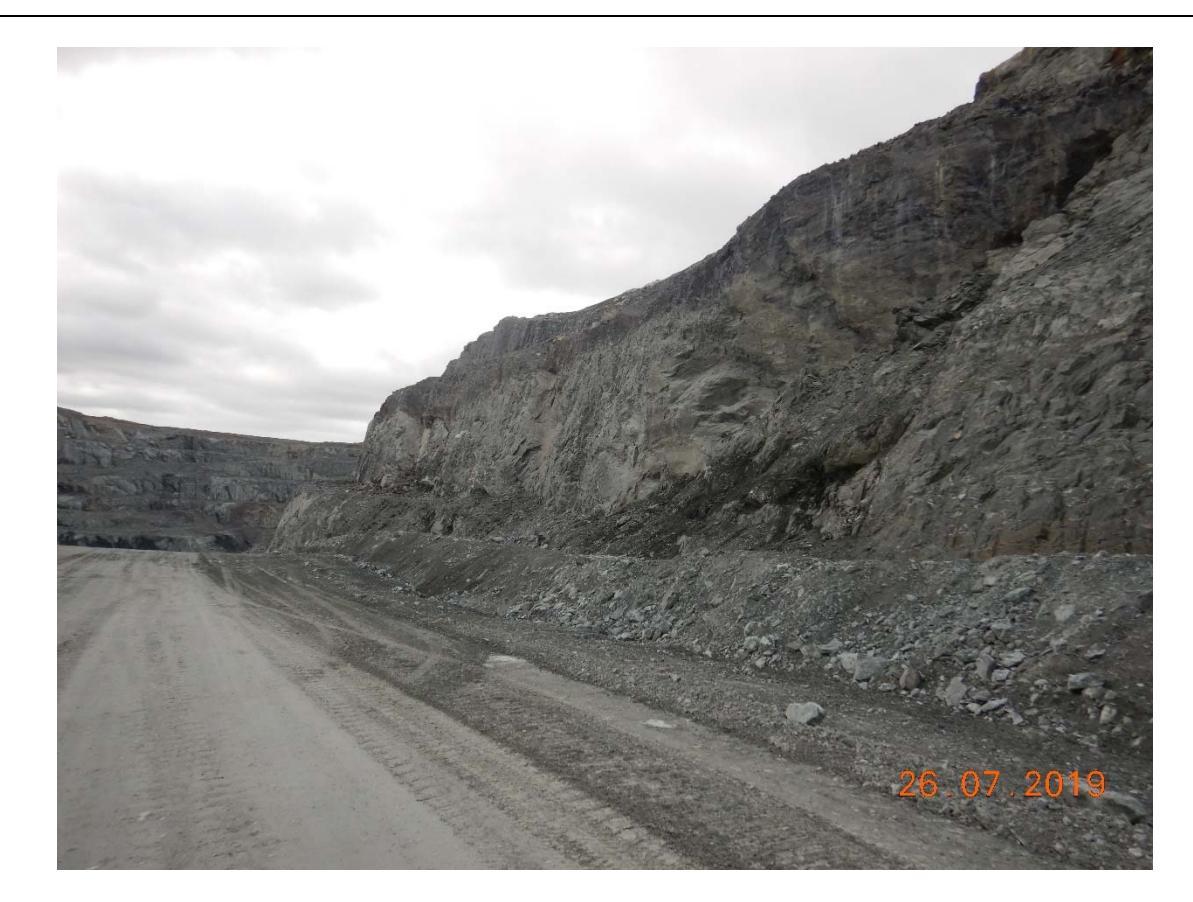
Zone E86: E5, West Wall: Need to clean up catchment berm along the ramp

Zone: E86 Pit: E5 Wall: East Bench: 5004	New: Catchment berm along the haulage ramp is filling up with loose rock.	New: Clean behind catchment berm	July 28, 2019

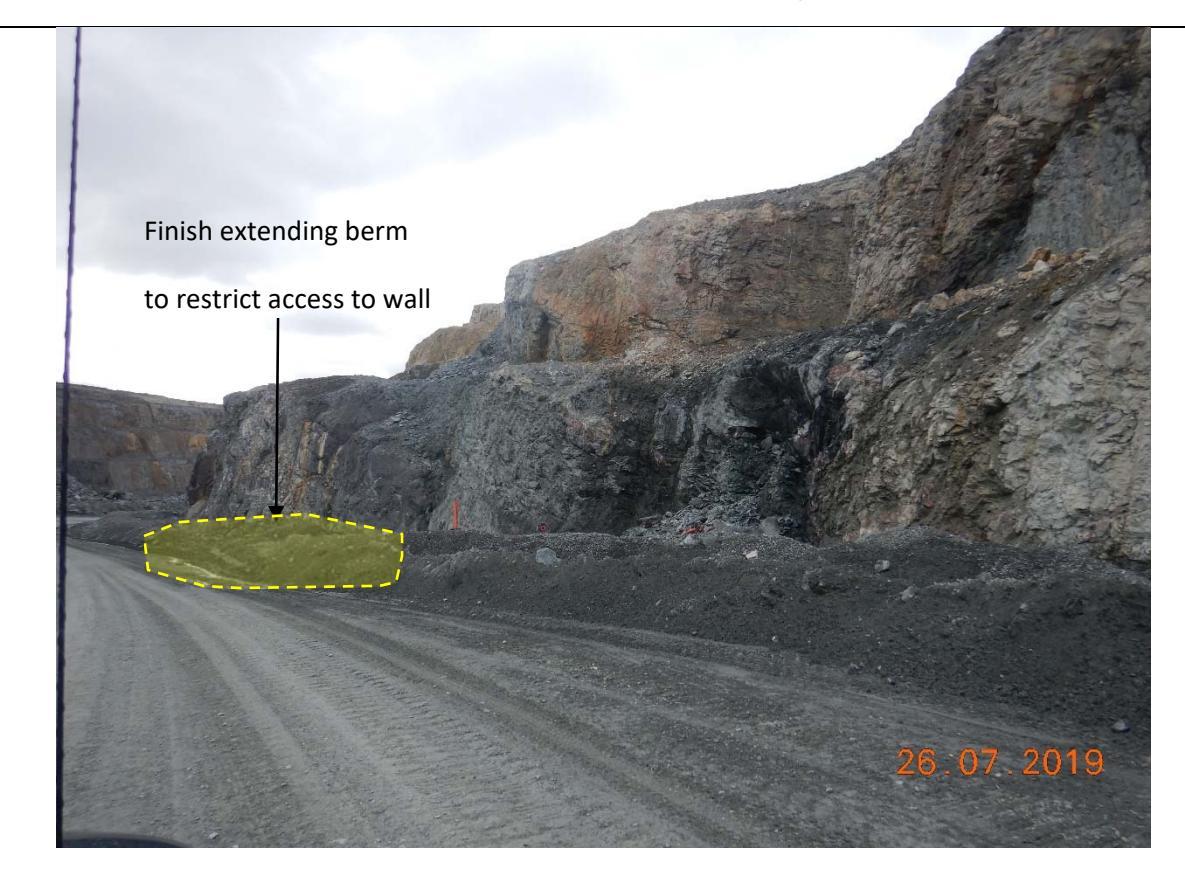
Zone E88: E5, West Wall Ramp: Need to extend safety berm to other berm.

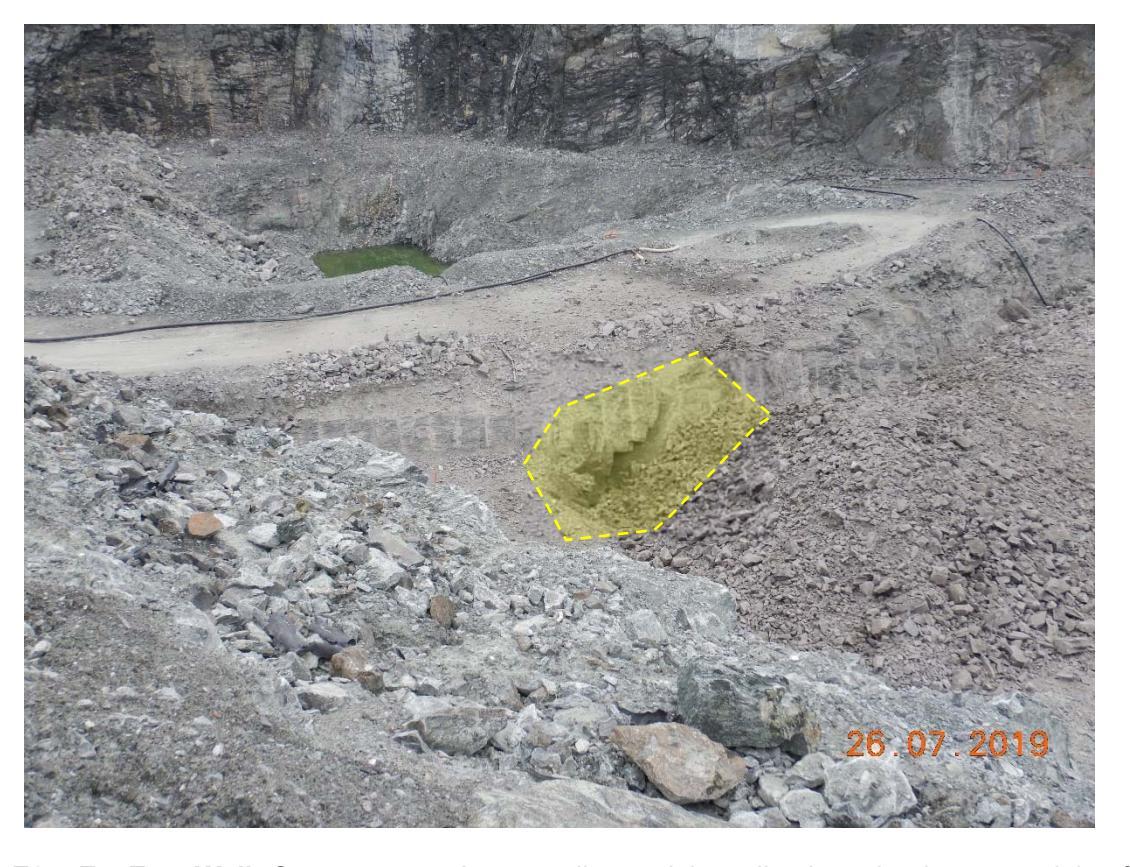
Zone E87: E5, East Wall: Once access, clean up all material on slip plane that has potential to fall. Put in place a buttress to prevent any falls.

<u>Zone:</u> E87 <u>Pit: E5</u> <u>Wall:</u> East <u>Bench:</u> 4990 _{Status:}	New: After blast, rock has become unstable and loose, along the slip plane that was now exposed.	New: Prior to going lower, create a buttress to help keep all material along the wall.	July 29 th , 2019	July 29 th , 2019
Zone: E88 <u>Pit: E5</u> <u>Wall:</u> West <u>Bench:</u> Ramp Status:	New: Rock fall occurred in ramp, near old sump.	New: Extend berm to restrict access and keep danger tape in place. No personnel to be in this area.	ASAP	July 28 th , 2019
<u>Zone:</u> BB19 <u>Pit:</u> BB Phaser <u>Wall:</u> South <u>Bench:</u> 5110 Status:	PREVIOUSLY: The pit is now currently inactive. Continue with previous recommendations if active again. UPDATE: Same as previous if reactivated.	PREVIOUSLY: Personnel on foot should not be venturing close to the wall in the zone. A berm could be build in the eventuality of drilling another pattern close by the wall. Update: Same as previous if reactivated.	TBD
