Meadowbank 2020 Annual Pit Slope Performance Review

2020 ANNUAL PIT SLOPE Performance Review

Meadowbank Mine, Nunavut

ISSUED FOR USE 704-ENG.ROCK03163-01

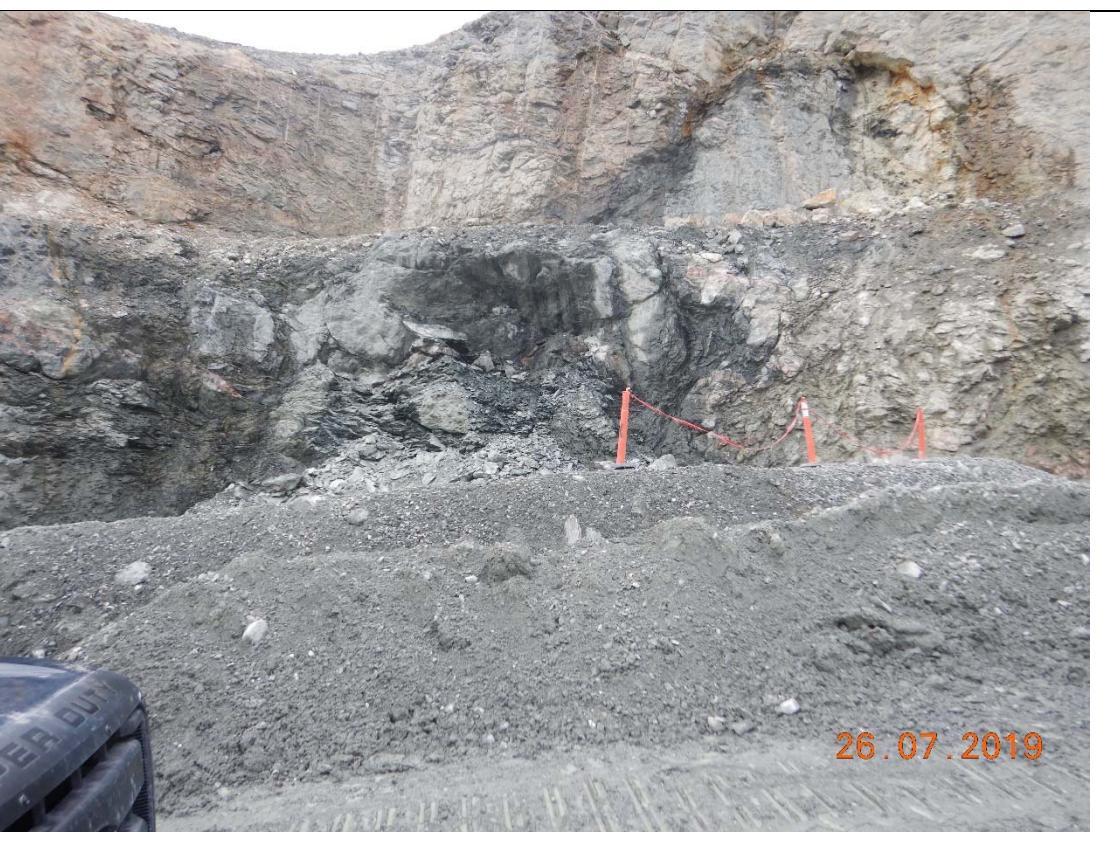
Zone E88: E5, West Wall Ramp: Keep danger tape to restrict access to wall.

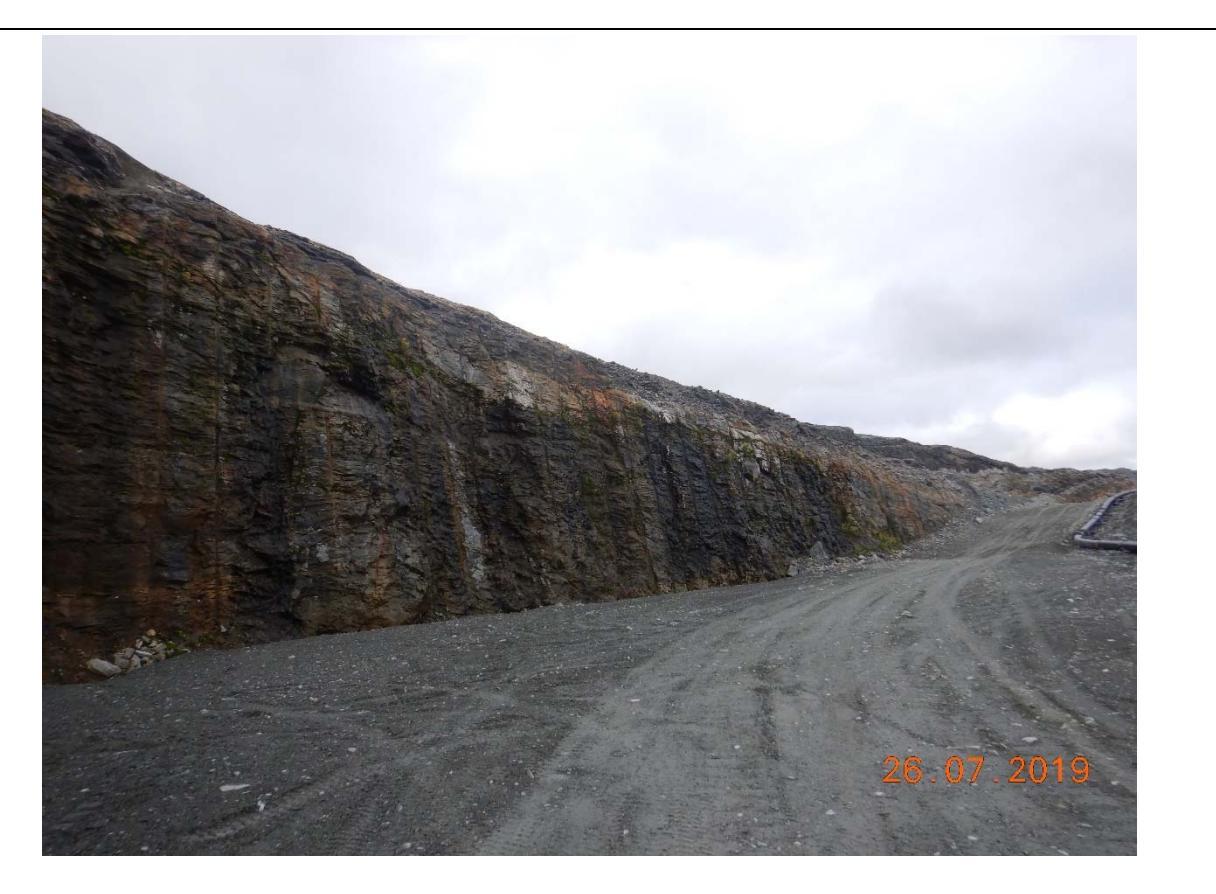
Zone BB19: BB Phaser, South Wall: BB Phaser bermed off at entrance. If re-opened bottom of the pit should be re-assessed

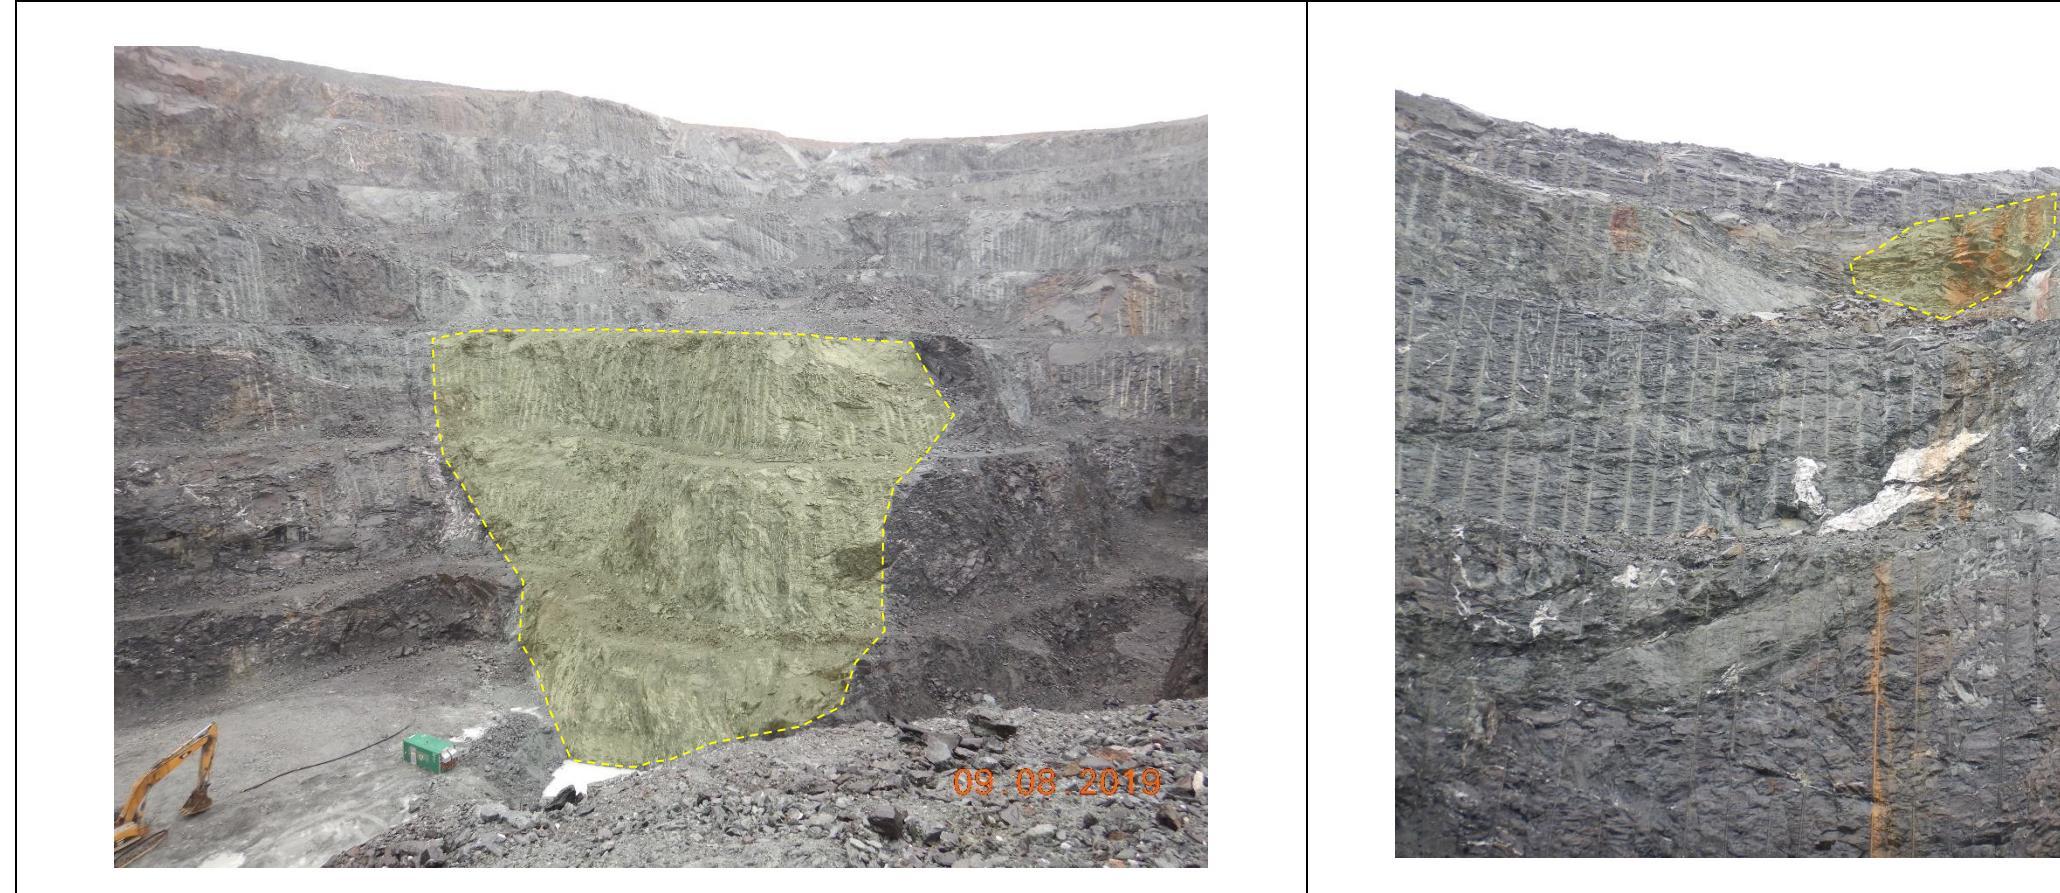
Zone E71: E5 South Wall: Potential wedge and cracks forming. Continuous Monitoring.

Location	Observations Recommendations		Due date	Date completed
Zone: E71 <u>Pit:</u> E5 <u>Wall:</u> South <u>Bench:</u> 5004 Status:	PREVIOUSLY: Ravelling was observed following the blast of the 4997663 pattern. This corner is made of ultramafic rocks slips dipping toward the east. However, the linear progression previously observed on the radar is not suggesting a trend anymore. UPDATE: Linear progression previously observed on the radar is not suggesting a trend anymore. Added rain fall and rock morphology increase the potential for wedges and rock fall.	PREVIOUSLY: Keep focusing on monitoring the zone and use caution when working below this area on the 4997 bench. UPDATE: The same recommendations applies for the 4990 bench.	Ongoing	NA
Zone: E80 <u>Pit:</u> E5 <u>Wall:</u> West <u>Bench:</u> 5067 Status:	 PREVIOUSLY: This zone constitutes a potential unstable area. A major rock fall did occurred last year and now with the freshet season, water is visible on the right side of the structure when facing it. Cracks are also visible on the crest of the potential hazard. In addition to that, the radar does not cover the zone. However, there is 3 catchments and a bumper to contain a possible rock fall. The bumper was built last year and is still in place and effective. UPDATE: There is no indications that rocks has fallen nor tension cracks have widened. 	PREVIOUSLY: Maintain the bumper in place. Look for unusual debris in the area; continue frequent monitoring of the zone. UPDATE: Same as previous.	Ongoing	NA

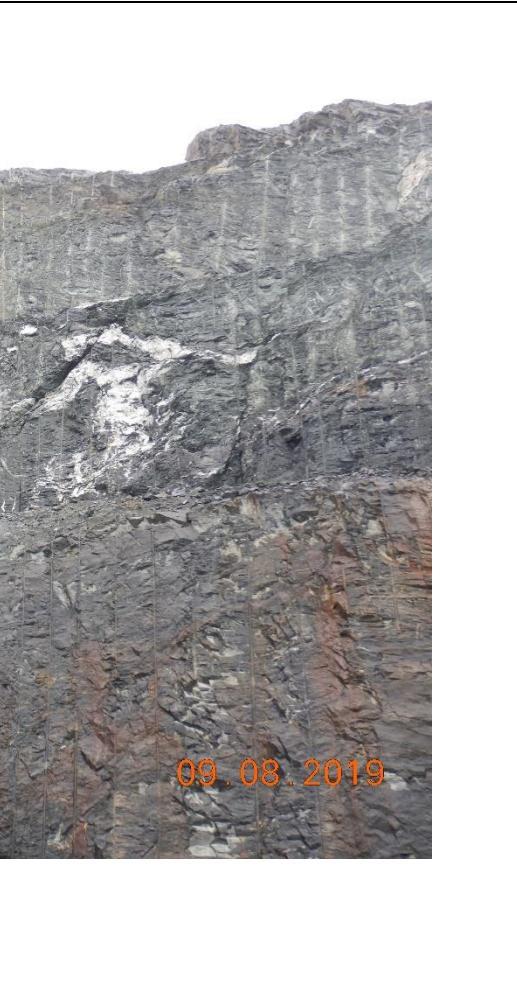
Zone E80: E5 West Wall: Potential unstable area.

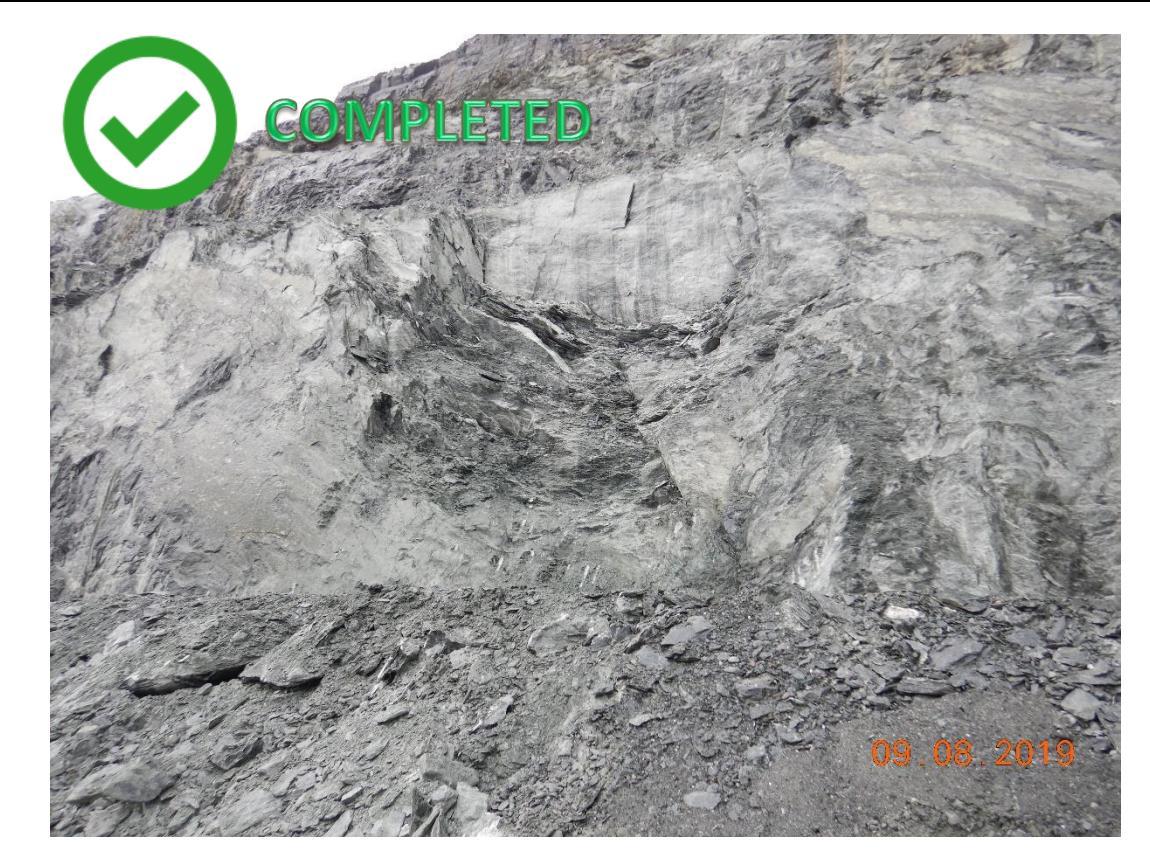
<u>Zone E86:</u> E5, West Wall Ramp: Catchment berm was cleaned up and extended.

Zone: E86 <u>Pit:</u> E5 Ramp <u>Wall:</u> West <u>Bench:</u> Ramp Status:	PREVIOUSLY: Catchment berm along the haulage ramp is filling up with loose rock. COMPLETED: The berm was cleaned up where a small rock fall did occurred.	PREVIOUSLY: Clean behind catchment berm UPDATE: Continue to clean the berm whenever it is required.	July 28, 2019	August 8, 2019

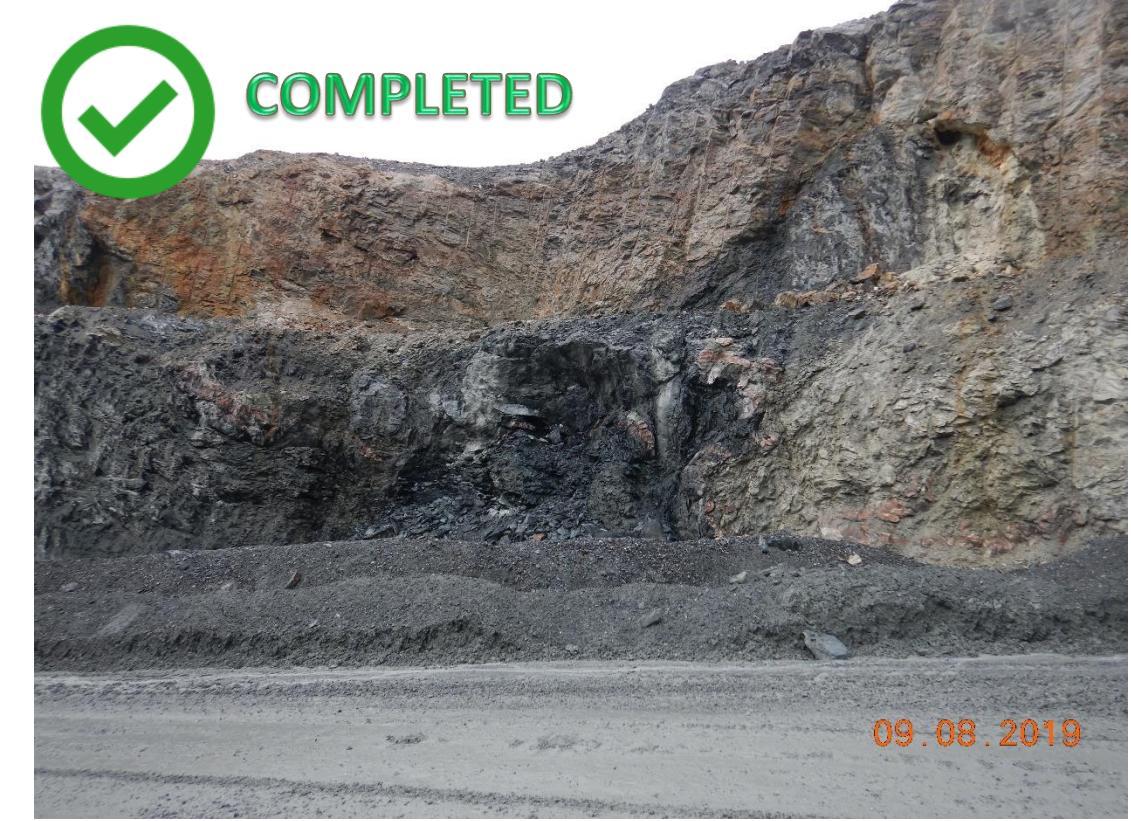
Zone E82: E5, South East Wall: Potential ultramafic wedge. Build berms nest to the dewatering ramp.

<u>Zone:</u> E82 <u>Pit:</u> E5 <u>Wall:</u> South East <u>Bench:</u> 5067 Status:	 PREVIOUSLY: This zone constitutes a potential unstable area. A wedge could be forming into this ultramafic rock structure as cracks and crumbles berms can be observed. Historically, rock falls did occurred in the same kind of structures. However, radar monitoring of the zone does not indicates an imminent threat. UPDATE: A portion of the berm above the structure progressively crumbled and has ended up on the catchment meaning that there is possible movement of the structure itself. There is a slight positive trend on the radar but it does not indicate an imminent threat so far. A specific target was input into the Radar for this area. 	PREVIOUSLY: Continue to monitor the zone with the radar and by visual inspection of the wall and crest. Keep genset away from high wall and close off area so it is not re-installed below the high wall. UPDATE: Build a berm on the dewatering ramp below protecting personnel and equipment from potential falling debris.	August 11, 2019	NA

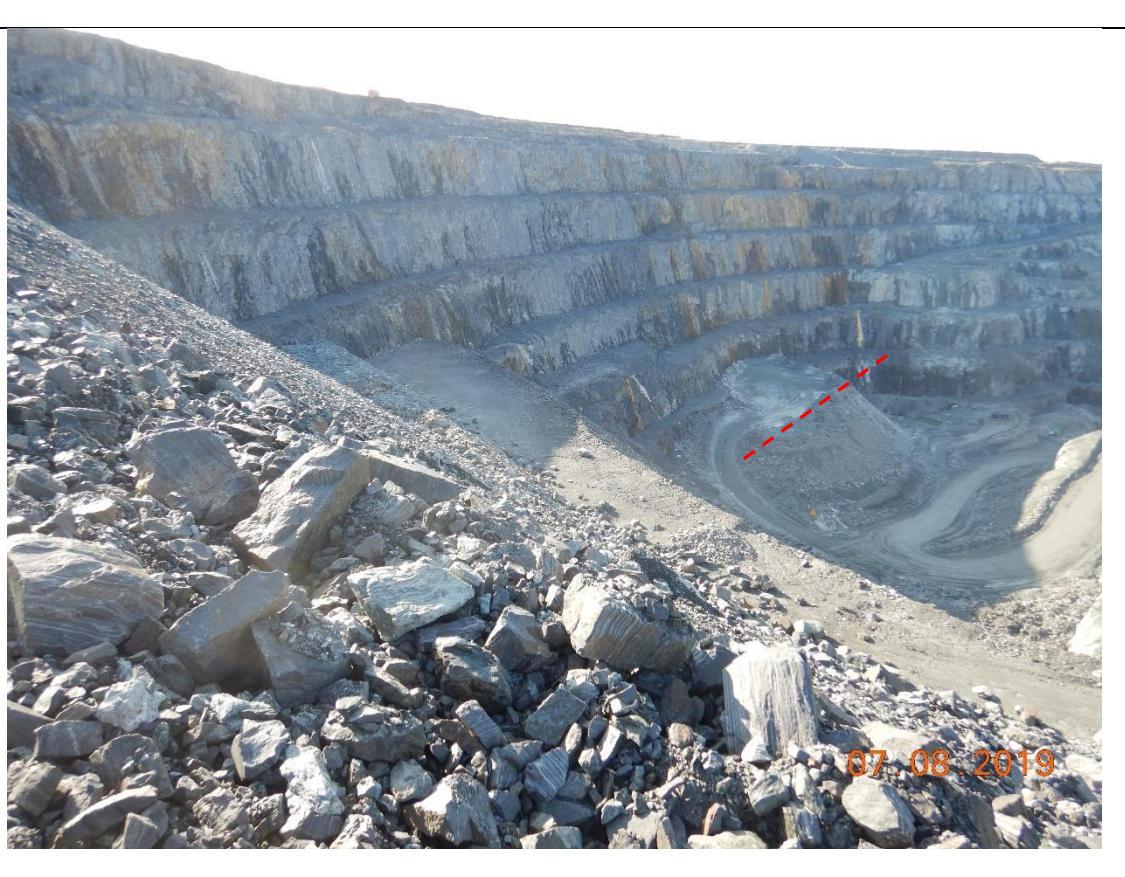
Zone E88: E5, West Wall Ramp: Berm was extended all around the old sump containing further rock falls.

Zone: E88 <u>Pit:</u> E5 <u>Wall:</u> West <u>Bench:</u> Ramp _{Status:}	PREVIOUSLY: A rock fall occurred in the ramp, near the old sump. UPDATE: The area is still unstable and is likely to collapse some more. However the area is well protected and berm was in place prior to the first rock fall event.	PREVIOUSLY: Extend berm to restrict access and keep danger tape in place. No personnel to be in this area. UPDATE: No further recommendation is required	NA	July 20 th , 2019
Zone: E89 <u>Pit:</u> E5 <u>Wall:</u> Dump <u>Bench:</u> 5032 Status:	NEW: The dump has reached it's western and southern limits.	NEW: When building another lift on the dump, do not push further on the west. Keep the berm free of muck at the bottom as the haul road is passing beside.	August 9, 2019	NA
<u>Zone:</u> E90 <u>Pit:</u> E5 <u>Wall:</u> North <u>Bench:</u> 4990 (mid) Status:	NEW: As the mid-bench was mucked, a new section of final wall was exposed. Loose volcanic and ultramafic rocks a present on the wall in front of the pre-shear barrels.	NEW: Scale and clean up debris after the bottom bench is mucked out.	TBD	NA

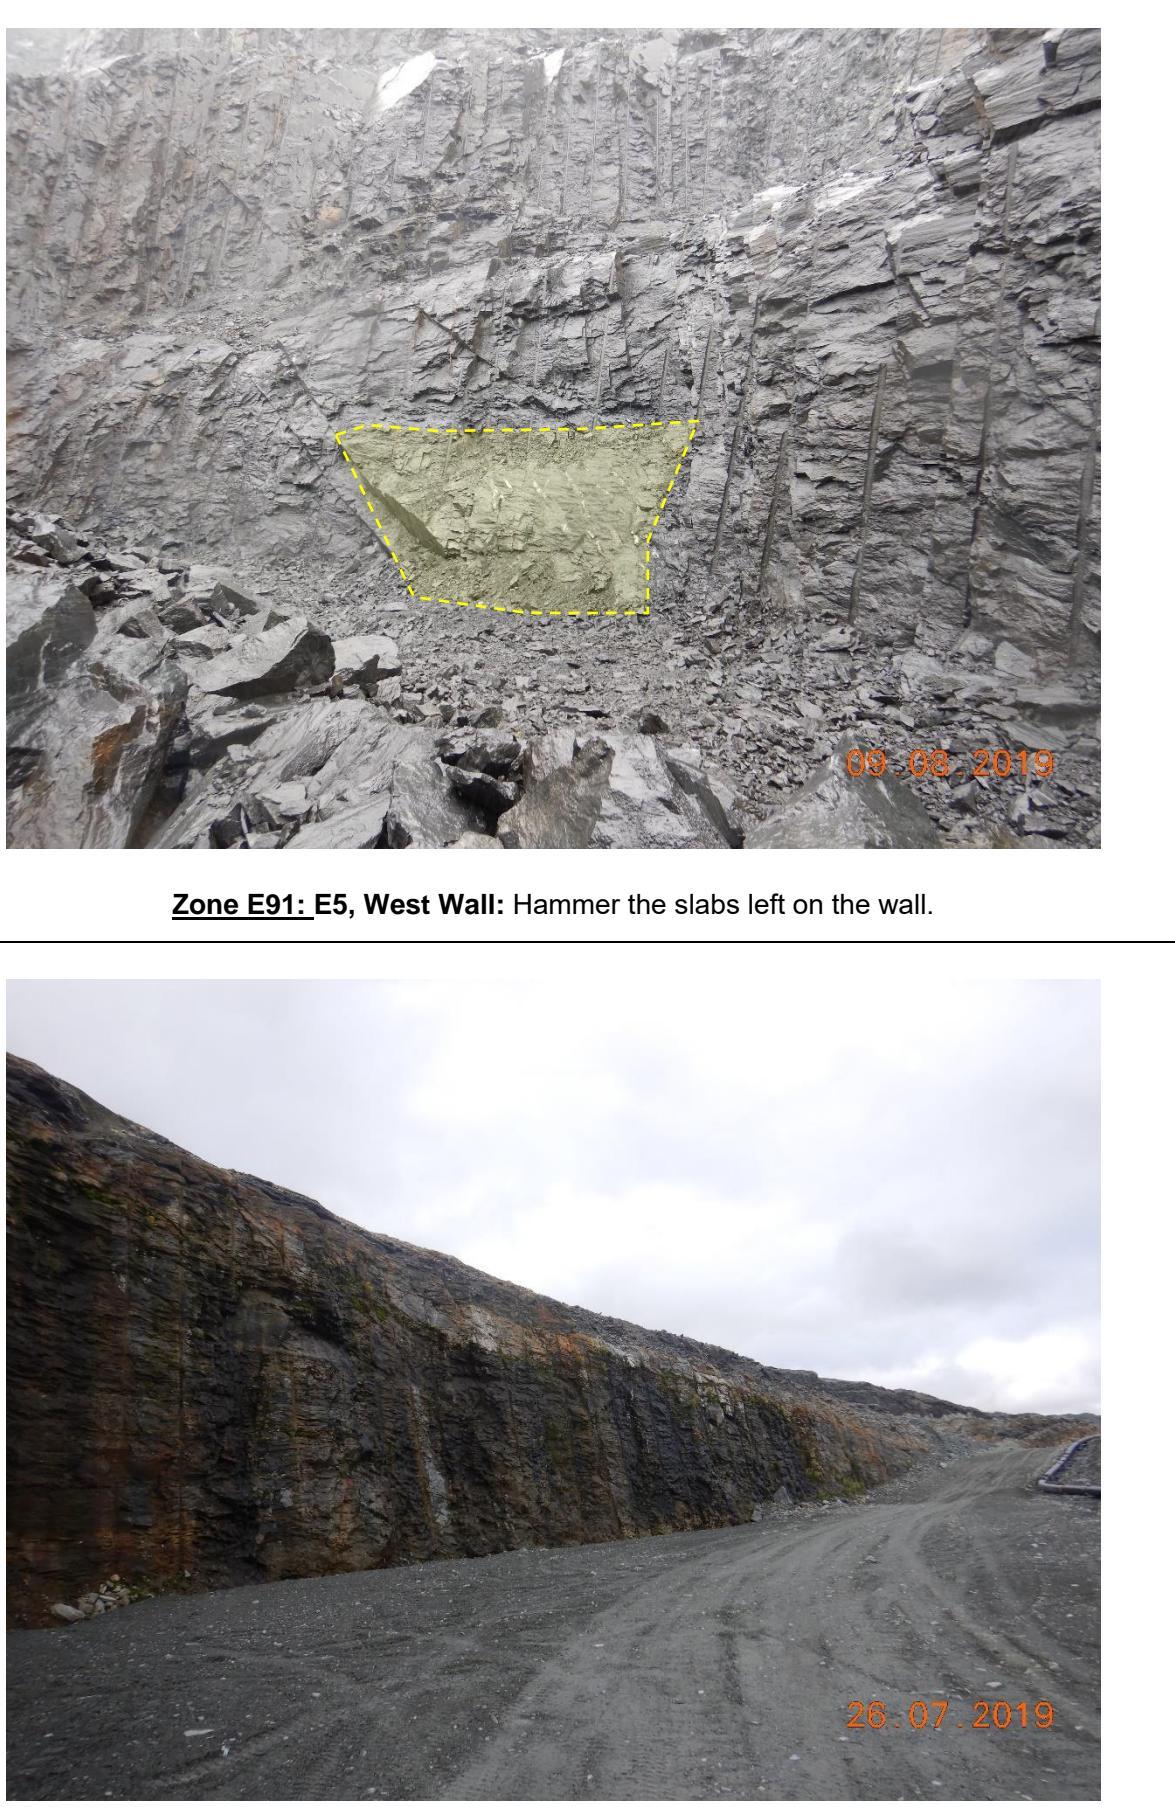
Zone E90: E5, North Wall: Scale the loose rocks on the final wall.

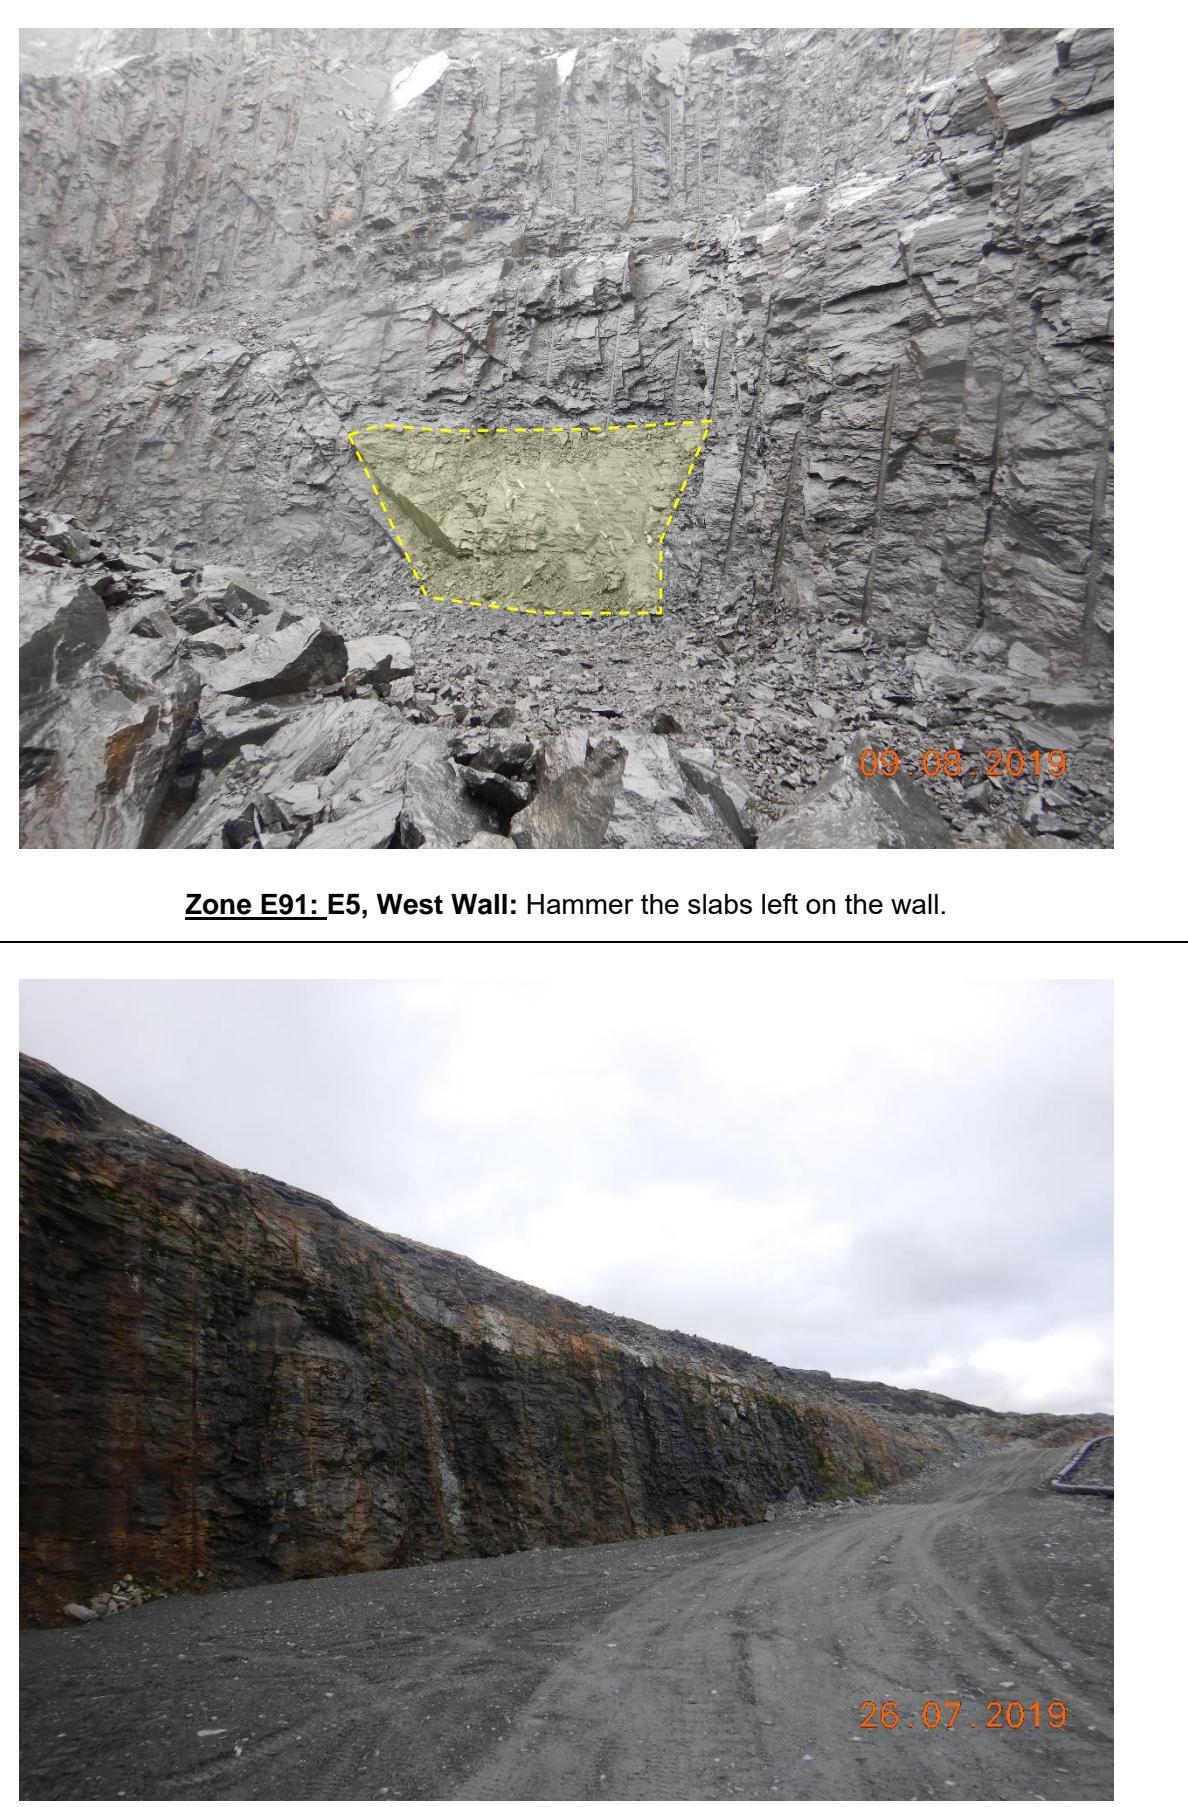
Zone E92: E5 South East Corner: Hammer the corner prior to drill next pattern.

<u>Zone:</u> E91 <u>Pit: E5</u> <u>Wall:</u> West <u>Bench:</u> 4990 (mid) _{Status:}	NEW: Iron formation slips are covering the mid section the high wall.	NEW: Hammer the slips to prevent creating overhangs on the next bench below.	August 23, 2019	NA
Zone: E92 <u>Pit:</u> E5 <u>Wall:</u> S/E Corner <u>Bench:</u> 4990 (mid) Status:	NEW: The junction in between the south and east wall is made of iron formation that was left in place because of the confinement of the blast in the area. A considerable amount of rock is being stuck in front of the pre-shear.	NEW: Hammer the zone preventing overhangs and missing row of holes on the next pattern below.	August 23, 2019	NA
Zone: A01 <u>Pit:</u> A <u>Wall:</u> East <u>Bench:</u> Ramp Status:	NEW: Two potential zone were identified within close distance from each other consisting mainly on undercut wedges and open cracks.	NEW: Build berm around the structure preventing rock fall debris to over spill into the Pit A ramp which is now a dewatering ramp.	NA	August 7, 2019

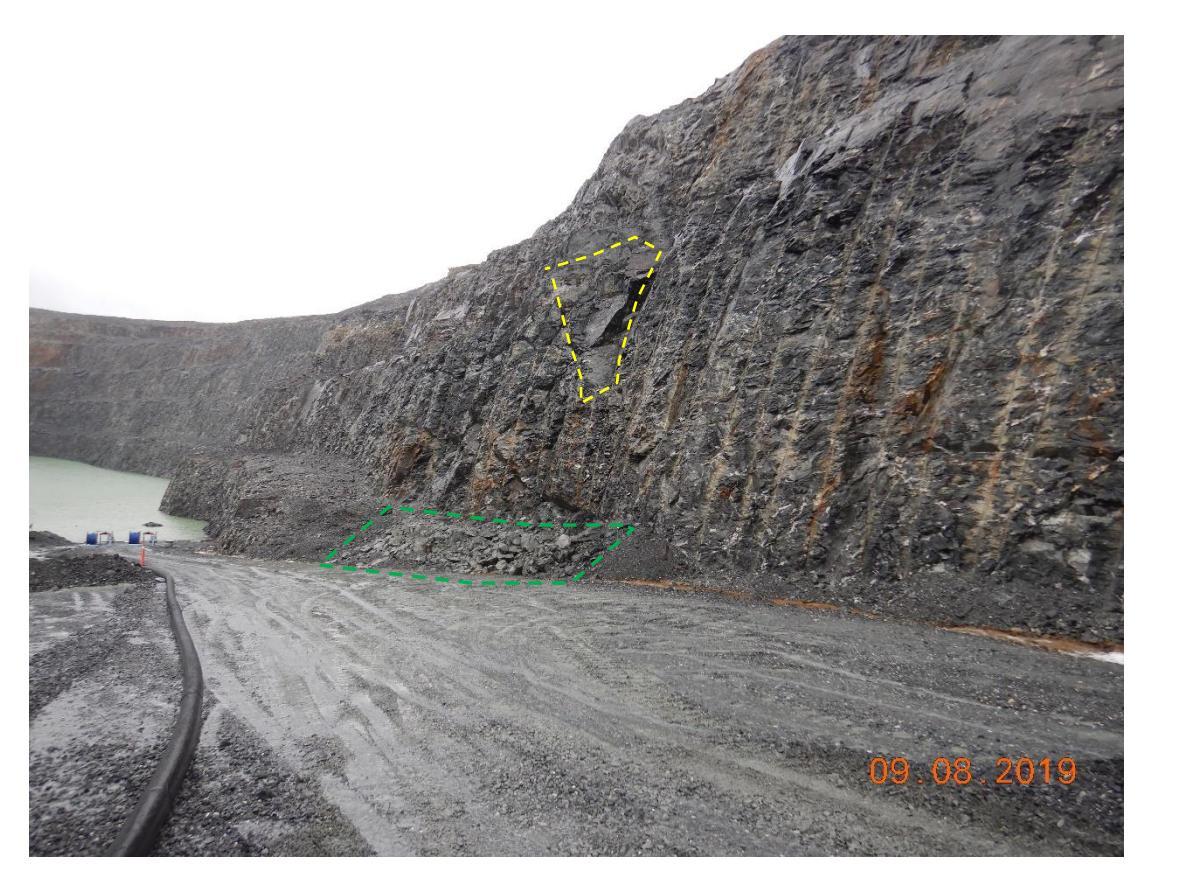
Zone A01: Pit A Ramp: Potential unstable area #1 and berm.

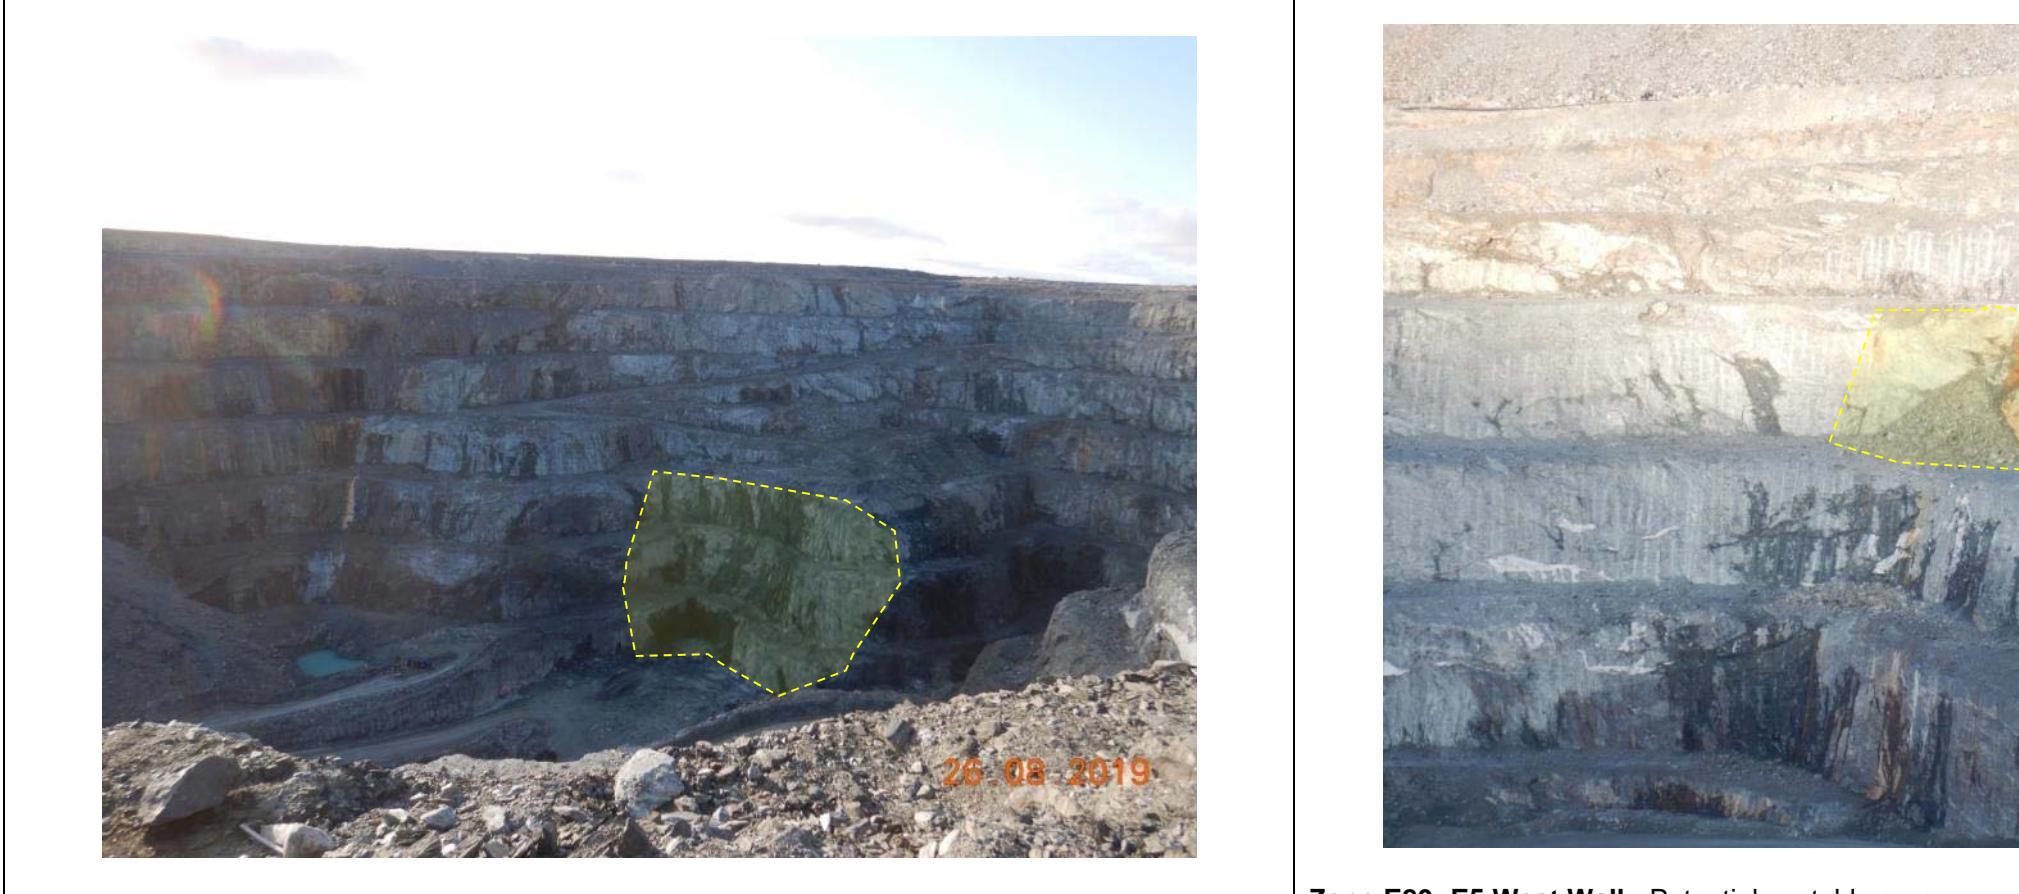
Zone E71: E5 South Wall: Potential wedge and cracks forming. Continuous Monitoring.

Location	Observations	Recommendations	Due date	Date completed
Zone: E71 <u>Pit:</u> E5 <u>Wall:</u> South <u>Bench:</u> 5004 Status:	PREVIOUSLY: Ravelling has been observed during this year. This corner is made of ultramafic rocks slips dipping toward the east. However, the linear progression previously observed on the radar is not suggesting a trend anymore UPDATE: Same as previous	PREVIOUSLY: Keep focusing on monitoring the zone and use caution when working below this area on the 4997 bench. UPDATE: The same recommendations apply for the 4990 bench.	Ongoing	NA
Zone: E80 <u>Pit:</u> E5 <u>Wall:</u> West <u>Bench:</u> 5067 _{Status:}	PREVIOUSLY: This zone constitutes a potential unstable area. A major rock fall occurred last year. Cracks are also visible on the crest of the potential hazard. In addition to that, the radar does not cover the zone. However, there are 3 catchments and a bumper to contain a possible rock fall. The bumper was built last year and is still in place and effective. UPDATE: There are no indications that more rocks have fallen nor tension cracks have widened.	PREVIOUSLY: Maintain the bumper in place. Look for unusual debris in the area; continue frequent monitoring of the zone. UPDATE: Same as previous.	Ongoing	NA

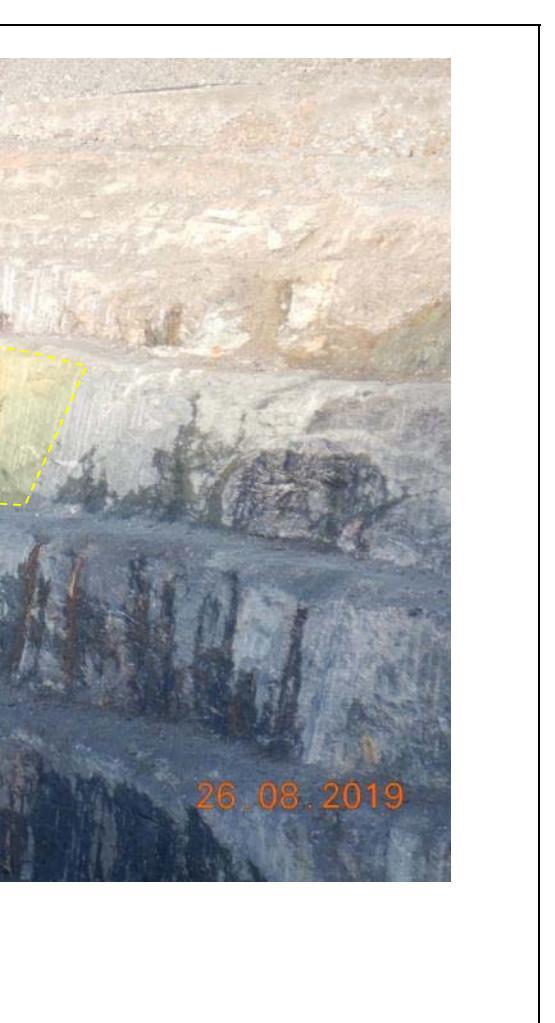
Zone E80: E5 West Wall: Potential unstable area.

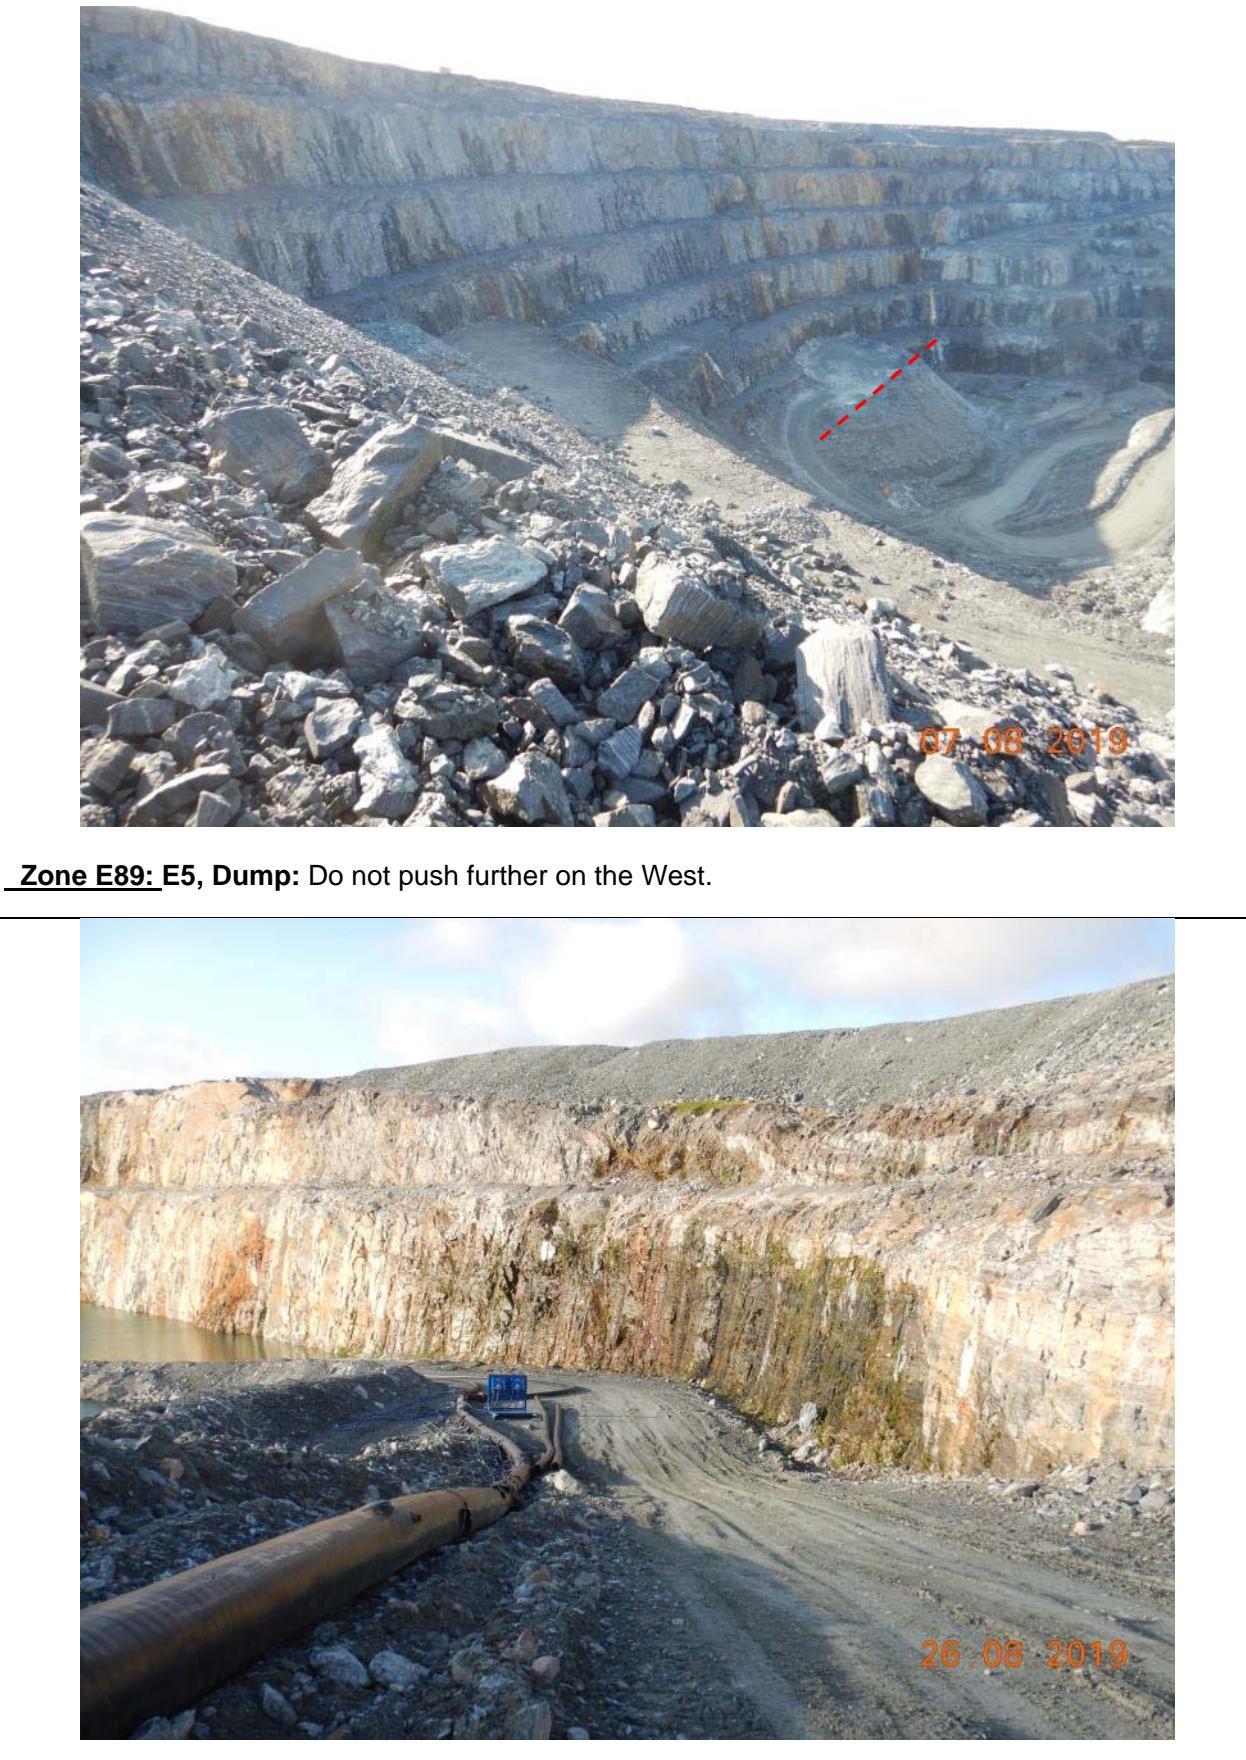
Zone E82: E5, South East Wall: Potential ultramafic wedge. Keep berms in place next to dewatering ramp.

<u>Zone:</u> E82 <u>Pit:</u> E5 <u>Wall:</u> South East <u>Bench:</u> 5067 _{Status:}	 PREVIOUSLY: This zone constitutes a potential unstable area. A wedge could be forming into this ultramafic rock structure as cracks and crumbles berms can be observed. Historically, rock falls did occurred in the same kind of structures. However, radar monitoring of the zone does not indicates an imminent threat. UPDATE: A portion of the berm above the structure progressively crumbled and has ended up on the catchment meaning that there is possible movement of the structure itself. There is a slight positive trend on the radar but it does not indicate an imminent threat so far. A specific target was input into the Radar for this area. 	PREVIOUSLY: Continue to monitor the zone with the radar and by visual inspection of the wall and crest. Keep generator away from high wall and close off area so it is not re-installed below the high wall. UPDATE: Build a berm on the dewatering ramp below protecting personnel and equipment from potential falling debris.	August 11, 2019	NA

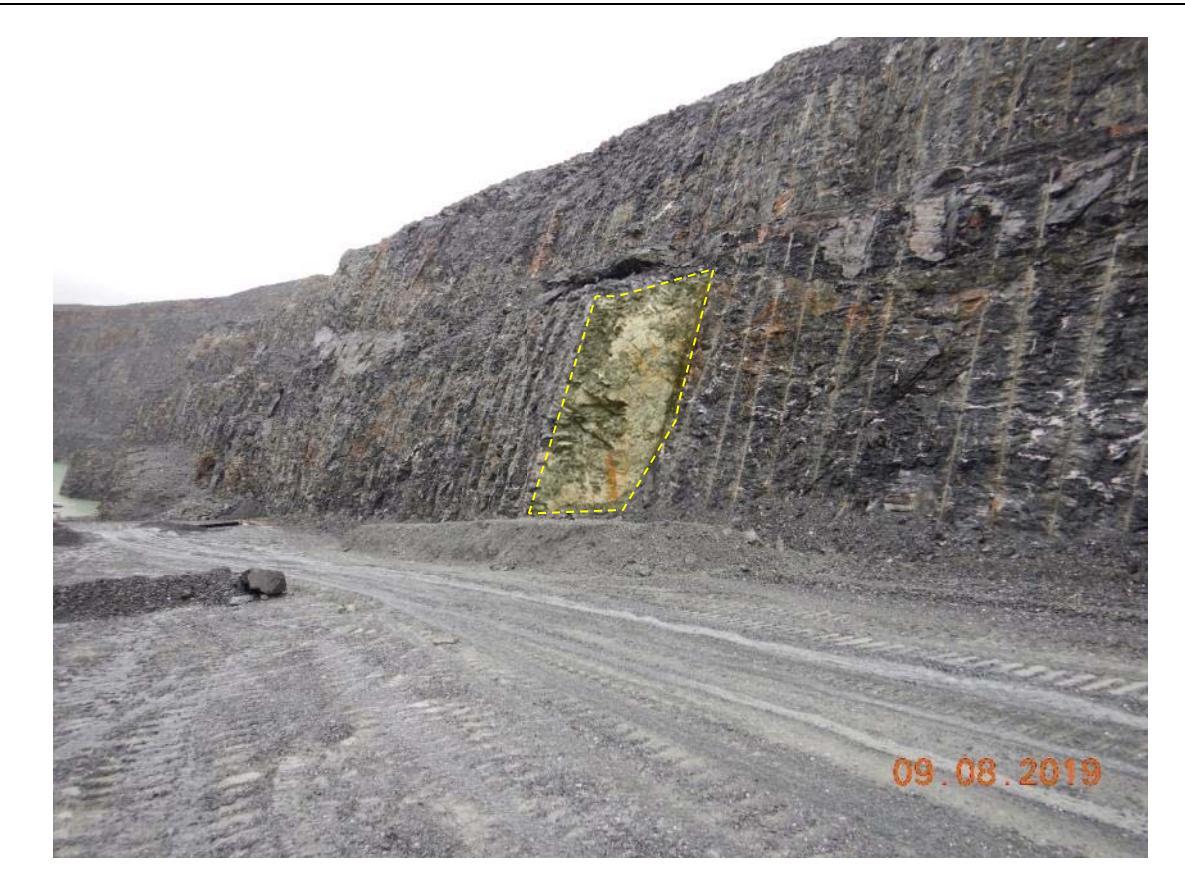
Zone BG: Bay Goose Pit, West Wall: Wall is stable with water flowing. Keep at least 10m away from wall when work required by dewatering crew.

Zone: Bay Goose				
<u>Pit:</u> Bay Goose		PREVIOUSLY: Keep 10m away from wall and		
<u>Wall:</u> West	PREVIOUSLY: Water flowing on the wall. Wall is stable and no visible signs of instability.	visual inspection by dewatering crew when	Ongoing	NIA
<u>Bench:</u> Ramp	UPDATE: Same as previously.	working in the area.	Ongoing	NA
Status:		UPDATE: Same as previously.

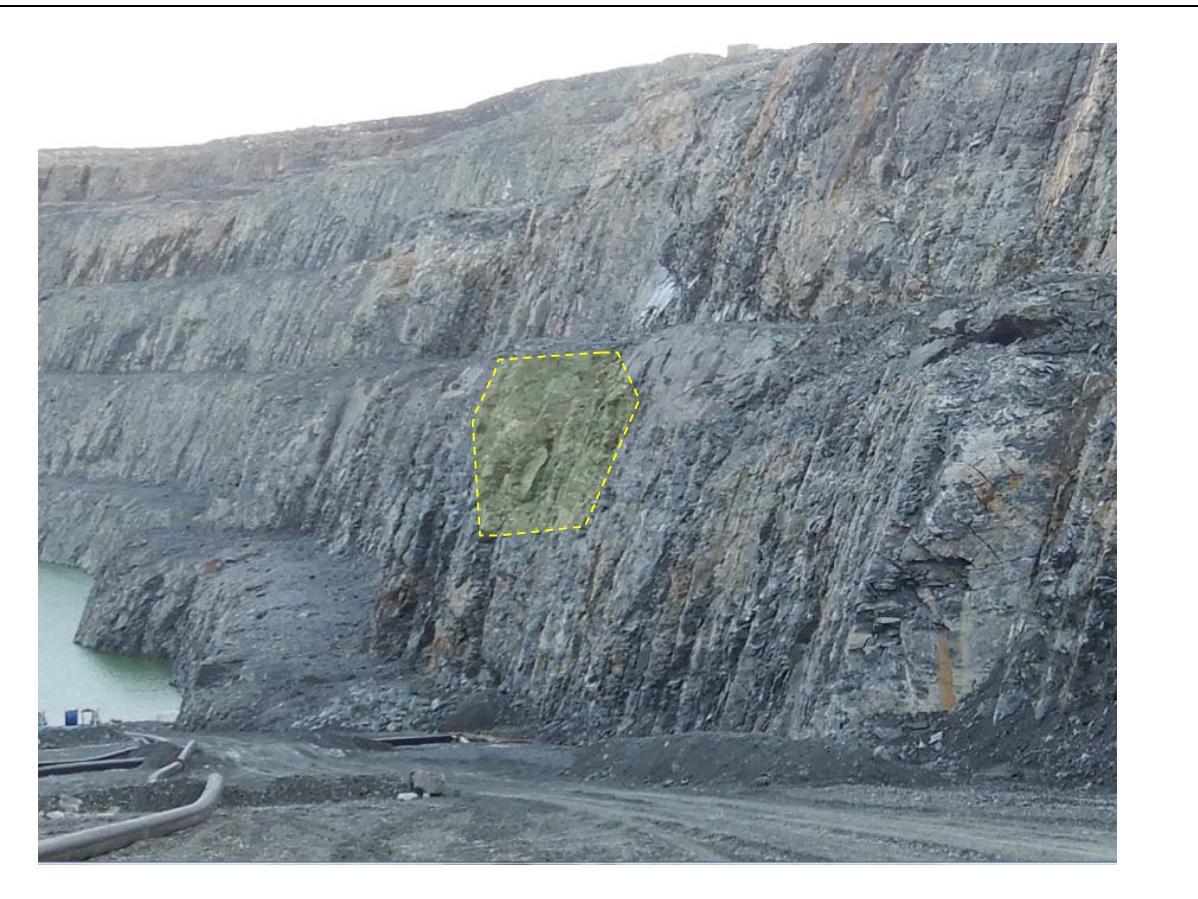
Zone A01: Pit A Ramp: Potential unstable area #1 and berm.

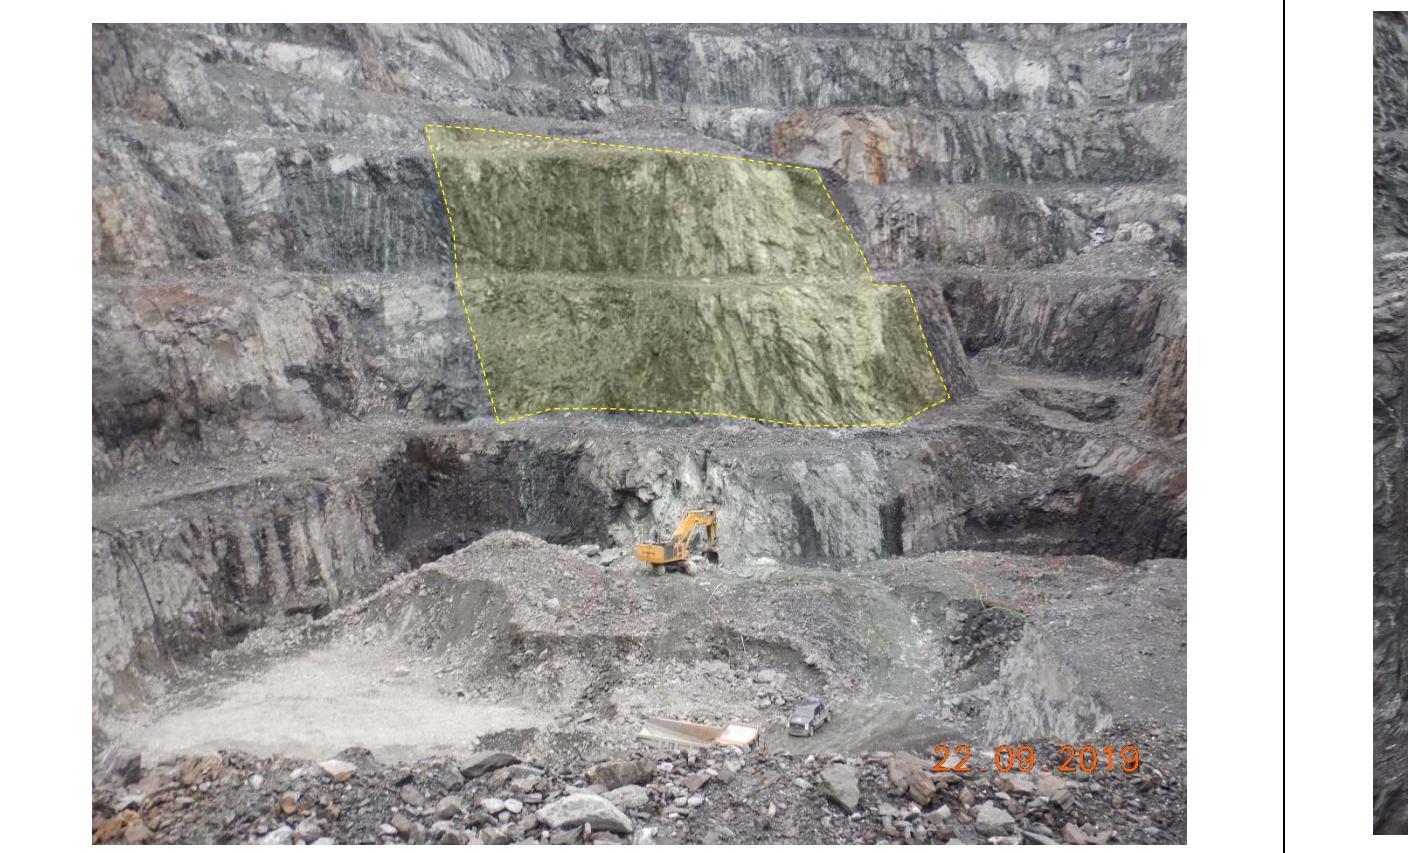
Zone E71: E5 South Wall: Potential wedge and cracks forming. Continuous Monitoring.
