Meadowbank 2020 Annual Pit Slope Performance Review

2020 ANNUAL PIT SLOPE Performance Review

Meadowbank Mine, Nunavut

ISSUED FOR USE 704-ENG.ROCK03163-01

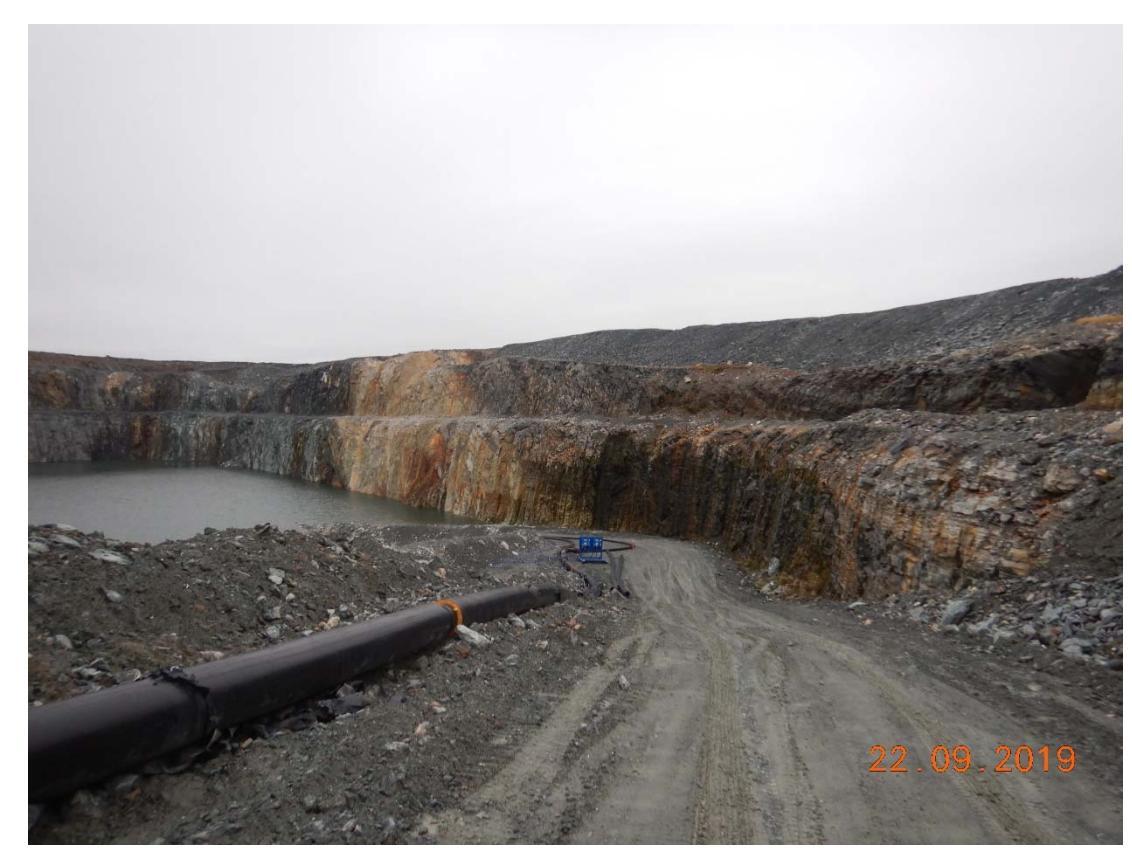
Zone BG: BG West Wall: The wall being permanently dripping water and subject to minor ravelling. Keep 10m away from the wall at all time

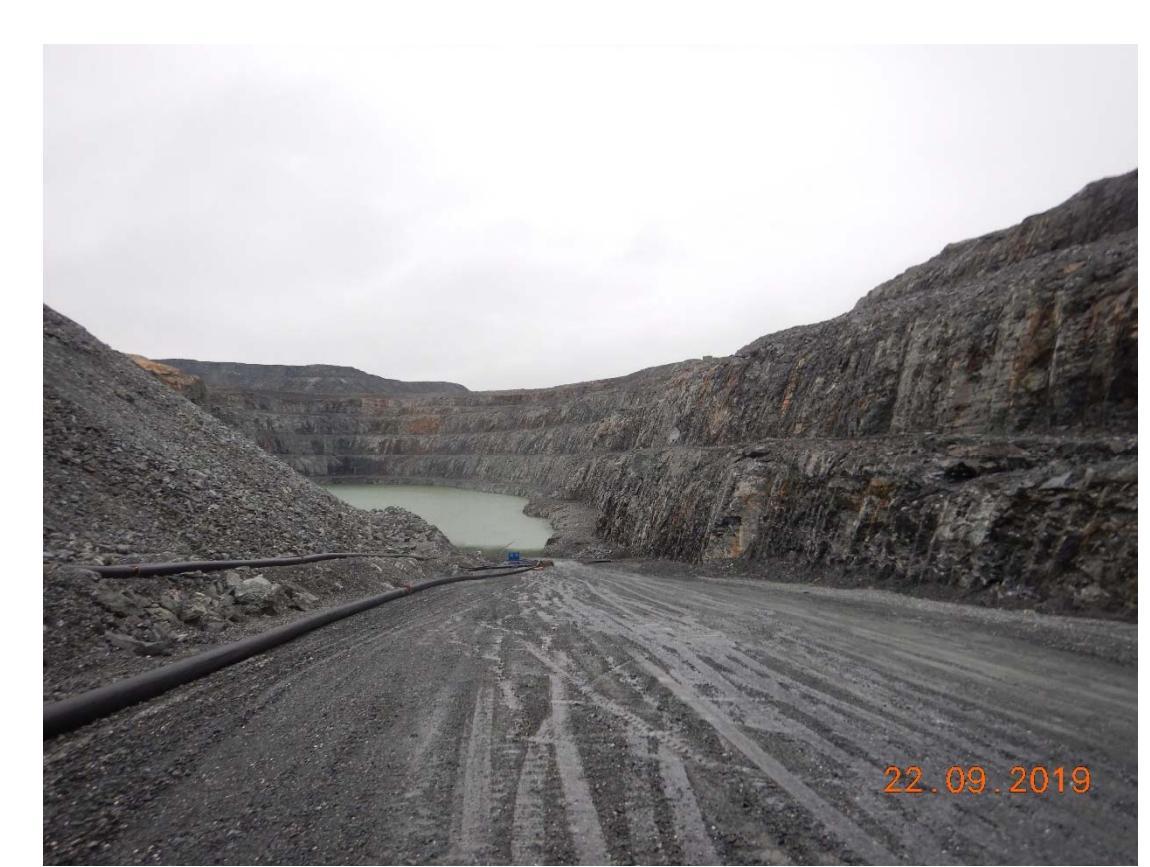
Zone A01: E5 West Wall: Berms were built and ramp is safe to travel by.

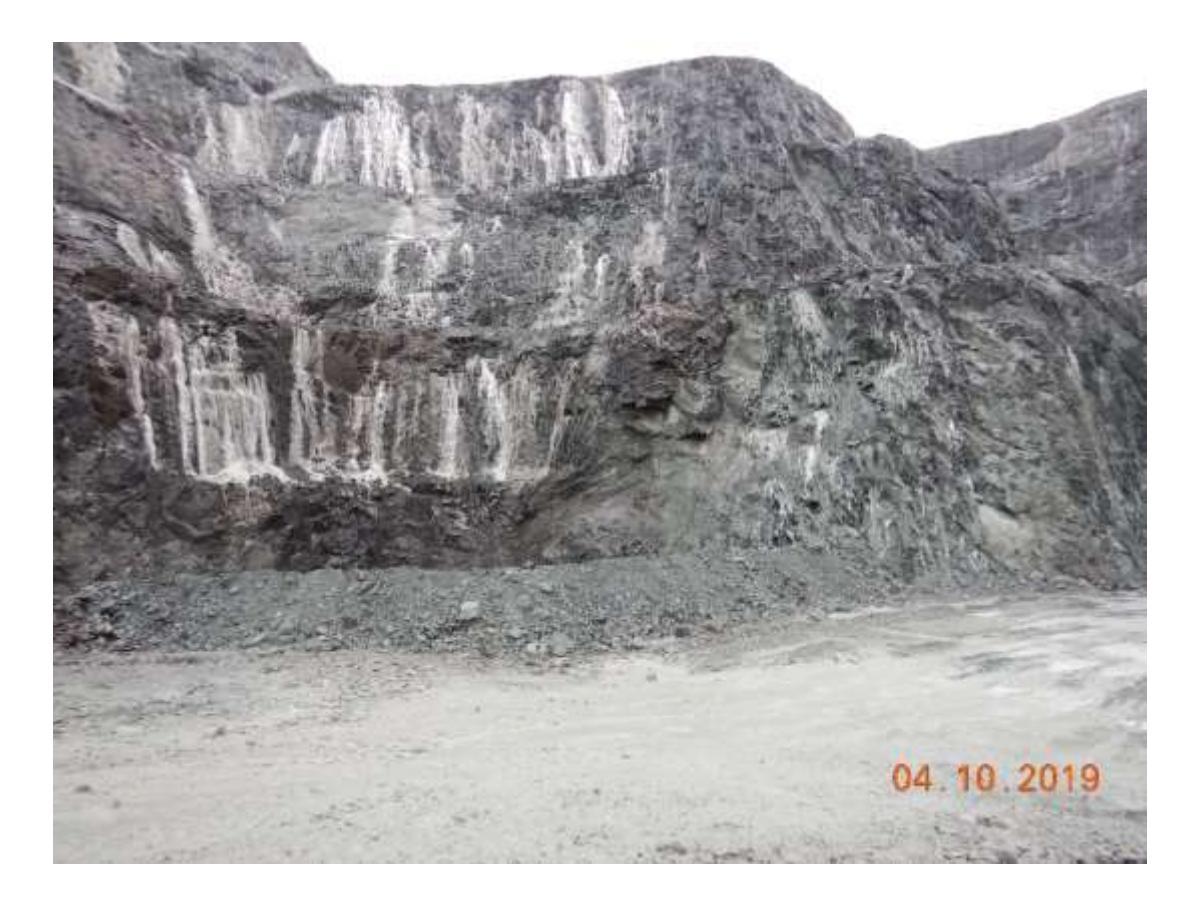
Location	Hazard	Corrective Actions	Due date	Date completed
Zone: E96 <u>Pit:</u> E5 <u>Wall:</u> South <u>Bench:</u> 4983 Status:	Potential unstable structure at the contact of iron/ultramafic formation. Minor rock fall has already happened at the bottom of the structure. The remaining of the block is created by open joints sets and undercutting ultramafic plane and has a potential of releasing around 600t.	Keep the area bermed off and cancel the last drill pattern in the area.	NA	Oct 4, 2019
Zone: E97 <u>Pit:</u> E5 <u>Wall:</u> North <u>Bench:</u> 4983 _{Status:}	This section of the wall was not pre-sheared and blocky rock formations are dipping toward the pit opening. In addition to that, the area directly above the wall has been used as a dump and the slope of the dump is on the crest of the wall.	Build a berm at the toe of the wall preventing direct access to personnel and debris from falling into the haul road. Adjust the berm in accordance with the last dill pattern planed in the area.	Oct 8, 2019	NA

Zone E96: E5 South Wall: NO ENTRY zone, berm is in place.

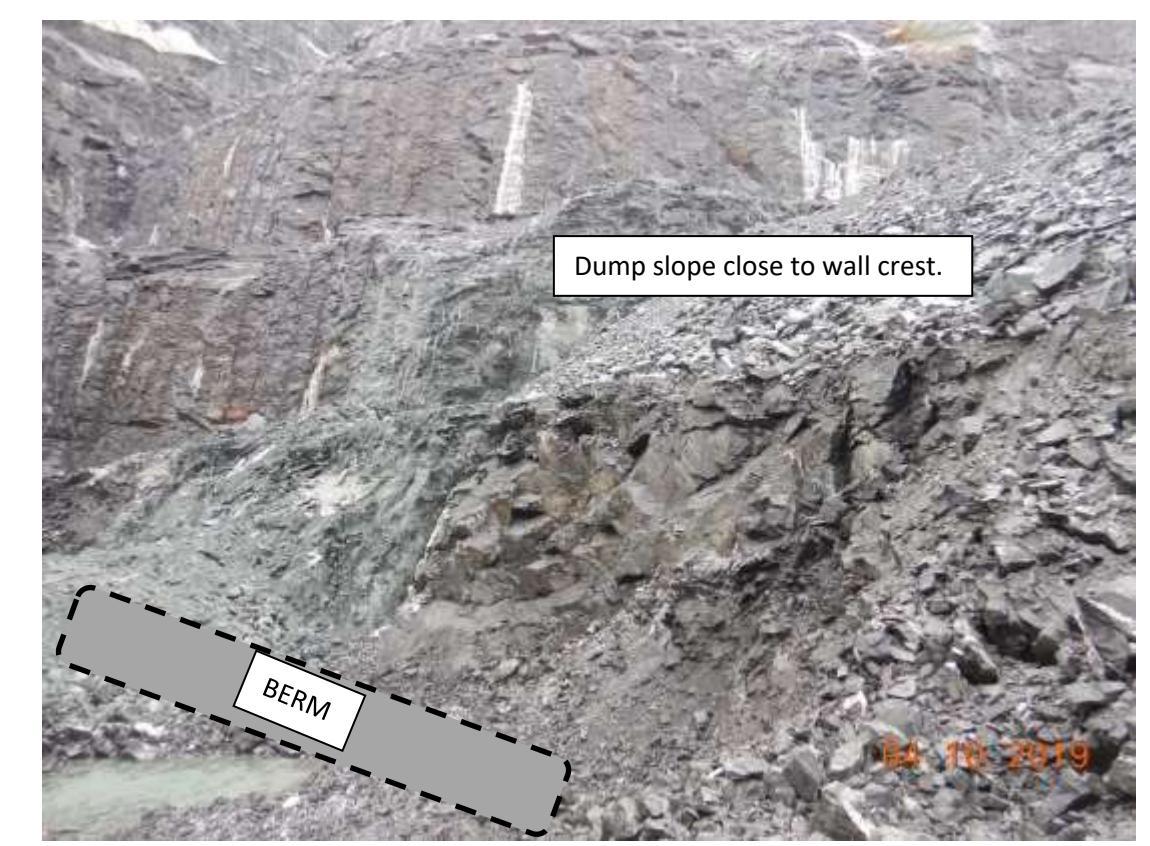
Zone E97:E5 North Wall: Build a berm at the toe of the north wall prior to drill the last pattern.

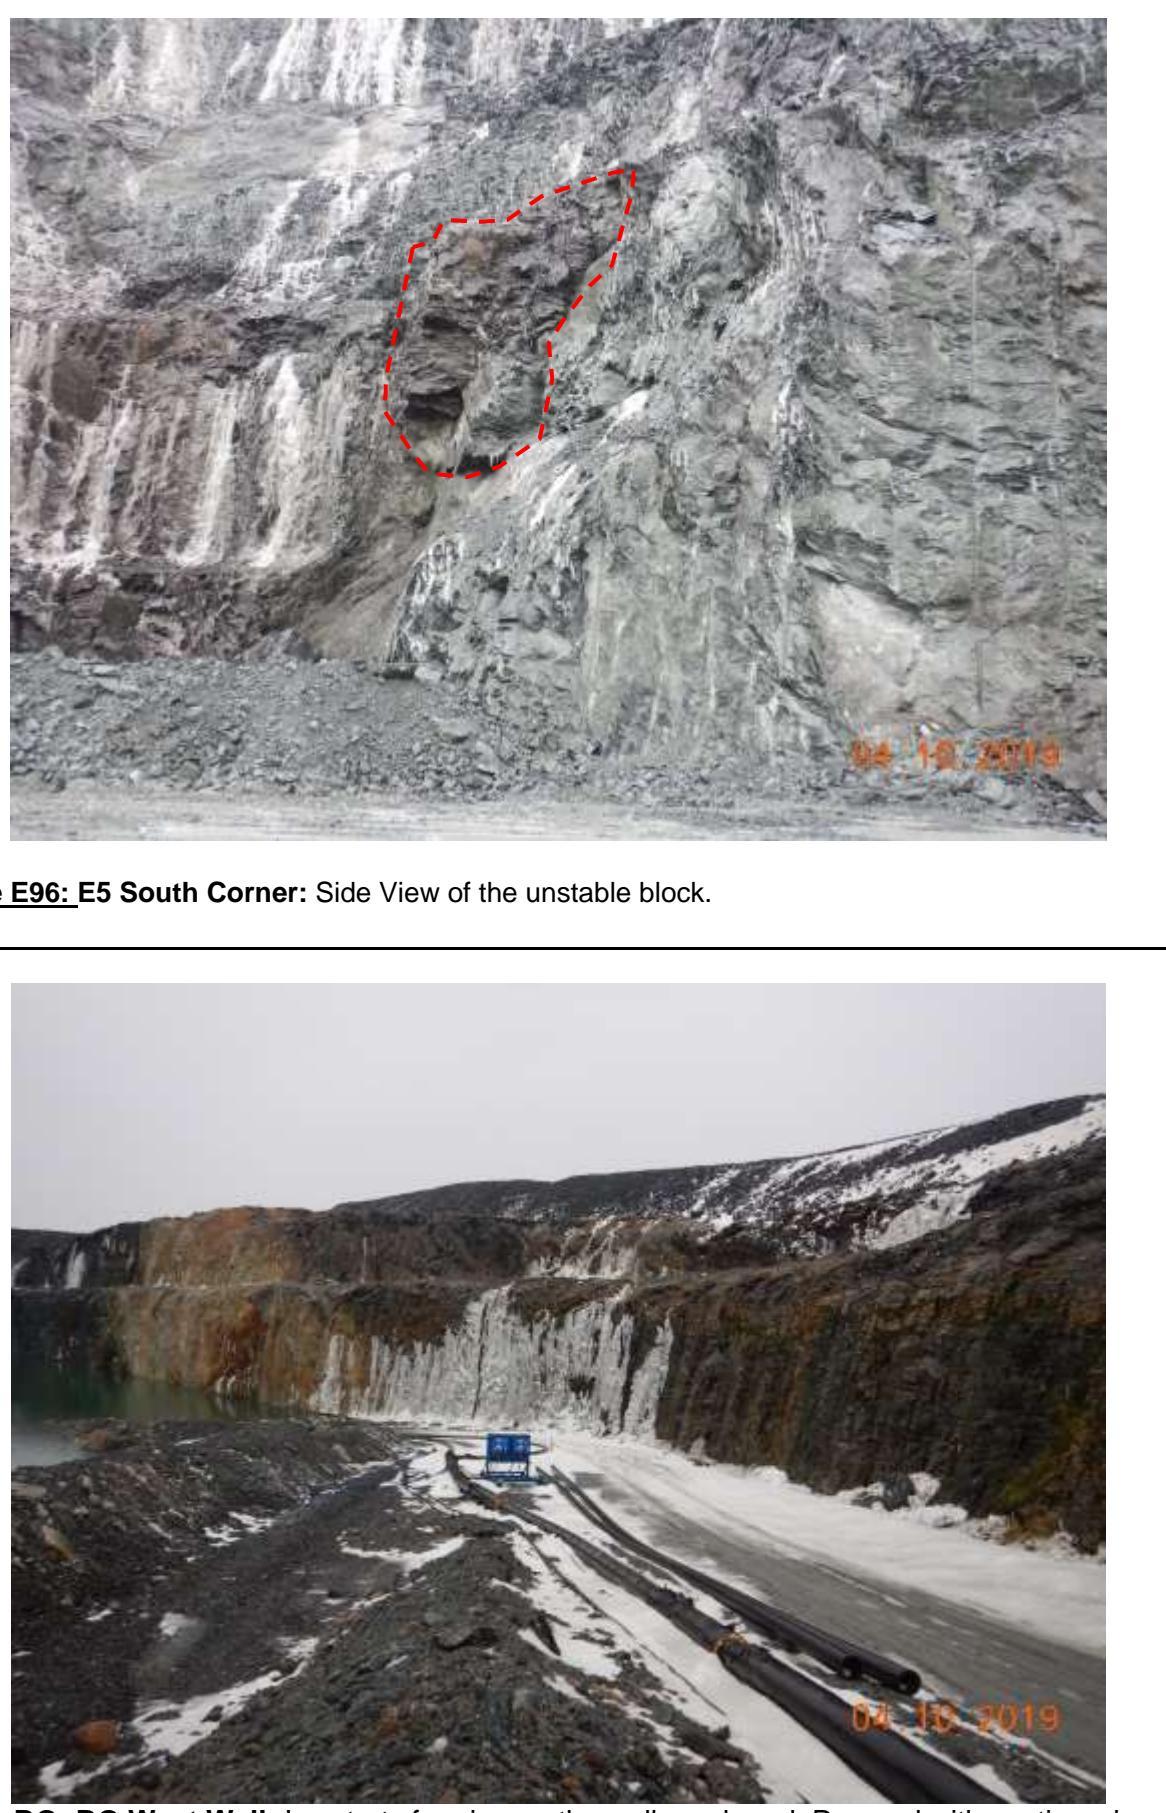
<u>Zone:</u> Bay Goose <u>Pit:</u> Bay Goose <u>Wall:</u> West <u>Bench:</u> Ramp _{Status:}	Ice is building on the wall and ramp near the pump.	Proceed with caution with light vehicles on the icy surface and stay clear from the wall.	Ongoing	NA

Zone BG: BG West Wall: Ice starts forming on the walls and road. Proceed with caution when accessing the pump.

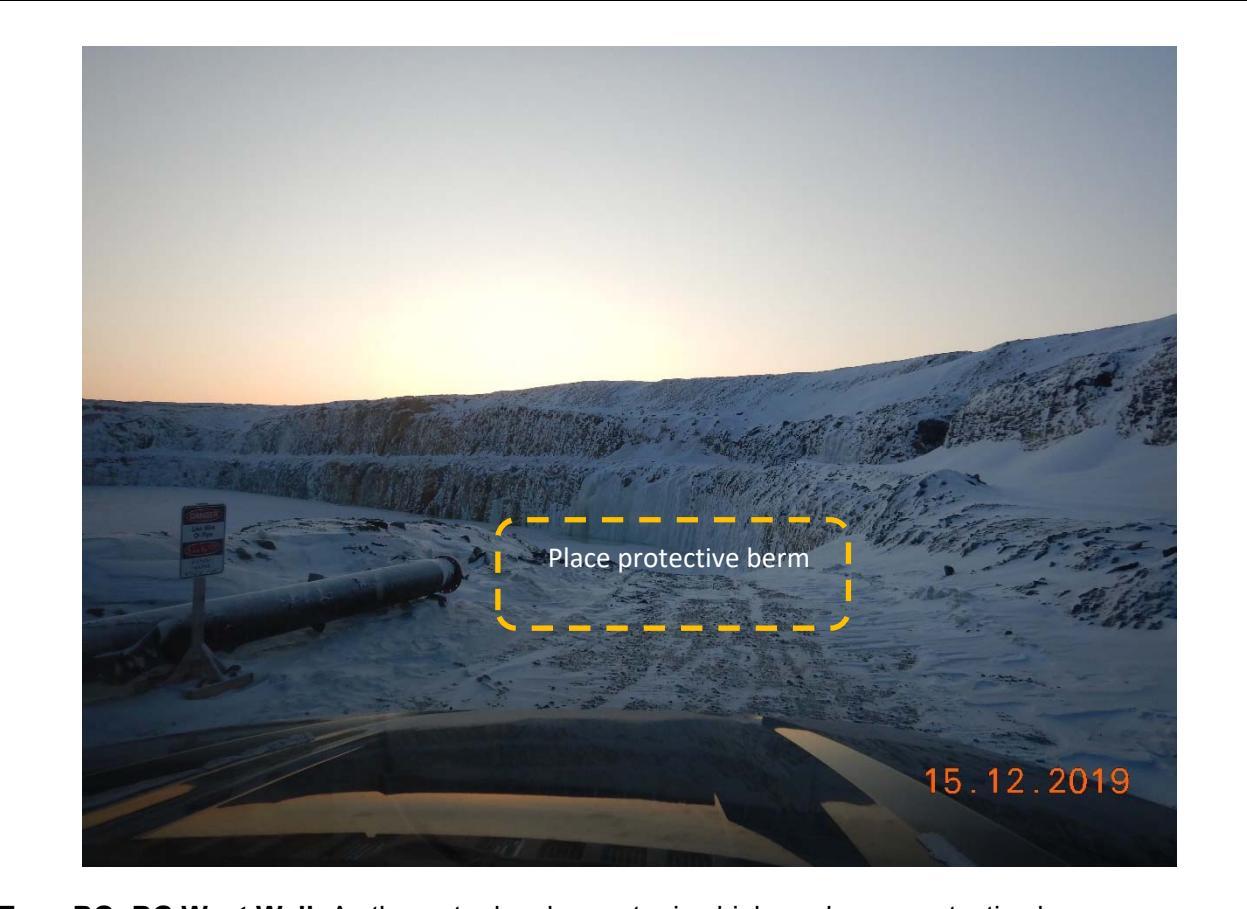
Location	Hazard	Corrective Actions	Due date	Date completed
Zone: Bay Goose <u>Pit:</u> Bay Goose <u>Wall:</u> West <u>Bench:</u> Ramp _{Status:}	Water level is rising.	Place berm at top of road to limit any accidental access into the water.	Ongoing	NA

Zone BG: BG West Wall: As the water has begun to rise higher, place a protective berm.

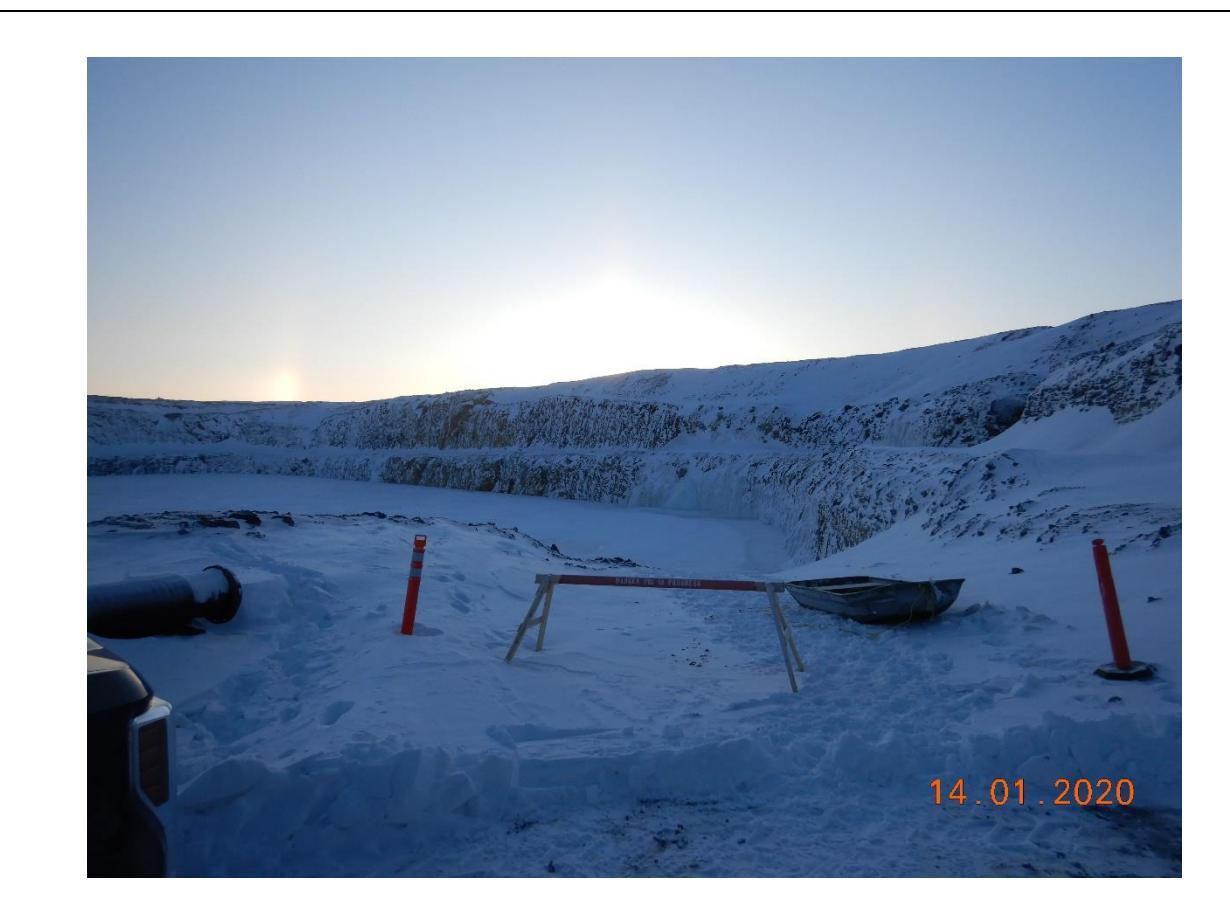
Zone BG: BG West Wall: Protective barrier placed..

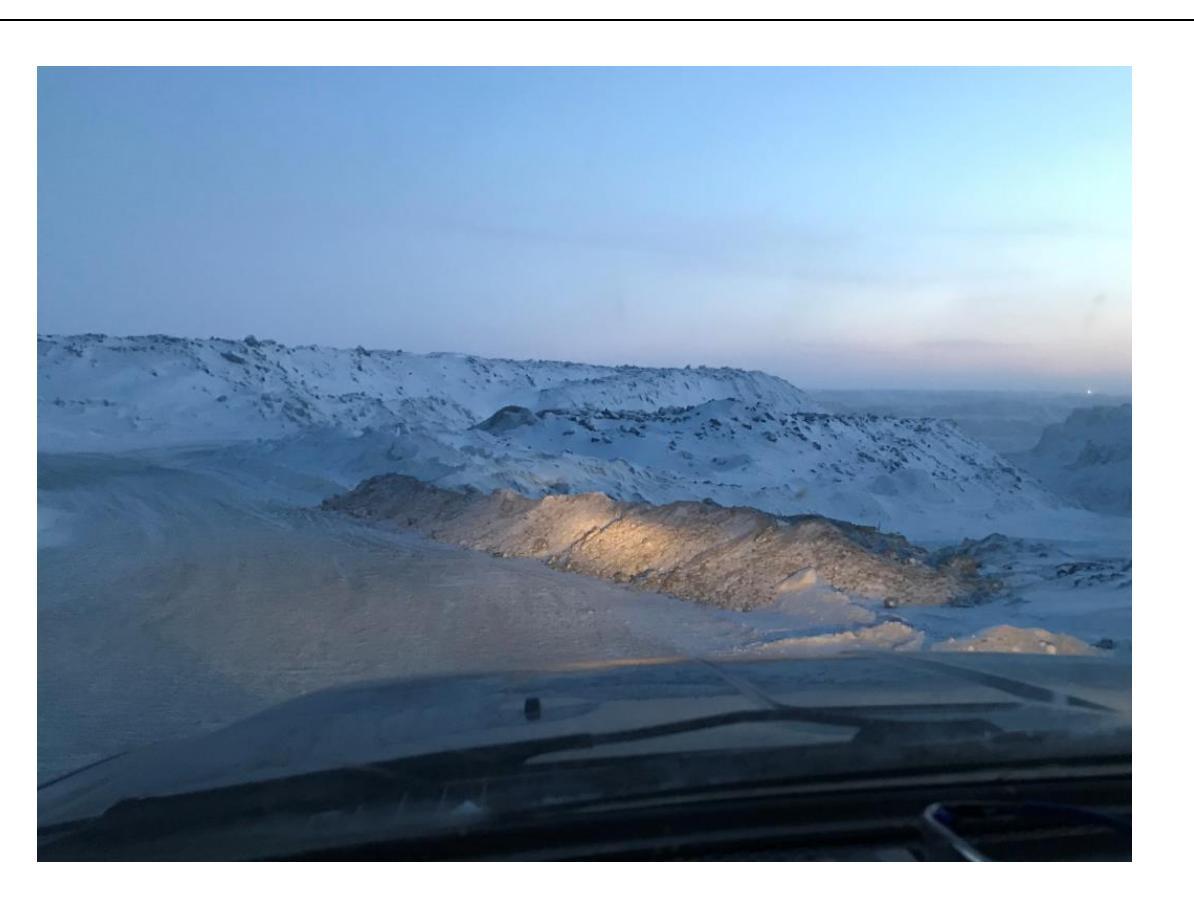
Zone Pit E: Pit E Ramp: Berm place to prevent access to below Pit D Dump.

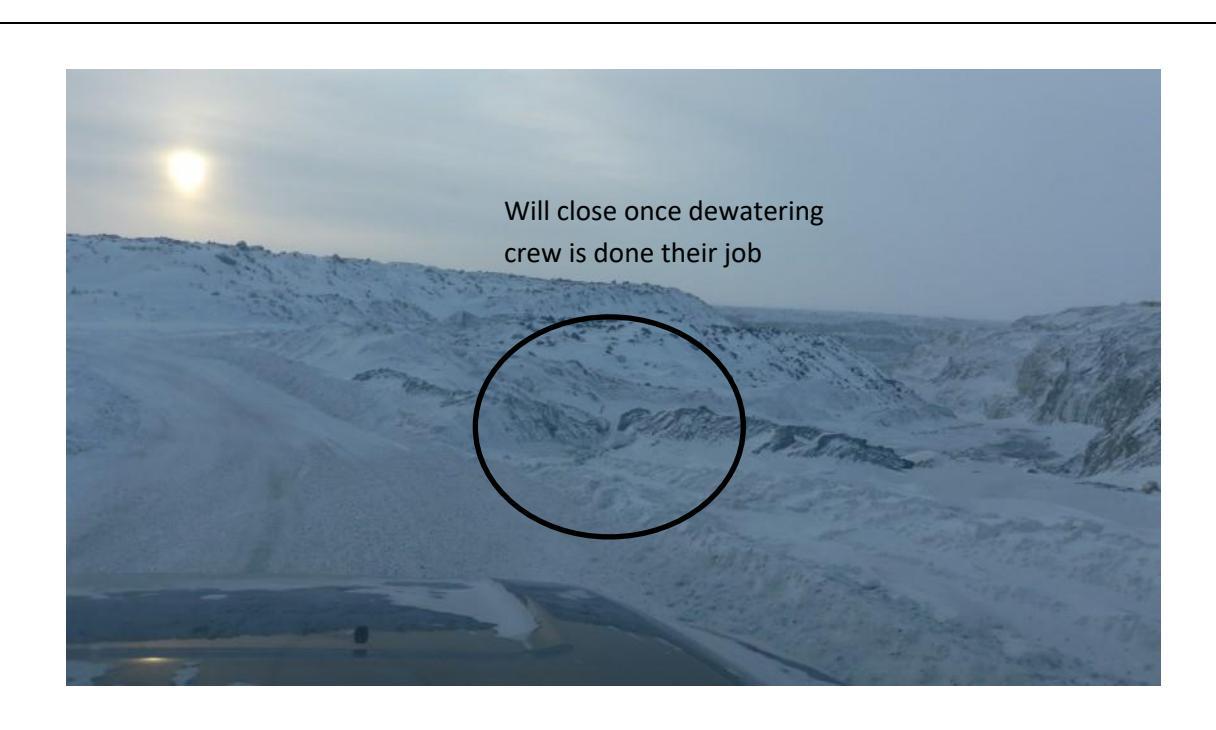
Zone BG: BG West Wall: Protective barrier placed.

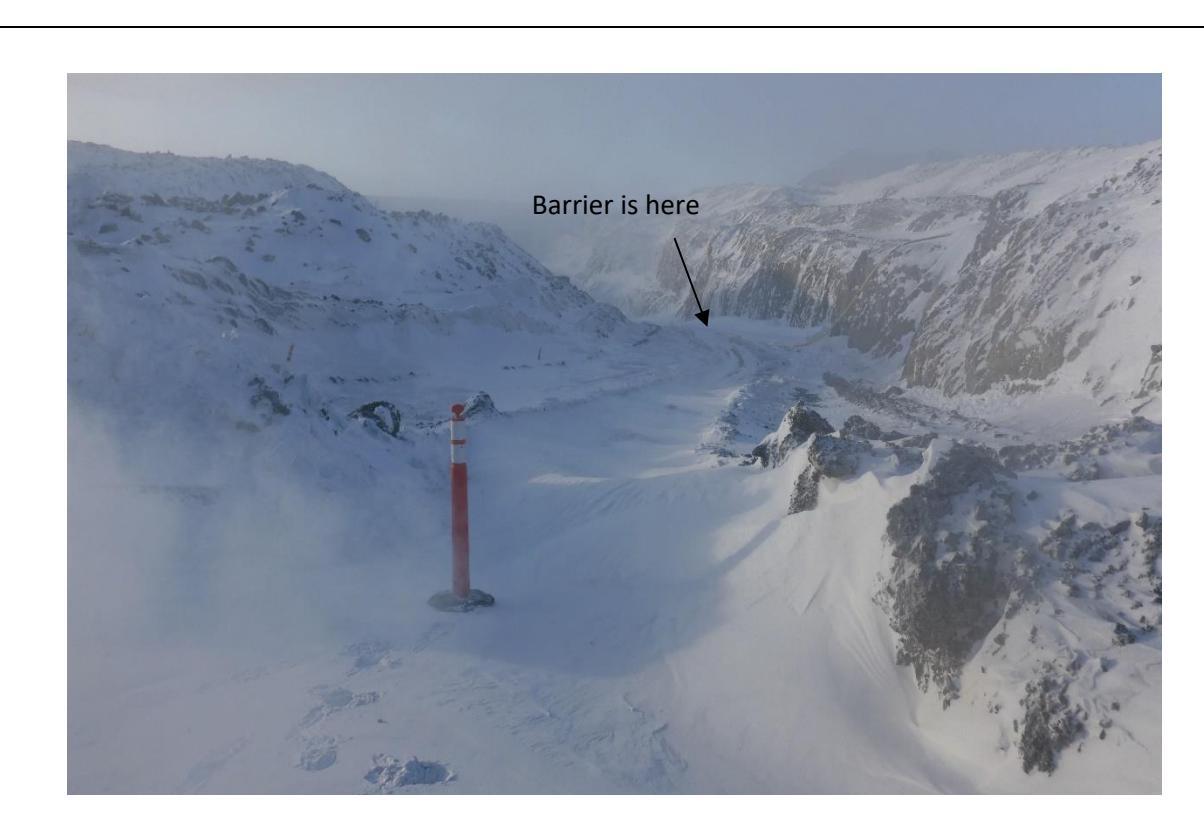
Zone Pit E: Pit E Ramp: Candle barrier at top and also barrier where pipe comes out. Required access for Dewatering crew only.

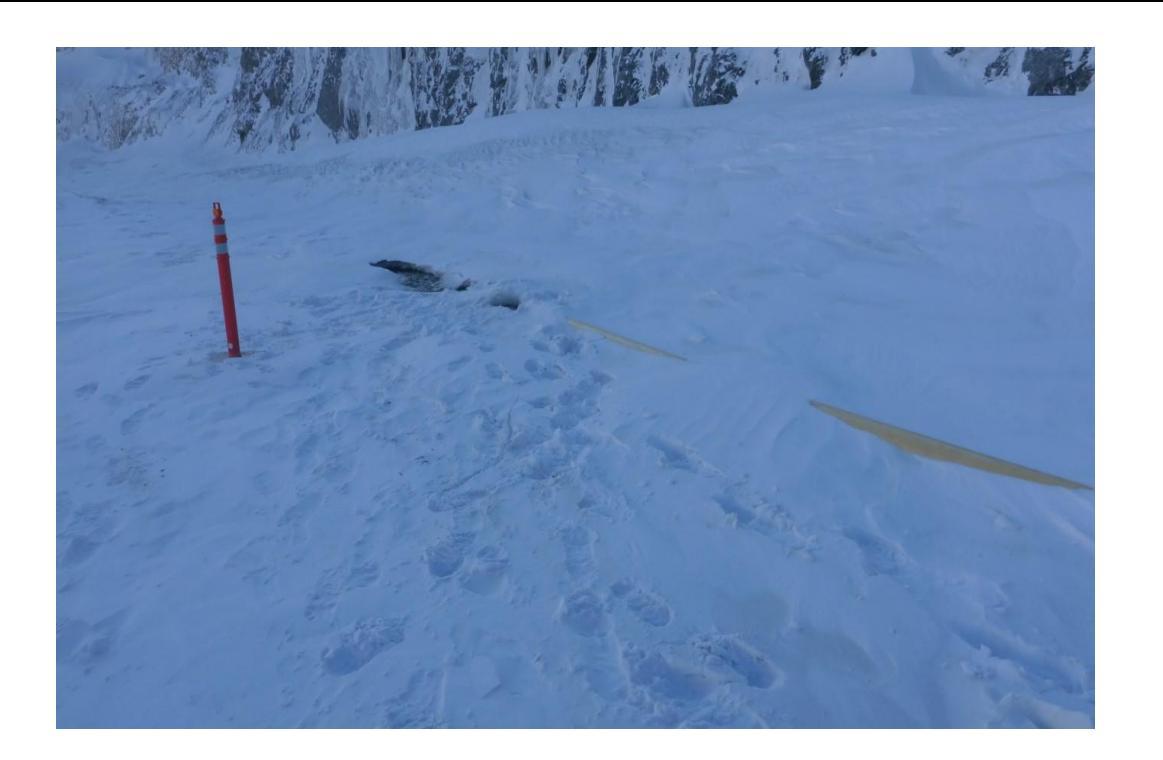
Zone Pit E: Pit E Ramp: Candle barrier where pipe outlet is.

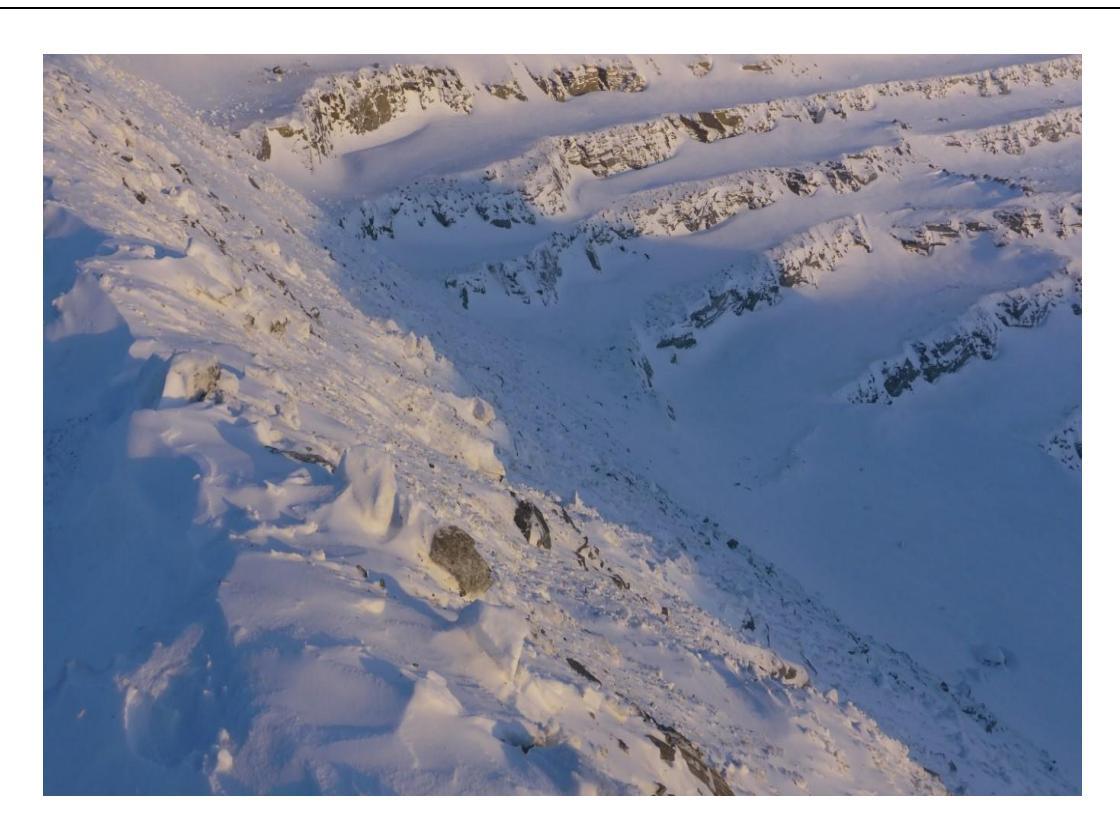
Zone Phaser Crossing: No signs of instabilities.

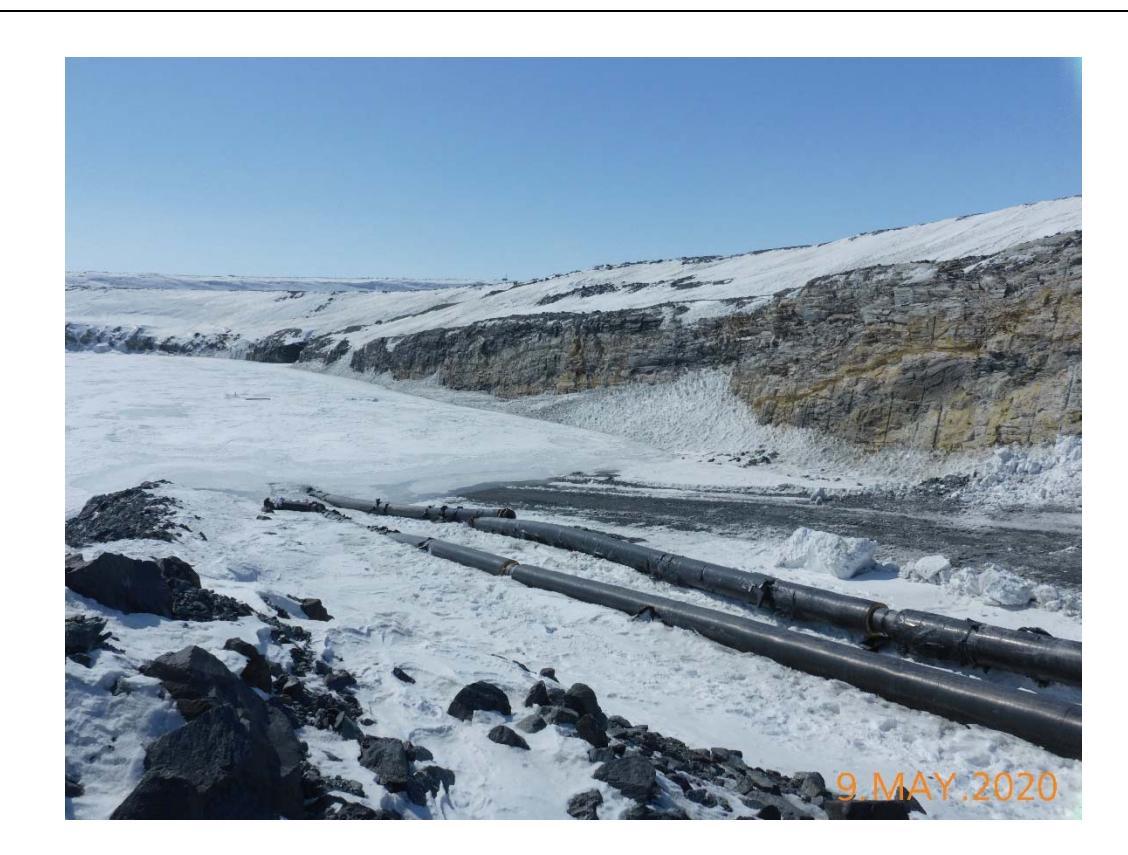
Zone BG: BG West Wall: Candles to be placed.

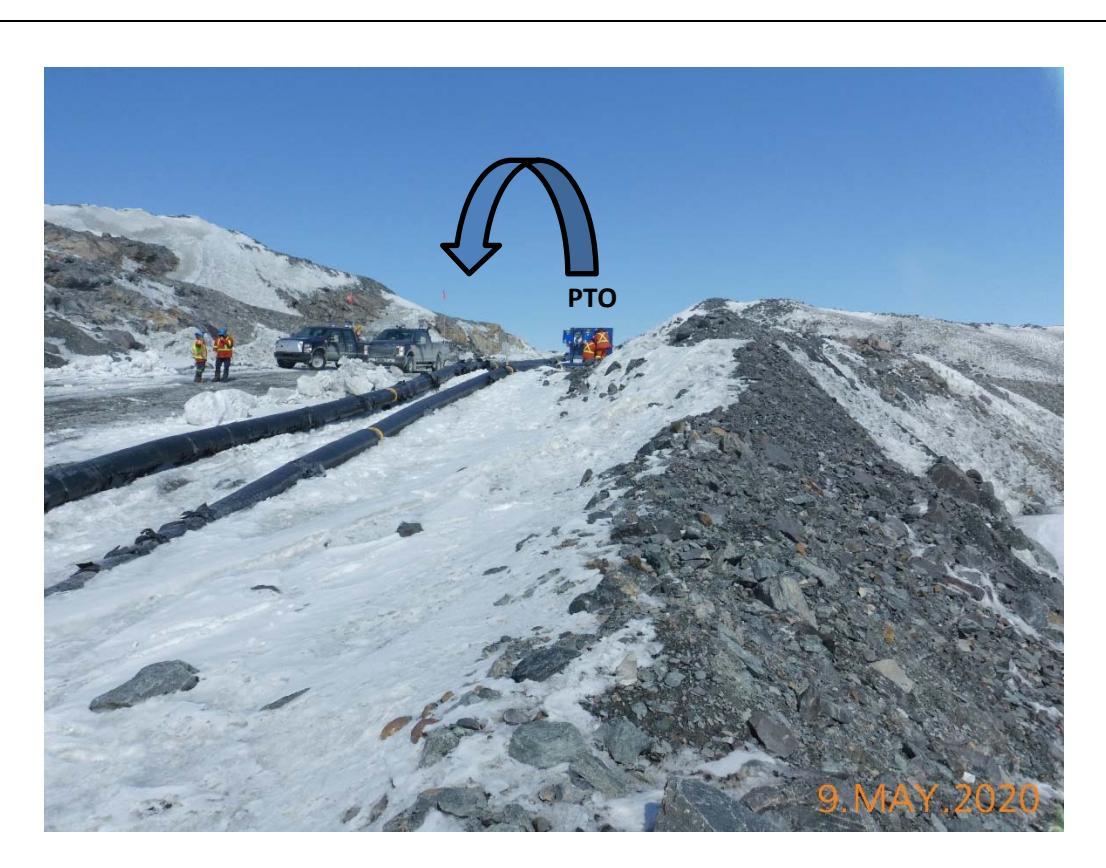
Zone BG: BG West Wall: Move the PTO on the other side of the ramp.

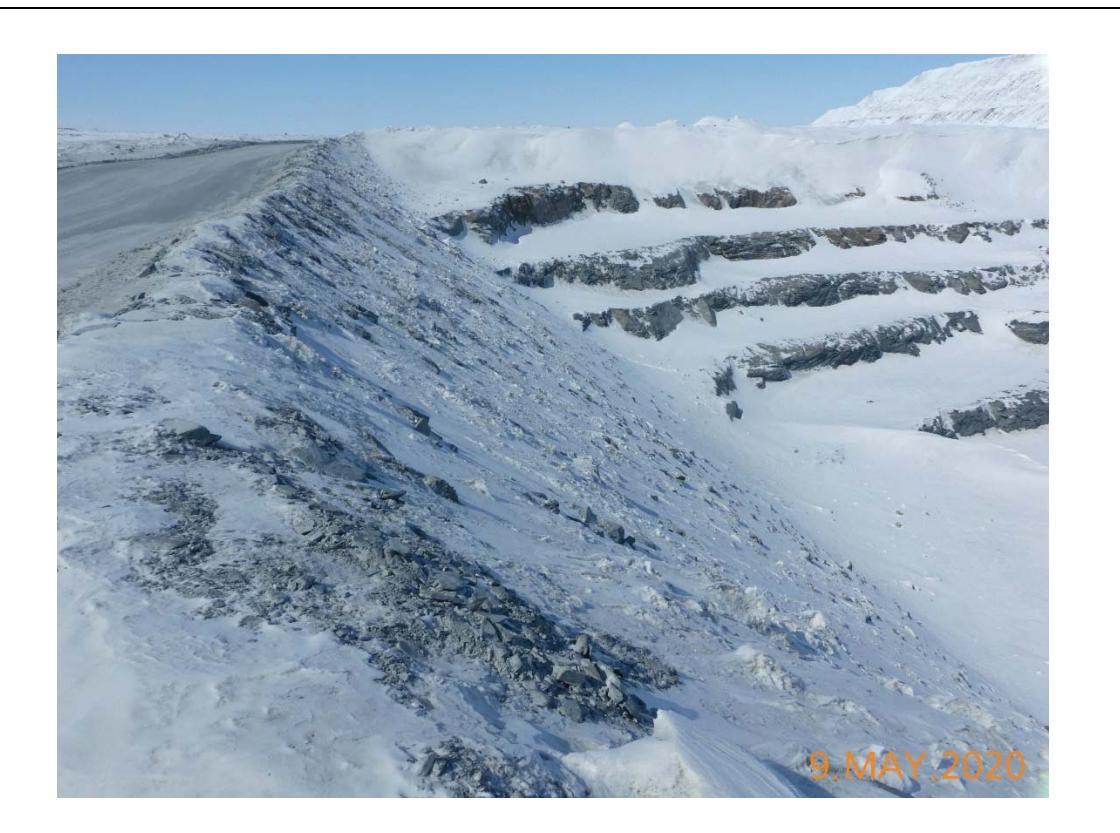
Zone Phaser Crossing: No signs of instabilities.

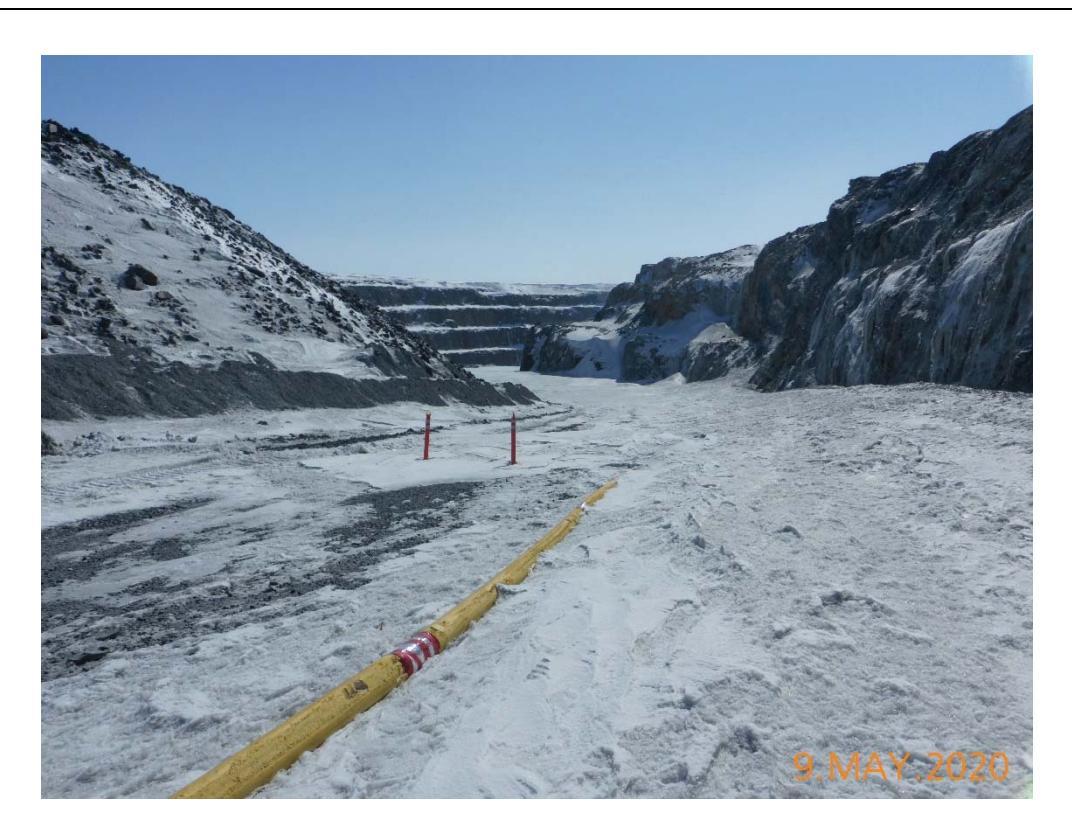
Zone Pit E: Pit E Ramp: Berm currently open for dewatering crew, candles to be replaced to restrict unauthorized access.

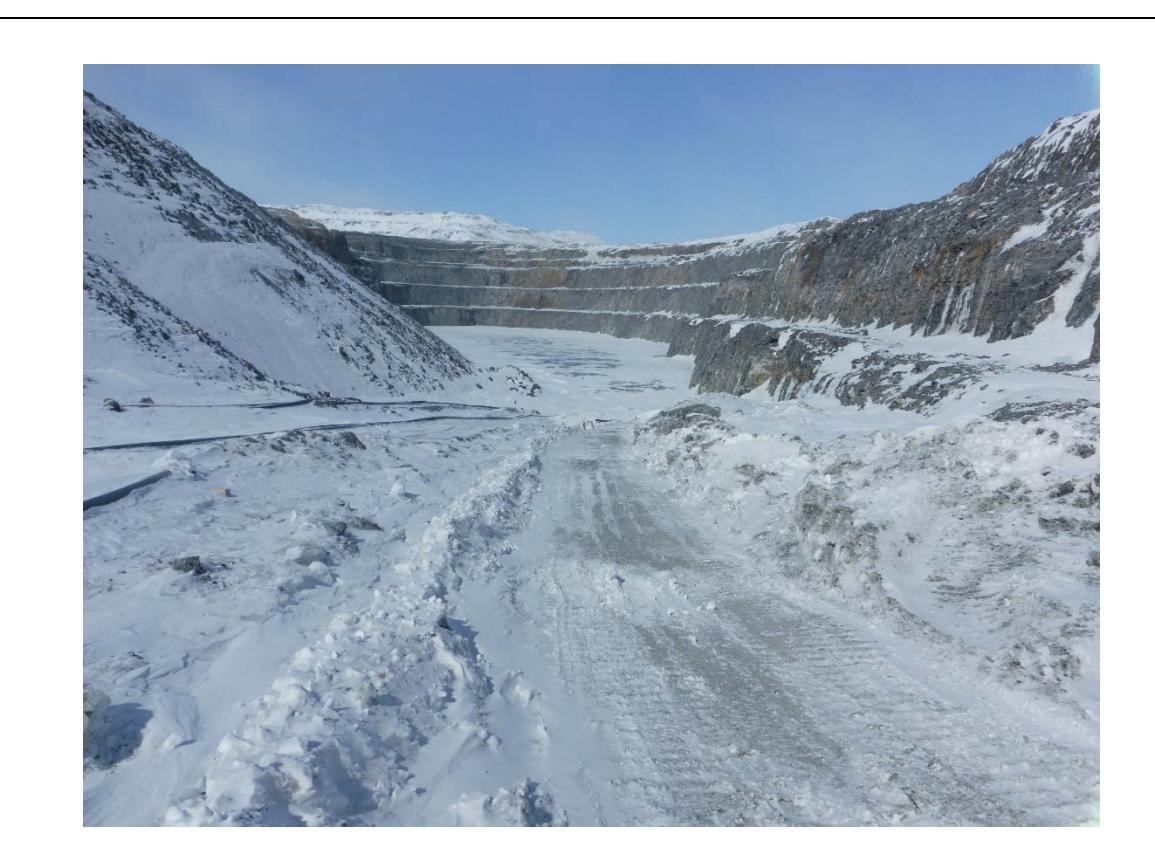
Zone Pit A: Pit A Ramp: Walls and dump does not present signs of instabilities.

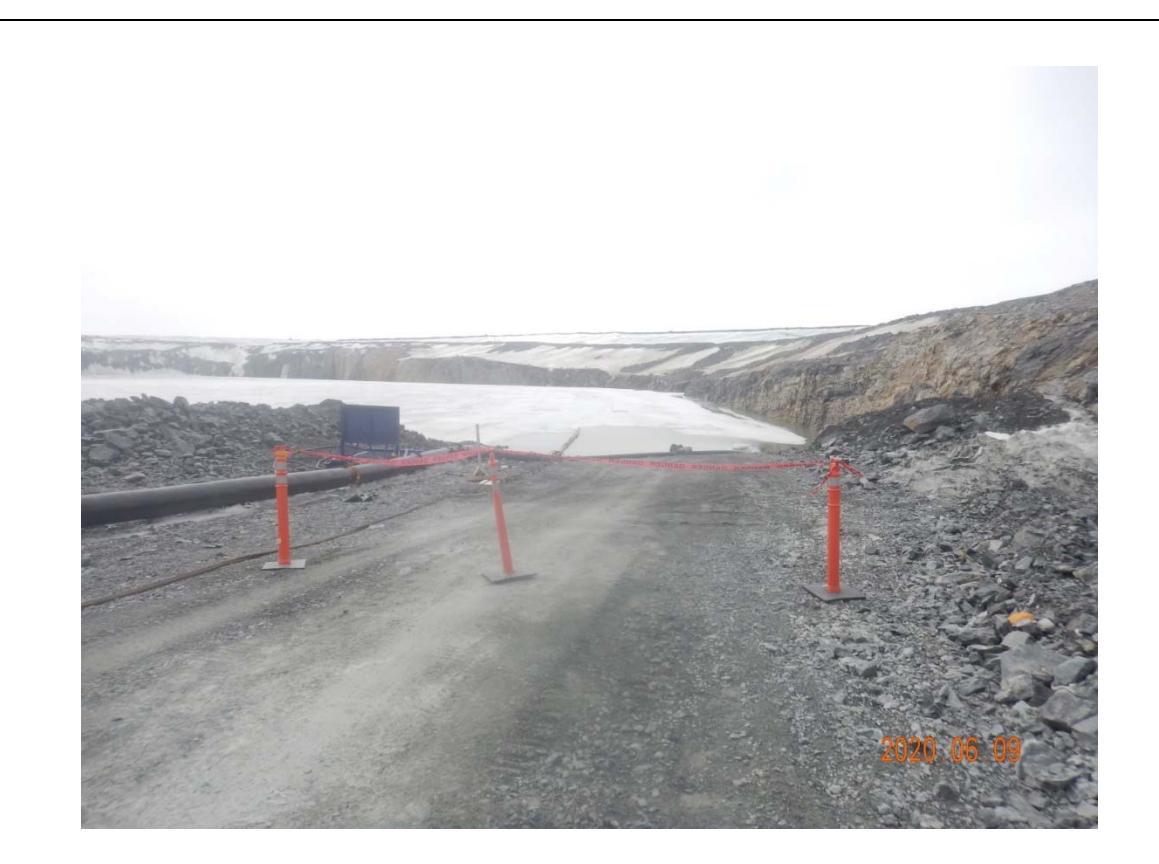
Zone BG: BG West Wall: Candles were replaced and danger tape added.

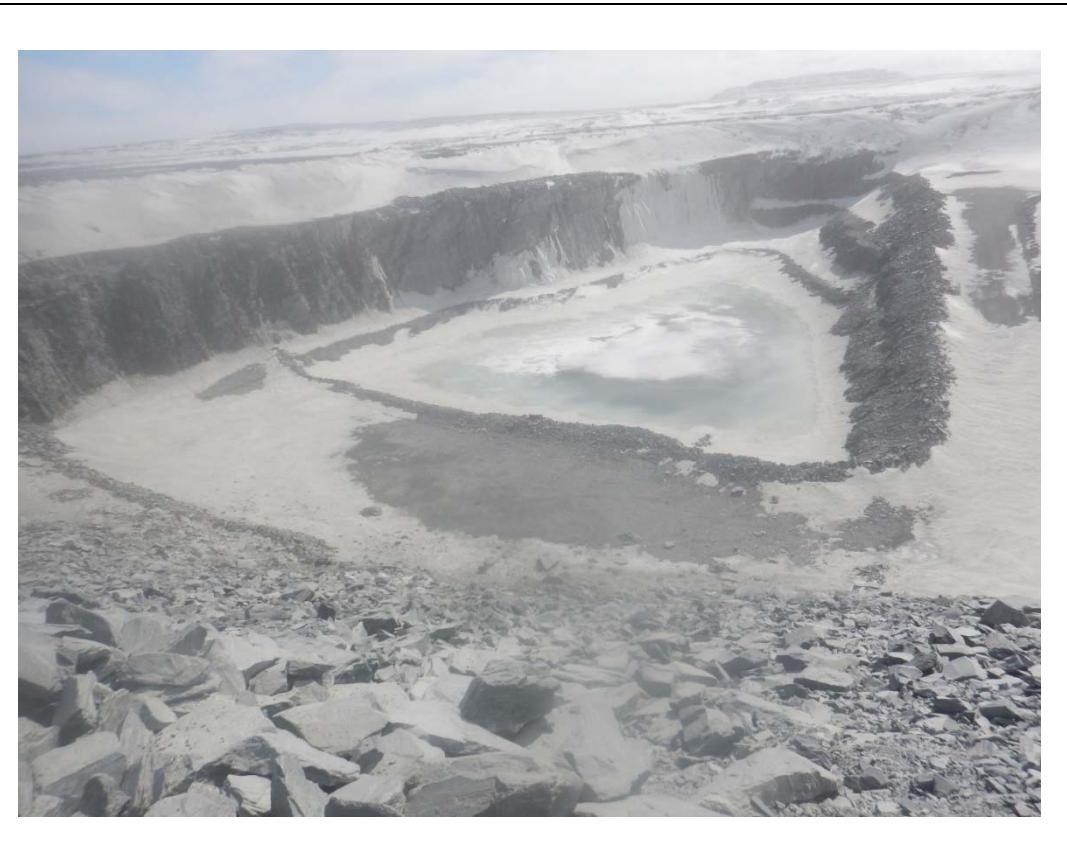
Zone Phaser Crossing: No signs of instabilities.

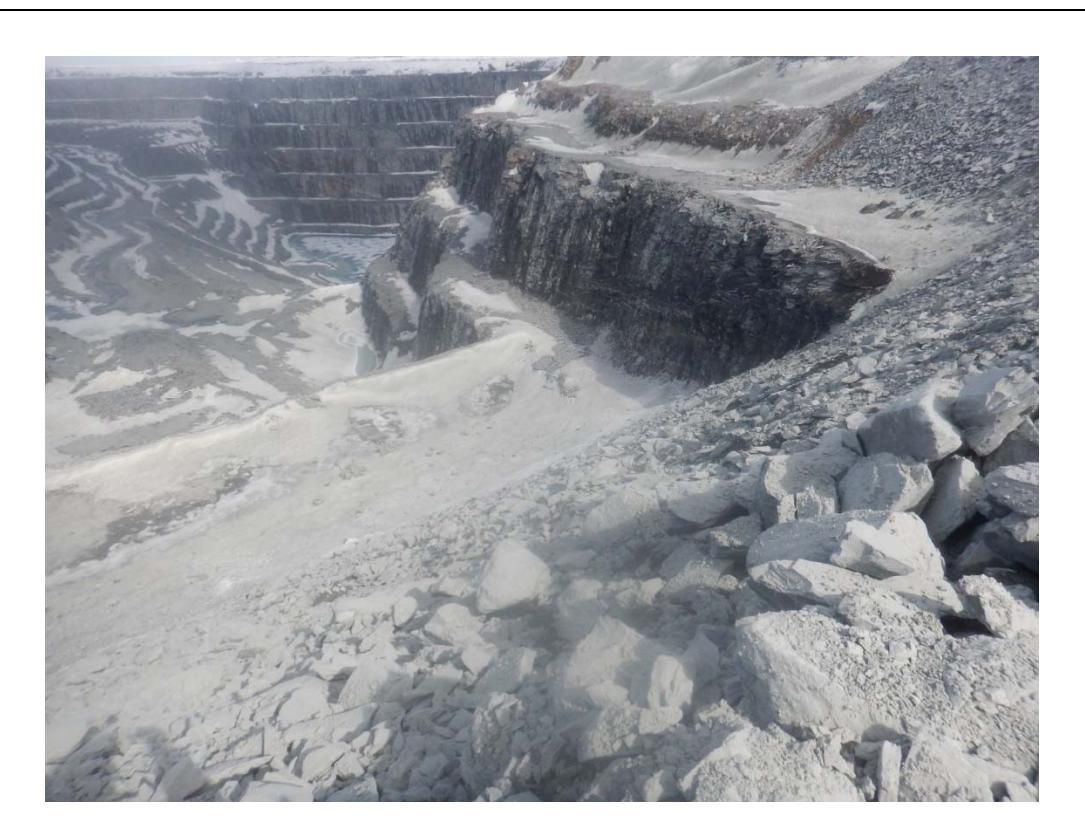
Zone Phaser Crossing: No signs of instabilities.

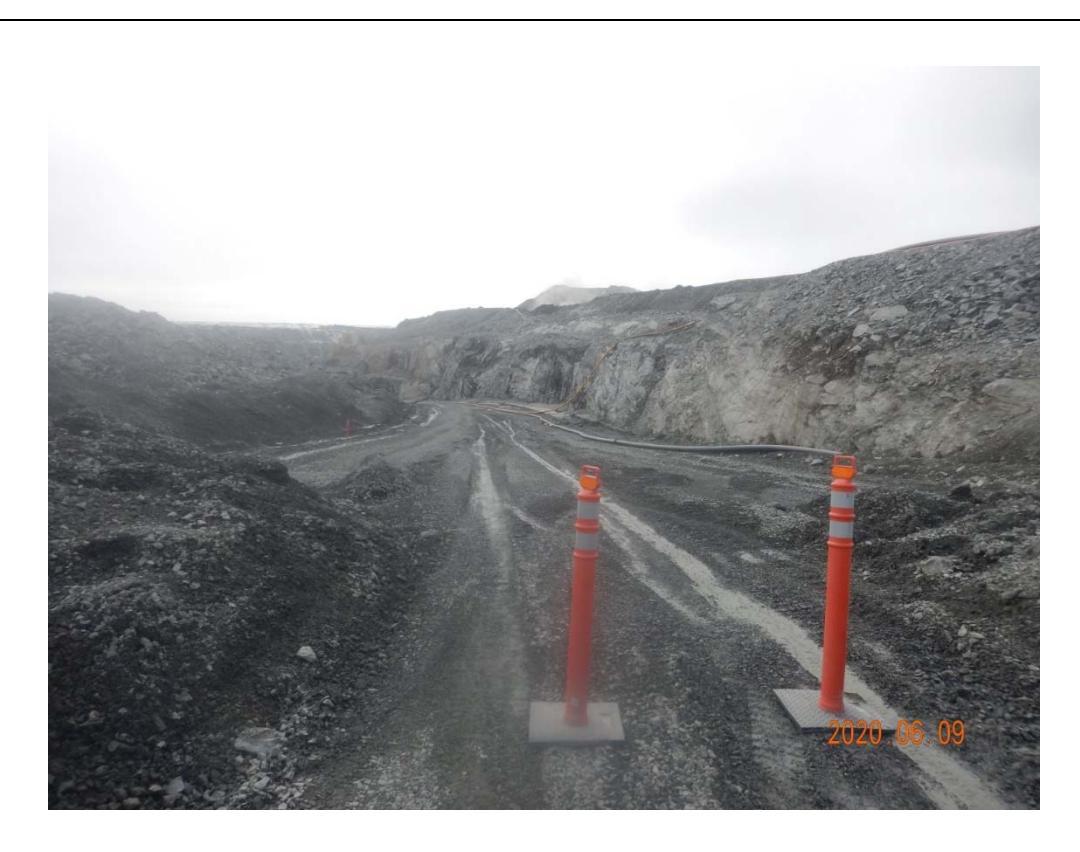
Zone Pit E: Pit E Ramp: Berm currently open for dewatering crew, candles were replaced to restrict unauthorized access.
