Meadowbank 2020 Annual Pit Slope Performance Review

2020 ANNUAL PIT SLOPE Performance Review

Meadowbank Mine, Nunavut

ISSUED FOR USE 704-ENG.ROCK03163-01

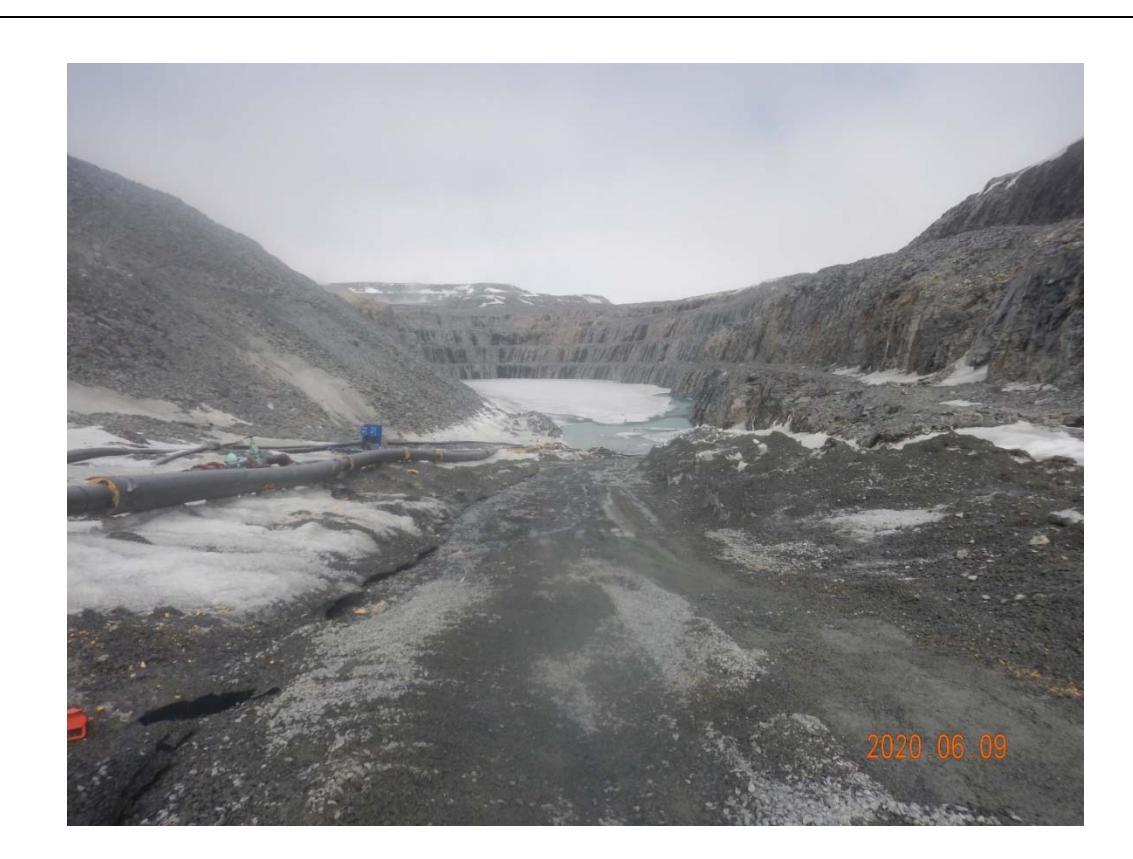
Zone Pit A: Pit A Ramp: Walls and dump does not present signs of instabilities.

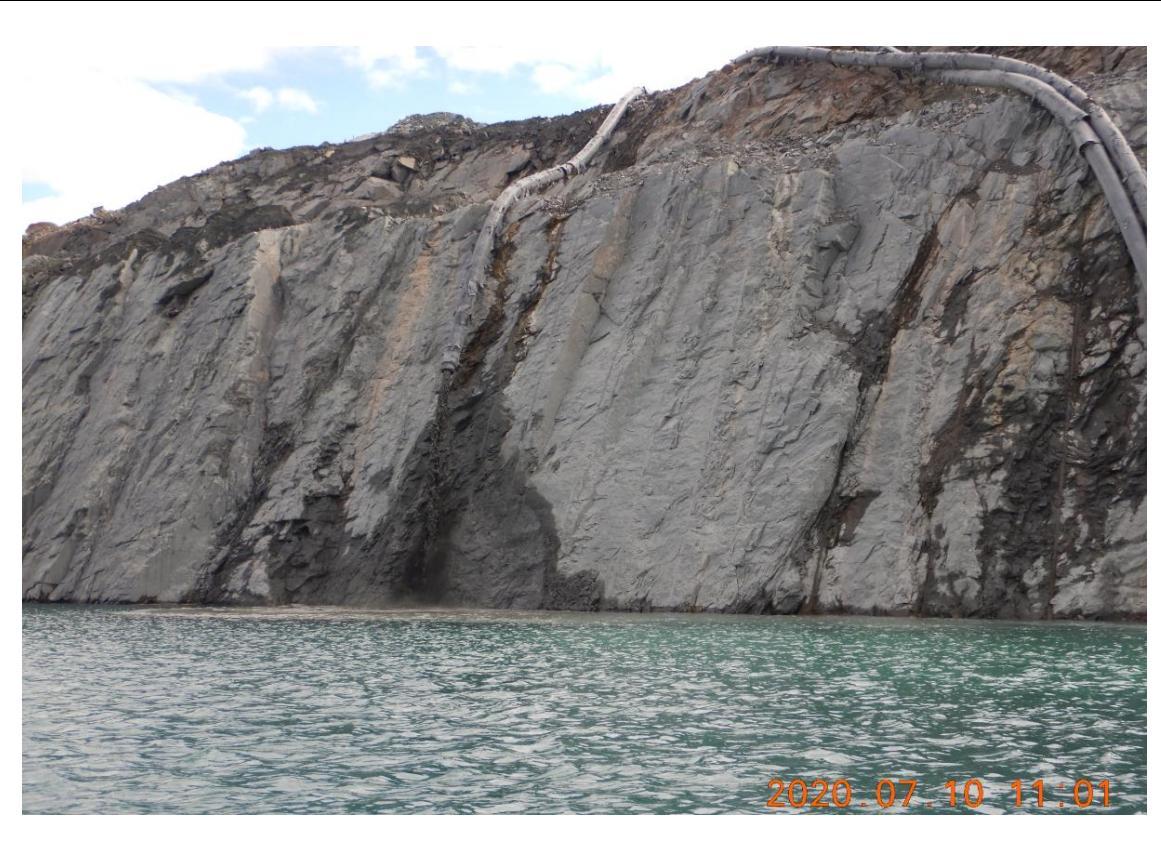
GOOSE PIT East Wall: Active Tailings Deposition

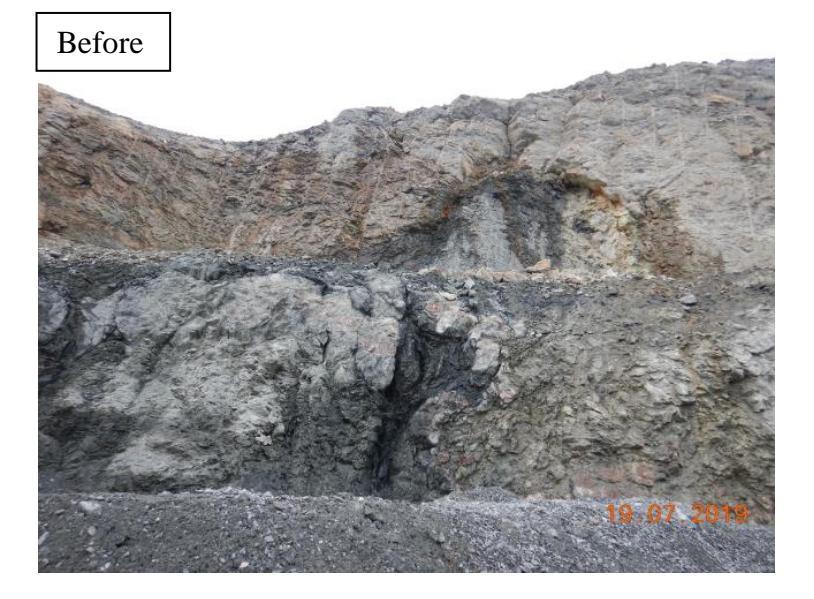
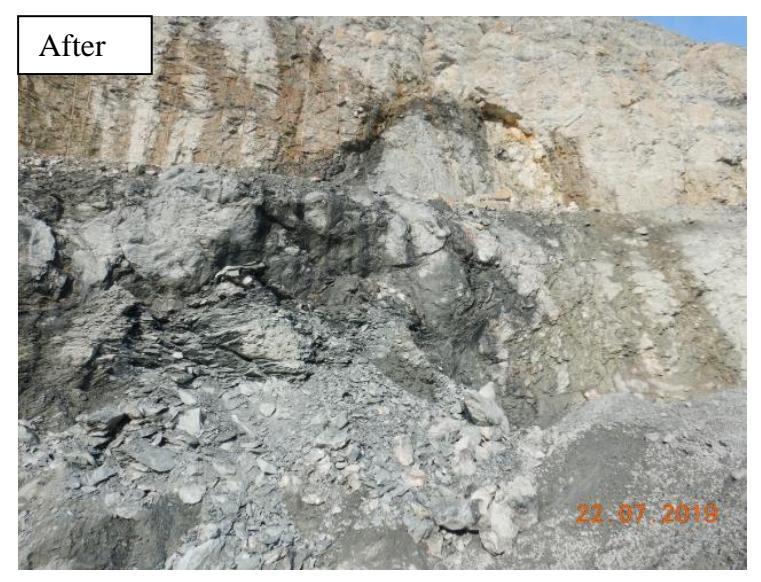
Fig.1: Photos taken before and after the rock fall was reported.

In the morning (between 7:00 & 9:00) of July 22, 2019 a rock fall of approximately 80 tonnes occurred. Pit Supervisor driving down the Portage E3 Ramp observed that a rock fall had occurred. Rocks coming off the wall fell inside an old inactive sump. Note that the area was already closed-off following a field visit conducted by geotechnical personal and pit supervisor on July 20, 2019. Berms and candles were already in place prior to the event. Note that this section of the pit is not covered by our radar.

No personnel were injured and no equipment damaged by the rock fall.

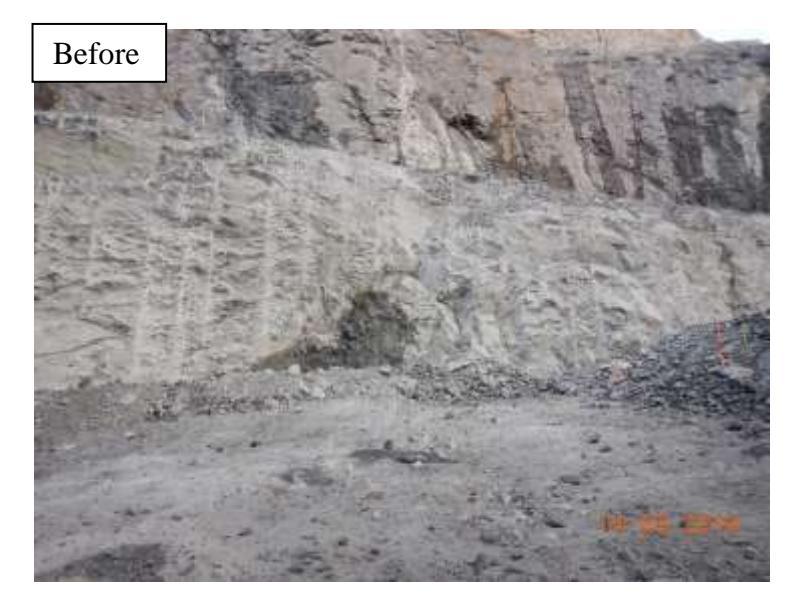
Fig.1: Photos taken before and after the rock fall was reported.

No personnel were injured and no equipment was damaged by the rock fall.

- Keep the area bermed off.
- Re-inforce, to all employee working in the pits, the importance of respecting the procedure "MBK-MINE-OPM-PRO Work close to pit walls".
- In the event we do need to go back drilling in the area, further remediation plan would be determine in time. That may include the possibility of a step-in.

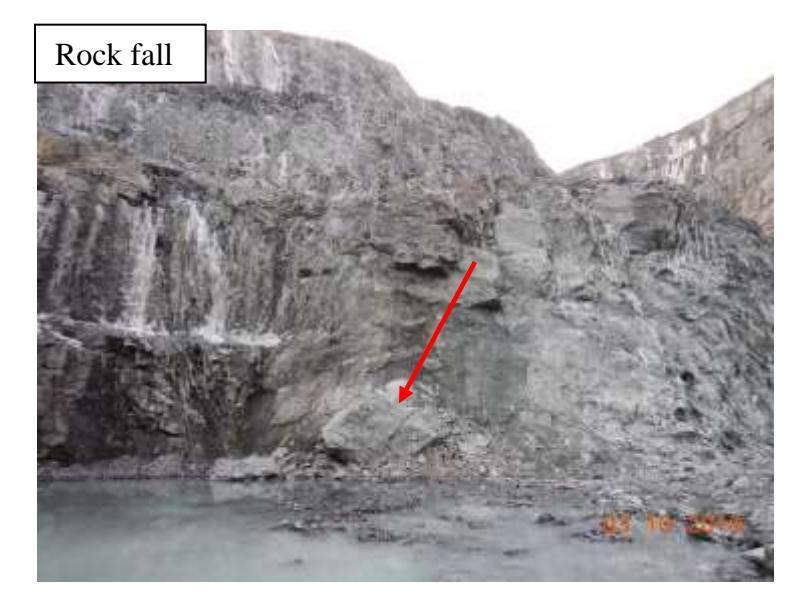
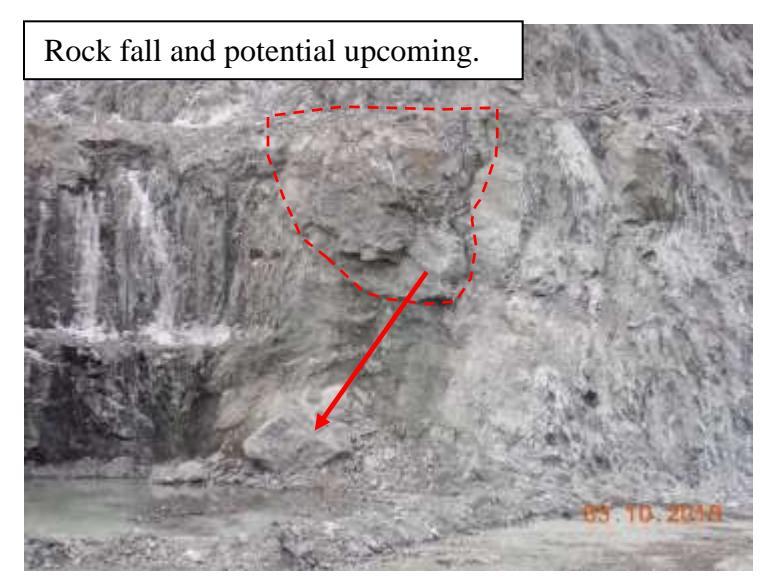
Fig.1: Photos of the Rock Fall.

No personnel was injured and no equipment was damaged by the rock fall as nobody was working in the immediate area.
