### **Whale Tail Open Pit - 2020 Annual Inspection**

## **RE: Amaruq Mine - Whale Tail Open Pit - 2019 Annual Inspection**

# Amaruq Project – Whale Tail Open Pit

## 2020 Annual Inspection

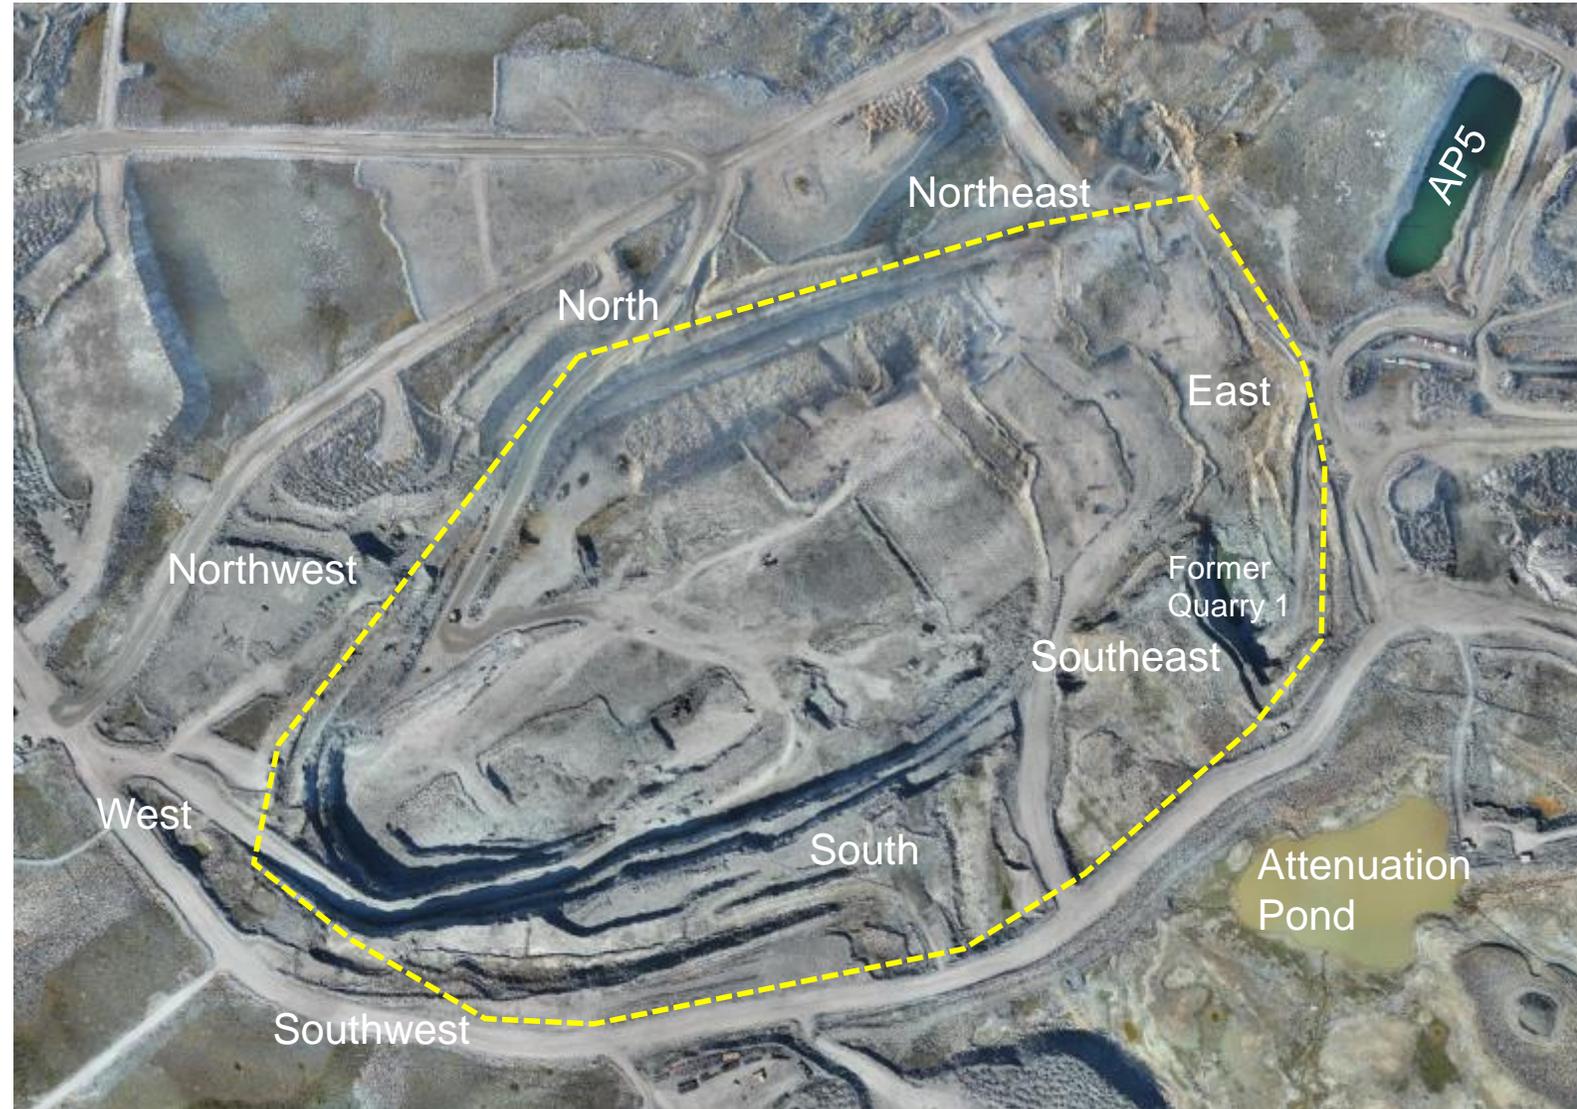
- The Whale Tail open pit was inspected on August 28. Observations made during the inspection are summarized on the following slides.
- The approximate current pit geometry is shown at right. The approximate final crest position (Phase 3) is marked by the dashed yellow line, and the walls inspected are labelled relative to mine north.

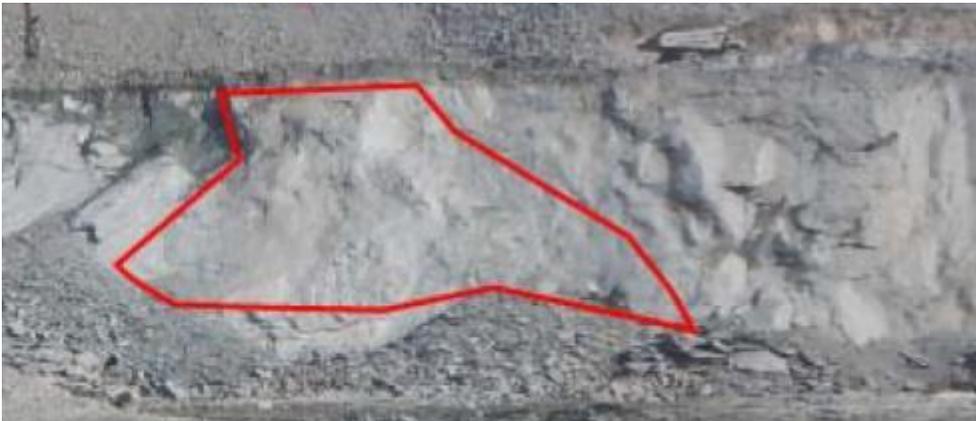
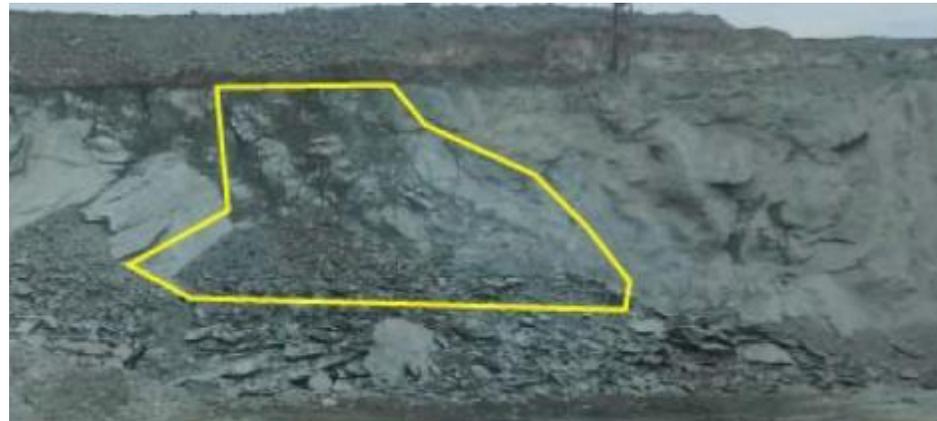
June 22, 254 tonnes  
Before & After

- Note that the benches were established in the winter and are understood to have performed well until the spring thaw, when the failures occurred.
- The failure mechanism has not yet been evaluated in detail but appears to consist primarily of both planar and wedge failures on the foliation, where the foliation is dipping at a shallower angle than the bench face. In some cases, an undulation in the foliation may form both sides of the wedge. In at least one instance, the brittle structure appears to be a contributing factor.

- In this particular design sector (A1), the average dip of the foliation was expected to be  $60^\circ$ .
- The Maptek scans of the failures suggest that they typically occurred on foliation dipping between  $55$  and  $60^\circ$ , slightly shallower than the BFA. In one instance the dip was  $50^\circ$ .

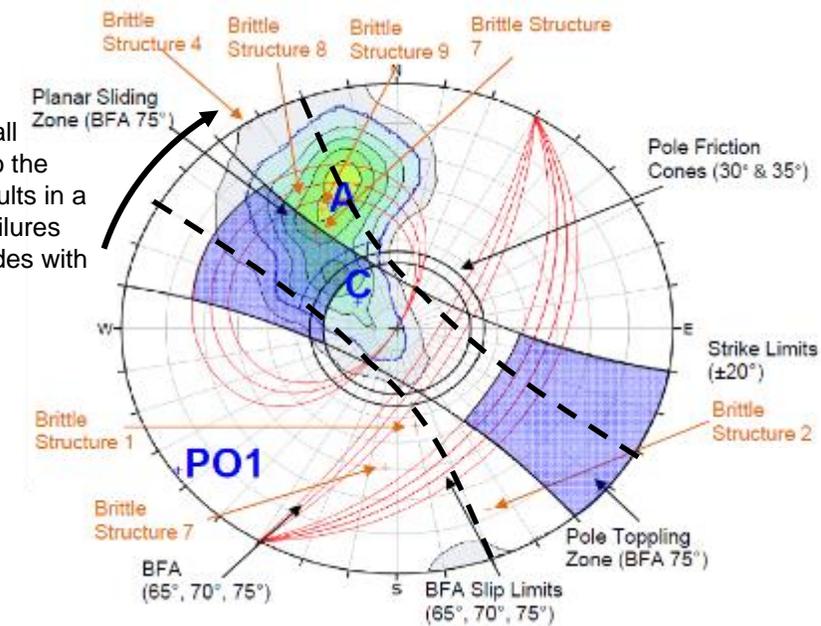
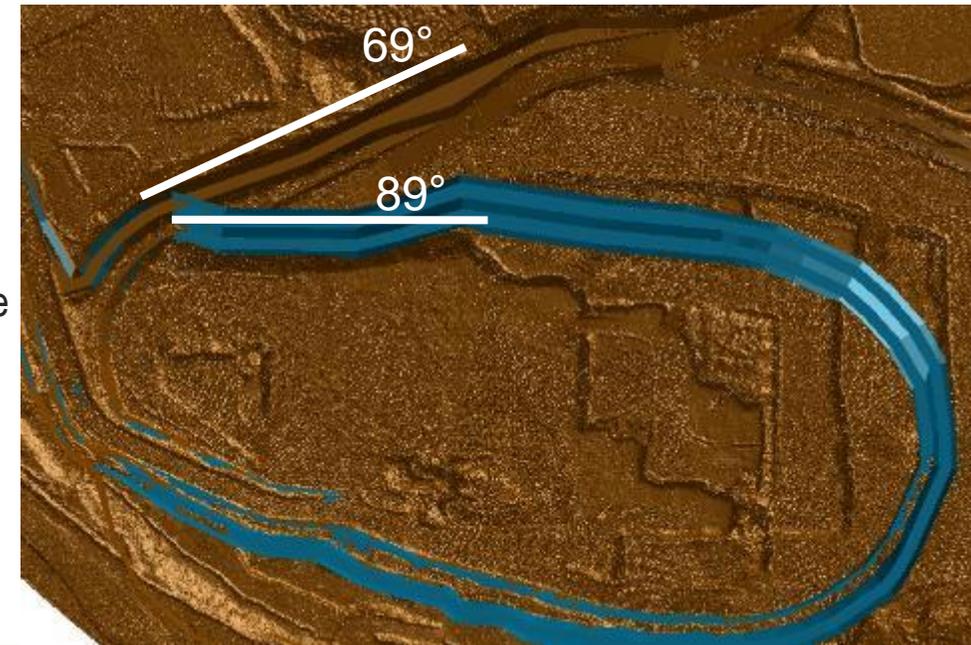
- This is the immediate cause of the failures. However, a significant contributing factor is the relative strike of the pit wall and the foliation.
- The slope recommendations (BFA of  $65^\circ$ , width of  $10.5$  m, IRA of  $46^\circ$ ) applied to the Phase 1 bench in the komatiite were originally developed for the final Phase 3 wall. There is a significant difference in the orientation of those walls in design sector A1:

- The strike of the Phase 1 wall is closer to that of design sector B1 than A1. The slope recommendations for design sector B1 were based on the expectation that the slope would fail back to  $55^\circ$ , which is largely consistent with the actual performance of this wall.

Clockwise rotation in the pit wall orientation from the Phase 3 to the Phase 1 wall configuration results in a predicted increase in planar failures (the planar sliding zone coincides with the foliation).

- AEM will complete stability analyses to confirm these recommendations and KP will review. In the interim, a BFA of  $55^\circ$  and a bench width of 10.5 m can be used for planning purposes.

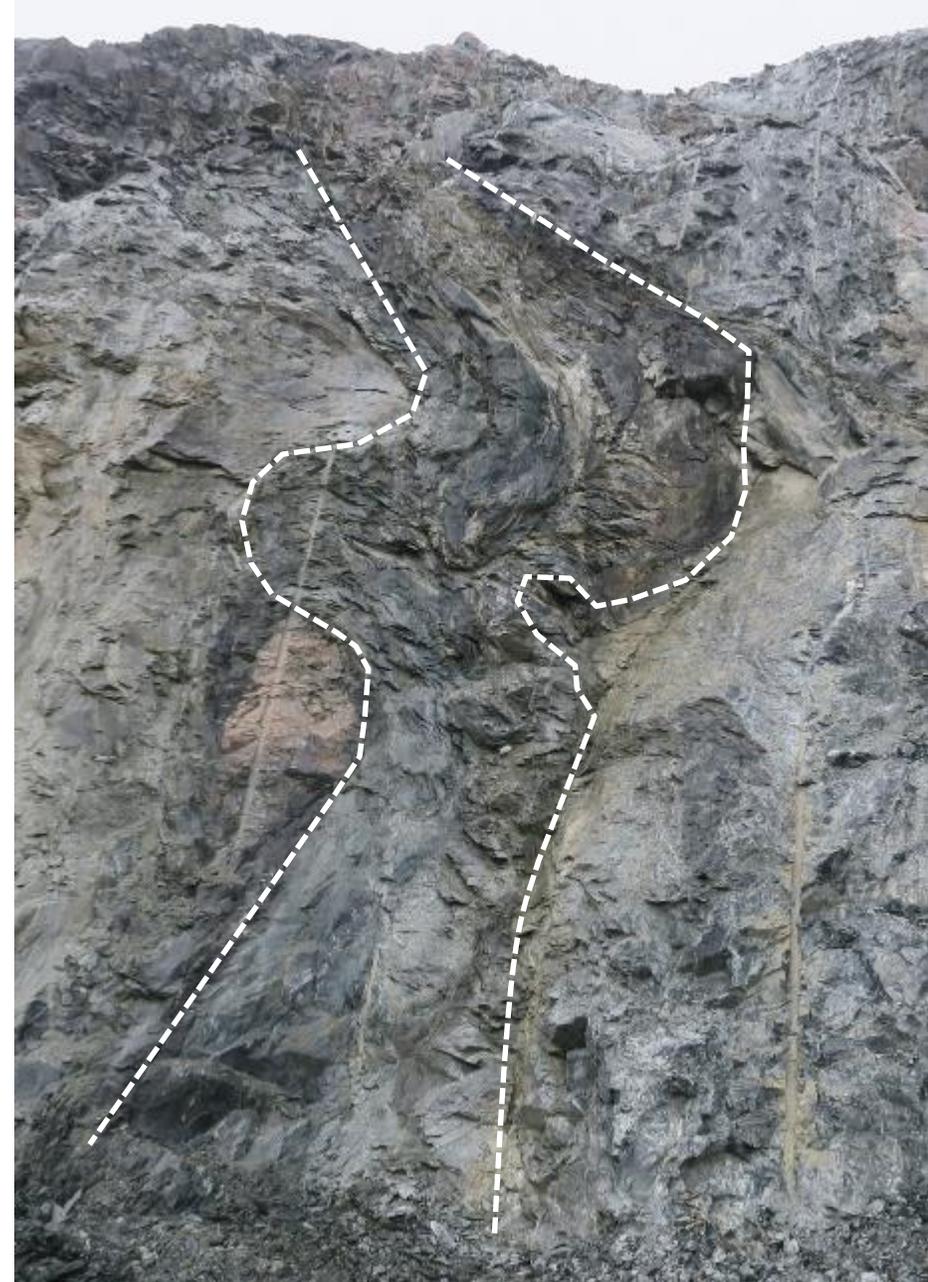
- It is important to note that the objective here is to reduce the frequency of the failures, not prevent them. Some failures will still occur due to the variability in the orientation of the foliation, particularly within the Komatiite.
- An example of the local variation in the dip of the foliation encountered over a 21 m bench in the komatiite is shown at right.

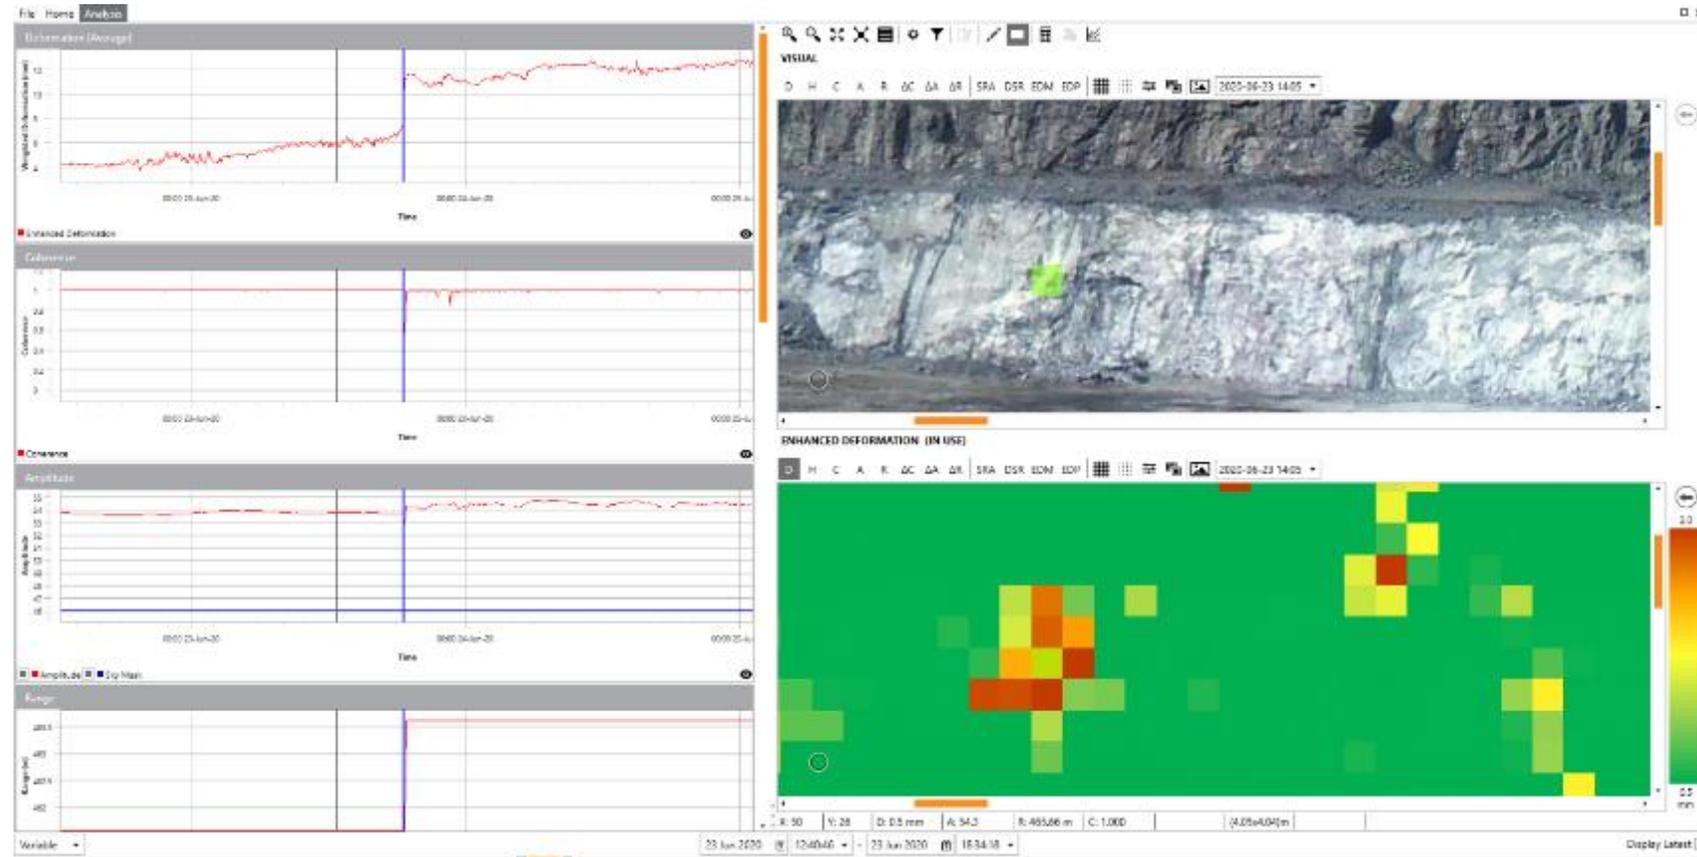
- A GroundProbe slope stability radar is installed on the south wall of the open pit, covering the north wall.
- A second radar has been purchased and is being brought to site.
- The SSR has been able to forecast 5 of the 10 bench scale failures that have occurred since it was installed (example from June 23, 2020 shown at right). However, 2 of the missed failures were obscured by equipment or muck.

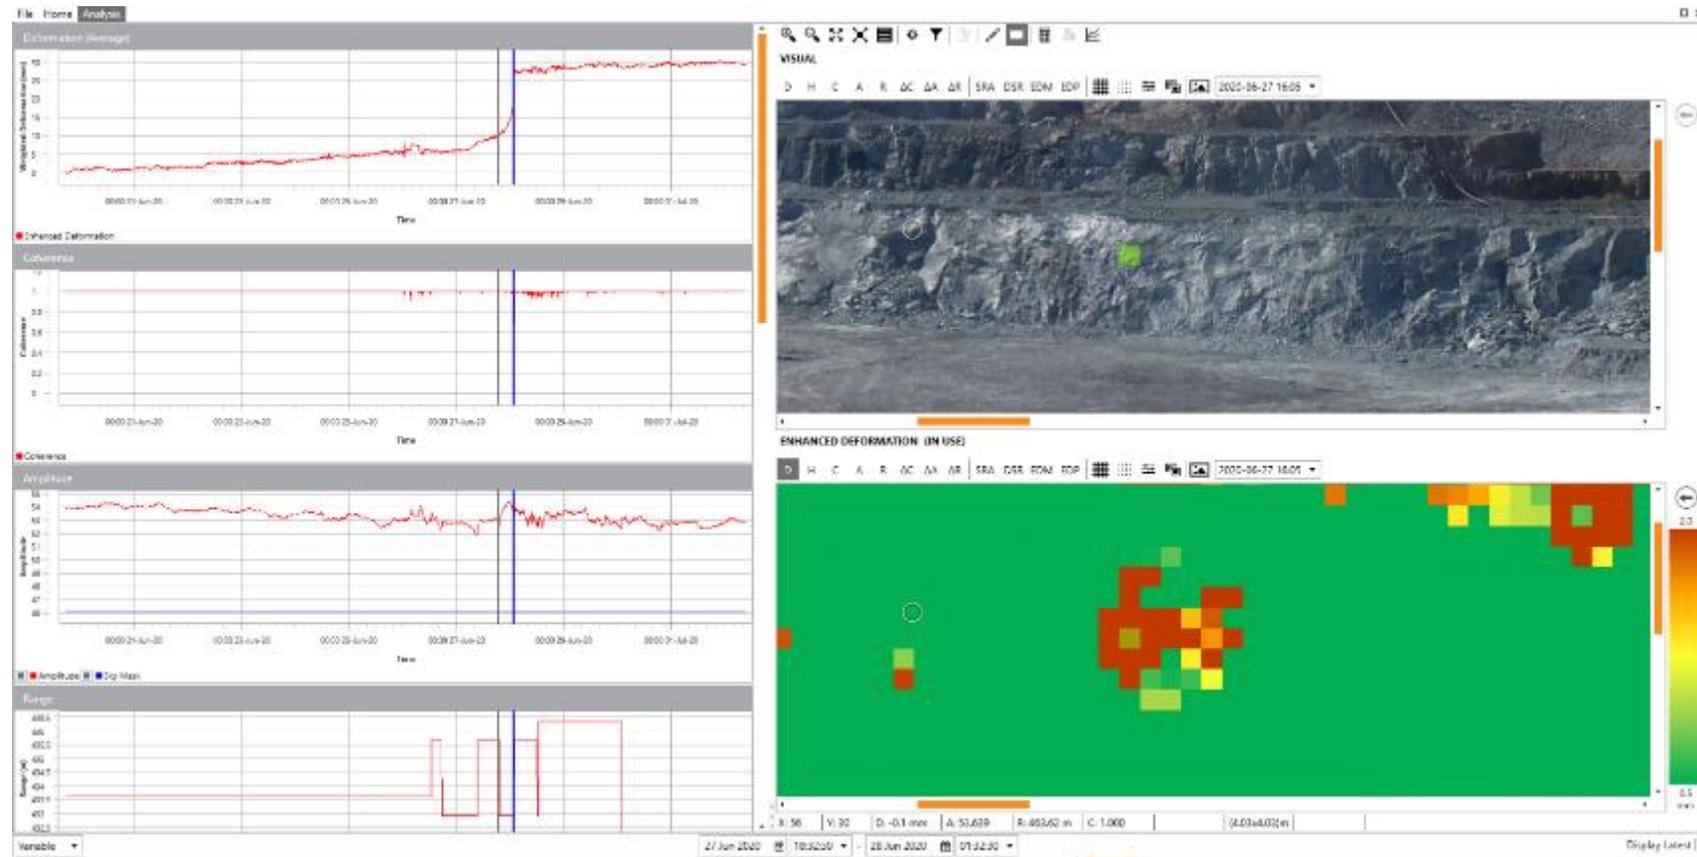
- The SSR is not always able to predict the bench scale failures that have occurred at the mine. This is primarily a function of the scale of the failure relative to the resolution of the radar, and how rapidly they occur.
- For example, the SSR predicted the June 29 failure (which was a continuation of the June 23 failure) only a few hours in advance and might not have triggered an alarm.

- While the SSR is a very valuable and effective tool, it is best suited to larger-scale failures and cannot always detect bench scale failures, especially if they are small and/or brittle failures. This highlights the importance of the on-going visual inspections.
- The effectiveness of the system can be increased by keeping the SSR close to the wall being monitored and orienting it as close as perpendicular to the wall as possible. With the acquisition of a second unit, the mine has the ability to use one SSR strategically (e.g. covering the north wall) and to use the other tactically (e.g. focussing on a key area such as a large exposure of komatiite while mining is in the area).

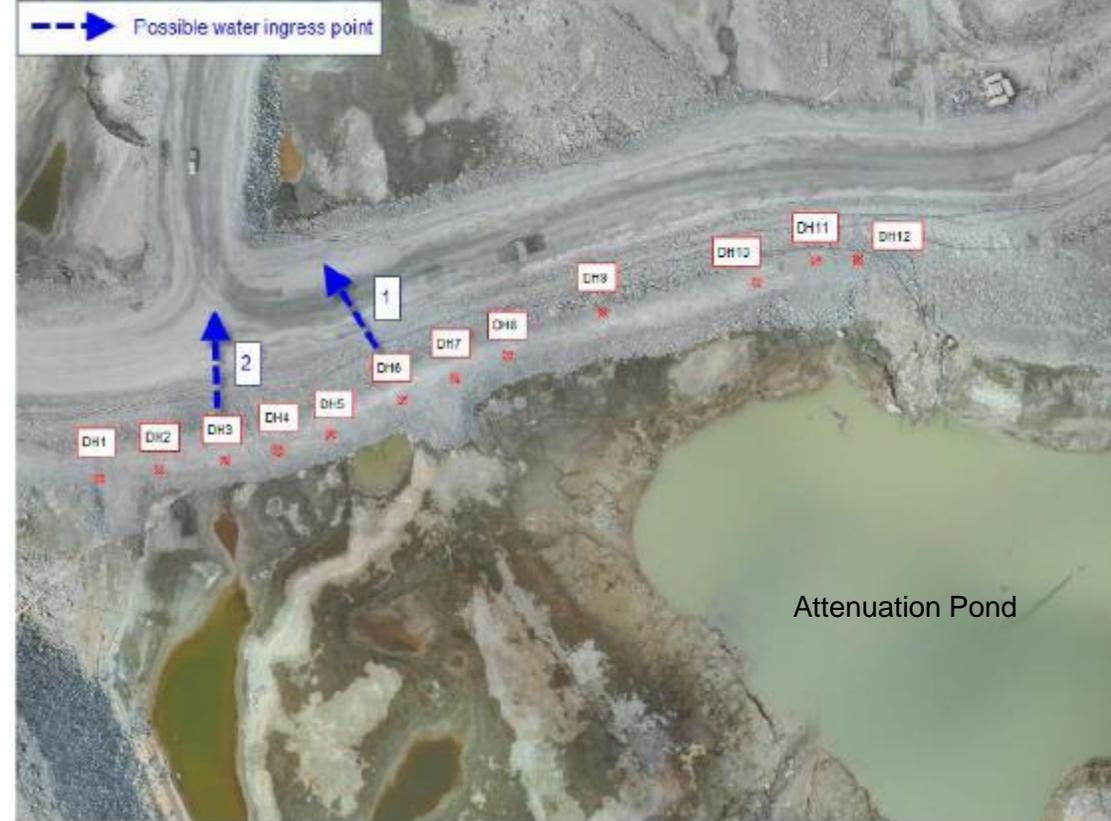
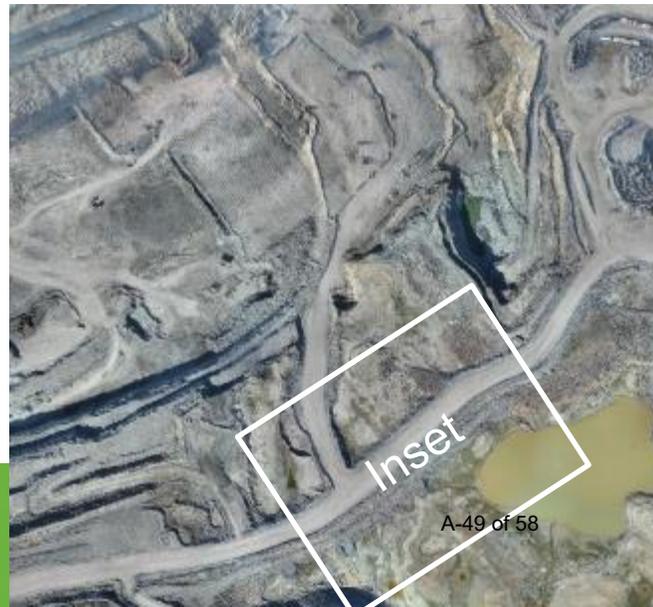
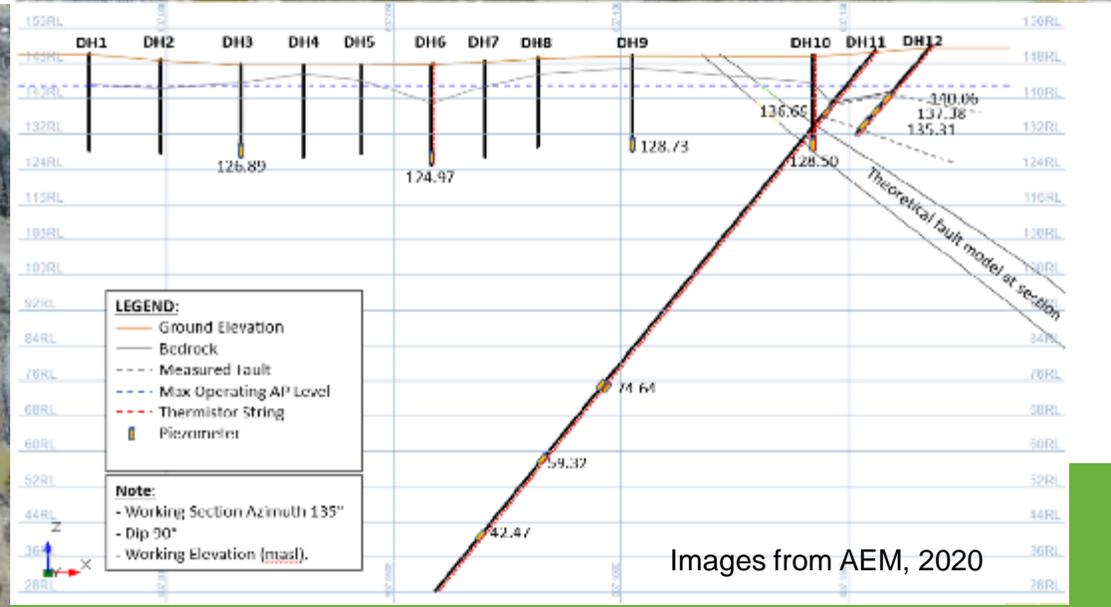
- AEM installed a series of piezometers and thermistors along the planned crest of the ultimate pit where it will be adjacent the attenuation pond and the lakebed of Whale Tail lake. The objective was to determine if the pond was the source of the water in the floor of the pit.
- The results suggest that water is flowing from the attenuation pond towards the open pit within the near-surface bedrock, as well as deeper fractured zones. There is a rapid response observed in the instruments (both piezometers and thermistors) when the water level in the attenuation pond rises (shown on next slide).
- Additional sensors are planned to better define the flow path to the open pit; this is encouraged.
- No evidence of flow along the Ramp Fault was observed in the instrumentation.
