### **Meadowbank 2021 Annual Open Pit Geomechanical Inspection**

**RE: Meadowbank Complex - Meadowbank Site - 2021 Annual Open Pit Geomechanical Inspection**

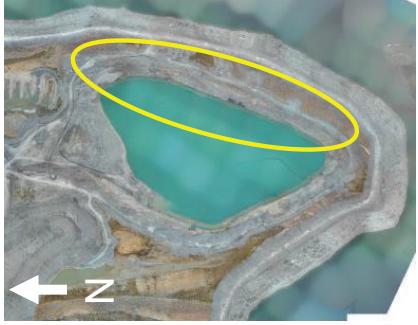
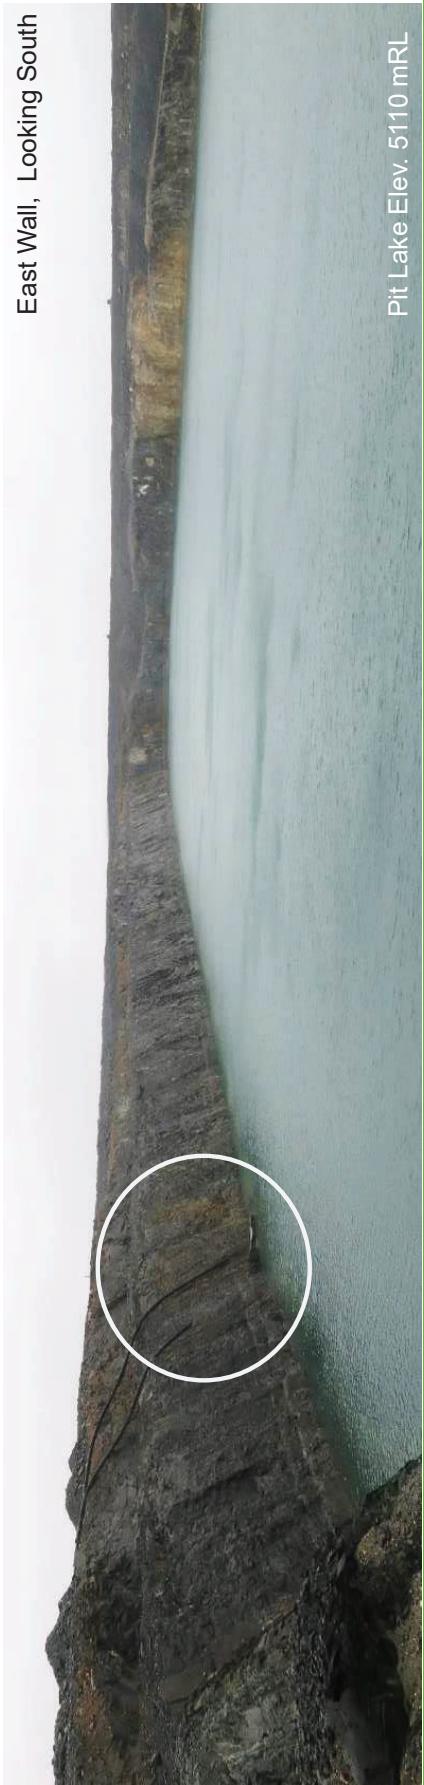
## Goose Open Pit - East Wall

- A portion of a single bench is exposed above the current pit lake.
- The wall was established in the Intermediate Volcanics and is performing well.
- The former tailings discharge point is circled below. No erosion of the slope was noted.
- No particular geomechanical concerns were noted.

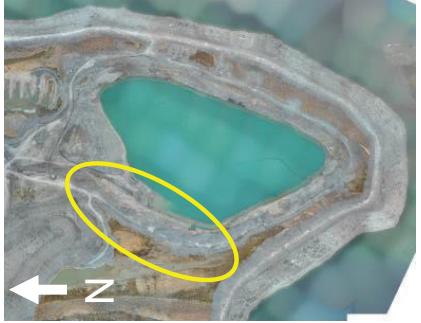
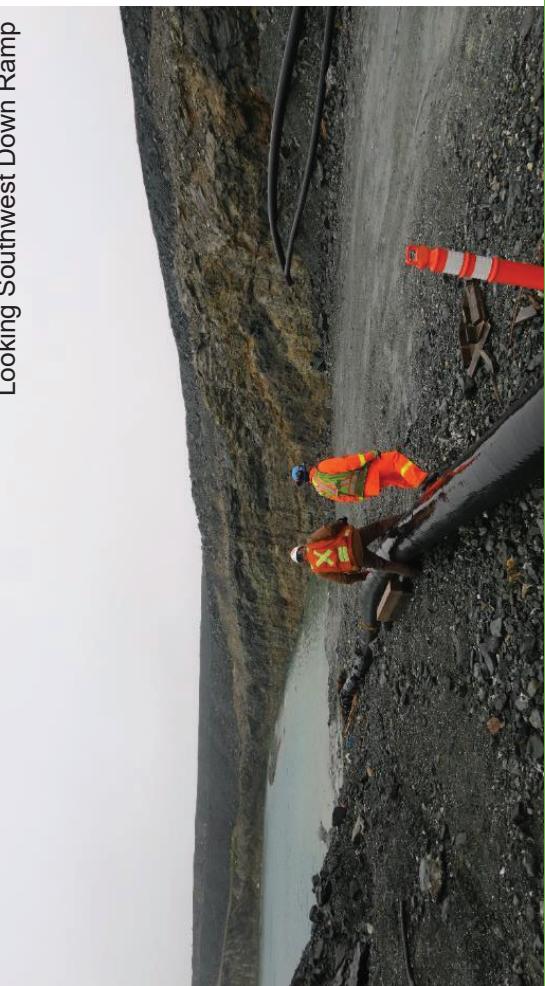
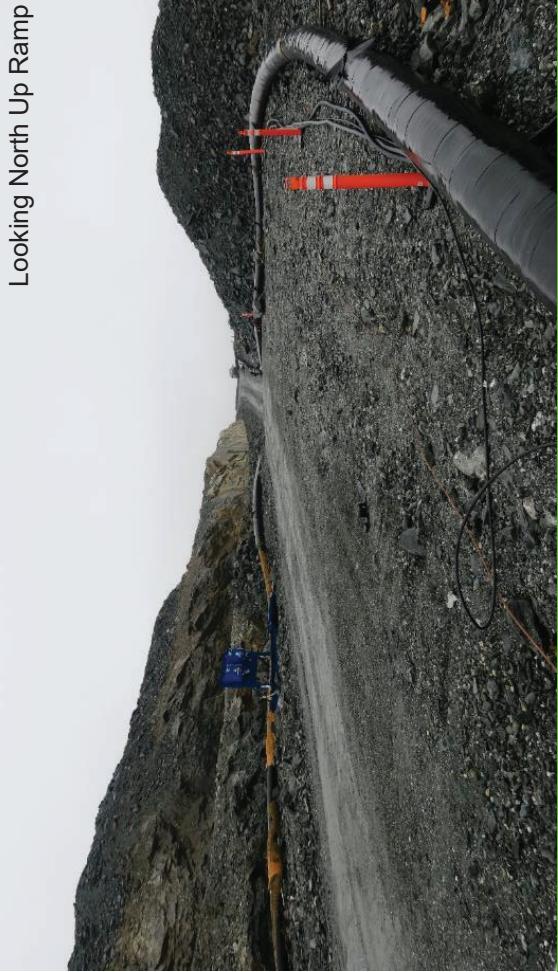
## Goose Open Pit - West Wall and Ramp

- At the time of the inspection, pylons were in place at the top of the ramp to restrict access to authorized personnel.
- The exposed bench faces along the ramp are relatively low and there is ample room to transit and work away from the wall. As a result, the rockfall risk is considered to be low. It is understood that a pump had been located adjacent the wall but was moved to the other side of the ramp to reduce exposure. The pump was not present at the time of the inspection.
- No particular geomechanical concerns were noted.

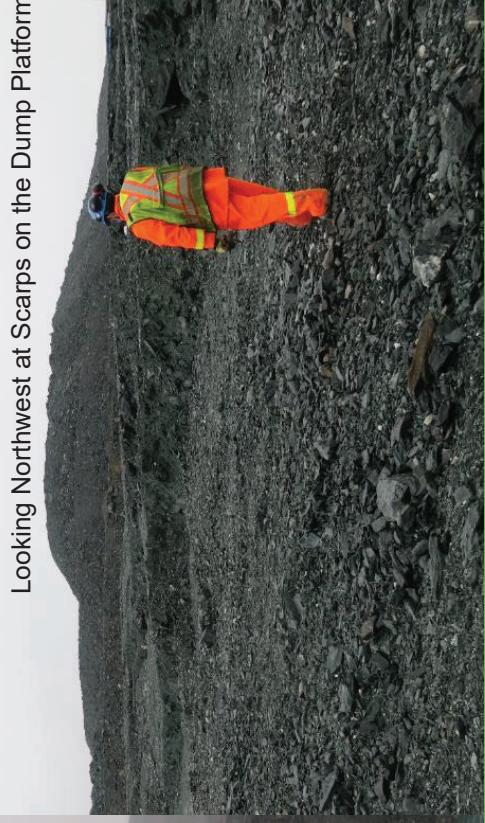
- The dump has been subsiding since 2015. The settlement is attributed to the deposition of water in the open pit, through a combination of thawing snow/ice lenses within the dump, thawing frozen contacts between rock blocks, and increasing porewater pressure. An example of one of the scarps formed by the settlement is shown at lower right.
- The settlement is monitored visually as part of monthly inspections by the Geotechnical team.
- The dump is inactive and access is prevented by both a rockfill berm and the presence of water pipes across the access point.
- Recommend continuing the monthly visual monitoring as long as access is still required to the open pit. There is an opportunity to use the drone imagery already collected by the mine to do a photogrammetry assessment of the subsidence on an annual basis.

Looking Northwest at Scarps on the Dump Platform

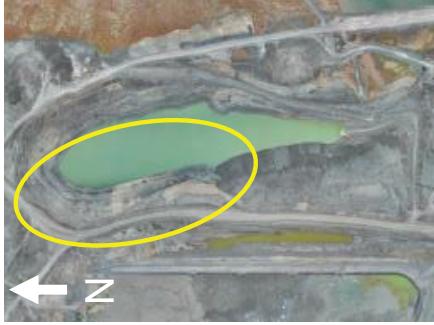
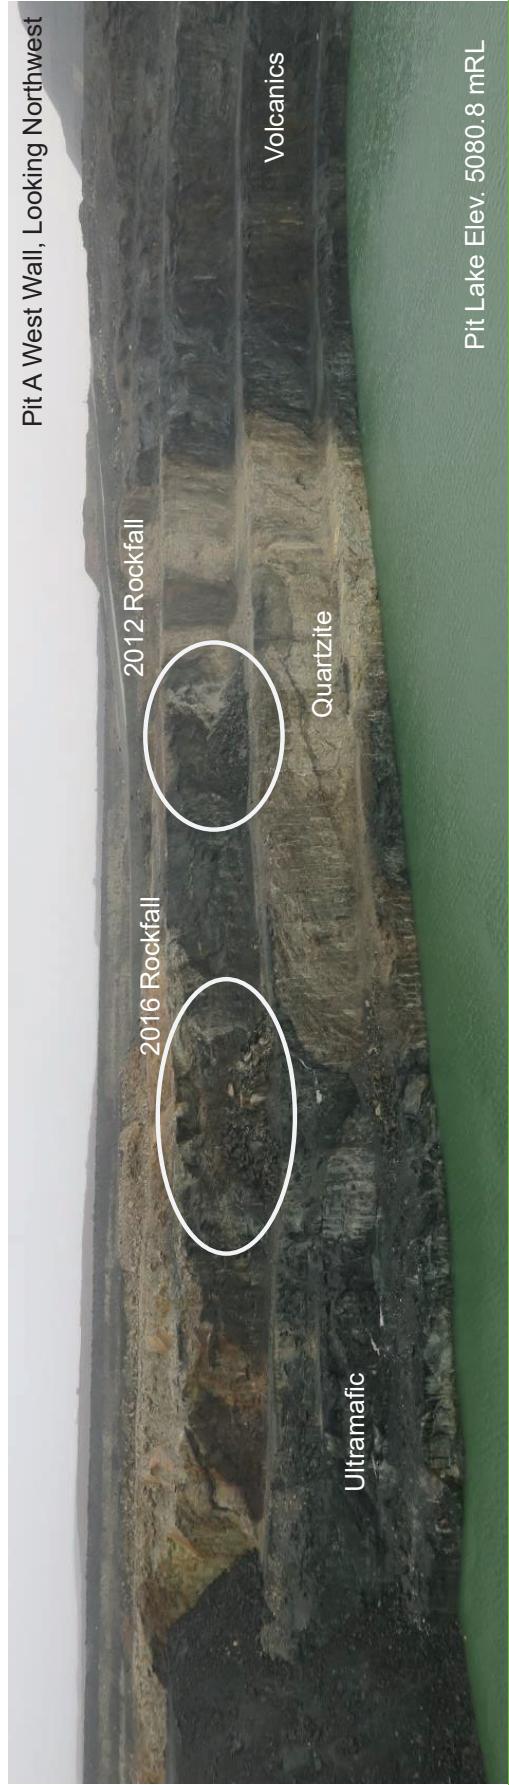
## Pit A - West Wall

- Approximately three benches are exposed above the pit lake in this area.
- Local bench scale failures have previously occurred within the Ultramafics on this wall. No significant change was observed in the failures remaining above the pit lake since the 2020 inspection.
- Several large voids are present within the Quartzite and were previously identified as a rockfall hazard. No significant change was observed since the 2020 inspection.
- No particular geomechanical concerns were noted.

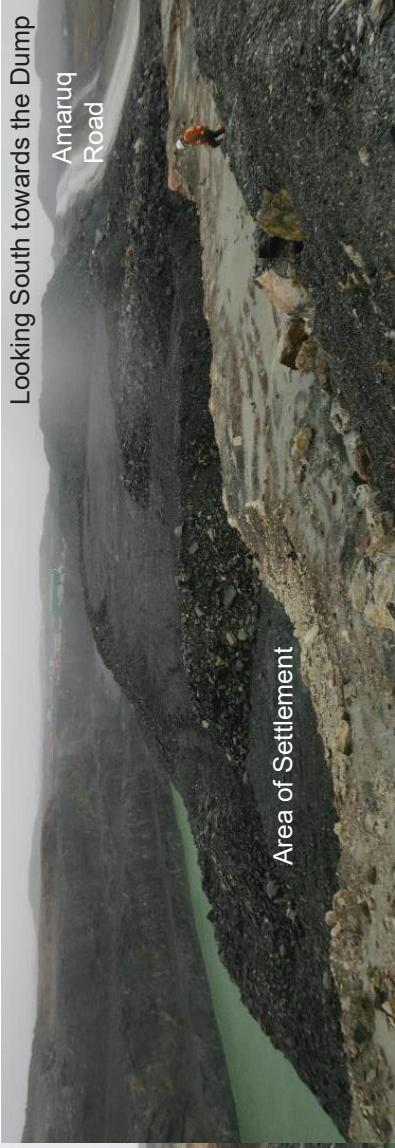
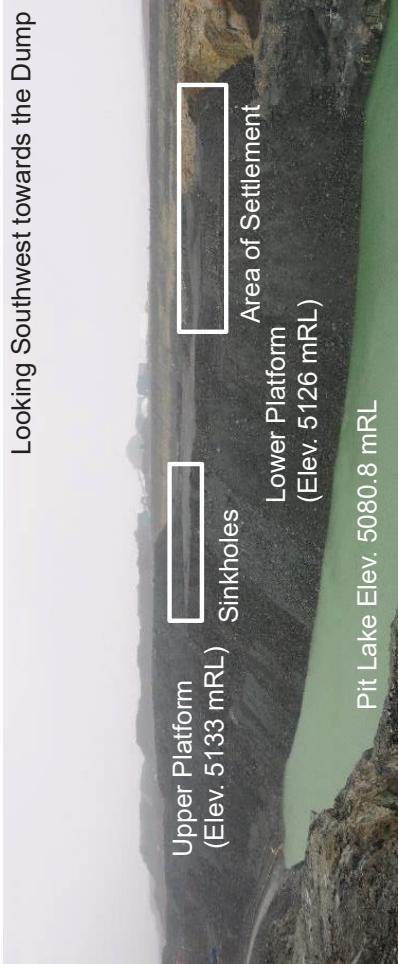
## B Dump

- The northern end of the Lower Platform above the pit lake has settled and tension cracks are present. Sinkholes have also formed at the southern end of the Lower Platform. These are discussed on the following slide.

- Failures of the dump slope are possible as the pit lake elevation rises, but have not been observed to date. Such a failure could cause a large wave in the pit lake, as discussed on the previous slide. The potential for a failure of the dump back towards the Amaruq Road (see photo at lower right) was discussed as it is not clear if the road is partially constructed on the dump. The topography and bedrock profile below the road and the dump should be reviewed to assess whether this is a plausible failure mode.

- A geotechnical inspection of the dump is completed on a monthly basis. The dump is not instrumented. Recommend continuing the inspections, particularly while access continues on the Pit A South Ramp below the dump.

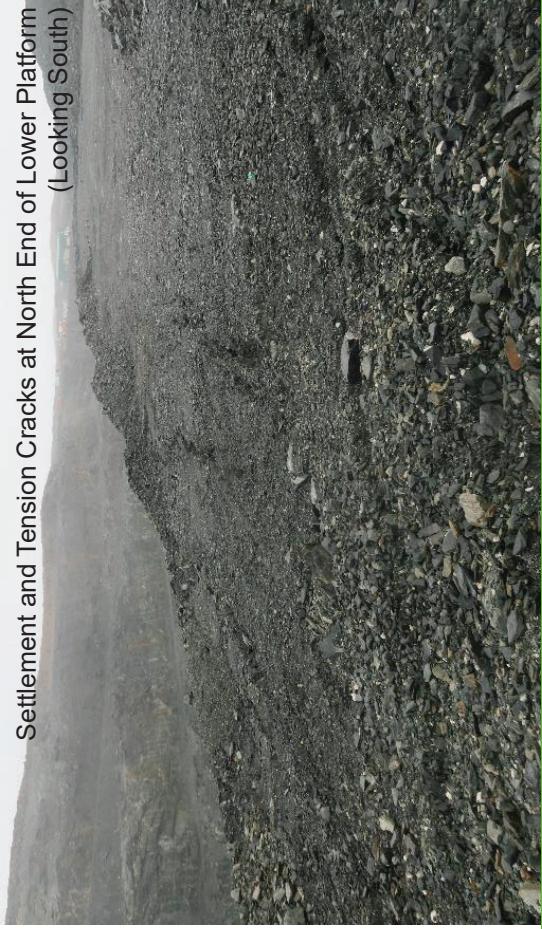
- Based on discussions with C. Clayton and C. Tremblay, there has been little change in the sinkholes and settlement since the 2020 inspection. No obvious bulging of the toe of the dump slope was observed. It was noted that the deposition of Ultramafics within the dump had previously contributed to settlement of the dump.
- Continue to monitor the settlement and tension cracks at the north end of the dump. Recommend surveying the cracks so that their development over time can be monitored.
- Recommend grading the Lower Platform prior to the winter in order to limit water infiltration during freshet.

Sinkholes at South End of Lower Platform  
(Looking South)

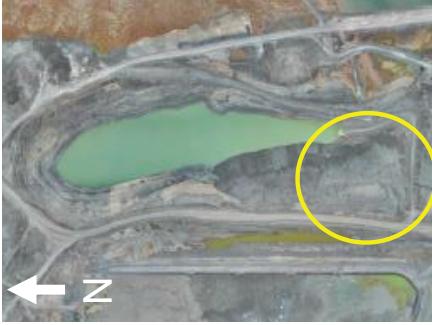
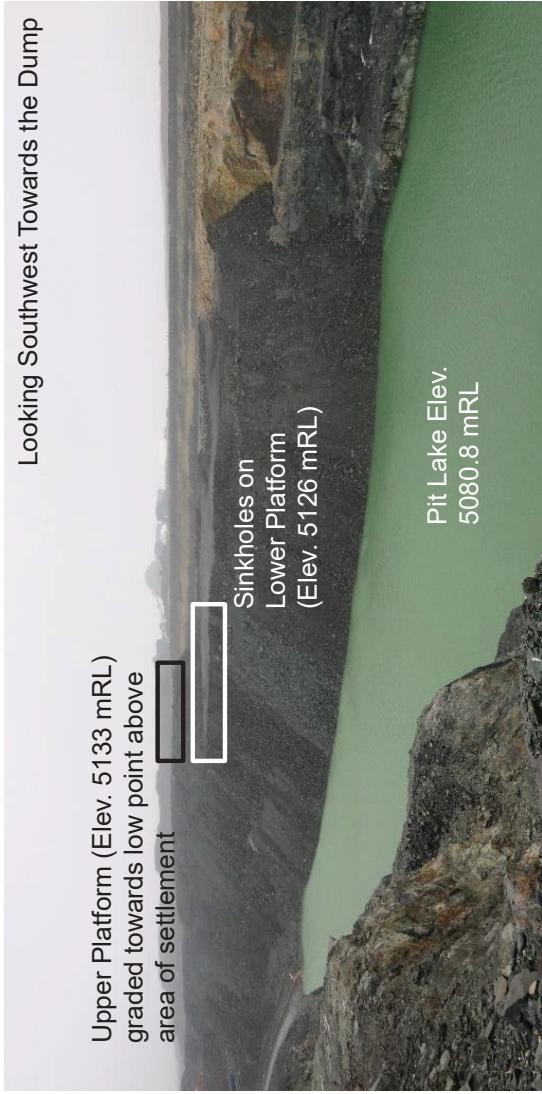
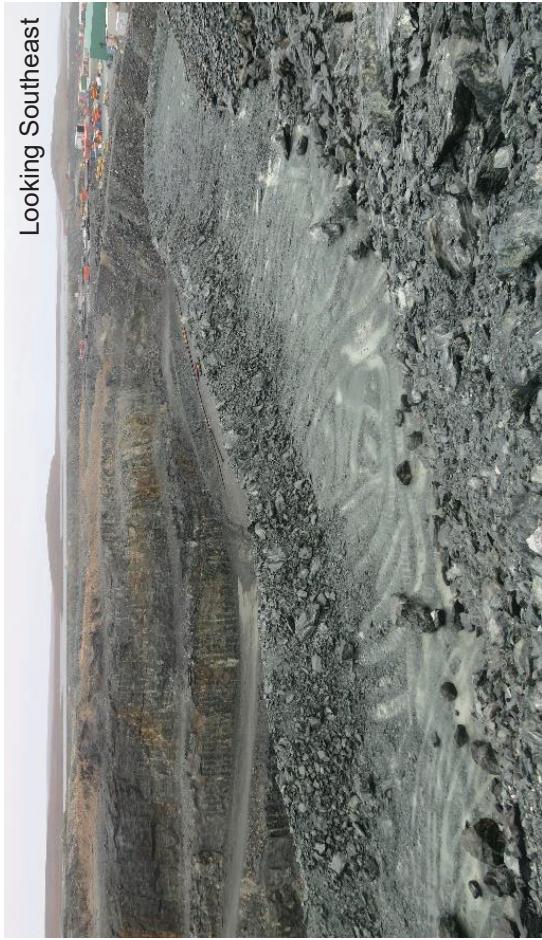
## B Dump - Upper Dump Platform

- Evidence of instability was not observed on the Upper Platform.
- The Upper Platform is graded so that water flows to a low point above the area of the Lower Platform where sinkholes have formed. This is a likely cause of the sinkholes. The recommendations from the previous annual inspection remain applicable; recommend filling the low point and re-grading the dump so that water is directed away from this area.
- Recommend constructing a berm to prevent access to the Upper Platform.

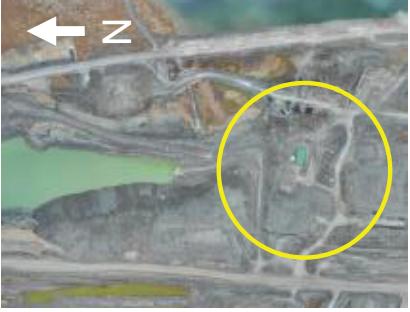
- Note that the 2020 inspection report identified a water/tailings elevation of 85 masl as a possible threshold for migration of water below the C Dump. The water elevation in Pit A at the time of the 2021 inspection was just under 81 masl. No evidence of instability was observed at the time of the 2021 inspection.

C Dump, Looking Southeast

- The associated geotechnical risks for the garage were discussed in detail in the 2020 inspection report. The recommendations from that report remain applicable. It is recommended that the garage be relocated outside of the immediate vicinity of the open pits, waste dumps and tailings/water management areas and that access to the C Dump be prevented with a berm.

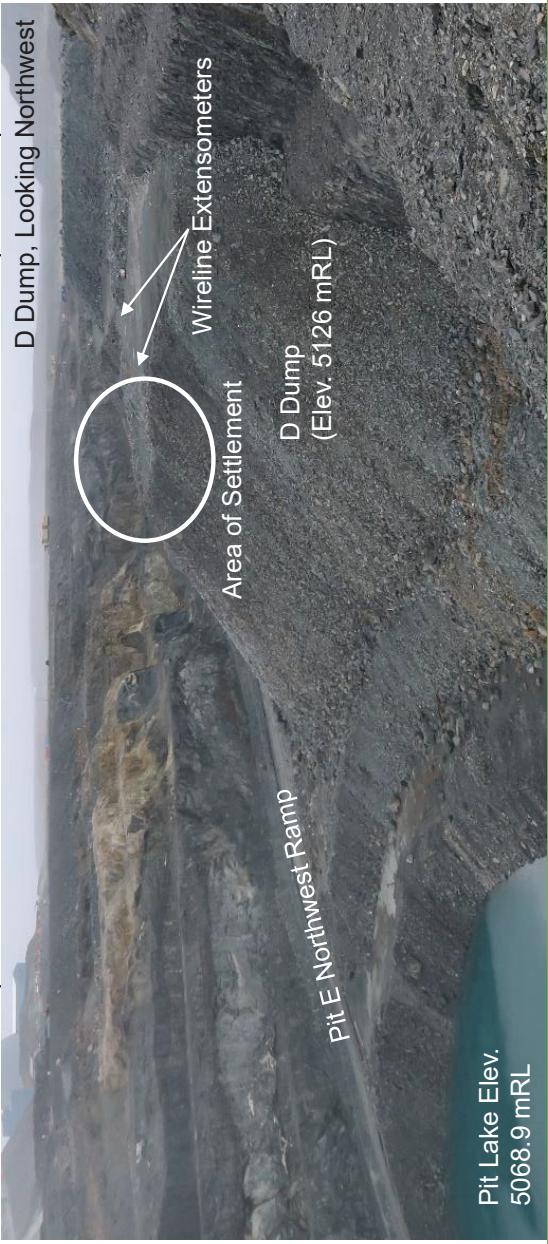
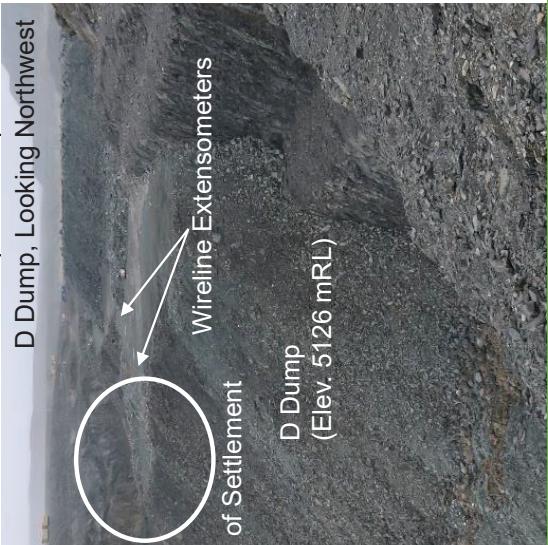
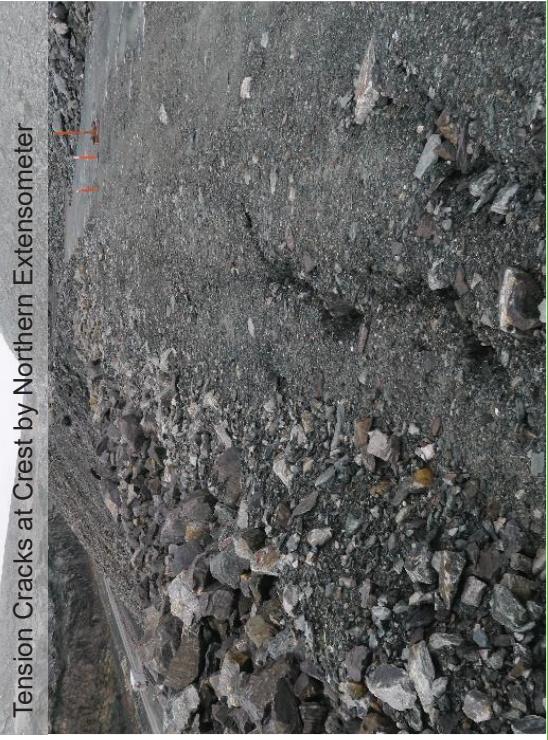
- The D Dump backfilled Pit D and forms the north wall of Pit E. The Pit E Northwest ramp runs along the western toe of the dump.
- The southwestern end of the dump started to settle in 2017 to 2018. Tension cracks are visible in this area as well as along the crest immediately to the north. It is understood that there has been limited change in the settlement or tension cracks since the 2020 inspection. Bulging of the toe of the slump was not observed. Access to the top of the dump is restricted by a berm.

- Two wirelines extensometers have been installed at the crest of the dump in the area of settlement and tensions cracks in 2019. The extensometers are monitored monthly. The data are discussed later in this presentation but the deformation rate is currently less than 1mm/day. The monitoring and the monthly visual inspections should continue while access to the Pit E Northwest ramp is still required.

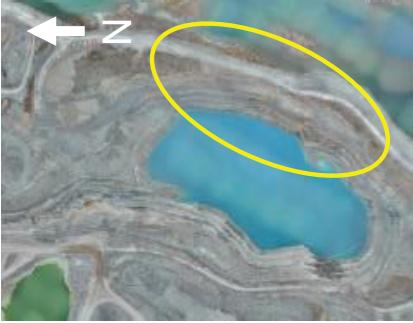
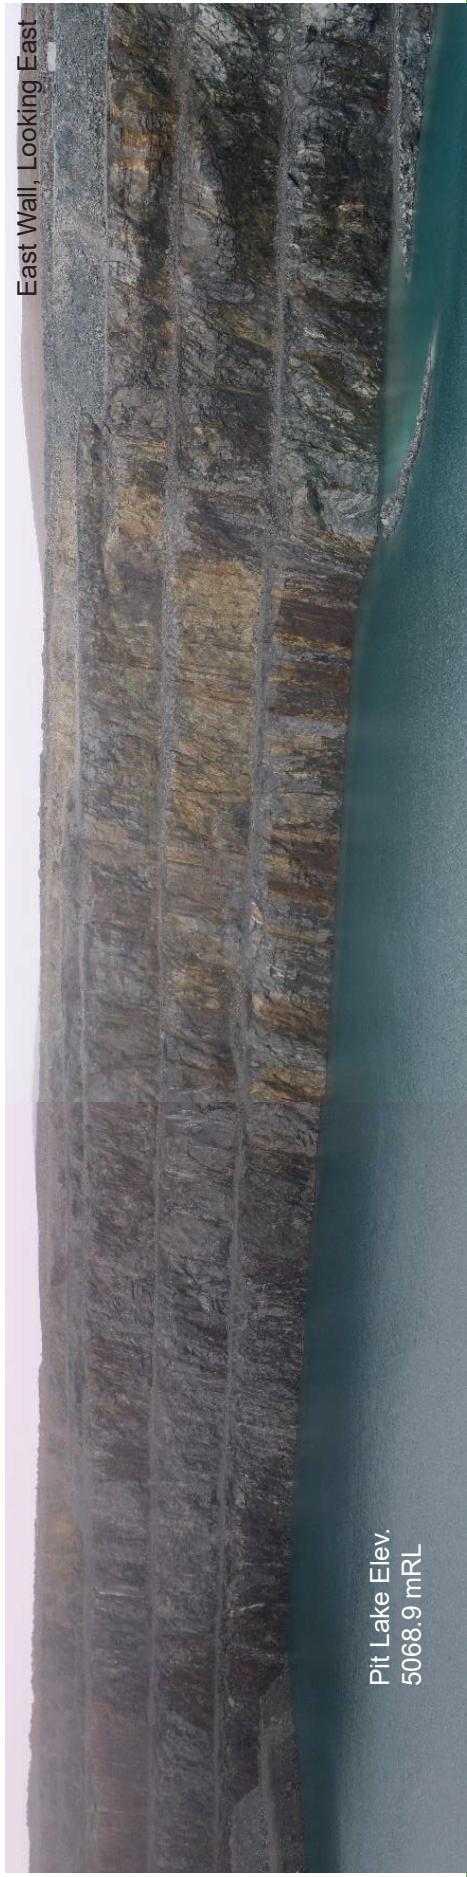
## Pit E - East Wall

- Approximately three benches are exposed above the pit lake in this area.
- The wall is performing well.
- No particular geomechanical concerns.

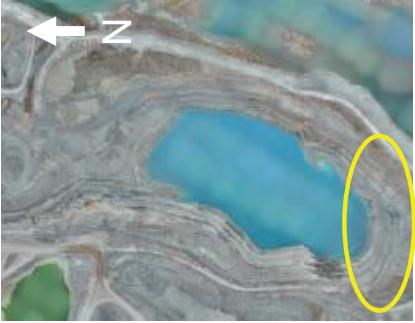
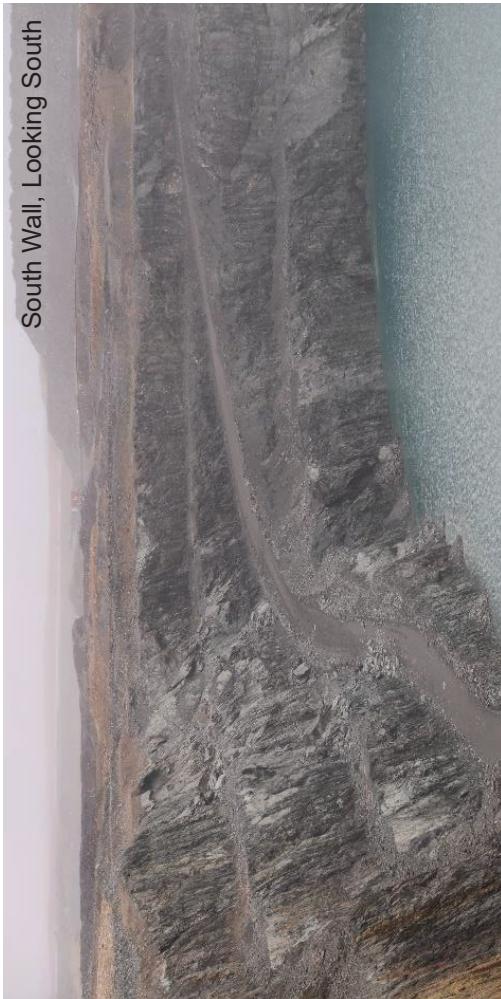
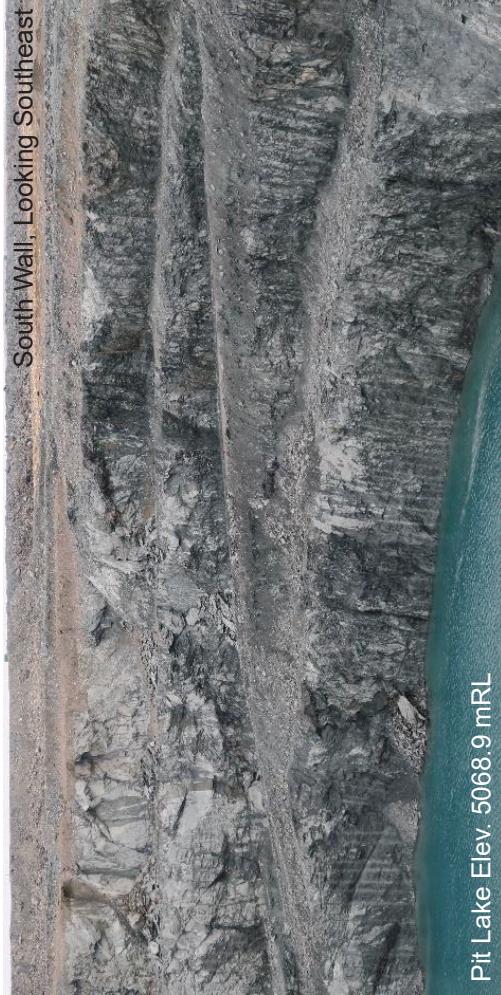
## Pit E - South Wall and Ramp

- The South Wall was established in Ultramafics and has experienced a series of bench-scale instabilities and rock falls.  
Approximately three benches are exposed above the pit lake in this area.
- At least one rockfall has occurred since the 2020 inspection, with material accumulating on the South Wall Ramp. As the South Wall Ramp has been closed since before the 2020 inspection, the instability did not pose a risk to personnel.
- A berm has been constructed at the top of the South Wall Ramp to prevent access.

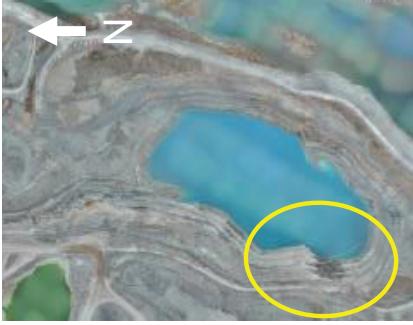
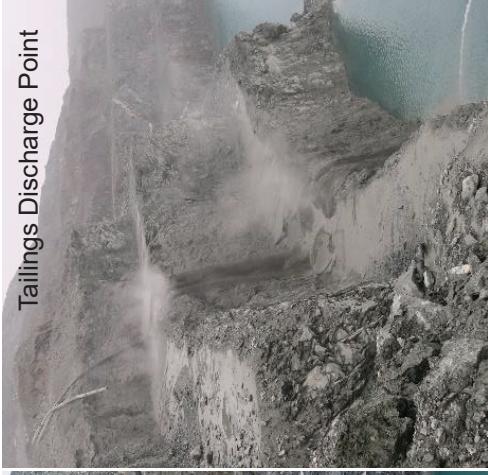
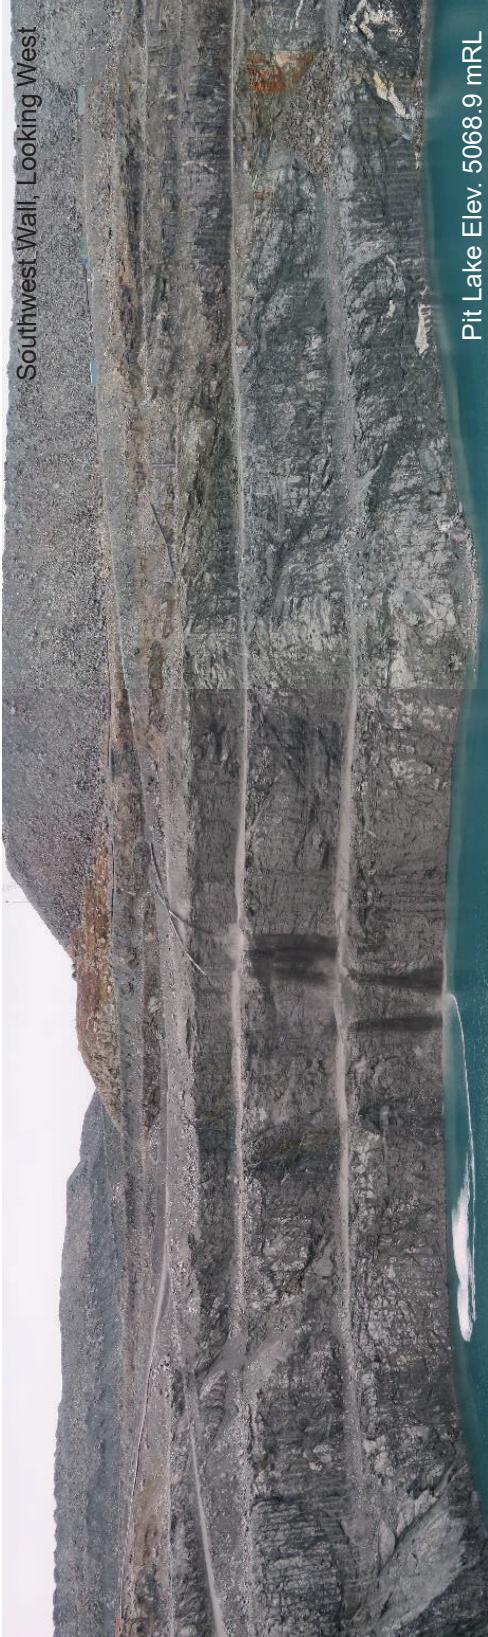
## Pit E - Southwest Wall

- The wall consists of Ultramafics overlying Intermediate Volcanics and is intersected by the Bay Fault. Approximately three benches in the Ultramafics are exposed above the pit lake. The wall is within talik associated with the Third Portage Lake.
- Tailings are discharged from a line at the crest of this wall. Tetra Tech recommended that tailings not be discharged over the Ultramafics due to the potential for erosion of the benches or slope instability due to water infiltration. No significant evidence of these hazards (e.g., erosion, cracking, seeps, etc.) were observed at the time of the inspection. Similarly, no settlement of the adjacent crest road was observed. The wall is performing well.
- Recommend continuing the monthly visual inspections to monitor the area for bench degradation/erosion, tension cracks, seeps, etc.

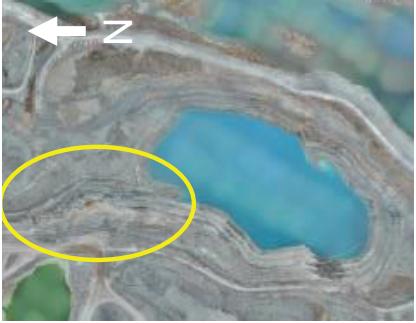
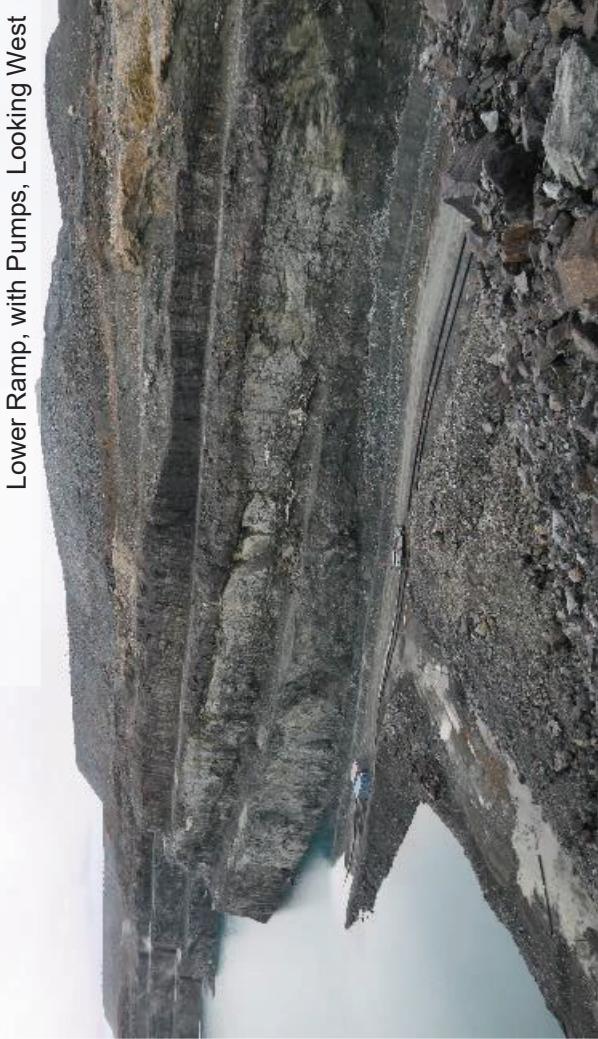
## Pit E - Northwest Wall and Ramp

- The Northwest Ramp is used to access the pit lake and water management infrastructure is present along the ramp.
- Many of the hazards identified during previous inspections have been flooded by the rising pit lake and no longer pose a risk to personnel.
- A rockfall berm was previously constructed and has been effective at managing rockfalls, including one that occurred in 2021. The capacity of the berm reduced over time and a second berm was constructed in 2021 further away from the wall. The two berms appear suitable to retain most rockfall but it is still possible that they could be overtopped in some circumstances. Geotechnical inspections of the area should continue while access to the ramp is still required.
- The water management infrastructure has been partially relocated up the ramp from the rockfall area, and to the outside of the ramp, which effectively reduces exposure.

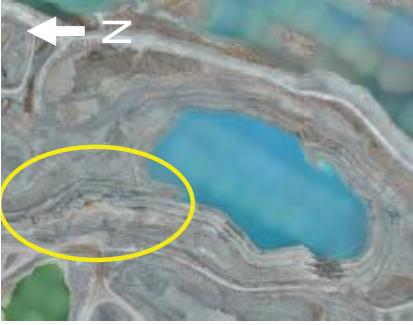
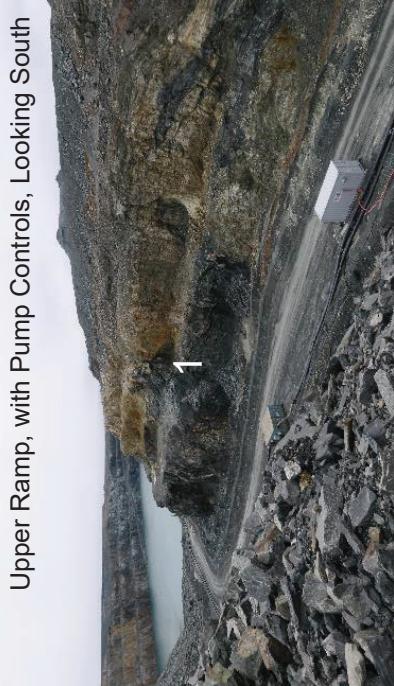
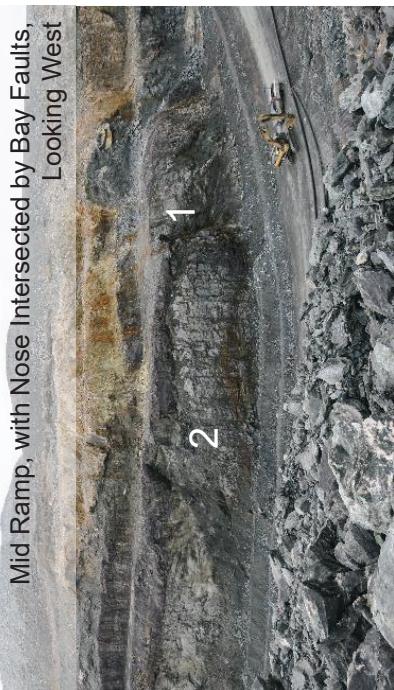
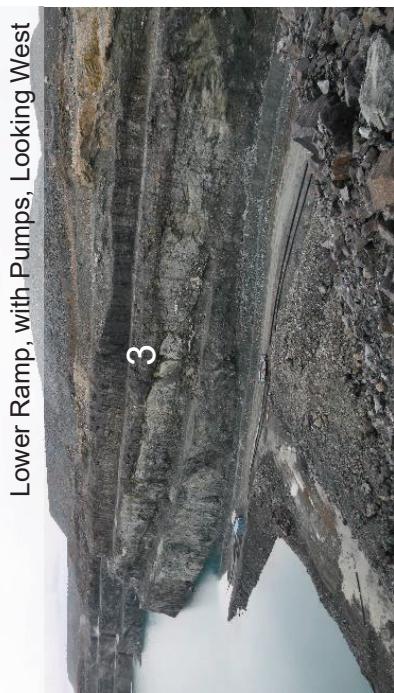
## Pit E - Northwest Wall and Ramp (Cont'd)

- Dump D is located along the eastern side of the ramp. Tension cracks are present along a portion of the crest above the ramp and a wireline extensometer has been installed to monitor the dump (see previous slide on Dump D). Bulging of the toe was not observed. A rockfall berm is in place at the toe of the dump and has capacity. Geotechnical inspections and monitoring of the dump should continue while access to the ramp is still required.
- The Bay Fault intersects the Northwest Wall adjacent the ramp. Several rockfalls have occurred along the wall in the past and rockfalls are expected to continue to occur. Examples of several potential instabilities are shown on the next slide (numbered below for reference).

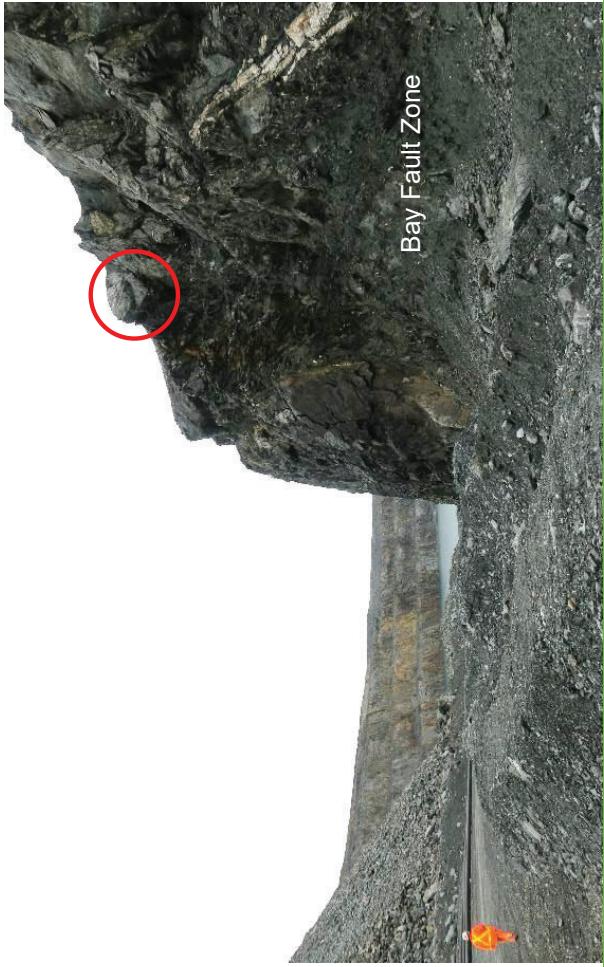
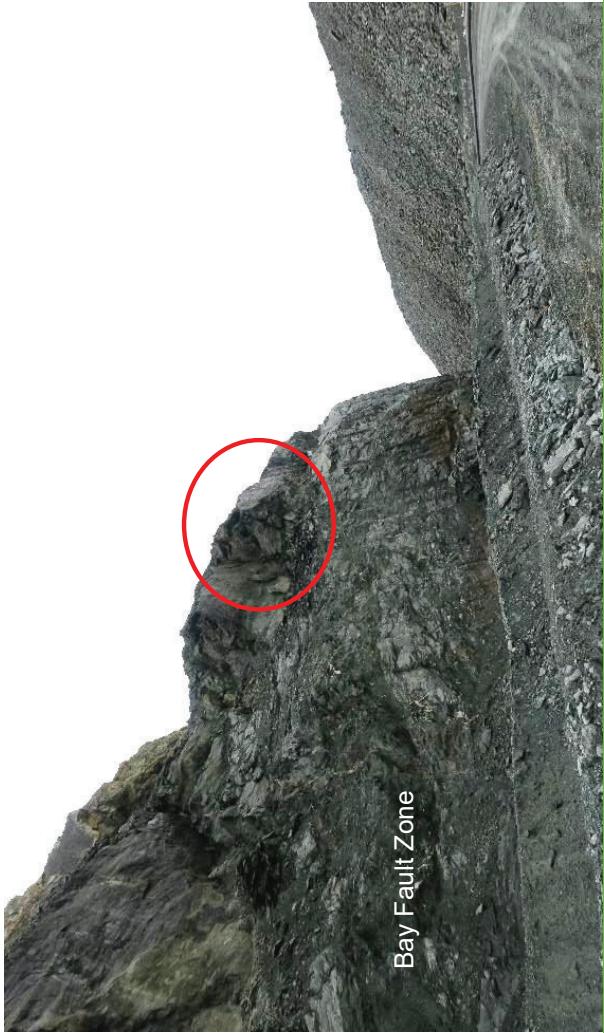
### Area 2 (Looking North)

- The nose in the Northwest Wall is intersected by the Bay Fault. The zone of reduced rock mass quality associated with the fault has ravelled over time, resulting in rockfall.
- A block was identified at the crest of the bench that represents a rockfall hazard. The block is expected to be retained by the rockfall berms.

- A large detached and potentially unstable block was identified on the southern side of the nose during the 2020 inspection.
- The block has the potential to overtop the rockfall berm and should continue to be monitored.

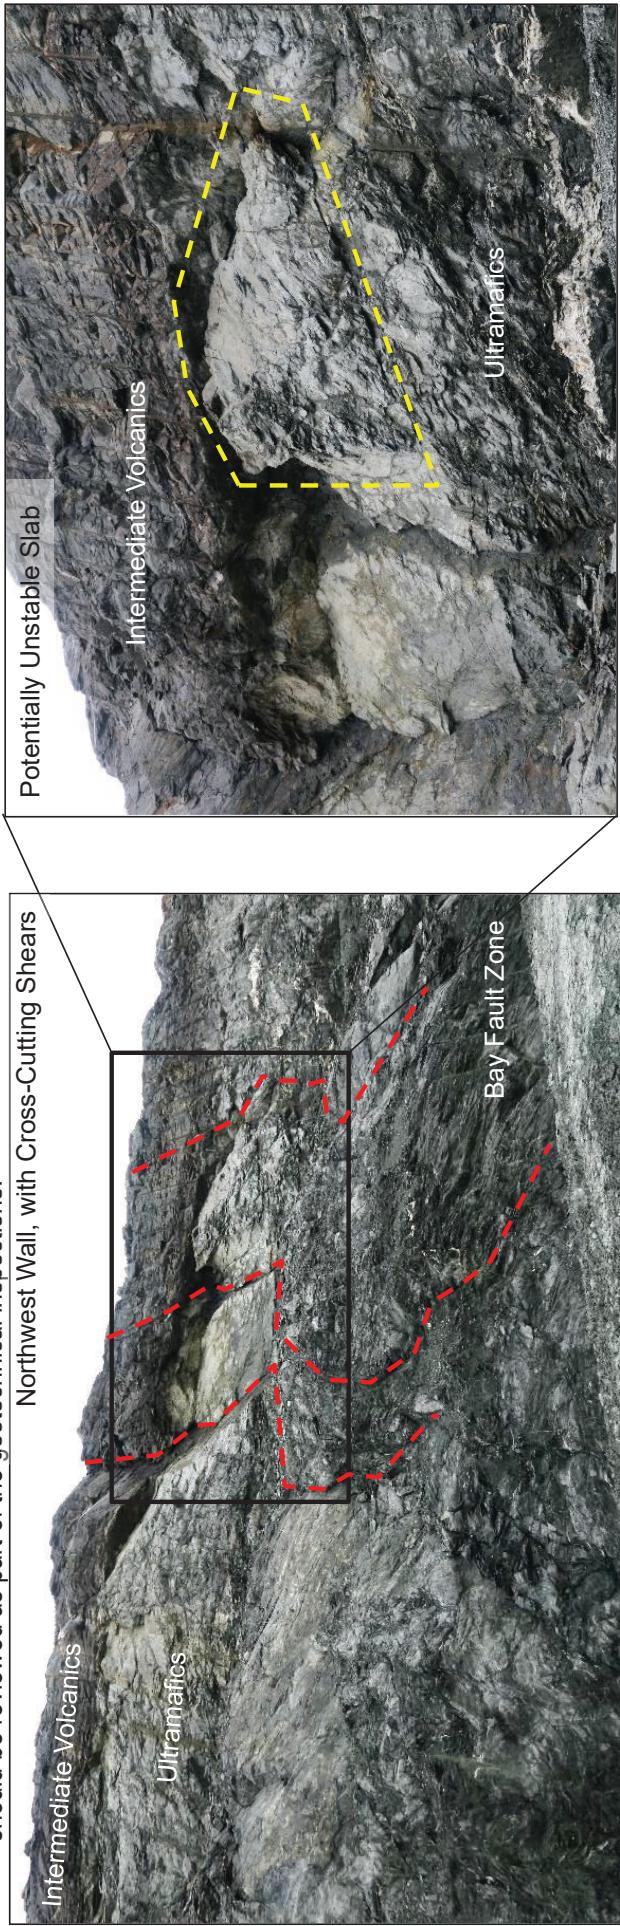
### Area 3 (Looking West)

- Several moderately to steeply dipping shear zones (in red below) cross-cut the northwest wall as well as the Bay Fault Zone and the contact between the Intermediate Volcanics and Ultramafics. The combination of the shears, contact, and other jointing has previously resulted in rockfalls.
- A potentially unstable slab was identified on the wall (in yellow below), bounded by the contact, two shears and a sub-vertical joint set. The condition of the slab should be reviewed as part of the geotechnical inspections.

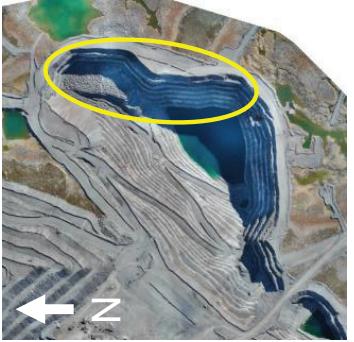
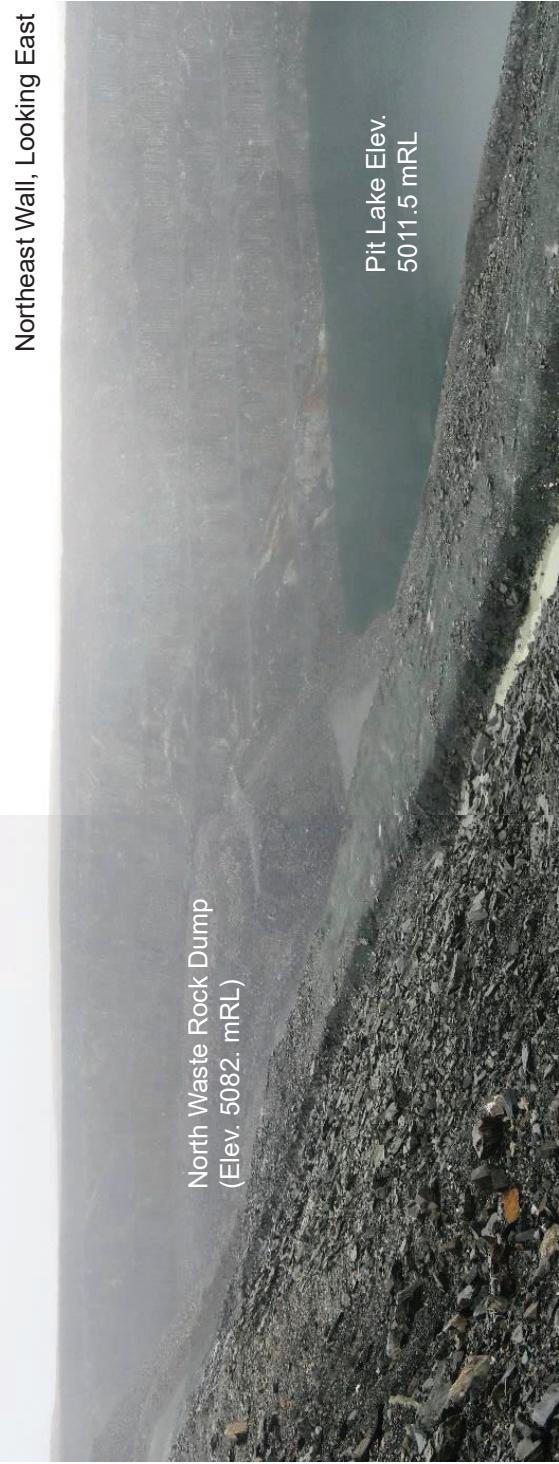
Northeast Wall, Looking East

- The wall is performing well.
- No particular geomechanical concerns.
- The North Waste Rock Dump is described on a subsequent slide.

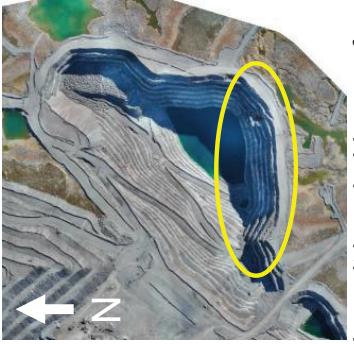
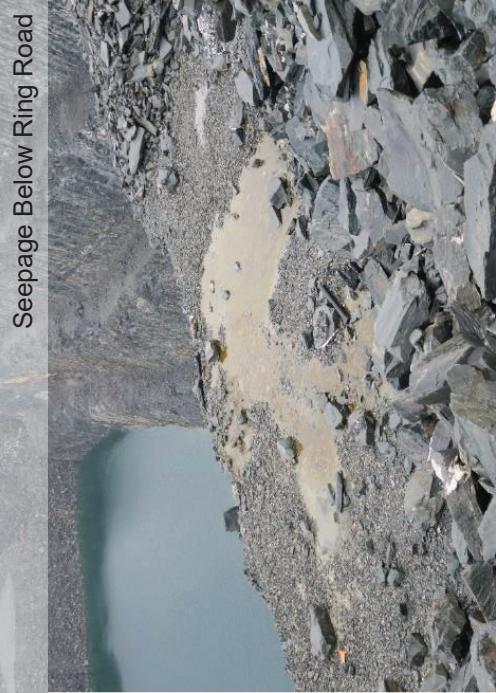
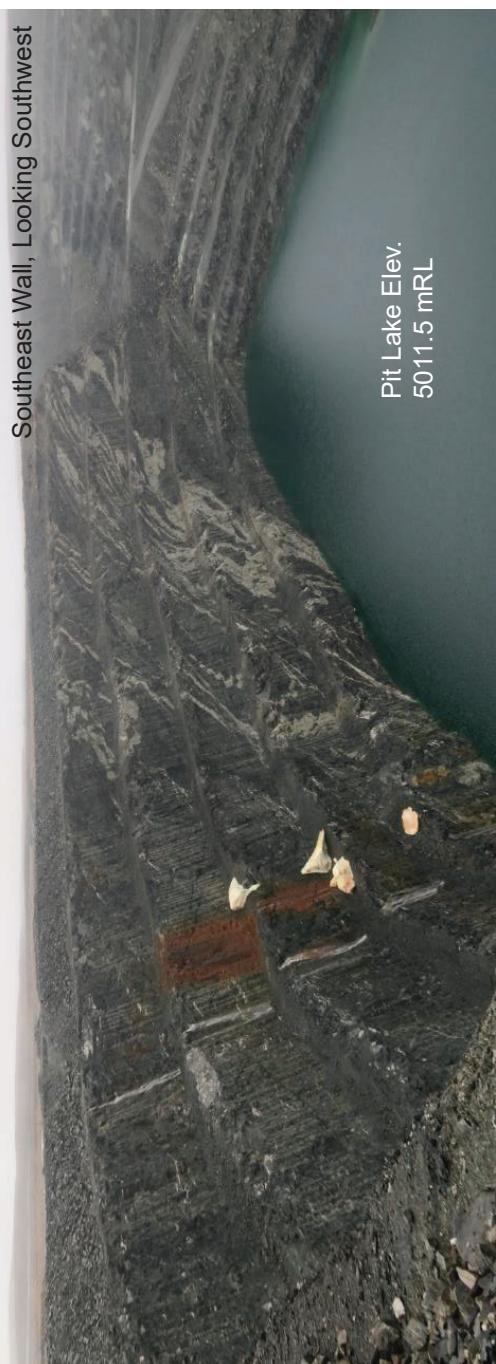
## Vault Open Pit - Southeast Wall

- The wall is performing well.
- A substantial quantity of water is flowing from Pond D, to the south of the pit, under the ring road and down the wall. The flow below the road at the crest of the wall is shown at lower right. No erosion of the slope was observed. The flow could result in subsidence of the road or the formation of sinkholes. Additional comments are provided on a subsequent slide focussed on the Ring Road.
- The ice wall continues to form each winter on and below the talik zone in this wall (roughly where the iron staining is present on the wall). Limited seepage through rock was observed at the time of the inspection.
- No particular geomechanical concerns. The area should continue to be visually inspected.

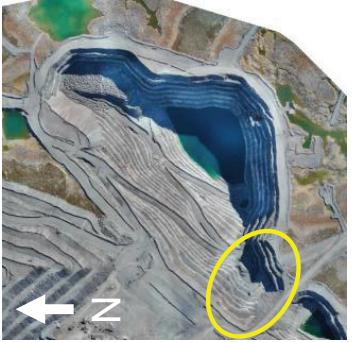
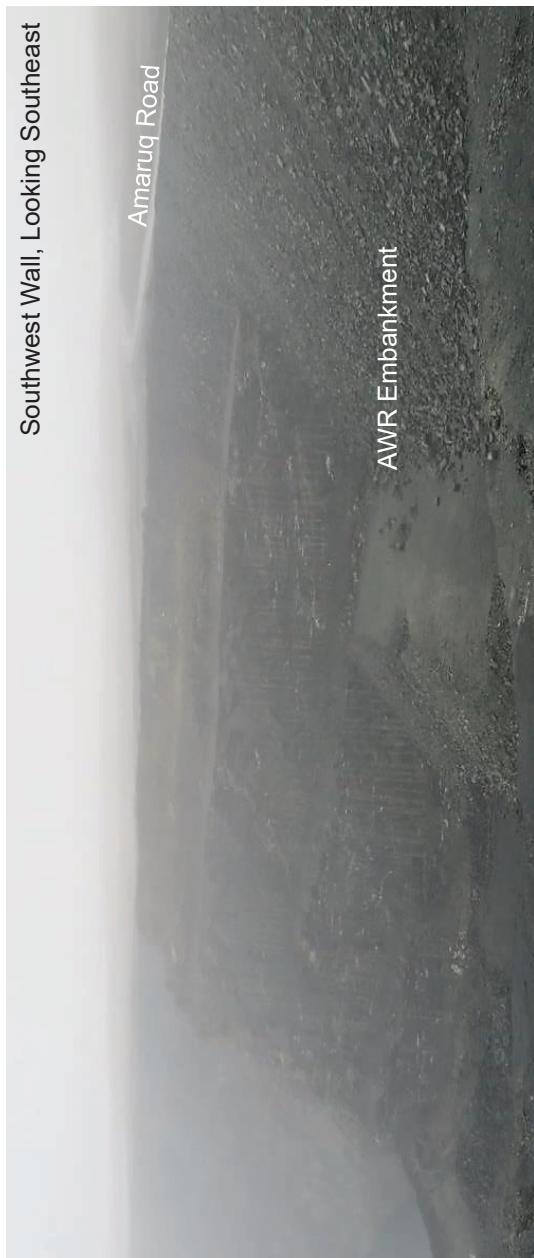
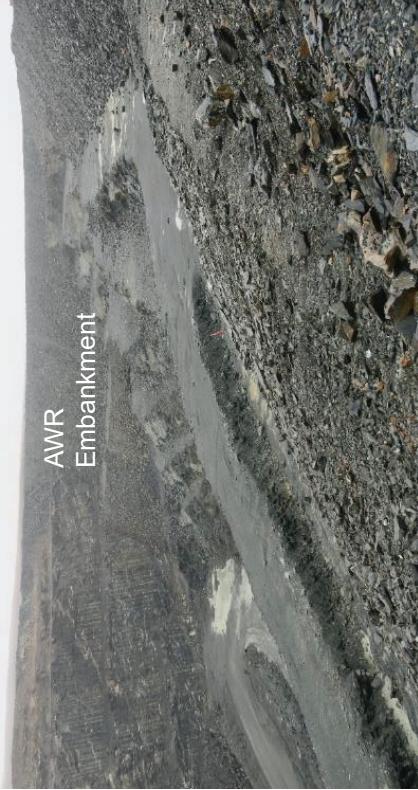
Southwest Wall, Looking Southeast

- The Amaruq AWR crosses a saddle between the Vault and Phaser pits on a rockfill embankment.
- No evidence of instability in the AWR embankment was observed. No tension cracks on the surface of the road or bulging of the embankment toe were noted. The embankment is included in the geotechnical inspections.
- The stability of the Amaruq AWR embankment could be adversely impacted if the water level in the Phaser Pit on the other side of the embankment increases and water ponds behind the embankment. No seepage was observed at the time of the inspection. The presence of seepage should be evaluated as part of the monthly inspections.
