### **Meadowbank 2021 Annual Open Pit Geomechanical Inspection**

**RE: Meadowbank Complex - Meadowbank Site - 2021 Annual Open Pit Geomechanical Inspection**

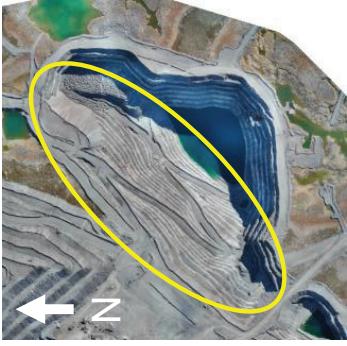
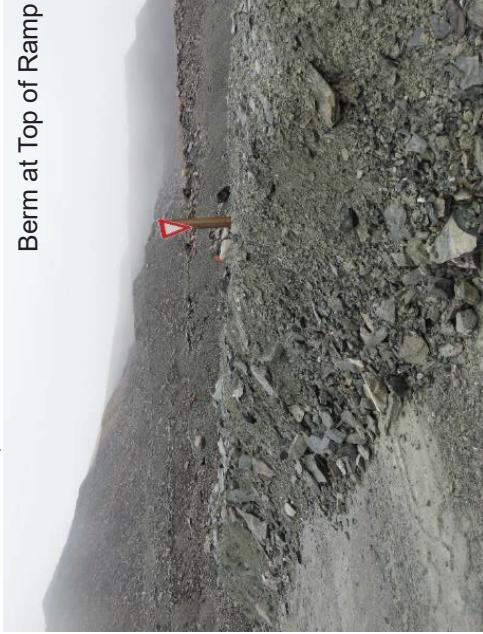
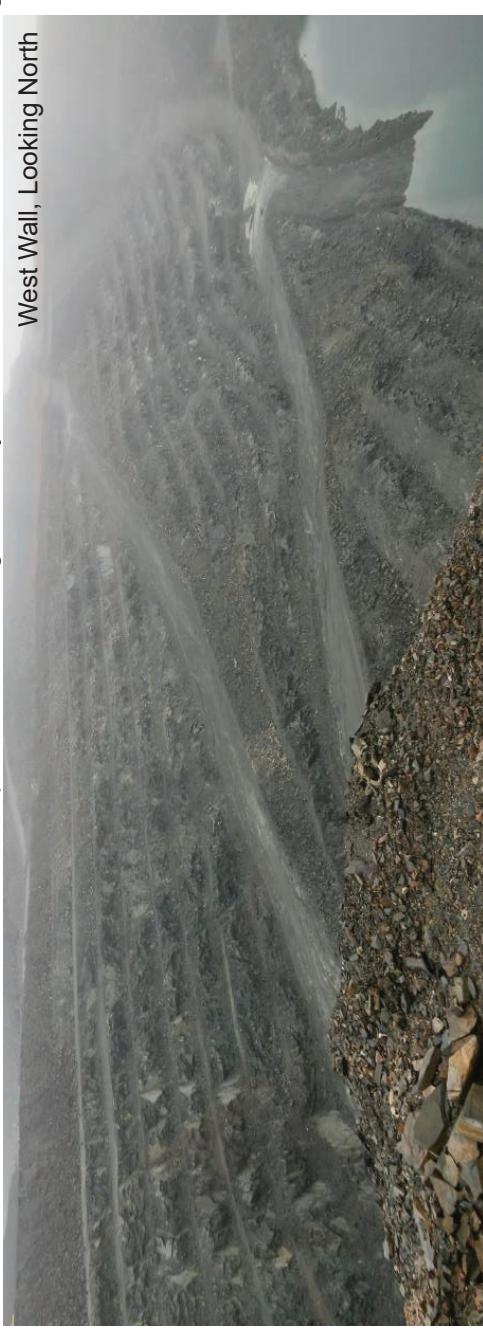
West Wall, Looking North

- The West Wall is located along the footwall of the deposit, which dips at approximately  $20^\circ$  to the east (mine grid). The wall was established with 7 m high single benches without pre-shear and commonly failed or was scaled back to the foliation.

- The ramp is located along this wall. At the time of the inspection, access to the ramp was prevented by a berm. However, it is understood that monthly water quality monitoring is completed during the summer. Documentation of geotechnical inspections of the ramp in 2021 was not available. A visual geotechnical inspection should be completed each time the pit is accessed (e.g., for water quality monitoring). In addition to the ramp itself, the inspection should consider the open pit walls and in-pit dump as a failure could create a wave in the pit lake. The integrity of the Ring Road between the open pit and Vault Lake should also be considered during the inspection as a failure could result in an inrush to the open pit.

- As an alternative to continued inspections of the Ring Road adjacent Vault Lake, consider breaching the road at that point so that it cannot retain water.

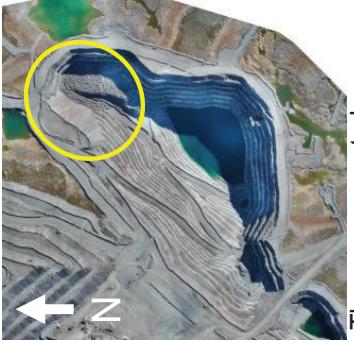
Looking North at Area of Settlement  
Looking South from Crest of Dump  
(Elev. 5133 mRL)

- A waste rock dump was constructed at the north end of the Vault Pit. The dump is inactive and consists of two platforms with elevations at approximately 5133 mRL and 5082 mRL.
- Settlement and tension cracks were observed at the crest of the upper platform at the north end of dump during the 2019 inspection. There appears to have been little change since that time. The affected area is relatively small and is not above the ramp. Consider including this area in the monthly visual inspections.
- No other evidence of instability was observed during the inspection.
- Access to the dump was not restricted at the time of the inspection. Recommend installing a berm to prevent access as the dump is inactive.

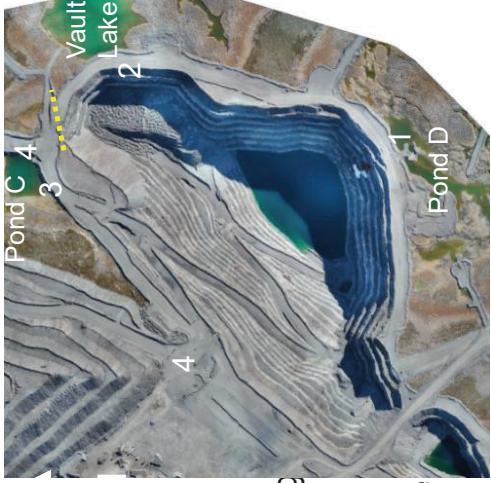
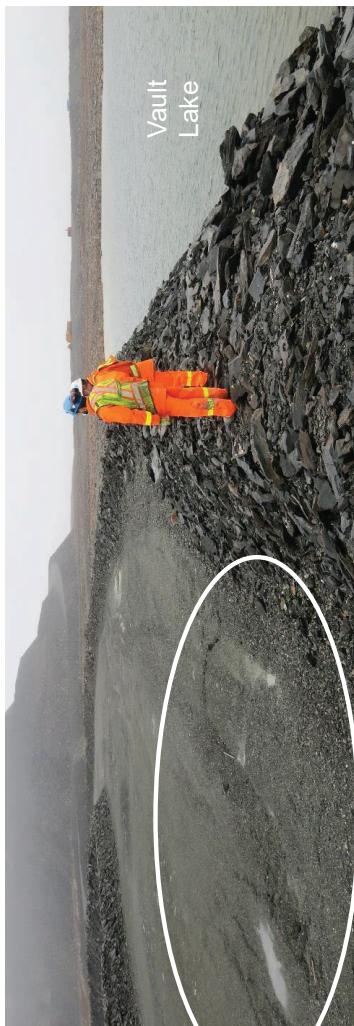
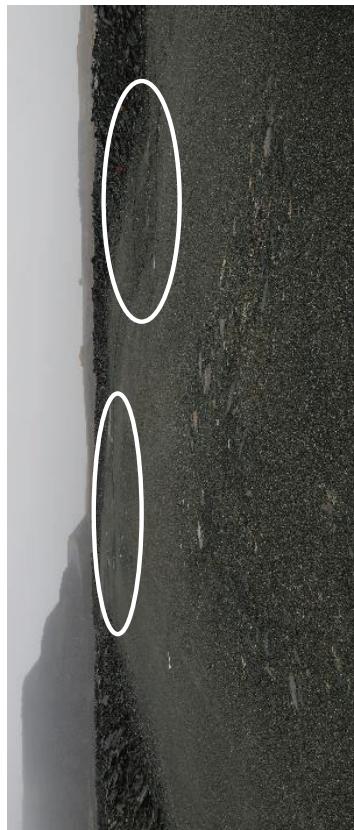
- A berm has been constructed at the northern end of the Ring Road to prevent thru-traffic (yellow dashed line) at rig 2 is still available from the southern end. Several geotechnical hazards have been identified along the road:

1. Seepage from Pond D is flowing under the road and down the pit wall. This previously only occurred during a high rainfall event in 2019. As the water level in Pond D raises, there is the potential for subsidence of the road in this area.

2. Subsidence of the road has occurred adjacent Vault Lake. No seepage was observed below road. It is understood that access to this area is no longer required. Recommend constructing a berm to prevent access to this area. The potential for a sudden inrush of water from Vault Lake into the open pit was previously identified as a hazard in the event of a breach or erosion of the Ring Road in this area. As a result, it is recommended that the area be inspected prior to accessing the open pit. Alternatively, the road could be purposely breached in this area to eliminate the hazard.

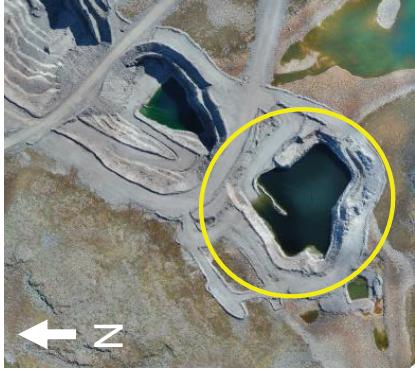
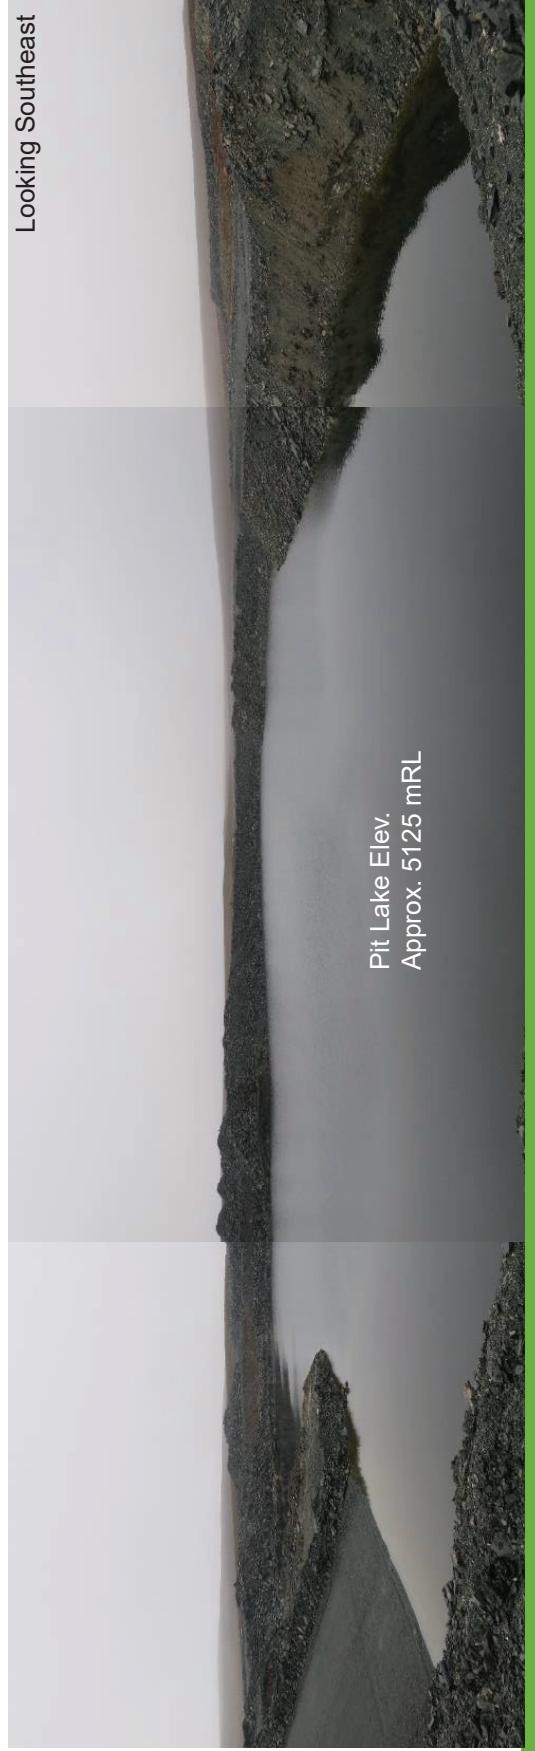
## BB Phaser Open Pit - General

- The open pit is flooded, with no rock slopes visible. The pit lake elevation appears to be a couple of meters higher than what was observed during the 2020 inspection.
- Access to the open pit is prevented by a berm.
- No particular geomechanical concerns were noted.

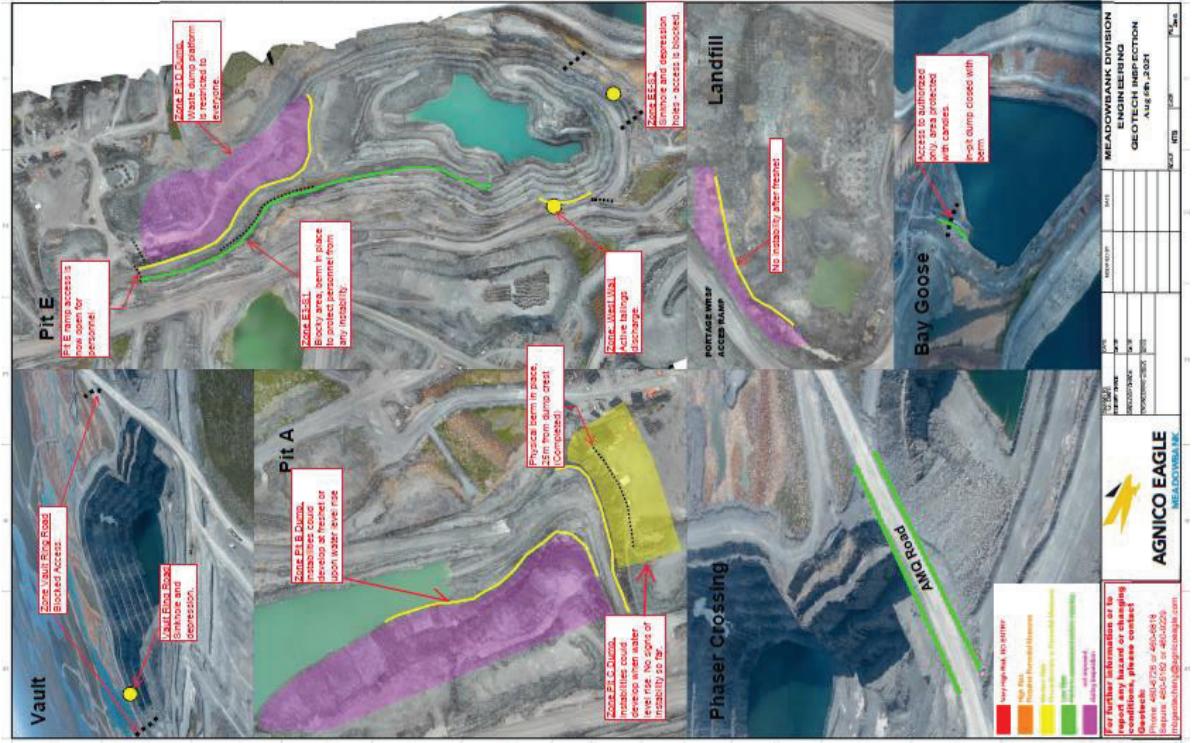
## Hazard Assessment

- The most recent hazard assessment map (August 6, 2021) was reviewed. A summary is shown at right and comments are provided below.
- Many but not all of the hazards identified during the annual inspection have been captured by the hazard assessment. Recommend including the following:

- Portage Pit A - Rockfall hazard along the east and west walls of the South Ramp, mitigated by the rockfall berm.
  - Vault Pit & Phaser Pit - Rockfall hazard along the ramp and the potential for a wave caused by a failure of the dump, pit slope or the Ring Road adjacent Vault Lake. Inspection required before accessing the ramp.

- Vault Pit - Subsidence hazards on the Ring Road adjacent Pond C and Pond D.
- The risk ratings assigned to the identified hazards are thought to be generally reasonable. The following comments are provided:

- Portage Pit A - The settlement of the B Dump represents a risk to personnel on the lower dump platform (5126 m<sup>3</sup>R<sub>L</sub>) as well as on the ramp below. Recommend enlarging the hazard area to fully encompass the lower dump platform.

- C Dump - As there is a rockfall berm at the toe of the dump and a berm at the crest, and the dump is inactive, the risk is likely Low rather than Moderate under current conditions.

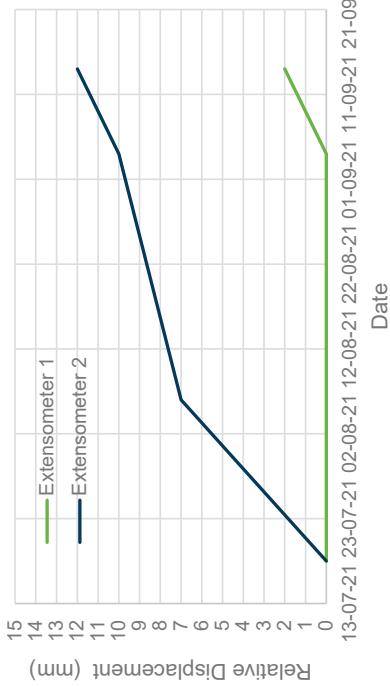
- Monthly readings for the extensometers are available since June, 2021 although both were reset in July. The data are shown above. Extensometer 2 is reporting displacement, though the current rate of <1 mm/day is much less than the 50 mm/day threshold that would trigger a response under the procedure. Monitoring of the extensometers should continue.

- The extensometers provide point measurements of displacement and are limited to Dump D. Settlement and tension cracks have been observed at most of the in-pit dumps. Recommend evaluating the use of the drone survey imagery and photogrammetry to evaluate settlement across all of the dumps on an annual basis. This would provide a more comprehensive solution without the need for an extensive network of instruments.
