Whale Tail 2021 Annual Open Pit Geomechanical Inspection

March 24, 2022

RE: Meadowbank Complex - Amaruq Site - 2021 Annual Open Pit Geomechanical Inspection

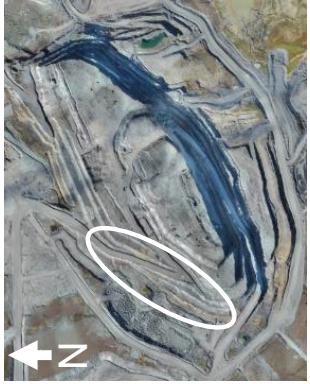
Whale Tail Open Pit Observations - Northwest Wall

- Final wall in Design Sector A1.
- The benches are generally performing well. There have been no further failures in the Komatiite since the last inspection.
- The Oxidized Greywacke is thought to be associated with a talik zone below what was the western end of Whale Tail Lake. It is of lower rock mass quality than the Greywacke and is prone to ravelling. The exposures along the ramp are limited in height and rockfall has not been a concern to date. If ravelling increases, a rockfall berm could be constructed along the inside of the ramp through this unit.
- Seepage was observed along the sheared contact between the Oxidized Greywacke and the Komatiite.

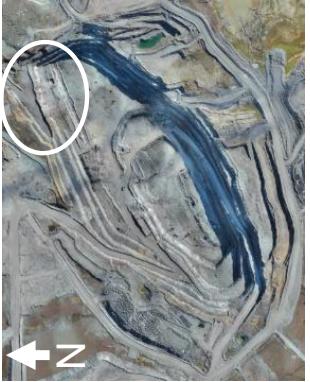
Observations - Northeast Wall

- Final wall in Design Sector D4.
- Four bench-scale failures have occurred along the foliation within the Komatiite in this sector in 2021. The failures have been reviewed in detail as part of the on-going WHL open pit design verification review. The failures are primarily kinematic but contributing factors include a reduction in rock mass quality within the Komatiite, the presence of brittle structures, and the infiltration of surface water due to the presence of talik.
- A rockfall berm was constructed below the failures and a temporary step-out left in order to separate mining activities from the failures.
- A revised design has been developed for this design sector and a pushback has been initiated to re-establish the slope. Further analyses are planned.

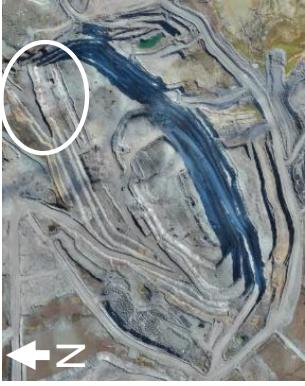
Observations - Northeast Wall Pushback

- Pushback to re-establish the final wall in Design Sector D4.
- Revised design incorporates a reduction in BFA to 55° , a reduction in bench height to 14 m (double benching) and an increase in bench width to 11 m
- While only two benches had been established at the time of the inspection, the bench faces were breaking back to the foliation as expected and were performing well.
- On-going rock mass characterization, with a particular focus on the orientation of the foliation, is recommended for this sector.

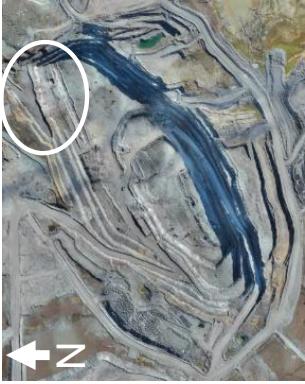
Observations - Blasting

- During the site visit, a relatively large choke blast was taken in the northeast corner of Phase 2. The blast was sequenced so that energy was directed towards the final wall. This will result in increased blast damage to the final walls, particularly when the dominant structure is oriented perpendicular to the wall (as the foliation is in the end wall in this case).
- As part of the on-going blasting study, recommend reviewing the blasting strategy. Where practical, direct blasts away from the final walls.
- From discussions with site staff, there is also a need to implement a drill and blast quality control program and a blast monitoring program.

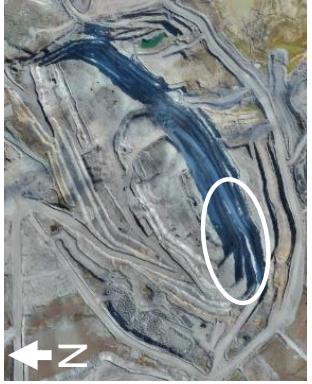
Observations - Phase 2 Southwest Wall

- Interim wall approximately within Design Sector I1. Also referred to as Phase 2 South (I1).
- The wall is generally performing well.
- The Phase 3 pushback is in progress above this wall. Spillover represents a rockfall hazard for traffic on the ramp. A rockfall berm has been constructed on the inside of the upper ramp, where rockfall has occurred (outlined in white below). The berm had limited capacity remaining at the time of the visit. The berm should be cleaned out and extended along the full length of the ramp below the pushback. The berm should be inspected and cleaned periodically.

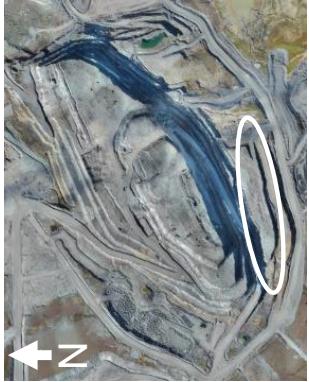
Observations - Phase 3 Pushback

- Temporary wall within the Phase 3 Pushback. Approximately corresponds to Design Sectors H6 and I6.
- The wall was established without pre-shear, as is standard practice for temporary walls. As a result, the condition of the face and crest is poor, and a rockfall hazard exists.
- Due to the pushback geometry, the working area is limited in places. A vehicle was observed parked at the toe of the bench. This is not consistent with the site's Work Close to Pit Wall procedure. The vehicle was moved. A berm should be constructed below the wall to prevent access and retain any rockfall.

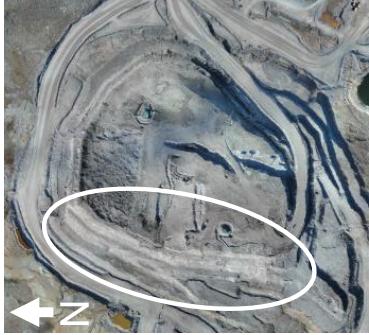
IVR V1 Open Pit Observations - Northwest Wall

- Final wall in Design Sector V0A. This sector encompasses the footwall of the deposit. The slope geometry was expected to be controlled by the potential for bench and inter-ramp scale planar failures on the foliation (Joint Set A).

- The bench design consists of a 45° bench face angle, 8 m bench width and a 14 m bench height (7 m benches in a double-bench configuration). Due to the shallow bench face angle, the bench faces are established with staggered blast holes ("stab" holes) rather than angled pre-shear holes in the final walls.

- While the initial benches broke to the foliation, the remainder have not performed as expected. This is discussed further on the following slide.
- The slope was expected to be established in the Komatiite and to be intersected by numerous brittle structures. However, mapping by Geology has identified intervals of Greywacke and Gabbro in the slope. These units are more competent.

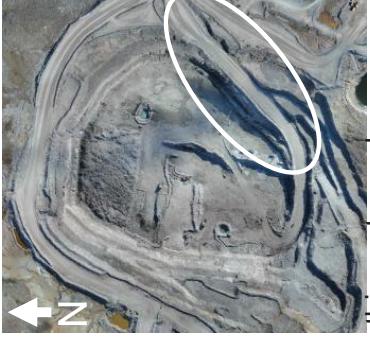
Observations - Southeast Wall

- Final wall in Design Sector V0C.
- In general the wall is performing well.
- The persistent cross-cutting features that were associated with the potential wedges in the Northeast Wall are also present in this sector and have locally controlled the achieved bench geometry (examples circled below). These structures were not prominent in the discontinuity orientation data used to design the open pit. The structures should be mapped and their potential impact on the slope performance reviewed.

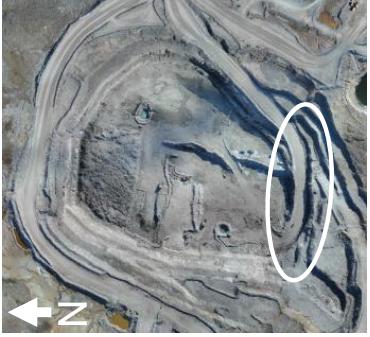
Observations - Southwest Wall

- Final wall in Design Sector V0D.
- The wall is generally performing well. While the benches are primarily within the Komatiite and Brittle Structures, the wall is oriented perpendicular to the foliation.

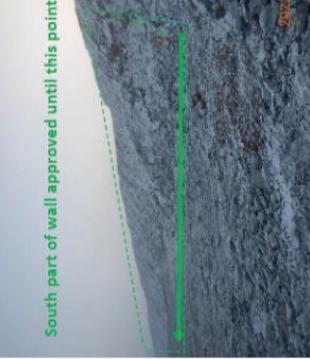
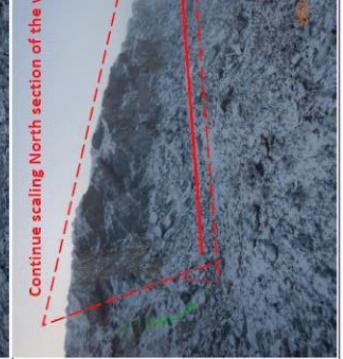
South part of wall approved until this point DATE: 2022-02-13		Continue scaling North section of the wall DATE: 2022-02-13
