### **Meadowbank and Whale Tail MDRB Report No.29**

Report No 29  
Meadowbank Mine Dike Review Board (MDRB)  
Site visit August 24<sup>th</sup> to 26<sup>th</sup>, 2021 and Conference call of November 22<sup>nd</sup>.

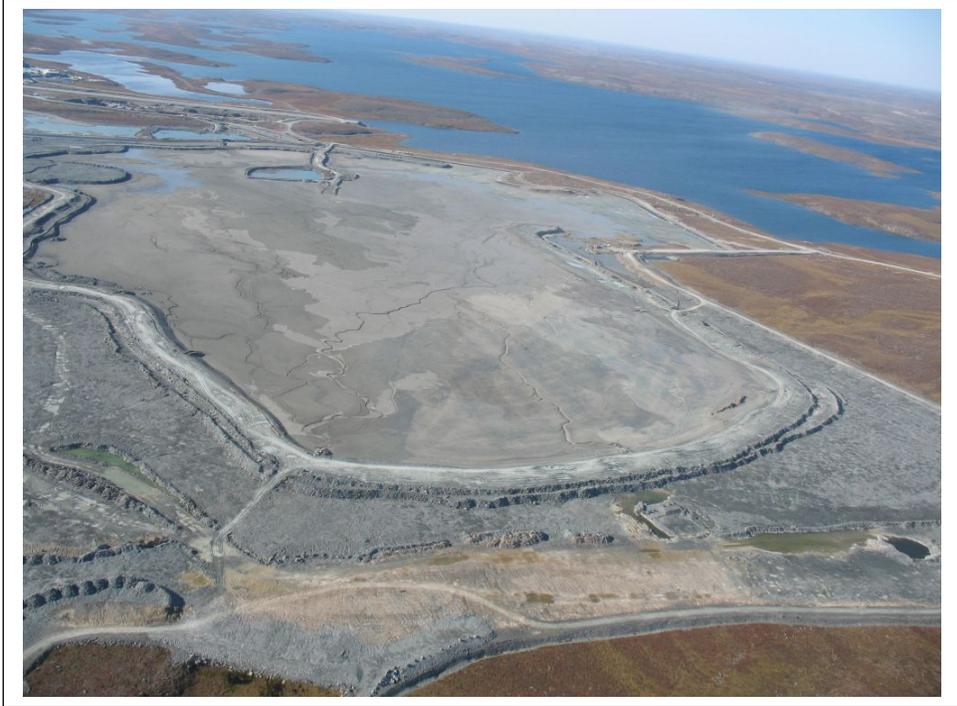
Photo No. 1 Meadowbank TSF, North Cell

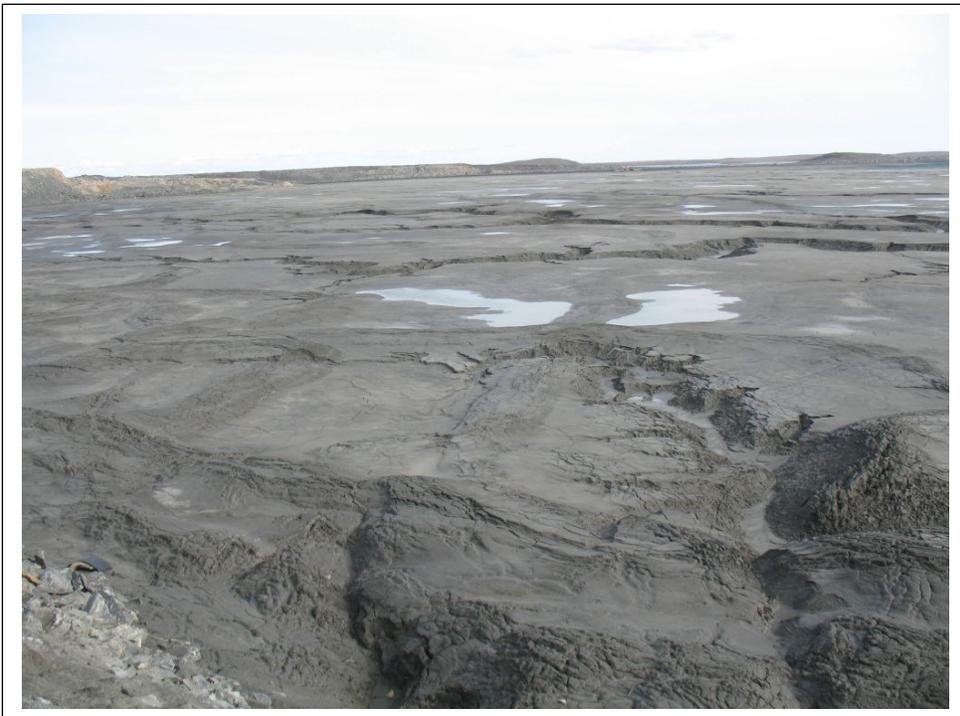
The tailings deposited in the South Cell (SC) has undergone consolidation since the 2020 deposition and near surface encapsulated ice and snow have melted leaving an irregular “lunar” surface in some areas. (Photo No. 2) Additional landscaping deposition in this cell would also be useful prior to the initiation of closure capping.

Photo No. 2 Meadowbank TSF, South Cell area adjacent to Stormwater Dike

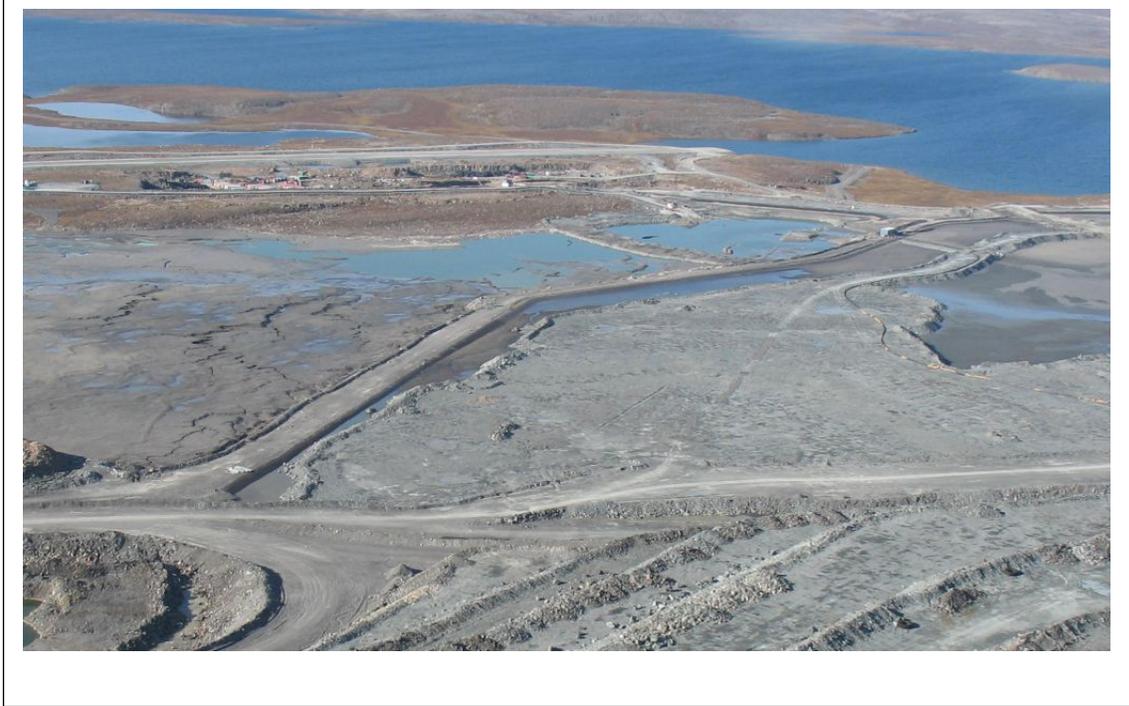
Photo No. 7 Meadowbank. Stormwater Dike and North (right) and South Cells of the TSF

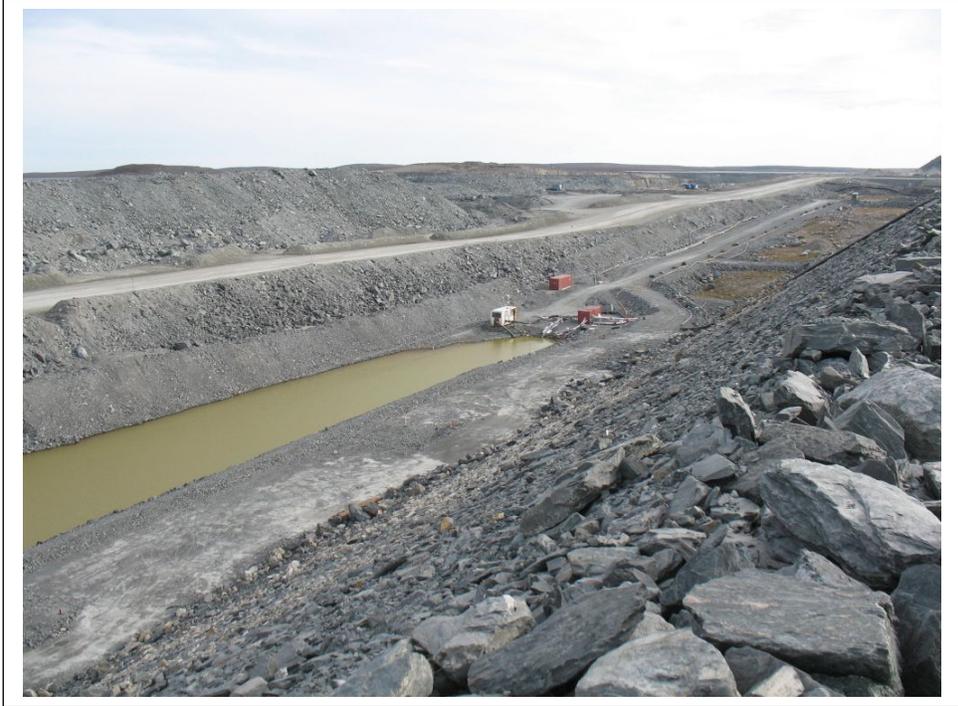
- The talik beneath the former Second Portage Lake is still a conductor with water seeping down through the tailings in both the NC and SC reporting to the Central Dike downstream pond as confirmed by thermistor and piezometric data. Nevertheless, the pumping rate at the pond continues to decline. See also the comment in section 3.3.
- Discussions should be held with Golder to establish whether the range of operating levels in the Central Dike downstream pond (Photo No. 9) could be widened to facilitate the pump operation. The range is currently set at 114.8 to 115.1m.

Photo No. 9 Meadowbank. Pond downstream of Central Dike. View from Central Dike.
