Meadowbank and Whale Tail 2021 Annual Geotechnical Inspection

2021 Annual Geotechnical Inspection

Meadowbank Complex, Nunavut

21468006-1606-R-Rev0

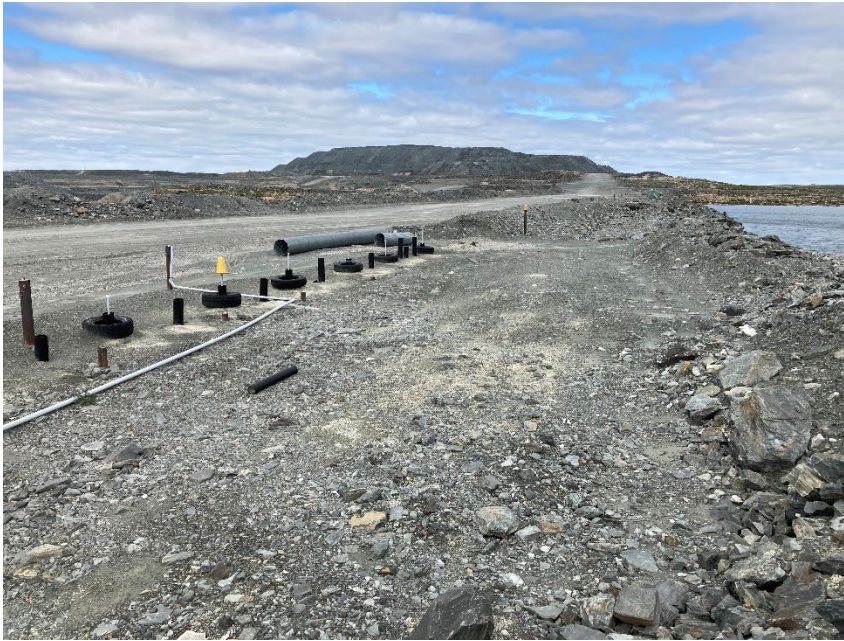
Photograph A1-1 East Dike

Description: From approximately Sta. 60+450, looking north at the crest.

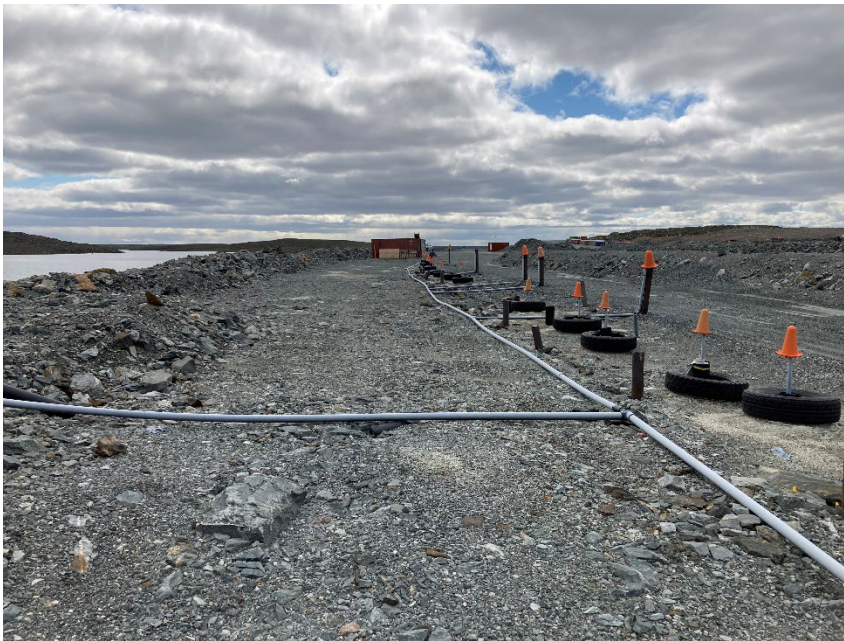
Photograph A1-2 East Dike

Description: From approximately Sta. 60+450, looking south at the crest.

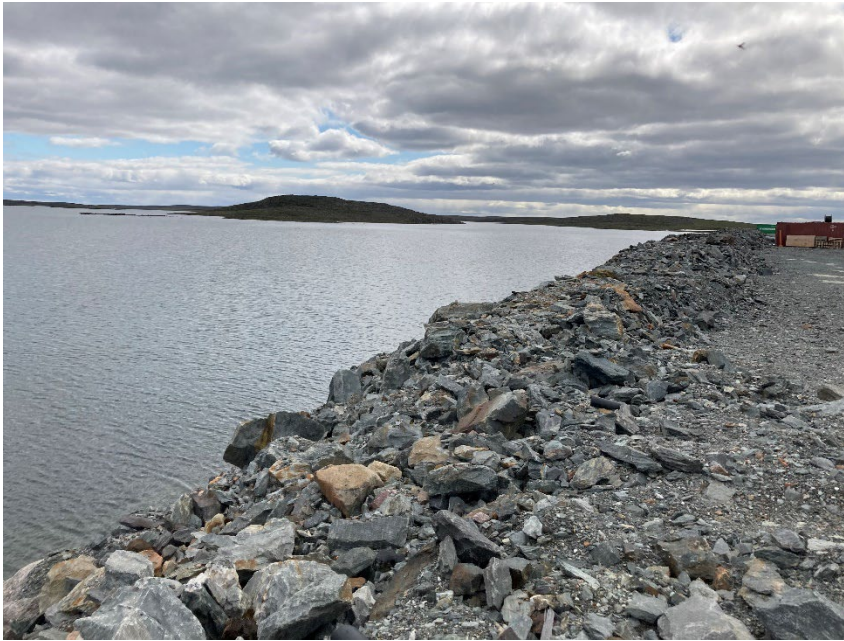
Photograph A1-3 East Dike

Description: From approximately Sta. 60+450 upstream, looking south at the crest.

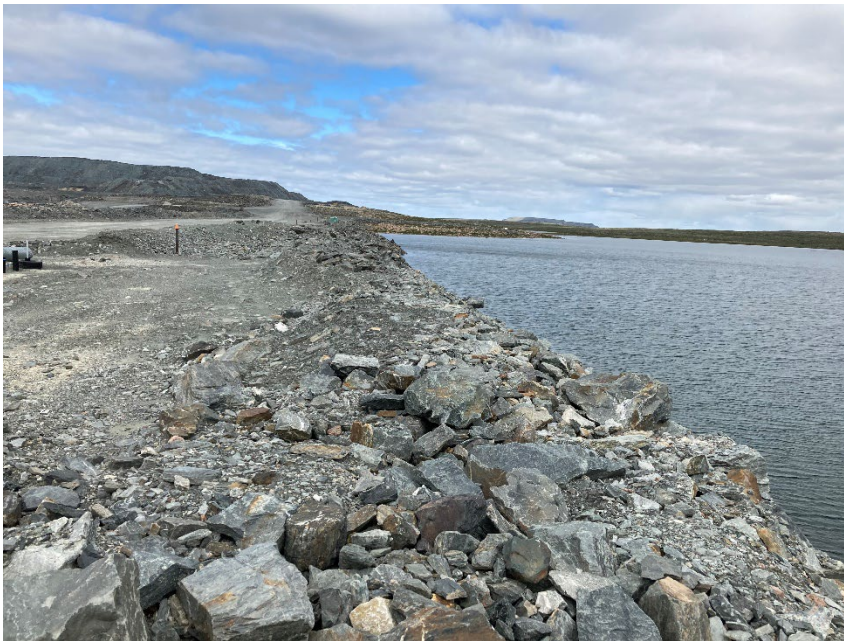
Photograph A1-4 East Dike

Description: From approximately Sta. 60+450 upstream, looking north at the crest.

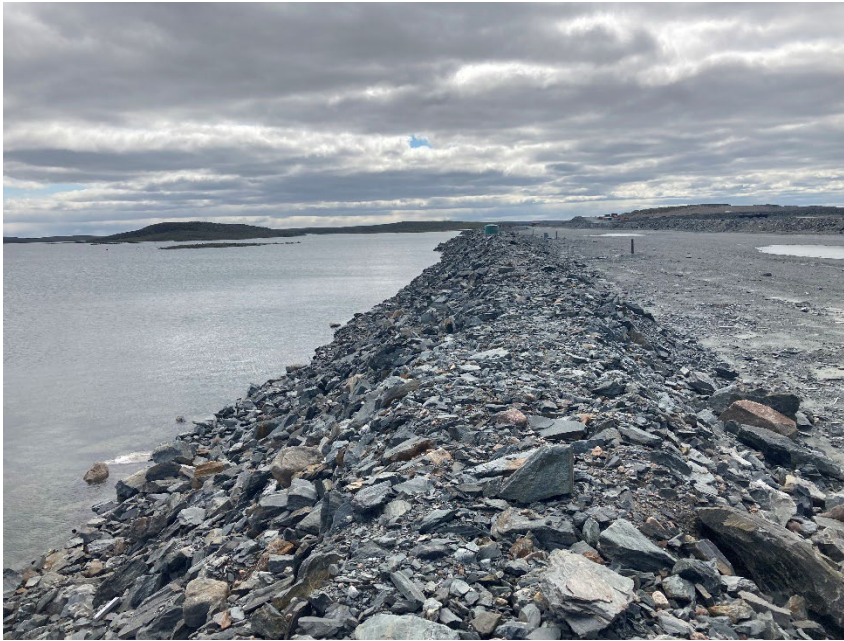
Photograph A1-5 East Dike

Description: From approximately Sta. 60+810, looking south at the crest and upstream slope.

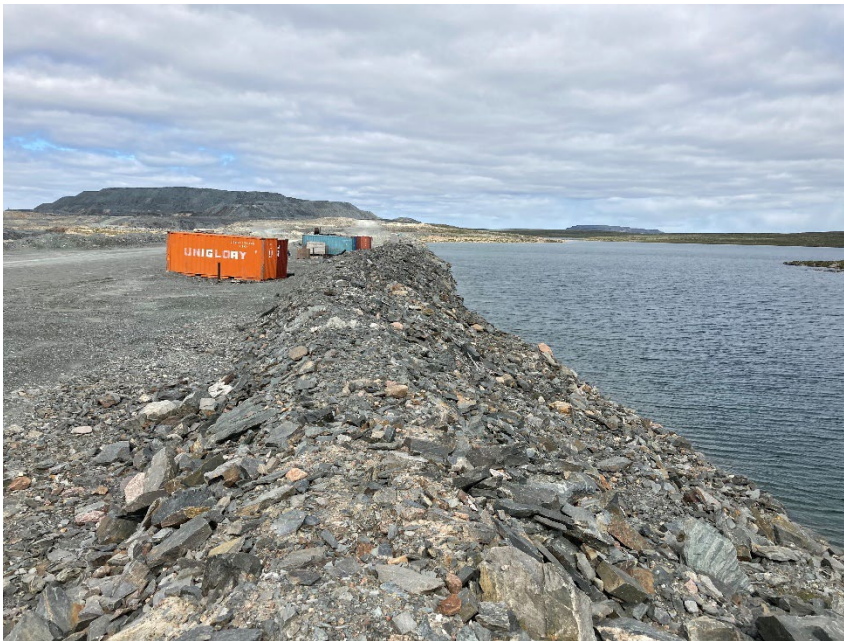
Photograph A1-6 East Dike

Description: From Sta. 60+300 upstream, looking north at the crest and upstream slope.

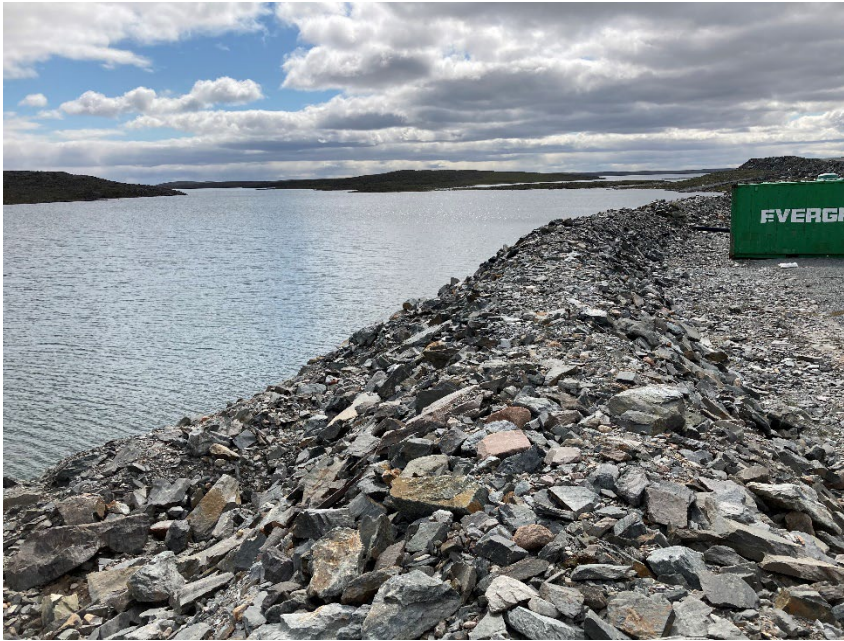
Photograph A1-7 East Dike

Description: From approximately Sta. 60+250 upstream, looking south at the upstream slope.

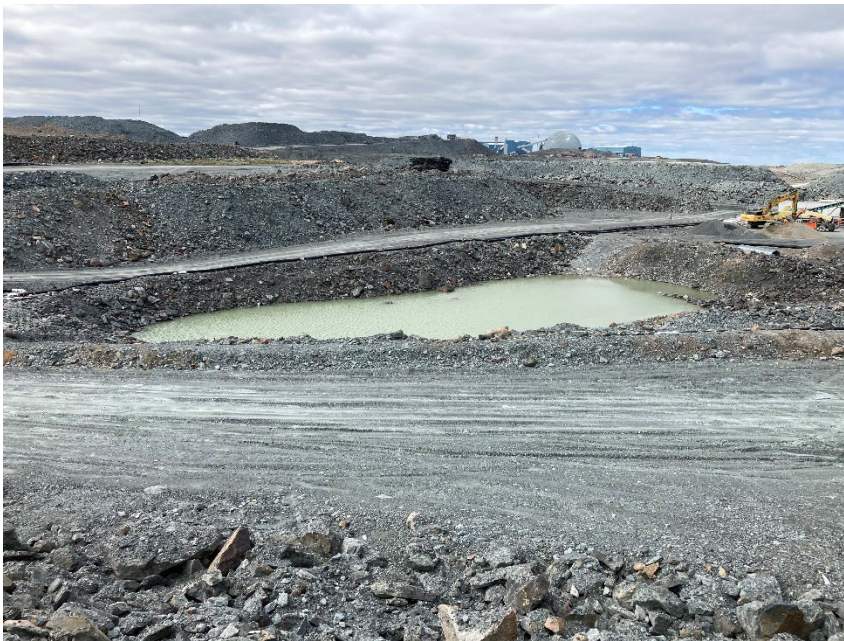
Photograph A1-8 East Dike

Description: From approximately Sta. 60+250, looking west at the downstream side and toe.

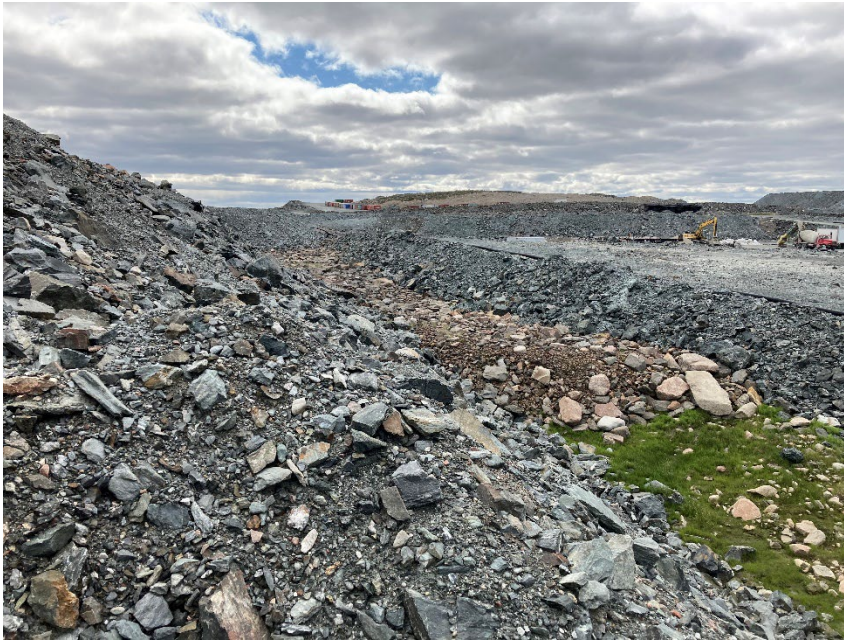
Photograph A1-9 East Dike

Description: From approximately Sta. 60+475, looking south at the downstream toe.

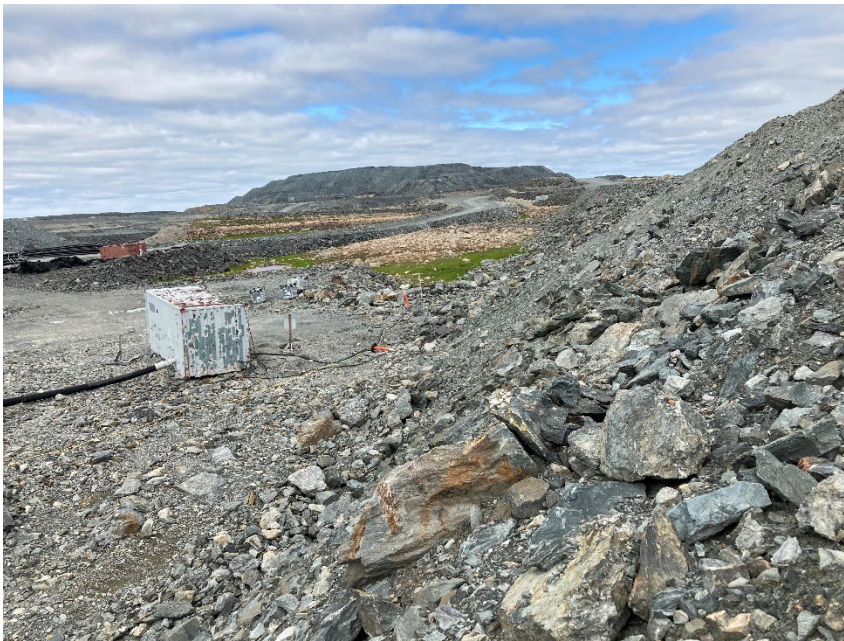
Photograph A1-10 East Dike

Description: From approximately Sta. 60+500, looking north at the downstream toe.

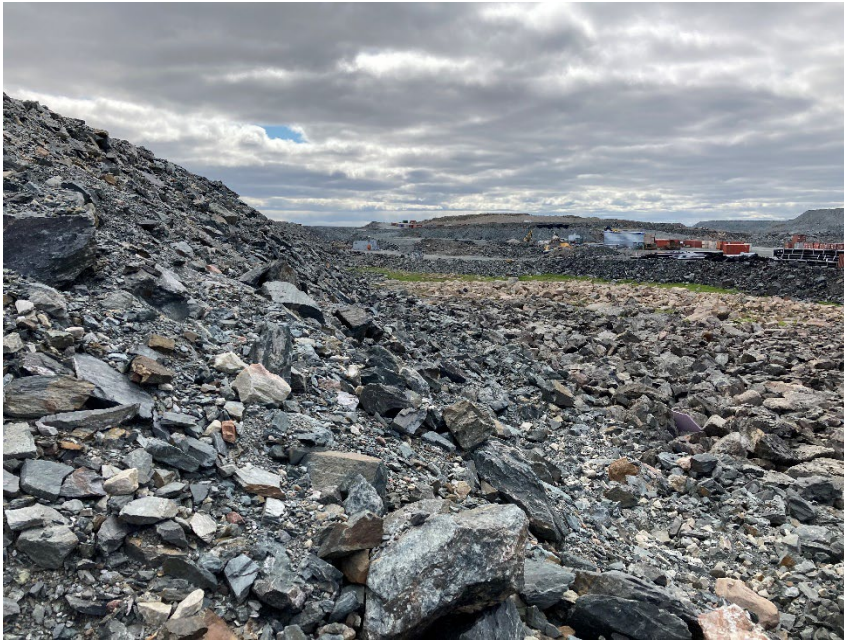
Photograph A1-11 East Dike

Description: From approximately Sta. 60+560, looking south at the downstream toe.

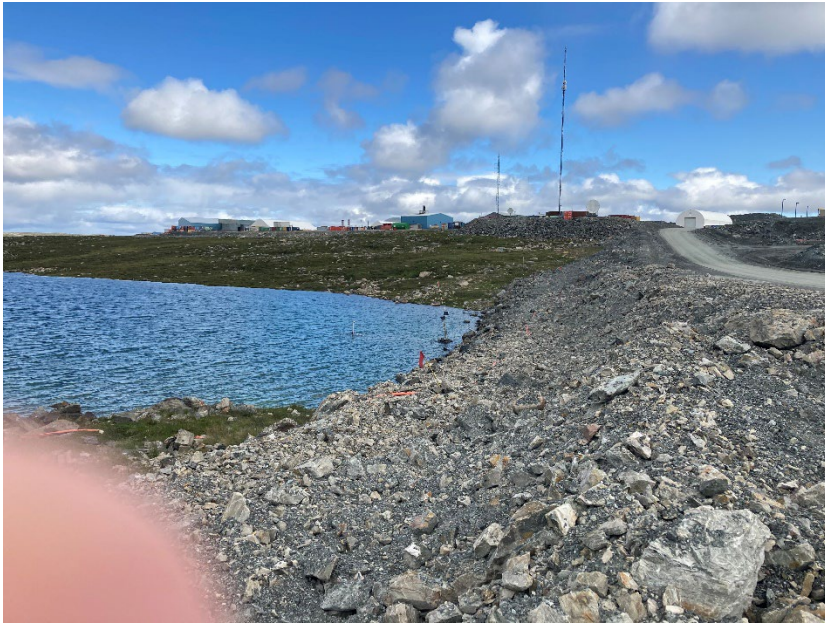
Photograph A2-1 South Camp Dike

Description: From the south abutment, looking north at the upstream slope and the thermistors instrumentation set-up.

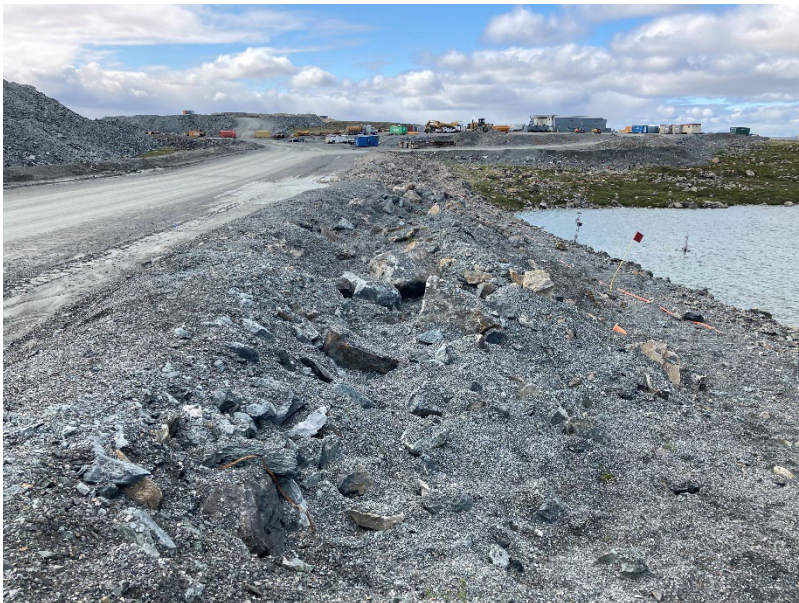
Photograph A2-2 South Camp Dike

Description: From the north abutment, looking south at the upstream slope and thermistors instrumentation set-up.

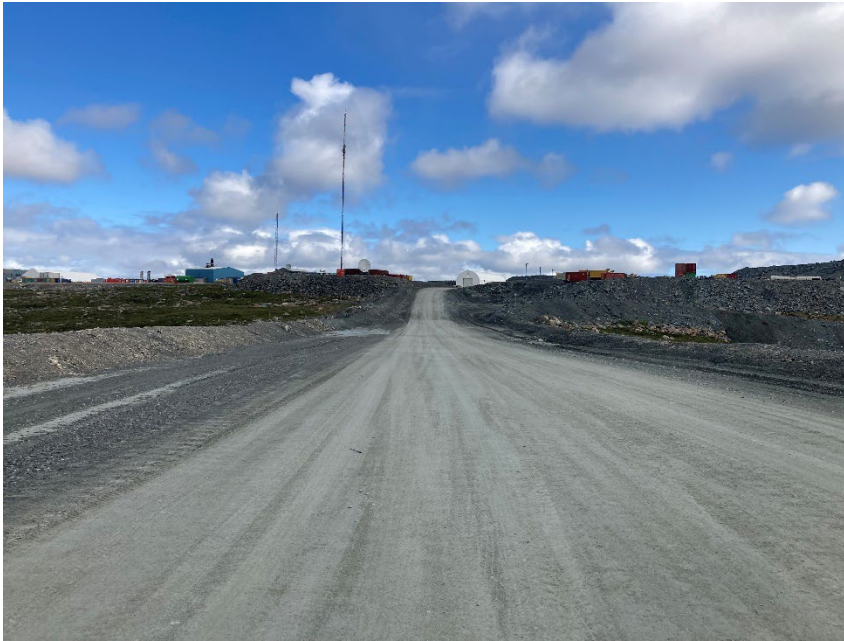
Photograph A2-3 South Camp Dike

Description: From the south abutment, looking north at the crest.

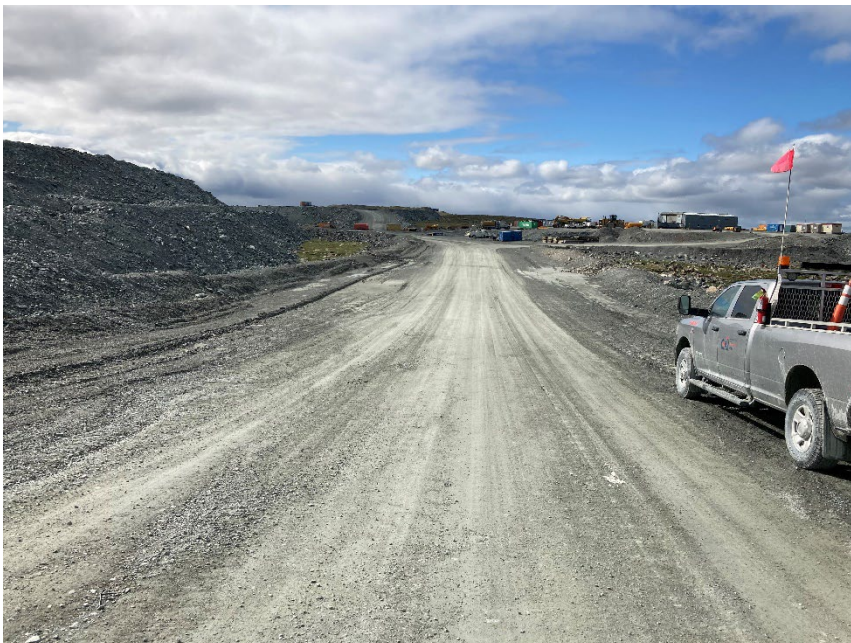
Photograph A2-4 South Camp Dike

Description: From the north abutment, looking south at the crest.

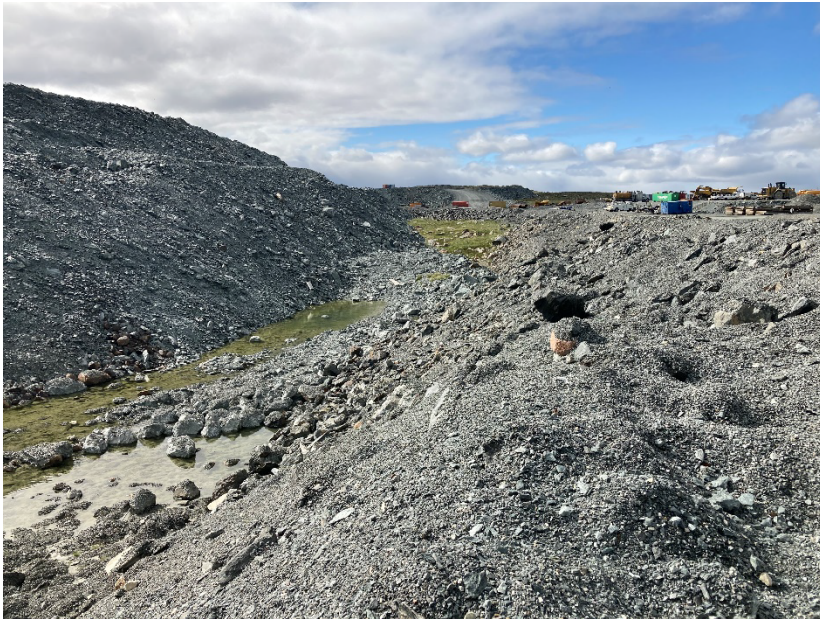
Photograph A2-5 South Camp Dike

Description: From the north abutment, looking south at the downstream slope. There is some water ponding, from run-off.

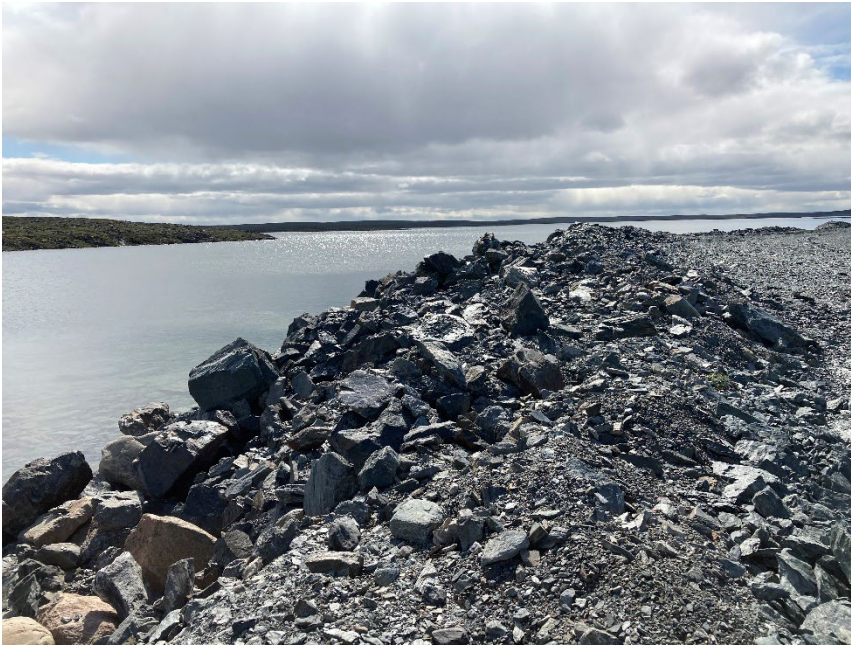
Photograph A3-1 Bay Goose Dike

Description: From approximately Sta. 30+142 (north abutment) looking southwest at the crest and upstream slope.

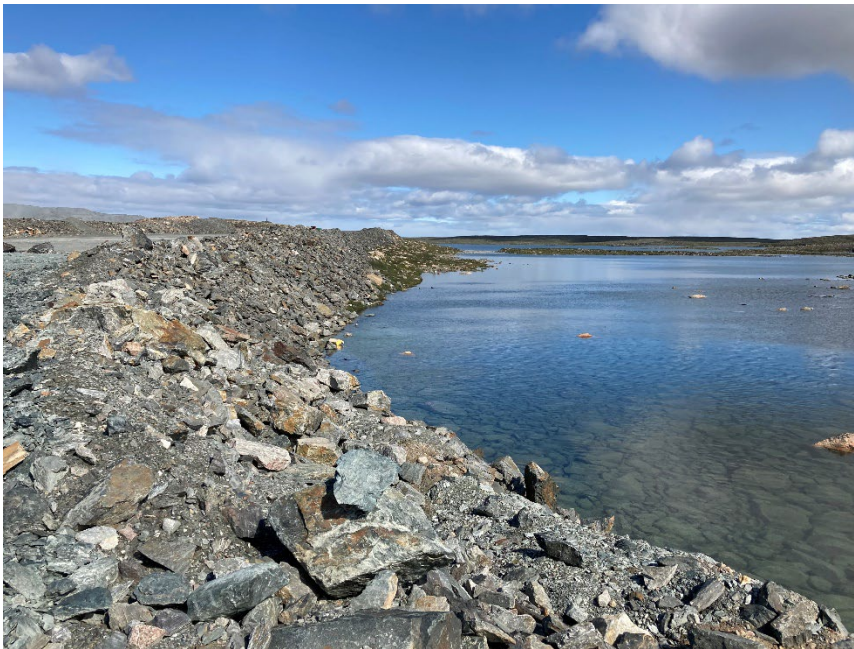
Photograph A3-2 Bay Goose Dike

Description: From approximately Sta. 30+130 (north abutment), looking north at the crest and upstream slope.

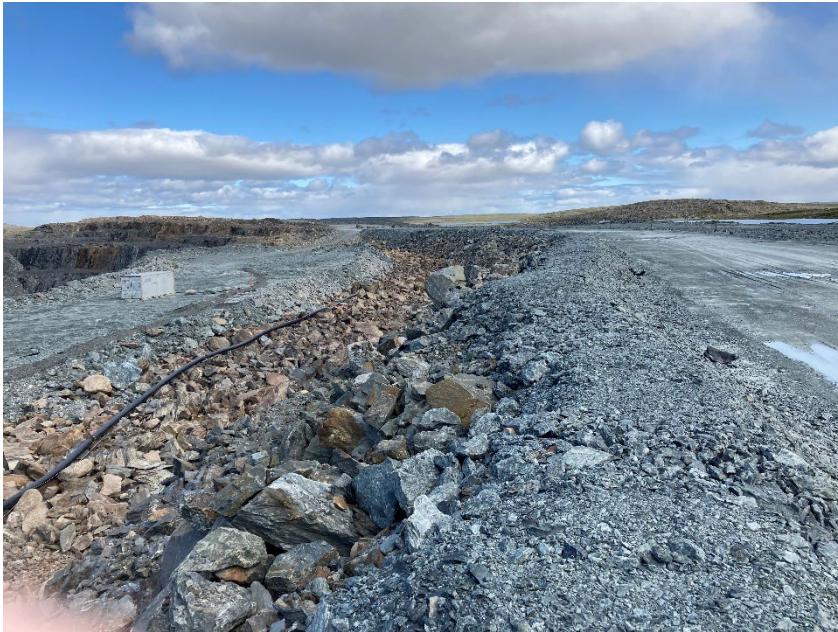
Photograph A3-3 Bay Goose Dike

Description: From approximately Sta. 30+340 on the crest, looking northeast at the dam crest and downstream slope

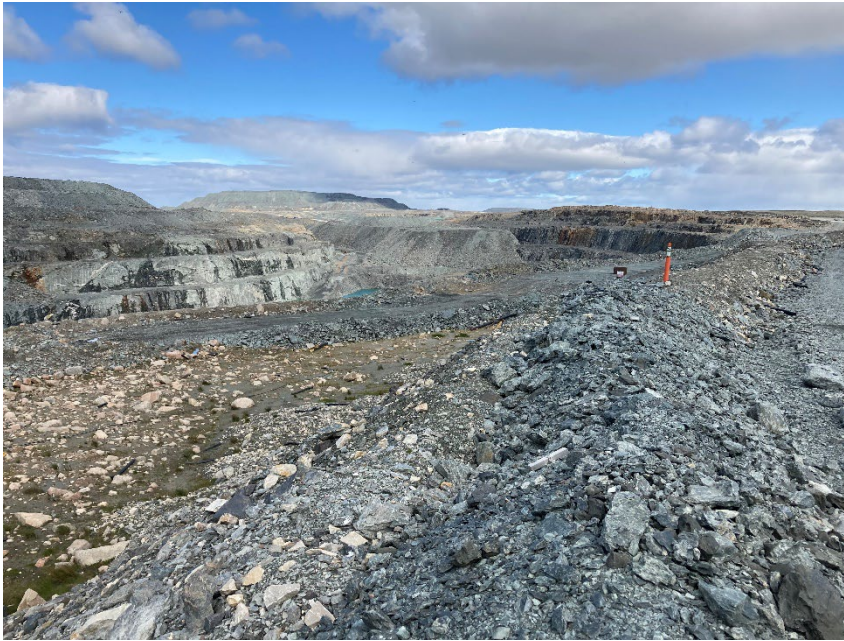
Photograph A3-5 Bay Goose Dike

Description: From approximately Sta. 30+450, looking north at the downstream slope.

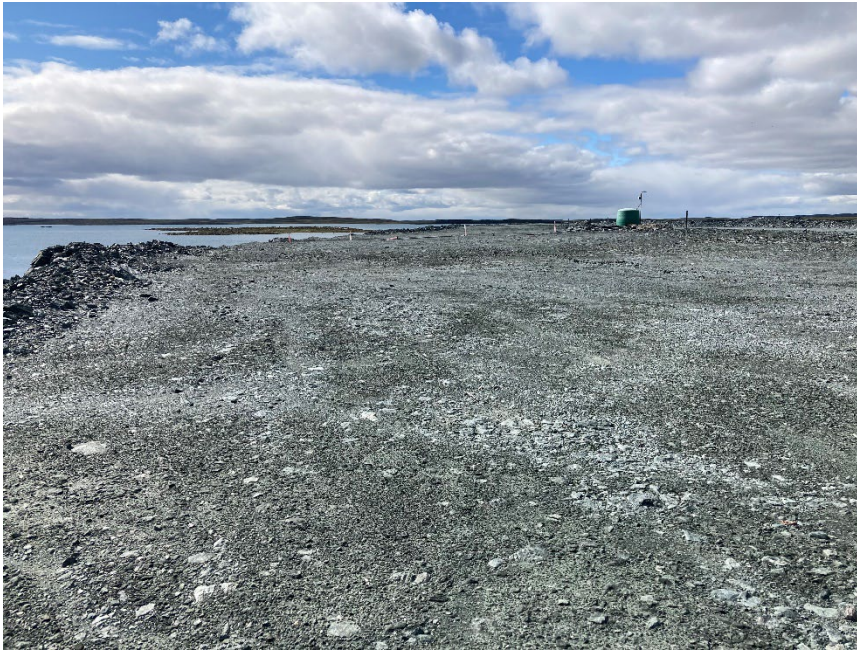
Photograph A3-13 Bay Goose Dike

Description: From approximately Sta. 31+080 on the crest, looking southwest at the pond of water at Central Channel seepage at Sta. 31+165.

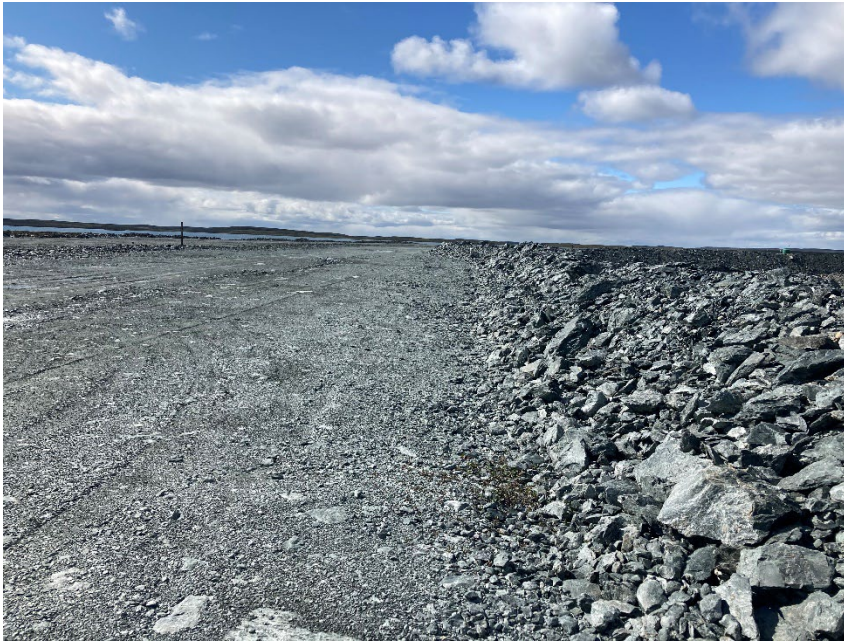
Photograph A3-17 Bay Goose Dike

Description: From approximately Sta. 31+280 on the crest, looking southwest at the downstream slope and the water pond at the downstream toe at Sta. 31+350.

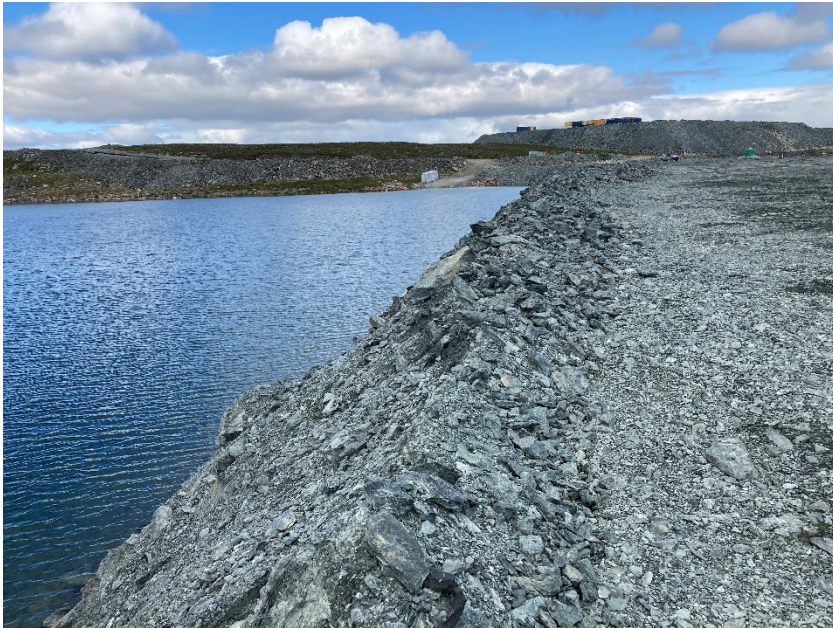
Photograph A3-29 Bay Goose Dike

Description: From the crest at approximately Sta. 31+740, looking north downstream at the water pond at Sta. 31+750.

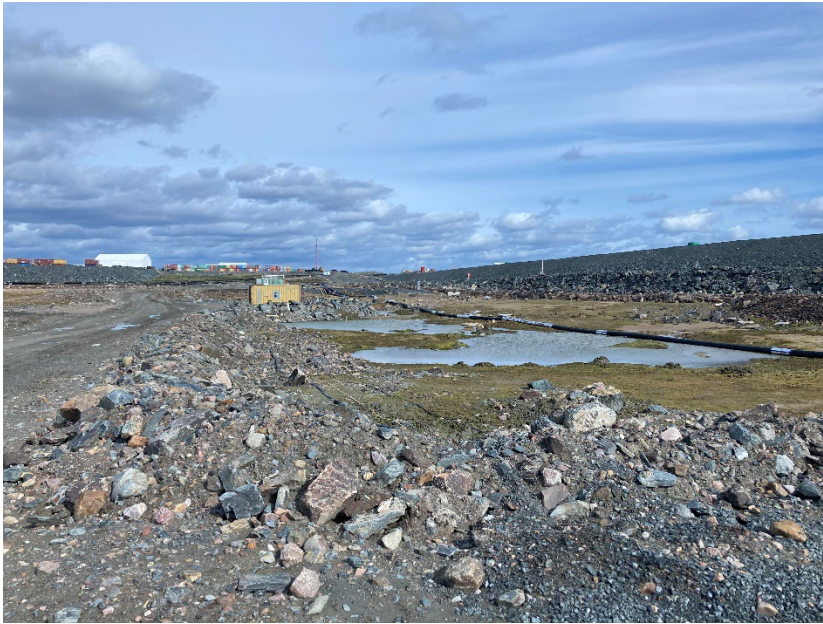
Photograph A5-1 Whale Tail Dike

Description: From approx. Sta. 0+250 downstream (P4 pumping station), looking east. A large amount of water is ponding.

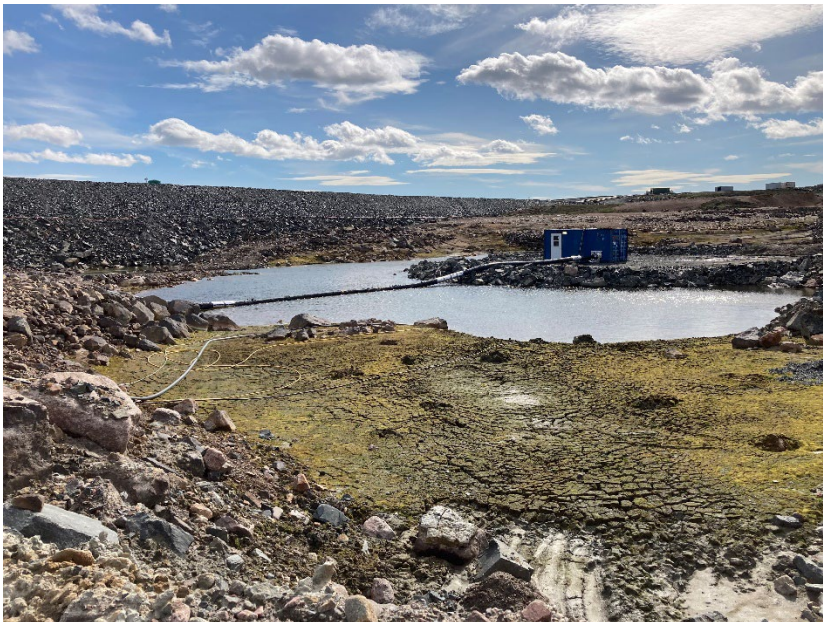
Photograph A5-2 Whale Tail Dike

Description: From approx. Sta. 0+250 downstream (P4 pumping station), looking southwest. A large amount of water is ponding.

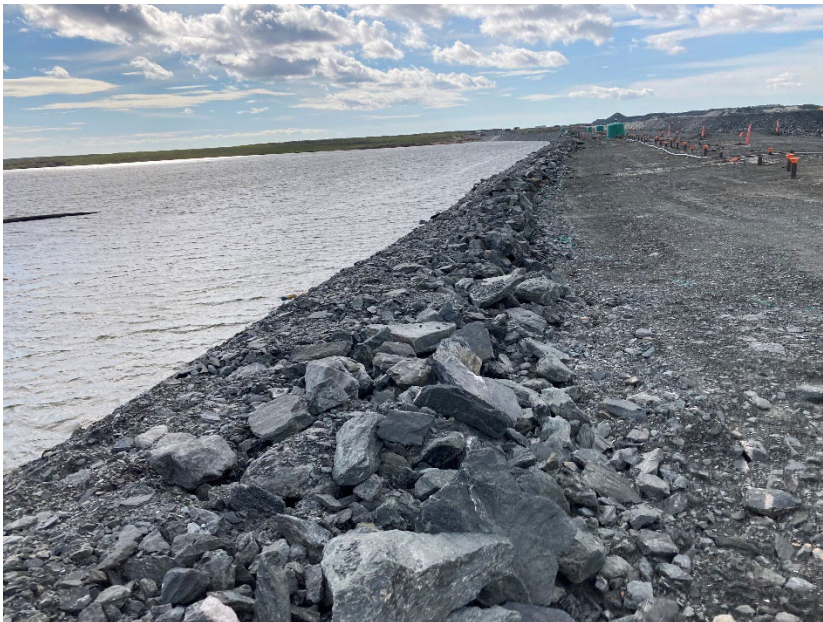
Photograph A5-4 Whale Tail Dike

Description: From approx. Sta. 0+725 (east abutment), looking southwest at the upstream slope and the discharge line from the water treatment plant.

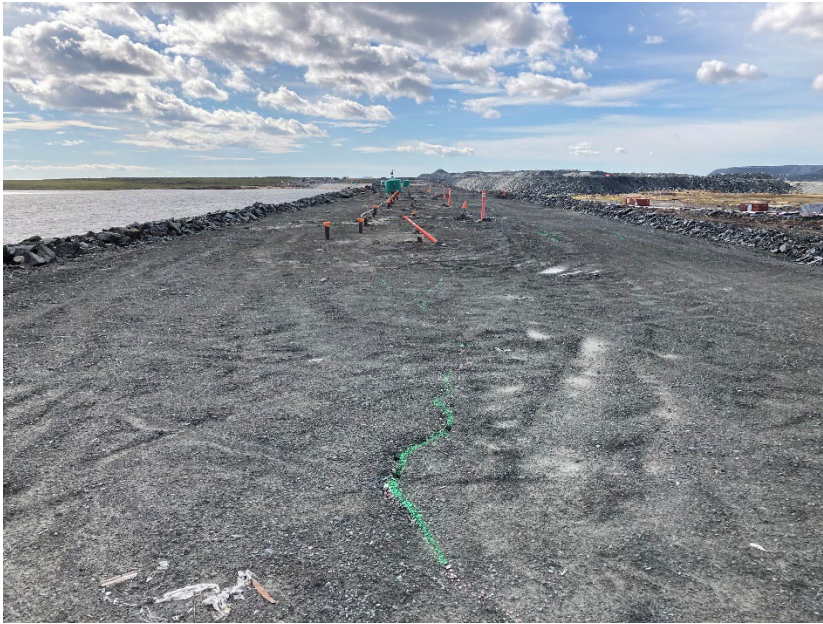
Photograph A5-5 Whale Tail Dike

Description: From approx. Sta. 0+725 (east abutment), looking west at the crest. Presence of tension cracks and settlement on the crest.

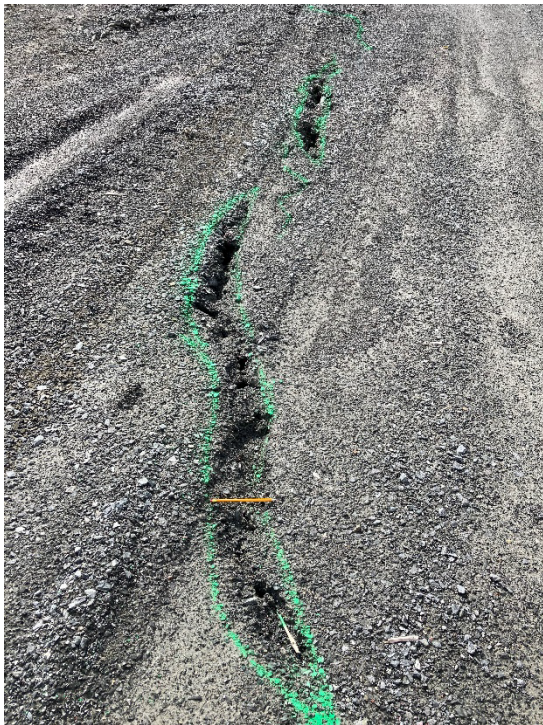
Photograph A5-7 Whale Tail Dike

Description: From approx. Sta. 0+700 (east abutment), looking west at the crest. Tension cracks (150 mm wide).

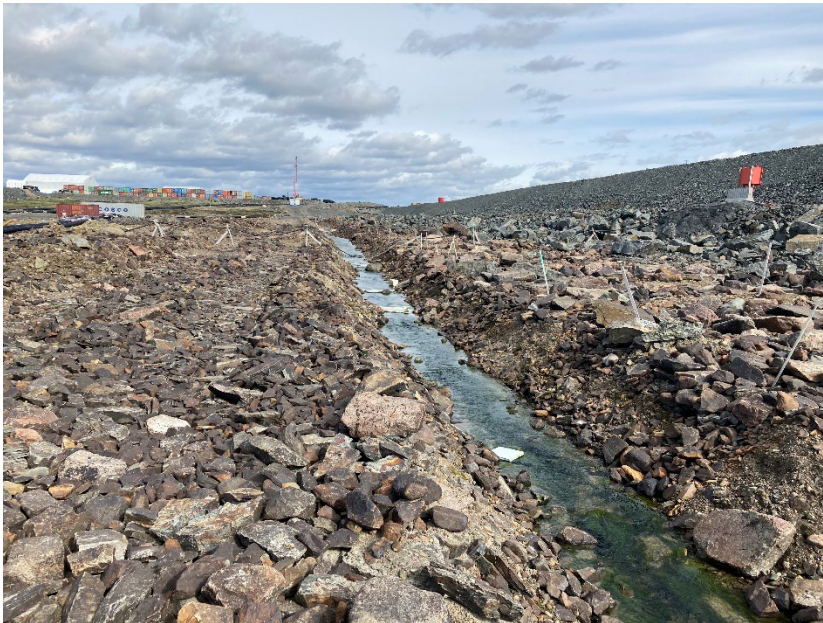
Photograph A5-22 Whale Tail Dike

INSPECTION ITEM	OBSERVATIONS DATA	PHOTO	COMMENTS & OTHER DATA
4. DOWNSTREAM TOE AREA		288, 295, 299, 301, 302, 303, 304, 305, 306, 307, 308	
4.1 Seepage from dam	Yes	306, 307	Collected in a trench from Sta. 0+430 to 0+720. Seepage interception system pumping water compose of 4 pumping stations (inactive).
4.2 Signs of erosion	None observed		
4.3 Signs of turbidity in seepage water	None		All seepage water is clear
4.4 Discoloration/staining	No		
4.5 Outlet operating problem (if applicable)	Not applicable		
4.6 Other unusual conditions	None		
5. ABUTMENTS			
5.1 Seepage at contact zone (abutment/embankment)	None observed		
5.2 Signs of erosion	None observed		
5.3 Excessive vegetation	No		
5.4 Presence of rodent burrows	None observed		
5.5 Other unusual conditions	None		
6. RESERVOIR		286, 289, 290, 293, 296	
6.1 Stability of slopes	Stable

Description: From approx. Sta. 0+450 downstream, looking east at the seepage collection trench and downstream toe.

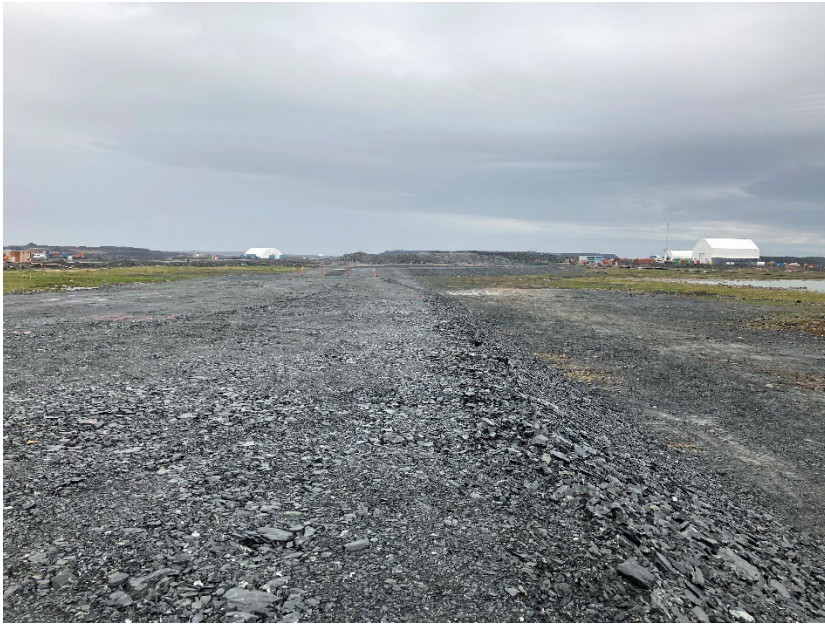
Photograph A6-1 IVR Dike D-1

Description: From approx. Sta. 0+540 (east abutment), looking west at the crest (thermal cap) and upstream slope.

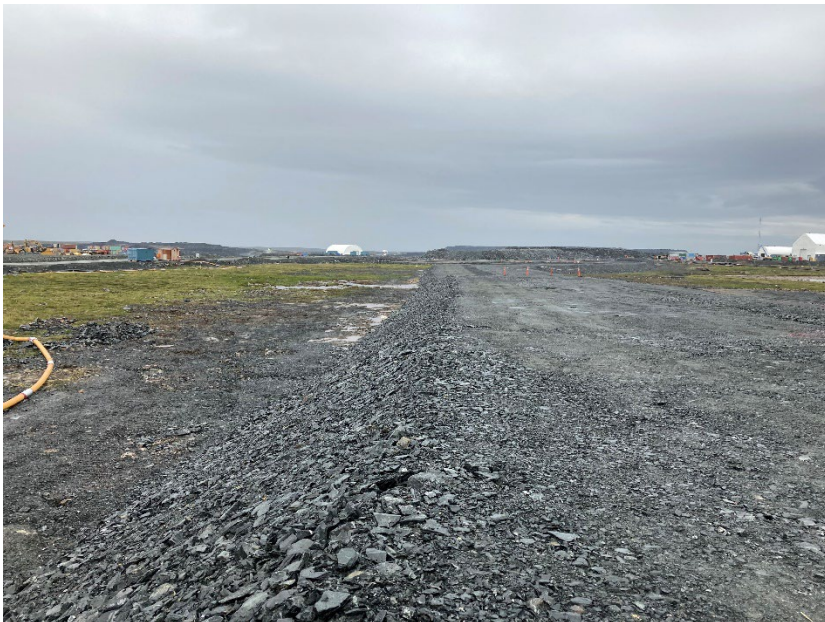
Photograph A6-2 IVR Dike D-1

Description: From approx. Sta. 0+540 (east abutment), looking west at the crest (thermal cap) and downstream slope.

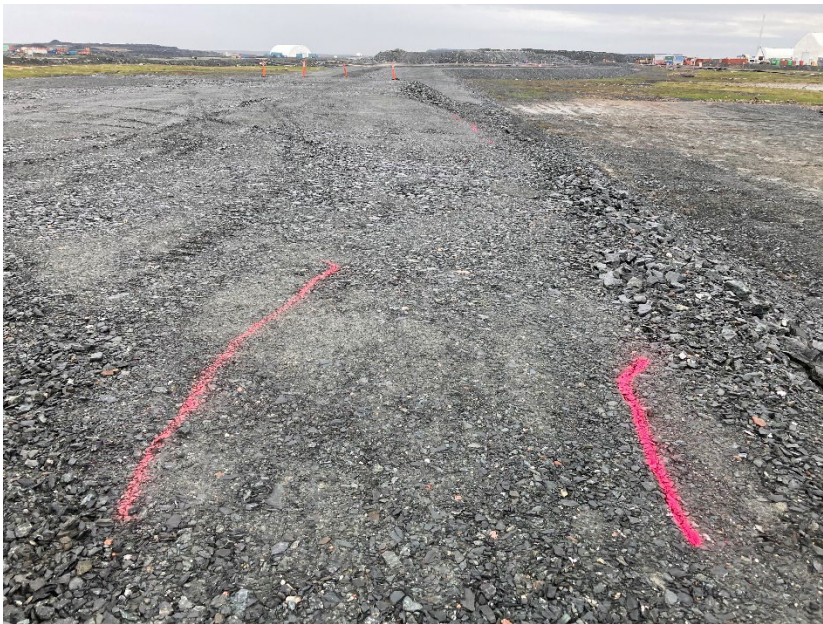
Photograph A6-3 IVR Dike D-1

Description: From approx. Sta. 0+480, looking west at the crest (thermal cap) and upstream slope. Presence of tension cracks in the rockfill of the thermal cap.

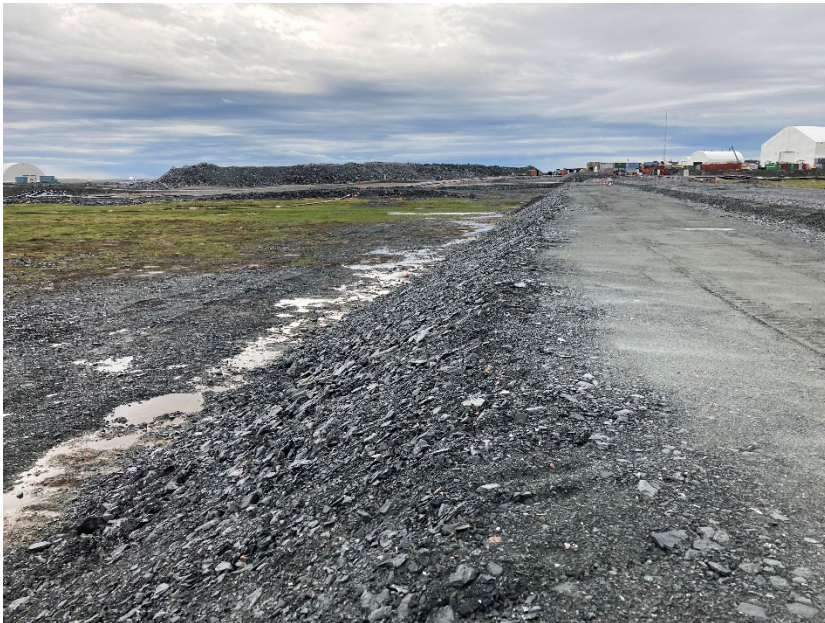
Photograph A6-8 IVR Dike D-1

Description: From approx. Sta. 0+300, looking northwest at the crest and downstream slope. Some water ponding at the toe.

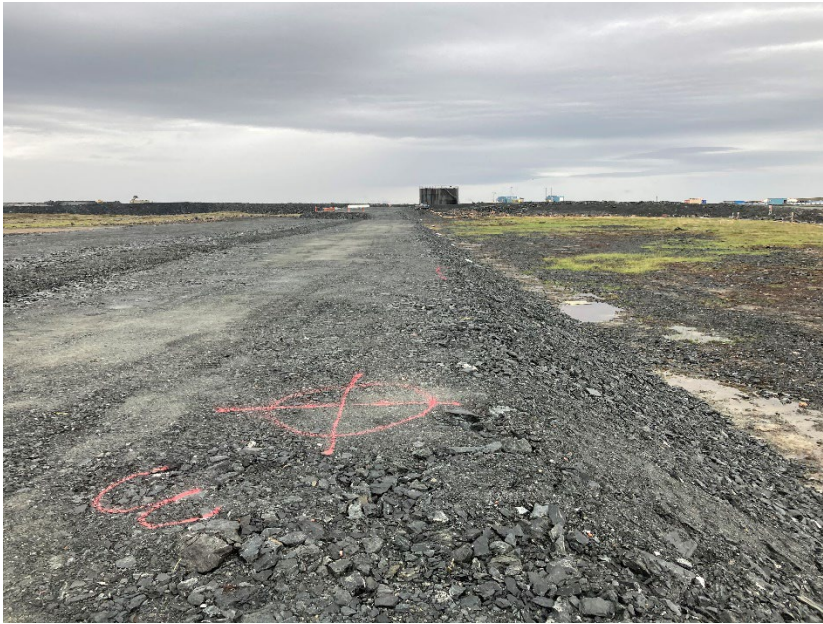
Photograph A6-9 IVR Dike D-1

Description: From approx. Sta. 0+300, looking east at the crest and downstream slope. Some water ponding at the toe.

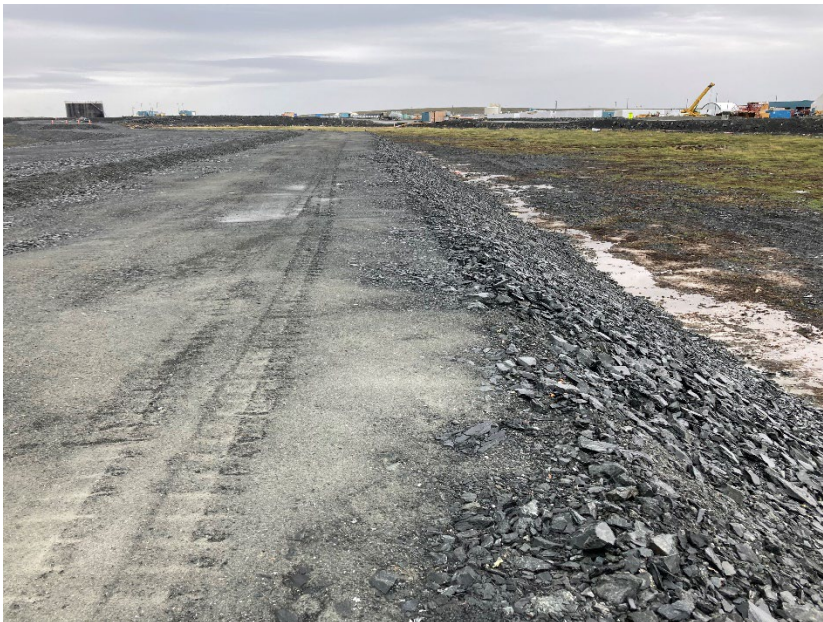
Photograph A6-10 IVR Dike D-1

Description: From approx. Sta. 0+220, looking southeast at the crest and downstream slope. Some water ponding at the toe.

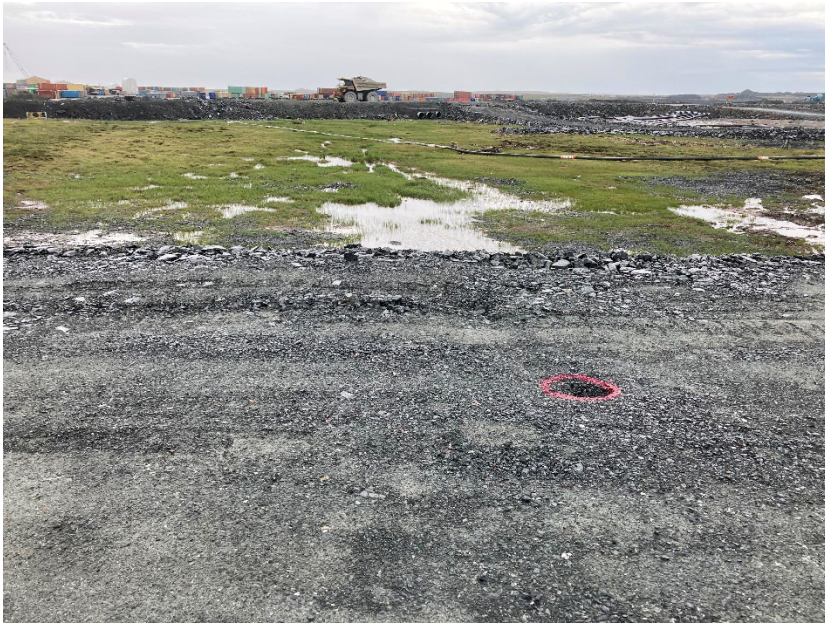
Photograph A6-11 IVR Dike D-1

Description: From approx. Sta. 0+190, looking southwest at the crest and downstream slope. Presence of potholes and water ponding at the toe.

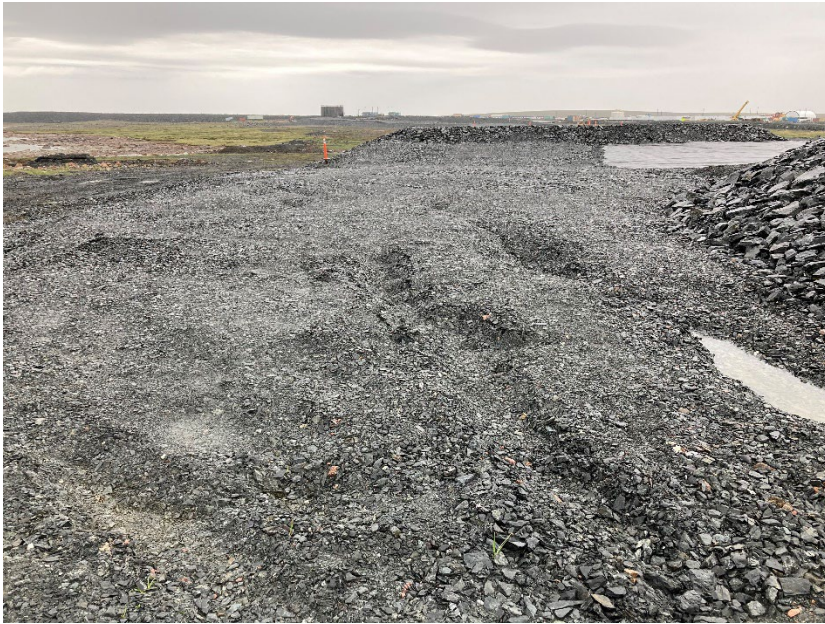
Photograph A6-15 IVR Dike D-1

Description: From approx. Sta. 0+030 (west abutment), looking southeast at the crest. Presence of settlement in the rockfill surface.

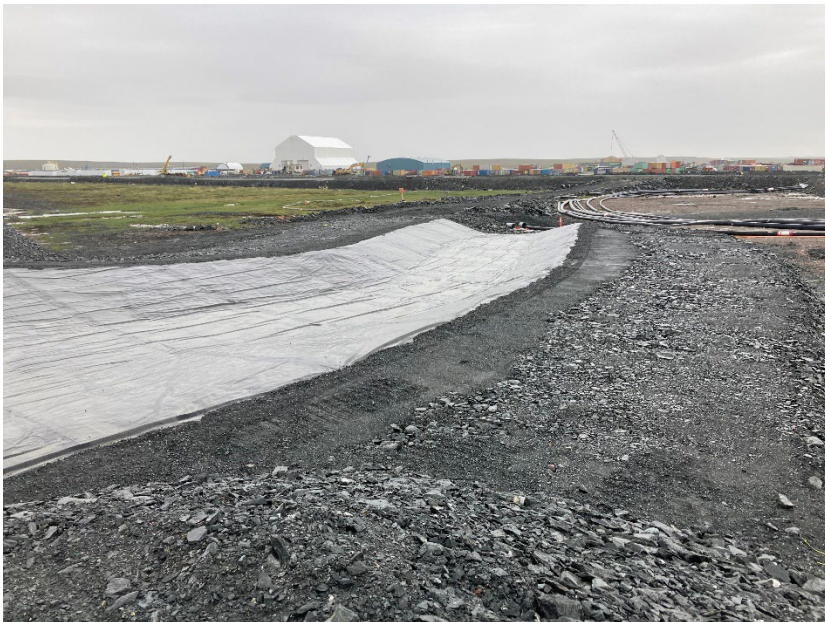
Photograph A6-16 IVR Dike D-1

Description: From approx. Sta. 0+050, looking south at the spillway. Presence of piping at the outlet of the spillway.

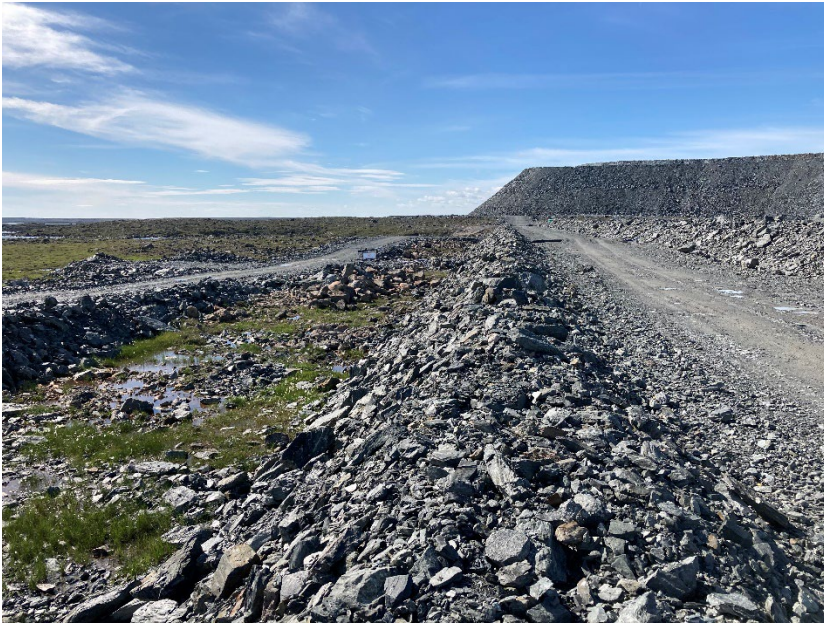
Photograph A7-1 WRSF Dike

Description: From approx. Sta. 0+350 (east abutment), looking west at the dike crest and downstream slope. Presence of water ponding at the toe.

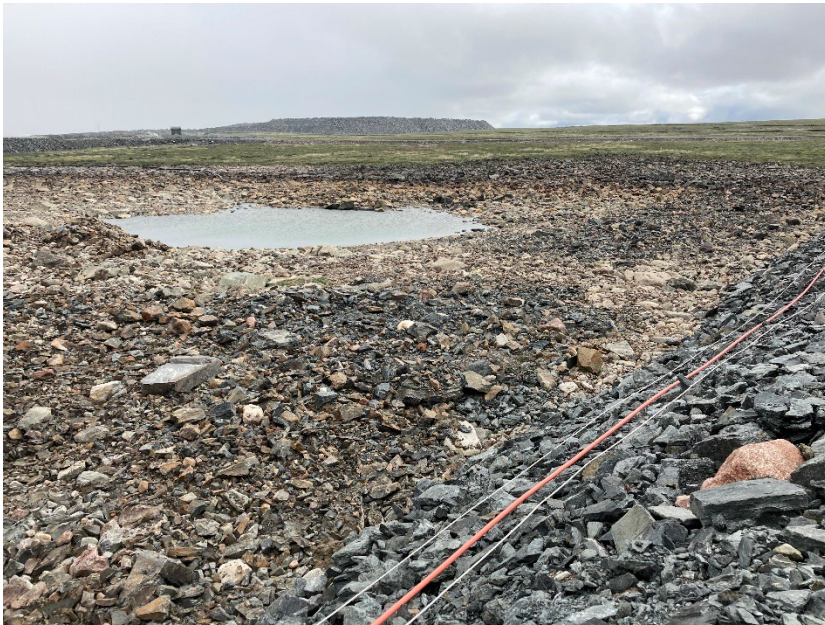
Photograph A8-4 Mammoth Dike

Description: From approx. Sta. 0+100 (north abutment), looking south downstream slope and downstream area. Presence of a water pond some distance away from the toe, equipped with a pump.
