Meadowbank and Whale Tail 2021 Annual Geotechnical Inspection

2021 Annual Geotechnical Inspection

Meadowbank Complex, Nunavut

21468006-1606-R-Rev0

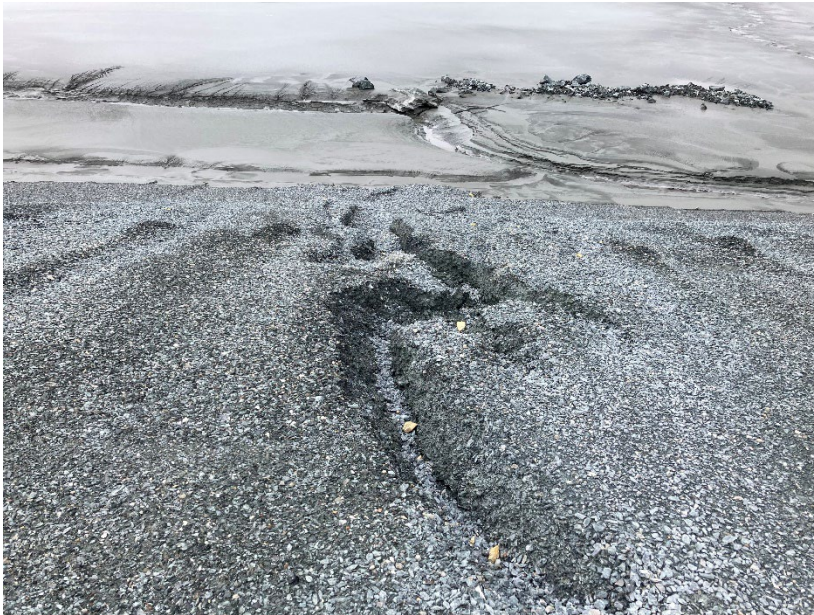
Photograph B1-7 Tailings Storage Facility

Description: From the North Cell Internal Structure at approx. Sta. 2+400, looking northwest at the upstream slope. Presence of erosion features in the fine filter.

INSPECTION ITEM	OBSERVATIONS DATA	PHOTO	COMMENTS & OTHER DATA
8.7 Weirs and flow monitors	No		A temporary seepage collection and pump back system is built and will be completed at a later time according to the design.
8.8 Data logger(s)	Yes		
8.9 Other			
9. DOCUMENTATION			
9.1 Operation, Maintenance and Surveillance (OMS) Plan			
9.1.1 OMS Plan exists	Yes		
9.1.2 OMS Plan reflects current dam conditions	Yes		
9.1.3 Date of last revision	July 2021		
9.2 Emergency Preparedness Plan (EPP)			
9.2.1 EPP exists	Yes		
9.2.2 EPP reflects current conditions	Yes		
9.2.3 Date of last revision	September 2021		
10. NOTES : Remediation plan is in preparation by the AEM team to repair the eroded fine filter layer.			
Inspector's Signature	Marion Habersetzer	Date:	July 28, 2021

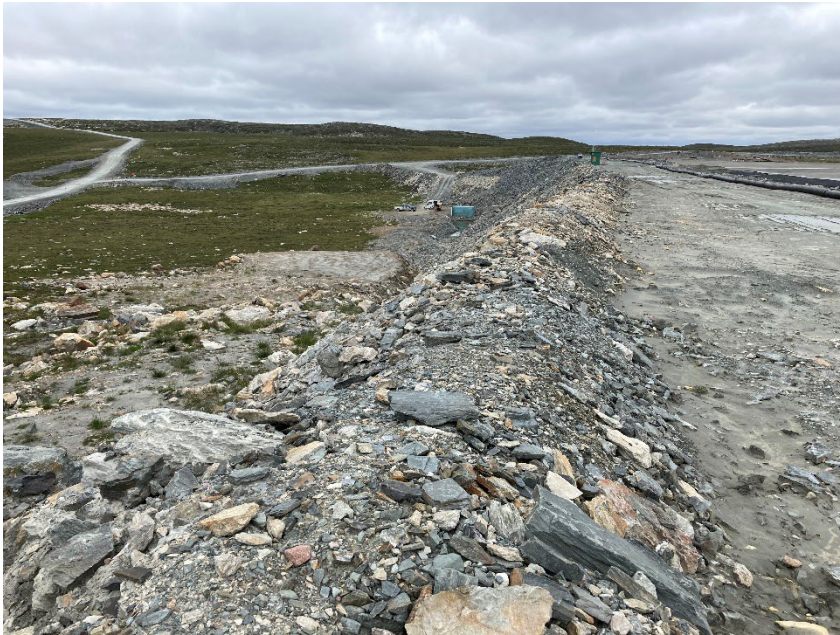
Photograph B2-1 Saddle Dam 1

Description: From the south abutment (Sta. 0+350) looking north at the downstream face. Notice the sea-can container where a sump is installed.

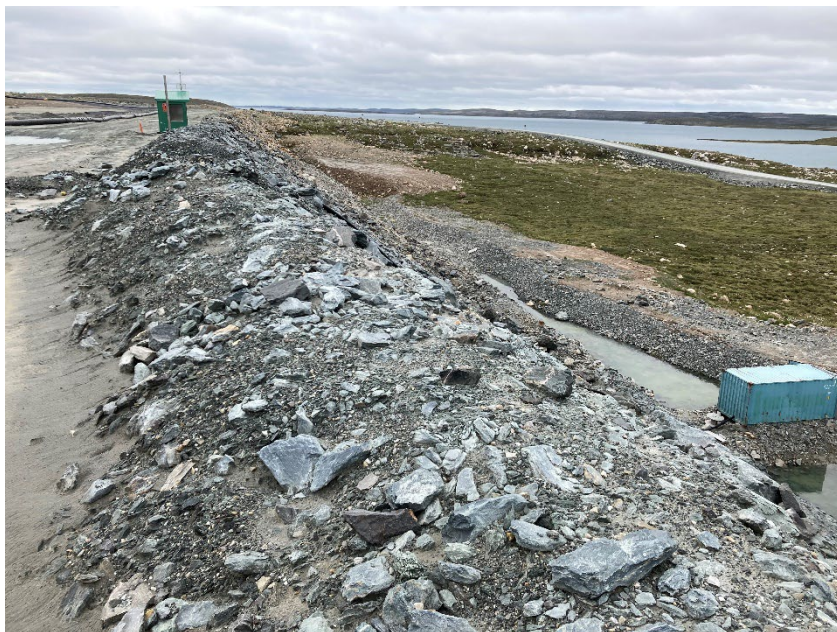
Photograph B2-2 Saddle Dam 1

Description: From Sta. 0+150 looking southwest at the downstream face. Notice the sea-can container where a sump is installed.

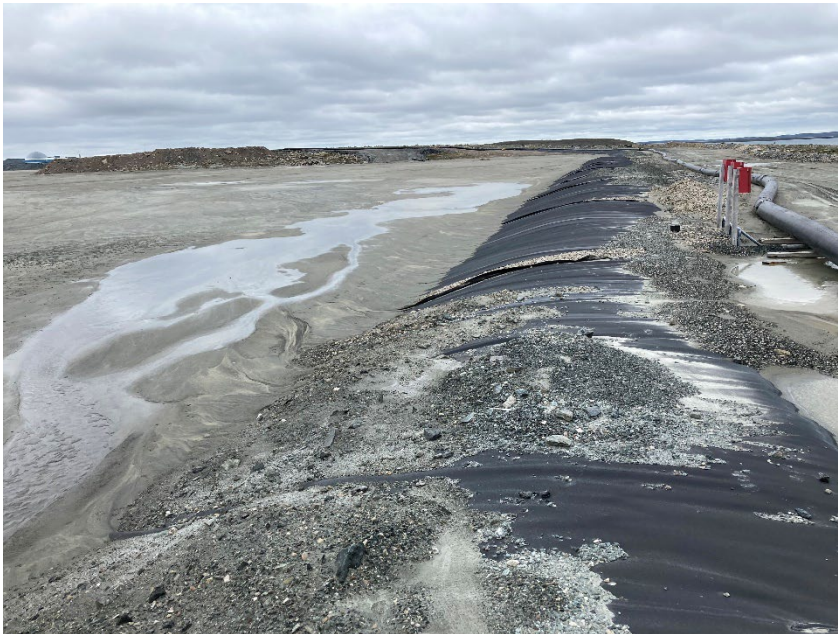
Photograph B2-6 Saddle Dam 1

Description: From approximately Sta. 0+195 upstream, looking south at the upstream slope. Adequate tailings beach against SD1. A small pond of water is present at the surface of the tailings and is not a concern.

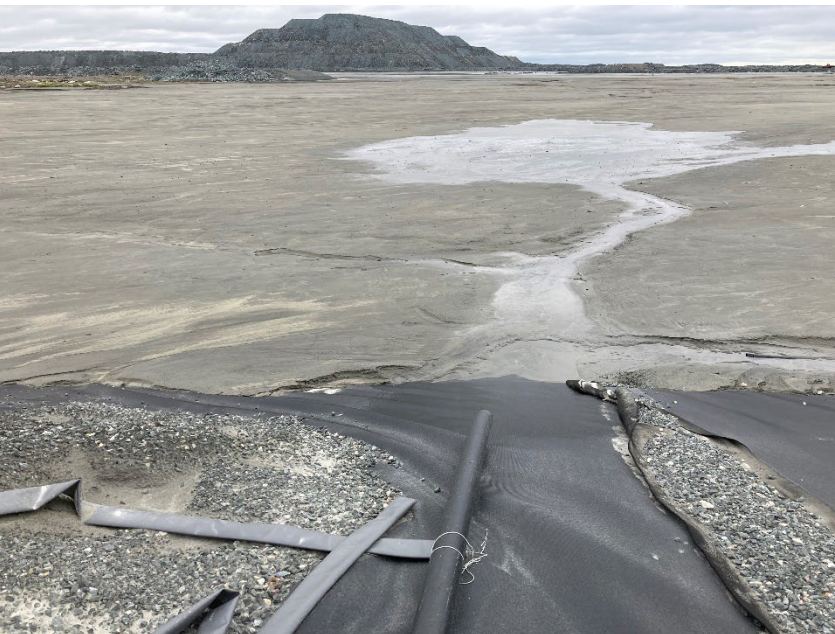
Photograph B2-8 Saddle Dam 1

Description: From approximately Sta. 0+195 upstream, looking east at the North Cell. Water discharging on the liner.

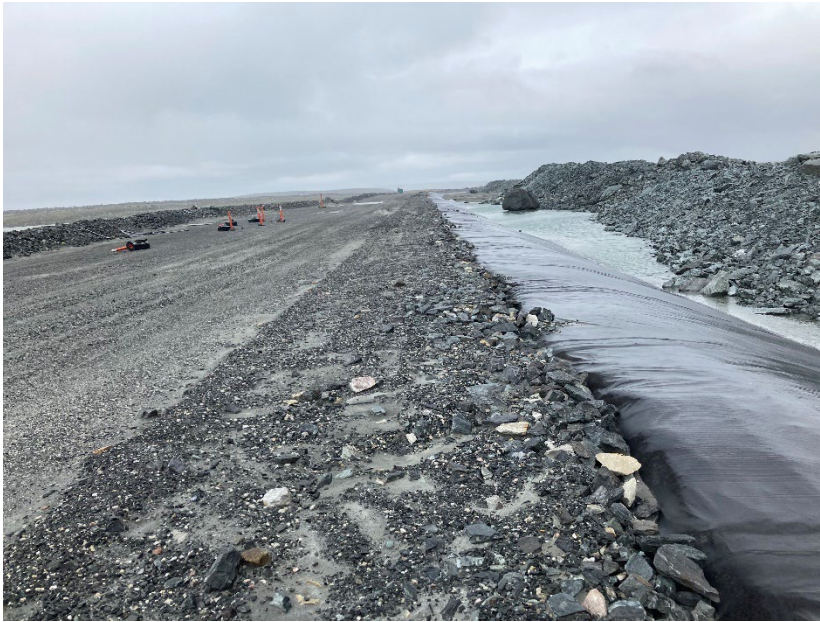
Photograph B4-1 Stormwater Dike

Description: From the east abutment (11+100 approximately), looking west at the upstream face and the rockfill cover of the North Cell. Shallow water ponding against portion of the dike (less than 30 cm deep). Large rocks are present near the liner.

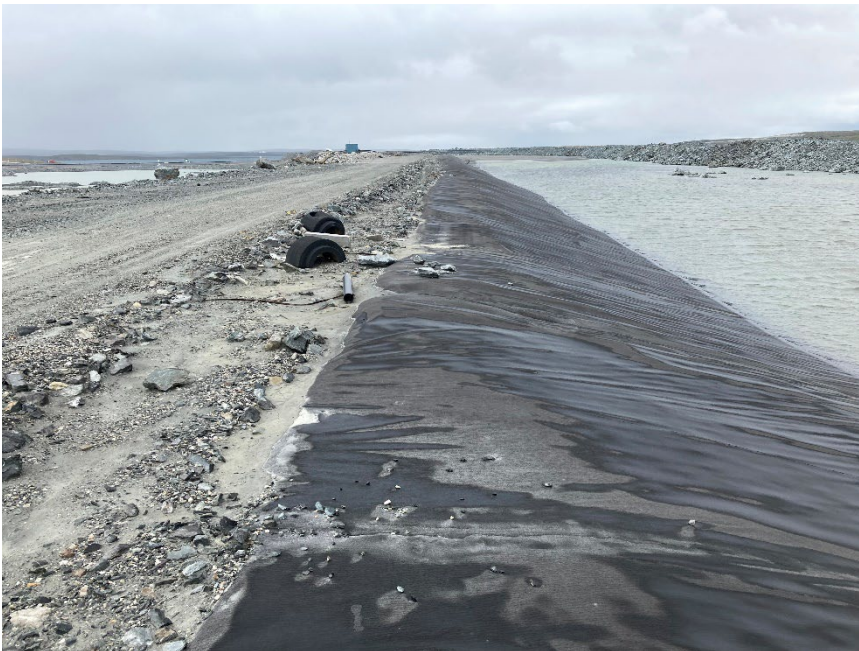
Photograph B4-4 Stormwater Dike

Description: From Sta. 10+650 looking west at the crest and upstream slope. Shallow water against portion of Stormwater Dike.

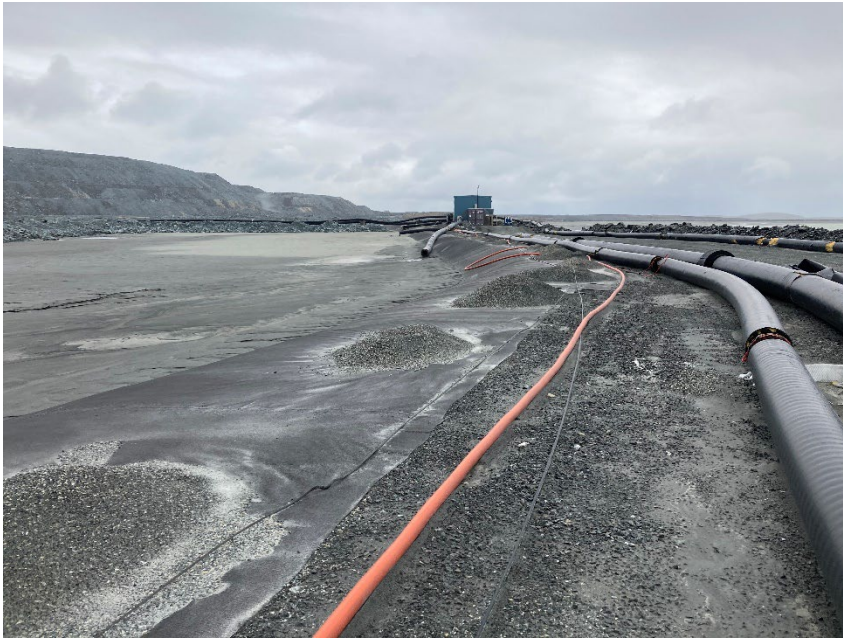
Photograph B4-7 Stormwater Dike

Description: From Sta.10+175, looking east at the upstream slope. The tailings beach is adequate.

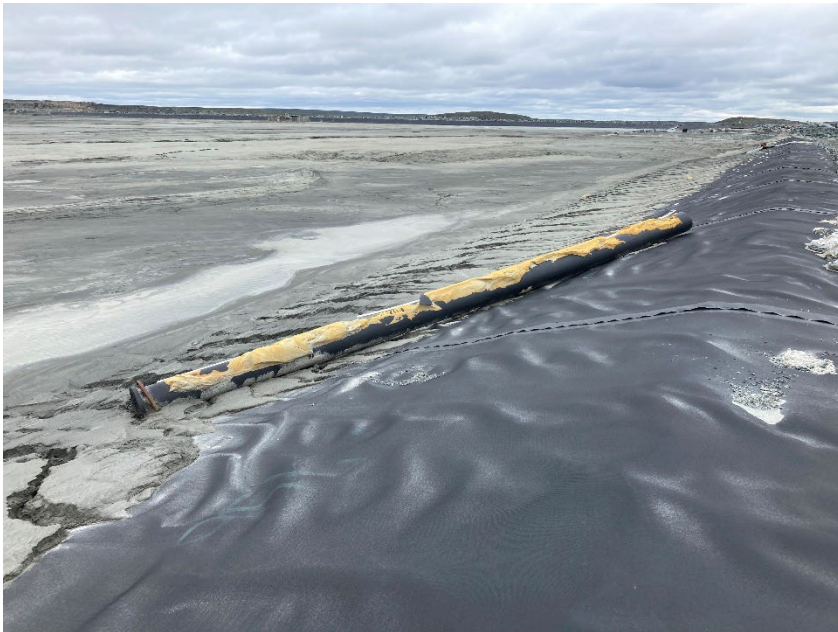
Photograph B6-6 Saddle Dam 4

Description: From 40+300 approximately, looking southeast at the crest and the upstream slope. Presence of a pipe on the liner.

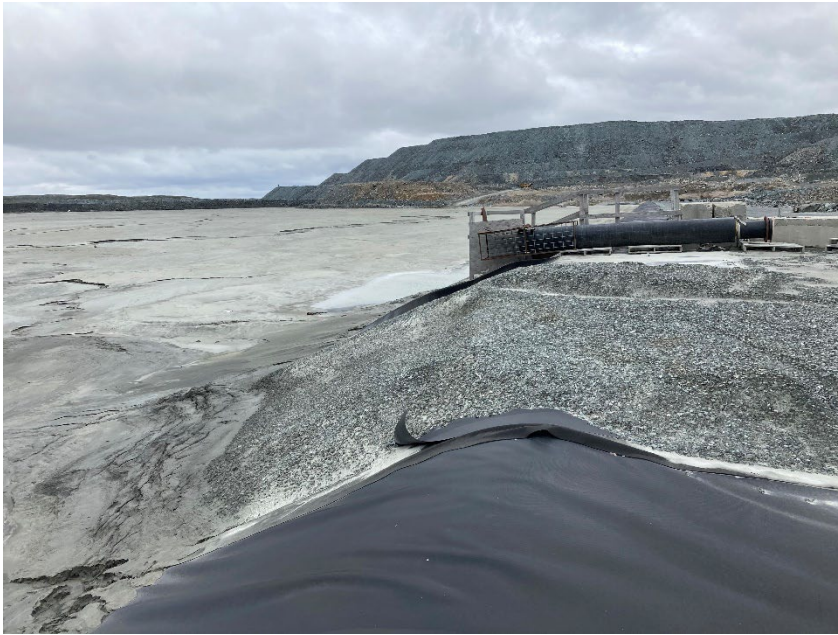
Photograph B7-1 Central Dike and Saddle Dam 5

Description: From approximately Sta. 0+400 (deposition point) looking west at the South Cell. Adequate tailings beach against the south section of the structure.

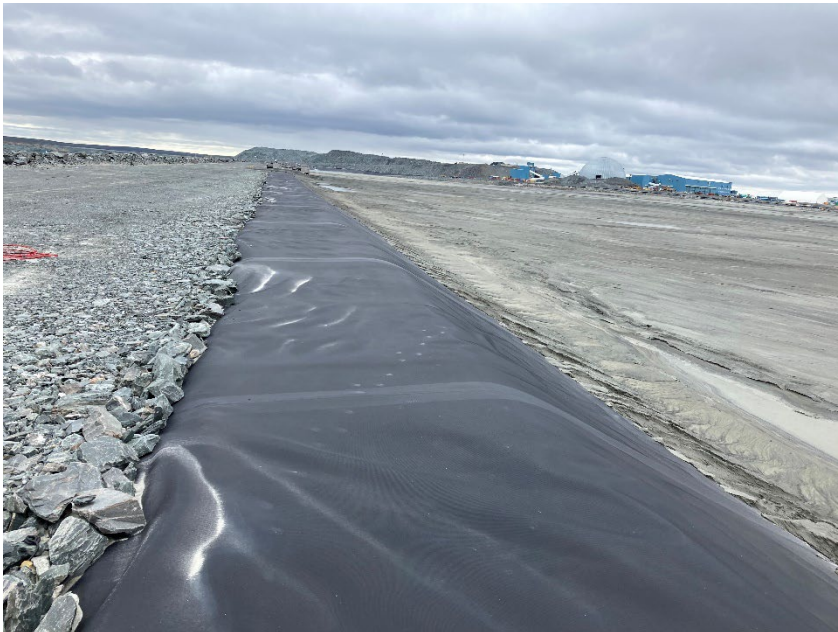
Photograph B7-2 Central Dike and Saddle Dam 5

Description: From approximately Sta. 0+400 (deposition point) looking south at the upstream slope. Adequate tailings beach against the south section of the structure.

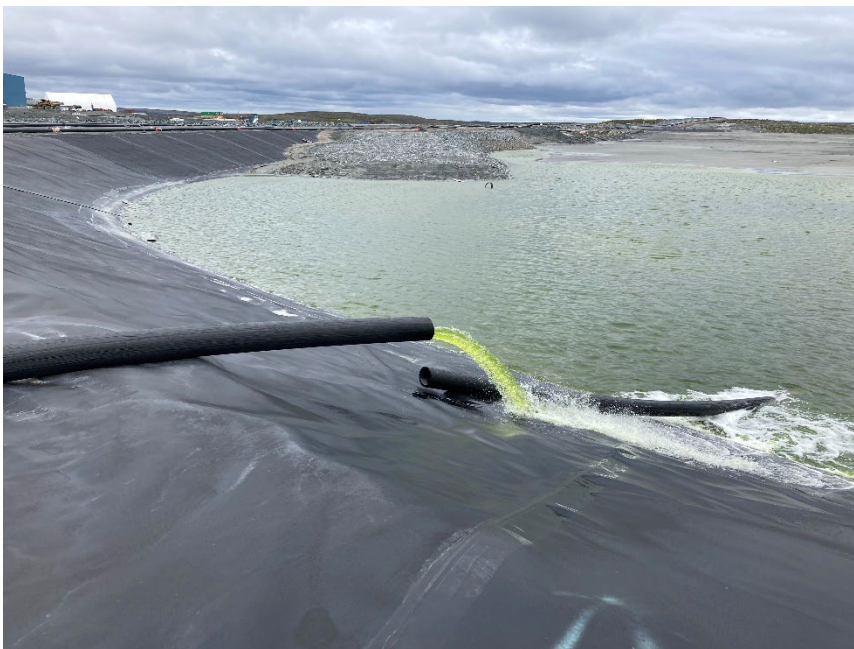
Photograph B7-10 Central Dike and Saddle Dam 5

Description: From approximately Sta. 0+950, looking west at the water discharge on the liner.

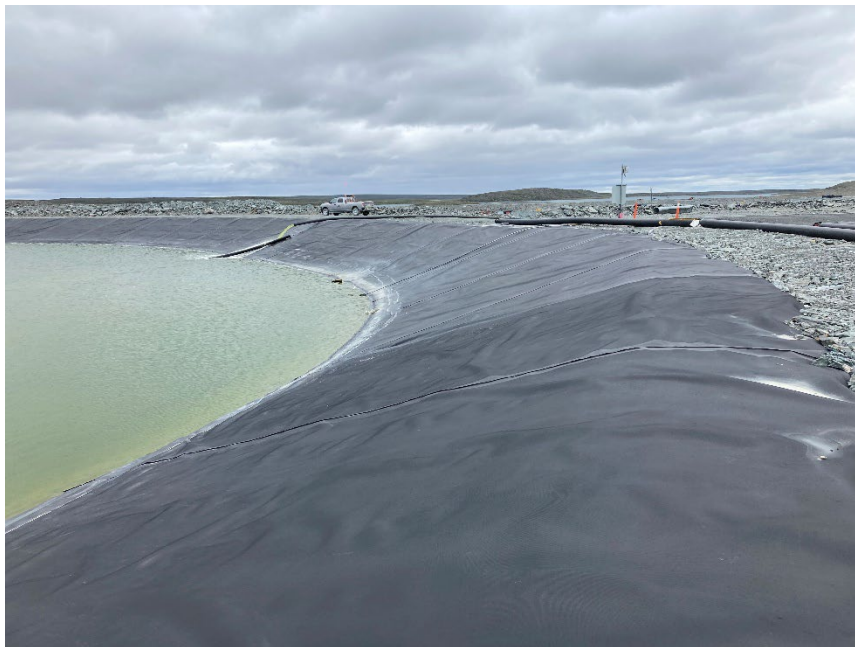
Photograph B7-12 Central Dike and Saddle Dam 5

Description: From approximately Sta. 1+000 looking east at the upstream slope of SD5 and Central Dike. Water is ponding against the liner.

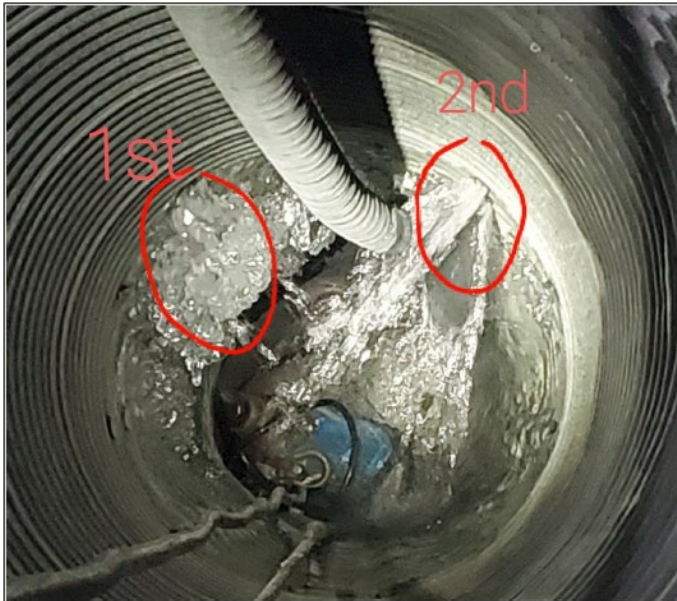
- Unusual increase in inflow in the East Dike seepage station at (0+195).
- Water entering into culvert higher than usual.
- No defect in culvert or pipes.

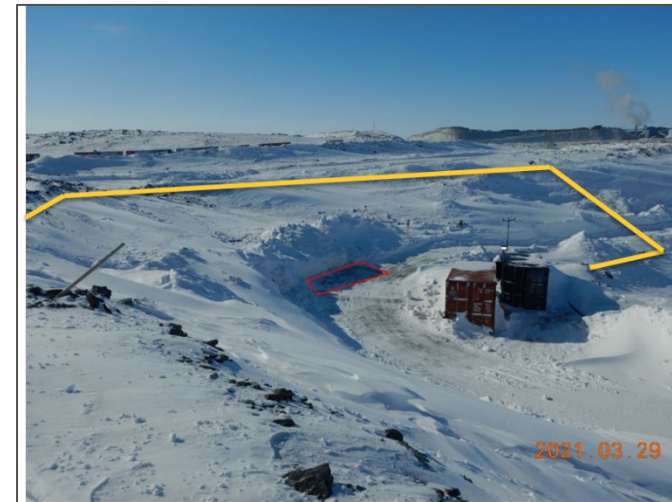
- Water on road surface (including ice).
- Almost no water in seepage station.
- No visual sign of instability. Piezometers in the sector (190 to 240) started to rise on March 11 (1.65 m).

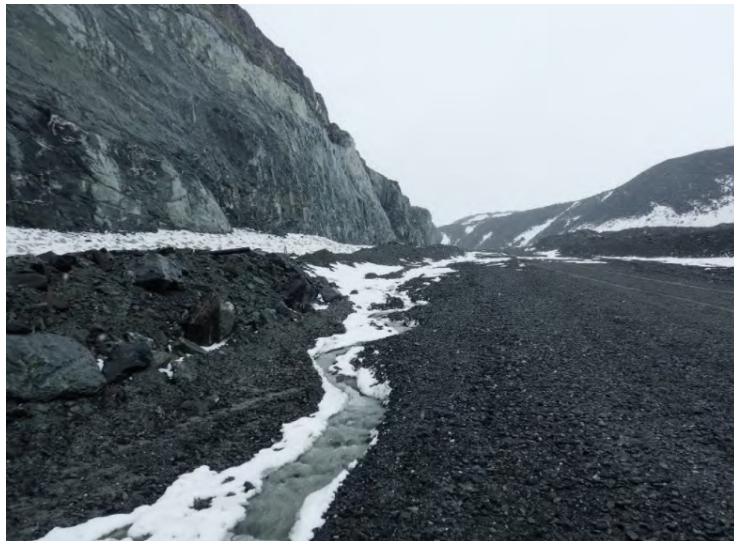
- Water level rising in downstream pond.
- New water inflow observed in Pit E ramp
- Piezometer pressure continues to rise but at a lower rate.
- Thermal regime shows warming up at shallow depth following air temperature trends

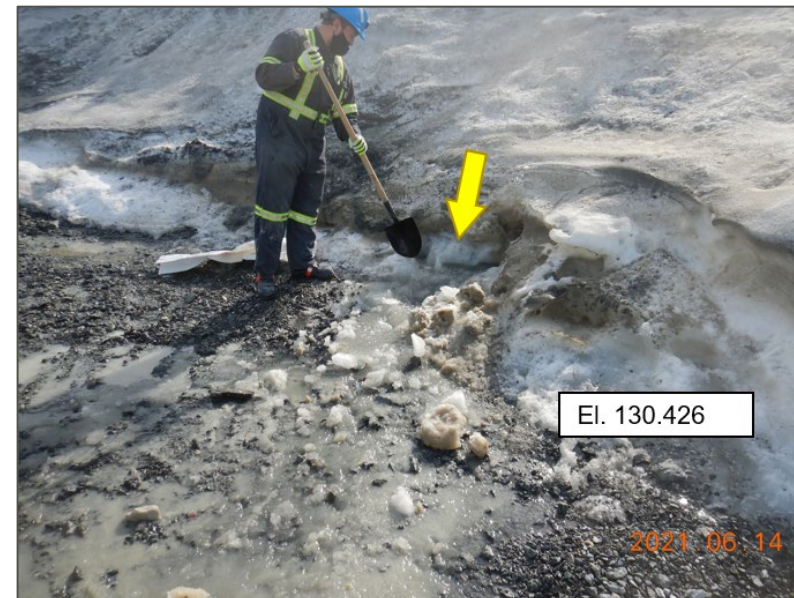
- Water flowing on the East Dike access road
- Downstream pond water level rose in freshet, then stabilized
- Piezometer pressure dropping

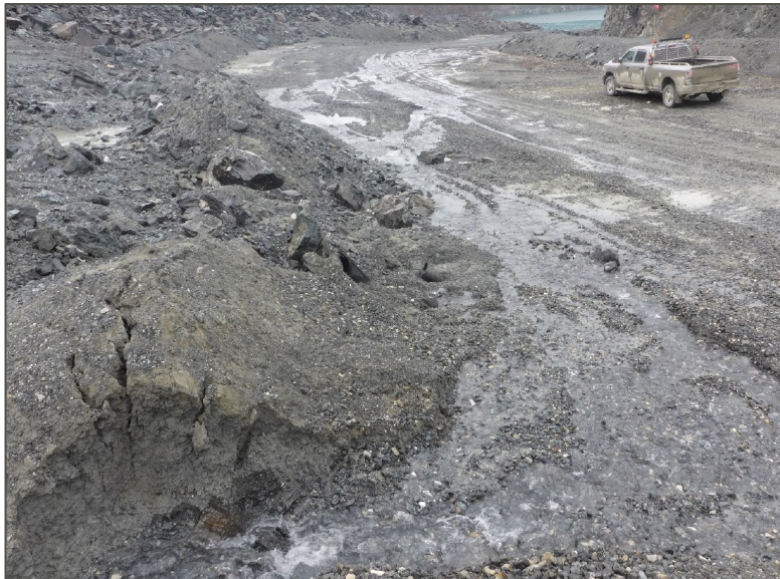
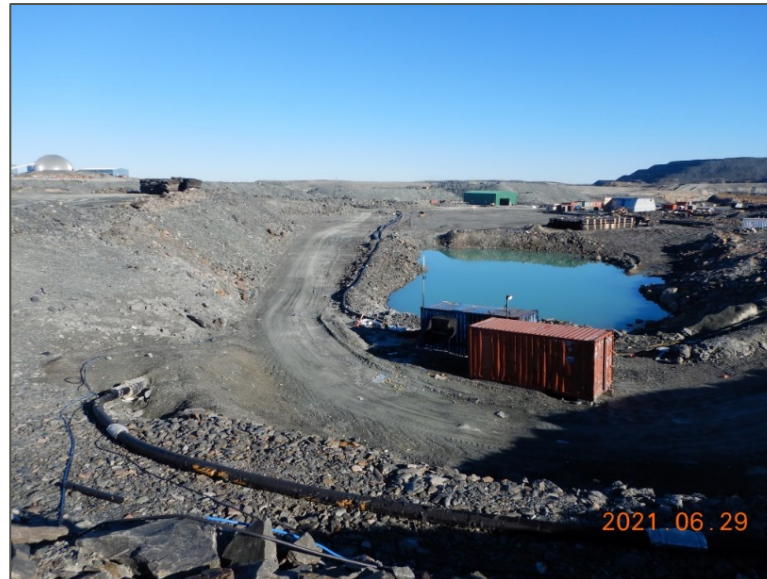
- No unusual observation on East Dike.
- Seepage stations are dry.
- Normal piezometric and thermal conditions for the summer.

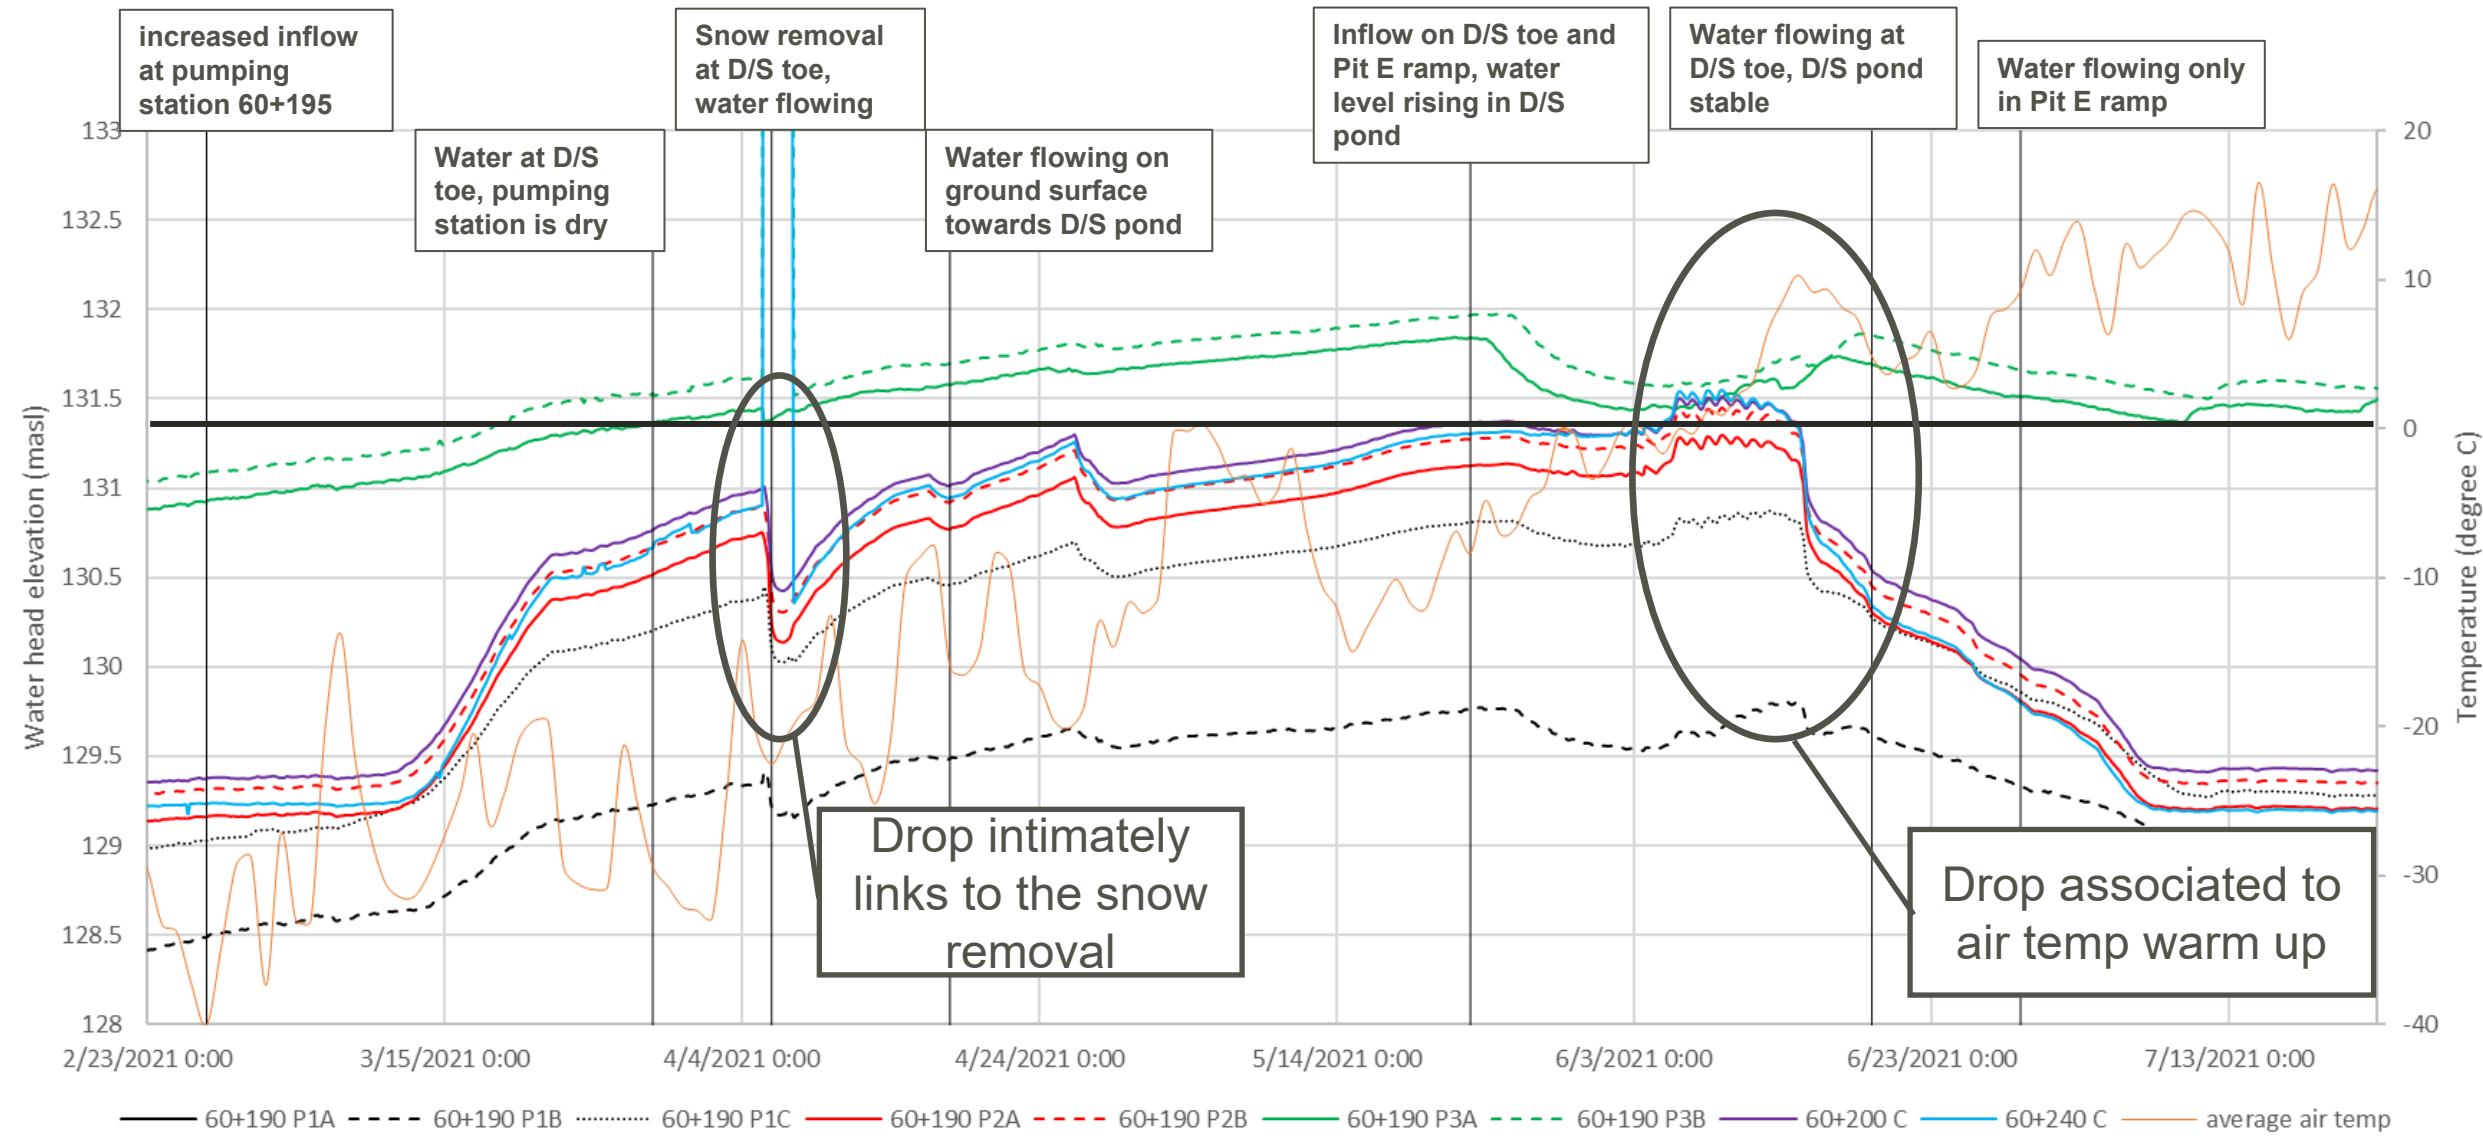
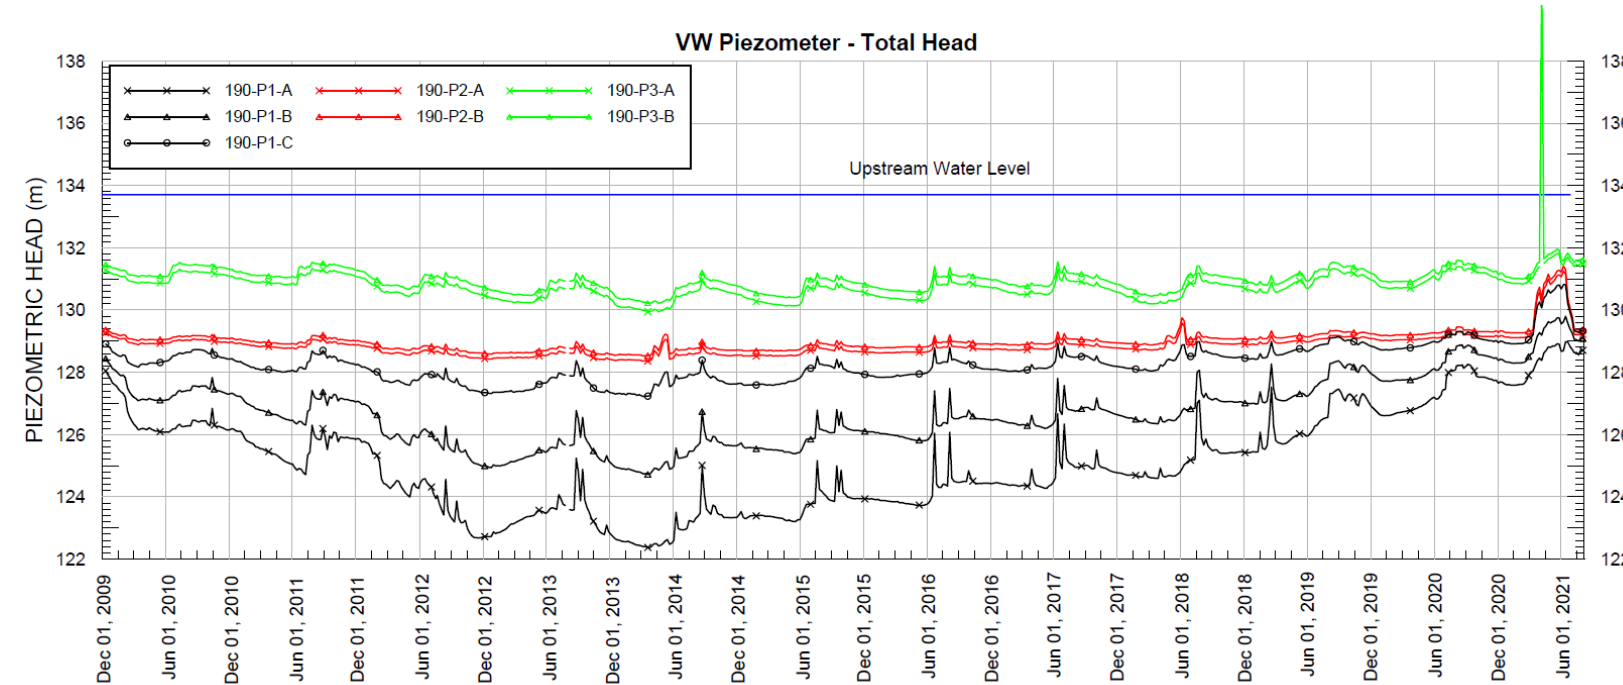
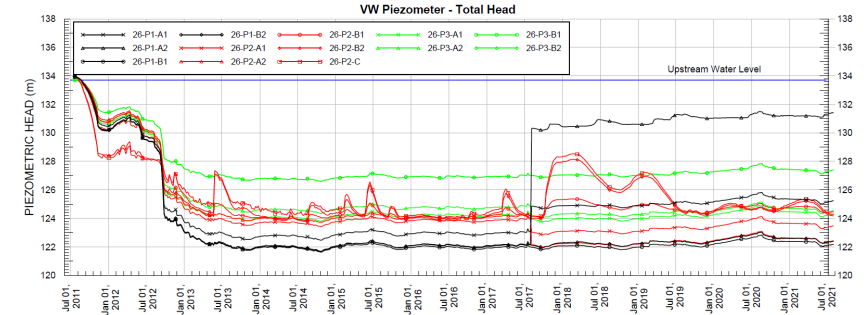
INSTRUMENTATION DATA - PIEZOMETERS

- Same periodic seasonal rising trend observed

- The 2 seepage zones (South Channel and North Channel) are not connected as water head remains below topographic heights in the separation.
- Piezometers are reacting to downstream toe ice blockage removal (important pressure release).
- Slight pressure release when seepage daylight on Pit E ramp (new seepage pathway).
- Fluctuations in pressures nearing freshet: possible impact of daily freeze/thaw of seepage pathway. Followed by rapid decrease in pressure when thawing starts.
- Overpressure entirely dissipated after thawing. Same pressure levels as before the event.

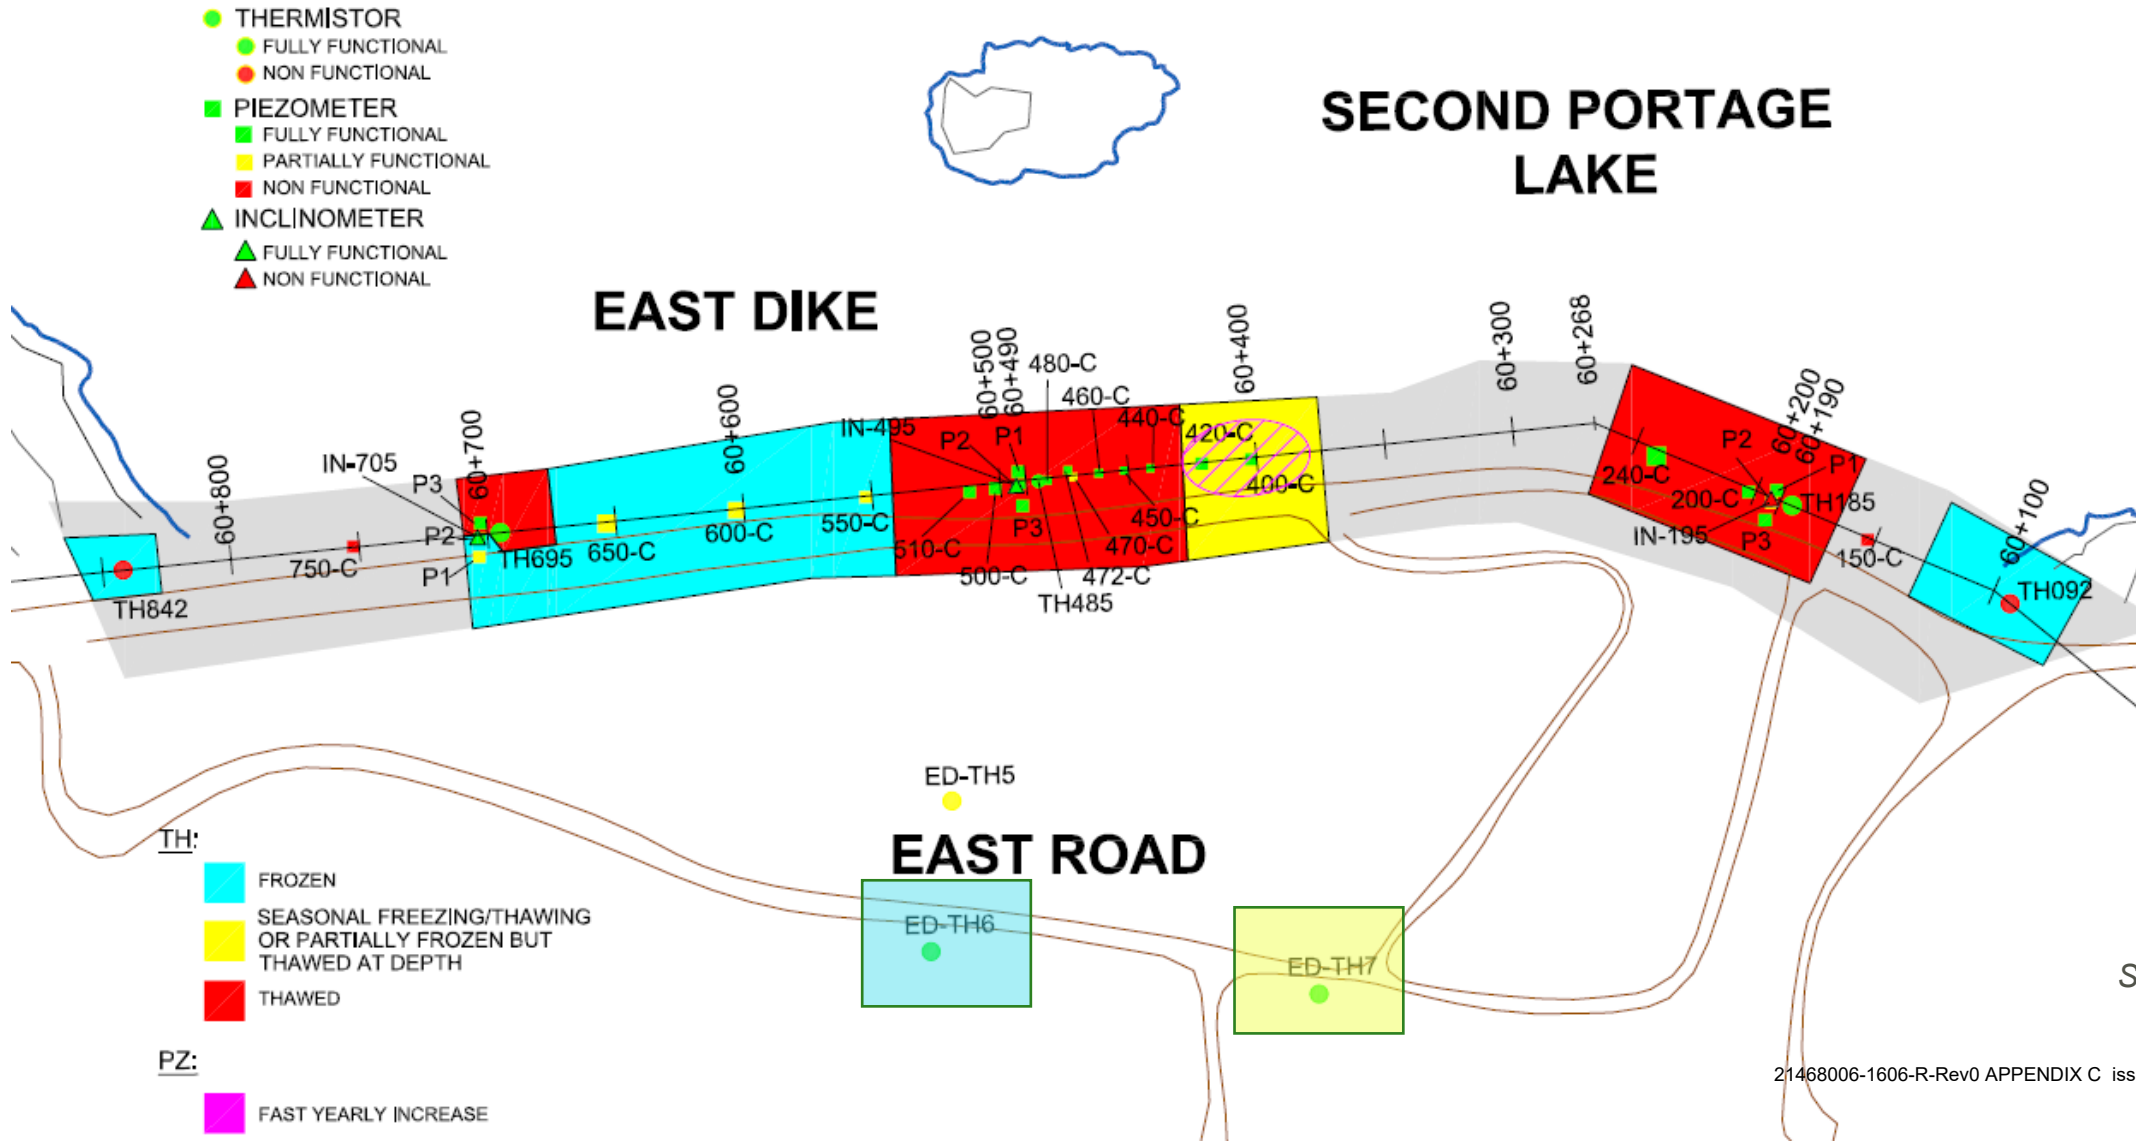
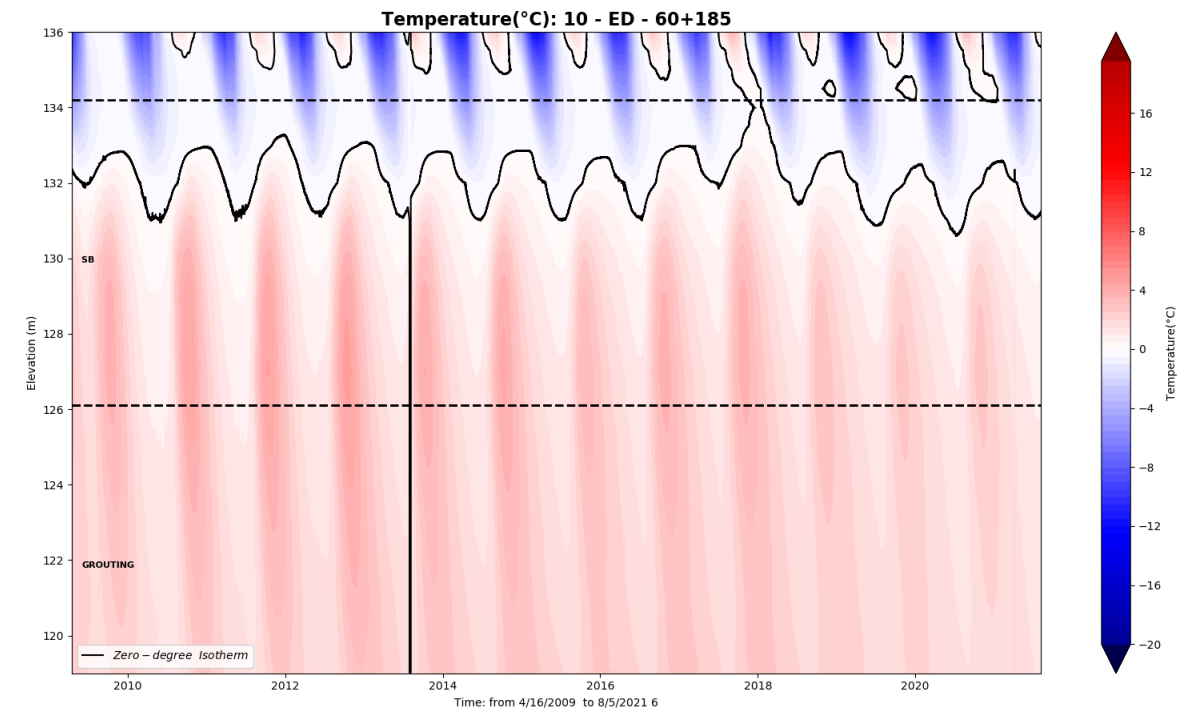
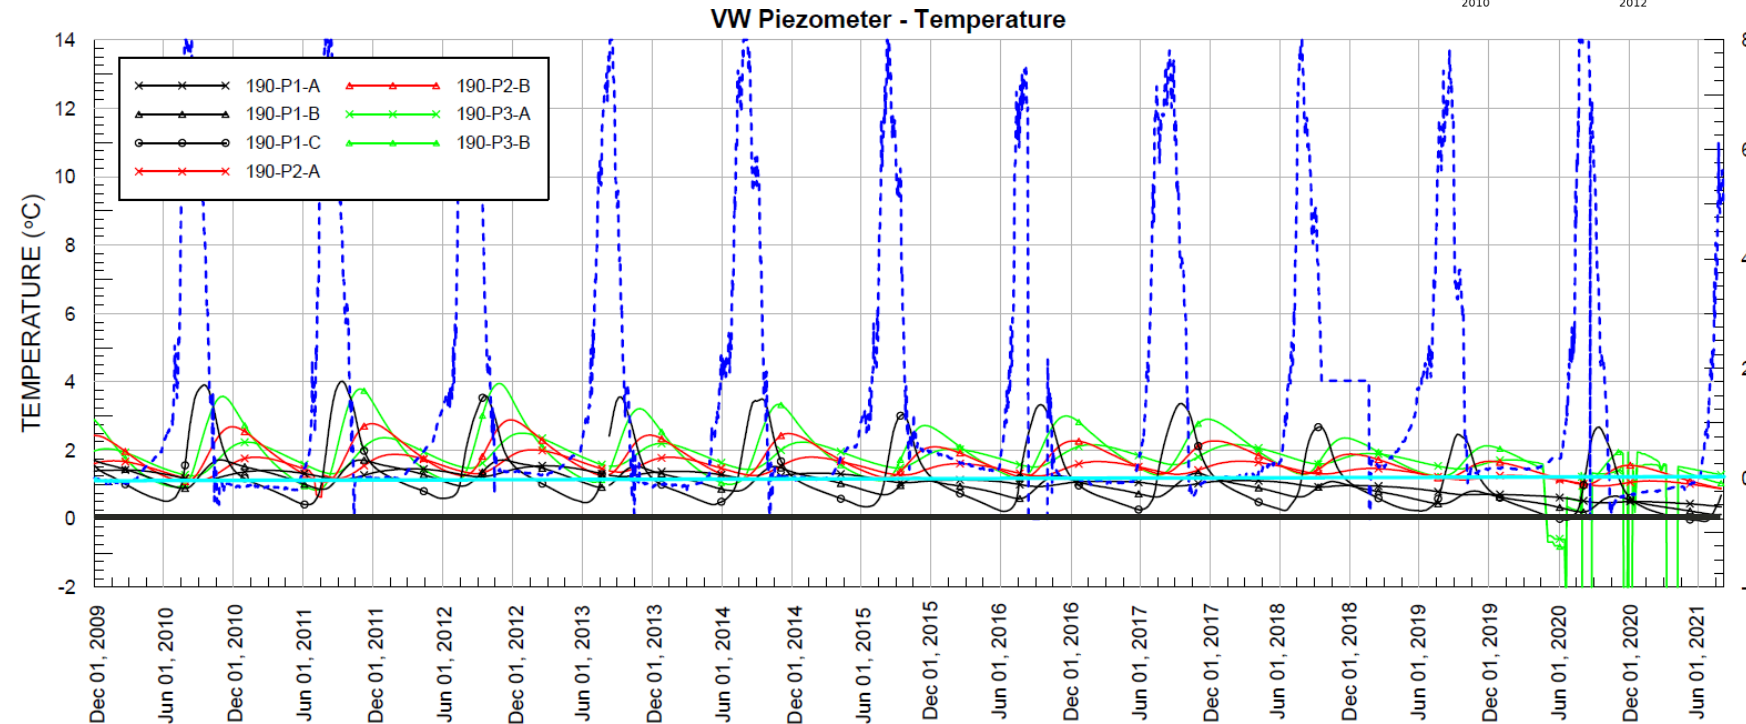
INSTRUMENTATION DATA - THERMISTORS

- General cooling trend in all instruments on East Dike.
- Downstream toe freezing at the South Channel: P1 piezometric line nearing 0°C.
- Downstream instruments: TH6 frozen, TH7 partially unfrozen in till and bedrock (potential pathway).
- North Channel and channels on Bay-Goose Dike see seepage zones narrowing due to surrounding area freezing.

- Thermal variations of decreasing amplitude over the years in seepage channels. Possibly due to the opening of the pit and seepage going through deeper bedrock.
- Lots of snow accumulating on the downstream side of East Dike, especially against the south portion (likely insulating the foundation and slowing down freezing).

- Install additional thermistors around the South Channel (both sides) to monitor the evolution of the lateral limits of the unfrozen zone and confirm seepage pathway restriction hypothesis.
- Install additional thermistors directly downstream of both seepage channels, at a longer distance from the downstream toe than P1 line.
- Separate the measurements for flows at each pumping station (separate flowmeters). At the moment values are not reliable when the pump is not fully submerged, which is most of the time. Improve flow measurement method to provide values continuously. Measure TSS in each pumping station (currently only station B, in the South Channel).

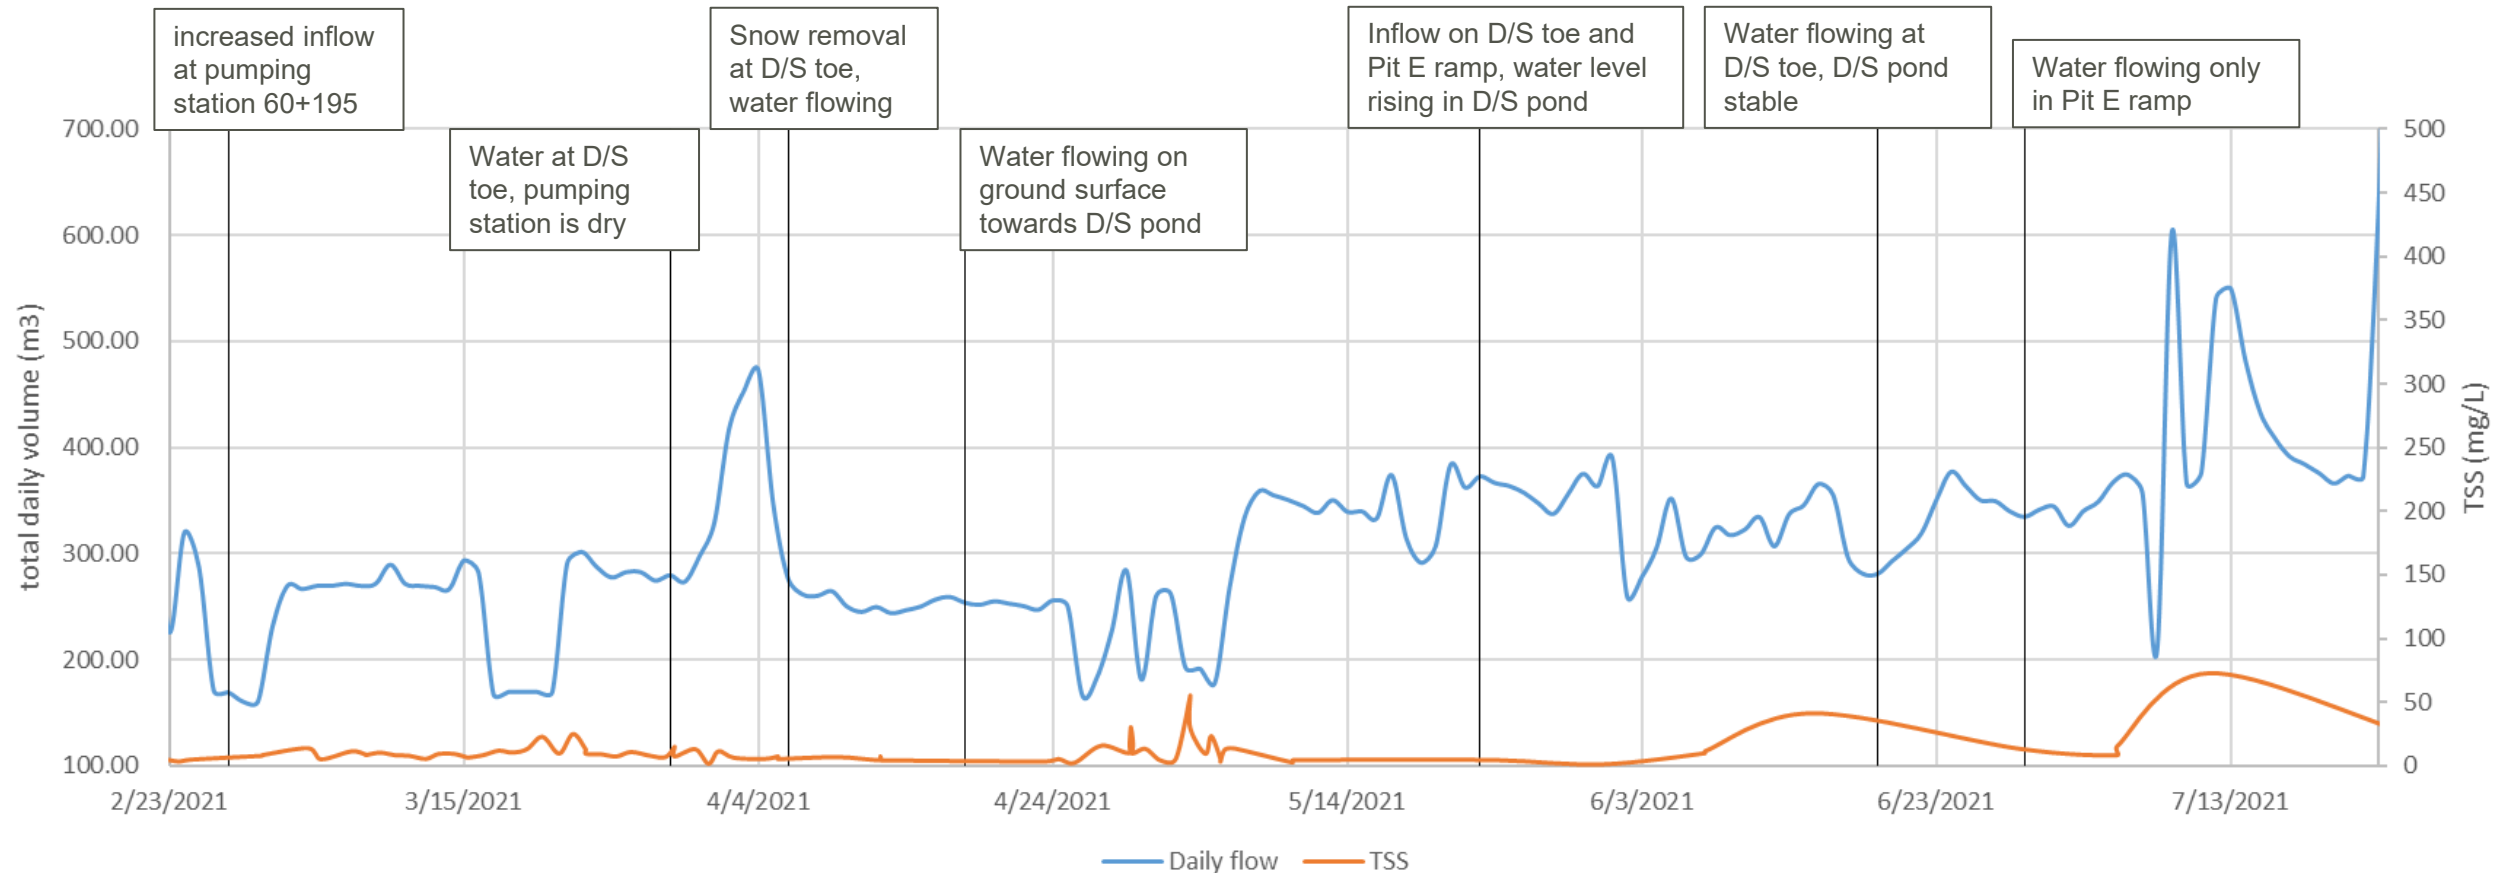
INSTRUMENTATION DATA – TSS AND PUMPING RATES

- During the event, lower pumping rate than historically (168 m3/h vs 700 m3/h): seepage seems to be reaching less the pumping well, flow rate is underestimating the seepage rate. Potential blockage in the seepage pathway causing seepage redirection towards the surface.
- No change in global flow or TSS, but TSS changes could be diluted too much to be noticed.

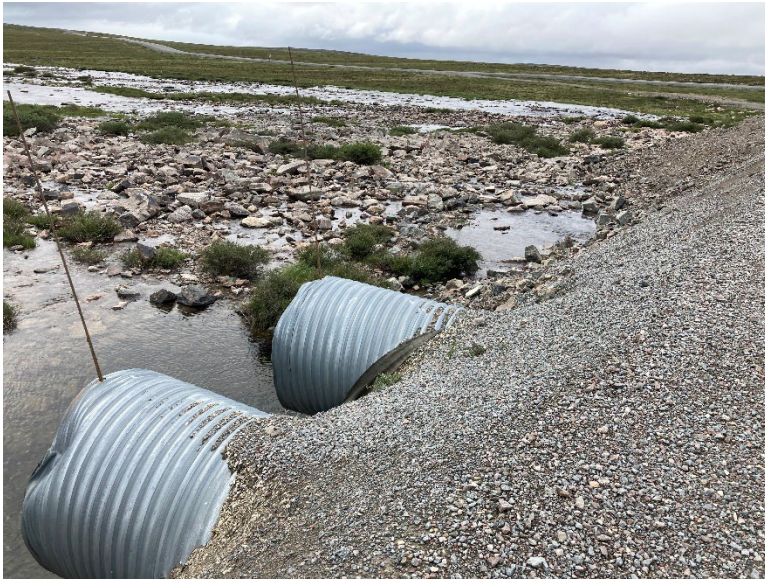
Photograph D2-1: PC-17A km 8+830

Description: View of the culvert outlets. No sign of degradation and the flow is stable south of the culverts (5-10 m away).

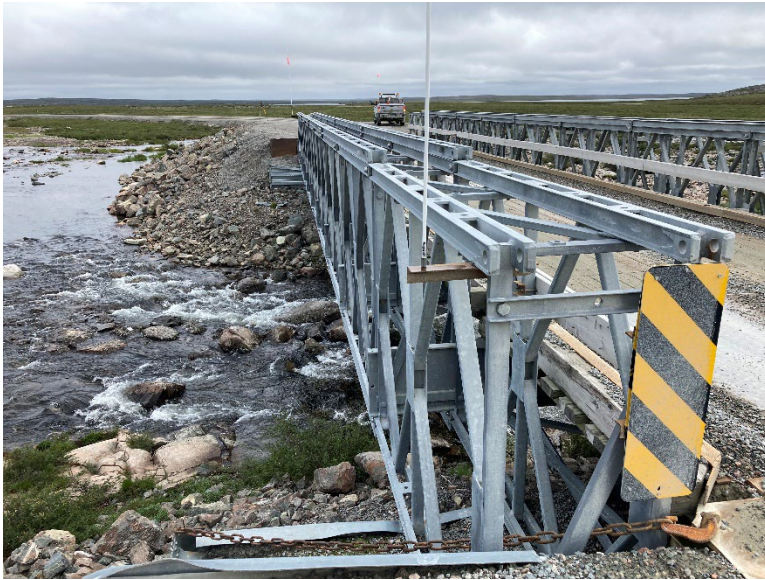
Photograph D3-1 Bridges 1 – R02 km 8+750

Description: Looking at the north abutment. The corrugated steel bin shows deformation under the weight of the bridge.
