Meadowbank and Whale Tail 2021 Annual Geotechnical Inspection

2021 Annual Geotechnical Inspection

Meadowbank Complex, Nunavut

21468006-1606-R-Rev0

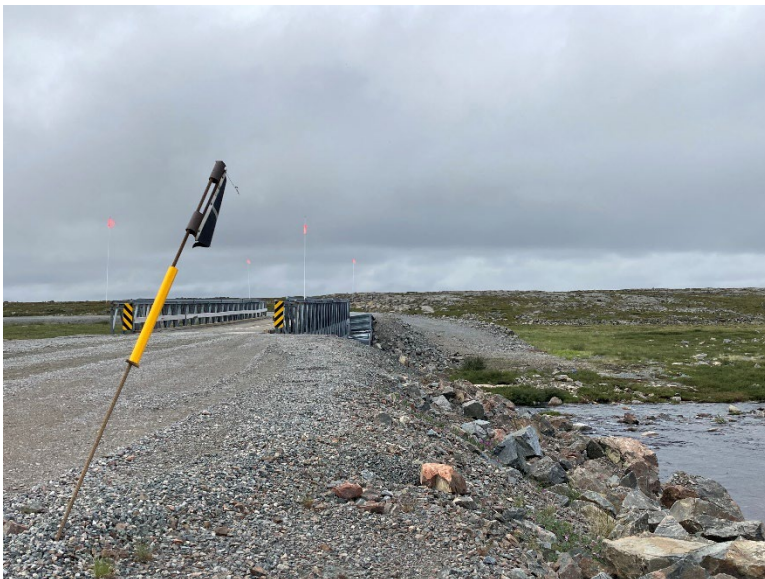
Photograph D3-2 Bridges 1 – R02 km 8+750

Description: Looking at the south abutment. The corrugated steel bin shows deformation under the weight of the bridge.

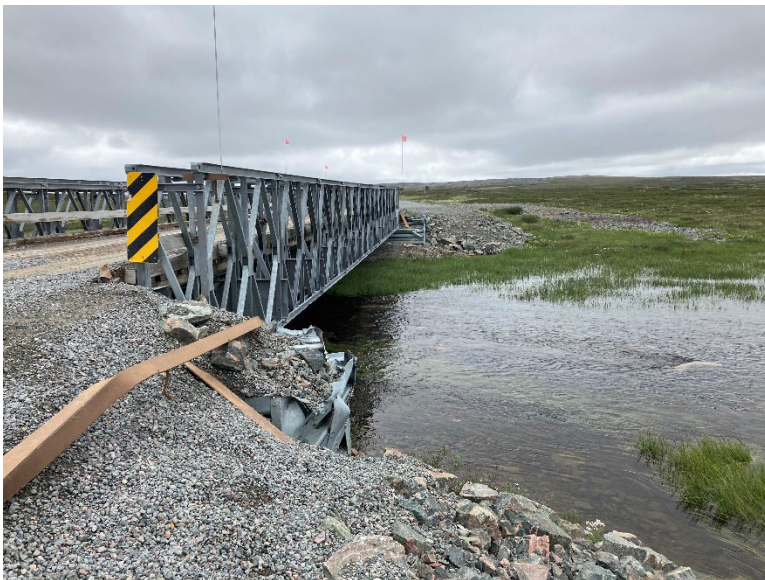
Photograph D3-4 Bridges 2 – R05 km 17+600

Description: Looking at the south abutment. Minor damage to the bin wall.

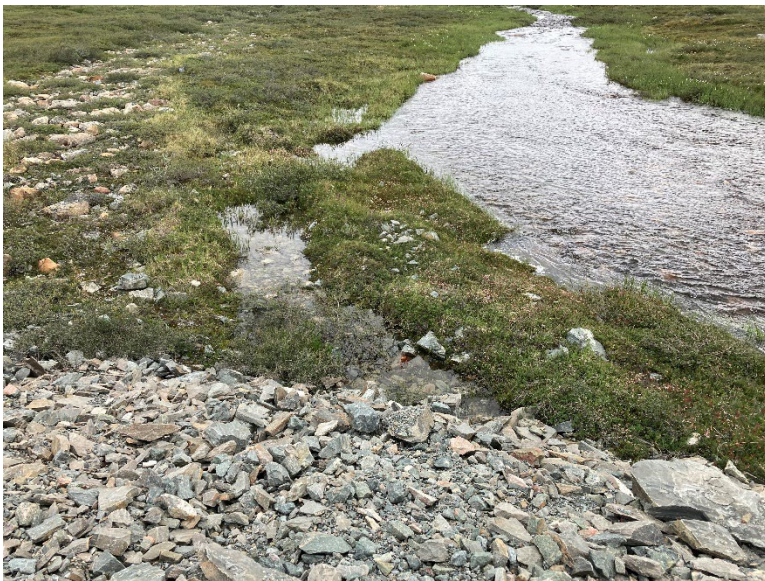
Photograph D3-8 Bridges 4 – R09 km 48+500

Description: Looking from the northeast abutment. Water is flowing under the abutment, no erosion.

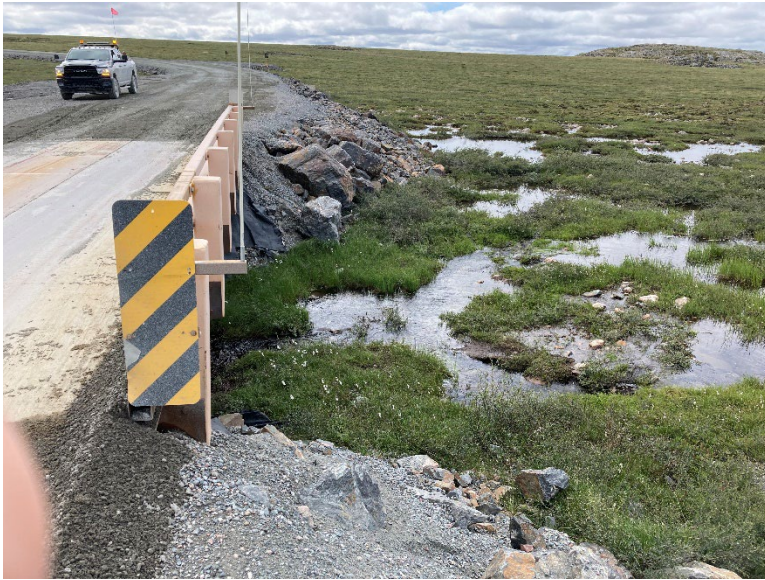
Photograph D3-15 Bridges 7 – R16 km 73+800

Description: Looking at the south abutment. In good condition.

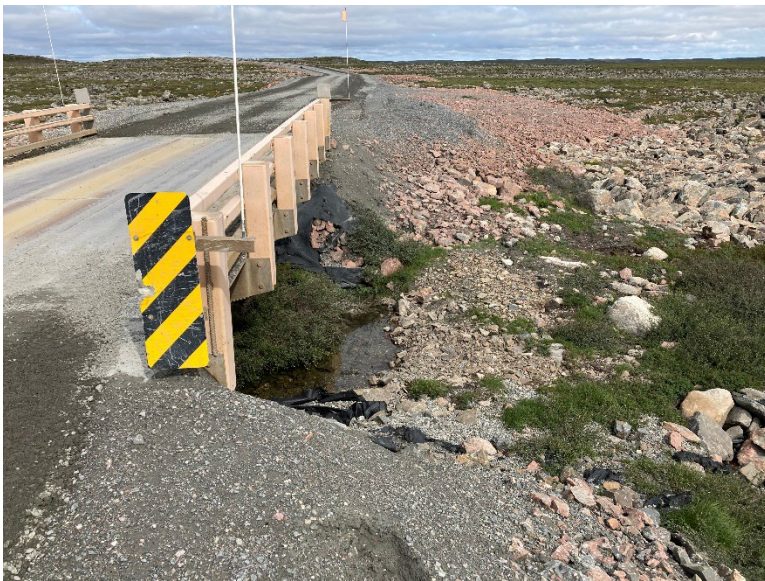
Photograph D3-16 Bridges 8 – R18 km 79+500

Description: Looking at the north abutment. In good condition.

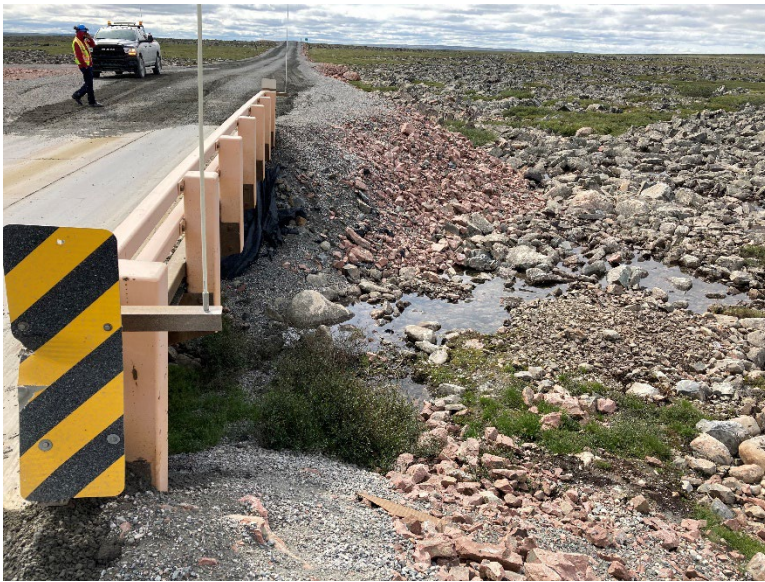
Photograph D3-17 Bridges 8 – R18 km 79+500

Description: Looking at the south abutment. In good condition.

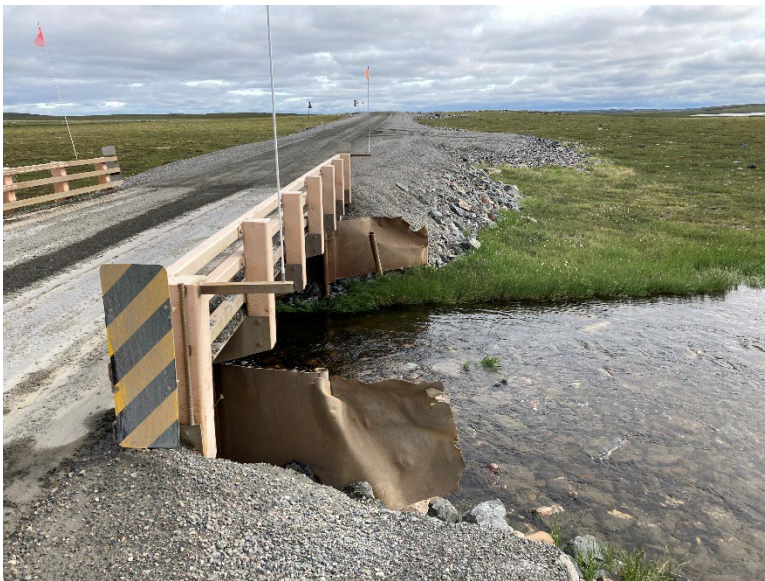
Photograph D3-18 Bridges 9 – R19 km 83+150

Description: Looking at the north abutment. Minor damage to steel plate due to snow removal activity.

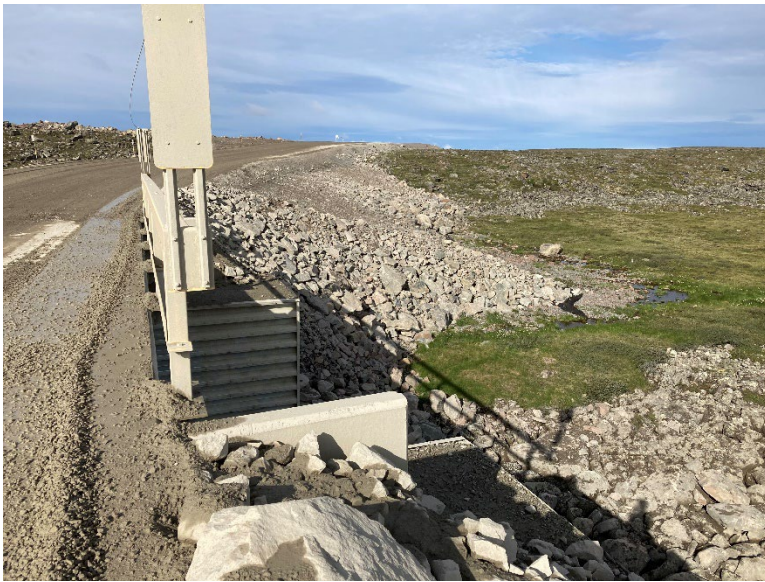
Description: Looking at the north abutment.

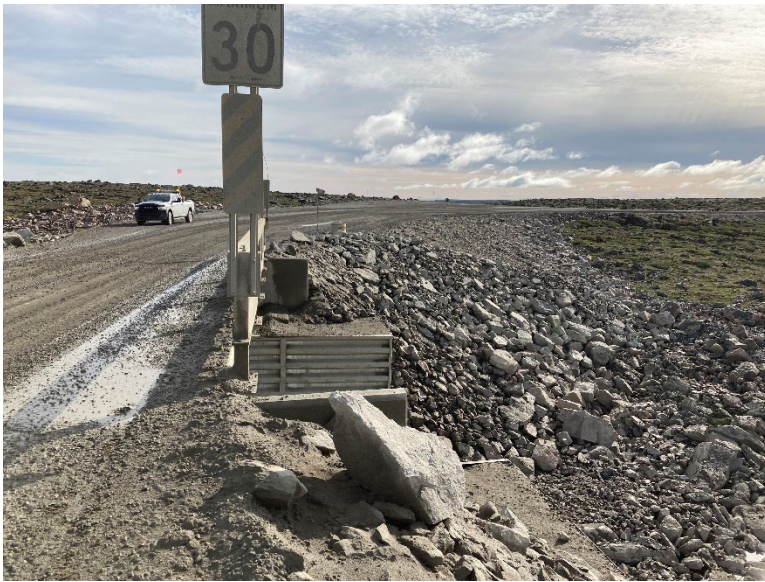
Photograph E3-13 Bridges 6 – km 142+100

STATION	NAME	STRUCTURE DESCRIPTION	COMMENTS	Photo
141+905	#109	800 mm	Not observed.	-
142+100	Bridge 26.1		In good condition. Southwest abutment bin wall appears tilted toward the West. No sign of instability, likely settling foundation.	225: north 226: southwest abutment 227: southeast abutment
142+350	#110	450 mm	Not observed.	-
142+461	#111	300 mm	In good condition but inlet buried.	-
142+630	#112	300 mm	Outlet collapsed and inlet totally buried.	-
142+736	#113	450 mm	In good condition but inlet is buried.	-
142+810	#114	450 mm	In good condition.	-
142+865	#115	300 mm	In good condition but outlet is buried.	-
142+940	#116	450 mm	In good condition but outlet is buried.	-
143+173	#117	700 mm	In good condition.	-
143+433	#118	450 mm	In good condition but inlet is half blocked.	-
143+777	#119	300 mm	In good condition.	-
144+125	#120	300 mm	In good condition.	-
144+300	#121	900 mm	In good condition.	-
144+302	#121-2	900 mm

Description: Looking at the southwest abutment. Bin wall slightly tilted to the west.

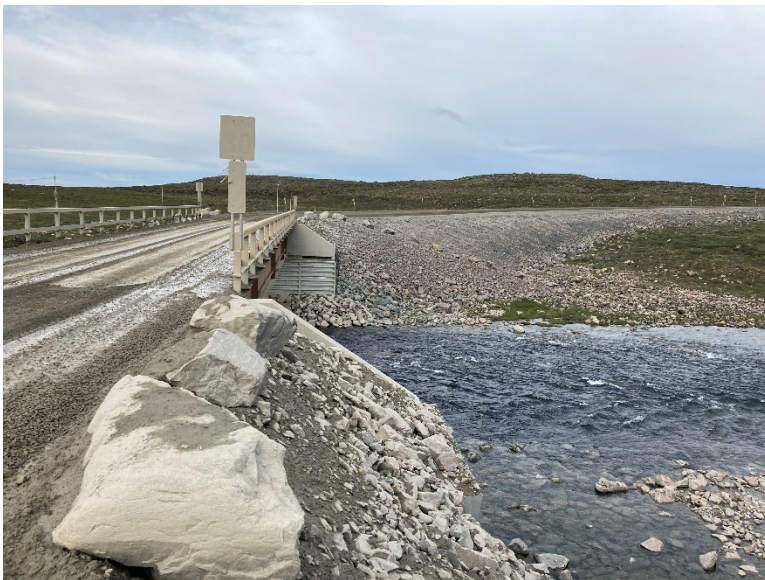
Description: Looking at the north abutment.

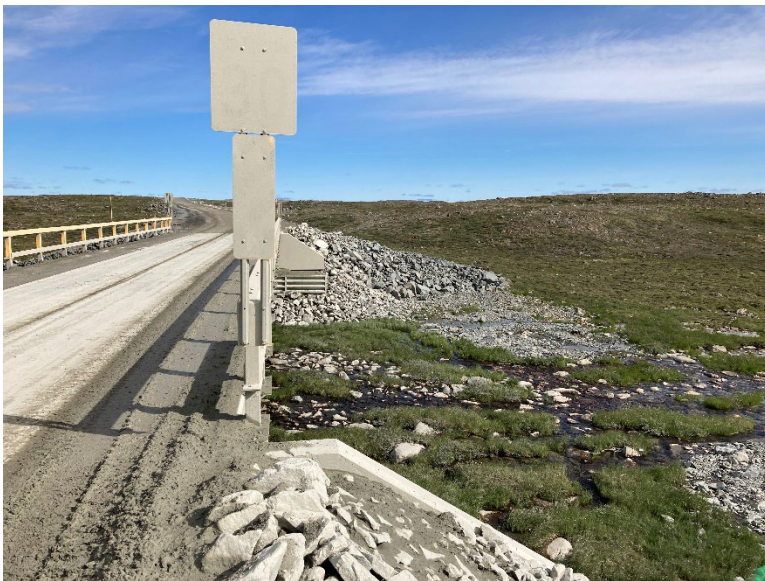
Photograph E3-18 Bridges 9 – km 160+800

Description: Looking at the north abutment. A crack is present in the concrete on the western side.

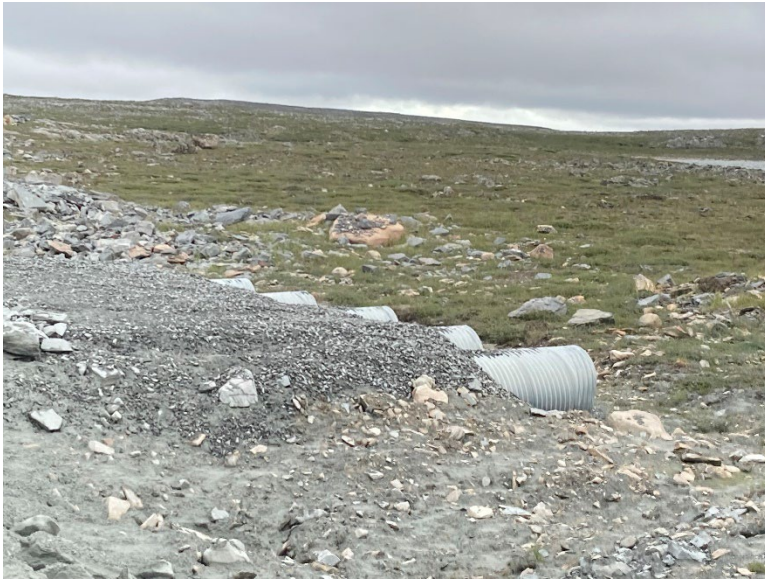
Photograph E4-1-1: #12 km 120+180

Description: View of the culvert outlets. No sign of degradation and the flow is stable south of the culverts (5-10 m away).

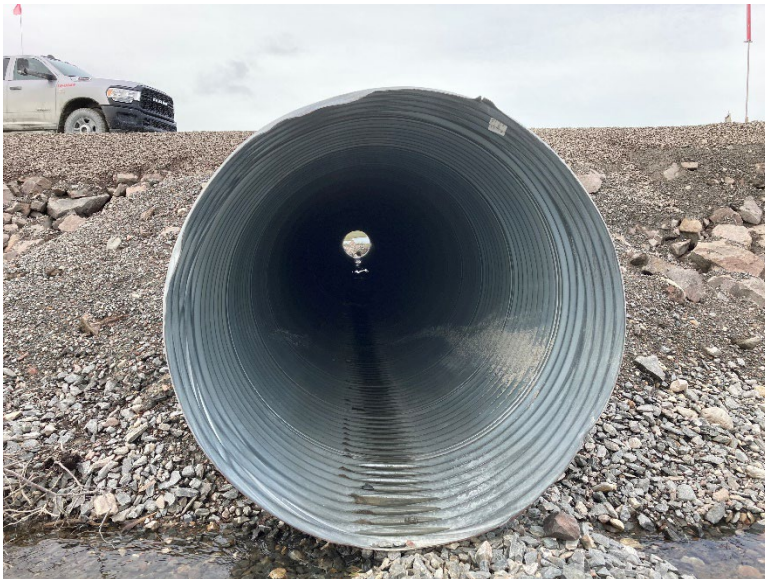
Photograph E4-2: #73 km 134+580

Description: View of the culvert inlet. Installed high but in good condition.

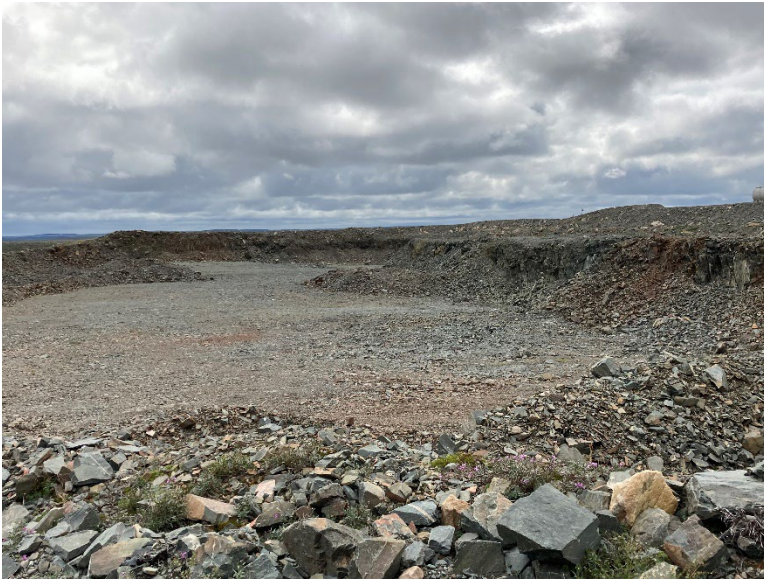
Photograph F-1: Quarry 12 – km 58+300

Description: View of north wall. Presence of loose blocks at the base of the wall.

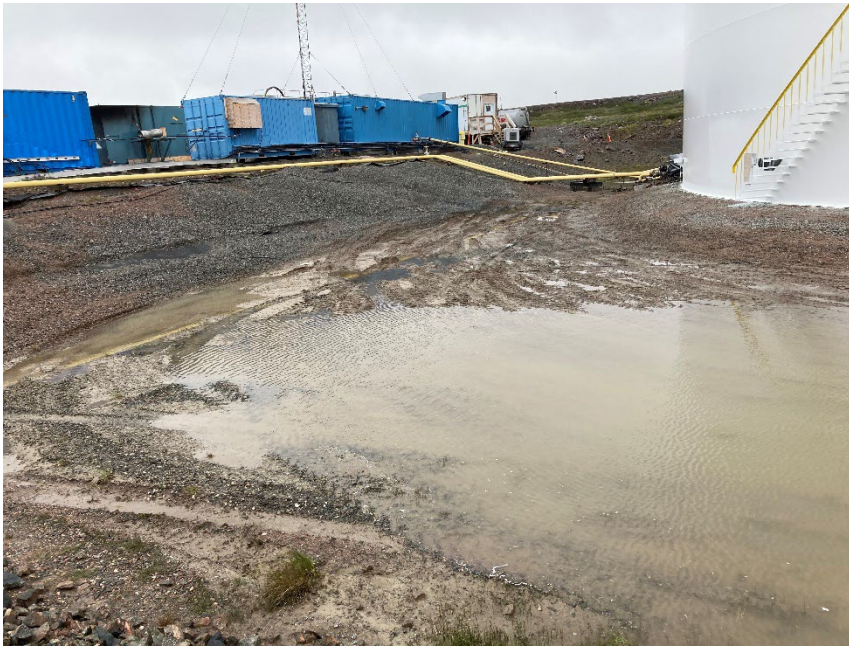
Photograph G1-1 Baker Lake Tank Farm

Description: From the south side of Tank 1, looking southeast at Tanks 1, 2, 3, and 4. Presence of water ponding.

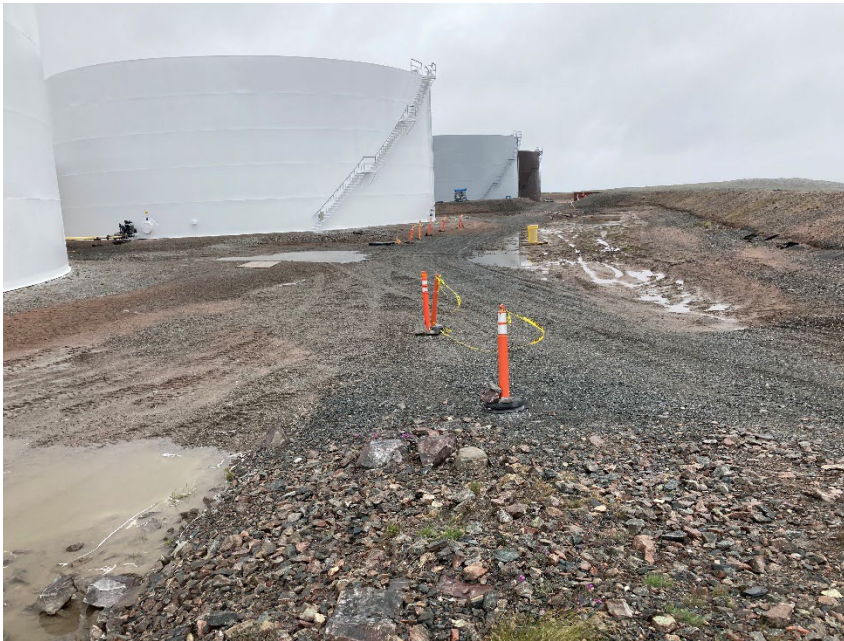
Photograph G1-2 Baker Lake Tank Farm

Description: Looking at the southwestern corner of Tank 1. Presence of water ponding.

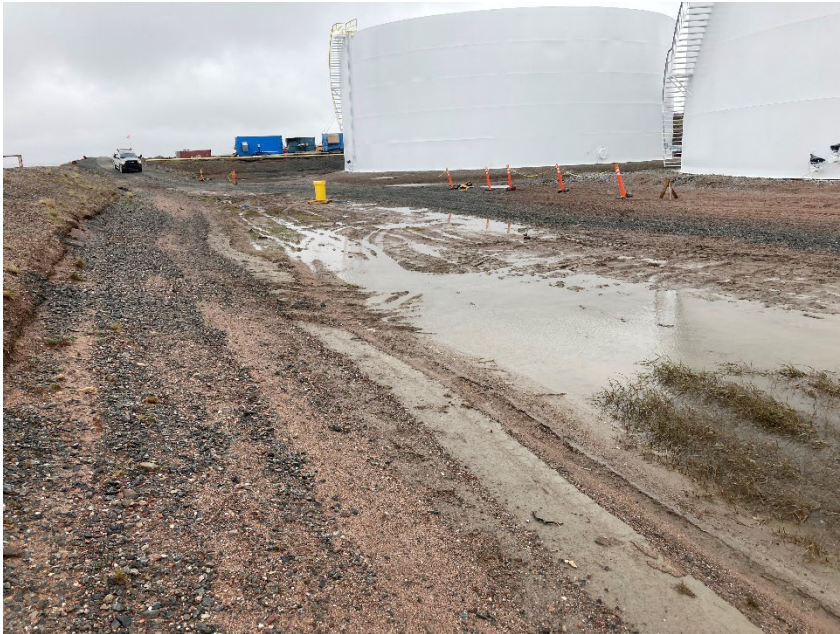
Photograph G1-3 Baker Lake Tank Farm

Description: Looking northwest toward the south wall of the tank farm. Presence of water ponding and exposed geosynthetics in the slope at the high water line.

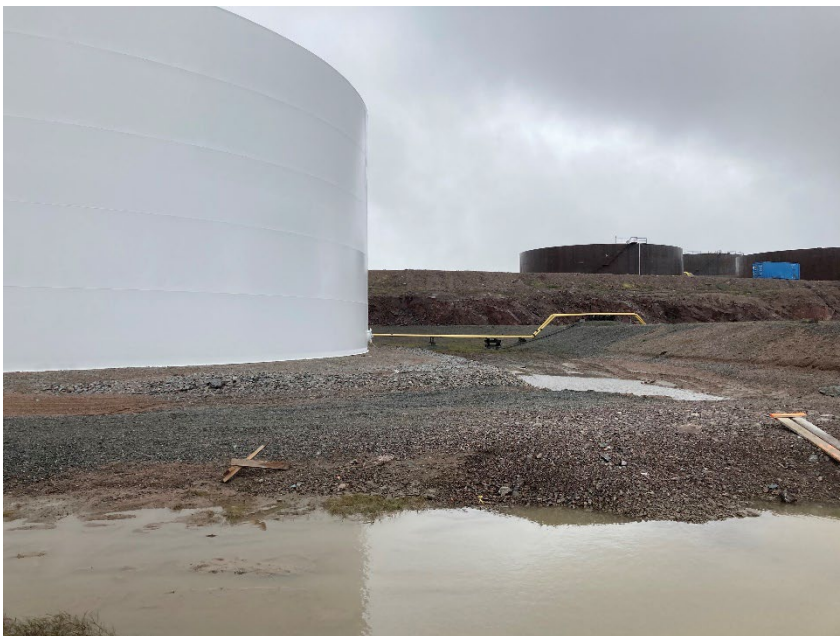
Photograph G1-4 Baker Lake Tank Farm

Description: Looking northeast toward Tank 2. Presence of water ponding.

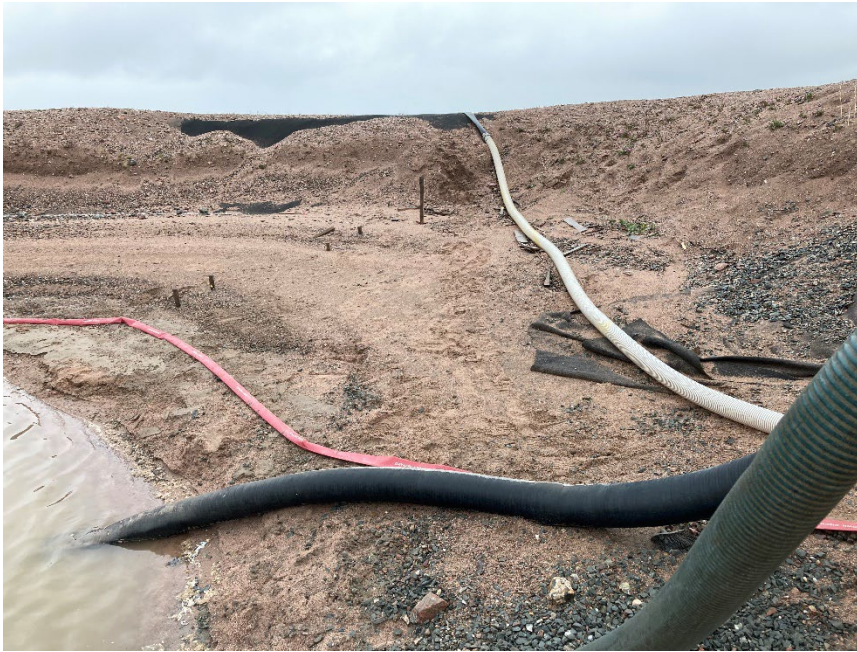
Photograph G1-5 Baker Lake Tank Farm

Description: Looking southwest. Presence of water ponding and exposed geosynthetics in the slope at the high-water line.

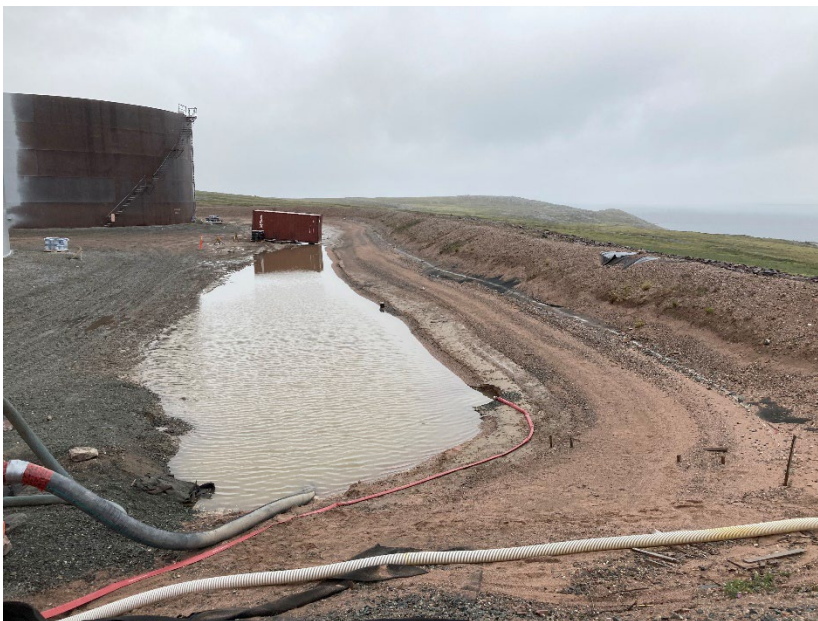
Photograph G1-6 Baker Lake Tank Farm

Description: From the southwestern corner of Tank 3 looking southeast. View of exposed geosynthetics.

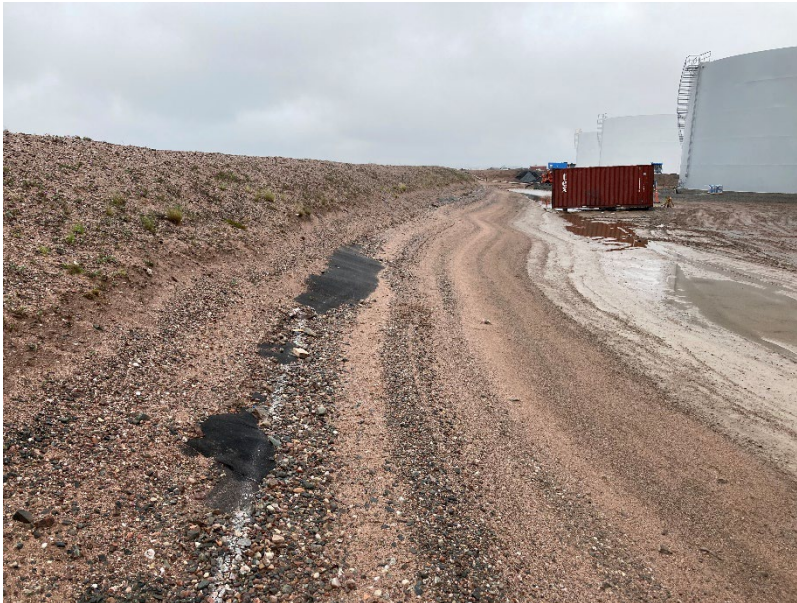
Photograph G1-7 Baker Lake Tank Farm

Description: From the south portion of the site looking northwest at the south side of Tank 3 and 4. View of exposed geosynthetics.

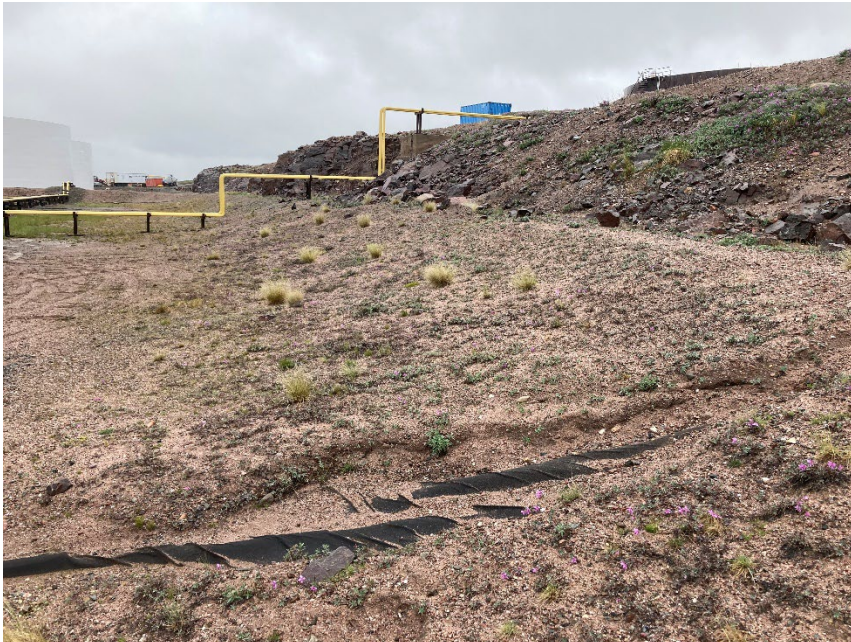
Photograph G1-10 Baker Lake Tank Farm

Description: From the northern side of Tank 4, looking northwest toward Tanks 4, 3, 2, and 1. Presence of exposed liner due to erosion of the granular cover.

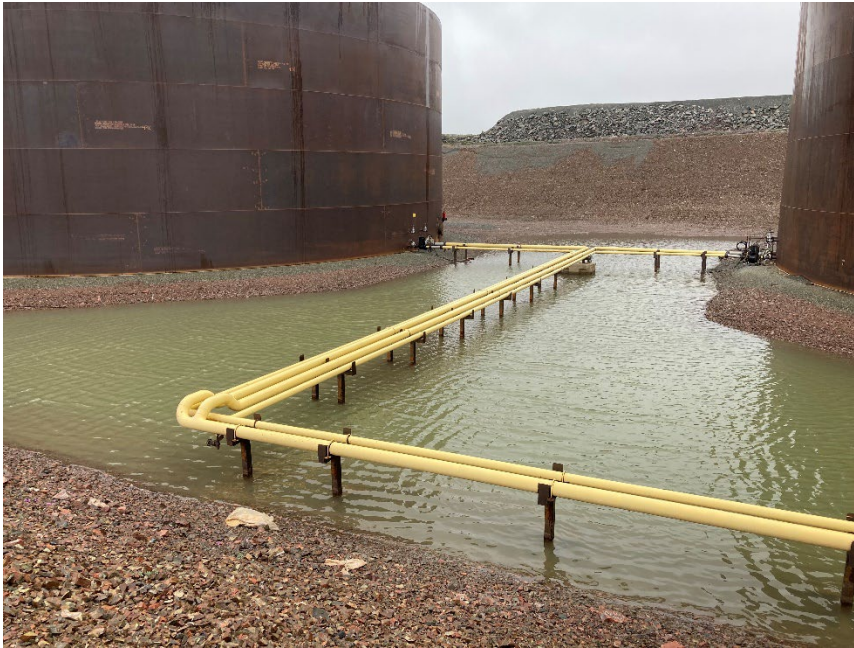
Photograph G1-13 Baker Lake Tank Farm

Description: Looking north between Tanks 5 and 6. Water ponding.

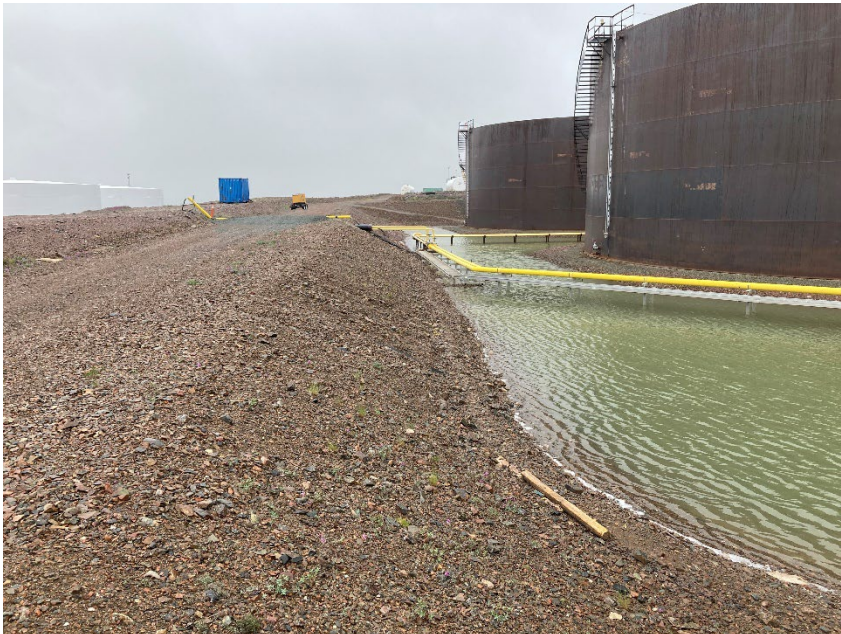
Photograph G1-14 Baker Lake Tank Farm

Description: From the southern corner of Tank 6, looking northeast at the southern side of Tanks 5 and 6. Presence of water ponding.

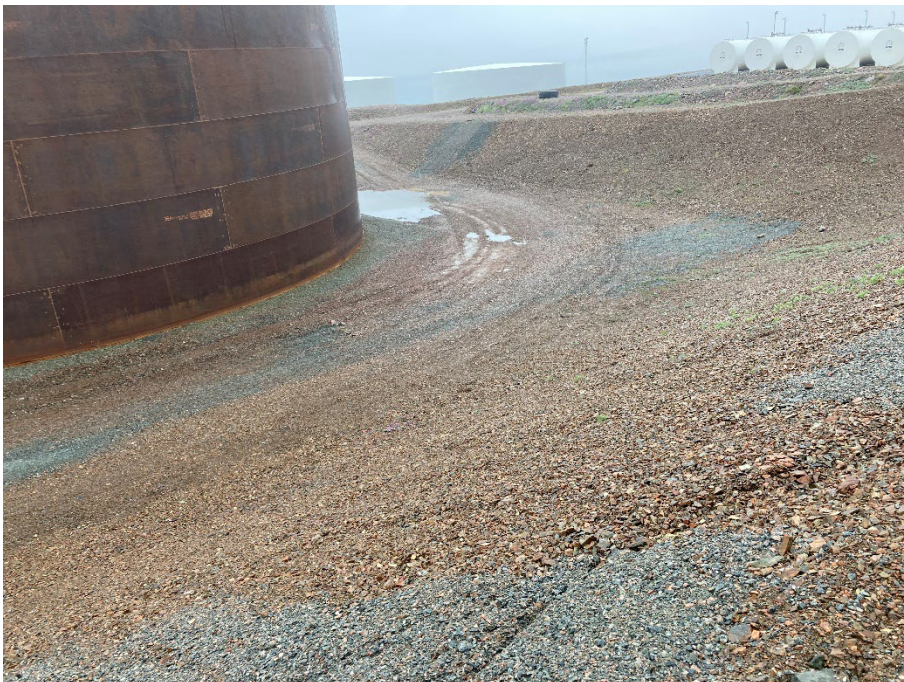
Photograph G1-16 Baker Lake Tank Farm

Description: Looking west at the crest on the northeastern side of Tank 5. Presence of old tension cracks.

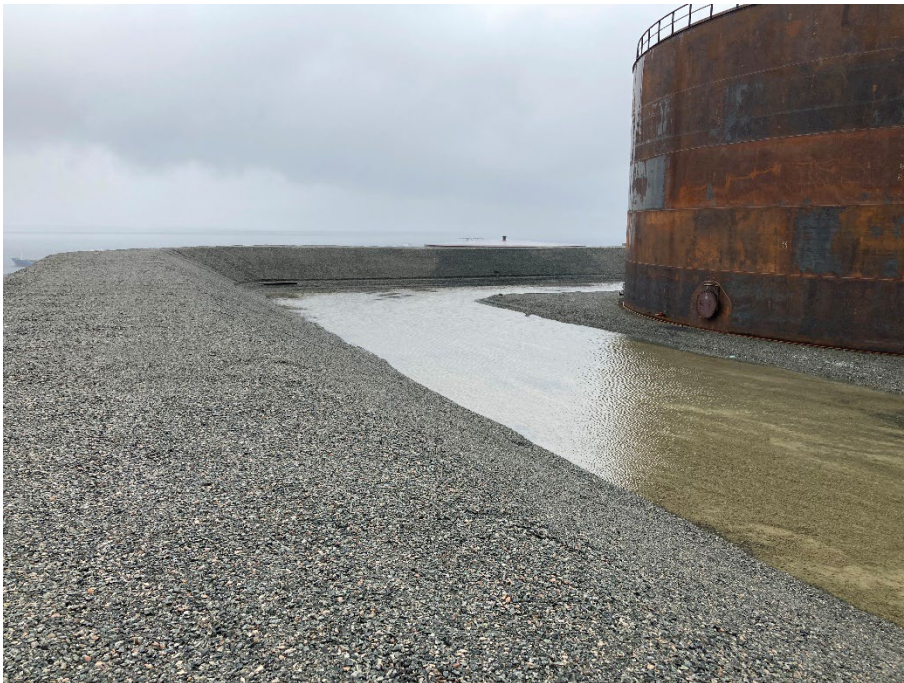
Photograph G1-17 Baker Lake Tank Farm

Description: Looking southwest at the crest on the northeast corner of Tank 7. Water ponding.

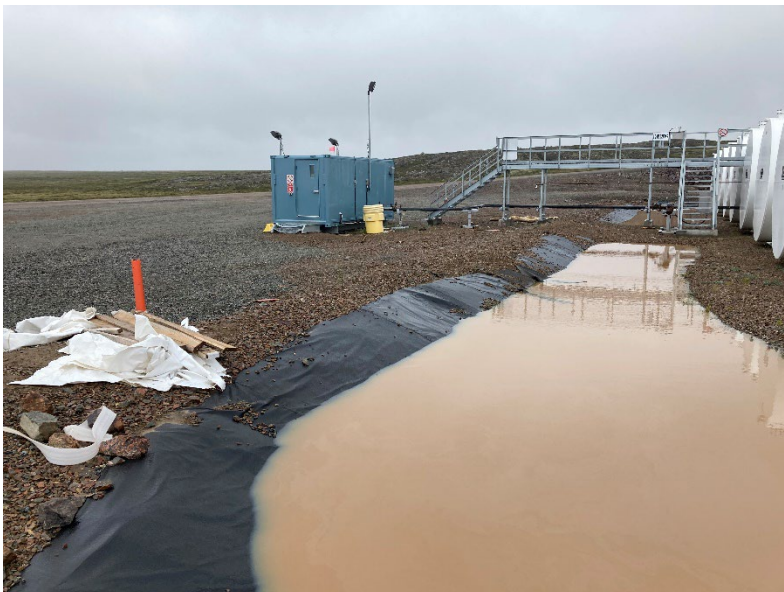
Photograph G1-18 Baker Lake Tank Farm

Description: From the southwestern corner of the Jet A fuel tanks looking northeast. Presence of exposed geomembrane and water ponding (high level).

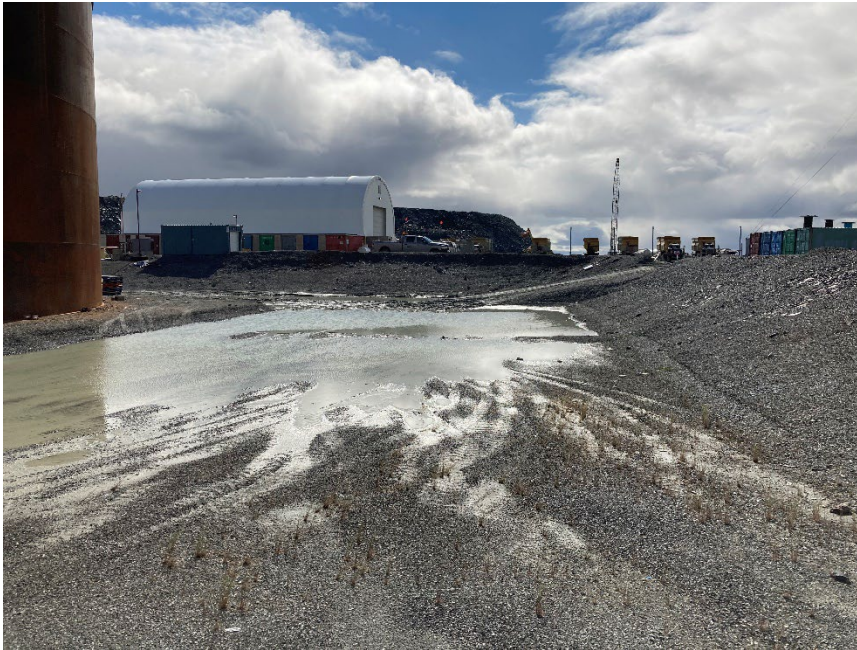
Photograph G2-1 Meadowbank Tank Farm

Description: From the western corner, looking southeast. Presence of water ponding.

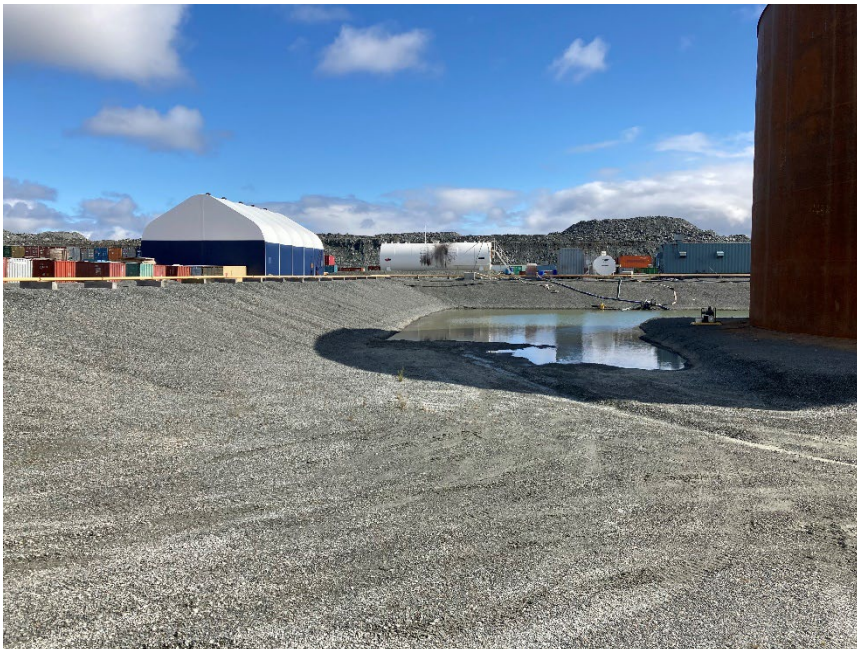
Photograph G2-2 Meadowbank Tank Farm

Description: From the western corner, looking northeast. Presence of water ponding.

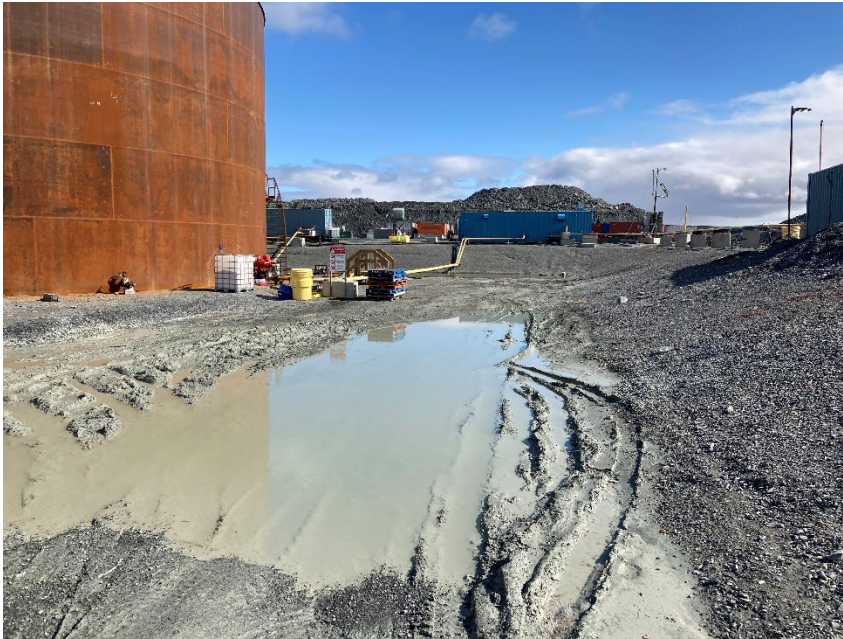
Photograph G2-3 Meadowbank Tank Farm

Description: Looking northeast from the southern corner. Accumulation of water in the eastern corner.

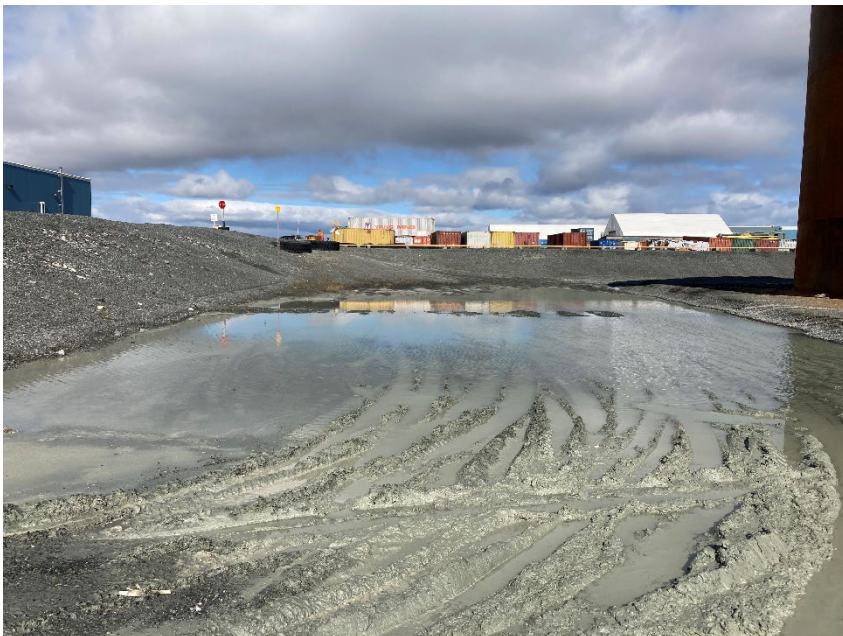
Photograph G2-4 Meadowbank Tank Farm

Description: Looking northwest from the southern corner. Presence of water ponding.

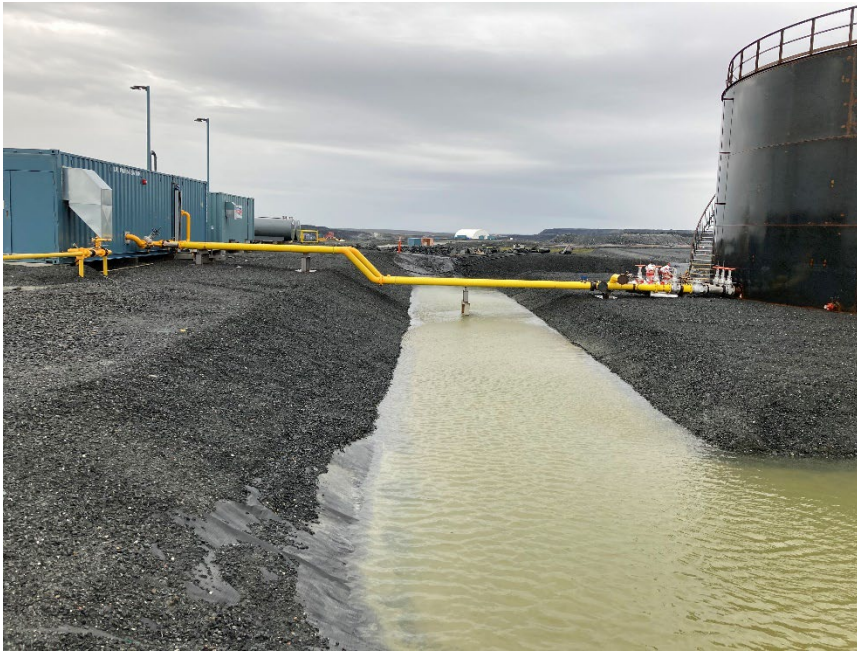
Photograph G3-4 Whale Tail Project Site Tank Farm

Description: From the fuelling pad, looking west at the Tank Farm. Presence of water ponding.

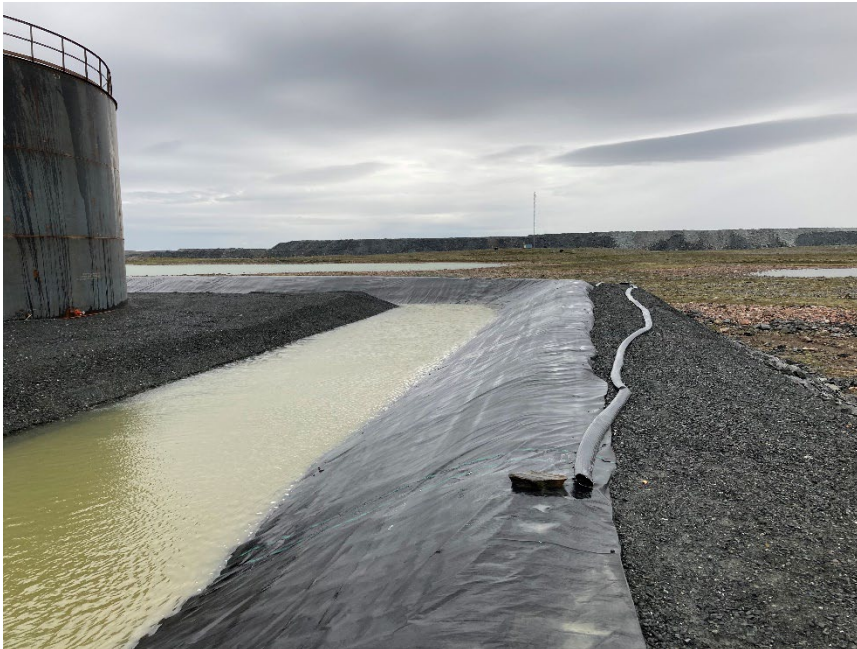
Photograph G3-5 Whale Tail Project Site Tank Farm

Description: From the fuelling pad, looking north at the Tank Farm. Presence of water ponding.

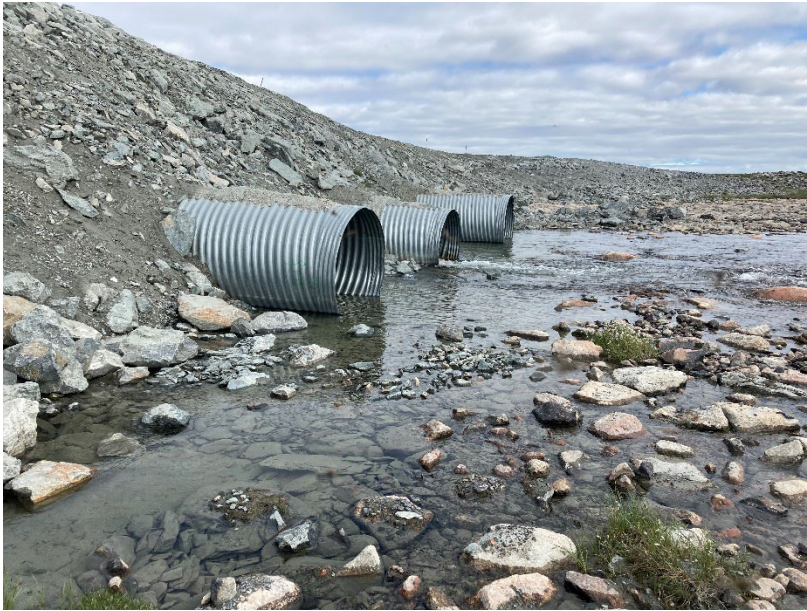
Photograph H1-1 Vault Road Culverts

Description: Looking at the outlet of the three culverts located on Vault Road at 640964E/7217466N. All of them are deformed in the middle.

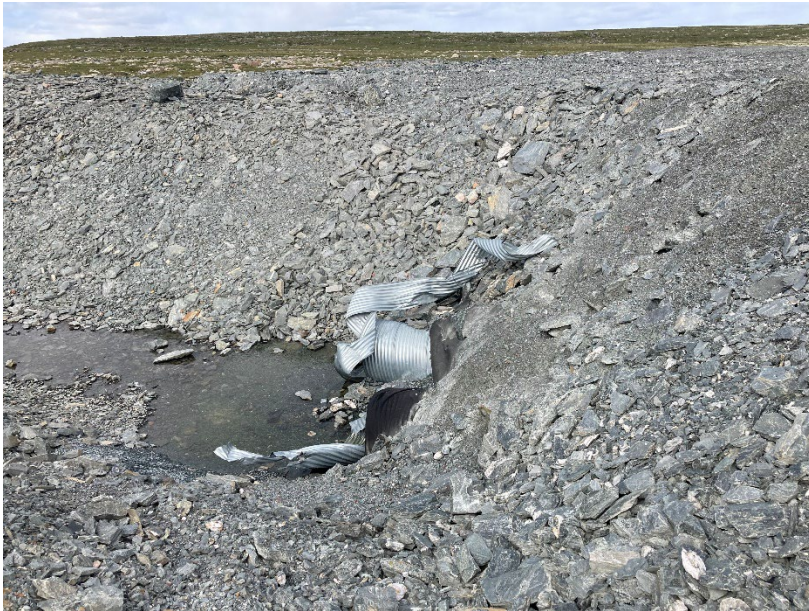
Photograph H2-1 Diversion Ditch and its Sediment and Erosion Protection Structure

Description: Looking east toward the inlet of the culverts beneath the road.

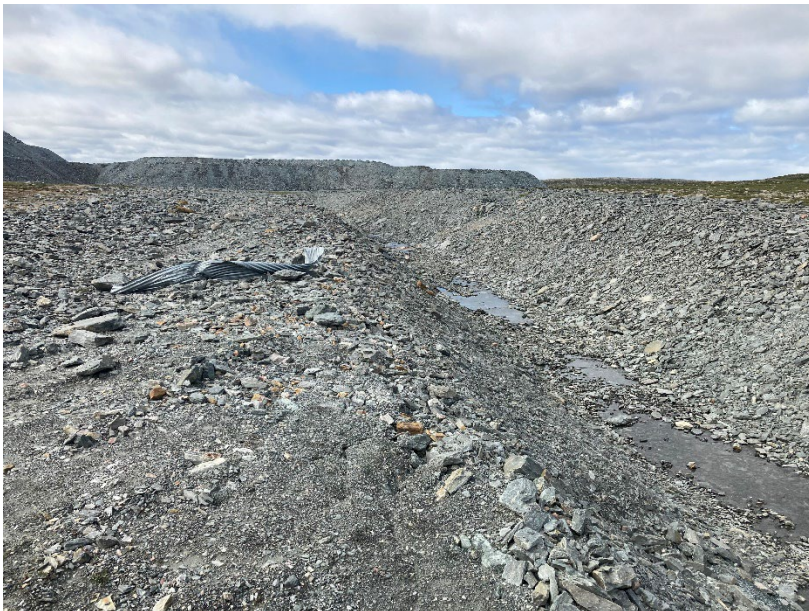
Photograph H2-2 Diversion Ditch and its Sediment and Erosion Protection Structure

Description: Looking west toward NP2 lake.

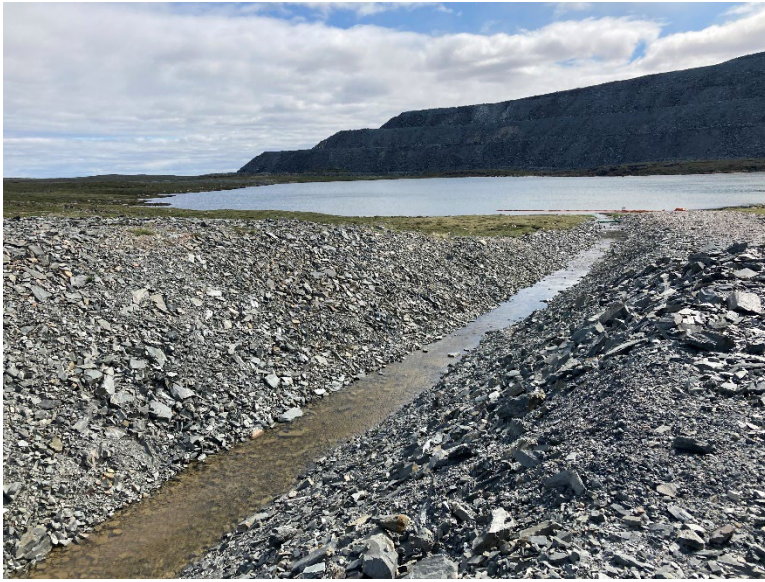
Photograph H2-3 Diversion Ditch and its Sediment and Erosion Protection Structure

Description: From the eastern diversion ditch looking south toward Lake NP2.

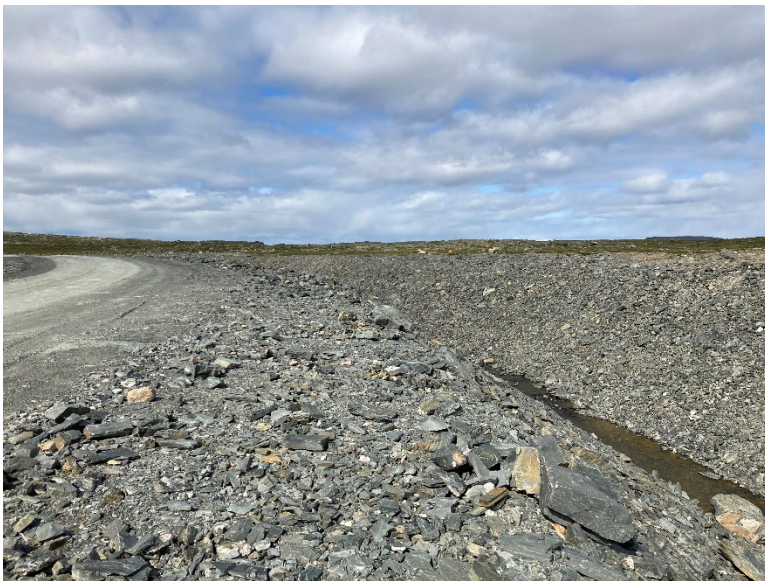
Photograph H2-4 Diversion Ditch and its Sediment and Erosion Protection Structure

Description: From the eastern diversion ditch looking northwest.

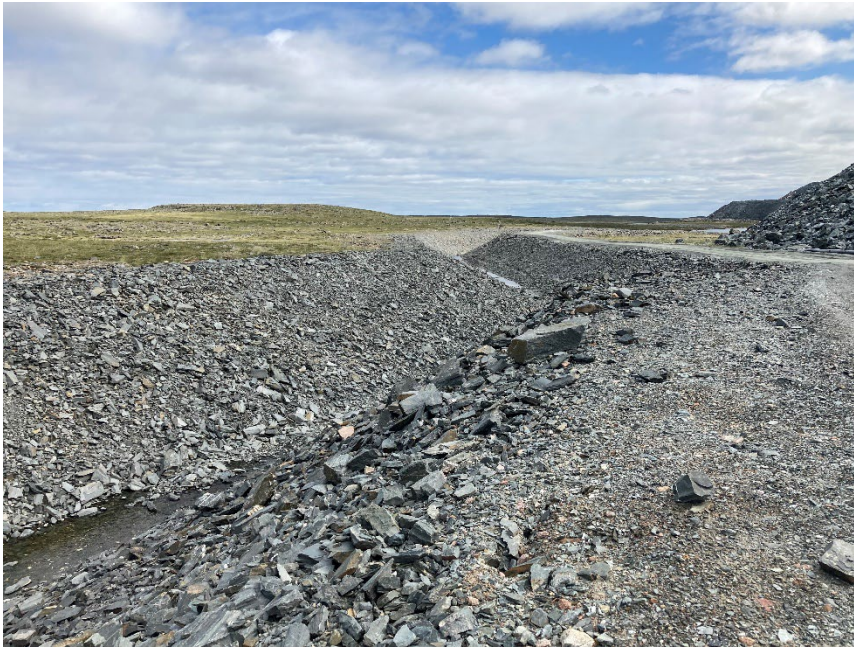
Photograph H2-5 Diversion Ditch and its Sediment and Erosion Protection Structure

Description: From the eastern diversion ditch, looking east.

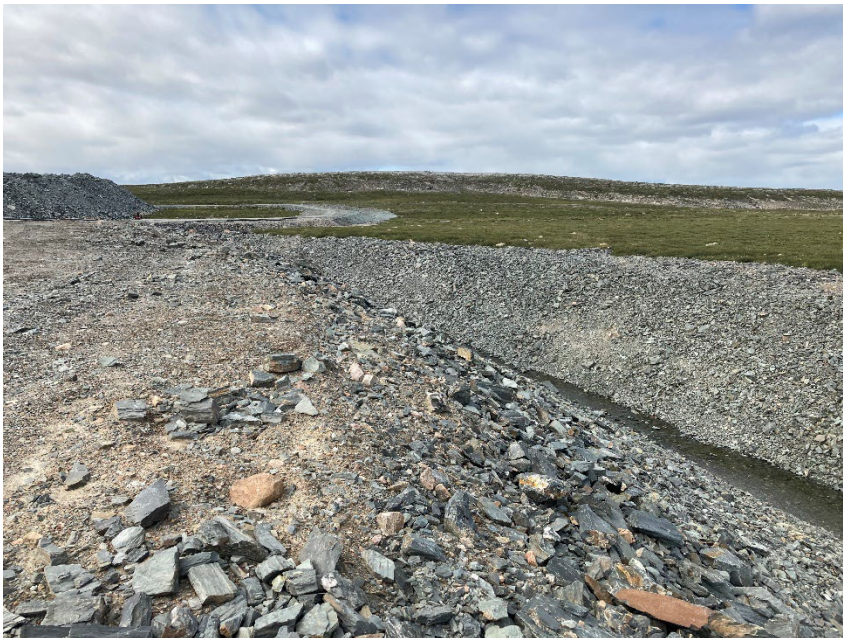
Photograph H2-6 Diversion Ditch and its Sediment and Erosion Protection Structure

Description: From the eastern diversion ditch, looking northwest.

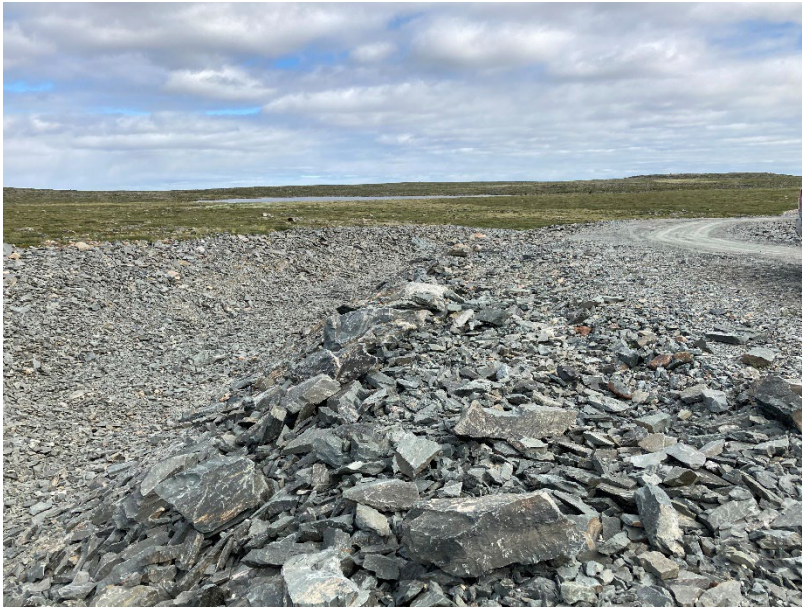
Photograph H2-7 Diversion Ditch and its Sediment and Erosion Protection Structure

Description: From the northern diversion ditch looking southeast.

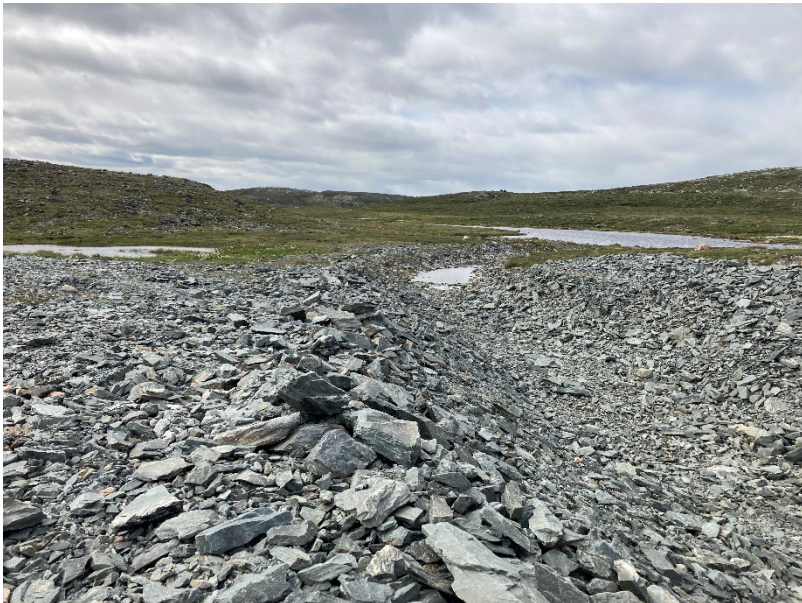
Photograph H2-8 Diversion Ditch and its Sediment and Erosion Protection Structure

Description: From the northern diversion ditch looking west.
