Meadowbank and Whale Tail 2021 Annual Geotechnical Inspection

2021 Annual Geotechnical Inspection

Meadowbank Complex, Nunavut

21468006-1606-R-Rev0

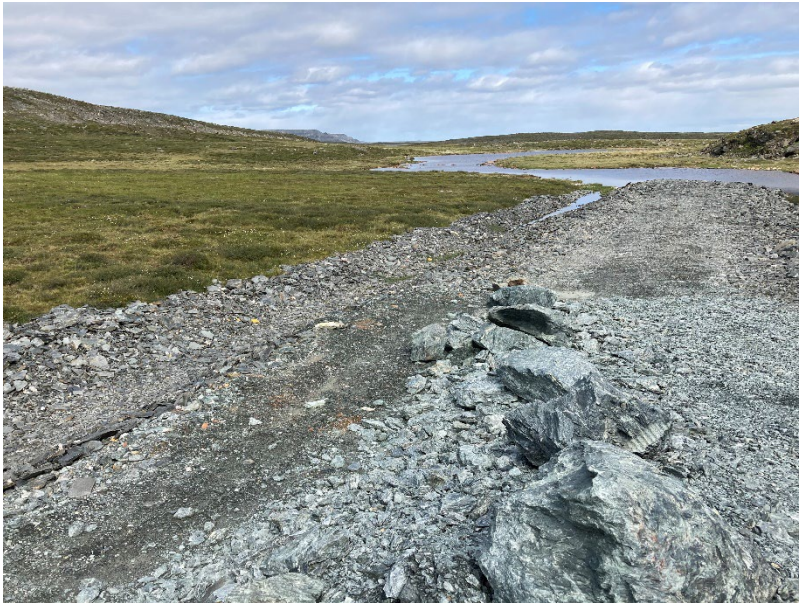
Photograph H2-9 Diversion Ditch and its Sediment and Erosion Protection Structure

From the northern diversion ditch looking east.

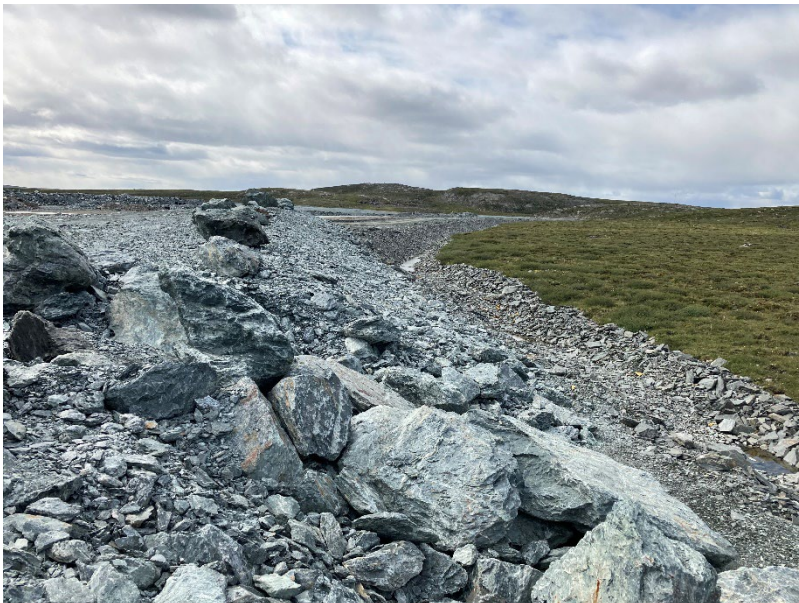
Photograph H2-10 Diversion Ditch and its Sediment and Erosion Protection Structure

From the northern diversion ditch looking west.

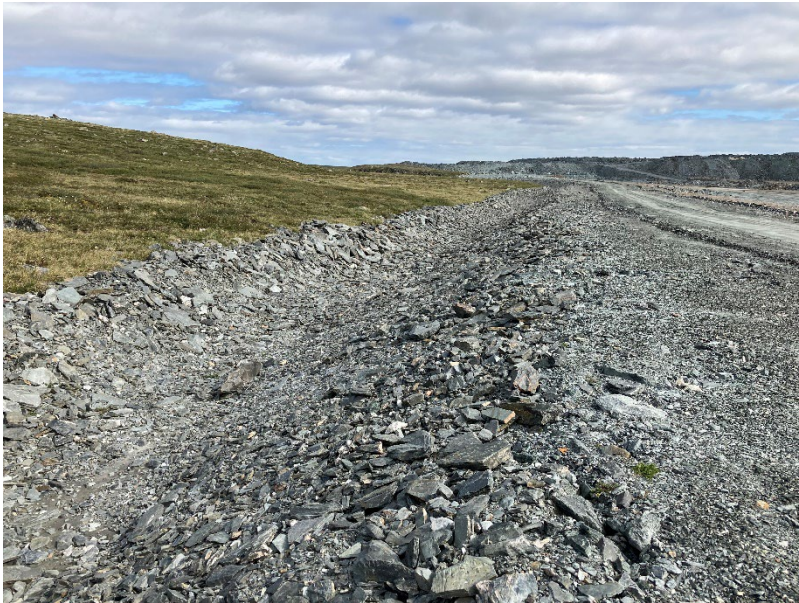
Photograph H2-11 Diversion Ditch and its Sediment and Erosion Protection Structure

Description: From the northern diversion ditch looking east.

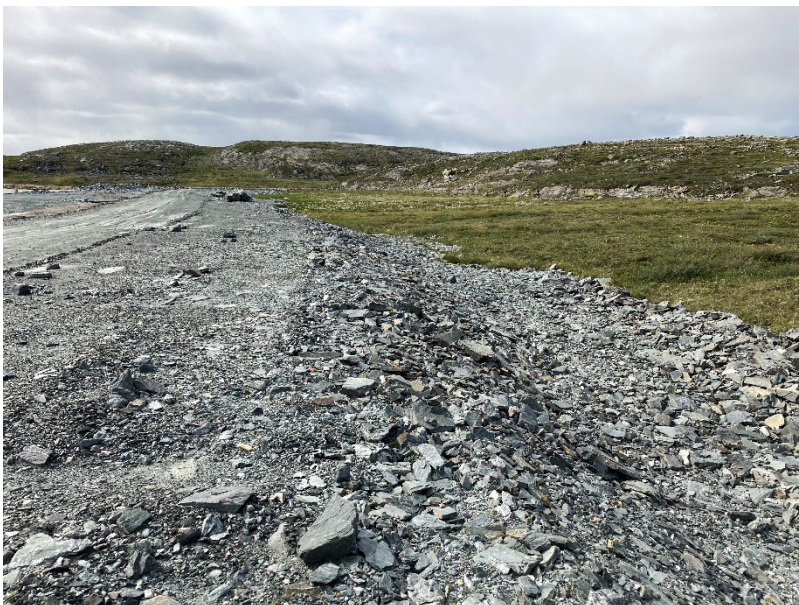
Photograph H2-12 Diversion Ditch and its Sediment and Erosion Protection Structure

Description: From the northern diversion ditch looking west.

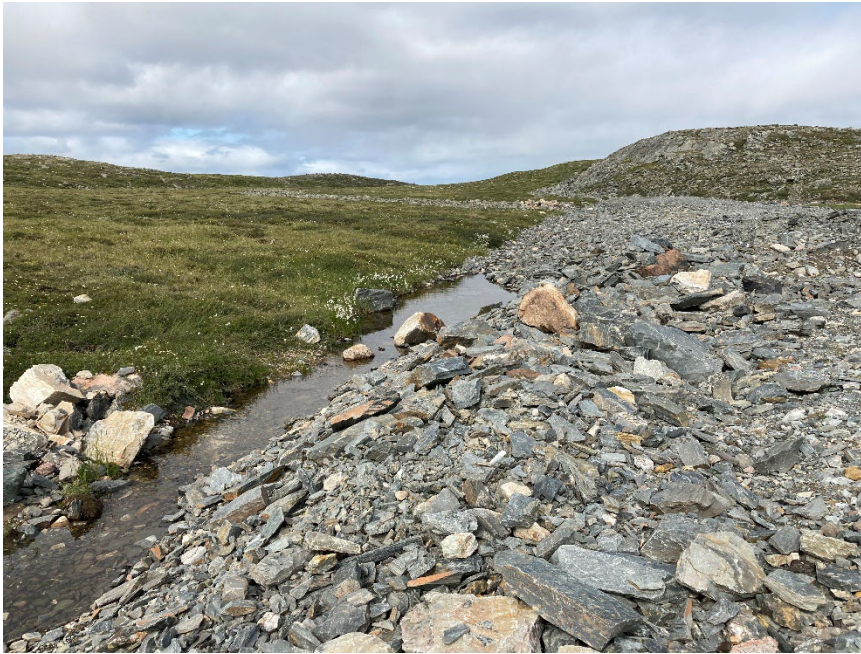
Photograph H2-13 Diversion Ditch and its Sediment and Erosion Protection Structure

Description: From 637281E/7216790N, looking north. View of the western diversion ditch.

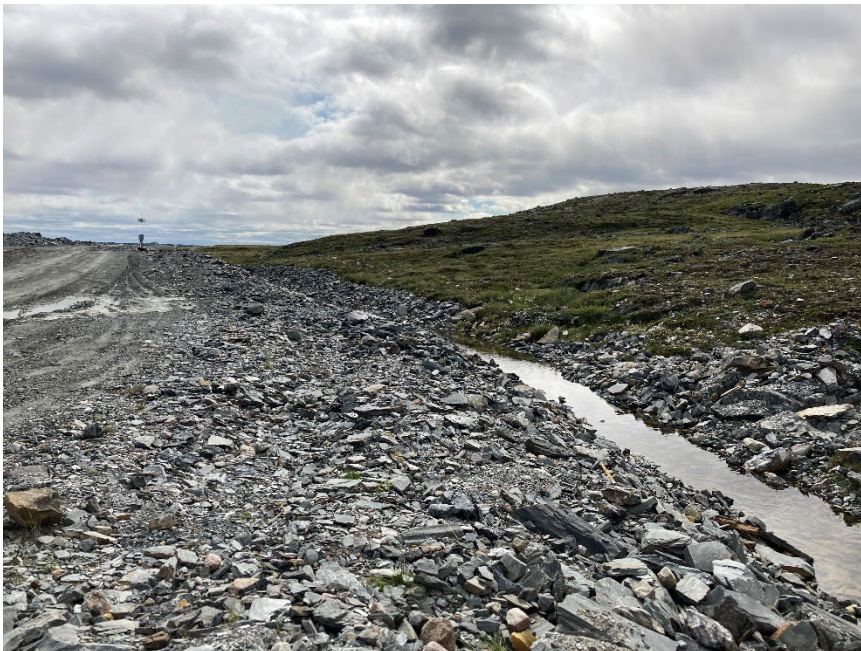
Photograph H2-14 Diversion Ditch and its Sediment and Erosion Protection Structure

Description: From 637281E/7216790N, looking south at the western diversion ditch.

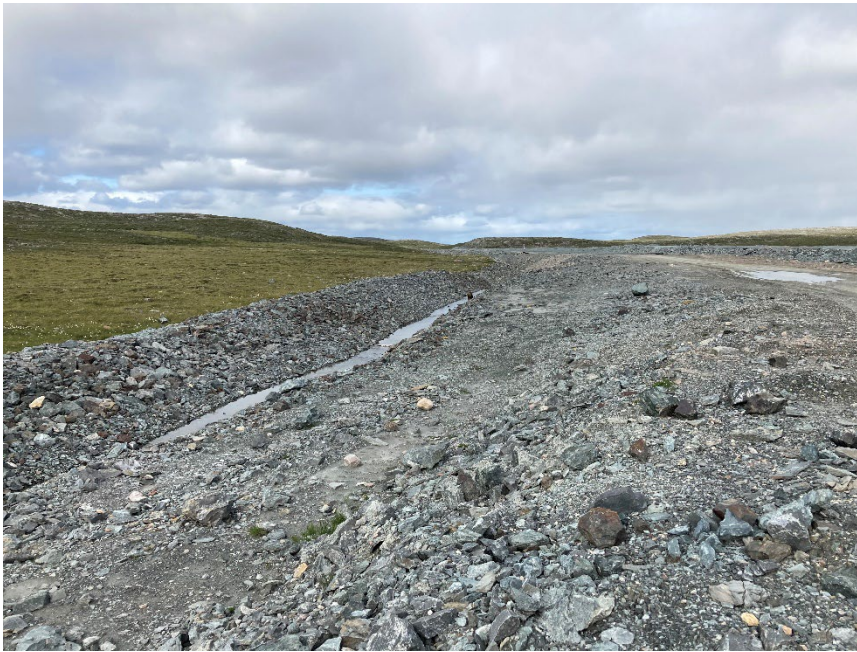
Photograph H2-15 Diversion Ditch and its Sediment and Erosion Protection Structure

Description: From 637251E/7216171N, looking north at the western diversion ditch.

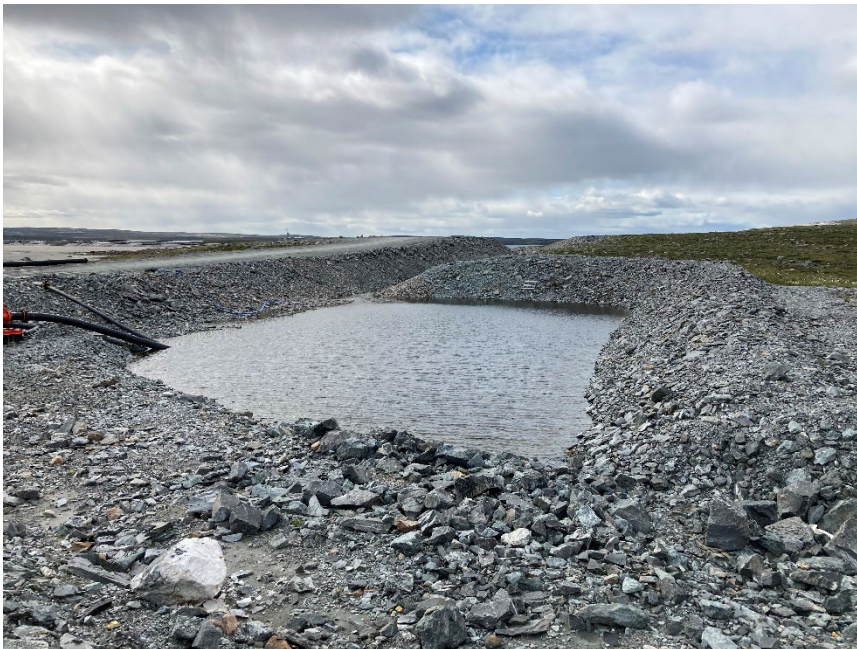
Photograph H2-16 Diversion Ditch and its Sediment and Erosion Protection Structure

Description: From 637251E/7216171N, looking southwest at the western diversion ditch and its retention basin.

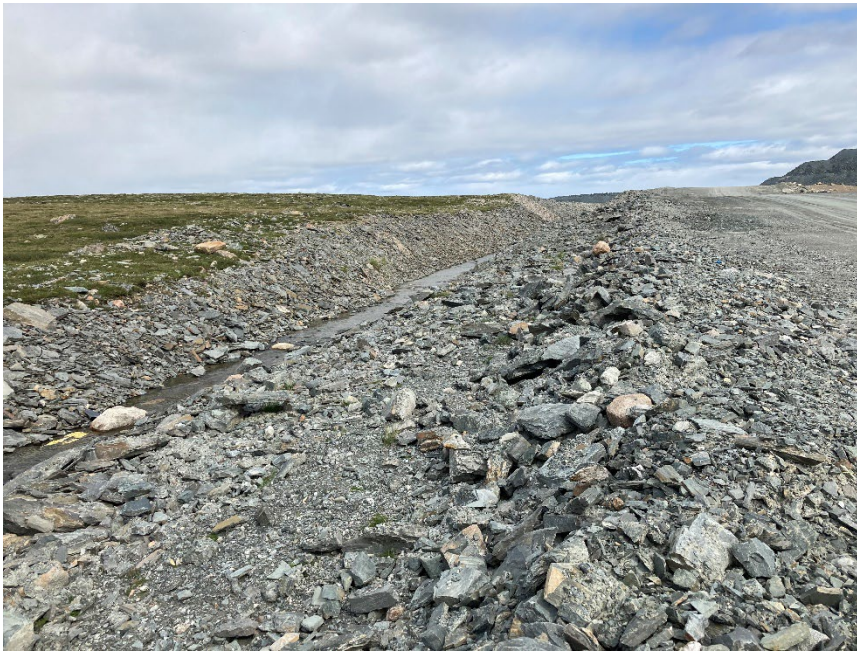
Photograph H2-17 Diversion Ditch and its Sediment and Erosion Protection Structure

Description: From 637074E/7216157N, looking east at the western diversion ditch.

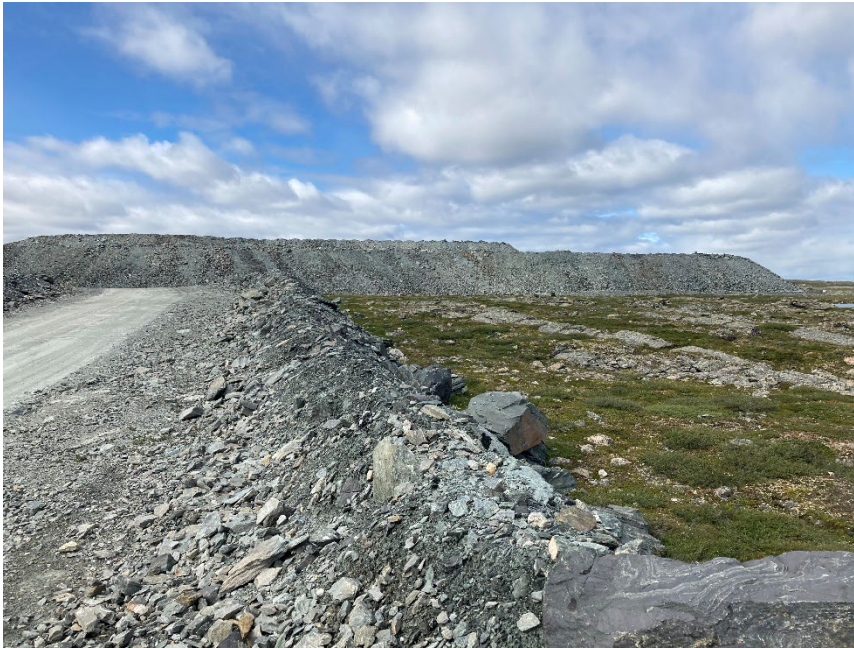
Photograph H3-1 RSF Till Plug

Description: From the south side of NP2 Lake (north of the diversion ditch) looking west at the RSF till plug.

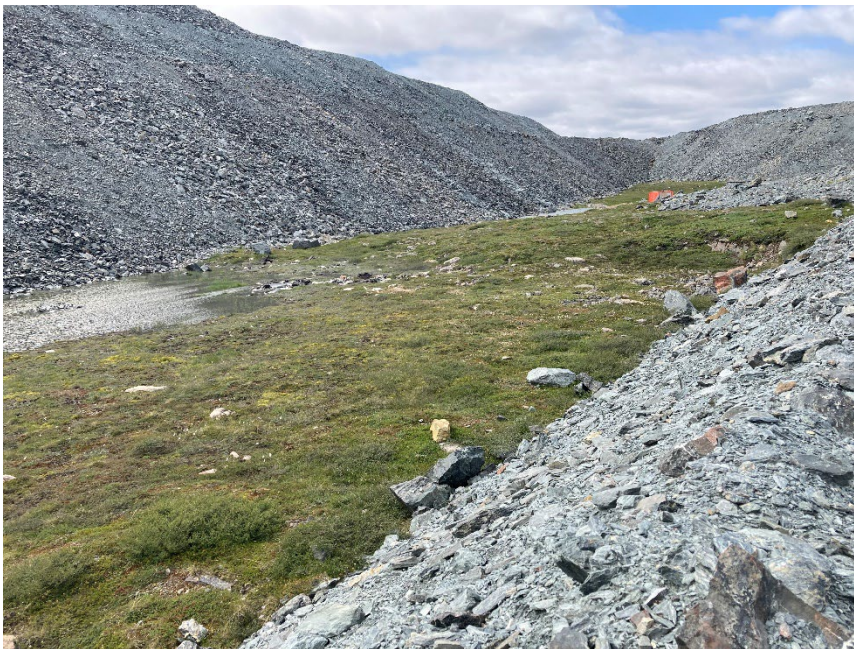
Photograph H3-2 RSF Till Plug

Description: From the south side of NP2 Lake (south of the diversion ditch) looking west at the RSF till plug.

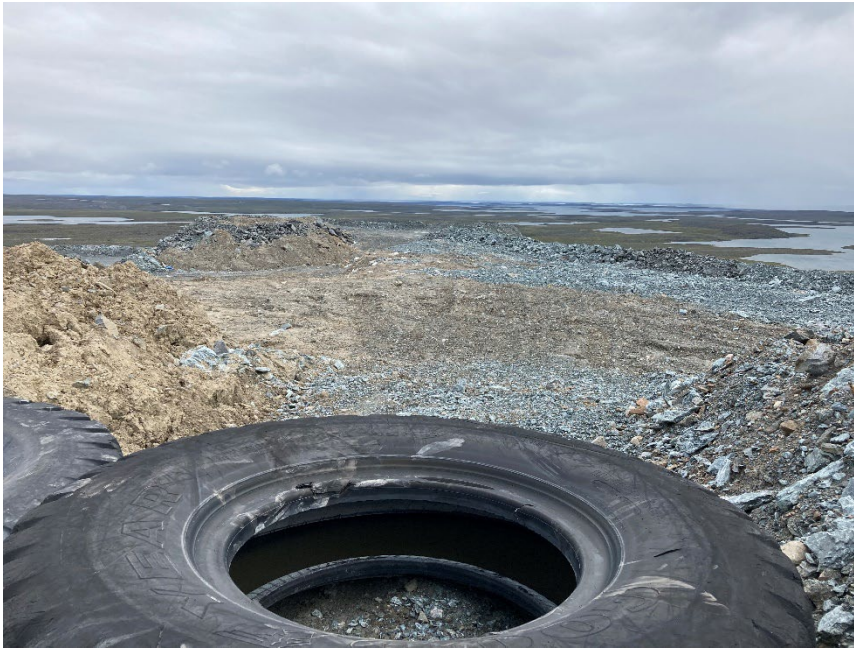
Photograph H4-1 Meadowbank Landfill

Description: From the 2020 landfill location within the Rock Storage Facility, looking southeast. Recently backfilled area, new one under development below.

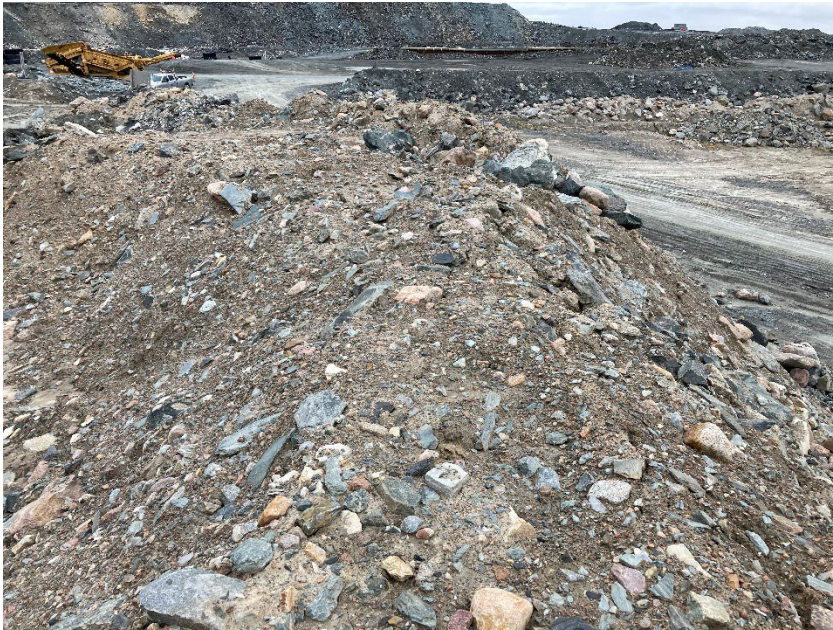
Photograph H5-1 Contaminated Soil Storage and Bioremedial Landfarm Facility

Description: From the eastern side of the Contaminated Soil Storage and Bioremedial Landfarm Facility, looking east at the containment berm. Small tension cracks are present on the crest.

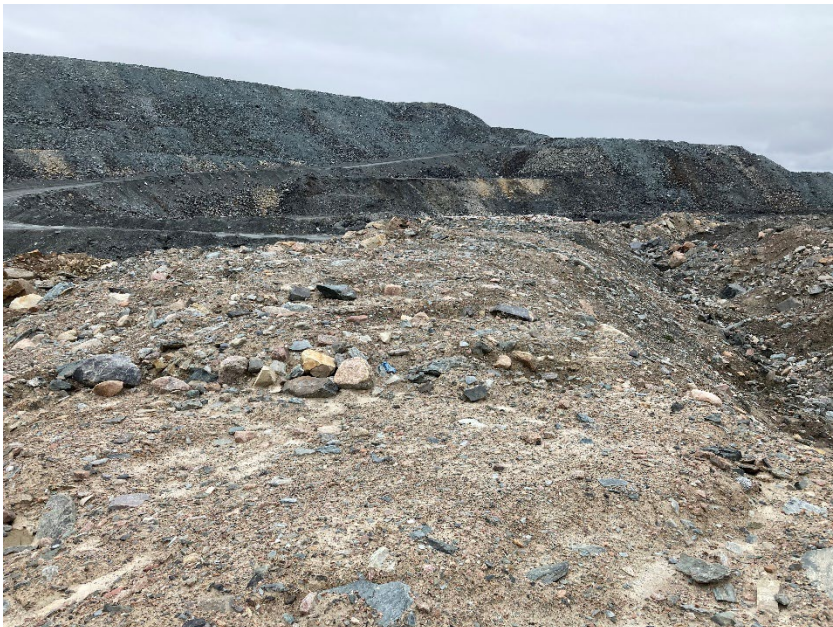
Photograph H5-2 Contaminated Soil Storage and Bioremedial Landfarm Facility

Description: From the northeast extremity of the South Cell, looking northeast at the Contaminated Soil Storage and Bioremedial Landfarm Facility. In good condition.

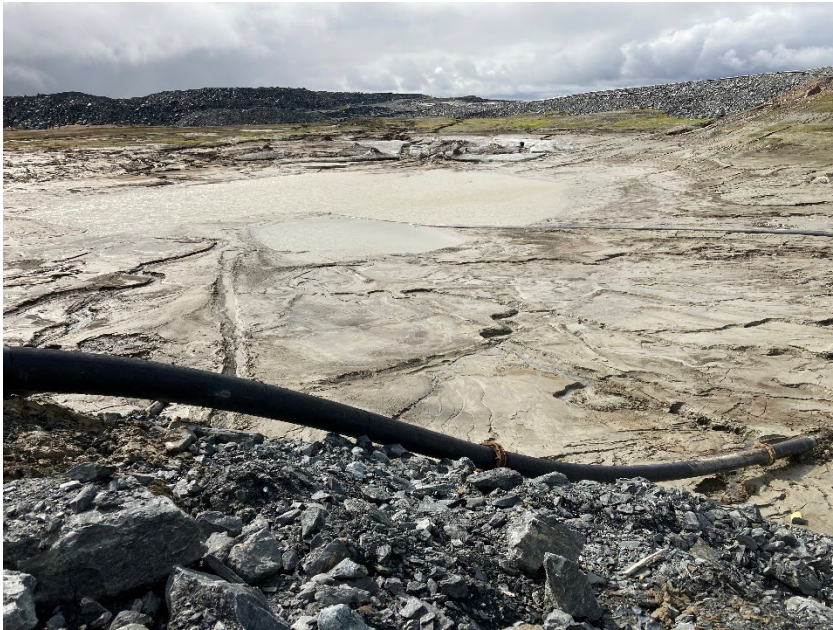
Photograph H7-1 Whale Tail Project Site Attenuation Pond Ramp

Description: From the pump pad, looking southwest at the attenuation pond and western slope of the pump pad.

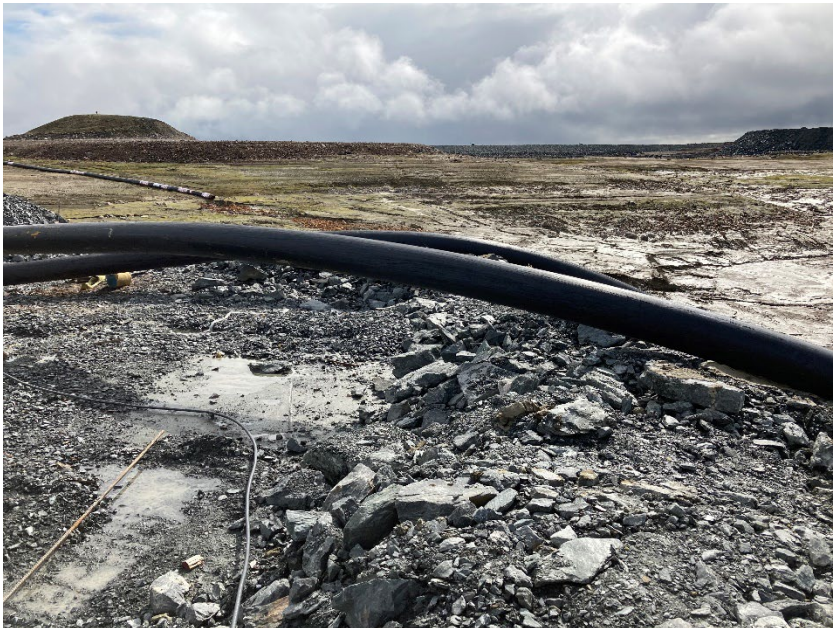
Photograph H7-2 Whale Tail Project Site Attenuation Pond Ramp

Description: From the pump pad, looking south at the pump pad.

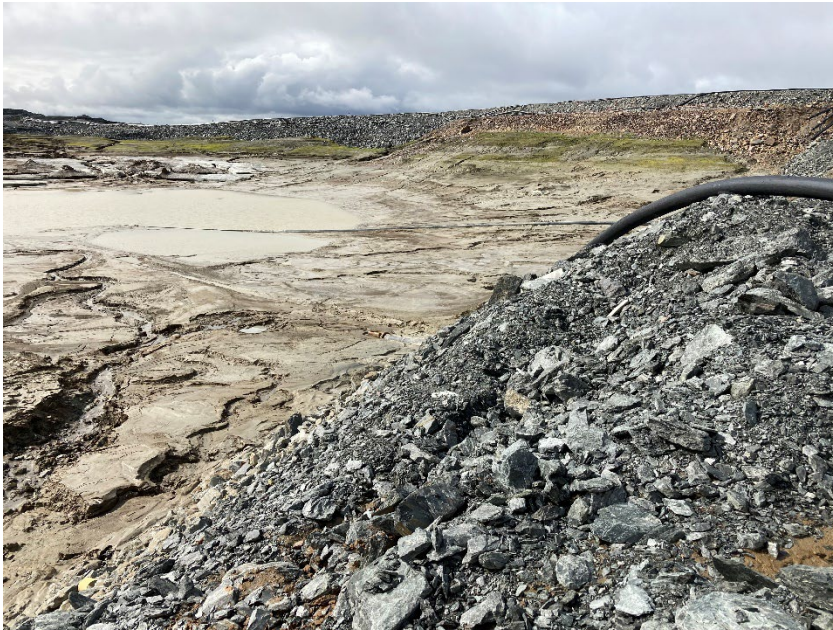
Photograph H7-3 Whale Tail Project Site Attenuation Pond Ramp

Description: From the pump pad, looking northwest at the southern slope of the pump pad.

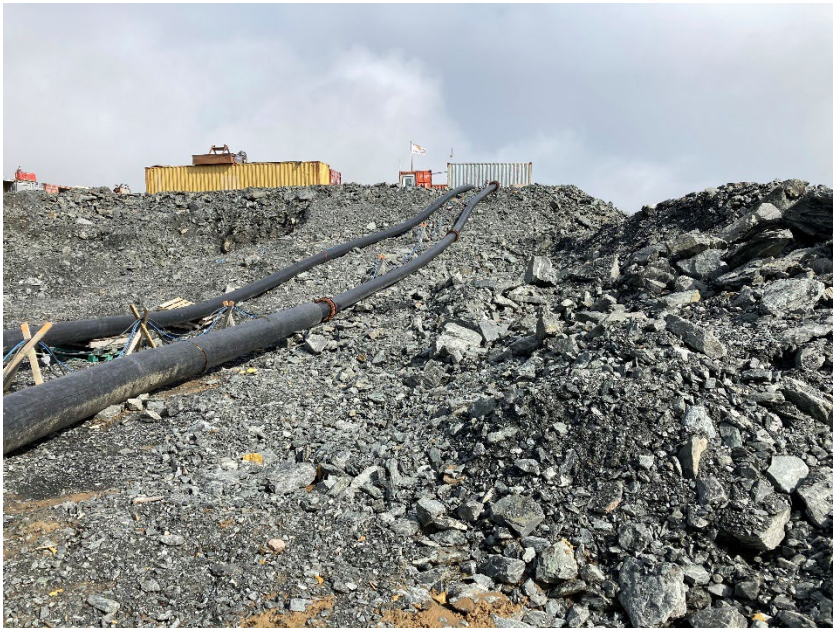
Photograph H7-4 Whale Tail Project Site Attenuation Pond Ramp

Description: From the pump pad, looking east at the pump pad and primary attenuation pond ramp.

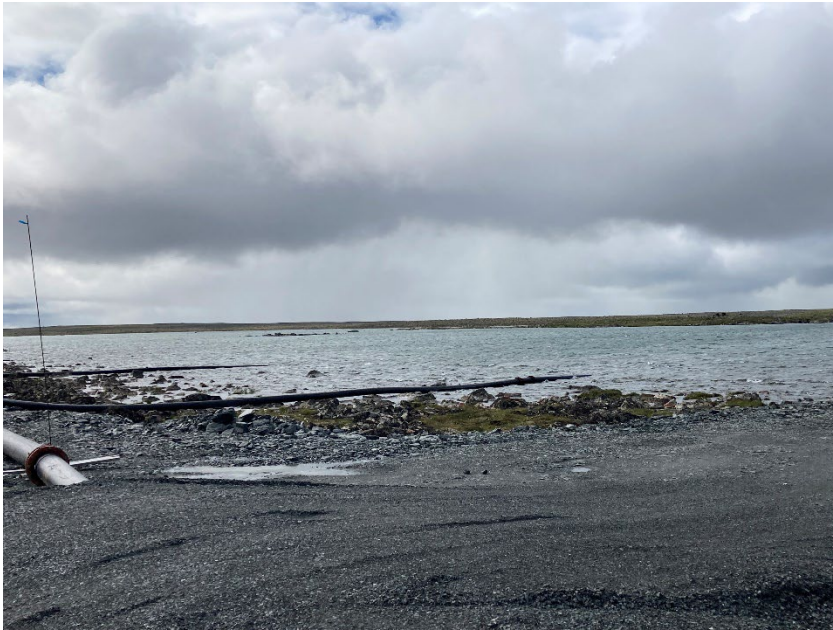
Photograph H8-1 Mammoth Lake Diffuser

Description: From the access road, looking west. Three diffusers are present and working normally.

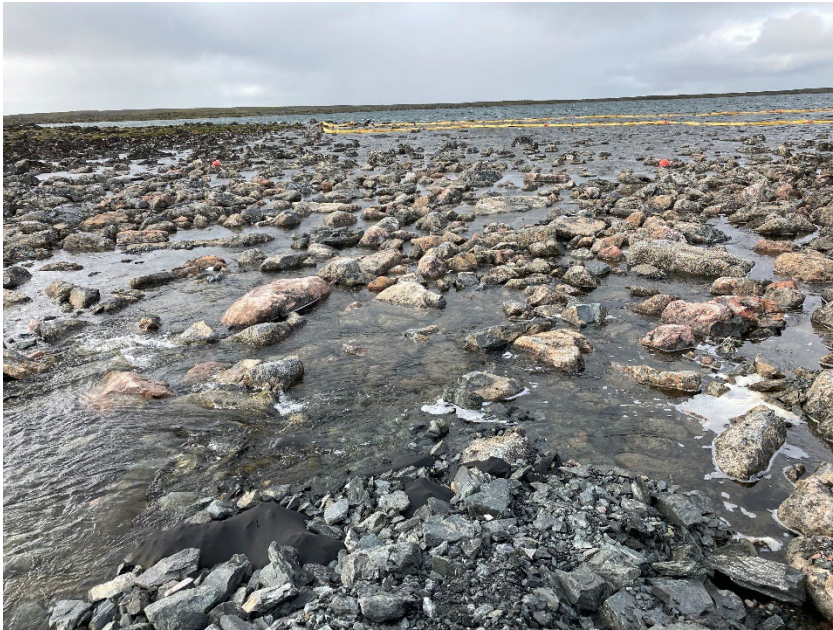
Photograph H9-1 South Whale Tail Channel

Description: From the outlet into Mammoth Lake, looking northwest. Two turbidity barriers are deployed in the lake.

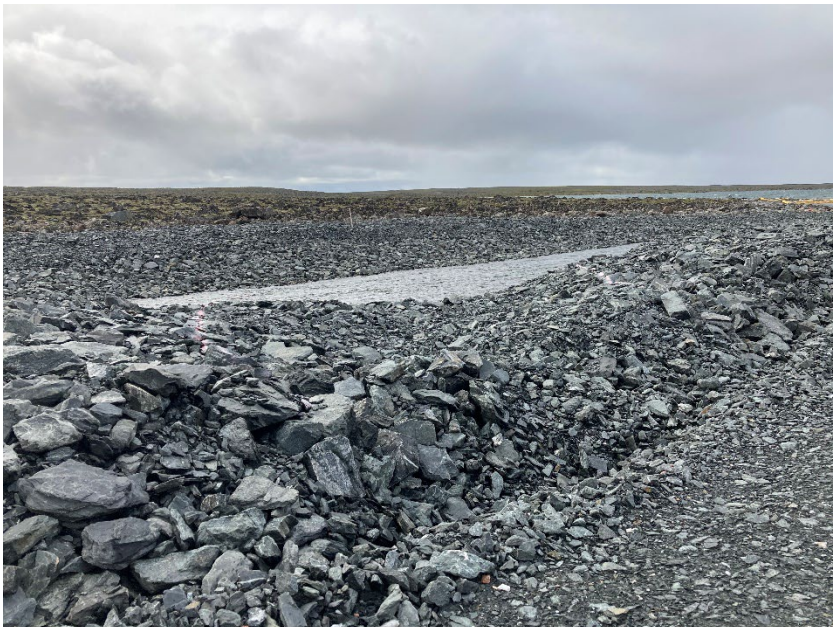
Photograph H9-2 South Whale Tail Channel

Description: From approx. Sta. 0+850, looking west. Settlement in the rockfill slope.

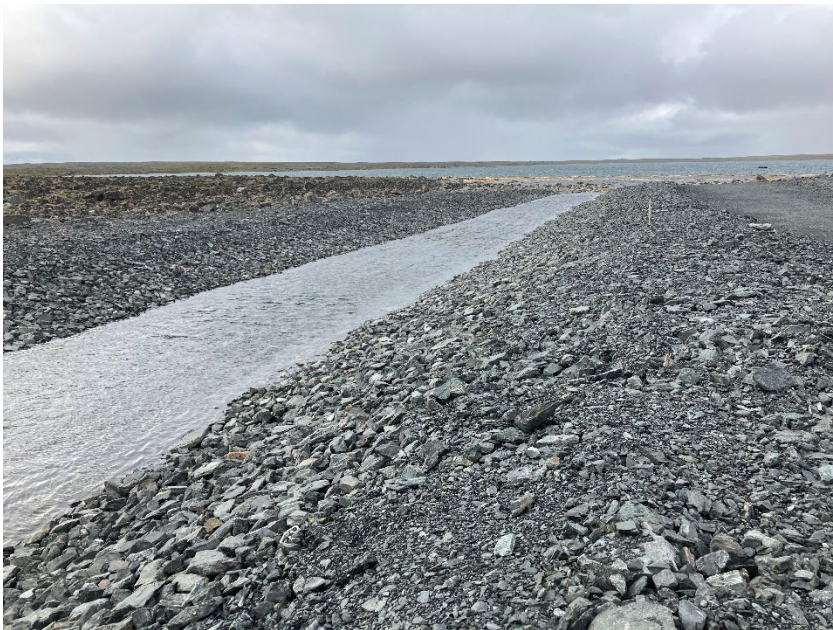
Photograph H9-3 South Whale Tail Channel

Description: From approx. Sta. 0+800, looking northwest.

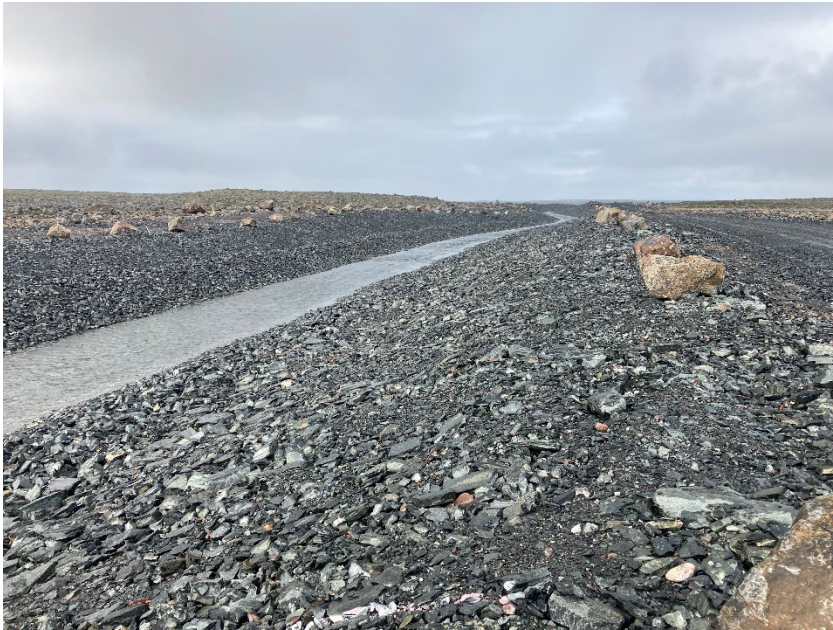
Photograph H9-5 South Whale Tail Channel

Description: From approx. Sta. 0+675, looking southeast.

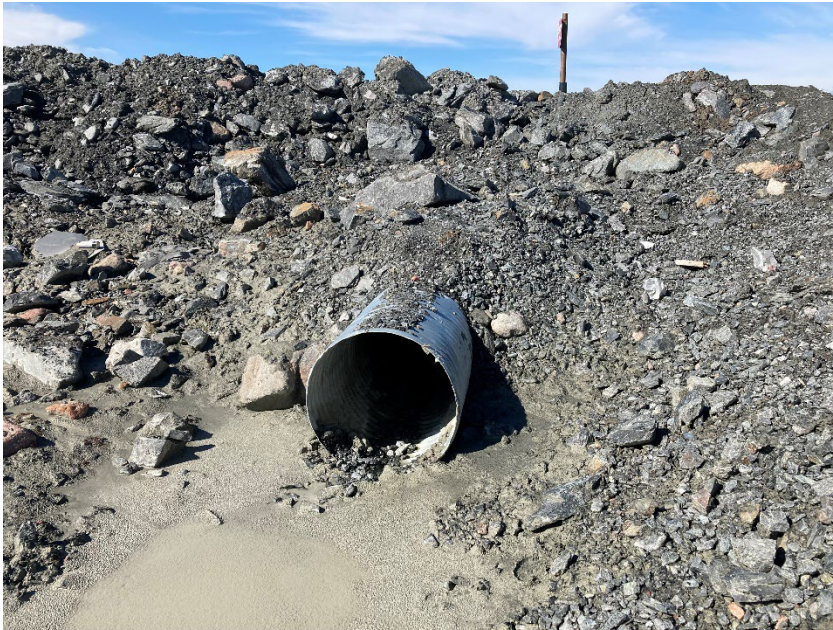
Photograph H10-1 Saline Ditch

Description: From the northern extremity of the Saline Ditch, looking west. The culvert is in good condition. Mud is accumulating in front of the inlet.

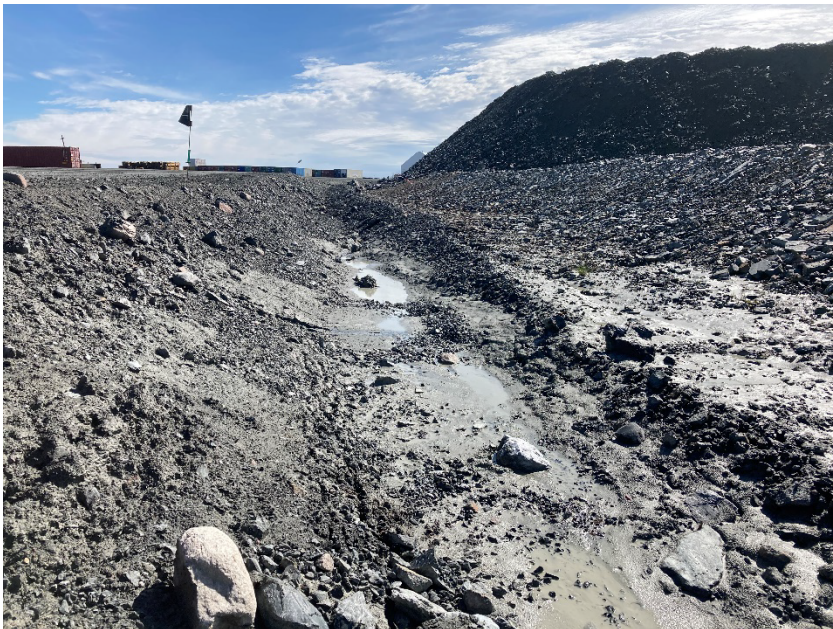
Photograph H10-2 Saline Ditch

Description: From the northern extremity of the Saline Ditch, looking east. Mud and gravel are present in the ditch.

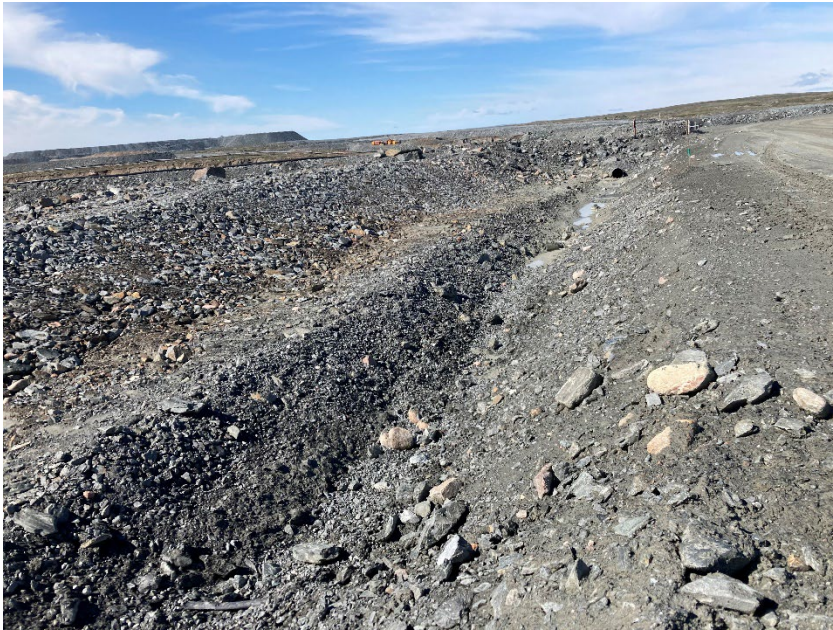
Photograph H10-3 Saline Ditch

Description: From approx. Sta. 0+140, looking northwest. Presence of boulders and gravel in the ditch.

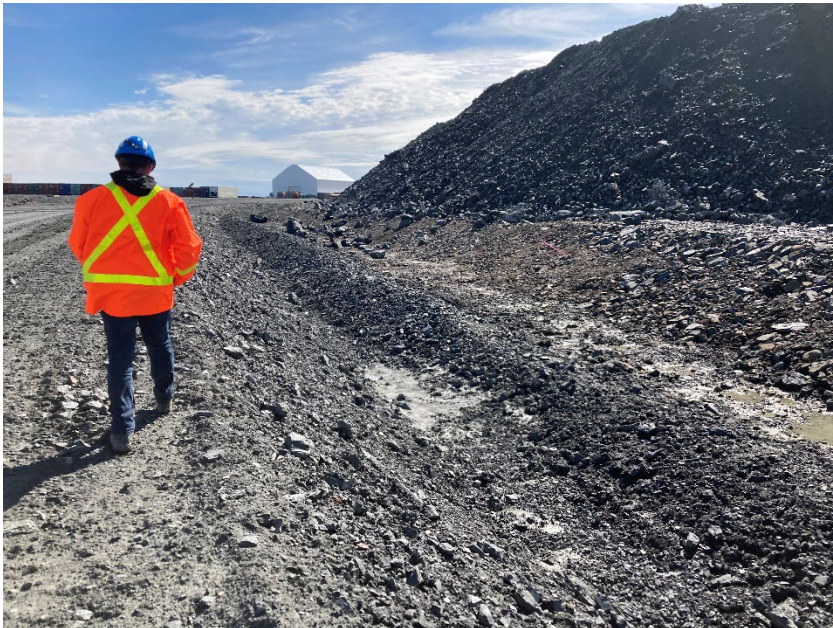
Photograph H10-4 Saline Ditch

Description: From approx. Sta. 0+140, looking southeast. Presence of gravel in the ditch.

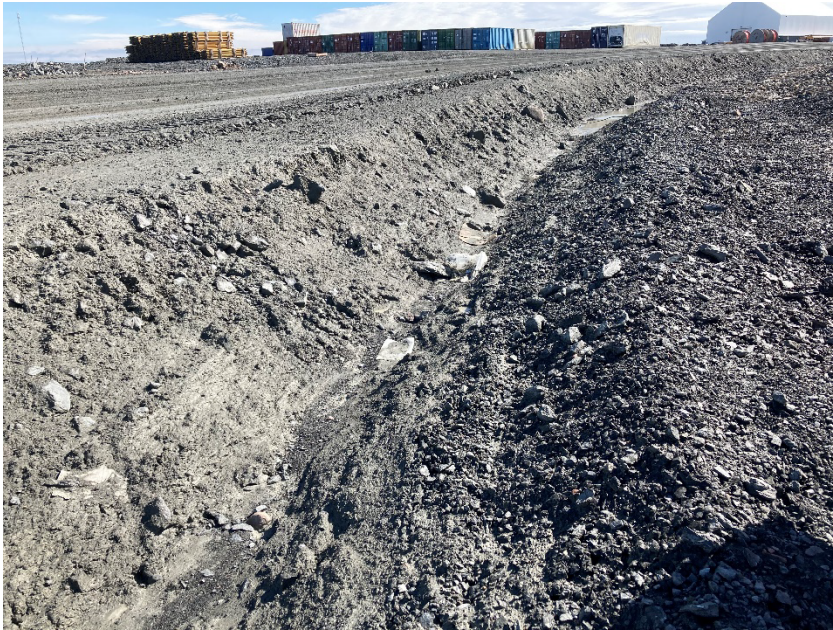
Photograph H10-5 Saline Ditch

Description: From approx. Sta. 0+140, looking southeast. Presence of mud and gravel in the ditch, as well as some water ponding.

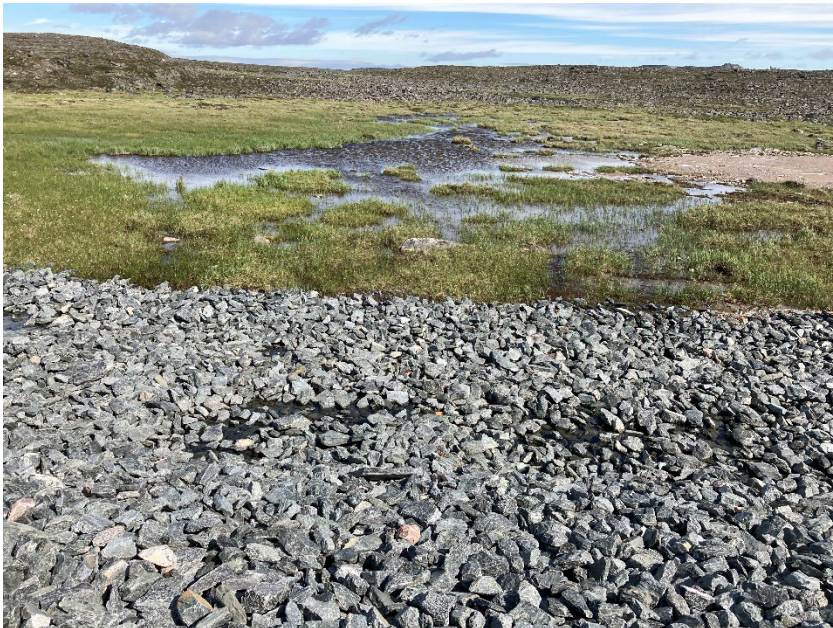
Photograph H12-2 IVR Diversion Channel

Description: From around Sta. 0+020, looking northeast. Water is entering the channel from the natural topography.

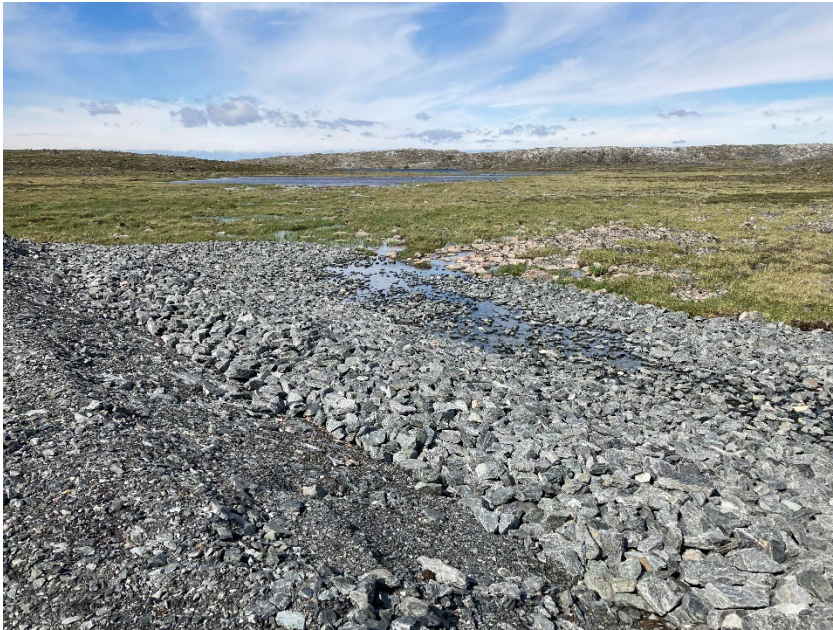
Photograph H12-5 IVR Diversion Channel

Description: From around Sta. 0+270, looking north at the outlet. Water is flowing well towards the lake.
