Appendix 16: 2021 Reportable Spills

Follow Up Report: #21-004

January 5, 2021 – 170 L Hydraulic Oil Spill

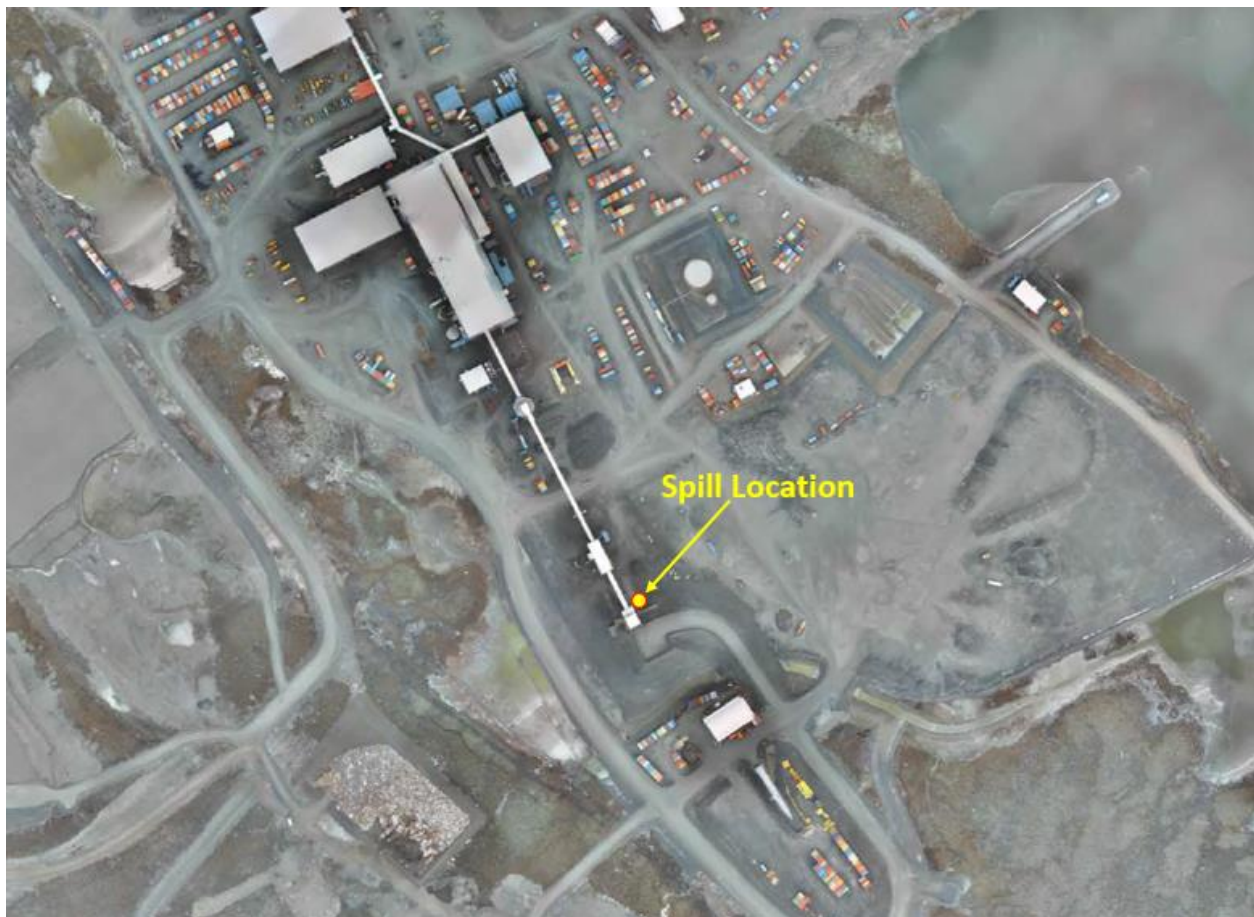
At approximately 1:30 am on January 5, 2021, a breakage in a section of a hydraulic line on the exterior of the apron feeder building led to the release of approximately 170 L of hydraulic oil. The oil ran down the eastern wall of the building onto the snow below and was confined to a small area allowing for complete recovery of the spill.

Figure 1: Location of the spill on East side of the apron feeder building.

The specific cause in this incident is attributed to wear and tear on the hydraulic lines, compounded by the cold temperatures the lines are exposed to. The strong vibrations caused by mechanical equipment inside the building, put additional stress on these lines and fittings. Although these lines are currently insulated and heat-traced to prevent temperature drops in the hydraulic system, a plan is in place to install a heated seacan to contain the hydraulic tanks and keep the overall system warmer. Ridged piping will also be installed over the current lines which will help with insulation and wear and tear.

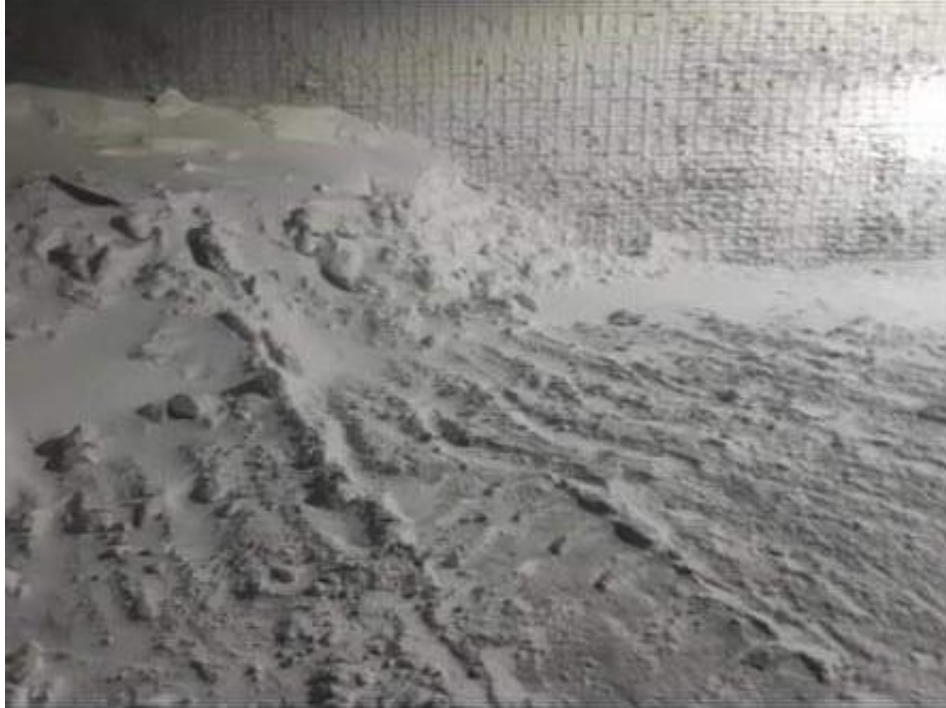
Figure 4: With the storage trailer moved away, the contaminated snow was able to be removed.

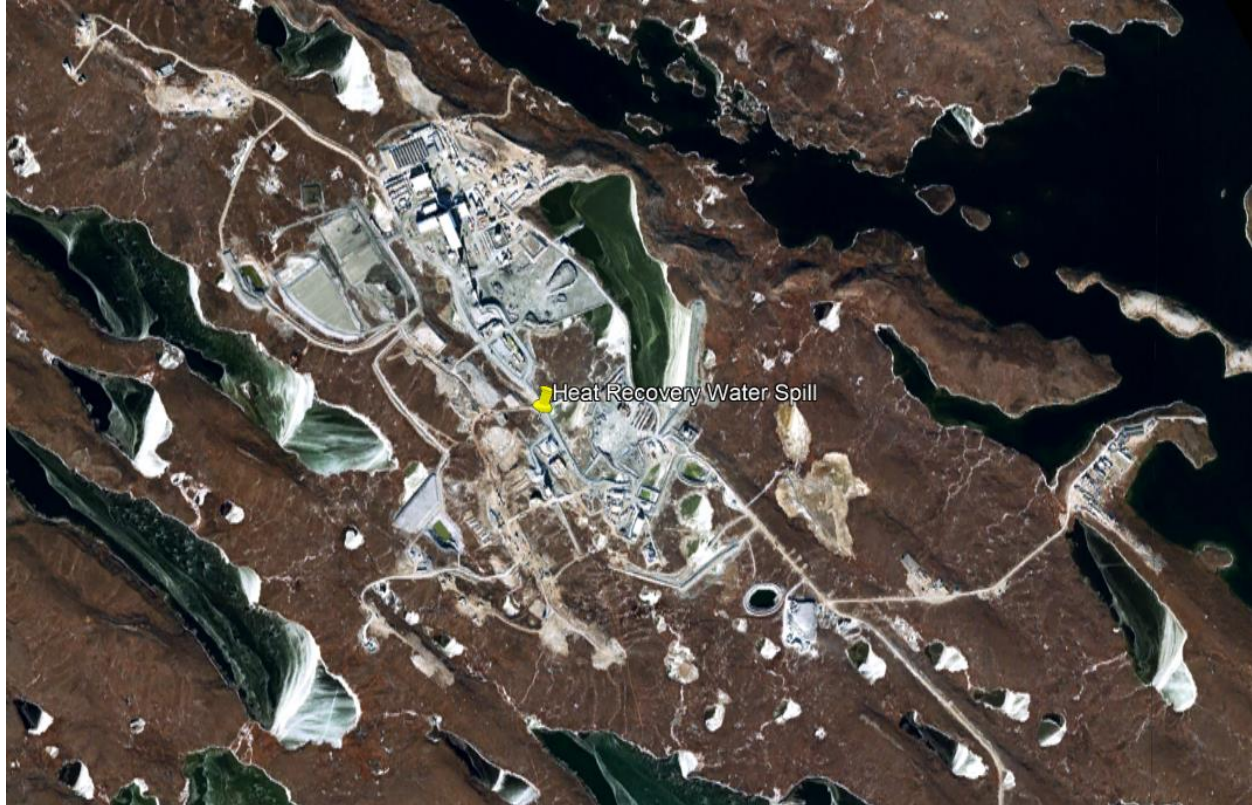
On January 18th, at approximately 1:00 pm, an estimated 165 m³ of heat recovery water was spilled as water was being conveyed via a 16" heat recovery waterline. Equipment was pushing snow near the heat recovery waterline. This action caused the line to break and the water within the line was released. A portion of the water froze on surface, with the remainder migrating below surface.

Figure 1: Location of spill 165 m³ heat recovery water spill in site catchment, east of WRSF 1.

The waterline has been disabled until it can be replaced in summer. Energy and Infrastructure (E&I) department will inspect the new line during recommissioning before resuming operations.

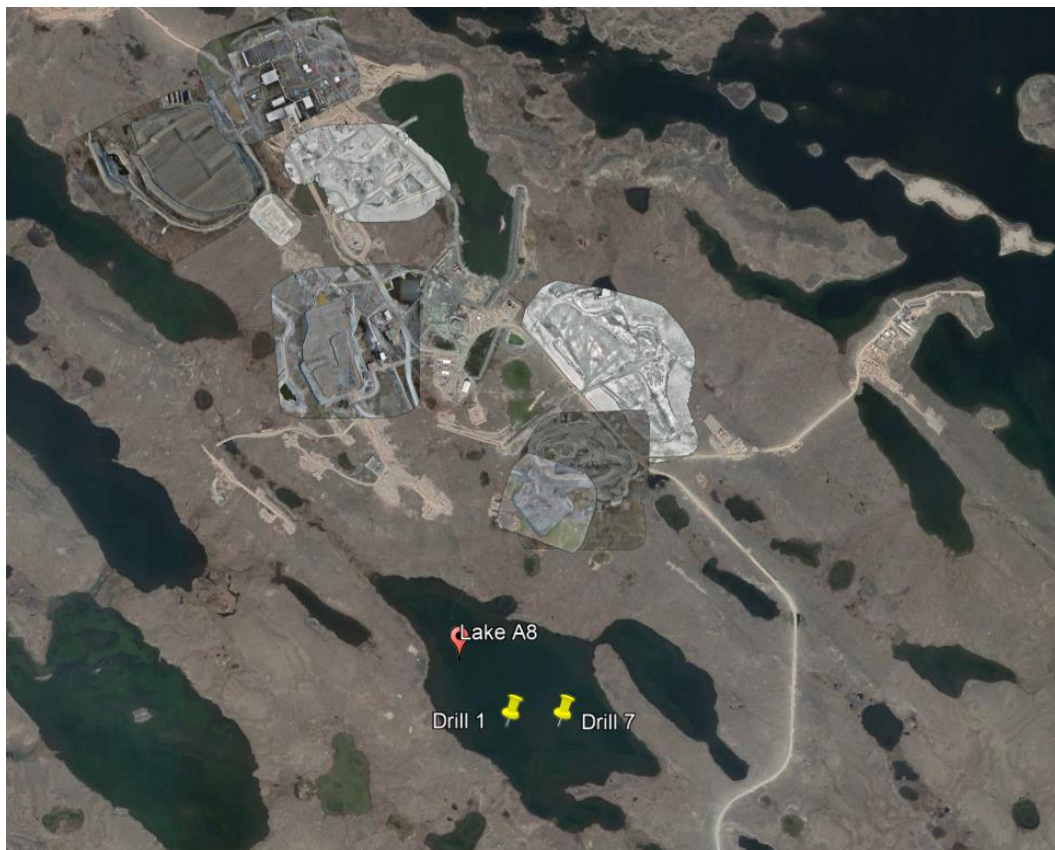
On March 29, at approximately 16:00 Environment Technicians were called to conduct an inspection of the surface drill rigs, operated by contractor Orbit Garant. Two drill rigs were operating on Lake A8 (Figure 1). During the inspection both rigs were found to have areas with small amounts of hydraulic oil dripping from inside the rigs onto the lake ice. Drill #1 was estimated to be approximately 20L (Figure 2), and Drill #7 was estimated to be approximately 3L (Figure 3).

Figure 1: Locations of Drill #1 and Drill #7 on Lake A8 on March 29.

The leaking fittings on the exterior hoses were repaired, and drip pans were installed beneath the ledges where oil was leaking from inside the rigs. The Orbit Garant supervisors held meetings with both shifts to discuss the importance of routine, regular inspections of their rigs. Due to the high worker turnover rates of Orbit Garant drillers, supervisors will ensure to reiterate these messages to new workers, and the Environment department will continue conducting regular inspections.

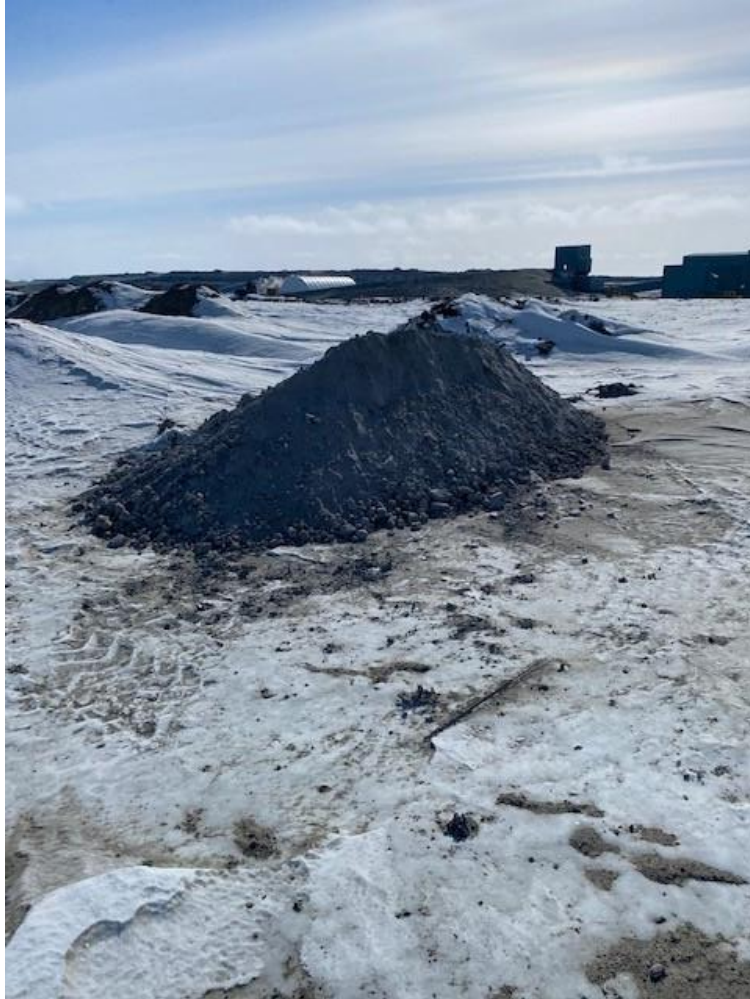
Figure 3: Contaminated material transferred to Landfarm A.

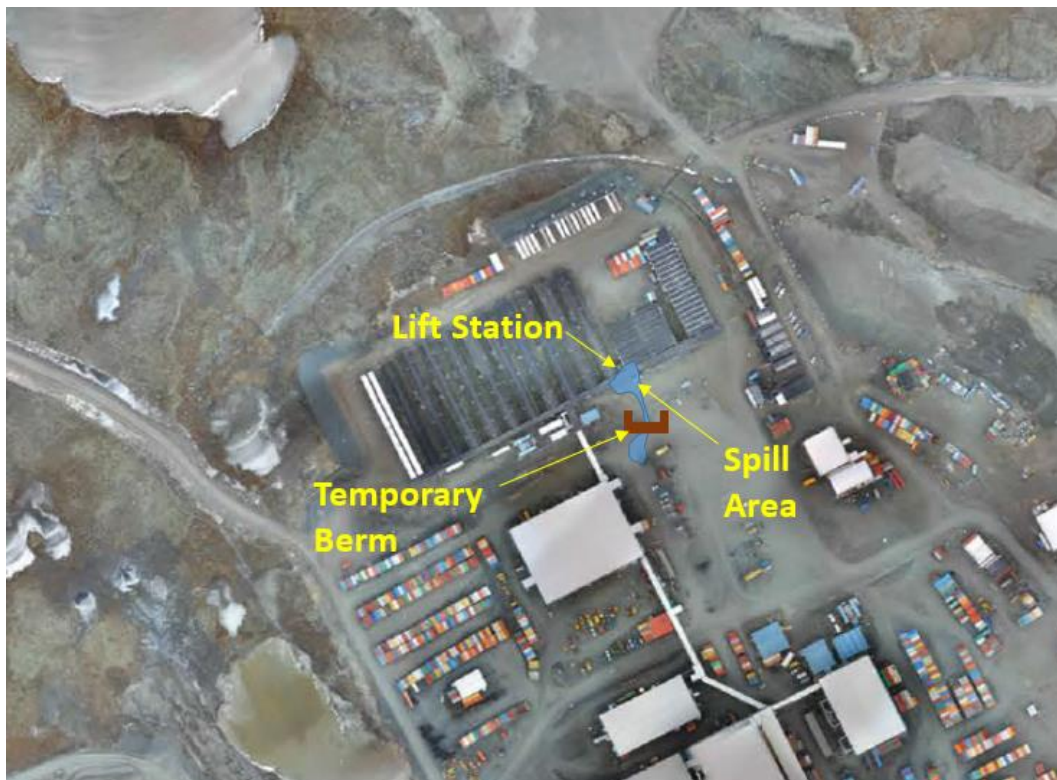
At approximately 05:15 am on May 13, 2021, the operator of the sewage treatment plant (STP) arrived to low level alarms in the EQ tank. The supervisor was then notified of a discrepancy with the amount of water consumed not matching the raw water received for the past 12 hours, suggesting that there may have been a breakage in the line somewhere. The lift station of the main camp was then inspected and upon arrival the access door was found open. With night temperatures dropping below zero, this likely led to freezing within the pipe/Y joint and eventually failure of the joint.

Figure 1: Location of the lift station and affected area in relation to the main camp.

The incident occurred as a result of the access door of the lift station being left open overnight. It is unknown whether it was left open accidentally, or if it was blown open by the wind, but the locking mechanism and door did not appear to operate properly. This led to the freezing and cracking of a pipe due to overnight temperatures below zero. The cracked pipe was replaced the same day and the systems were restored. Repairs are scheduled for the door and locking mechanism to allow it to close fully and lock more securely from the outside. A low temperature alarm is planned to be installed inside the lift station, and other sensors and alarms are being considered (pressure sensors, moisture alarm on the floor, etc.). A full inspection of all exterior drainage systems throughout the MSB and camp is planned to be completed this summer.

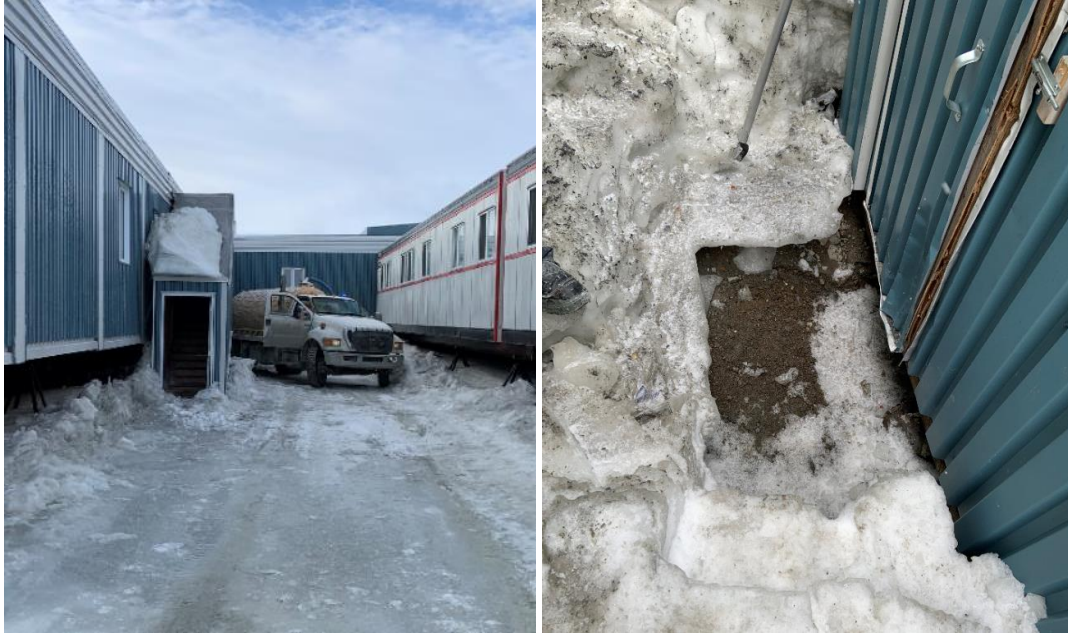
Figure 5: The sucker truck was utilized to empty the lift station holding tank and to collect pooling water outside of the lift station.

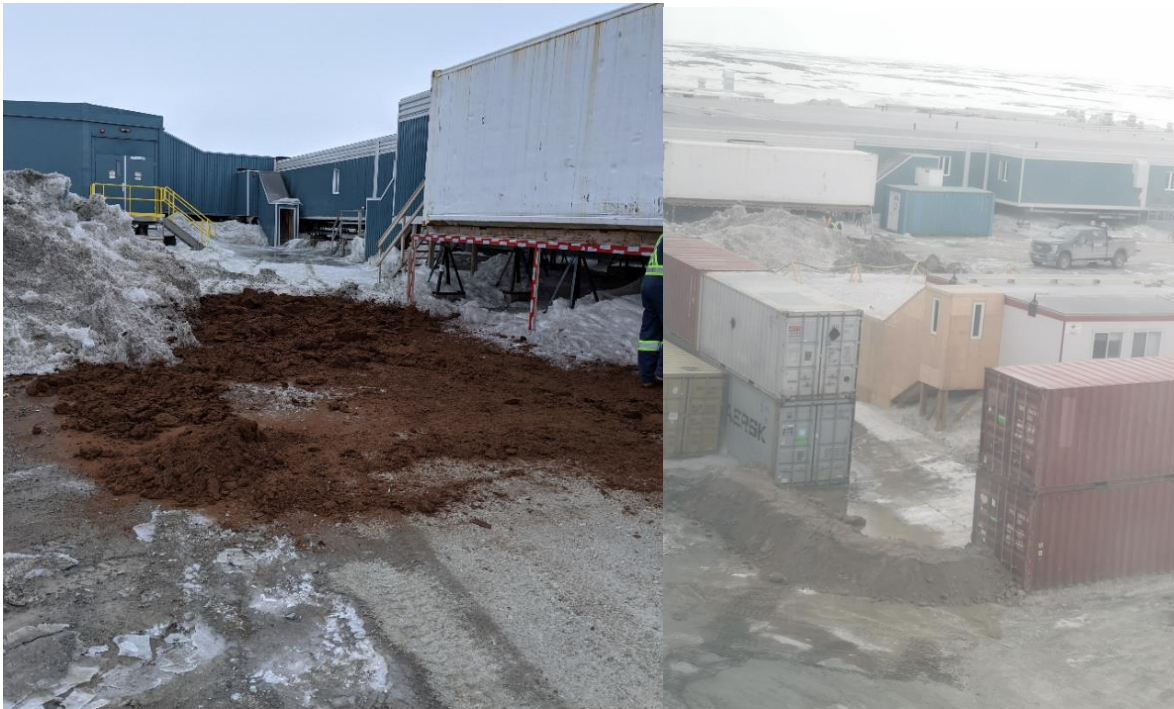
Figure 6: Clean peat/soil was used to absorb pooling water, and a temporary berm construction to mitigate downstream flow.

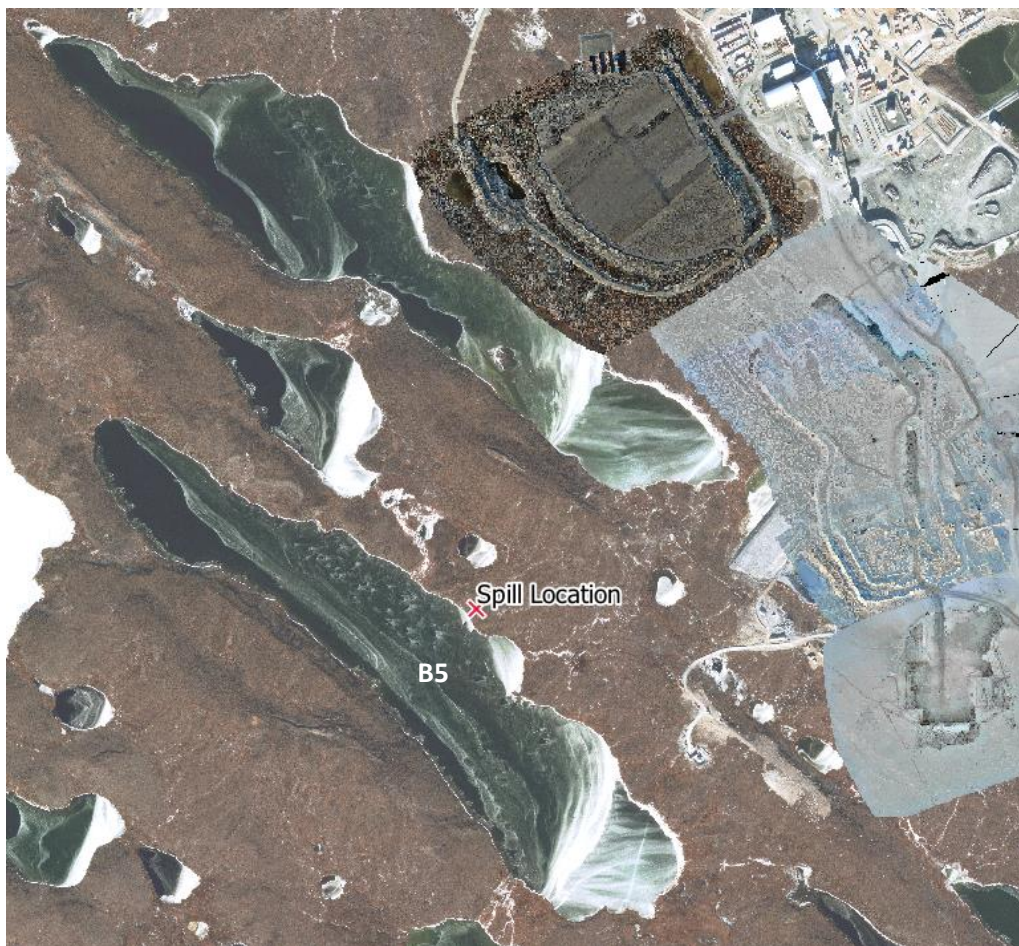
During an exploratory drilling campaign near local lake B5, workers noticed a hydrocarbons sheen on the surface runoff surrounding the drill. The drill was set up approximately 39m from the ordinary high water mark of the lake, in a low-lying area prior to freshet, which later encountered substantial surface runoff as temperatures warmed. Hydrocarbon residues on the components and surfaces of the drill equipment were being washed off by the freshet runoff towards B5 lake. The spill volume was approximated at 5 L.

Figure 1: Location of the spill near B5 lake.

The specific cause in this incident is attributed to the selection of the location and timing for drilling (in relation to freshet onset). In this case and as previously mentioned, the drill was shut down and materials such as fuel tanks, hoses and other equipment which may contain hydrocarbons contaminated surfaces were moved to higher ground away from freshet runoff. The Environment department will continue conducting regular inspections. Orbit Garant supervisors will ensure to reiterate the importance of inspections of their rigs to their workers to prevent any environmental incident. The procedure for drilling just prior and during freshet is being modified to ensure that drills are not operational during this period where large freshet inflows can be problematic.

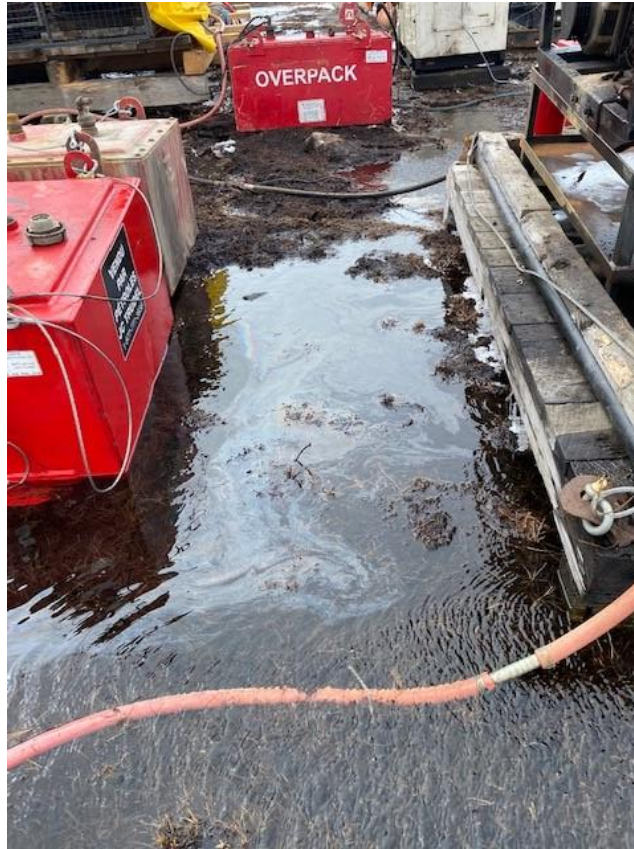
Figure 2: Hydrocarbons sheen on the surface of water by the drill

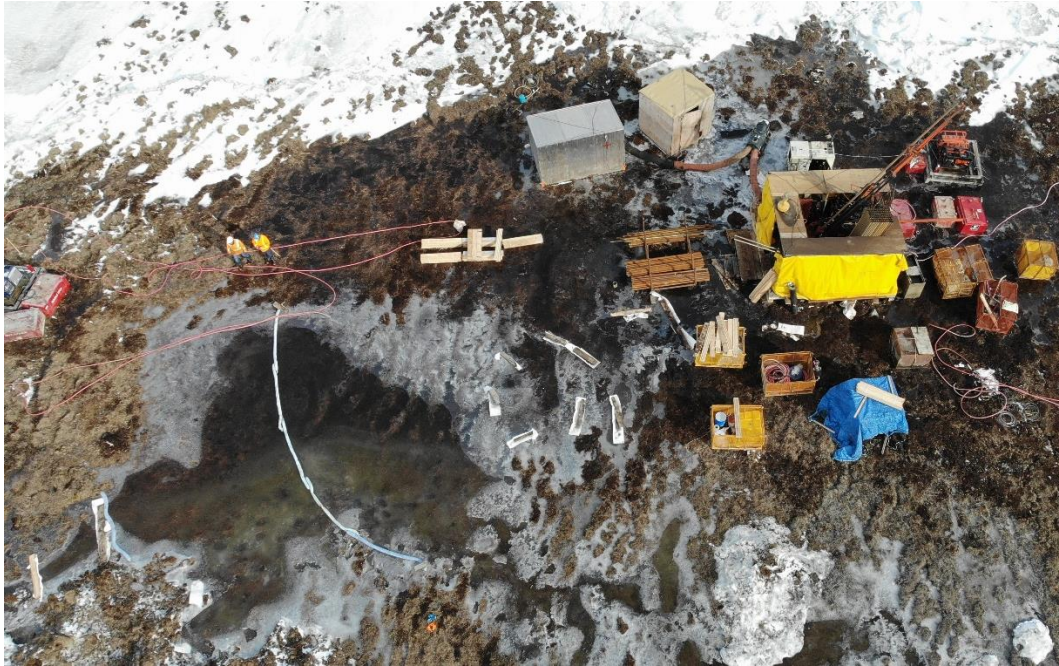
Figure 4: Absorbent pads and booms were deployed to capture the hydrocarbons at the surface of water.

The drill was shut down on May 31st to address the issue and materials such as fuel tanks, hoses and other equipment which may present hydrocarbon contaminated surfaces were moved to higher ground away from freshet runoff. Absorbent pads and booms were put in place to capture the hydrocarbons at the surface of water. The contaminated absorbent materials were recovered into Quatrex hazmat bags.

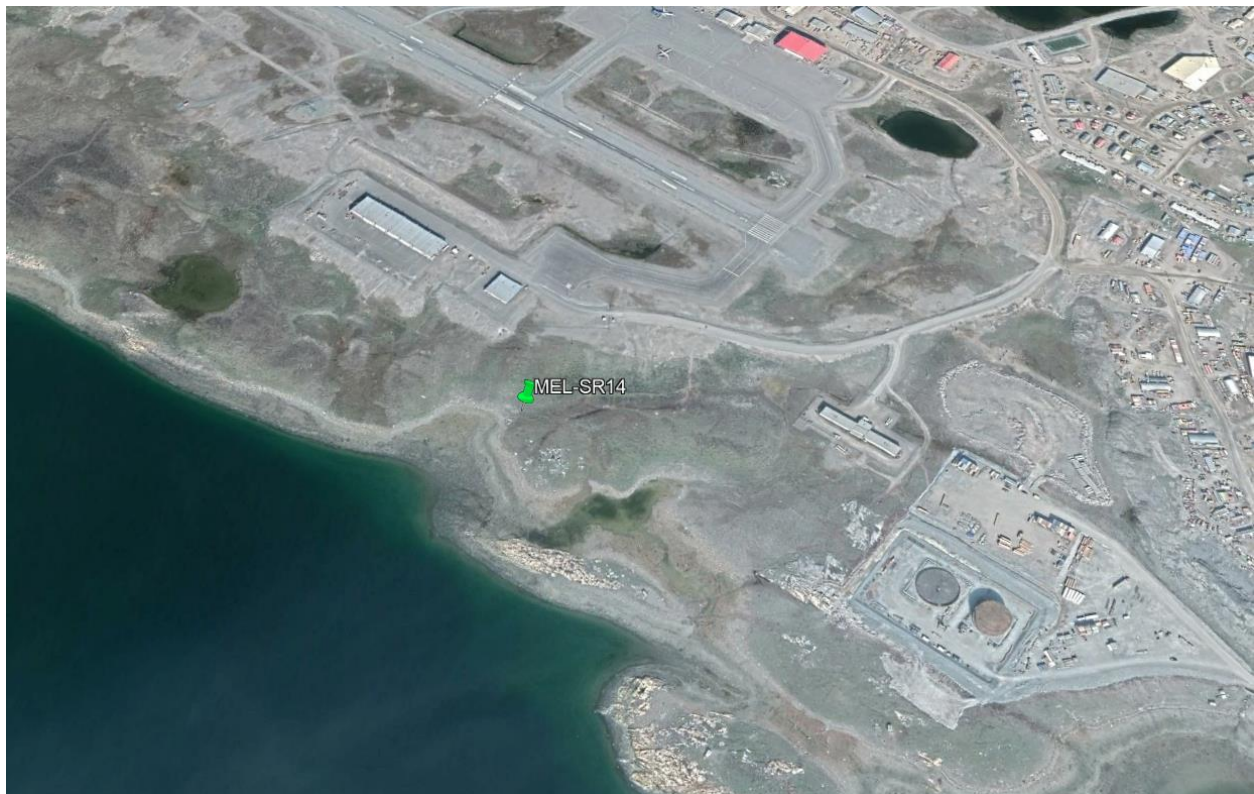
Figure 1: Sample location MEL-SR14, southwest of the Bypass Road

- The water flowing at MEL-SR14 did not appear turbid, it was very clear;
- Very little TSS was observed in the water (sand or clay particles);
- The flow at the MEL-SR14 sampling station was minimal at the time of sampling, so the sample had to be collected with the sampling bottles very close to the ground (tundra), downstream of the culvert.

Hence, it is possible the sampling method caused TSS entrainment in the sample, by collecting particles from the ground in the sampling bottles.

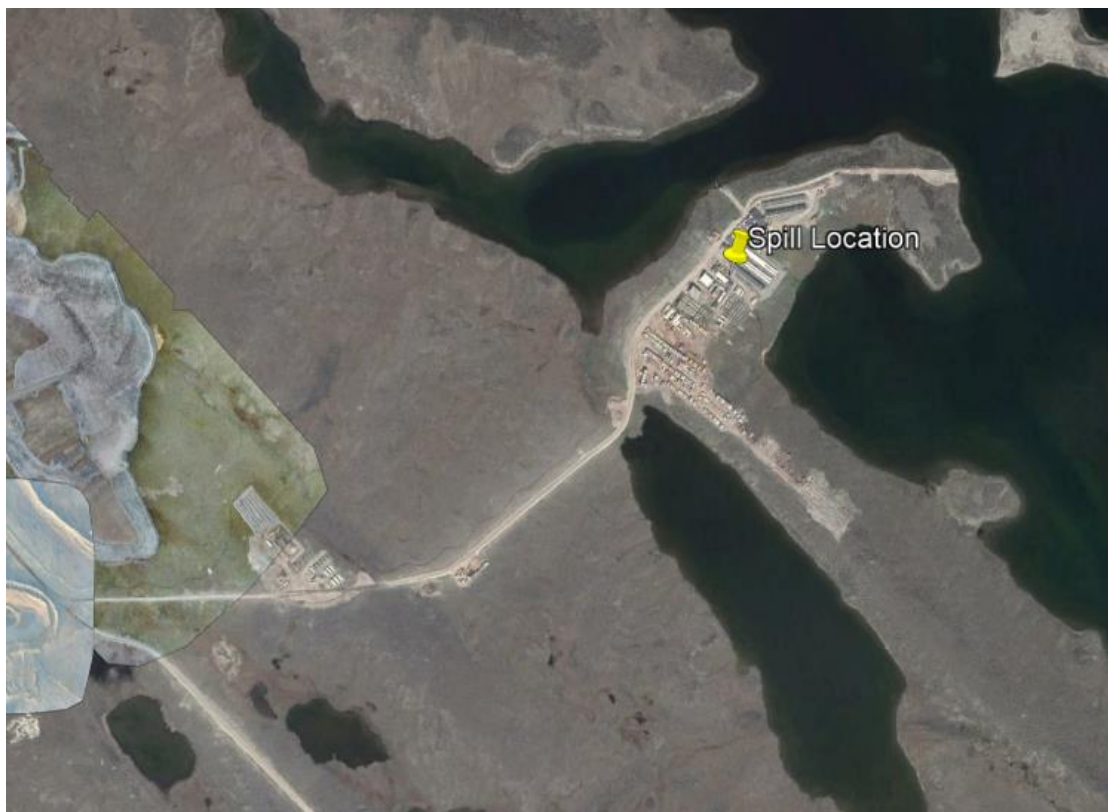
On the morning of June 4th, workers noticed the smell of fuel in the exploration camp core shack. A fuel line from an exterior above-ground heating fuel tank had cracked, releasing an estimated 250 L of fuel. Most the fuel migrated under the building, while some of it flowed away from the building onto the gravel driveway area.

The supply copper line to a furnace located approximately 10 m away cracked, likely due to the cold conditions and the presence of water in the line.

Figure 1: Location of the 250 L Diesel Spill

The remaining fuel in the tank was pumped out and the tank was disconnected from the building. An identical tank on an adjacent building was inspected to ensure the fuel line was in a safe condition. The contaminated wood was removed and disposed of as hazmat, and the water was treated through the oil/water separator.

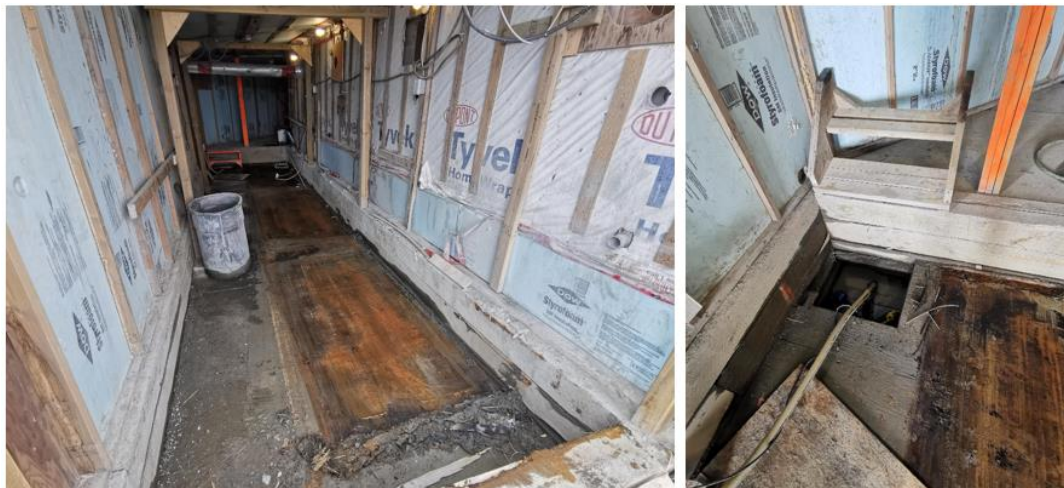
The decantation room inside the building contains a down slope sump, which began to fill with diesel. A submersible pump was used to periodically pump the diesel and contaminated water into a tote. The entire decantation room was dismantled and cleared of material so that the subfloor could be inspected more thoroughly.

Figure 5: Decantation room cleared of all materials, and the down slope sump actively being pumped of standing diesel.

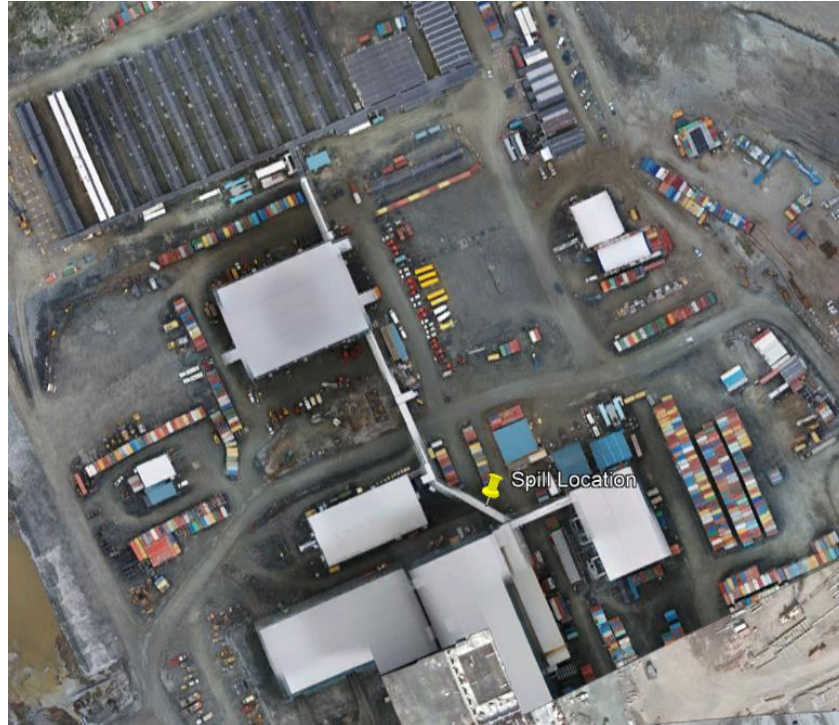
Due to failure of an expansion joint on the heat recovery system, approximately 8 m³ of water containing corrosion inhibitor (Drewgard 4109) spilled in the south end of the Arctic corridor (between the Multi Service Building (MSB) and the process plant), and then leaked to the ground below on the Industrial Pad. The mix of Drewgard to water in the system was estimated to be 11 L of Drewgard to every 1000 L of water.

Figure 1: Location of the spill source was inside the arctic corridor, which then leaked to the ground below on the Industrial Pad.

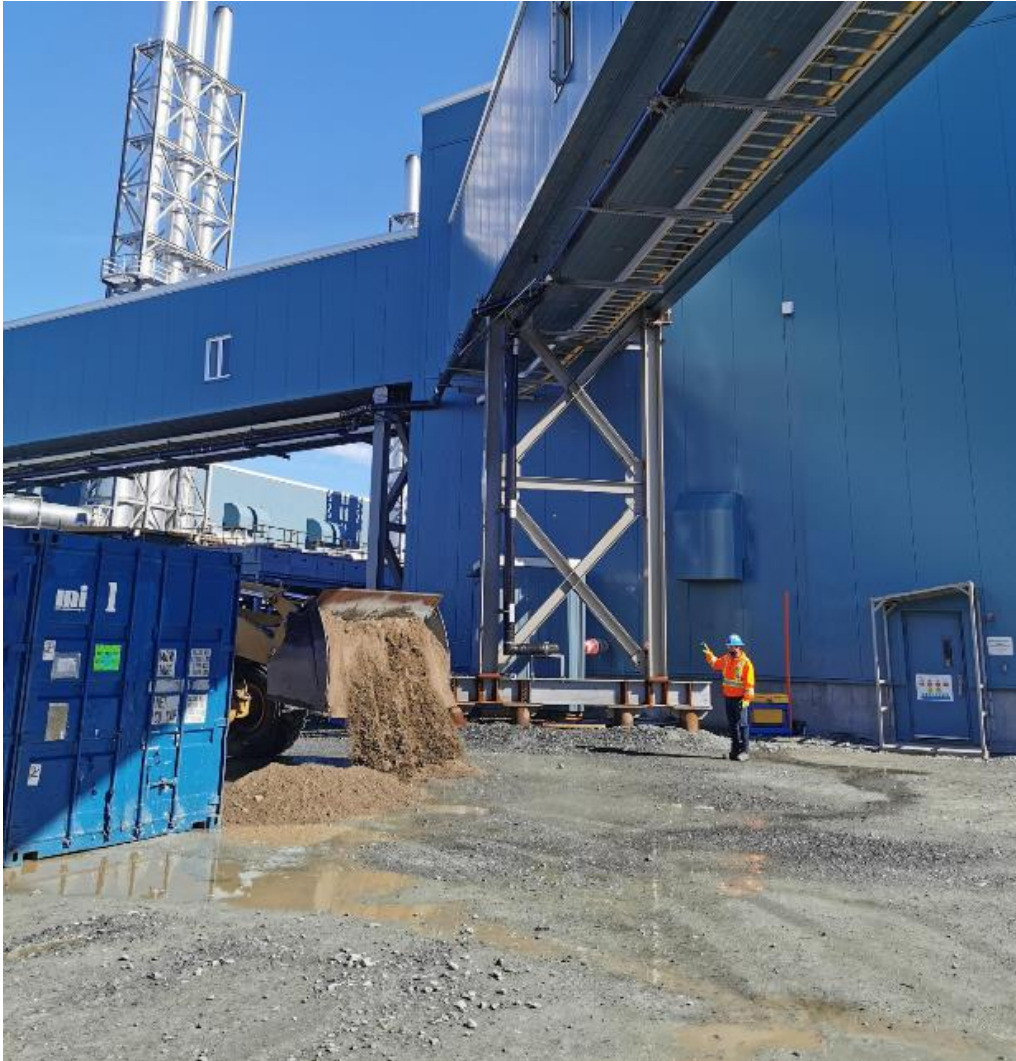
Figure 2: Sand berm being created at the south end of the spill location to contain the heat recovery water.

Sand berms were constructed in order to contain the spilled water in a central area and mitigate further migration until site personnel were able to shut down the system, preventing further release of heat recovery water. Contaminated material was removed with a front-end loader, placed in the Waste Rock Storage Facility 1 (WRSF1) and encapsulated in waste rock.

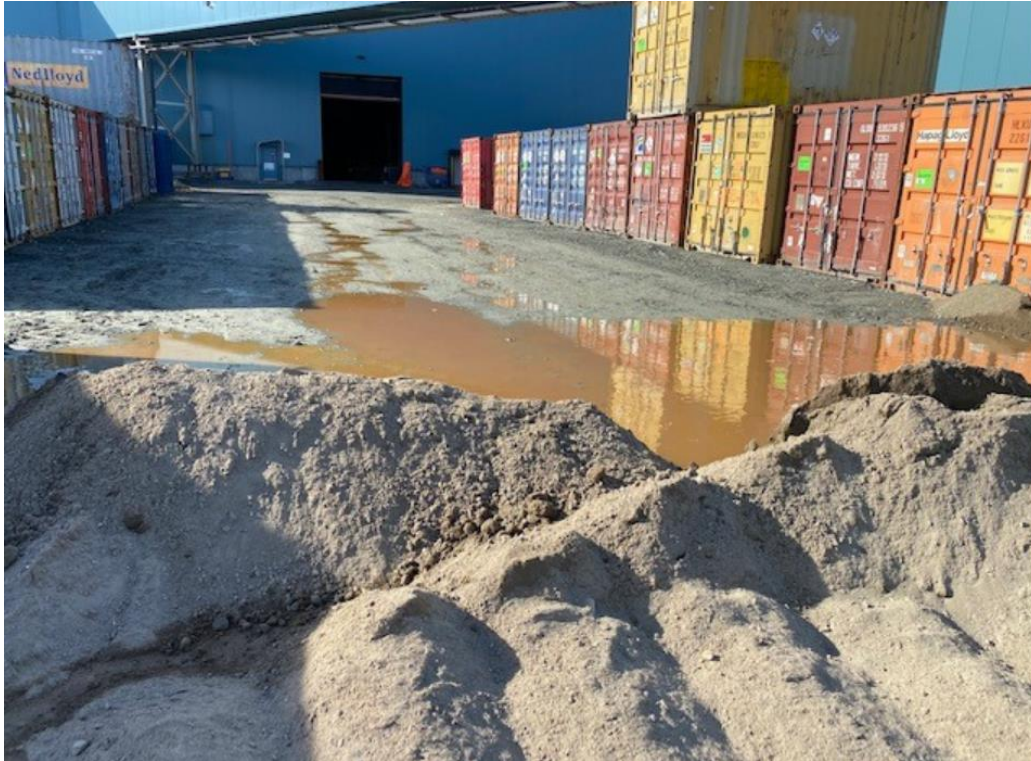
Figure 3: Sand berms constructed at the north end of the spill location.

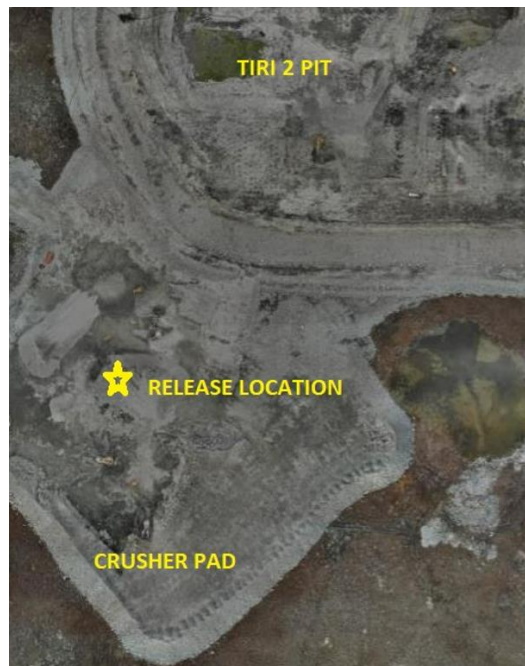
At approximately 16:30 on July 7, 2021, a hydraulic line ruptured while operating an excavator leading to the release of approximately 150 L of hydraulic oil. The oil was contained beneath the equipment, which was located at the onsite rock crushing pad.

Figure 1: Location of the spill on Crushing Pad.

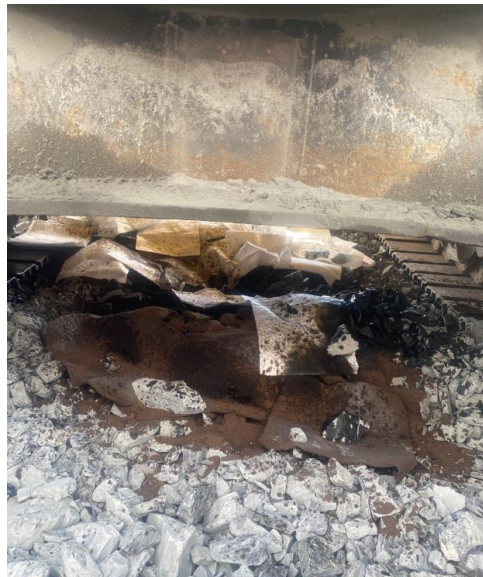
Figure 3: Spill containment

The excavator was shut down as soon as the operator noticed the stick (bucket) was not responding. Sorbent pads were placed under the excavator to collect the hydraulic fluid. The spill was contained within the immediate area around the excavator and remained on the crusher pad. The Pit Operations organized the clean-up of the area which involved using excavator to remove the material. An approximate volume of $\frac{1}{4}$ of a bucket from the 980 loader of contaminated material was recovered and brought to the Meliadine Type A Landfarm.

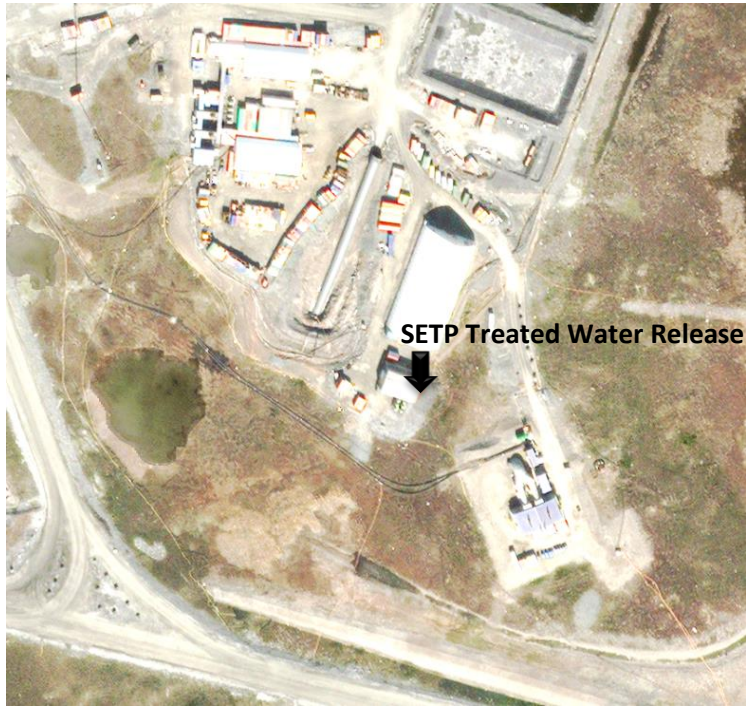
Figure 2: Location of SETP treated water spill within Meliadine's water management area.

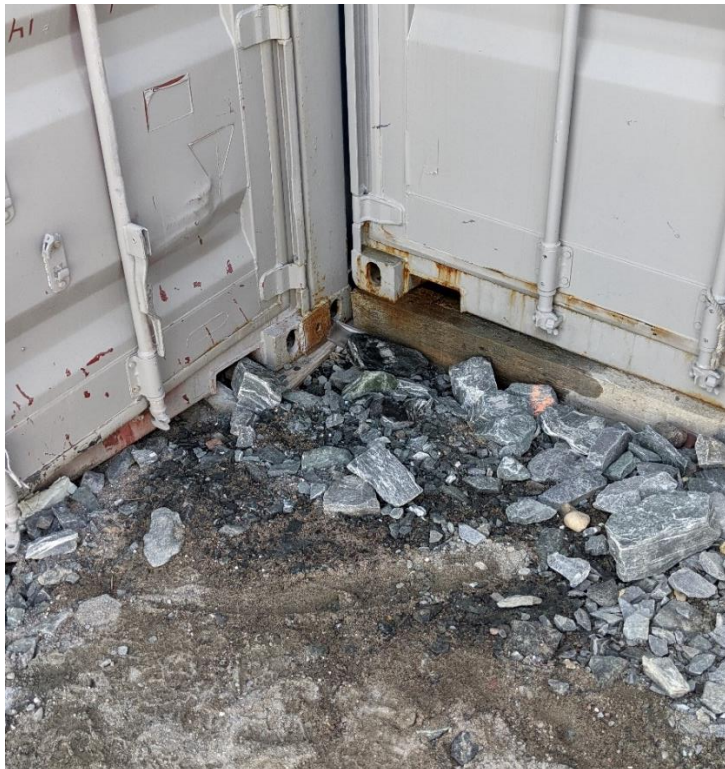
Figure 3: Treated water flow outside SETP.

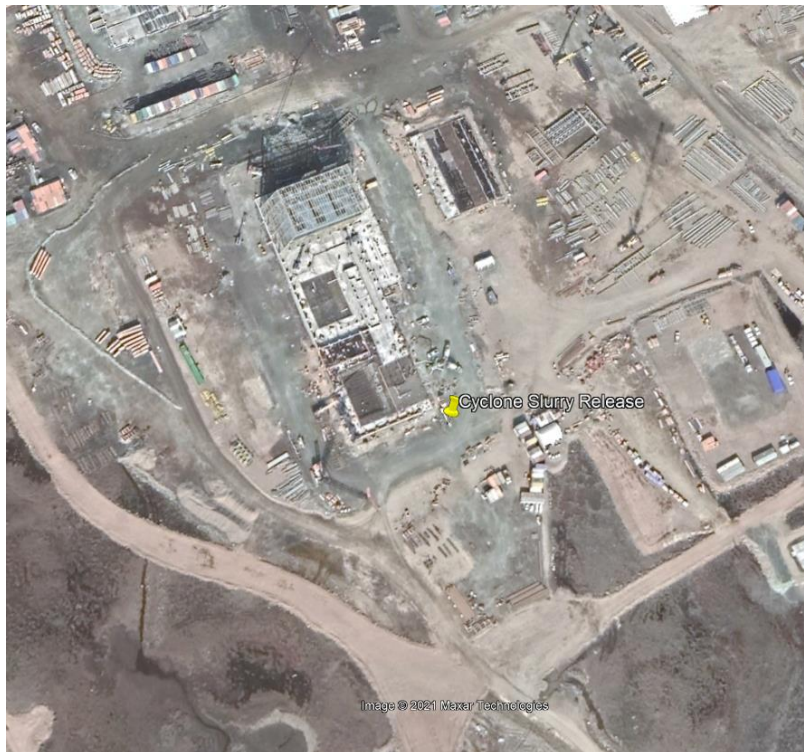
At approximately 6:00 am, July 14th, 2021, a blockage in the cyclone system within the process plant occurred preventing cyclone slurry (solid and water mix) from passing through the cyclone unit. The system backed up causing cyclone slurry to overflow to the floor of the process plant. Approximately 20m³ of cyclone slurry flowed outside of the building, onto the industrial pad. The spill volume was estimate based on the area and depth of the spilled material.

Figure 1: Location of process water spill within Meliadine's water management area.

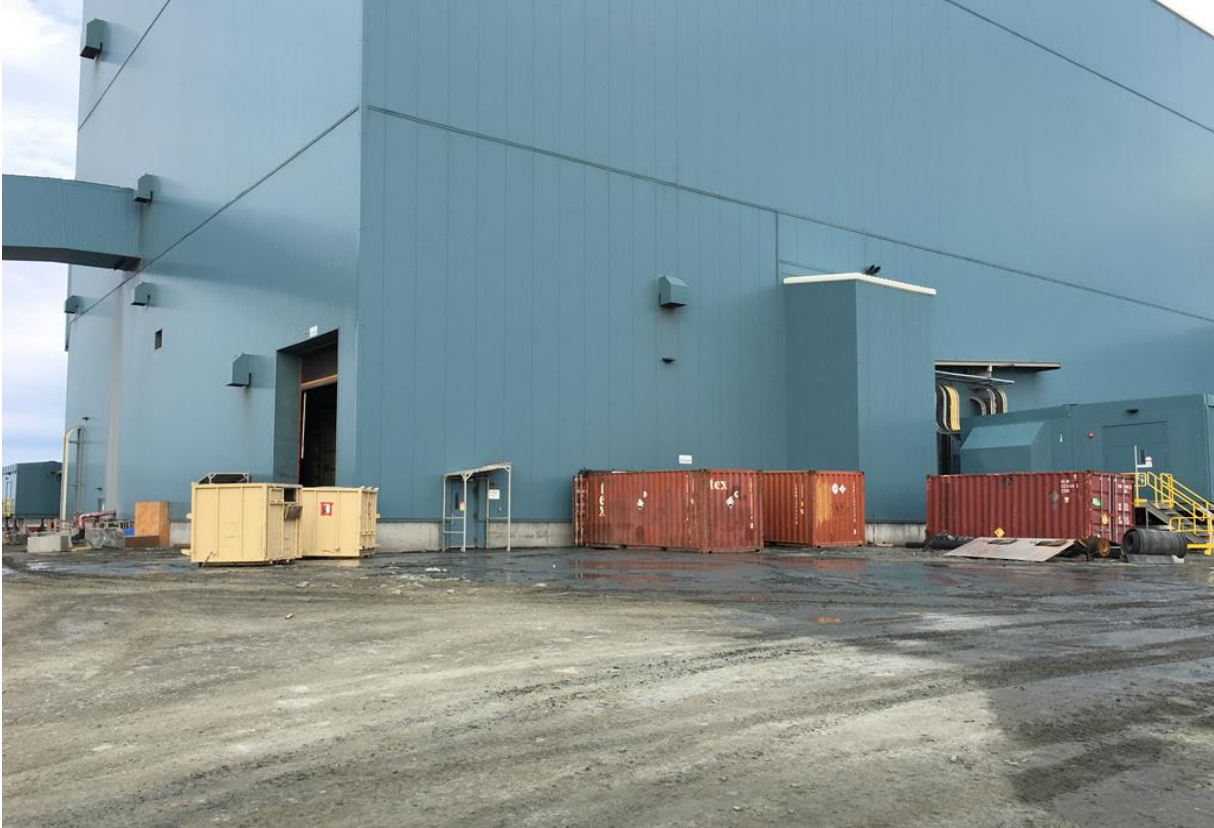
Figure 2: Cyclone slurry flow outside process plant.

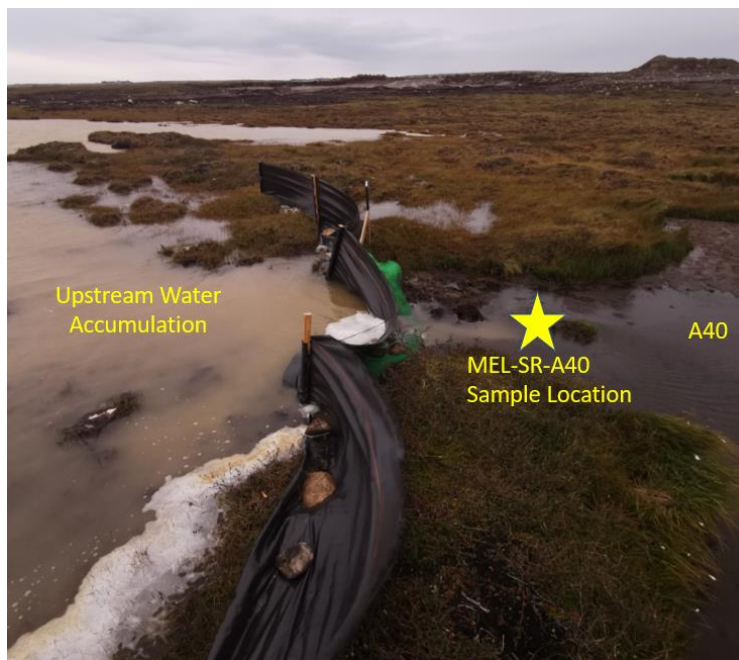
Upon being notified of the situation, Environment personnel acted quickly to retrieve sediment control logs from storage and to investigate the area of concern. Upon arrival the trench was observed to have turbid water flowing through it and accumulating into an area of ponded water upstream of A40. Upon closer inspection, the Environment personnel realized that the accumulated water was very turbid and was making its way to a smaller pond (A40) approximately 90m downstream which then flowed into a larger lake (A8) approximately 700m downstream. Without delay, sediment control logs were deployed at the outlet of the accumulated water and at the inlet of A40 (Figure 1). At this time a plume of turbid water had reached the inlet of A40, and a sample was collected.

Figure 2: Installation of sediment control fence and logs. Sample location established immediately downstream of the sediment control fence.

A sediment control fence and additional wood chip logs were installed at that location to prevent additional sediment from entering the pond and immediately lowered the turbidity of water entering A40 (Figure 2).

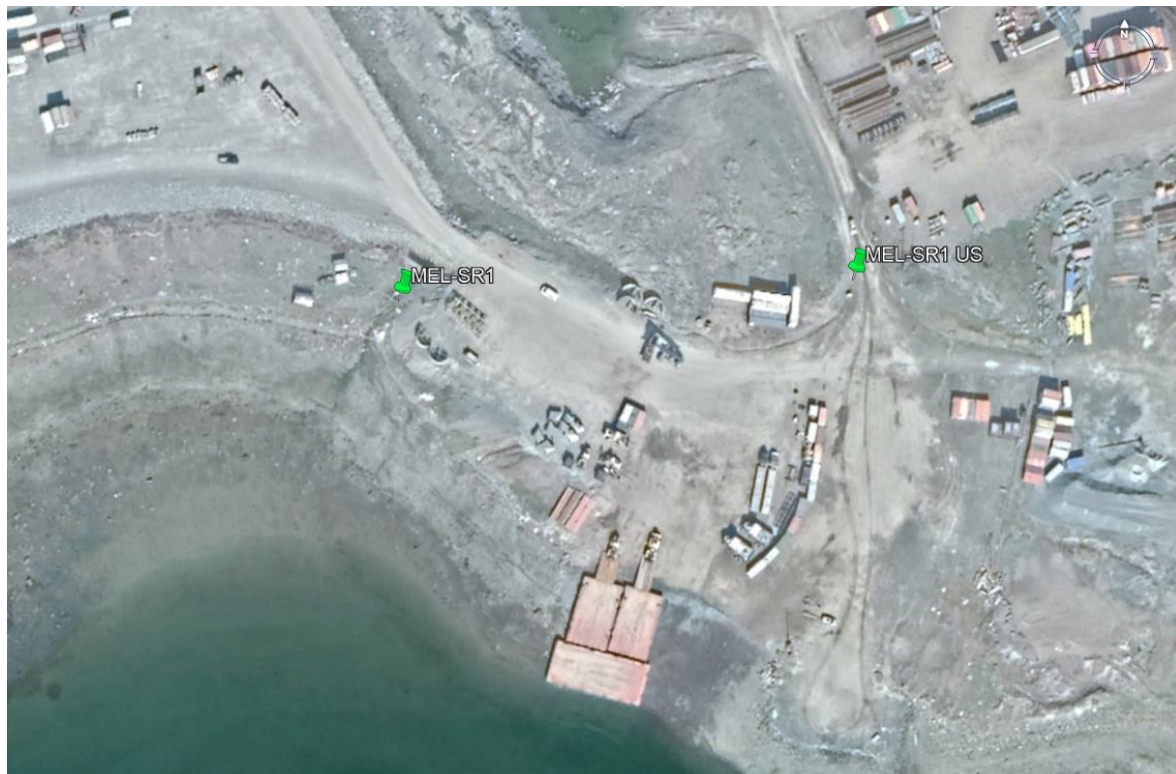
While conducting a routine inspection on August 12th, 2021, surface runoff water was observed at sampling station MEL-SR1 located on the south side of the Itivia site. Heavy rainfall resulted in an increased flow from the hamlet of Rankin Inlet through the Itivia site. Samples were collected at MEL-SR1 and analyzed for Total Suspended Solids (TSS) concentration and other water quality parameters. Laboratory results were received on September 9, 2021 and a concentration of 300 mg/L TSS was measured. This exceeded the criteria of 100 mg/L TSS, as per the obligations under the Nunavut Water Board License 2AM-MEL1631, Part D, item 18. When the analytical results were received and the exceedance identified Agnico Eagle Mines immediately reported the exceedance.

Figure 1: Sample locations MEL-SR1 and MEL-SR1 US

Location	Parameter	Value
MEL-SR1	TSS	300 mg/L
MEL-SR1 US	TSS	1000 mg/L

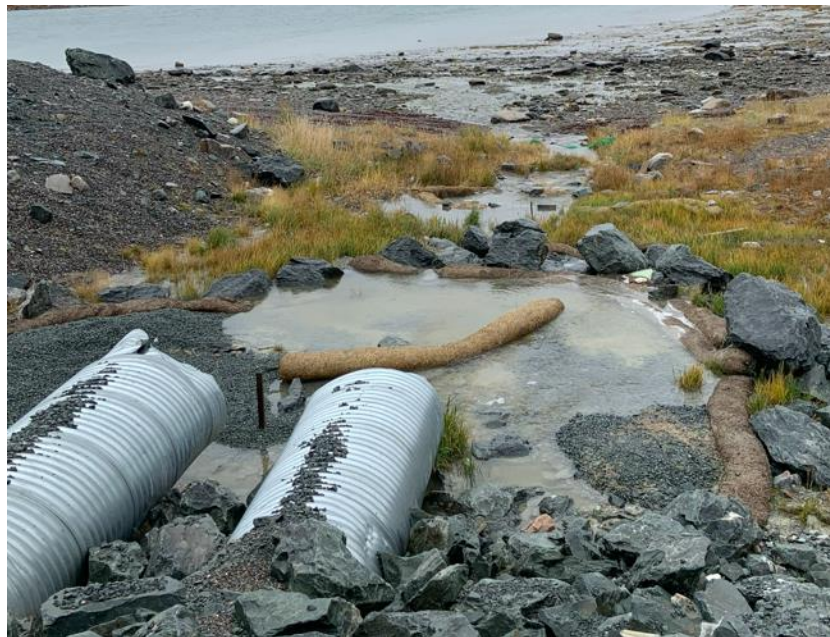
Figure 2: Sediment control at discharge

Sediment control devices (straw logs) are replaced as needed and seen in figure 2. Certificate of analysis for the August 12, 2021 sampling event is attached in appendix A.
