Appendix 16: 2021 Reportable Spills

Follow Up Report: #21-004

January 5, 2021 – 170 L Hydraulic Oil Spill

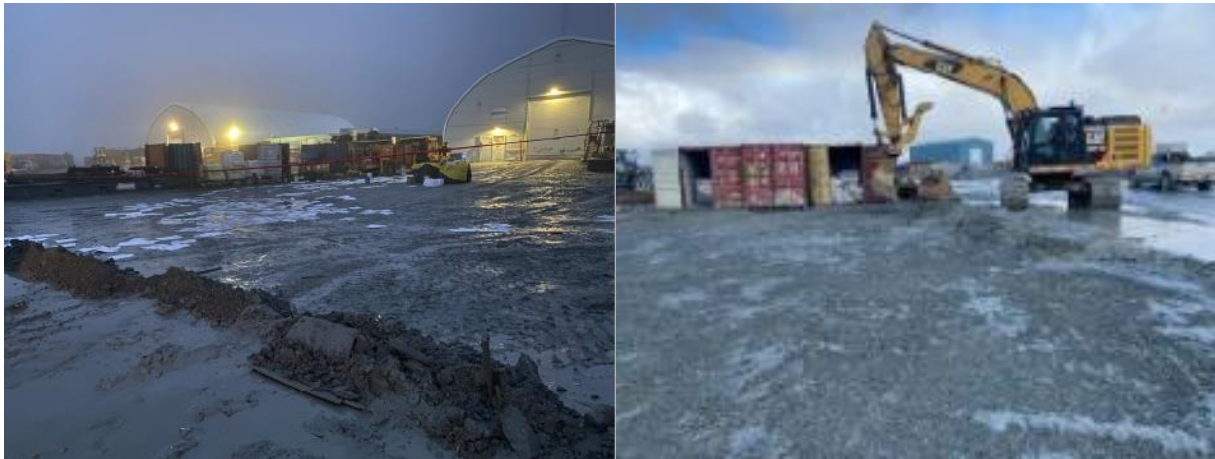
Spill pads were immediately placed on the affected area and a berm was constructed to contain the oil. The Underground Mine Supervisor and Environment Department organized a clean-up of the area. The area was cleaned up using an excavator and haul truck. All contaminated material was disposed of in the Landfarm.

Figure 3: Containment berm and excavator clean up.

The specific cause in this incident is attributed to human error and not following procedures. A review of the requirements was carried out with the individual to ensure proper understanding of the procedure and associated inspection checklist.

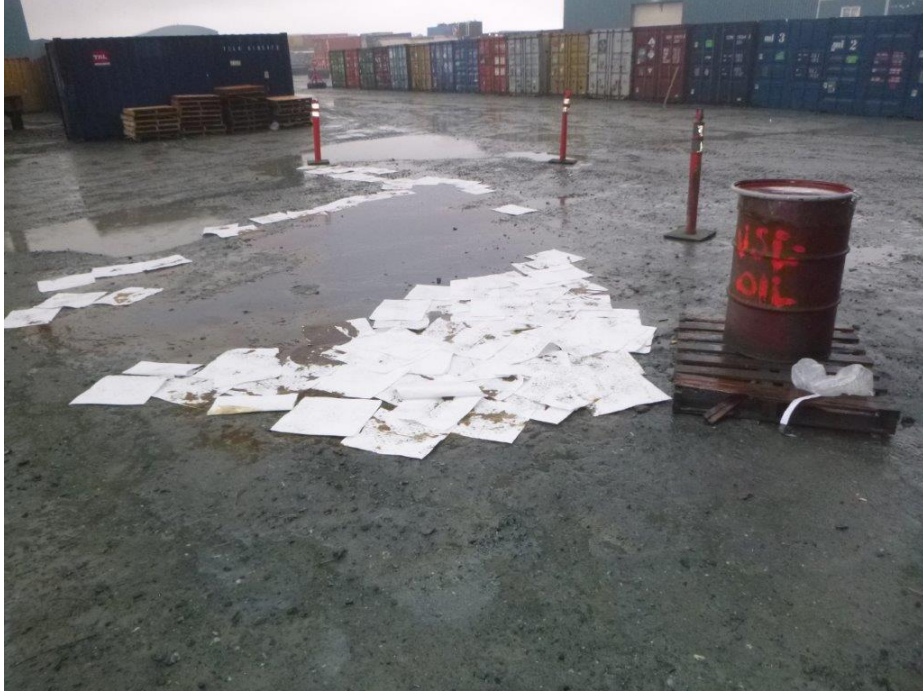
On October 4th the Environment Department was notified of a spill which occurred near the north side of the process plant. An employee walking to the process plant observed a barrel that had tipped over with industrial grease from the process plant and maintenance shop flowing out of the barrel, roughly 150L of grease was spilled.

Figure 2: Initial spill response; spill rags.

The employee that discovered the drum immediately placed the drum upright, contacted his supervisor and deployed spill rags (Figure 2).

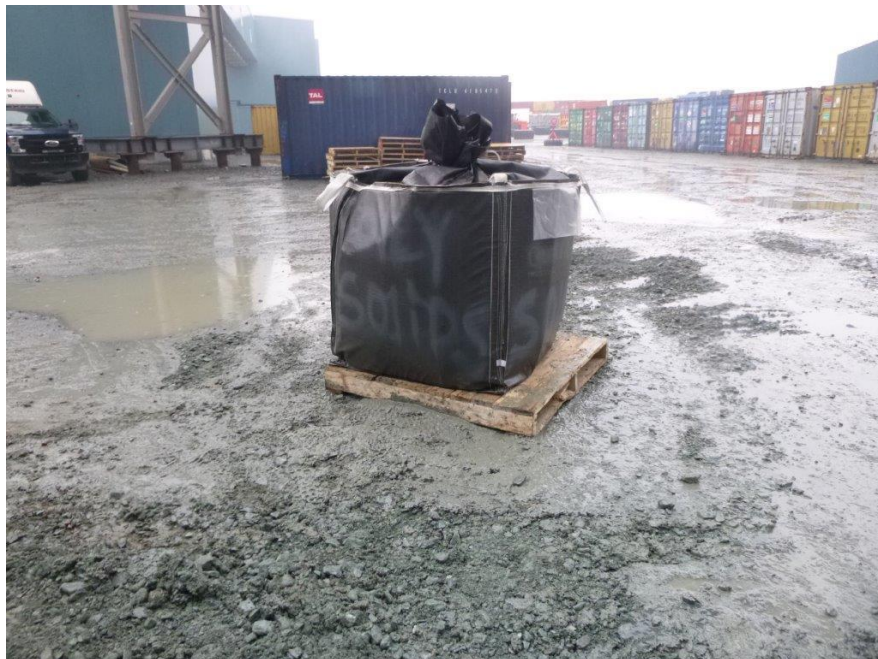
Figure 3: hazardous waste quatrex

After the surface material was collected with spill rags these were placed in a quatrex bag and brought to the hazardous waste laydown for proper storage (figure 3)

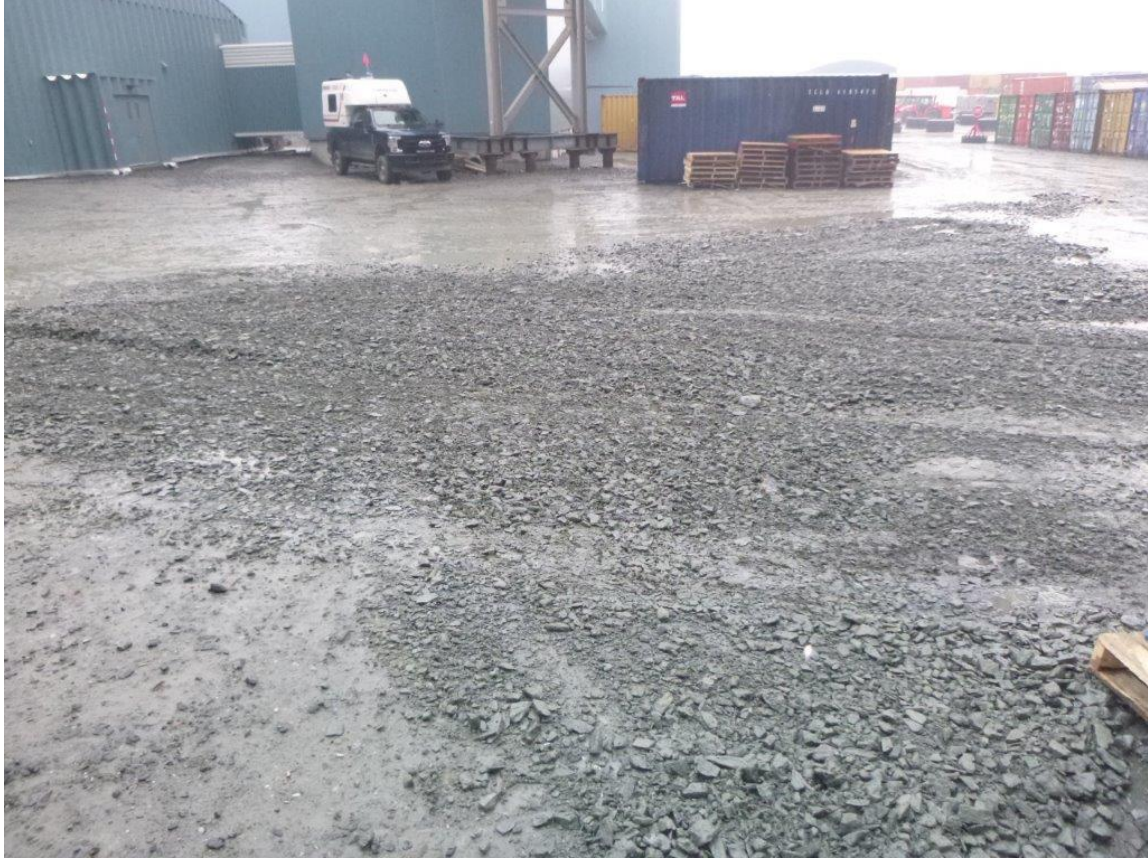
Figure 4: Spill area cleaned by heavy equipment

The contaminated area affected from the industrial grease spill was scraped up and brought to Landfarm A for remediation (figure 4)

2 cubic meters of contaminated gravel was removed from the surface of this pad. An investigation was completed with all departments involved and the Environment Department has provided them with a list of corrective and preventative measures. These include ensuring that personnel use a mandatory spotter when moving hazardous materials with forked equipment, having drums with hazardous waste secured on pallets prior to movement, repacking any improperly stored sea cans, and ensuring that staff are inspecting work areas for potential hazardous obstructions.

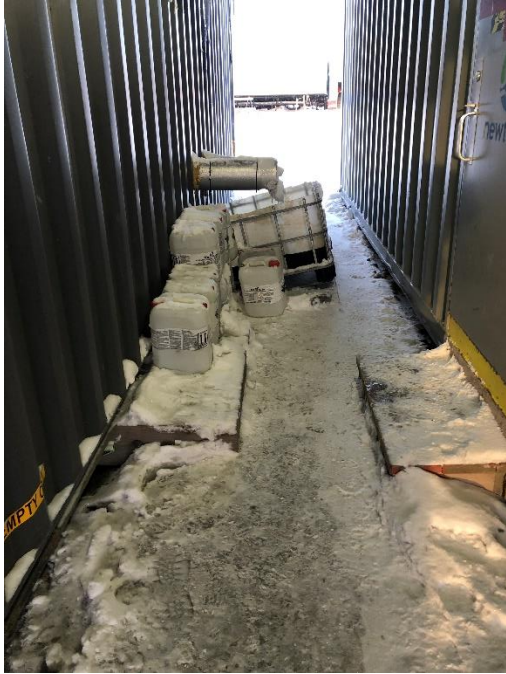
During normal operations, a suction effect from a tee in the piping system triggered a false alarm and activated an interlock that stopped both discharge pumps on the treated water tank. The high limit of the tank also failed resulting in a continuous flow of water to the tank and an eventually overflow. This resulted in a spill of 200 liters of treated water to the ground.

Figure 3: Frozen treated water outside STP.

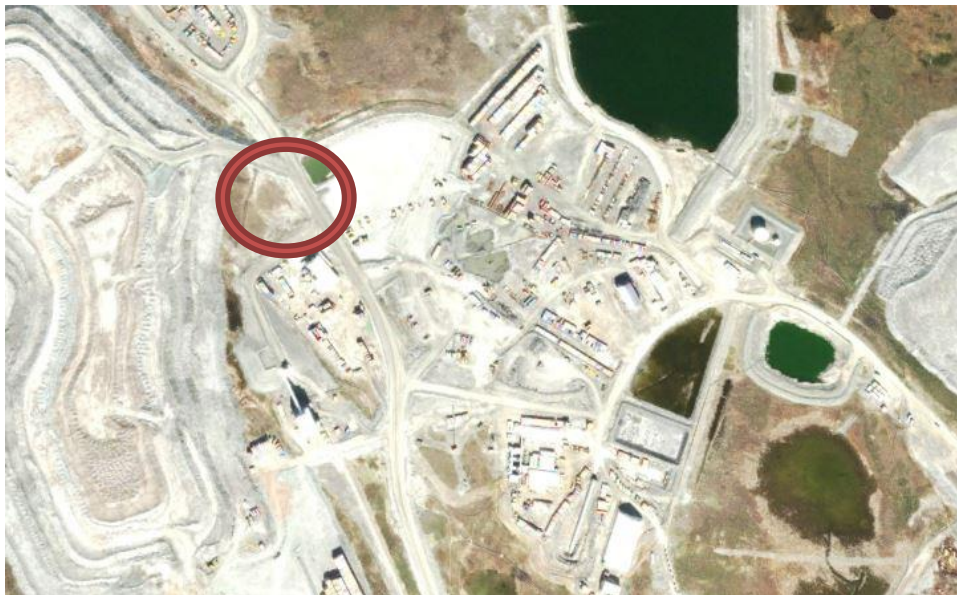
Figure 3: Contaminated material was placed at the contaminated snow cell

On December 9th the Orbit Garant drilling team was able to plow all the contaminated snow and ice into a large pile and brought this material to the Snow Cell (Figure 3) on our mine site where it will be stored until the summer and then treated through the oil-water separator.

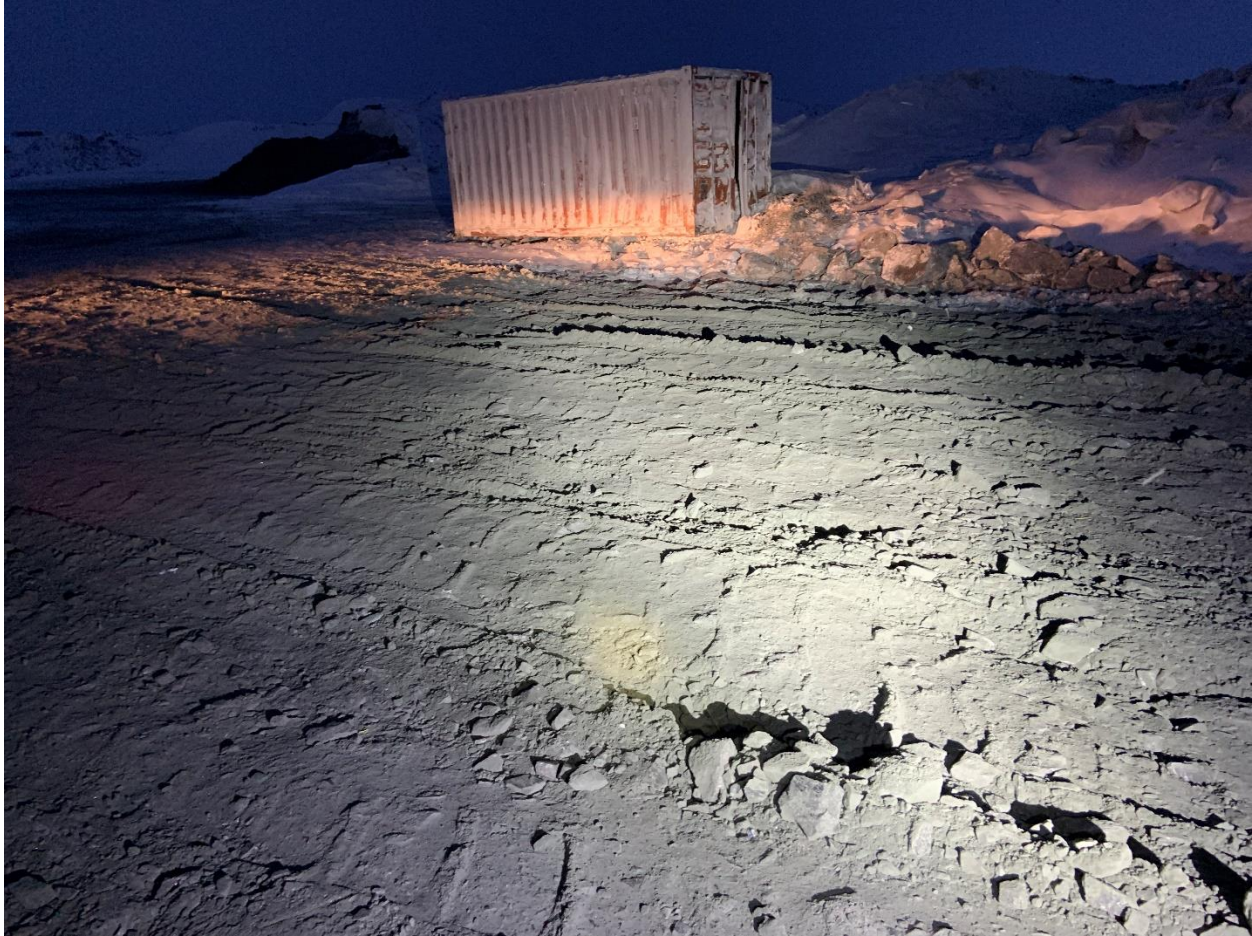
At approximately 14:00 on December 25, 2021, a 50-ton haul truck working on the Ore Pad 2 (OP2) experienced a hydraulic hose failure when moving its box forward. The operator lost hydraulic power and noticed the oil leaking. Approximately 100L of hydraulic oil was released onto the ore pad waste pile.

Figure 2: Area remediated of contaminated material

Operators used absorbent pads to absorb the oil and two quatex bags of oily rags were collected. The pad material below was scraped up with a loader and approximately one cubic meter of pad gravel was removed and brought to the Landfarm A, for future remediation.
