## Appendix 16: 2022 Reportable Spills

# Follow Up Report: #2022019

## January 25<sup>th</sup>, 2022 – Thickener Water Spill

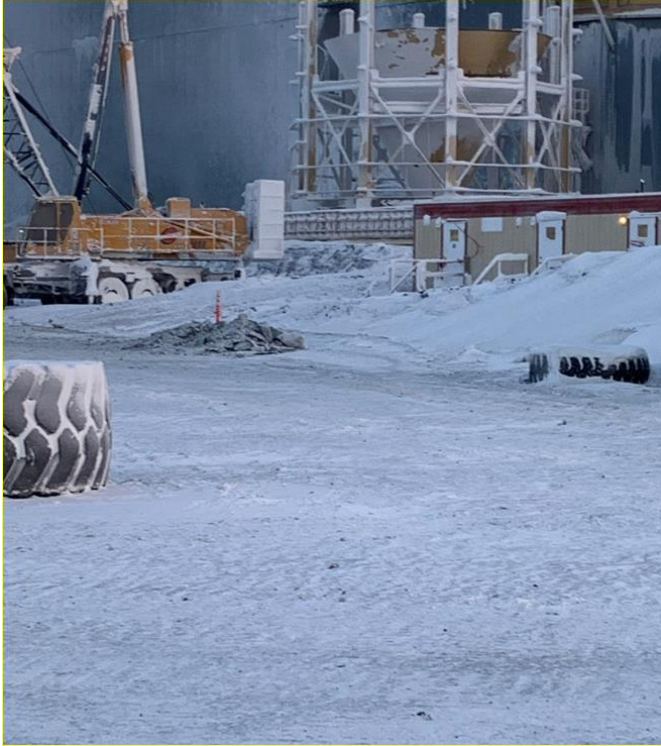
**Figure 2:** Final clean up.

The investigation into the cause of the release identified ice build at the overflow discharge pipe following a plant shutdown during blizzard conditions. The ice buildup resulted in a blockage of the discharge causing the thickener tank to overflow.

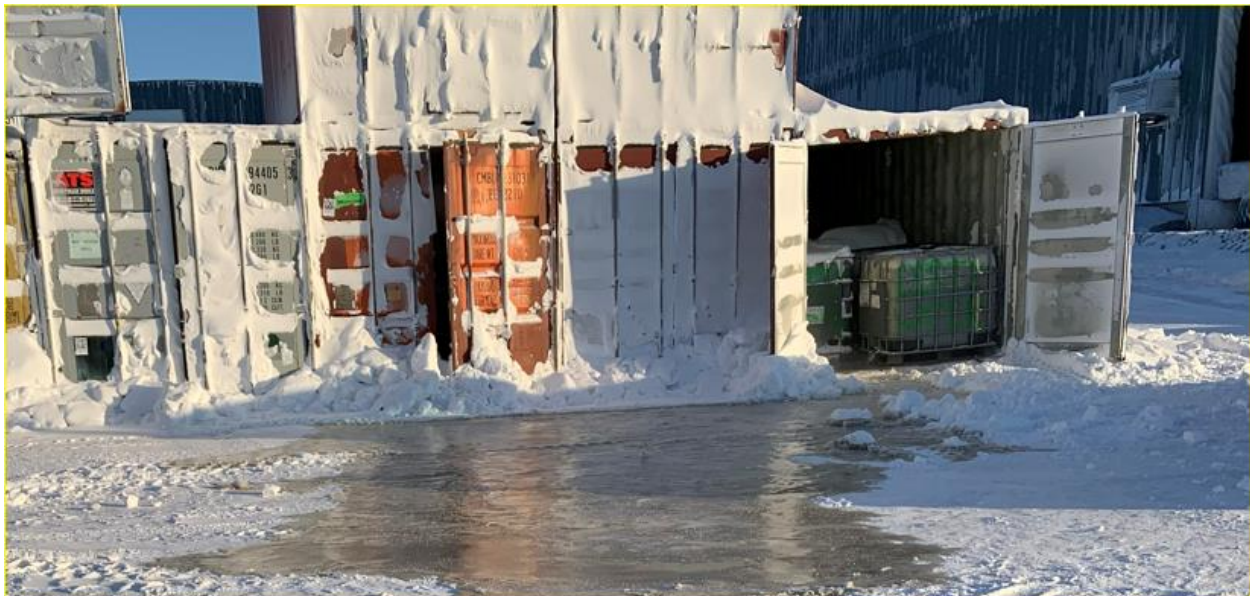
On January 30, 2022, an operator was using a skid steer to load oil contaminated wastewater totes into a seacan. The skid steer forks came into contact with a tote inside the seacan spilling the contents to the ground. Approximately 1000 litres of oil contaminated wastewater was spilled to the ground.

**Figure 1:** Spill scene January 30, 2022.

Frozen condition and the flat surface kept the spill contained to the local area as shown in Figure 1. The spill was cleaned up using a skid steer and the contaminated snow was disposed of in the contaminated snow cell.

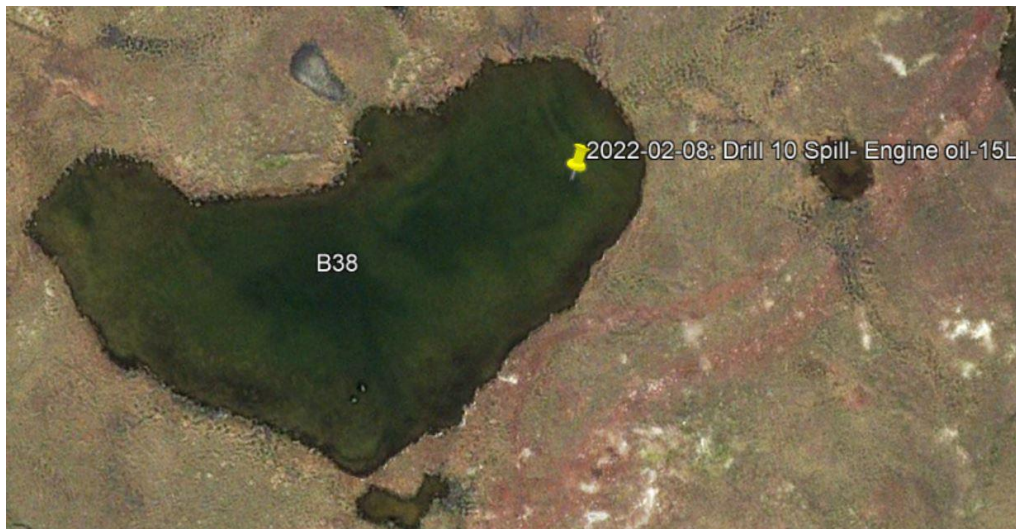
On February 8<sup>th</sup>, at approximately 14:00, Environment Technicians were conducting an inspection of surface Drill# 10, operated by AEM's contractor Orbit Garant. During the inspection, areas with small amounts engine oil dripping from inside the rigs onto the lake ice were observed. The drill released approximately 15 L of engine oil. The coordinates of the spill are: 63° 0' 28.93" N, 92°12' 31.50"W, on the Water body B38, which is a shallow pond with a maximum depth of 1.5 m (therefore it is generally assumed to freeze completely to the bottom and would not support fish through the winter season).

**Figure 1: Incident Location**

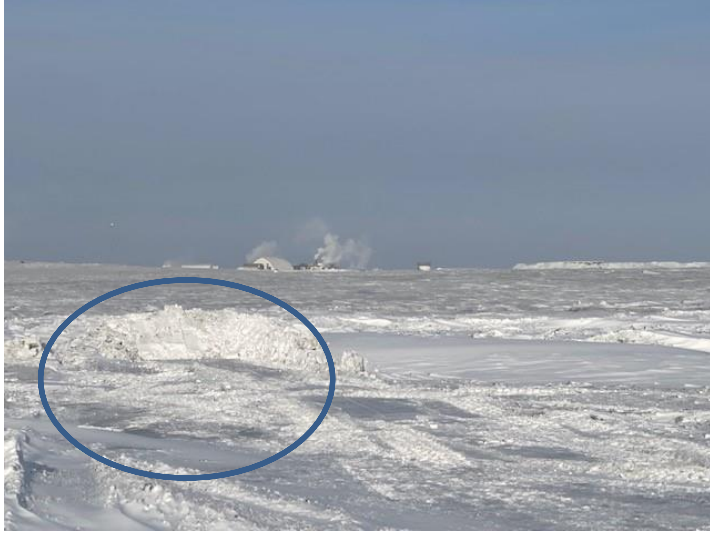
The drill was completed to another borehole location on February 14<sup>th</sup>, and the site remediation was performed during the following night. A dozer was used to scrape the contaminated snow and ice and a composite sample was collected on the ice surface of Pond B38 on February 15<sup>th</sup> in the incident area. The ice sample was sent to the laboratory for analysis of the following parameters: BTEX, F1-F4 Hydrocarbons, Oil & Grease, total metals, Conductivity, pH, and Total Suspended Solids (TSS).

Results showed concentrations below detection limit for BTEX and F1-F4 Hydrocarbons, while total Oil & Grease concentration is of 0.8 mg/L. For reference, the maximum concentration of any grab sample applicable to Effluent discharge in Meliadine Lake at monitoring station MEL-7 is of 5 mg/L for Oil & Grease and no visible sheen, as per Water Licence 2BB-MEL1424 Part D Item 11. The certificate of analysis is attached and identified as Appendix A.

**Figure 2: Area after remediation efforts**

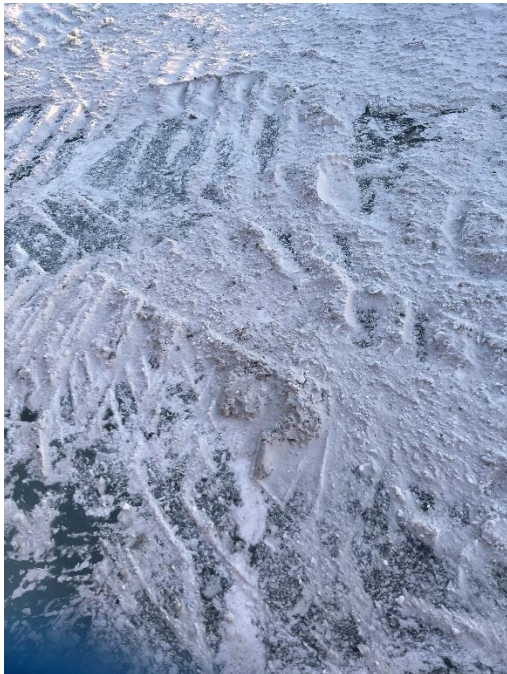
**Figure 3: Ice surface after remediation efforts**

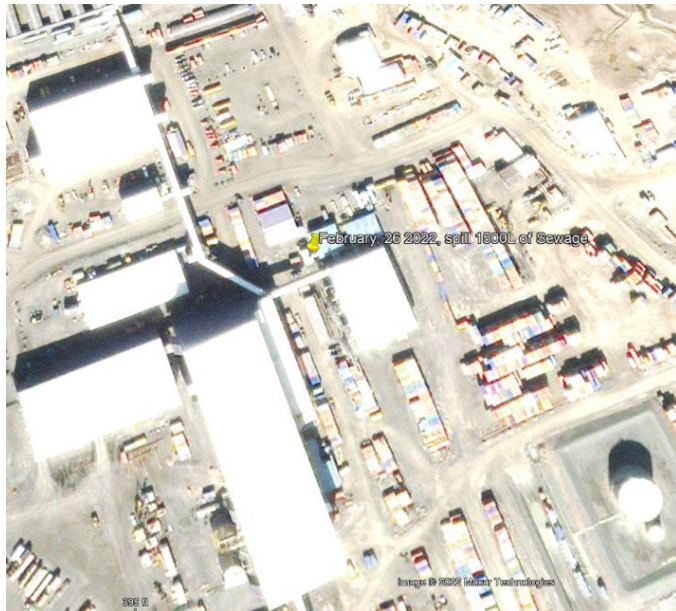
At approximately 9:00 on February 26, 2022, the Environment department was notified of a spill of approximately 1500 L of sewage. The power plant lift station overflowed resulting in a spill of 1500 L of sewage on the industrial pad.

**Figure 1:** Location of the spill by the power plant lift station

A malfunction on the pump discharge line caused wastewater from the process plant to backfill into the power plant lift station, causing an overflow.

Following this event, a plumber was sent to inspect and repair the line. The check valve on the pump discharge line was replaced and the high-level float preventing the pump from continuously running was also serviced. Furthermore, daily lift station checks are being conducted by the Energy and Infrastructure Department.

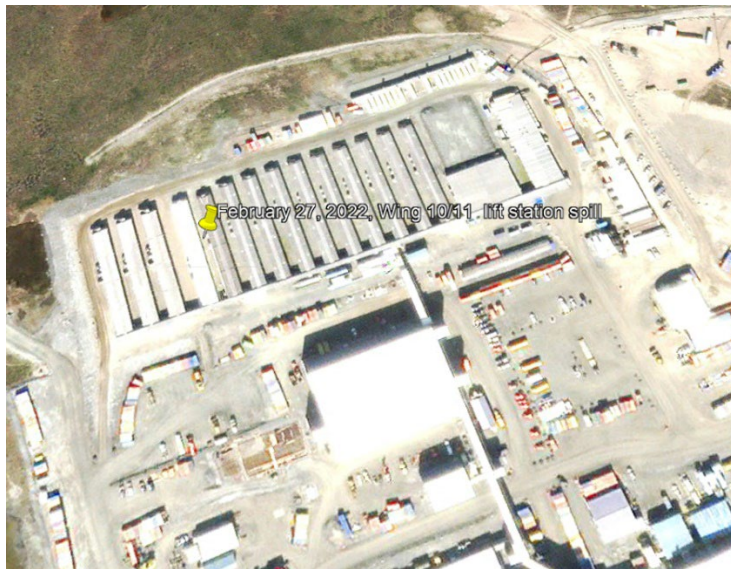
At approximately 22:00 on February 27, 2022, sewage was spilled from the Wing 10 and 11 lift station. The exact volume of the spill could not be estimated due to health and safety concerns as there are electrical lines in the area which restrict equipment and personnel access. Approximately 150 L of visible and accessible sewage was removed using hand tools.

**Figure 1:** Location of the spill between wings 10 and 11.

The door of the lift station was found opened. This led to the discharge lines freezing and resulted to an overflow in the lift station. Additionally, the alarm in the lift station froze in the cold weather, rendering it inoperable.

A door latch has been installed to keep the door closed and a frost fighter was also installed to prevent the line from freezing in the future.

Furthermore, an electrician has performed an inspection of all safety/warning systems (strobes and horns) on all lift stations to ensure that safety systems are working as designed and has recommended installation of alarms supporting colder conditions which will be installed in the upcoming weeks.

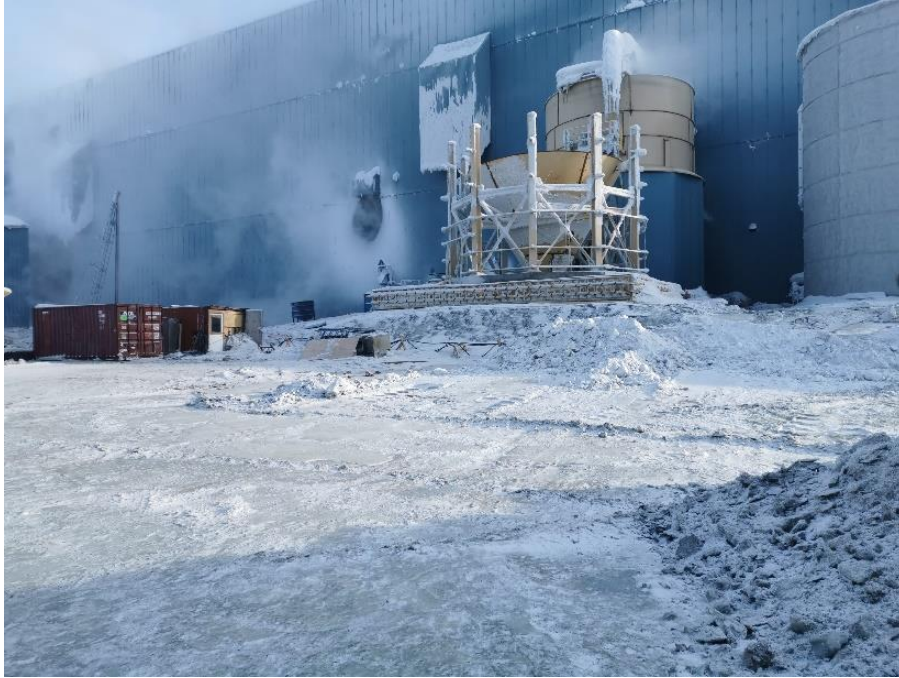
**Figure 2:** Thickener process water spill clean up

The investigation into the cause of the release identified ice build at the overflow discharge pipe. The ice buildup resulted in a blockage of the discharge causing the thickener tank to overflow.

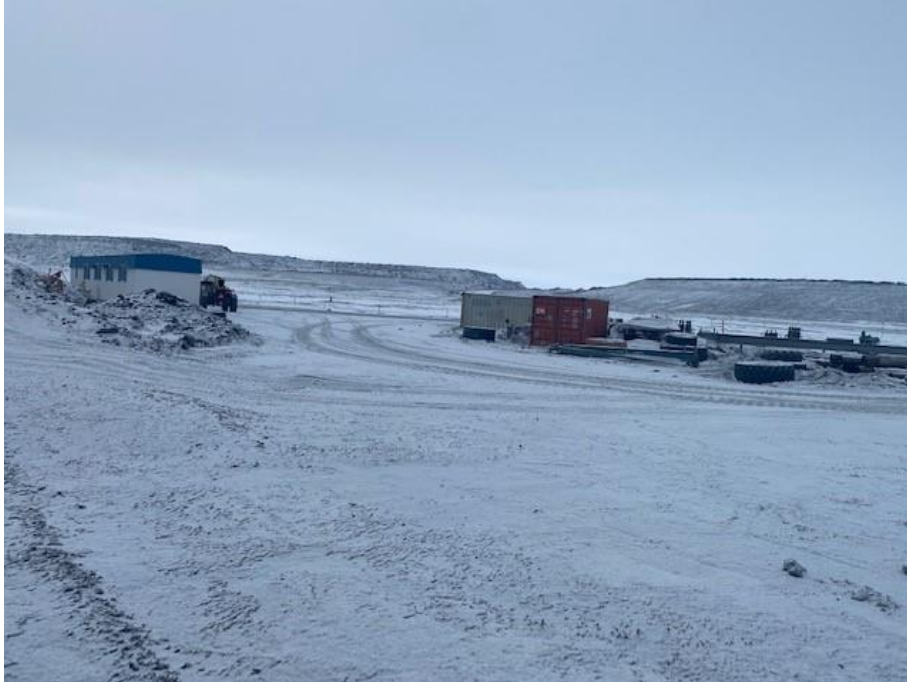
**Figure 2:** Thickener process water spill clean up area

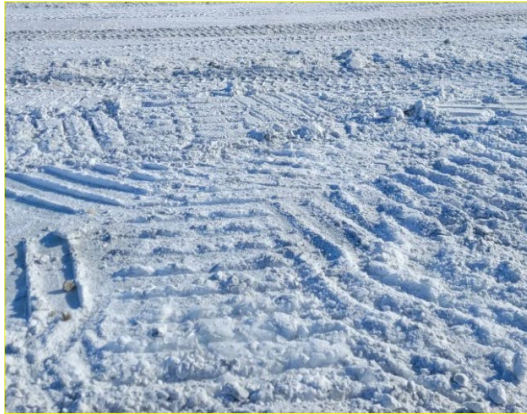
It is expected that minimal impacts occurred to the waterbody as the spill occurred on the lake ice, facilitating the recovery of the contaminated material – the contaminated ice was scrapped off.

A composite sample was collected on the ice surface of waterbody A8 on March 23<sup>rd</sup>, 2022, in the incident vicinity and was analyzed for the following parameters: BTEX, F1-F4 Hydrocarbons, Oil & Grease, total metals, Conductivity, pH, and Total Suspended Solids (TSS). The certificate of analysis is attached and identified as Appendix A; results showed concentrations below all Licence criteria for effluent release.

**Figure 3: Spill location after drill removal and completion of cleanup**

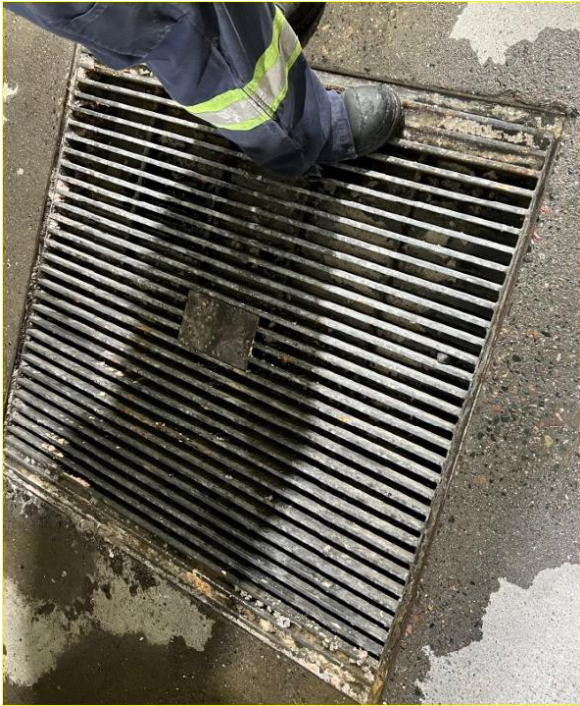
**Figure 3:** Dyno Equipment Shop collection sump

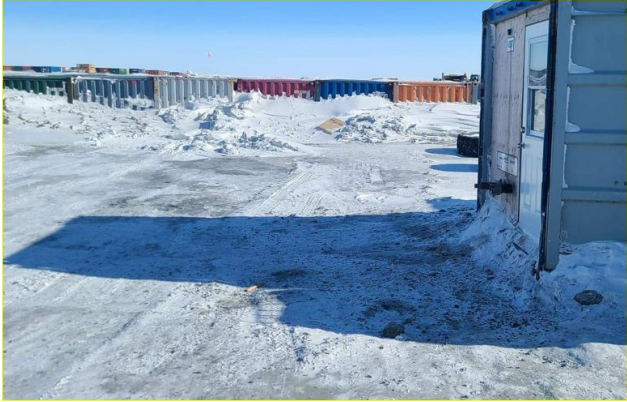
The spill was contained to the local area. The topography of the area and the freezing conditions prevented the sewage from migrating off site, facilitating spill recovery. Frozen contaminated material was collected using a backhoe and placed in drums to be returned to the sewage treatment system at a later date.

**Figure 2:** KCG sewage lift station tank spill cleanup

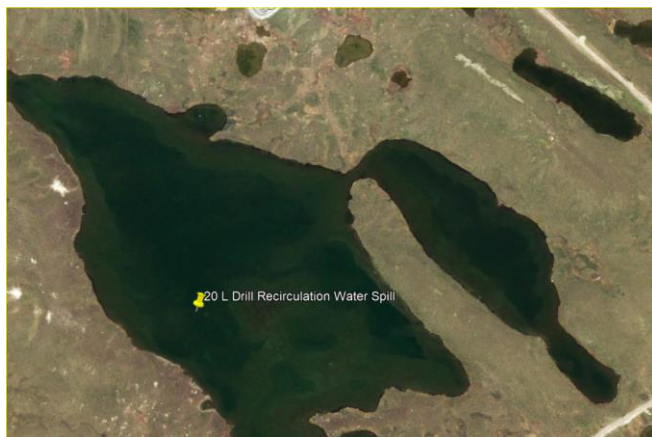
On March 29<sup>th</sup>, 2022 during an environmental inspection of the Orbit Garant drill rigs located on waterbody A8, a worker identified that 20 L of drilling recirculation water had overflowed from the decantation tank to the surface of the ice.

**Figure 1: Drilling recirculation water spill location**

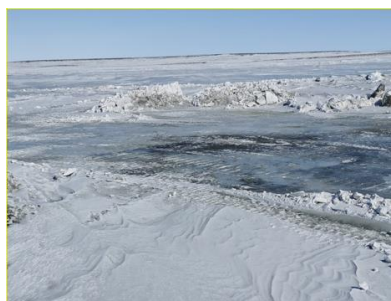
At the time of inspection, the decantation tank was no longer overflowing, and drilling recirculation water was no longer spilling onto the ice. The cleanup of the spill was completed as part of the final site cleanup as all drilling operations were complete at the site. During the drill site cleanup all impacted snow and ice was removed and sent to the drill cuttings disposal area with the remaining drill cuttings.

**Figure 2: Spill Location- Post cleanup**

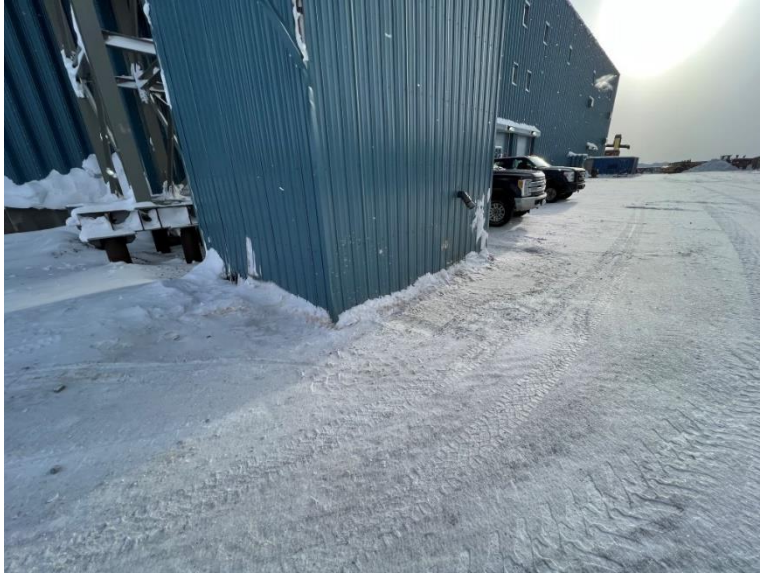
The spill was contained to the local area. The topography of the area and the freezing conditions prevented the sewage from migrating off site, facilitating spill recovery. Frozen contaminated material was collected and placed in a drum which will be sent south for hazardous waste disposal (contaminated ice and gravel).

**Figure 2:** MSB lift station spill clean up

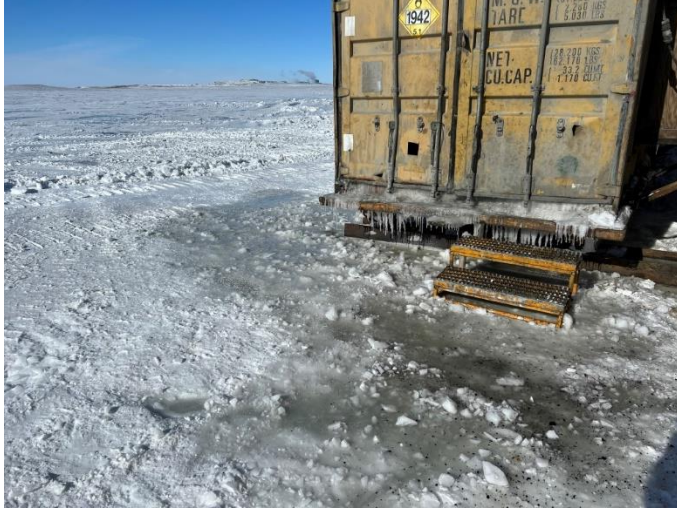
At the time of inspection, the decantation tank was no longer overflowing, and drilling recirculation water was no longer spilling onto the ice. The cleanup of the spill was completed as part of the final site cleanup as all drilling operations were complete at the site. During the drill site cleanup all impacted snow and ice was removed and sent to the drill cuttings disposal area with the remaining drill cuttings.

**Figure 2:** Spill Location- Pre-cleanup

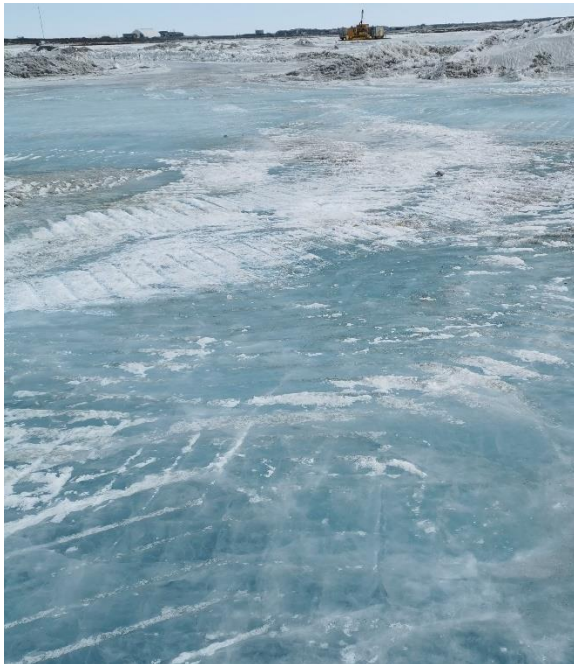
**Figure 3:** Spill Location- Post cleanup

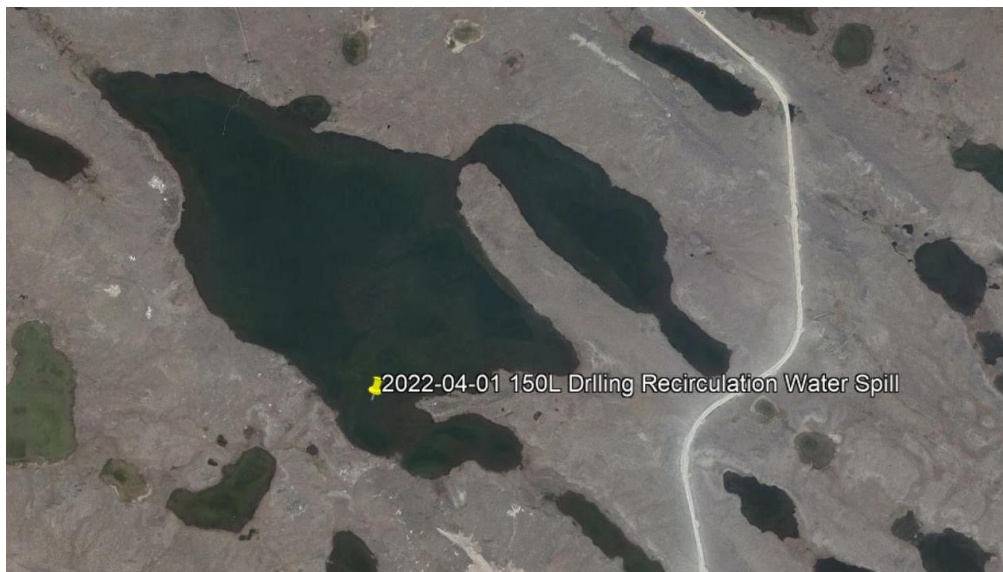
On April 1<sup>st</sup>, 2022, during an environmental inspection of the Orbit Garant drill rigs located on waterbody A8, a worker identified that 150 L of drilling recirculation water had overflowed from the decantation tank to the surface of the ice.

**Figure 1:** Drilling recirculation water spill location

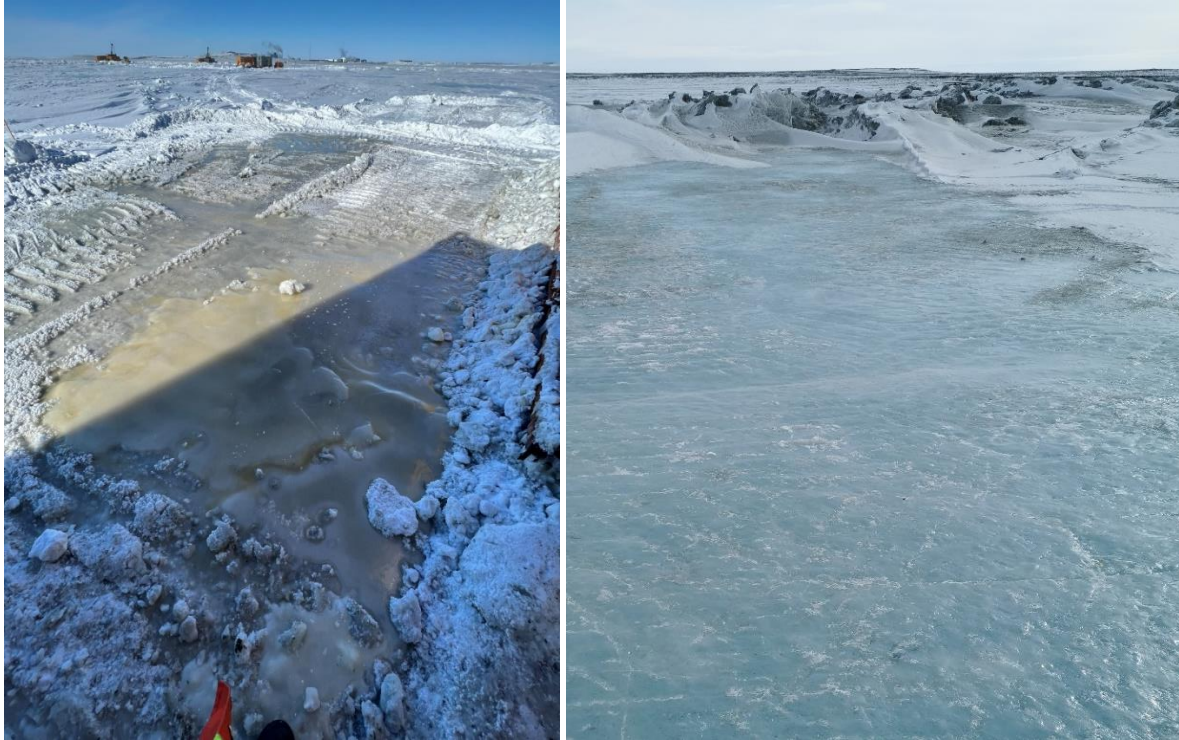
At the time of inspection, the decantation tank was no longer overflowing, and drilling recirculation water was no longer spilling onto the ice. The cleanup of the spill was completed as part of the final site cleanup as all drilling operations were complete at the site. During the drill site cleanup all impacted snow and ice was removed and sent to the drill cuttings disposal area with the remaining drill cuttings.

**Figure 2&3:** Spill Location- Pre-clean (left) and post clean up (right)

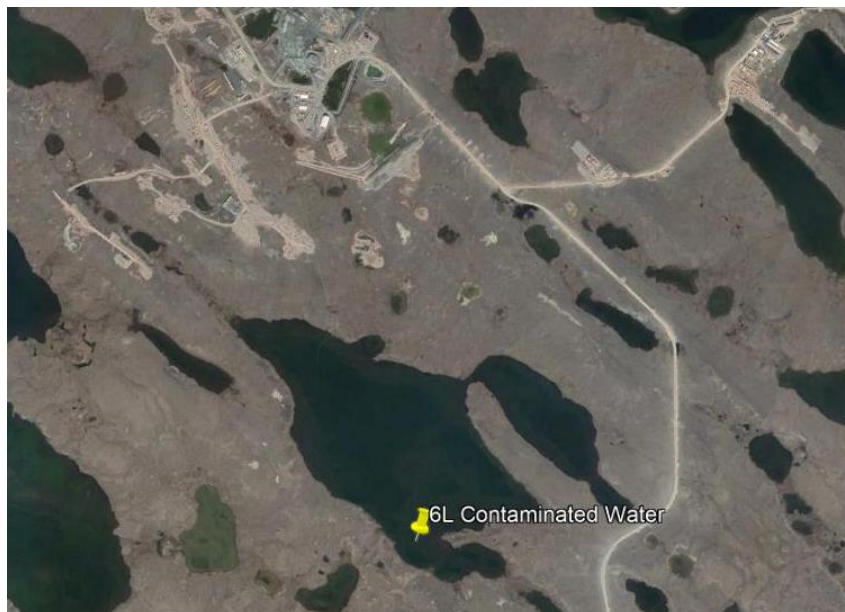
On April 3<sup>rd</sup>, 2022, during an environmental inspection of the Orbit drill rigs located on waterbody A8, a worker identified water leaking from the heating unit sea-can to the surface of the ice. Upon inspecting the heating unit sea-can, it was discovered that the water recirculation pump had failed, which resulted in 6 L of contaminated water to leak inside on the sea-can floor thus being released on the surface of the ice. It is suspected the water came in contact with the heating sea-can floor which contained traces of hydrocarbons, and therefore is treated as contaminated water spill. No contaminated water entered the waterbody as it was contained on the surface of the ice cover.

**Figure 1:** Contaminated water spill location

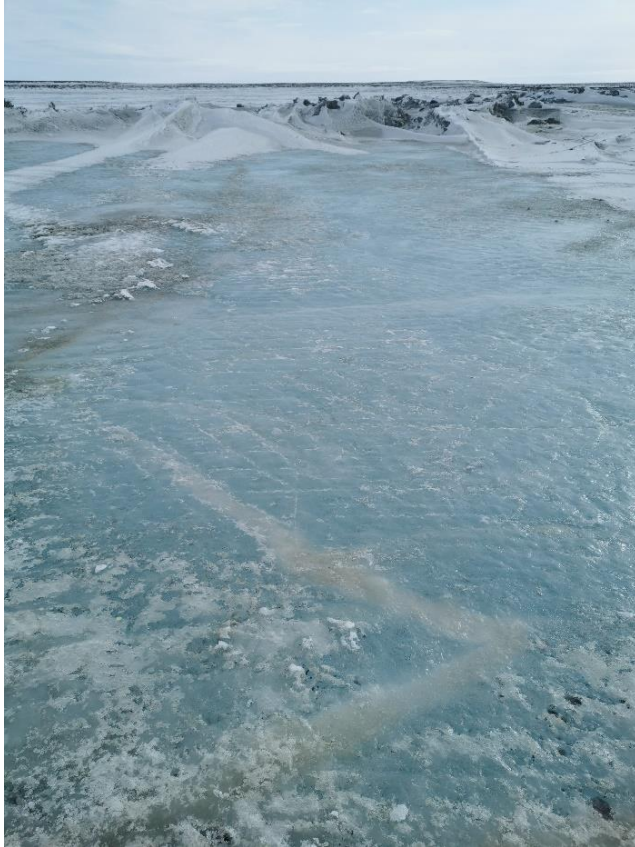
Orbit Garant immediately stopped the recirculation water pump. The contaminated ice and water were shoveled and brought to the contaminated snow cell where it will be stored until snowmelt, at which point the contaminated water will be transferred to the Landfarm for treatment at the oil-water separator, with the other existing material accumulated during Winter, as per the Water Management Plan.

**Figure 2:** Spill Location- Post cleanup

The release was a result of equipment failure as the pump recirculation pump failed. The pump was changed immediately to prevent another potential spill.

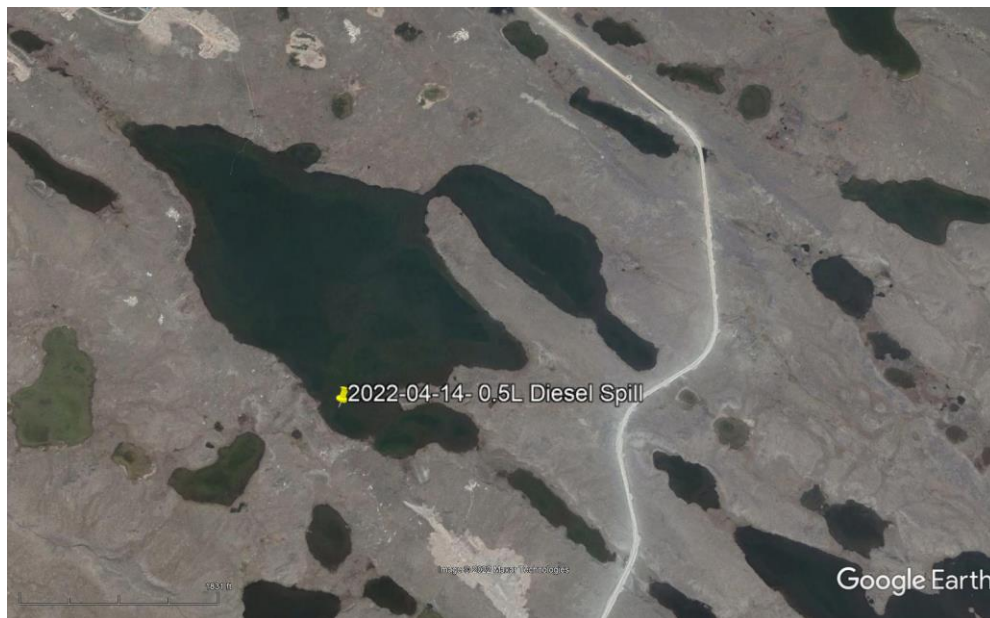
On April 14<sup>th</sup>, 2022, at approximately 10:30, the Environment Department was conducting an inspection of the surface drill areas, operated by AEM's contractor Orbit Garant. During the inspection, 0.5 L of diesel fuel was observed underneath the fuel over pack can at Drill 4 on the surface of the lake ice.

**Figure 1: Incident Location**

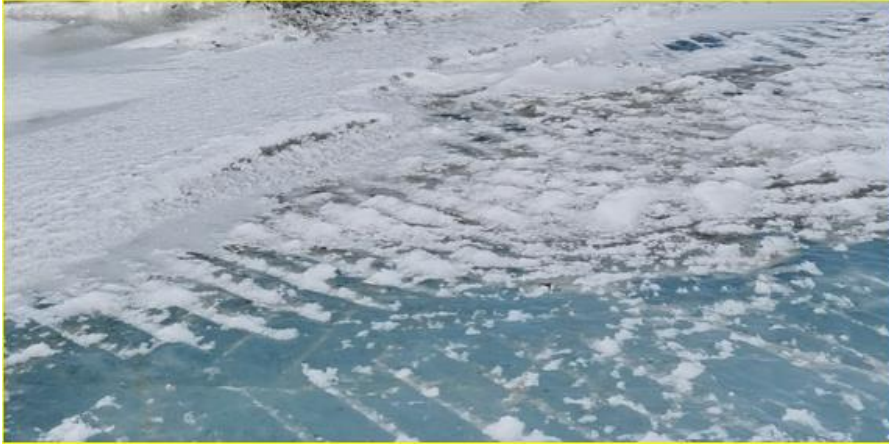
**Figure 3: Spill location after completion of cleanup**

The cause of the spill was identified as equipment failure. The fuel hose was damaged by normal use. The fuel hose was immediately changed to prevent another spill.

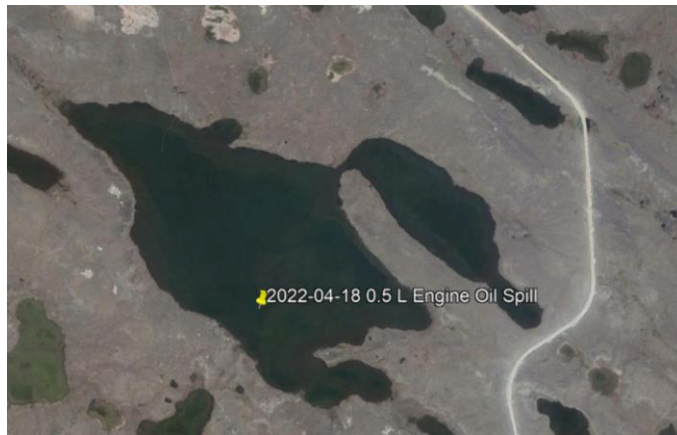
On April 18<sup>th</sup>, 2022 at approximately 11:30, Environment Technicians were conducting an inspection of surface Drill# 7 M22-3396, operated by Orbit Garant. During the inspection, areas with small amounts engine oil coming out of the drill shack and from underneath the drill onto the lake ice were observed. It is estimated approximately 0.5 L of engine oil was released onto the lake ice.

**Figure 1: Incident Location**

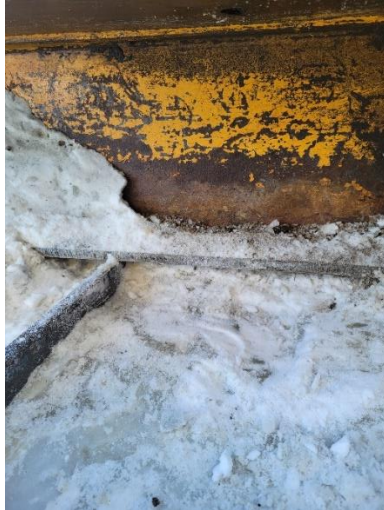
**Figure 2: Spill Location – Post cleanup**

The release was a result of a human error as the worker didn't use a funnel to fill the tank. Some engine oil was spilled inside the drill and released outside the drill through the drain hole.

Funnels are now used. A spill tray was also installed under the drain hole to collect any other substance that could be released through the drain hole.

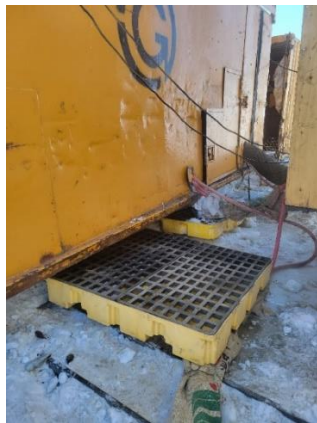
**Figure 3: Spill tray installed under the drain hole**

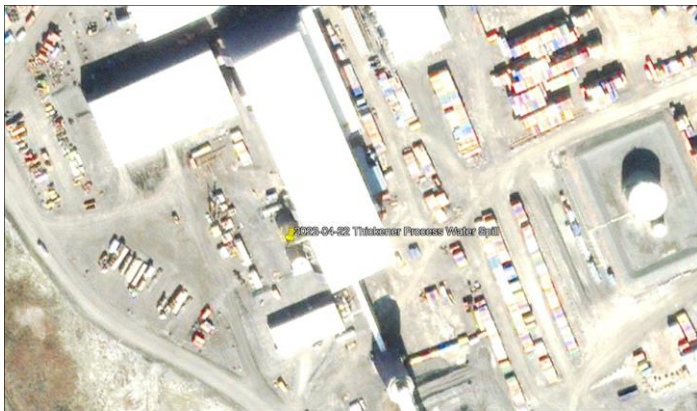
On April 22<sup>nd</sup>, 2022, a shutdown of the clarifier in the process plant caused process liquids to backup, resulting in an overflow of thickener. 10 cubic meters of thickener process water flowed onto the ground outside of the process plant.

**Figure 1:** Location of the April 22<sup>nd</sup>, 2022, thickener process water spill.

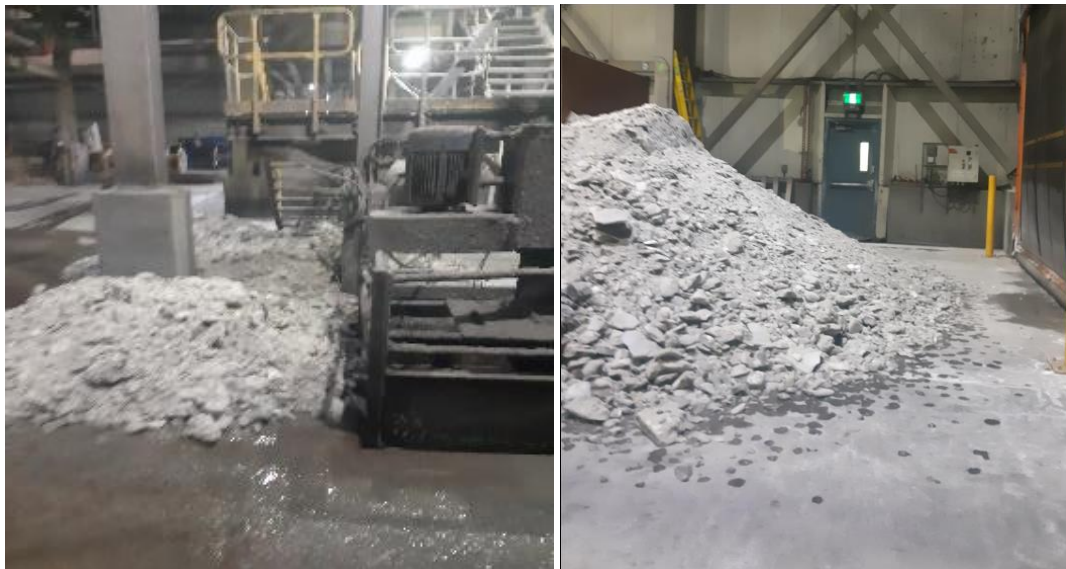
The topography of the area and the freezing conditions caused the thickener process water to pool and freeze on the west side of process road. A loader and haul truck were used to cleanup the material. All material collected was placed in the process plant where it will melt and be returned to the process plant system.

**Figure 3:** Thickener process water spill material disposal location

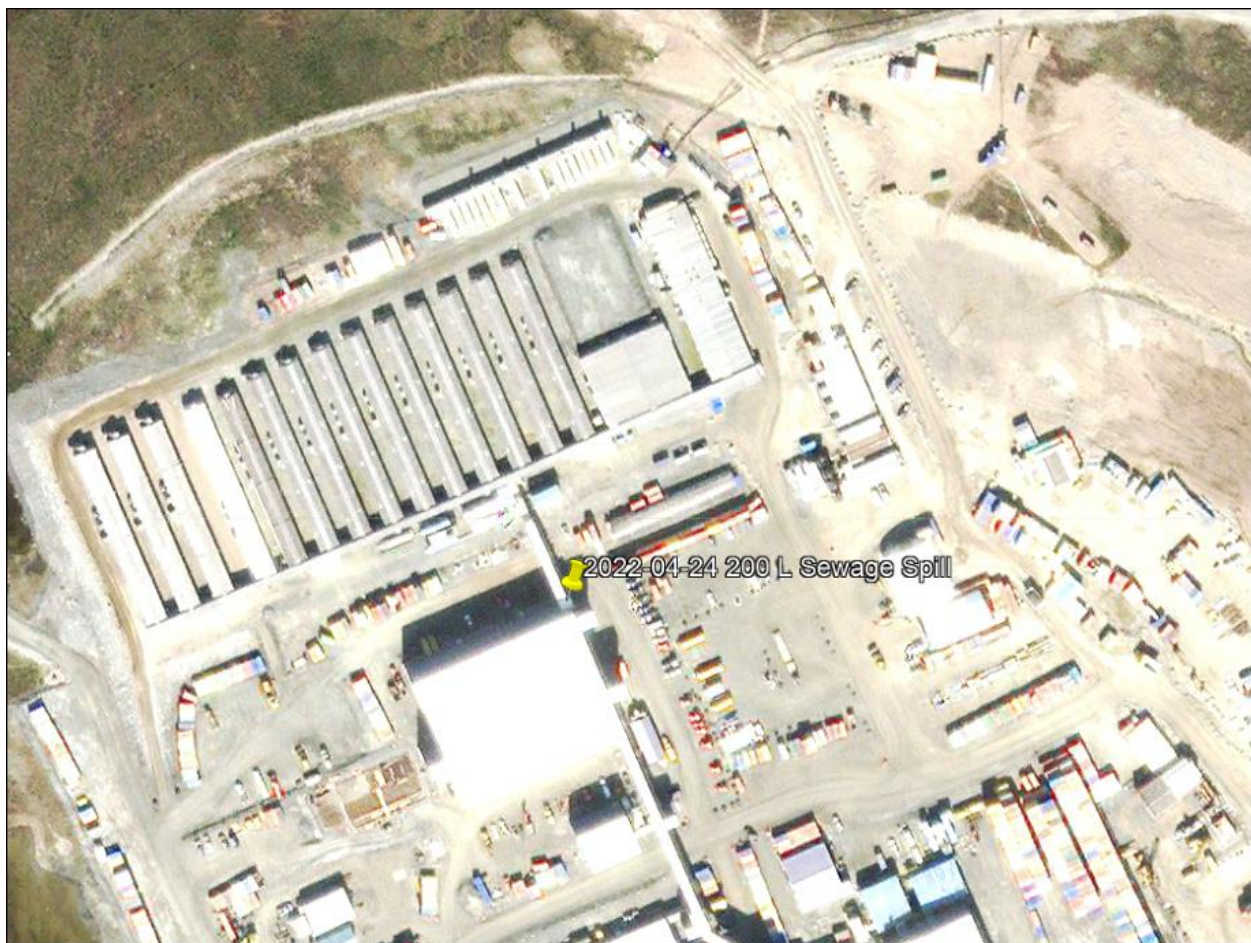
At approximately 03:30 on April 24<sup>th</sup>, 2022, 200 L of sewage was spilled at the Multi Service Building (MSB) lift station when the lift station pump failed.

**Figure 1:** Location of the MSB lift station spill

- the pump overload limits were increased to prevent the pump from early tripping;
- the float control system was adjusted to start the pump earlier;
- the pump selector was verified to ensure it is functioning properly and the selector was set to the alternate position during normal operations (this will allow pump #1 to start should pump #2 fail).

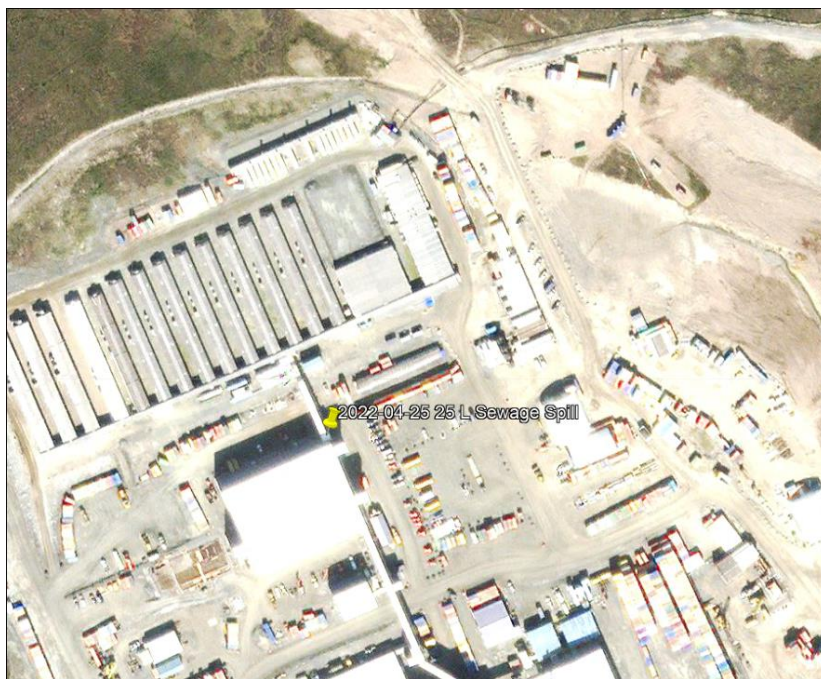
At approximately 16:30 on April 25<sup>th</sup>, 2022, 25 L of sewage was spilled at the Multi Service Building (MSB) lift station when a CamLock connector failed.

**Figure 1:** Location of the MSB lift station spill

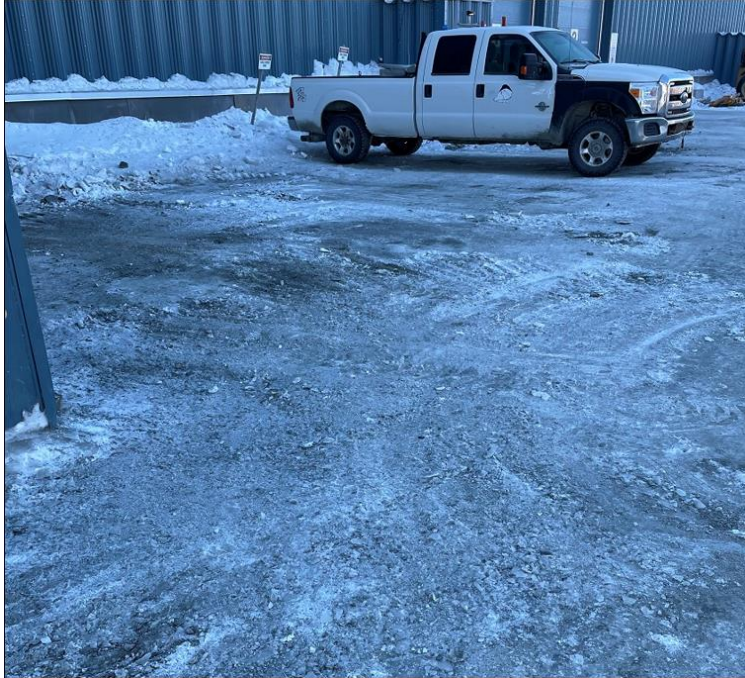
The spill was contained to Lift station building and the local area. The freezing conditions prevented the sewage from migrating, facilitating spill recovery. Frozen contaminated material was in an open area allowing the material to be collected with a loader and placed in a drum and disposed of after the frozen material has melted.

**Figure 2:** MSB lift station spill cleanup

While transferring the content of the vacuum truck into the MSB lift station, the operator inadvertently used a broken CamLock connector to connect the hose to the lift station. The sewage vacuum hose became dislodged releasing sewage inside the MSB lift station and to the ground outside the life station.

- the defective CamLock fitting was replaced;
- a threaded coupler that has less tendency to fail as there are no movable latches has been ordered and will replace the current latching style of CamLock fitting when they arrive;
- whip check cables have been installed to reduce hose movement during sewage transfer.

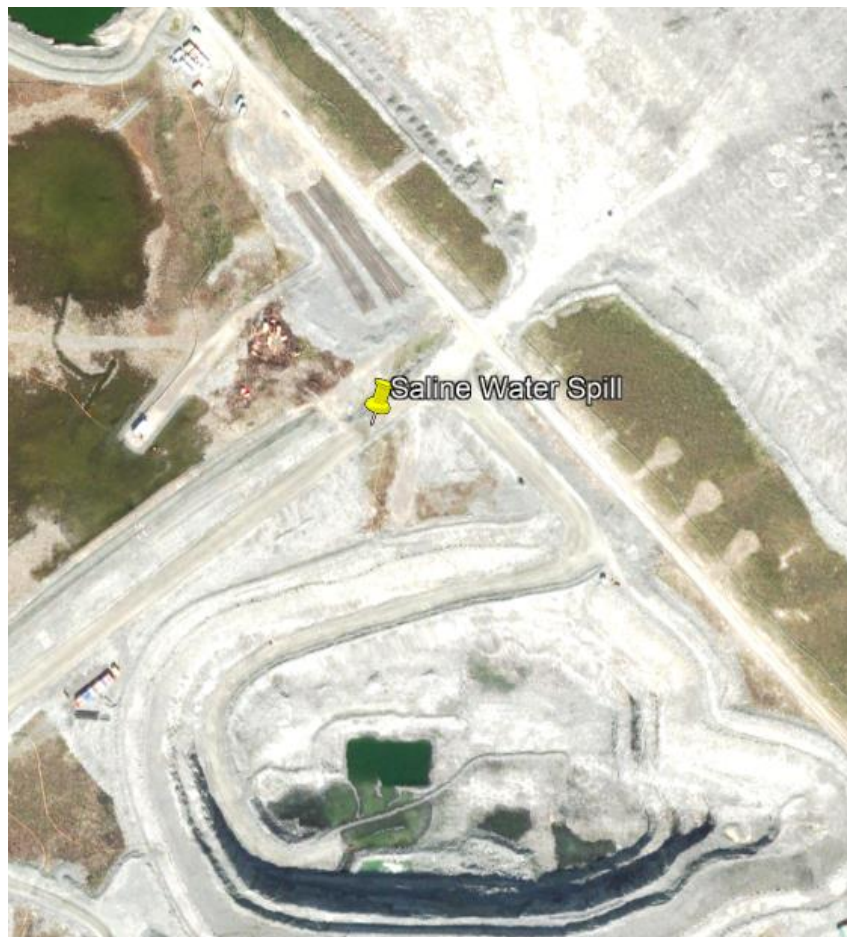
On May 8<sup>th</sup>, 2022 a water pump was turned on to pump saline water from one saline pond to another; from Saline Pond 1 to Tiriganiaq Pit 2. Shortly after, the Environment Department was informed that water was observed coming up from the Haul road north of Tiriganiaq Pit 2. Upon investigation, it was found that the pipe that transports the saline water had been broken; the pump at Saline Pond 1 was immediately turned off to stop the flow of saline water. It is estimated that a cumulative volume of approximately 800 L of saline water was discharged onto the Haul Road. Based on local topography, the runoff of this saline water will have entered Tiriganiaq Pit 2 (a saline pond) during the snowmelt period. The spill occurred due to a damaged pipe that had been struck by a grader when it was conducting routine maintenance of the Haul Road. Due to repeated grading activities on the road, enough material was removed to expose the pipe which resulted in the damage.

Figure 1: Location of saline water spill on the haul road north of Tiriganiaq pit 2.

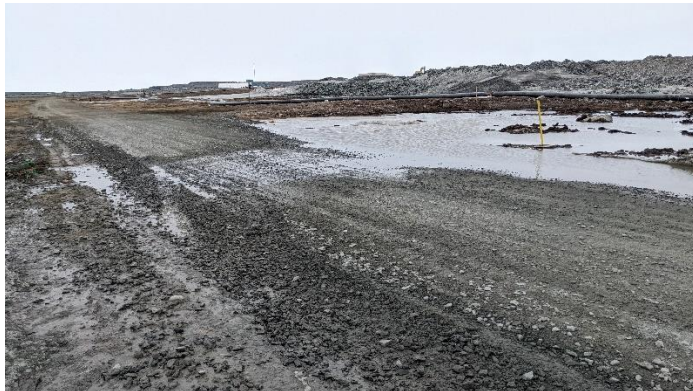
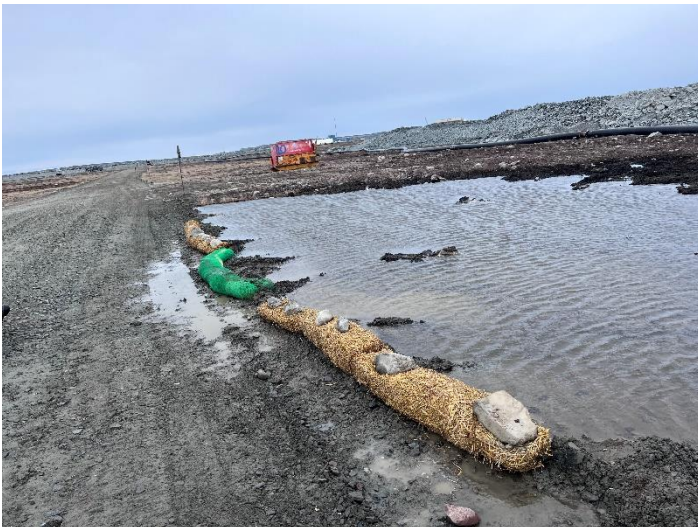
**Figure 2-3:** During the event and after the event

- Turbidity measurements were taken to confirm visual observations
- A MEL-SR sample was taken as per the 2AM-MEL1631 Water Licence
- Straw logs and wood chip logs were installed on both sides of the road to filter out entrained sediment and to minimize flow velocity to encourage decantation of sediment from the flowing water
- The potential exceedance of Part D Item 18 of the 2AM-MEL1631 Amended Licence was reported as due diligence within 24 hours of the observation

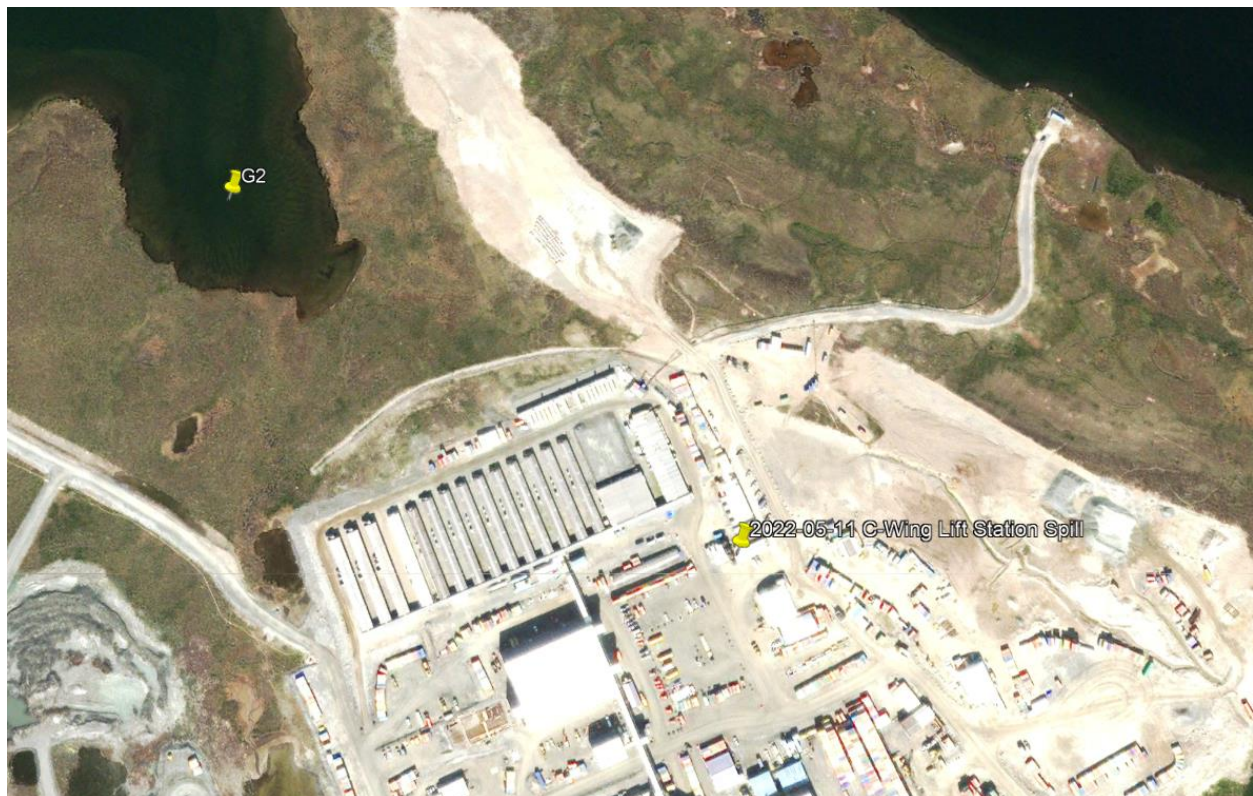
At approximately 11:30 on May 11<sup>th</sup>, 2022, the C wing lift station overflowed resulting in a 15 L of sewage spill to the industrial pad.

**Figure 1:** Location of the C wing lift station spill

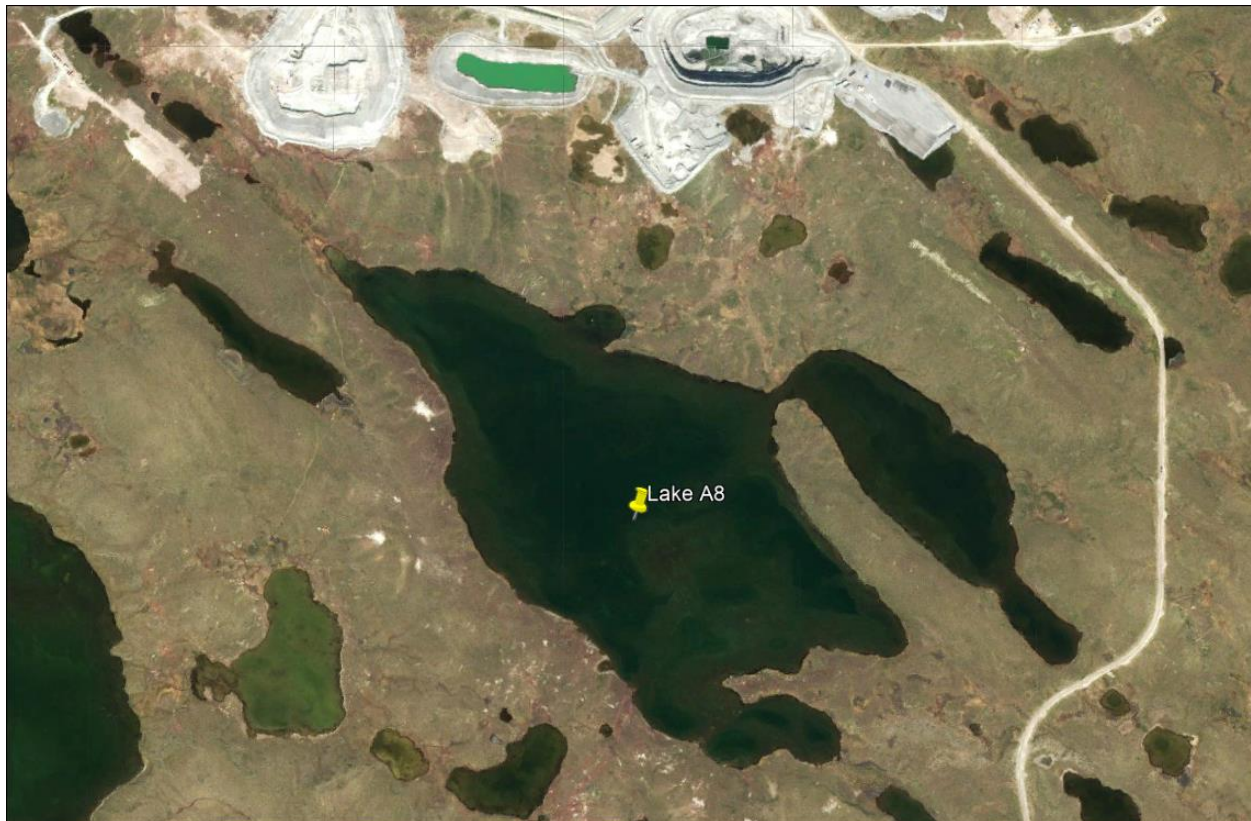
- grey material, suspected to be drill cuttings were observed on the ice surface of lake A8;
- some pools of water within the piles of snow on the surface of the ice containing unknown materials;
- the smell of hydrocarbons was present in some locations; and
- oily rags, garbage and wood debris were found on the surface of the ice.

**Figure 1: Lake A8 Spills locations**

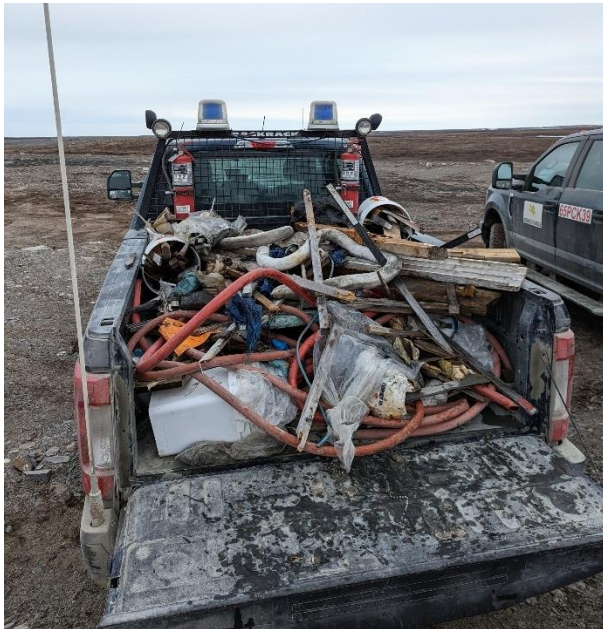
After the inspection, Orbit Garant and AEM's Exploration Geology and Environment Departments began a collaborative effort to clean up lake A8 and the shore of lake A8 on a regular basis (up to daily; Table 1), pending conditions were safe to proceed. The clean-up efforts began on May 14<sup>th</sup>, 2022 and were completed on June 5<sup>th</sup>, 2022. Each clean-up activity is documented in Table 1.

**Figure 2: Drilling debris clean-up from clean-up efforts on May 29<sup>th</sup>, 2022**
