## Appendix 16: 2022 Reportable Spills

# Follow Up Report: #2022019

## January 25<sup>th</sup>, 2022 – Thickener Water Spill

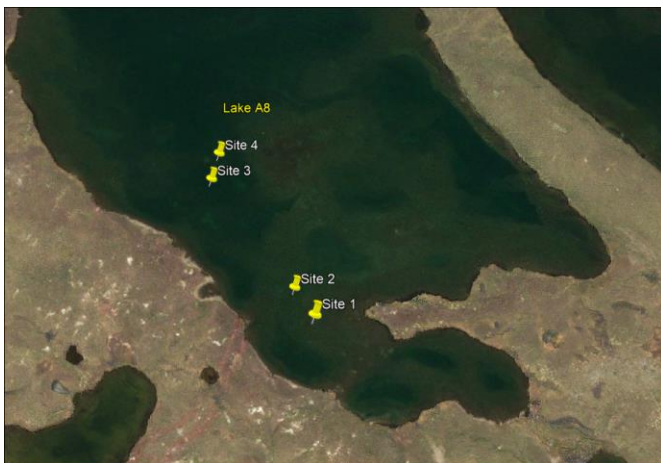
On May 18<sup>th</sup>, 2022, CIRNAC returned to lake A8 with Environment and Climate Change Canada (ECCC) to conduct sampling of ponded water on the lake ice at four sampling locations (Figure 3). AEM also took samples at these locations, for which analytical results have been included in Appendix A. As seen in Appendix A, all four samples collected were reported as not acutely toxic (passed LC50 tests).

**Figure 3: CIRNAC lake A8 sampling locations**

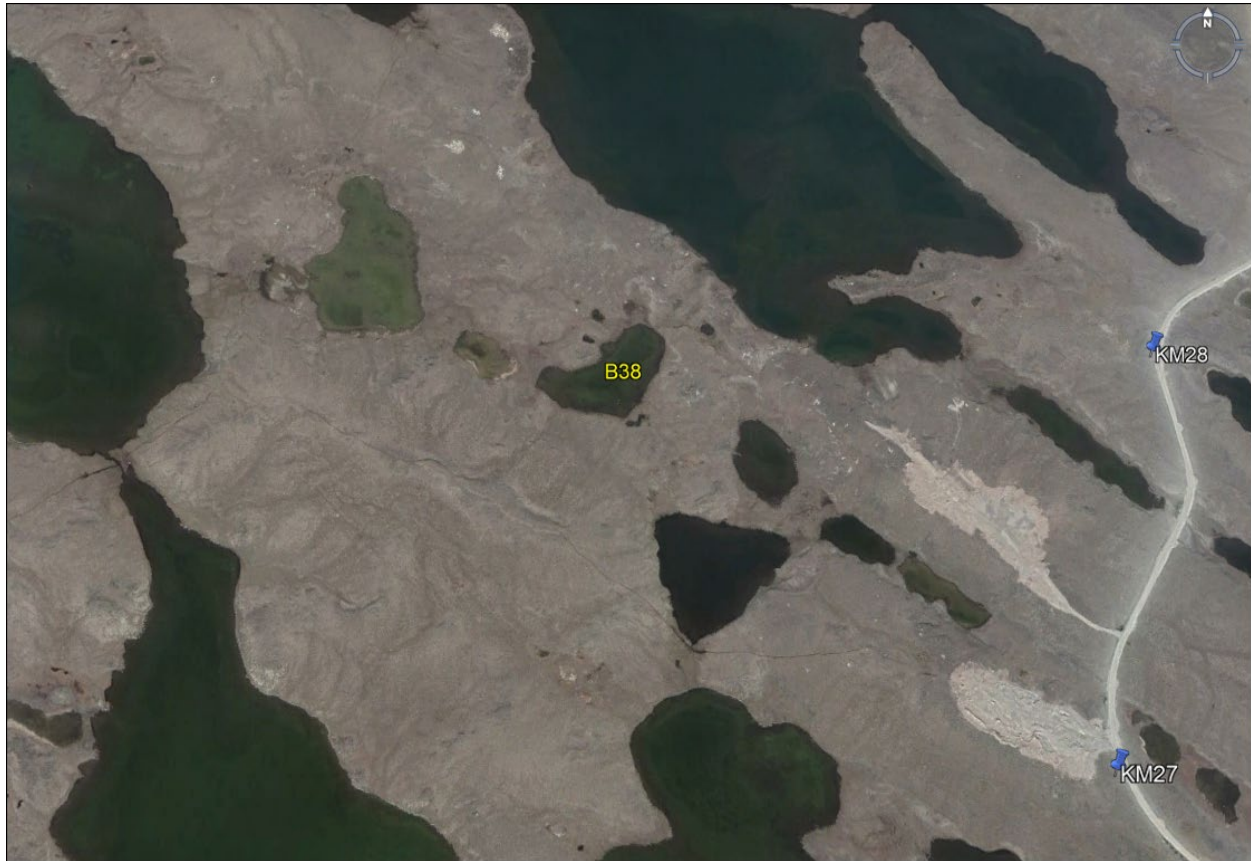
On May 24<sup>th</sup>, 2022, during a post drilling visual inspection AEM identified material related to drilling activities on lake B38. Similar to report 2002188 activities to cleanup the material were immediately initiated.

**Figure 1: Lake B38 location**

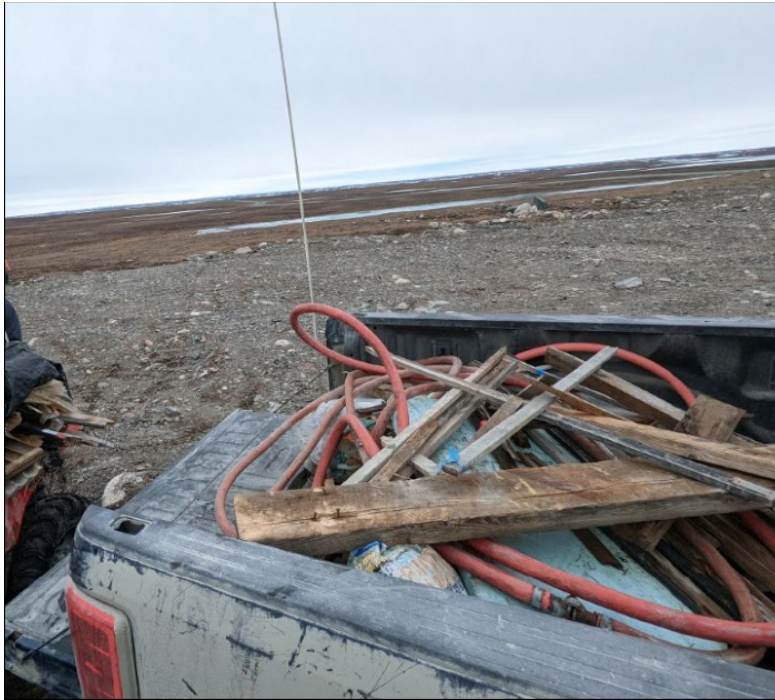
After the inspection, Orbit Garant and AEM's Exploration Geology and Environment Departments began a collaborative effort to clean up lake B38 and the shore of lake B38 on a regular basis, pending conditions were safe to proceed. The clean-up efforts began on May 24<sup>th</sup>, 2022 and were completed on May 29<sup>th</sup>, 2022. Each clean-up activity is documented in Table 1.

**Figure 2: Drilling debris clean-up from clean-up efforts on May 29<sup>th</sup>, 2022**

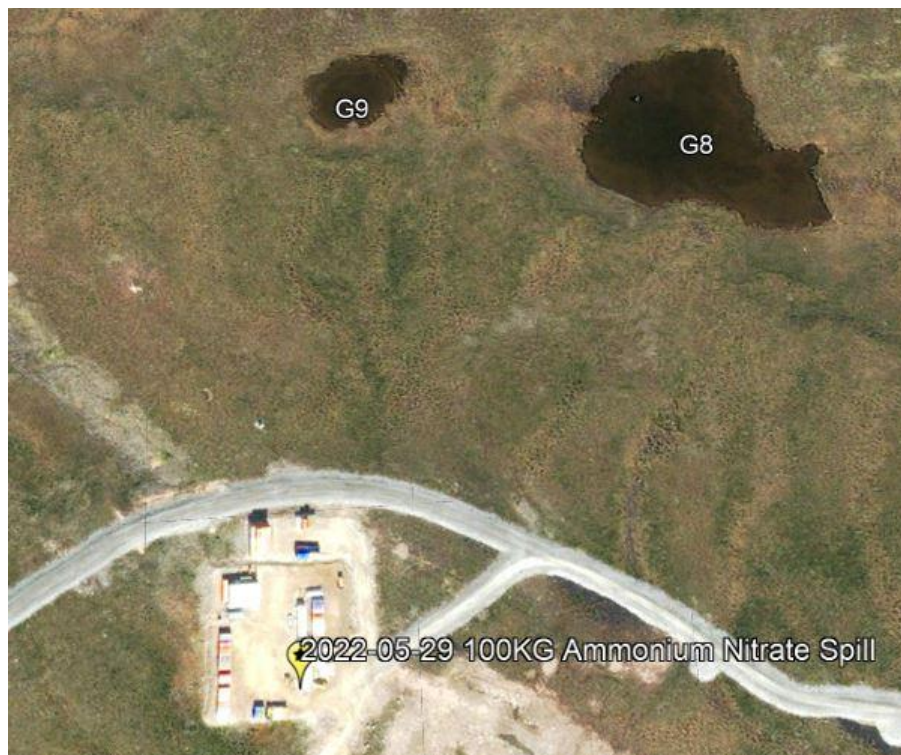
On May 29, 2022 at approximately 8:30AM, the plant operator was loading the process belt with 1000 kg bags of Ammonium Nitrate (pellets). During this task the Ammonium Nitrate bag hit the doorway causing the bag to split open, spilling 100 kg of Ammonium Nitrate to the ground.

Figure 1: Location of 100 kg Ammonium Nitrate spill

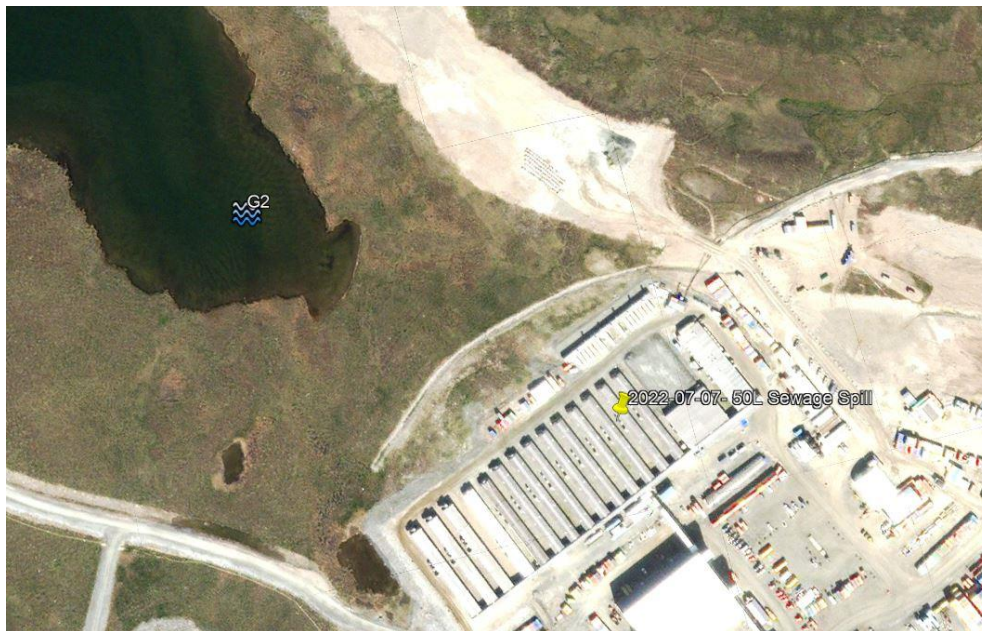
At approximately 8:00 pm on July 7<sup>th</sup>, 2022, an estimated 50 liters of untreated sewage was spilled to the gravel pad from the Wing 2 lift station when two lift station pumps failed to engage.

**Figure 1:** Location of sewage spill.

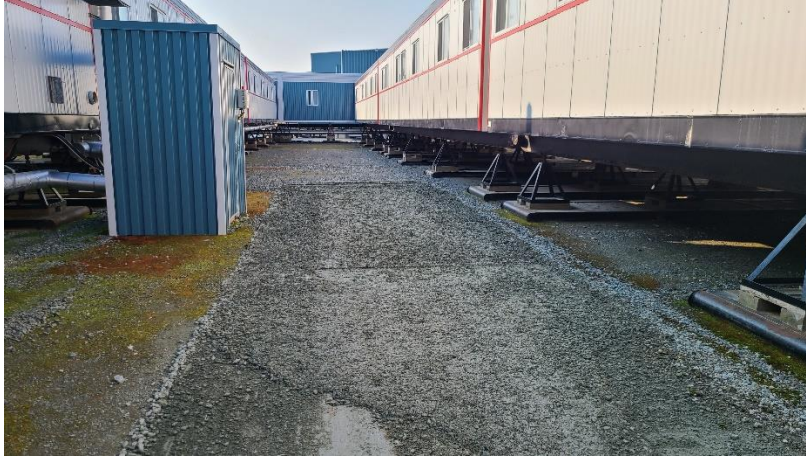
Upon discovery of the spill, a vacuum truck was dispatched to empty the lift station and recover the liquid sewage outside the lift station. The recovered liquid was pumped into the Mine Services Building (MSB) lift station for processing at the sewage treatment plant. The sewage contaminated gravel was scrapped by a loader and placed in Waste Rock Storage Facility 1 for final disposal.

**Figure 2:** Location of sewage spill post-cleanup.

An electrician and plumber were sent to inspect the lift station to determine the cause of the overflow. A piece of material presumed to have been flushed down a toilet had jammed a pump. A backup pump in this lift station did not engage as it was also jammed with waste material. Material was cleaned from both pump inlets, the pumps were tested and were operating as designed and put back into service. Installation of a new 20 amp breaker was completed on July 8<sup>th</sup> as a preventative maintenance measure.

Each lift station is equipped with two Liberty ProVore 1HP 120 volt sewage grinder pumps. Each grinder pump has a cutting element located at the inlet that is subject to wear/tear, which could result in reduced cutting performance and clogging. An audit of each grinder pump is underway to assess the conditions of the cutting elements and replace them as required. Each lift station is also equipped with a local audio/visual alarm; however, AGNICO EAGLE is actively investigating options for these alarms to be communicated remotely.

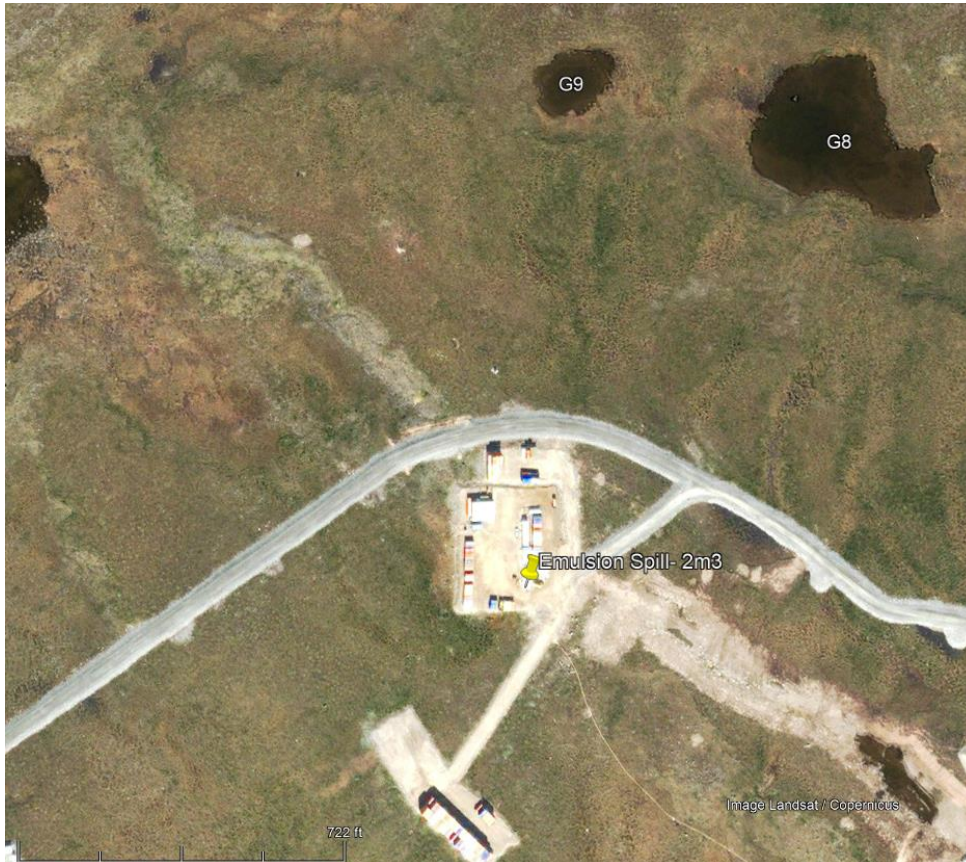
On July 28<sup>th</sup>, 2022, at approximately 11:30 am, an estimated 2m<sup>3</sup> of emulsion was spilled on surface at the emulsion plant. An overflow from tank RU7000 (T3) occurred during underground emulsion production. No water bodies were impacted by this spill. The closest water body (G8) is approximately 315 meters north as seen in Figure 1.

**Figure 1:** Location of emulsion spill and proximity to water bodies.

Prior to manufacturing the batch of emulsion, the tank inventory sheet was verified to ensure there would be enough room to produce the required amount of emulsion. However, it was later discovered that an

error was made on the available underground emulsion tank inventory which led to the emulsion production tank overflowing.

- The tank inventory sheet is now updated by the person filling bins/producing emulsion;
- A field for weights/quantities on the back of the work cards has been added as a reminder;
- All operators indicate what bins have been loaded and emulsion produced on the back of their work cards
- High level sensor has been installed on August 23<sup>rd</sup>
- The site supervisor now verifies tank inventory daily and compares it to billing information;
- Each time tanks are emptied a visual confirmation is made and noted on the inventory sheet;
- Visual confirmation of the tank level is made prior to large production blends (>10,000kg).

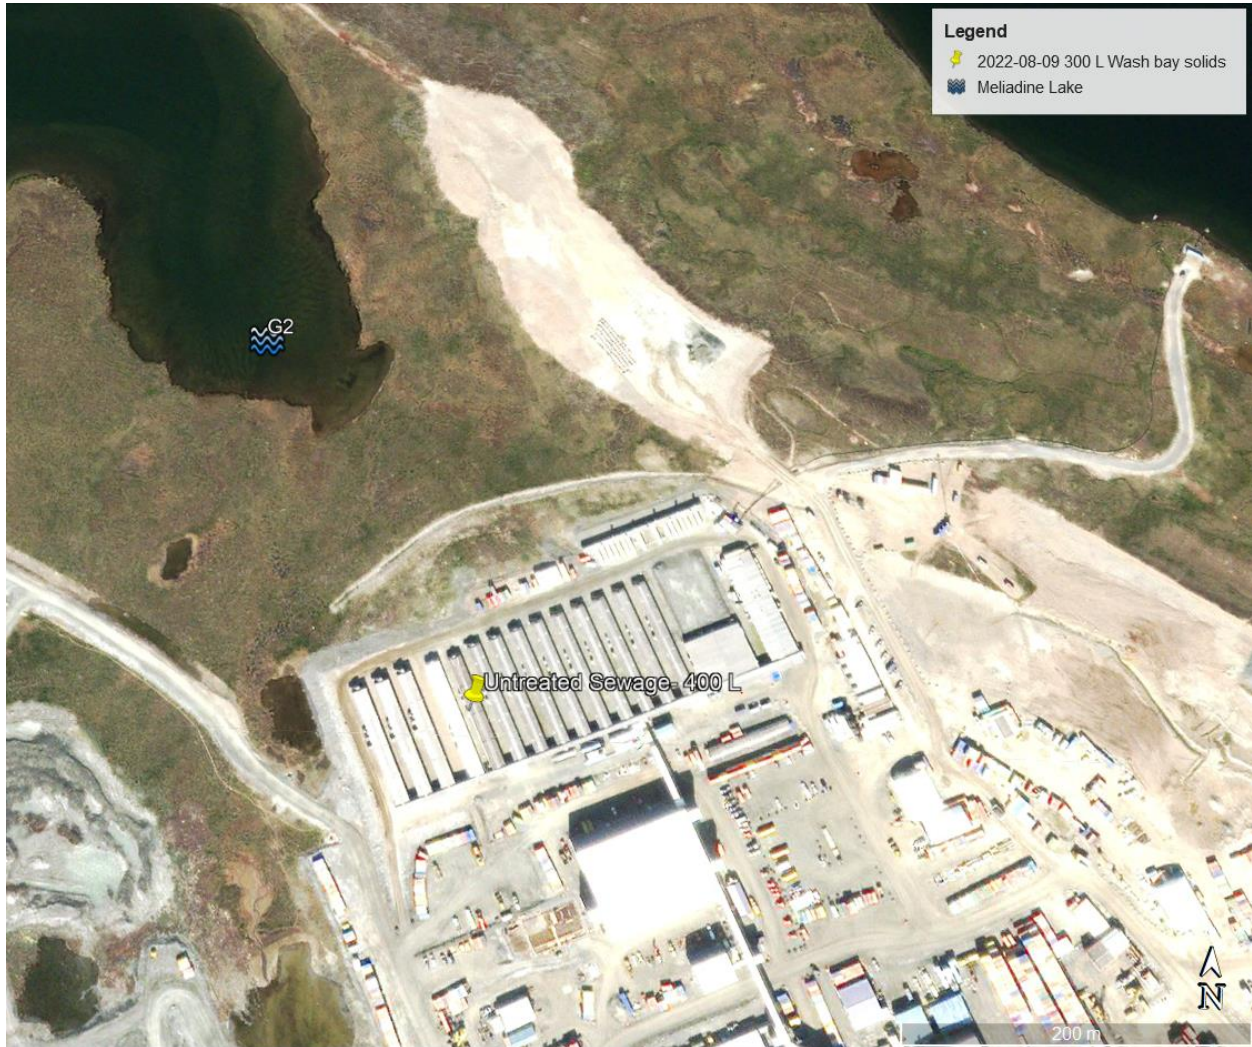
On August 2<sup>nd</sup>, 2022, at approximately 7:00 pm, an estimated 400 L of untreated sewage was spilled on the industrial pad due to an overflow of the Wing 10 lift station. No water bodies were impacted by this spill. The closest water body (G2) is approximately 200 meters north, as seen in Figure 1.

**Figure 1:** Location of untreated sewage spill and proximity to water bodies.

- A plumber closed a valve to perform an inspection of the Wing 10 lift station and failed to open the valve upon completion.

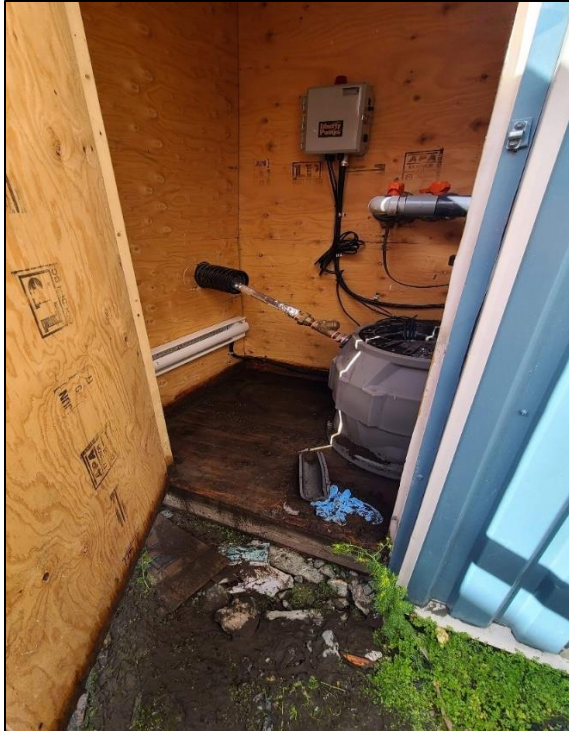
**Photo 1:** Wing-C lift station spill

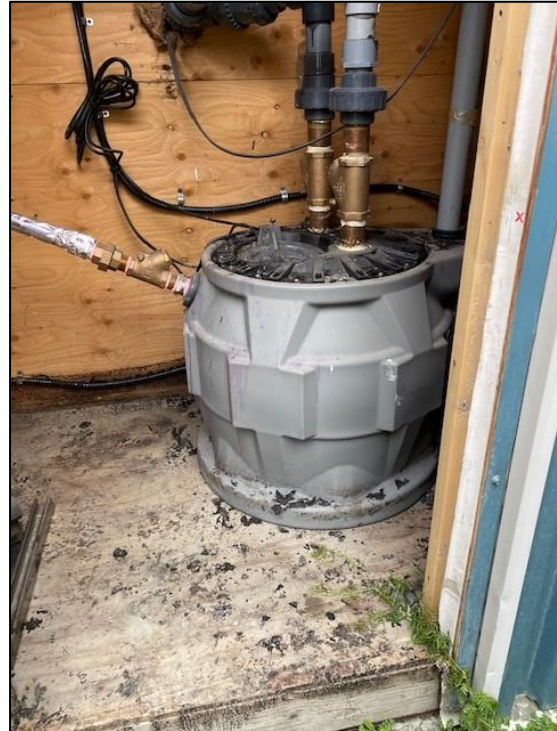
**Photo 2:** Wing C lift station spill remediation

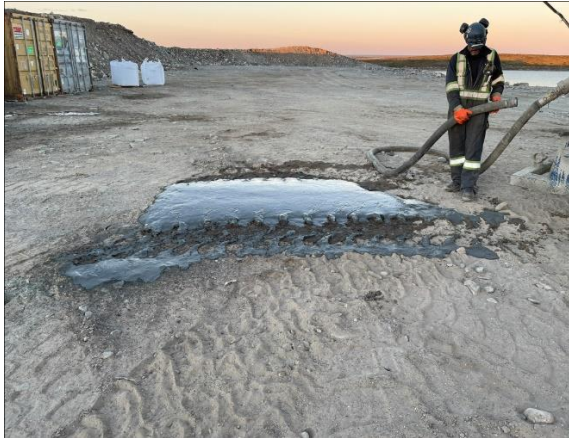
- A wash bay waste handling procedure outlining handling and disposal of the wash bay waste streams has not been developed.

**Photo 1:** Wash bay solids spill

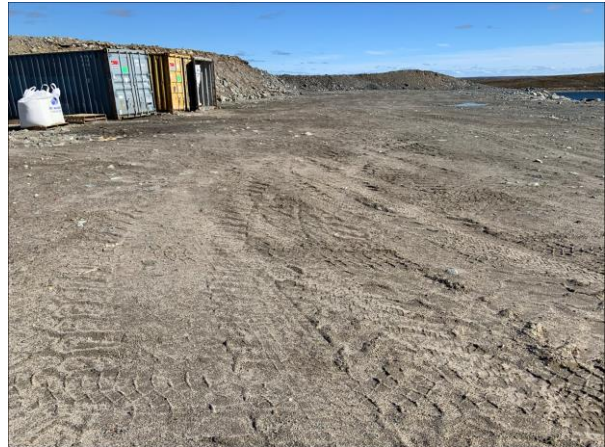
**Photo 2:** Wash bay solids spill remediation

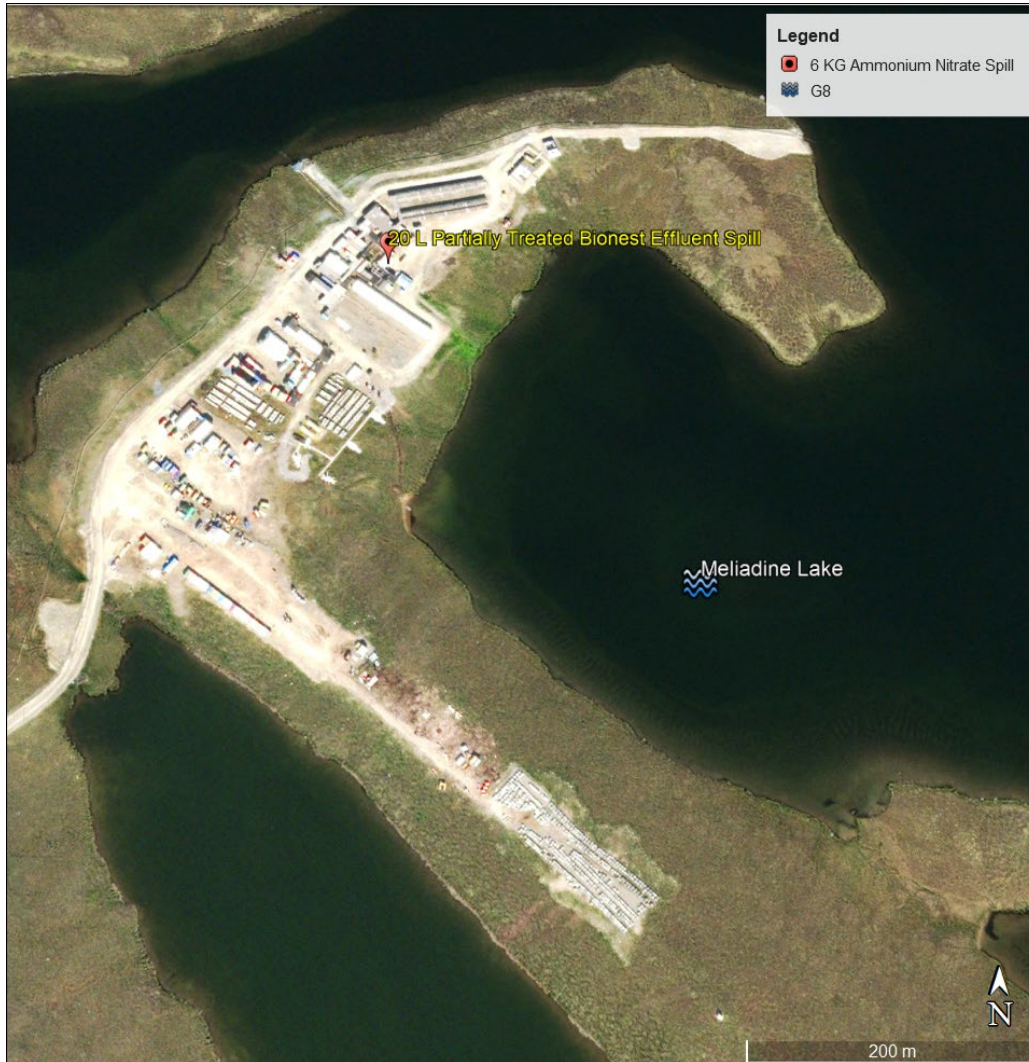
On August 16<sup>th</sup>, 2022, effluent inside the bionest vessel was found to be leaking through the bolt holes of the seacan the vessel is housed in. No water bodies were impacted by this spill. The closest water body (Meliadine Lake) is approximately 100 meters south as seen in Figure 1.

**Figure 1:** Location of partially treated bionest effluent spill and proximity to water bodies.

- Improper shut down and winterization of the Exploration sewage treatment plant.

Upon discovery of the spill, sorbent pads and spill trays were placed under the bionest seacan to collect partially treated effluent and a vacuum truck was used to ensure the spill trays did not overflow. A frost fighter was used to thaw the remaining partially treated effluent and a vacuum truck removed the liquid as it thawed. The recovered material was processed through the Meliadine sewage treatment plant.

After removal of the bionest seacans an inspection of the area under the seacan will be completed to determine if further remediation is required.

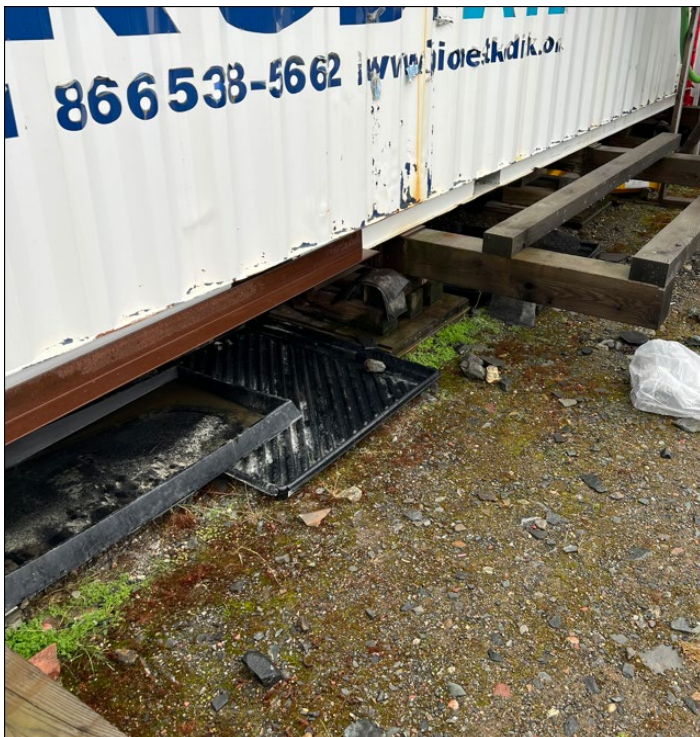
**Photo 2:** Bionest partially treated Effluent spill collection

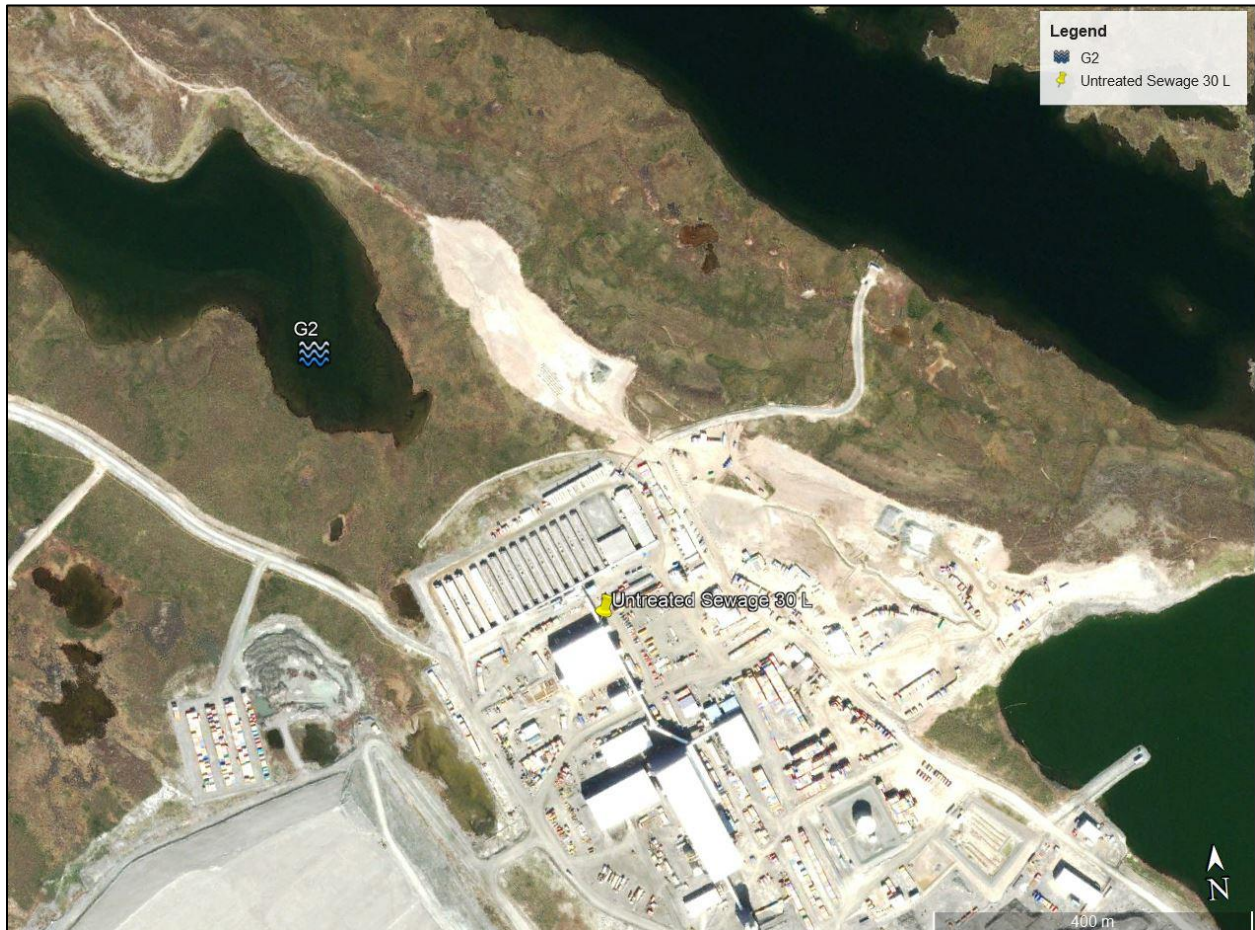
On September 13<sup>th</sup>, 2022, at approximately 7:30 am, an estimated 30 L of untreated sewage was spilled on the industrial pad due to a loose sewage cleanout cap at the MSB lift station. No water bodies were impacted by this spill. The closest water body (G2) is approximately 325 meters northwest, as seen in Figure 1.

**Figure 1:** Location of sewage spill and proximity to water bodies.

- Cleanout cap was not installed correctly when completing the sewage line tie in for new accommodation wings 15 and 16.
- Employee tightening the cleanout cap had a lack of knowledge for the task.
- Inadequate final inspection of the installation.

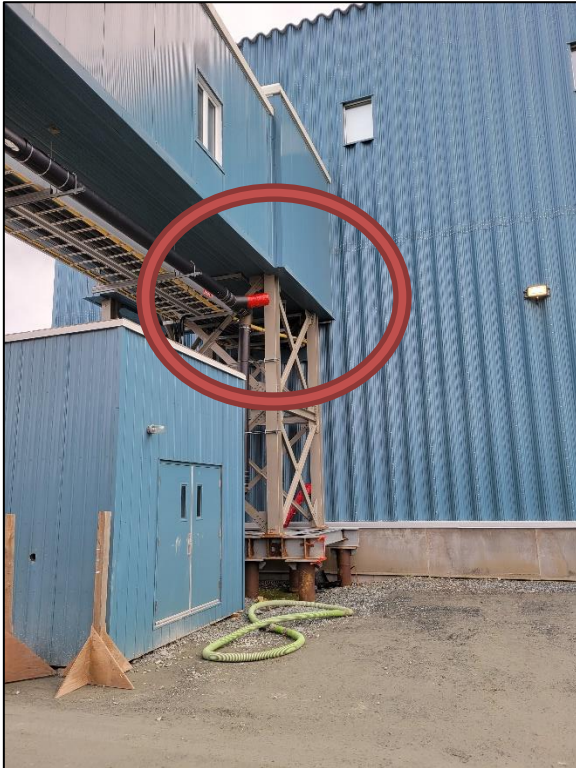
**Photo 1:** MSB remediated spill area.

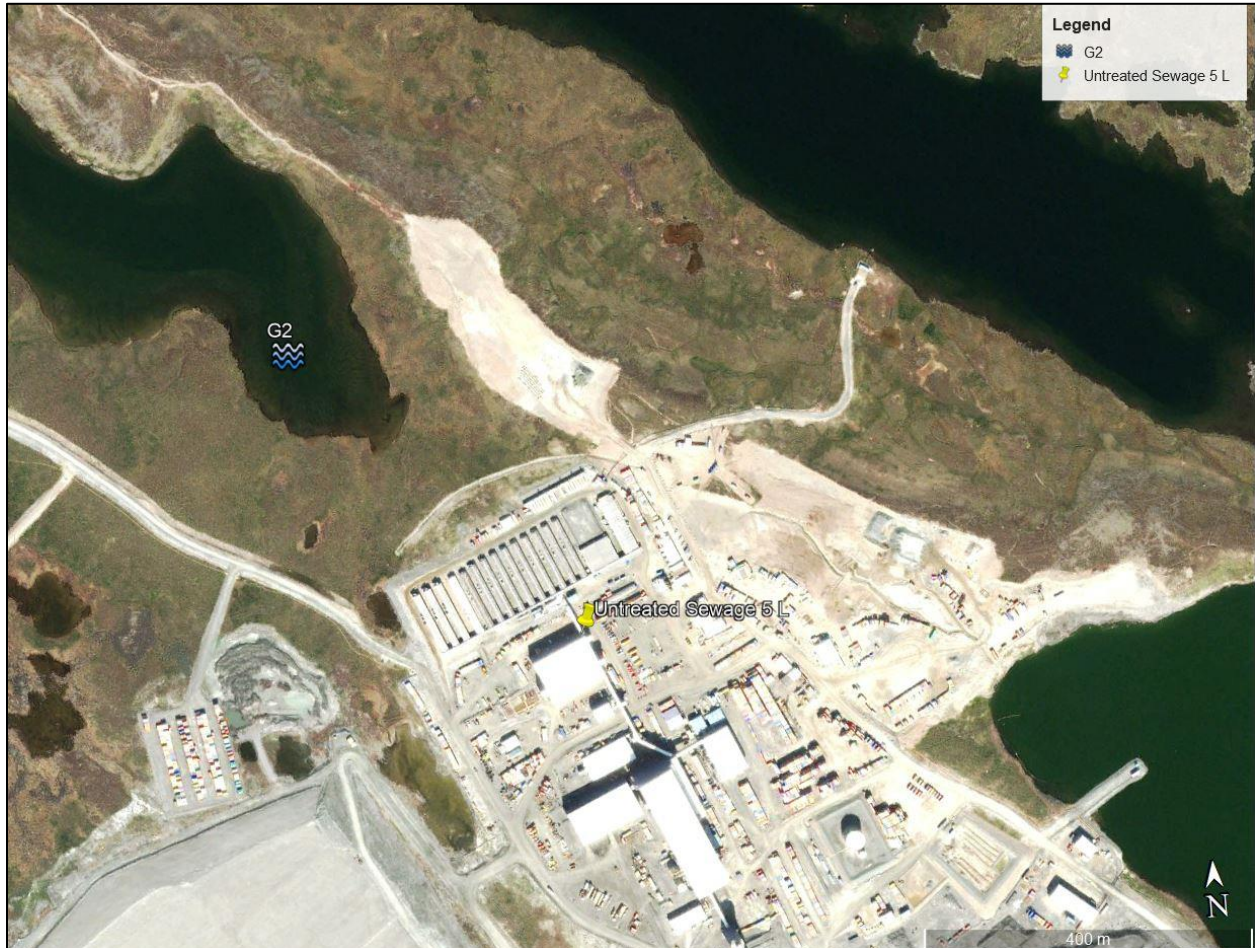
On September 14<sup>th</sup>, 2022, at approximately 2:45 pm, an estimated 5 L of untreated sewage was spilled on the industrial pad due a cracked end cap. No water bodies were impacted by this spill. The closest water body (G2) is approximately 325 meters northwest, as seen in Figure 1.

**Figure 1:** Location of sewage spill and proximity to water bodies.

- a hairline fracture was identified on the cleanout cap

When the plumber noticed a leak coming from the cleanout cap he immediately stopped the MSB lift station. Once the lift station was stopped a new cap was installed. The impacted surface area was hand excavated and an estimated 5 kg of material was brought to Landfarm A as per Landfarm Management Plan.

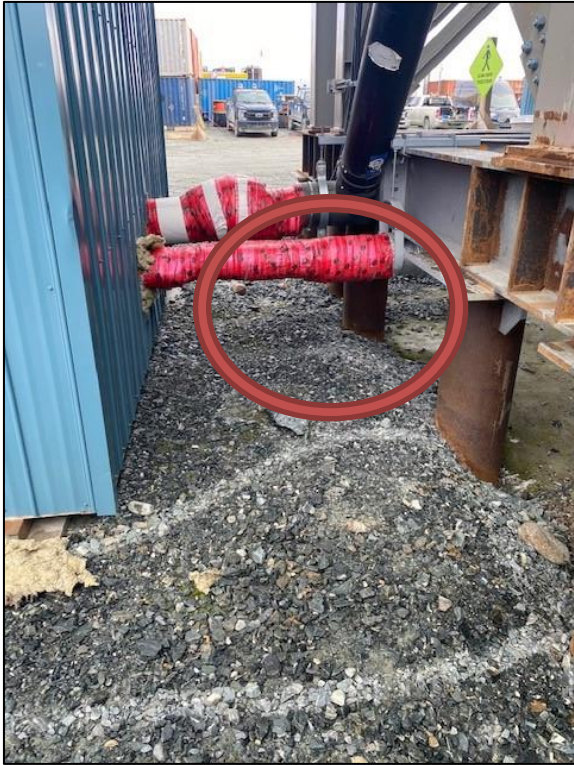
**Photo 1:** Sewage spill location

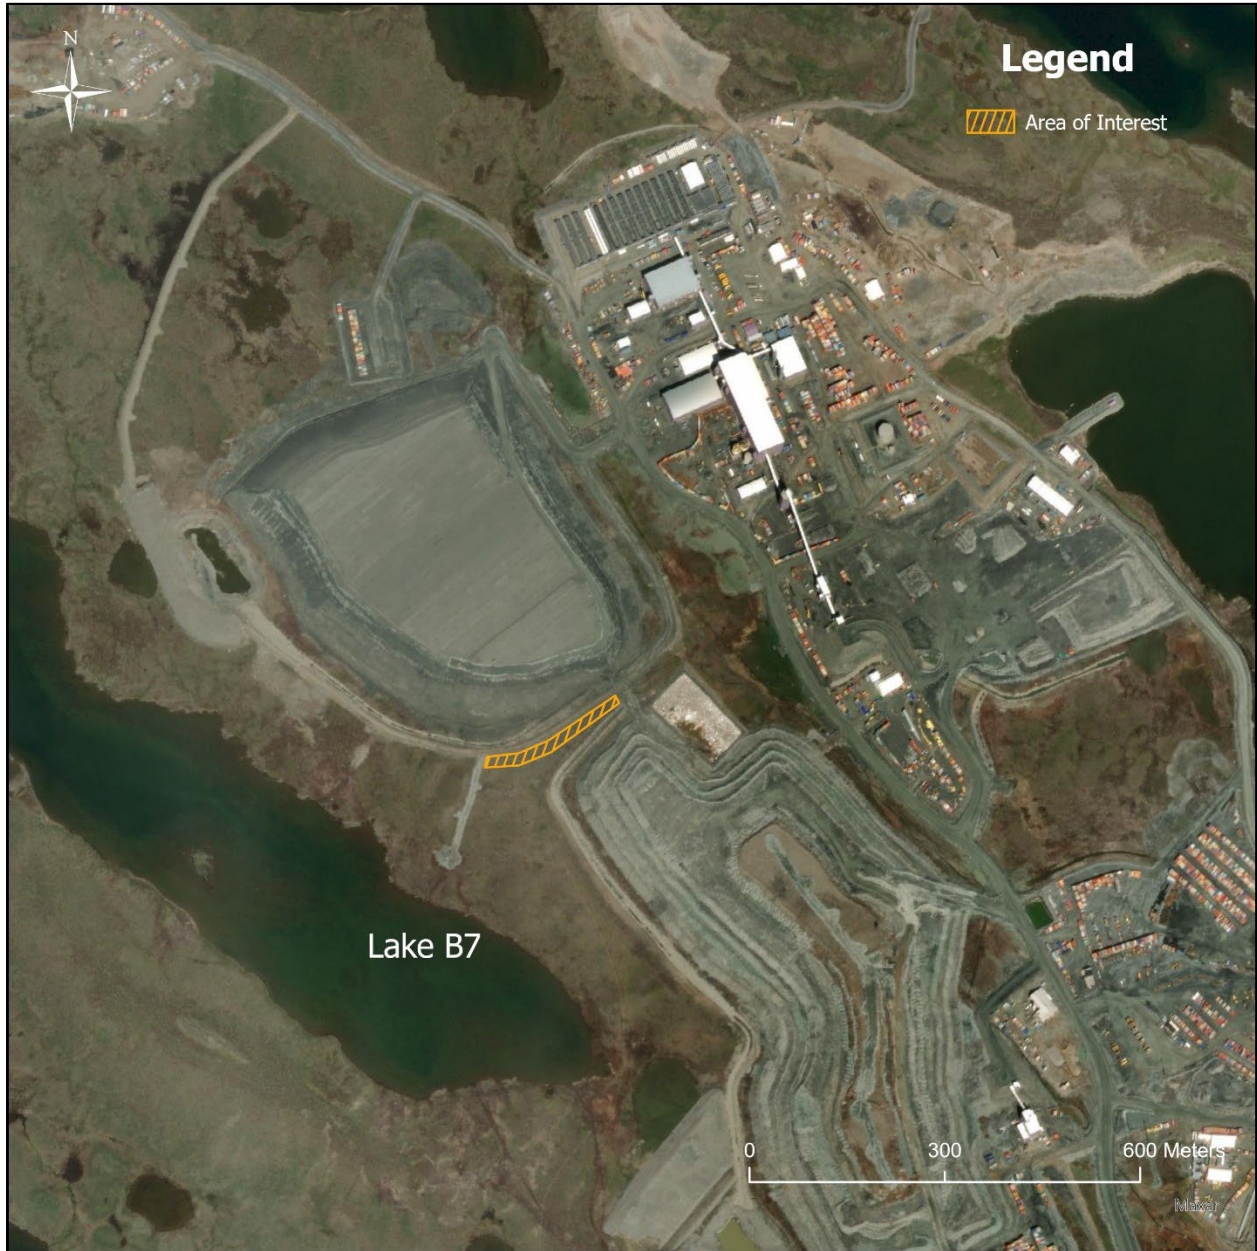
**Figure 1:** Area of interest and proximity to water bodies.

Analysis of historical aerial drone imagery revealed that drill cuttings had been deposited in and around the area of interest in 2021 and 2022, an authorized disposal method under the 2BB-MEL1424 Water License. Geochemical analysis of samples collected within the area of interest suggests that the material represents a mix of tailings, drill cuttings, and/or road sediments. These determinations were supported by field observations and particle size distribution, which showed material of varying colour and particle size.

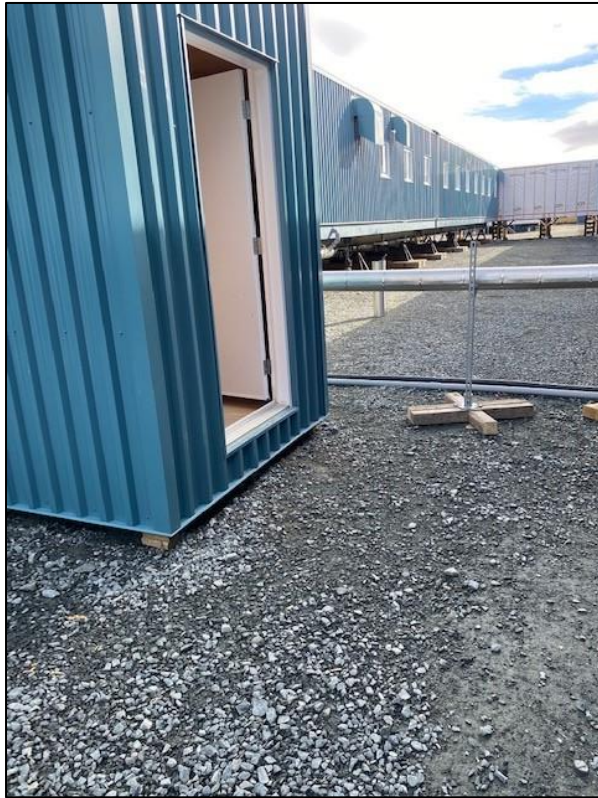
**Photo 1:** Wing 16 lift station (spill location)

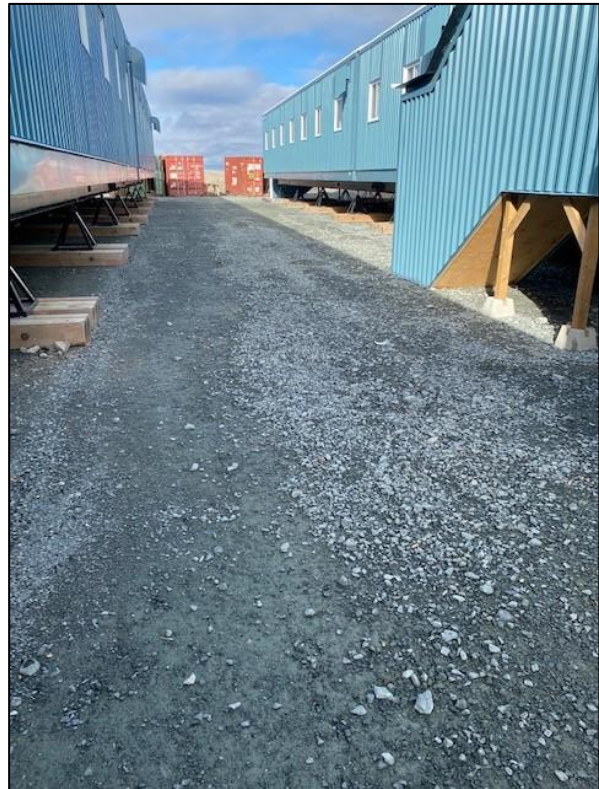
**Photo 2:** Wing 16 lift station clean up area

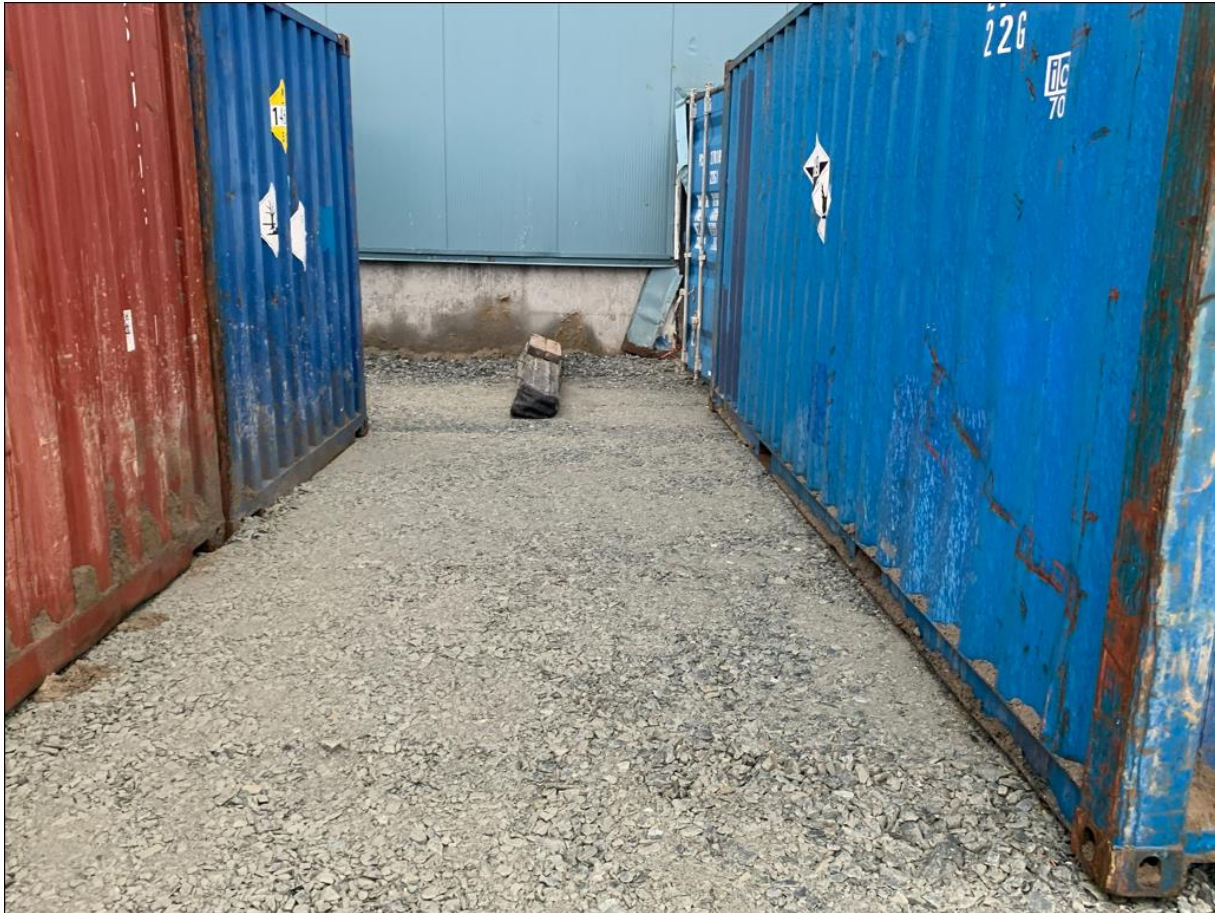
**Photo 3:** HCl spill final remediation

to be hazard free, the area of contamination was delineated and an excavator and shovels were used to remove the contaminated material to a depth of approximately eight inches. The impacted material was directed to the reclaim feeder for reprocessing through the process plant.

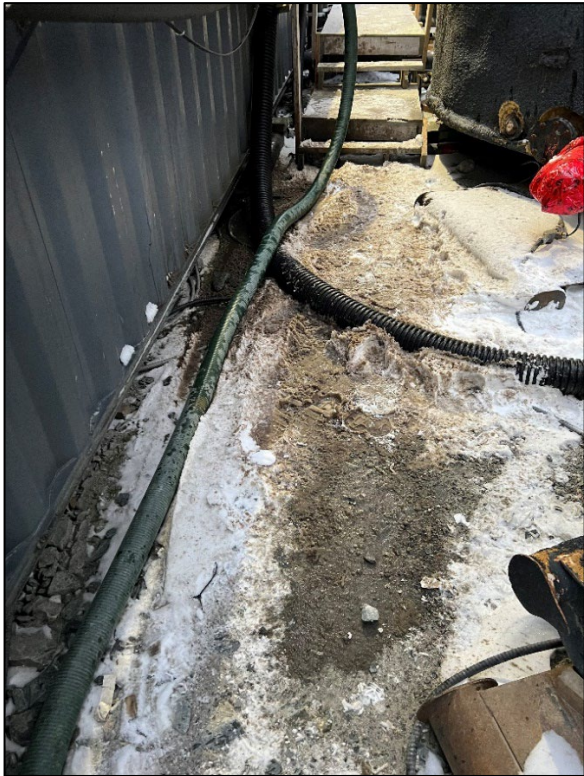
On October 18<sup>th</sup>, 2022, at approximately 8:15 am, an estimated 30 L of untreated sewage was spilled on the industrial pad due to a miscommunication between two operators during sewage transfer from the sewage treatment plant (STP) sludge tank and the sewage vacuum truck. No water bodies were impacted by this spill. The closest water body (G2) is approximately 370 meters northwest, as seen in Figure 1.

- Only one out of the two operators involved in the sewage transfer had a radio causing inadequate communication between them.
- The vacuum truck procedure was not followed.

**Photo 1:** Sewage spill area

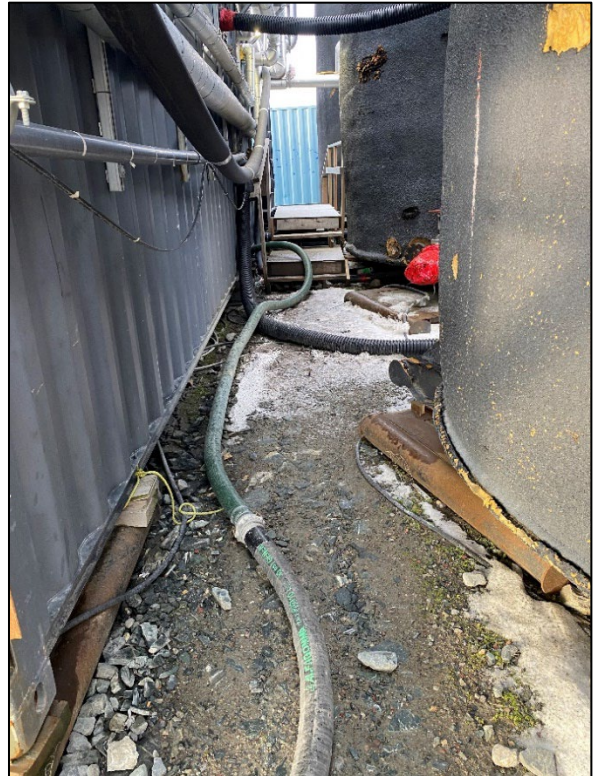
**Photo 2:** Spill remediation area

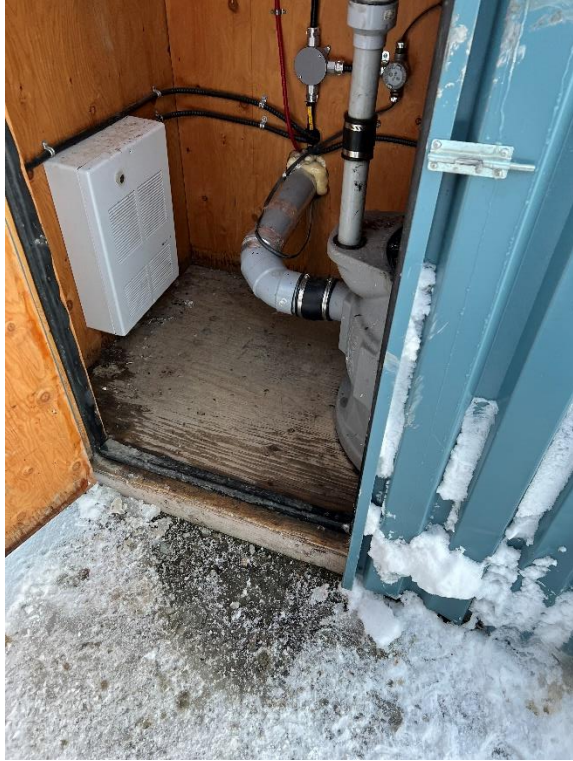
On November 15<sup>th</sup>, at approximately 6:00 am, an estimated 10 L of sewage was spilled on the industrial pad due to an overflow of the wing three lift station. No water bodies were impacted by this spill. The closest water body (G2) is approximately 222 meters northwest, as seen in Figure 1.

**Photo 1:** Wing three lift station spill

- Grinder pump blades are to be replaced at wing three lift station. These have been ordered and will be replaced upon arrival to the Meliadine site.
- Secondary containment has been installed around wing three and work is ongoing for each of the wing lift station.

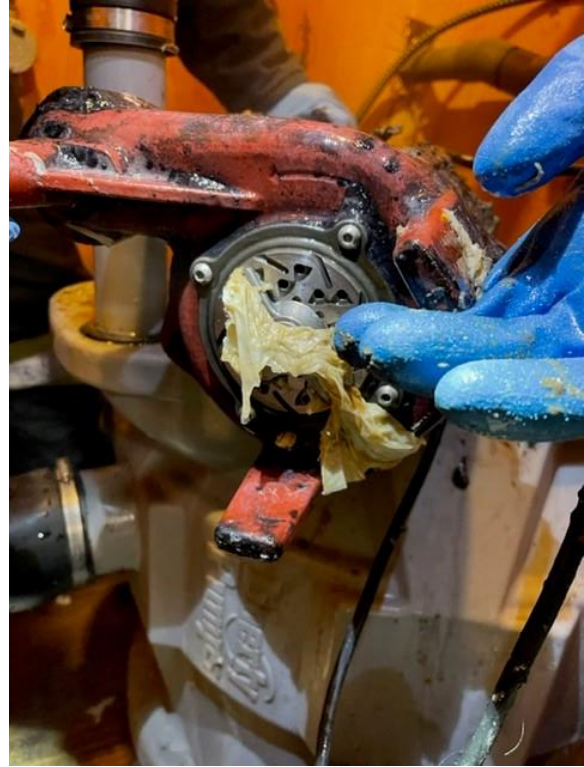
**Photo 2:** Wing three lift station grind pump blade

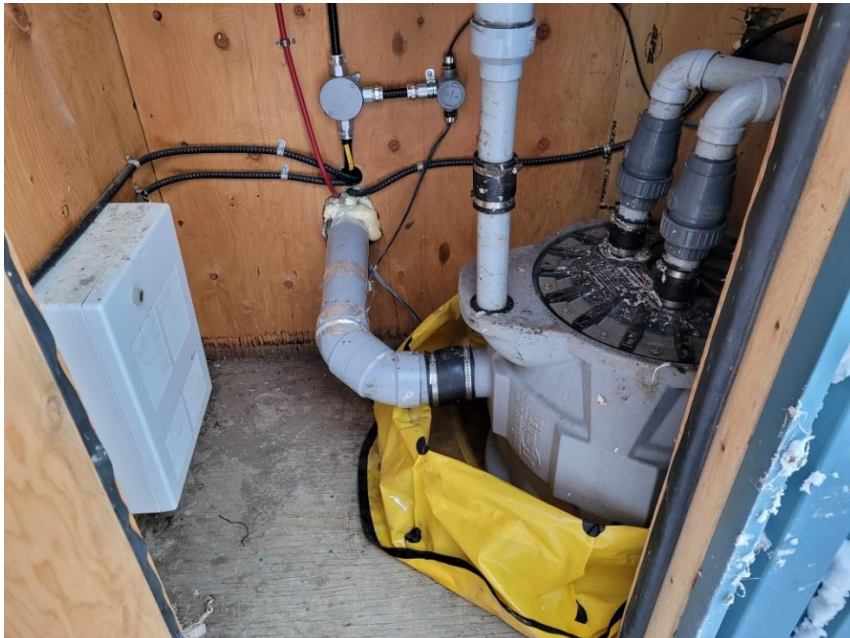
**Photo 4:** Wing three lift station with secondary containment installed.

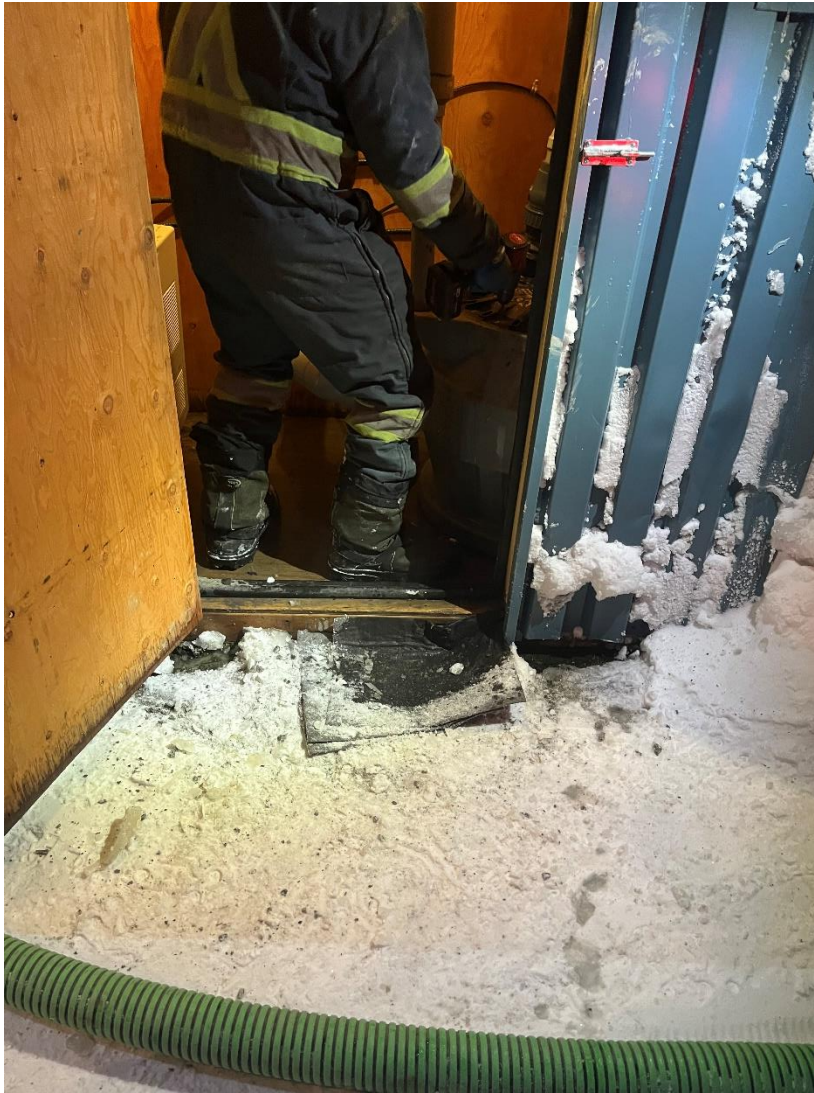
On November 17<sup>th</sup>, at approximately 8:00 am, an estimated 5 L of sewage was spilled on the industrial pad due to an overflow of the wing three lift station. No water bodies were impacted by this spill. The closest water body (G2) is approximately 222 meters northwest, as seen in Figure 1.

**Photo 1:** Wing three lift station 5 L spill

- Grinder pump blades are to be replaced at wing three lift station. These have been ordered and will be replaced upon arrival to the Meliadine site.
- Secondary containment has been installed around wing three and work is ongoing for each of the wing lift station.

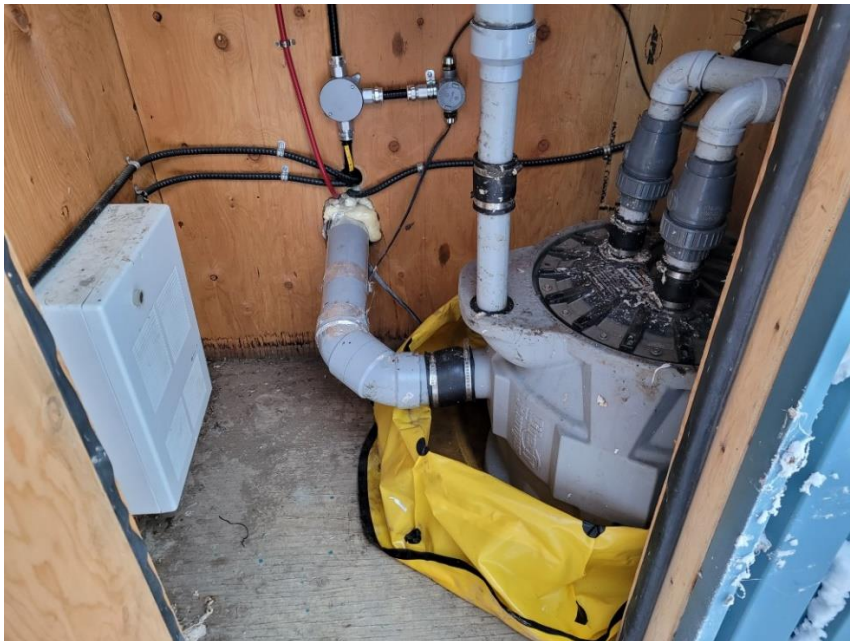
**Photo 3:** Wing three lift station with secondary containment installed post cleanup
