## Appendix 16: 2022 Reportable Spills

# Follow Up Report: #2022019

## January 25<sup>th</sup>, 2022 – Thickener Water Spill

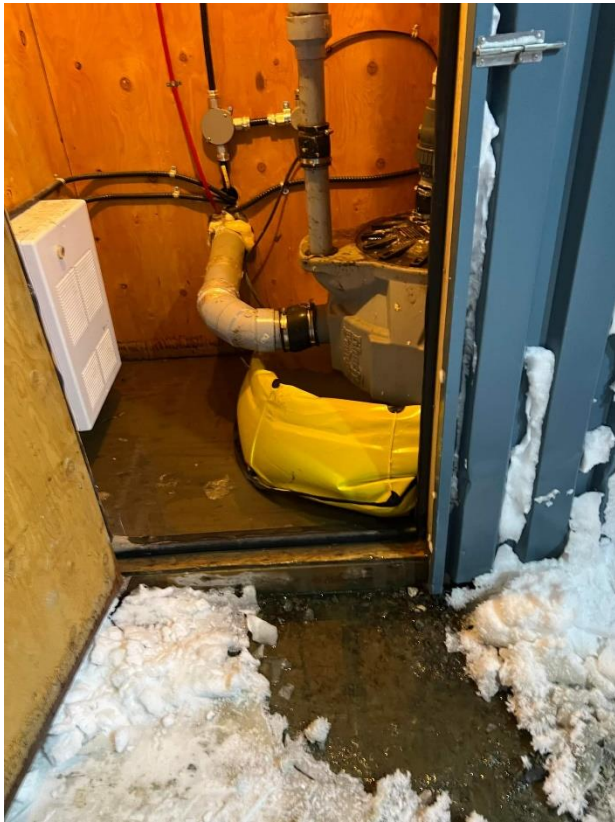
On November 24<sup>th</sup>, at approximately 6:30 pm, sewage overflowed from the pump of the wing 3 lift station. No water bodies were impacted by this spill. The closest water body (G2) is approximately 222 meters northwest, as seen in Figure 1.

**Photos 1&2:** Wing three lift station 30 L spill

Upon discovery of the spill, personnel noticed the pump was not running and manually engaged the pump to reduce the level in the lift station. Personnel requested a vacuum truck to recover the liquid untreated sewage spilled outside the lift station. Hand tools were used to clean up the frozen material and placed in a drum for disposal at Landfarm A as per section 3.4.4 of the Landfarm Management plan.

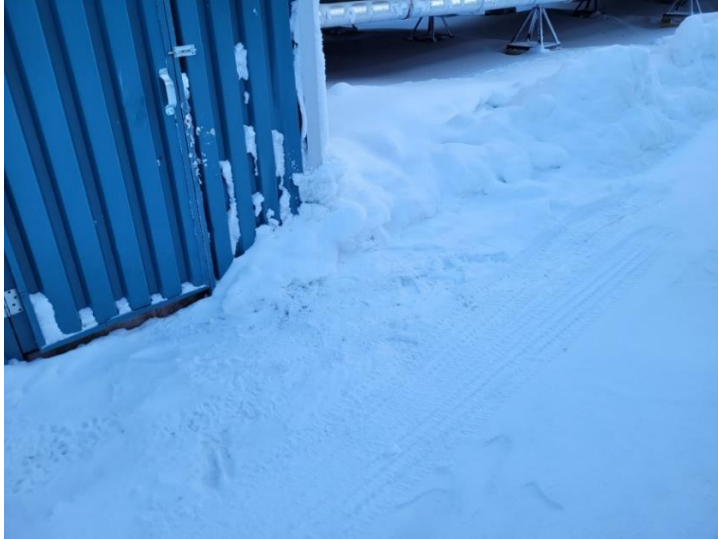
**Photo 3:** Ground area outside the wing three lift station, post cleanup.

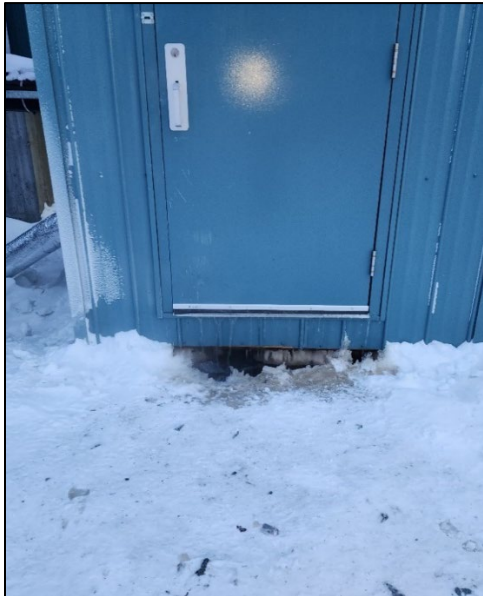
**Photos 1:** Sewage spill outside life station.

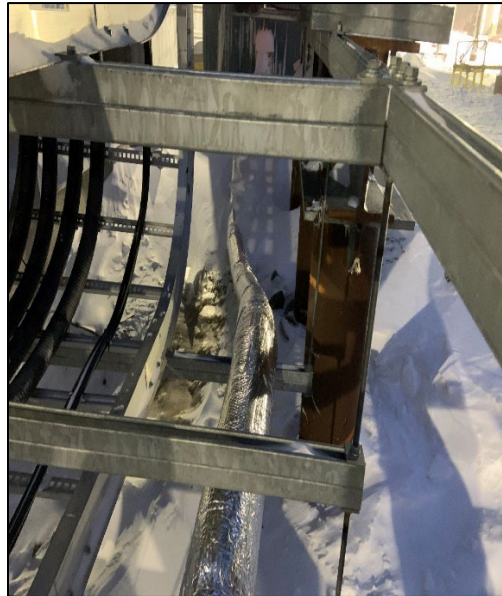
**Photos 2:** Sewage spill under infrastructure.

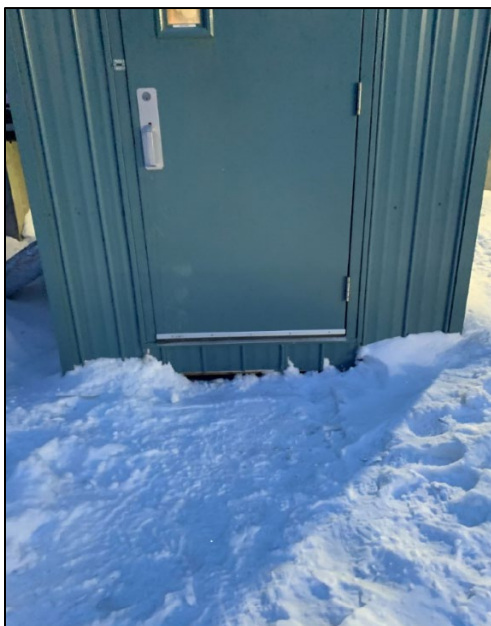
**Photo 3:** Sewage spill location post clean up.

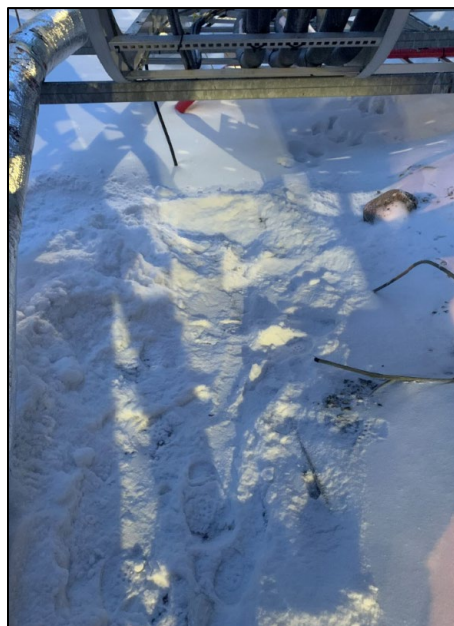
**Photo 4:** Sewage spill location post clean up.
