Appendix 6: 2022 Annual Geotechnical Inspection Report

2022 Annual Geotechnical Inspection Meliadine Gold Project, Rankin Inlet, Nunavut

PRESENTED TO
Agnico Eagle Mines Limited

FEBRUARY 17, 2023
ISSUED FOR USE
FILE: 704-ENG.EARC03140-31
AGNICO EAGLE DOCUMENT NUMBER: 65-600-230-TCR-001

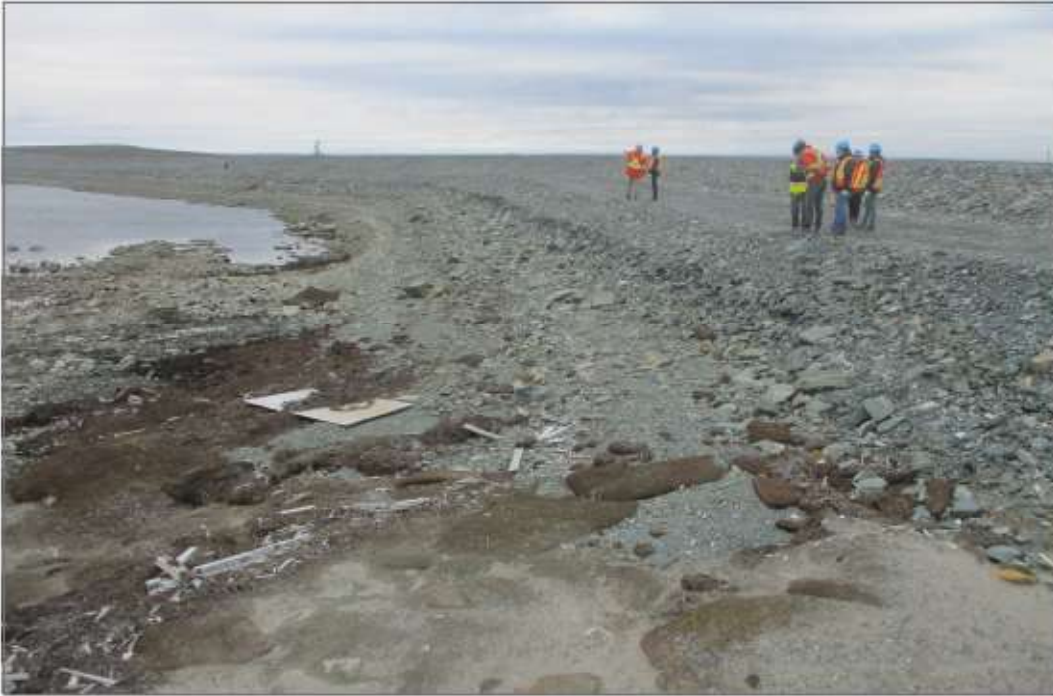
Photo 1: Dike D-CP1 - Upstream face—some wave erosion evident from 2019 event.

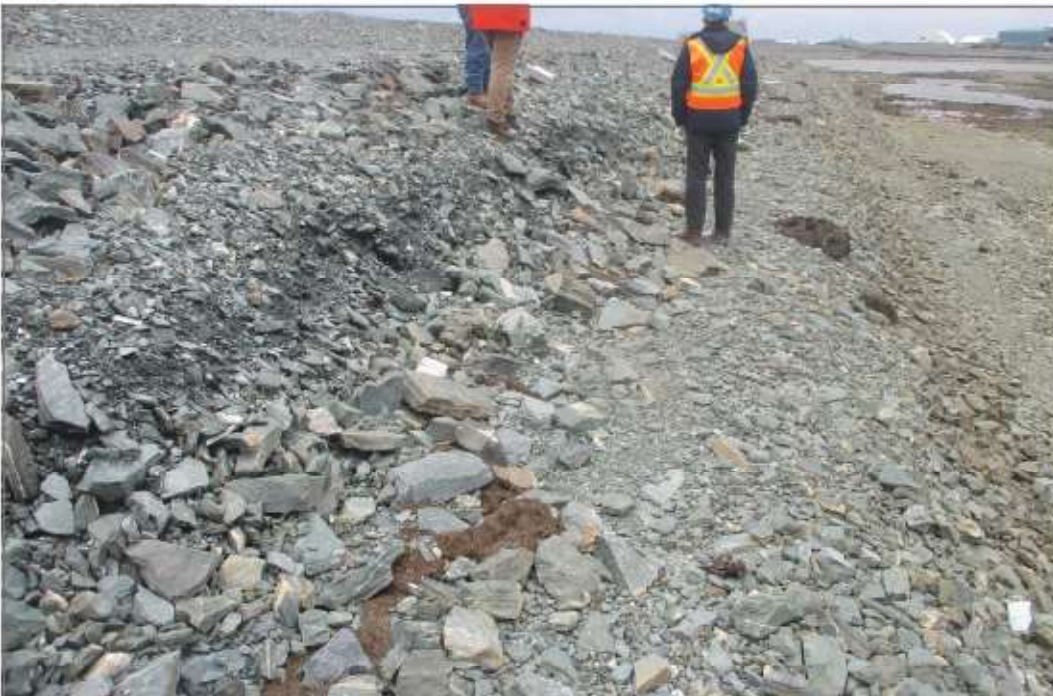
Photo 2: Dike D-CP1—Upstream face—some wave erosion evident, scarp approximately 1 m high. Erosion also evident on lower portion of slope. Slope is self armoured with larger particles in ROM fill.

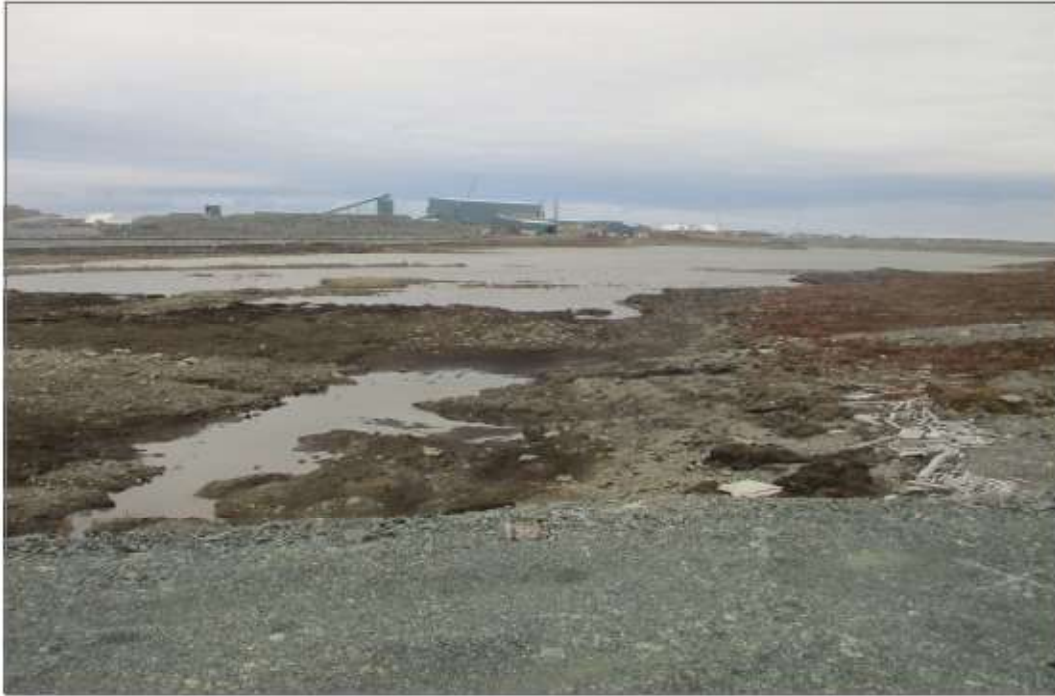
Photo 3: Dike D-CP1 - Upstream area of CP1, water levels well managed.

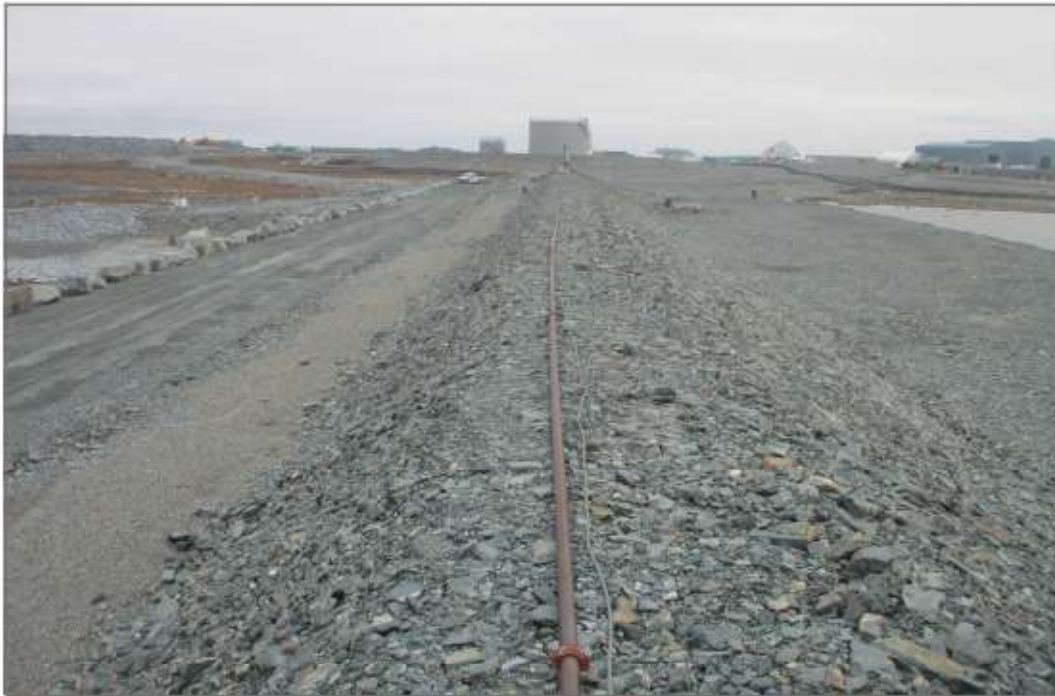
Photo 4: Dike D-CP1 - Crest. Upstream on right, downstream on left.

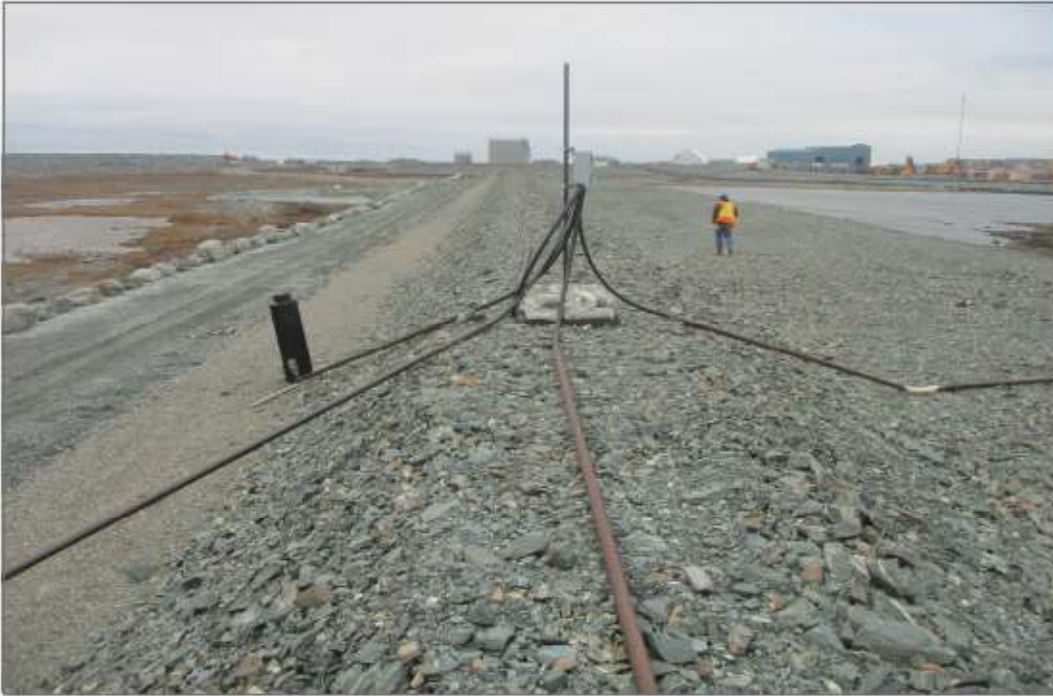
Photo 5: Dike D-CP1 - Crest—Center and downstream. GTC housing and datalogger.

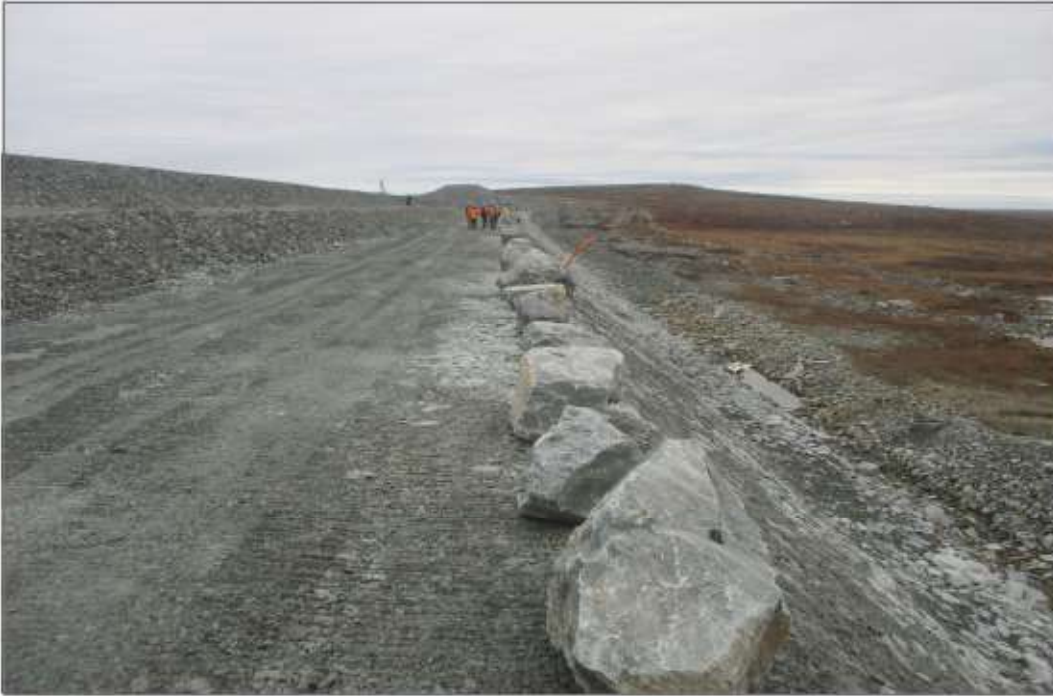
Photo 7: Dike D-CP1 - Downstream crest of toe berm constructed in fall of 2021.

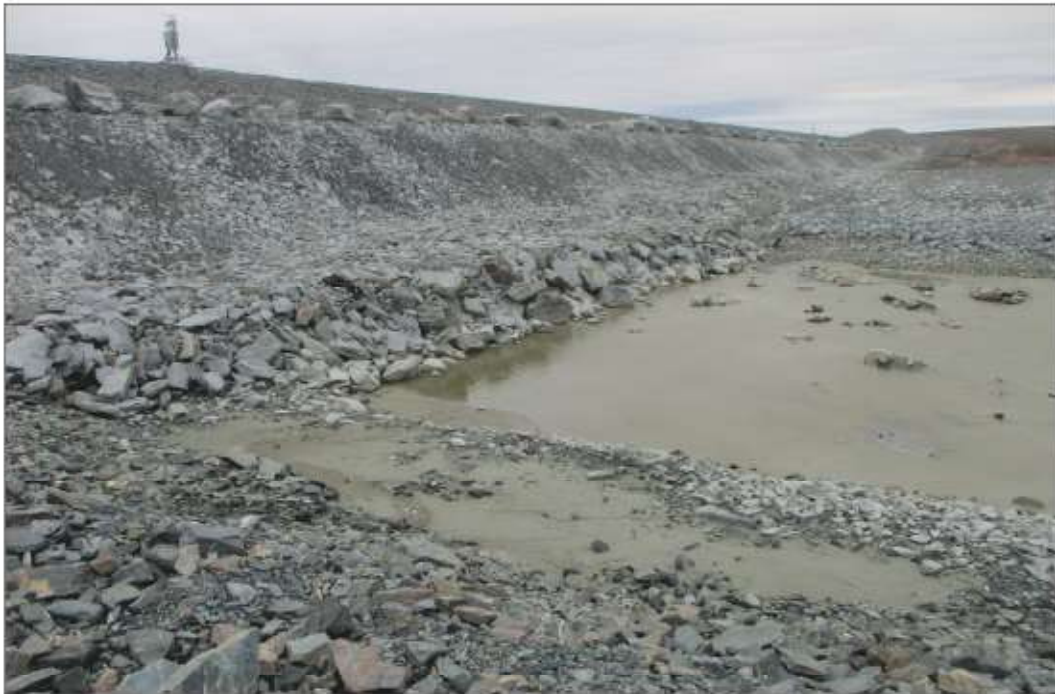
Photo 8: Dike D-CP1 - Downstream crest and sump built up with rockfill.

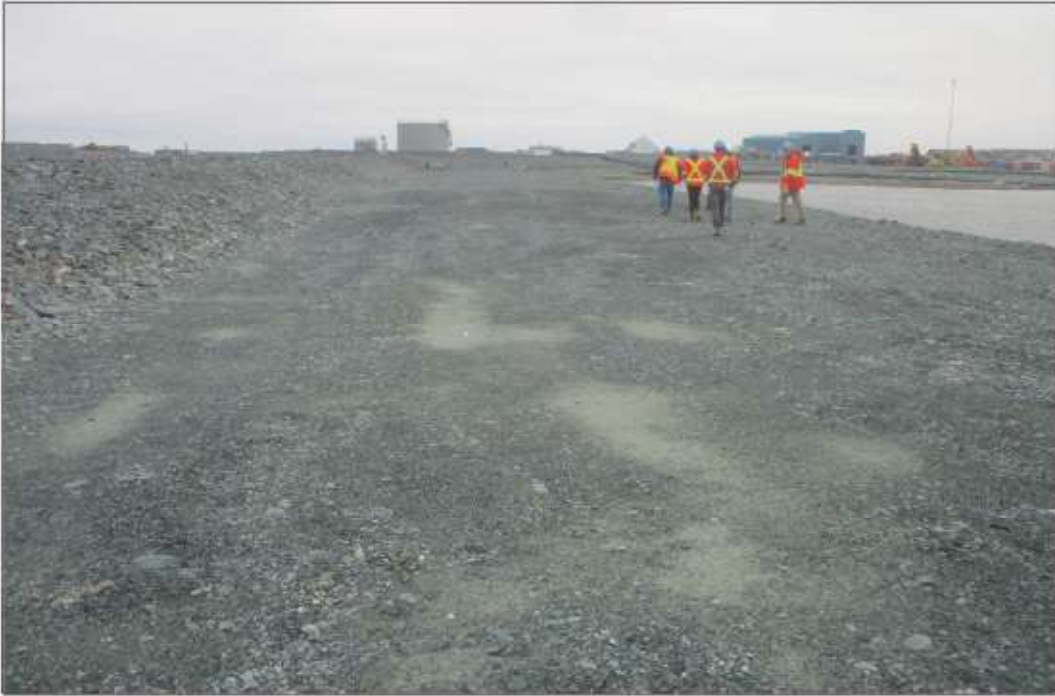
Photo 9: Dike D-CP1 - Upstream crest in good condition.

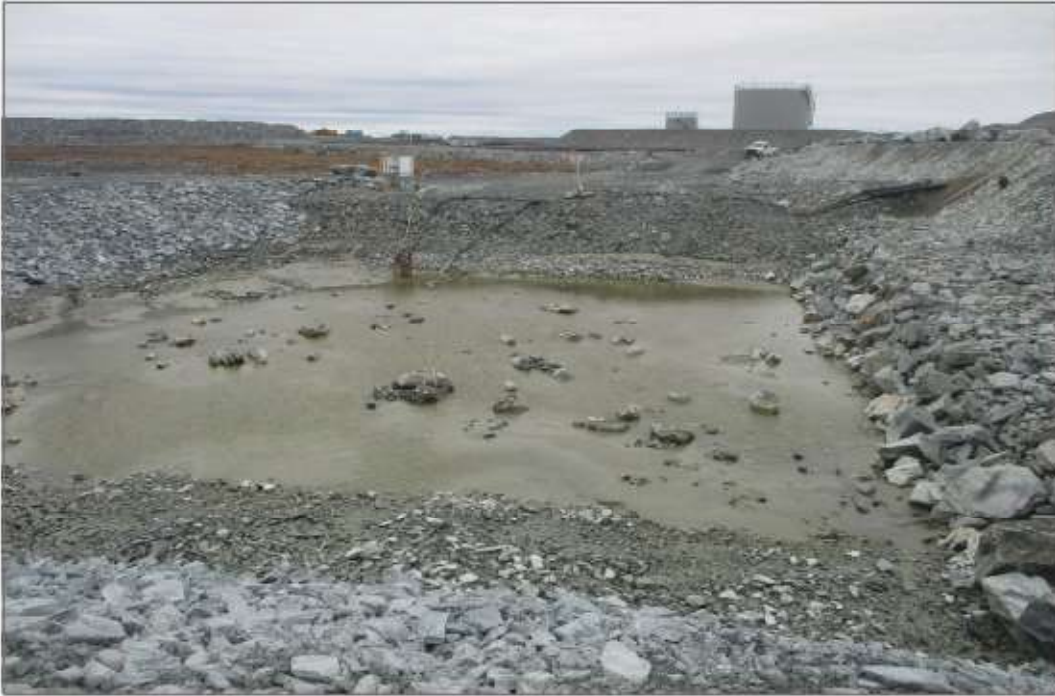
Photo 11: Dike D-CP1 - Water collection pond, east side, rockfill embankments restored.

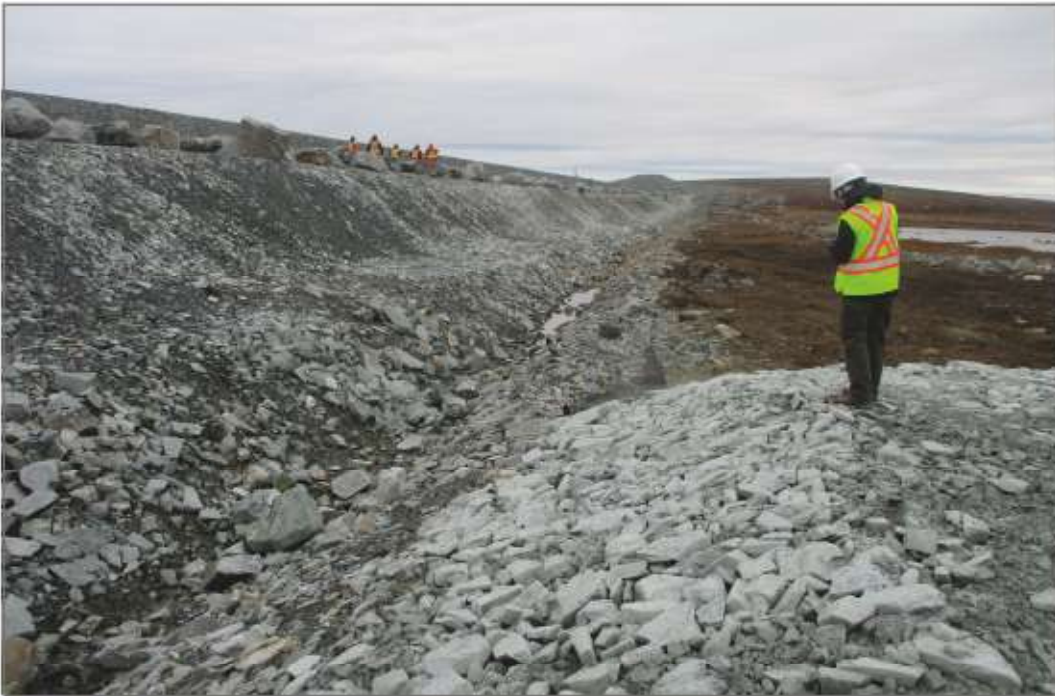
Photo 12: Dike D-CP1 - ground between the dike toe and water collection channel covered with rockfill toe berm.

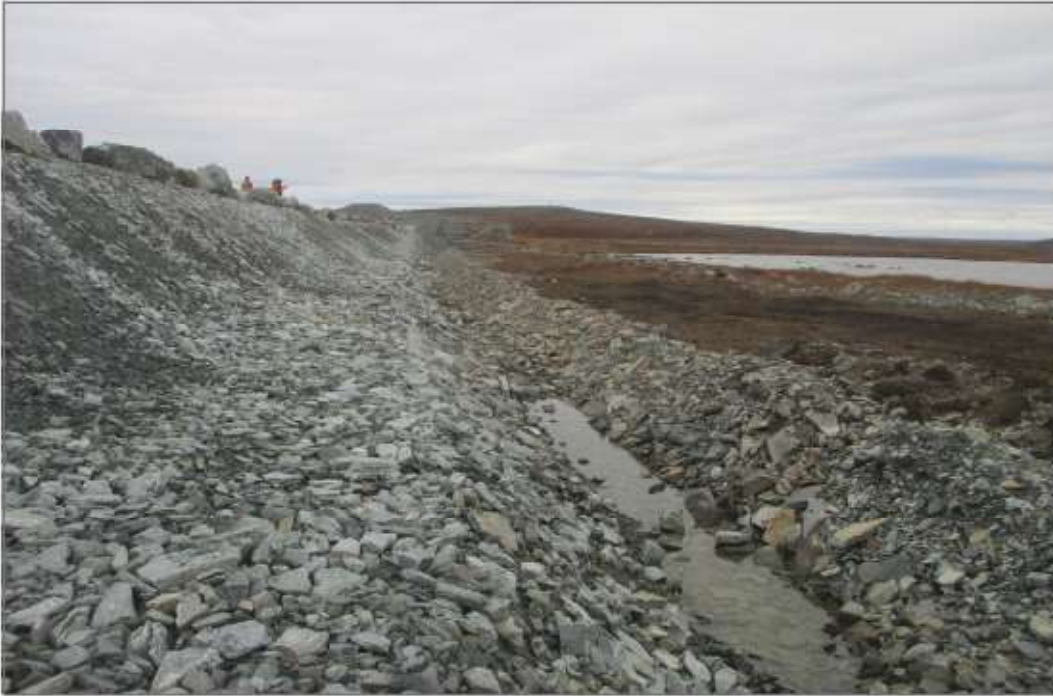
- Thaw subsidence has occurred in the native ground along the slopes of the collection channels downstream of Dike D-CP1 as shown in Photos 13 and 14.
- No seepage was observed from the downstream toe.

Photo 13: Dike D-CP1 - Seepage collection channel. Subsidence in base of channel.

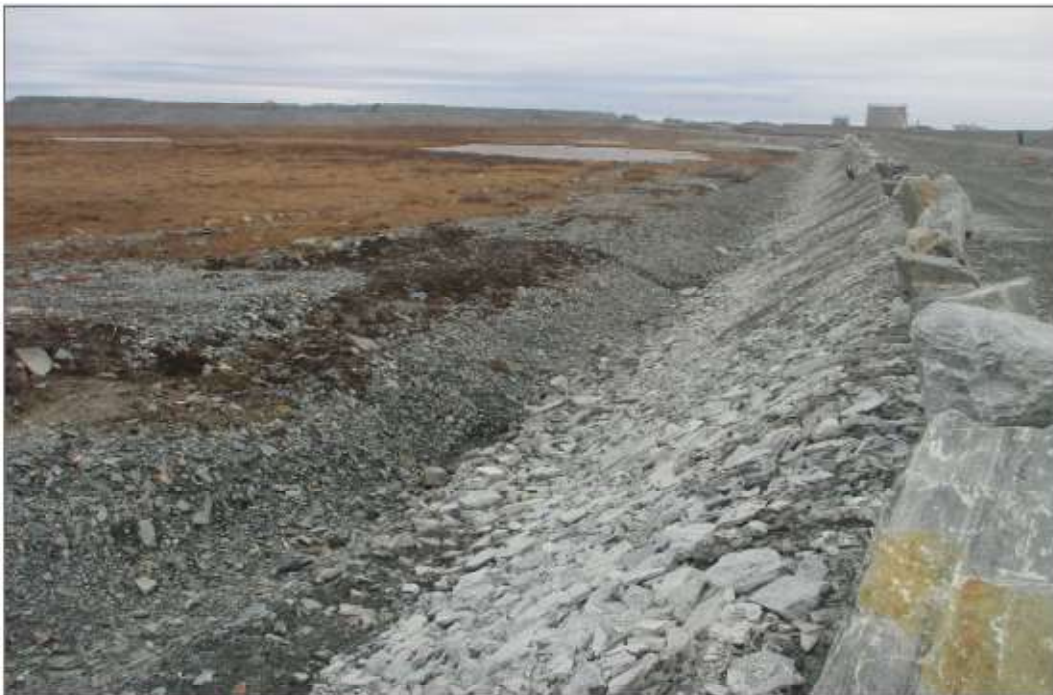
Photo 14: Dike D-CP1 - North end of disturbed ground between dike toe and seepage collection channel.

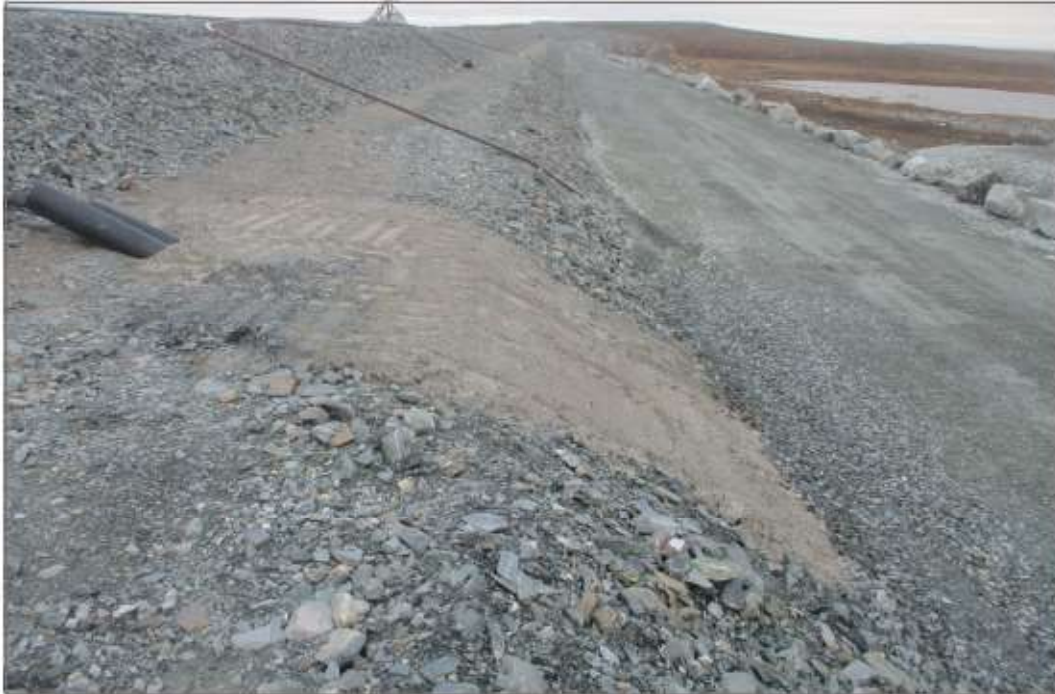
Photo 15: Dike D-CP1 - Buried line along downstream crest of dike for dewatering seepage collection pond.

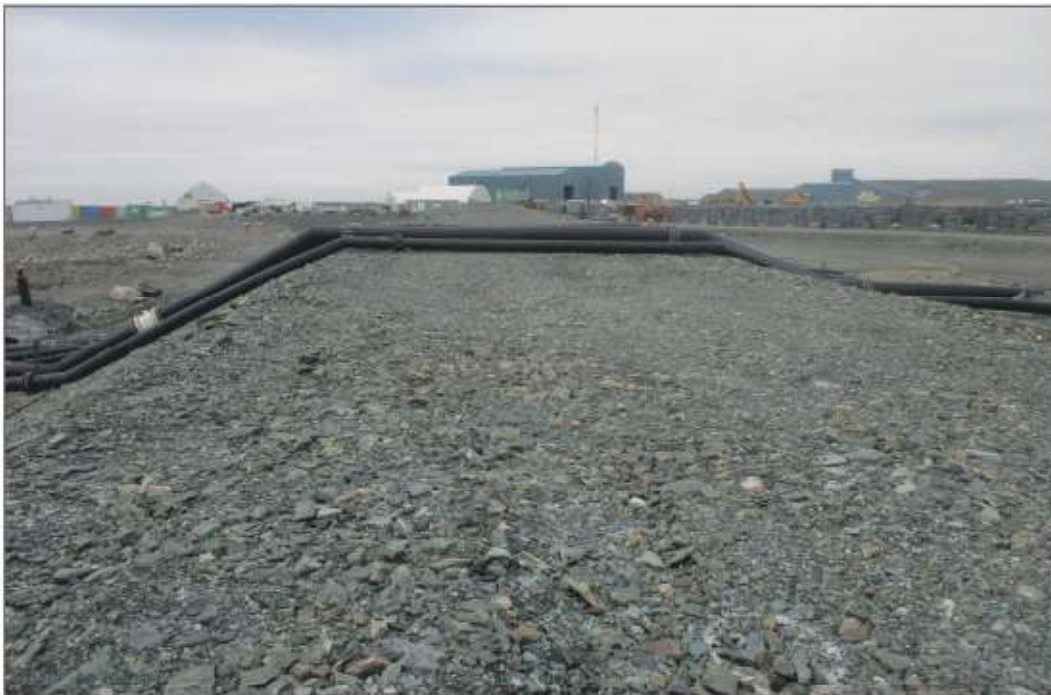
Photo 16: Dike D-CP1 - Multiple pipelines crossing D-CP1 at west abutment.

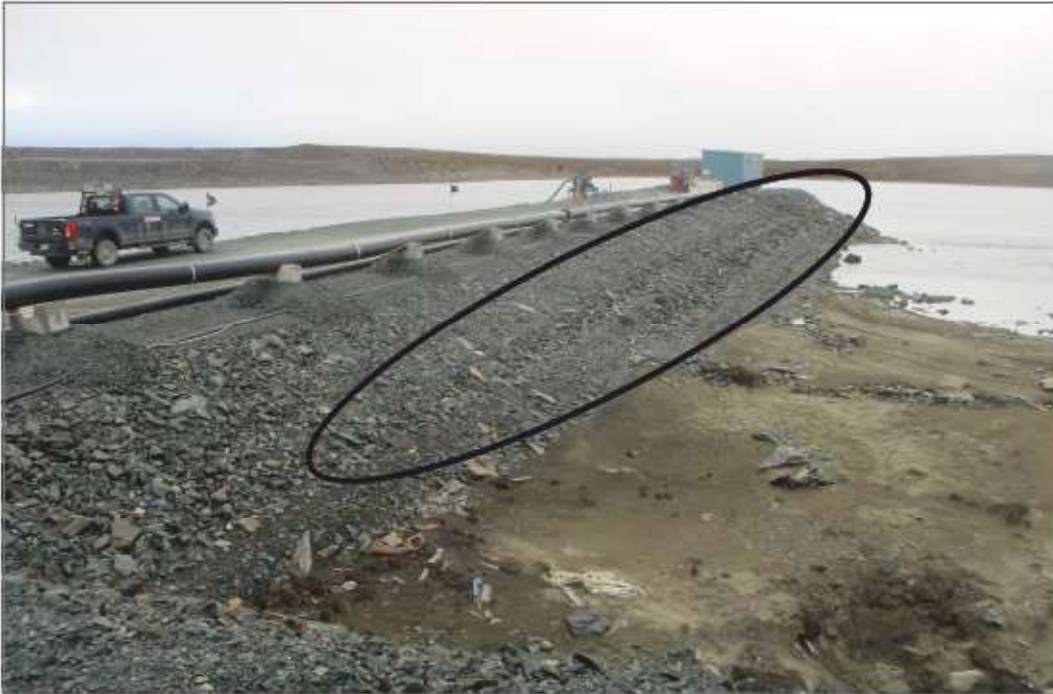
Photo 17: Dike D-CP1 Jetty 1 - Erosion at south east side of Jetty 1. No change from previous years.

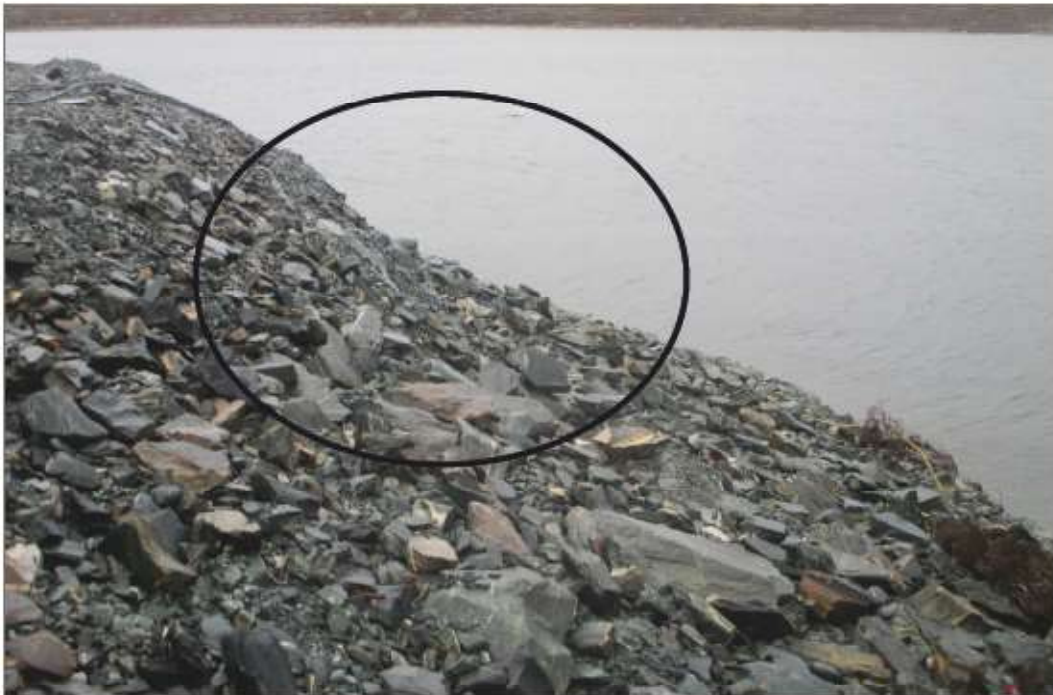
Photo 18: Dike D-CP1 Jetty 1—Erosion at southeast corner—under cutting top portion of fill. No change from previous years.

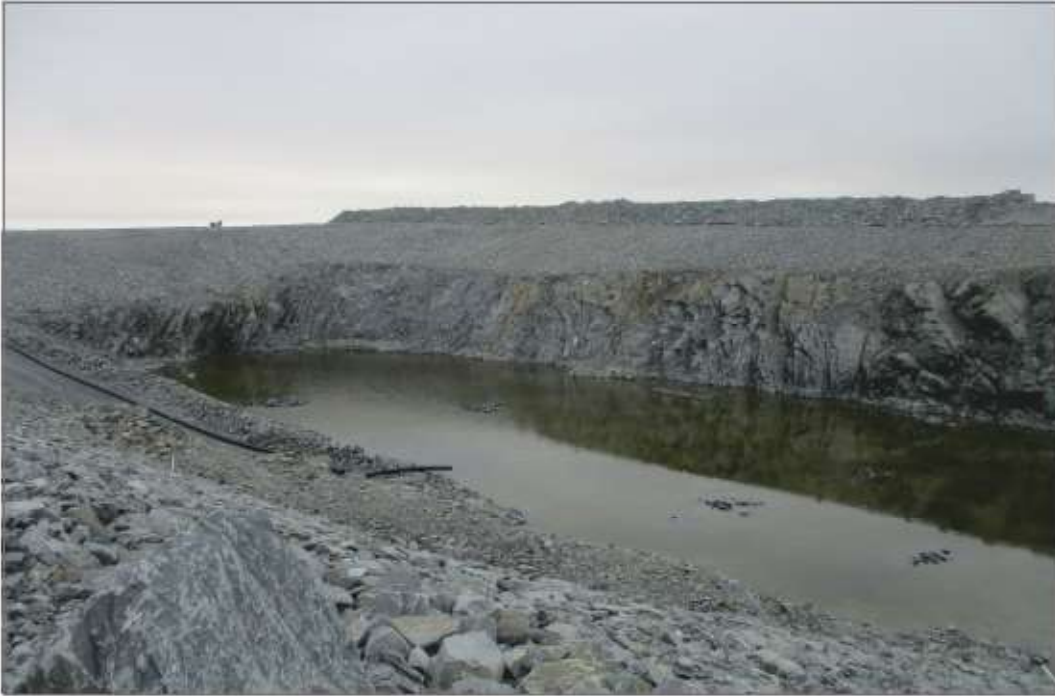
Photo 1: Pond CP2—Looking southwest, WRSF3 in background. Water running into CP2 from Channel 10.

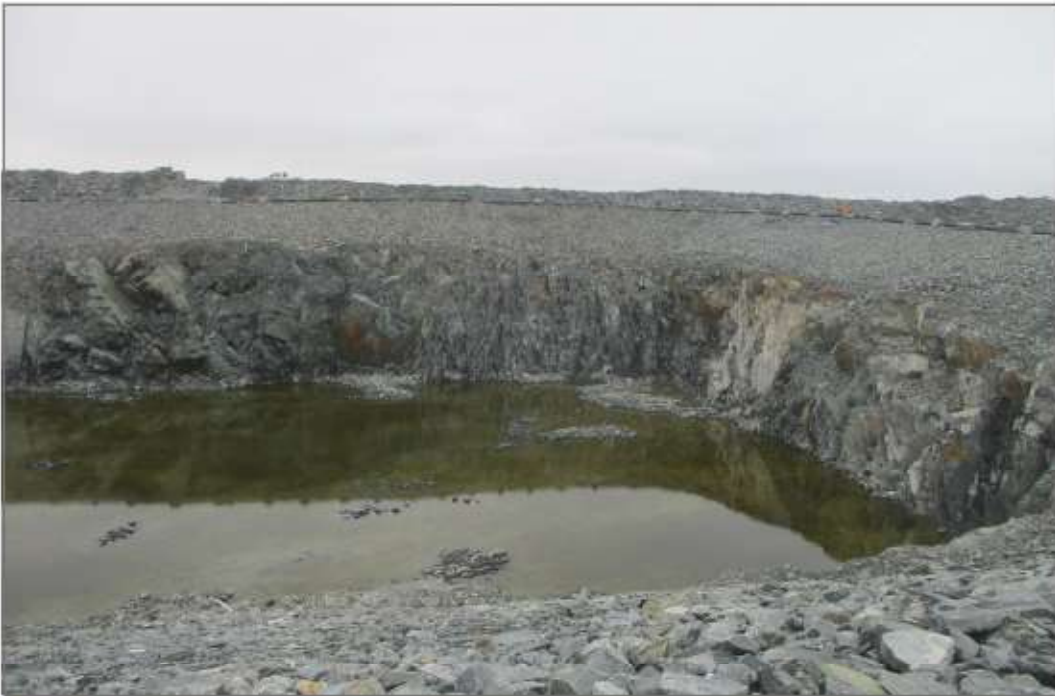
Photo 2: Pond CP2—Looking west, water running into CP2 from Channel 9 on north side.

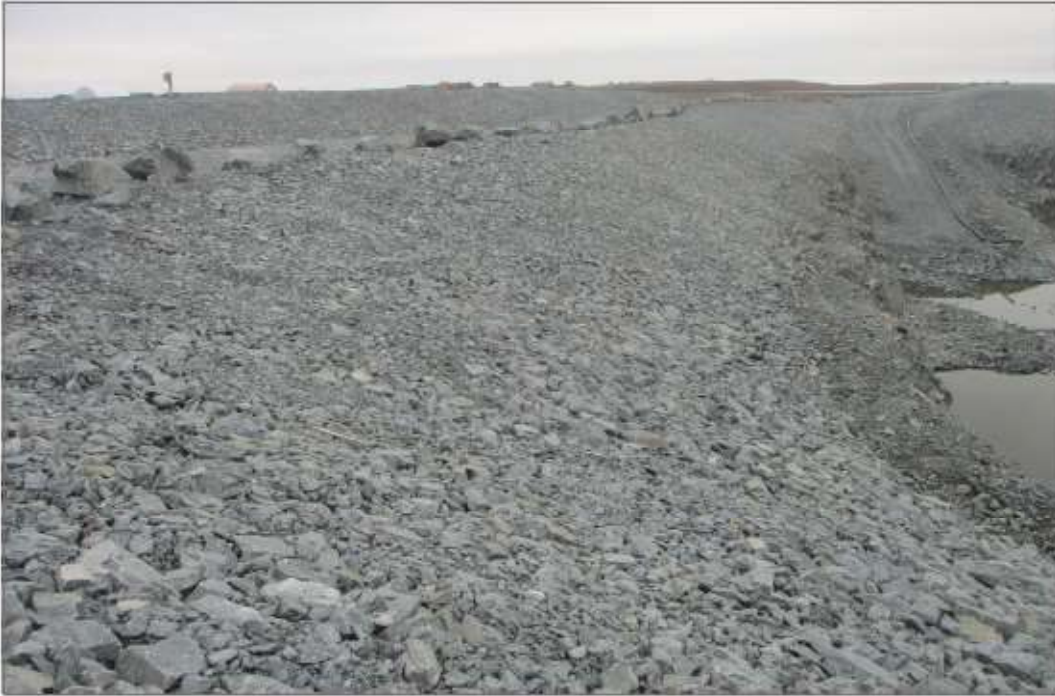
Photo 3: Pond CP2—Looking south, rockfill covered overburden along east side of CP2.

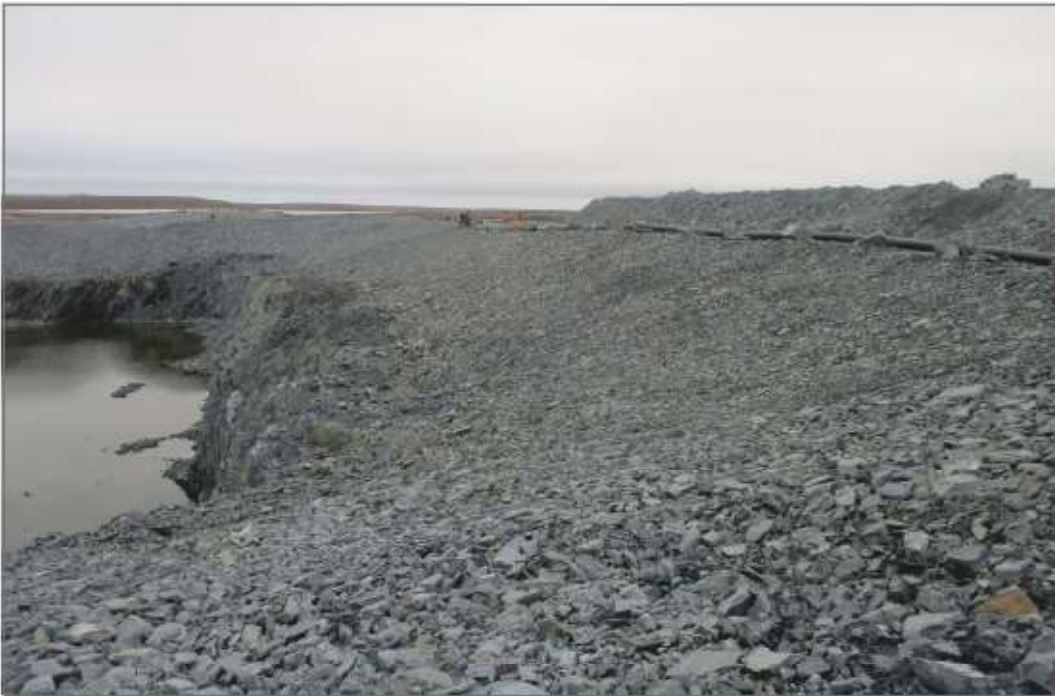
Photo 4: Pond CP2—Looking south, rockfill covered overburden along west side of CP2.

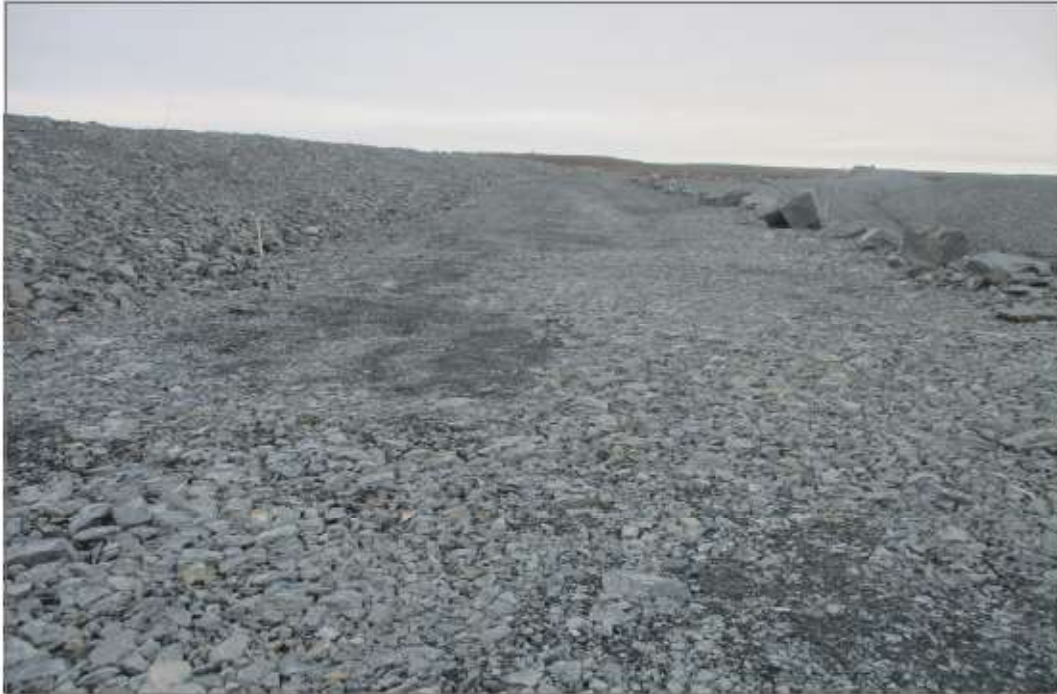
Photo 5: Pond CP2—Rockfill covering original ground between CP2 and berm.

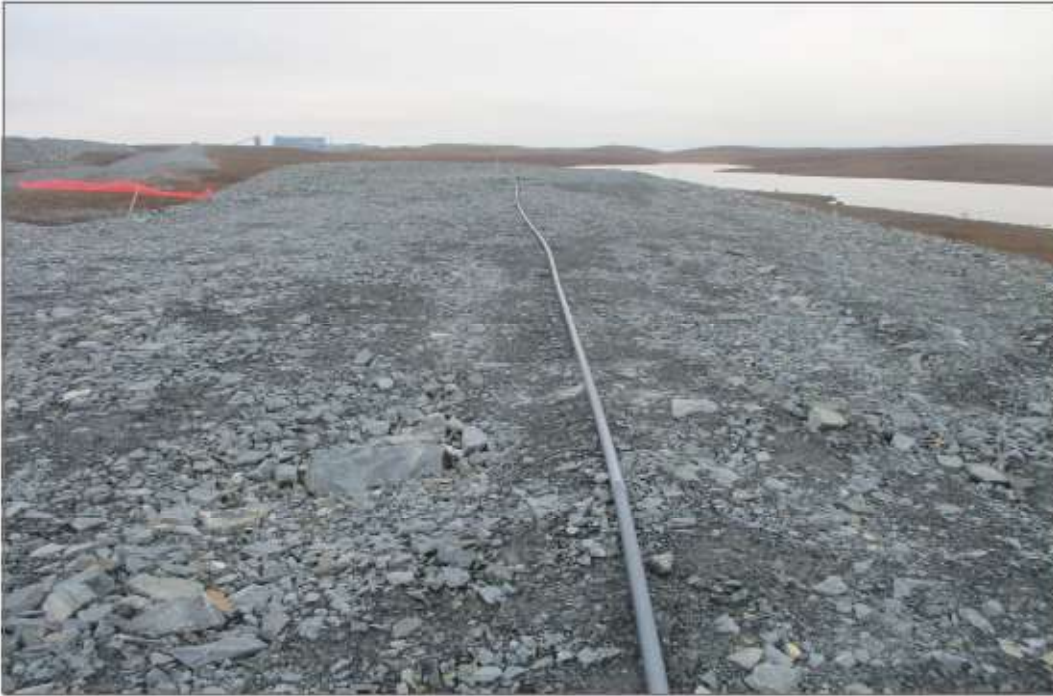
Photo 7: Berm CP2—Surface of berm looking north. GTC instrumentation installed on berm.

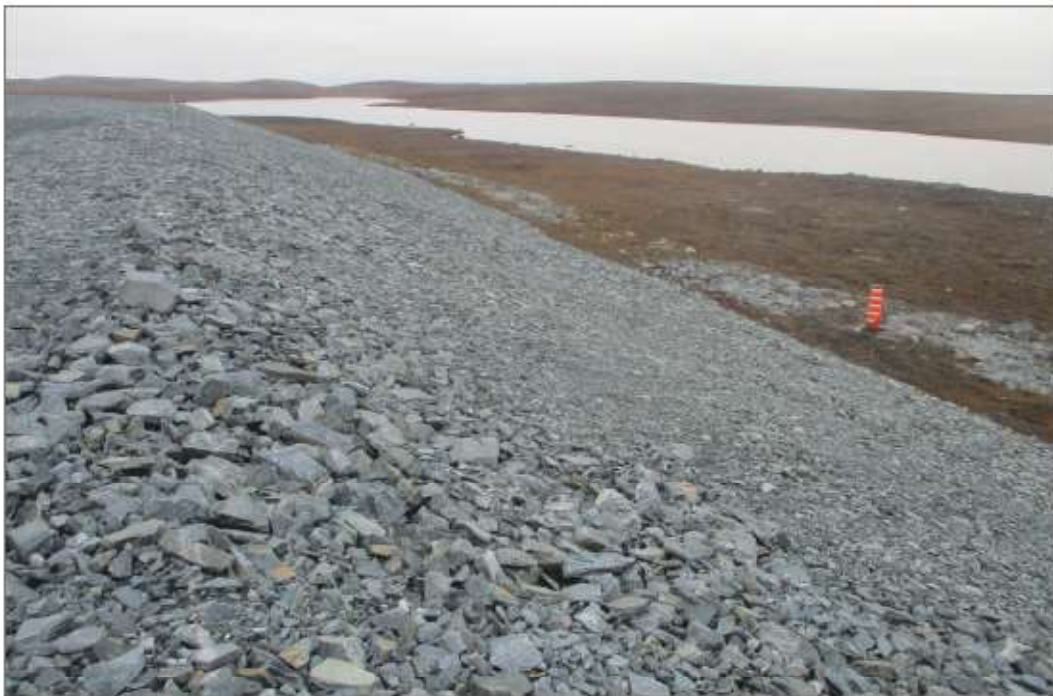
Photo 8: Berm CP2—Downstream crest of berm looking north.

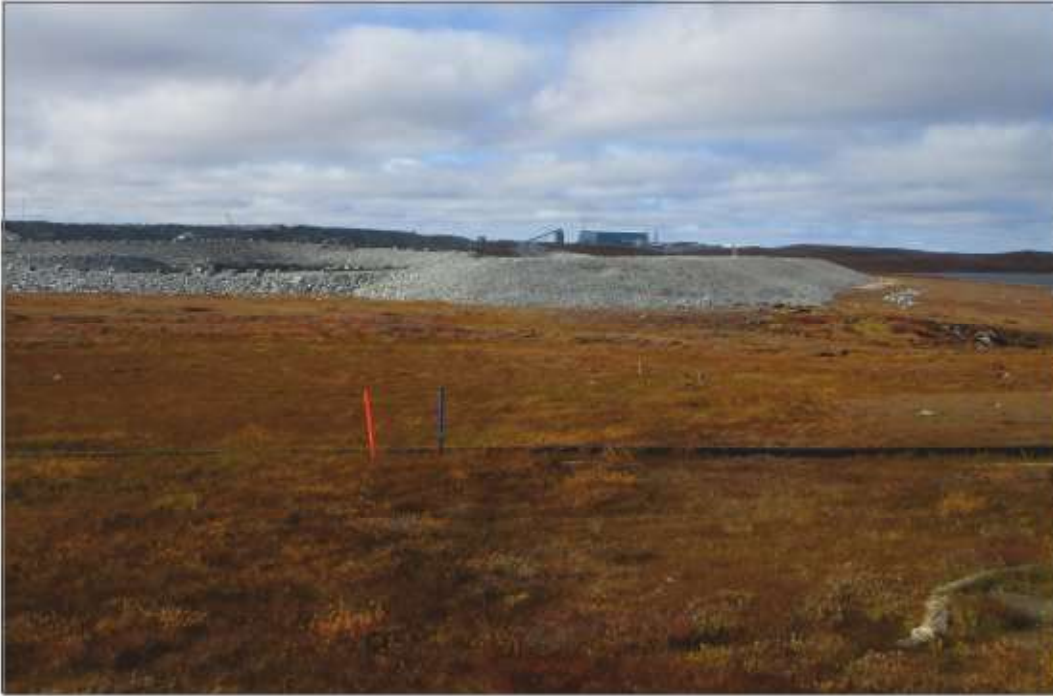
Photo 9: Berm CP2—Overview of berm and downstream area, looking north.

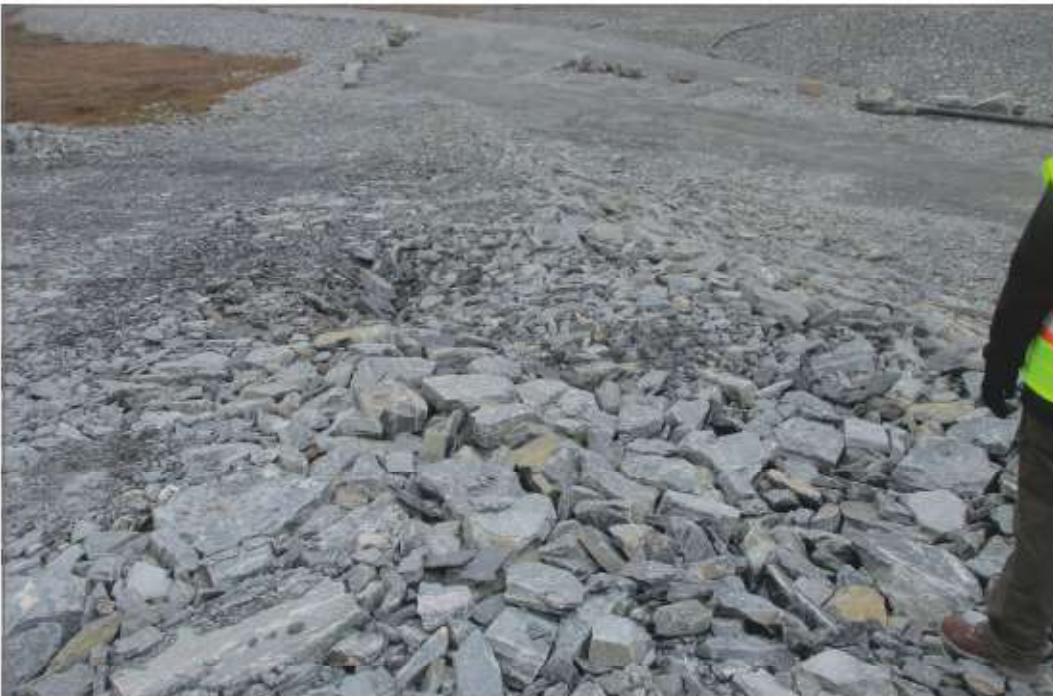
Photo 10: Pond CP2—Settlement underneath rockfill cover near ramp entry, looking south.

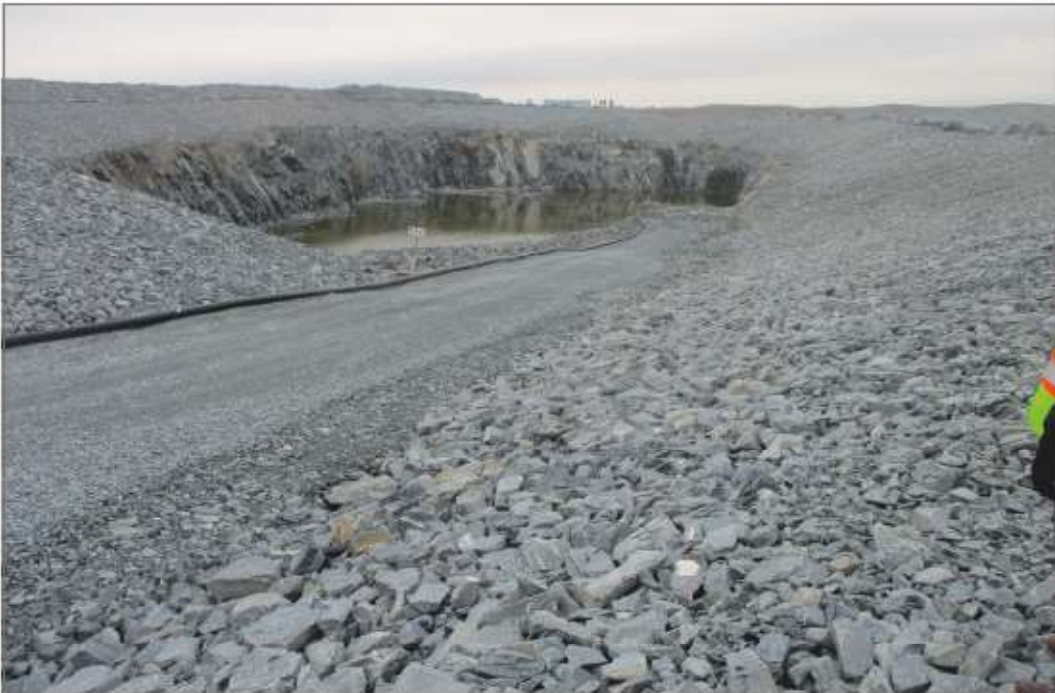
Photo 11: Pond CP2 - Access ramp, looking north.

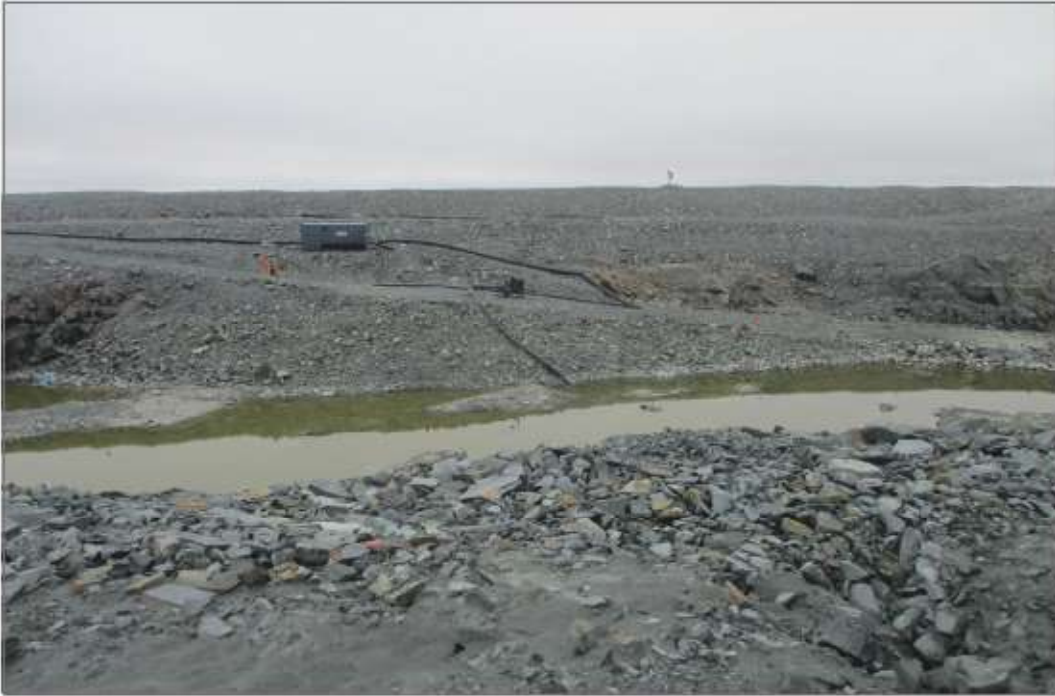
Photo 1: Pond CP3 - Looking southwest, bedrock overburden contact, access ramp into pond.

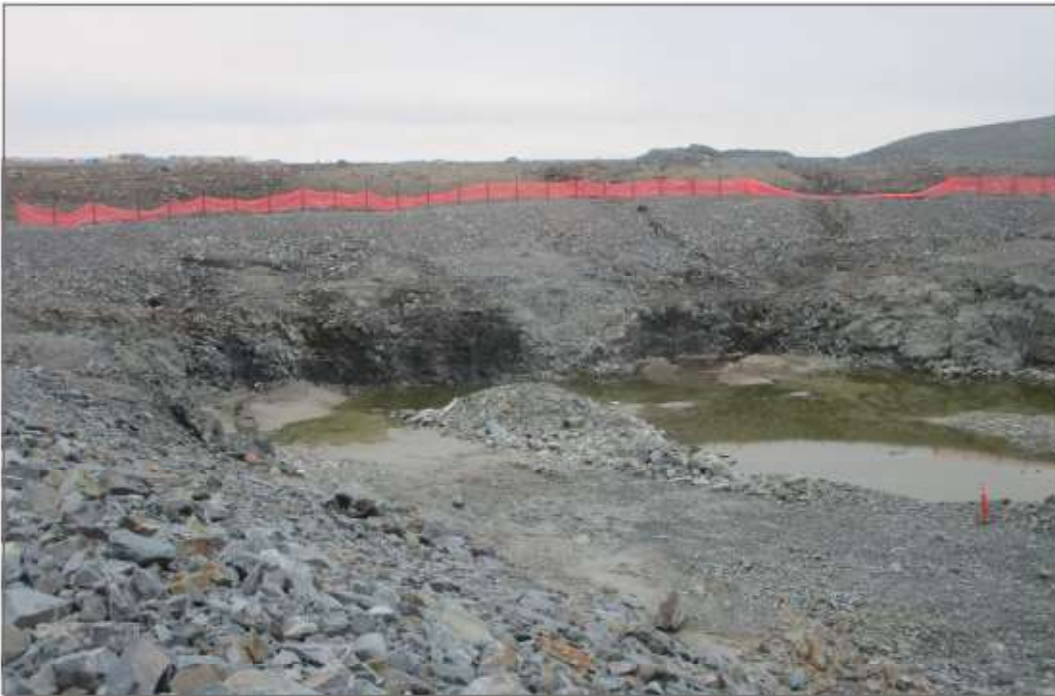
Photo 2: Pond CP3—Looking northeast, water running into CP3 along several points on north side.

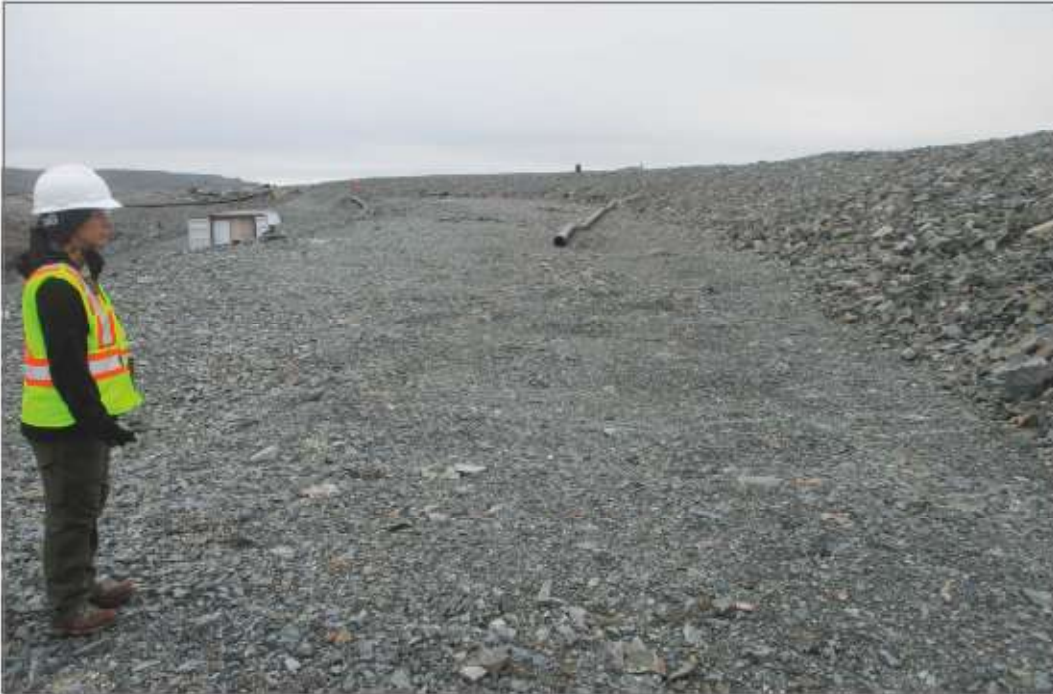
Photo 3: Pond CP3 - Looking south, rockfill covered overburden in foreground. Settlement along the overburden between CP3 and berm.

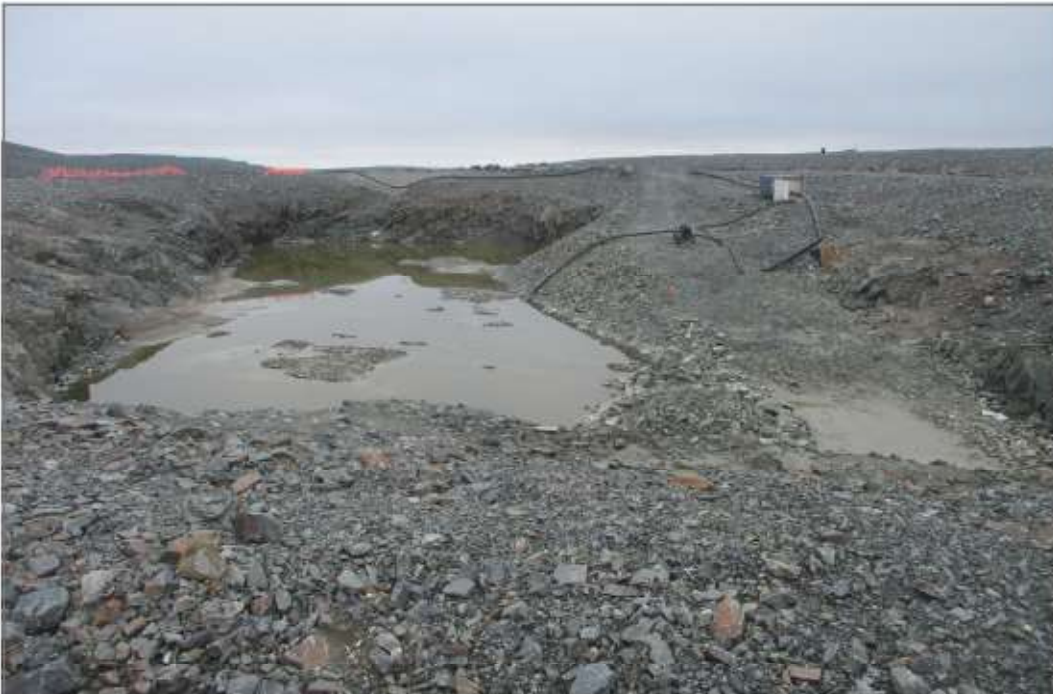
Photo 4: Pond CP3 - Looking south, water level within bedrock.
