Appendix 6: 2022 Annual Geotechnical Inspection Report

2022 Annual Geotechnical Inspection Meliadine Gold Project, Rankin Inlet, Nunavut

PRESENTED TO
Agnico Eagle Mines Limited

FEBRUARY 17, 2023
ISSUED FOR USE
FILE: 704-ENG.EARC03140-31
AGNICO EAGLE DOCUMENT NUMBER: 65-600-230-TCR-001

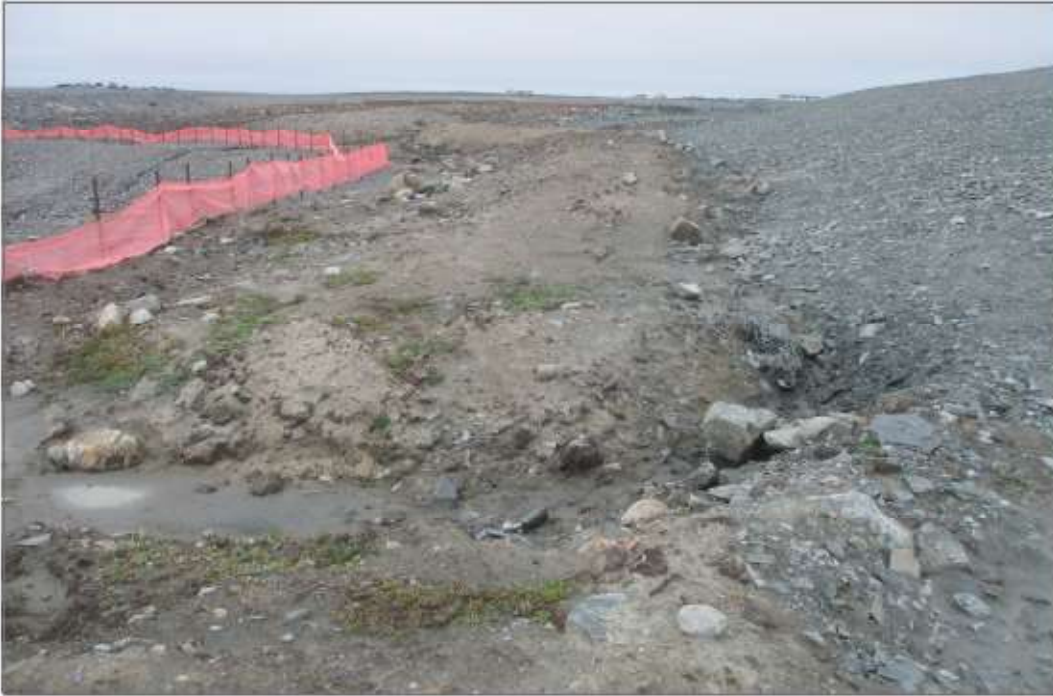
Photo 5: Pond CP3 - Runoff/erosion channels into pond from north end of TSF drainage, located on north side of pond.

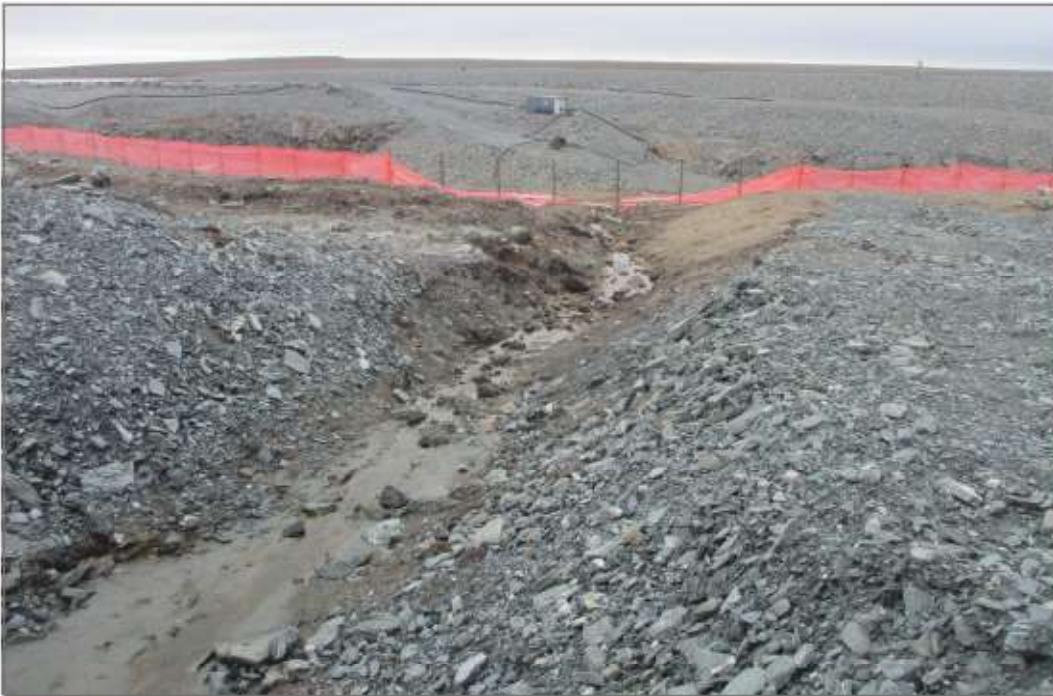
Photo 6: Pond CP3 - Constructed runoff channel into pond from north end of TSF drainage, located on east side of pond.

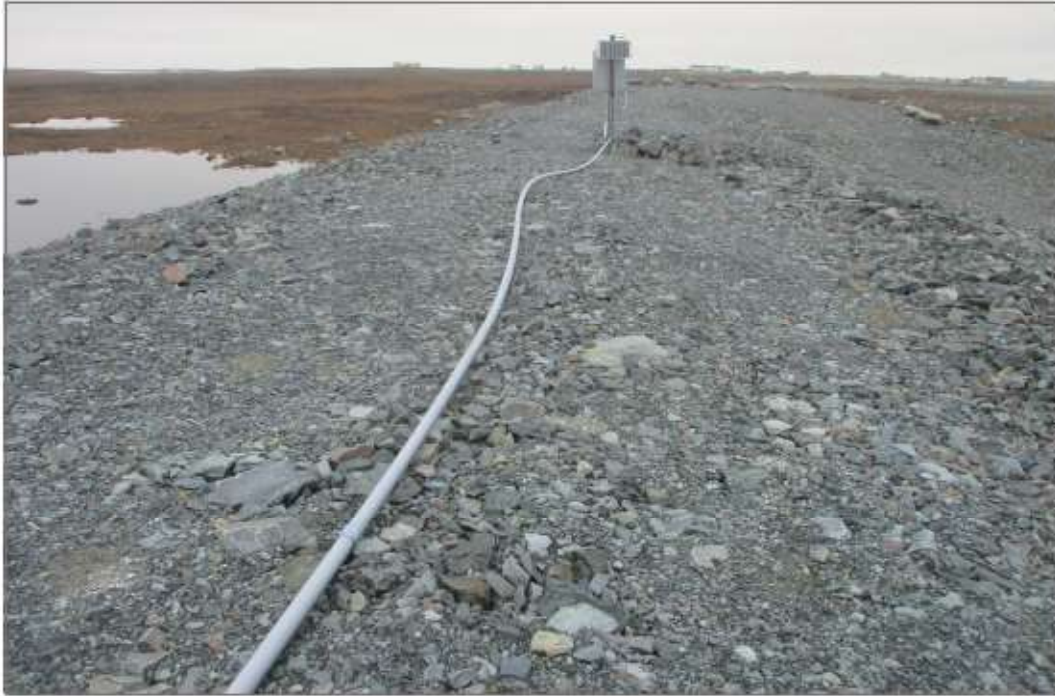
Photo 7: Berm CP3 - GTC instrumentation loggers installed on berm.

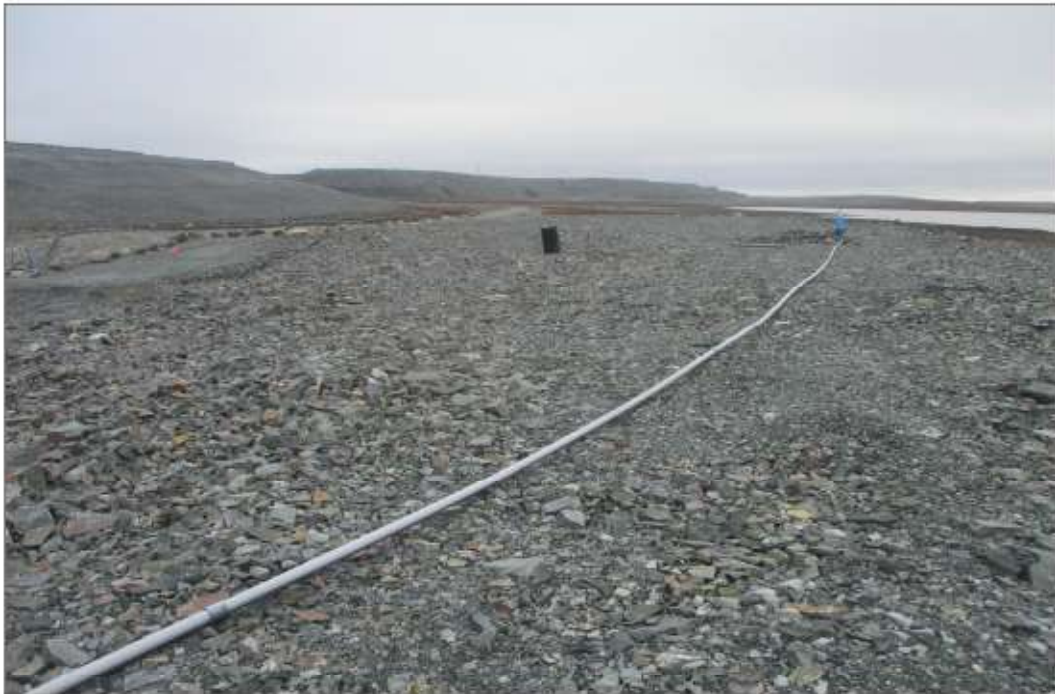
Photo 8: Berm CP3 - Looking south, surface of berm. Undulating settlement and subsidence.

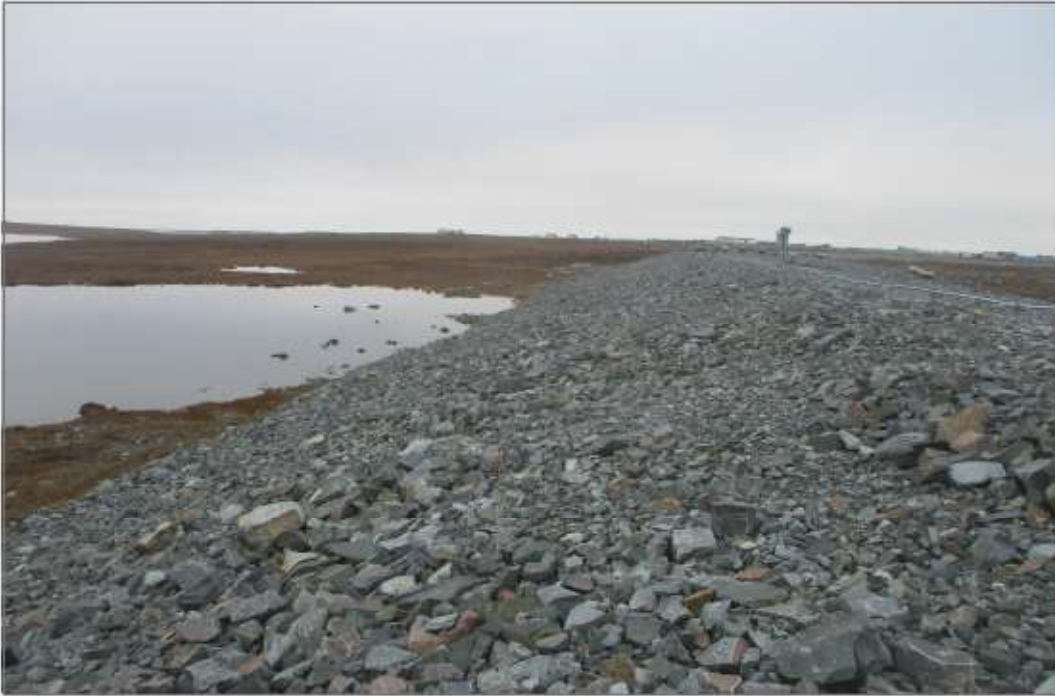
Photo 9: Berm CP3 - Berm downstream crest, looking North.

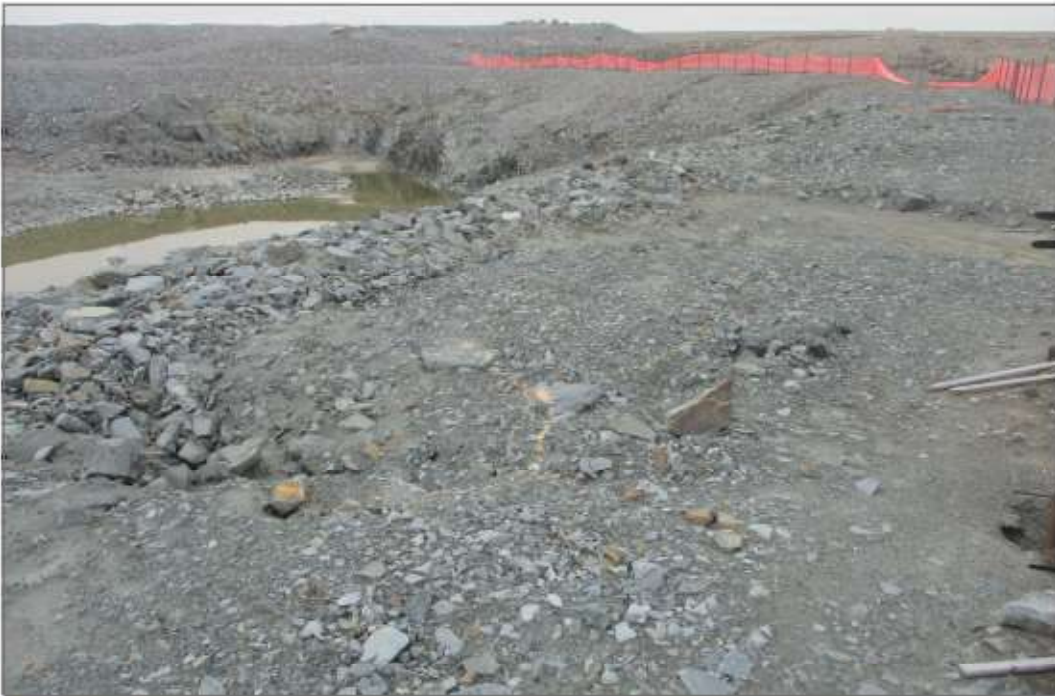
Photo 10: Pond CP3 - Looking north, settlement and erosion at overburden crest.

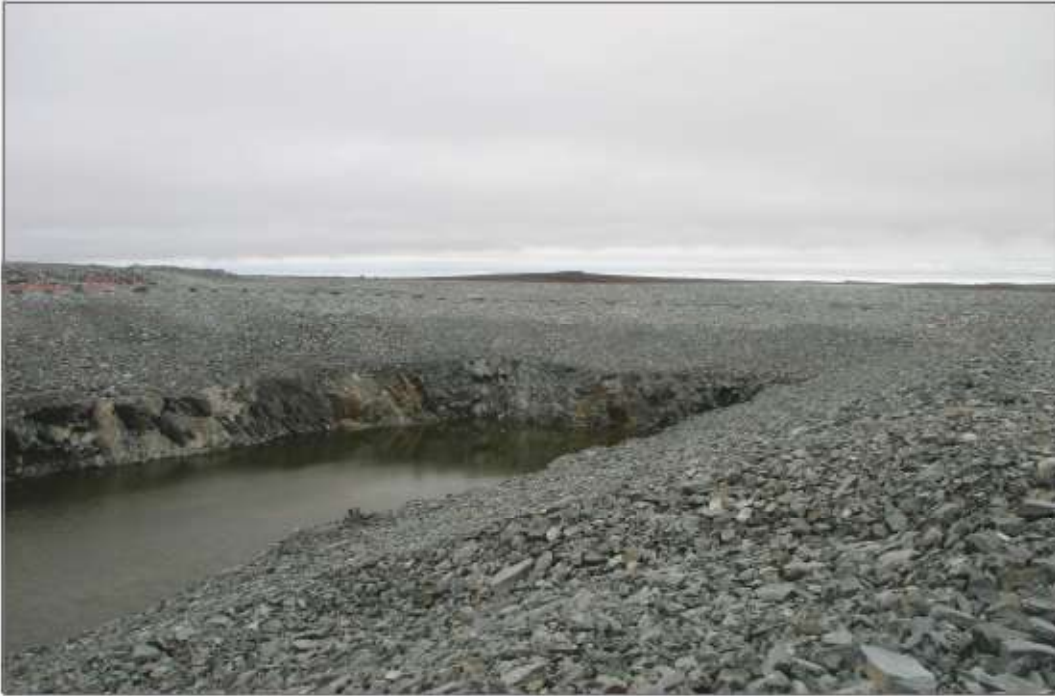
Photo 1: Pond CP4 - Looking northwest, Berm CP4 in the background.

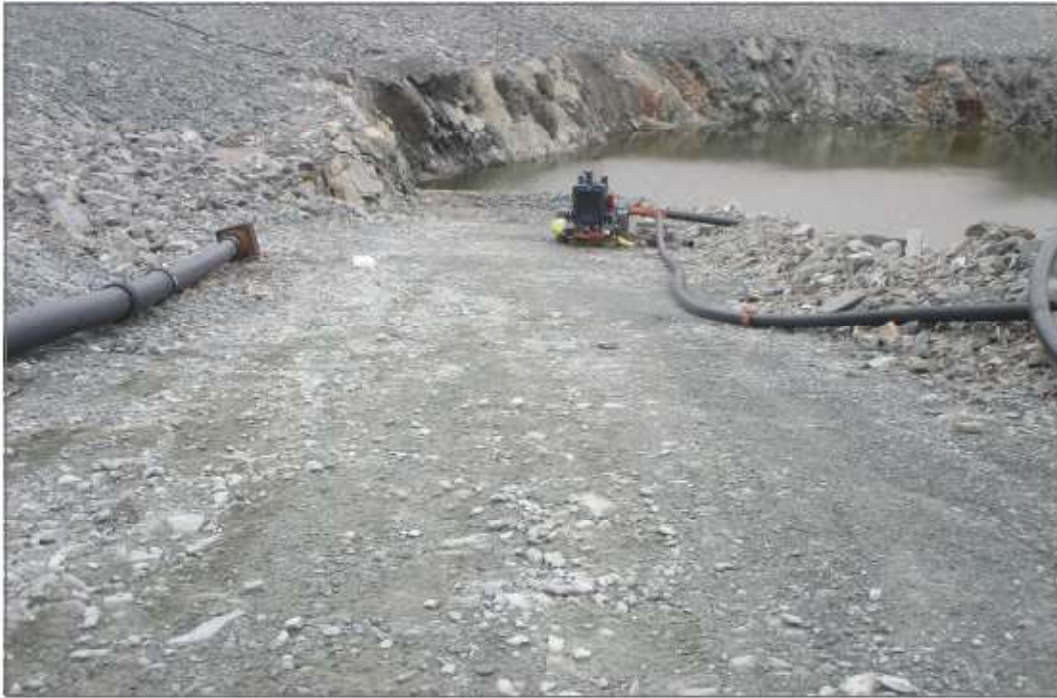
Photo 3: Pond CP4 - Looking north at the ramp into the pond.

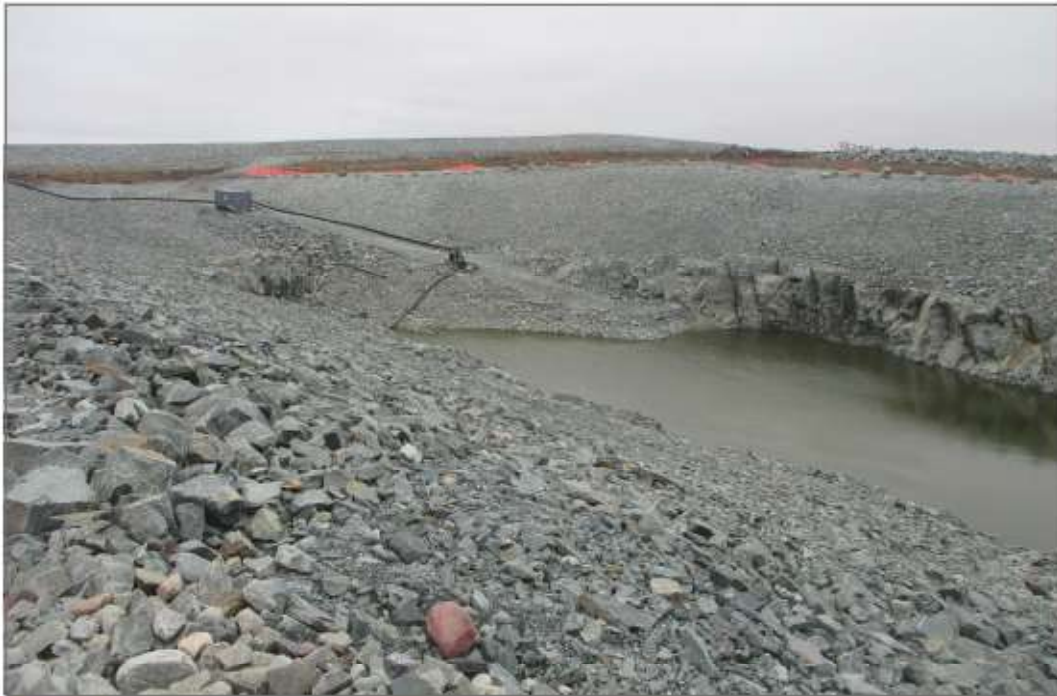
Photo 4: Pond CP4 - South slope—rockfill covered slope, no obvious signs of distress.

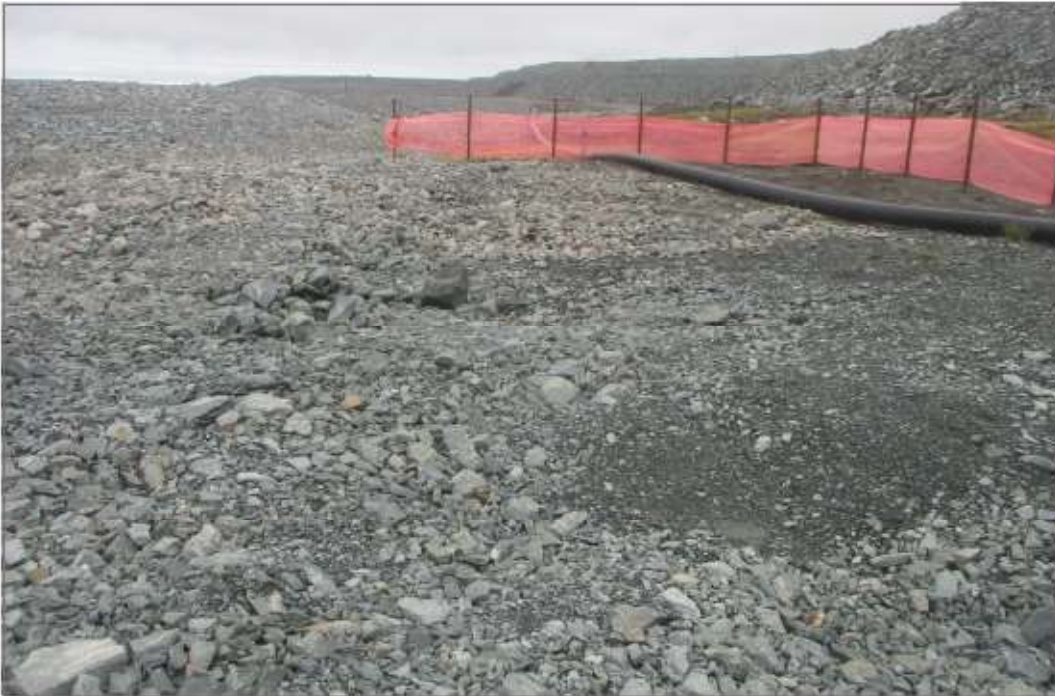
Photo 5: Pond CP4 - Settlement and cracking above east slope.

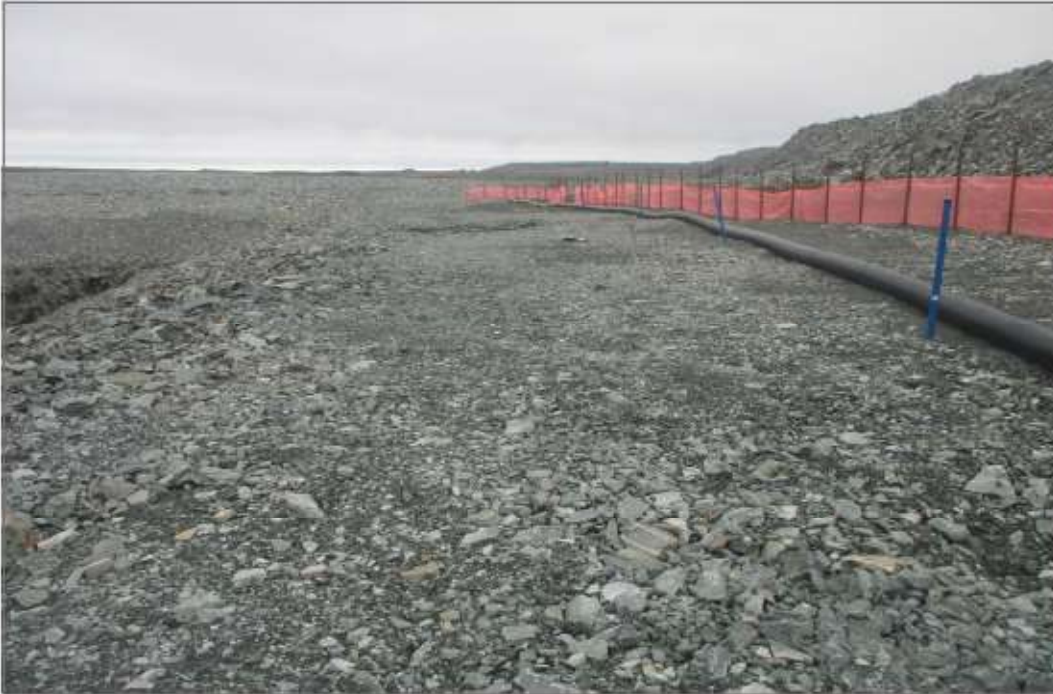
Photo 7: Pond CP4 - Ground above rockfill covered overburden slope. Settlement and subsidence in the area.

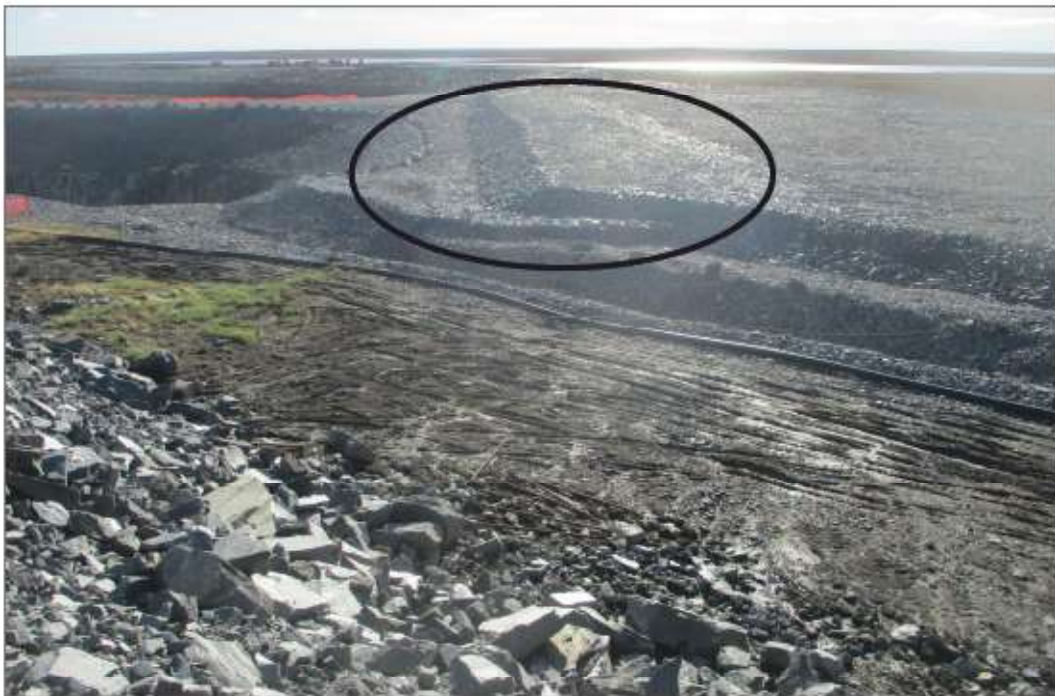
Photo 8: Pond CP4 - North slope, Rockfill placed in area between rockfill covered slope and thermal berm in 2022.

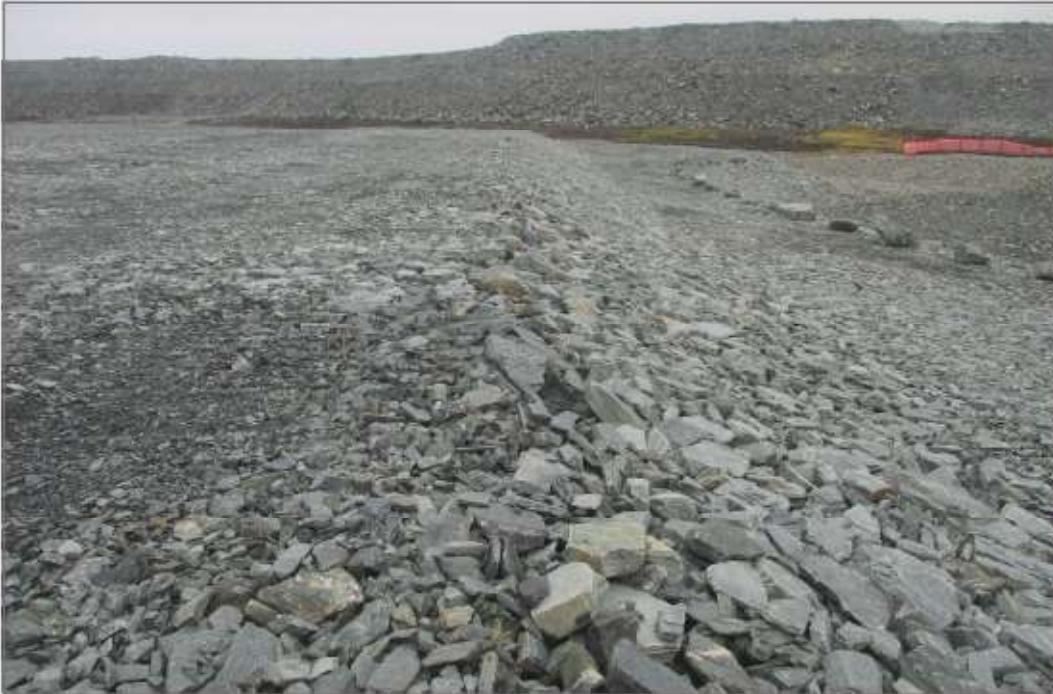
Photo 9: Pond CP4 - Rockfill placed between CP4 slope and berm to reduce thaw subsidence observed in 2021 inspection.

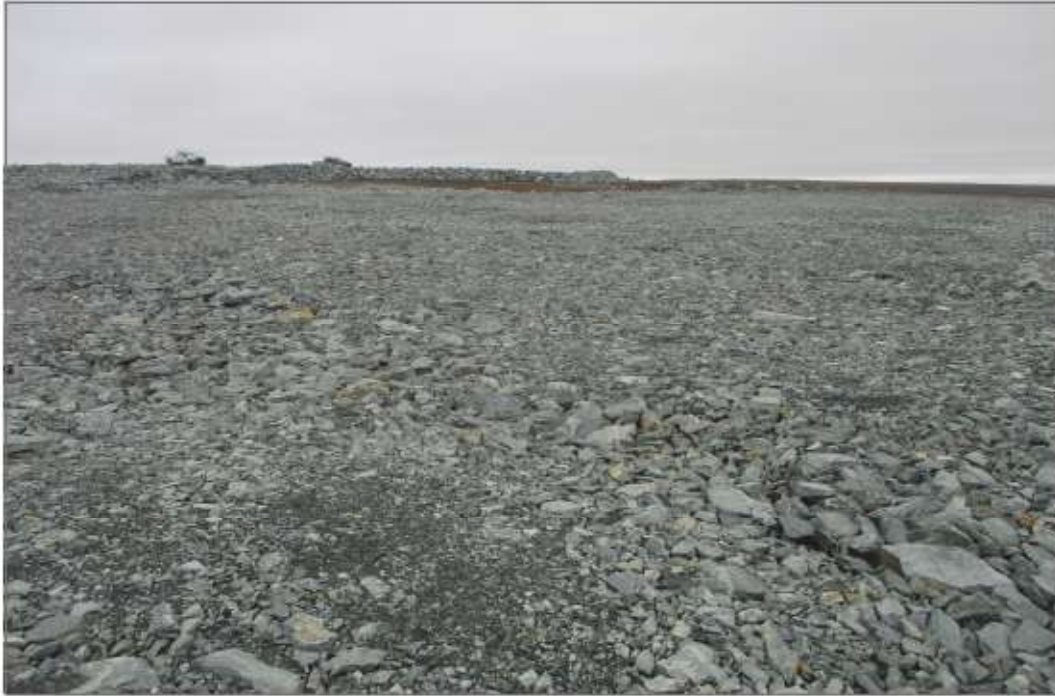
Berm CP4 was constructed of overburden till obtained from the excavation of CP4. The till was a combination of frozen and unfrozen material when it was placed in the berm. The till was covered with a layer of rockfill also obtained from the excavation. The slopes of the berm were in good condition. The crest of the berm had undulating settlement up to 0.3 m deep throughout the surface as shown in Photo 11, Appendix E. The settlement does not impact the berms function which is to insulate the original ground.

Photo 11: Berm CP4 - Undulating settlement up to 0.3 m throughout surface of berm.

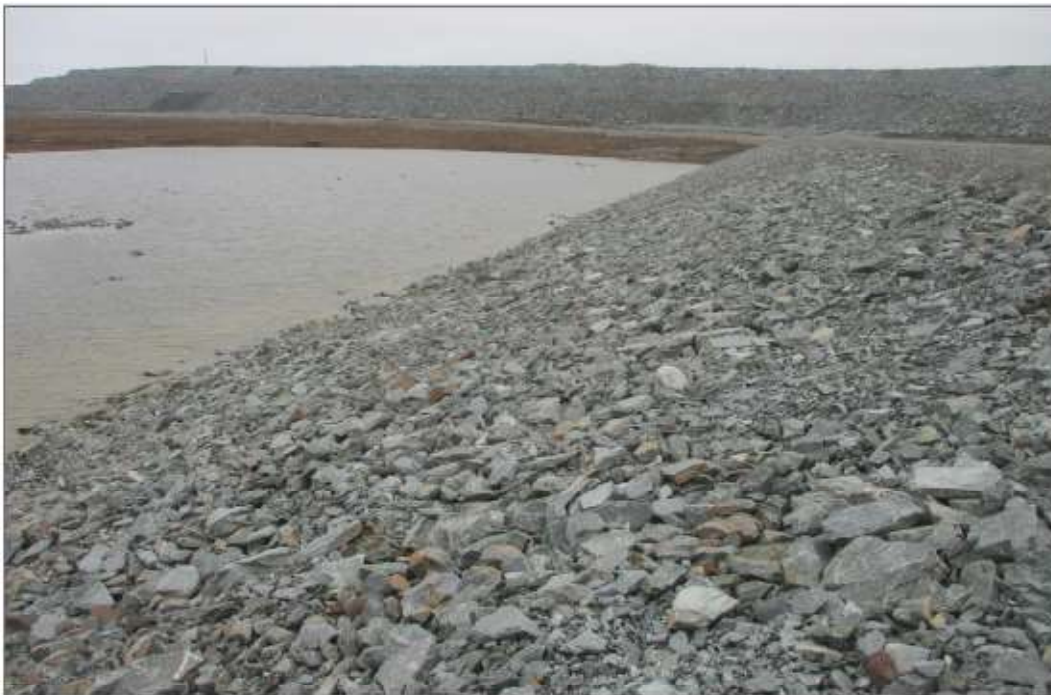
Photo 12: Berm CP4 - Downstream embankment of CP4 berm against lake B8.

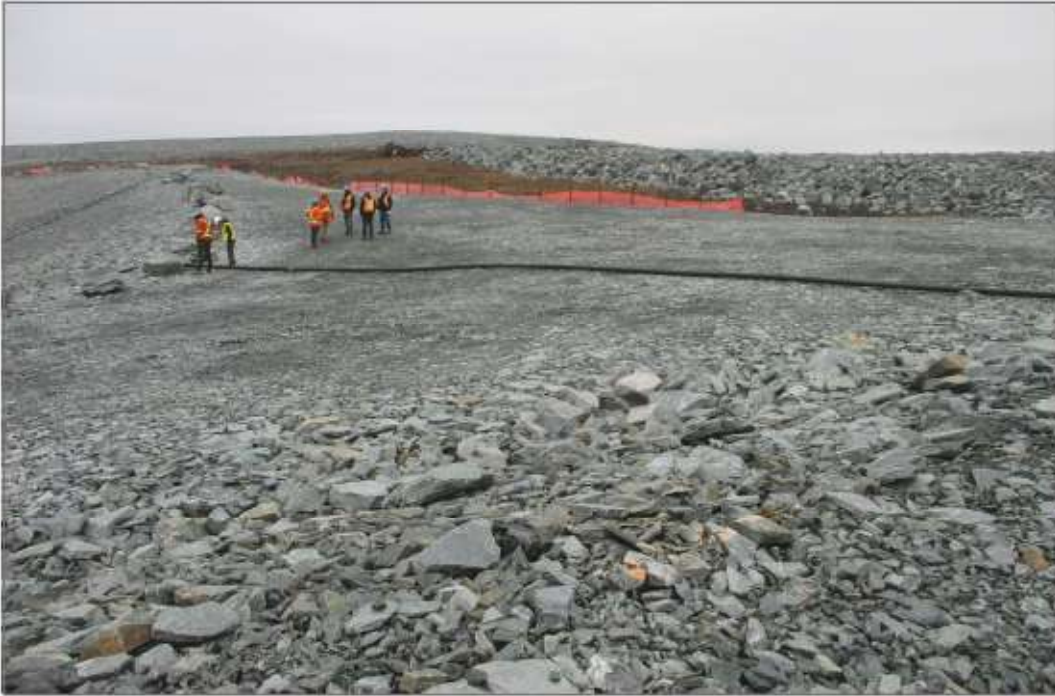
At the time of inspection CP4 was filled with water to approximately Elevation 53.2 m (measured September 20, 2022). The slopes of the pond are a combination of overburden and bedrock. The overburden is covered with a layer of rockfill obtained from the pond excavation. No obvious signs of instability were observed in the bedrock or overburden slopes. During the 2021 inspection, thaw settlement up to 0.75 m deep was observed in the native ground above the overburden slope protection rockfill along the west and south sides of CP4. The native ground above the overburden slope has been covered with a protective layer of rockfill along the west and south sides of CP4 prior to the 2022 inspection to prevent additional thaw settlement. The rockfill cover placement is shown in Photo 13 and 14, Appendix E.

Photo 13: Pond CP4 - Rockfill cover placed over native ground above slopes of CP4.

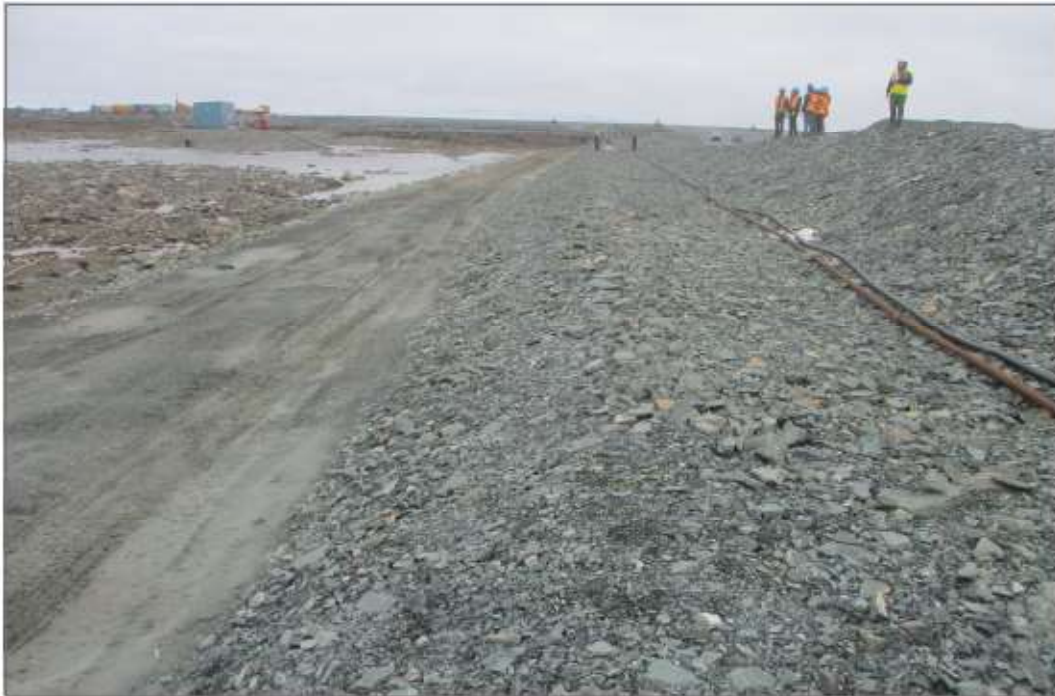
Photo 1: D-CP5 Dike - looking towards the northeast, upstream.

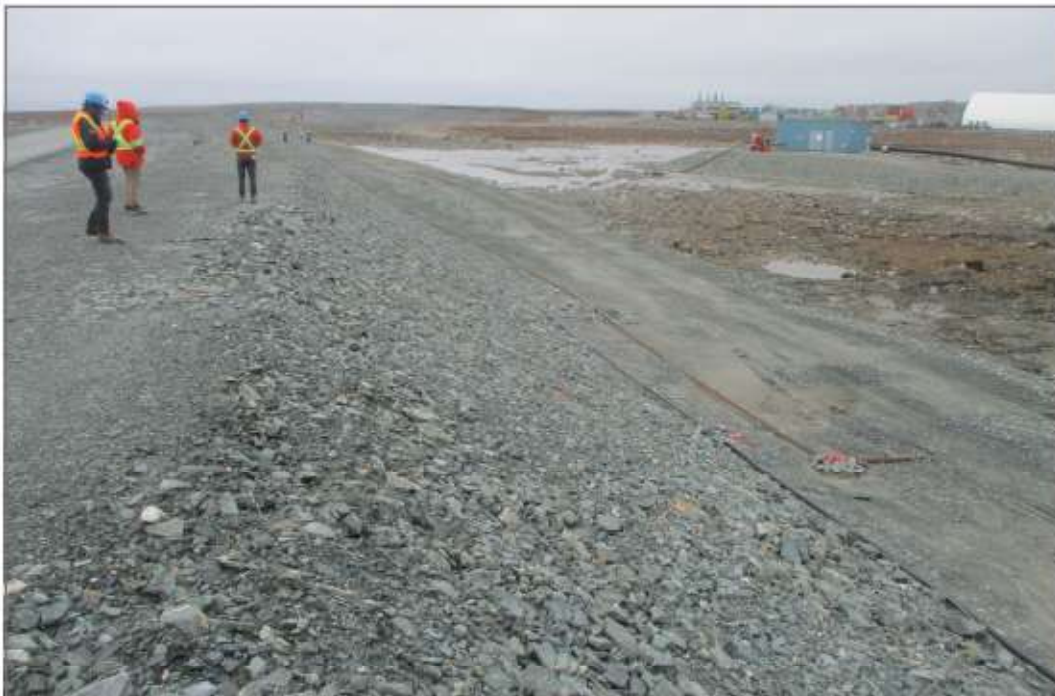
Photo 2: D-CP5 Dike - looking towards the southwest, upstream.

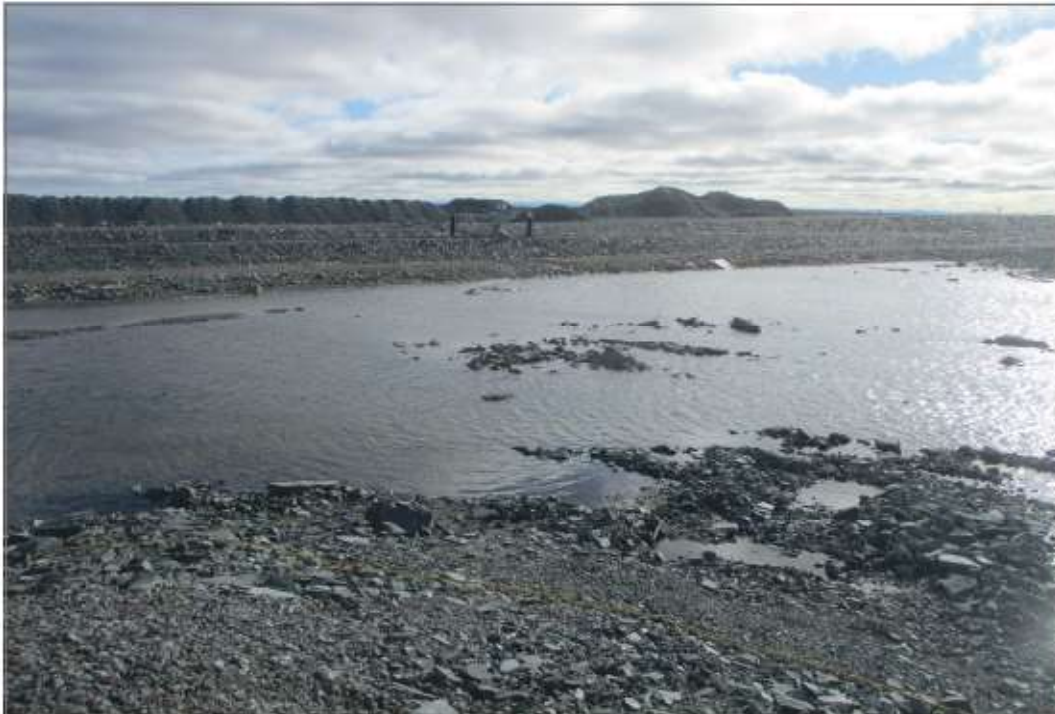
Photo 3: D-CP5 Dike - Looking towards upstream embankment from Jetty.

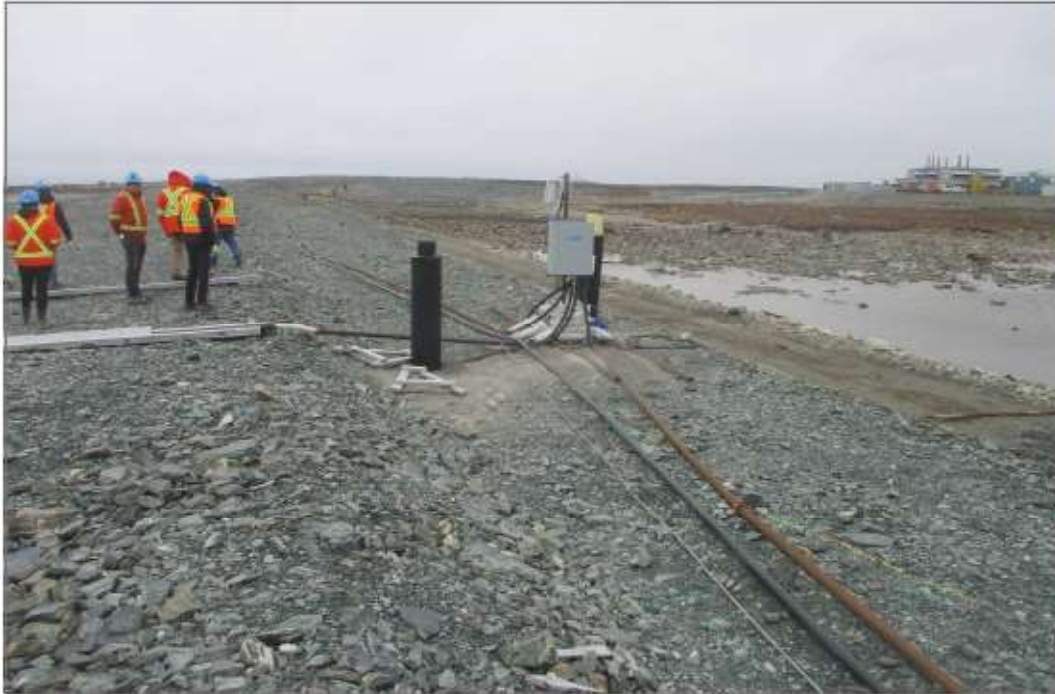
Photo 5: D-CP5 Dike - upstream, data logger, and GTC housings.

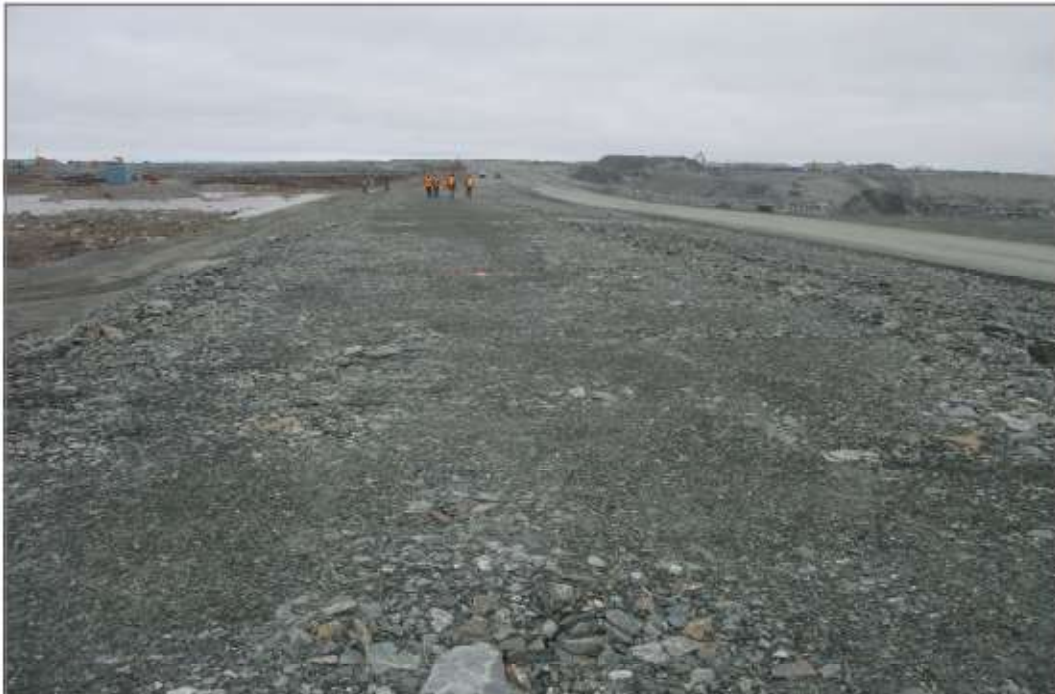
Photo 6: D-CP5 Dike - Crest of dike, looking northeast.

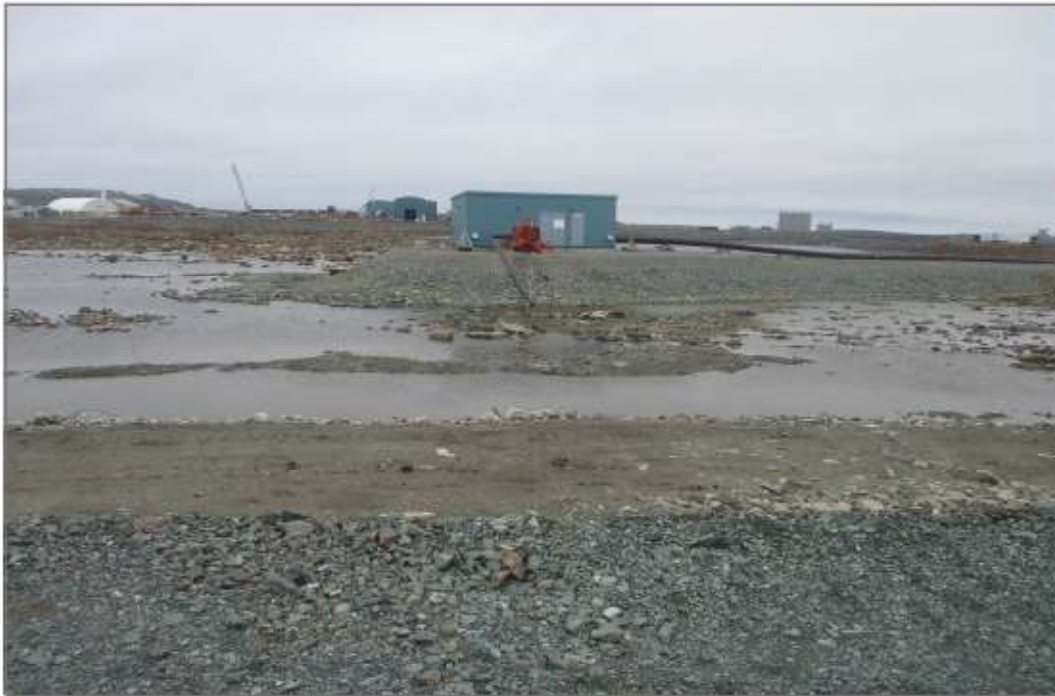
Photo 8: CP5 Jetty 5—Diesel Pumping into Jetty 5 pump well.

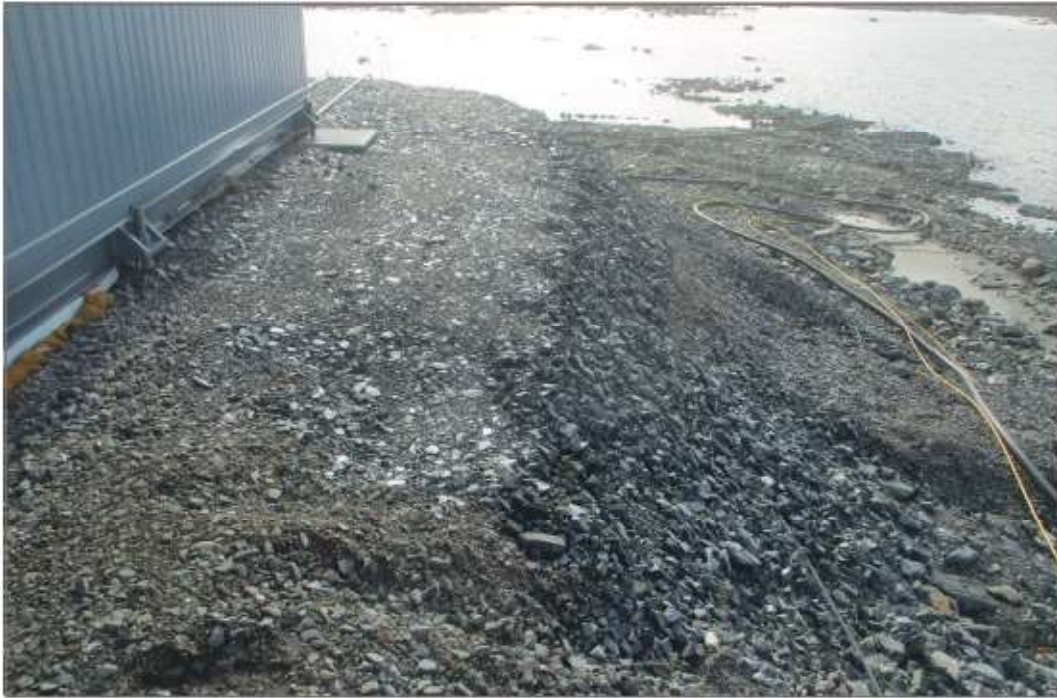
Photo 9: CP5 Jetty 5 - Repaired footing erosion from 2021.

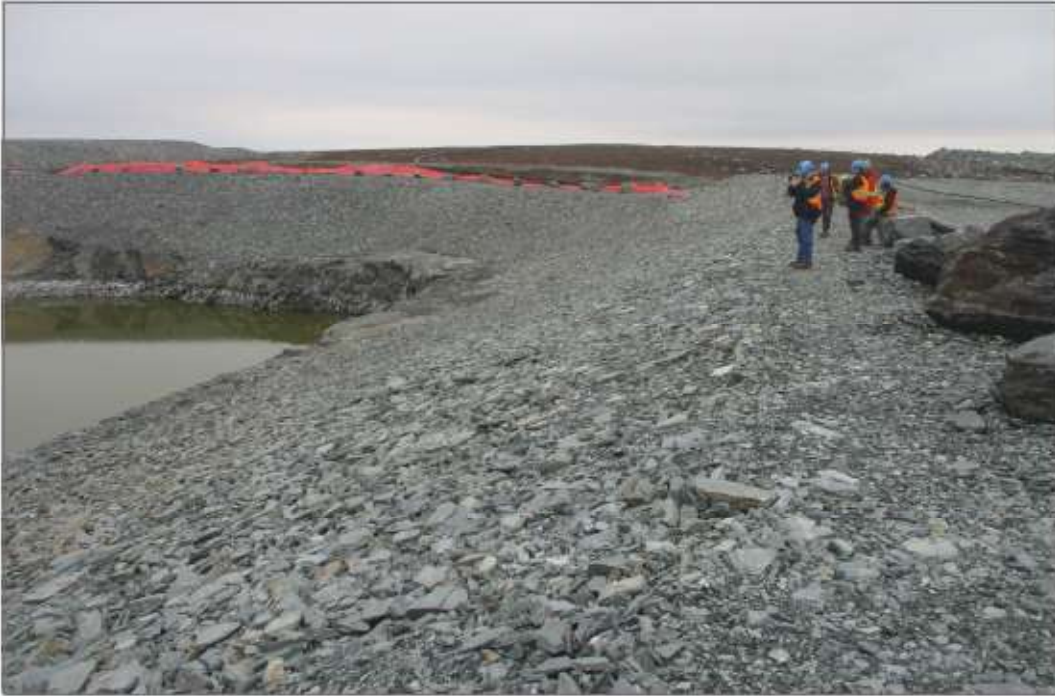
Photo 1: Pond CP6 - Looking east —Rockfill covered overburden, south embankment.

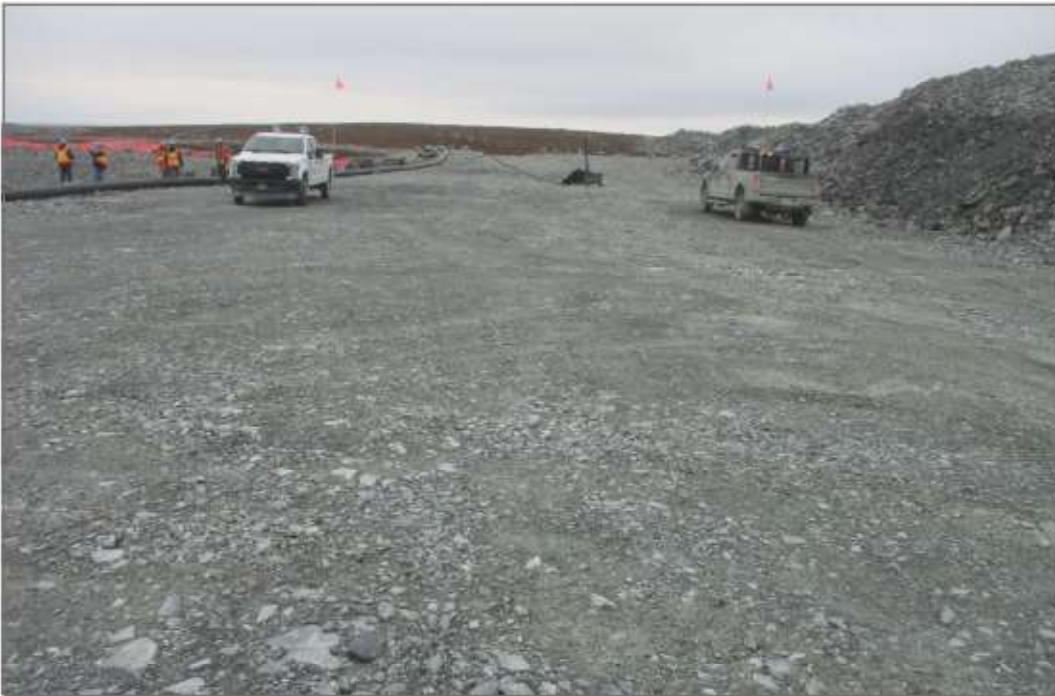
Photo 2: Pond CP6—Ground between WRSF3 and CP6—filled with ROM June 2021. ROM placed to reduce erosion in former lakebed sediments.

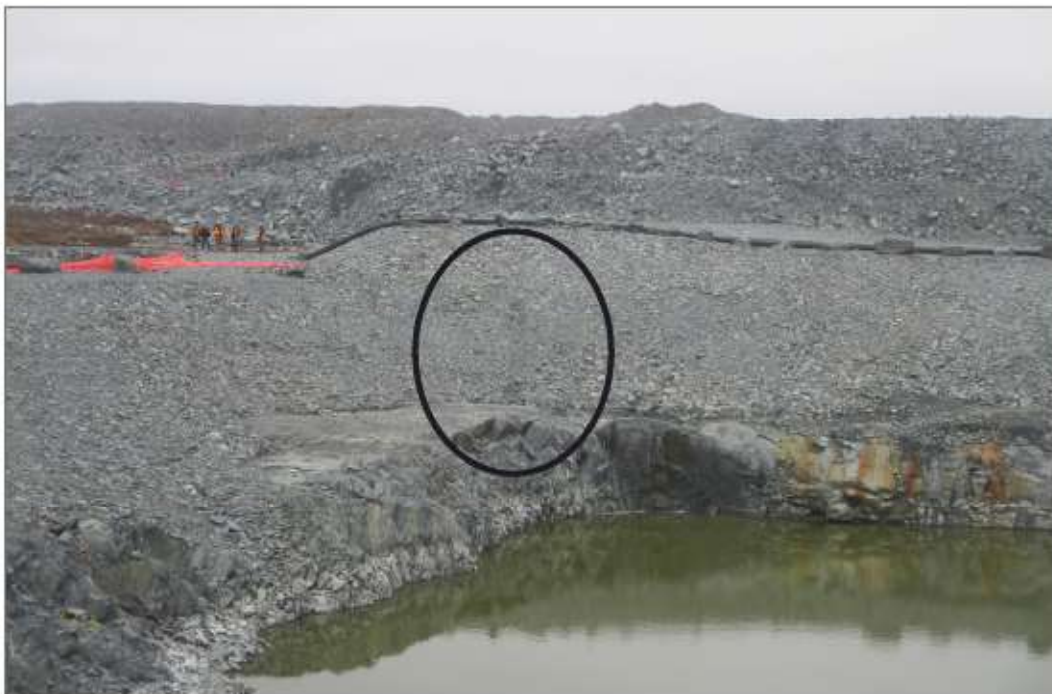
Photo 4: Pond CP6—South side of pond, WRSF3 above pond, water inflow on bedrock surface in southeast corner of pond, deformed ROM, indication of subsurface flow.

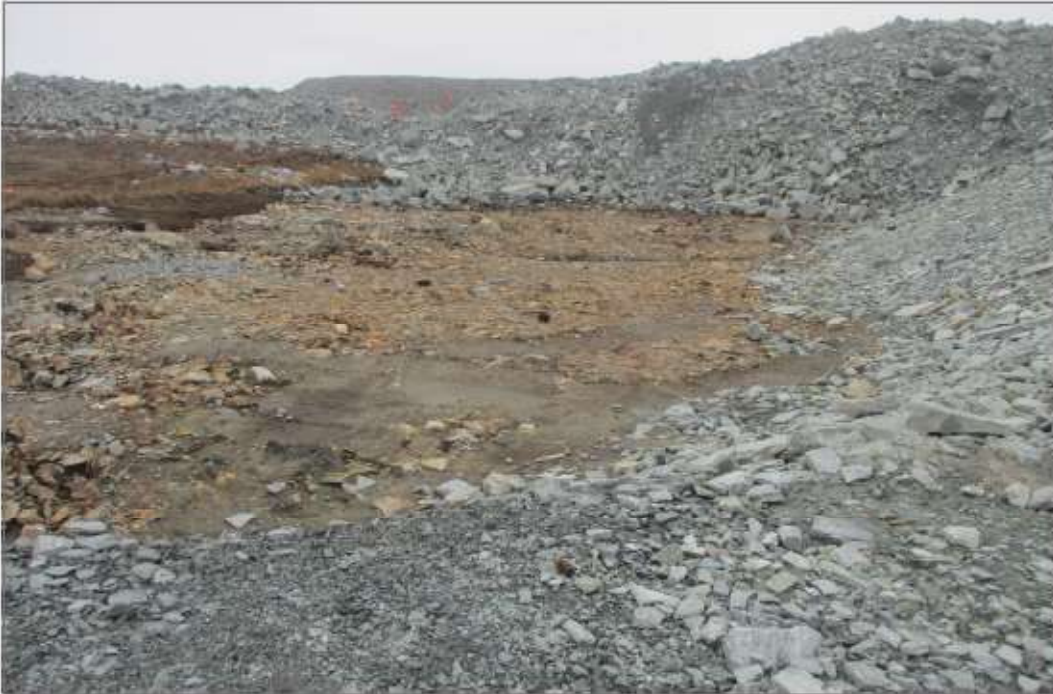
Photo 5: Pond CP6 - Remaining lakebed above CP6. WRSF3 in back ground. Inside corners of WRSF3 reported to be large snow catch areas.

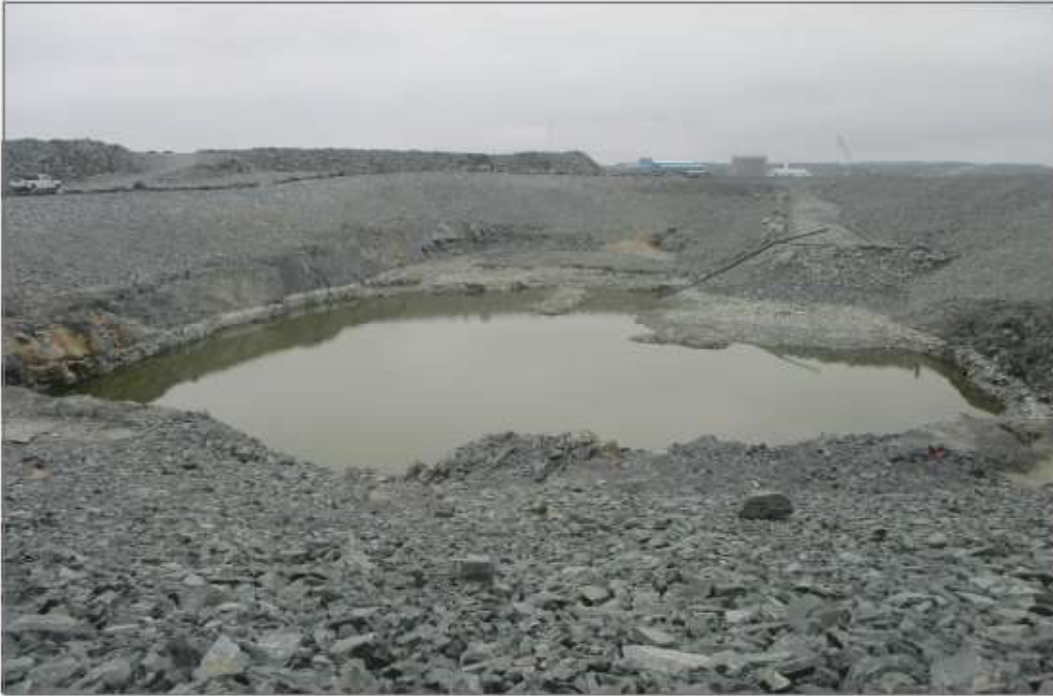
Photo 9: Pond CP6 - Embankments of CP6 showing no significant deformation.

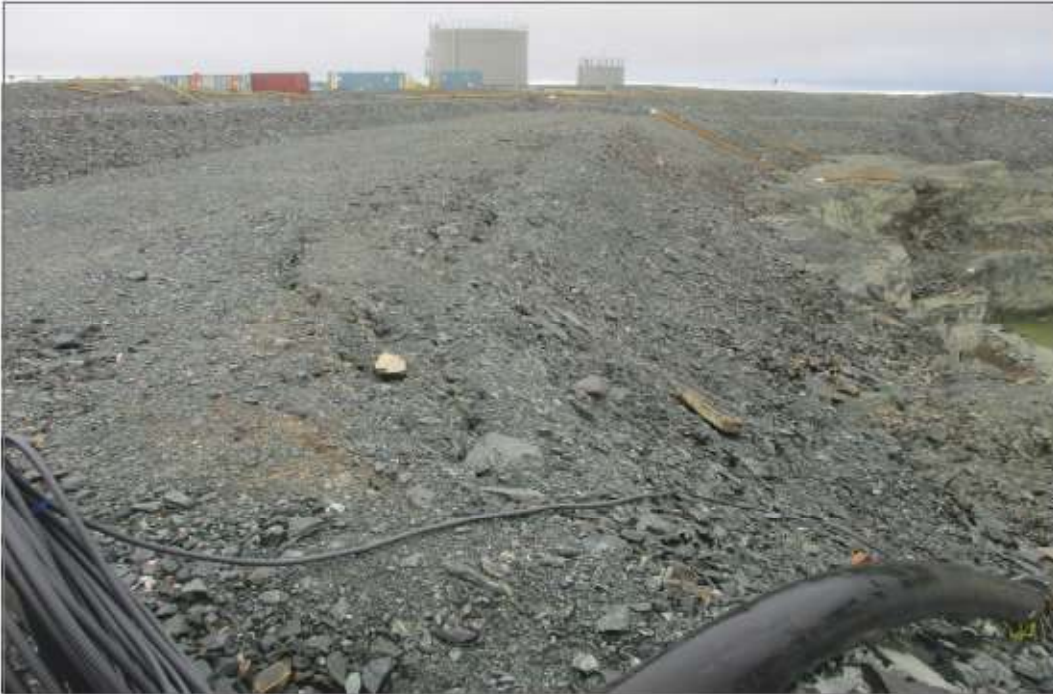
Photo 3: SP1 Saline Pond - Deformation and cracking in top of overburden protected slope, southwest corner of pond.
