Appendix 6: 2022 Annual Geotechnical Inspection Report

2022 Annual Geotechnical Inspection Meliadine Gold Project, Rankin Inlet, Nunavut

PRESENTED TO
Agnico Eagle Mines Limited

FEBRUARY 17, 2023
ISSUED FOR USE
FILE: 704-ENG.EARC03140-31
AGNICO EAGLE DOCUMENT NUMBER: 65-600-230-TCR-001

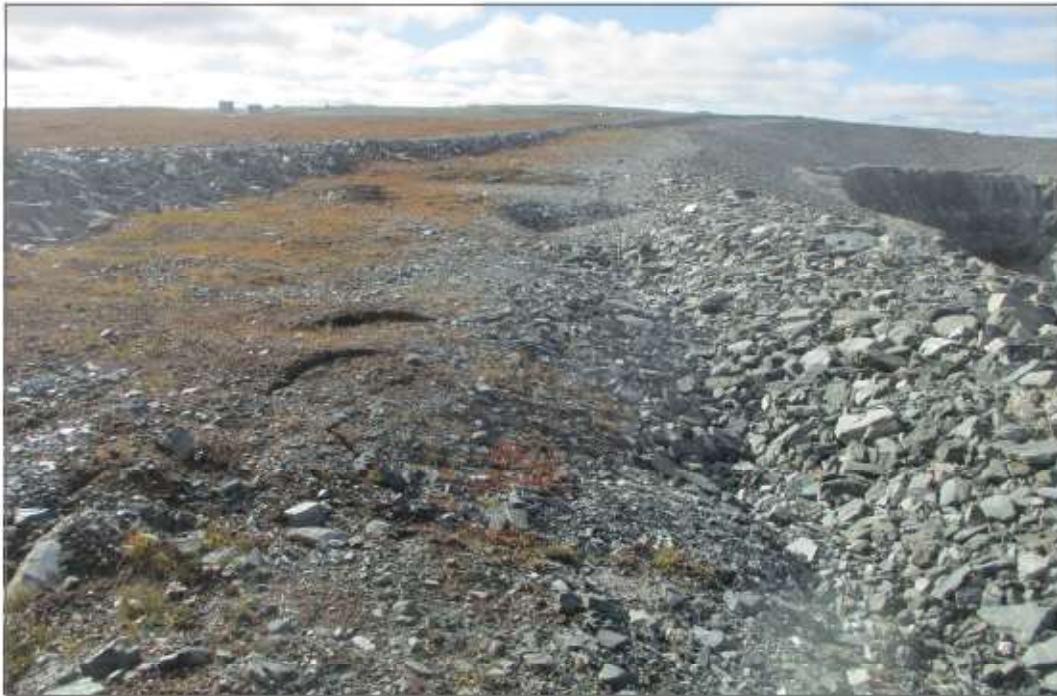
- Overall, the pond rockfill covered overburden slopes and bedrock appeared stable, with no significant geotechnical concerns identified. (Photo 12 and 15, Appendix H). Subsidence in original ground at crest of slope, behind rockfill cover. Conditions appeared like the 2021 inspection.
- There was a small volume of water in the pond at the time of the site visit that was well below the top of the bedrock excavation (Photos 8 and 13, Appendix H). The pond was almost drained in preparation for freeze up and decommissioning.
- Some thaw subsidence was in the crest of the rock fill overburden cover as shown in Photo 14, Appendix H.
- Cracking and thaw subsidence areas were observed in the original ground above the rockfill covered overburden slopes (Photos 10 and 11, Appendix G).
- No significant seepage into the saline pond was observed during the inspection.

Photo 10: SP4 Saline Pond—Looking west General subsidence between overburden and rock-fill cover.

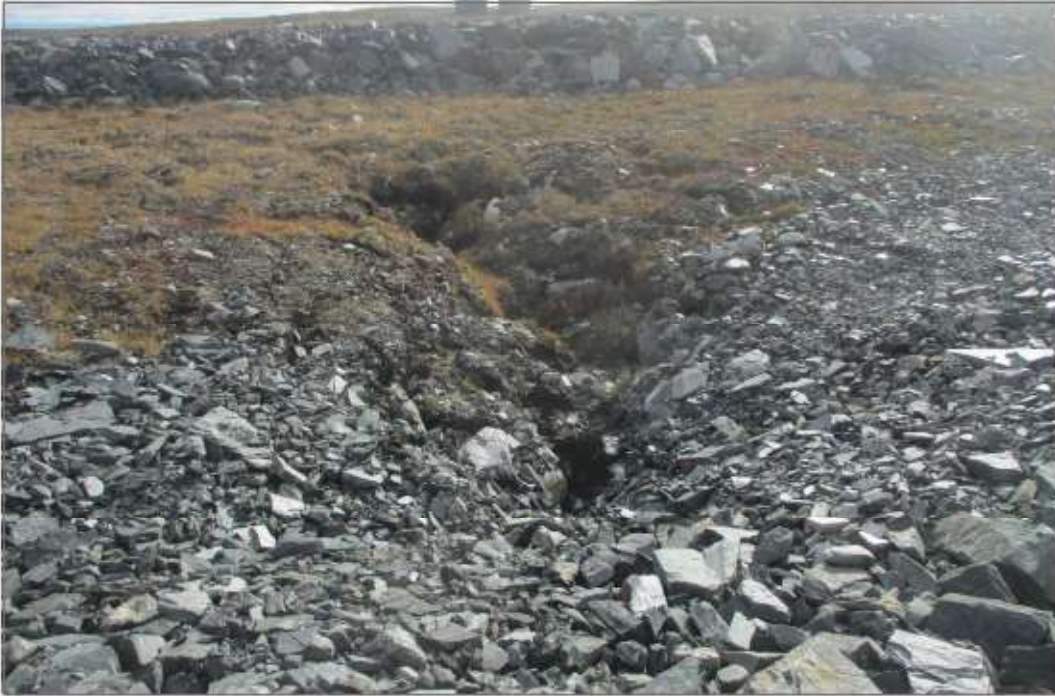
Photo 11: SP4 Saline Pond—Settlement in disturbed overburden above rockfill covered slope.

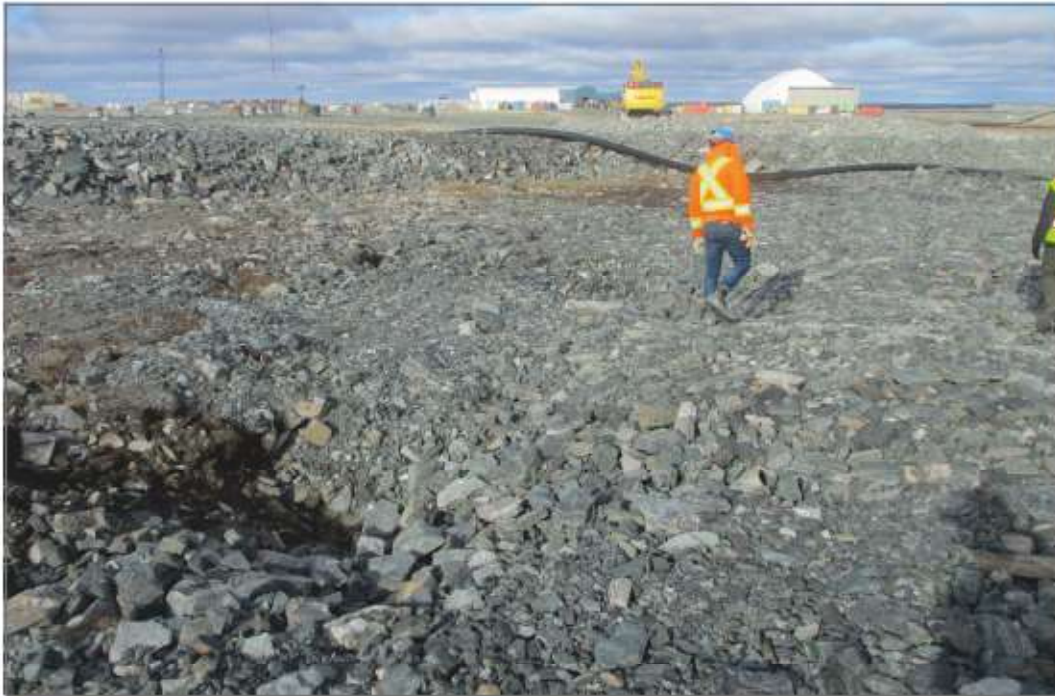
Photo 14: SP4 Saline Pond—Thaw subsidence underneath rockfill covered overburden slope.

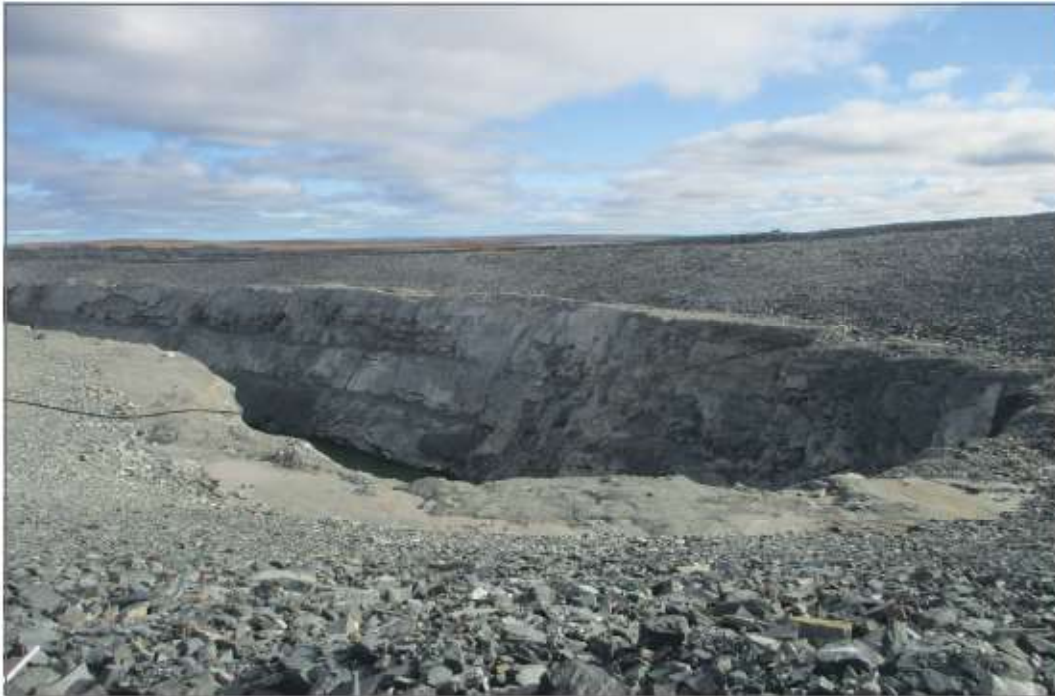
Photo 15: SP4 Saline Pond—Rockfill cover, no significant deformation. Bedrock below slope.

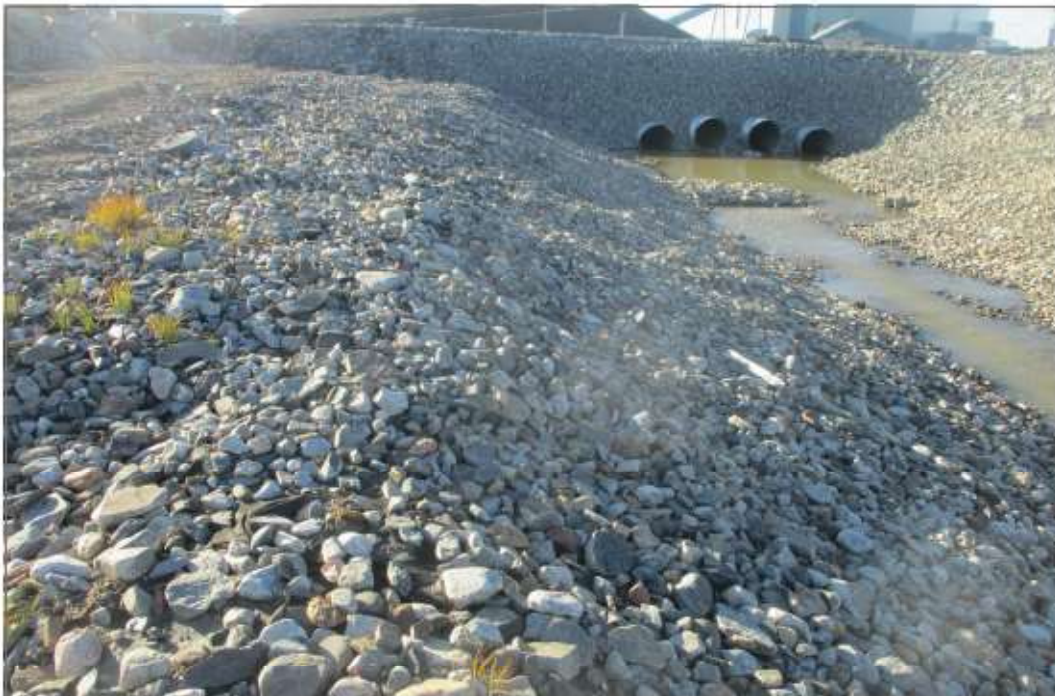
Photo 4: Channel 1—Downstream of crusher ramp, crest subsidence and erosion into channel.

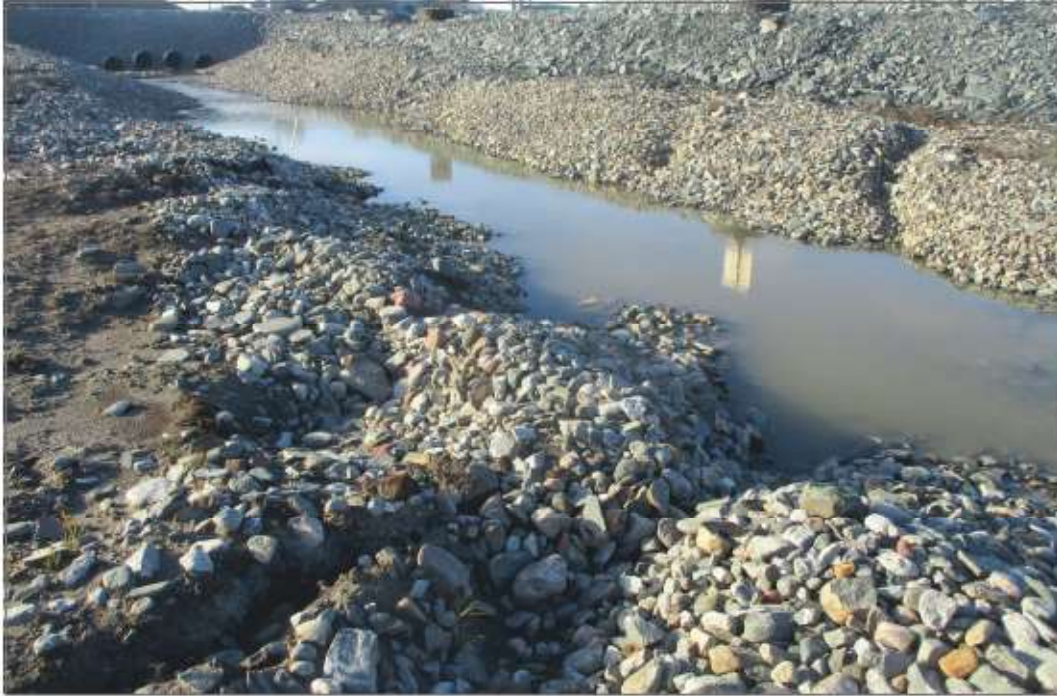
Photo 5: Channel 1—Downstream of crusher ramp, crest subsidence and erosion into channel.

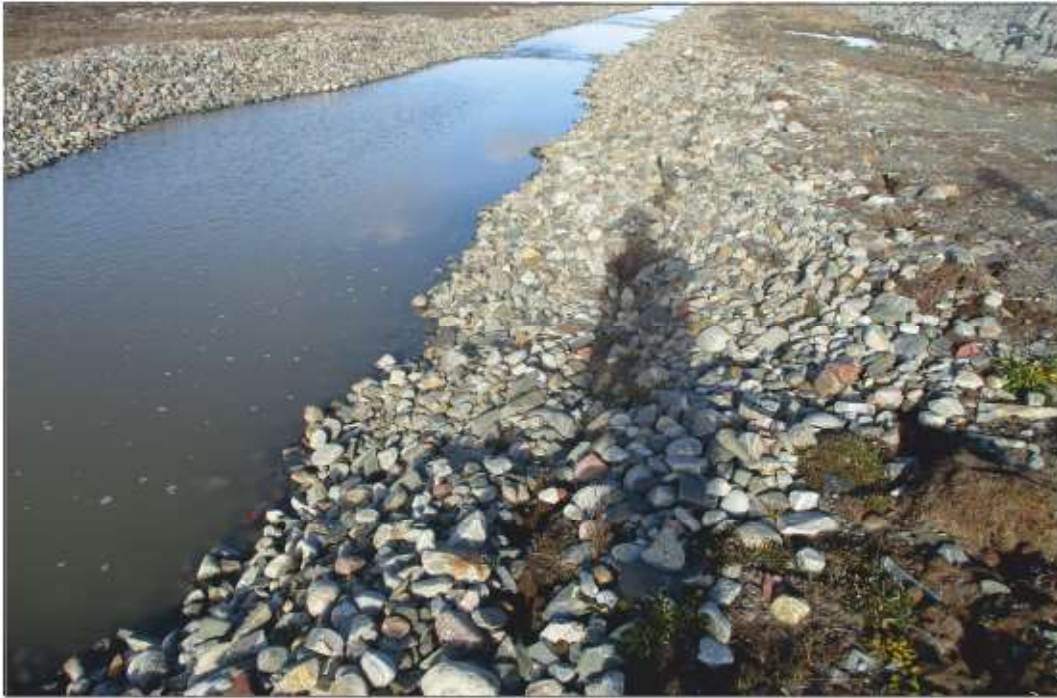
Photo 7: Channel 1—Rip settlement and cracking along crest of overburden.

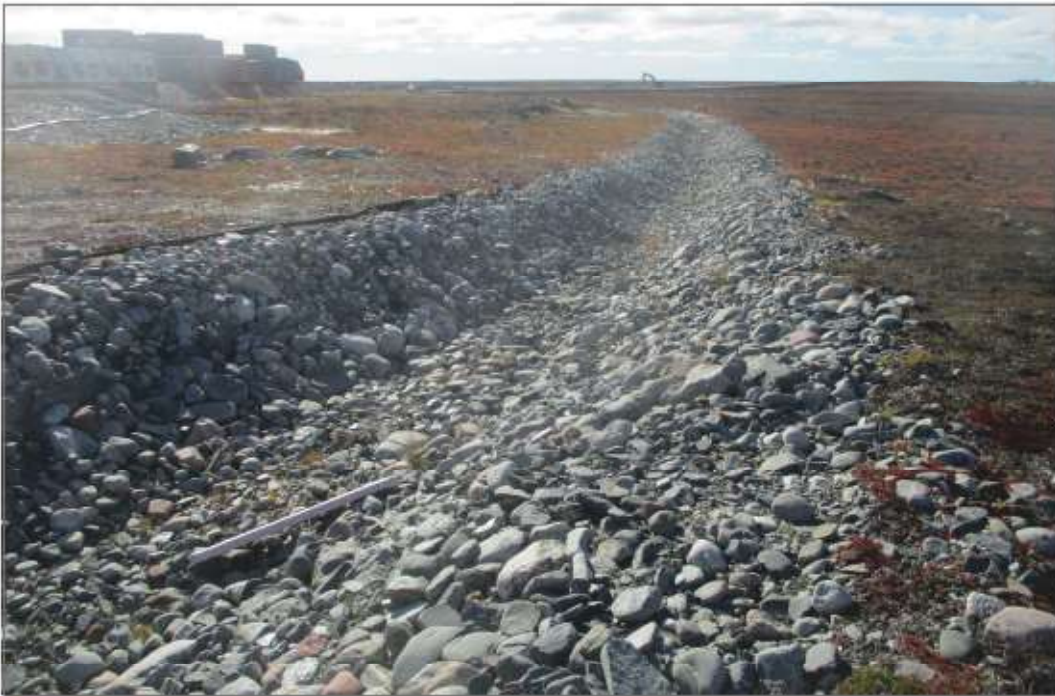
Photo 10: Channel 2—In good condition.

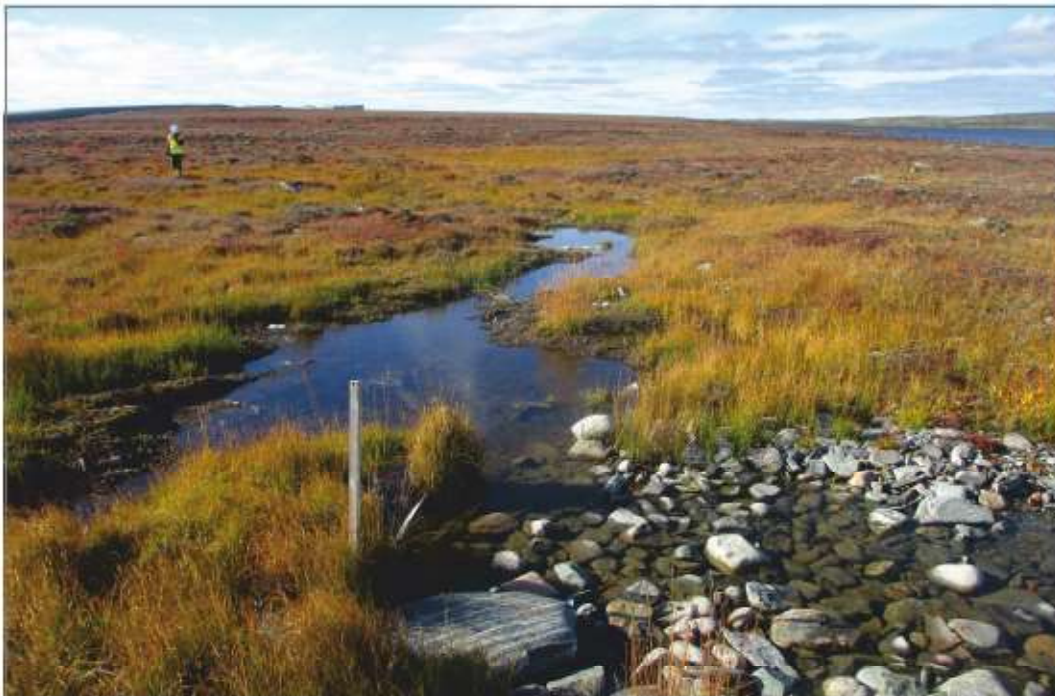
Photo 12: Channel 2—Lower reach, water pooling around discharge.

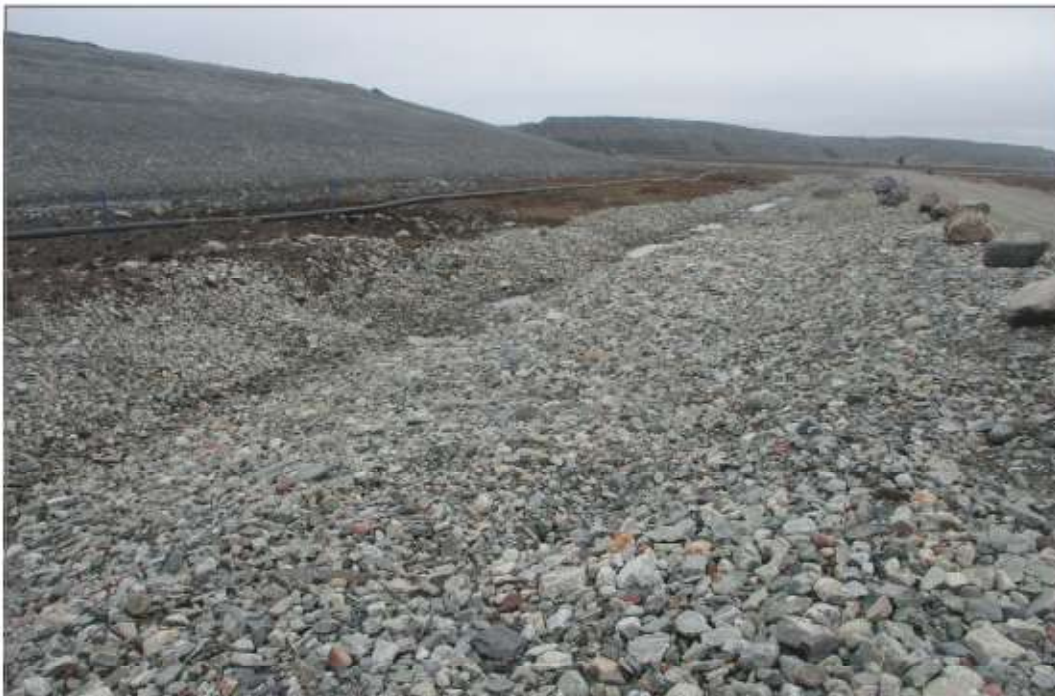
Photo 16: Channel 3—Undulating settlement along base of channel causing ponding.

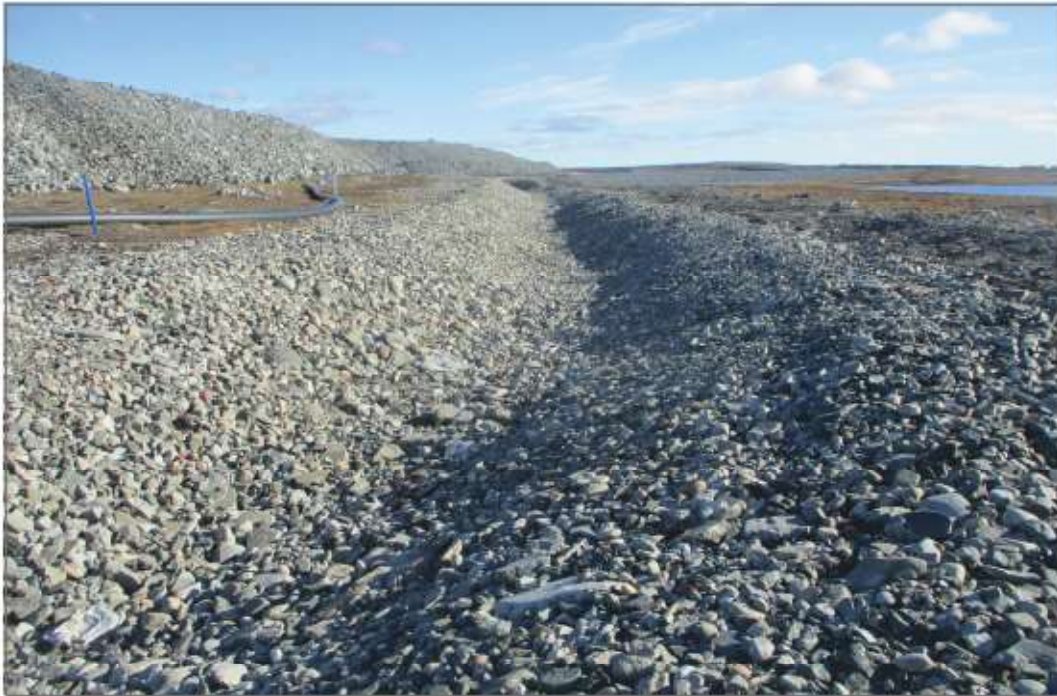
Photo 24: Channel 4—Looking south.

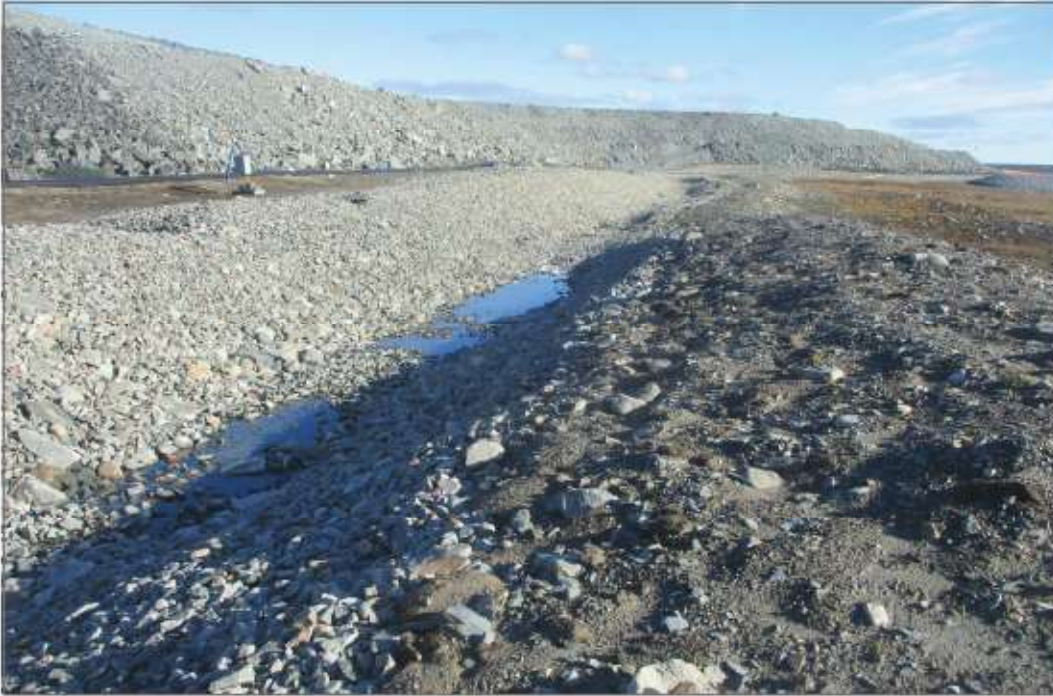
Photo 25: Channel 4 - Settlement in base of channel resulting in minor ponding.

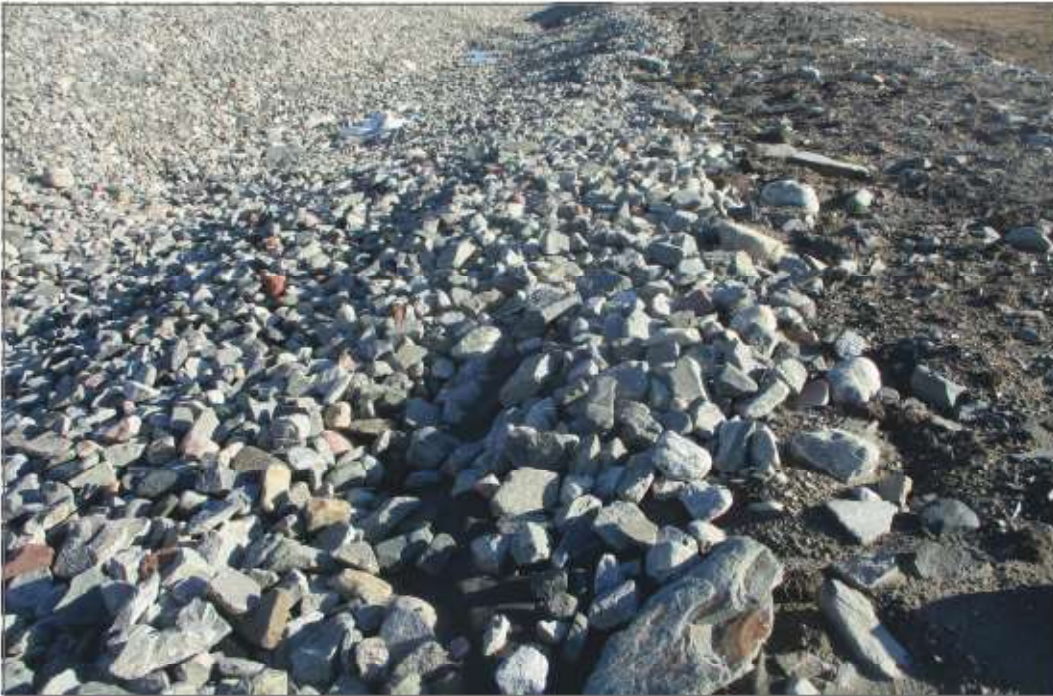
Photo 26: Channel 4 - Minor subsidence between original ground and channel rip rap.

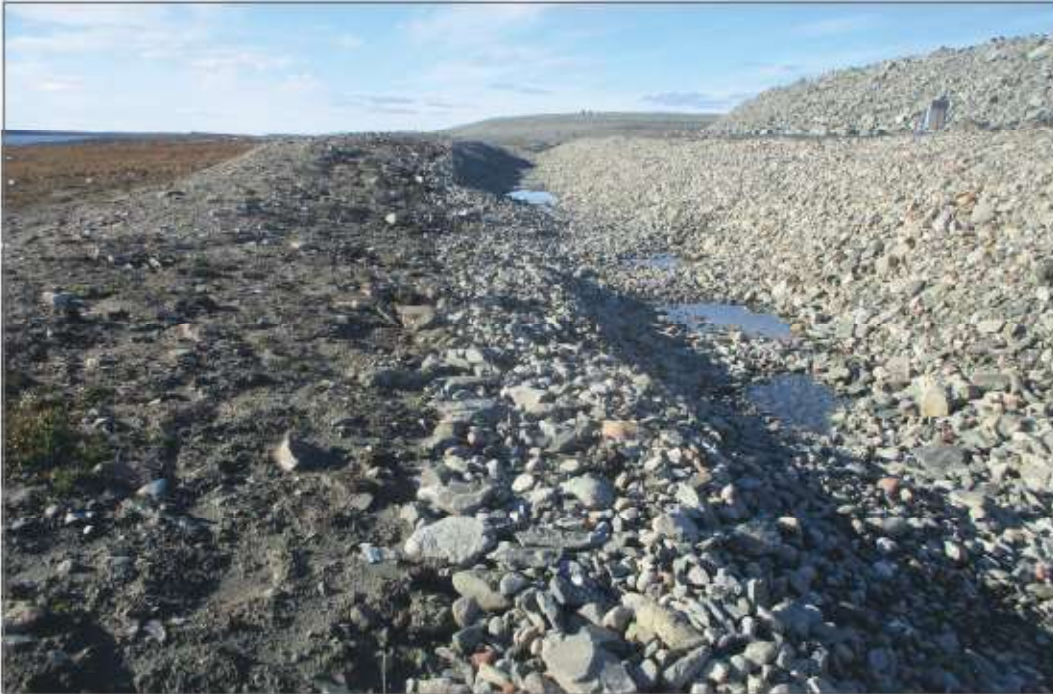
Photo 27: Channel 4 - Subsidence in downstream slope (west slope) of channel.

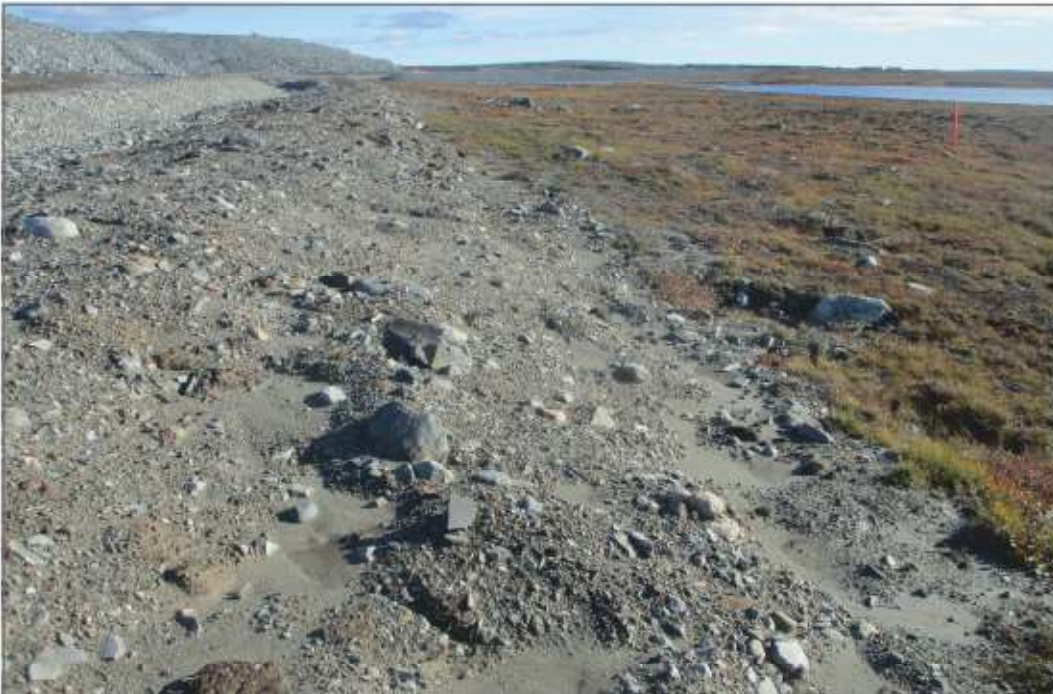
Photo 28: Channel 4 - Migration of fines from un-armoured overburden berm.

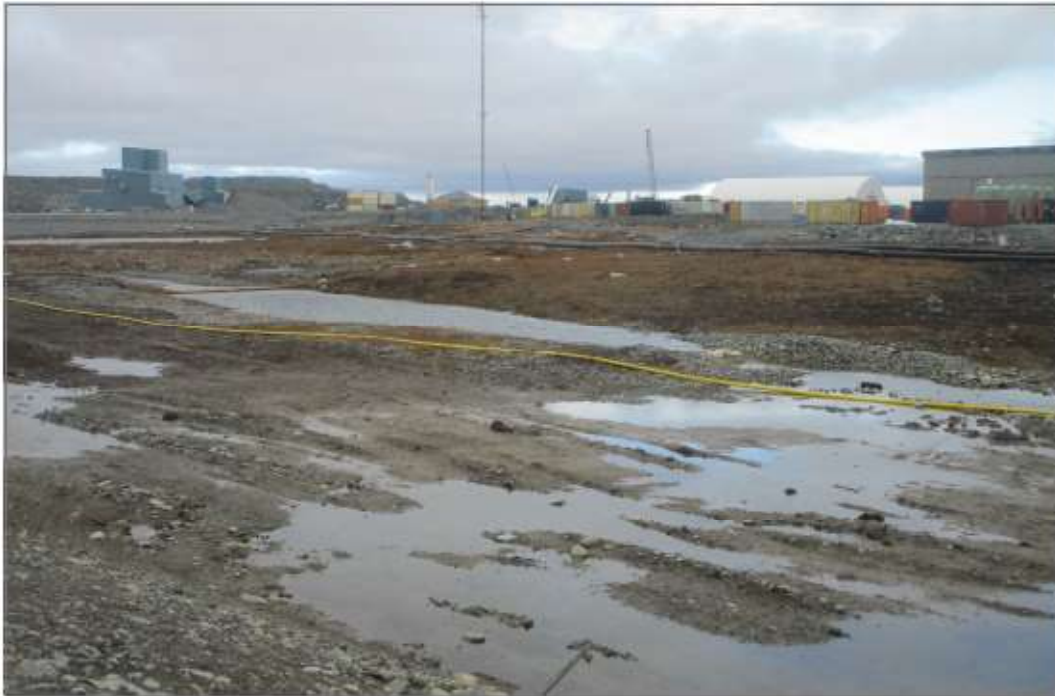
Photo 31: Channel 5—Upper reach, south of Portal2, significant subsidence and cracking along slopes with rip rap settled below water level in channel.

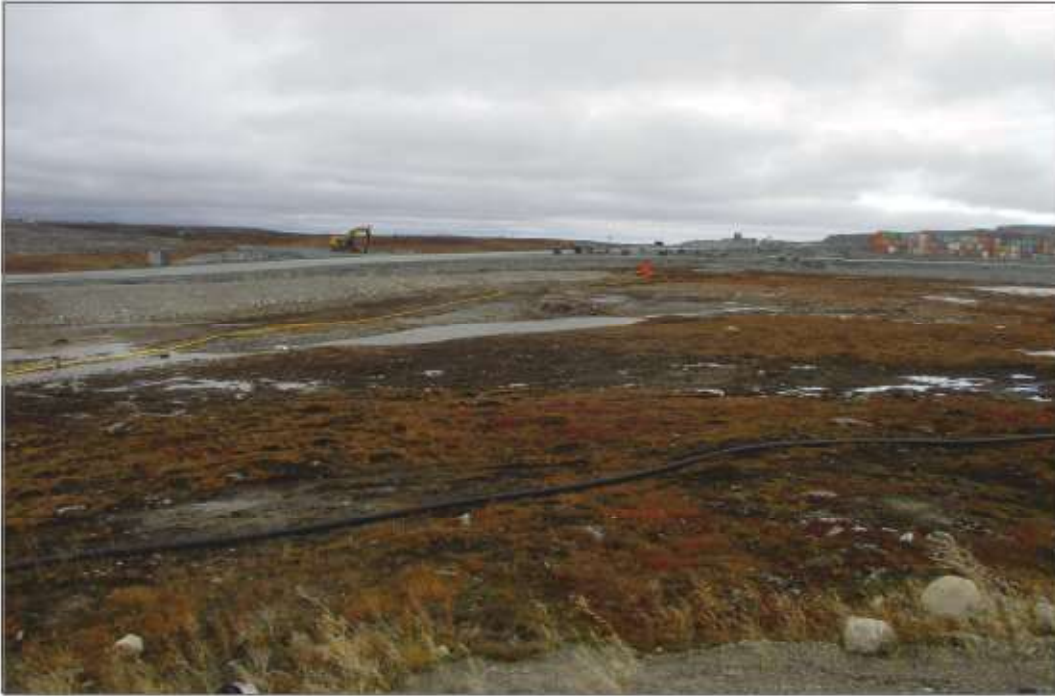
Photo 33: Channel 5—Upper reach looking southwest.

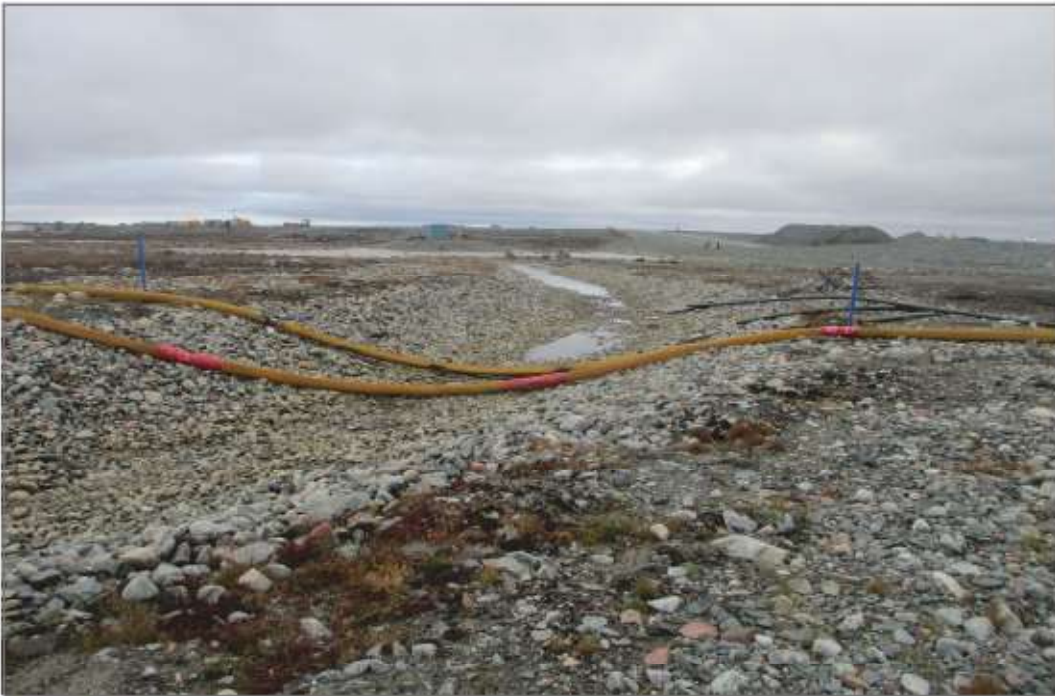
Photo 34: Channel 5—Lower reach, outlet into CP5, looking northeast.

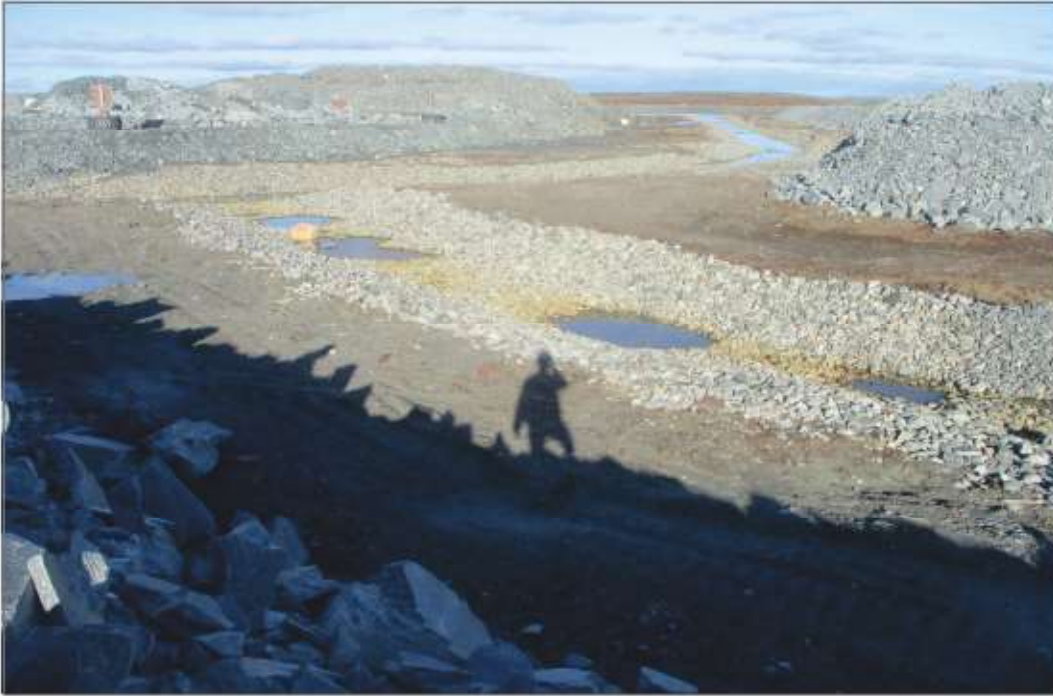
Photo 37: Channel 7—Outlet into Channel 1, ore stockpile in background.

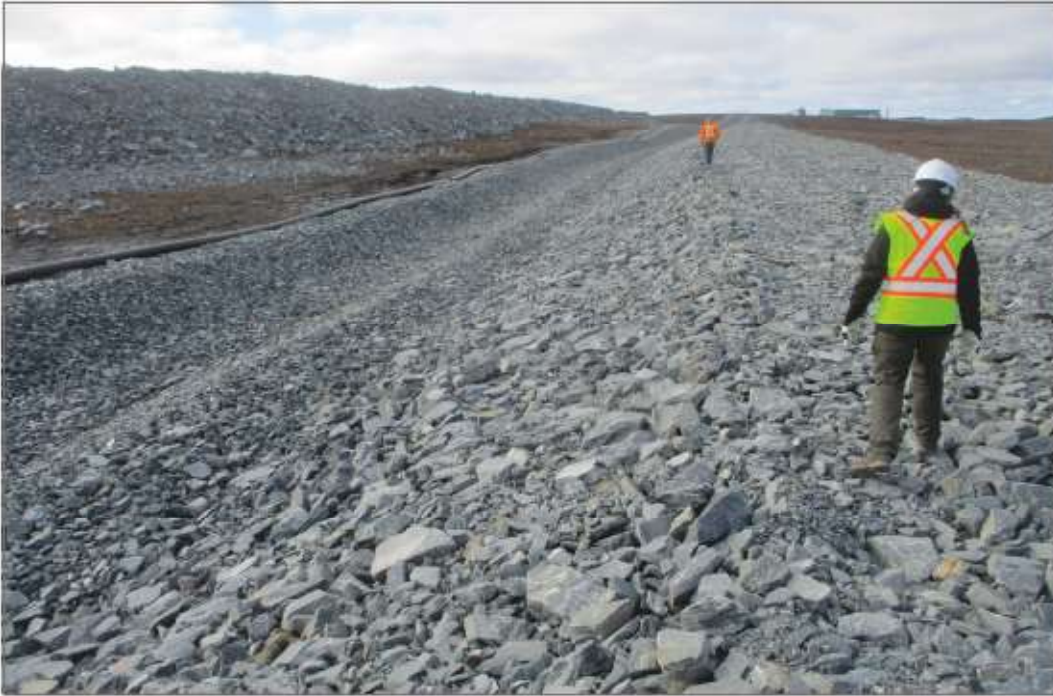
Photo 39: Channel 9—Armoured diversion berm downstream of channel.

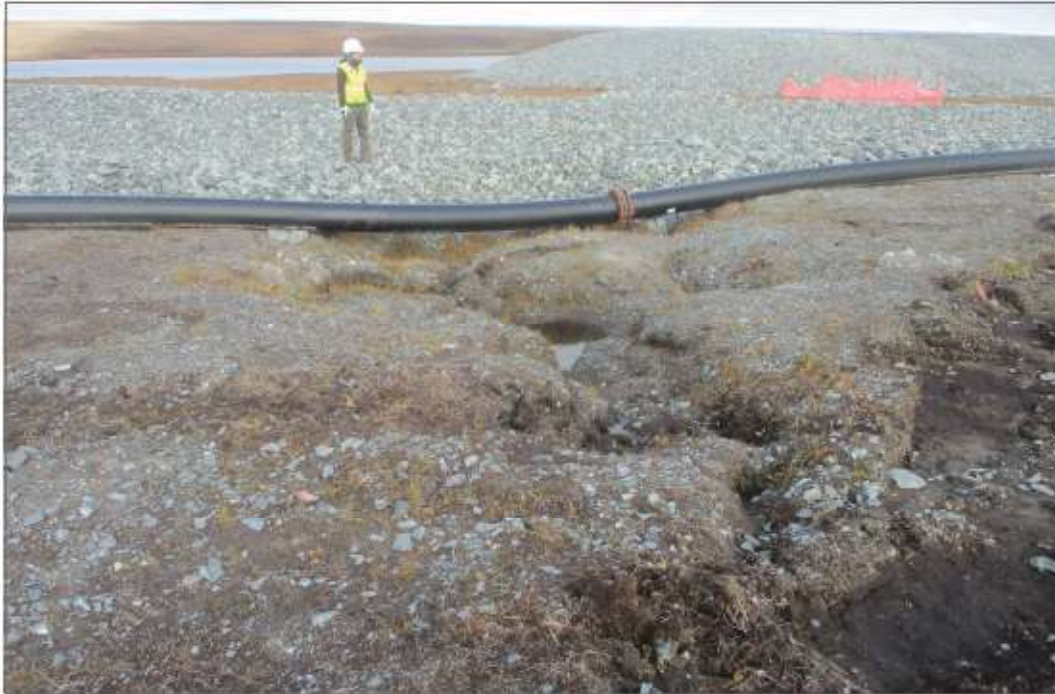
Photo 41: Channel 9—Thermal degradation of original ground upstream of channel.

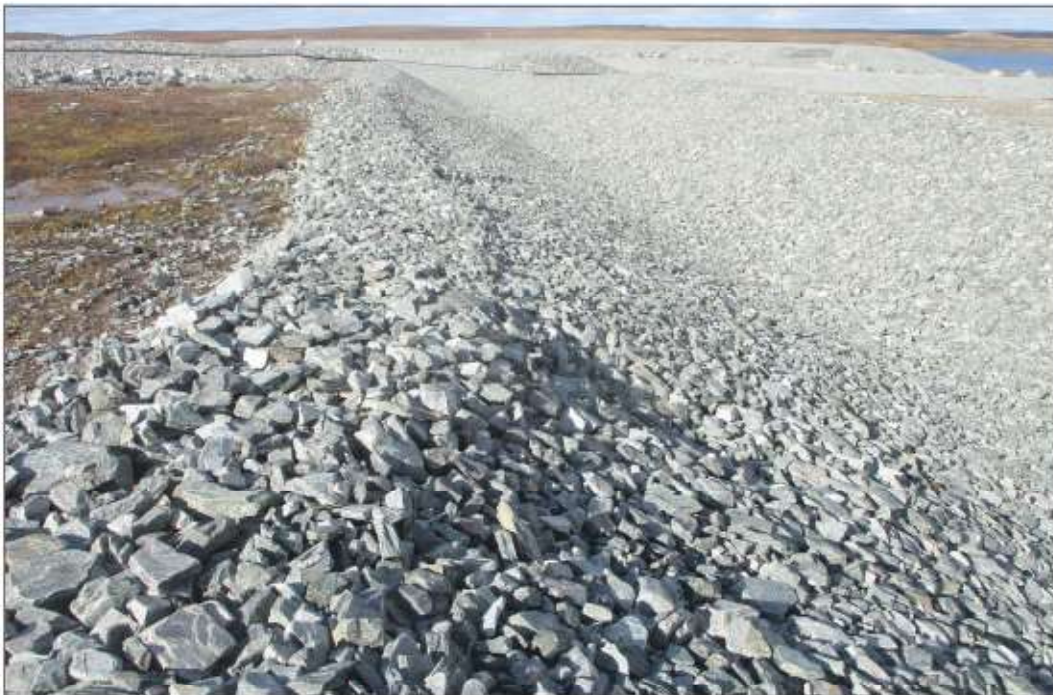
Photo 44: Channel 10—Slight subsidence of upstream slope and rip rap.

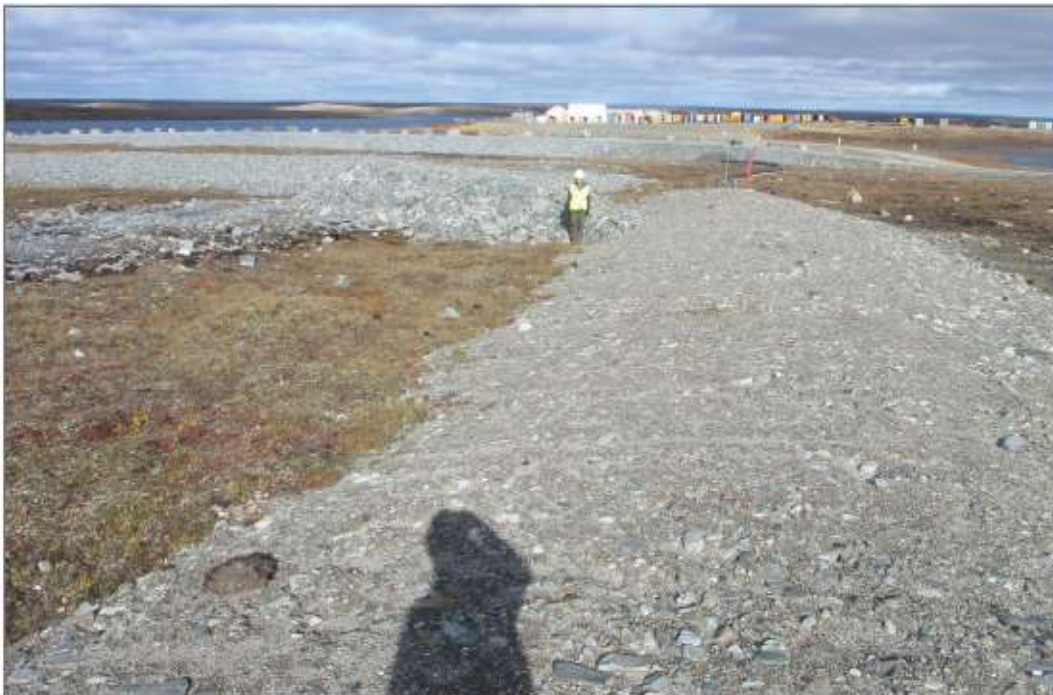
Photo 46: Channel 10—Channel inlet diversion berms, low area in berm tie-in .

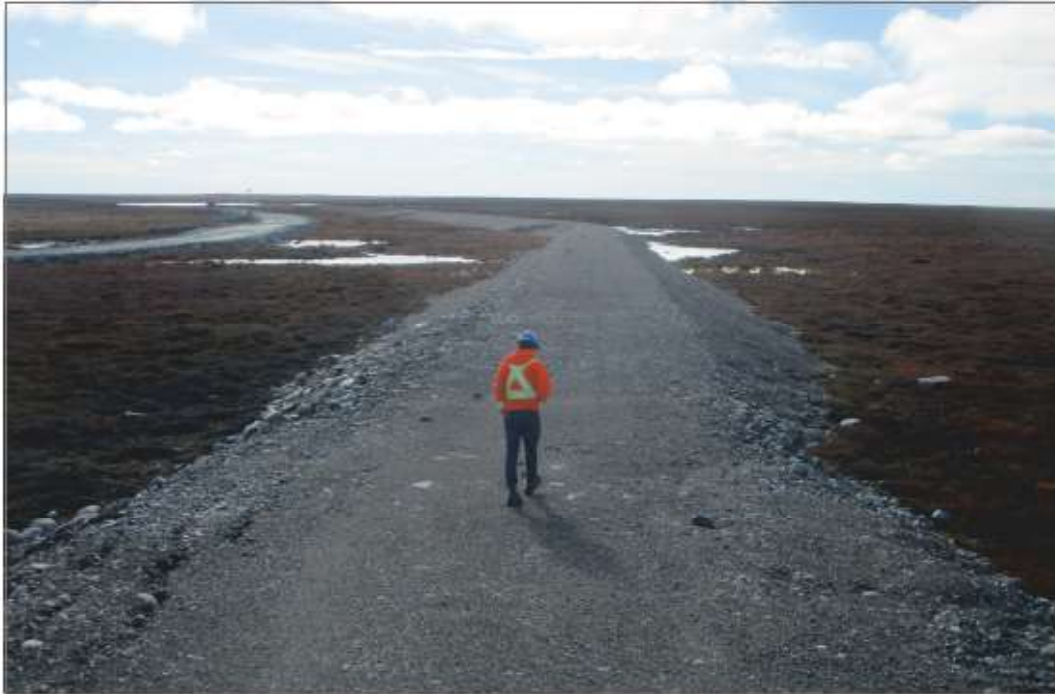
Photo 47: Berm 2—East abutment.

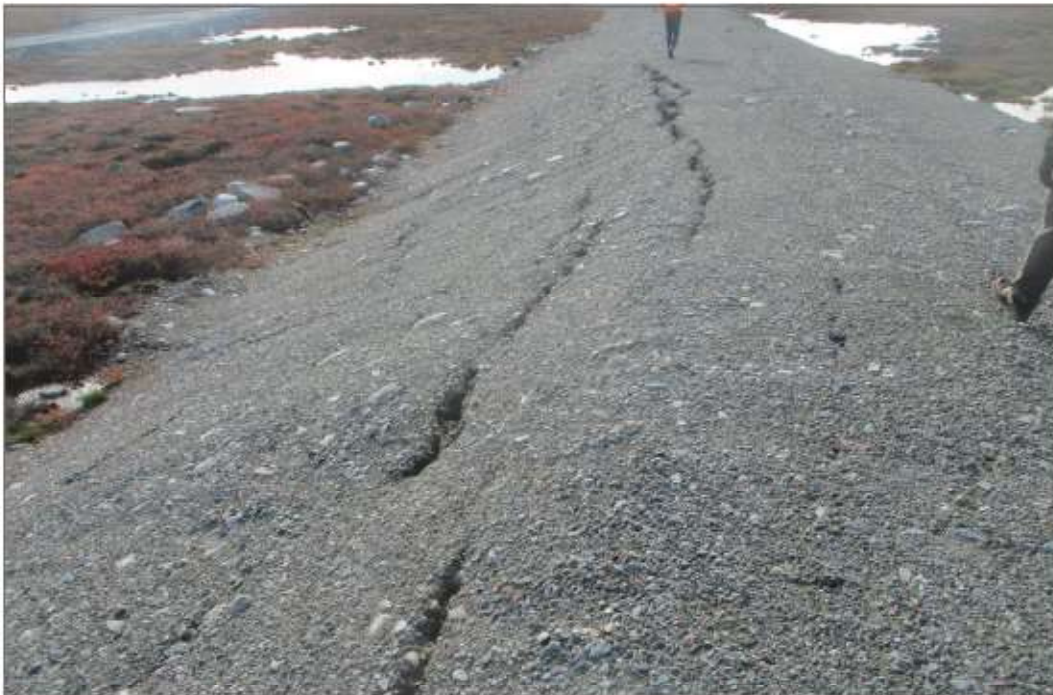
Photo 48: Berm 2—Longitudinal cracking along downstream slope and crest .

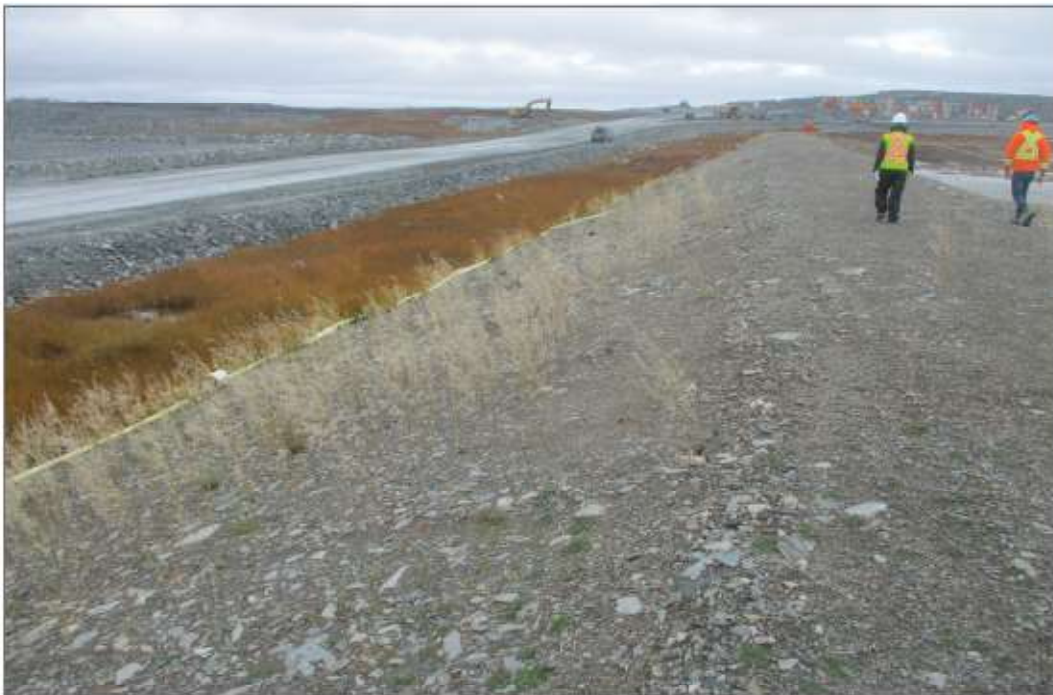
Photo 52: Berm 3—Downstream crest with vegetation growth.

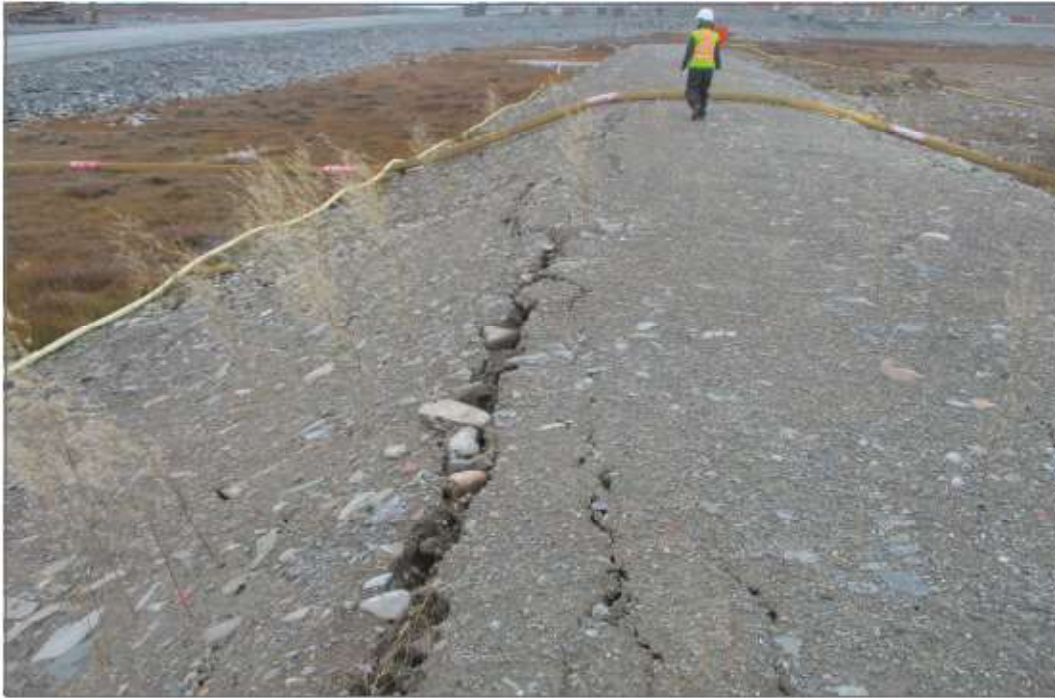
Photo 53: Berm 3—Cracking along slopes and crest.

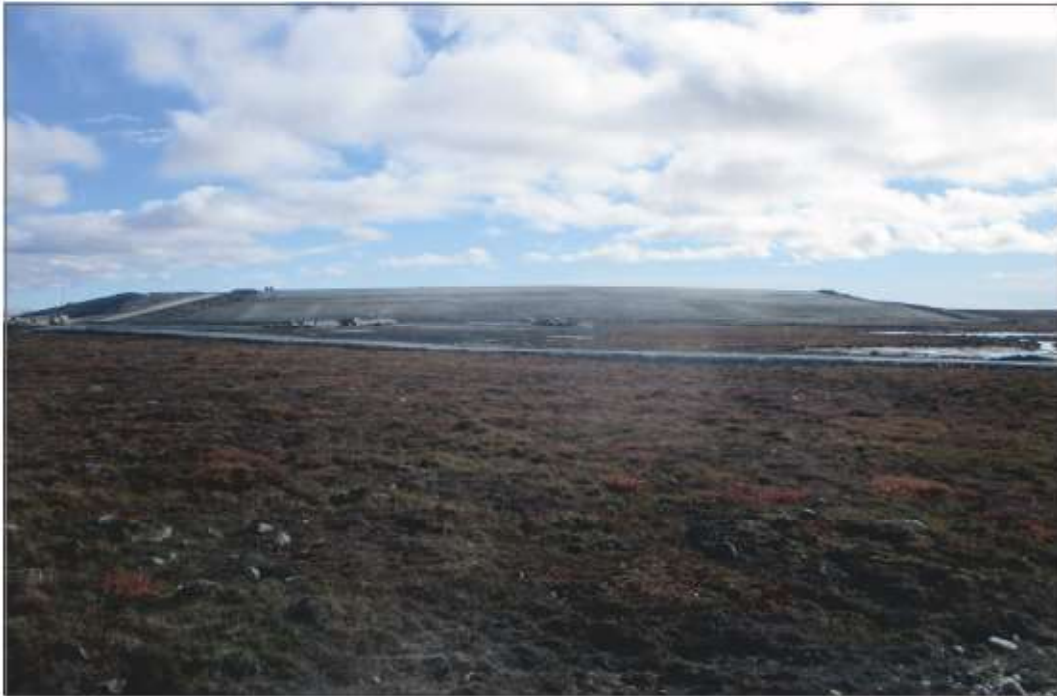
Photo 1: TSF - North side of Cell 1

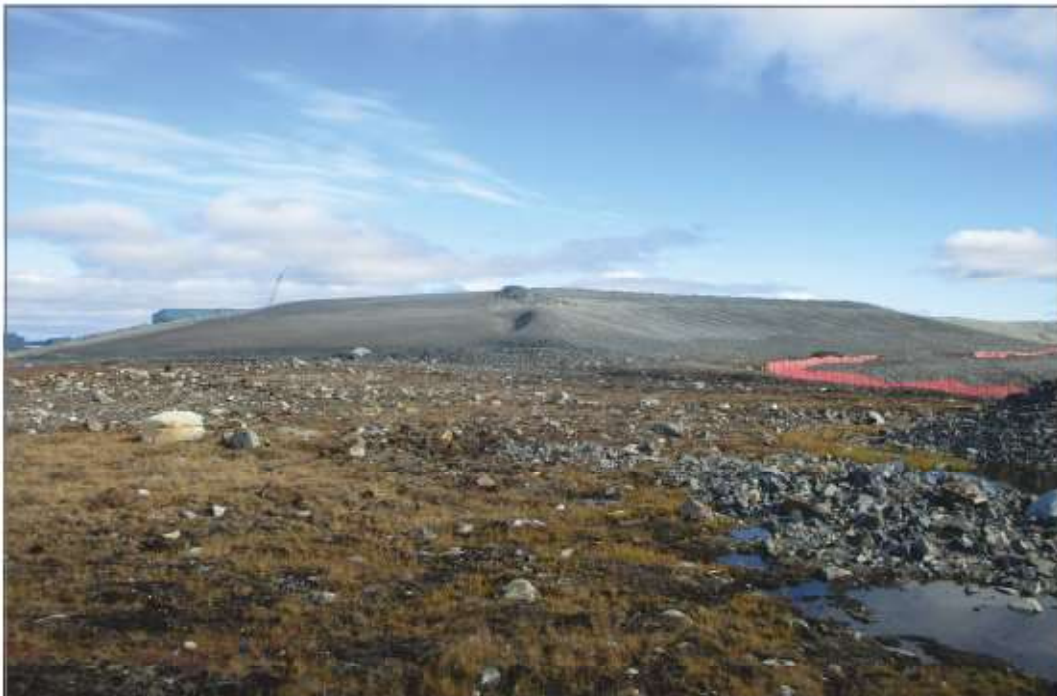
Photo 2: TSF—North side of Cell 1—Rockfill slope covering west side of TSF

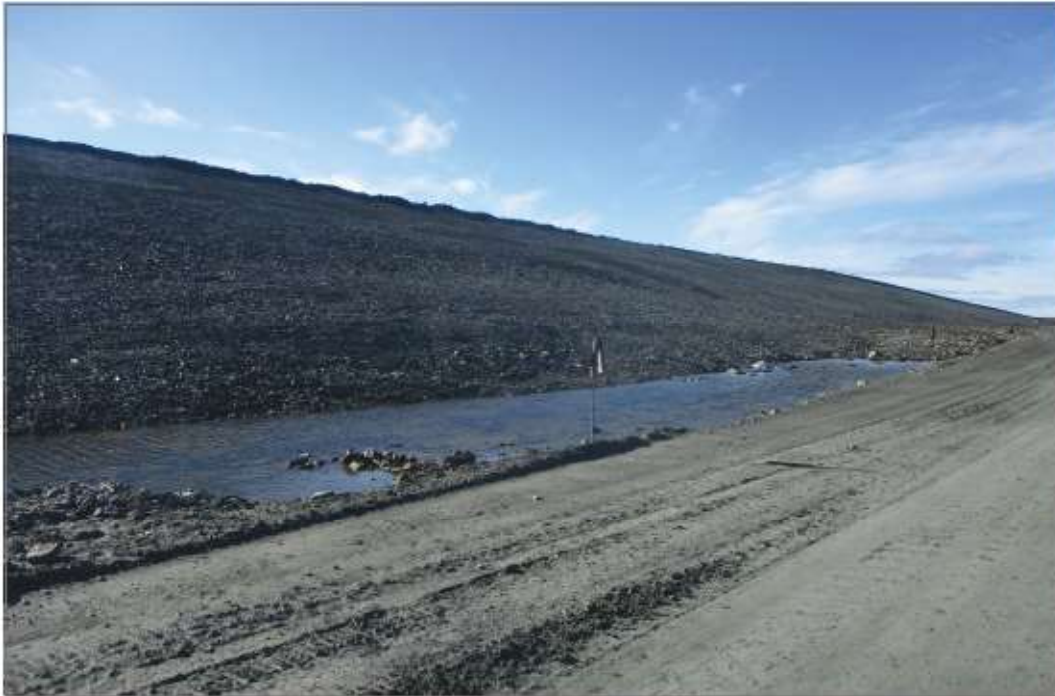
Photo 3: TSF - East slope, access road in foreground.
