Appendix 6: 2022 Annual Geotechnical Inspection Report

2022 Annual Geotechnical Inspection Meliadine Gold Project, Rankin Inlet, Nunavut

PRESENTED TO
Agnico Eagle Mines Limited

FEBRUARY 17, 2023
ISSUED FOR USE
FILE: 704-ENG.EARC03140-31
AGNICO EAGLE DOCUMENT NUMBER: 65-600-230-TCR-001

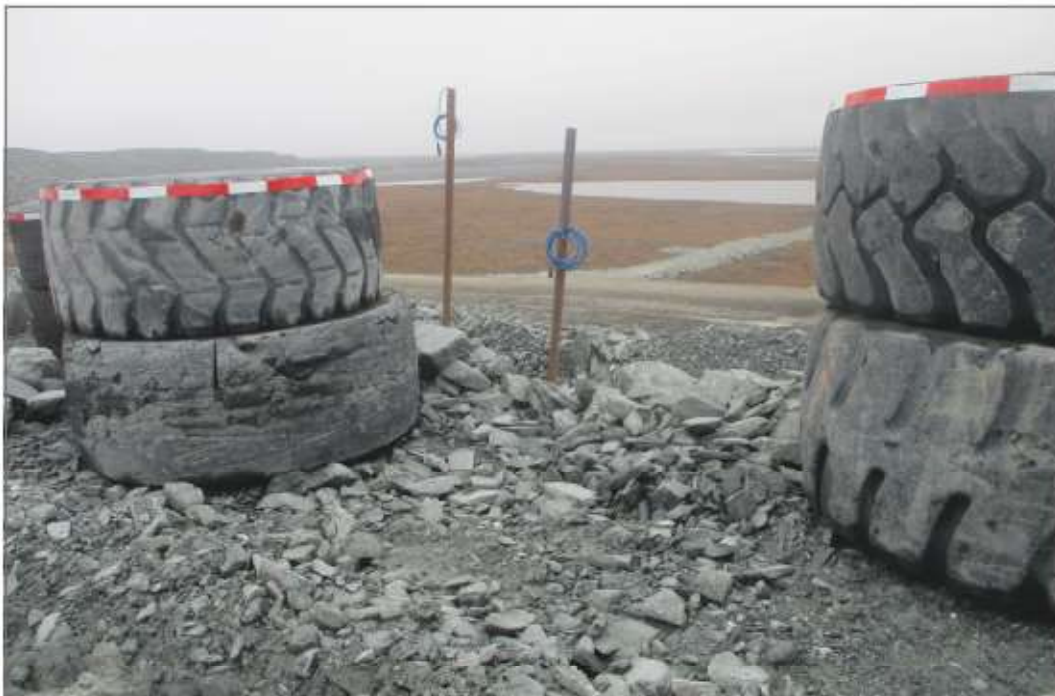
Photo 4: TSF - Thermistors located on edge of TSF embankment.

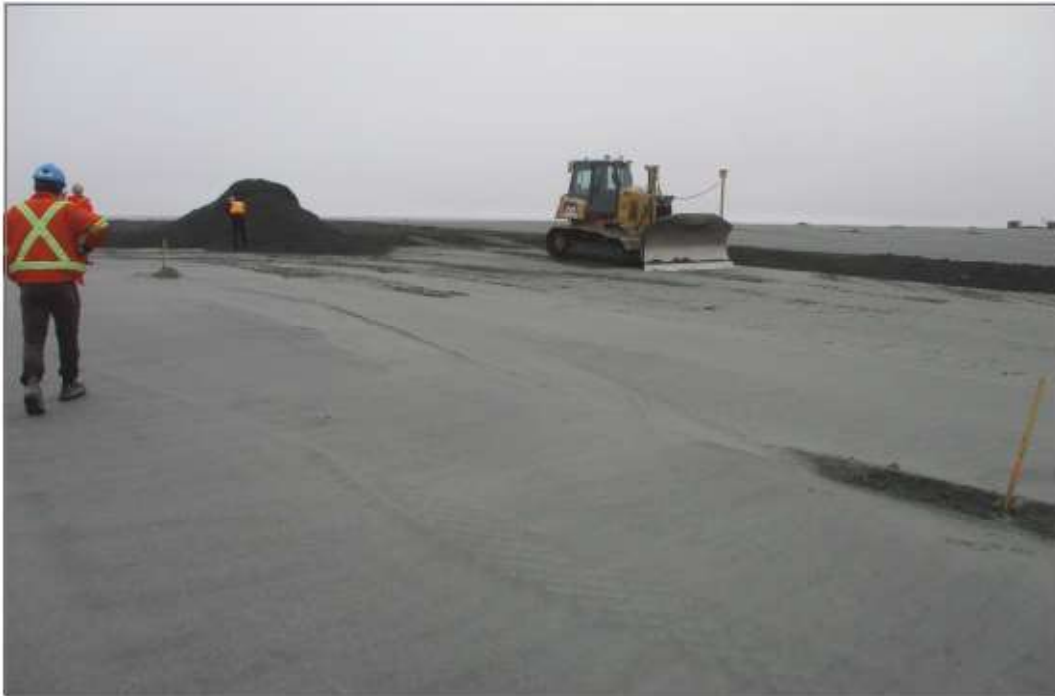
Photo 5: TSF - Spreading tailings.

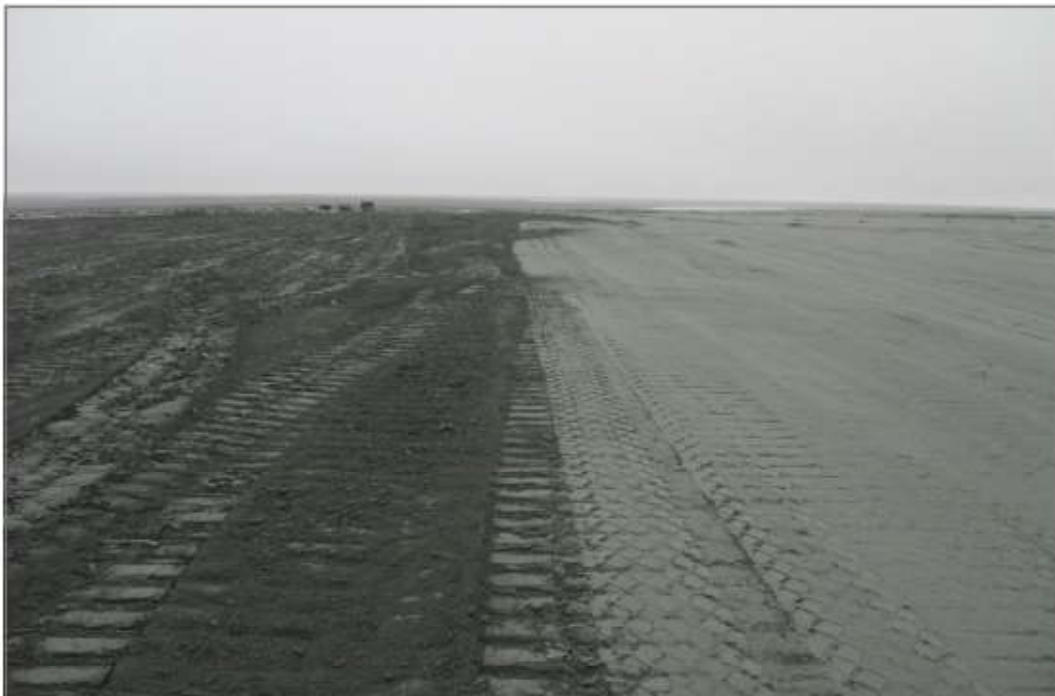
Photo 6: TSF - Compacting tailings.

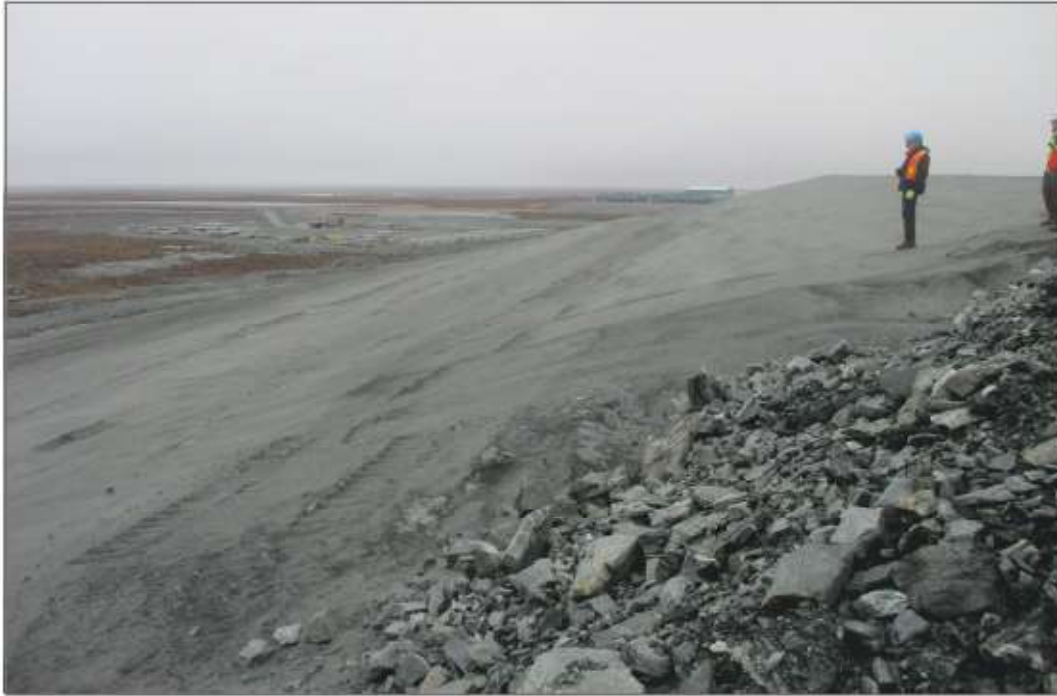
Photo 7: TSF - Slope between Cell 1 and future Cell 2.

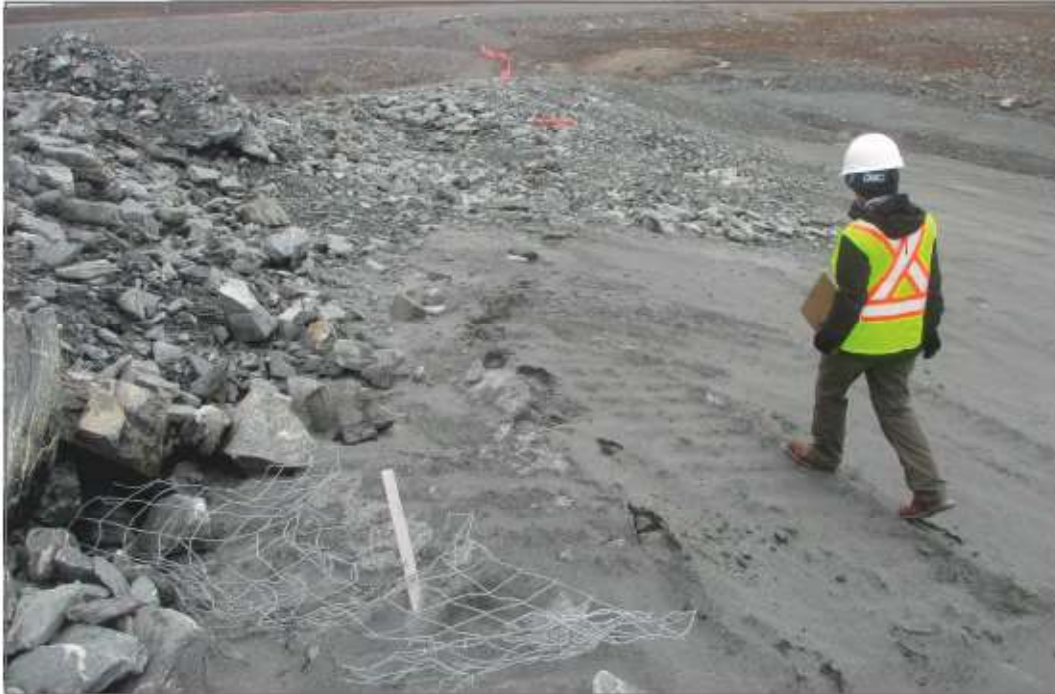
Photo 9: TSF - contact between rockfill cover and tailings at the northwest corner of Cell 1.

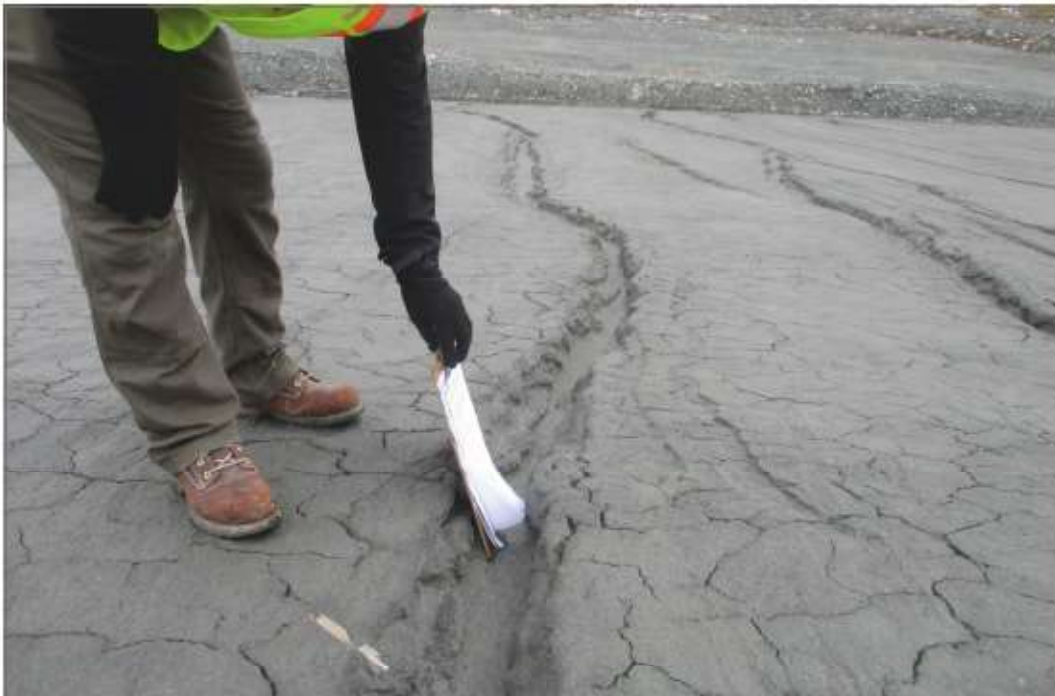
Photo 10: TSF - Erosion channels on exposed north embankment.

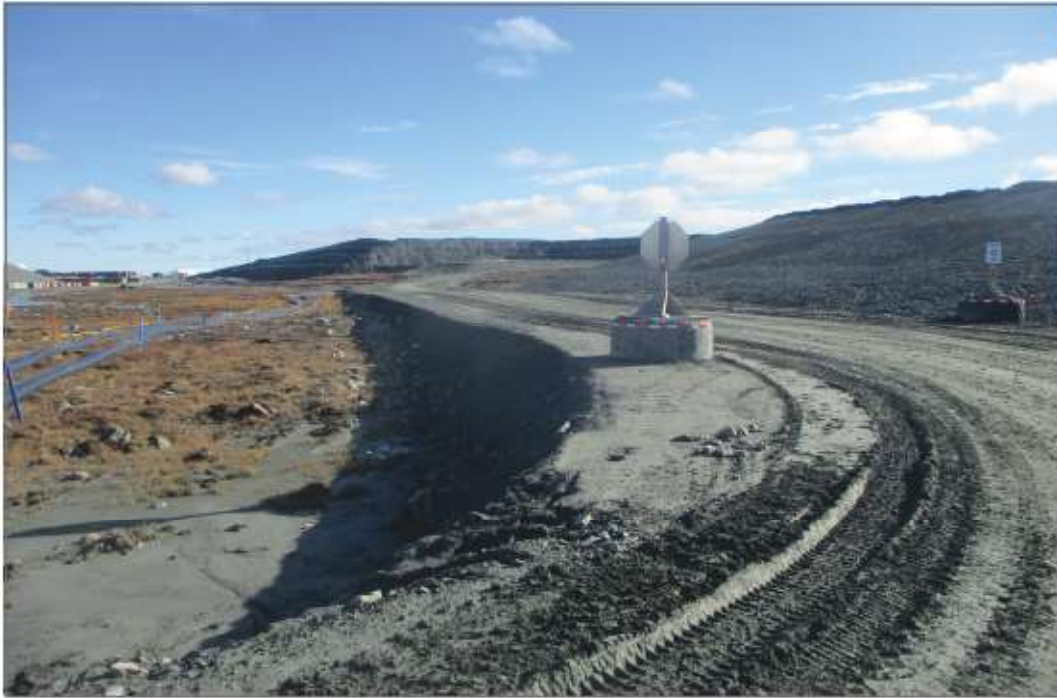
Photo 1: Site Roads—Road to landfill adjacent the TSF.

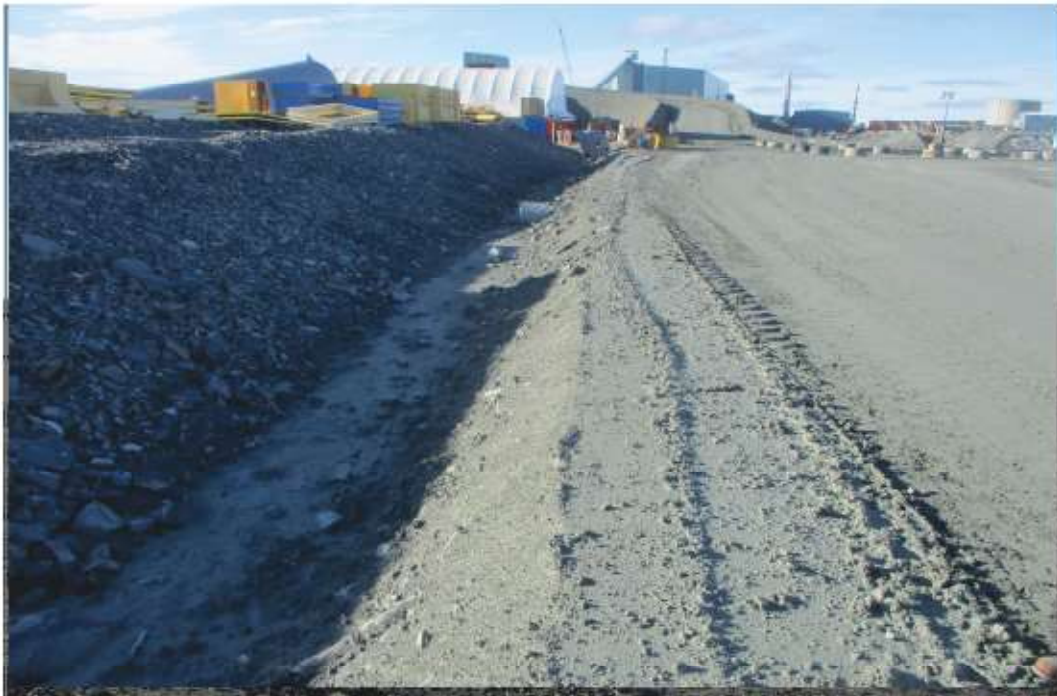
Photo 2: Site Roads—Drainage swale and road to ore stockpile.

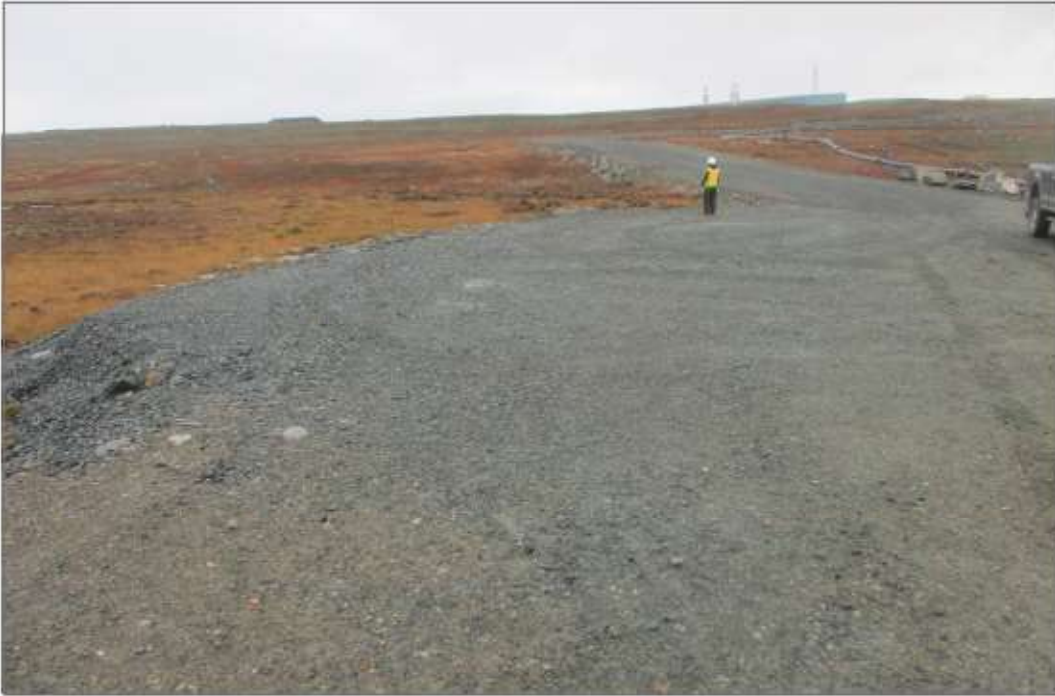
Photo 3: Freshwater Intake Road and turnaround.

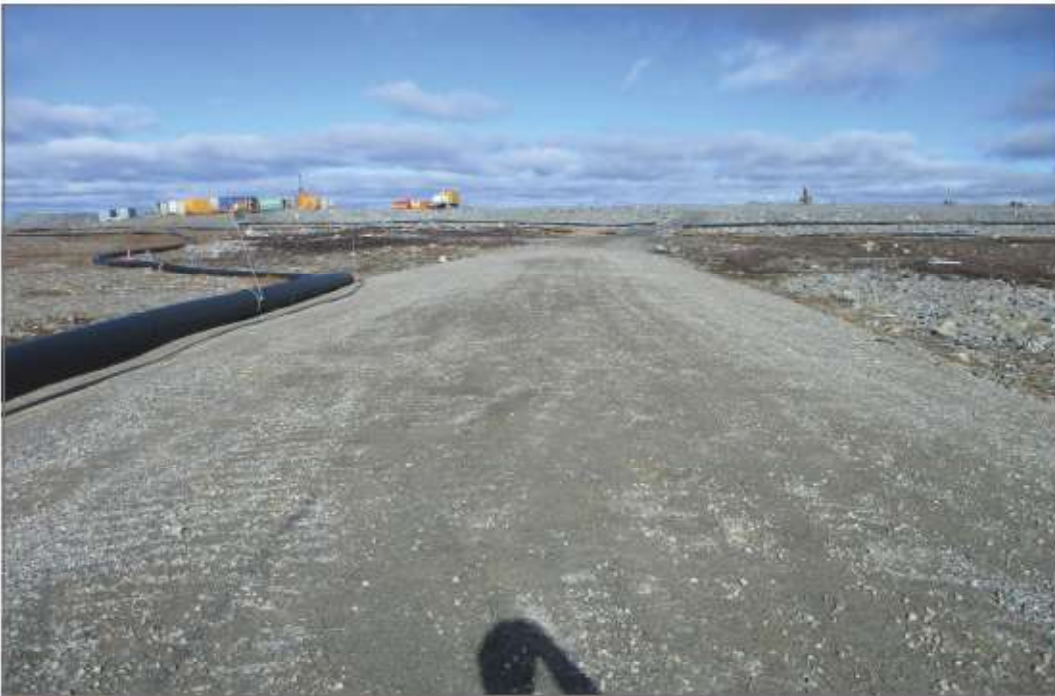
Photo 4: Site Roads—CP5 Jetty Road.

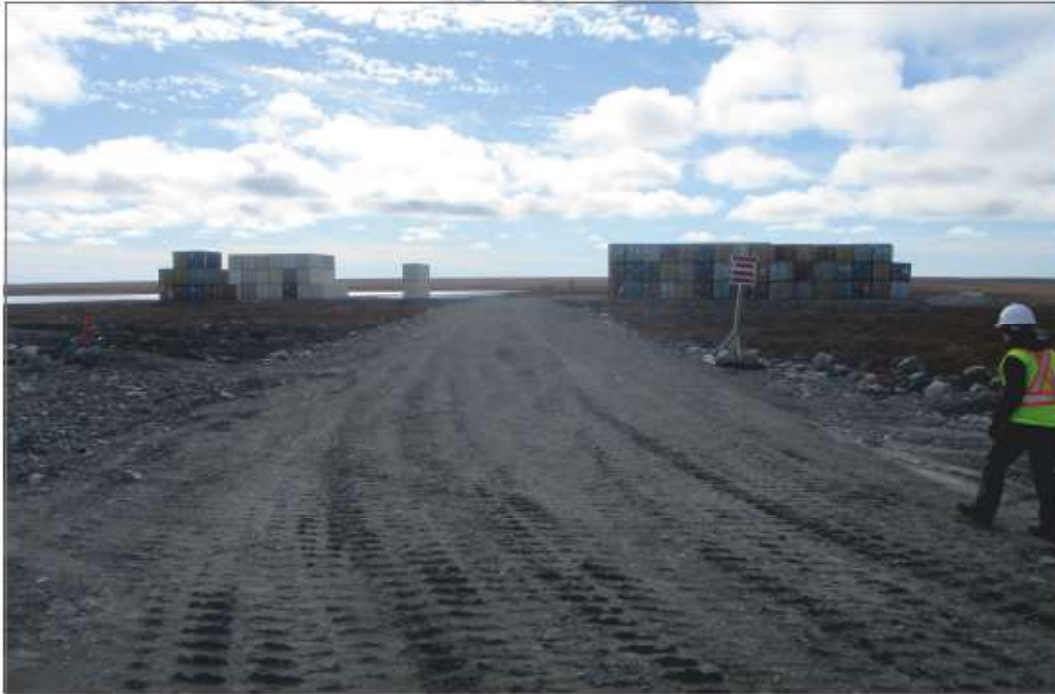
Photo 5: Emulsion Storage Pad access road.

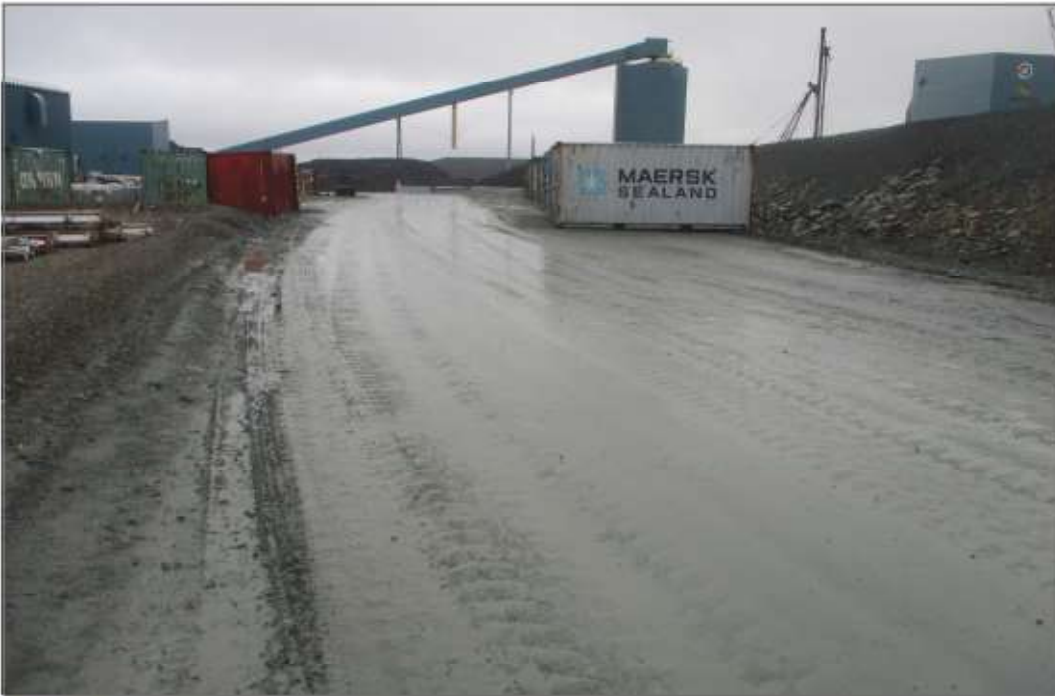
Photo 8: Site Roads—Service road adjacent landfarm and industrial tankfarm.

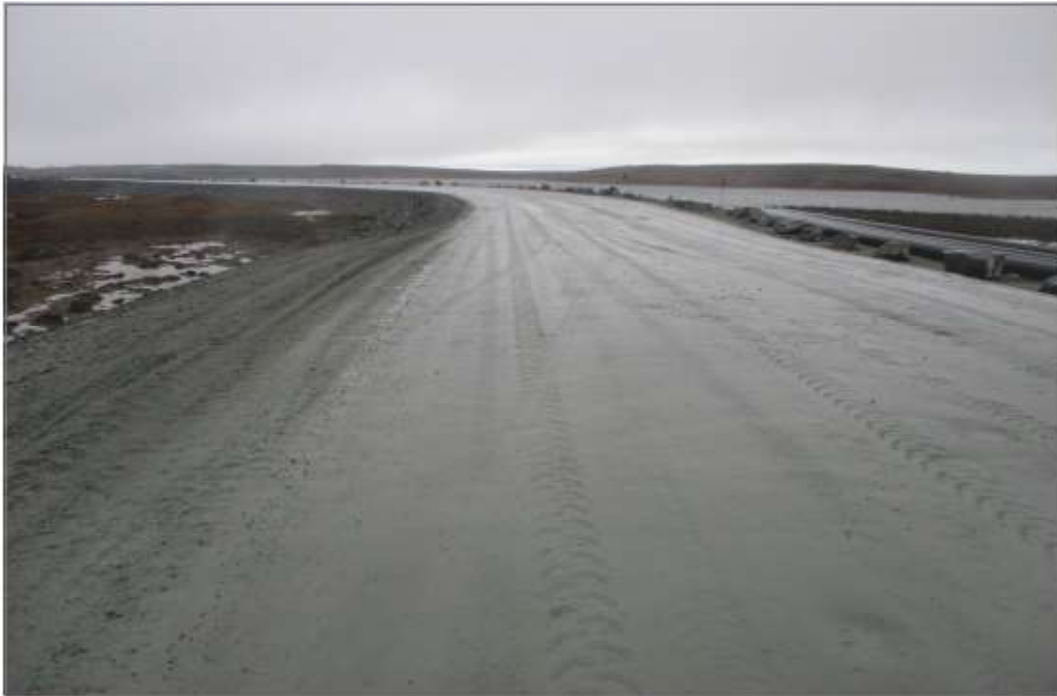
Photo 9: Site Roads—Service road adjacent CP1, looking north.

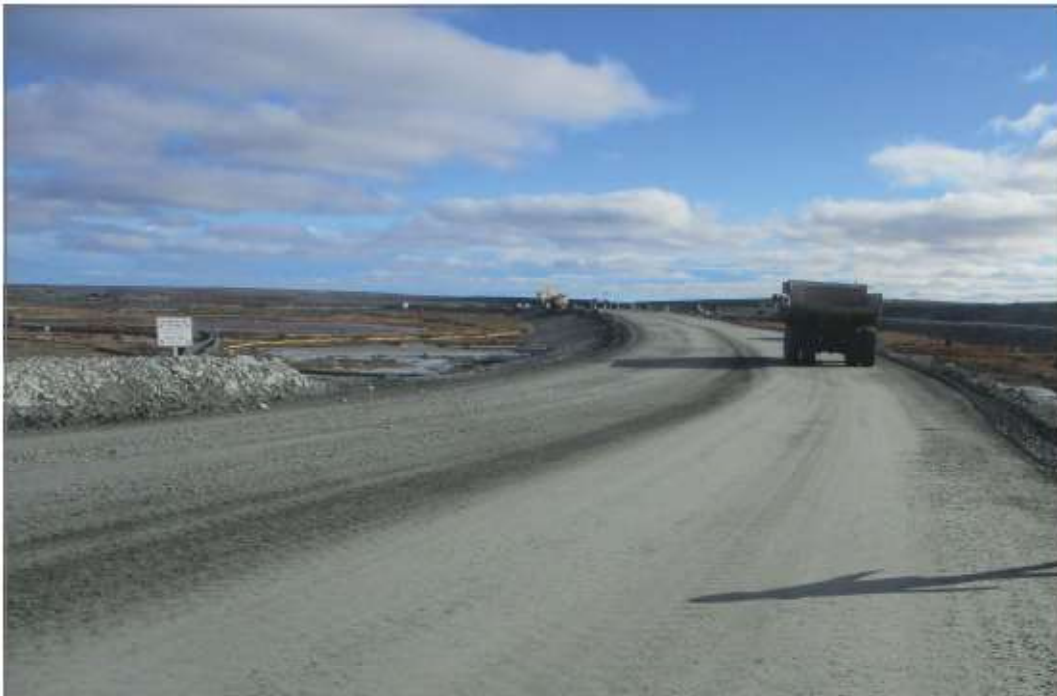
Photo 10: Site Roads—WRSF1 Haul Road, looking south.

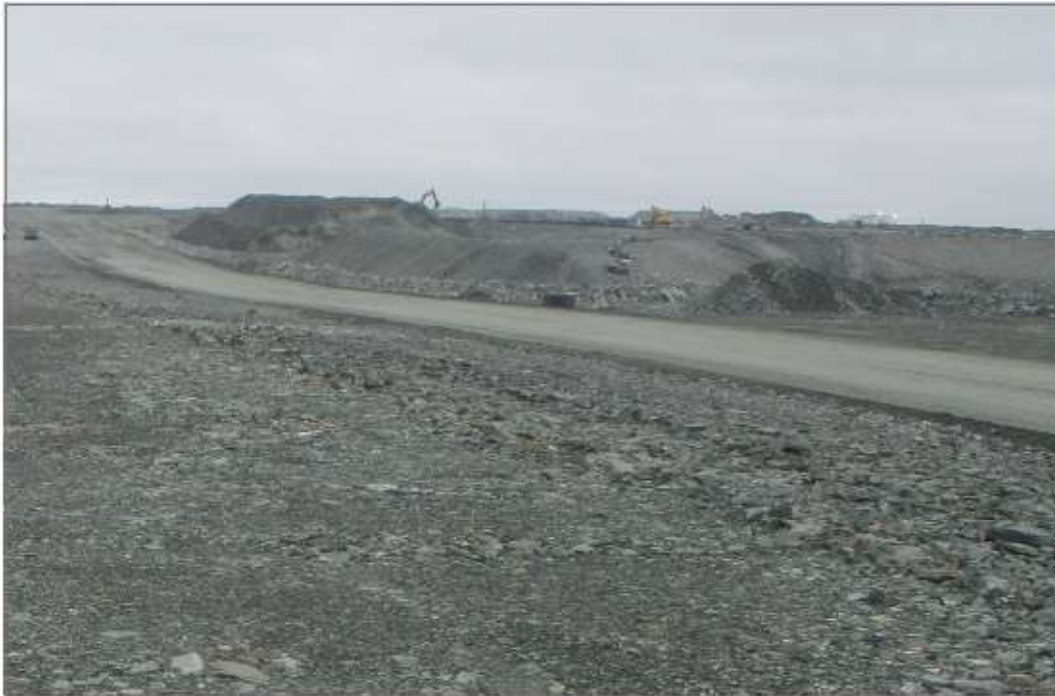
Photo 11: Site Roads—Haul road between Tiri1 and Tiri2 Pits, adjacent D-CP1.

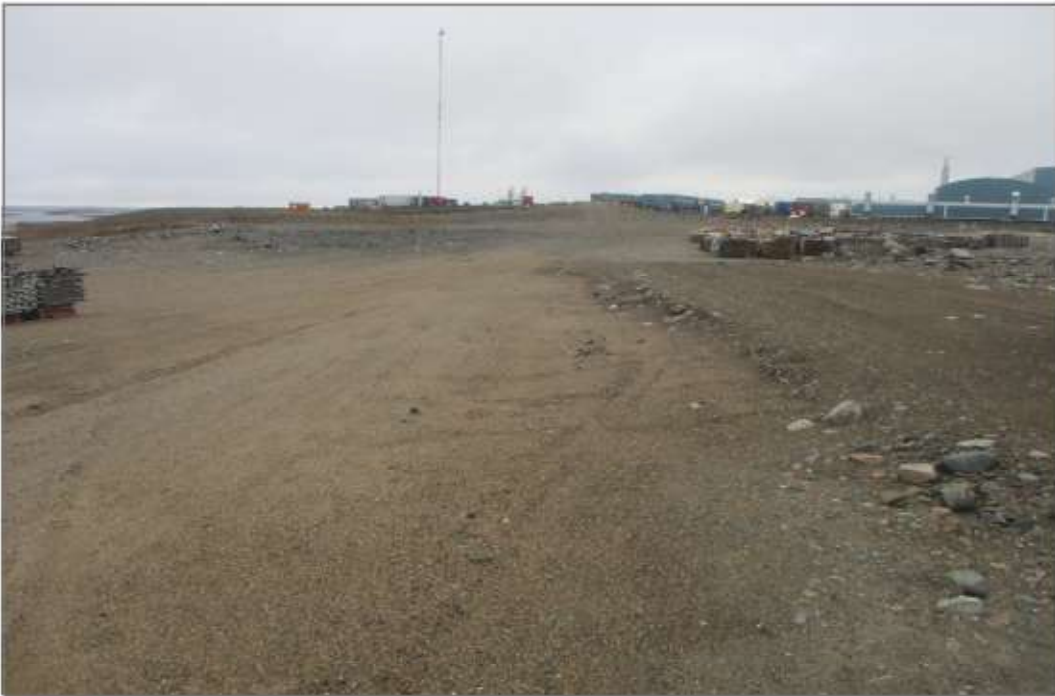
Photo 2: North Esker—Looking south.

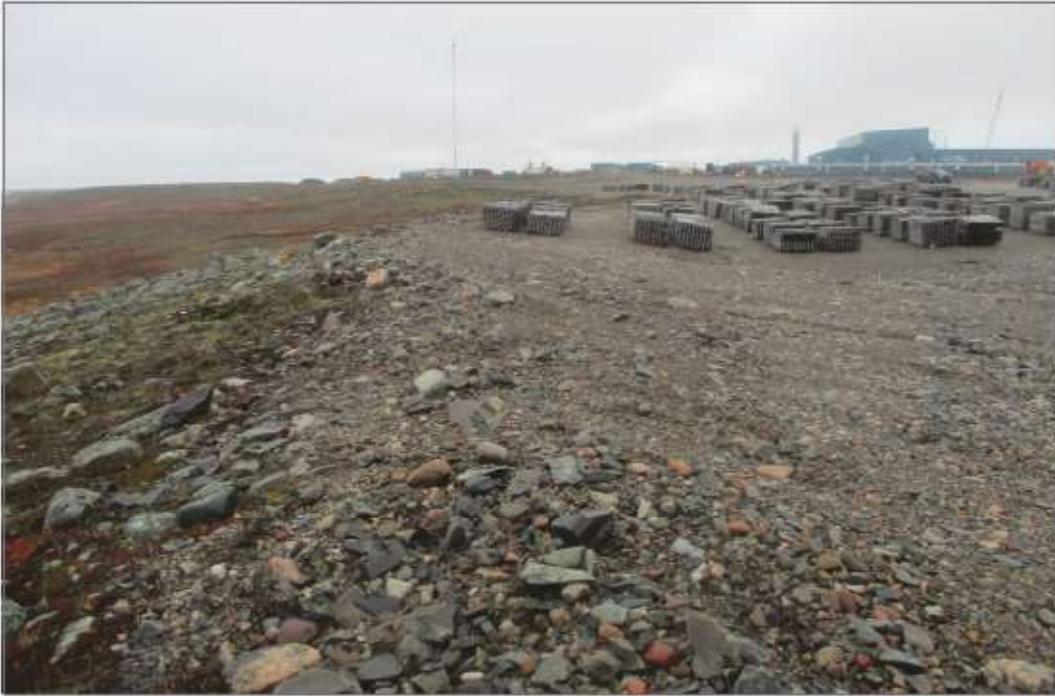
Photo 3: North Esker—Looking south.

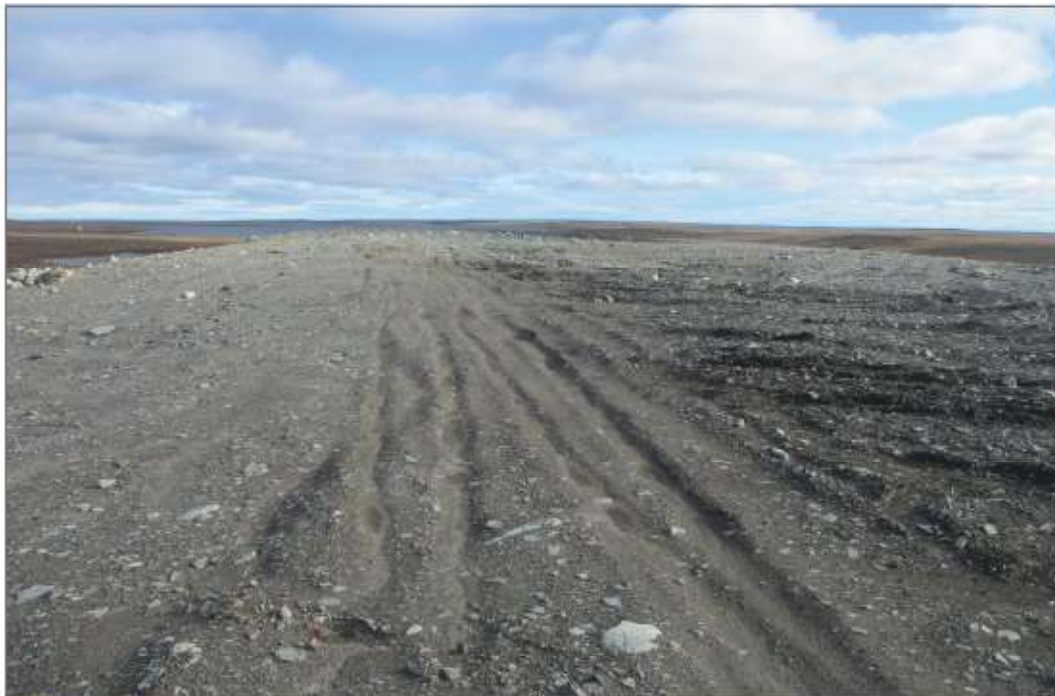
Photo 4: Wesmeg Esker—Access, looking northwest.

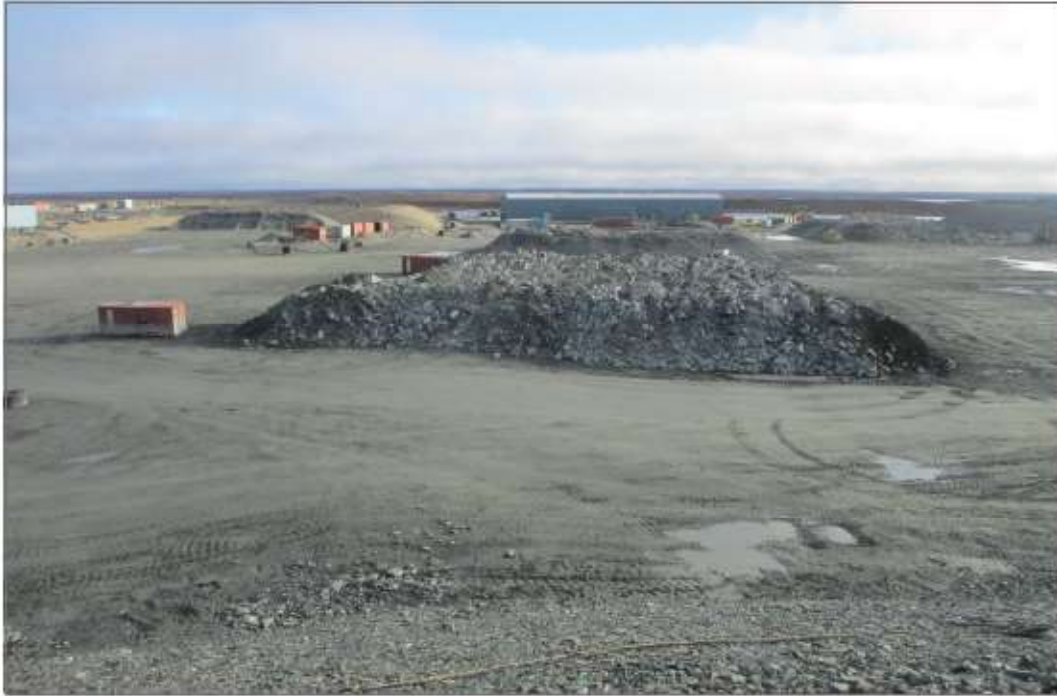
Photo 1: Ore Stockpile Area—Viewed from crusher ramp.

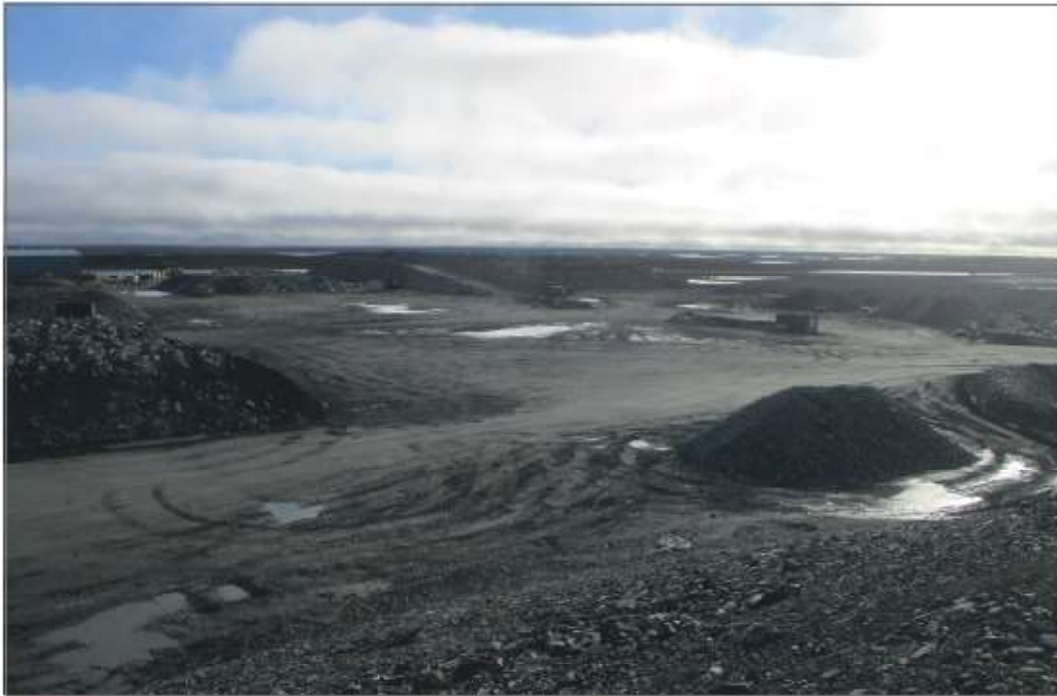
Photo 2: Ore Stockpile Area—Viewed from crusher ramp.

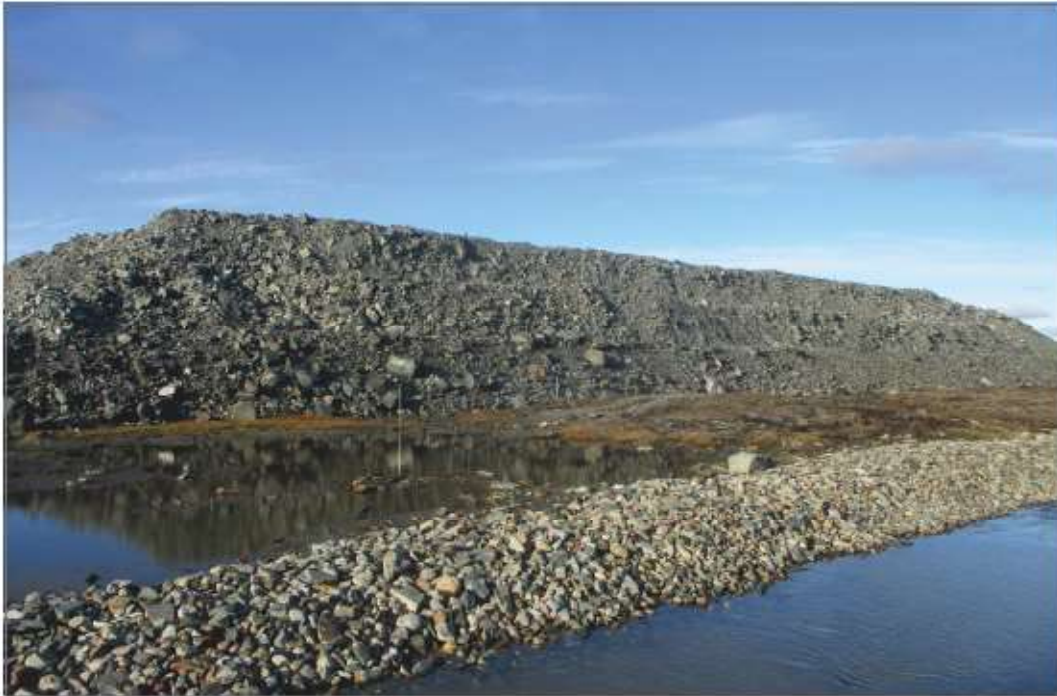
Photo 5: Ore Stockpile—South side viewed from Channel 1.

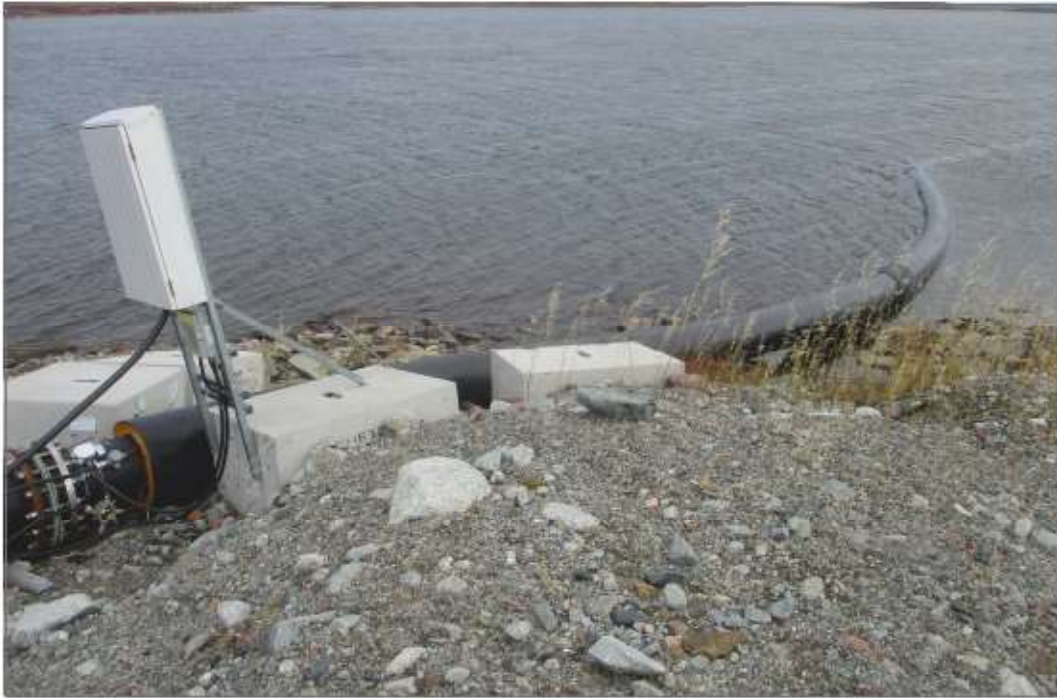
Photo 5: Exploration Camp—Diffuser line

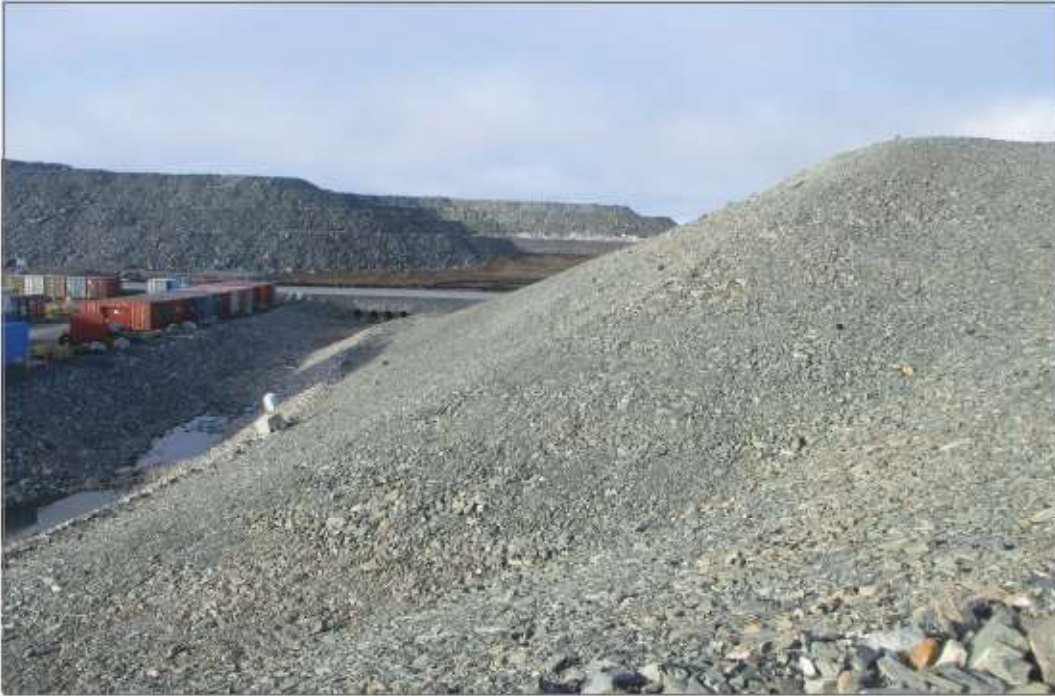
Photo 3: Crusher Pad—South slope.

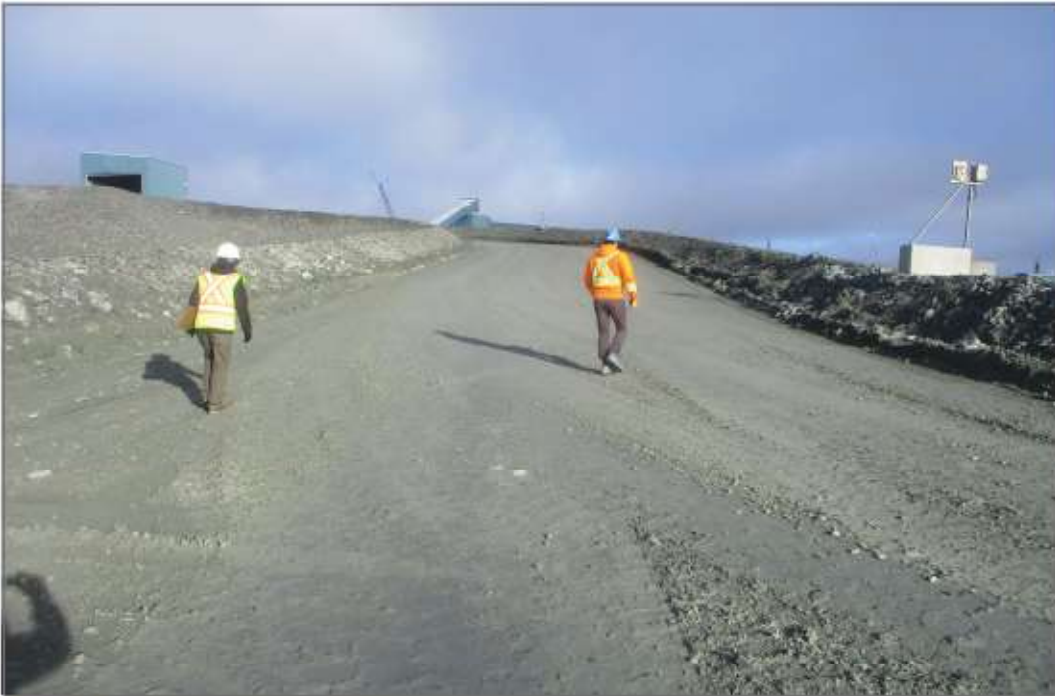
Photo 4: Crusher Pad —Ramp access.

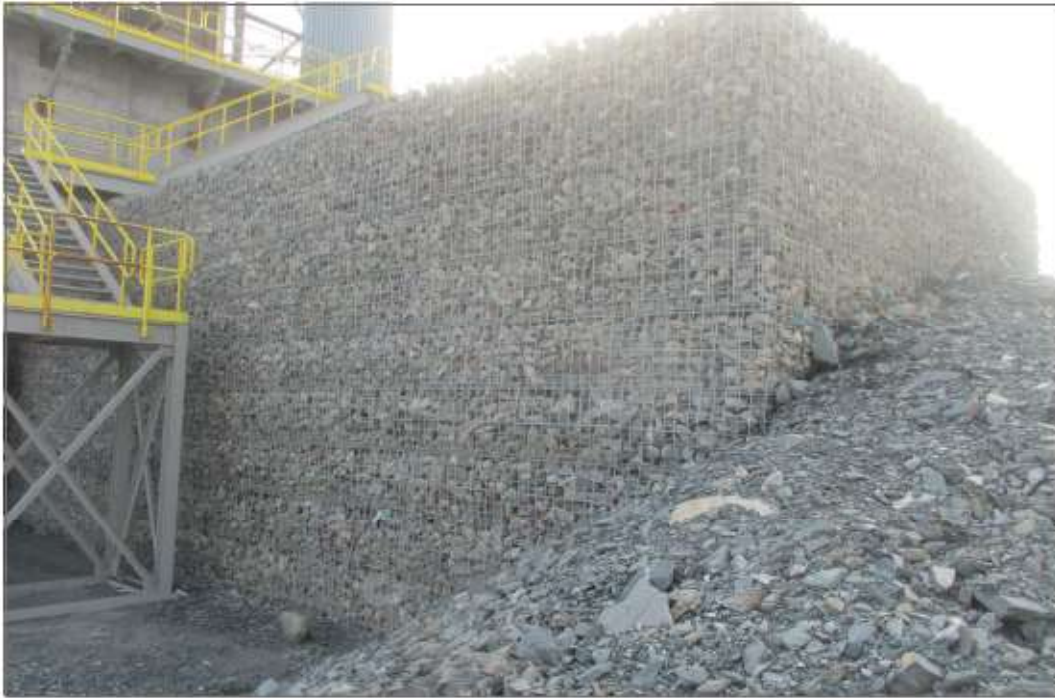
Photo 5: Crusher Pad—MSE Wall on the northwest corner.

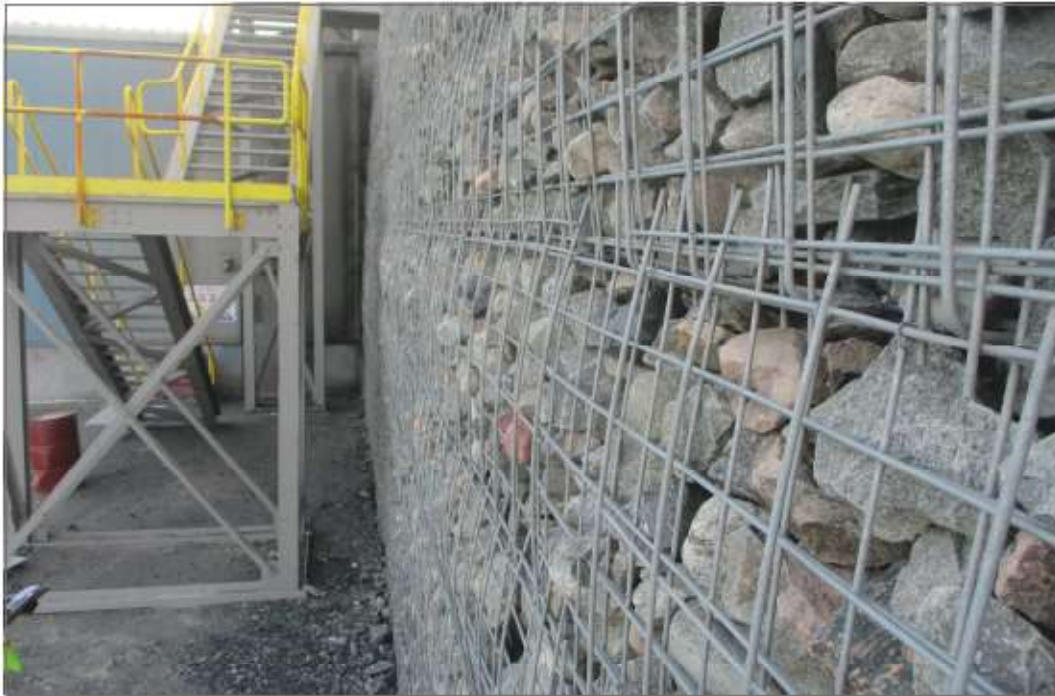
Photo 6: Crusher Pad—Closeup of MSE Wall on the northwest corner.

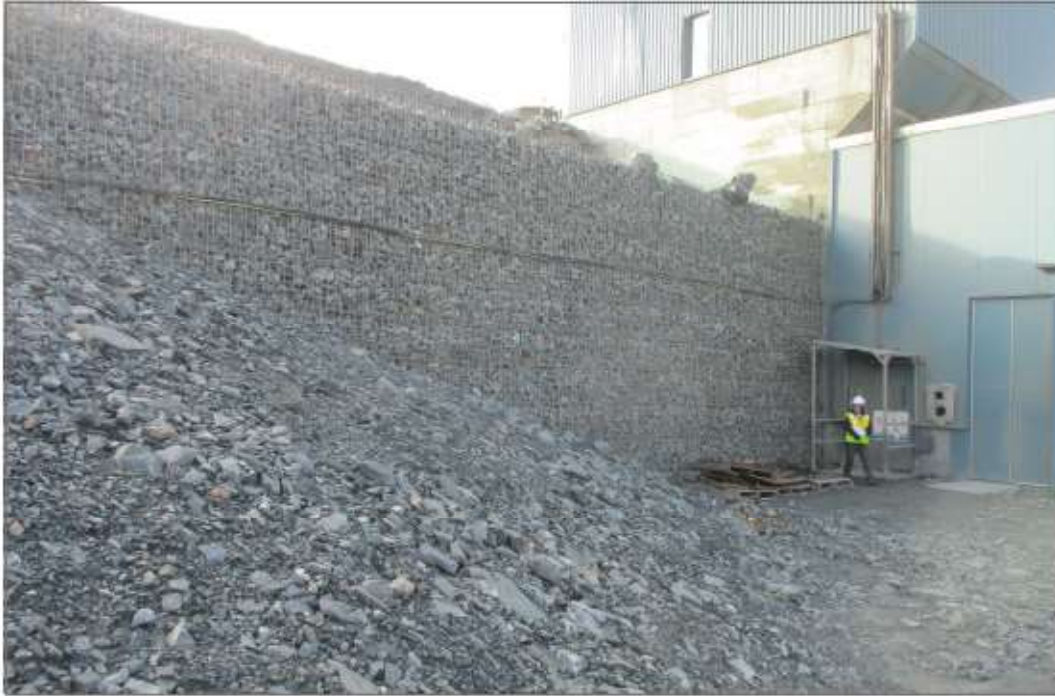
Photo 7: Crusher Pad—MSE wall, north east side.

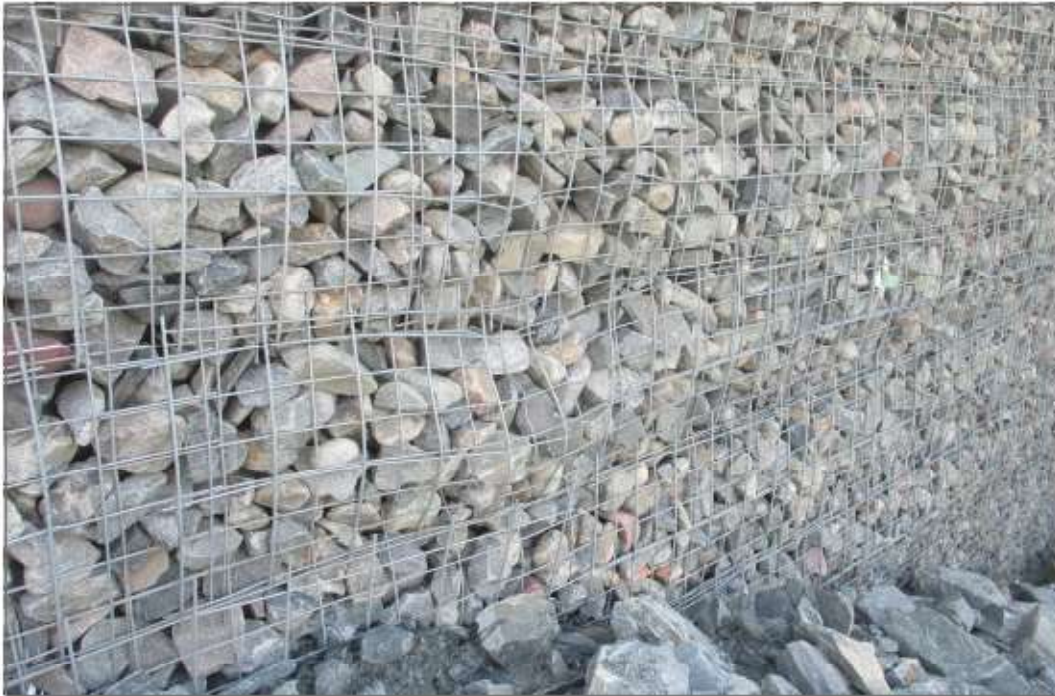
Photo 8: Crusher Pad—MSE wall, north east side. Slight localized bulge and distortion of gabion cage.

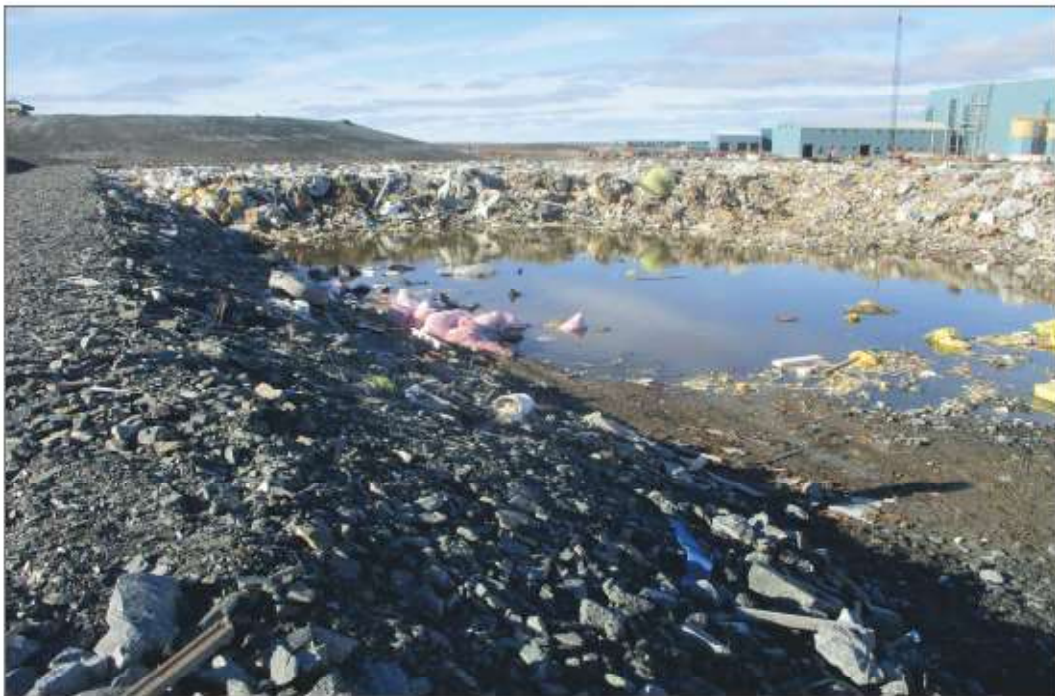
Photo 10: Landfill - WRSF1 Landfill with ponded water.

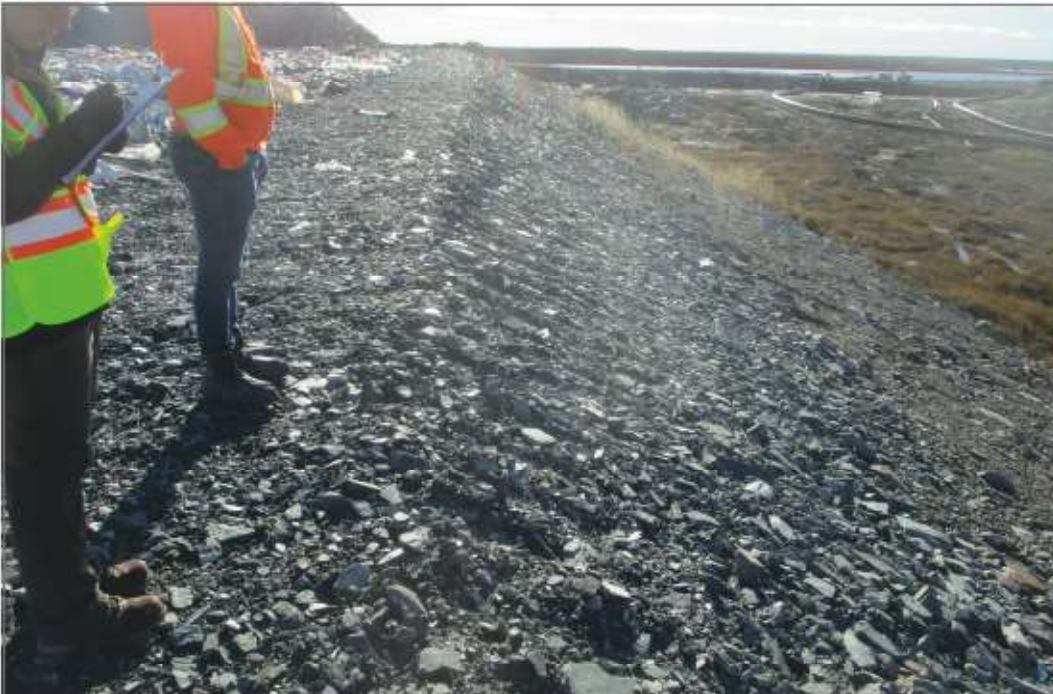
Photo 14: Landfill - WRSF1 Landfill—Northwest berm—some revegetation.

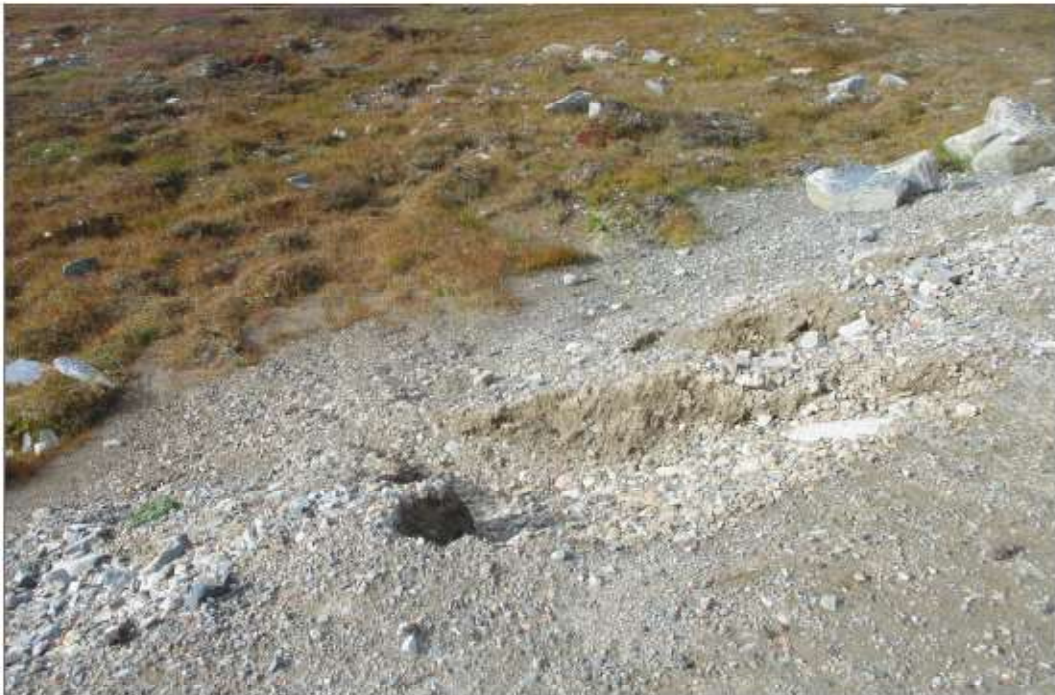
Photo 16: Emulsion Plant—west side of pad, erosion in pad slope.
