Appendix 6: 2022 Annual Geotechnical Inspection Report

2022 Annual Geotechnical Inspection Meliadine Gold Project, Rankin Inlet, Nunavut

PRESENTED TO
Agnico Eagle Mines Limited

FEBRUARY 17, 2023
ISSUED FOR USE
FILE: 704-ENG.EARC03140-31
AGNICO EAGLE DOCUMENT NUMBER: 65-600-230-TCR-001

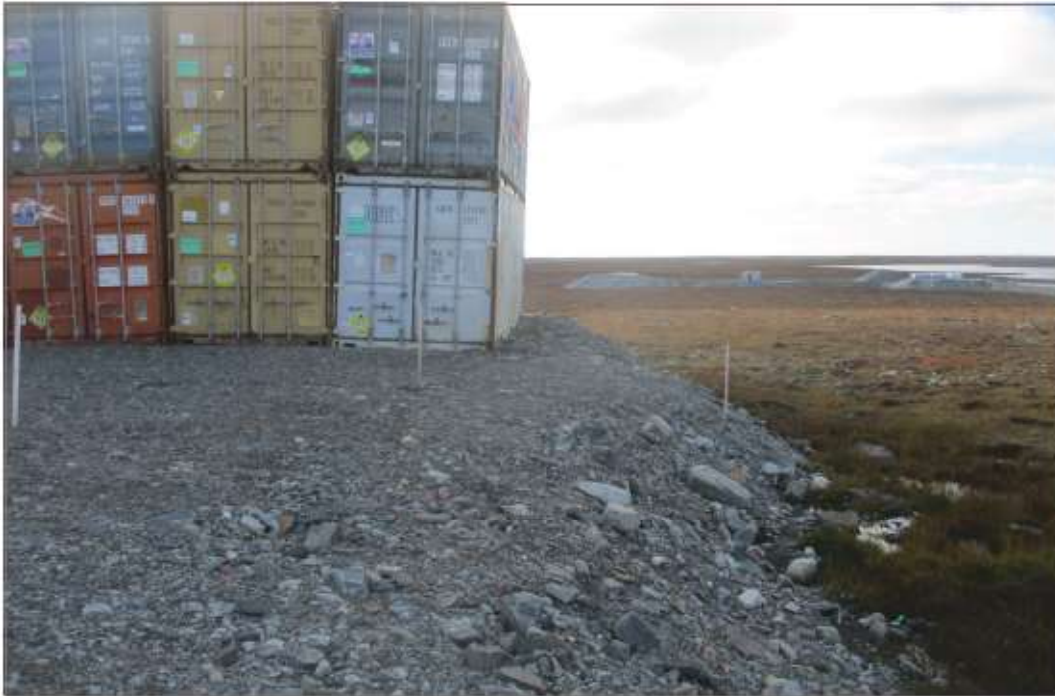
Photo 17: Emulsion Plant—Storage Area—slope on north edge of pad, slight lean to shipping containers.

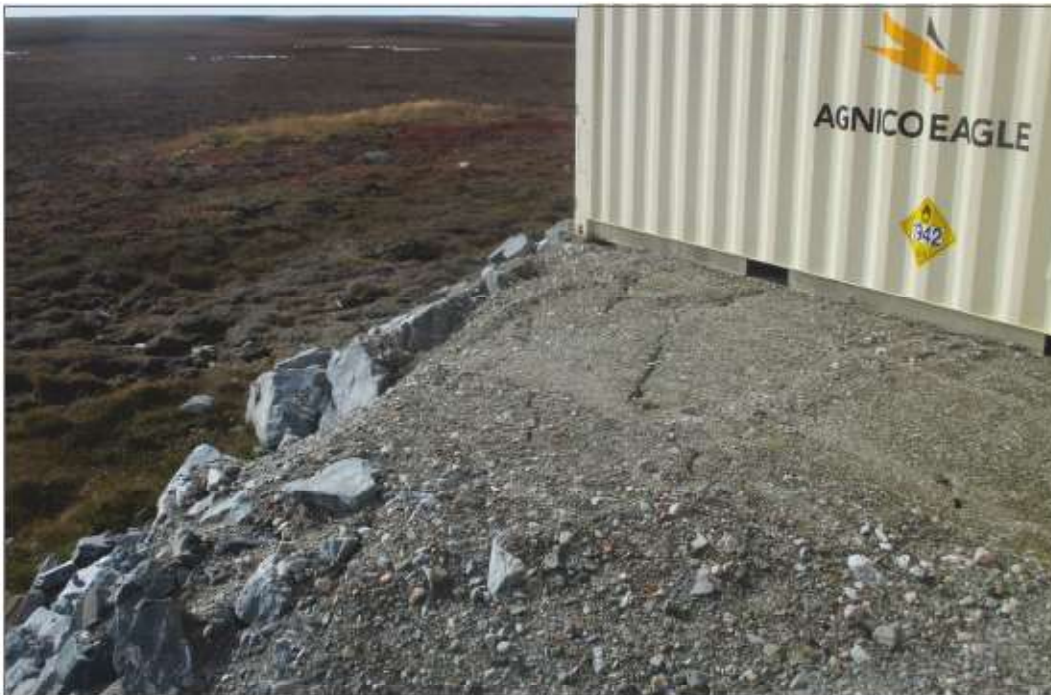
Photo 18: Emulsion Plant—Storage Area—Shipping container placed on edge of pad crest at south corner.

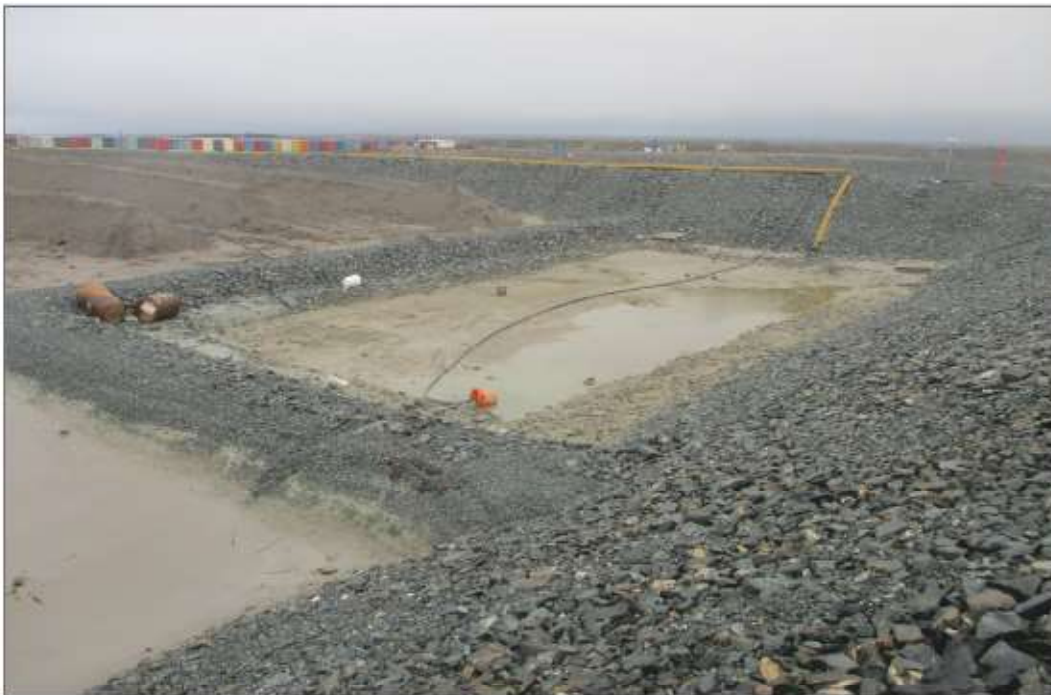
Photo 20: Landfarm—Water collection pond with low ponding and sedimentation.

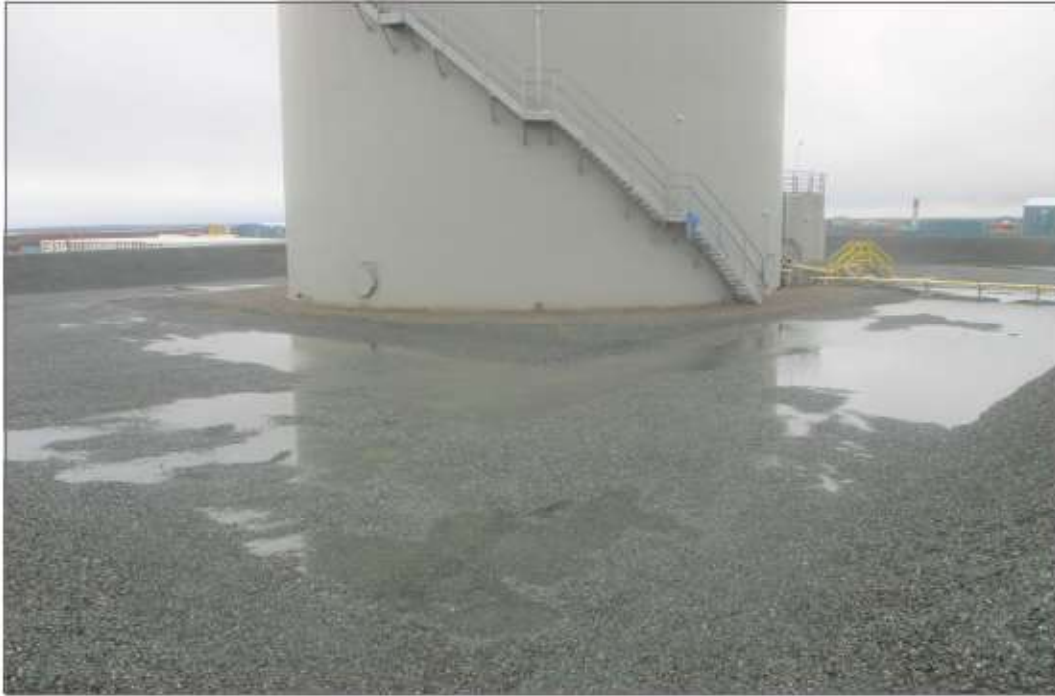
Photo 25: Industrial Fuel Storage Tanks.—Ponded water in tankfarm.

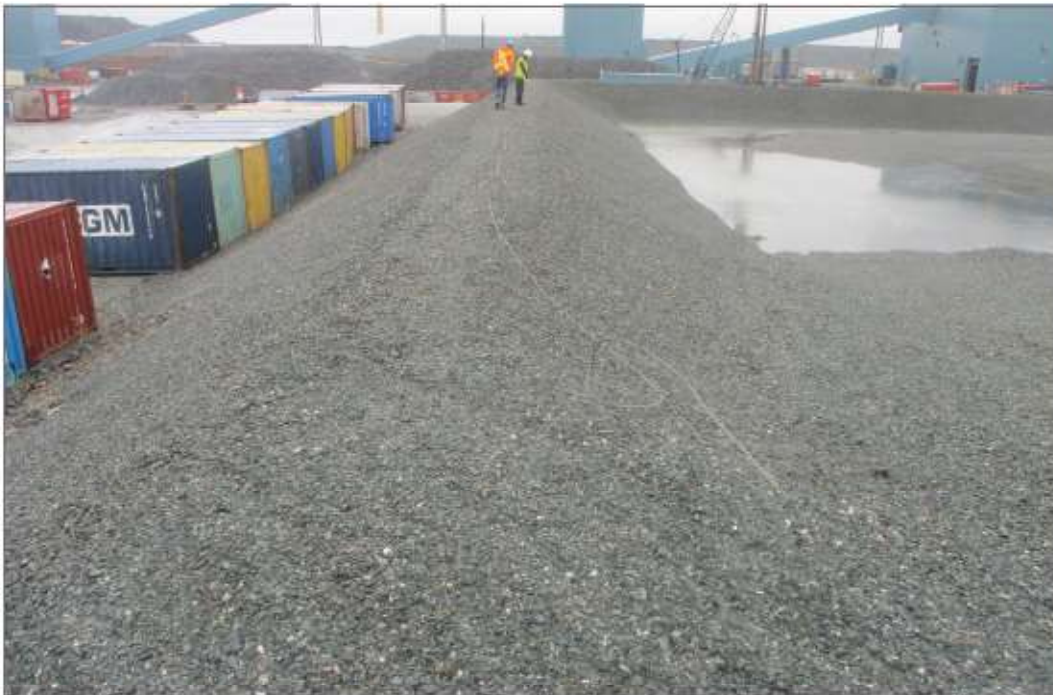
Photo 28: Industrial Fuel Storage Tanks—Exposed grounding cable on berm crest.

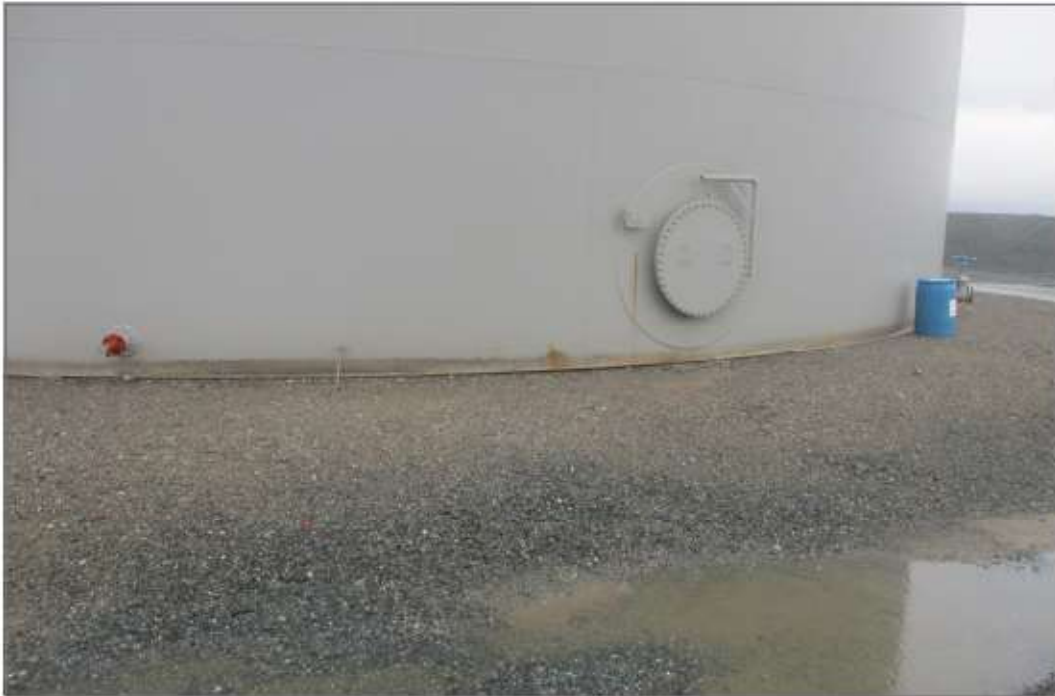
Photo 29: Industrial Fuel Storage Tanks—Small amount of erosion on tank pedestals.

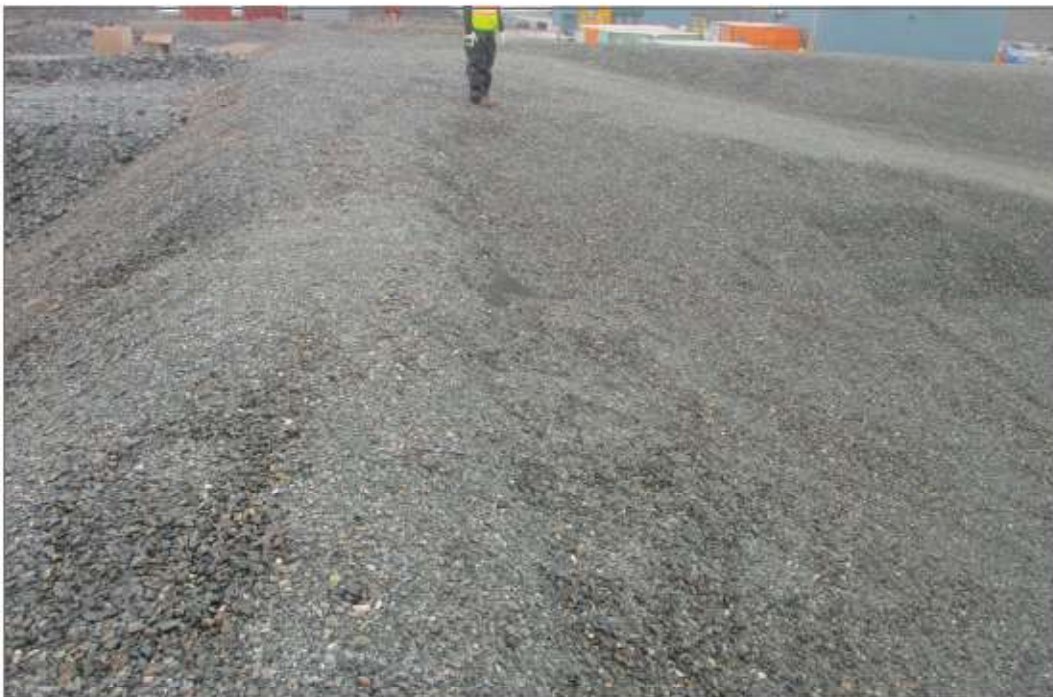
Photo 30: Industrial Fuel Storage Tanks—Exposed geotextile along inside of berm.

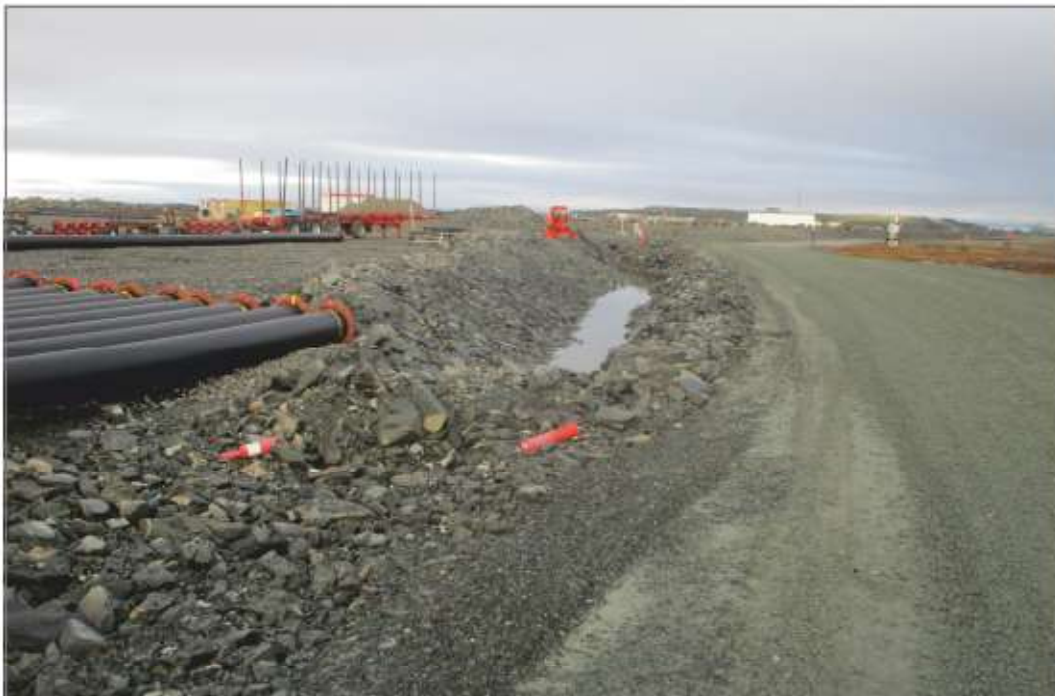
Photo 33: No culvert km 28.7

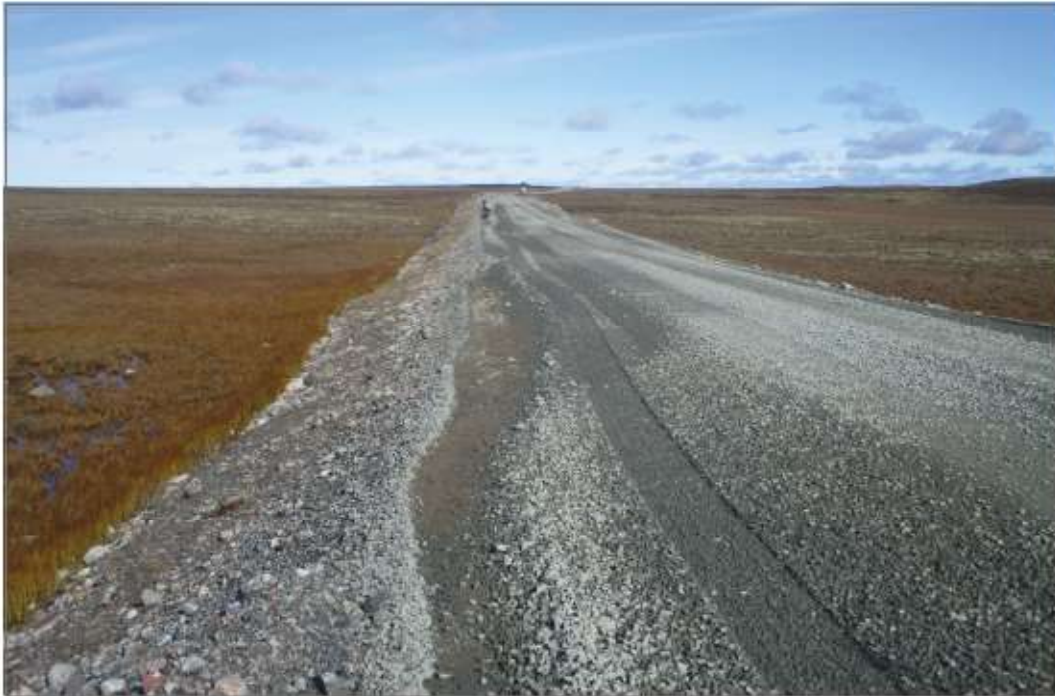
Photo 1: Overview of Bypass Road from KM 5.1 North

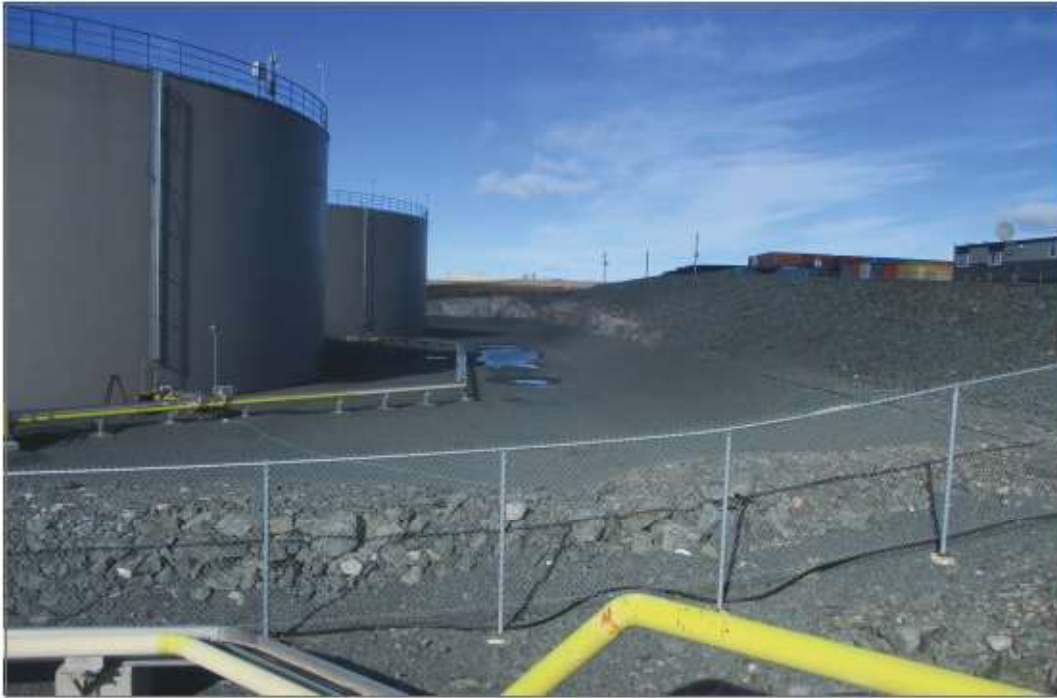
Photo 11: ITIVIA Tankfarm—North of tanks.

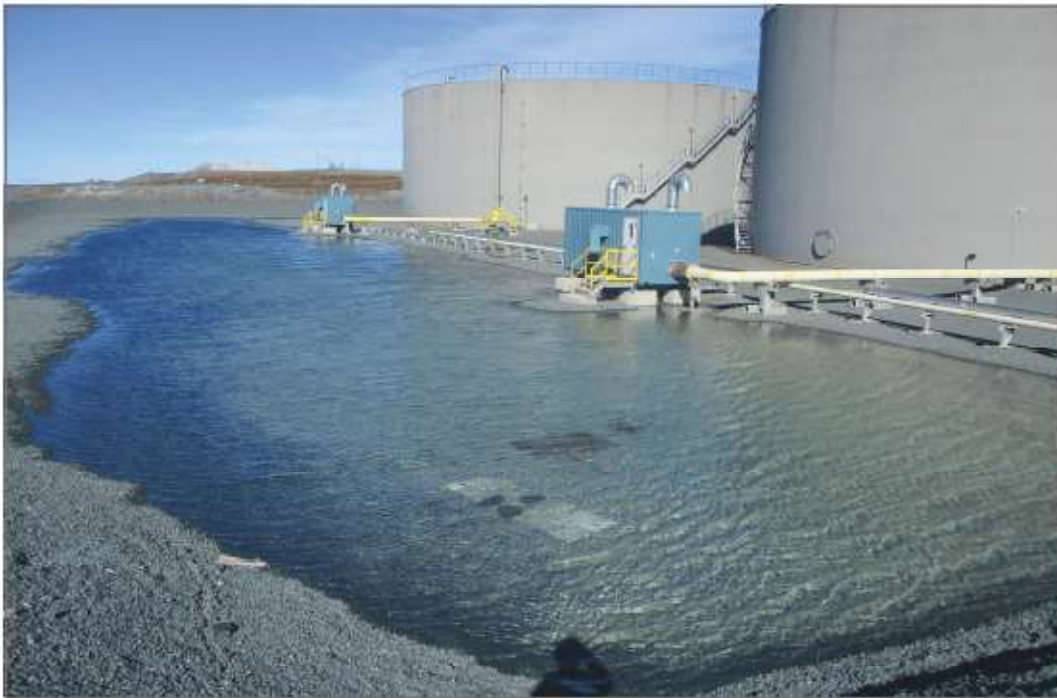
Photo 12: ITIVIA Tankfarm—Ponded water in facility.

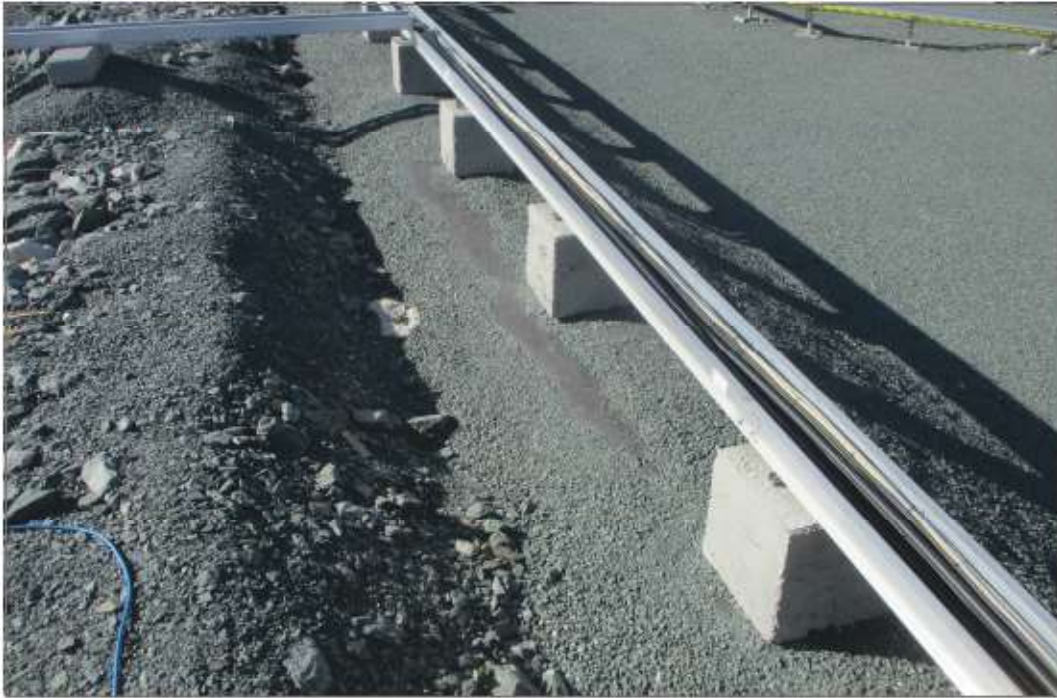
Photo 13: ITIVIA Tankfarm— Geotextile exposed along south berm crest.

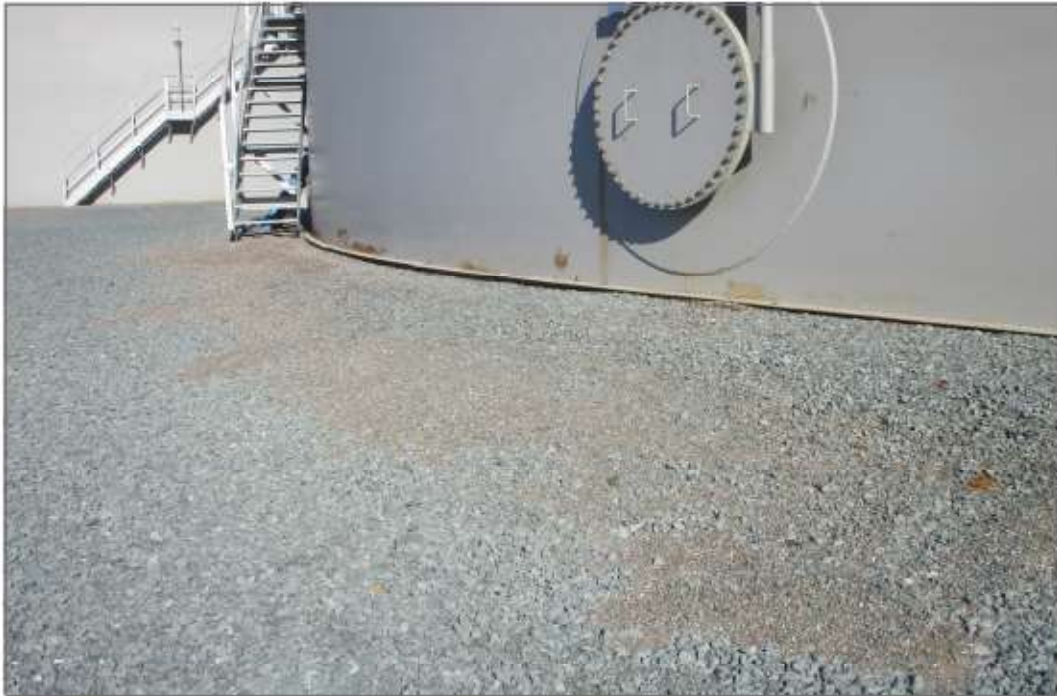
Photo 14: ITIVIA Tankfarm—Perimeter of tank base on pedestal.

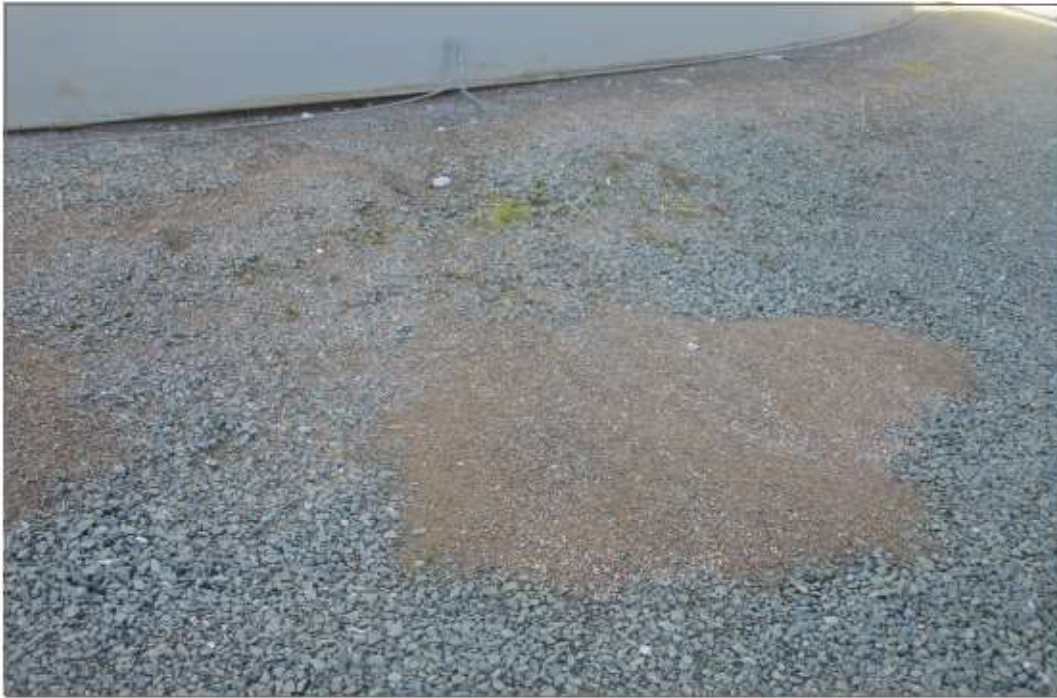
Photo 15: ITIVIA Tankfarm—Fines erosion on edge of tank pedestal.

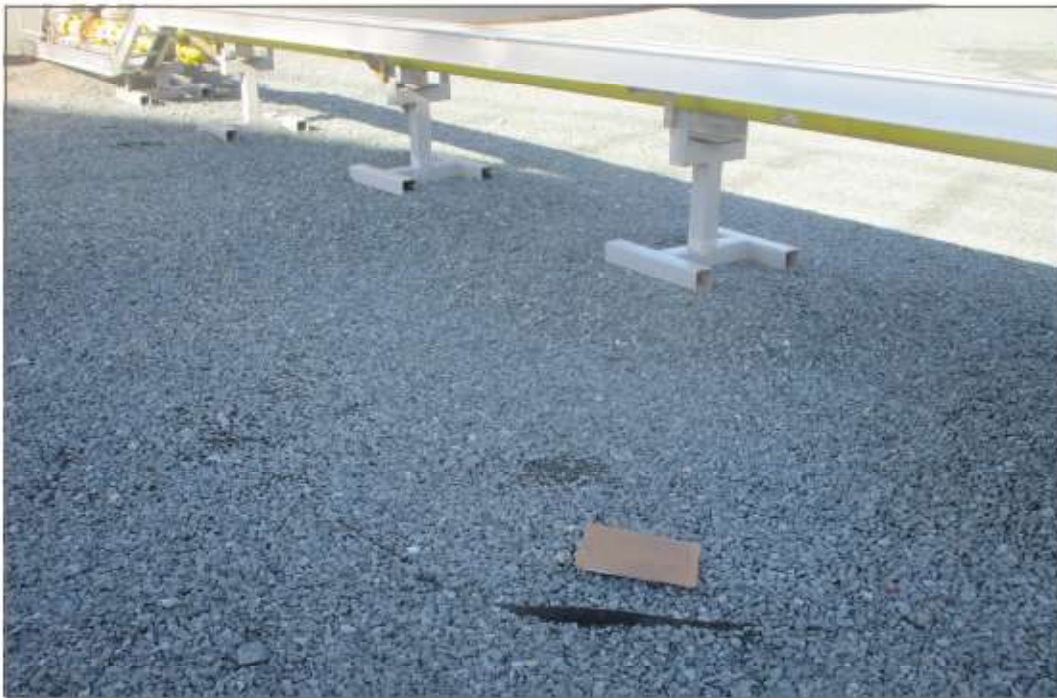
Photo 16: ITIVIA Tankfarm—Geotextile exposed in pad base.

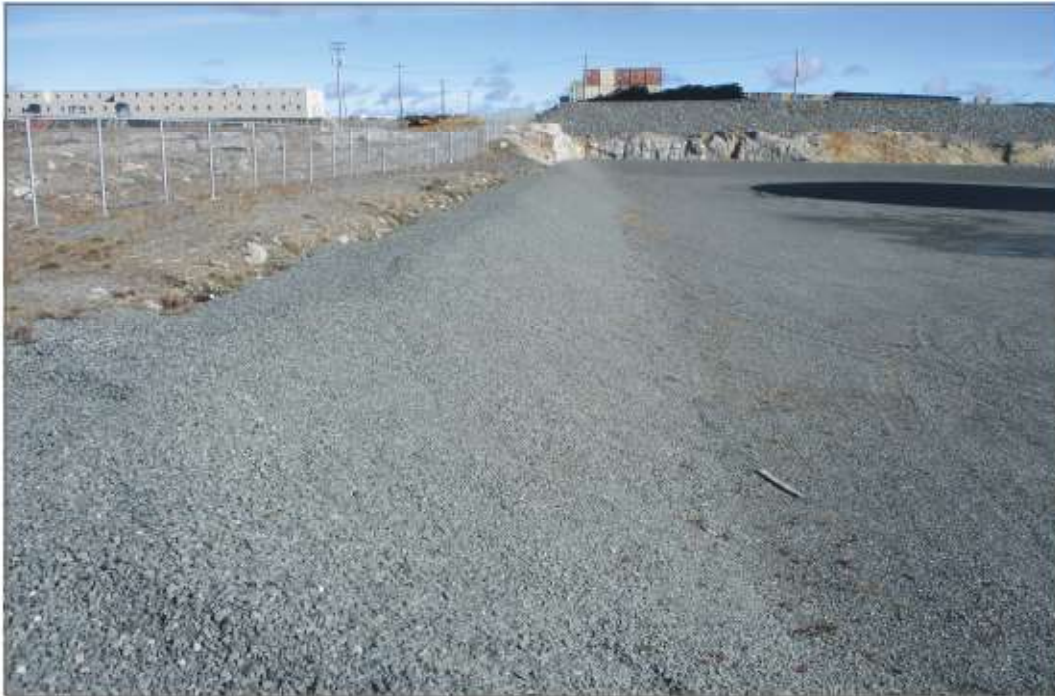
Photo 17: ITVIA Tankfarm—West berm of tankfarm

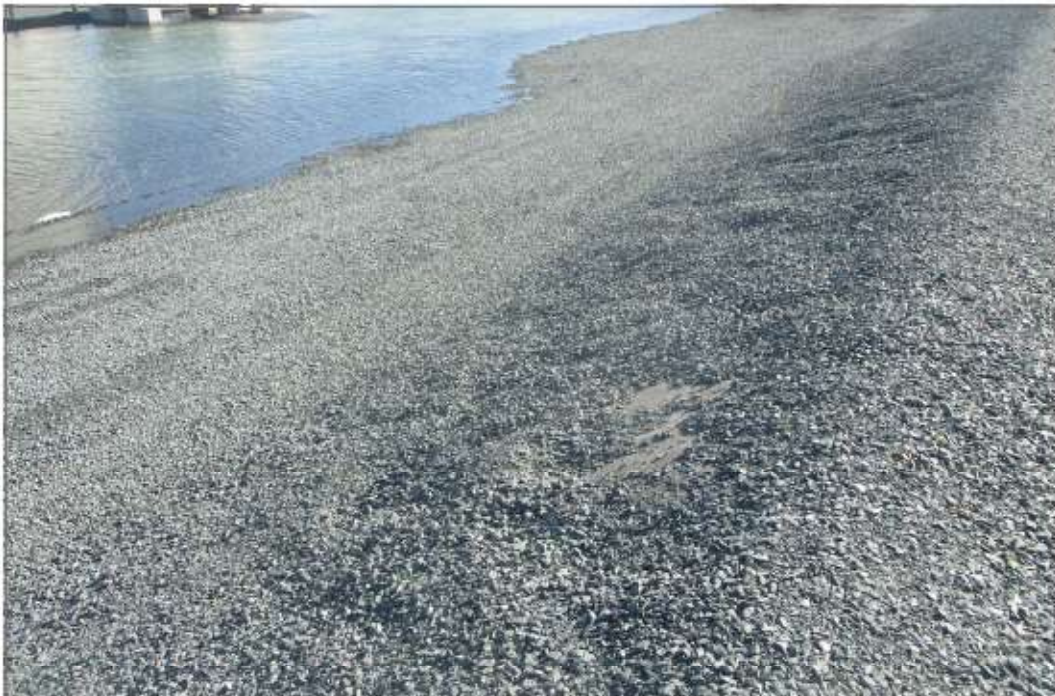
Photo 18: ITVIA Tankfarm—Exposed geotextile on south berm embankment.

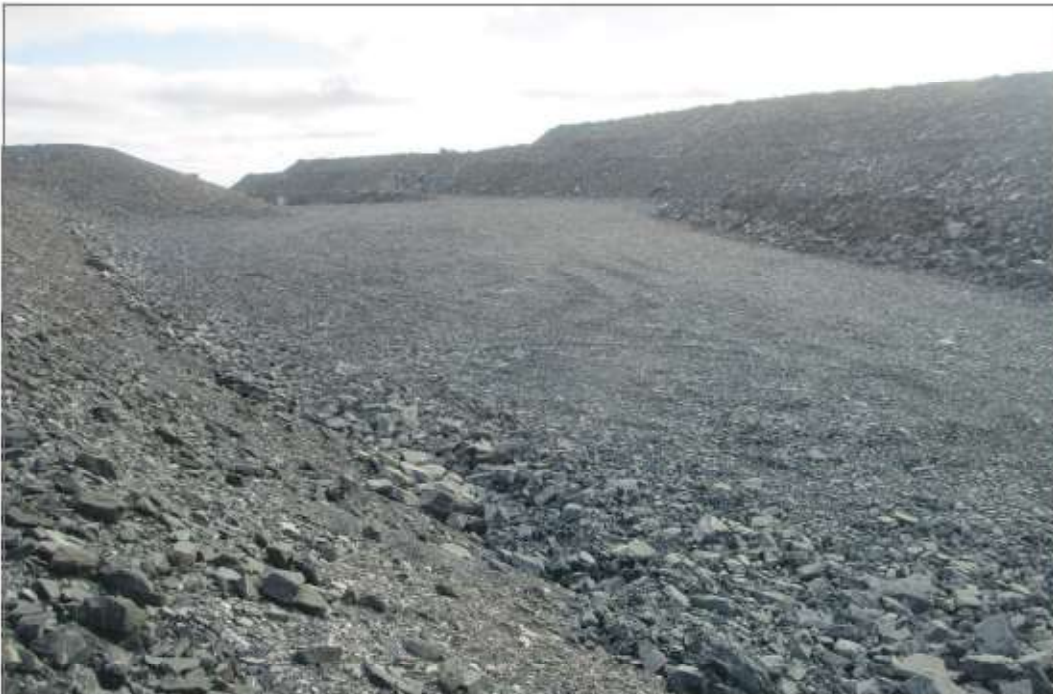
Photo 2: WRSF1—Viewed from Paste Plant Ramp— Backfilled low point along toe of WRSF.

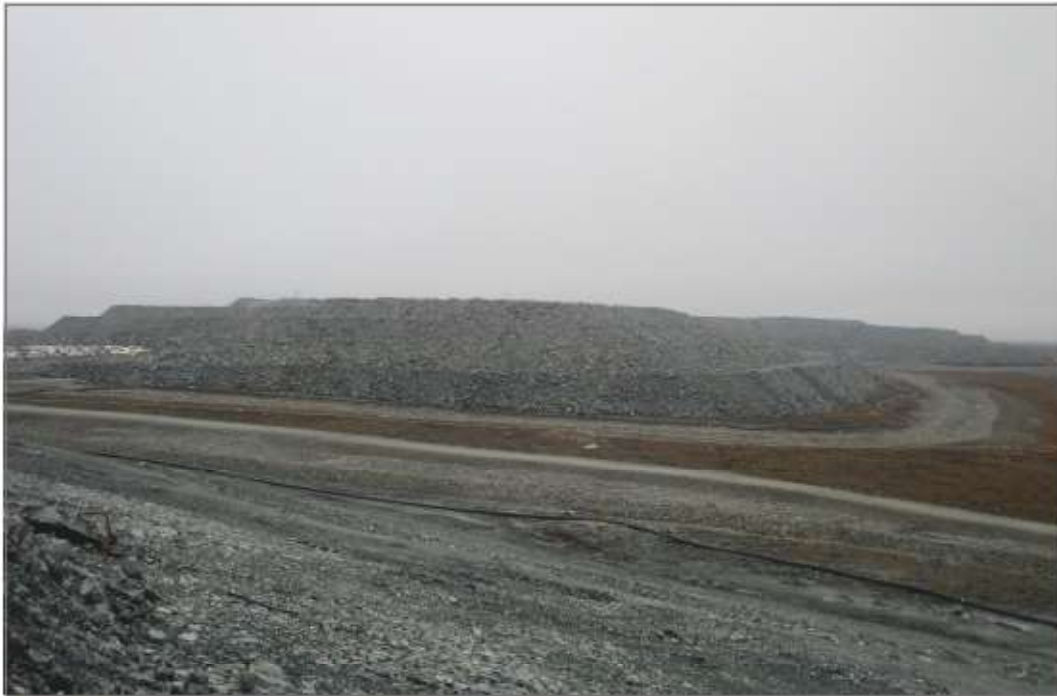
Photo 4: WRSF1—North side of WRSF, viewed from TSF.

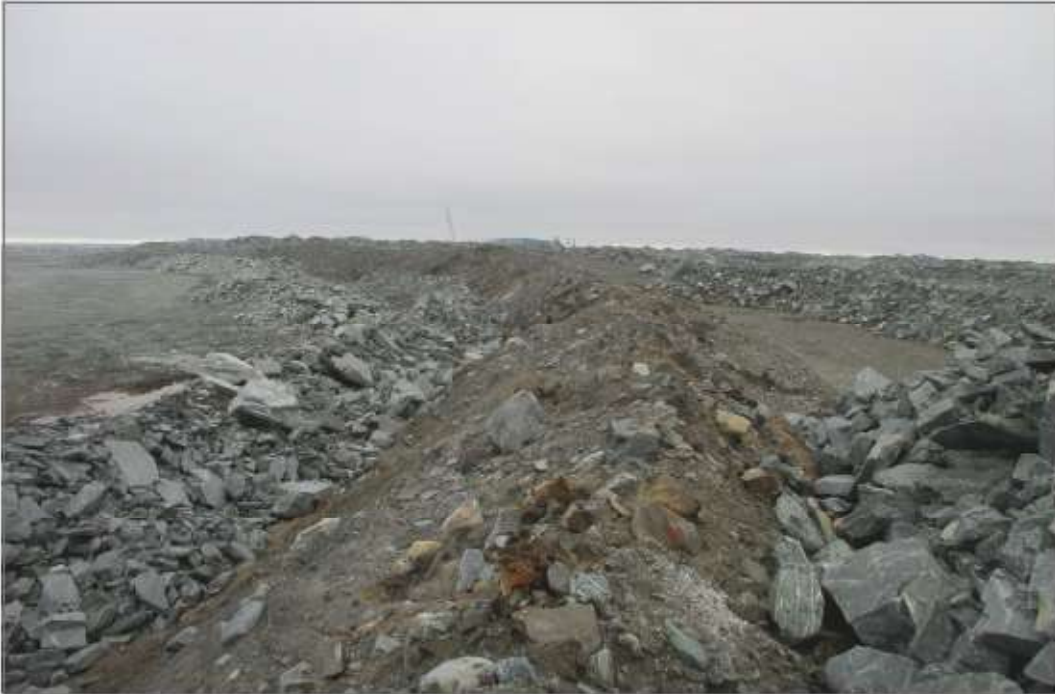
Photo 5: WRSF1—97 m bench surface, overburden placed within limits.

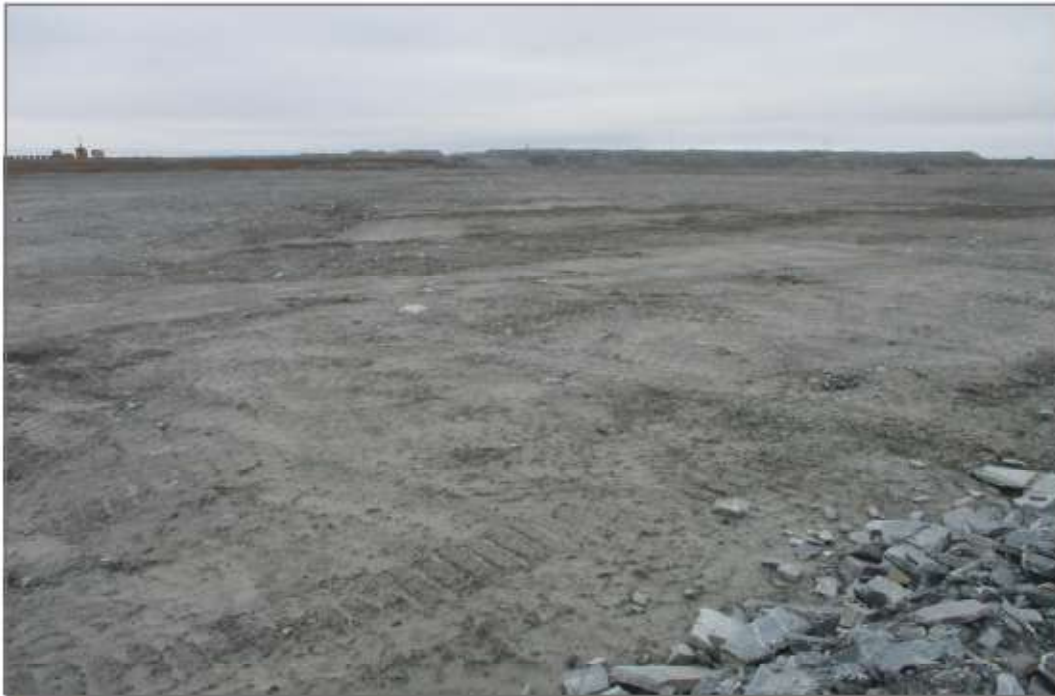
Photo 2: WRSF3 - Condition of overburden surface placed during west expansion.

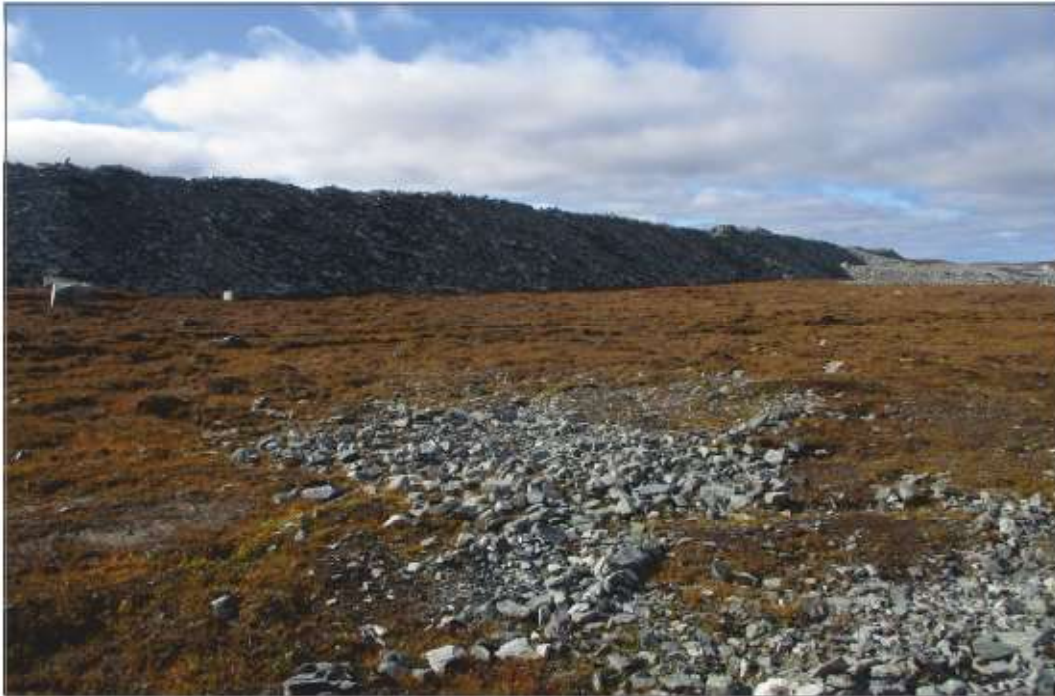
Photo 3: WRSF3—Toe on east side of WRSF.

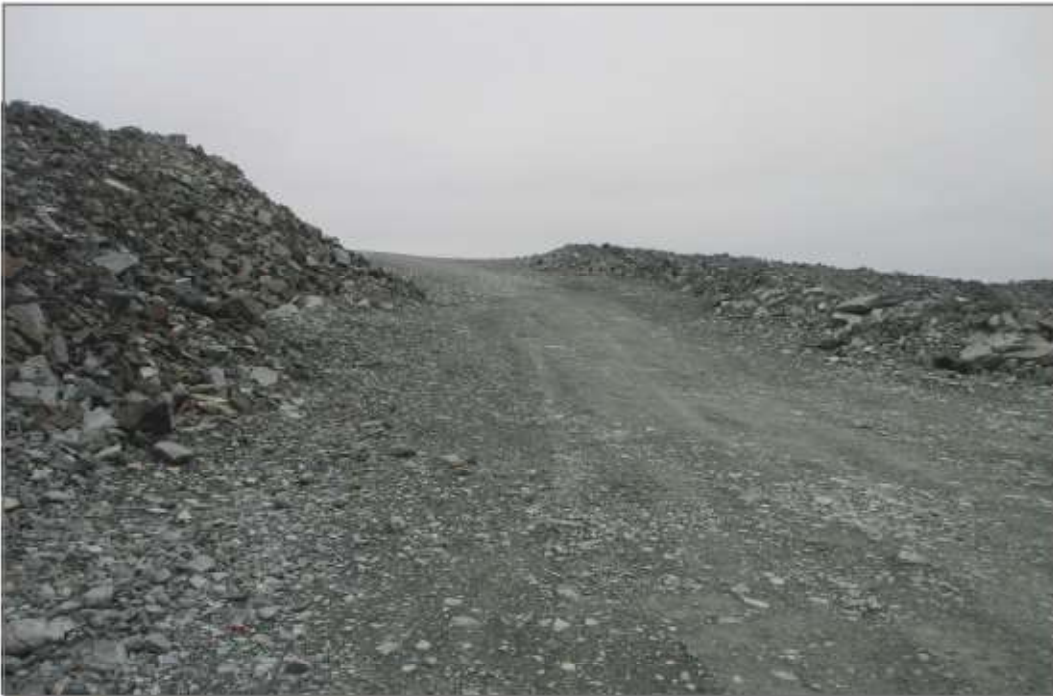
Photo 6: WRSF3—Access ramp from WRSF3 to CP6.

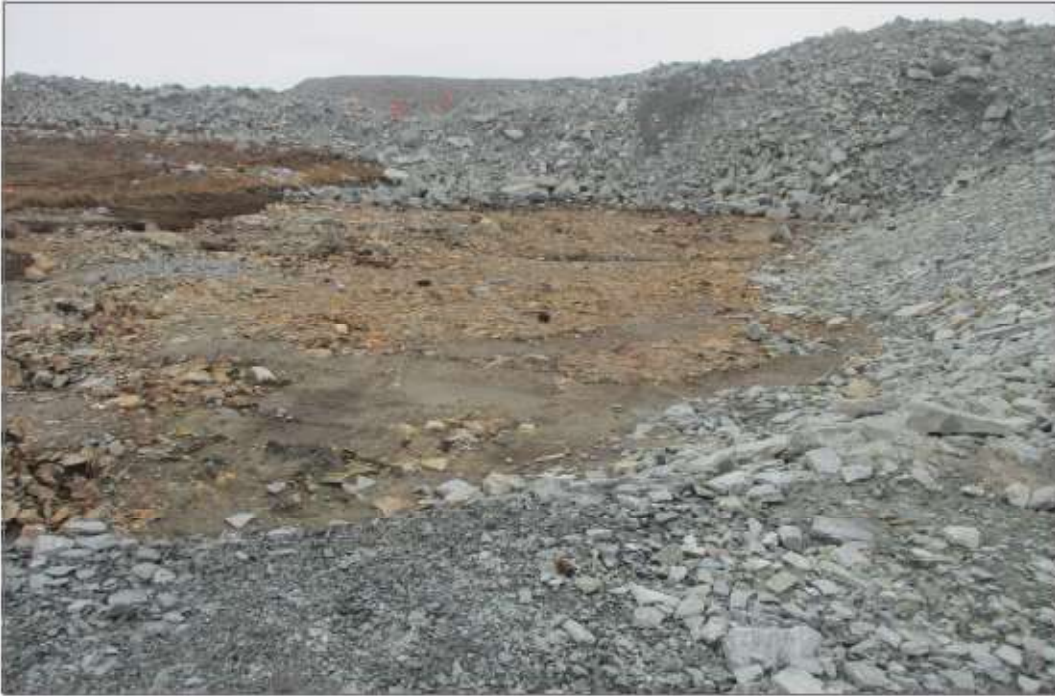
Photo 7: WRSF3—Flow path of former lakebed from northeast corner of WRSF to CP6.
