### **Meadowbank 2022 Annual Open Pit Geomechanical Inspection**

**September 2, 2022**

**RE: Meadowbank Complex - Meadowbank Site - 2022 Annual Open Pit Geomechanical Inspection**

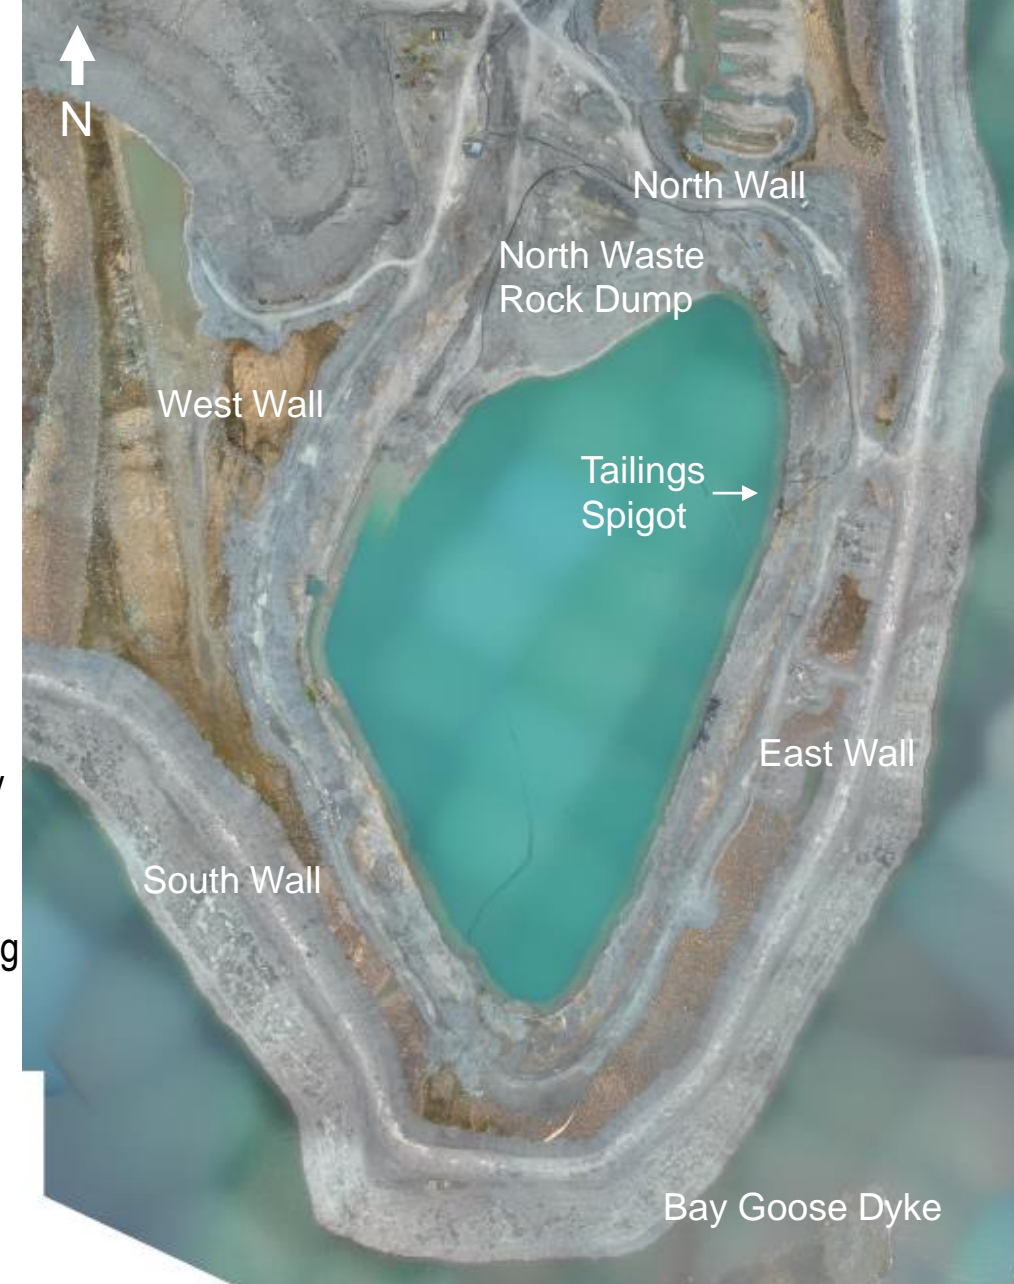
- A portion of a single bench is exposed above the current pit lake.
- The wall was established in the Intermediate Volcanics and is performing well.
- The former tailings discharge point is circled below. No erosion of the slope was noted.
- No particular geomechanical concerns were noted.

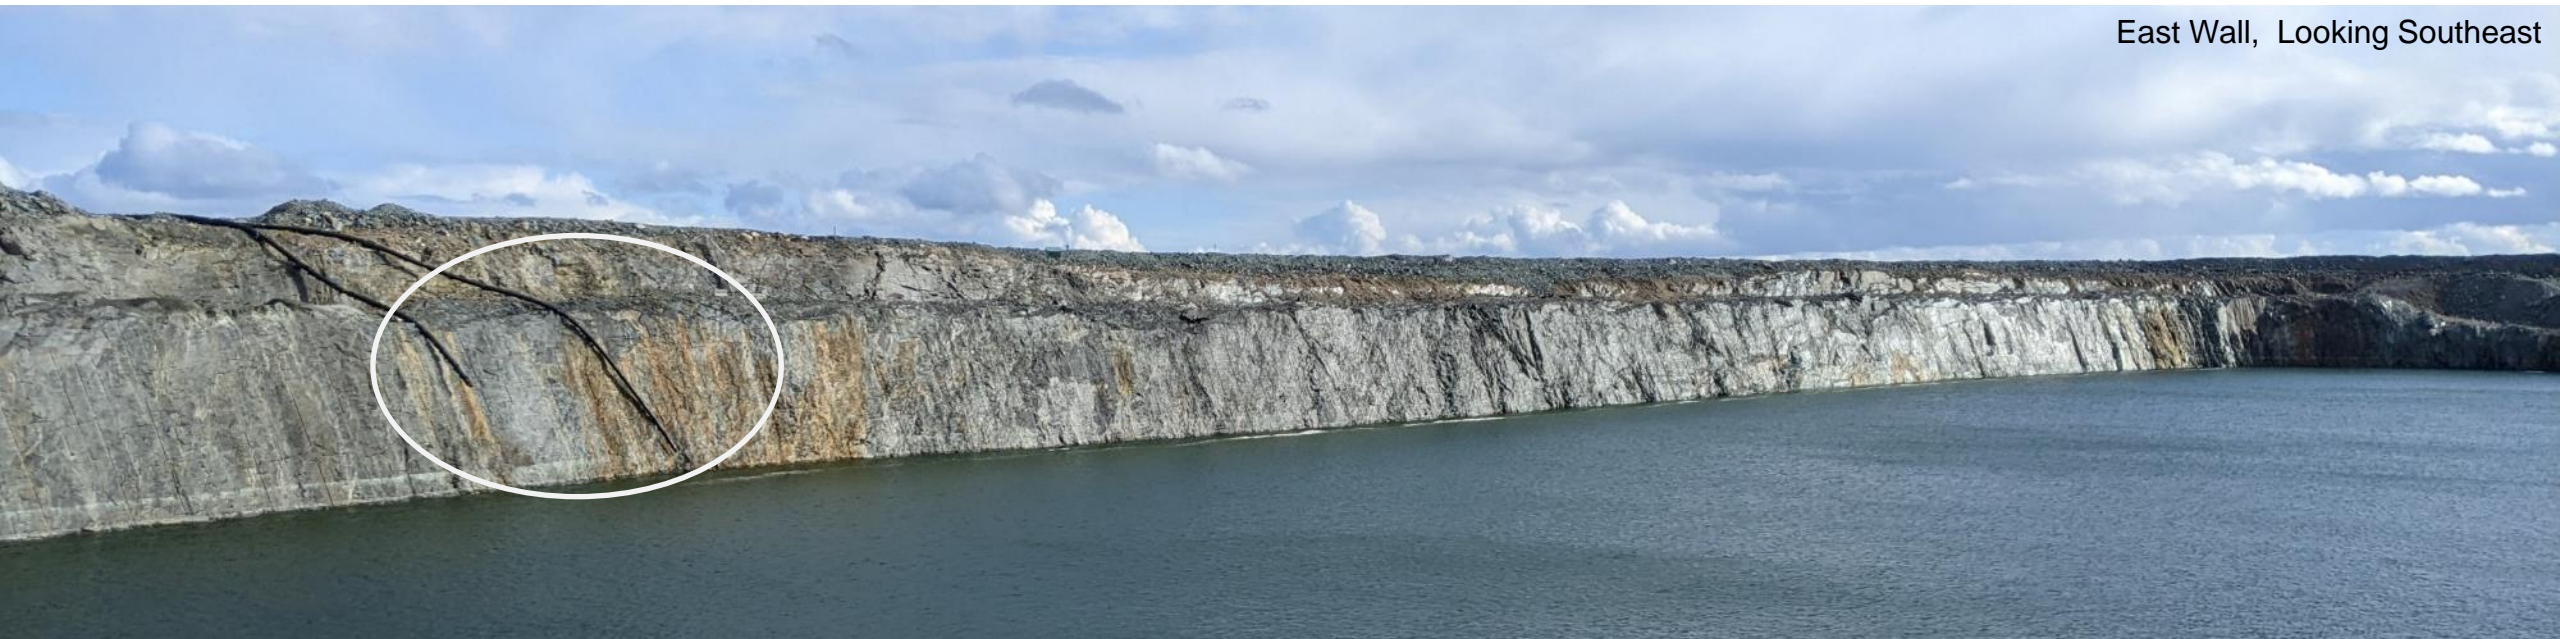
- A portion of a single bench is exposed above the current pit lake.
- The wall is performing well.
- No particular geomechanical concerns were noted.

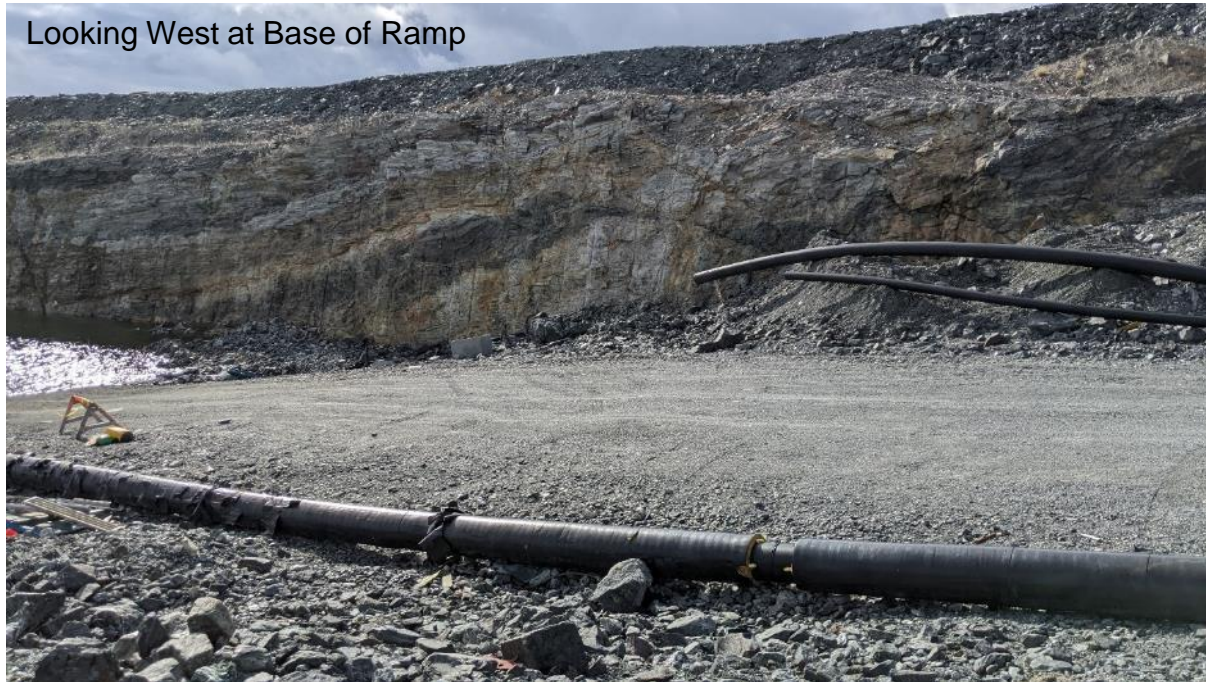
Looking West at Base of Ramp

- At the time of the inspection, barricades were in place at the base of the ramp. These were moved to the top of the ramp during the inspection in order to better to restrict access to authorized personnel.
- The exposed bench faces along the ramp are relatively low and there is ample room to transit and work away from the wall. As a result, the rockfall risk is considered to be low.
- No particular geomechanical concerns were noted.

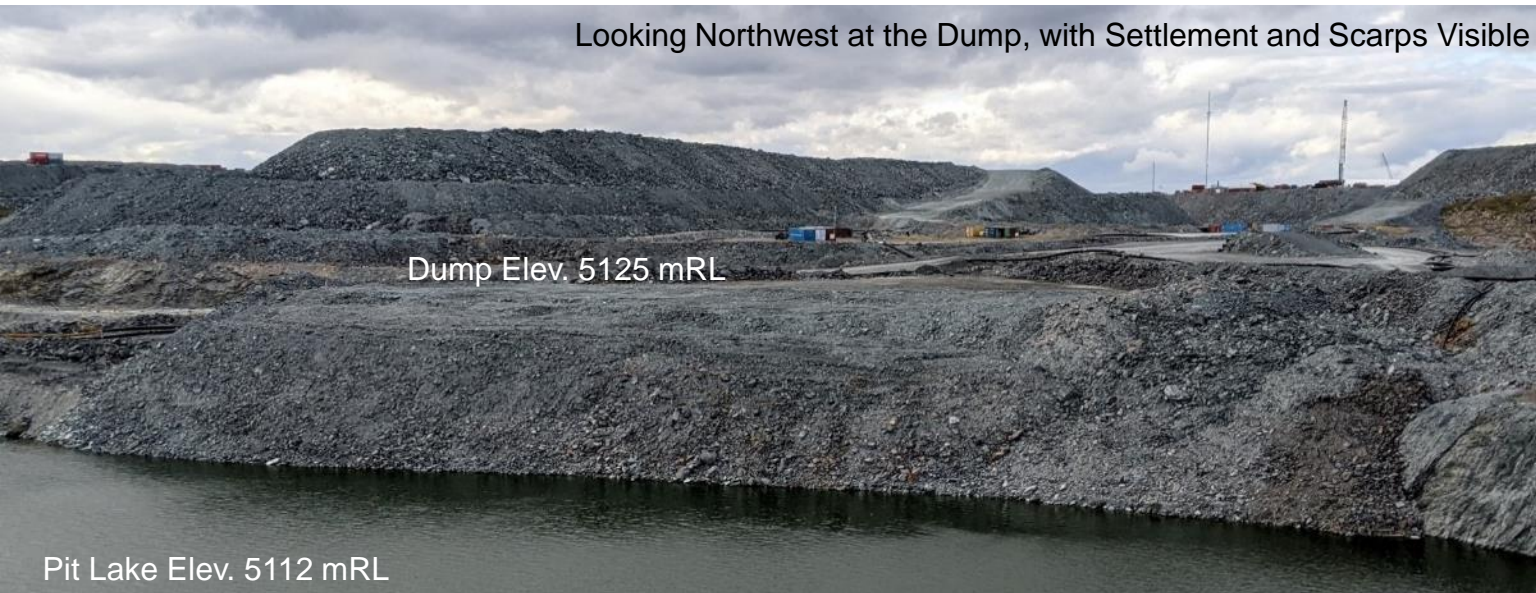
Looking Northwest at the Dump, with Settlement and Scarps Visible

- The dump has been subsiding since 2015. The settlement is attributed to the deposition of water in the open pit, through a combination of thawing snow/ice lenses within the dump, thawing frozen contacts between rock blocks, and increasing porewater pressure. An example of one of the scarps formed by the settlement is shown at lower right.
- The settlement is monitored visually as part of monthly inspections by the Geotechnical team.
- The dump is inactive and access is prevented by both a rockfill berm and the presence of water pipes across the access point.
- Recommend continuing the monthly visual monitoring as long as access is still required to the open pit. There is a need to better quantify the extents and rate of deformation. Survey pins, extensometers or drone photogrammetry are possible options.

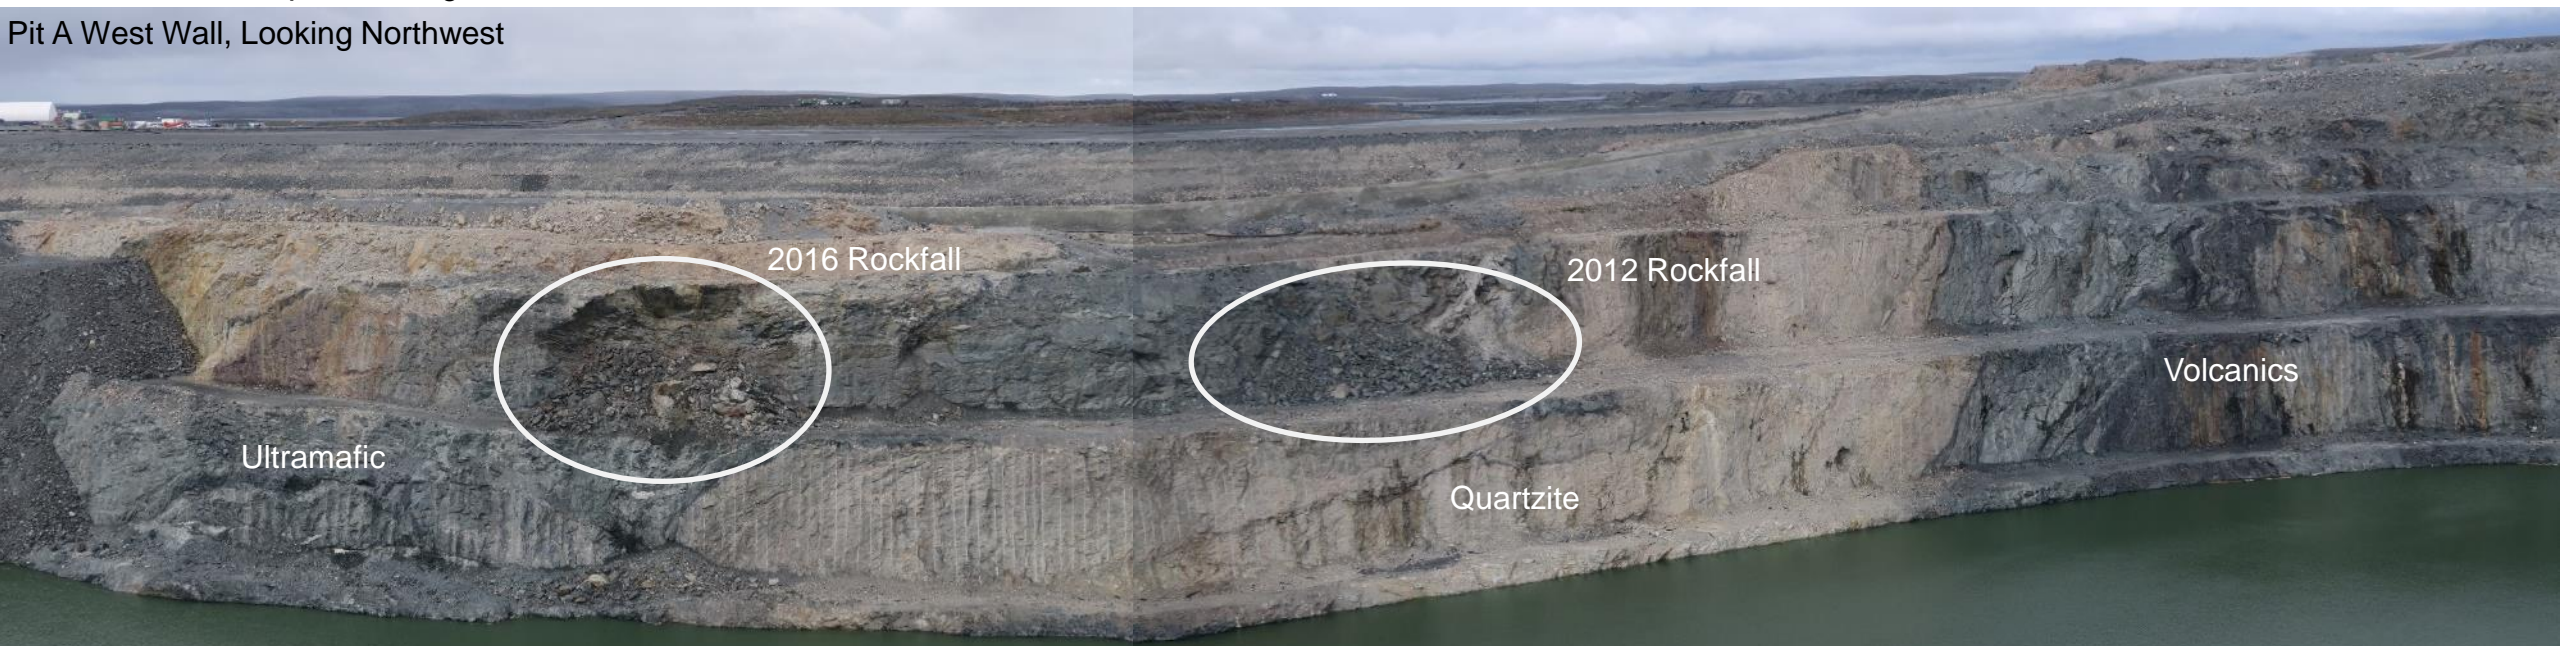
Pit A West Wall, Looking Northwest

- Approximately two benches are exposed above the pit lake in this area.
- Local bench scale failures have previously occurred within the Ultramafics on this wall. No significant change was observed in the failures remaining above the pit lake since the 2020 and 2021 inspections.
- Several large voids are present within the Quartzite and were previously identified as a rockfall hazard. No significant change was observed since the 2020 and 2021 inspections.
- No particular geomechanical concerns were noted.

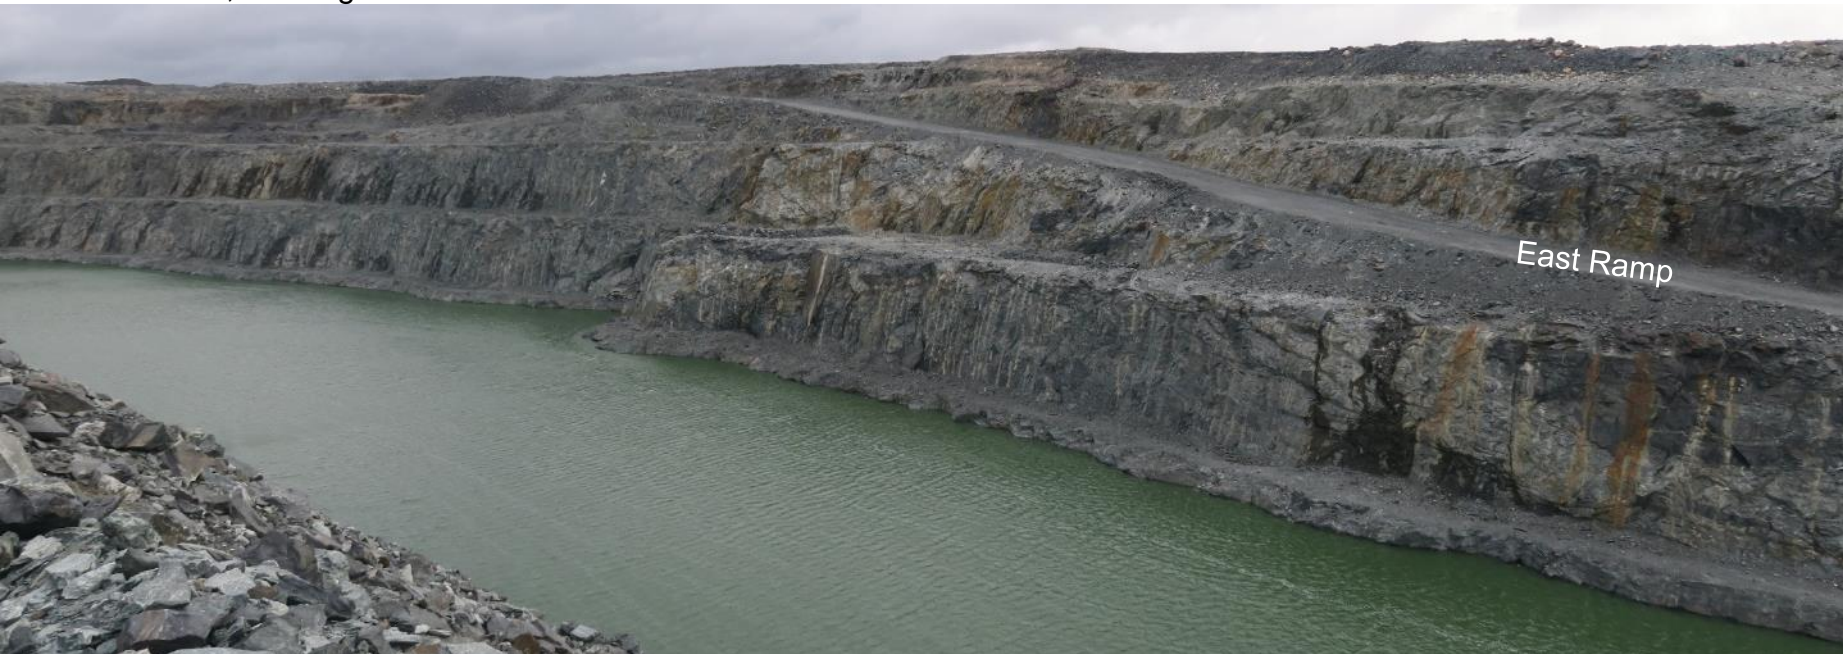
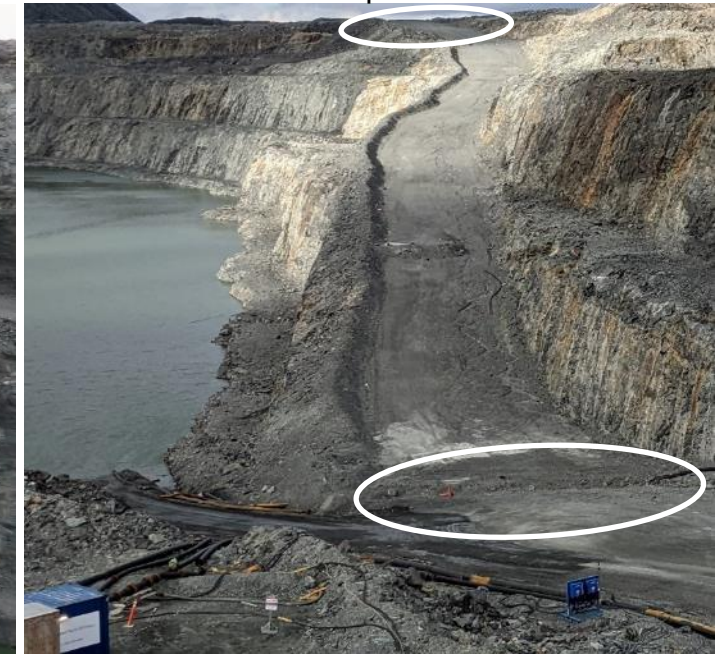
Berms on the East Ramp

- Approximately two benches are exposed above the pit lake in this area.
- Access to the East Ramp is now restricted by berms at the top and bottom of the ramp (circled in image below).
- The wall is performing well.
- No particular geomechanical concerns were noted.

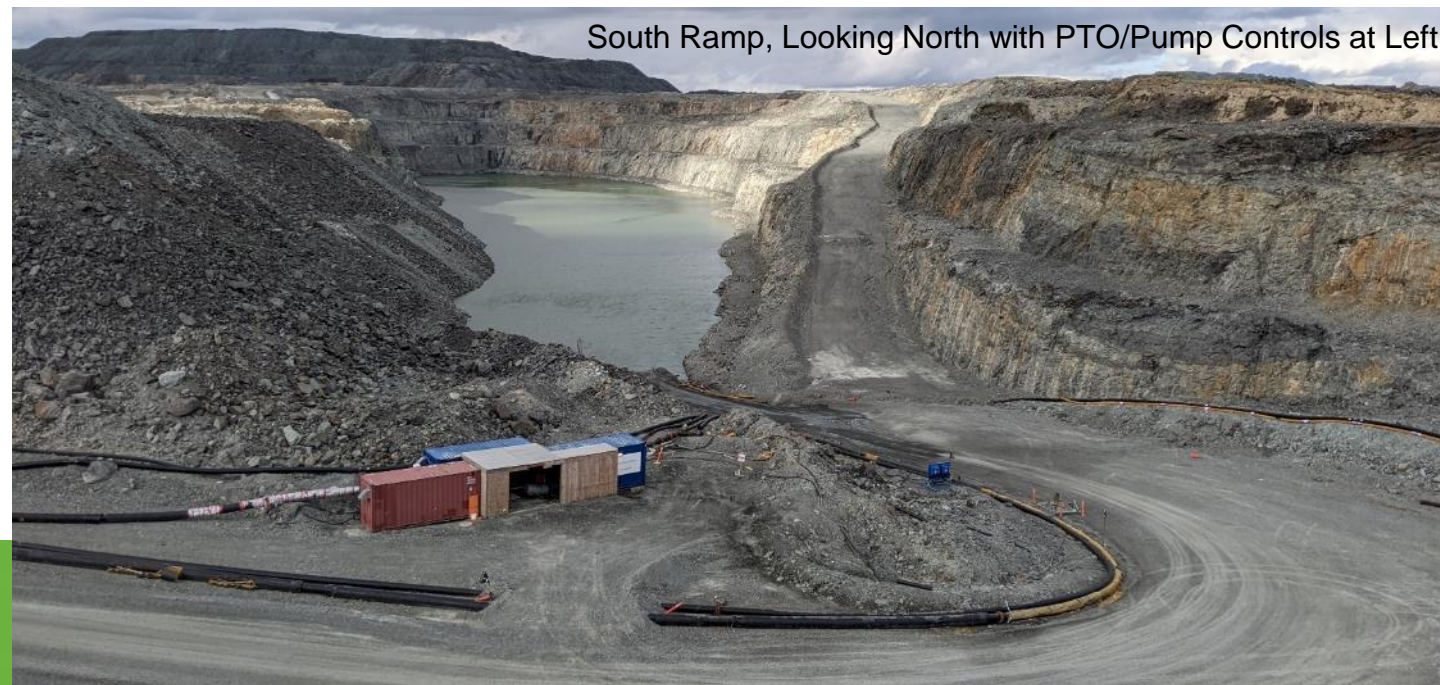
South Ramp, Looking North with PTO/Pump Controls at Left

- The south ramp is used to access the pit lake and water management infrastructure is present along the ramp.
- A rockfall berm is present along both sides of the ramp. The berm is in good condition and has capacity to retain any future rockfall.
- The PTO / Pump controls are located well up the ramp, away from the areas of greatest rockfall hazard associated with the dump and the highwall. The controls are also well away from the pit lake, mitigating the risk associated with a wave caused by a failure of the open pit slope or the dump. This is a good practice.
- Specific geotechnical considerations relating to Dump B are discussed on the next slide. Bulging of the toe of the dump slope was not observed.
- No particular geomechanical concerns were noted.

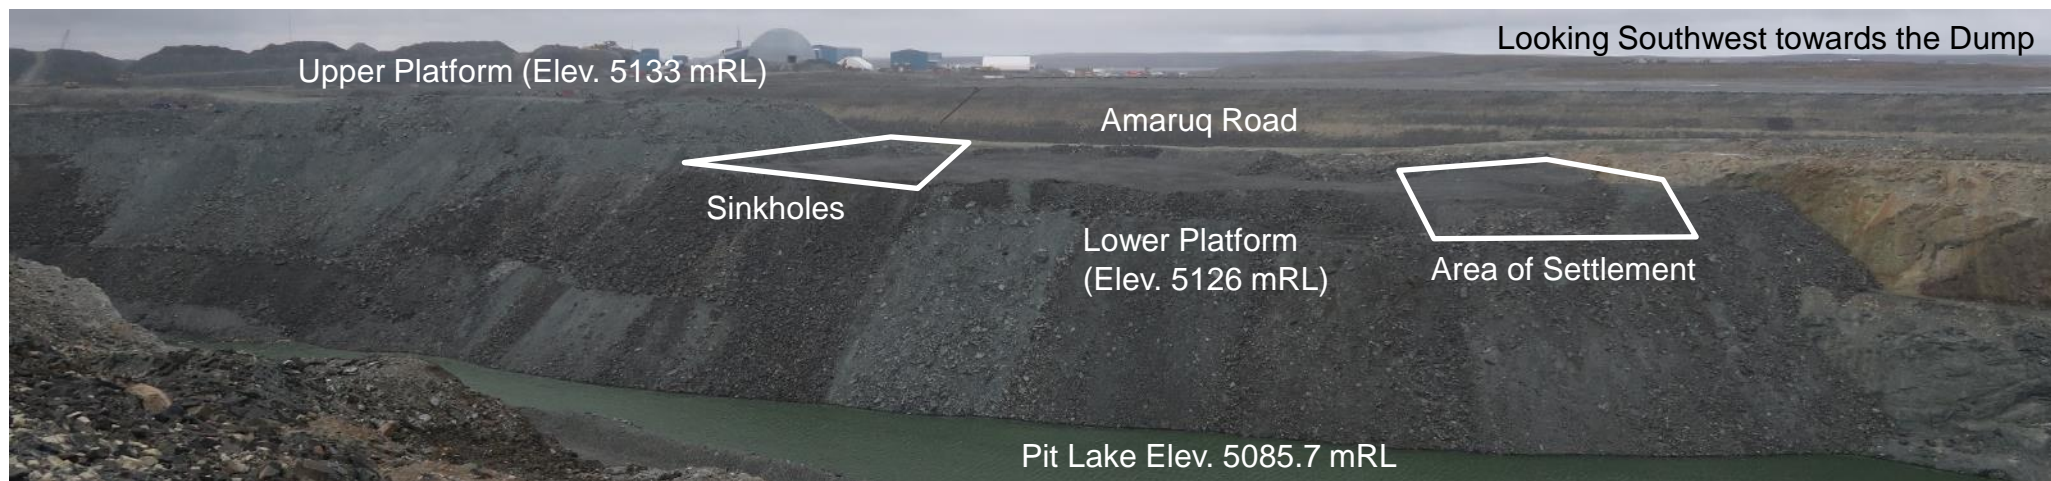
- The Pit B Dump consists of an Upper and Lower Platform, both of which are inactive. Access to both platforms is now prevented by berms.
- Failures of the dump slope are possible as the pit lake elevation rises, but have not been observed to date. Such a failure could cause a large wave in the pit lake, as discussed on the previous slide.
- The northern end of the Lower Platform above the pit lake has settled and tension cracks are present. Sinkholes and tension cracks have also formed at the southern end of the Lower Platform. These are discussed on the following slides.
- A geotechnical inspection of the dump is completed on a monthly basis. The dump is not instrumented. Recommend continuing the inspections, particularly while access continues to the Pit A South Ramp below the dump.

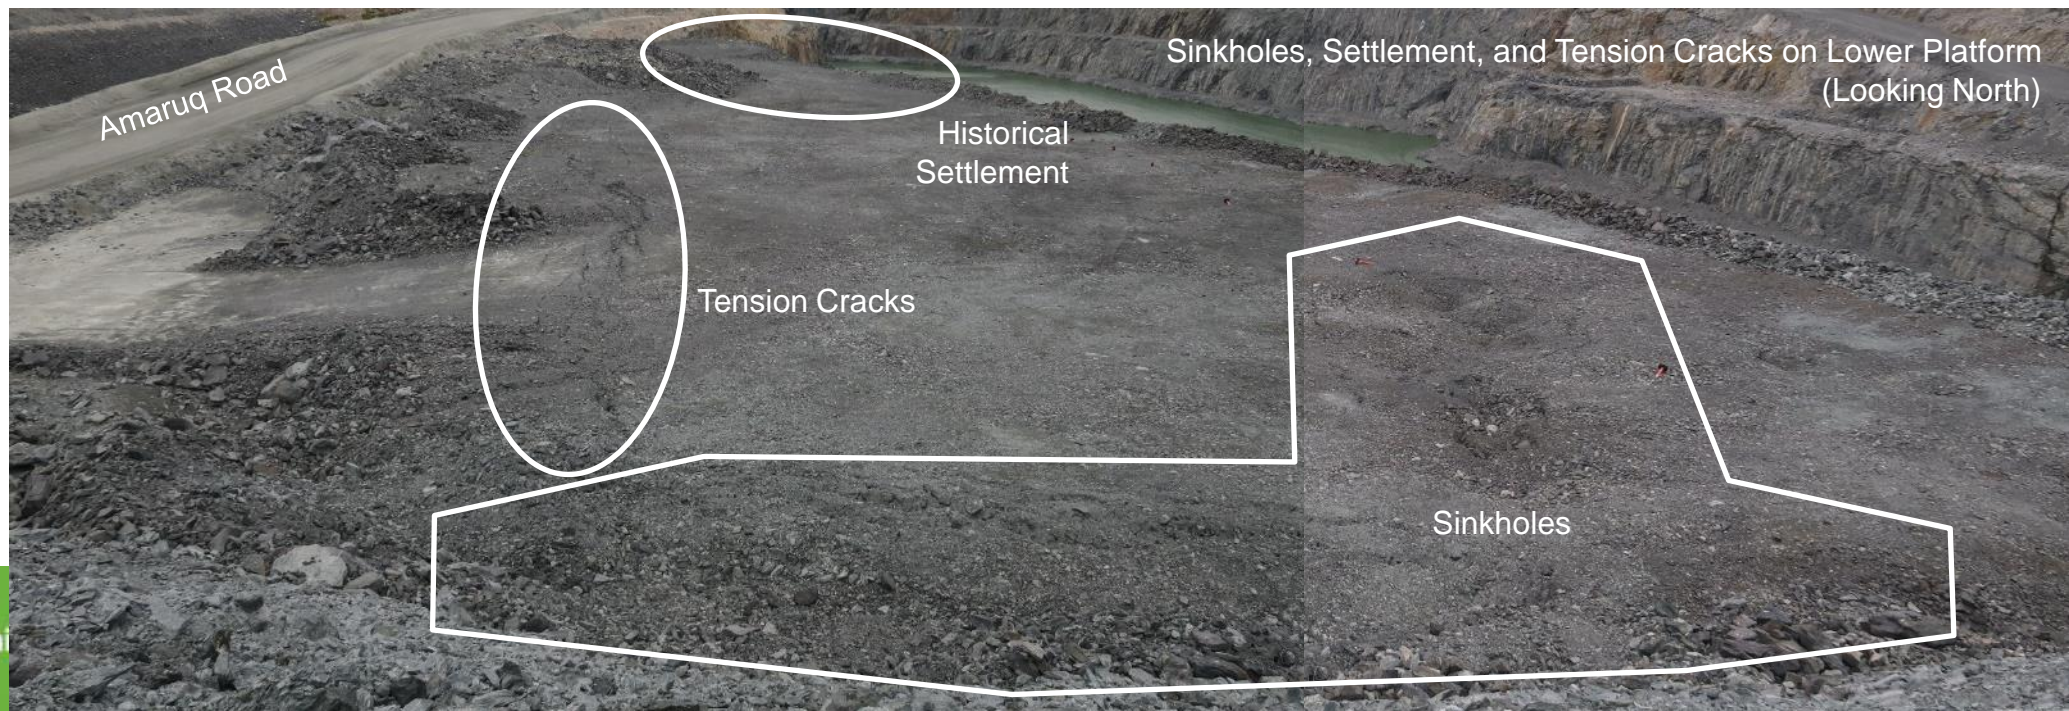
- There has been limited change in the sinkholes and area of settlement since the 2021 inspection. No obvious bulging of the toe of the dump slope was observed.
- The tension cracks along the western limit of the dump appear to have progressed. The tension cracks are far from the dump crest and it is not clear if they indicate deep-seated movement of the dump or simply differential settlement across the position of the bench/ramp below the dump.
- Continue to monitor the settlement and tension cracks on the dump. Recommend surveying the cracks so that their development over time can be monitored and so that their position relative to the geometry of Pit B below the dump can be understood.
- The recommendation from the previous inspection to grade the Lower Platform in order to limit water infiltration remains applicable.

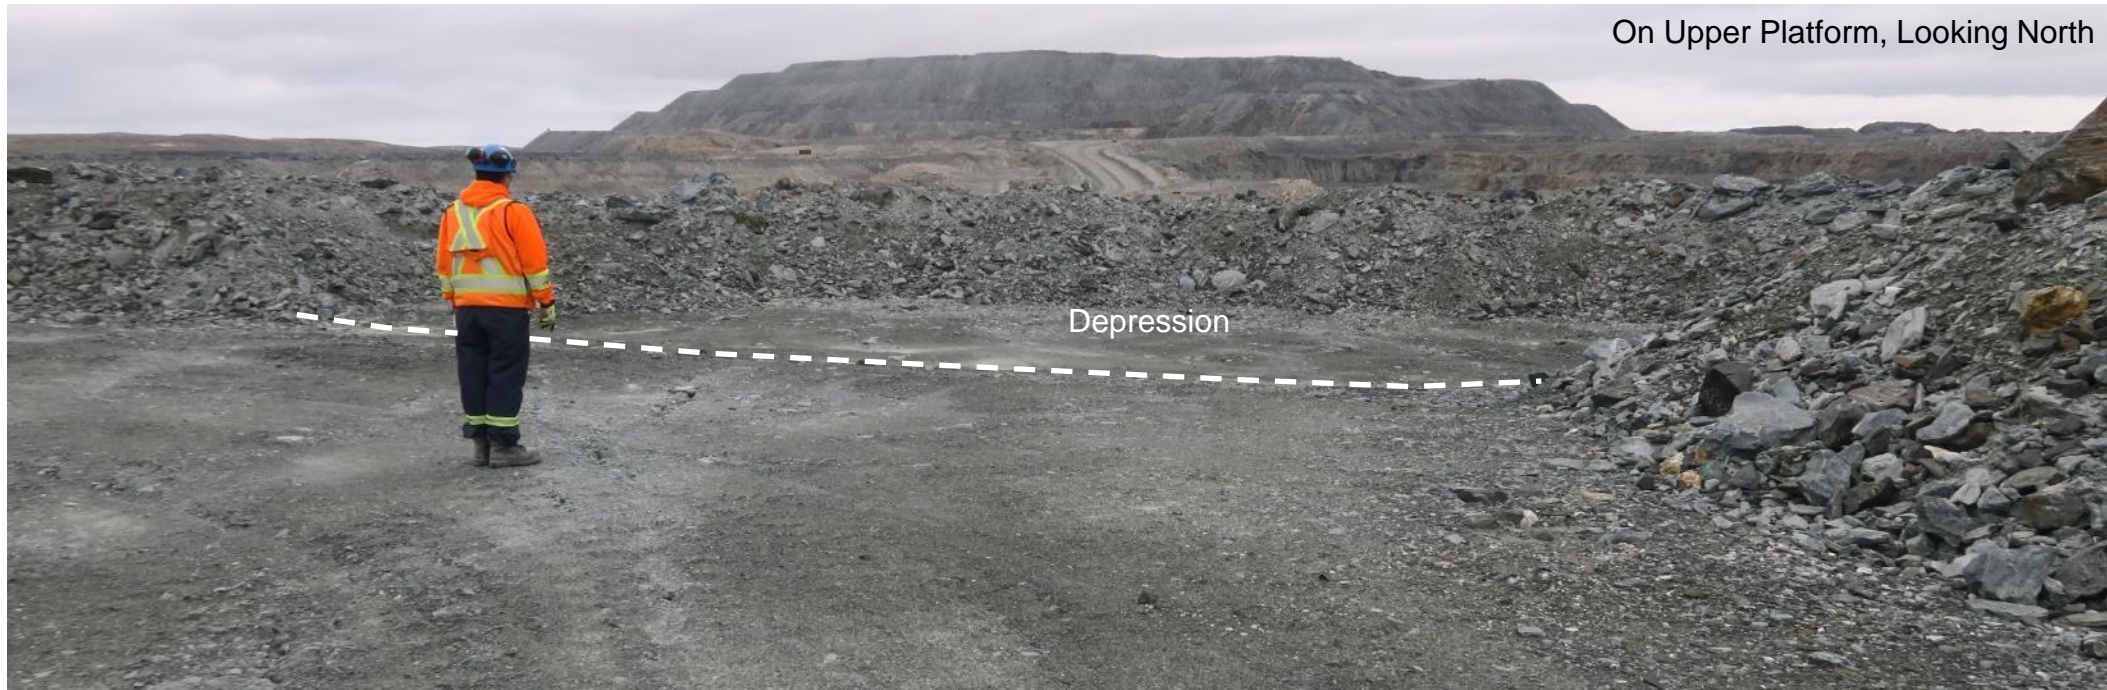
On Upper Platform, Looking North

- Evidence of instability was not observed on the Upper Platform.
- The Upper Platform is graded so that water flows to a low point above the area of the Lower Platform where sinkholes have formed. This is a likely cause of the sinkholes. The recommendations from the previous annual inspection remain applicable; recommend filling the low point and re-grading the dump so that water is directed away from this area.
- Recommend constructing a berm to prevent access to the Upper Platform.

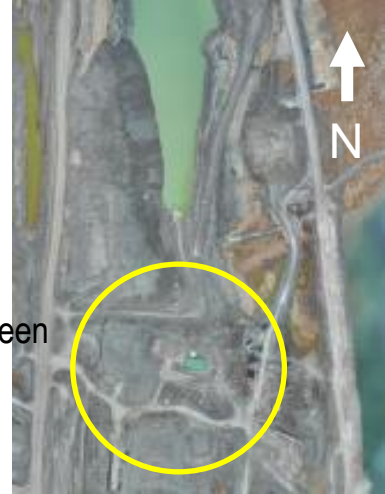
C Dump, Looking East

- The ABF Garage is currently in the process of being dismantled and moved off of the dump. This is endorsed.
- The seacan used to provide power to the Pit A pumps is inside the berm constructed along the crest and should be moved outside of the berm.

- As no evidence of instability has been observed, the on-going use of the dump as a laydown is considered acceptable (at least for now).

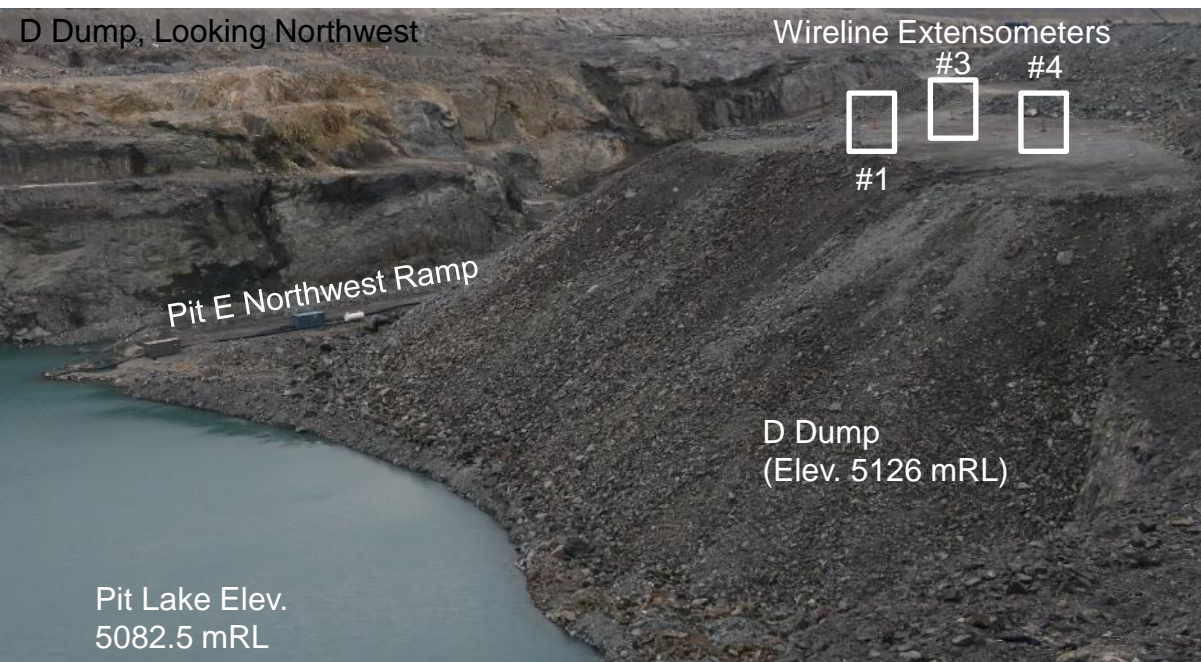
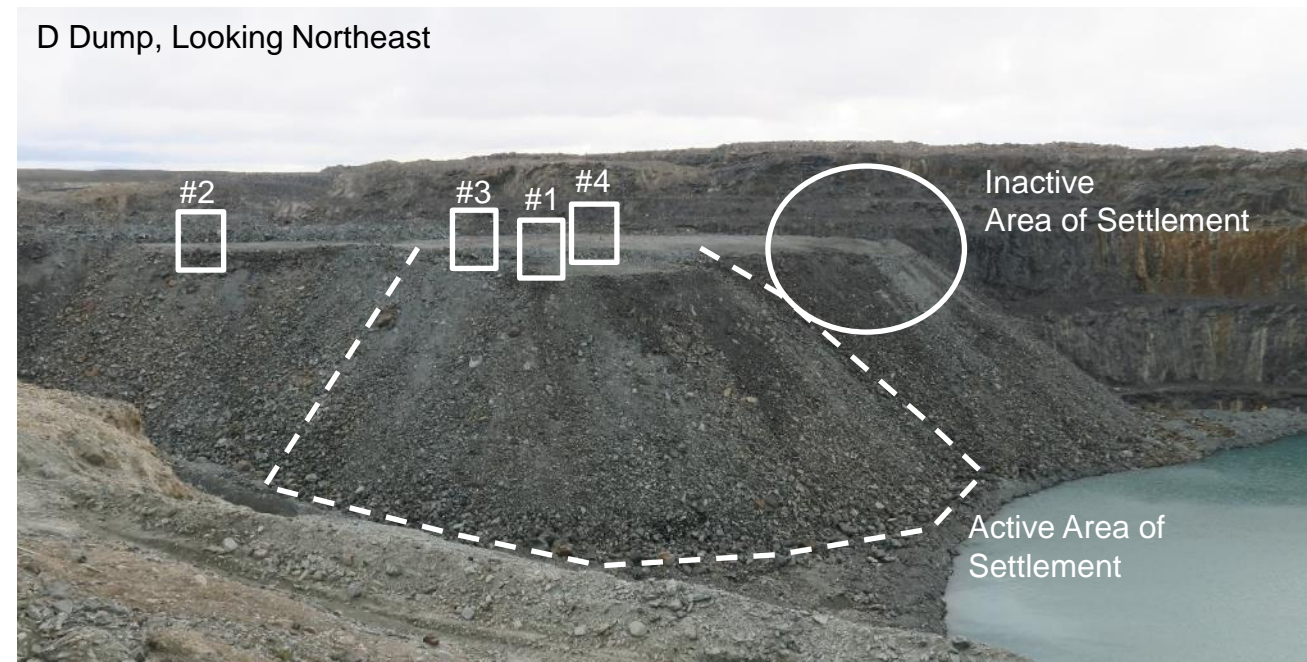
- The D Dump backfilled Pit D and forms the north wall of Pit E. The Pit E Northwest ramp runs along the western toe of the dump.
- Access to the top of the dump is restricted by a berm.
- The southwestern end of the dump started to settle in 2017. Tension cracks are visible in this area as well as along the crest immediately to the north. The current conditions are described on the following slides.
- Four wirelines extensometers have been installed at the crest of the dump in the area of settlement and tensions cracks and are discussed on a following slide.
- The dewatering pumps for Pit E are located at the toe of the dump. As the pumps are moved up the Northwest Ramp, the exposure of personnel to the dump will decrease.

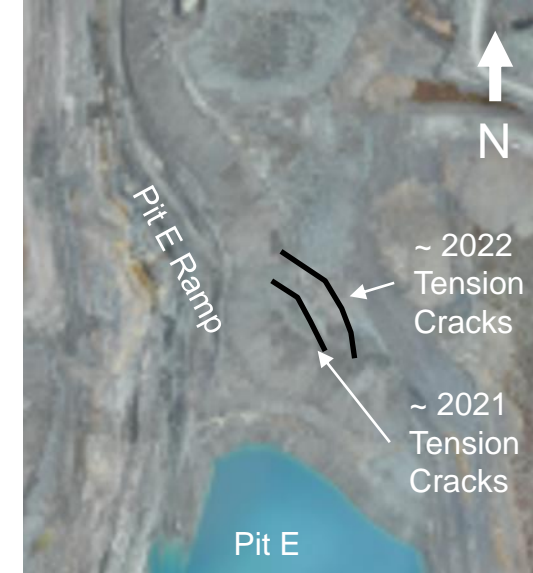
Tension Cracks on Dump, Looking Southeast

- Since the 2021 inspection, a network of tension cracks have developed 10 to 20 m behind Extensometer #1. Extensometers #3 and #4 have been installed behind the most recent tension cracks. The extensometer data is discussed on the next slide.

- The Geotechnical Group has been painting the cracks to track their change over time. This is endorsed and should continue.
- The tension cracks suggest that the direction of movement is to the southwest (i.e., towards the point where the Pit E Ramp terminates in the pit lake) rather than to the south, directly towards the pit lake. The reason for this is not currently known.

- On-going deformation of the dump could result in a rockfall hazard to the ramp. A berm is currently in place at the toe of the dump but its capacity and evidence of rockfall should be monitored.

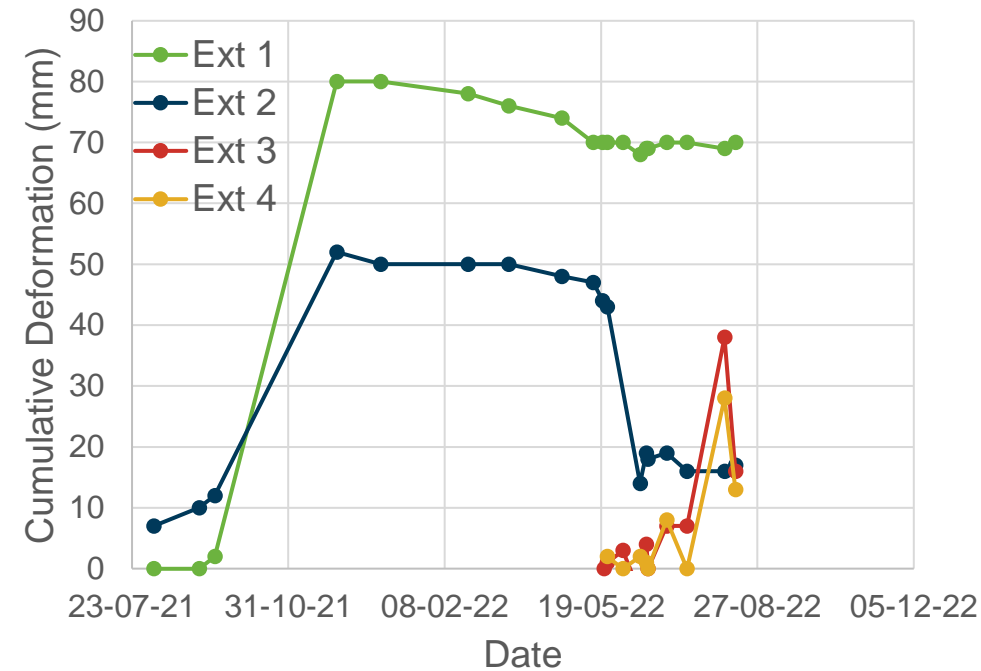
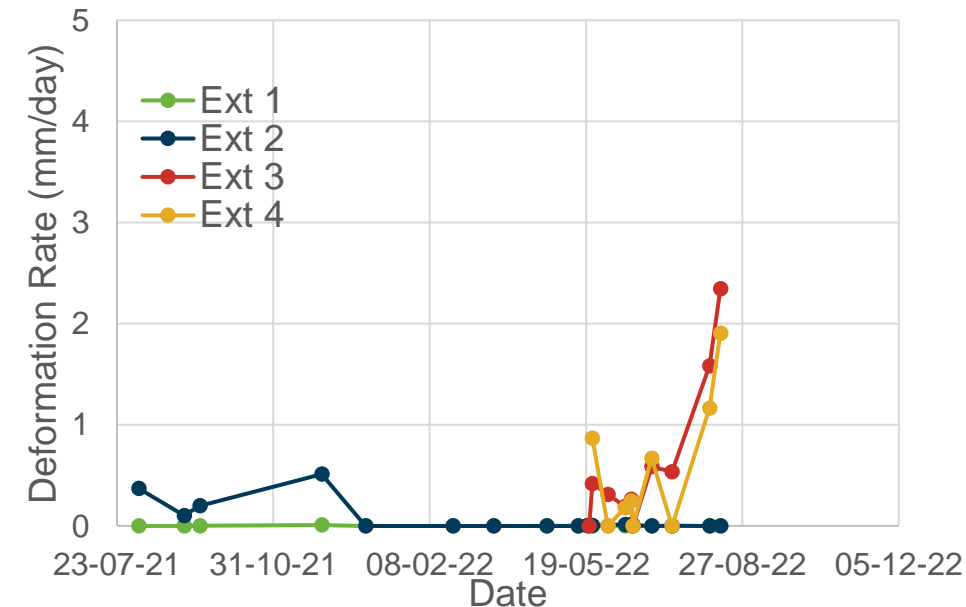
- Both Ext 1 and 2 reported a significant increase in displacement in December 2021. No action was taken and the cause is unknown. While the deformation rate was less than the trigger of 50 mm/day, the sudden change in rate should have triggered a review.

- Both Ext 3 and 4 are reporting a steady increase in deformation rate as of June, 2022. This suggests a change in conditions and readings should continue to be collected every two weeks until the deformation stabilizes or the slope behaviour is better understood.

- In all cases, the current rate of <5 mm/day is much less than the 50 mm/day threshold that would trigger a response under the procedure. Continue monitoring the extensometers.

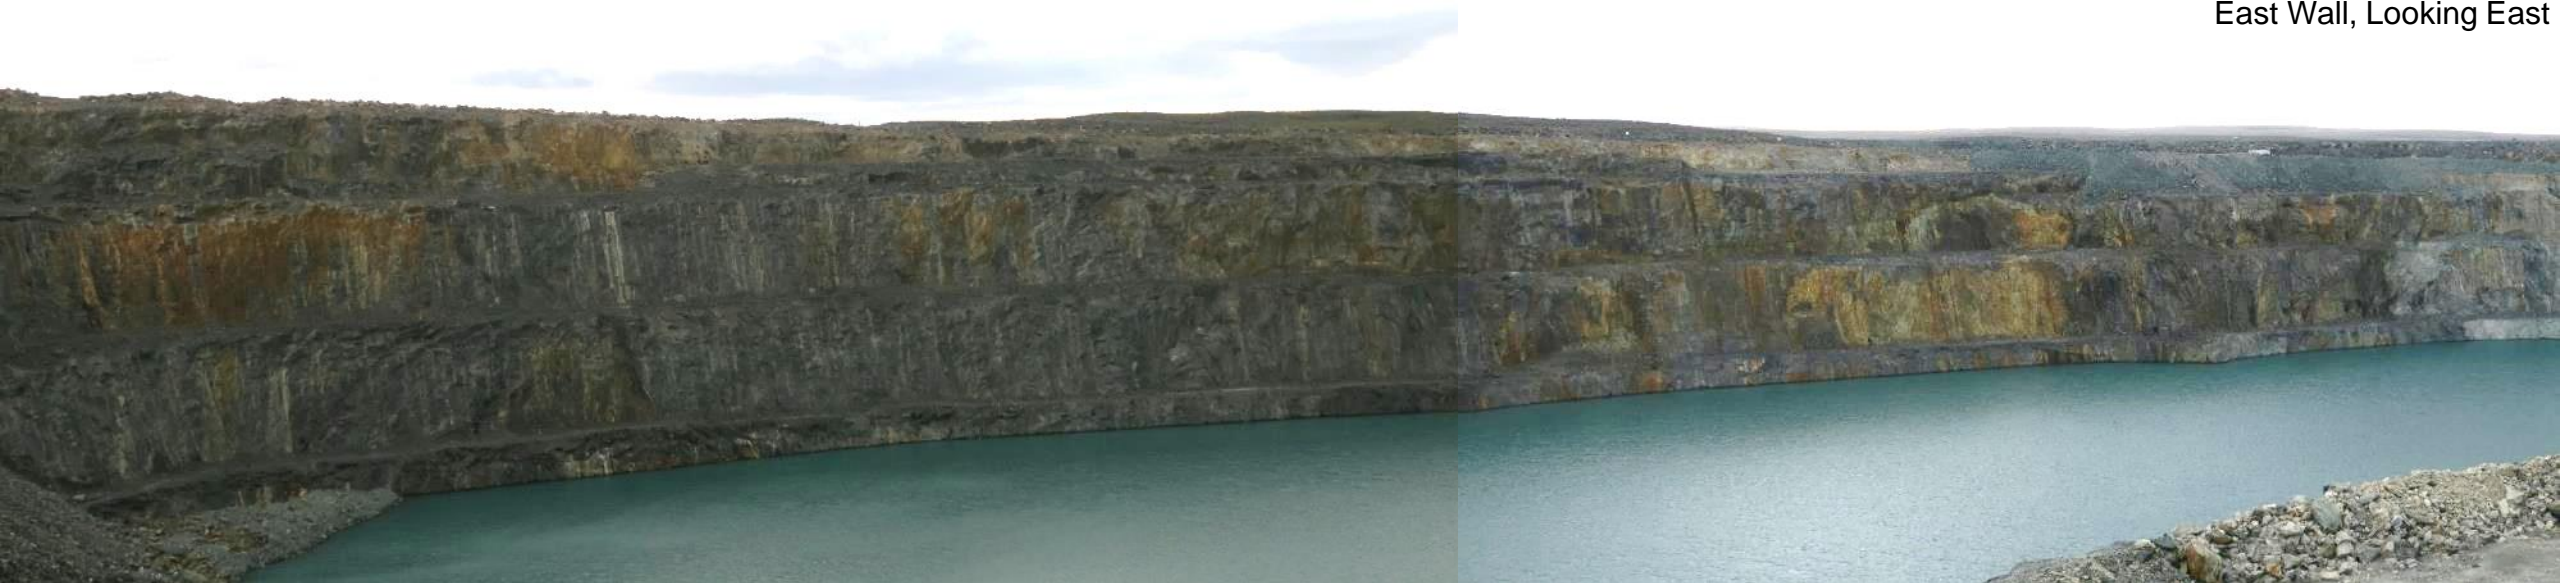
East Wall, Looking East

- Approximately three benches are exposed above the pit lake in this area.
- The wall is performing well.
- No particular geomechanical concerns.

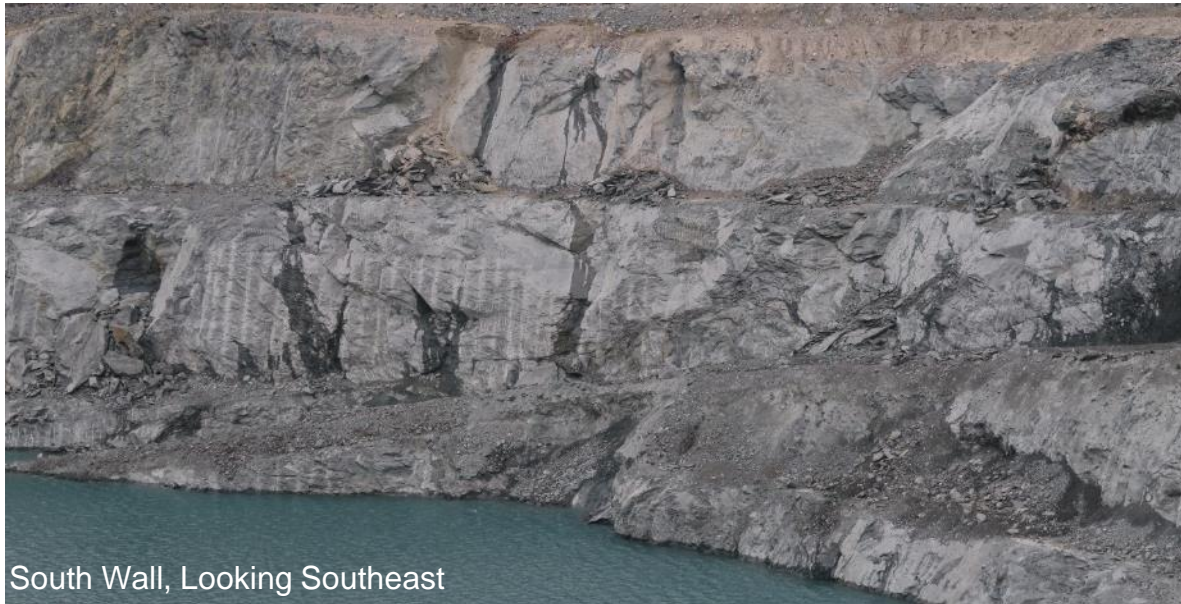
South Wall, Looking Southeast

- The South Wall was established in Ultramafics and has experienced a series of bench-scale instabilities and rock falls. Approximately three benches are exposed above the pit lake in this area.
- A berm prevents access to the South Wall Ramp.
- No rockfalls have been reported since the 2021 inspection.

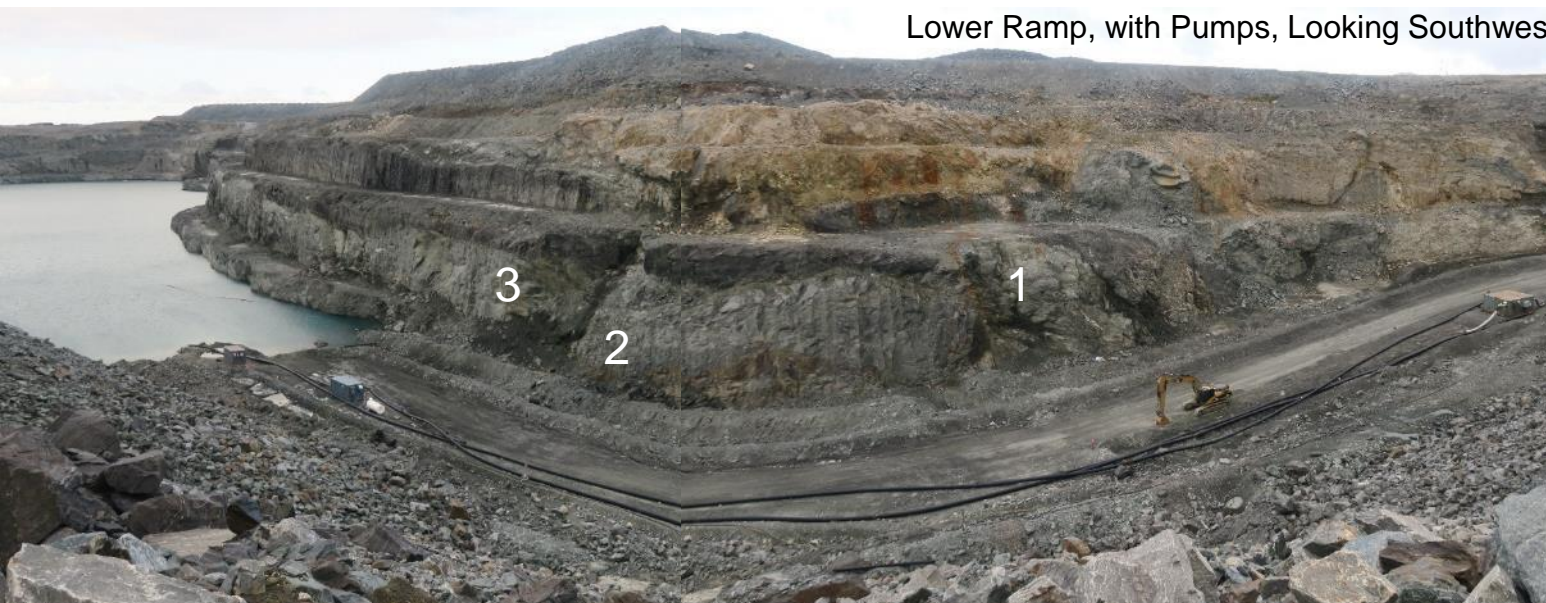
Lower Ramp, with Pumps, Looking Southwest

- Dump D is located along the eastern side of the ramp. Tension cracks are present along a portion of the crest above the ramp and wireline extensometers have been installed to monitor the dump (see previous slide on Dump D). Bulging of the toe was not observed. A rockfall berm is in place at the toe of the dump and has capacity. Geotechnical inspections and monitoring of the dump should continue while access to the ramp is still required.
- The Bay Fault intersects the Northwest Wall adjacent the ramp. Several rockfalls have occurred along the wall in the past and rockfalls are expected to continue to occur. Examples of several potential instabilities are shown on the next slide (numbered below for reference).
