### **Meadowbank 2022 Annual Open Pit Geomechanical Inspection**

**September 2, 2022**

**RE: Meadowbank Complex - Meadowbank Site - 2022 Annual Open Pit Geomechanical Inspection**

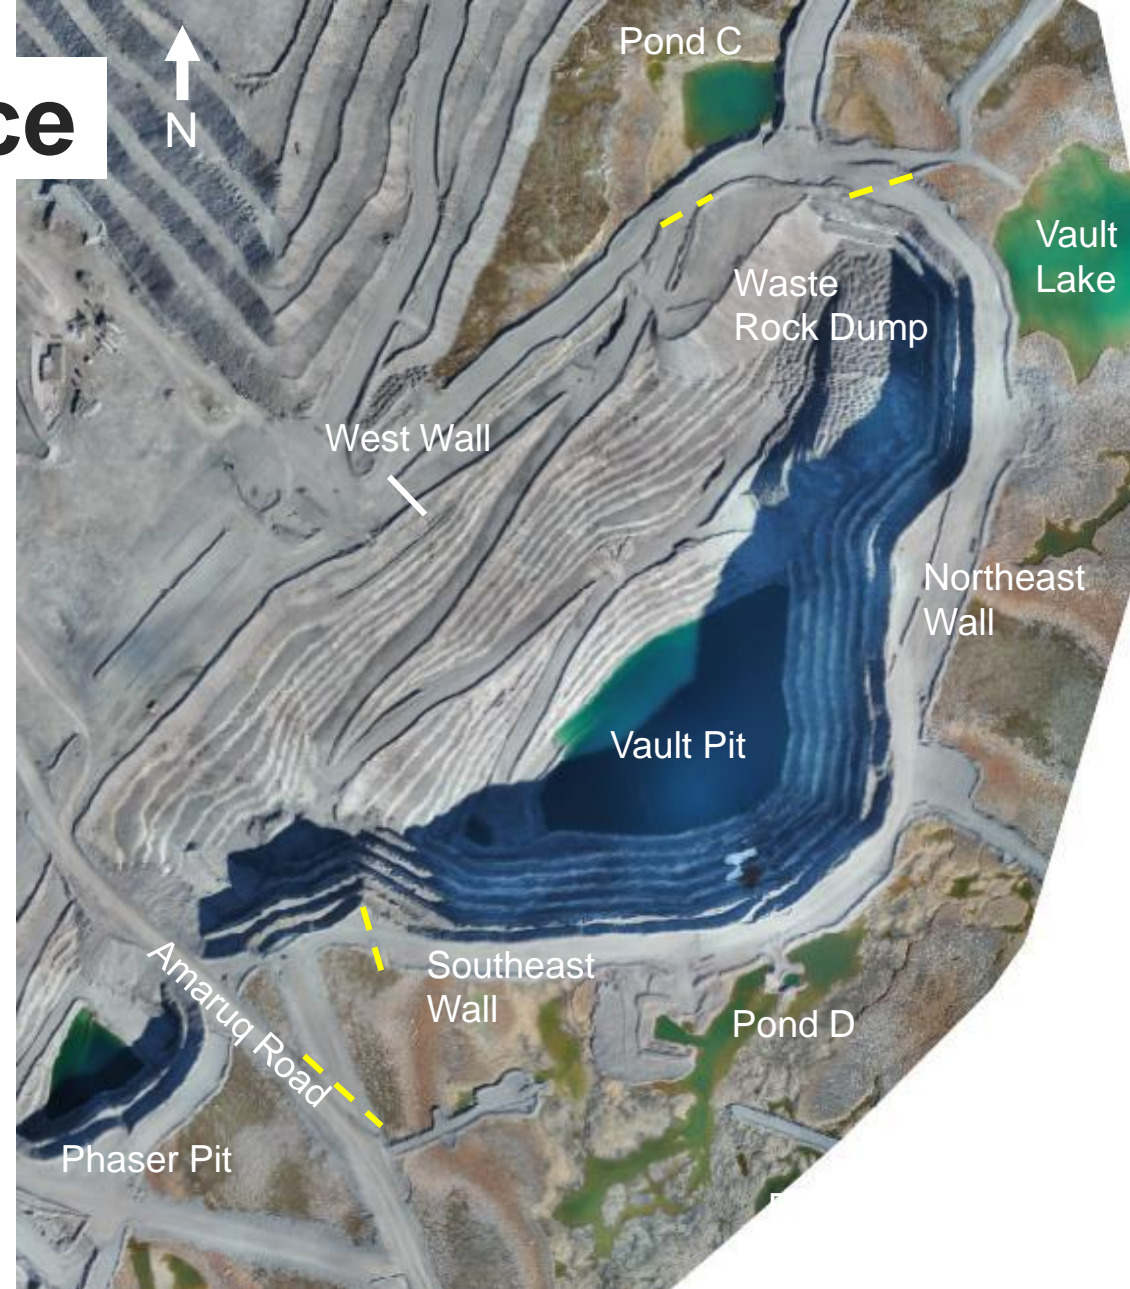
- Access to the open pit is limited to monthly water quality sampling when the pit lake is not frozen.
- At the time of the inspection, access to the open pit was restricted by a barricade. Access to the ring road is restricted by berms at the north and south ends of the road. The barricade (white) and berms (yellow) are shown at right.

- The open pit is partially flooded. The elevation of the pit lake was last measured in June, 2022 when it was approximately 5039 mRL.
- The Amaruq All Weather Road (AWR) crosses between the Vault and Phaser Pits on a rockfill embankment.

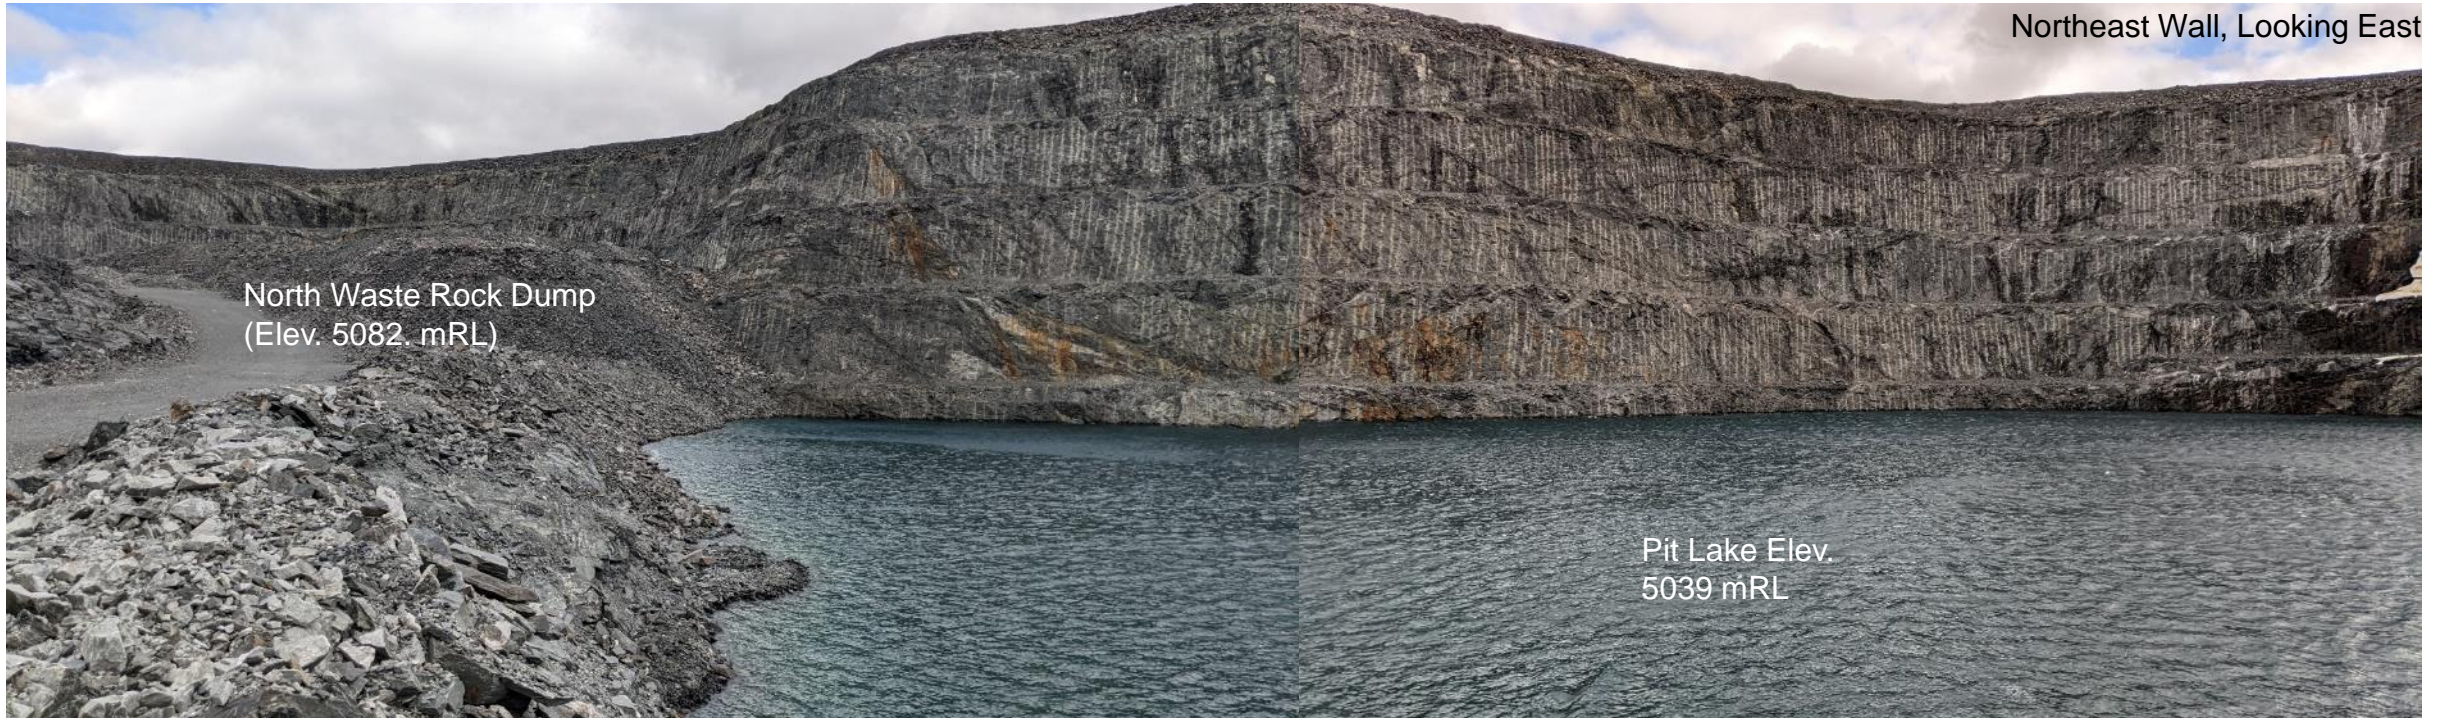
- The wall is performing well.
- No particular geomechanical concerns.
- The North Waste Rock Dump is described on a subsequent slide.

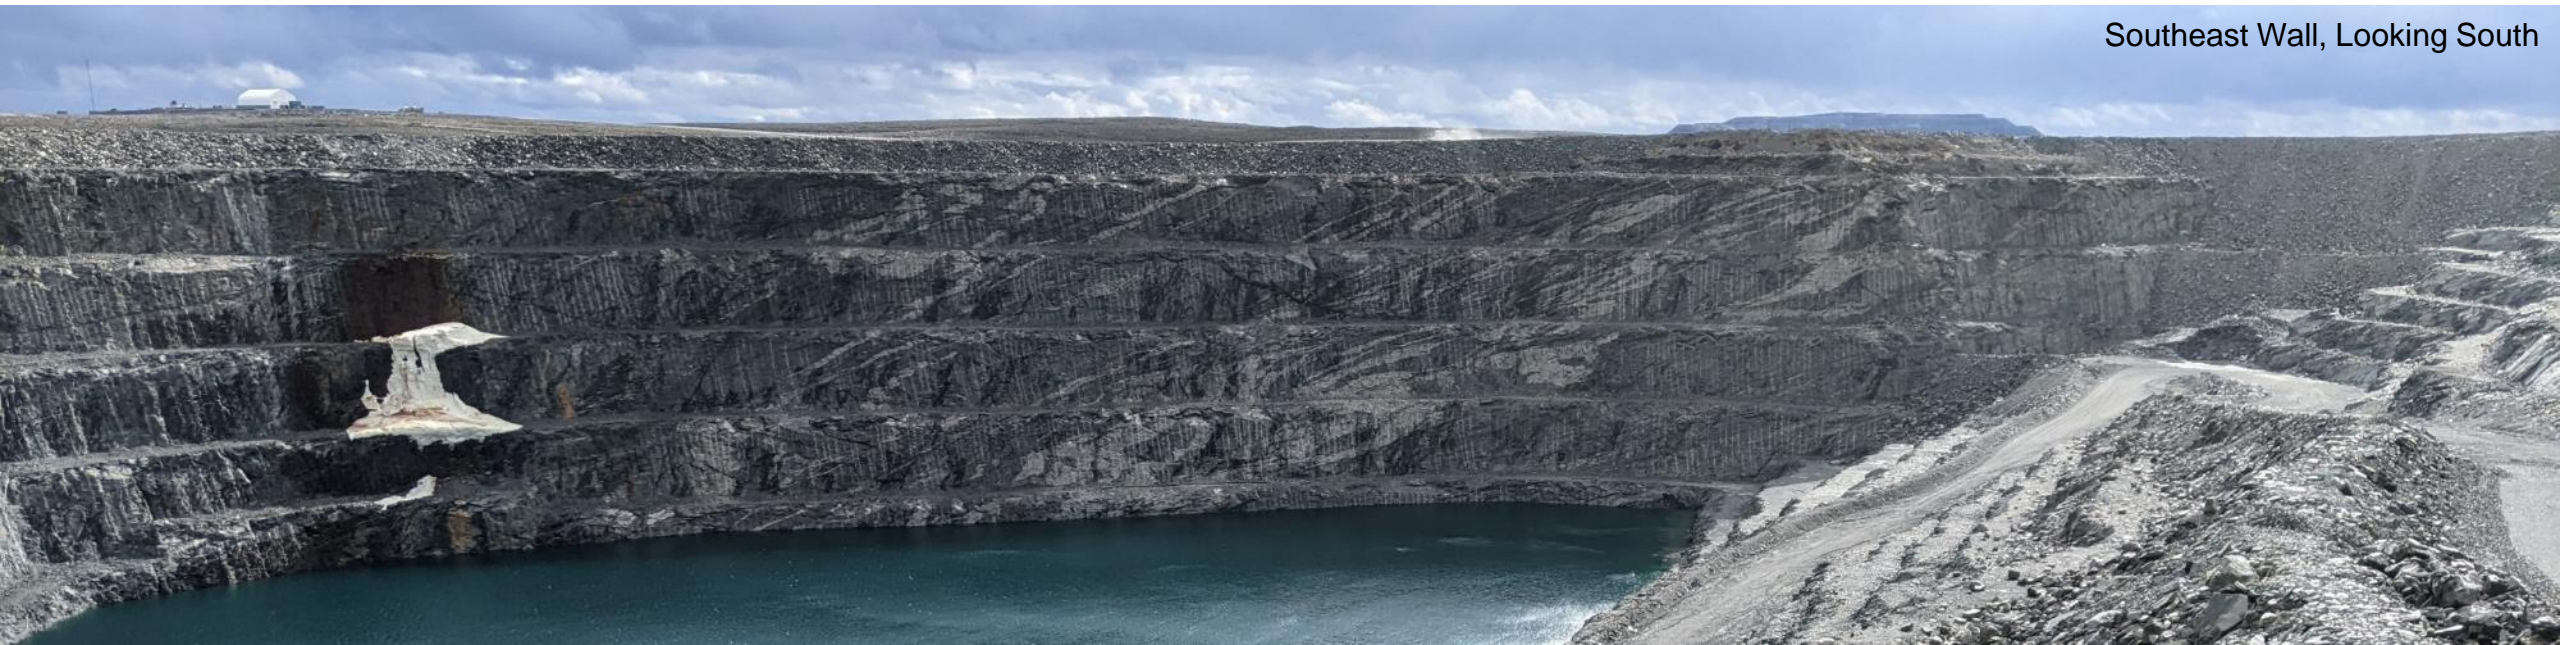
Southeast Wall, Looking South

- The wall is performing well.
- Water has been observed flowing from Pond D, to the south of the pit, under the ring road and down the wall during previous inspections. However, no flow below the road at the crest of the wall was observed at the time of this inspection.
- The ice wall continues to form each winter on and below the talik zone in this wall (roughly where the iron staining is present on the wall). Limited seepage through rock was observed at the time of the inspection.
- No particular geomechanical concerns. The area should continue to be visually inspected.

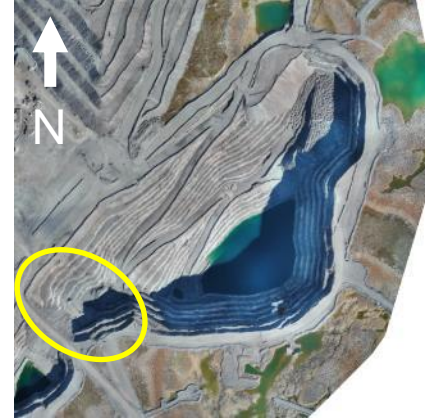
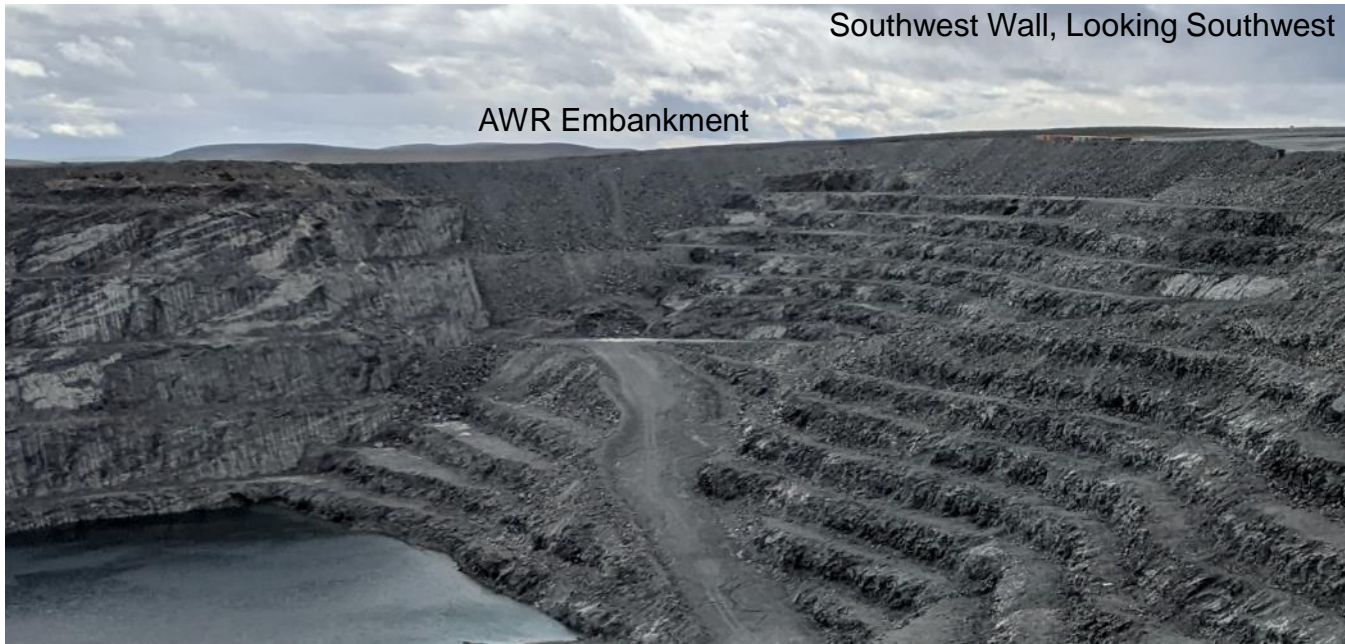
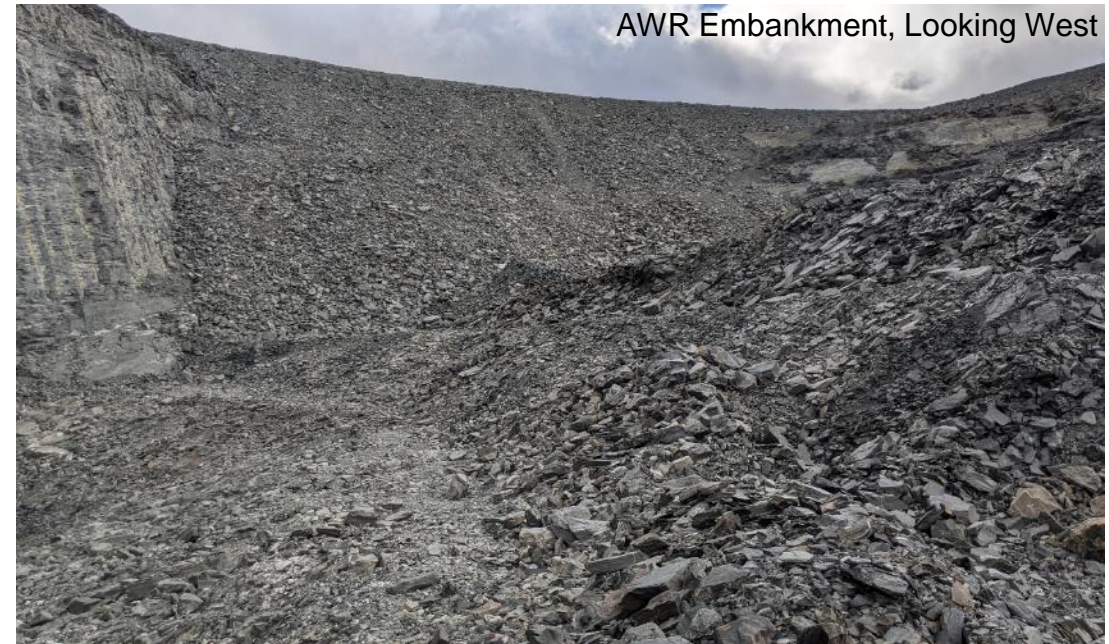
## Vault Open Pit - Southwest Wall

- The Amaruq AWR crosses a saddle between the Vault and Phaser pits on a rockfill embankment.
- No evidence of instability in the AWR embankment was observed. No tension cracks on the surface of the road or bulging of the embankment toe were noted. The embankment is included in the geotechnical inspections.
- The stability of the Amaruq AWR embankment could be adversely impacted if the water level in the Phaser Pit on the other side of the embankment increases and water ponds behind the embankment. No seepage was observed at the time of the inspection. The presence of seepage should continue to be evaluated as part of the monthly inspections.

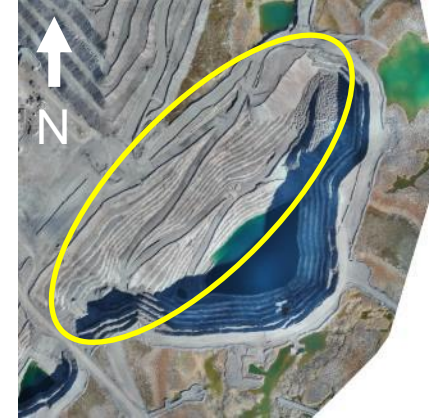
West Wall, Looking North

- The West Wall is located along the footwall of the deposit, which dips at approximately 20° to the east (mine grid). The wall was established with 7 m high single benches without pre-shear and commonly failed or were scaled back to the foliation.

- The ramp is located along this wall. At the time of the inspection, access to the ramp was restricted by a barricade. Personnel must contact the Geotechnical Group before entering the open pit; this is understood to be limited to monthly water quality monitoring during the summer.

- While the ramp is inspected as part of the monthly geotechnical inspections, the condition of the ramp is not documented in the inspection report. The ramp should be included in the inspection report. The inspections should continue to consider the open pit walls and in-pit dumps, as well as the integrity of the Ring Road between the open pit and Vault Lake as a failure could result in a wave in the pit lake or inrush to the open pit.

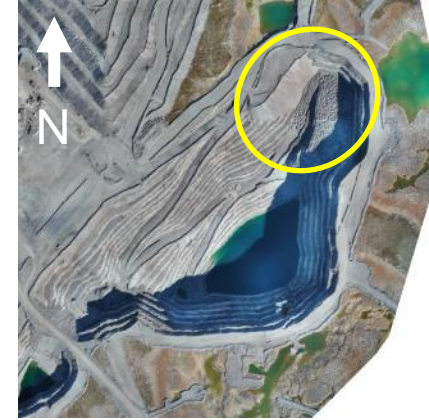
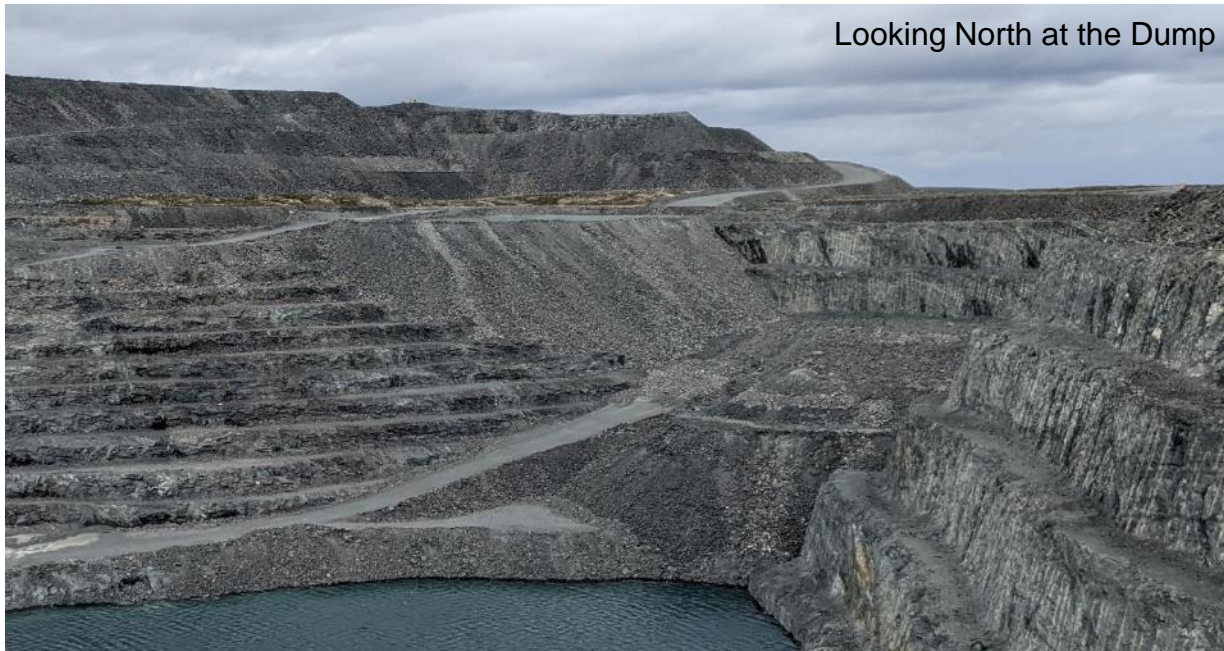
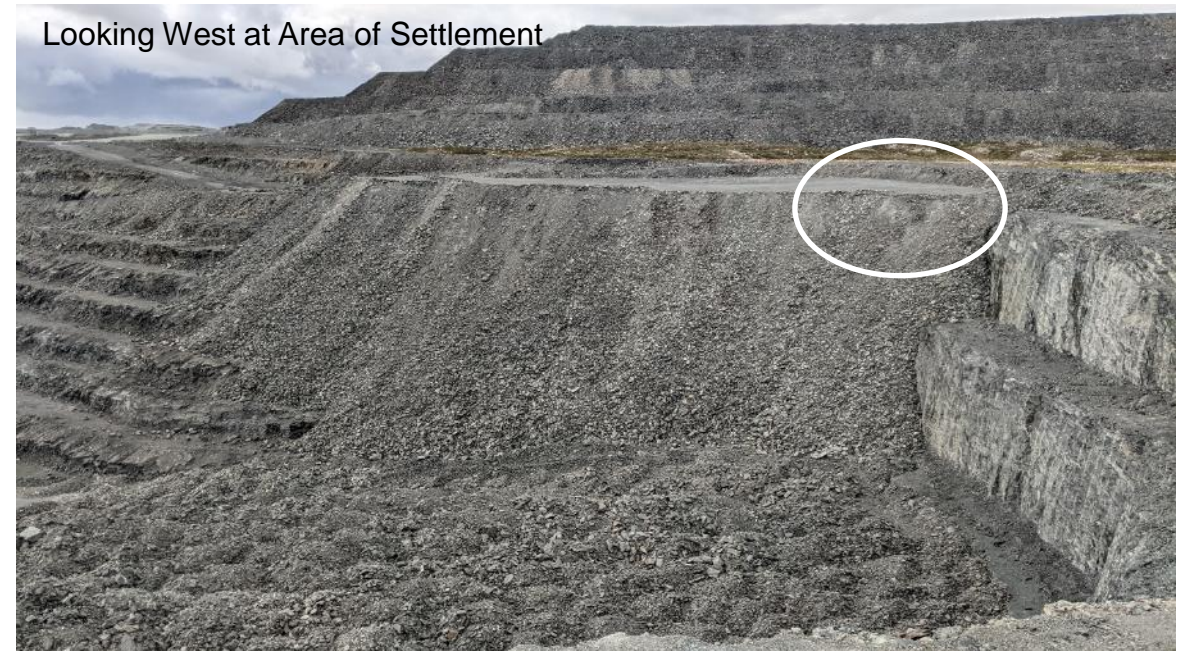
## Vault Open Pit - North Waste Rock Dump

- A waste rock dump was constructed at the north end of the Vault Pit. The dump is inactive and consists of two platforms with elevations at approximately 5133 mRI and 5082 mRL.
- Settlement and tension cracks were observed at the crest of the upper platform at the north end of dump during the 2019 inspection. There appears to have been little change since that time. The affected area is relatively small and is not above the ramp. Consider including this area in the monthly visual inspections.
- No other evidence of instability was observed during the inspection.
- Access to the dump is now prevented with a berm.

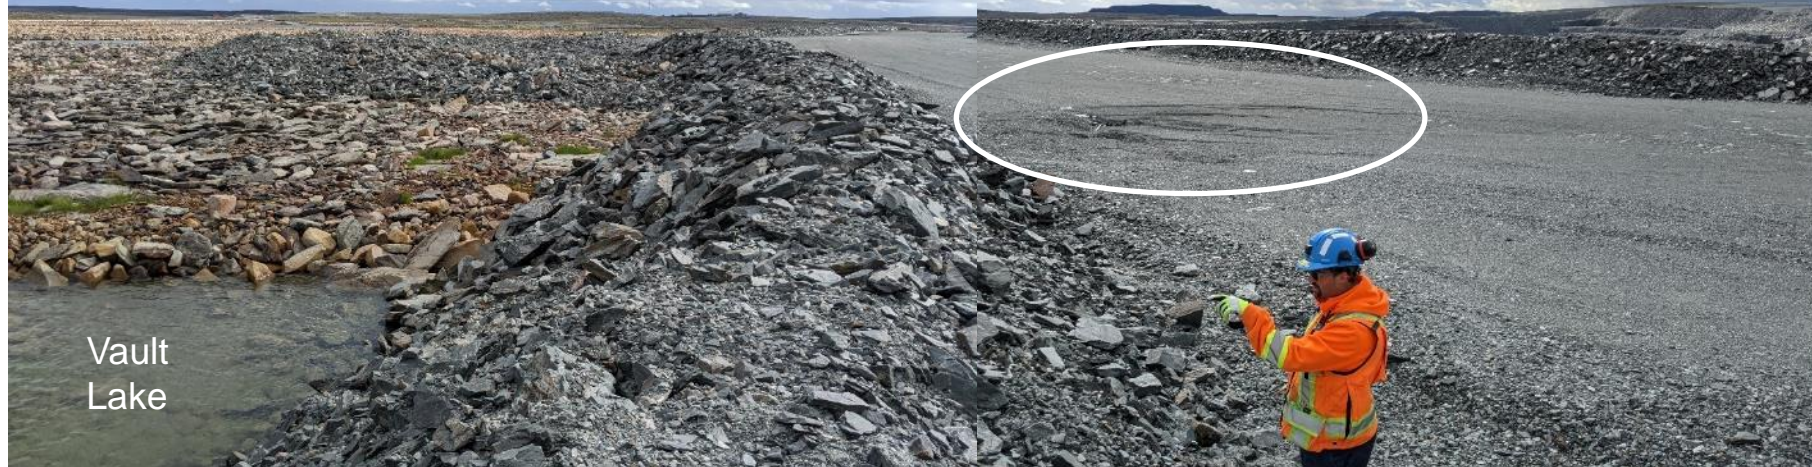
Area 2 Looking South with Subsidence Circled

- A berm has been constructed at both ends of the Ring Road to prevent access (yellow dashed lines at right). Several geotechnical hazards have previously been identified along the road:

1. Seepage from Pond D has flowed under the road and down the pit wall in 2019 and 2021. This was not observed during the current inspection; the water level in Pond D is low.
2. Subsidence of the road has occurred adjacent Vault Lake. No change was observed since 2021.

No seepage was observed below road. The potential for a sudden inrush of water from Vault Lake into the open pit was previously identified as a hazard in the event of a breach or erosion of the Ring Road in this area. As a result, it is recommended that the area be inspected prior to accessing the open pit. Alternatively, the road could be purposely breached in this area to eliminate the hazard.

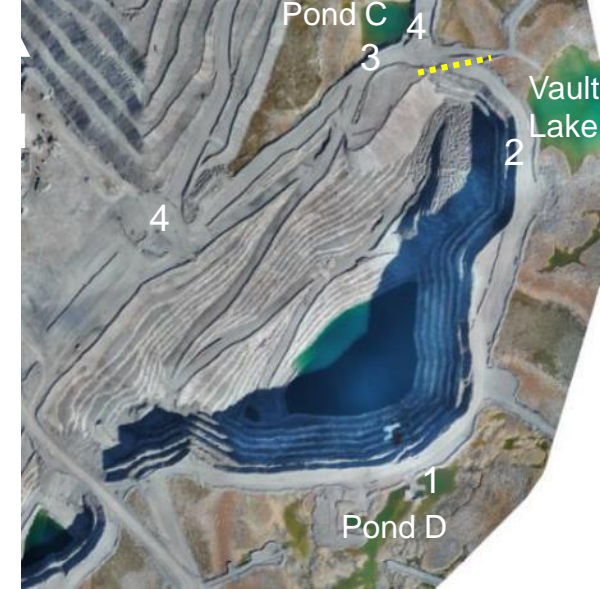
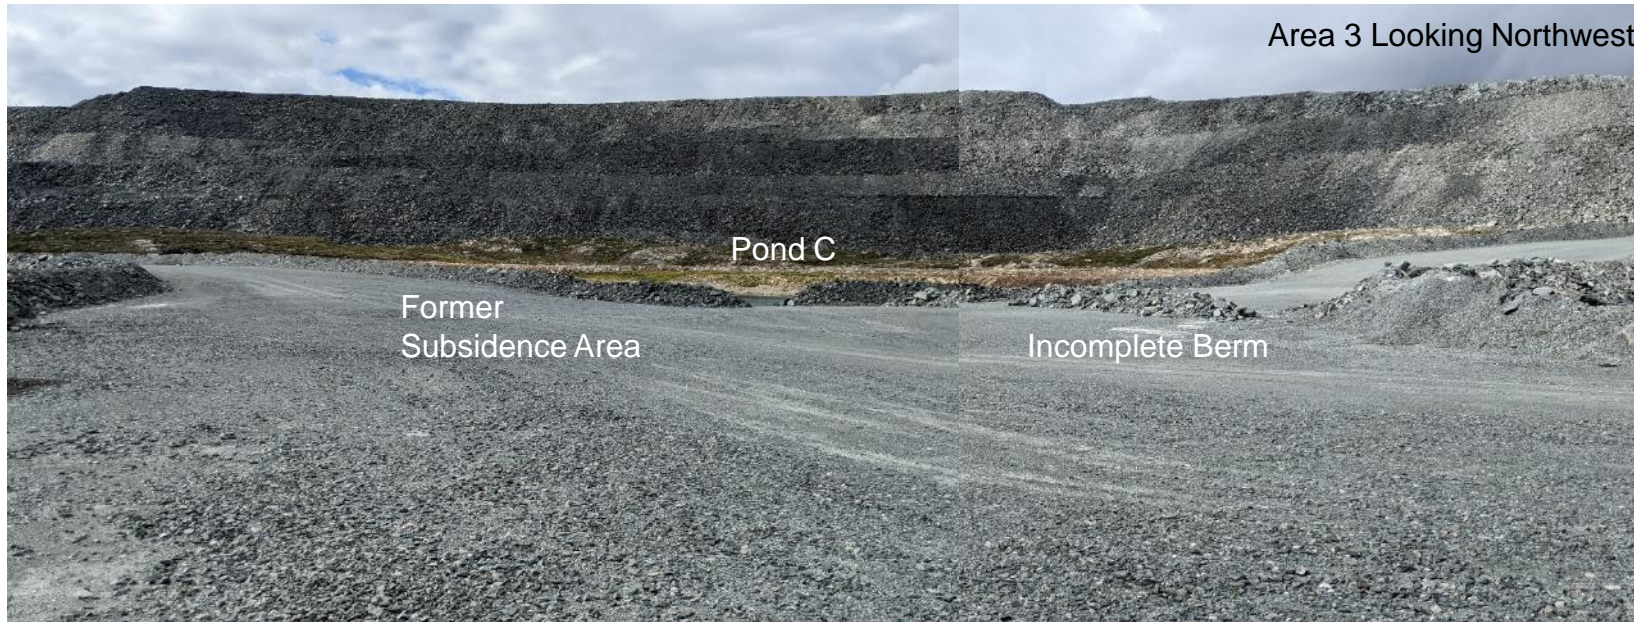
## Vault Open Pit - Ring Road (Cont'd)

3. Subsidence of the road previously occurred adjacent Pond C. The subsidence has been backfilled and regraded since the 2021 inspection.
4. The ramps to the waste rock dump are only partially blocked by berms. It is understood that the berms were completed in 2022 but have since been removed to allow access to the dump for the crushing operation. The berms should be re-built once access is no longer required.

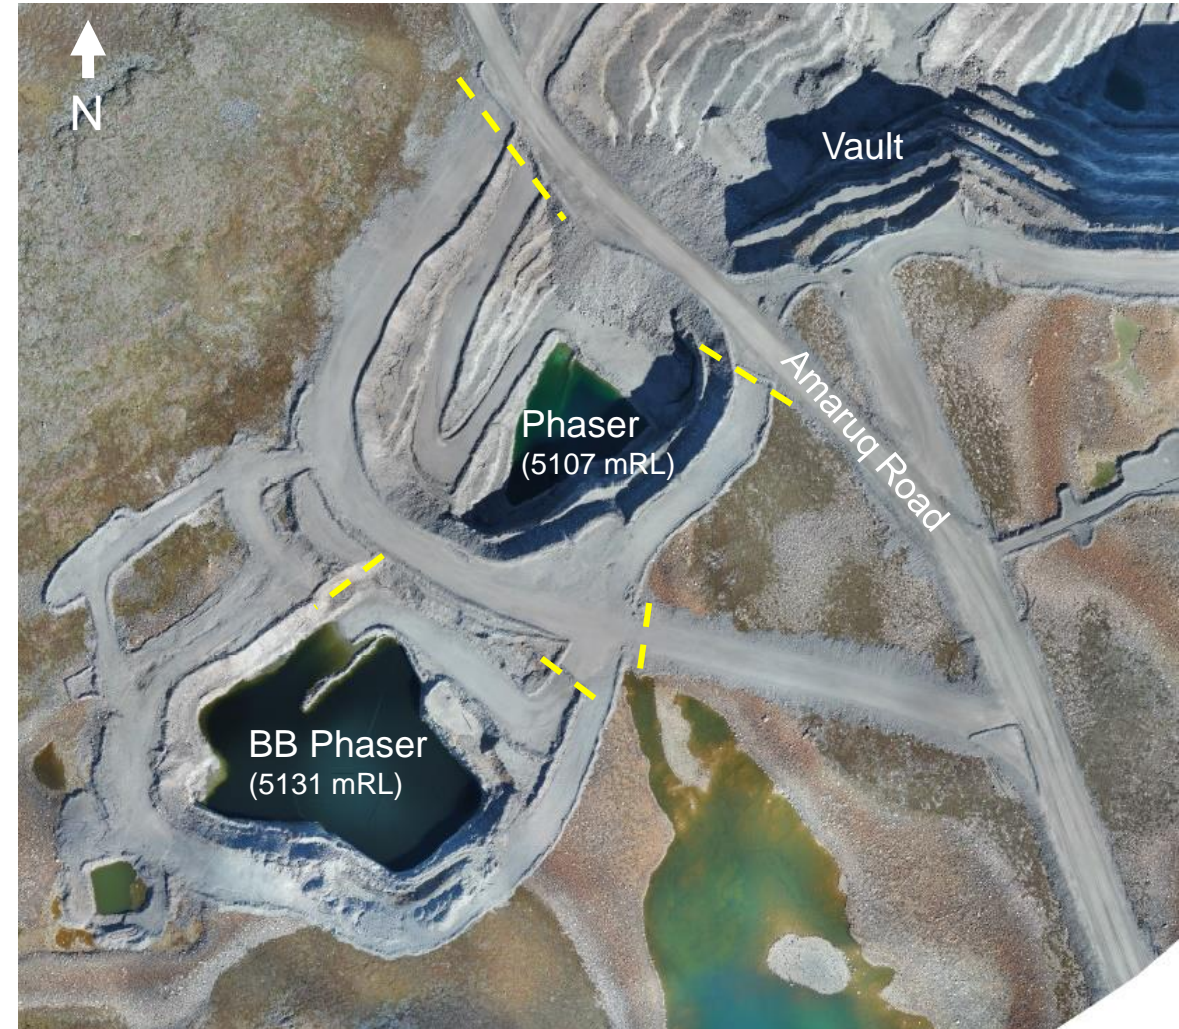
## Phaser and BB Phaser Pits - General

- Access to the open pits is limited to monthly water quality sampling when the pit lake is not frozen.
- At the time of the inspection, the accesses to the open pits were barricaded by berms (shown as dashed lines at right). This now includes the road between the two open pits.

- Note that the Amaruq All Weather Road (AWR) crosses between the Vault and Phaser Pits on a rockfill embankment.
- AEM continues to complete monthly geotechnical inspections of the open pits as on-going access to the pits is still required for water quality sampling. The AWR is also included in the inspections. These inspections should continue, though the open pit inspections could be discontinued during periods when water quality sampling is not occurring.

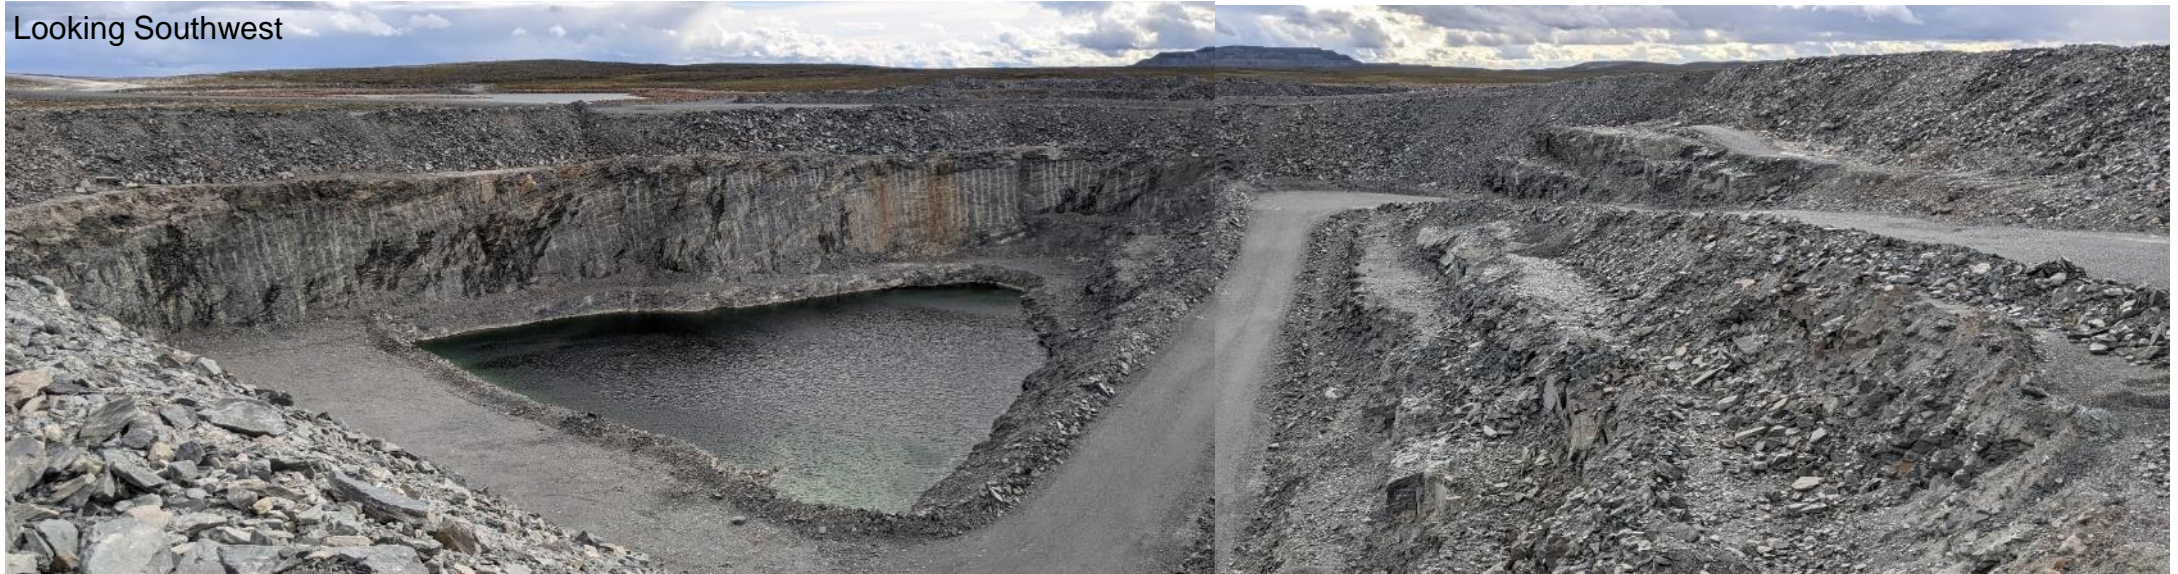
Looking Southwest

- The open pit is partially flooded, limiting the current rock exposures to a single bench. No particular concerns were noted.
- Access to the open pit is prevented by a berm.
- No evidence of instability was observed in the Amaruq AWR embankment.
- Water inflow, likely from the BB Phaser pit, was noted at the south end of the pit in 2021. No inflow was observed during the current inspection. The stability of the Amaruq AWR embankment could be adversely impacted if the water level in the Phaser pit increases and water ponds behind the embankment. A visual assessment of the water level in the open pit should be incorporated into the monthly inspections. Note that the pit lake elevation does not appear to have significantly changed since the 2021 inspection.

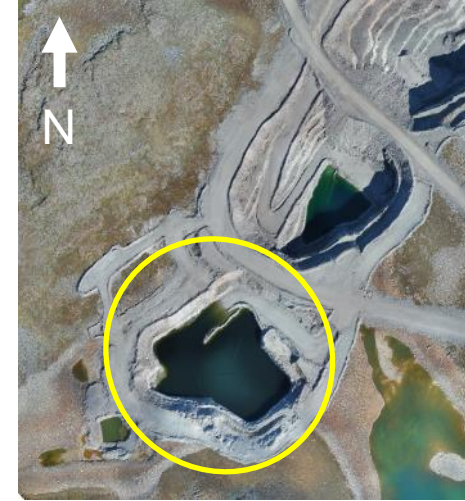
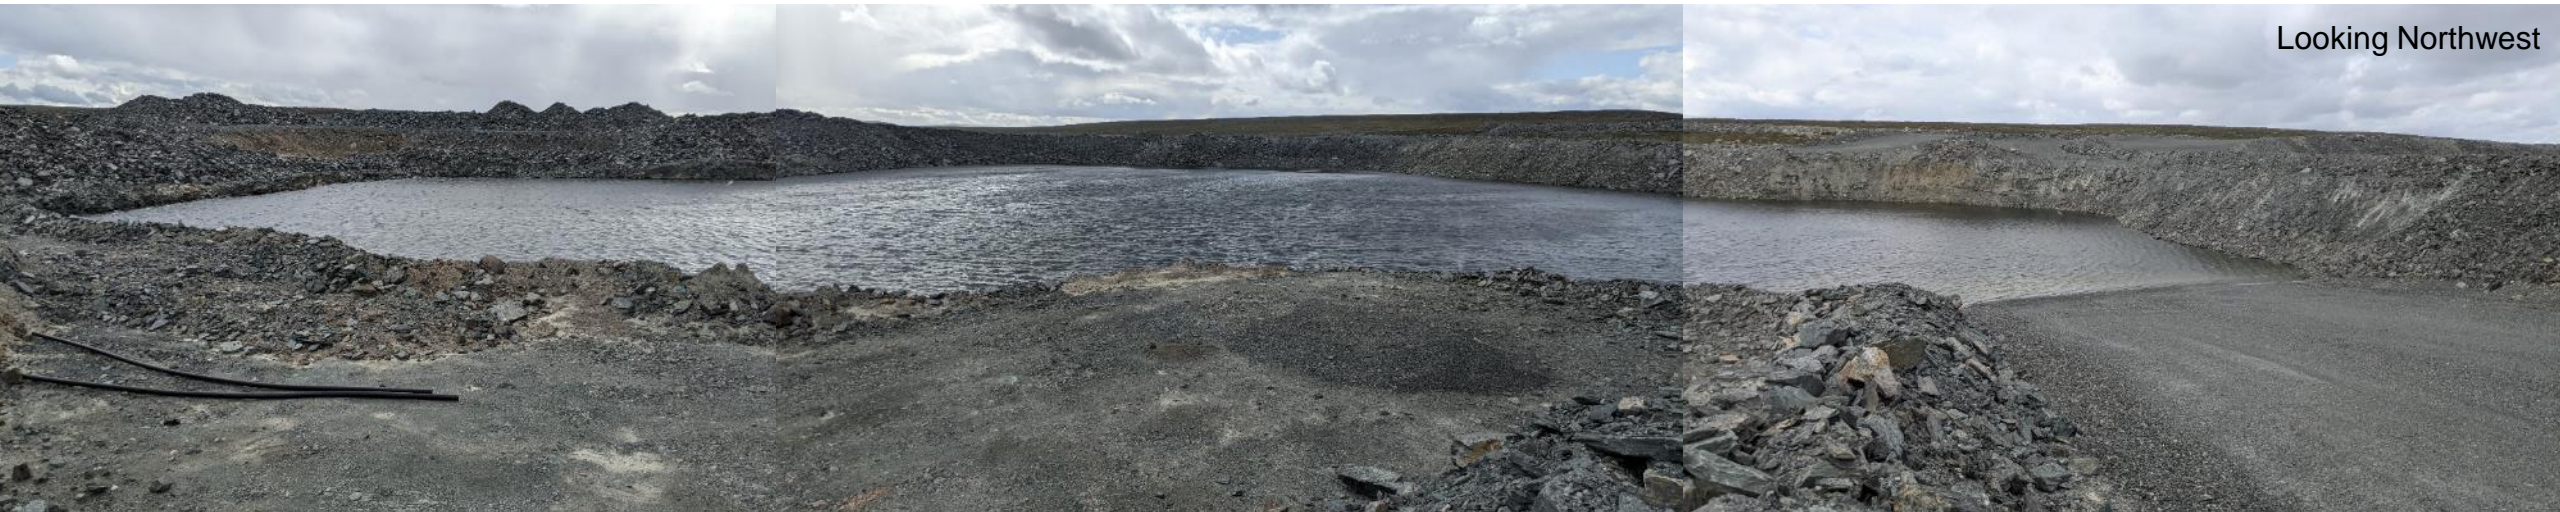
## BB Phaser Open Pit - General

- The open pit is flooded, with no rock slopes visible. The pit lake elevation is several meters higher than what was observed during the 2021 inspection.
- Access to the open pit is prevented by a berm.
- No particular geomechanical concerns were noted.
