Whale Tail Project 2019 Annual Geotechnical Inspection

Final Report (Rev. 01)

Agnico Eagle Mines Limited

2019 | 12 | 16

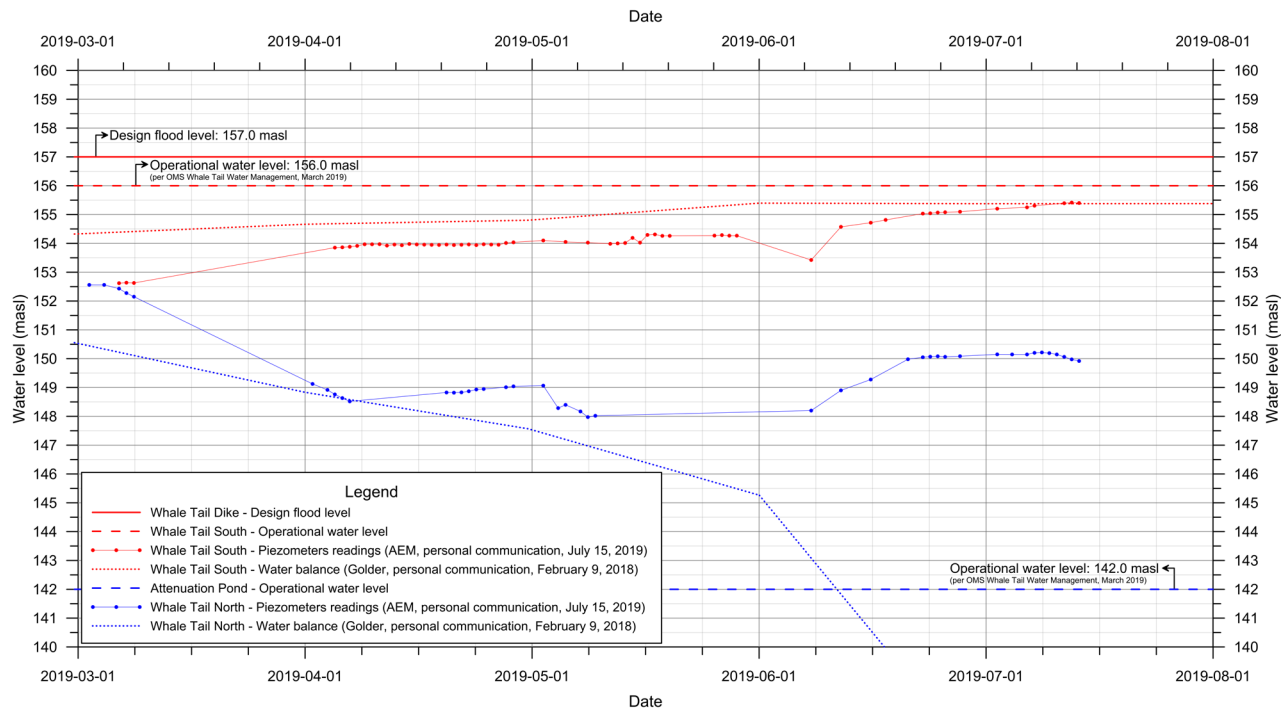
Figure 4-1: Water level of Whale Tail Lake (North and South basins)

On July 14, 2019, the upstream water level (Whale Tail South) was 155.40 masl and the downstream water level (Whale Tail North) was 149.92 masl. The water levels of South and North basins compared with the water balance provided by Golder are shown on Figure 4-1.

The water balance provided by Golder shows the expected water levels of the North and South basins over time. Monthly water level data are based on several assumptions, such as the start of the dewatering of Whale Tail Lake (North Basin) in March 2019.

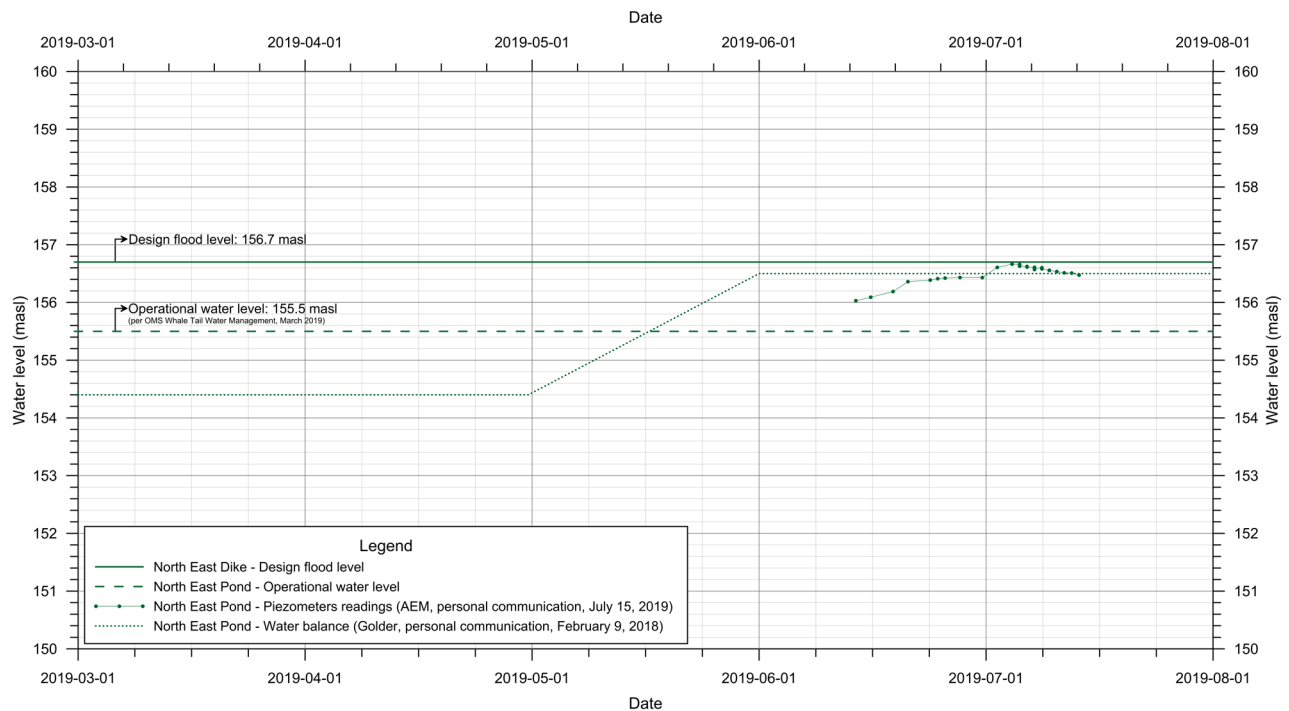
Figure 4-2: North East Pond water level

According to the information sent by AEM, the maximum water level reached at the North East Pond was 156.66 masl on July 5, 2019. The elevation of the liner in NE Dike is 156.7 masl, which implies that the water level was at only 0.04 m below the design flood elevation. The evolution of the North East Pond water level over time is shown on Figure 4-2.

Since July 5, 2019, the water level of the North East Pond has been decreasing steadily. By July 14, 2019, the water level reached the expected elevation as per Golder's water balance. However, the water level of North East Pond has been consistently above its operational level since the start of data recording on June 14, 2019.

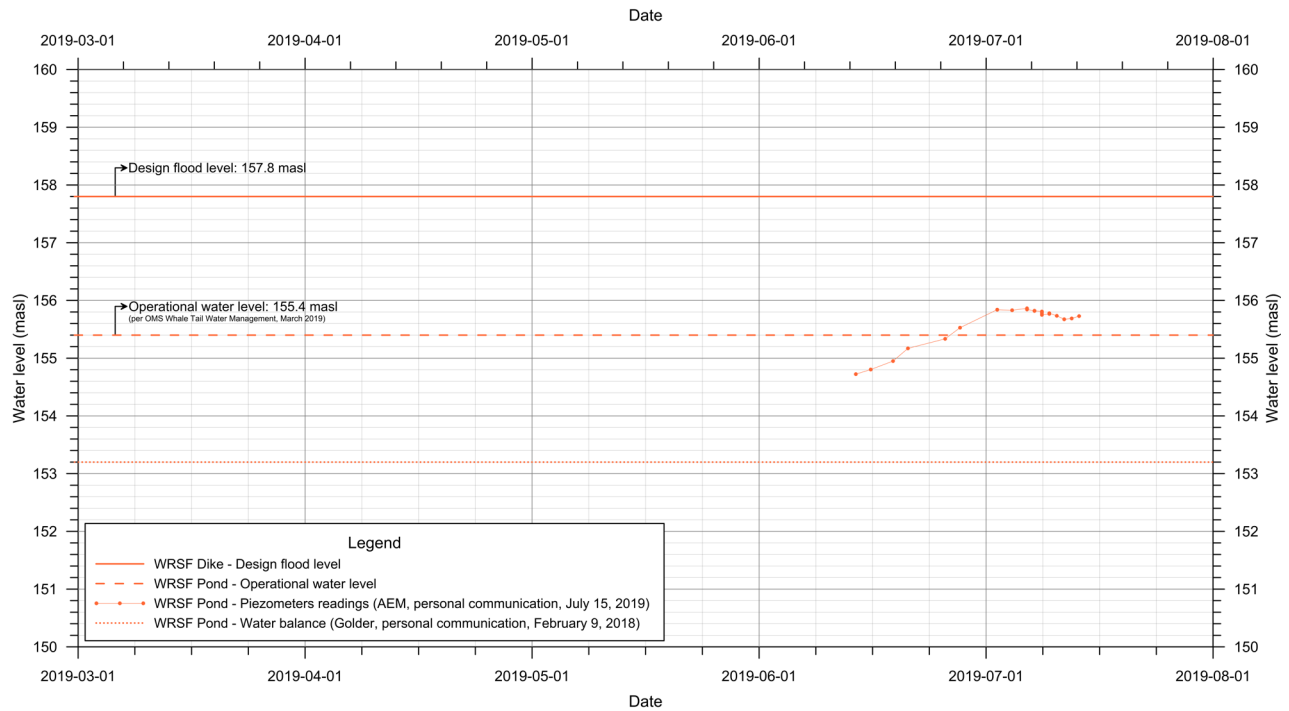
Figure 4-3: WRSF Pond water level

The WRSF Pond water level exceeded the operational elevation of 155.4 masl on June 28, 2019. The maximum water level of 155.86 masl was reached on July 7, 2019. Following this, it was agreed with SNC-Lavalin to temporarily raise the operating level in the WRSF Pond to collect runoff water from site. By July 14, 2019, the water level was at 155.73 masl. The pump was not working during the inspection of the WRSF Dike. The evolution of the WRSF Pond water level over time is shown on Figure 4-3.

Pumping of the WRSF Pond was ongoing on July 6, 2019 and allowed the water level to decrease by 0.13 m in seven days. The water level was still around two metres under the design flood elevation of 157.8 masl of the WRSF Dike.

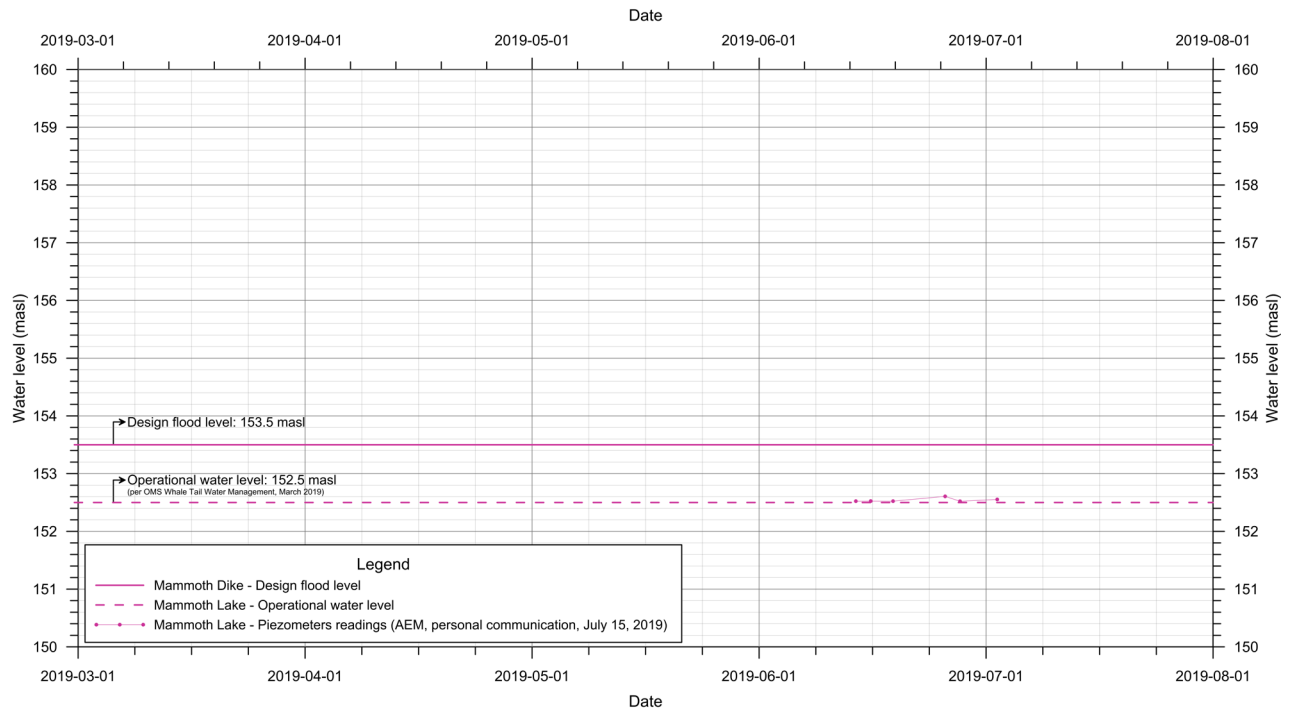
Figure 4-4: Mammoth Lake water level

The Mammoth Lake elevation is approximately one metre under the design flood of Mammoth Dike and right on its operational water level as shown on Figure 4-4.

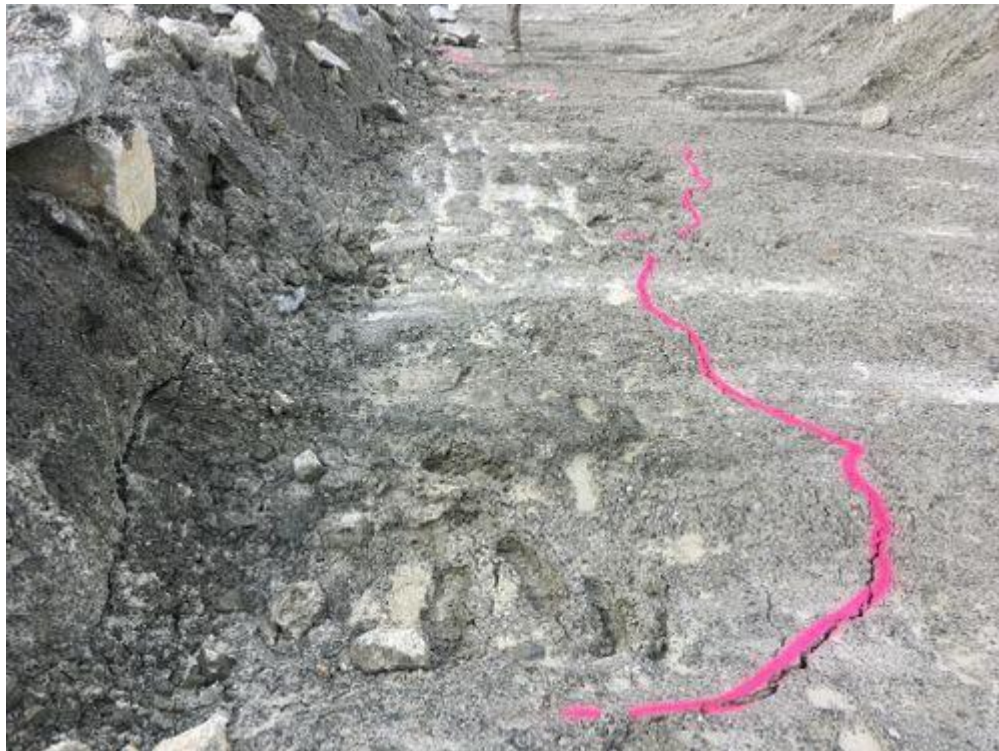
Internal ID: 190717-112047-DURAM16

Location and component	Whale Tail Dike Crest
Reported observation	Cracking
Preventive or corrective actions to take	Monitor any cracking evolution, reprofile if required
Priority level	P-4: Best Management Practice – further improvements are necessary to meet industry best practices or reduce potential risks.
Observation date	2019-07-17

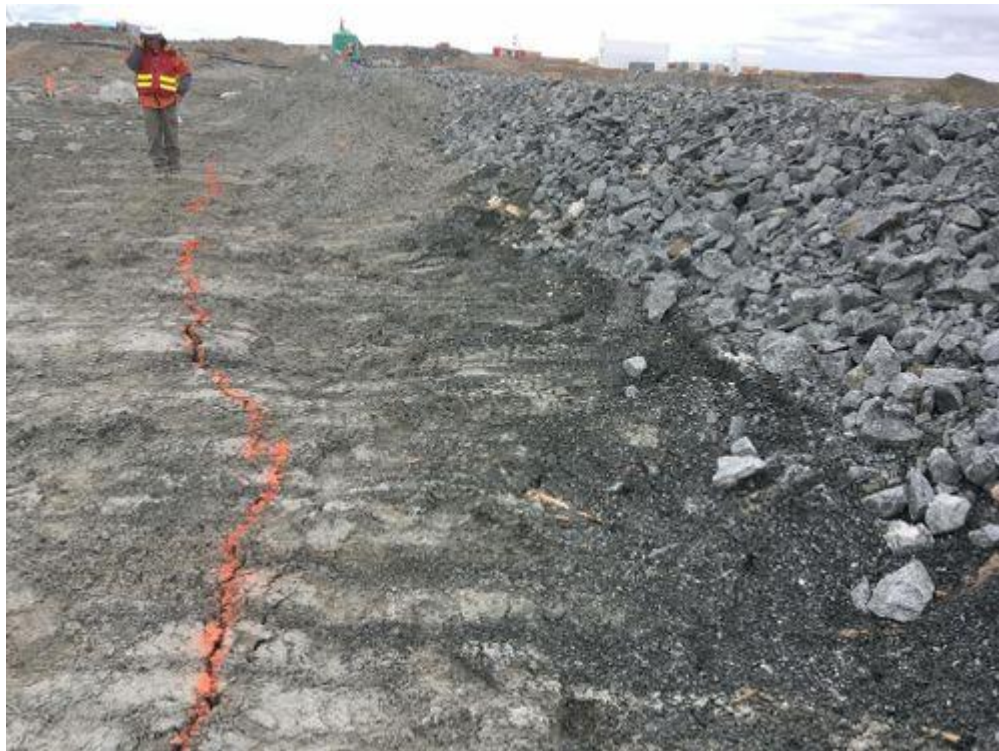
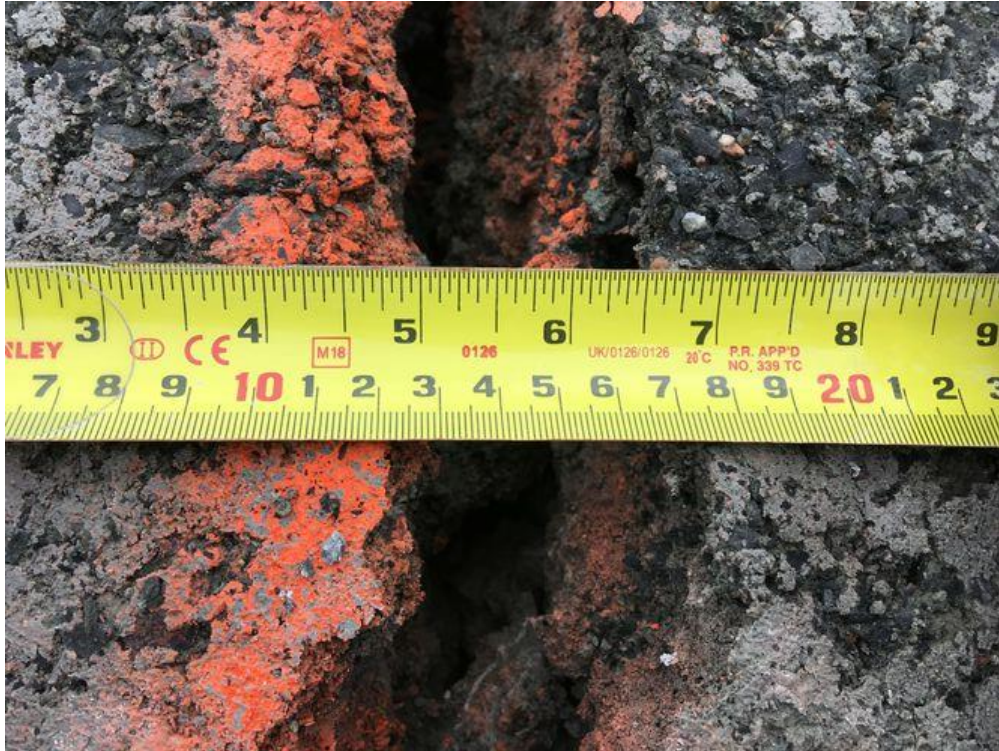
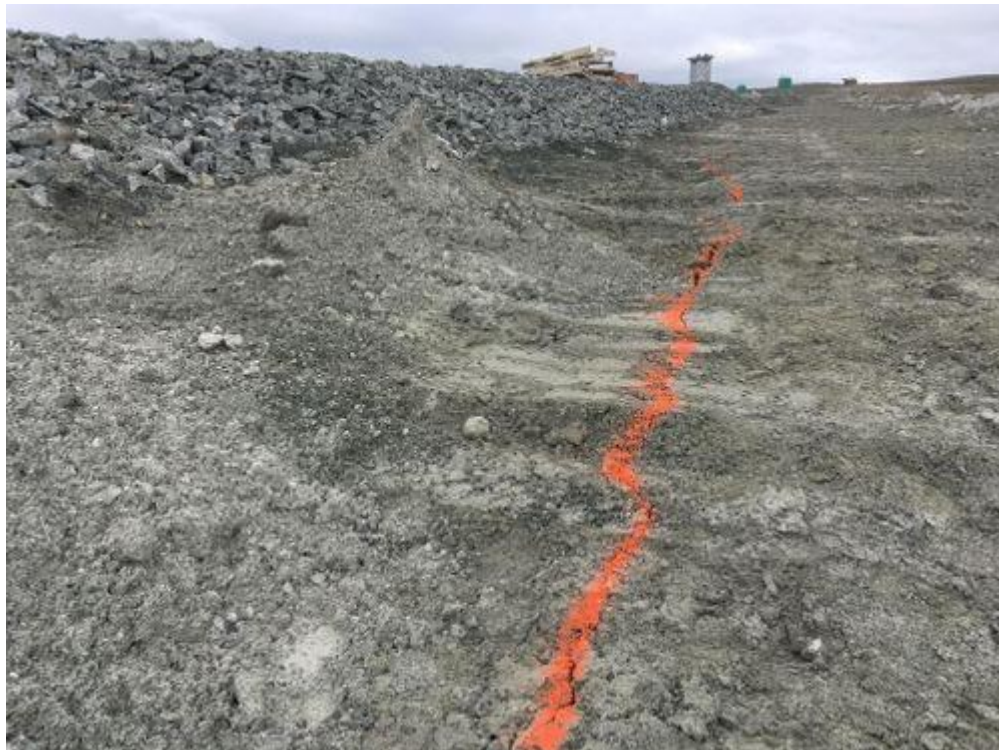
Internal ID: 190717-110755-DURAM16

Location and component	Whale Tail Dike Crest
Reported observation	Cracking
Preventive or corrective actions to take	Monitor any cracking evolution, reprofile if required
Priority level	P-4: Best Management Practice – further improvements are necessary to meet industry best practices or reduce potential risks.
Observation date	2019-07-17

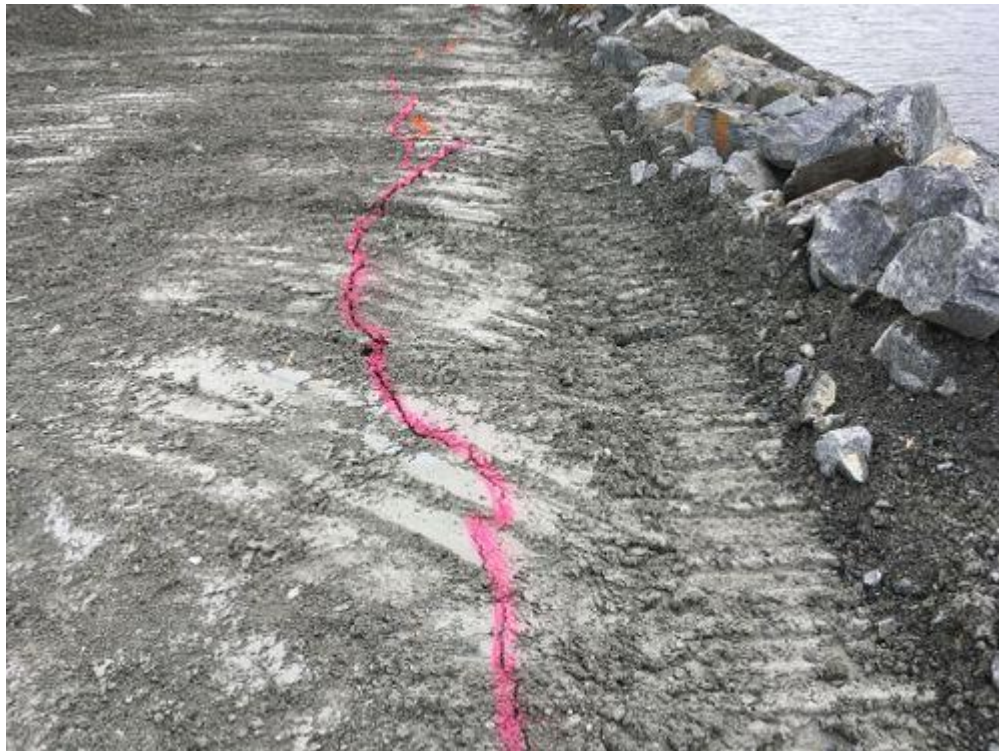
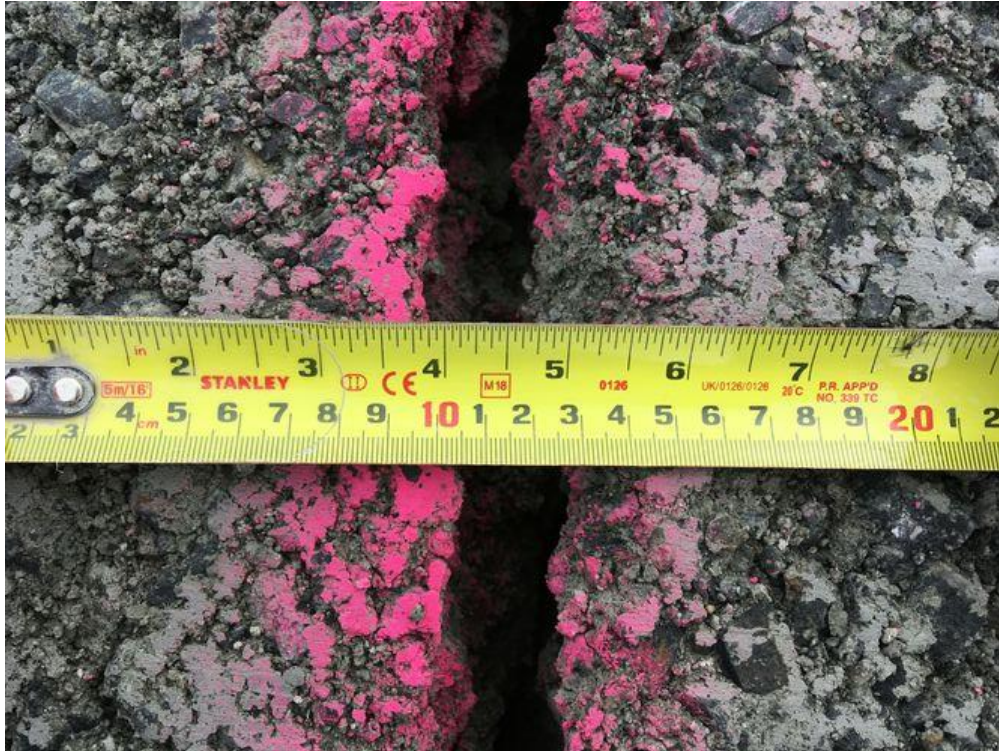
Internal ID: 190717-110424-DURAM16

Location and component	Whale Tail Dike Crest
Reported observation	Cracking
Preventive or corrective actions to take	Monitor any cracking evolution, reprofile if required
Priority level	P-4: Best Management Practice – further improvements are necessary to meet industry best practices or reduce potential risks.
Observation date	2019-07-17

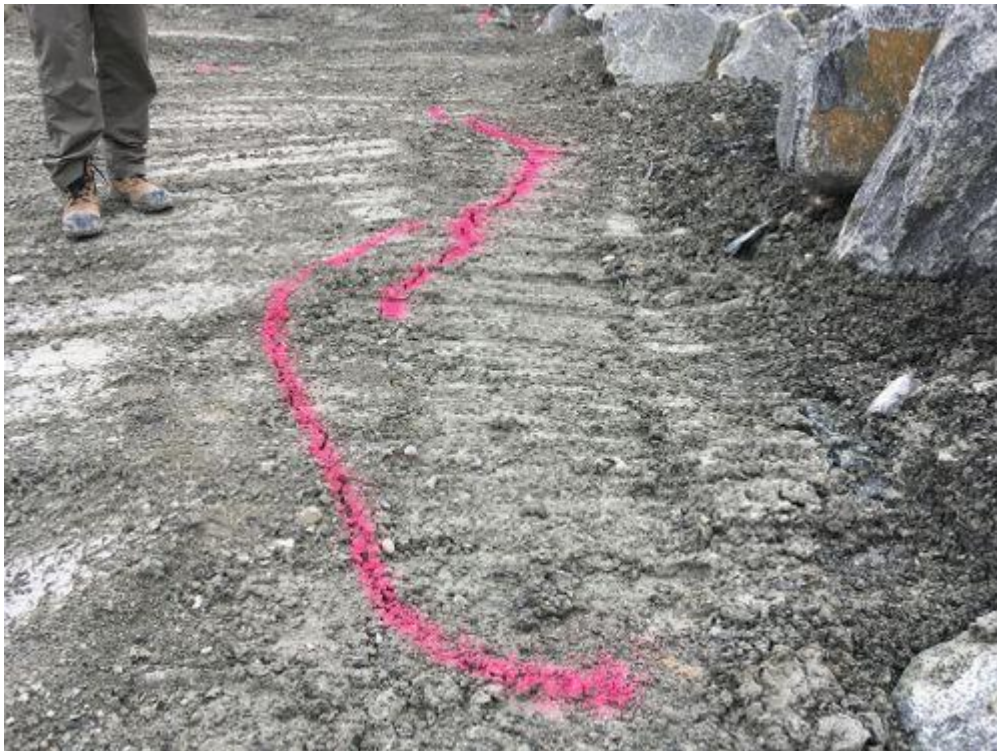
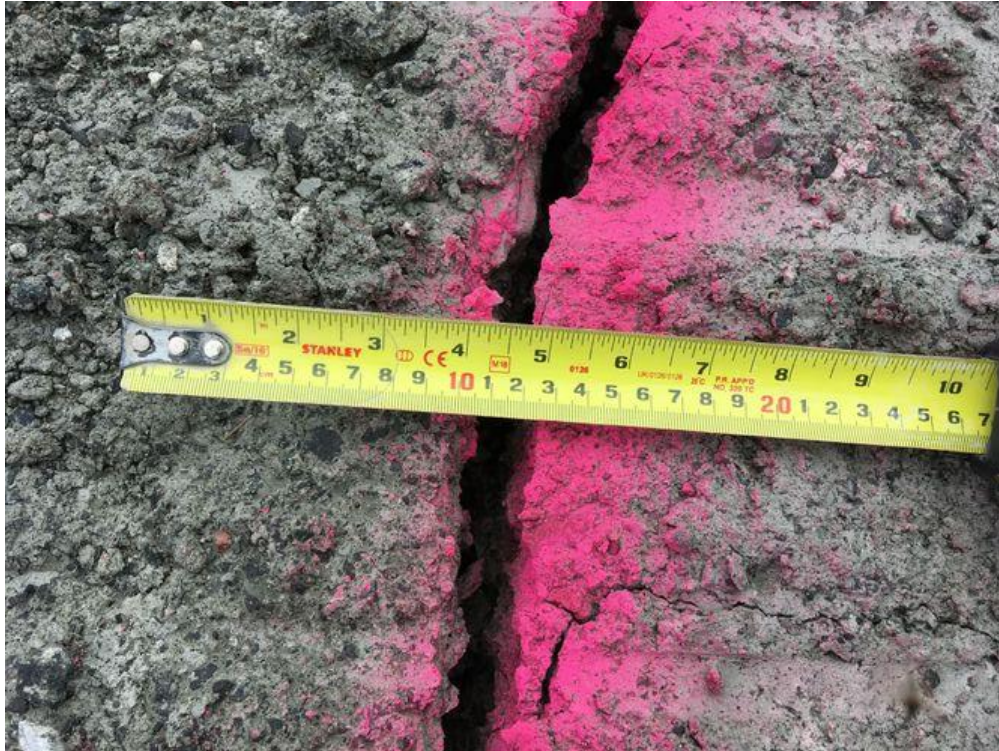
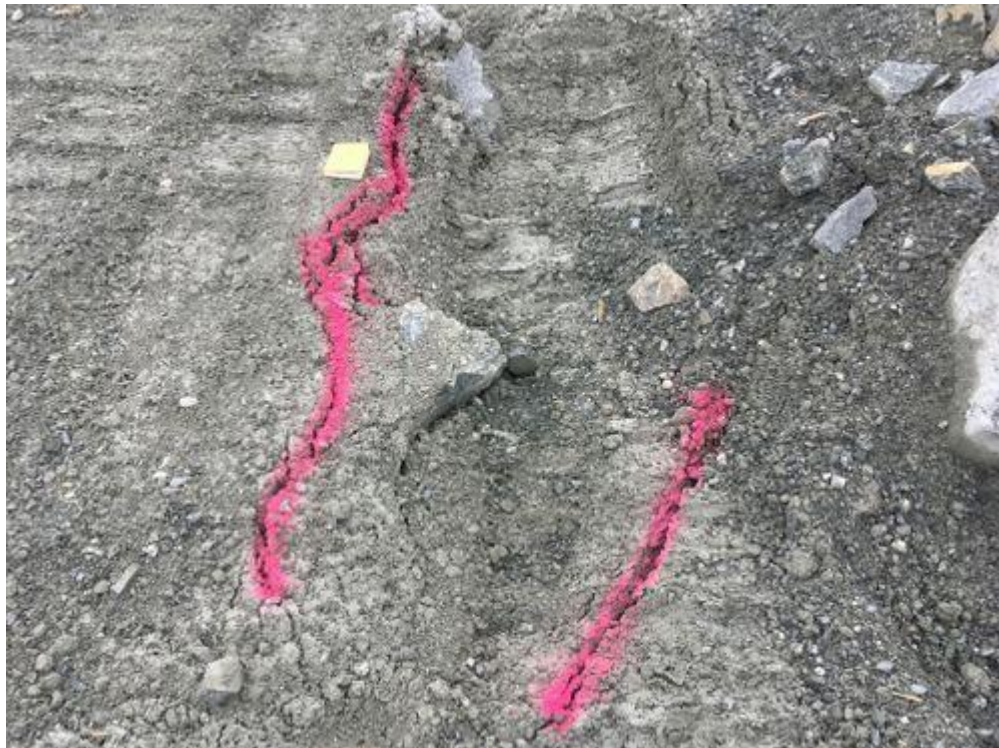
Internal ID: 190717-105858-DURAM16

Location and component	Whale Tail Dike Crest
Reported observation	Cracking
Preventive or corrective actions to take	Monitor any cracking evolution, reprofile if required
Priority level	P-4: Best Management Practice – further improvements are necessary to meet industry best practices or reduce potential risks.
Observation date	2019-07-17

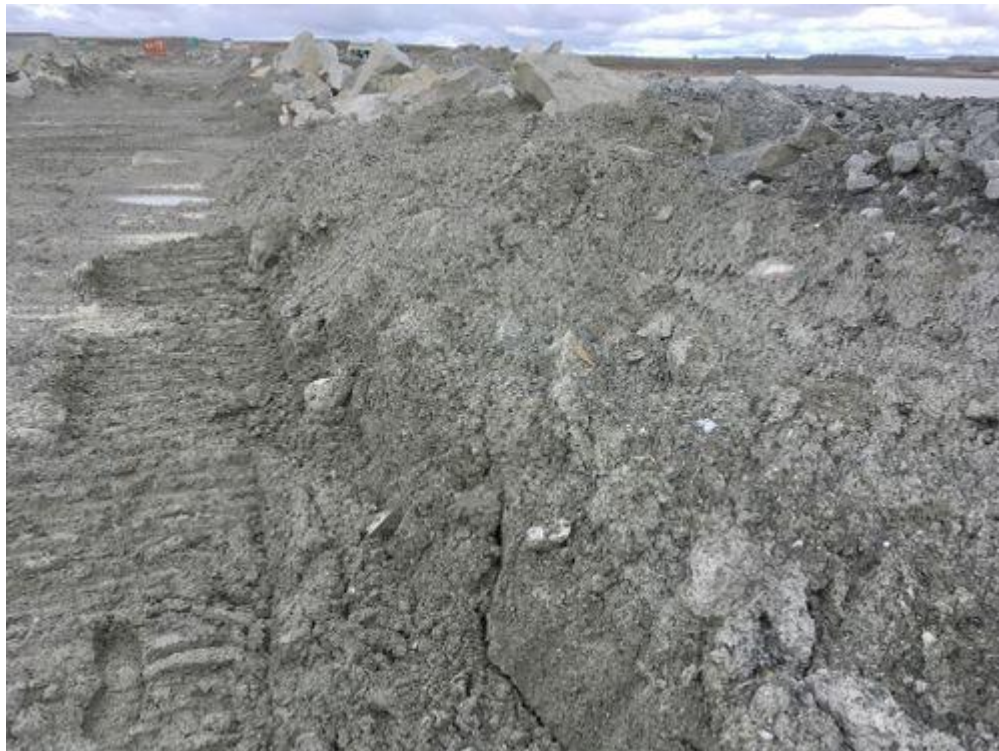
Internal ID: 190717-112326-DURAM16

Location and component	Whale Tail Dike Crest
Reported observation	Presence of deleterious materials above elevation 157.0 m
Preventive or corrective actions to take	Remove deleterious materials above elevation 157.0 m
Priority level	P-3: Single occurrences of deficiencies or non-conformance that alone would not be expected to result in structure safety issues.
Observation date	2019-07-17

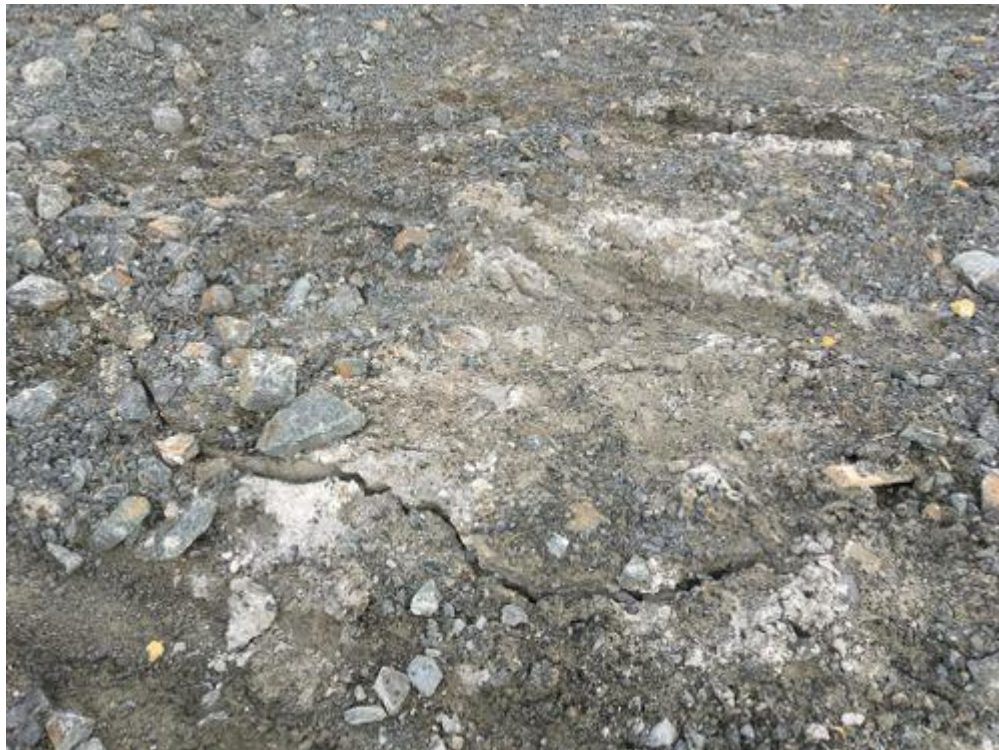
Observation 8

Location and component	Whale Tail Dike Crest
Reported observation	Crest materials require profiling and compaction (east abutment)
Preventive or corrective actions to take	Proceed with final grade and compaction on the crest
Priority level	P-3: Single occurrences of deficiencies or non-conformance that alone would not be expected to result in structure safety issues.
Observation date	2019-07-16

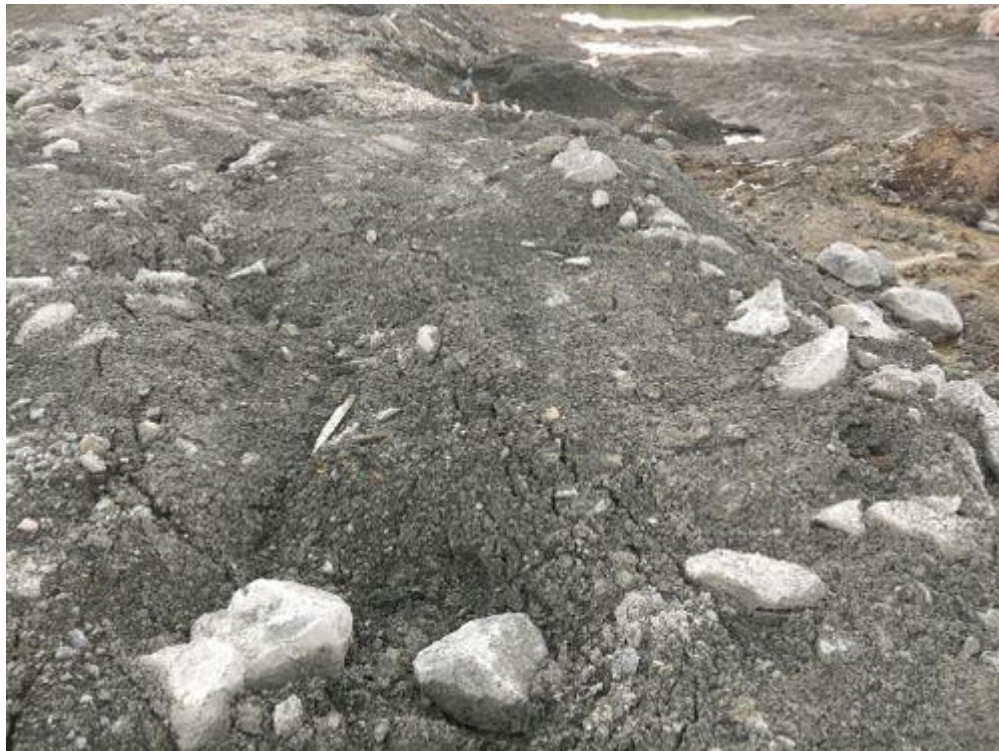
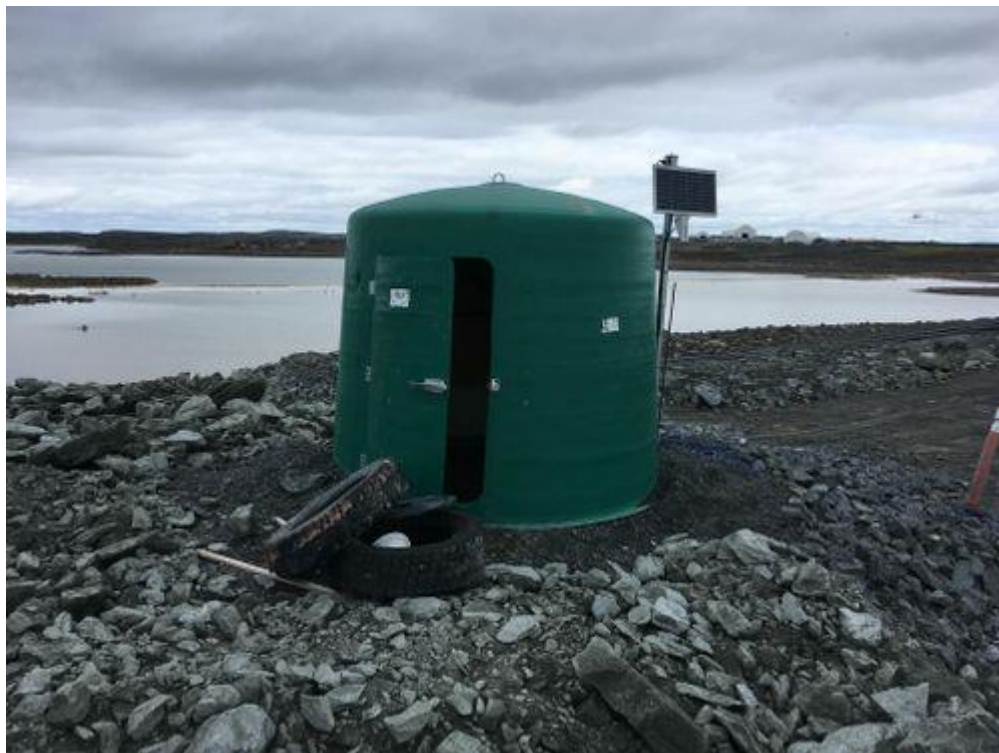
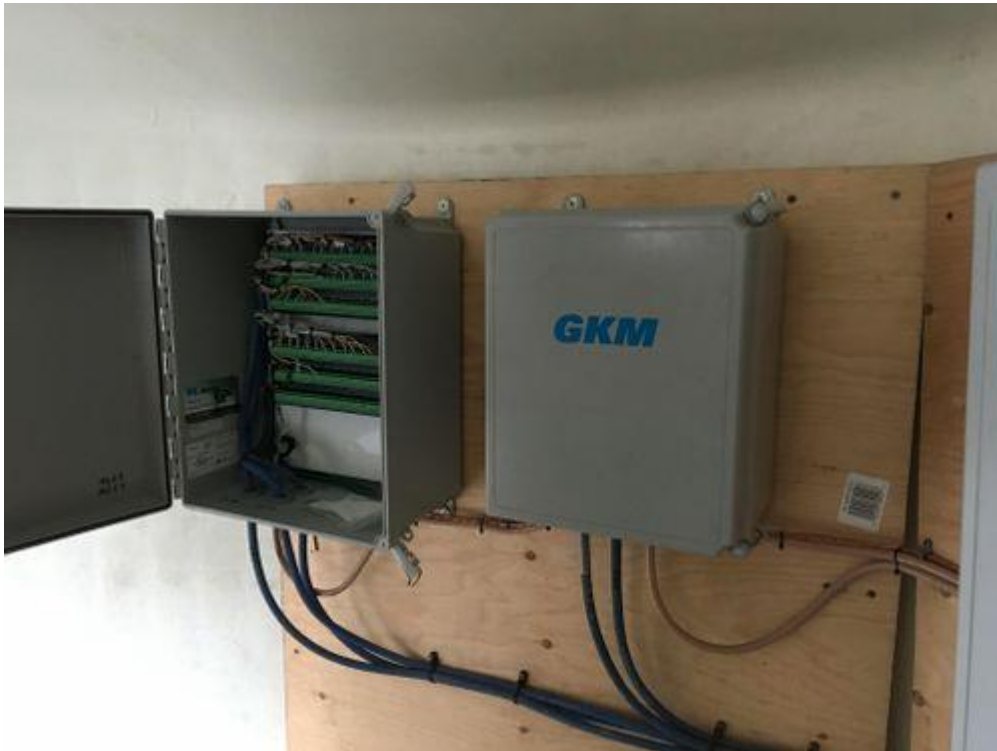
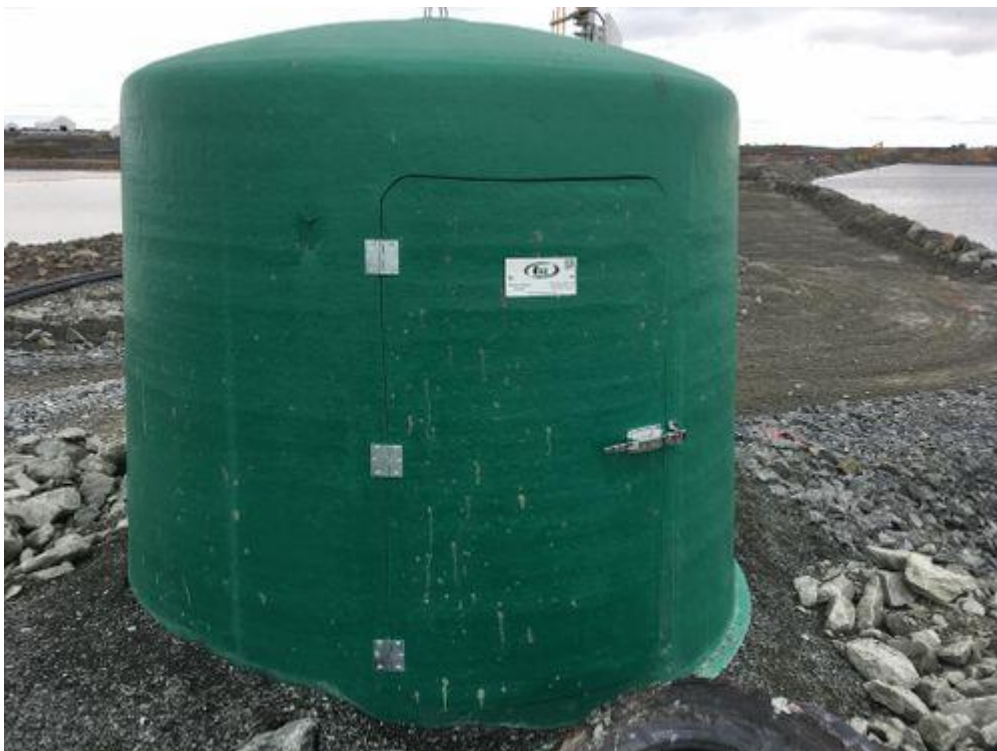
Observation 9

Location and component	Whale Tail Dike Instrumentation shelter
Reported observation	Instrumentation cables well protected
Preventive or corrective actions to take	
Priority level	P-4: Best Management Practice – further improvements are necessary to meet industry best practices or reduce potential risks.
Observation date	2019-07-17

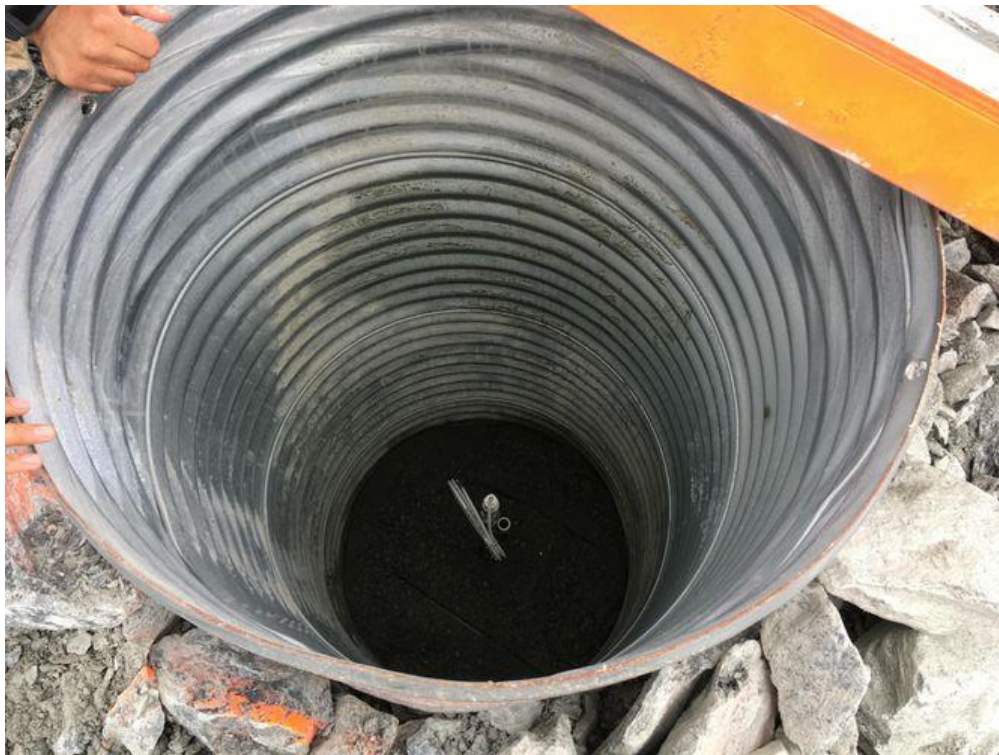
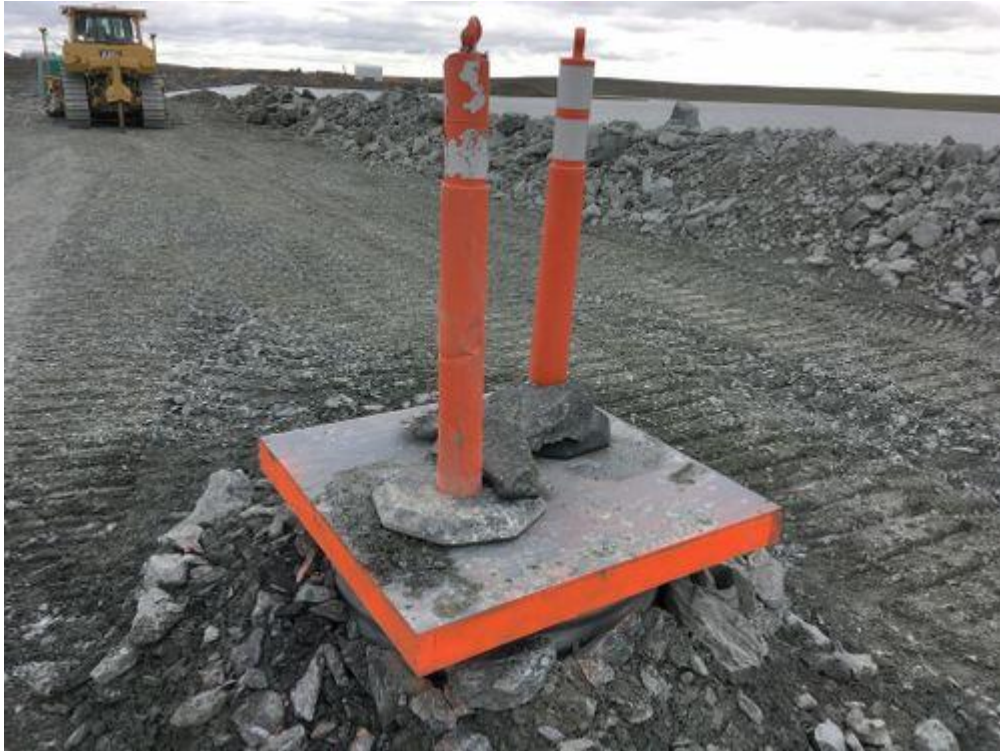
Observation 10

Location and component	Whale Tail Dike Inclinometer
Reported observation	Instrumentation facility well built, protection is adequate
Preventive or corrective actions to take	
Priority level	P-4: Best Management Practice – further improvements are necessary to meet industry best practices or reduce potential risks.
Observation date	2019-07-17

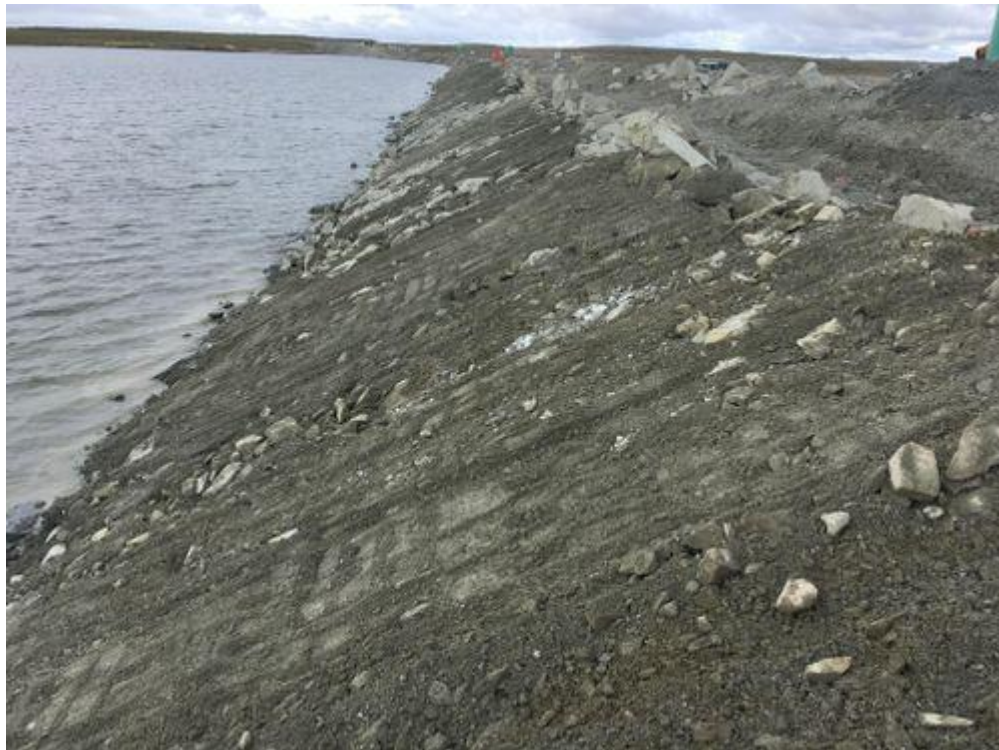
Observation 13

Location and component	Whale Tail Dike Upstream water level
Reported observation	Unknown water level
Preventive or corrective actions to take	A stake showing the operational and maximum water levels should be installed to monitor the water level in real time
Priority level	P-4: Best Management Practice – further improvements are necessary to meet industry best practices or reduce potential risks.
Observation date	2019-07-17

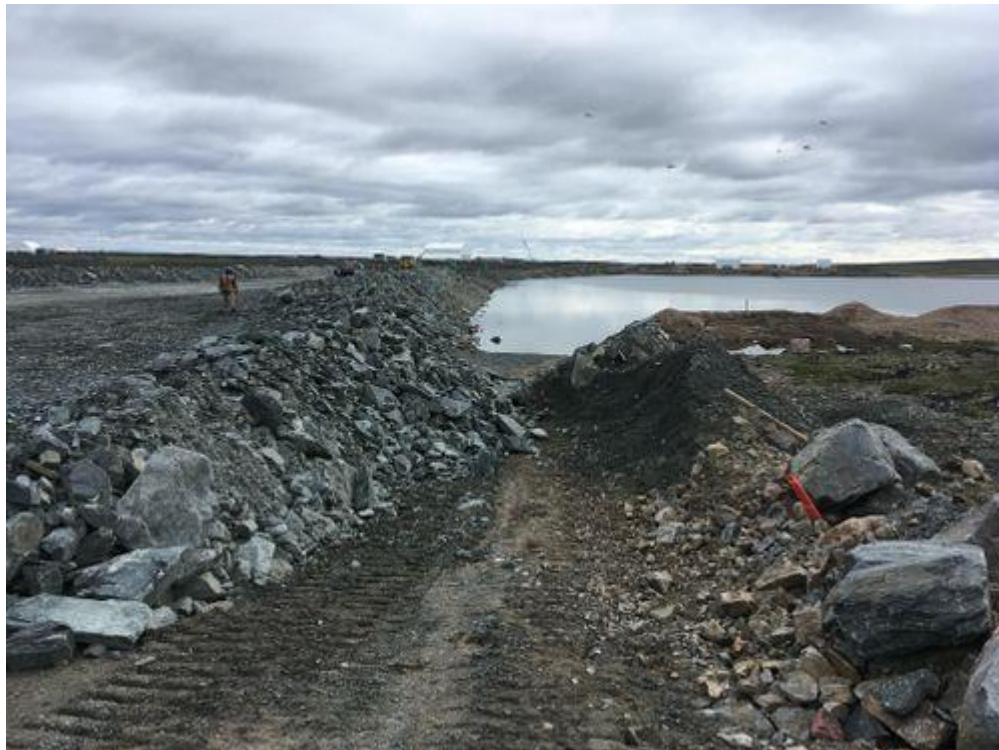
Observation 14

<p>DigitalGlobe, ... Powered by Esri</p>	Location and component	Whale Tail Dike Upstream slope
	Reported observation	Small amount of material is blocking the upstream platform of WTD
	Preventive or corrective actions to take	Confirm with safety staff that this blockage meets AEM safety requirements for the type of equipment used at Amaruq
	Priority level	P-3: Single occurrences of deficiencies or non-conformance that alone would not be expected to result in structure safety issues.
	Observation date	2019-07-17

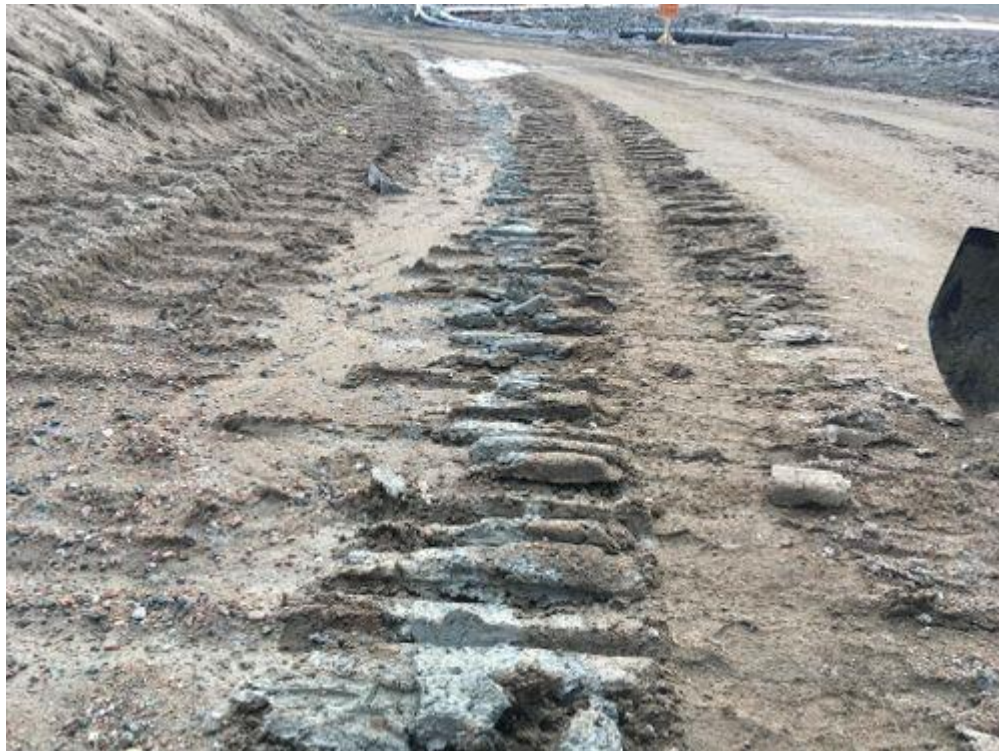
Observation 16

Location and component	Whale Tail Dike Access road
Reported observation	Presence of cement on the downstream platform and access road
Preventive or corrective actions to take	Remove the cement material from the surface
Priority level	P-3: Single occurrences of deficiencies or non-conformance that alone would not be expected to result in structure safety issues.
Observation date	2019-07-16

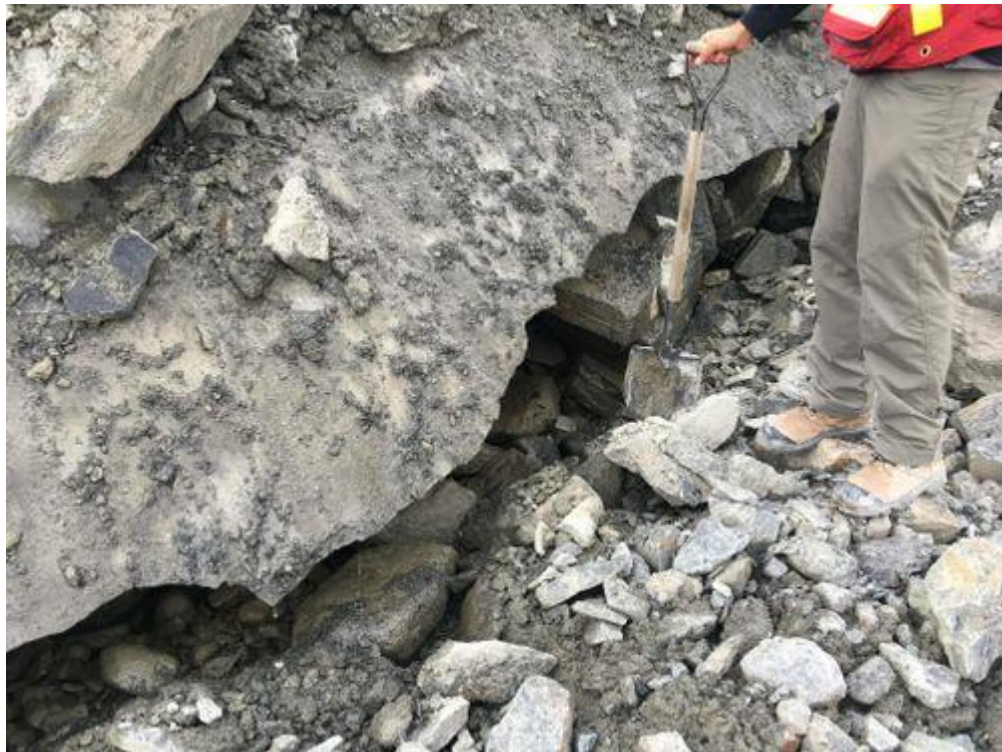
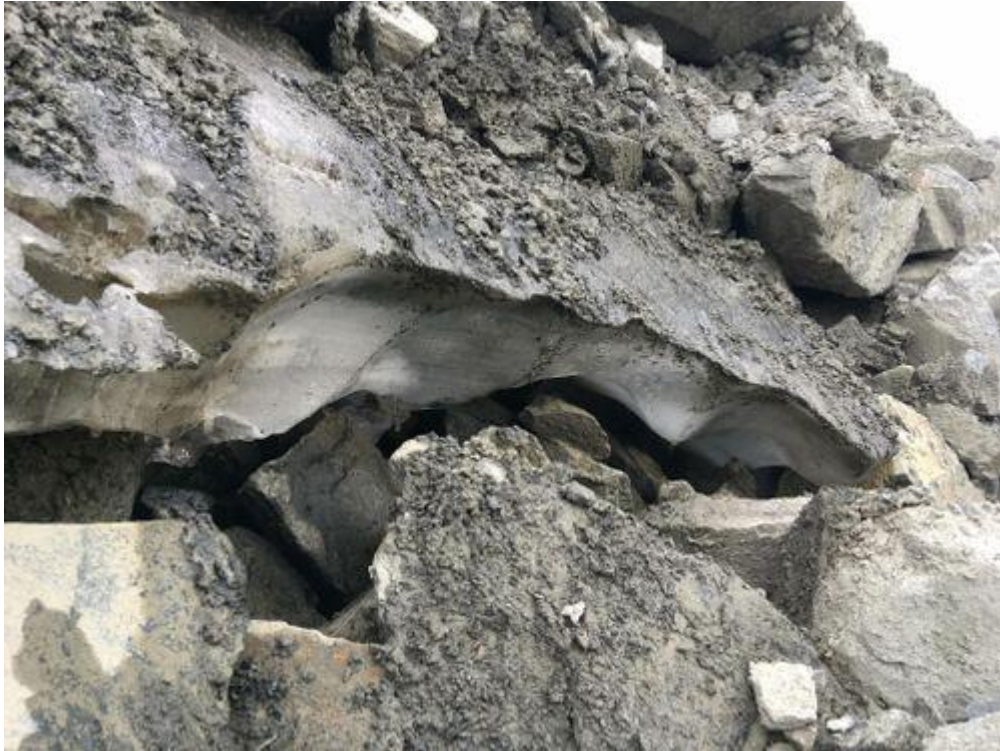
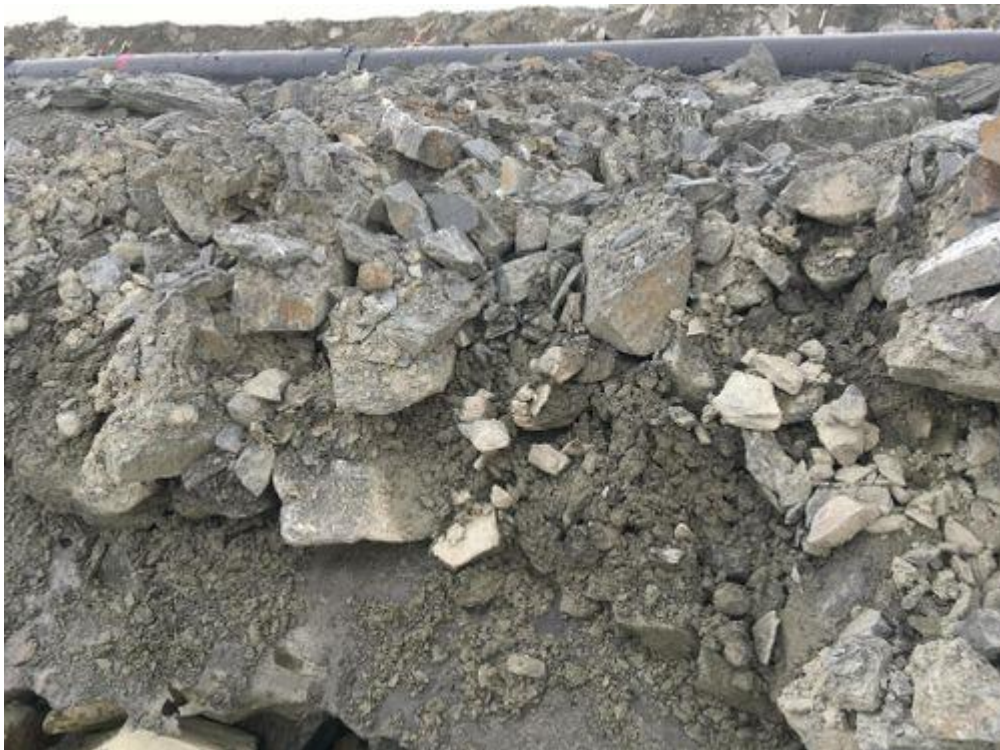
Observation 18

Location and component	Whale Tail Dike Downstream toe
Reported observation	Trapped snow
Preventive or corrective actions to take	Follow up settlement of the downstream platform due to snow melt close to the dewatering pipes
Priority level	P-4: Best Management Practice – further improvements are necessary to meet industry best practices or reduce potential risks.
Observation date	2019-07-16
