Whale Tail Project 2019 Annual Geotechnical Inspection

Final Report (Rev. 01)

Agnico Eagle Mines Limited

2019 | 12 | 16

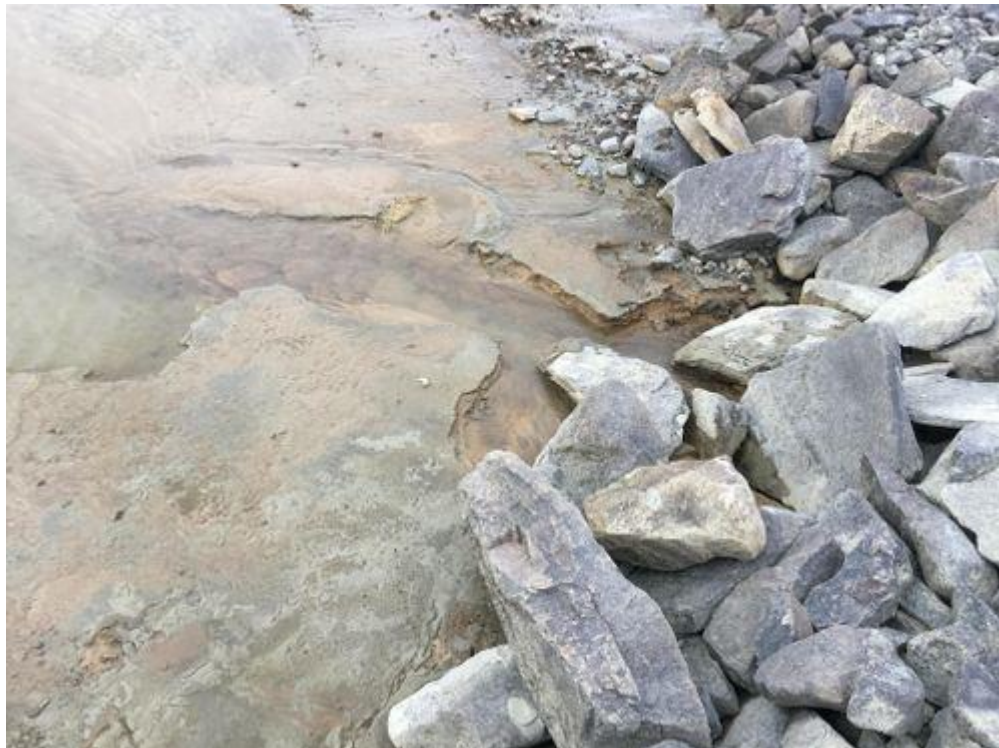
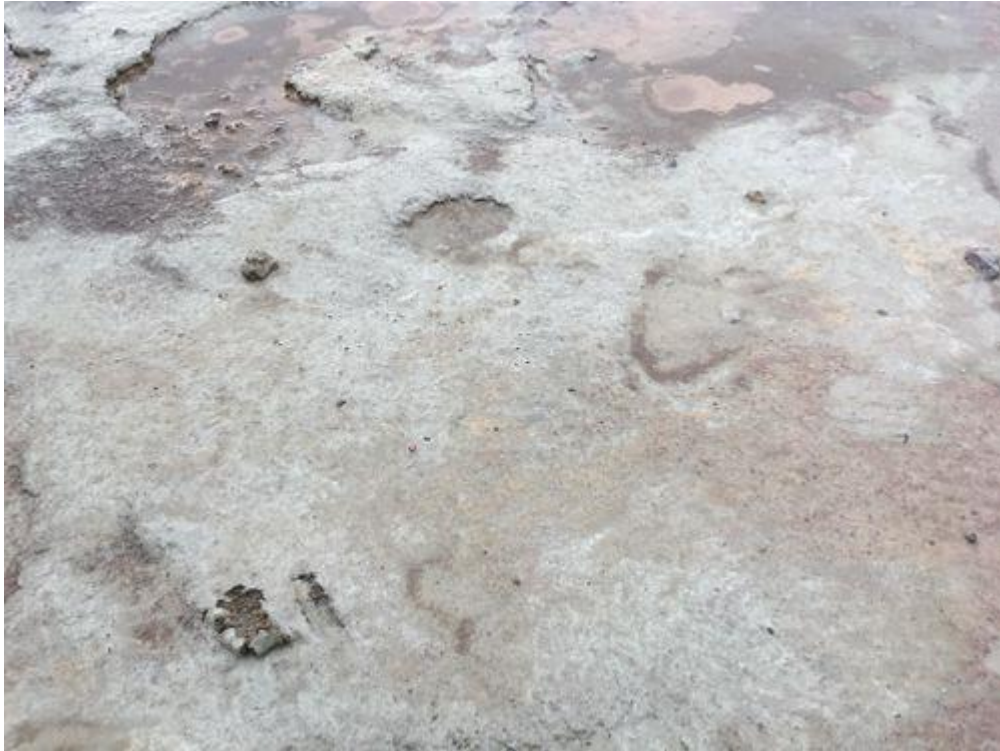
Observation 19

Location and component	Whale Tail Dike Downstream toe
Reported observation	Cement-like deposits close to seepage channels
Preventive or corrective actions to take	Take samples to identify if cement is flowing along seepage water or if there is any increase of total suspended solids with time
Priority level	P-2: If not corrected, could likely result in structure safety issues leading to injury, environmental impact, or significant regulatory enforcement; or a repetitive deficiency that demonstrates a systematic breakdown of procedures.
Observation date	2019-07-16

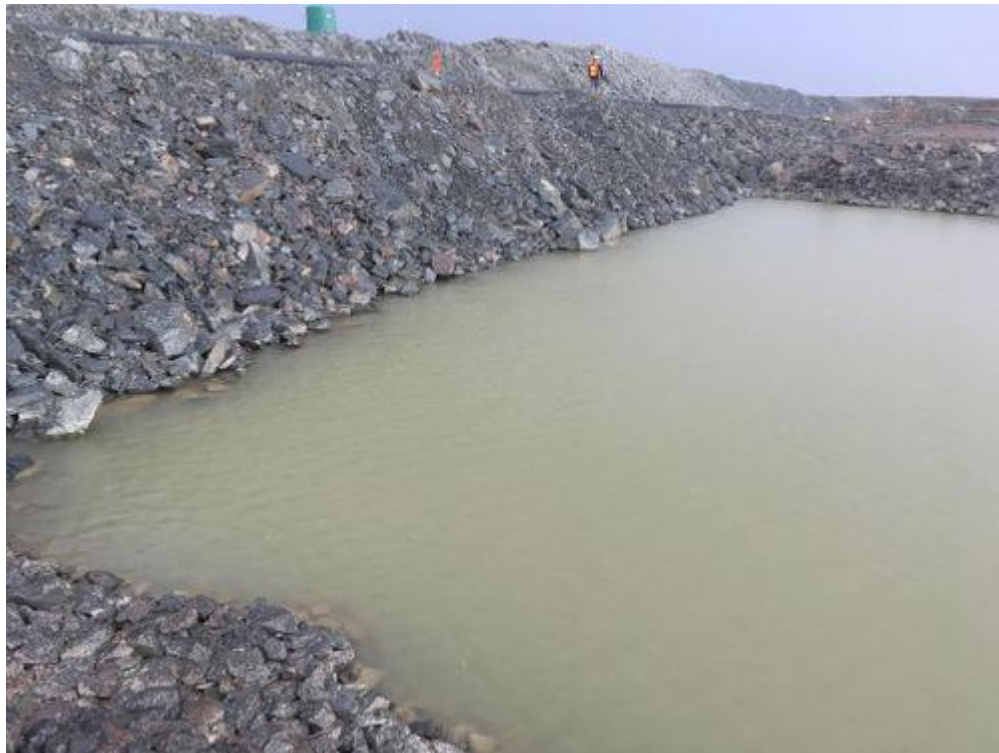
Observation 20

<p>DigitalGlobe, ... Powered by Esri</p>	<p>Location and component</p>	<p>Whale Tail Dike Downstream toe</p>
	<p>Reported observation</p>	<p>Seepage</p>
	<p>Preventive or corrective actions to take</p>	<p>Follow up seepage at 0+276 once the downstream water level drops</p>
	<p>Priority level</p>	<p>P-2: If not corrected, could likely result in structure safety issues leading to injury, environmental impact, or significant regulatory enforcement; or a repetitive deficiency that demonstrates a systematic breakdown of procedures.</p>
	<p>Observation date</p>	<p>2019-07-16</p>

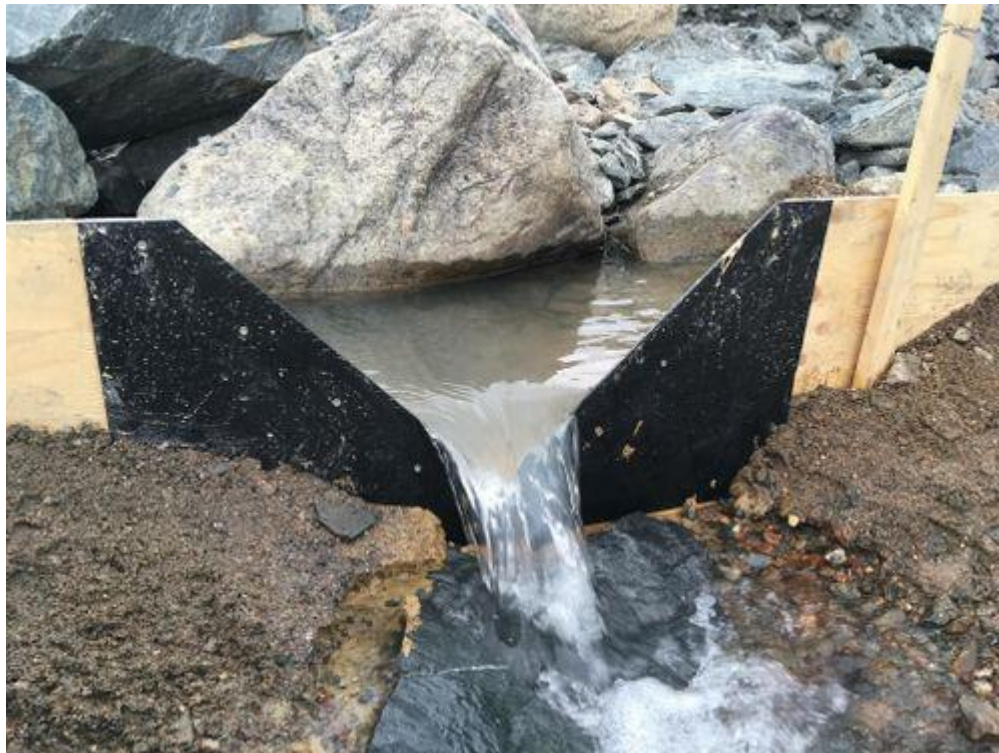
Observation 21

<p>DigitalGlobe, ... Powered by Esri</p>	Location and component	Whale Tail Dike Downstream toe
	Reported observation	Seepage monitoring using a V-notch weir
	Preventive or corrective actions to take	Continue seepage rate monitoring
	Priority level	P-2: If not corrected, could likely result in structure safety issues leading to injury, environmental impact, or significant regulatory enforcement; or a repetitive deficiency that demonstrates a systematic breakdown of procedures.
	Observation date	2019-07-16

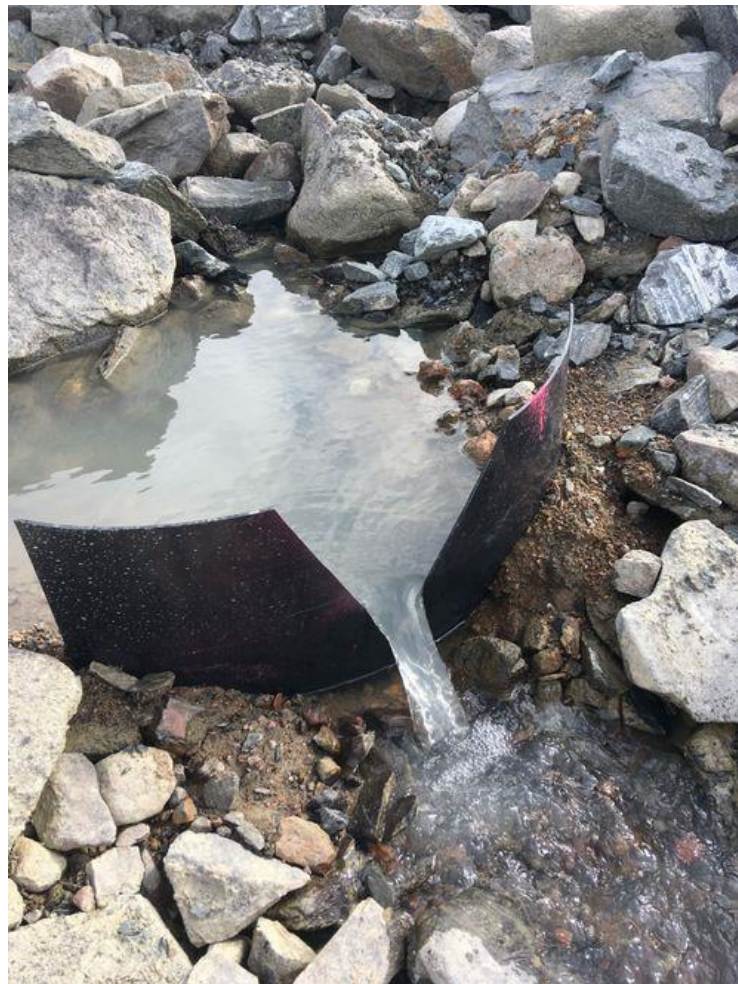
Observation 21

Location and component	Whale Tail Dike Downstream toe
Reported observation	Seepage monitoring using a V-notch weir
Preventive or corrective actions to take	Continue seepage rate monitoring
Priority level	P-2: If not corrected, could likely result in structure safety issues leading to injury, environmental impact, or significant regulatory enforcement; or a repetitive deficiency that demonstrates a systematic breakdown of procedures.
Observation date	2019-07-16

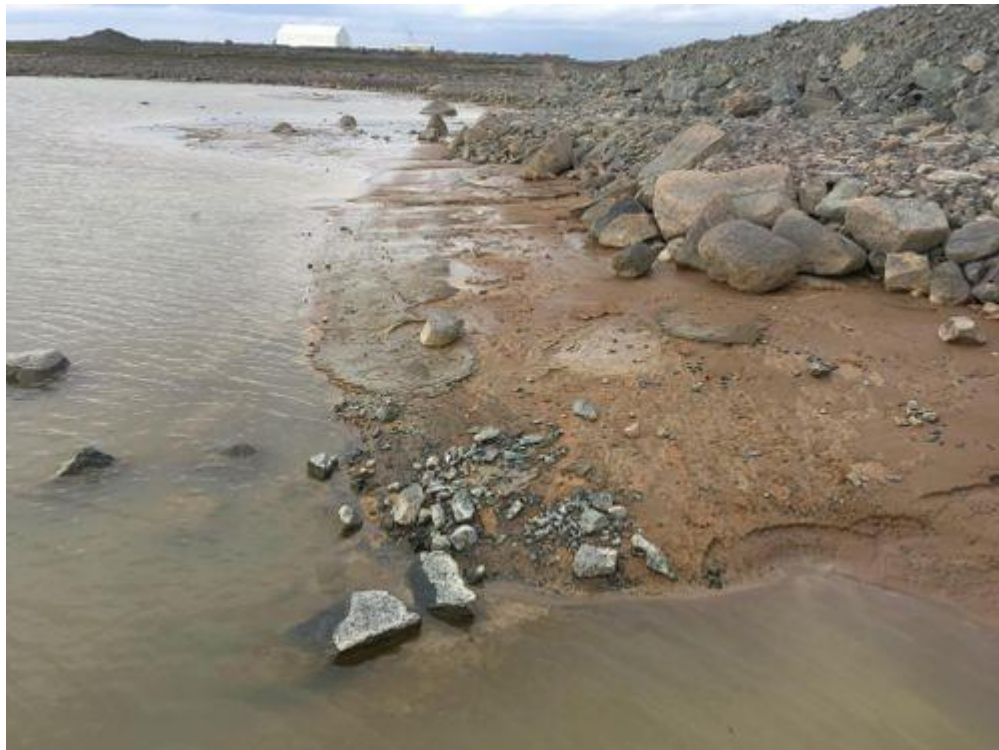
Observation 22

P-2:
If not corrected, could likely result in structure safety issues leading to injury, environmental impact, or significant regulatory enforcement; or a repetitive deficiency that demonstrates a systematic breakdown of procedures.

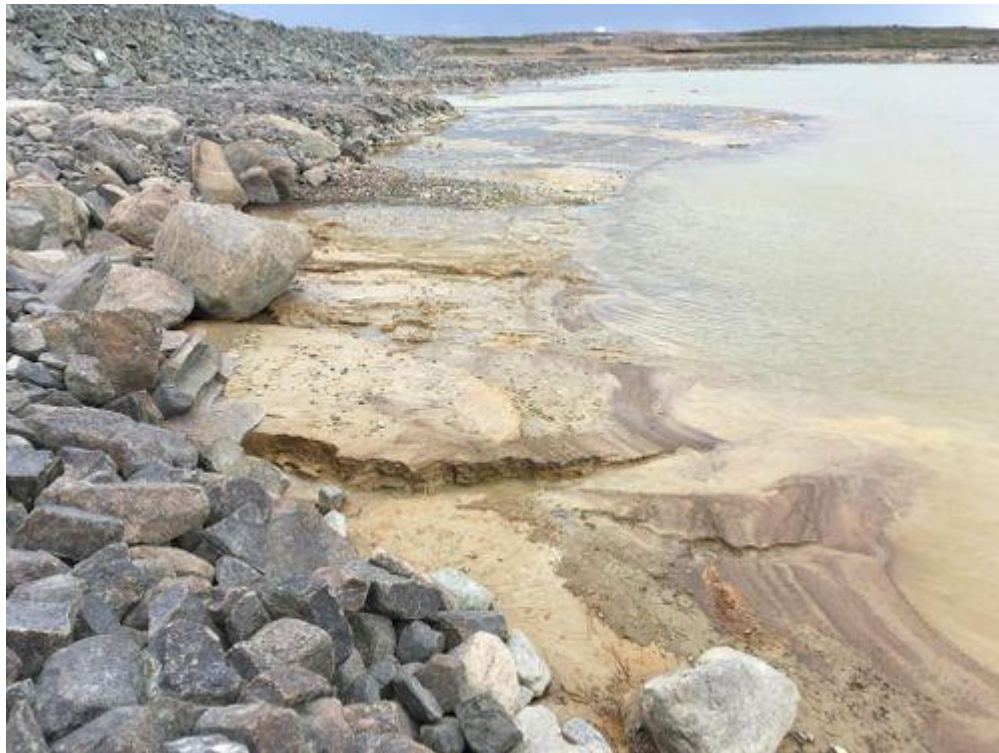
Observation 22

<p>DigitalGlobe, ... Powered by Esri</p>	<p>Location and component</p>	<p>Whale Tail Dike Seepage channels</p>
	<p>Reported observation</p>	<p>Seepage</p>
	<p>Preventive or corrective actions to take</p>	<p>Monitor minor channels to assess any change of seepage rate with time</p>
	<p>Priority level</p>	<p>P-2: If not corrected, could likely result in structure safety issues leading to injury, environmental impact, or significant regulatory enforcement; or a repetitive deficiency that demonstrates a systematic breakdown of procedures.</p>
	<p>Observation date</p>	<p>2019-07-16</p>

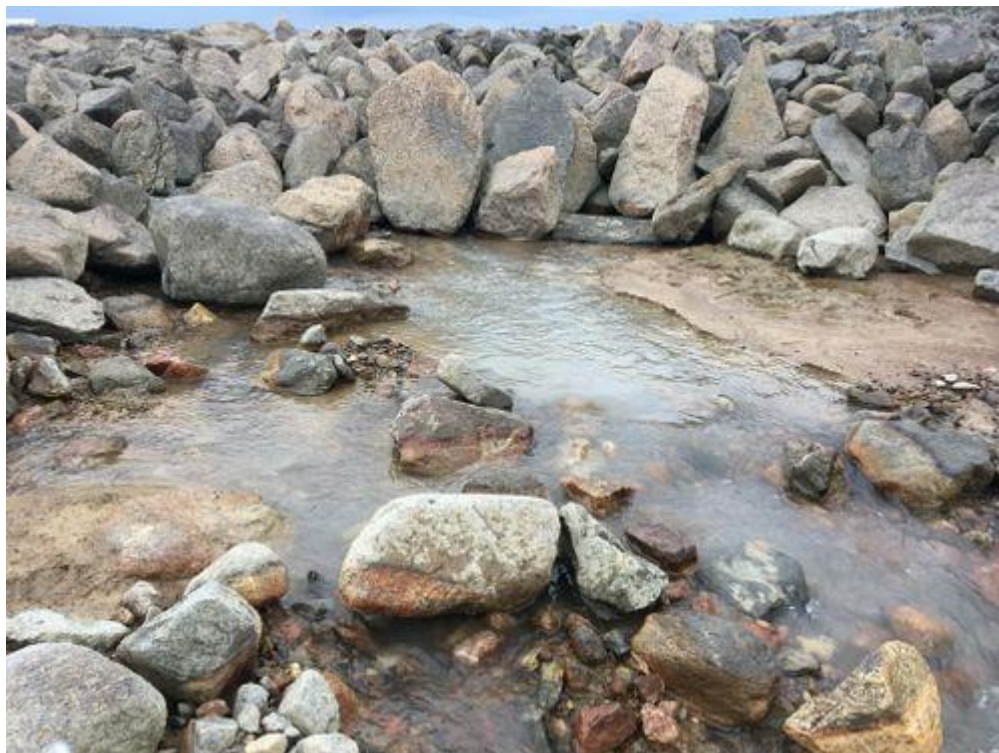
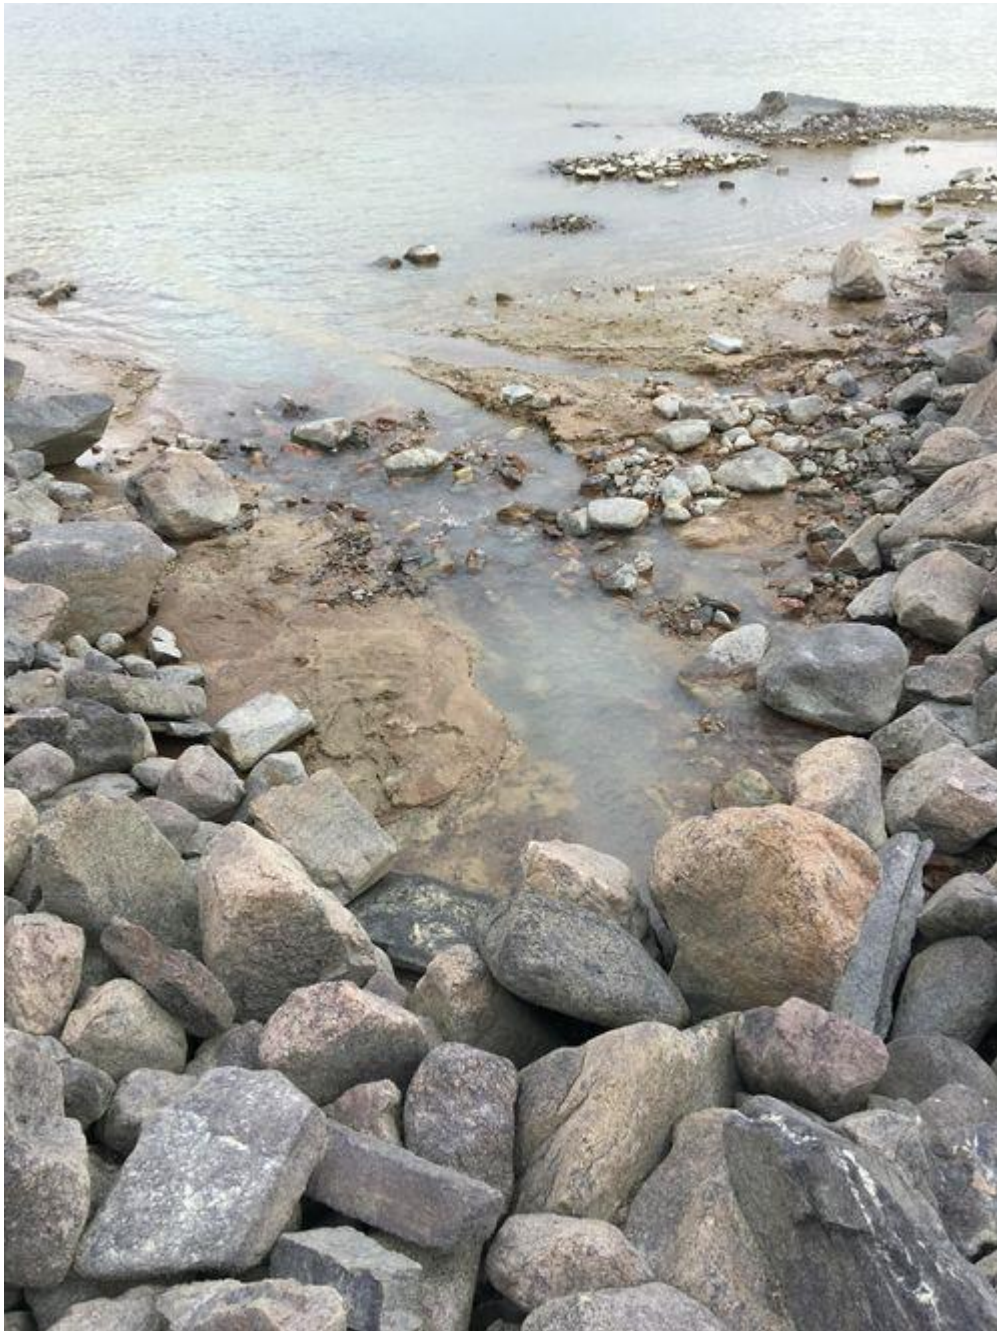
Observation 22

<p>DigitalGlobe, ... Powered by Esri</p>	<p>Location and component</p>	<p>Whale Tail Dike Seepage channels</p>
	<p>Reported observation</p>	<p>Seepage</p>
	<p>Preventive or corrective actions to take</p>	<p>Monitor seepage rates using a V-notch weir to assess if there are any changes with time</p>
	<p>Priority level</p>	<p>P-2: If not corrected, could likely result in structure safety issues leading to injury, environmental impact, or significant regulatory enforcement; or a repetitive deficiency that demonstrates a systematic breakdown of procedures.</p>
	<p>Observation date</p>	<p>2019-07-16</p>

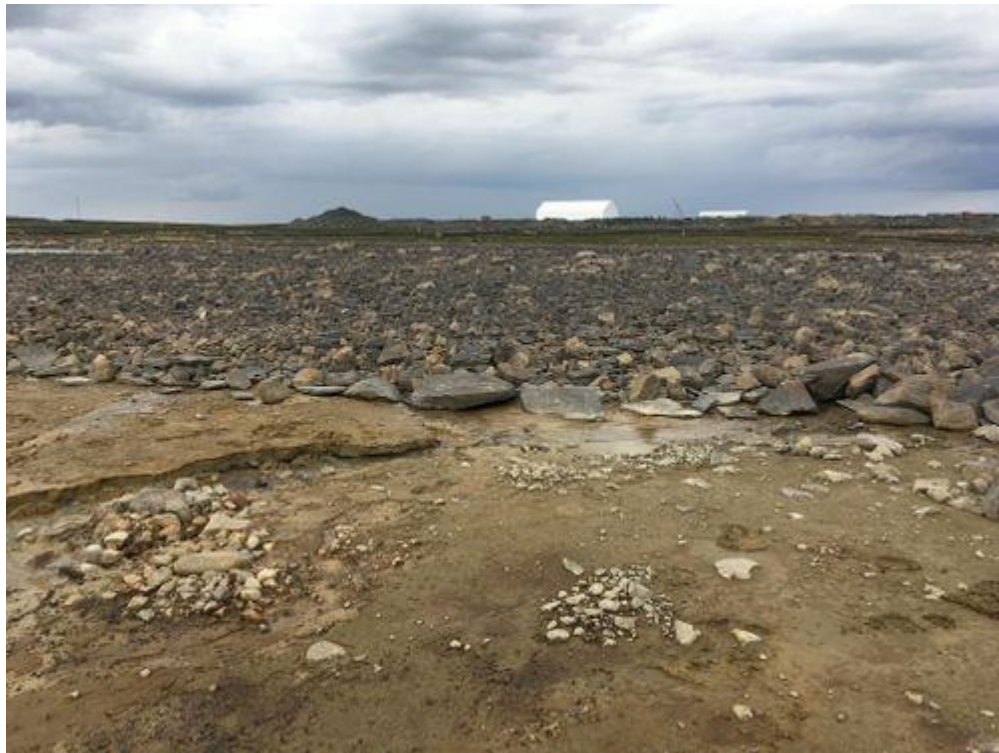
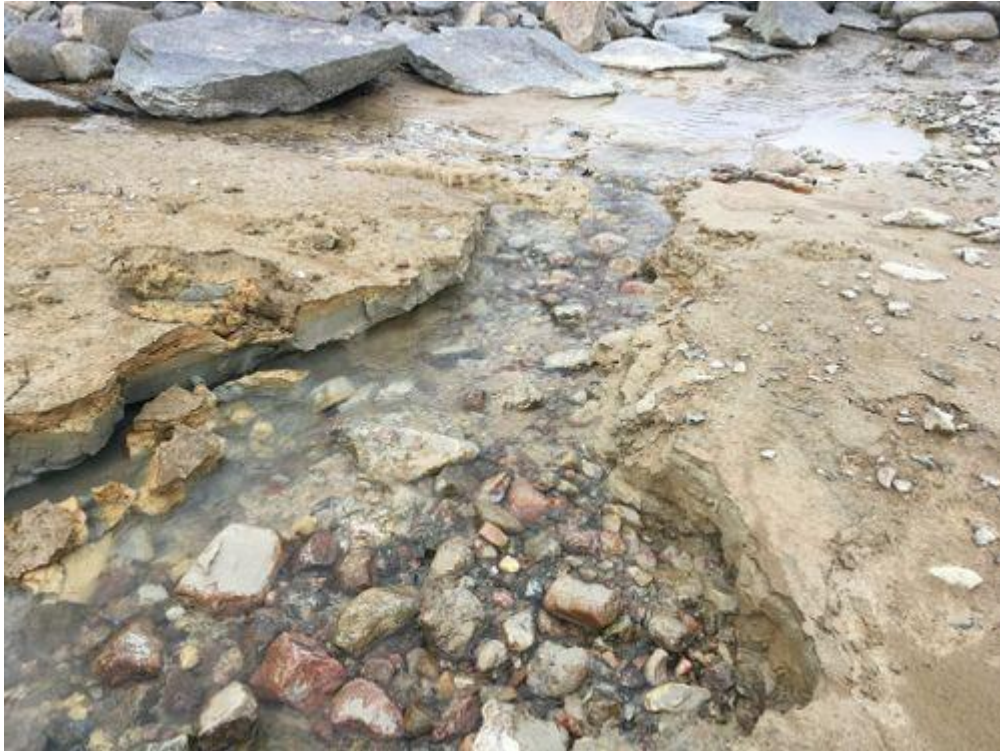
Observation 22

<p>DigitalGlobe, ... Powered by Esri</p>	Location and component	Whale Tail Dike Seepage channels
	Reported observation	Seepage
	Preventive or corrective actions to take	Install V-notch weirs at the principal channels to monitor seepage rate
	Priority level	P-2: If not corrected, could likely result in structure safety issues leading to injury, environmental impact, or significant regulatory enforcement; or a repetitive deficiency that demonstrates a systematic breakdown of procedures.
	Observation date	2019-07-16

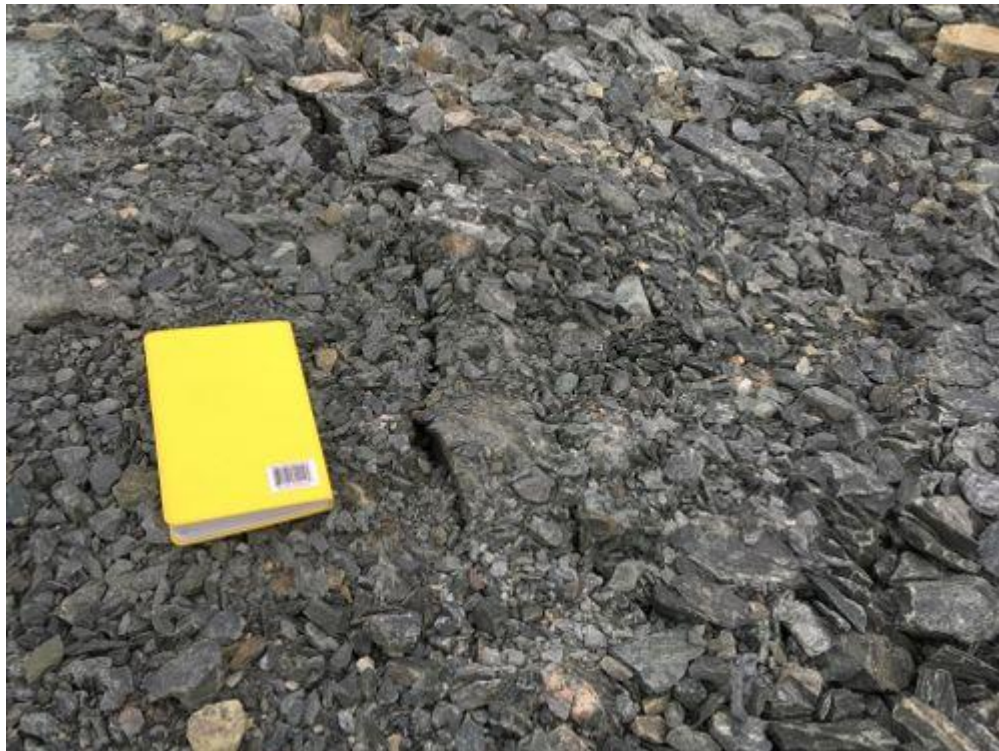
Observation 23

Location and component	North East Dike Upstream platform
Reported observation	Cracking
Preventive or corrective actions to take	Monitor any cracking evolution, reprofile if required
Priority level	P-4: Best Management Practice – further improvements are necessary to meet industry best practices or reduce potential risks.
Observation date	2019-07-18

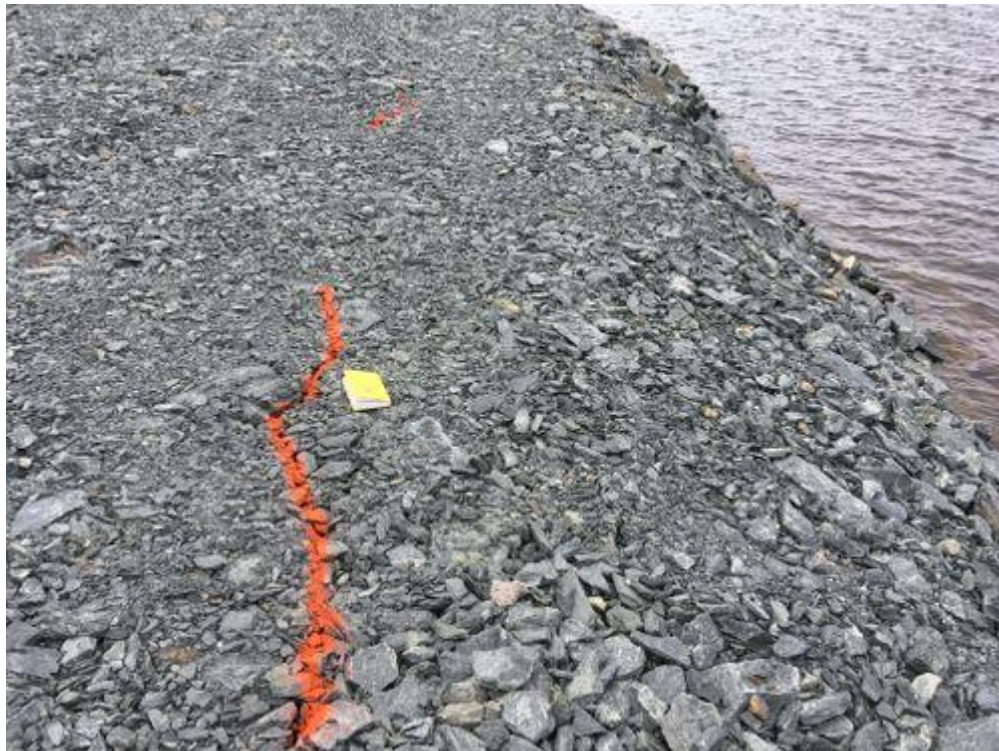
Observation 23

Location and component	North East Dike Upstream platform
Reported observation	Cracking
Preventive or corrective actions to take	Monitor any cracking evolution, reprofile if required
Priority level	P-4: Best Management Practice – further improvements are necessary to meet industry best practices or reduce potential risks.
Observation date	2019-07-17

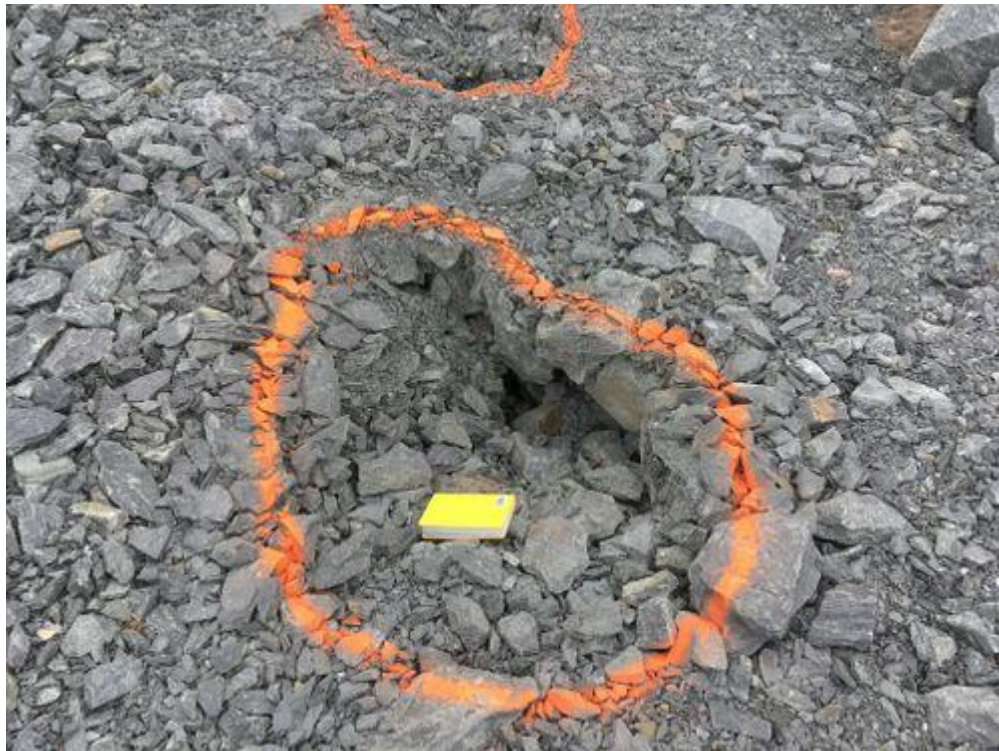
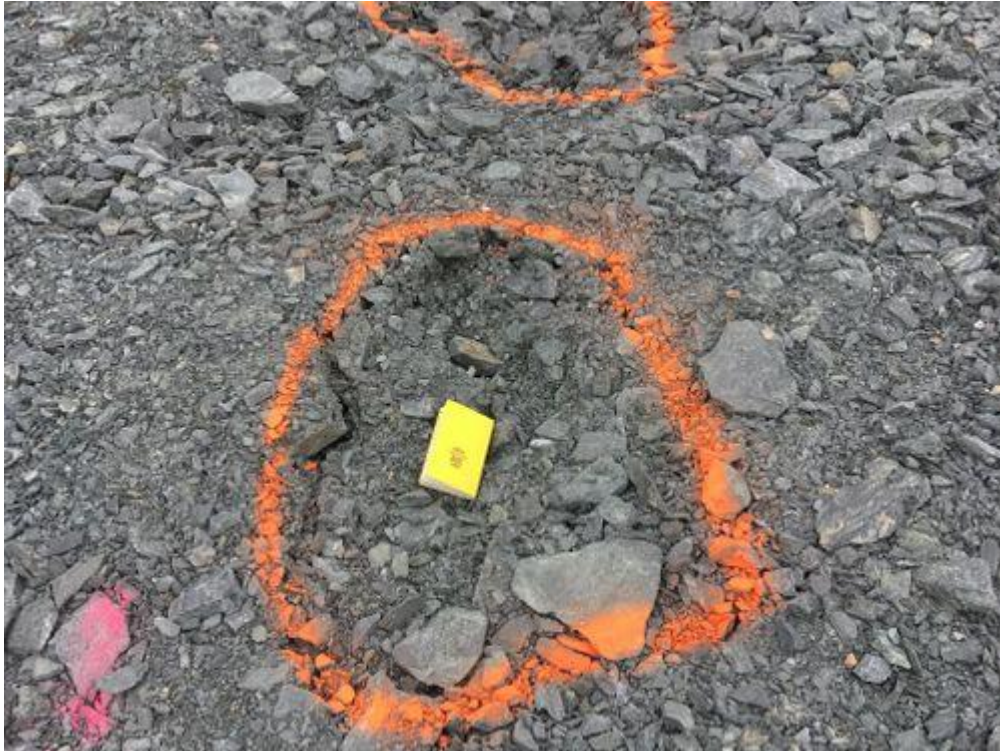
Observation 24

Location and component	North East Dike Upstream platform
Reported observation	Sink holes
Preventive or corrective actions to take	Add rockfill material to fill the holes and continue monitoring at that location
Priority level	P-3: Single occurrences of deficiencies or non-conformance that alone would not be expected to result in structure safety issues.
Observation date	2019-07-17

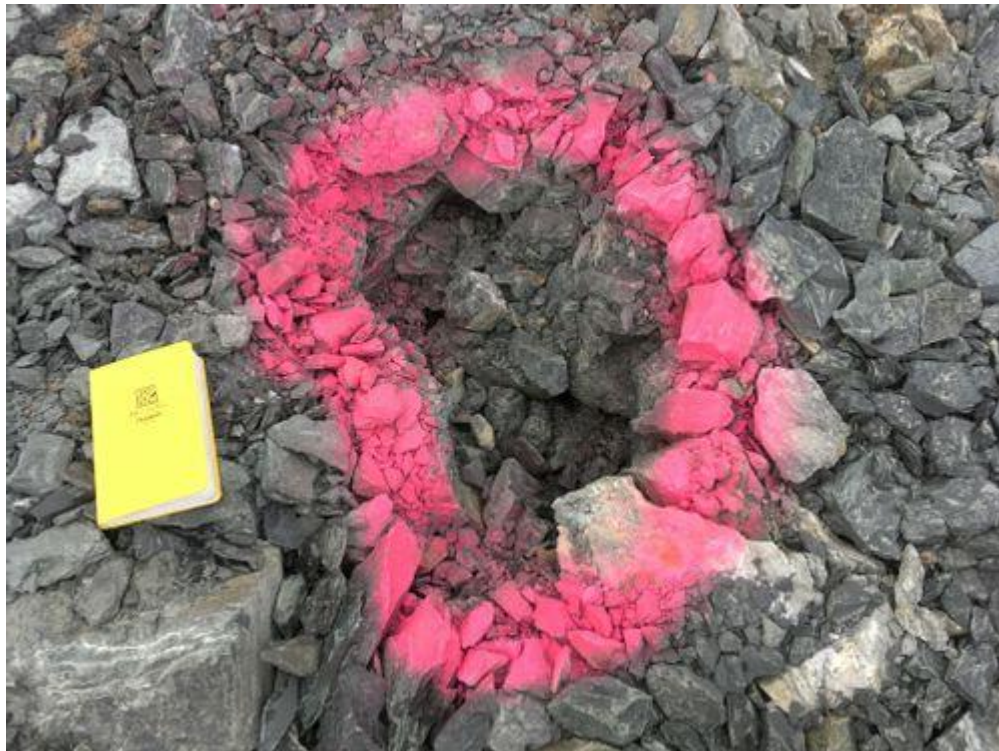
Observation 25

Location and component	North East Dike Upstream platform
Reported observation	Potholes
Preventive or corrective actions to take	Monitor potholes, reprofile the crest if required
Priority level	P-4: Best Management Practice – further improvements are necessary to meet industry best practices or reduce potential risks.
Observation date	2019-07-18

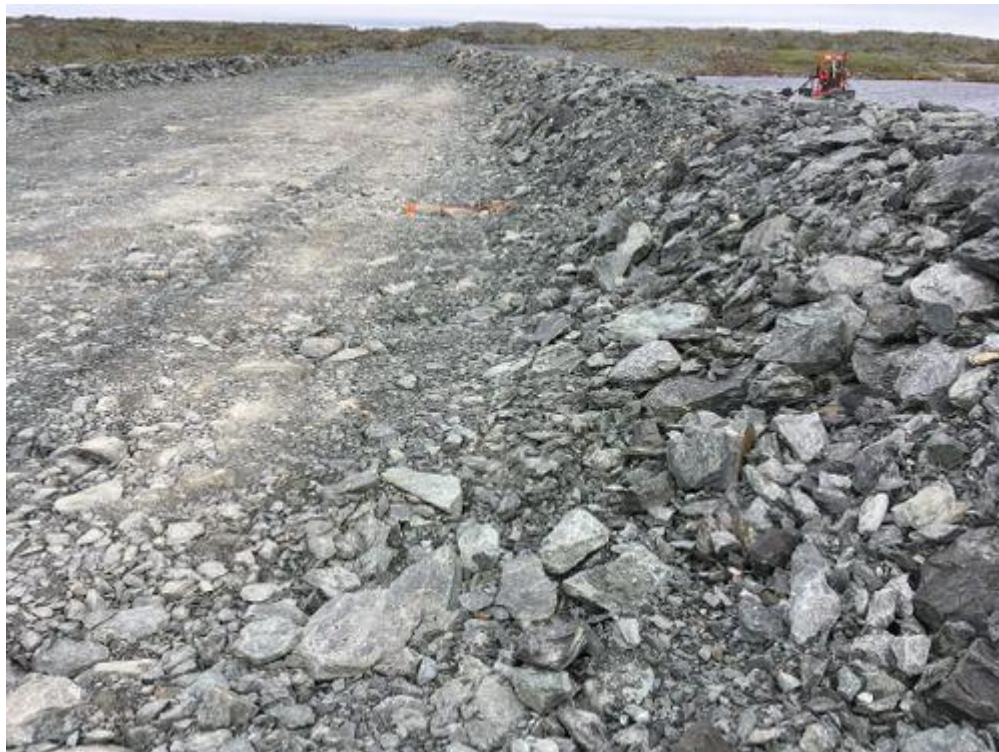
Observation 26

Location and component	North East Dike Crest
	Reported observation	Settlement close to the upstream safety berm
	Preventive or corrective actions to take	Review as-built survey and confirm that little or no deformations occur in the area the geomembrane is installed
	Priority level	P-3: Single occurrences of deficiencies or non-conformance that alone would not be expected to result in structure safety issues.
	Observation date	2019-07-18

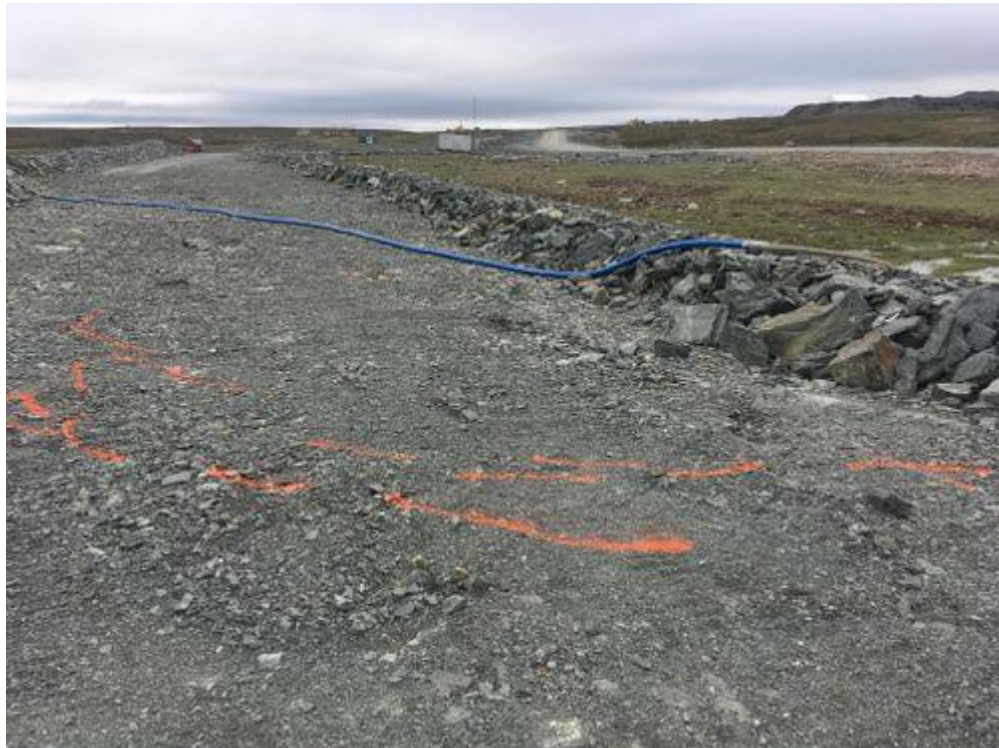
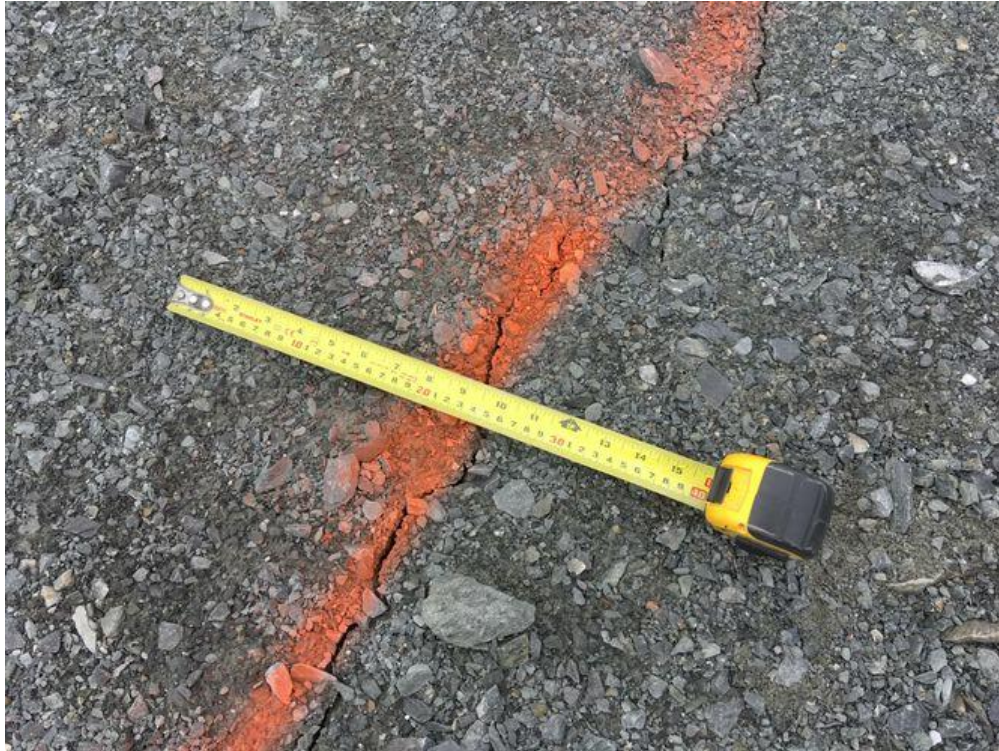
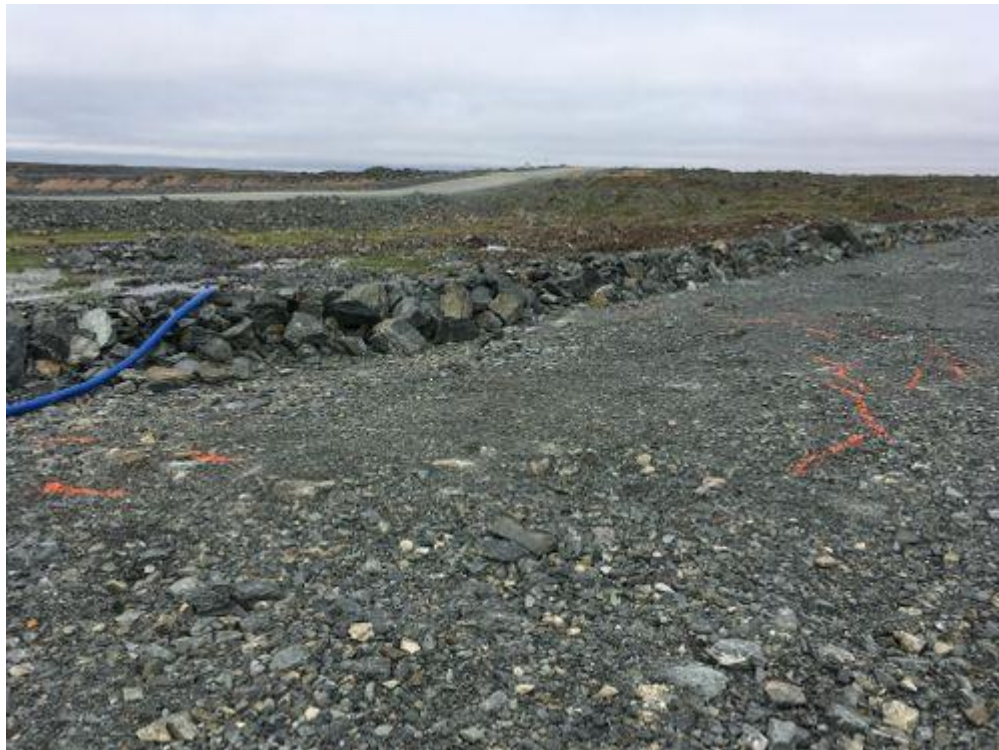
Observation 28

<p>DigitalGlobe, ... Powered by Esri</p>	Location and component	North East Dike Crest
	Reported observation	Circular network of cracks located where water is ponding at the downstream toe
	Preventive or corrective actions to take	Cracking observed on a pattern of approximately 17 m x 7 m; promote drainage at the toe area, monitor for any evolution of the settlement and reprofile if required
	Priority level	P-3: Single occurrences of deficiencies or non-conformance that alone would not be expected to result in structure safety issues.
	Observation date	2019-07-18

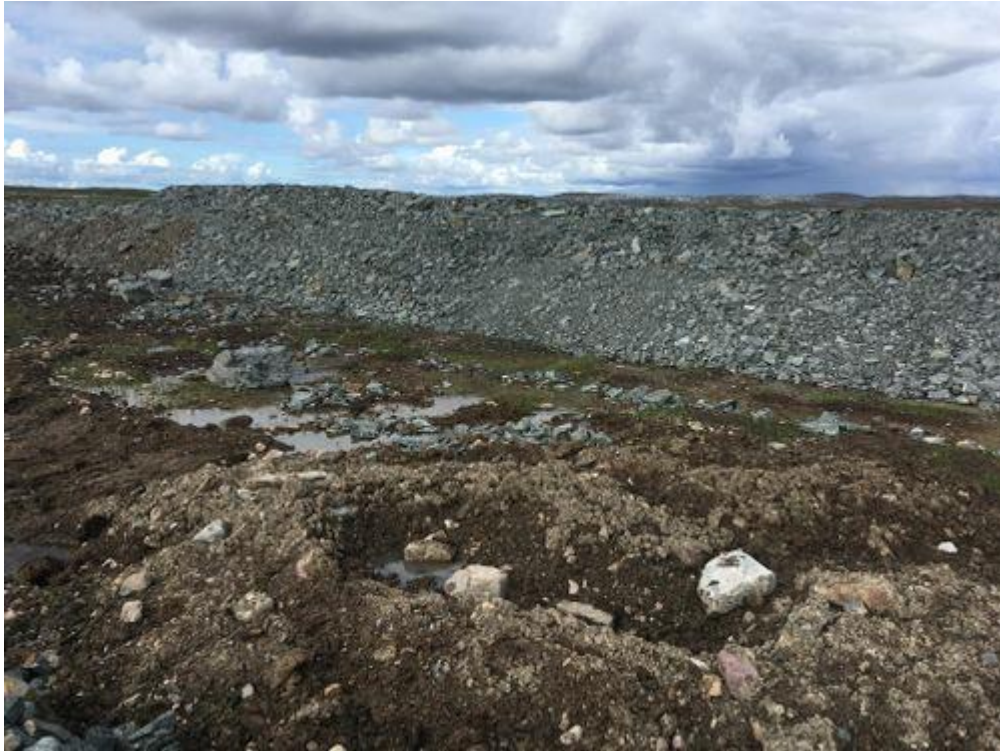
Observation 30

Location and component	North East Dike Downstream toe
Reported observation	Water ponding
Preventive or corrective actions to take	Promote drainage away from the toe and monitor for any sign of seepage
Priority level	P-3: Single occurrences of deficiencies or non-conformance that alone would not be expected to result in structure safety issues.
Observation date	2019-07-18

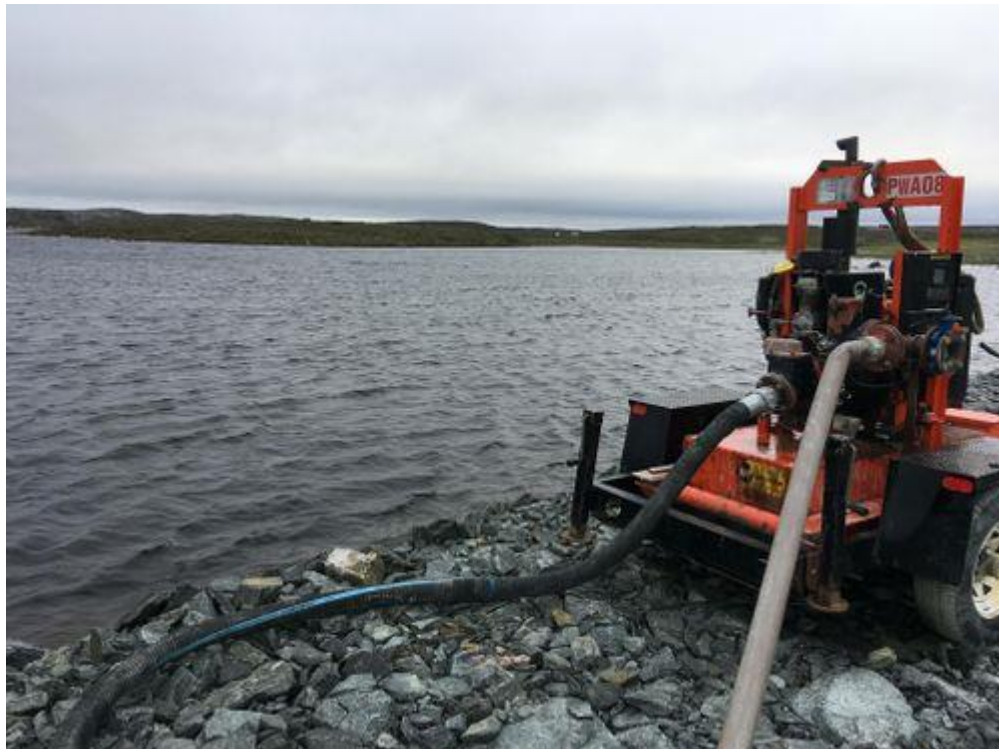
Observation 31

<p>DigitalGlobe, ... Powered by Esri</p>	Location and component	North East Dike Upstream water level
	Reported observation	Unknown water level
	Preventive or corrective actions to take	Water was pumped from the upstream to the downstream by the time of the inspection. A stake showing the operational and maximum water levels shall be installed to monitor the water level in real time
	Priority level	P-4: Best Management Practice – further improvements are necessary to meet industry best practices or reduce potential risks.
	Observation date	2019-07-18

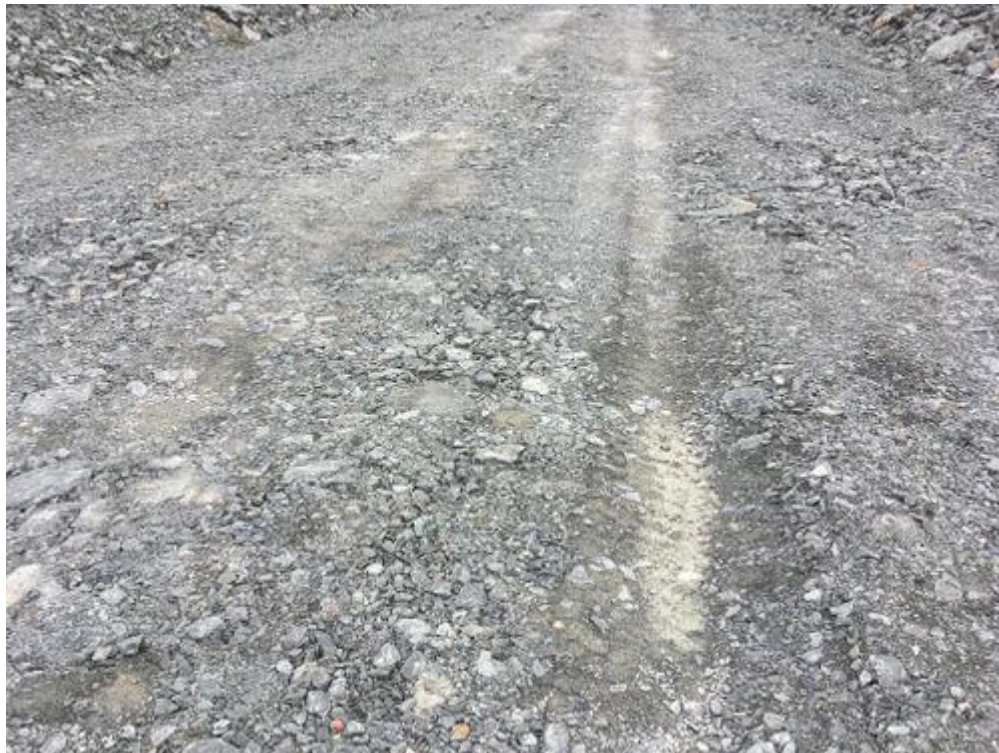
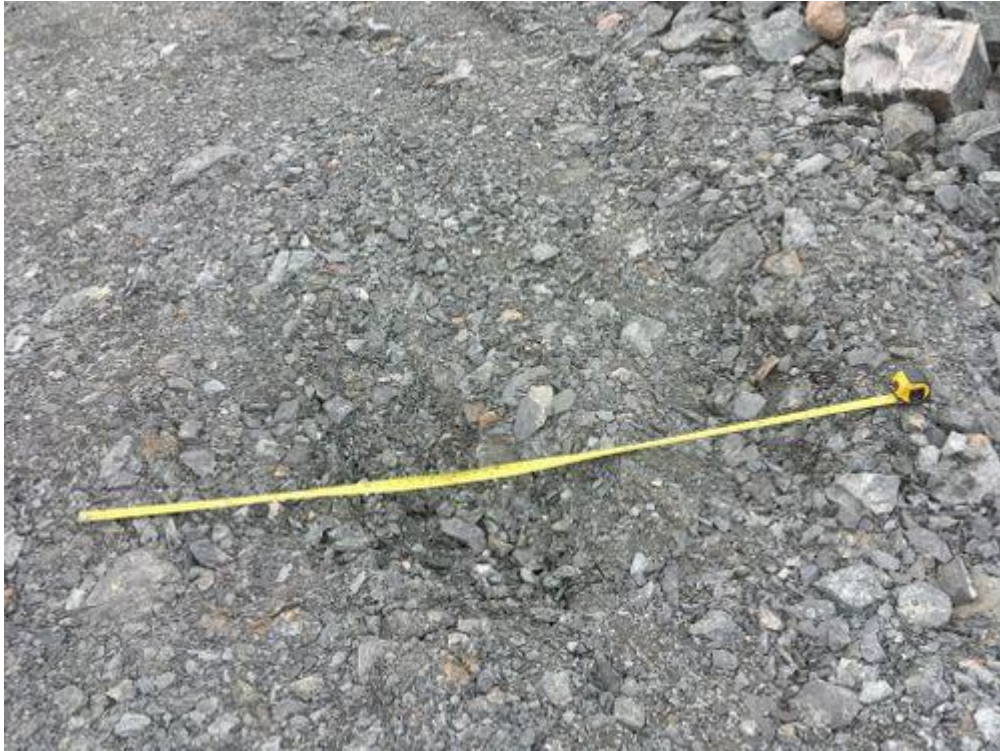
Observation 32

Location and component	WRSF Dike Crest
Reported observation	Minor deformations
Preventive or corrective actions to take	Monitor deformations and reprofile if required
Priority level	P-4: Best Management Practice – further improvements are necessary to meet industry best practices or reduce potential risks.
Observation date	2019-07-17

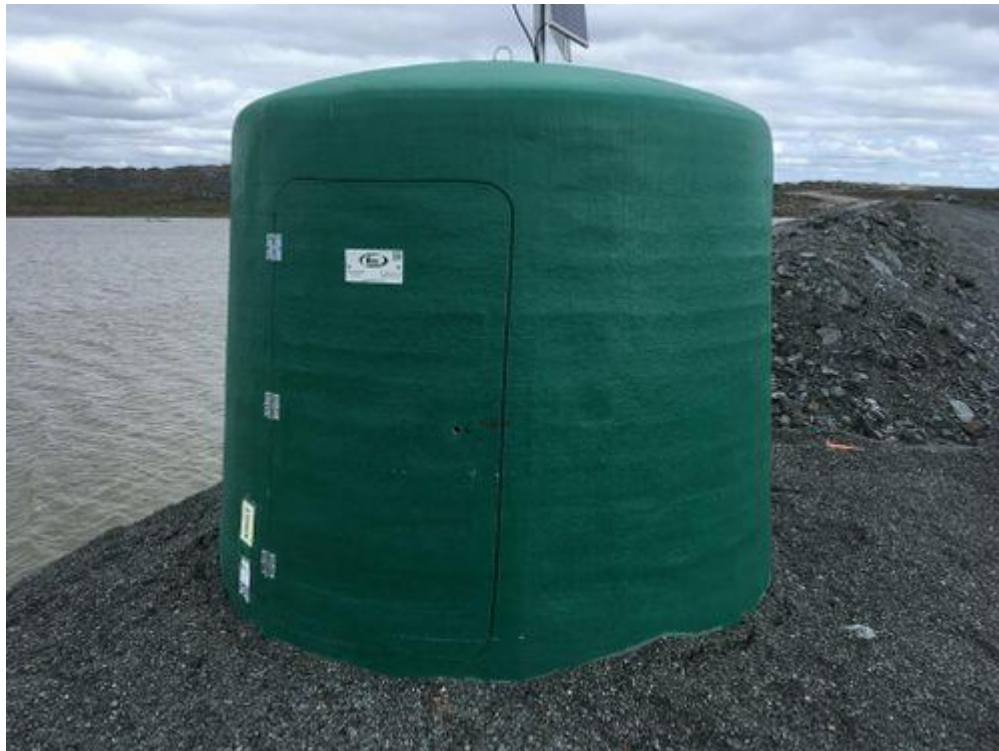
Observation 34

Location and component	WRSF Dike Instrumentation shelter
Reported observation	Missing a handle
Preventive or corrective actions to take	Add a handle to properly secure the door
Priority level	P-4: Best Management Practice – further improvements are necessary to meet industry best practices or reduce potential risks.
Observation date	2019-07-17

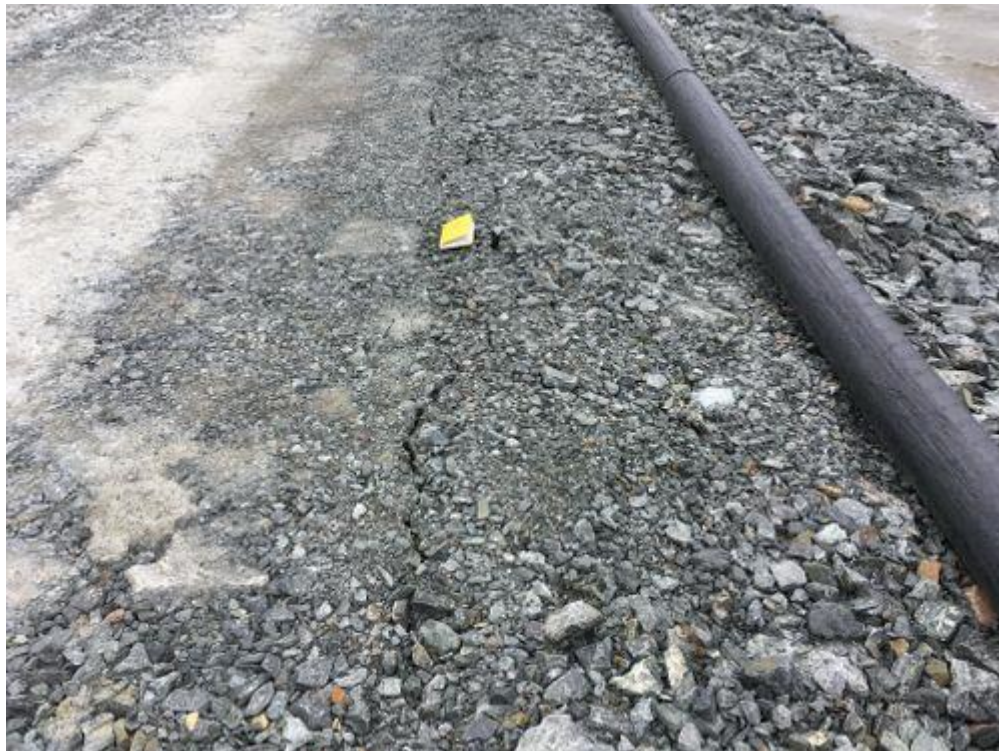
Observation 35

Location and component	WRSF Dike Upstream platform
Reported observation	Cracking
Preventive or corrective actions to take	Monitor cracking along the pipe and reprofile if required
Priority level	P-4: Best Management Practice – further improvements are necessary to meet industry best practices or reduce potential risks.
Observation date	2019-07-17
