Whale Tail Project 2019 Annual Geotechnical Inspection

Final Report (Rev. 01)

Agnico Eagle Mines Limited

2019 | 12 | 16

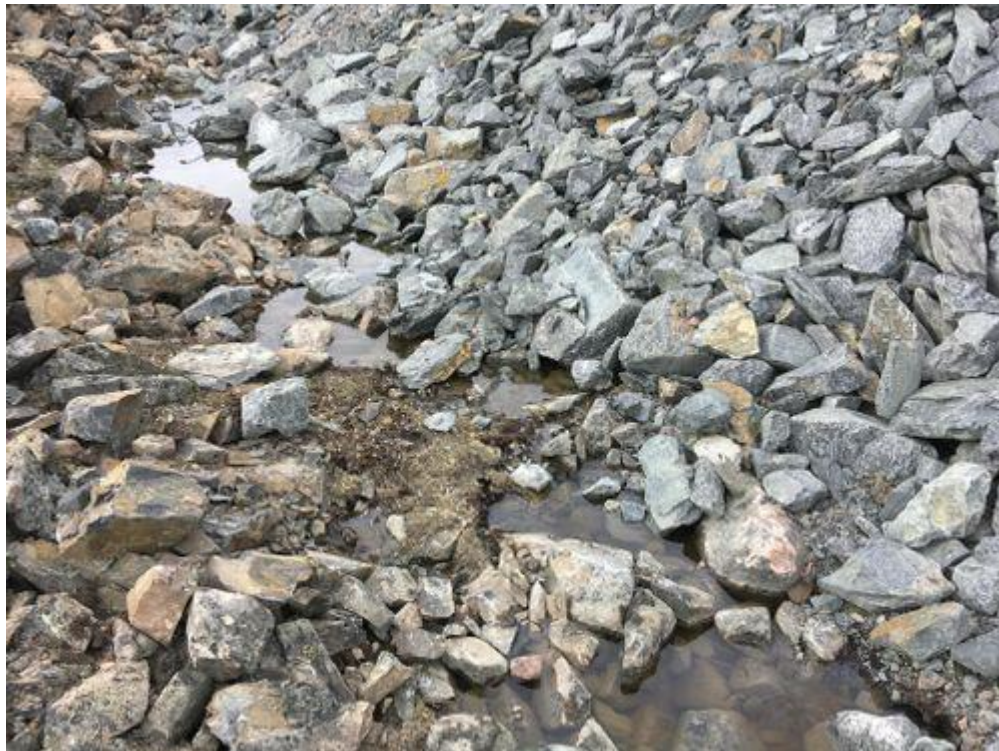
Observation 39

Location and component	WRSF Dike Downstream toe
Reported observation	No evidence of any seepage in the water ponding downstream
Preventive or corrective actions to take	Monitor water ponding for any signs of seepage water
Priority level	P-3: Single occurrences of deficiencies or non-conformance that alone would not be expected to result in structure safety issues.
Observation date	2019-07-17

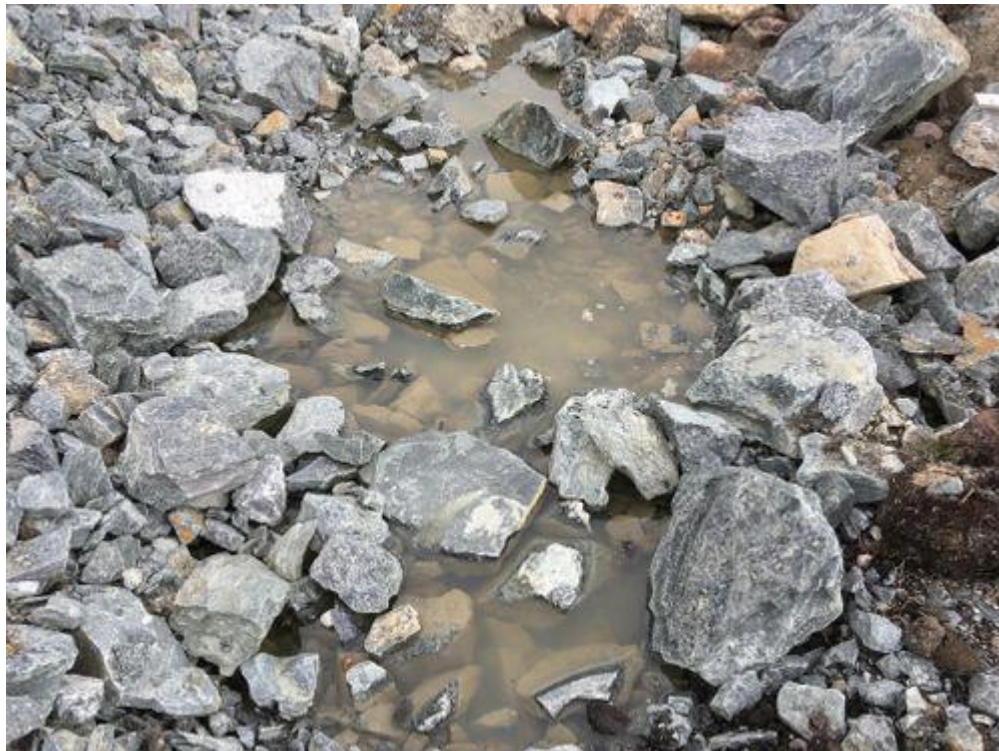
Observation 39

Location and component	WRSF Dike Downstream toe
Reported observation	Water ponding
Preventive or corrective actions to take	Promote drainage away from the toe and monitor for any sign of seepage
Priority level	P-3: Single occurrences of deficiencies or non-conformance that alone would not be expected to result in structure safety issues.
Observation date	2019-07-17

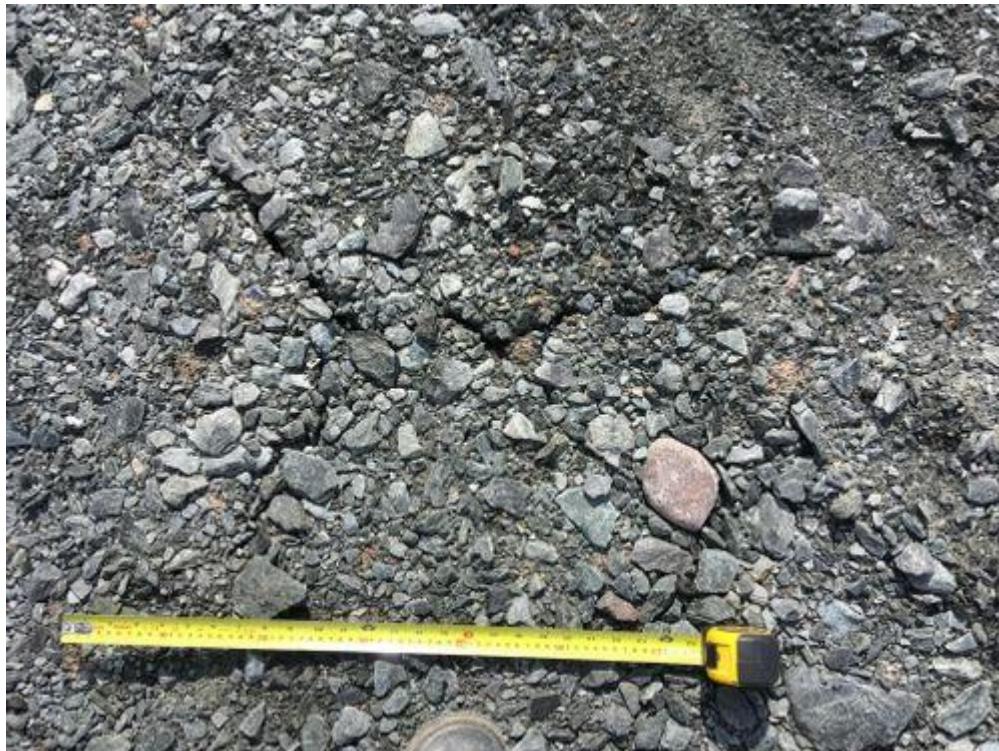
Observation 42

Location and component	Mammoth Dike Crest
Reported observation	Cracking
Preventive or corrective actions to take	Monitor any cracking evolution, reprofile if required
Priority level	P-4: Best Management Practice – further improvements are necessary to meet industry best practices or reduce potential risks.
Observation date	2019-07-17

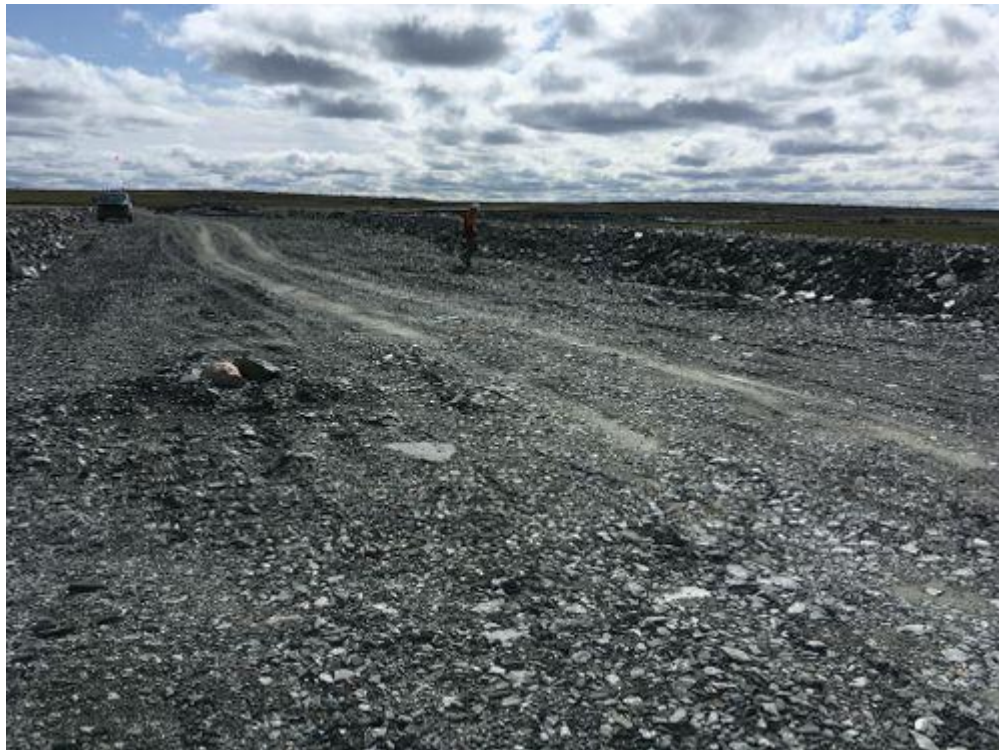
Observation 43

<p>DigitalGlobe, ... Powered by Esri</p>	Location and component	Mammoth Dike Crest
	Reported observation	Slightly uneven surface
	Preventive or corrective actions to take	As the crest is not used as a road, continue monitoring deformations of the crest periodically and reprofile if required
	Priority level	P-4: Best Management Practice – further improvements are necessary to meet industry best practices or reduce potential risks.
	Observation date	2019-07-17

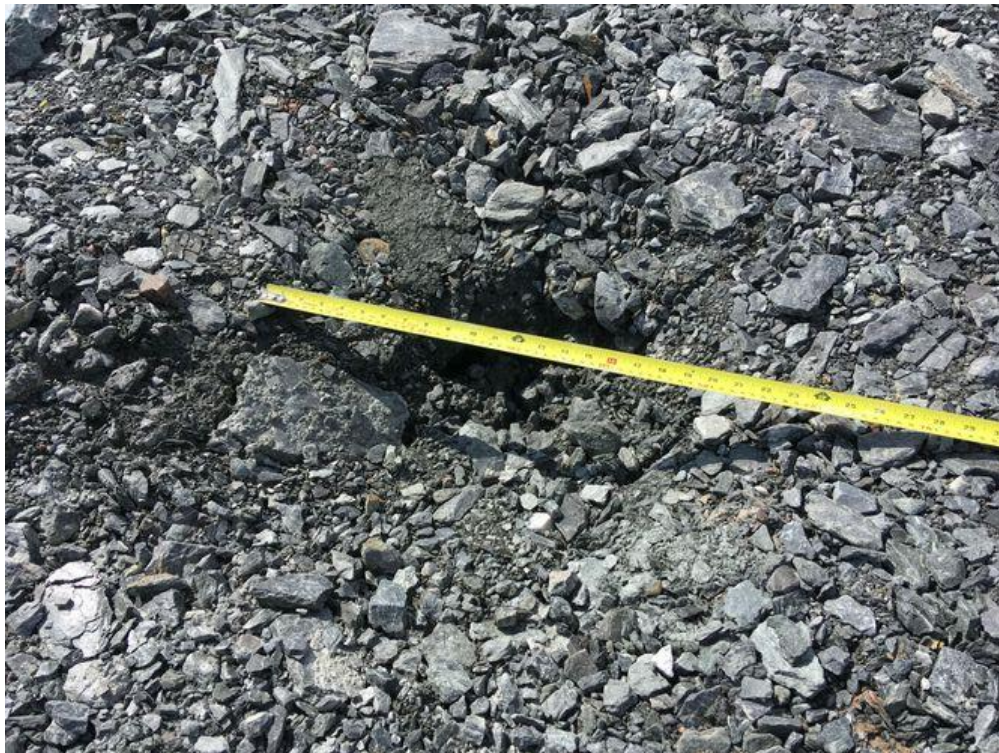
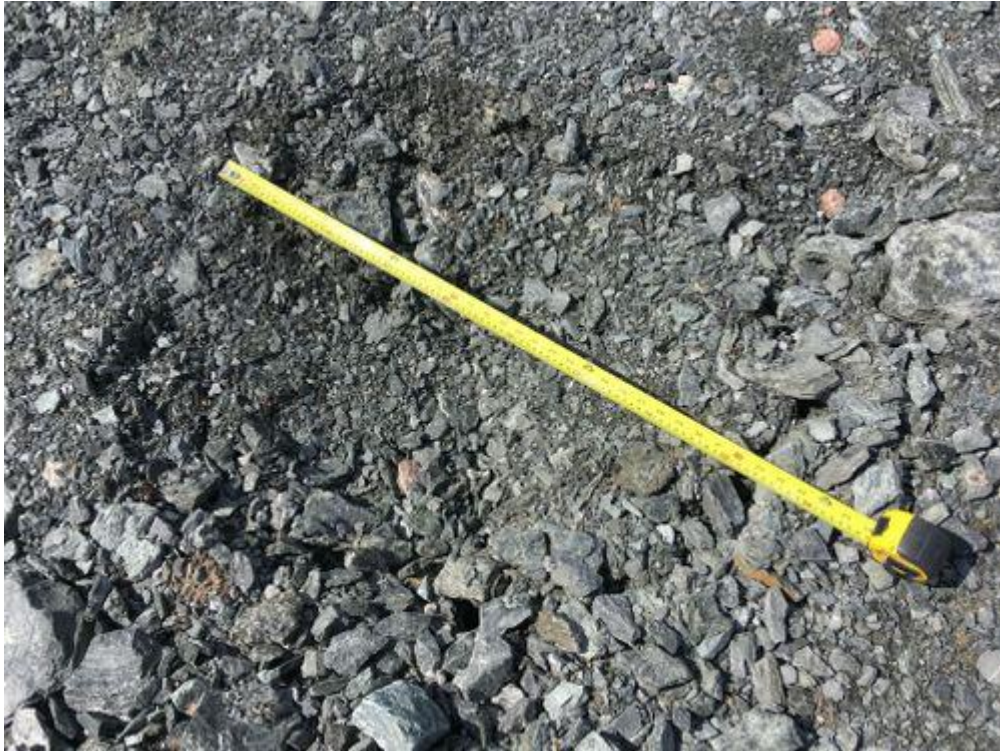
Observation 44

Location and component	Mammoth Dike Crest
Reported observation	Potholes
Preventive or corrective actions to take	Monitor potholes, reprofile the crest if required
Priority level	P-4: Best Management Practice – further improvements are necessary to meet industry best practices or reduce potential risks.
Observation date	2019-07-17

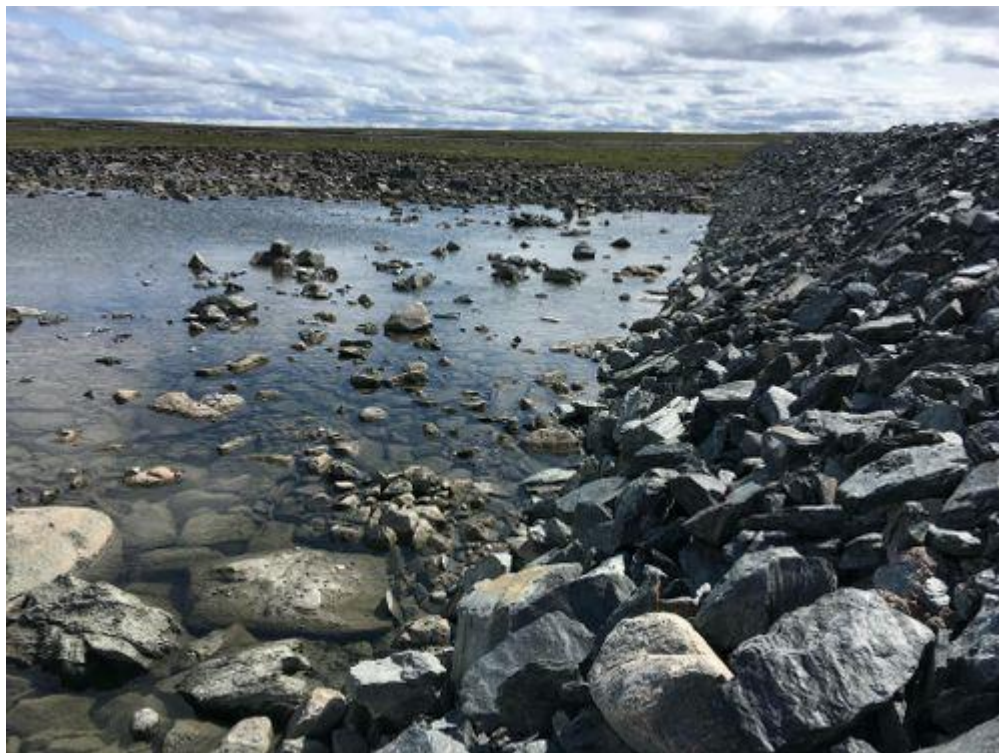
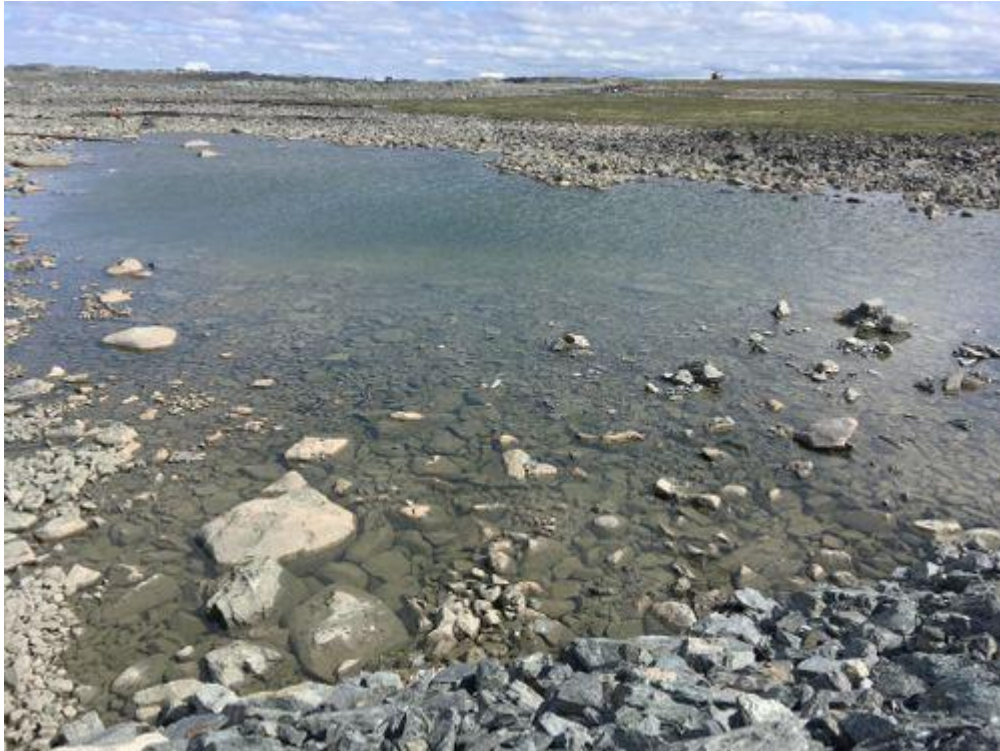
Observation 46

Location and component	Mammoth Dike Downstream toe
Reported observation	Water ponding
Preventive or corrective actions to take	Dry the downstream area of Mammoth Dike by pumping the water out
Priority level	P-3: Single occurrences of deficiencies or non-conformance that alone would not be expected to result in structure safety issues.
Observation date	2019-07-17

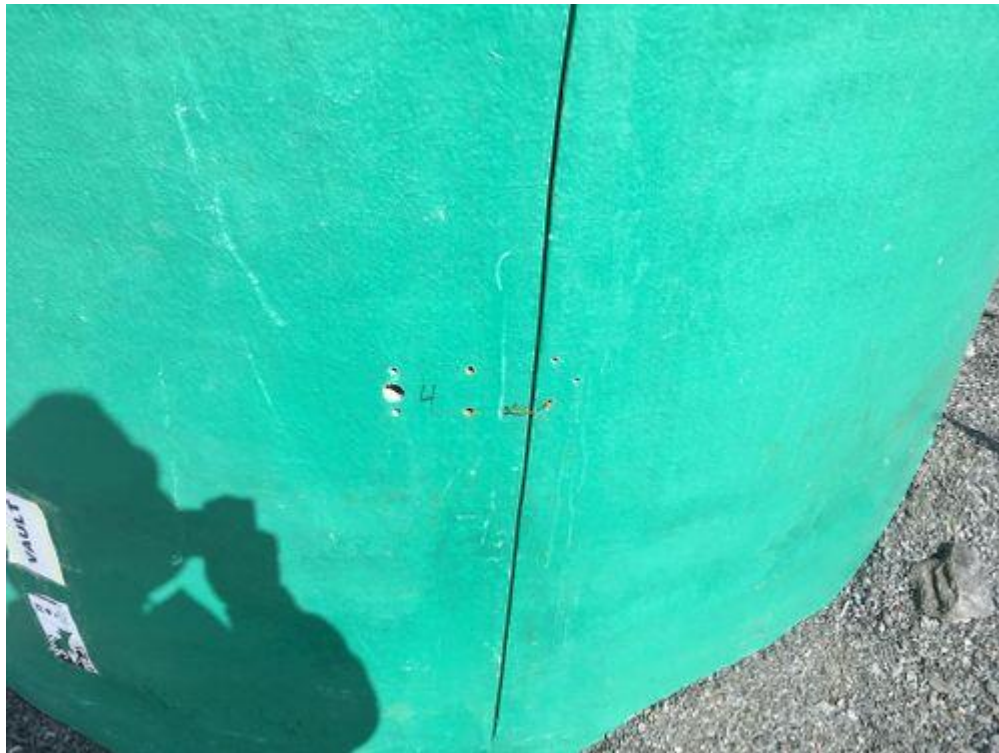
Observation 48

Missing a handle

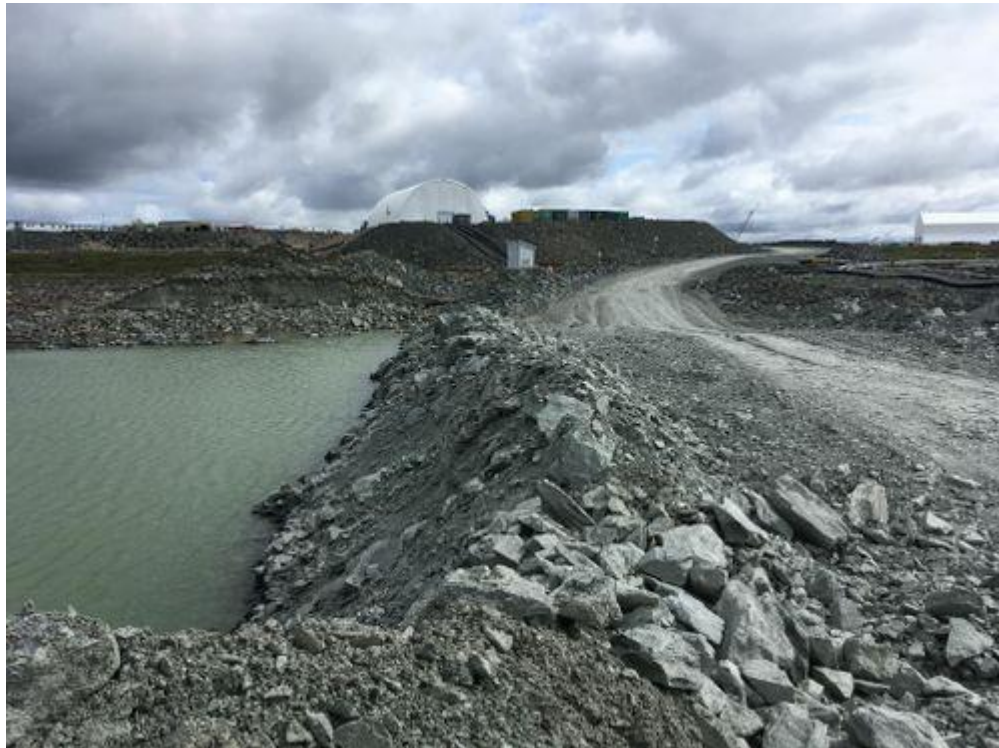
Observation 50

<p>DigitalGlobe, ... Powered by Esri</p>	Location and component	Main dewatering ramp Slope
	Reported observation	Potentially constructed on ice or fill material may contain massive ice sheets
	Preventive or corrective actions to take	Monitor closely the stability of the slope as the water level decreases in Whale Tail North basin
	Priority level	P-2: If not corrected, could likely result in structure safety issues leading to injury, environmental impact, or significant regulatory enforcement; or a repetitive deficiency that demonstrates a systematic breakdown of procedures.
	Observation date	2019-07-18

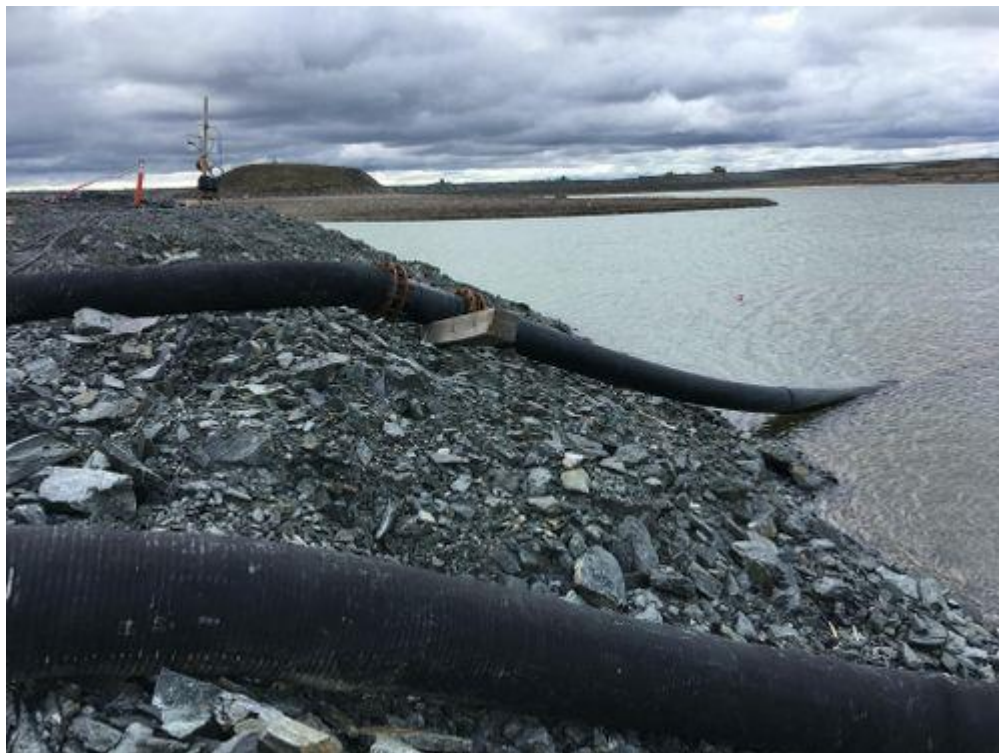
Observation 51

<p>DigitalGlobe, ... Powered by Esri</p>	Location and component	Main dewatering ramp Slope (end)
	Reported observation	Probable instability of the ten-metre-high embankment during dewatering
	Preventive or corrective actions to take	Review the design and reroute the ramp if instability conditions are confirmed
	Priority level	P-2: If not corrected, could likely result in structure safety issues leading to injury, environmental impact, or significant regulatory enforcement; or a repetitive deficiency that demonstrates a systematic breakdown of procedures.
	Observation date	2019-07-18

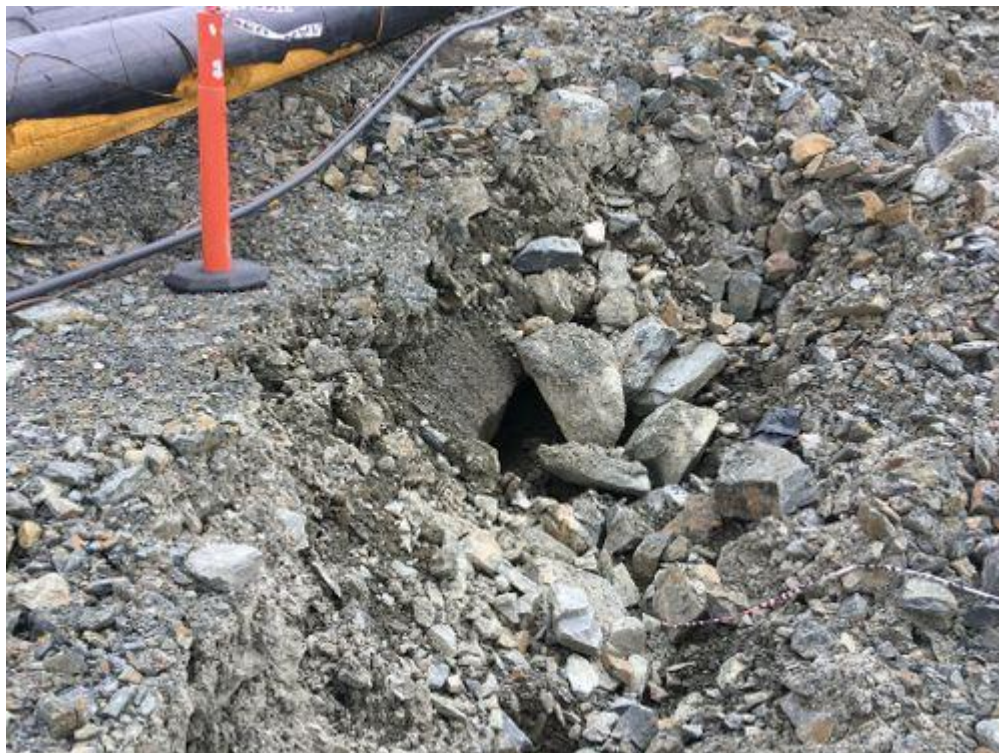
Observation 52

<p>DigitalGlobe, ... Powered by Esri</p>	Location and component	Main dewatering ramp Access road
	Reported observation	Ice trapped under the access ramp
	Preventive or corrective actions to take	Ramp was closed by AEM, other ramp located north built right beside. Continue monitoring for any sign of instability as the water level decreases in Whale Tail North basin
	Priority level	P-4: Best Management Practice – further improvements are necessary to meet industry best practices or reduce potential risks.
	Observation date	2019-07-18

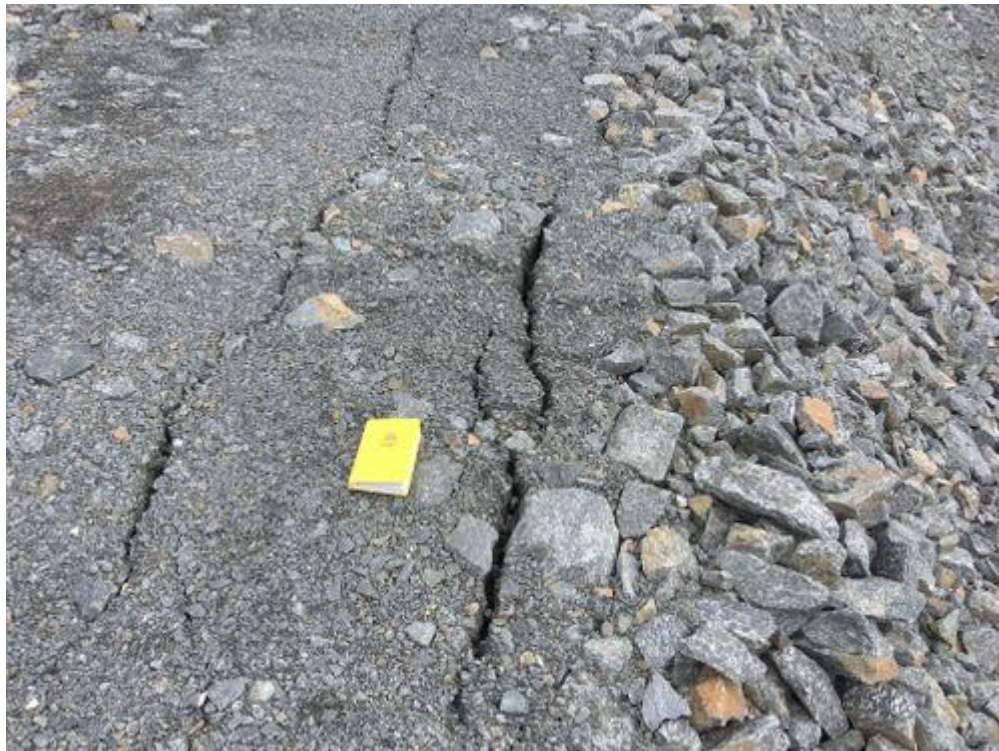
Observation 53

Location and component	Saline protection ditch Crest
Reported observation	Cracking
Preventive or corrective actions to take	Monitor any cracking evolution, reprofile if required
Priority level	P-4: Best Management Practice – further improvements are necessary to meet industry best practices or reduce potential risks.
Observation date	2019-07-18

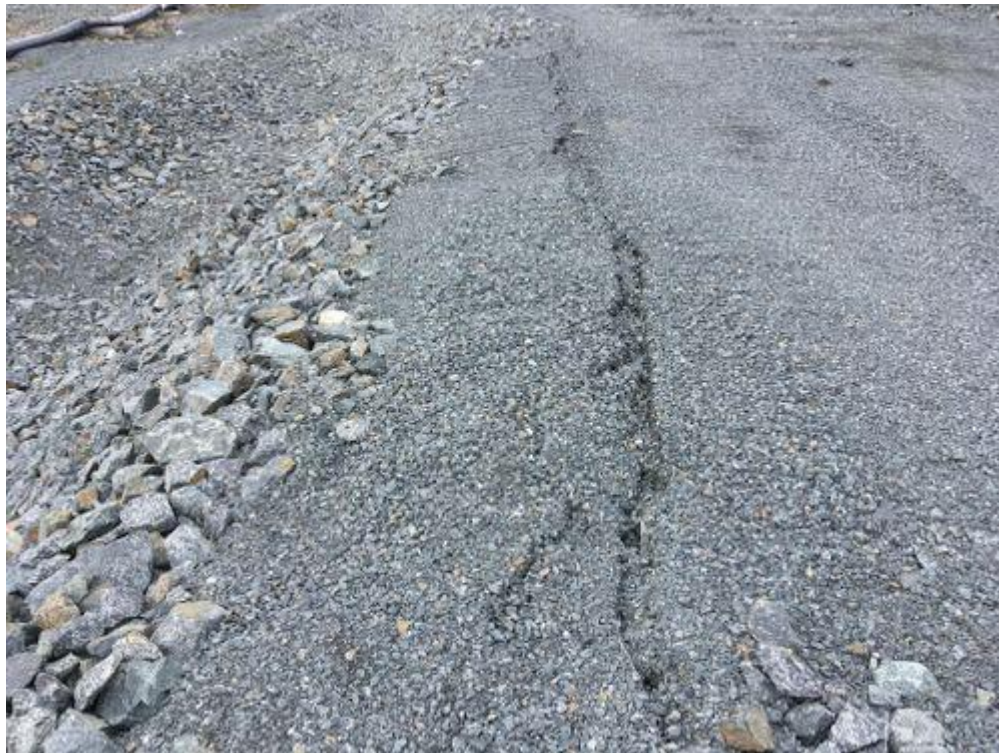
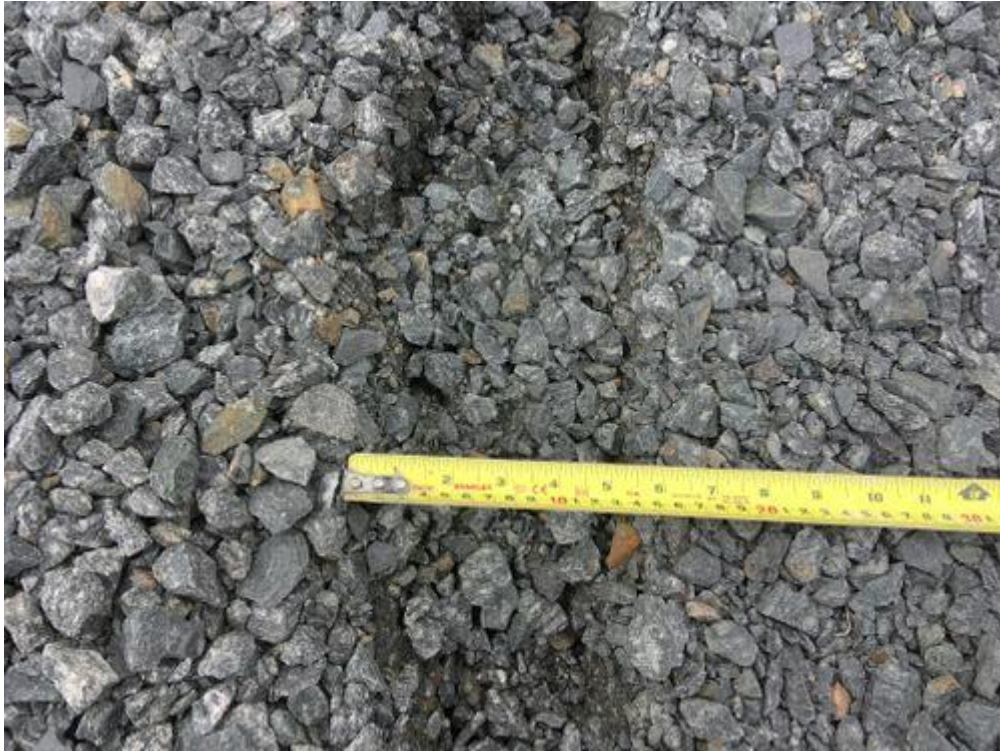
Observation 53

Location and component	Saline protection ditch Slope
Reported observation	Cracking
Preventive or corrective actions to take	Monitor any cracking evolution, reprofile if required
Priority level	P-4: Best Management Practice – further improvements are necessary to meet industry best practices or reduce potential risks.
Observation date	2019-07-18

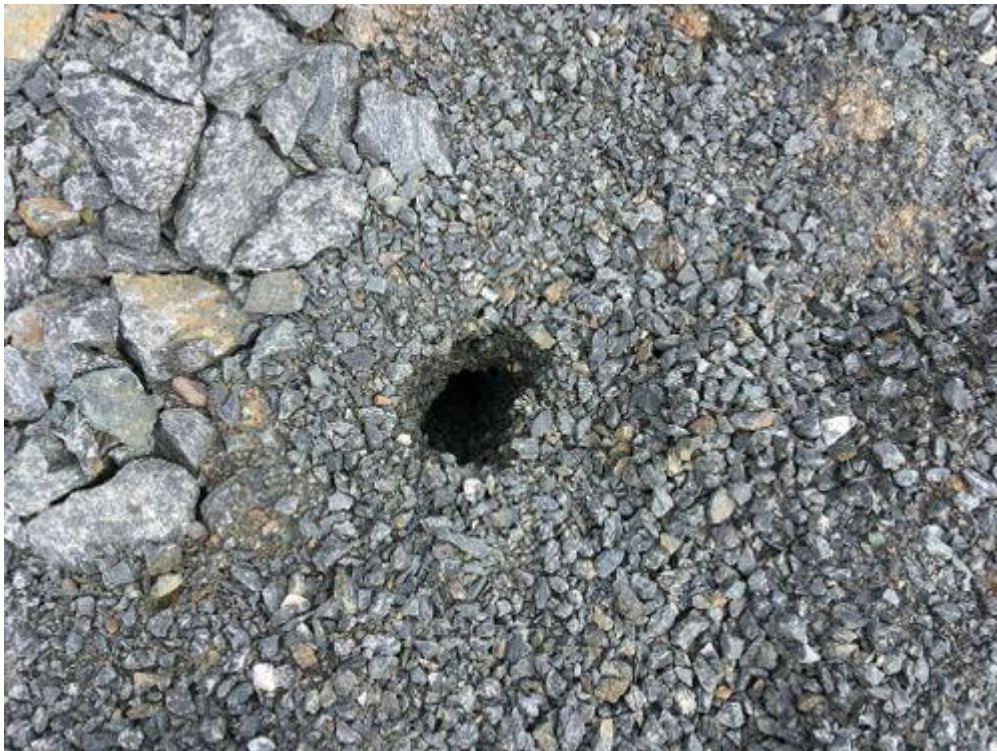
Observation 54

P-3:
Single occurrences of deficiencies or non-conformance that alone would not be expected to result in structure safety issues.

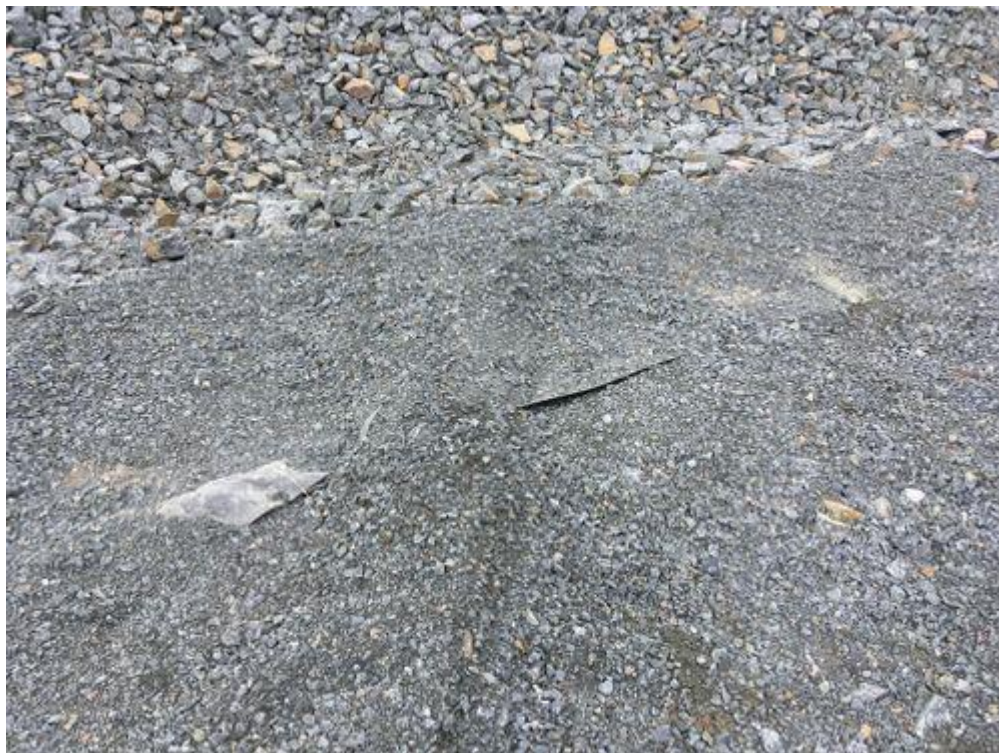
Observation 55

<p>DigitalGlobe, ... Powered by Esri</p>	<p>Location and component</p>	<p>Saline protection ditch Crest</p>
	<p>Reported observation</p>	<p>Exposed geomembrane</p>
	<p>Preventive or corrective actions to take</p>	<p>Review the anchor design of the liner and cover the geomembrane with 0-20 mm material accordingly</p>
	<p>Priority level</p>	<p>P-2: If not corrected, could likely result in structure safety issues leading to injury, environmental impact, or significant regulatory enforcement; or a repetitive deficiency that demonstrates a systematic breakdown of procedures.</p>
	<p>Observation date</p>	<p>2019-07-18</p>

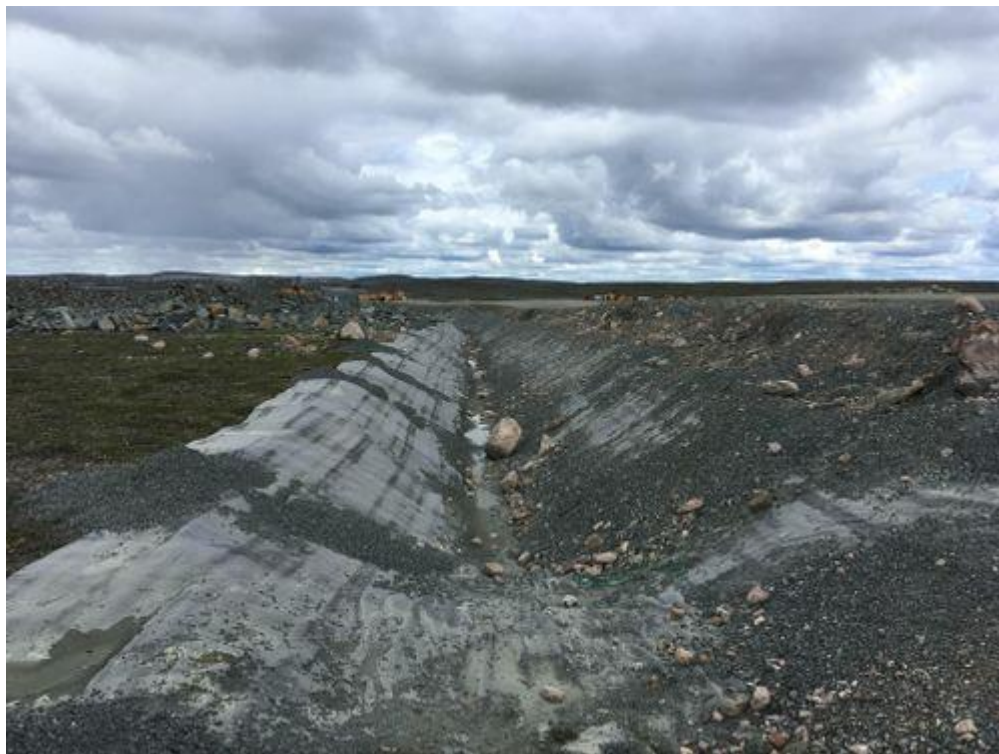
Observation 56

Location and component	Saline protection ditch General view
Reported observation	Cobbles falling in the ditch on the liner
Preventive or corrective actions to take	AEM requested the construction of a berm to the right to prevent snow/road material falling into the ditch
Priority level	P-3: Single occurrences of deficiencies or non-conformance that alone would not be expected to result in structure safety issues.
Observation date	2019-07-18

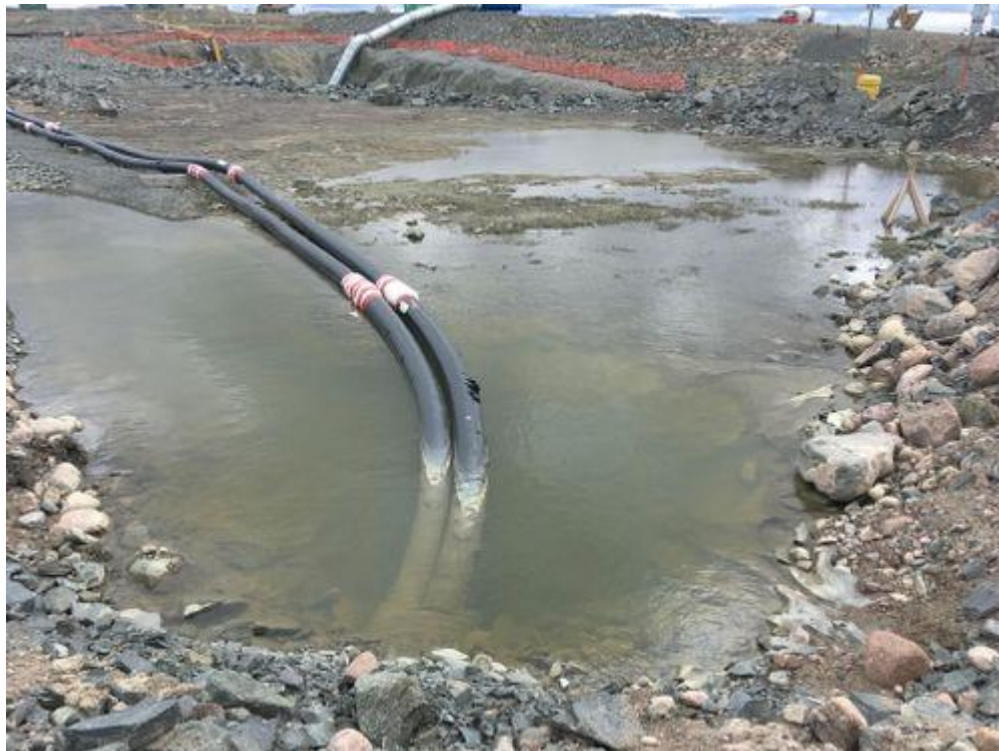
Observation 57

Location and component	Saline protection ditch Water outlet
Reported observation	Water ponding
Preventive or corrective actions to take	Unblock the culvert to allow water flowing toward AP5
Priority level	P-3: Single occurrences of deficiencies or non-conformance that alone would not be expected to result in structure safety issues.
Observation date	2019-07-18

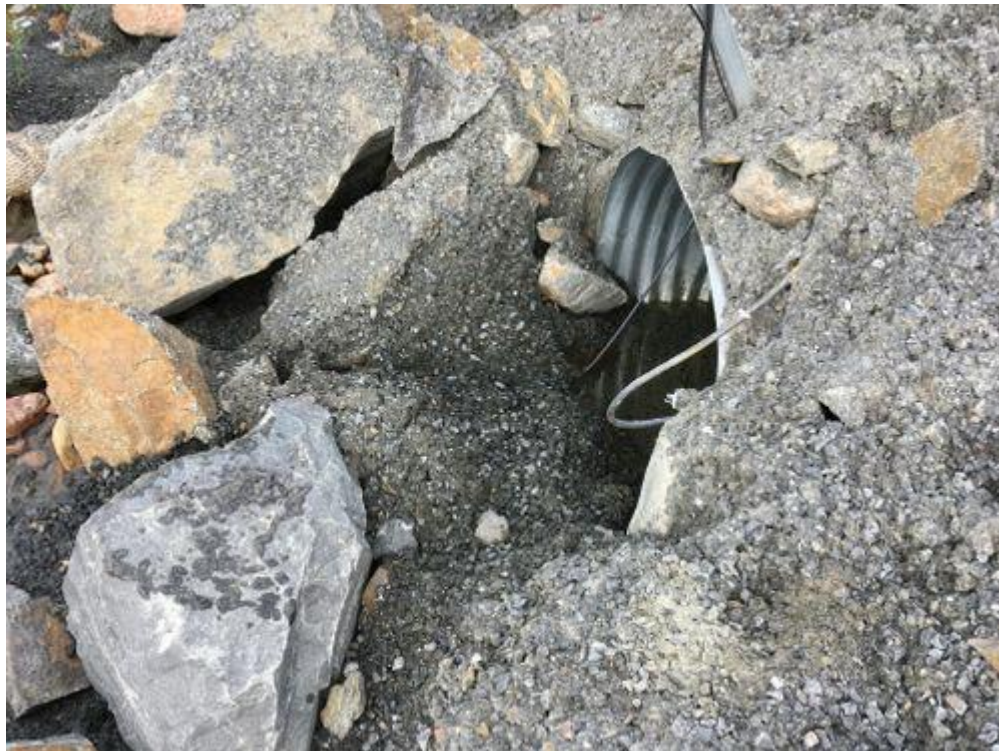
Observation 58

Location and component	Site haulage road Culvert
Reported observation	Blocked culvert
Preventive or corrective actions to take	Remove materials to free the flow of water
Priority level	P-3: Single occurrences of deficiencies or non-conformance that alone would not be expected to result in structure safety issues.
Observation date	2019-07-18

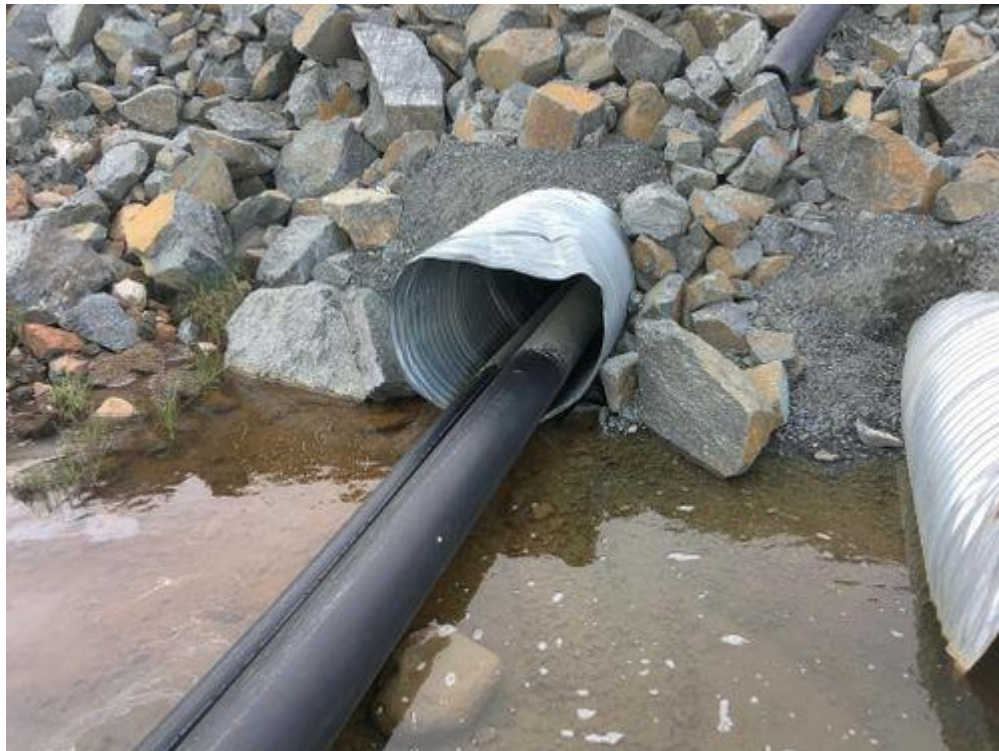
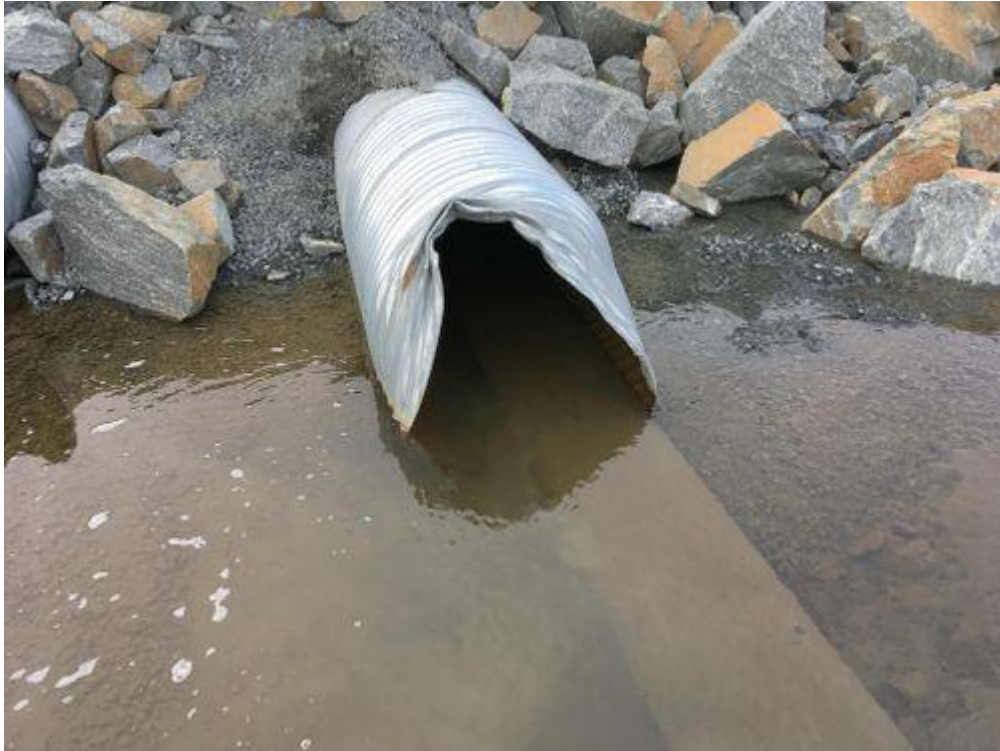
Observation 59

Location and component	Site haulage road Culvert
Reported observation	Deformations of the corrugated steel pipe
Preventive or corrective actions to take	Water is still flowing through the culvert. Monitor for any excess deformation
Priority level	P-4: Best Management Practice – further improvements are necessary to meet industry best practices or reduce potential risks.
Observation date	2019-07-18

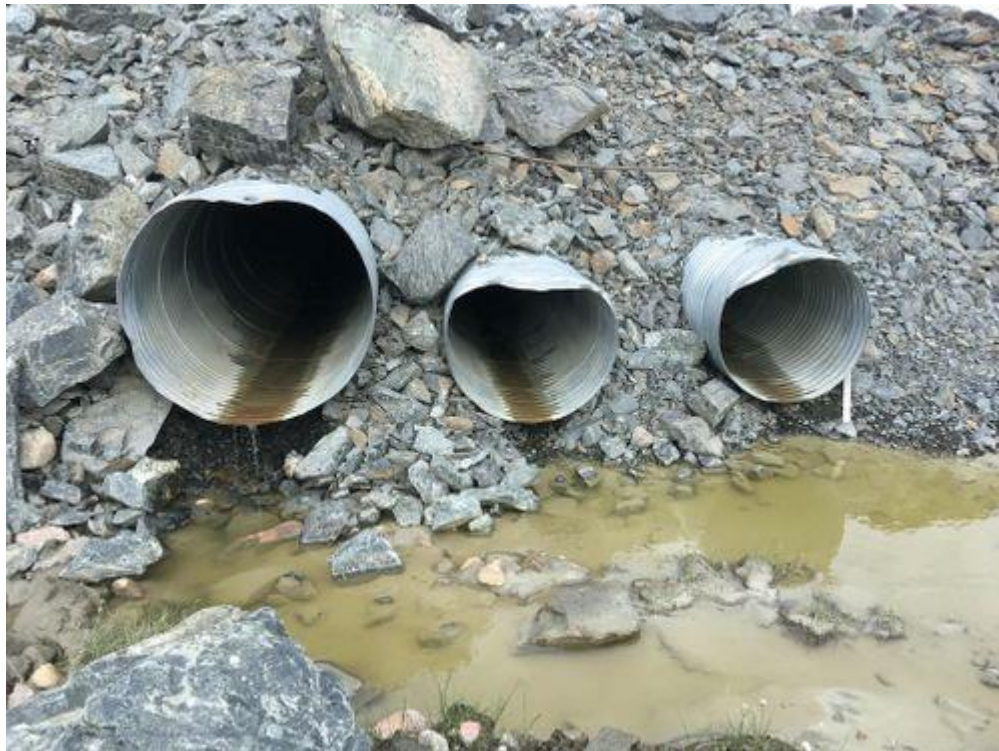
Observation 59

Location and component	Site haulage road Culvert
Reported observation	Culverts are too high from ground and slightly distorted
Preventive or corrective actions to take	Water is still flowing through the culvert. Monitor for any excess deformation
Priority level	P-4: Best Management Practice – further improvements are necessary to meet industry best practices or reduce potential risks.
Observation date	2019-07-18

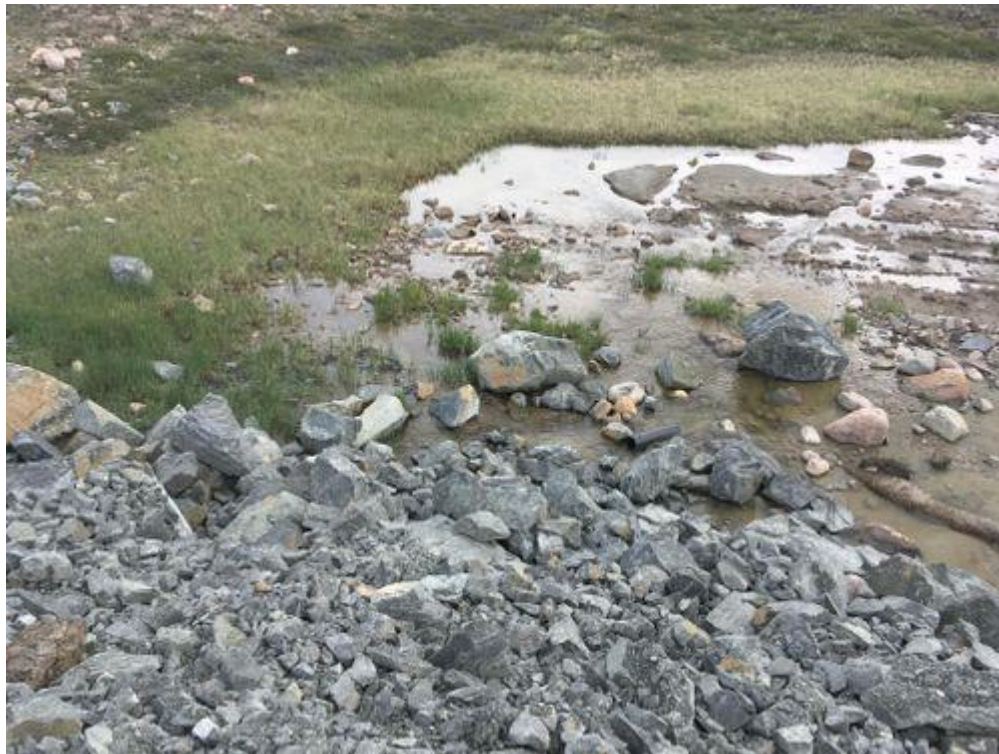
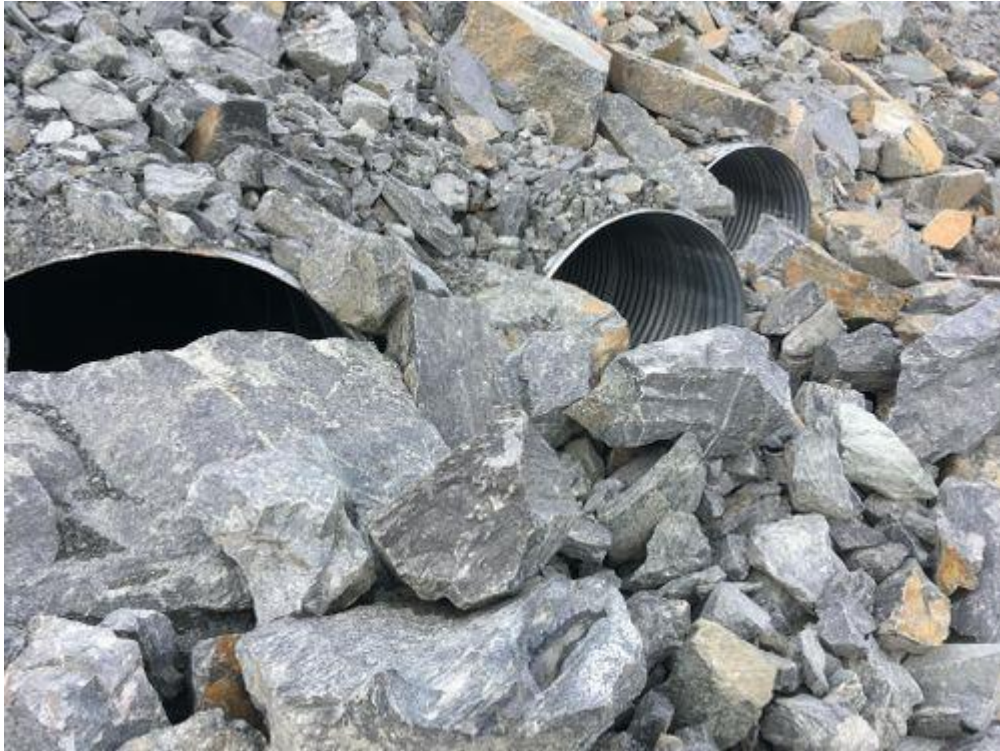
Observation 60

Location and component	Site haulage road Culvert
Reported observation	Culverts buried following the widening of the road
Preventive or corrective actions to take	Consider other solutions to ensure proper drainage in that area. Review water management plan for the sector
Priority level	P-3: Single occurrences of deficiencies or non-conformance that alone would not be expected to result in structure safety issues.
Observation date	2019-07-18
