Whale Tail Project 2019 Annual Geotechnical Inspection

Final Report (Rev. 01)

Agnico Eagle Mines Limited

2019 | 12 | 16

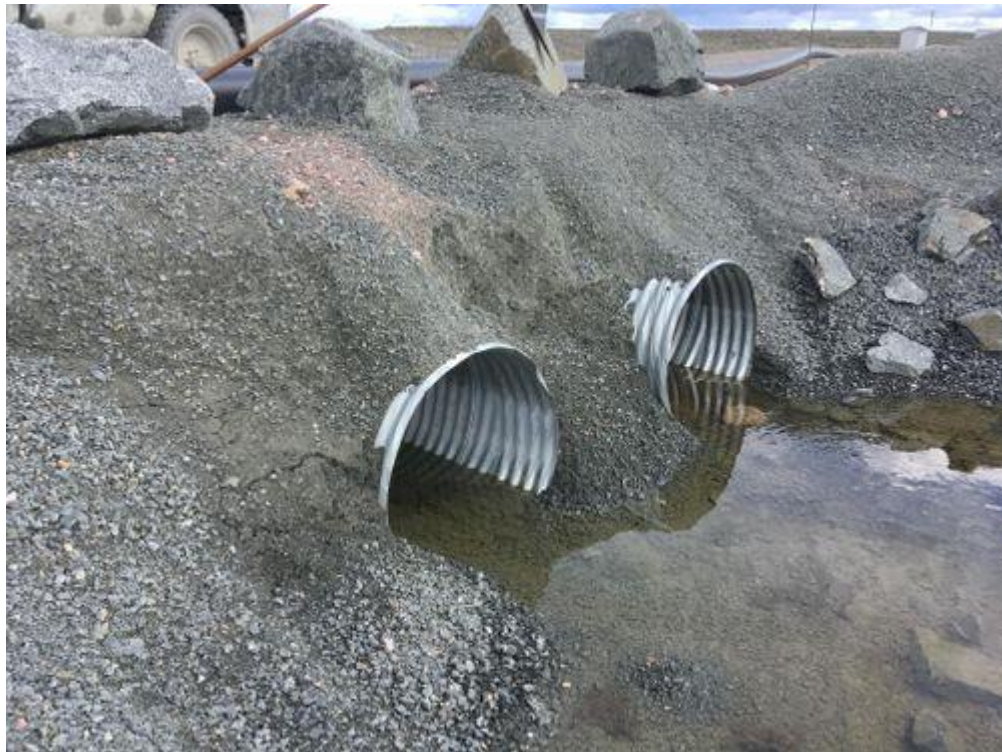
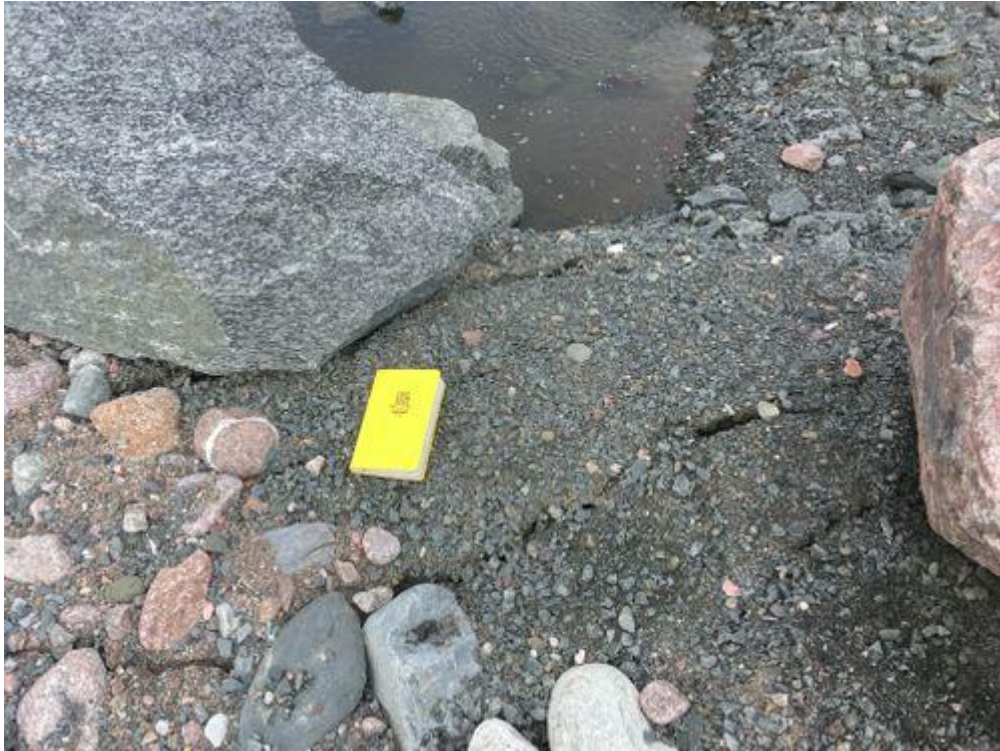
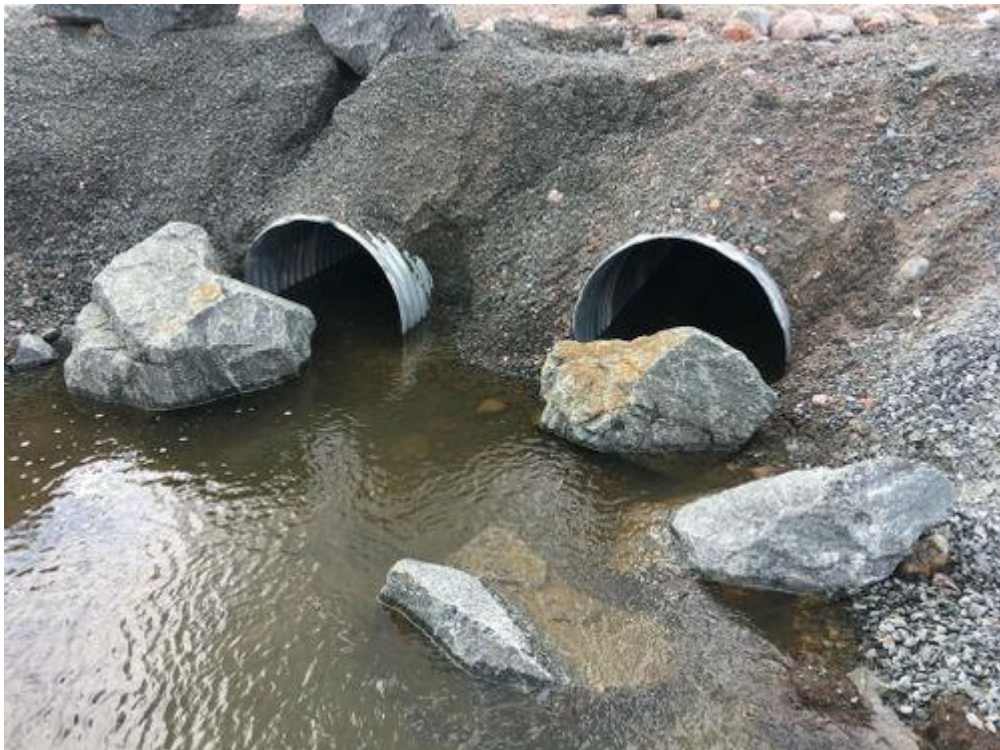
Observation 61

Location and component	Site haulage road Culvert
Reported observation	Culvert is too short/slope is too steep
Preventive or corrective actions to take	Consider reprofiling the road with rockfill material around the culvert for a more stable structure
Priority level	P-4: Best Management Practice – further improvements are necessary to meet industry best practices or reduce potential risks.
Observation date	2019-07-18

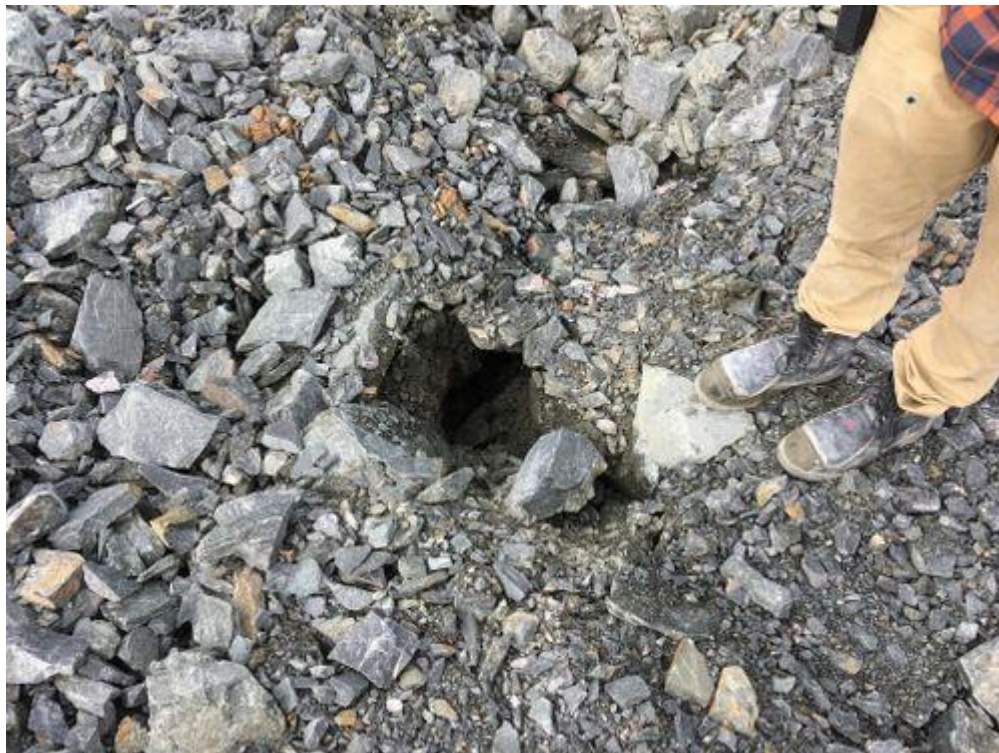
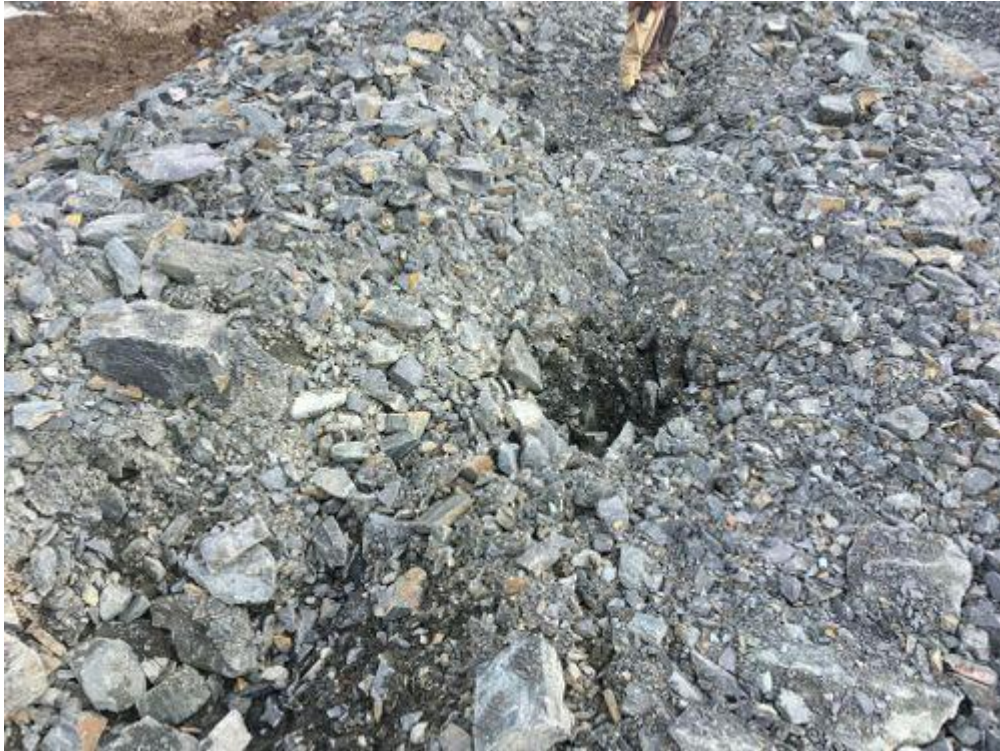
Observation 62

DigitalGlobe, ... Powered by Esri	Location and component	Site haulage road Road
	Reported observation	Sink holes located on the edge of the road
	Preventive or corrective actions to take	Reprofile by adding and compacting material on top of the sinkholes; continue monitoring for further deformations
	Priority level	P-3: Single occurrences of deficiencies or non-conformance that alone would not be expected to result in structure safety issues.
	Observation date	2019-07-18

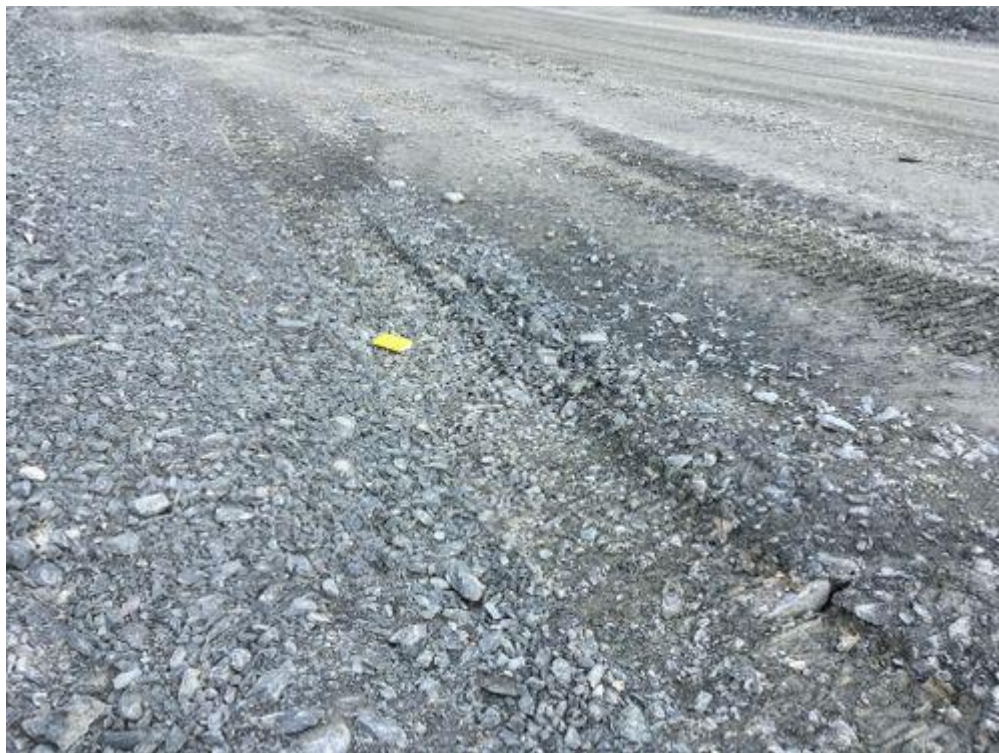
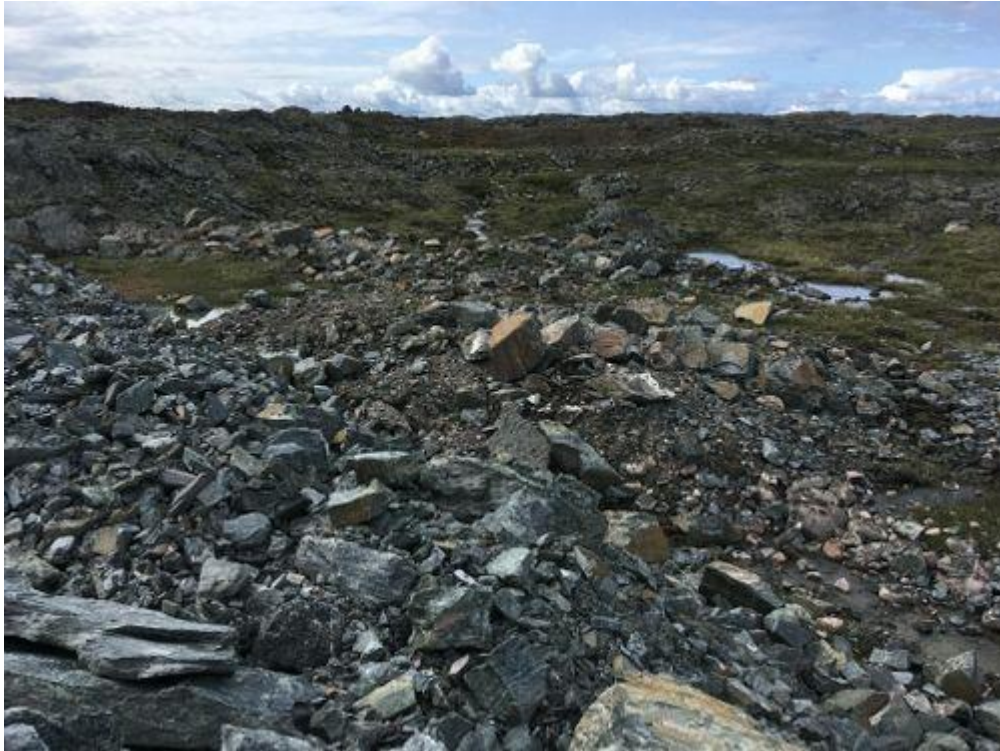
Observation 63

<p>DigitalGlobe, ... Powered by Esri</p>	<p>Location and component</p>	<p>Site haulage road Access road</p>
	<p>Reported observation</p>	<p>Significant subsidence on the edge of the road</p>
	<p>Preventive or corrective actions to take</p>	<p>Potential safety hazard; re-profile that area and monitor any subsequent settlement. Review water management plan for that section</p>
	<p>Priority level</p>	<p>P-1: A high priority or actual structure safety issue considered immediately dangerous to life, health, or the environment; or a significant risk of regulatory enforcement.</p>
	<p>Observation date</p>	<p>2019-07-18</p>

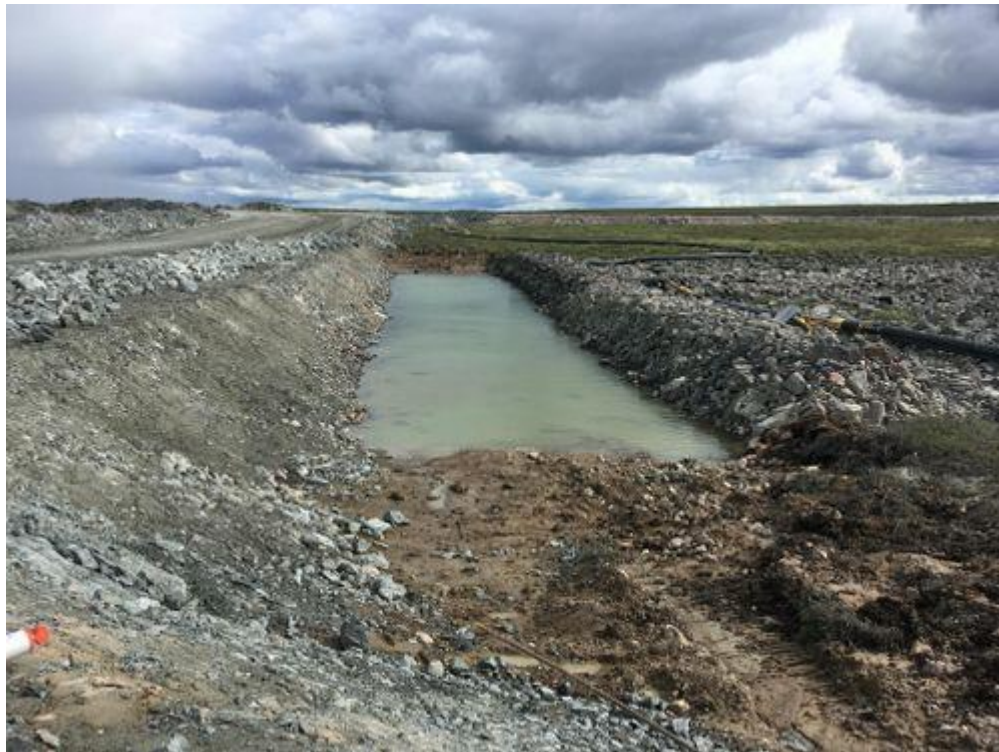
Observation 64

Location and component	Site haulage road Access road
Reported observation	Water collected in a pond on the west side of the road
Preventive or corrective actions to take	Small pond used as a contingency basin (last catch basin before entering the open pit). Water to be transferred at an adequate location
Priority level	P-4: Best Management Practice – further improvements are necessary to meet industry best practices or reduce potential risks.
Observation date	2019-07-18

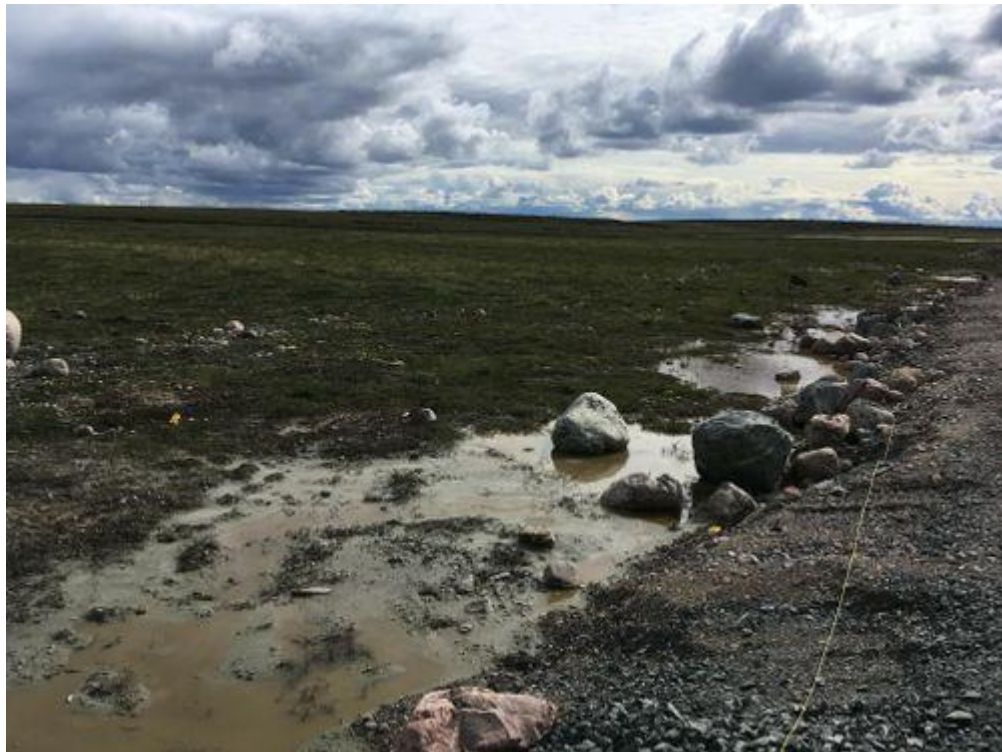
Observation 65

Location and component	Site haulage road General view
Reported observation	As per AEM, the watershed shown on the photograph is flooding the downstream area of Mammoth Dike
Preventive or corrective actions to take	Add culverts to promote drainage and reduce permafrost degradation
Priority level	P-3: Single occurrences of deficiencies or non-conformance that alone would not be expected to result in structure safety issues.
Observation date	2019-07-18

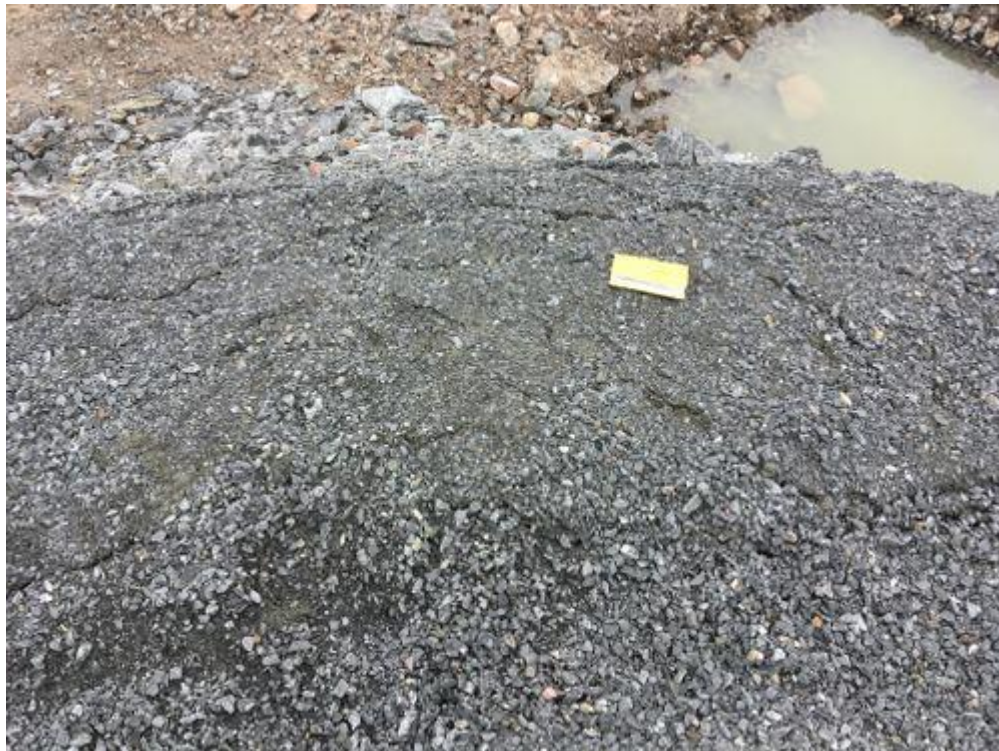
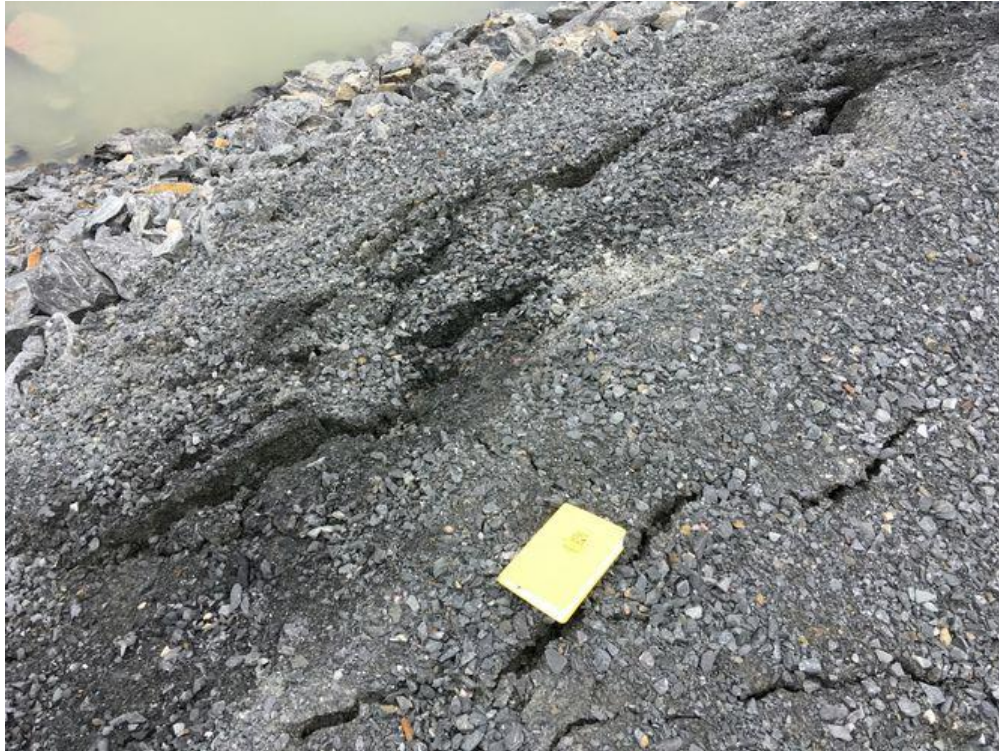
Observation 66

Location and component	Amaruq bulk fuel storage facility Downstream slope
Reported observation	Cracking
Preventive or corrective actions to take	Monitor any cracking evolution, reprofile if required
Priority level	P-4: Best Management Practice – further improvements are necessary to meet industry best practices or reduce potential risks.
Observation date	2019-07-18

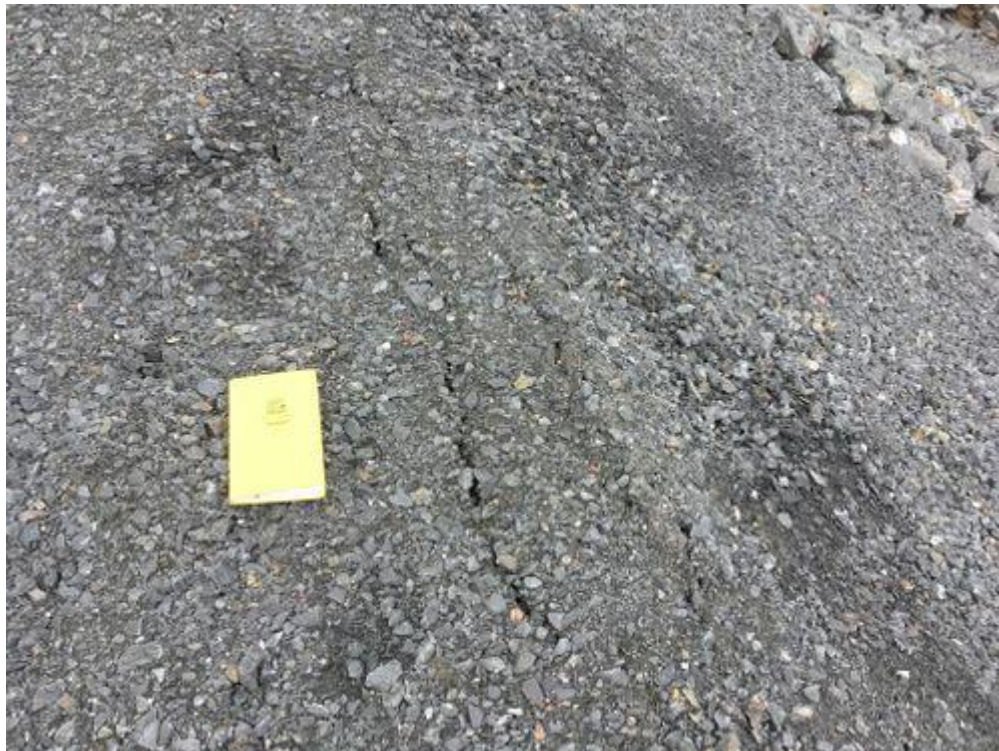
Observation 66

Location and component	Amaruq bulk fuel storage facility Crest
Reported observation	Cracking
Preventive or corrective actions to take	Monitor any cracking evolution, reprofile if required
Priority level	P-4: Best Management Practice – further improvements are necessary to meet industry best practices or reduce potential risks.
Observation date	2019-07-18

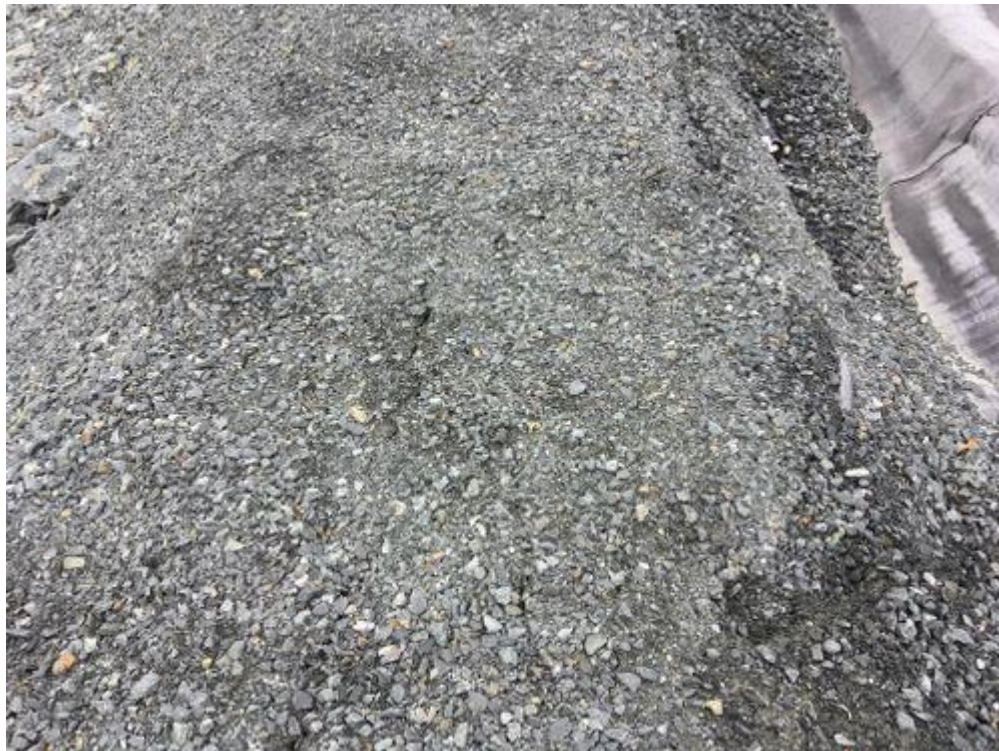
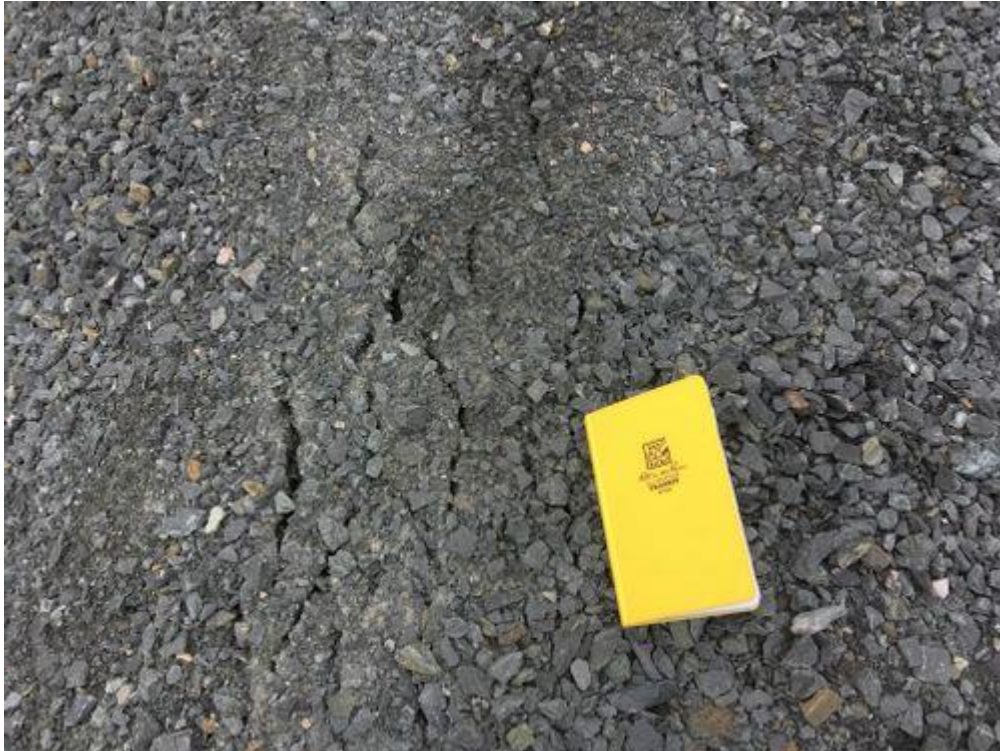
Observation 66

Location and component	Amaruq bulk fuel storage facility Downstream slope
Reported observation	Cracking
Preventive or corrective actions to take	Monitor any cracking evolution, reprofile if required
Priority level	P-4: Best Management Practice – further improvements are necessary to meet industry best practices or reduce potential risks.
Observation date	2019-07-18

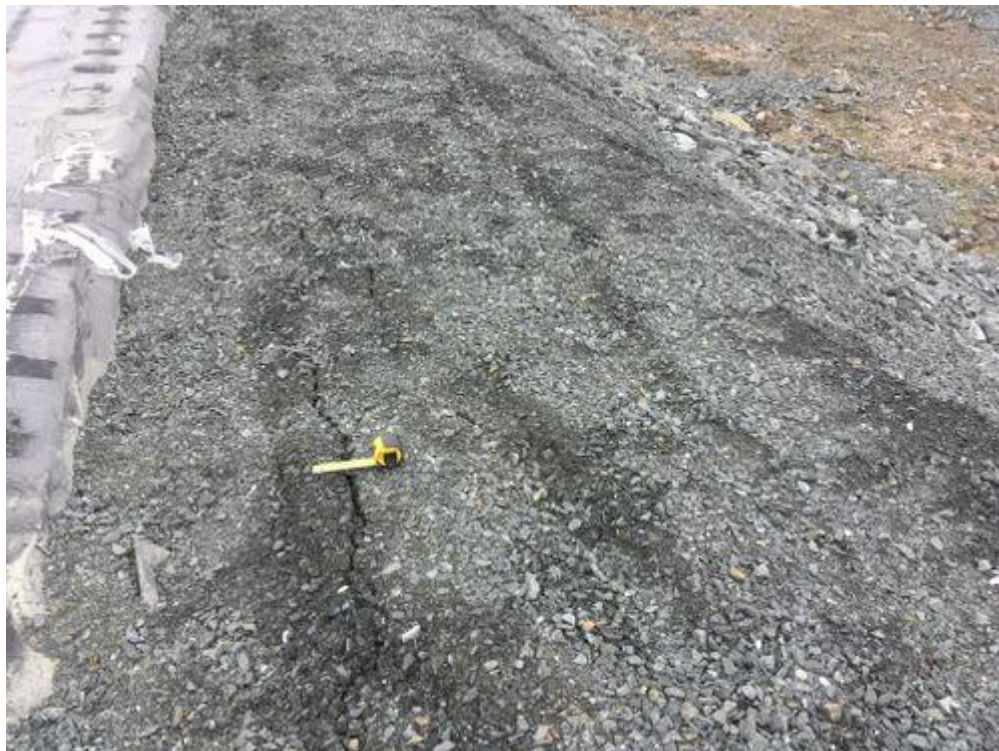
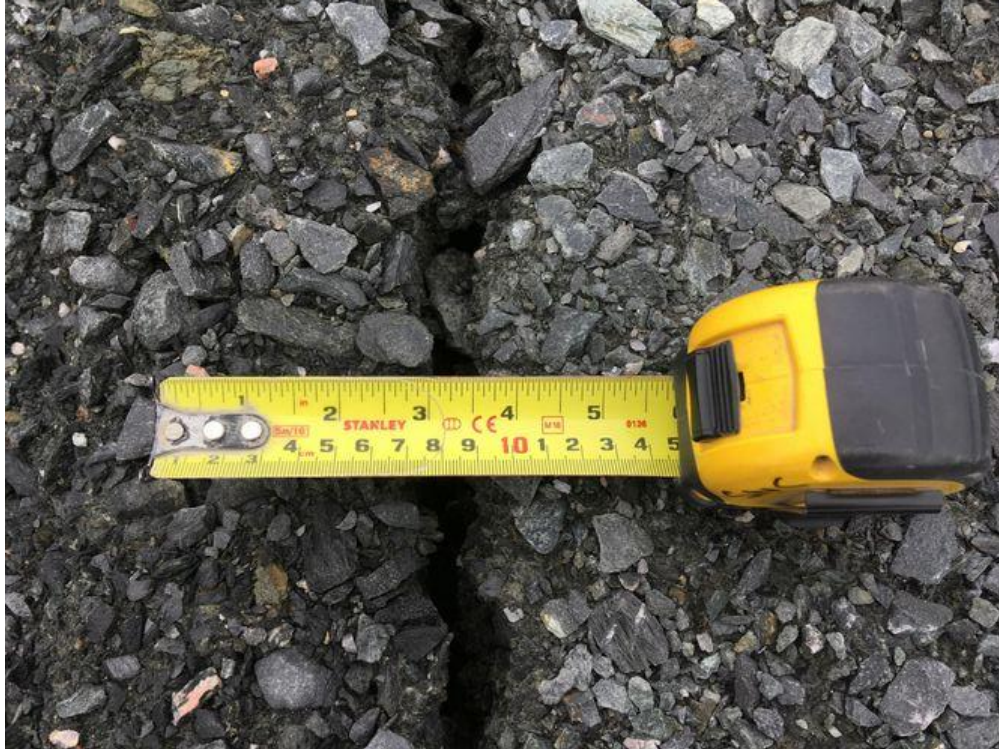
Observation 67

<p>DigitalGlobe, ... Powered by Esri</p>	Location and component	Amaruq bulk fuel storage facility Crest
	Reported observation	Tensile and circular cracking
	Preventive or corrective actions to take	Review the design for the downstream slope requirements. Some steep sections should be more gentle. Monitor any cracking evolution, reprofile if required
	Priority level	P-2: If not corrected, could likely result in structure safety issues leading to injury, environmental impact, or significant regulatory enforcement; or a repetitive deficiency that demonstrates a systematic breakdown of procedures.
	Observation date	2019-07-18

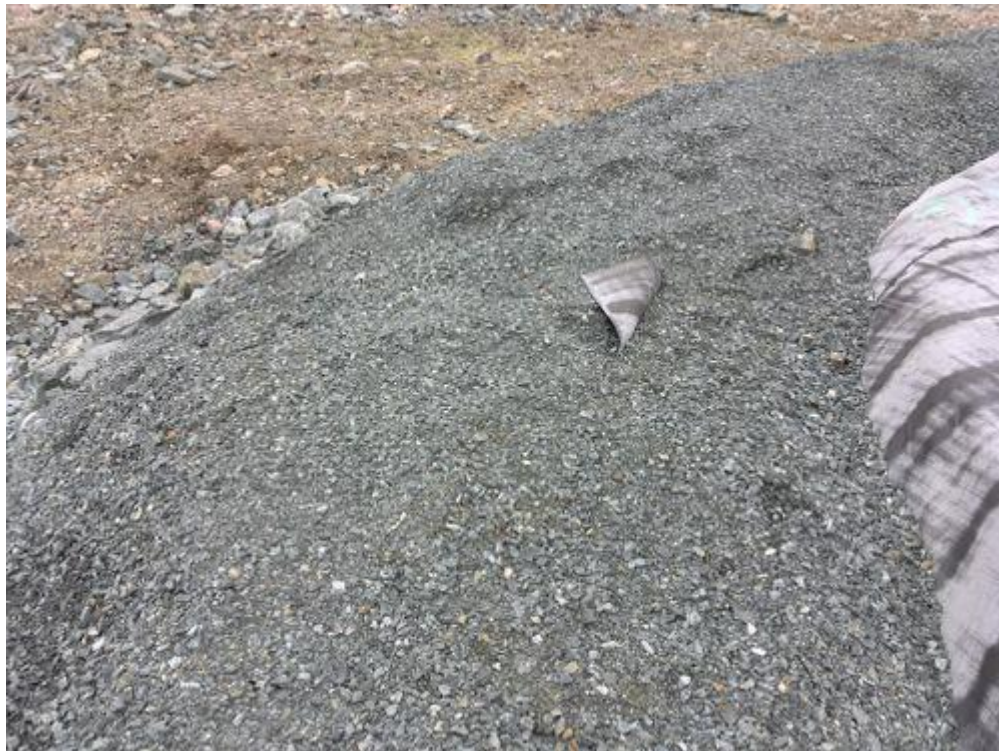
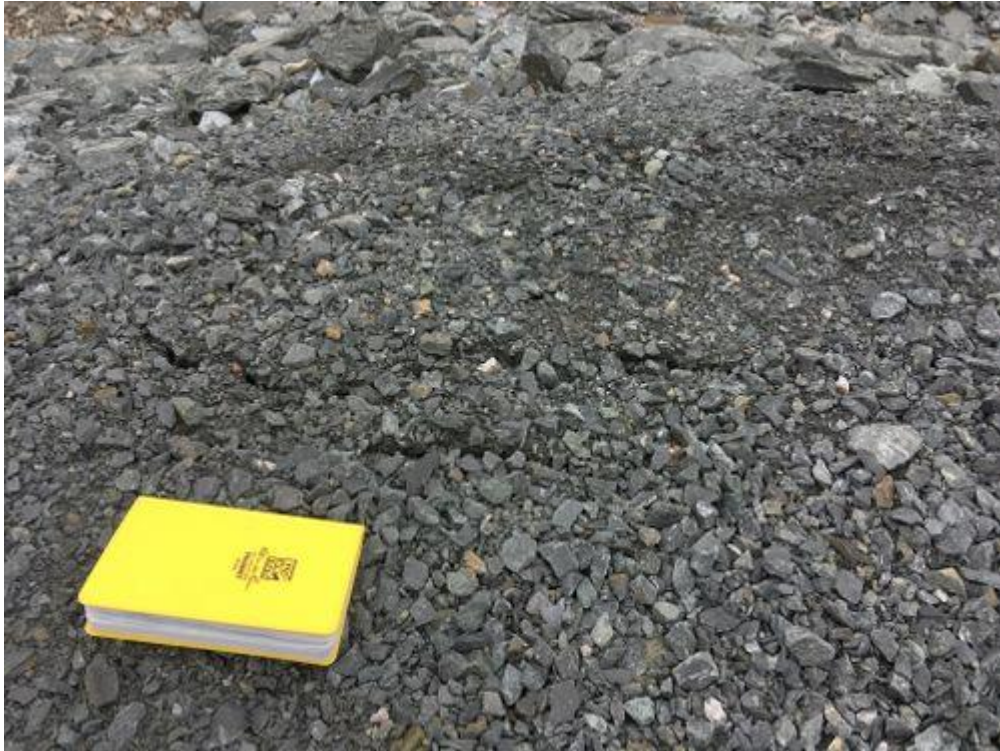
Observation 68

Settlement and cracks on the 0-20 mm material

P-3:
Single occurrences of deficiencies or non-conformance that alone would not be expected to result in structure safety issues.

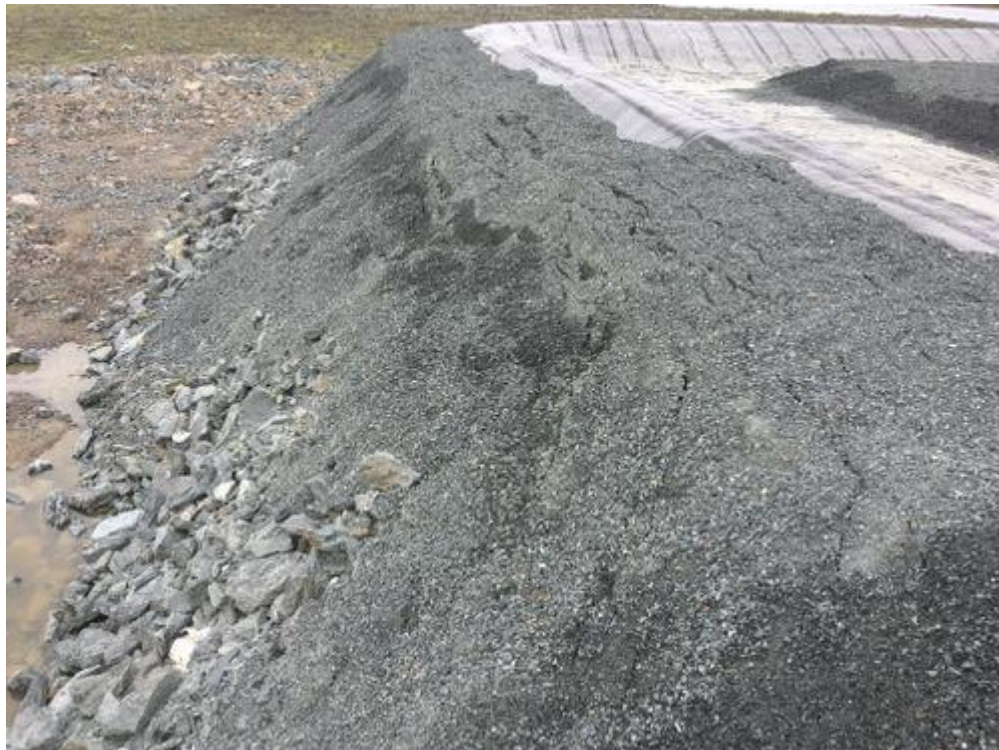
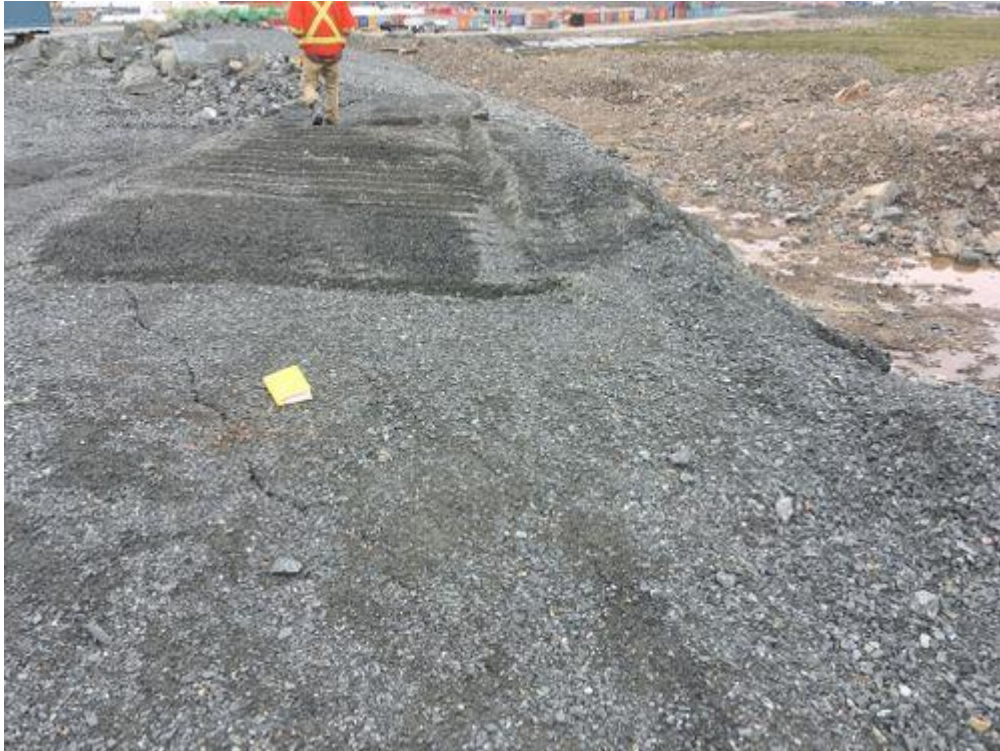
Observation 69

<p>DigitalGlobe, ... Powered by Esri</p>	Location and component	Amaruq bulk fuel storage facility Downstream slope
	Reported observation	Cracking and instability
	Preventive or corrective actions to take	Review the design. Slopes appear to be steep and instabilities are clearly visible at many locations. Densification of the 0-20 mm material may be required
	Priority level	P-3: Single occurrences of deficiencies or non-conformance that alone would not be expected to result in structure safety issues.
	Observation date	2019-07-18

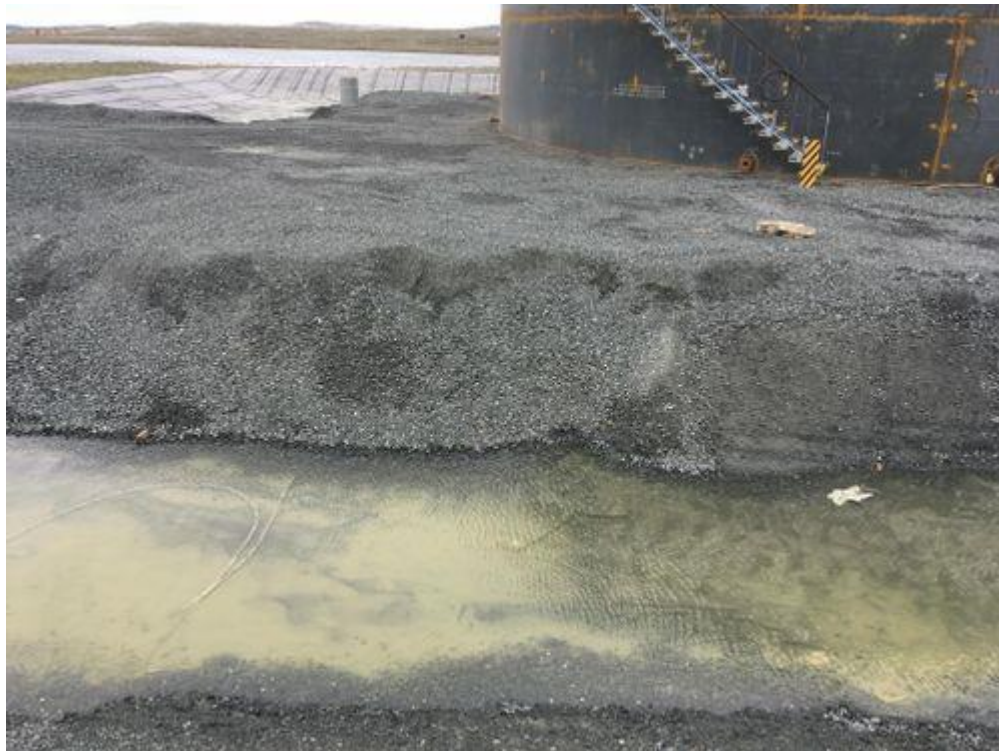
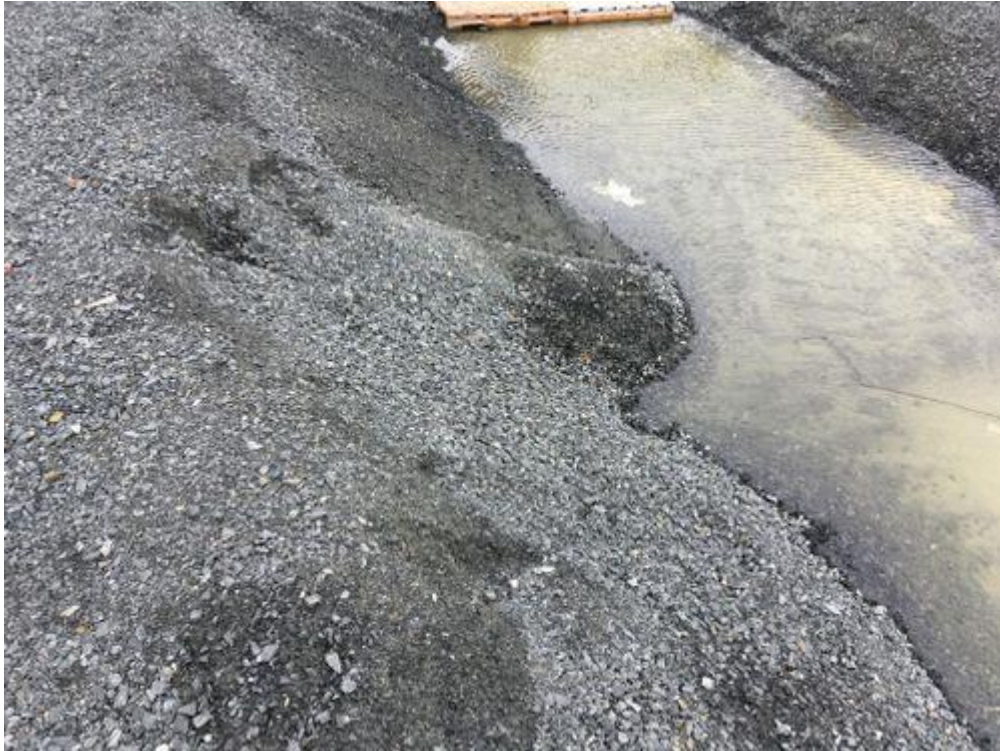
Observation 70

Location and component	Amaruq bulk fuel storage facility Ditch
Reported observation	Instability
Preventive or corrective actions to take	Reprofile with gentler slope if required
Priority level	P-4: Best Management Practice – further improvements are necessary to meet industry best practices or reduce potential risks.
Observation date	2019-07-18

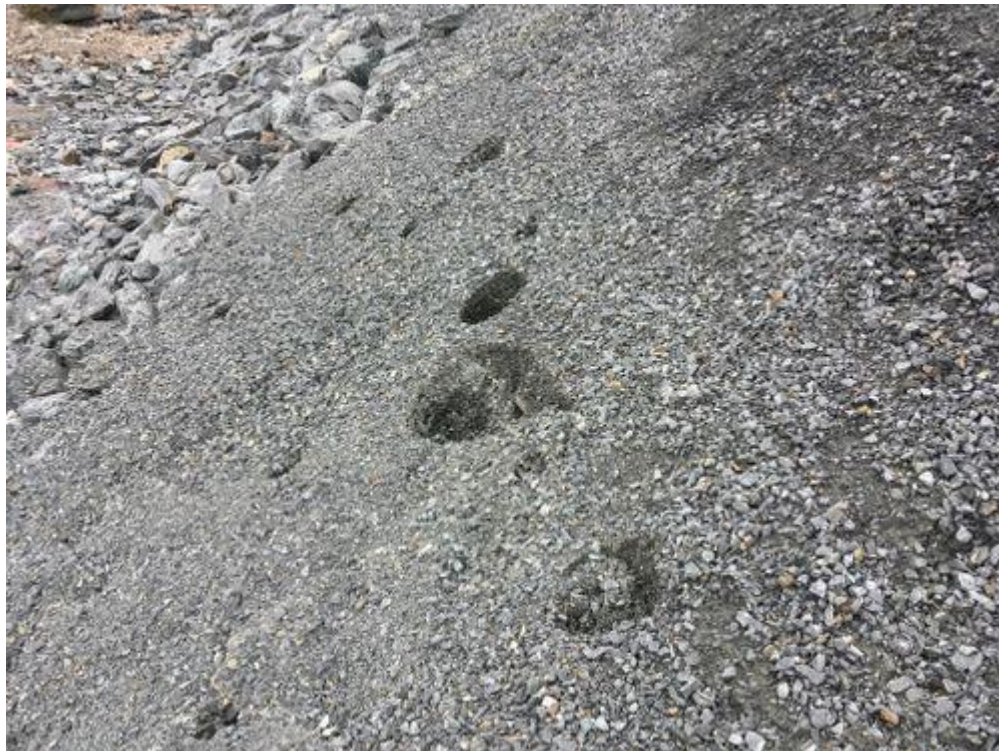
Observation 71

Location and component	Amaruq bulk fuel storage facility Downstream slope
Reported observation	Cavities that may be associated with lack of compaction
Preventive or corrective actions to take	Monitor any evolution of the cavities, reprofile if required
Priority level	P-4: Best Management Practice – further improvements are necessary to meet industry best practices or reduce potential risks.
Observation date	2019-07-18

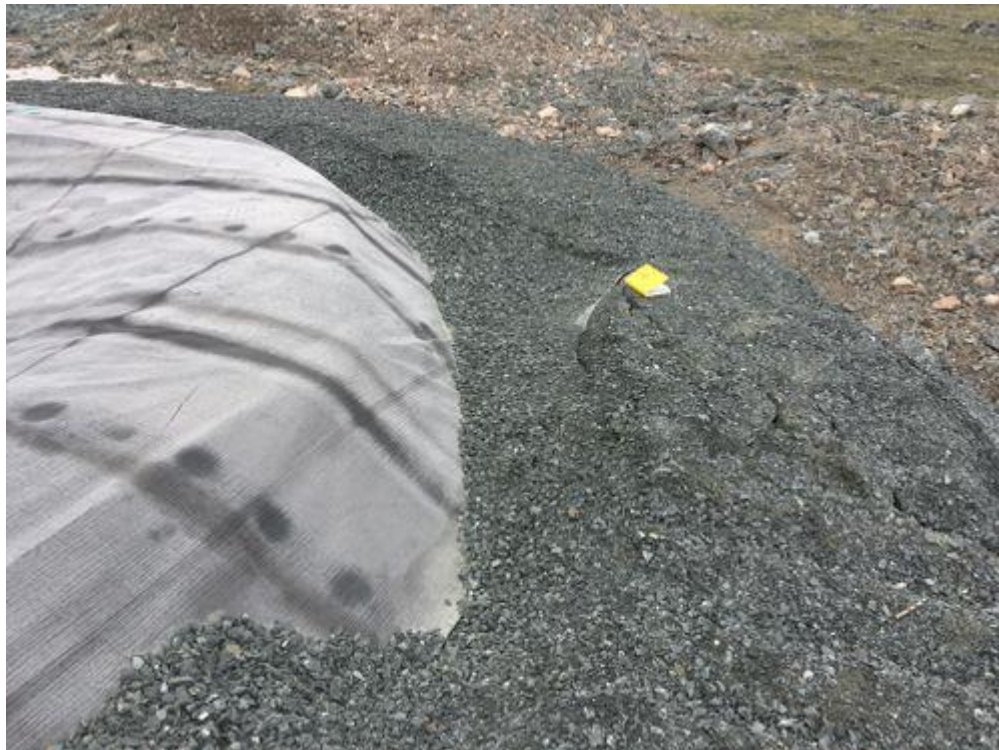
Observation 72

<p>DigitalGlobe, ... Powered by Esri</p>	<p>Location and component</p>	<p>Amaruq bulk fuel storage facility Crest</p>
	<p>Reported observation</p>	<p>Lack of material</p>
	<p>Preventive or corrective actions to take</p>	<p>Review design for the anchor requirements. If required, add 0-20 mm material on top of the liner and compact it</p>
	<p>Priority level</p>	<p>P-4: Best Management Practice – further improvements are necessary to meet industry best practices or reduce potential risks.</p>
	<p>Observation date</p>	<p>2019-07-18</p>

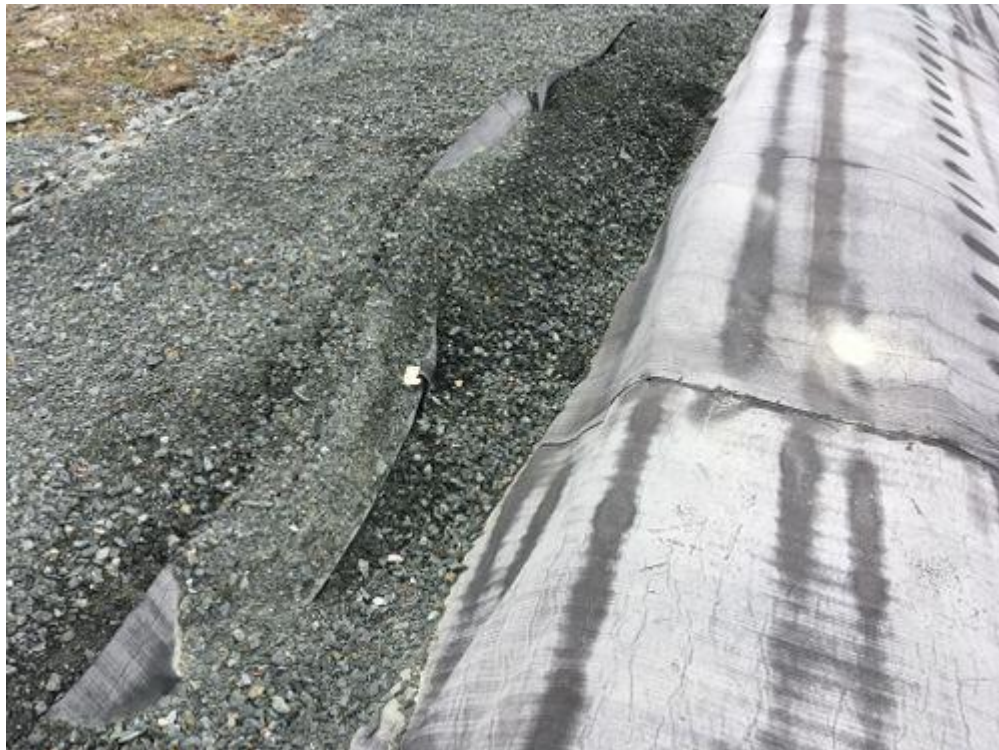
Observation 72

<p>DigitalGlobe, ... Powered by Esri</p>	Location and component	Amaruq bulk fuel storage facility Crest
	Reported observation	Lack of material
	Preventive or corrective actions to take	Review design for the anchor requirements. If required, add 0-20 mm material on top of the liner and compact it
	Priority level	P-4: Best Management Practice – further improvements are necessary to meet industry best practices or reduce potential risks.
	Observation date	2019-07-18

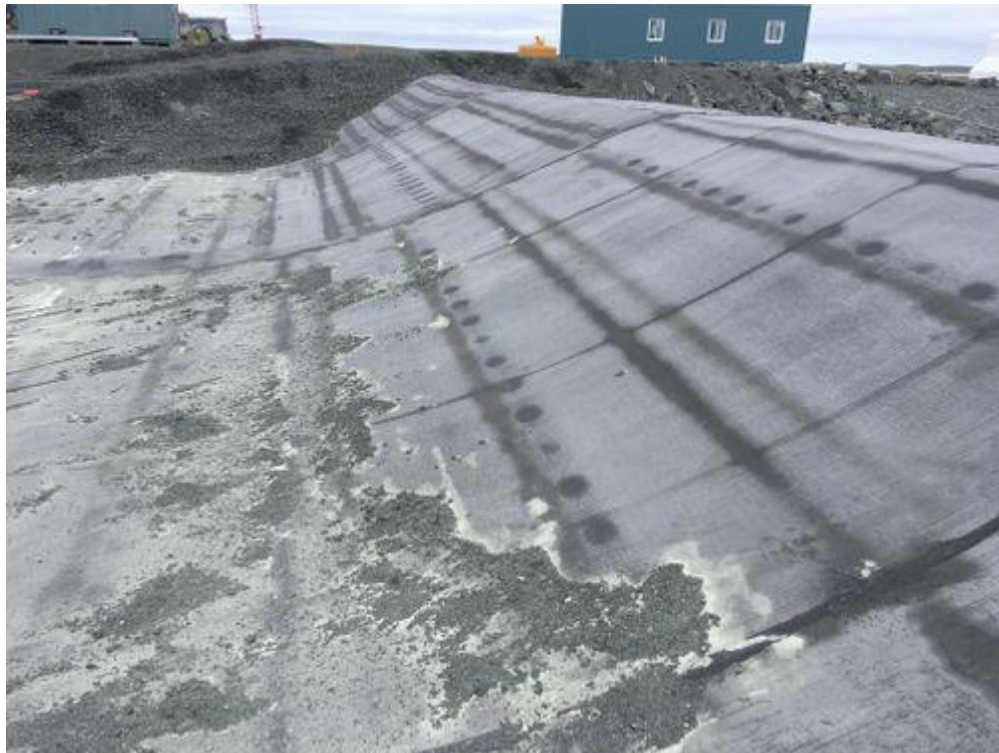
Observation 73

<p>DigitalGlobe, ... Powered by Esri</p>	<p>Location and component</p>	<p>Amaruq bulk fuel storage facility Liner</p>
	<p>Reported observation</p>	<p>No material on top of the geomembrane and tensions were observed in the liner at some locations</p>
	<p>Preventive or corrective actions to take</p>	<p>Review the design to validate if the geomembrane is intended to be left exposed. Monitor any tension cracking of the liner</p>
	<p>Priority level</p>	<p>P-3: Single occurrences of deficiencies or non-conformance that alone would not be expected to result in structure safety issues.</p>
	<p>Observation date</p>	<p>2019-07-18</p>

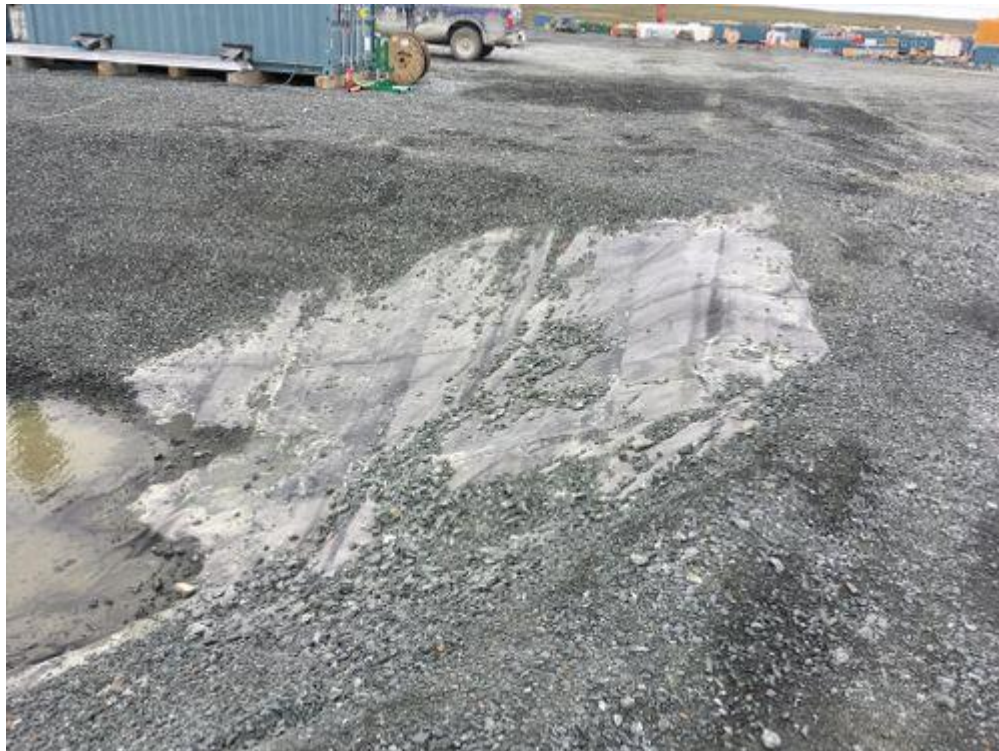
Observation 73

Location and component	Amaruq bulk fuel storage facility Liner
Reported observation	Exposed liner
Preventive or corrective actions to take	Review the design requirements and add material on top if needed
Priority level	P-3: Single occurrences of deficiencies or non-conformance that alone would not be expected to result in structure safety issues.
Observation date	2019-07-18
