Whale Tail Project 2019 Annual Geotechnical Inspection

Final Report (Rev. 01)

Agnico Eagle Mines Limited

2019 | 12 | 16

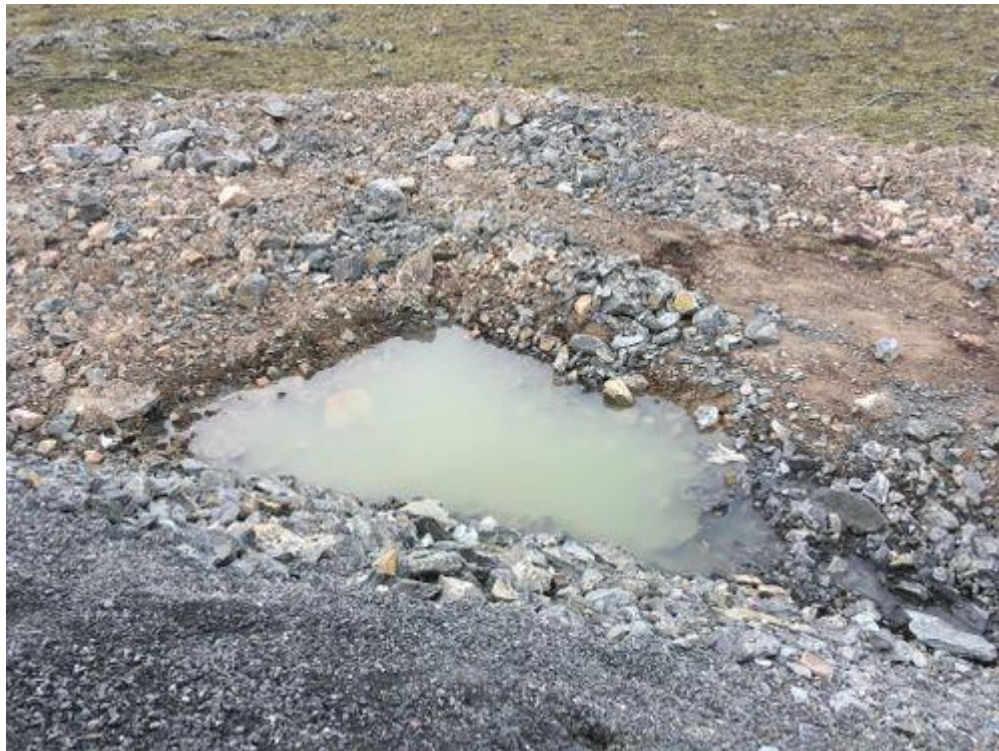
Observation 74

Location and component	Amaruq bulk fuel storage facility Downstream toe
Reported observation	Water ponding
Preventive or corrective actions to take	Drain the water further away from the embankment
Priority level	P-3: Single occurrences of deficiencies or non-conformance that alone would not be expected to result in structure safety issues.
Observation date	2019-07-18

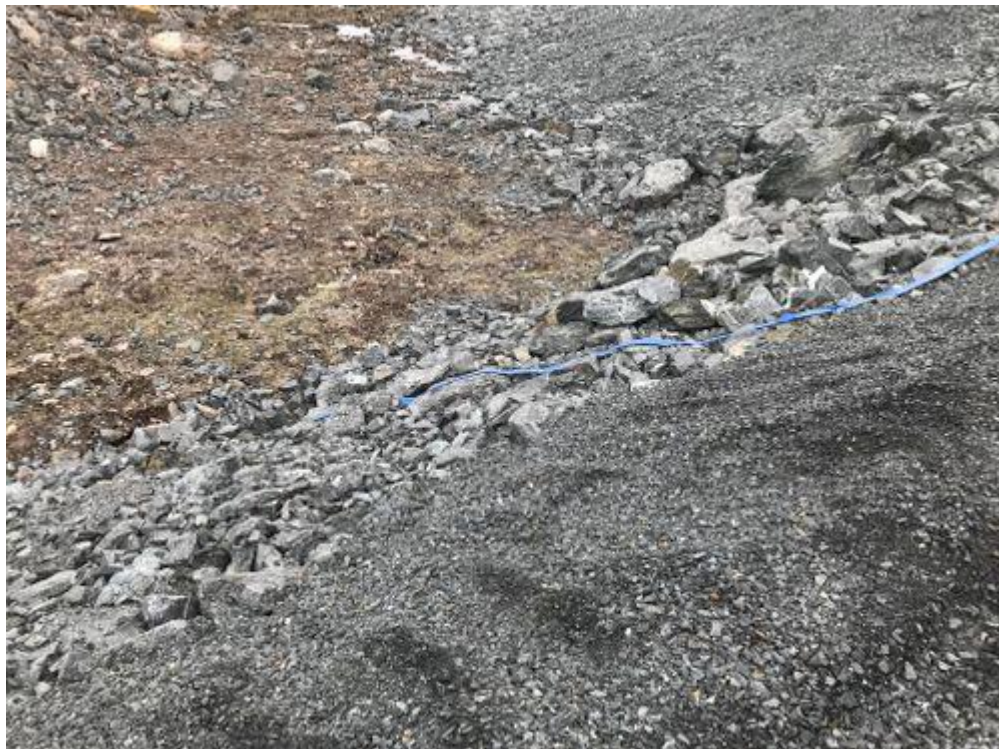
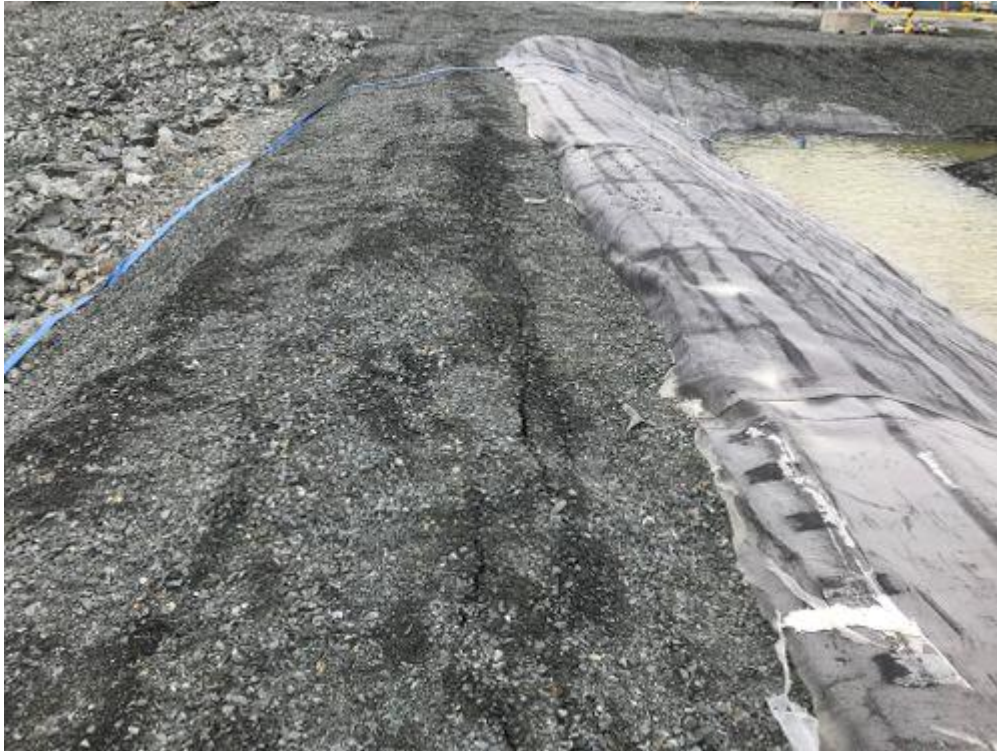
Observation 75

<p>DigitalGlobe, ... Powered by Esri</p>	Location and component	Amaruq bulk fuel storage facility Downstream slope
	Reported observation	Discharge point of the pump is located within the slope
	Preventive or corrective actions to take	Discharge point should be moved further of the toe to minimize risks of permafrost degradation under the embankment which could lead to instability
	Priority level	P-2: If not corrected, could likely result in structure safety issues leading to injury, environmental impact, or significant regulatory enforcement; or a repetitive deficiency that demonstrates a systematic breakdown of procedures.
	Observation date	2019-07-18

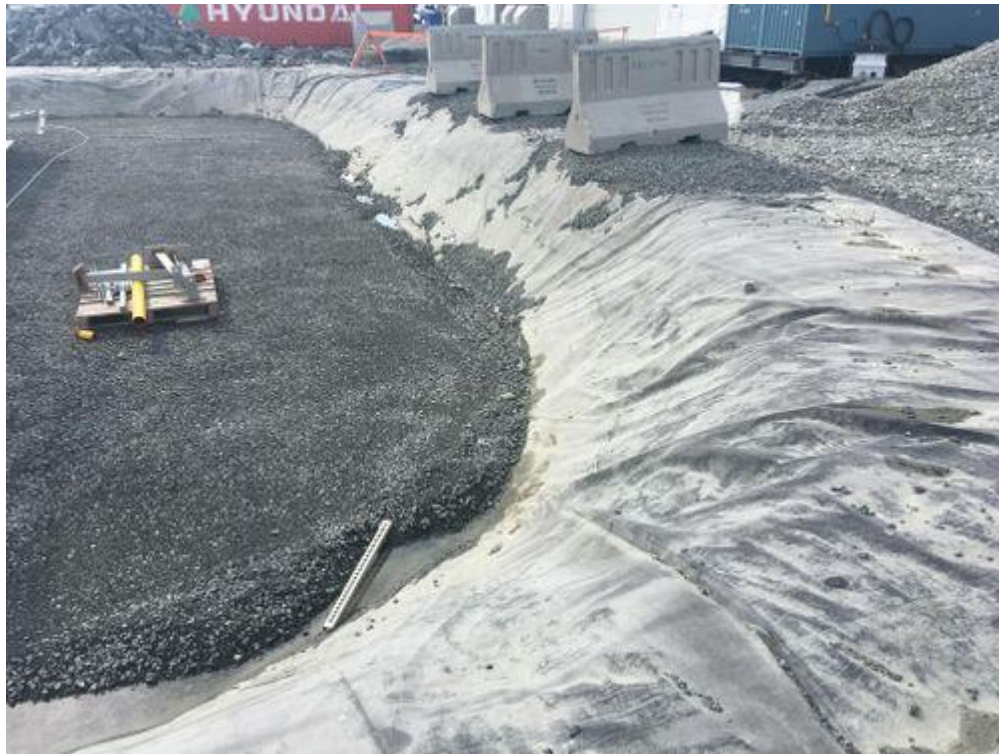
Internal ID: 190718-171537-DURAM16

Location and component	Fuel Storage Facility #2 Liner
Reported observation	Membrane panels welded all in the same direction (east-west)
Preventive or corrective actions to take	Monitor the structure for any deformation that may affect the seams of the geosynthetic
Priority level	P-4: Best Management Practice – further improvements are necessary to meet industry best practices or reduce potential risks.
Observation date	2019-07-18

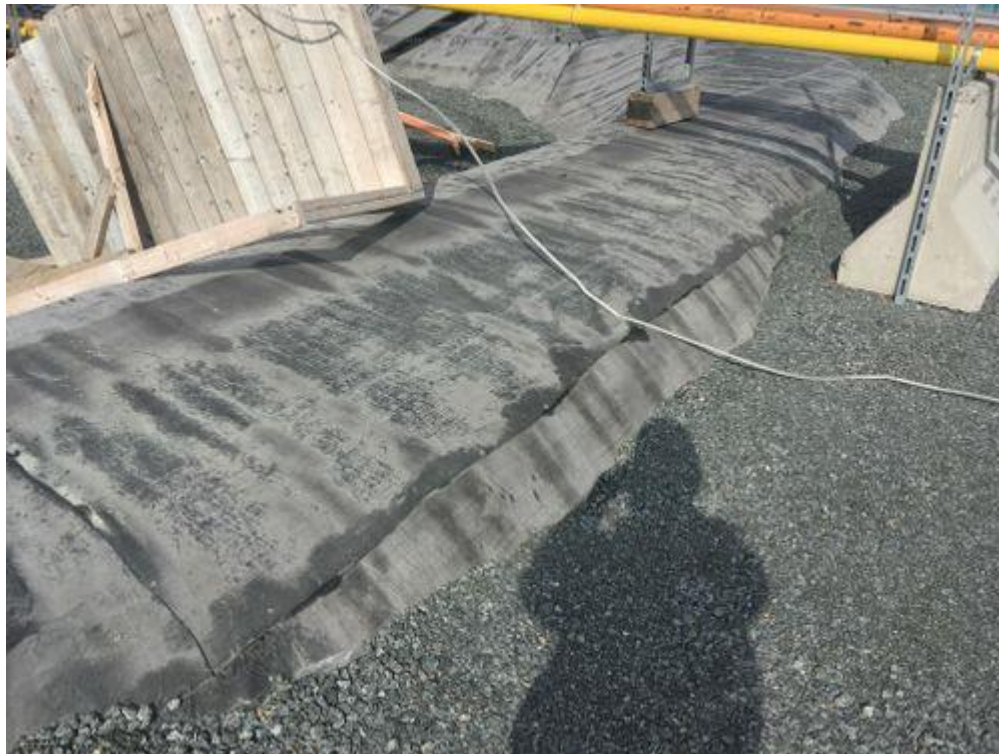
Observation 76

Location and component	Fuel Storage Facility #2 Downstream slope
Reported observation	Horizontal seam, should have been welded perpendicular to the slope
Preventive or corrective actions to take	Monitor the structure for any deformation that may affect the seams of the geosynthetic
Priority level	P-4: Best Management Practice – further improvements are necessary to meet industry best practices or reduce potential risks.
Observation date	2019-07-18

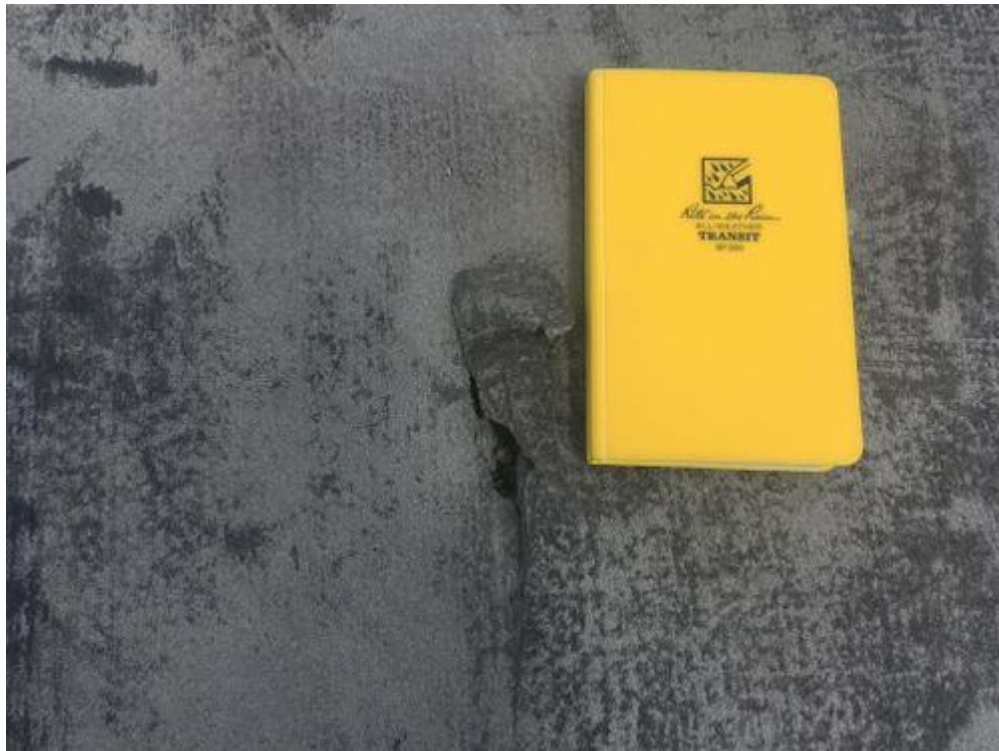
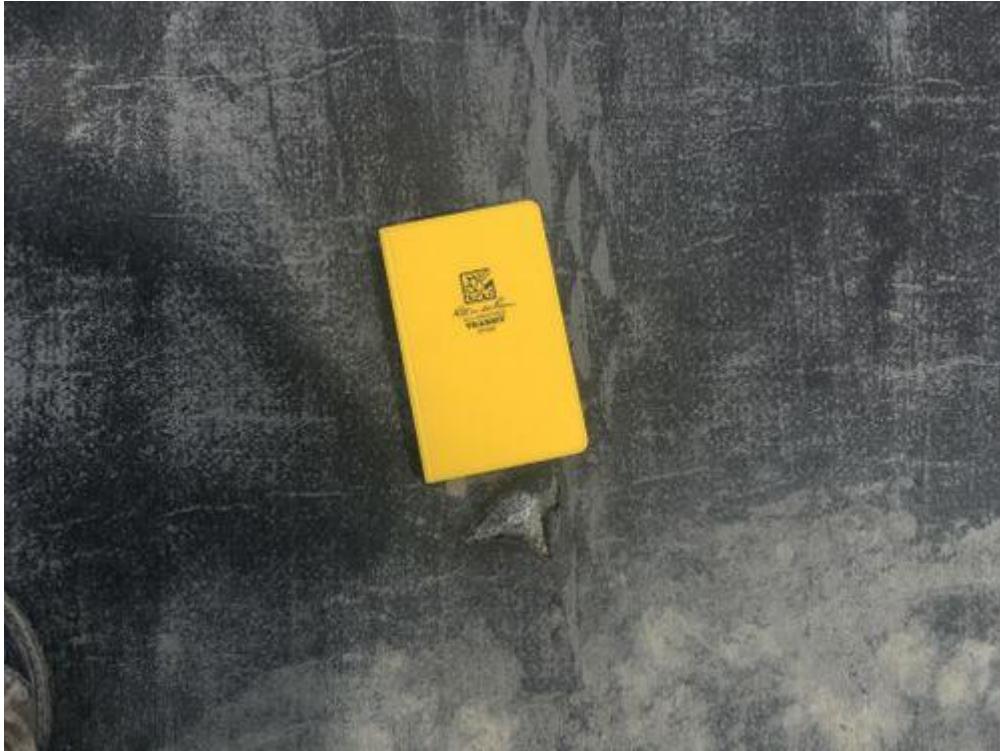
Observation 77

Location and component	Fuel Storage Facility #2 Upstream slope
Reported observation	Holes in liner
Preventive or corrective actions to take	Patch the holes using the same type of liner
Priority level	P-3: Single occurrences of deficiencies or non-conformance that alone would not be expected to result in structure safety issues.
Observation date	2019-07-18

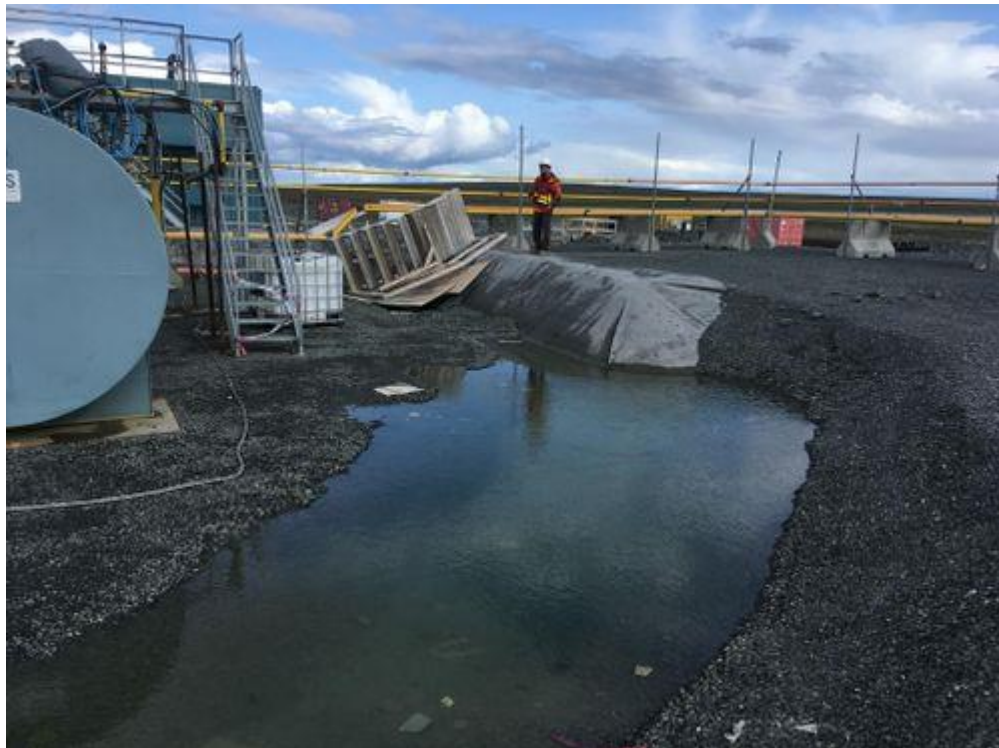
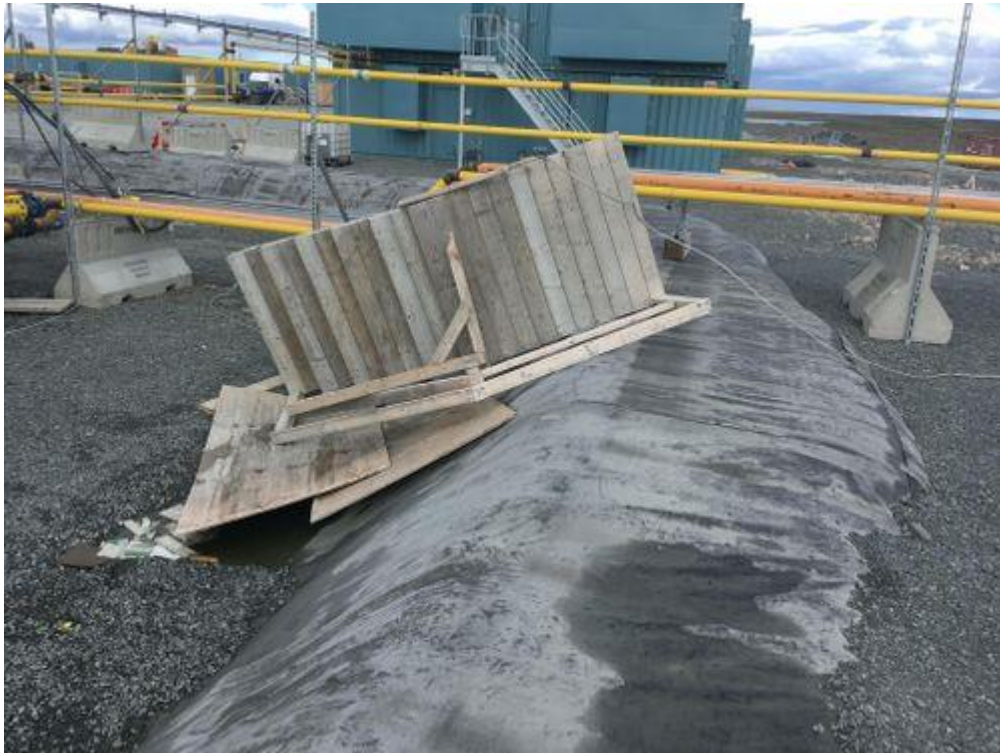
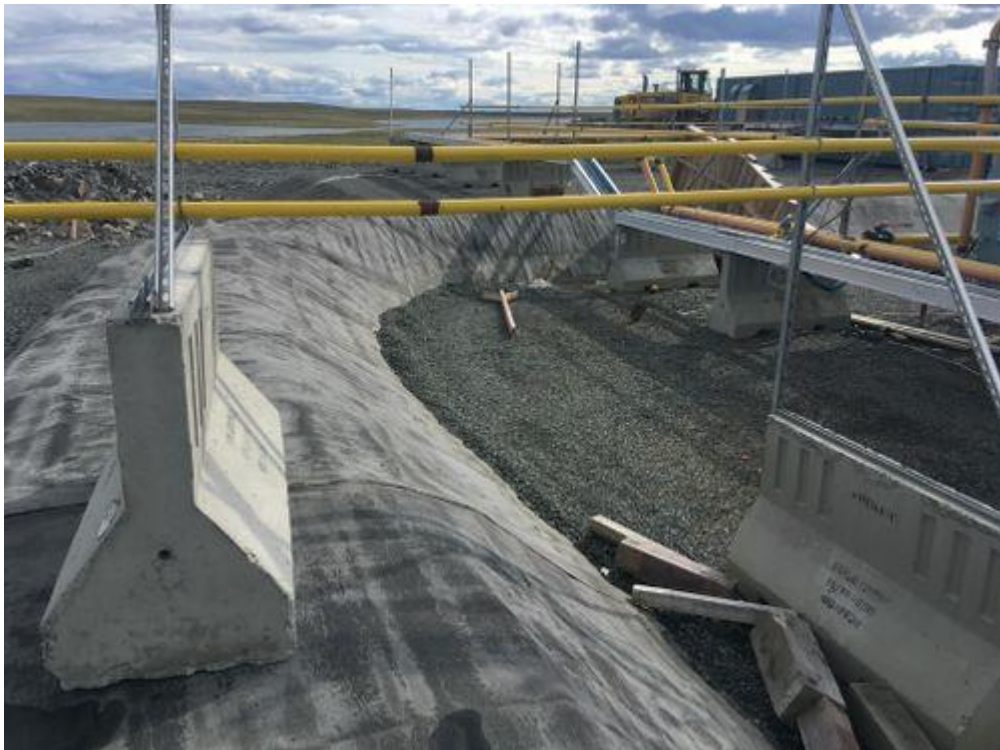
Observation 78

<p>DigitalGlobe, ... Powered by Esri</p>	Location and component	Fuel Storage Facility #2 Upstream slope
	Reported observation	Material on liner
	Preventive or corrective actions to take	Review the design to validate that the liner can stay exposed and unprotected. Remove any object in contact with the liner which could damage and perforate the membrane
	Priority level	P-2: If not corrected, could likely result in structure safety issues leading to injury, environmental impact, or significant regulatory enforcement; or a repetitive deficiency that demonstrates a systematic breakdown of procedures.
	Observation date	2019-07-18

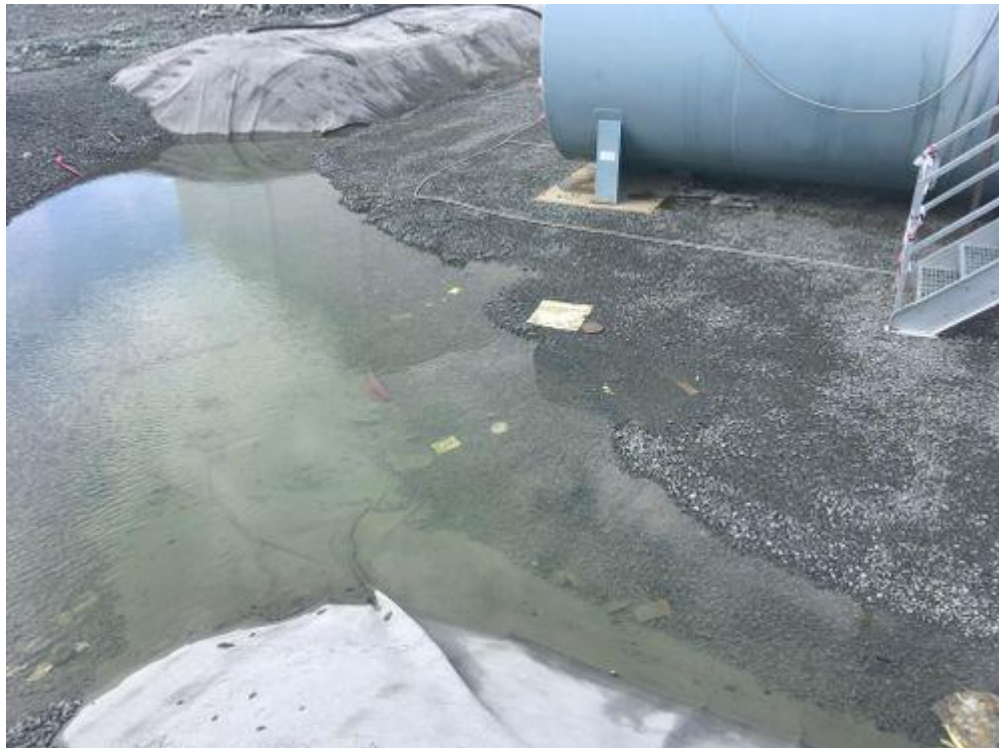
Location and component	Fuel Storage Facility #2 Water elevation
	Reported observation	Very little freeboard observed
	Preventive or corrective actions to take	Review the design for the operating water level and its minimum freeboard requirement. Monitor the water level ponding at the southwest corner of the structure and pump the water out if required
	Priority level	P-4: Best Management Practice – further improvements are necessary to meet industry best practices or reduce potential risks.
	Observation date	2019-07-18

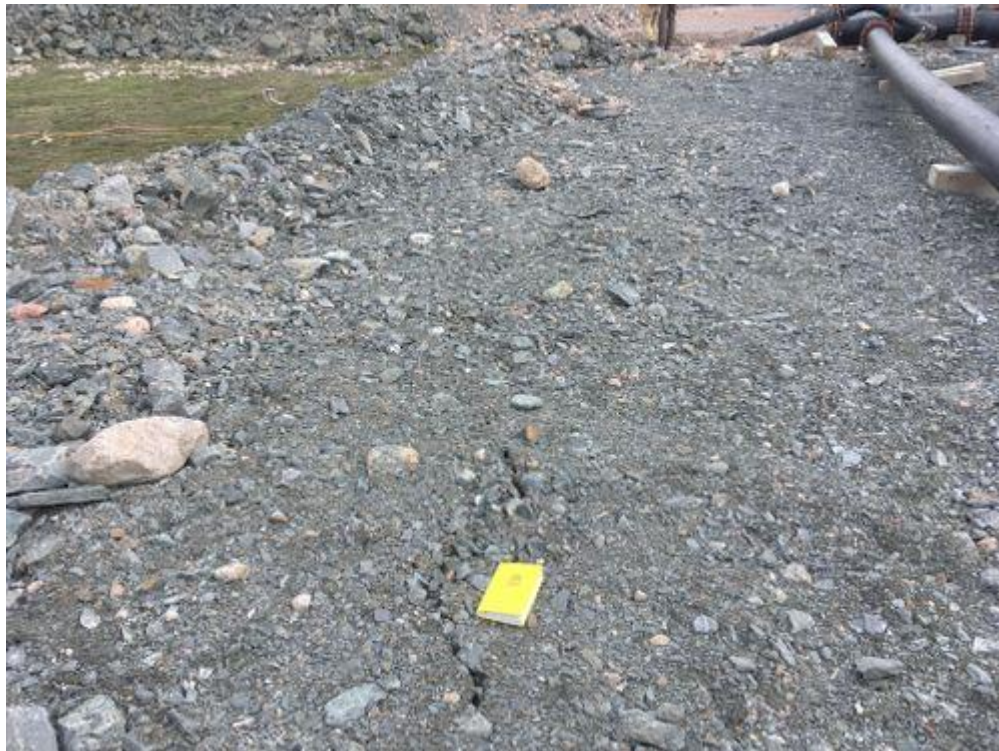
Observation 80

Location and component	WTP pad Crest
Reported observation	Cracking
Preventive or corrective actions to take	Monitor any cracking evolution, reprofile if required
Priority level	P-4: Best Management Practice – further improvements are necessary to meet industry best practices or reduce potential risks.
Observation date	2019-07-18

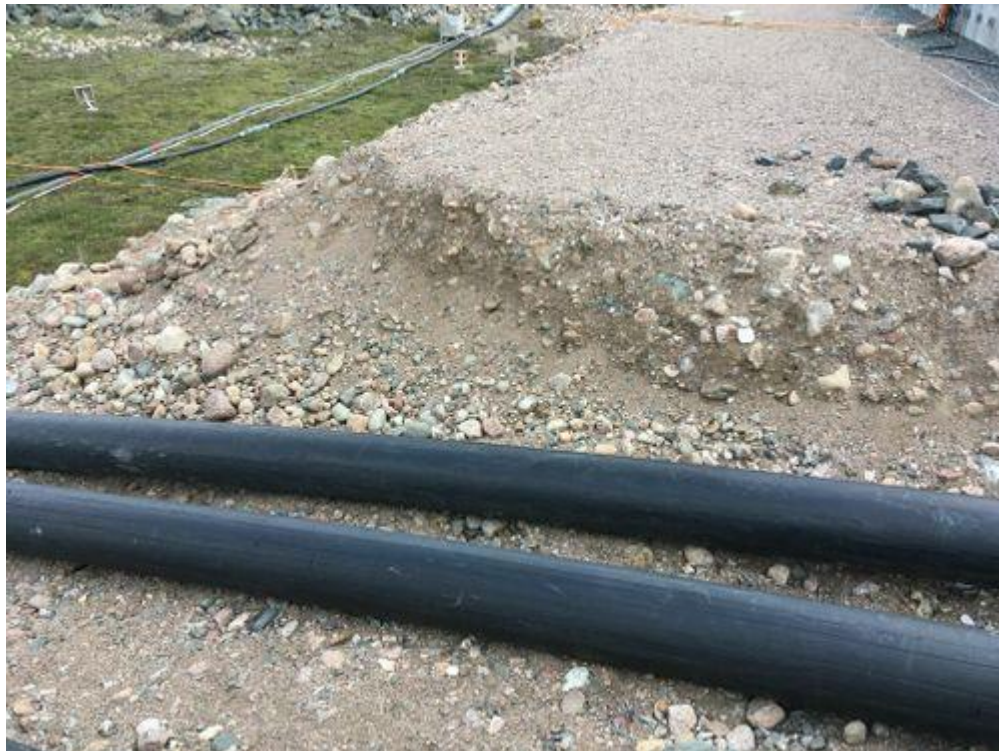
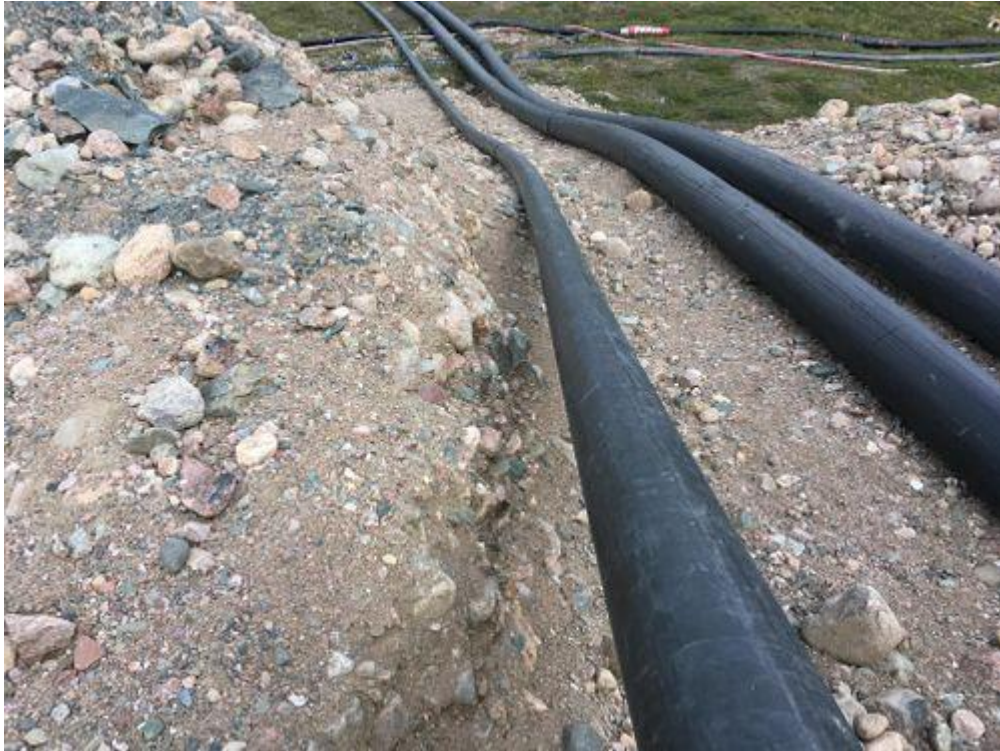
Observation 81

Location and component	WTP pad Slope
Reported observation	Raveling
Preventive or corrective actions to take	Soften the slope and compact with crushed rock
Priority level	P-4: Best Management Practice – further improvements are necessary to meet industry best practices or reduce potential risks.
Observation date	2019-07-18

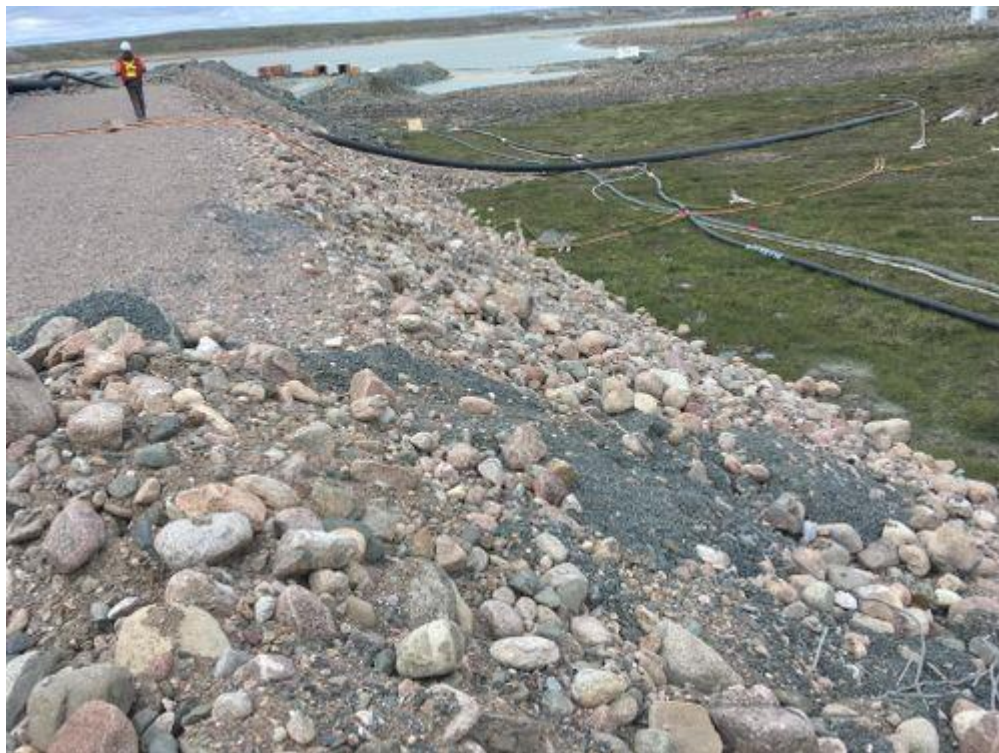
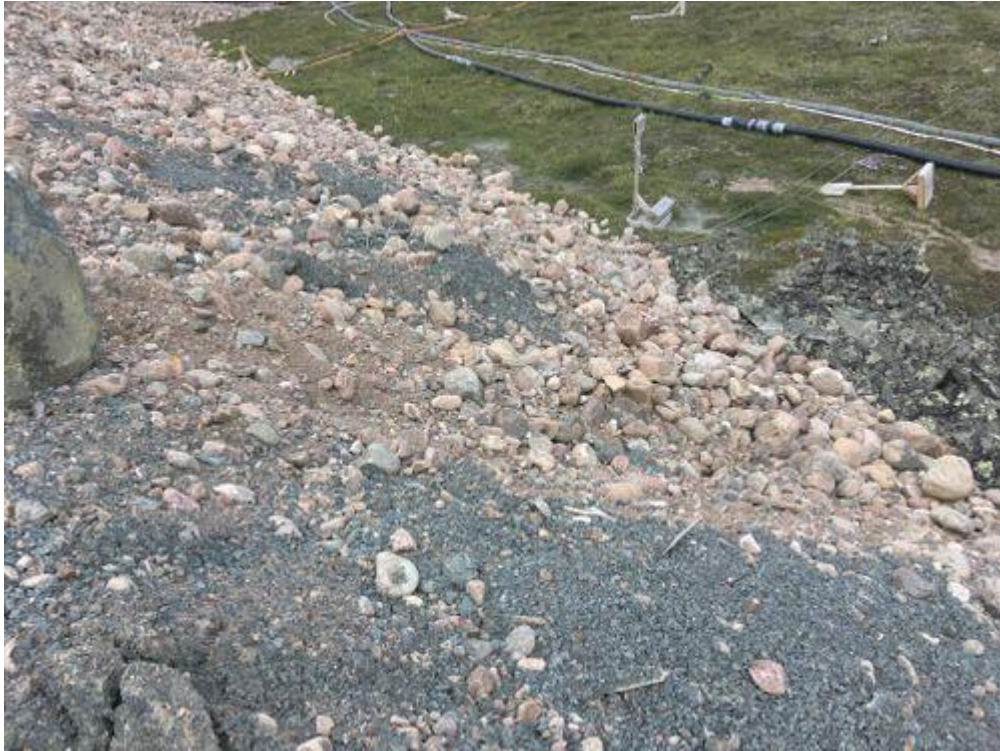
Observation 82

<p>DigitalGlobe, ... Powered by Esri</p>	Location and component	WTP pad Downstream slope
	Reported observation	Instability and puddles of water at the toe
	Preventive or corrective actions to take	Gentle the slope using esker material (rounded cobbles) or use crushed rock material which is more stable. Monitor the water ponding at the toe which could also contribute to instability
	Priority level	P-4: Best Management Practice – further improvements are necessary to meet industry best practices or reduce potential risks.
	Observation date	2019-07-18

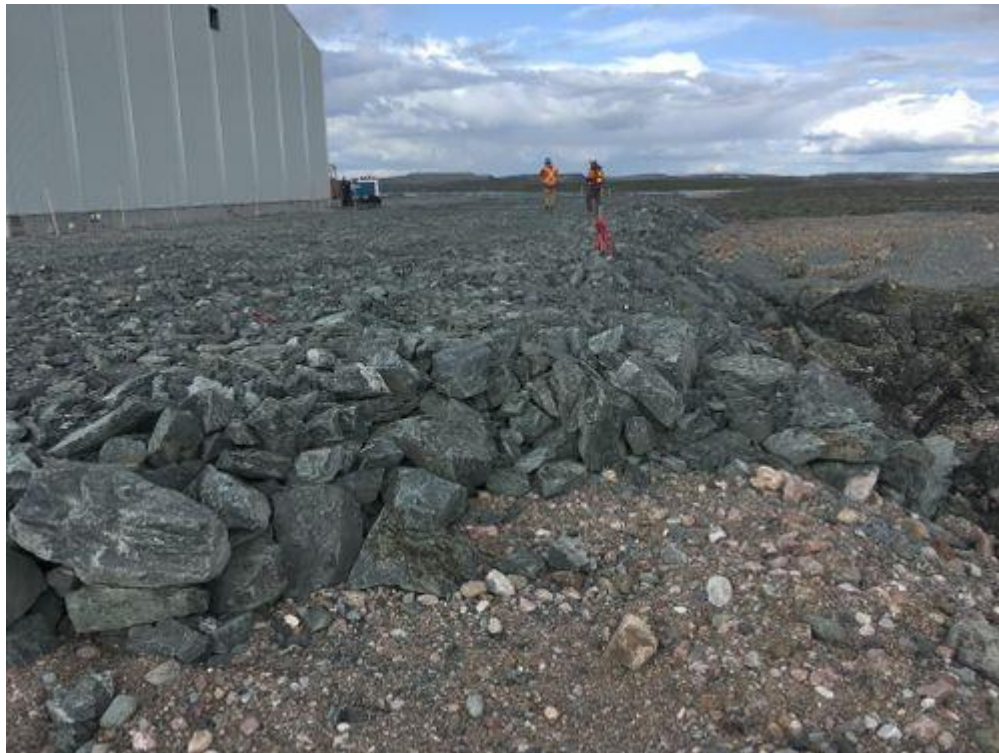
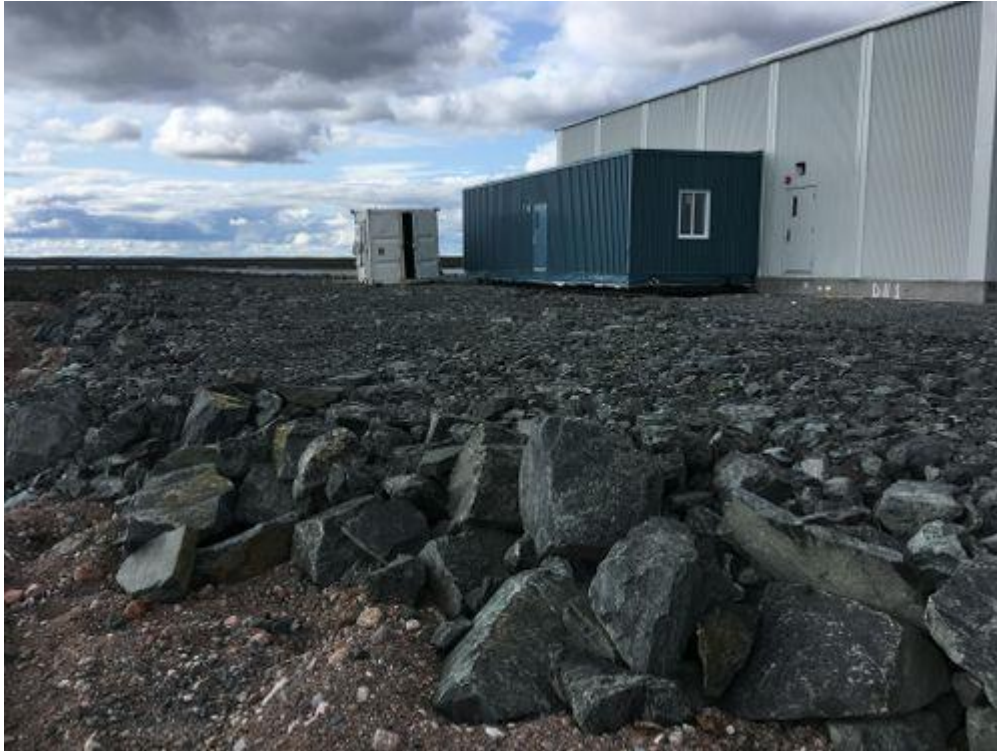
Observation 83

Location and component	Emulsion plant Pad
Reported observation	Pad and slopes are straight, uniform and show no evidence of deformation
Preventive or corrective actions to take	
Priority level	P-4: Best Management Practice – further improvements are necessary to meet industry best practices or reduce potential risks.
Observation date	2019-07-18

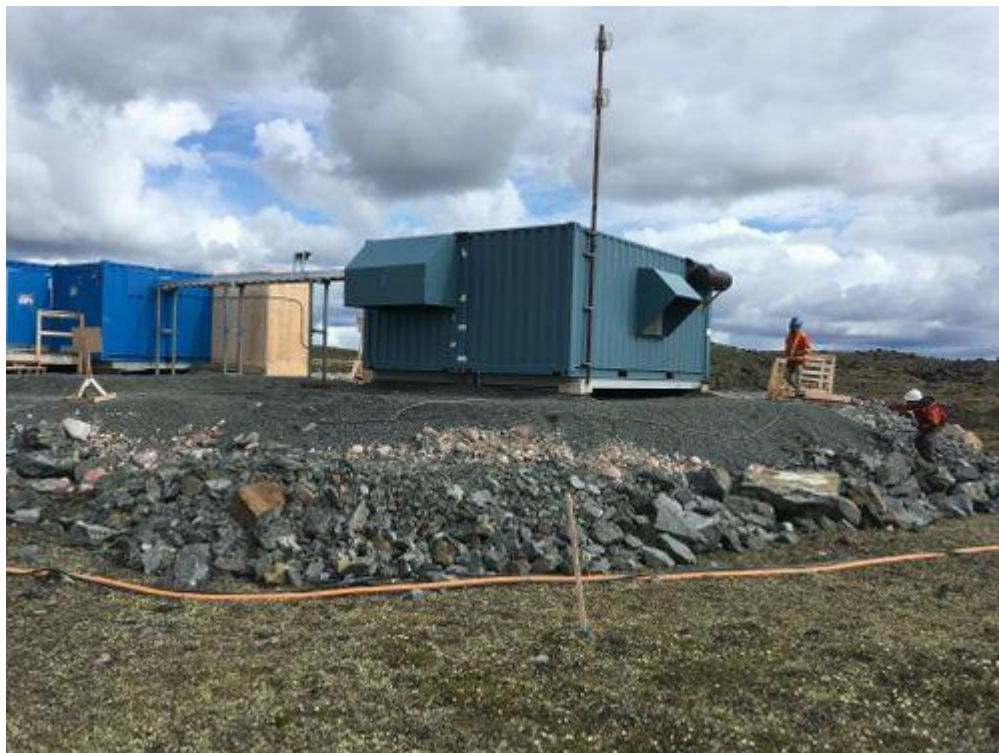
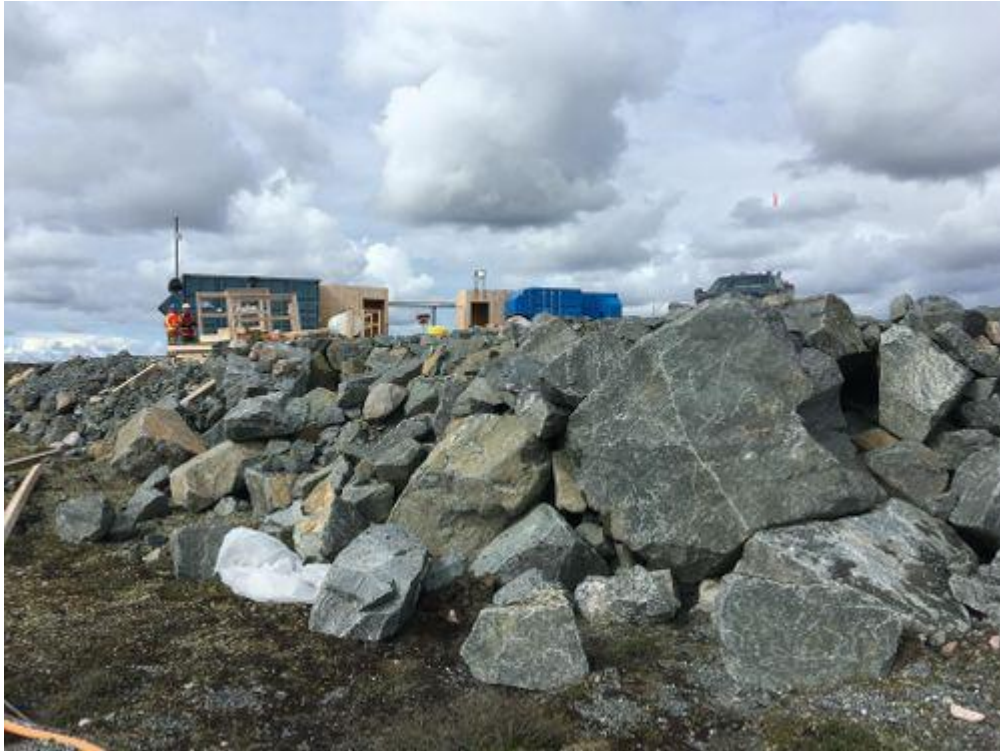
Observation 84

Location and component	Nemo lake Pad
Reported observation	Pad and slopes are straight and show no sign of deformation
Preventive or corrective actions to take	
Priority level	P-4: Best Management Practice – further improvements are necessary to meet industry best practices or reduce potential risks.
Observation date	2019-07-18

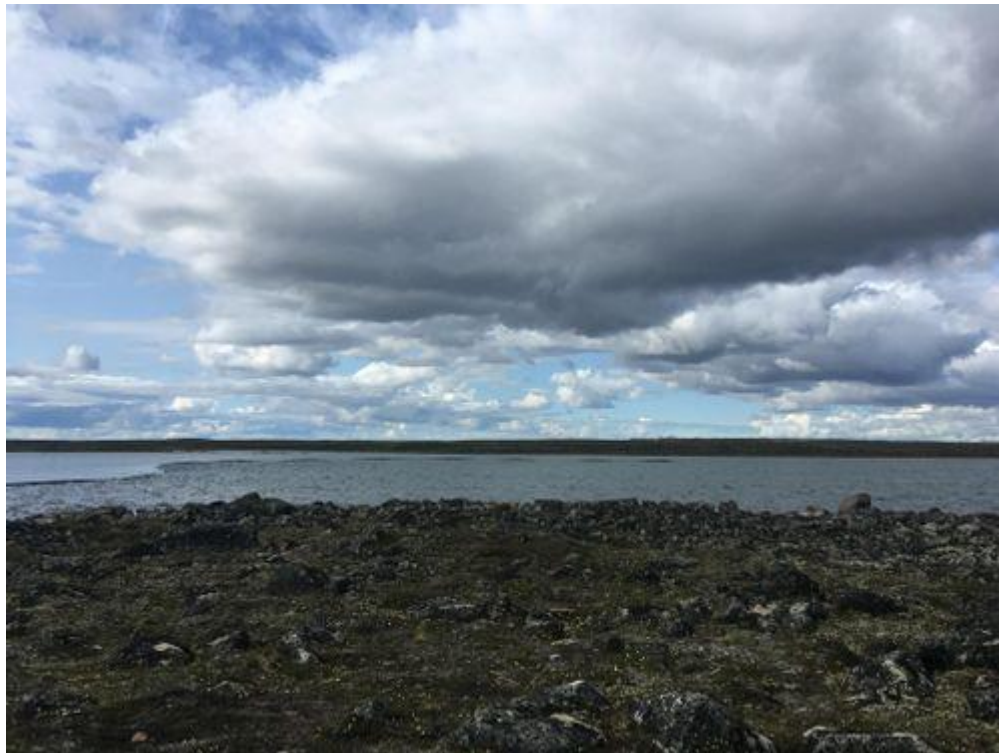
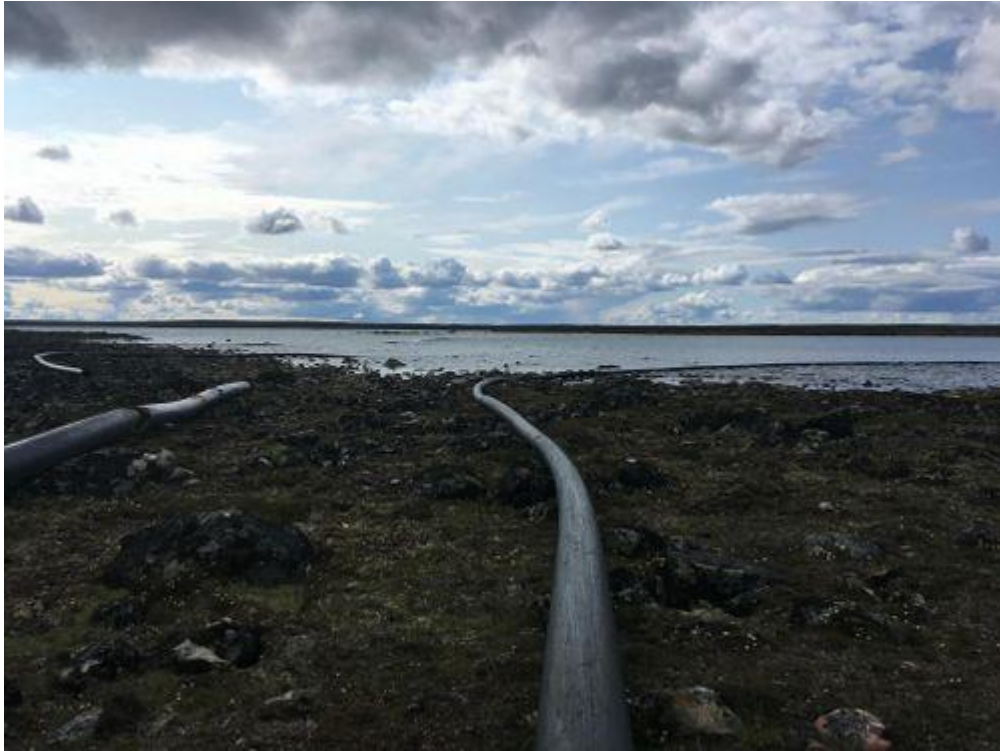
Observation 85

Location and component	Diffuser General view
Reported observation	As per AEM, diffuser should have stalled in the bottom of Mammoth Lake
Preventive or corrective actions to take	As per AEM, the diffuser will be reinstalled this year
Priority level	P-3: Single occurrences of deficiencies or non-conformance that alone would not be expected to result in structure safety issues.
Observation date	2019-07-18

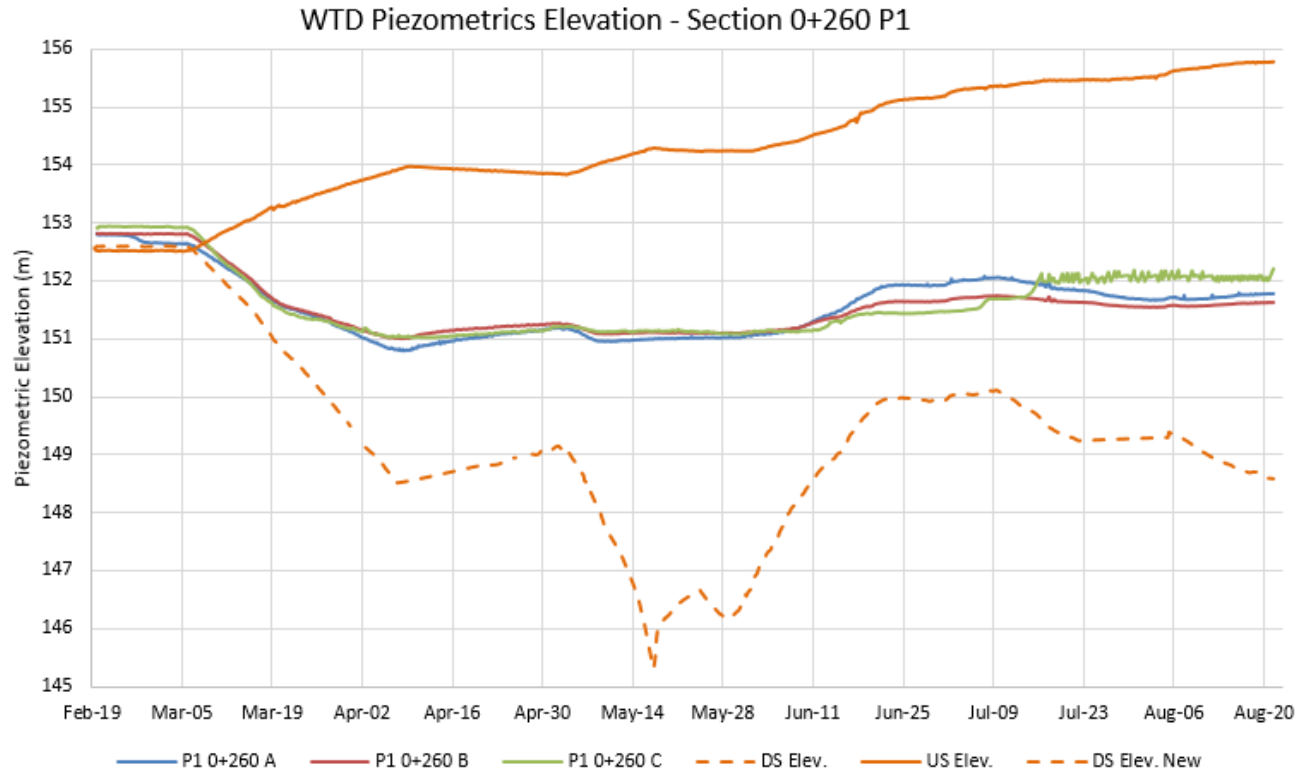
Whale Tail Instrumentation Report
Piezometer 0+260_P1 (A-B-C)

Comments:
 Total Head on August 21st, 2019

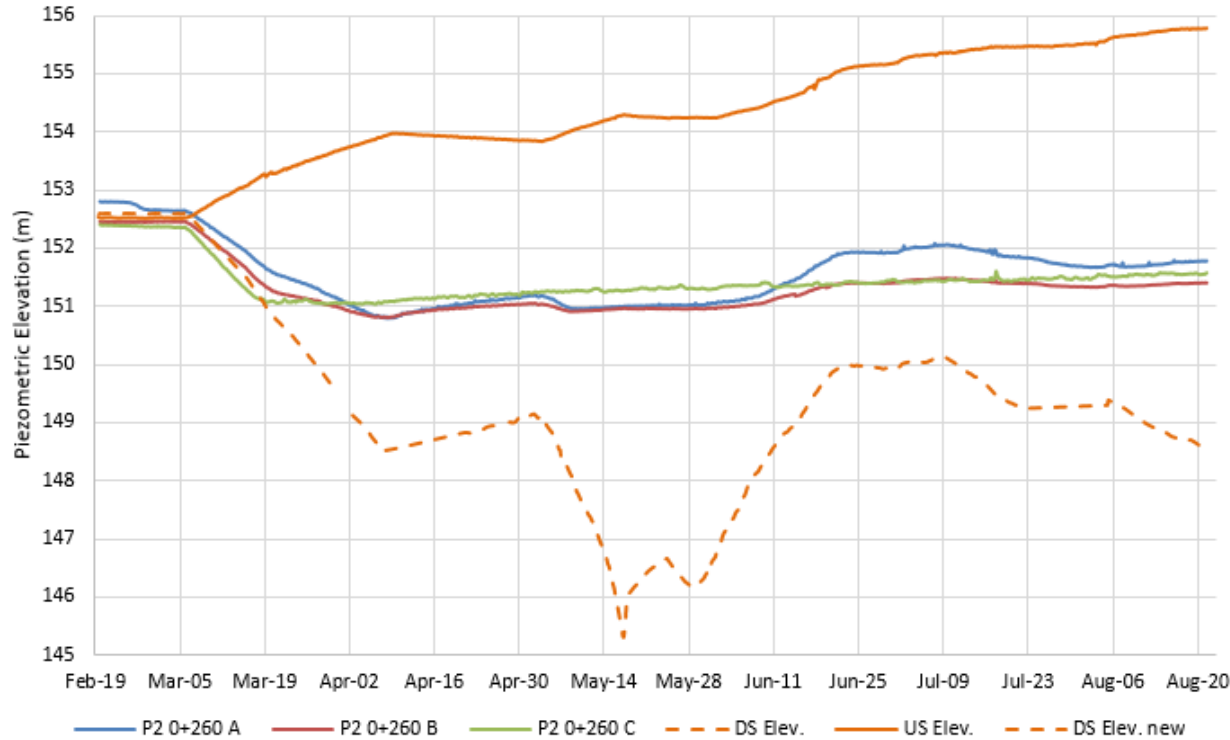
WTD Piezometrics Elevation - Section 0+260 P2

Comments:
 Total Head on August 21st, 2019

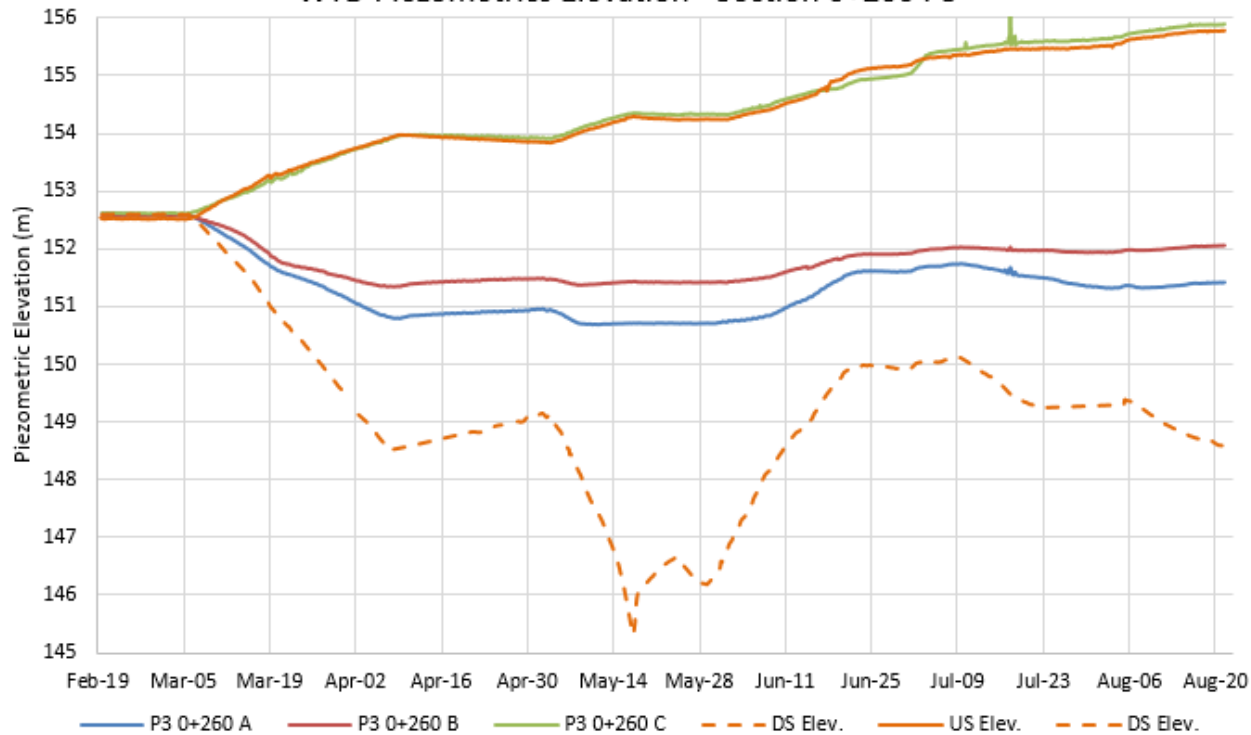
WTD Piezometrics Elevation - Section 0+260 P3

Total Head on August 21st, 2019

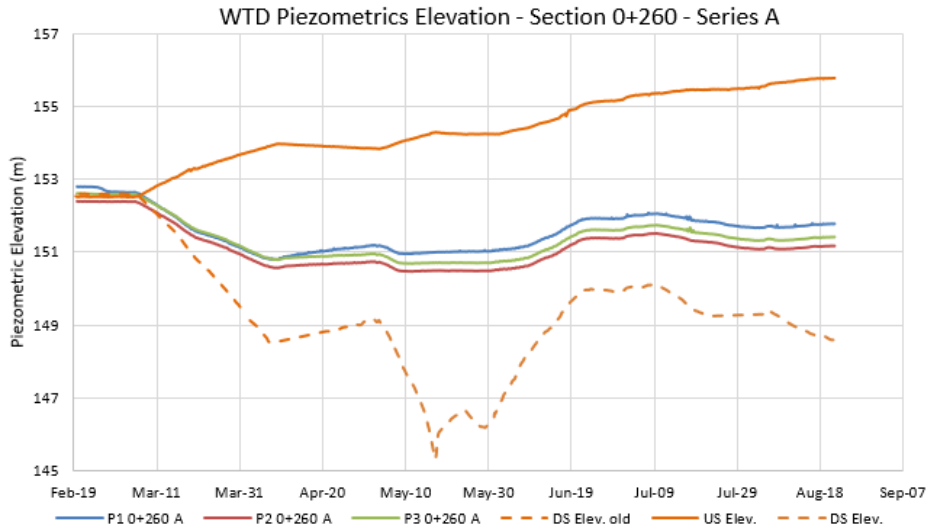
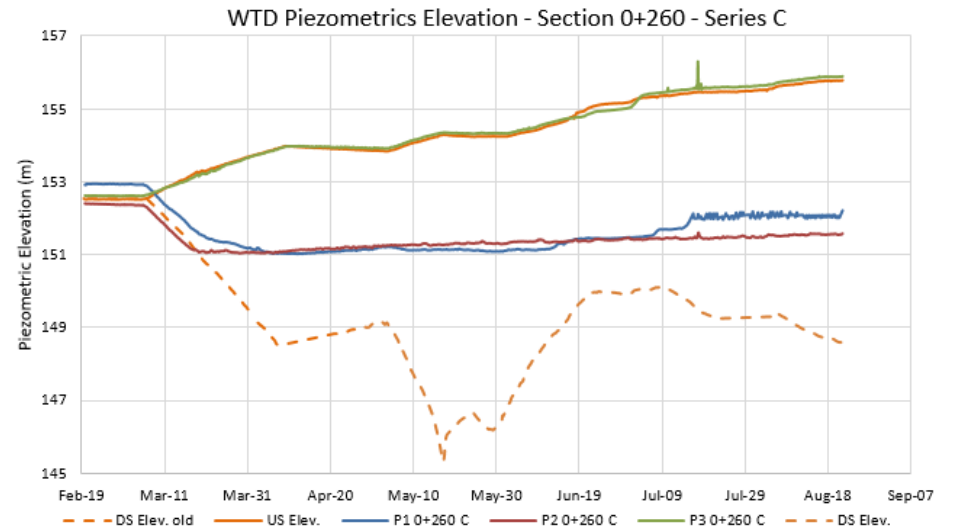
Piezometer 0+260 Graph By A, B and C series

Comments: Total Head on August 21st, 2019
