Whale Tail Project 2019 Annual Geotechnical Inspection

Final Report (Rev. 01)

Agnico Eagle Mines Limited

2019 | 12 | 16

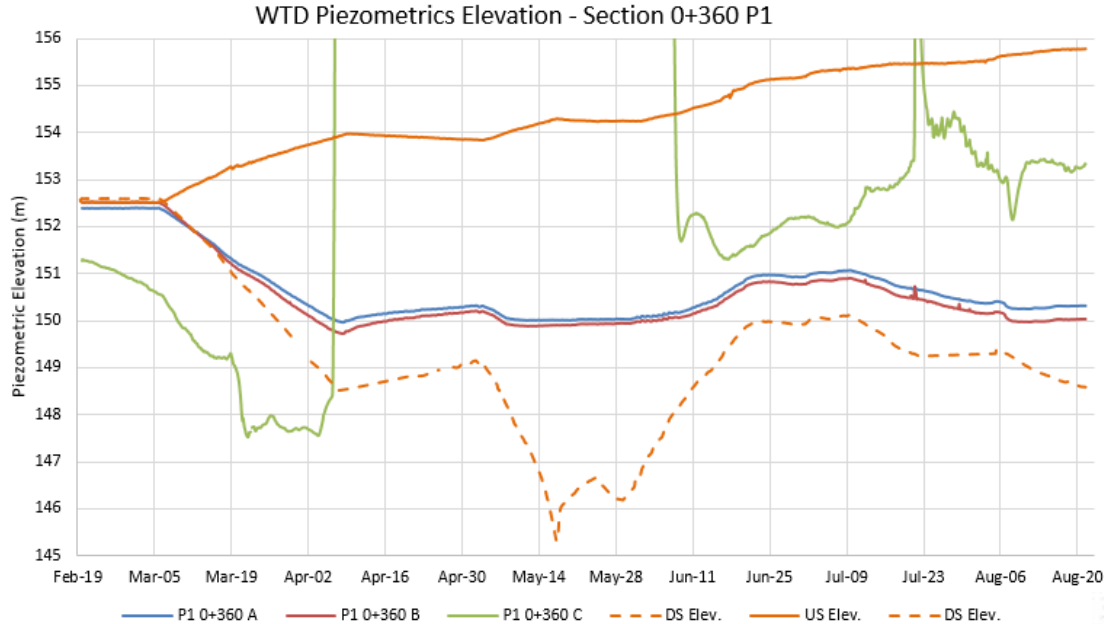
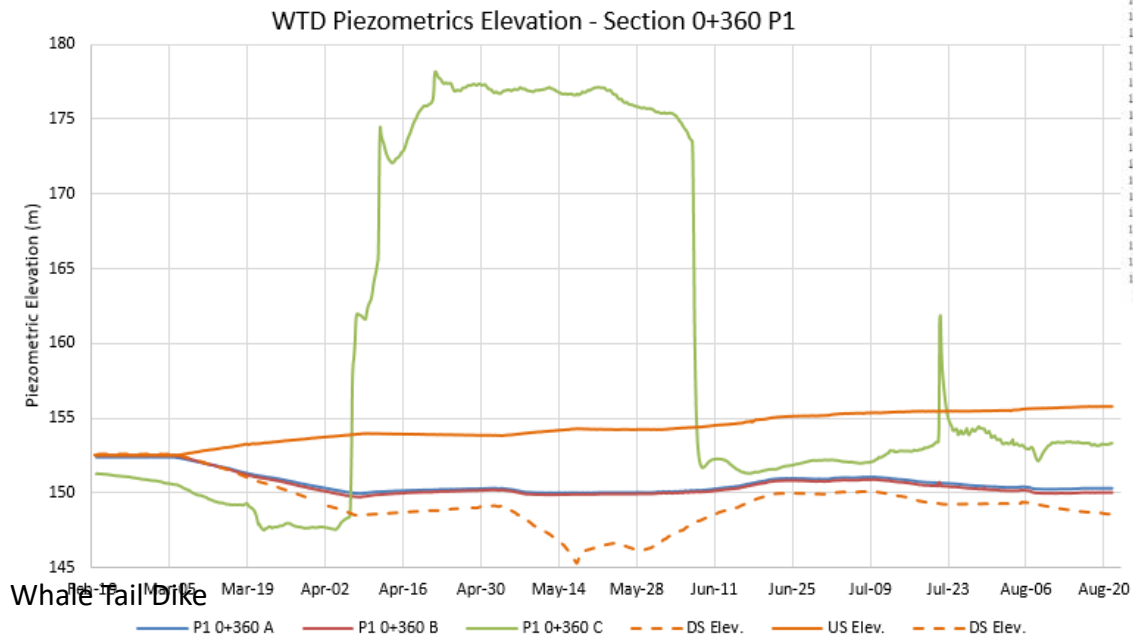
Whale Tail Instrumentation Report
Piezometer 0+360_P1 (A-B-C)

Comments:
 Total Head on August 21st, 2019

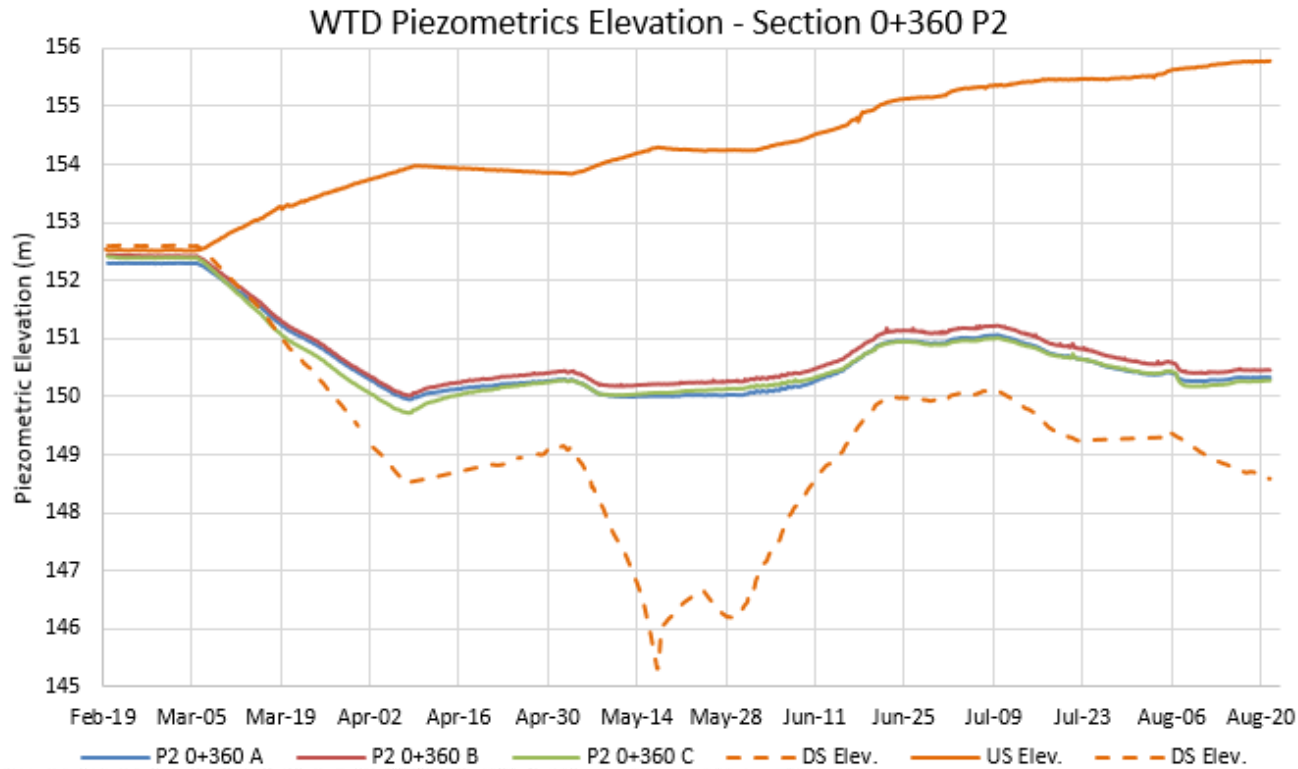
Whale Tail Instrumentation Report
Piezometer 0+360_P2 (A-B-C)

Comments:
 Total Head on August 21st, 2019

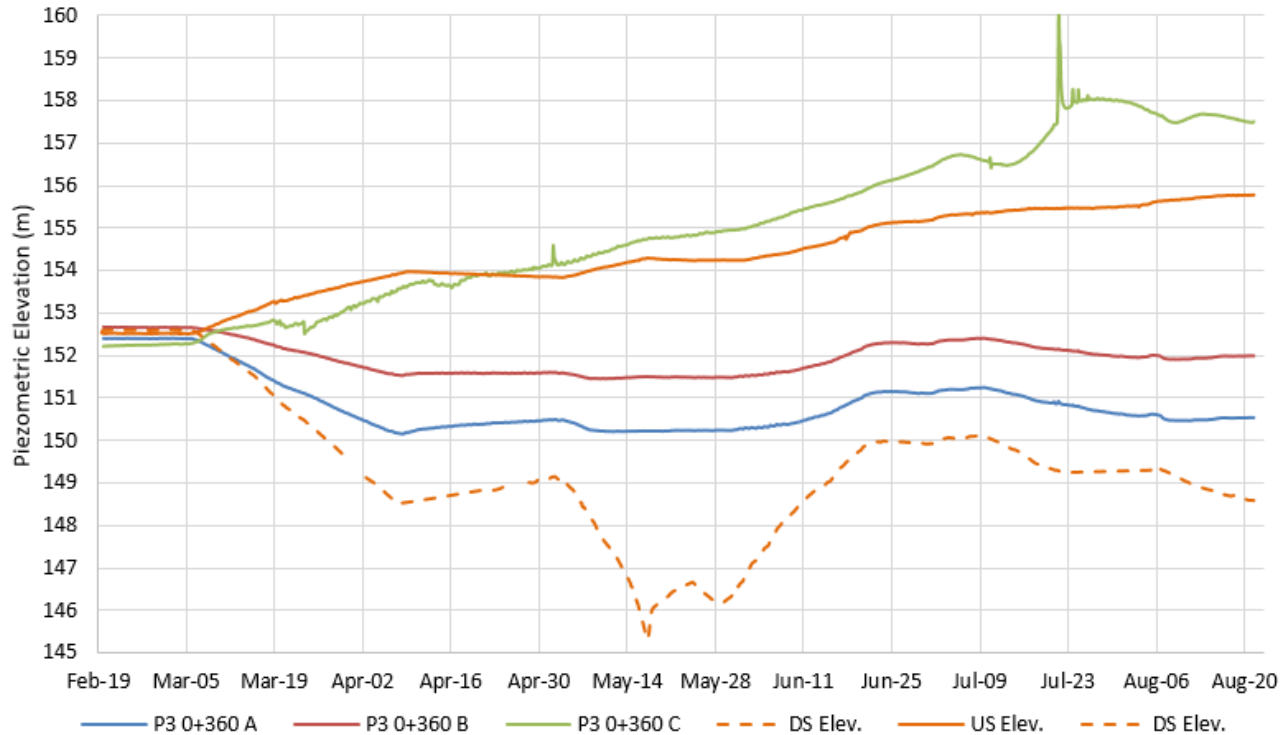
WTD Piezometrics Elevation - Section 0+360 P3

Comments:
 Total Head on August 21st, 2019
