Whale Tail 2022 Annual Open Pit Geomechanical Inspection

March 17, 2023

RE: Meadowbank Complex - Amaruq Site - 2022 Annual Open Pit Geomechanical Inspection

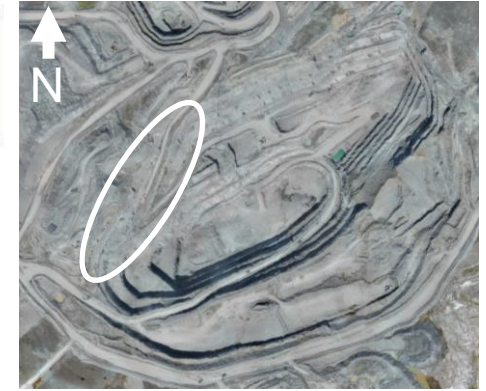
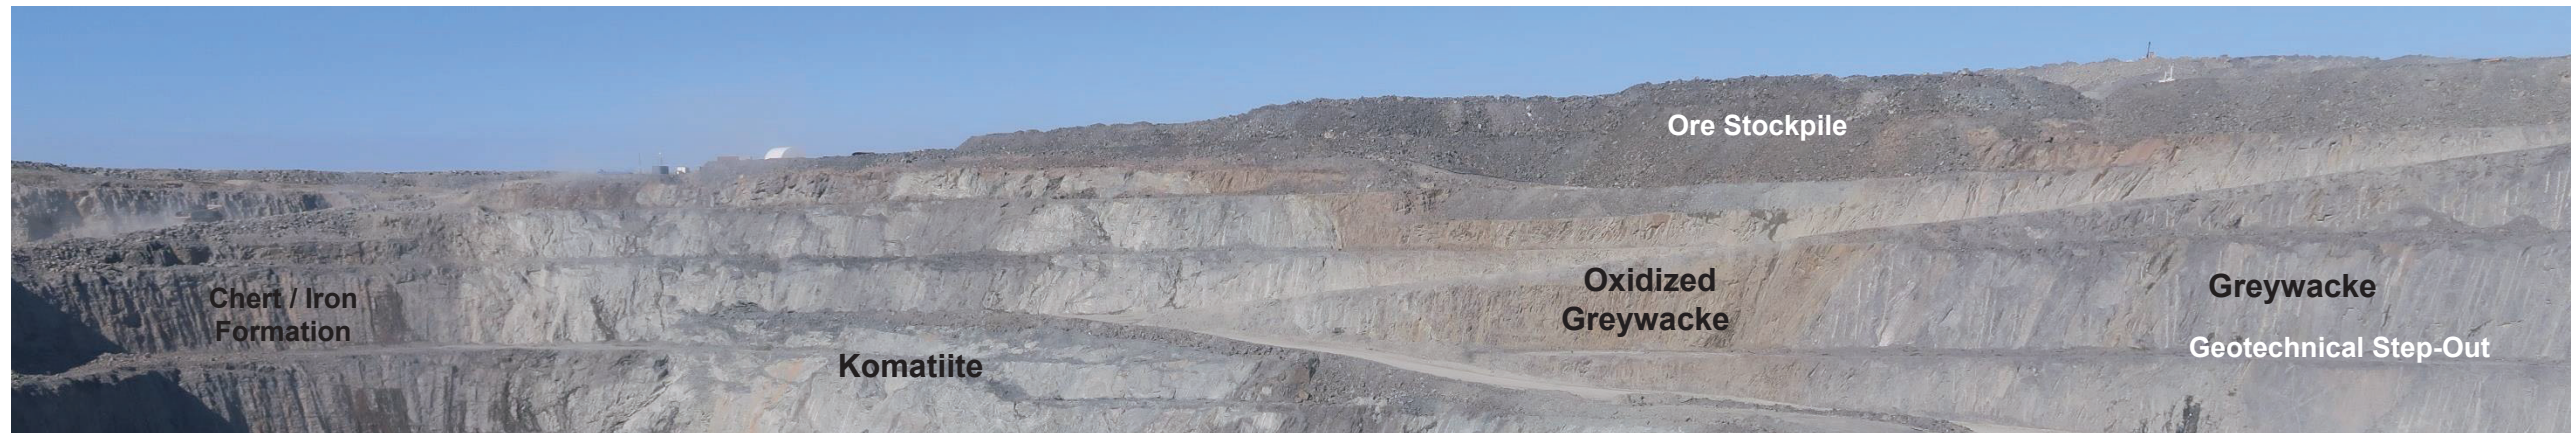
Observations - Northwest Wall

BFA: 65°
Bench Width: 10 m
Bench Height: 21 m
IRA: 47°

- Final wall in Design Sector A1/A1K.
- No mining has occurred in this area and there have been no slope failures since the last annual inspection.
- The benches are generally performing well.
- The Oxidized Greywacke is thought to be associated with a talik zone below what was the western end of Whale Tail Lake. It is of lower rock mass quality than the Greywacke and prone to ravelling. The exposures along the ramp are limited in height and rockfall has not been a concern to date. If ravelling increases, a rockfall berm could be constructed along the inside of the ramp through this unit.

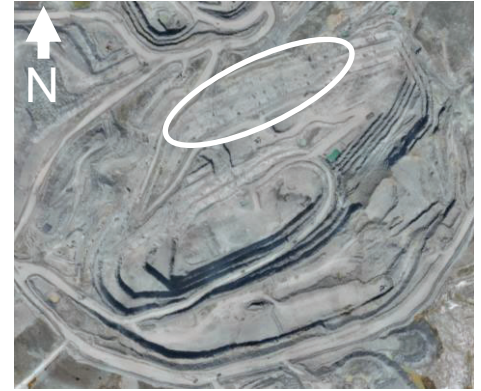
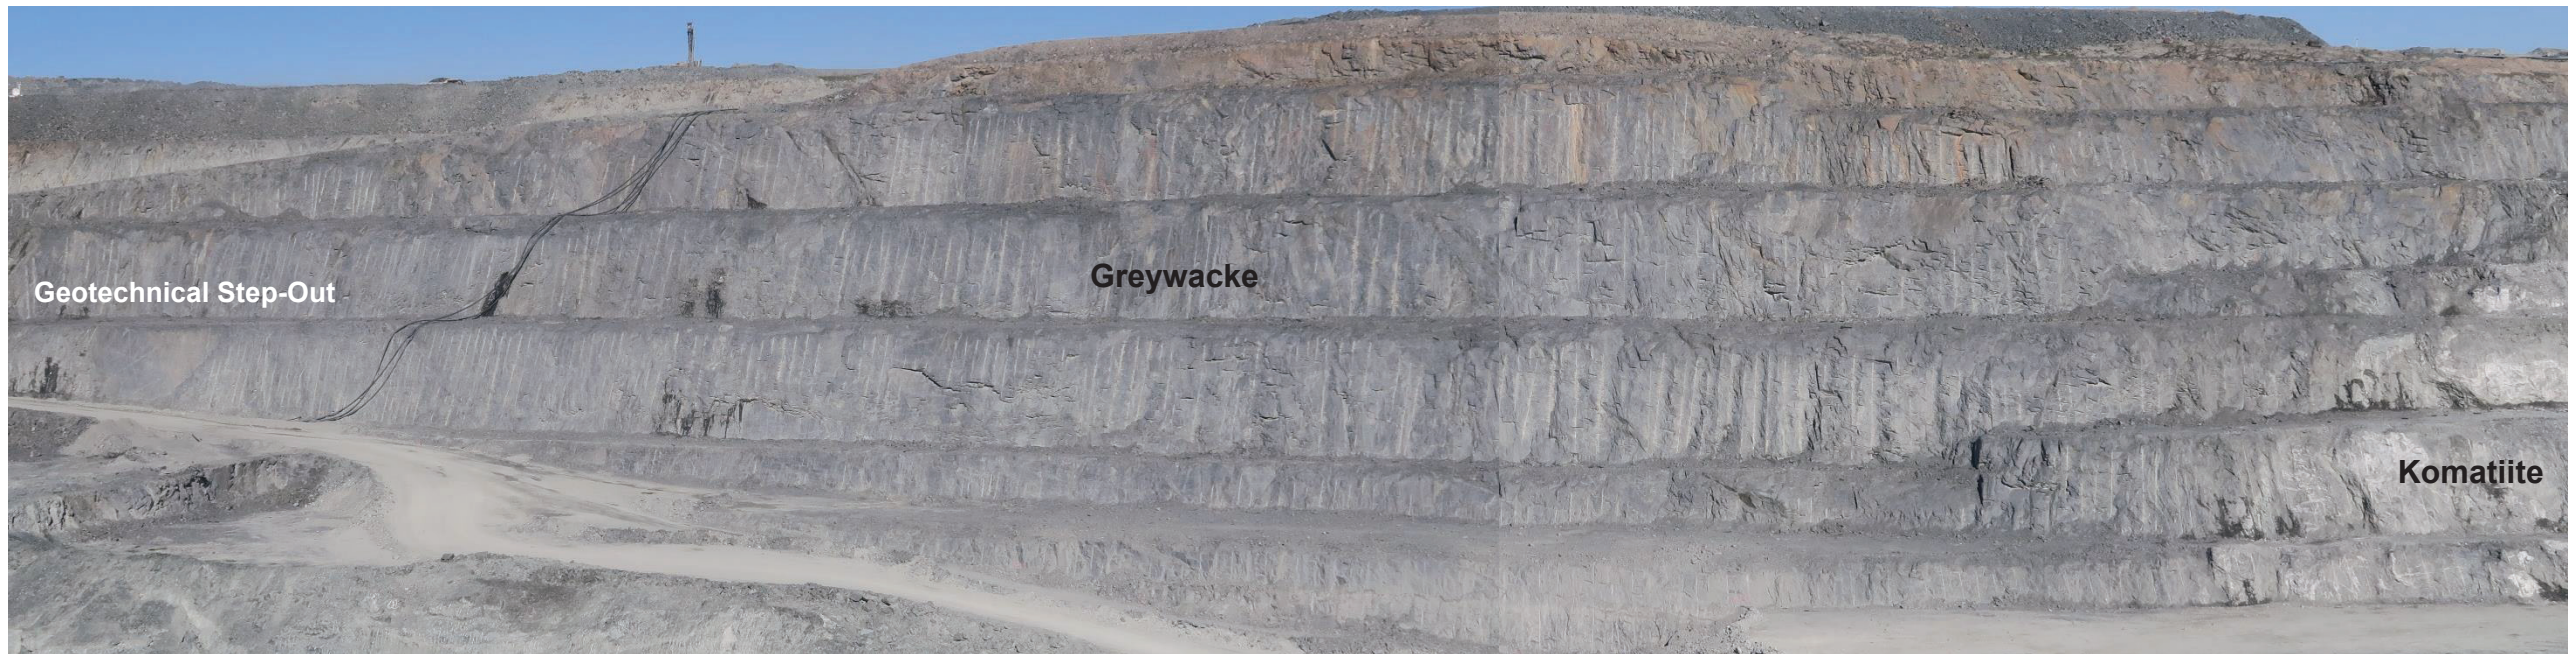
Observations - North Wall

BFA: 65°
Bench Width: 10 m
Bench Height: 21 m
IRA: 47°

- Final wall in Design Sector B1.
- Limited mining has occurred in this area and there have been no slope failures since the last annual inspection.
- The benches are performing better than expected, with the bench face often standing steeper than the foliation.
- The 2021/2022 design review found that many of the pre-shear drillholes have been drilled at an angle shallower than the planned 60°, reducing the effective bench width. Comments on drill and blast quality control are provided later in this presentation.

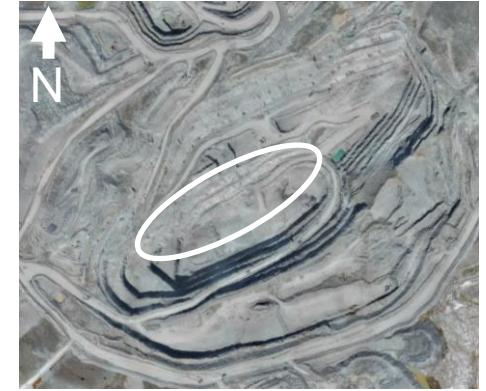
Observations - Phase 1 North Wall

- Interim wall in Phase 1. Phase 1 has been the focus of production over the past year.
- The wall was established in the Komatiite, parallel to the foliation. As expected, a series of bench-scale failures have occurred in areas where the foliation locally dips at a shallower angle than the bench face.

- The implementation of a 55° pre-shear has improved slope performance and half barrels are visible in many areas. Bench-scale failures have and will continue to occur. AEM continues to complete extensive scaling in this sector in order to remove potential hazards and reduce the likelihood of a failure. This is endorsed.

- The bench failures almost always occur during freshet or the summer months.
- As a result, the development of the ramp along the this wall was prioritized during the 2021-2022 winter in order to minimize the rockfall risk to personnel. A berm was installed along the inside of the ramp prior to freshet.

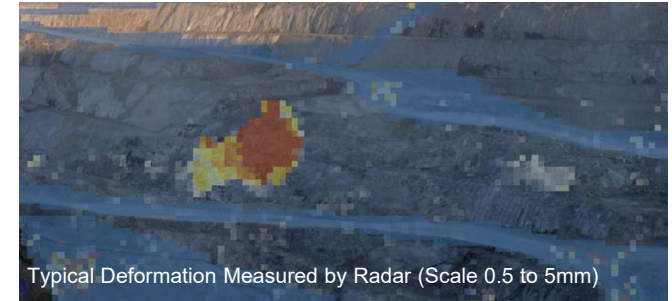
Observations - Phase 1 North Wall (2)

- A multi-bench failure has occurred progressively within the Komatiite over multiple events between May 14 and July 16, 2022.
- The area was identified as a potential instability during development and a berm constructed below the wall prior to freshet.
- The failure appears to be bounded by persistent structures. This could represent an undulation in the foliation, as similar geometries have resulted in bench scale failures in the past. The eastern contact appears to be more linear and may be a Brittle Structure.
- The failure mass continues to exhibit steady, gradual deformation in the radar data, in the order of 5 to 6 mm/day.

- A review of the lithology model suggests that the failure is unlikely to propagate significantly further back behind the crest due to the presence of the Greywacke.

- The potential for the failure to continue to propagate with depth was discussed as the structure defining the eastern boundary of the failure daylights below the ramp. The failure is larger than others along the Phase 1 North Wall and should be reviewed in greater detail to better understand the failure mechanism, likely contributing factors, and the potential for the failure to continue below the ramp. It may be possible to use the radar data to better understand the possible structural controls on the failure. A Maptek scan is recommended to document the failure geometry in detail.

- The Phase 1 pit will be used as a sump for managing water into 2024. Personnel will be travelling on the ramp below this failure during that time.
- Options for reducing the risk to personnel if the failure continues to progress were discussed. These include:

- Buttressing the failure. This would limit the ramp to single lane traffic but that is expected to be manageable.
 - Allowing the water level to rise a point on the ramp above the failure. This would allow the pumps to be located above the failure, removing the requirement for personnel to travel below the failure. However, the infiltration of water into the toe of the failure mass would like adversely influence the performance of the failure. The potential risks associated with storing this much water above the underground workings would also need to be reviewed.

- The failure should continue to be monitored with the radar and the berm maintained.
- Once mining of Phase 1 is complete, the risks associated with on-going access below the failure should be reviewed and mitigation measures implemented as appropriate.

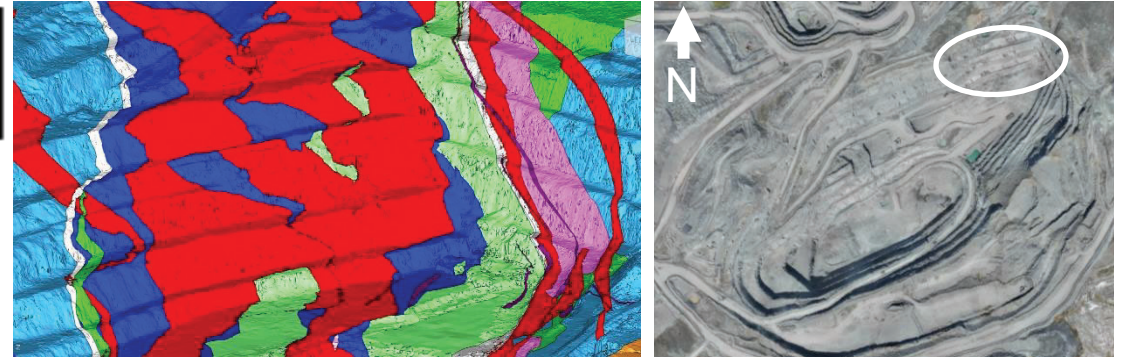
Observations - Northeast Wall

BFA: 55°
Bench Width: 11 m
Bench Height: 14 m
IRA: 34°

- Final wall in Design Sector D4K.
- This sector is within the Komatiite and has been characterized by a series of bench scale failures. The failures are currently understood to be a hybrid of failure on the foliation and failure of the weak rock mass, influenced by water (i.e., a combination of seepage within the talik and surface runoff) and the Brittle Structures.

- A revised slope design was developed in December 2021 and a pushback of the upper two benches completed to re-establish the slope. The pushback will eventually form part of the planned Whale Tail Extension to the northeast.

- The performance of the benches has improved with the revised slope design. Several bench-scale failures have occurred and will continue to occur.
- A series of bench-scale failures have occurred at the eastern end of the sector (outlined at right). The failures have almost, but not yet, linked up. This area is discussed on the following slide.

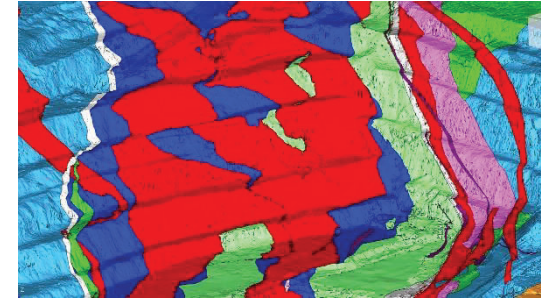
Observations - Northeast Wall (2)

- Seven rockfalls and bench scale failures have been reported in this sector in 2022, ranging in tonnage between approx. 150 and 1500 tonnes. All but one are associated with a series of progressive failures associated with the area outlined in the left photo.

- The failures occurred during freshet, between May 28 and July 17, with most occurring in June. Failures were expected and a rockfall berm was constructed below this area prior to freshet.

- The middle photo shows the outlined area at the time of many of the initial failures in June. These failures were relatively small and several appear to be associated with surface water or erosion of the face (see next slide). The rock mass quality was noted to reduce as the rock mass thawed and these failures progressed over time. The failures on the two benches have almost linked up.

- The western limit of the failures appears to be defined by the foliation. The eastern limit of the failures appears to have a structural control (see right photo). This may be one of the brittle structures (see image at upper right, with brittle structures in red).

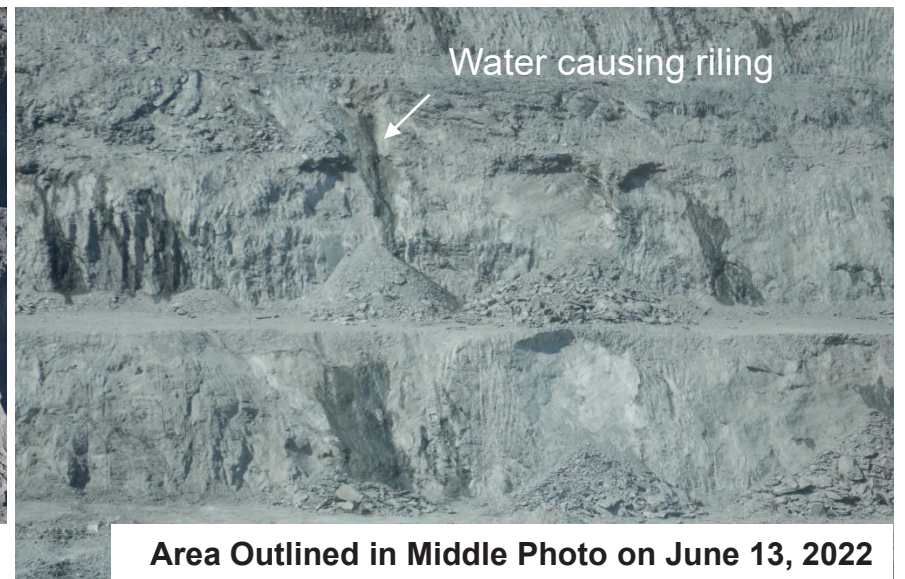
Area Outlined in Middle Photo on June 13, 2022

- The site team believes that the infiltration of surface water and the erosion of brittle structures in the bench face likely contributed to the initial failure in May.

- The pushback is located within the drainage for what was the northeastern lobe of Whale Tail lake and water reports to the area. An unlined sump has been established at the base of the pushback at the top of the slope (left photo). The sump is on the Komatiite-Greywacke contact, which is likely promoting infiltration.

- Photos prior to the failures show surface water running across the bench face and eroding the weak rock mass (right photo). The water appears to be concentrated along the potential structure bounding the western edge of the failures.

- It seems reasonable that water is contributing to the failures. It is recommended that surface water be diverted away from the area to the extent possible and that the sump be lined.

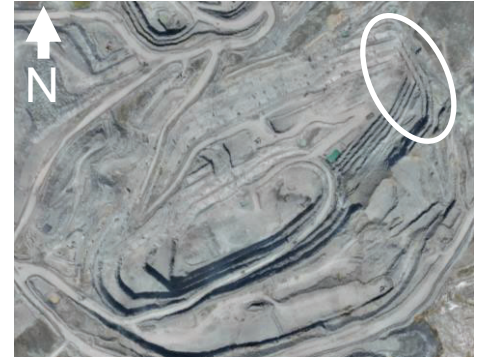
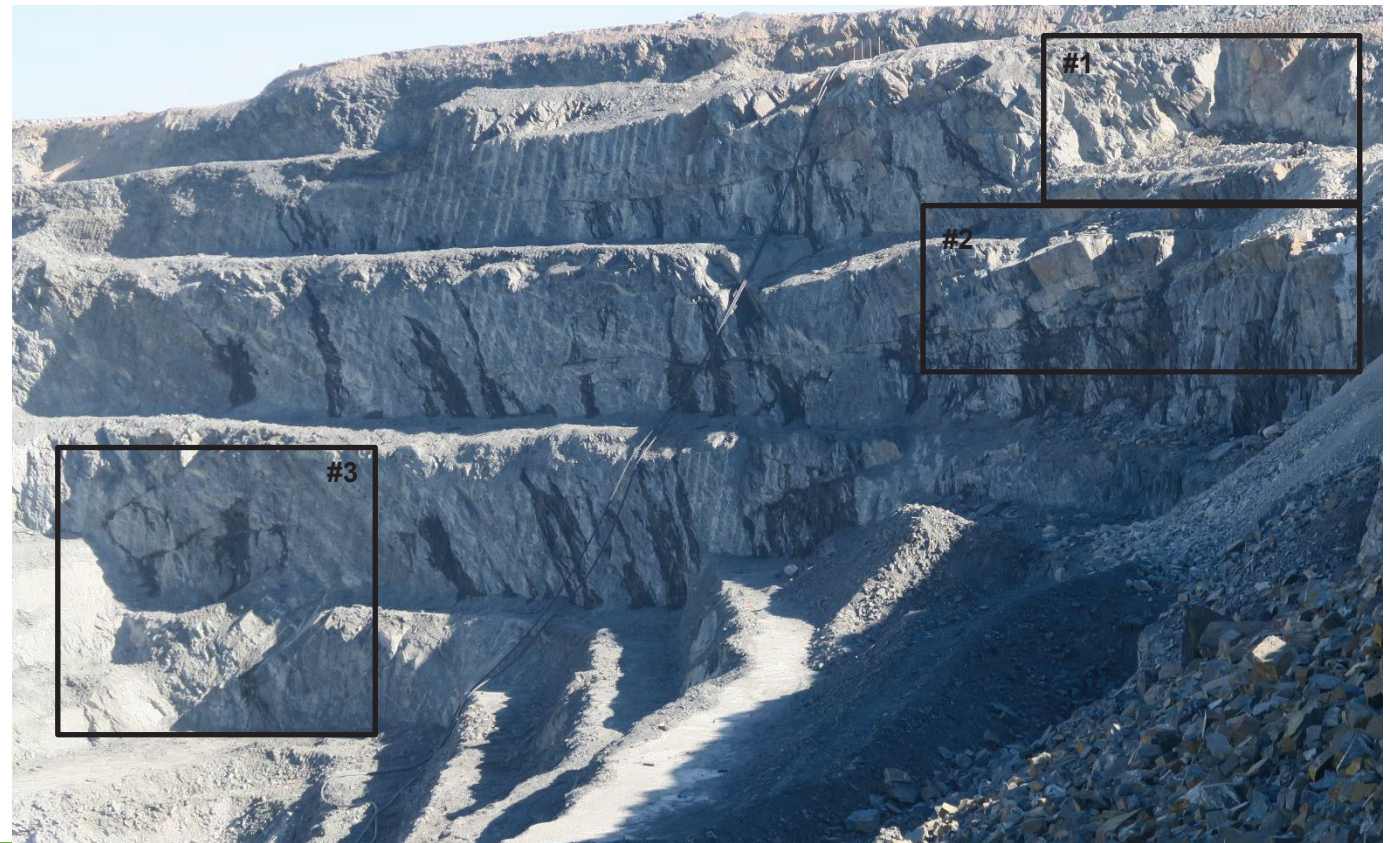
Observations - East Wall

BASE CASE
BFA: 75°
Bench Width: 10 m
Bench Height: 21 m
IRA: 53°

- Final wall in Design Sector E4.
 - Limited mining has occurred along this wall since the 2021 review. Specific areas of note are listed below and outlined on the photo.

1. Material from a former in-pit dump remains on the face of the upper bench. A rockfall berm was constructed to retain ravelling material. No significant changes have been observed.

2. The Greywacke near the Diorite has experienced crest loss and previous rockfall events. A temporary step-out has been left below the area to reduce the exposure to personnel. The intention is to scale the area, clean the catch benches and recover the step-out as part of the Phase 3 pushback. This is endorsed. Several potentially unstable blocks were previously identified and should continue be monitored as part of the visual inspections. The drone should be used to supplement these inspections.

3. A joint set cross-cutting the foliation and dipping to the north is prominent in the Iron Formation near the Komatiite contact. It has locally resulted in increased crest loss.

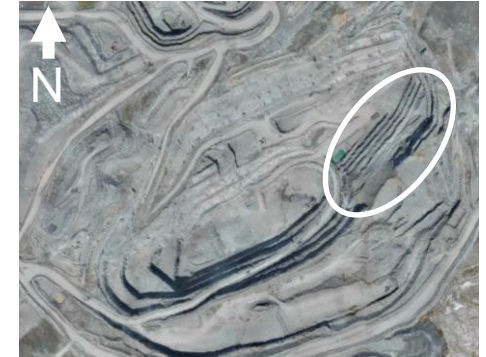
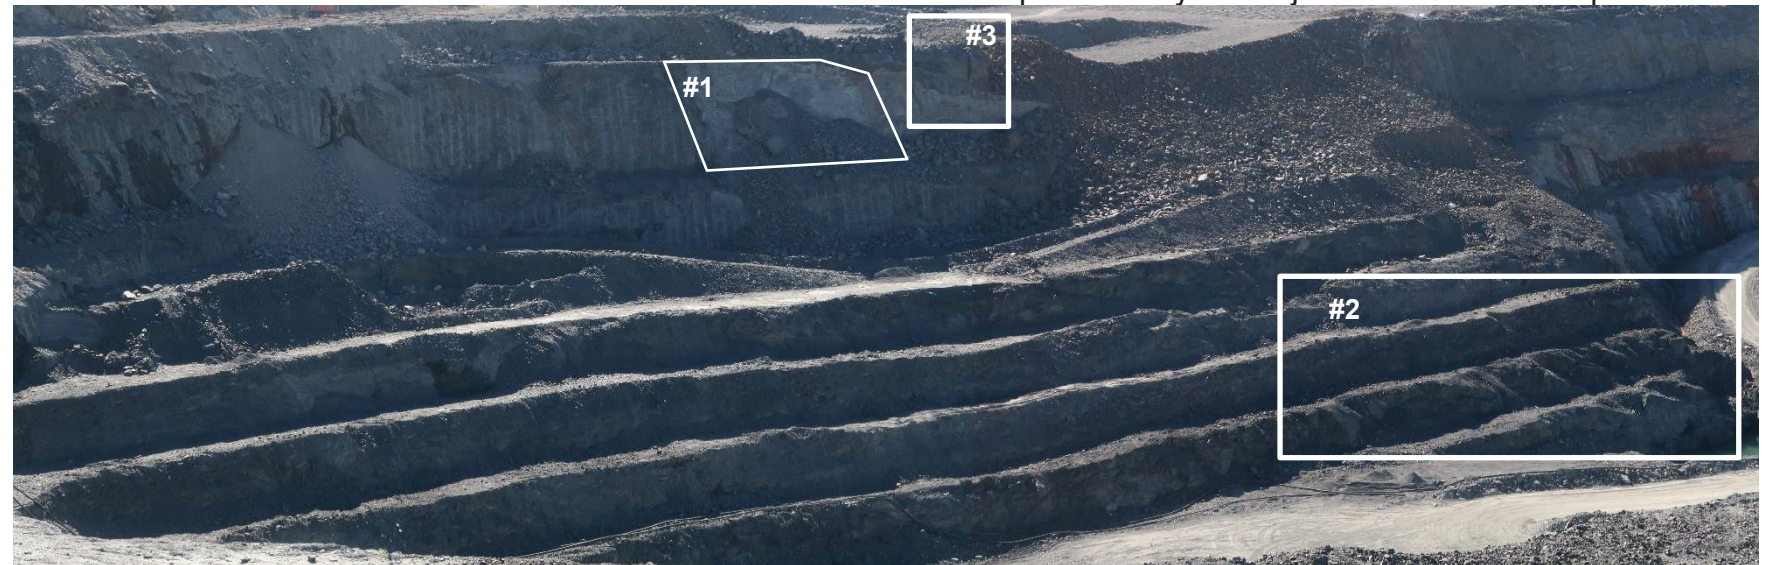
Observations - Phase 2 Southeast Wall

KOMATIITE
BFA: 75°
Bench Width: 10.5 m
Bench Height: 21 m
IRA: 52°

- Interim wall approximately within Design Sector G5. Also referred to as Phase 2 South (G5).
 - The lower portion of the wall has been developed with single benches. This was initiated due to the rockfall hazard at the transition with the East Wall.

- The wall is in the process of being mined out as part of the Phase 3 pushback. Spillover from the pushback is accumulating on the uppermost catch benches. The single benches have been effective and material has not yet reached the lower benches or the pit floor. This should continue to be monitored.

- Specific areas of note are listed below and outlined on the photo.
1. A bench-scale failure occurred along a sub-vertical contact between the Komatiite and the Greywacke in 2021. The failure will be mined out by the pushback. It is likely that localized bench-scale failures will occur on adversely oriented contacts as mining progresses.

2. A joint set dipping to the northwest is prominent at the western end of the lower wall . This set does not correspond to any of the joint sets defined as part of the structural domains for the open pit, but may correspond to Joint Set F identified in the underground mine. These structures are locally forming wedges and should be mapped. If joints with this orientation occur more regularly, the bench design in this area should be reviewed.

3. A potentially unstable block is present at the edge of the pushback. See comments on next slide.

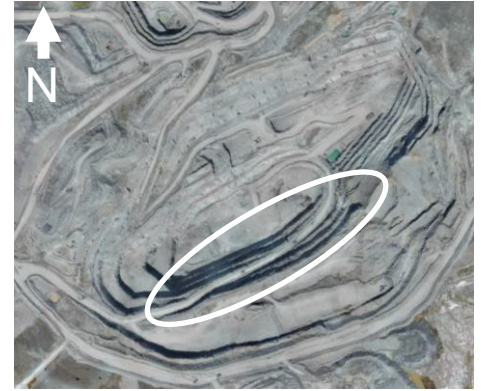
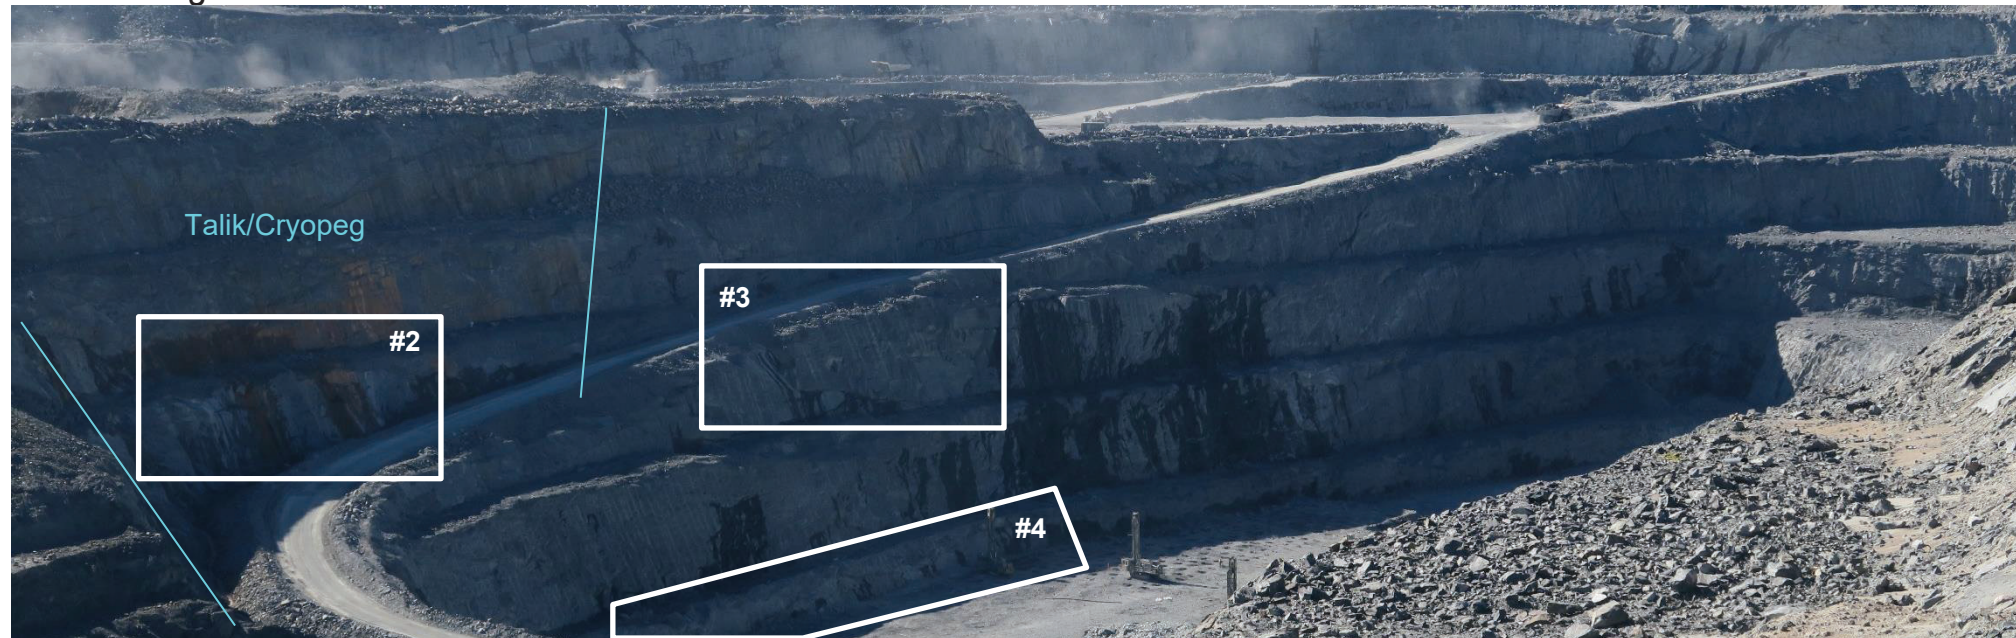
Observations - Phase 2 South Wall

- Interim wall approximately within Design Sector H5. Also referred to as Phase 2 South (H5).
- The wall is generally performing well. Specific areas of note are listed below and discussed on the following slides.
 1. Spillover from the Phase 3 pushback has created a rockfall hazard along the Phase 1 ramp (not numbered below as it occurs throughout).
 2. Seepage within the talik associated with Whale Tail Lake.
 3. A possible unstable block was previously identified below the ramp.
 4. Poor scaling of the lowermost bench has created a rockfall hazard.

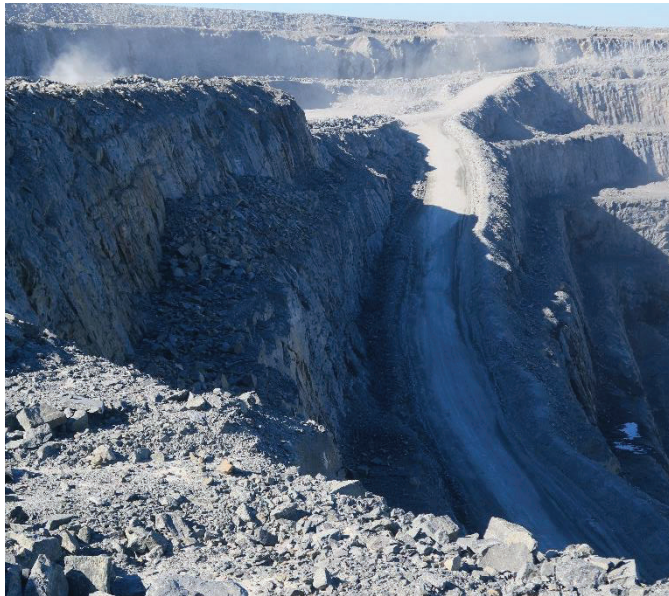
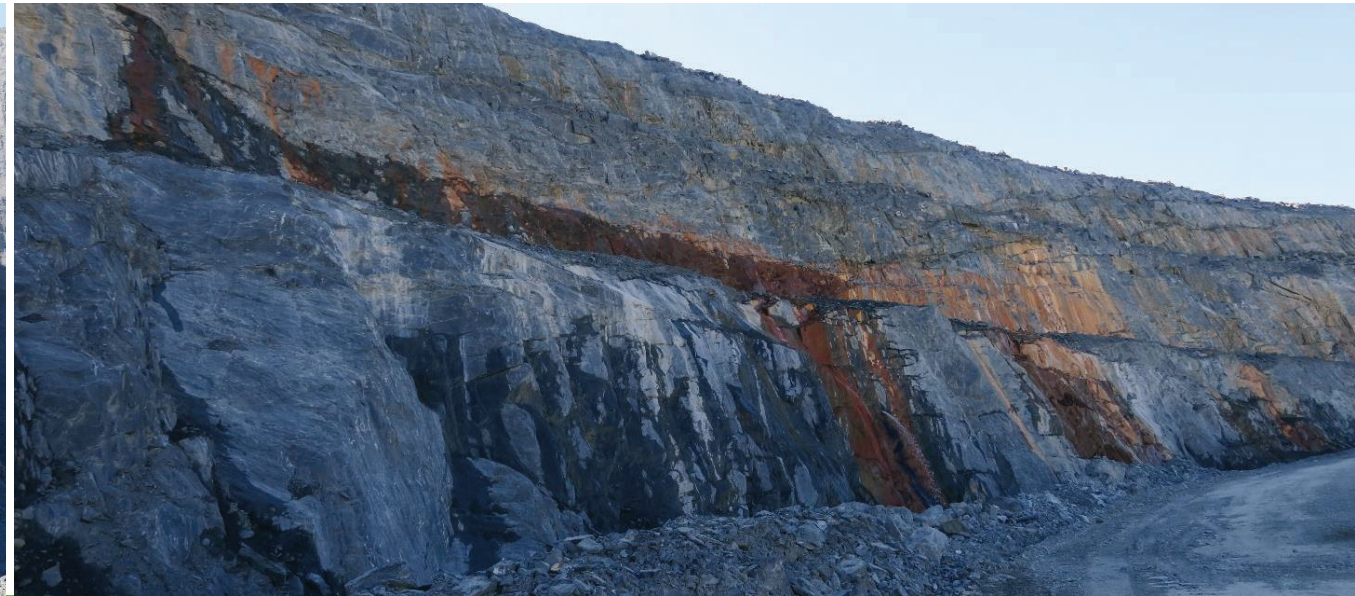
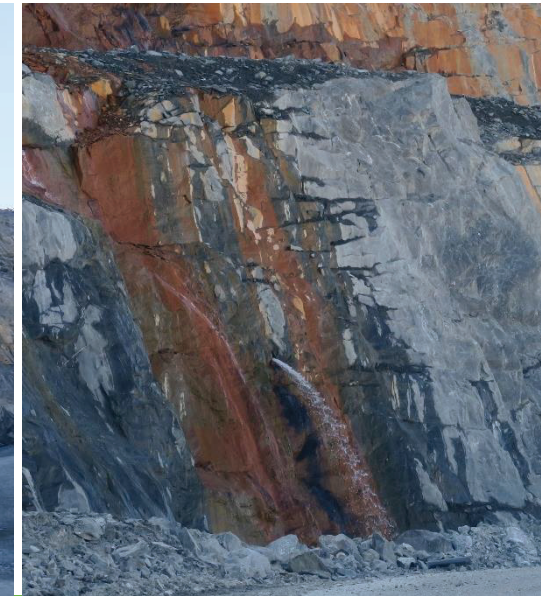
Observations - Phase 2 South Wall (2)

1. Spillover from the Phase 3 pushback has accumulated on the catch benches above the Phase 1 ramp and has previously blocked the ramp. The mine has limited the ramp to light vehicles and has partially constructed a rockfall berm along the inside of the ramp. The berm needs to be extended along the full length of the ramp and built up to ensure a consistent 2 m height (left photo). Some rockfall has accumulated behind the berm and it will need to be regularly inspected and maintained.

2. Prominent seeps are present in the lower South Wall, concentrated along sub-horizontal structures (centre photo). The seepage resulted in an ice wall but no significant ice falls occurred and the mine was able to manage this successfully. A water-management pushback has been planned to help mitigate this risk, which is endorsed. A test horizontal drain hole was completed (right photo) and has both consistently made water (including over the winter) and influenced the seeps on the wall. This suggests that horizontal drains may be viable in intercepting and managing seepage.

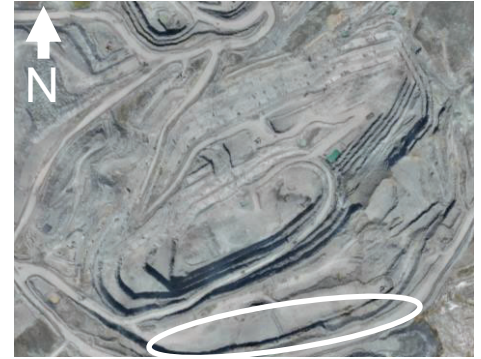
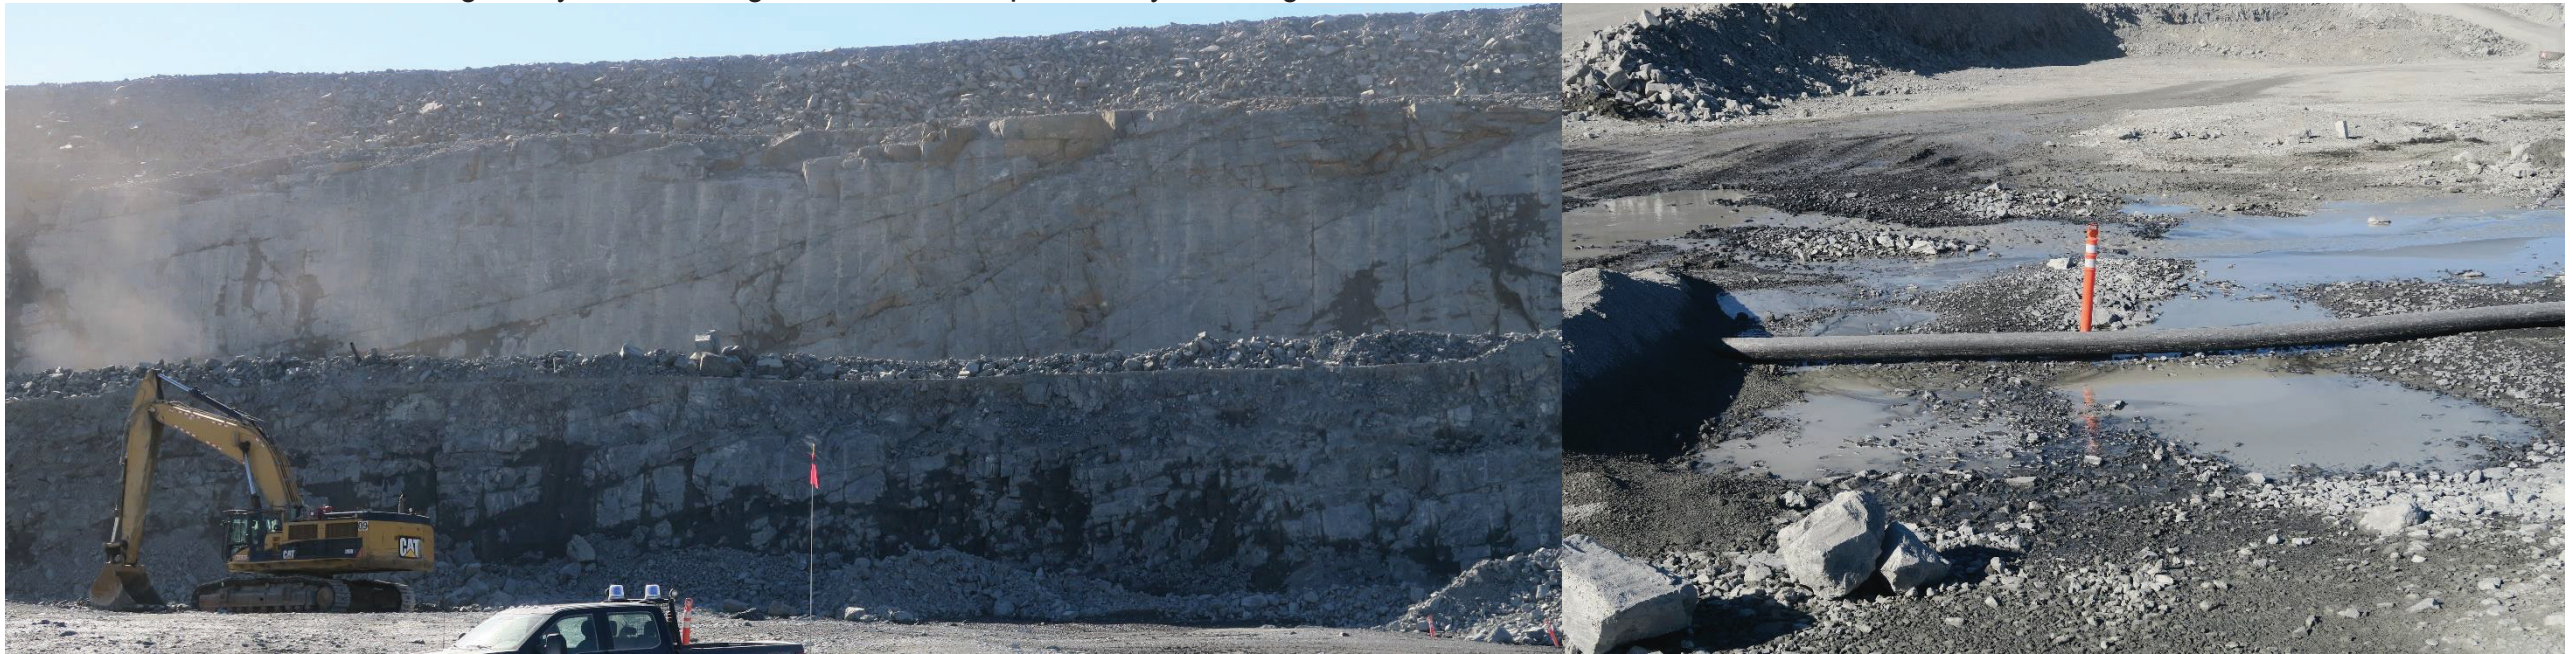
Observations - Phase 3 South Wall

BASE CASE
BFA: 75°
Bench Width: 10 m
Bench Height: 21 m
IRA: 53°

- Final wall within the Phase 3 Pushback (Design Sectors H6 and I6). The wall is predominantly Diorite.
- The area is a focus of current mining activity.
- Curvilinear structures are prominent in the wall and have locally contributed to crest loss (see left photo).
- Seepage from the lower bench face and floor was observed in the active mining area (see right photo). It is understood that this is a relatively recent development and is thought to be linked to a change in the blast pattern design, which now leaves a rock ridge between the pushback and the Phase 2 crest; the ridge may be retaining water that was previously draining into Phase 2.

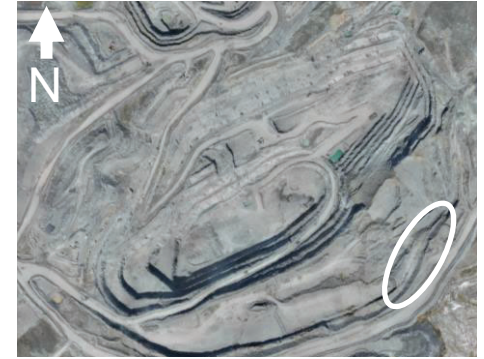
Observations - Phase 3 South Wall (4)

- A prominent fault, believed to be the Ramp Fault, has been exposed in the southeast wall of the Phase 3 Pushback.
- The fault is associated with a zone of reduced rock mass quality 1 to 2 m thick and 10 to 20 cm of gouge.
- A considerable amount of loose was present on the wall. It is understood that the wall had not yet been approved and that additional scaling will be recommended. This is endorsed.

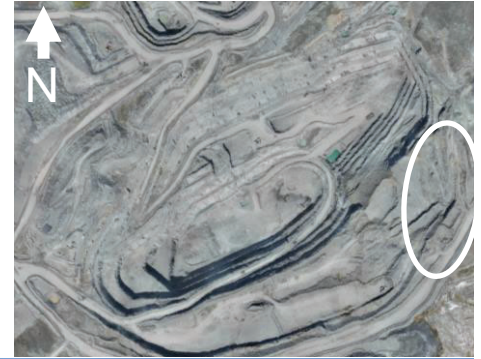
Observations - Phase 3 Southeast Wall

- Final wall in Design Sector F6.
- The slope geometry recommendations for this sector were adjusted in late 2021 as the strike of the sector had changed, increasing the potential for planar failure on Joint Set C.
- The achievable bench geometry is sensitive to both the persistence of Joint Set C and blasting and scaling practices. With careful blasting and scaling, a BFA of 75° and IRA of 44° could be achievable if the persistence is limited to 10 m or less, though with backbreak in the order of 8 m. However, if these practices are not used or are not effective, a BFA of 50° and IRA of 39° will be required.
- Geotechnical inspections and Bench Approvals were identified as a critical control for managing potential crest loss, rockfall and bench-scale failures.
- These are the first benches established in this sector and it is important to validate the bench design and implementation.

BFA: 75°
Bench Width: 16 m
Bench Height: 21 m
IRA: 44°

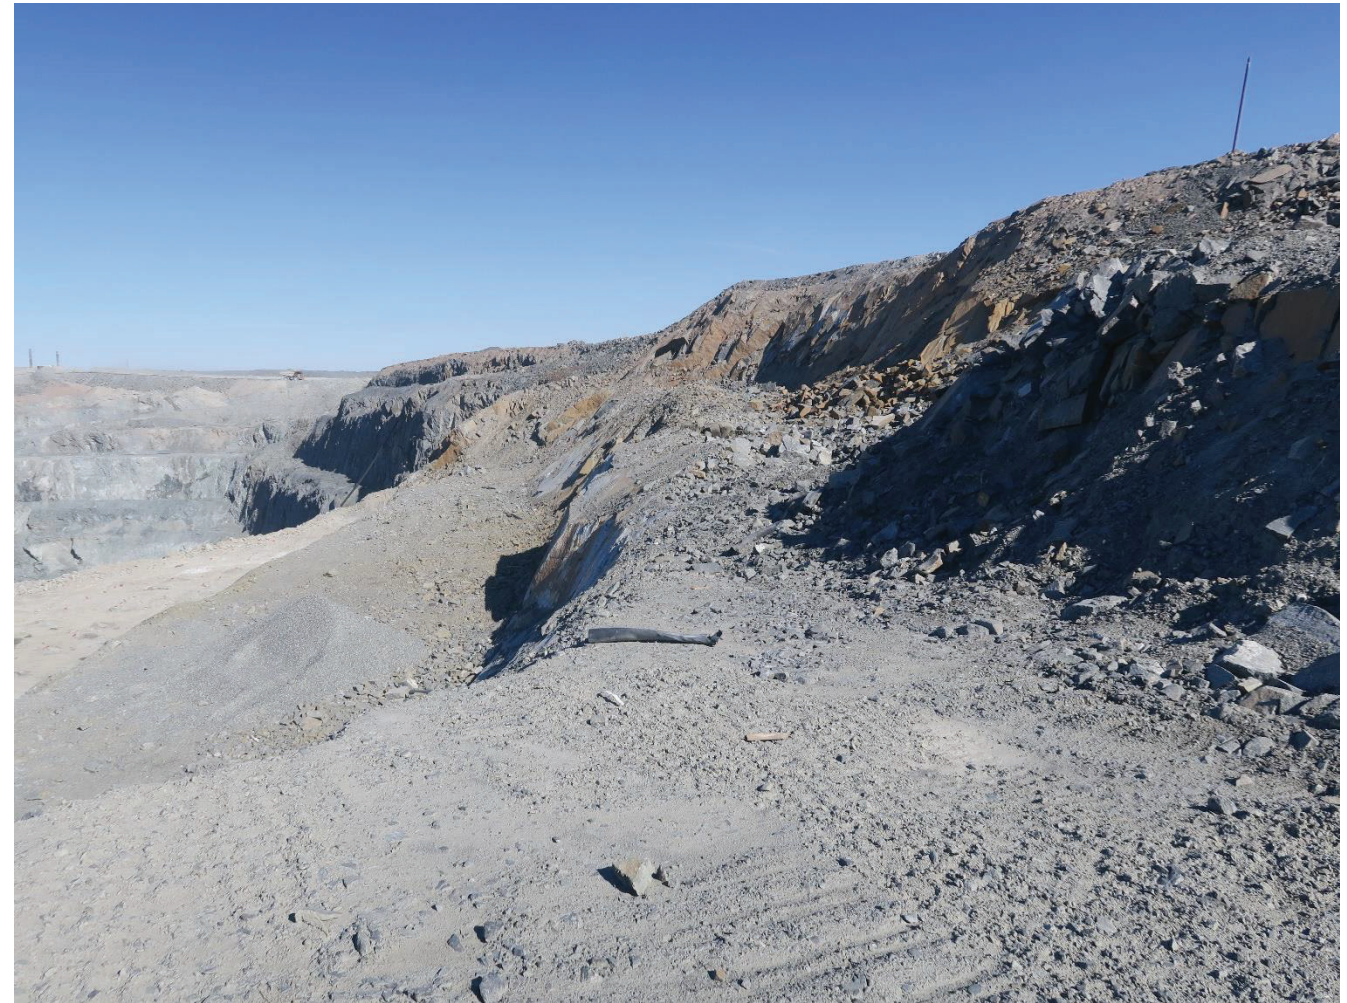
Observations - Phase 3 Southeast Wall (2)

- The first two benches were established as single 7m high benches without pre-shear. The reason for this is not clear.
- The bench faces have broken back to Joint Set C. The resulting catch bench width appears to be less than the 8 m minimum in at least some areas.

- Several discontinuities defining the bench faces appear to be persistent over both benches (i.e., a persistence > 10 m).
- It is not clear whether the Bench Approval process was followed for these two benches. If it was, it did not achieve the desired outcome.

- The design bench geometry will not be achievable if the approach used for these two benches is continued. Mining practices have improved for the third bench, which is discussed on the next slide.

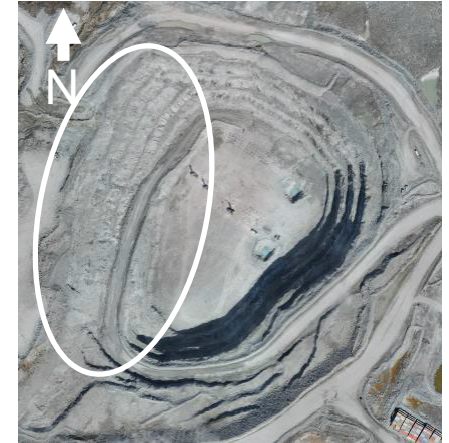
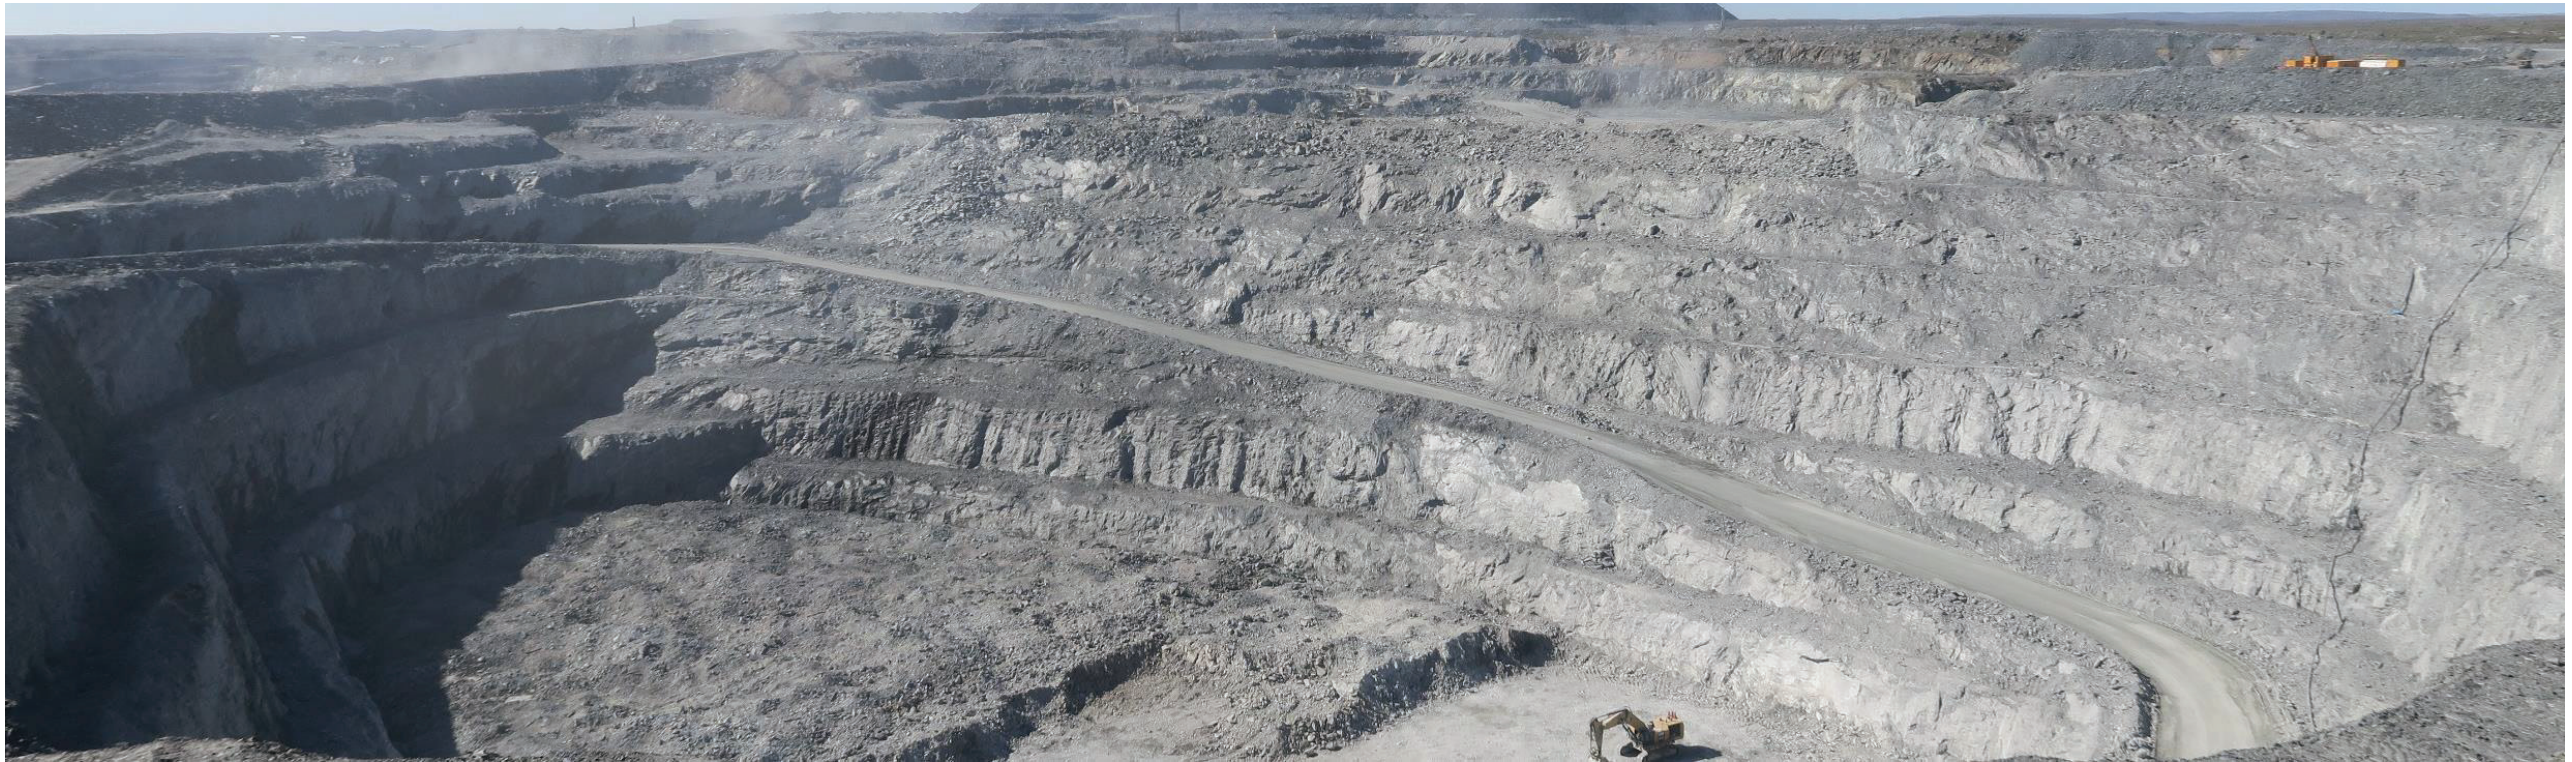
Observations - Northwest Wall

- Final wall in Design Sector V0A. This sector encompasses the footwall of the deposit.
- The slope geometry was expected to be controlled by the potential for bench and inter-ramp scale planar failures on the foliation (Joint Set A).
- Specific comments are provided on the following slides.

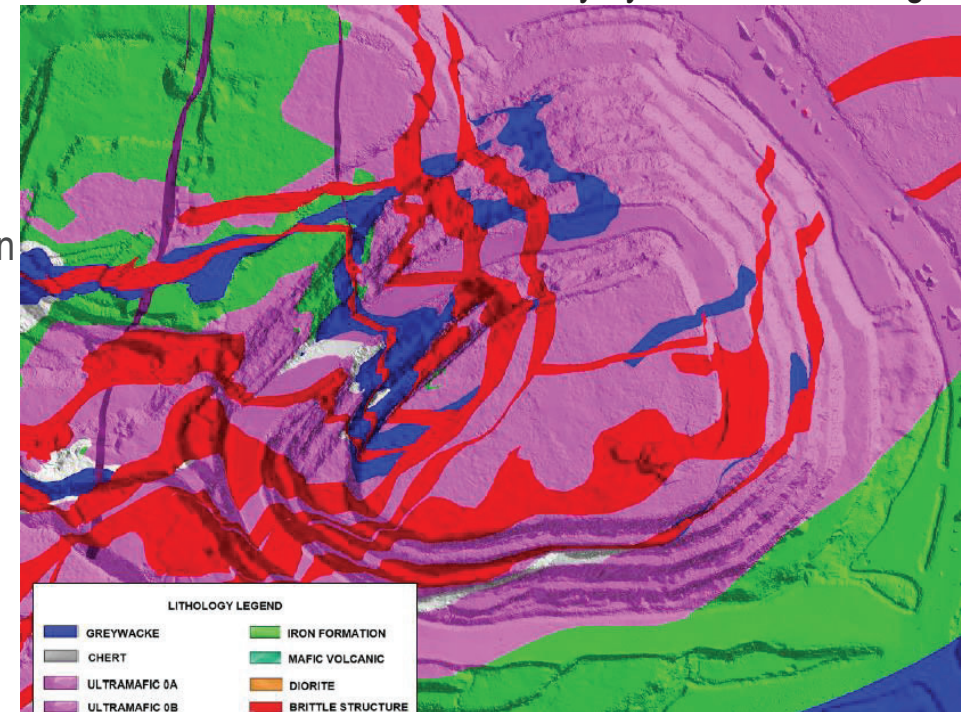
Observations - Northwest Wall

- **Bench Design and Implementation:** The original design was for a 45° BFA established using staggered blast holes. This proved impractical to implement, at least partially due to poor control of the blast hole depth resulting in over-drilling. The mine has trialled pre-shear blasting of 55° and 65° BFAs, which is discussed in greater detail on the next slide. In both cases the catch bench width was increased to maintain the design IRA.

- Recommend documenting the lithology, rock mass structure, and bench performance at regular intervals along the Northeast Wall in order to better understand the controls on the wall performance. While relatively few benches remain in the IVR V2 pit, the results are relevant to the footwall of the IVR V1 pit.
