Whale Tail 2022 Annual Open Pit Geomechanical Inspection

March 17, 2023

RE: Meadowbank Complex - Amaruq Site - 2022 Annual Open Pit Geomechanical Inspection

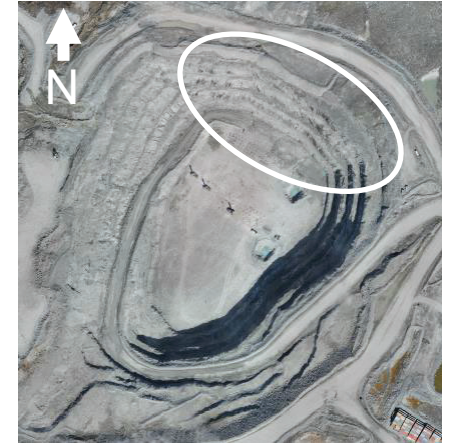
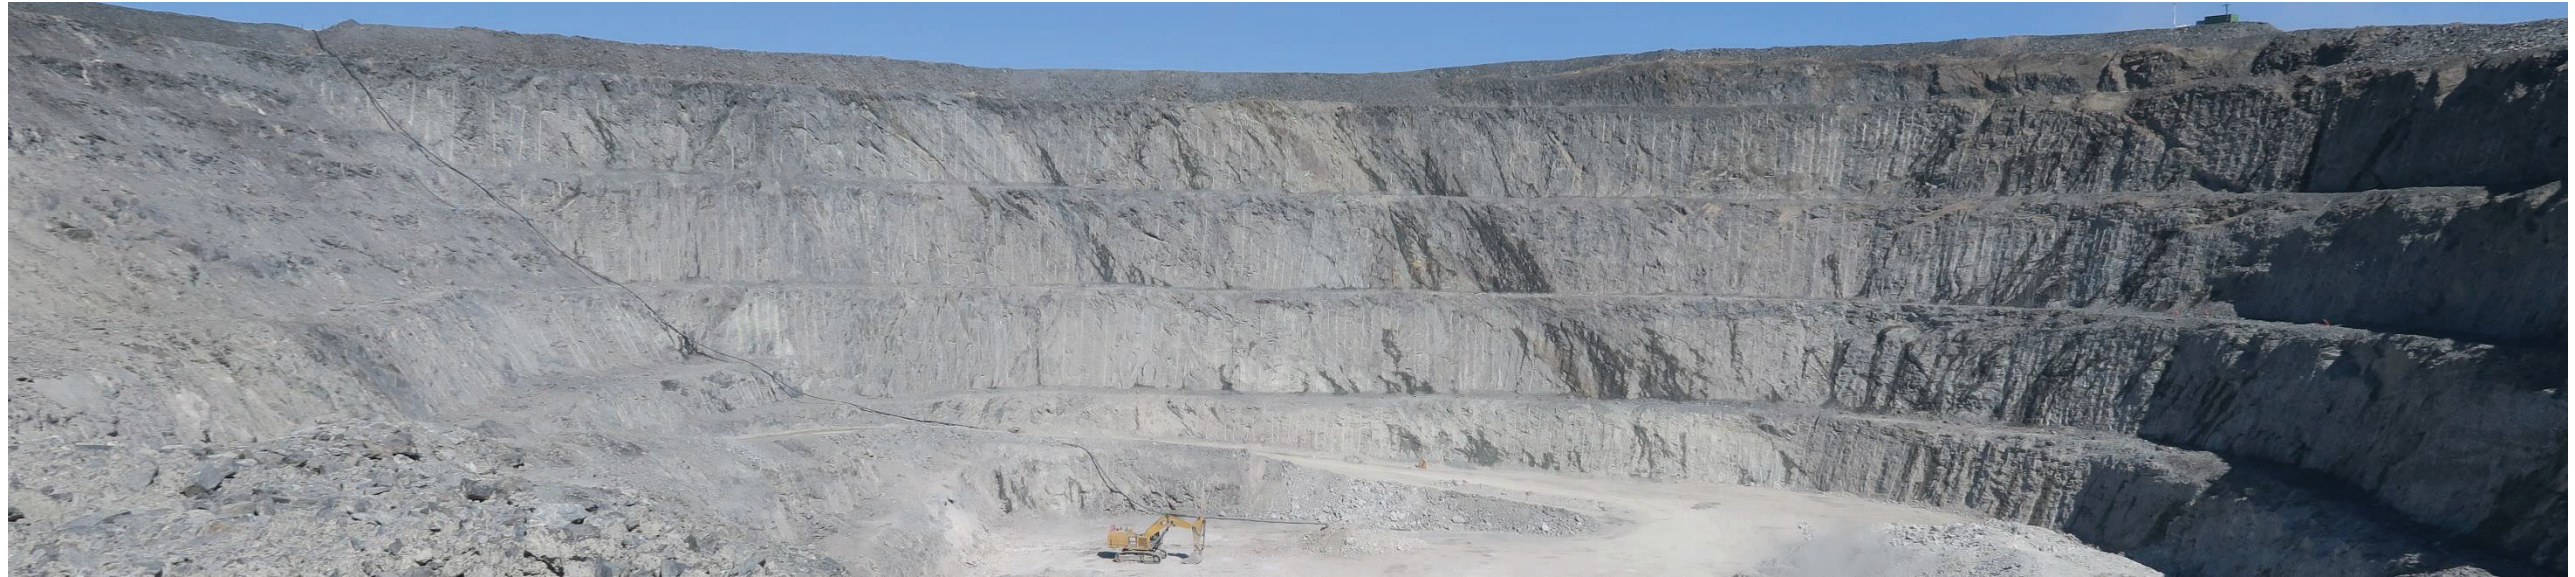
Observations - Northeast Wall

- Final wall in Design Sector V0B.
- The wall is performing well. Half-barrels are visible. The foliation is oriented perpendicular to the wall.
- Cross-cutting structures resulted in numerous small wedges in the upper benches and significant scaling was required when the benches were established. There was a concern that the benches would ravel over time. However, to date, very little material has accumulated on the catch benches.
- No evidence of movement has been observed on several potential wedges identified during the 2021 inspection.

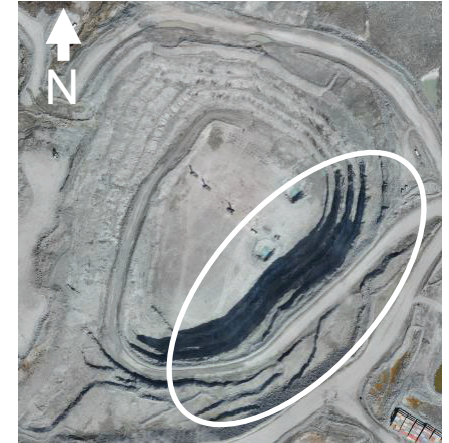
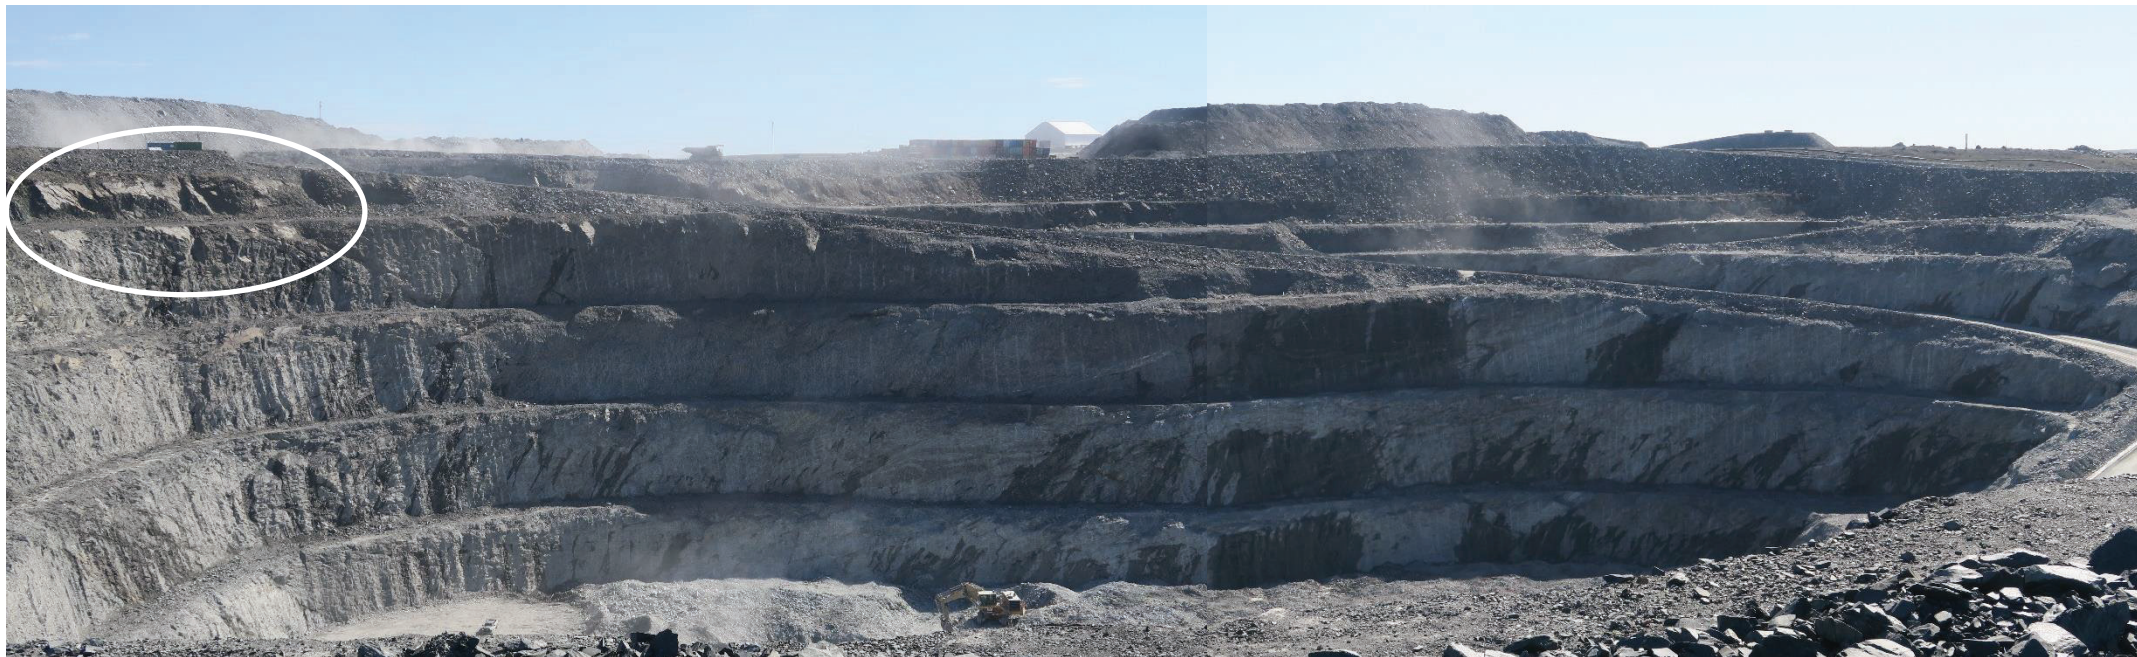
Observations - Southeast Wall

- Final wall in Design Sector V0C.
- The wall is performing well. Half barrels are visible and very little material is present on the catch benches.
- Several persistent cross-cutting features were identified during the 2021 inspection (examples circled below). These structures were not prominent in the structural data underlying the design of the open pit and there was a concern that they could impact the achievable slope geometry. It now appears that these structures were localized as they have not influenced the bench performance at depth.

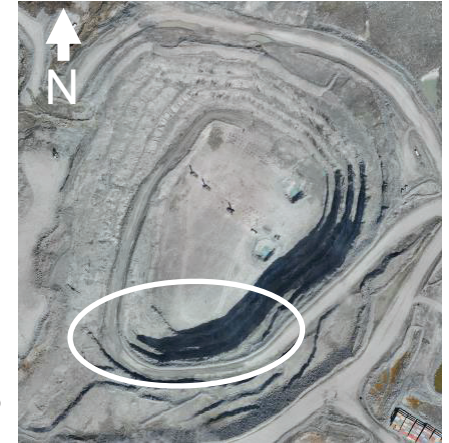
Observations - Southwest Wall

- Final wall in Design Sector V0D.
- The wall is generally performing well. While the benches are primarily within the Komatiite and Brittle Structures, the wall is oriented perpendicular to the foliation.
- Numerous seeps are present in the wall. As the pit is thought to be entirely within permafrost, the seeps are assumed to be in the active layer.
- In the southwest corner of the pit, the seepage is sufficient to have caused a prominent Brittle Structure to erode (circled at left with close-up at right). The area should be monitored for ravelling over time.

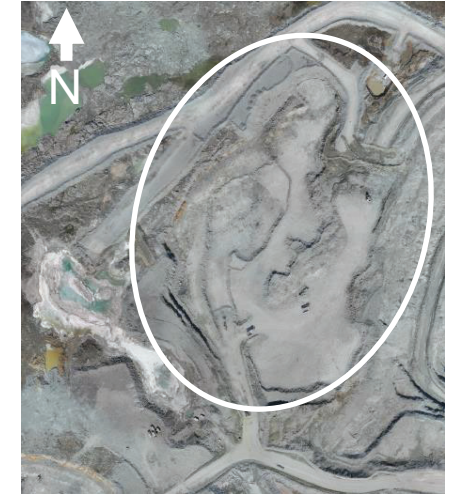
Observations - General

- The IVR V2 open pit is in the early stages of mining; approximately two benches have been established.
- These initial benches represent an important opportunity to validate the rock mass characterisation and slope geometry recommendations that underpin the open pit design. Recommend documenting the bench performance and key rock mass characteristics and comparing them to expectations.
- As noted earlier, managing spillover from the IVR V2 pit to the IVR V1 pit is an on-going challenge. The mine has adapted the blasting sequence to leave a small ridge adjacent the IVR V1 pit and then blasts the ridge into the V2 pit. This has been effective at reducing spillover.
- Comments on specific locations within the pit are provided on the following slides.

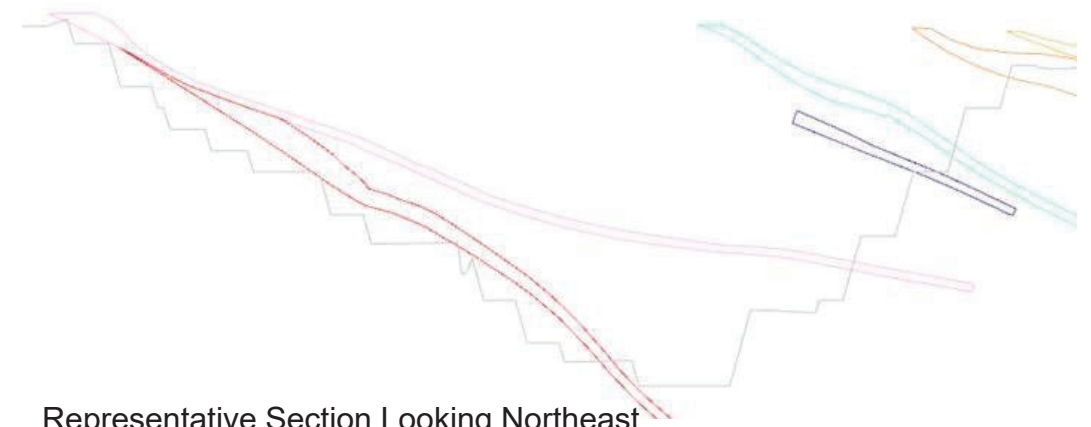
Observations - North Wall

- The north wall is located along the footwall of the deposit.
- Based on the results of the stability analyses, a decision was made to push back the wall so that it was located within the Mafic Volcanics rather than the Komatiite. This is expected to reduce the potential for bench- and multi-bench scale planar failures on the foliation. It also reduces the potential for inter-ramp scale planar failures on the brittle structures (see representative section below). If it is not possible to establish the wall in the Mafic Volcanics, it is likely that a much shallower slope will be required.
- It is important to verify that the slope is in fact being established in the Mafic Volcanics and below/behind the Brittle Structure expected along the contact between the Mafic Volcanics and the Komatiite.
- The performance of the initial two benches in this wall has been reasonable to date.

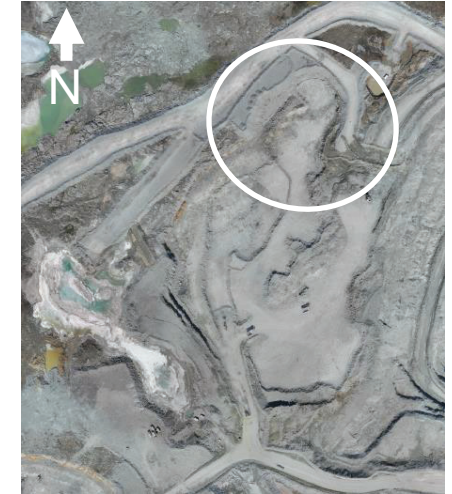
Observations - North Wall “Turtlehead”

- Scaling of the end wall was in progress at the time of the inspection. Frequent hard toes were noted by the operator. The foliation is perpendicular to the wall in that area and significant scaling was required due to the presence of numerous small wedges/blocks. A potentially unstable block was observed on the wall (outlined below in black).

- A portion of the safety berm was missing at the end of the crest road where the photos below were taken. The berm should be re-established.

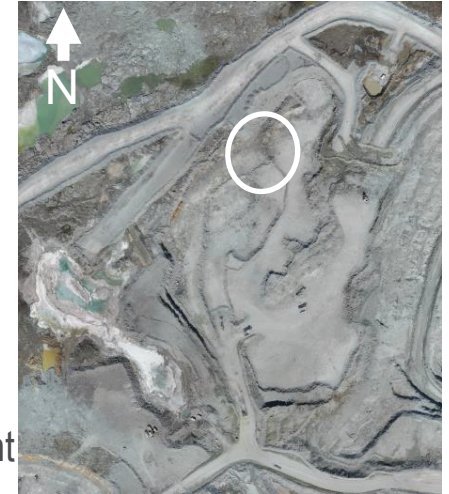
Observations - North Wall Noses

- A nose has been left in the final north wall adjacent the “Turtlehead” (shown in the photos below). The nose is intersected by a lens of Graphitic Chert aligned parallel to the north wall (circled in lower left photo).
- The creation of small, abrupt noses like this one should be avoided, particularly through contacts. The reduced confinement acting on the rock mass increases the potential for ravelling and instabilities over time.
- The nose may deteriorate further over time and should be specifically included in the visual inspection of the open pit.

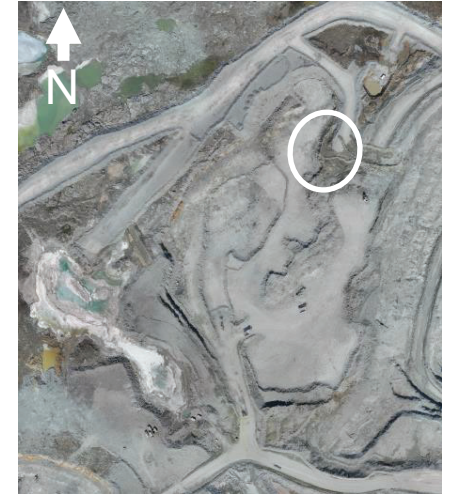
Observations - Nose between IVR V1 and IVR V2

- A nose will be left on the uppermost bench at the point where the two open pits meet.
- The nose is in poor condition and had not been fully scaled at the time of the inspection. It should be scaled to reduce the rockfall hazard.
- The nose may deteriorate further over time and should be specifically included in the visual inspection of the open pit.

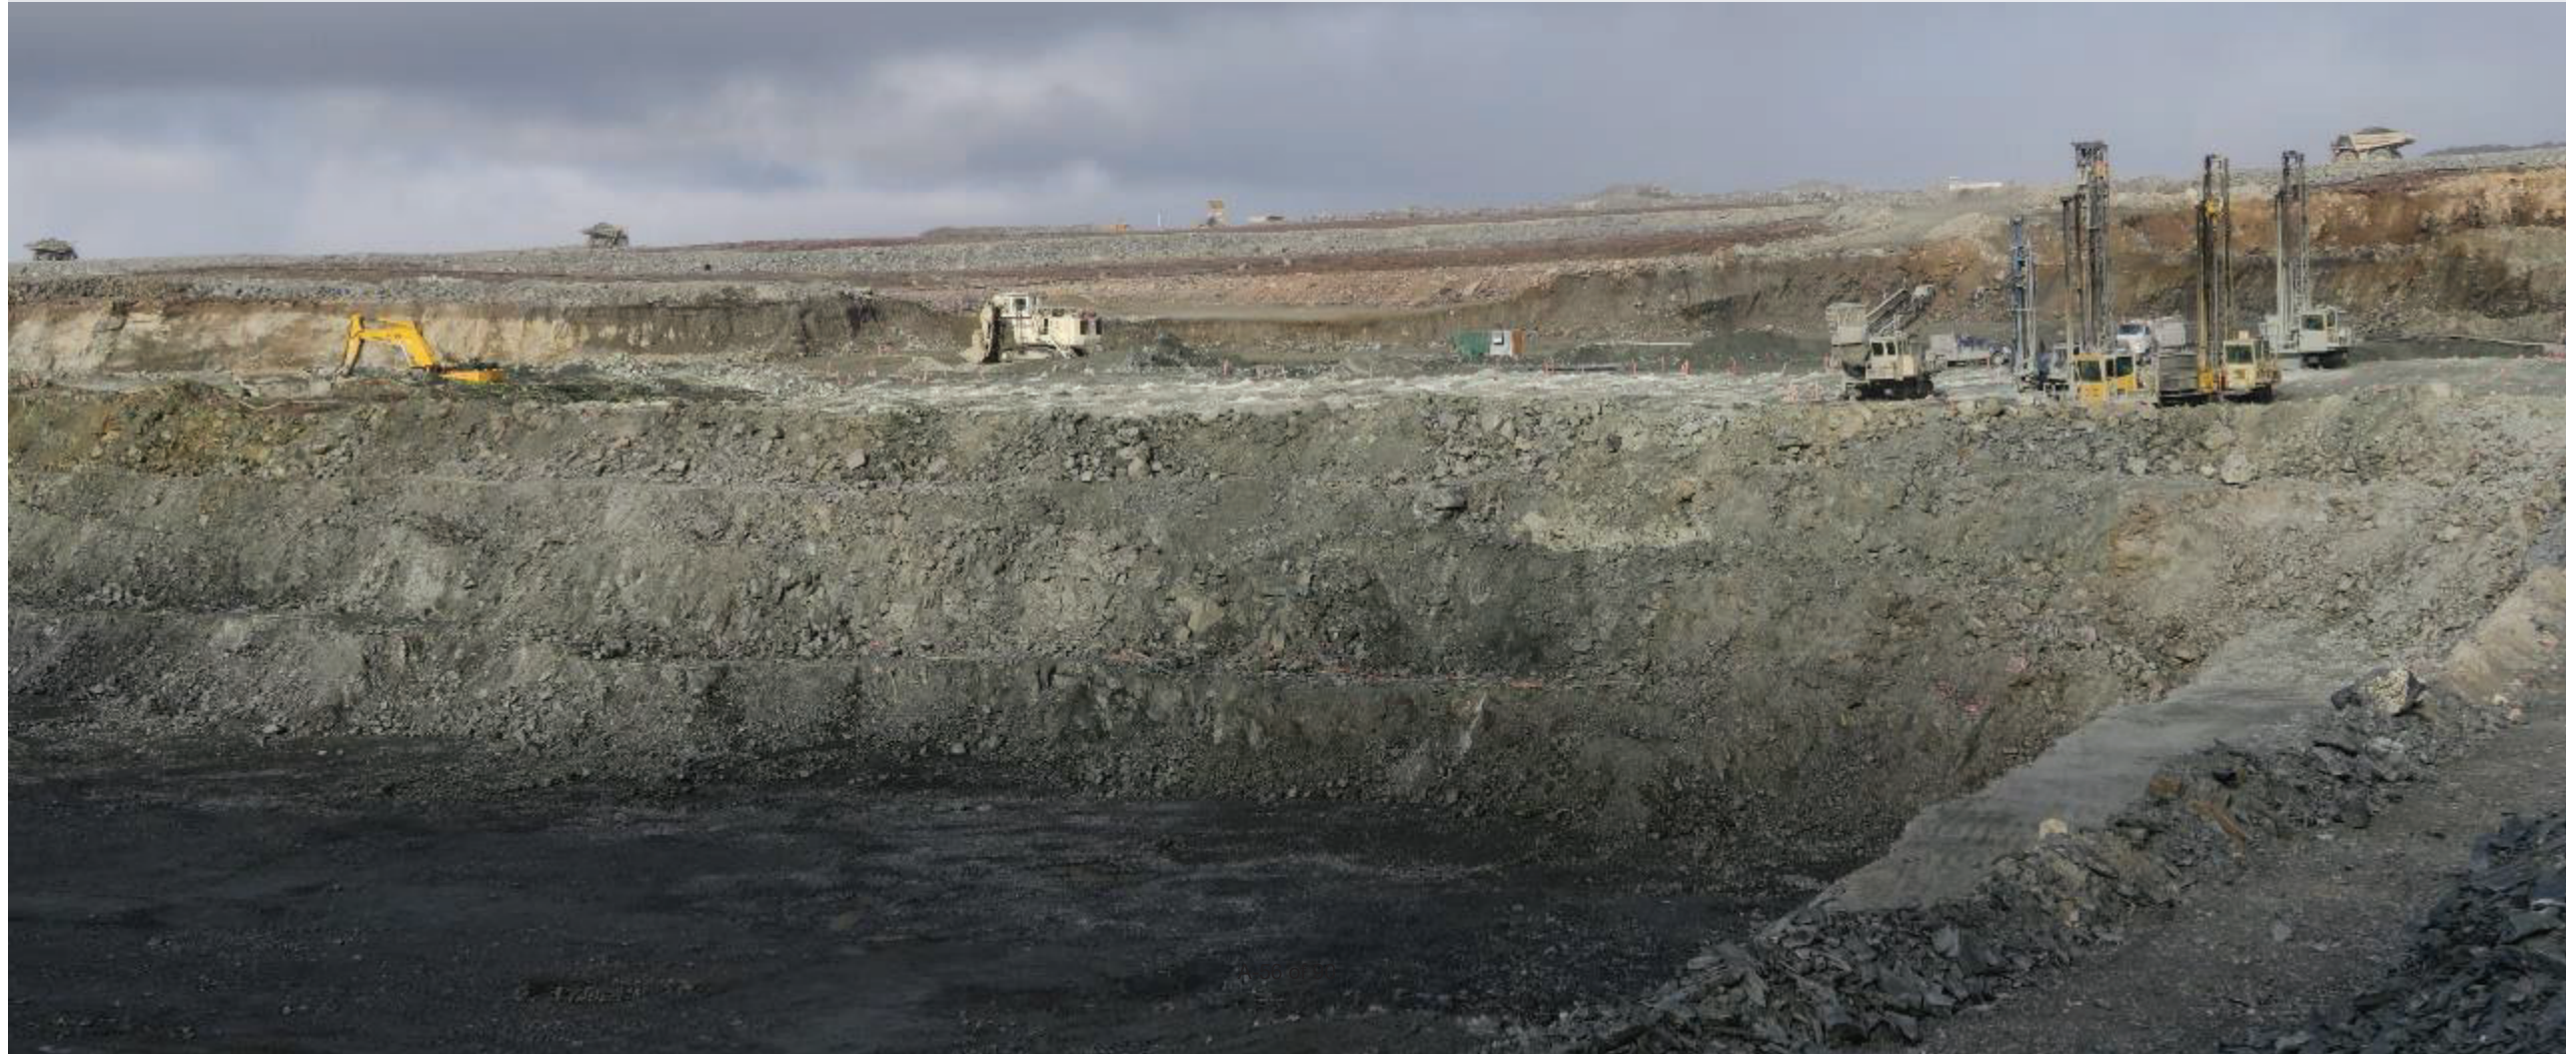
Looking Northeast

- Several rockfall hazards were observed along the northeast wall, above the ramp (circled at right).
- A thermal cap has not been constructed for the overburden between IVR West 1 and IVR West 2, and the overburden has started to slough. It is currently manageable, but if it progresses it could become a rockfall hazard.
- Recommend scaling the wall and constructing a rockfall berm along the inside of the ramp.
- The IVR V2 Extension is planned to merge with the east wall of this pit. The rockfall risk associated with spillover from blasting and the potential creation of noses at the breakthrough will need to be reviewed and managed.

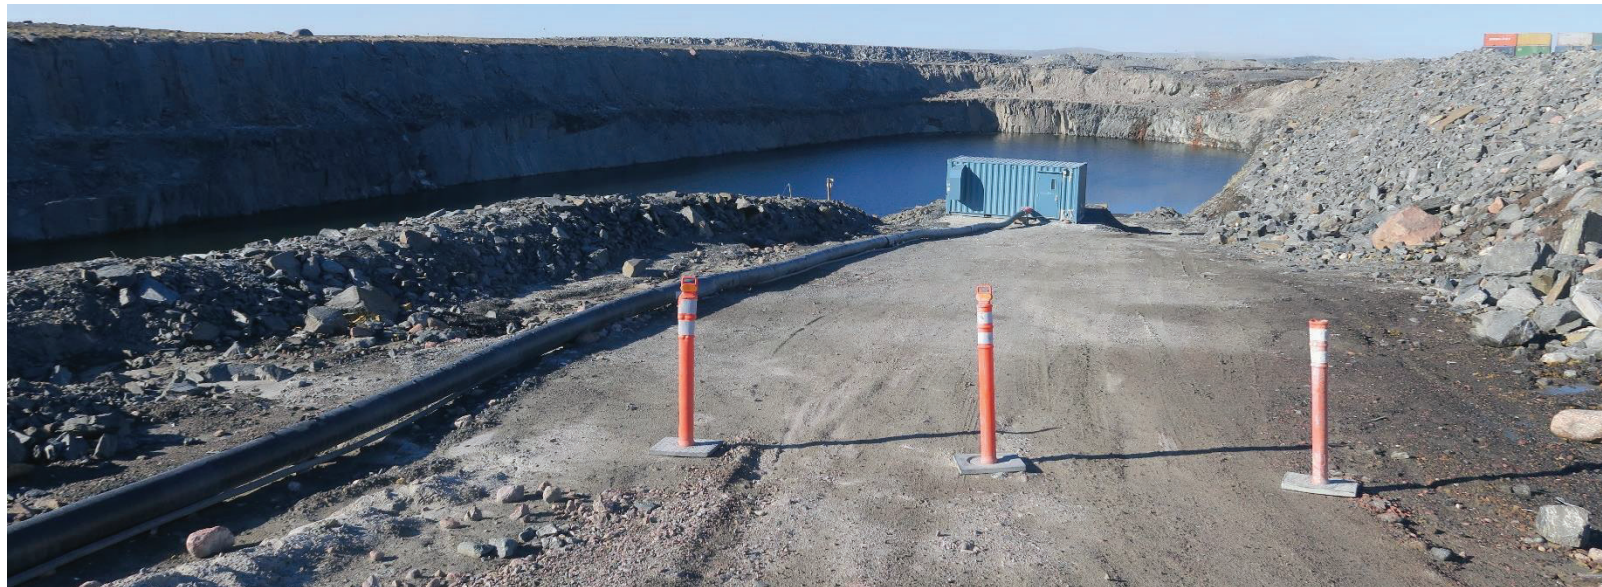
AP5

- Attenuation Pond 5 is a former quarry located to the east of the WHL open pit that is now used for water management. The pond was inspected on August 15, 2022.
- The pond is partially flooded, with one to two benches exposed above the pond water level. As a result, a detailed inspection could not be completed.
- No stability concerns were identified in the exposed slopes.
- Pumps were present at the time of the inspection. Access to the ramp and pit was unrestricted, but pylons were installed during the inspection.

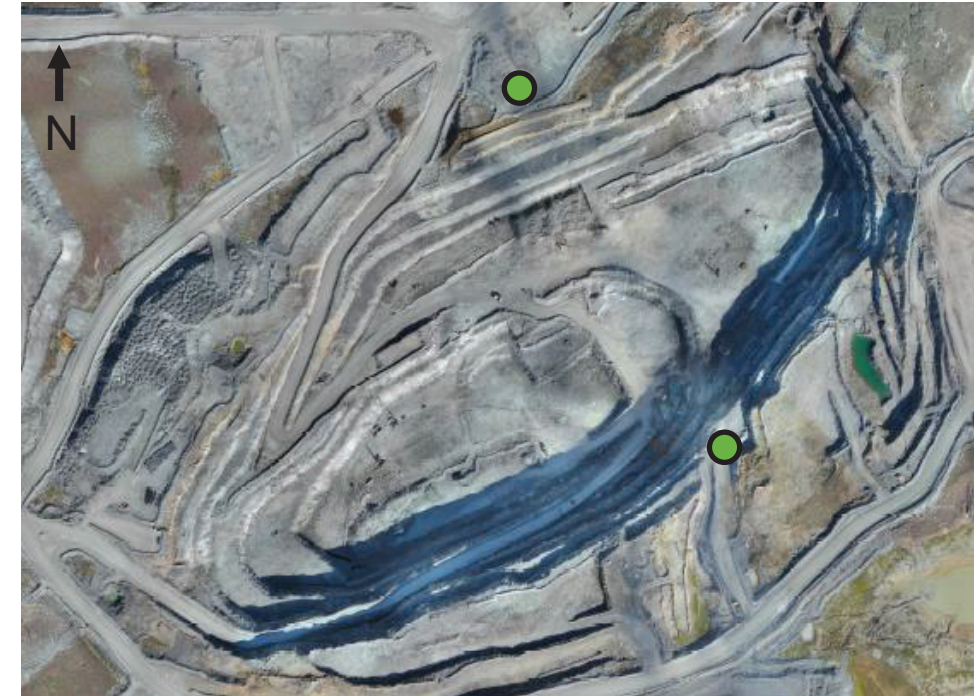
- The actions to be taken by Dispatch in the event of a Grey or Orange alarm specifically state that operations are not to be stopped. This is often at odds with the guidance provided by Rock Mechanics and creates room for confusion. Recommend modifying the response, so that the first action is to contact Rock Mechanics (or the Pit Supervisor).

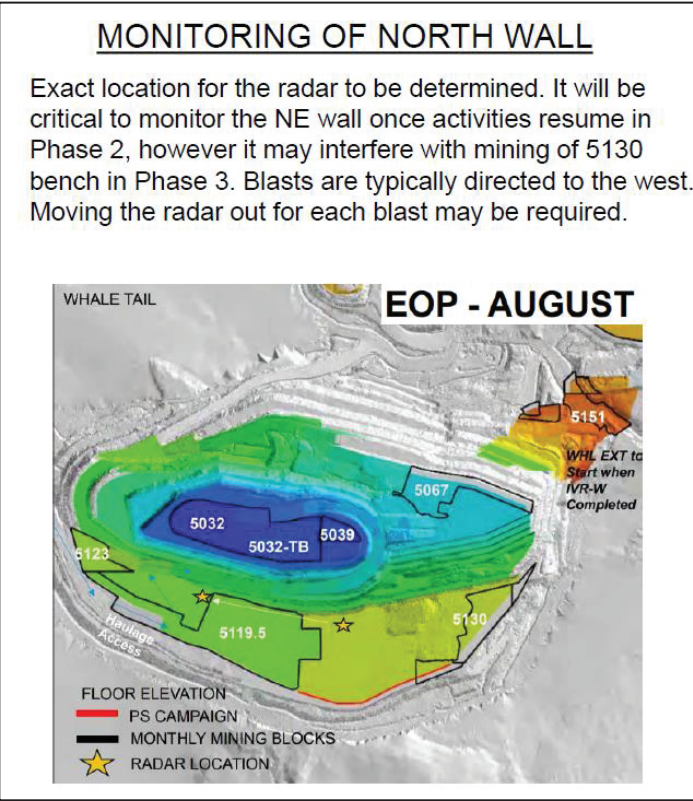
- Radar SSR253 was damaged by flyrock and was only operating 18% of the time in Q1. The radar was repaired in April and availability improved in Q2 to 53% (a large proportion of the remaining downtime was due to intensive mining in Phase 3, represented by the orange “User” category in the chart).

- Radar SSR560 was operating 100% of the time in Q1, reducing to 60% of Q2 due to an internal computer failure.
- It is understood that GroundProbe’s technical support has improved and this has helped with radar availability.

- As the radar is the sole quantitative monitoring system for the open pit slopes, this amount of downtime has a significant impact on the mine’s ability to manage geotechnical risk. This reinforces the need for additional monitoring systems.

- The SSR is a critical control for achieving an acceptable level of residual risk in sectors of the pit with an increased likelihood of slope failures (e.g., D4K, Phase 1 North Wall). Develop a formal process to stop or modify mining activities in these areas when radar coverage is not available. This can be linked to the Grey alarms.
