### **Meadowbank 2018 TSF As-built report**

**2018 CONSTRUCTION SEASON AS-BUILT REPORT  
TAILINGS STORAGE FACILITY  
MEADOWBANK GOLD PROJECT, NUNAVUT**

1897439-1578-R-Rev0

November 2018

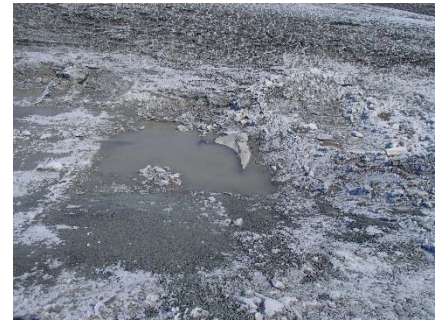
**SD3-302 (2018-05-18), looking NE from Sta. 20+595/-42 m. View of water ponding on the first compacted sieved till layer of upstream toe liner tie-in. A portion of exposed damaged LLDPE liner is visible.**

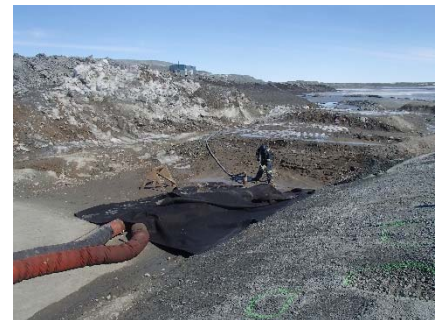
**SD3-305 (2018-06-05), looking NE from Sta. 20+590/-48 m. Dewatering of the water ponding on the first compacted sieved till layer of upstream toe liner tie-in. A Genset Frost-fighter is heating the sieved till layer and a pump is evacuating the water.**

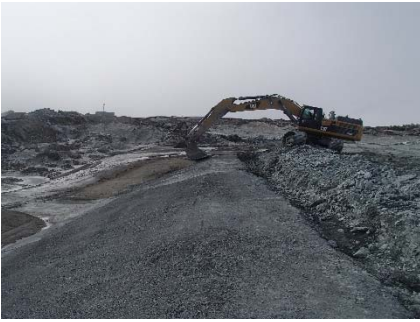
**SD3-306 (2018-06-06), looking S from Sta. 20+780/-25 m. Correction of the surface of the fine filter in the upstream slope and the top of the first class compacted sieved till layer with an excavator from Sta. 20+803 m to 20+793 m.**

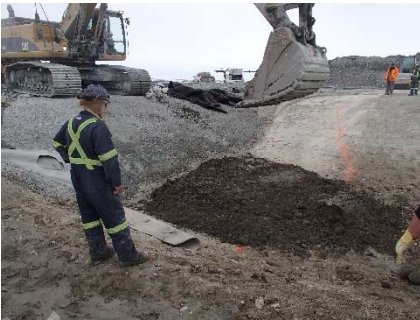
**SD3-312 (2018-06-08), looking W from Sta. 20+610/-48 m. Placement of a 0.15 m thick lift of compacted sieved till from Sta. 20+596.4 m to 20+601.6 m (o.s. -42.6 to -46.3 m) to fill the depression in the compacted sieved till layer.**

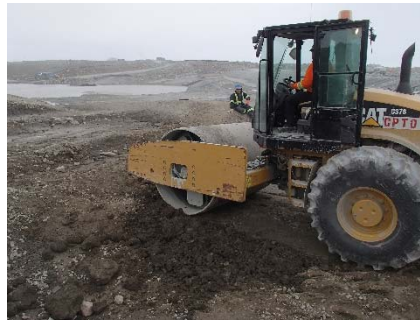
**SD3-313 (2018-06-08), looking S from Sta. 20+600/-52 m. Compaction of the 0.15 m-thick lift of compacted sieved till with a 10-tonne smooth-drum compactor without vibration (4 passes) from Sta. 20+596 m to 20+601 m.**

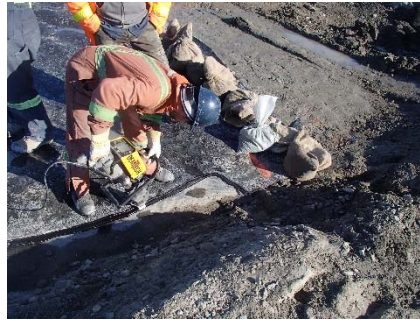
**SD3-316 (2018-06-09), looking NW from Sta. 20+610/-45 m.** Repairs on the extrusion fillet seam between LLDPE panel 965 and the existing LLDPE panel at Sta. 20+600 m (approx.).

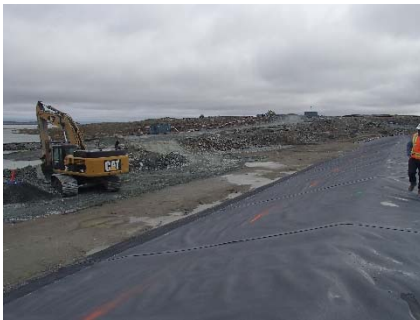
**SD3-318 (2018-07-07), looking SE from Sta. 20+710/-24 m.** Placement of IV rockfill in the water up to El. 142m with an excavator from Sta. 20+785 m to 20+730 m, at the bottom of the upstream slope of SD3 to widen the rockfill layer and allow access to the erosion protection.

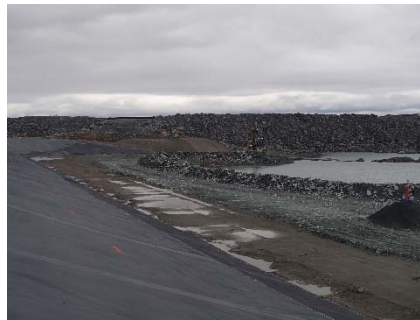
**SD3-319 (2018-07-08), looking NE from Sta. 20+740/-31 m.** Placement of IV rockfill in the water up to El. 142m with an excavator from Sta. 20+730 m to 20+610 m, at the bottom of the upstream slope of SD3 to widen the rockfill layer and allow access to the erosion protection.

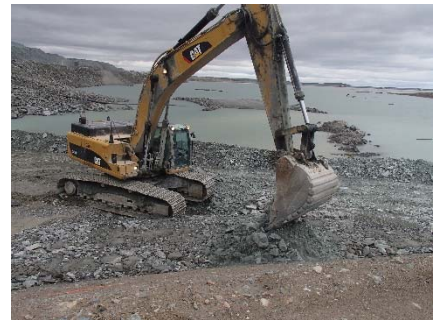
**SD3-320 (2018-07-08), looking E from Sta. 20+620/-67 m.** Placement of a 1 m thick (approx.) lift of fine IV rockfill over the compacted till in the upstream slope from El. 142 m to 144 m with an excavator from Sta. 20+600 m to 20+610 m.

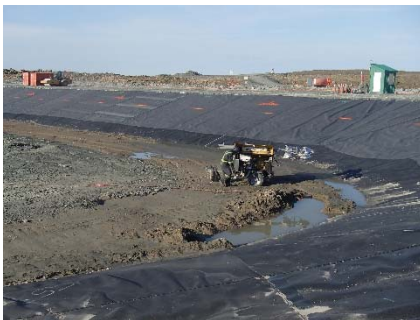
**SD3-321 (2018-07-09), looking SW from Sta. 20+610/-56 m.** Water ponding at El. 142m on the compacted sieved till layer of the upstream toe liner tie-in at approx. Sta. 20+620 m to 20+630 m was pumped.

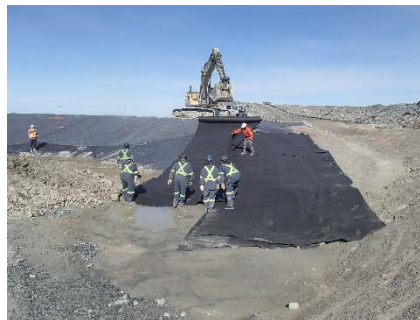
**SD3-322 (2018-07-09), looking W from Sta. 20+625/-63 m.** Installation of two layers of geotextile on the upstream slope 3H:1V between El. 142 m and 143 m (approx.) from Sta. 20+610 m to 20+800 m.

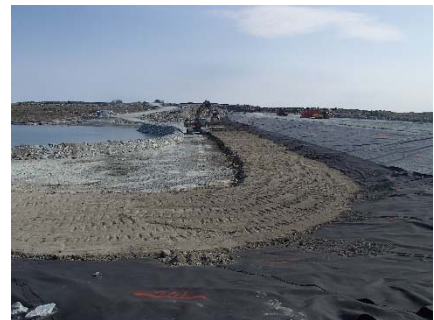
**SD3-323 (2018-07-09), looking S from Sta. 20+610/-43 m.** Placement of the first 0.5 m thick lift of low quality till (0-150 mm) from El. 142 m to 142.5 m from Sta. 20+610 m to 20+715 m.

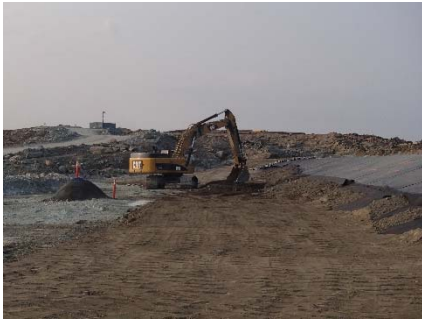
**SD3-324 (2018-07-10), looking S from Sta. 20+680/-39 m. Placement of a 0.5 m thick lift of low quality till (0-150 mm) from El. 142 m to 142.5 m from Sta. 20+715 m to 20+760 m.**

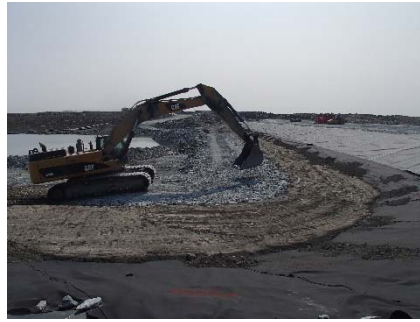
**SD3-325 (2018-07-10), looking S from Sta. 20+610/-43 m. Placement of a first 0.5 m thick lift of fine rockfill (0-500 mm) upstream of the low quality till from El. 142 m to 142.5 m from Sta. 20+610 m to 20+760 m.**

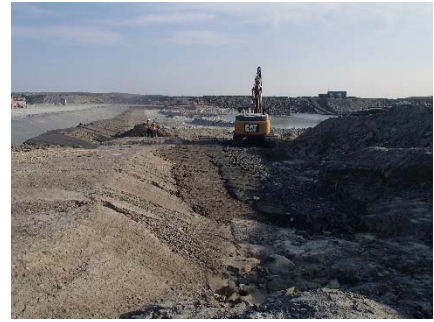
**SD3-326 (2018-07-11), looking N from Sta. 20+820/-34 m. Placement of the 0.5 m thick lift of low class till, fine filter, coarse filter and fine rockfill on the upstream slope of the upstream toe liner tie-in with an excavator from Sta. 20+780 to 20+810 m.**

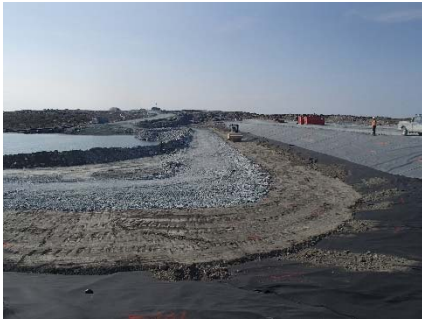
**SD3-327 (2018-07-11), looking S from Sta. 20+610/-43 m. Compaction of the 0.5 m lift of low quality till (0-150 mm) at El. 142.5 m with a 10-tonne smooth-drum compactor with vibration (4 passes) from Sta. 20+610 m to 20+615 m and from Sta. 20+635 m to 20+760 m.**

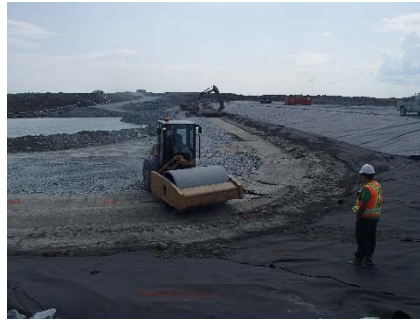
**SD3-328 (2018-07-11), looking N from Sta. 20+820/-34 m. Compaction perpendicular to the longitudinal axis of Saddle Dam 3 of the 0.5 m lift of low quality till (0-150 mm) at El. 142.5 m with a 10-tonne smooth-drum compactor without vibration (4 passes) from Sta. 20+615m to 20+635 m.**

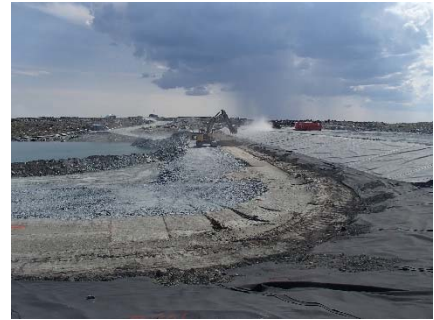
**SD3-329 (2018-07-11), looking N from Sta. 20+820/-34 m. Placement of a 0.5 m thick lift of low quality till (0-150 mm) from El. 142.5 m to 143 m from Sta. 20+610 m to 20+760 m.**

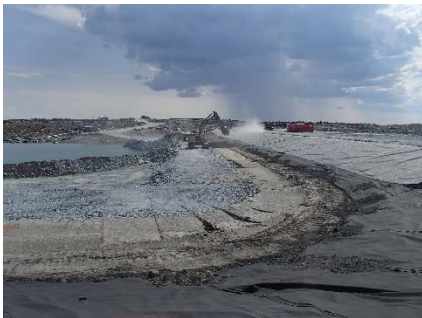
**SD3-329 (2018-07-11), looking N from Sta. 20+820/-34 m. Placement of a 0.5 m thick lift of low quality till (0-150 mm) from El. 142.5 m to 143 m from Sta. 20+610 m to 20+760 m.**

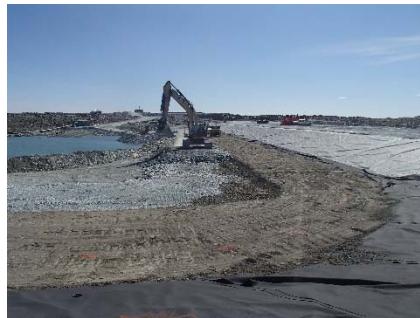
**SD3-330 (2018-07-12), looking S from Sta. 20+610/-43 m. Placement of a second 0.5 m thick lift of fine rockfill (0-500 mm) upstream of the low quality till (0-150mm) from El. 142.5 m to 143 m from Sta. 20+610 m to 20+760 m.**

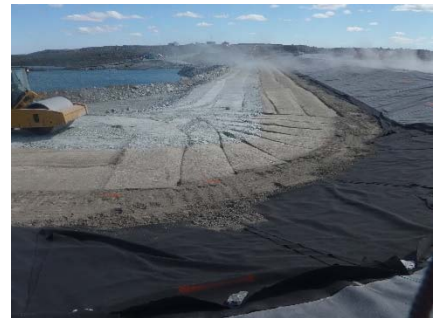
**SD3-331 (2018-07-12), looking S from Sta. 20+610/-43 m. Compaction of the 0.5 m lift of low quality till (0-150 mm) at El. 143 m with a 10-tonne smooth-drum compactor with vibration (4 passes) from Sta. 20+610 m to 20+760 m.**

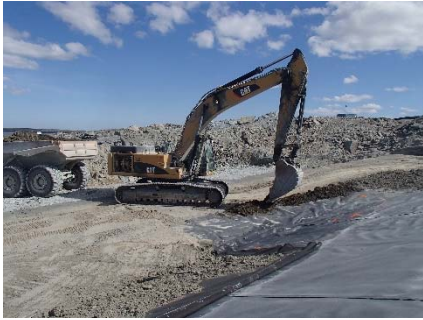
**SD3-332 (2018-07-12), looking SE from Sta. 20+775/-23 m. Placement of a first 0.5 m thick lift of compacted sieved till over the LLDPE geomembrane on the upstream toe liner tie-in with an excavator from Sta. 20+775 m to 20+800 m.**

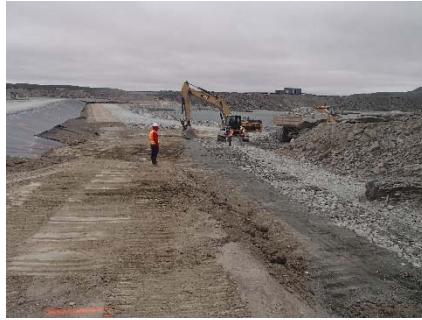
**SD3-333 (2018-07-13), looking N from Sta. 20+817/-29 m. Placement of a second 0.5 m thick lift of fine rockfill on the upstream slope of the upstream toe liner tie-in with an excavator from Sta. 20+775 m to 20+800 m.**

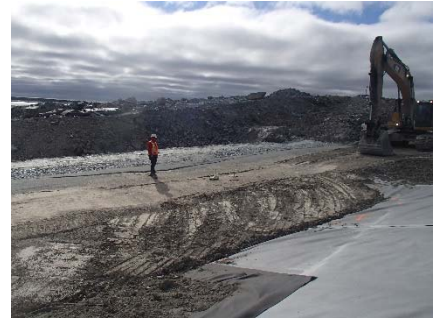
**SD3-334 (2018-07-13), looking SE from Sta. 20+780/-26 m. Compaction of the second 0.5 m thick lift of compacted sieved till and third lift of fine filter, coarse filter and fine rockfill of the upstream toe liner tie-in with a 10 tonne smooth-drum compactor with vibrations from Sta. 20+770 m to 20+800 m.**

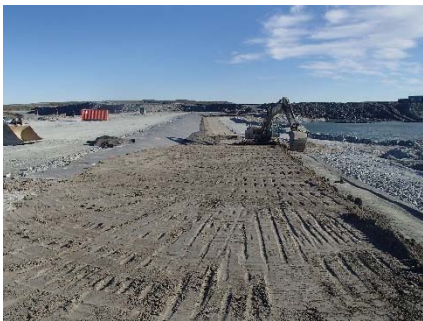
**SD3-335 (2018-07-14), looking N from Sta. 20+815/-27 m. Placement of a third 0.5 m thick lift of compacted sieved till on the upstream slope of the upstream toe liner tie-in with an excavator from Sta. 20+760 m to 20+810 m.**

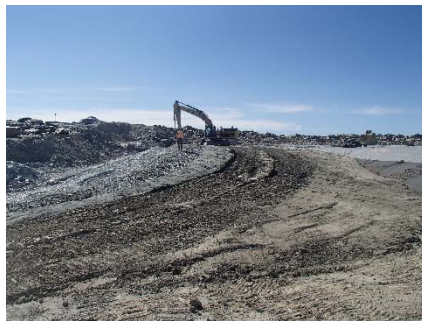
**SD3-336 (2018-07-14), looking S from Sta. 20+755/-48 m. Placement of a fourth 0.5 m thick lifts of fine filter, coarse filter and fine rockfill on the upstream slope of the upstream toe liner tie-in with an excavator from Sta. 20+770 to 20+800 m.**

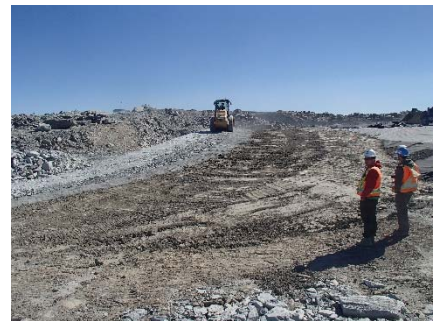
**SD3-337 (2018-07-14), looking S from Sta. 20+760/-37 m. Compaction of the fourth 0.5 m thick lifts of fine filter, coarse filter and fine rockfill on the upstream slope of the upstream toe liner tie-in with a 10 tonne smooth-drum compactor with vibrations (4 passes) from Sta. 20+770 to 20+800 m.**

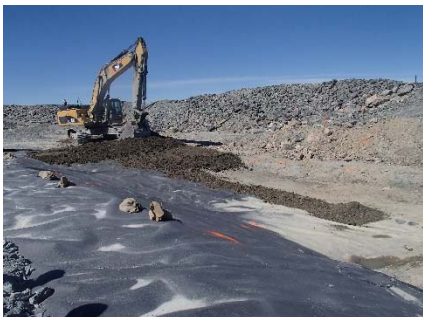
**SD3-338 (2018-07-14), looking NW from Sta. 20+610/-43 m. Placement of a first 0.5 m thick lift of compacted sieved till over the LLDPE geomembrane on the upstream toe liner tie-in with an excavator from Sta. 20+588 m to 20+599 m.**

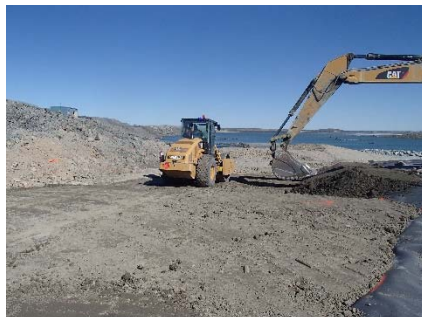
**SD3-339 (2018-07-15), looking E from Sta. 20+600/-29 m. Compaction of a first 0.5 m thick lift of compacted sieved till on the upstream toe liner tie-in with an excavator from Sta. 20+588 m to 20+599 m.**

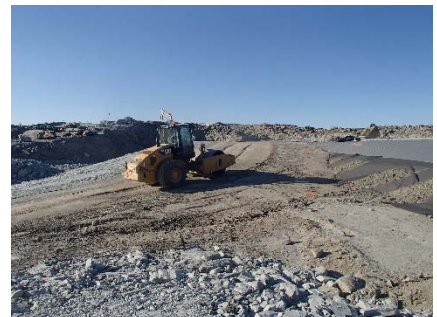
**SD3-340 (2018-07-15), looking S from Sta. 20+750/-40 m. Compaction of the third 0.5 m thick lift of compacted sieved till on the upstream toe liner tie-in with an excavator from Sta. 20+760 m to 20+820 m.**

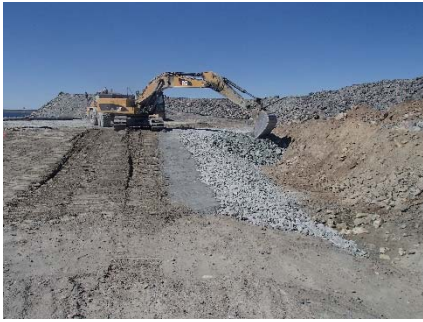
SD3-341 (2018-07-15), looking W from Sta. 20+600/-59 m. Placement of a first 0.5 m thick lift of fine rockfill on the upstream slope of the upstream toe liner tie-in with an excavator from Sta. 20+588 m to 20+599 m.

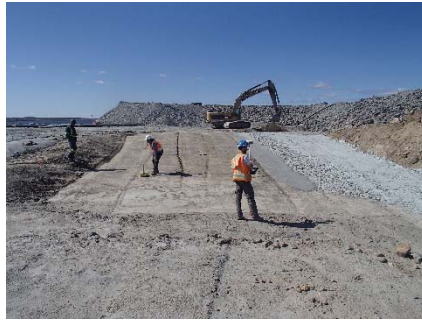
SD3-342 (2018-07-15), looking W from Sta. 20+600/-58 m. View of the compaction test and view of the filling of the depression between SD2 and SD3 with low quality till up to El. 145 m.

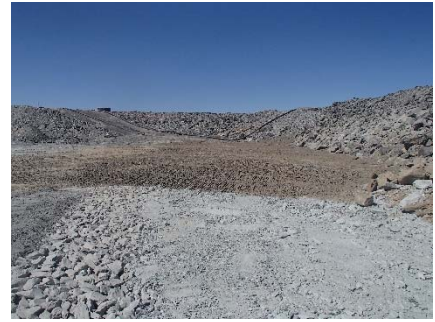
SD3-343 (2018-07-16), looking W from Sta. 20+590/-40 m. View of the depression between SD2 and SD3 backfilled with low quality till up to El. 145 m.

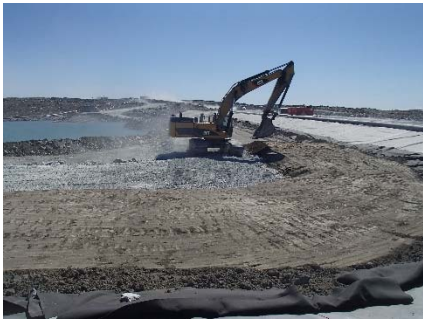
SD3-344 (2018-07-16), looking S from Sta. 20+610/-43 m. Placement of a third 0.5 m thick lift of low quality till (0-150 mm) from El. 142.5 m to 143 m from Sta. 20+570 m to 20+590 m.

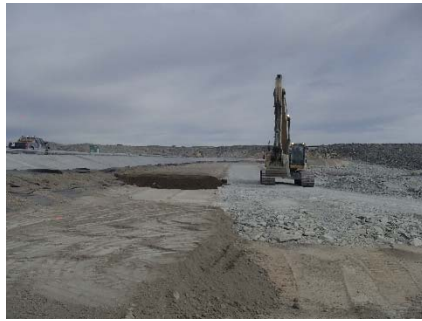
SD3-345 (2018-07-17), looking NW from Sta. 20+760/-42 m. Placement of a fourth 0.5 m thick lift of low quality till (0-150 mm) from El. 143 m to 143.5 m from Sta. 20+619 m to 20+777 m.

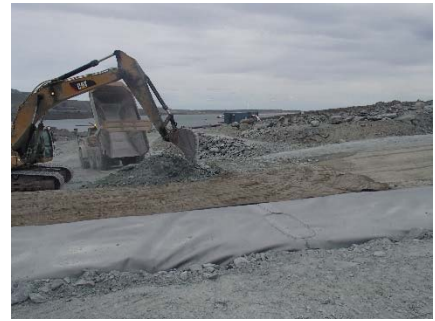
SD3-346 (2018-07-17), looking E from Sta. 20+760/-21 m. Placement of a third 0.5 m thick lift of fine UM rockfill (0-500 mm) upstream of the low quality till (0-150mm) from El. 143 m to 143.5 m from Sta. 20+668 m to 20+777 m.

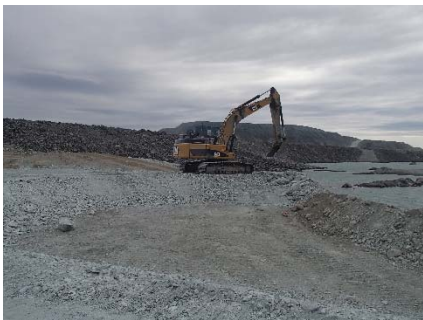
SD3-347 (2018-07-18), looking W from Sta. 20+640/-41 m. Placement of a third 0.5 m thick lift of fine UM rockfill (0-500 mm) upstream of the low quality till (0-150mm) from El. 143 m to 143.5 m from Sta. 20+688 m to 20+619 m.

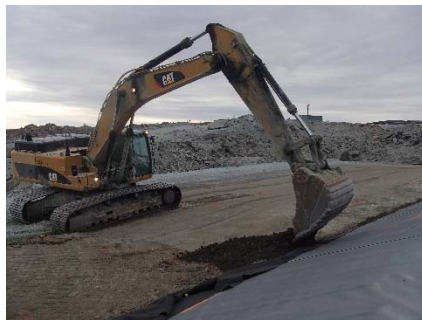
SD3-348 (2018-07-18), looking E from Sta. 20+760/-25 m. Placement of a 0.5 m thick layer of compacted sieved till on the upstream slope of SD3 with an excavator from Sta. 20+777 m to 20+807 m. No large rock was allowed to be placed against the LLDPE liner.

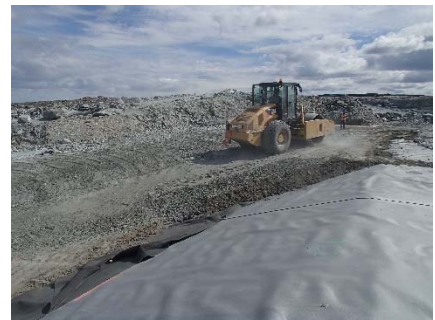
SD3-349 (2018-07-18), looking SE from Sta. 20+765/-29 m. Compaction of the 0.5 m thick lift of fine filter on the top of the upstream toe liner tie-in with a 10 tonne smooth-drum compactor with vibration (4 passes) from Sta. 20+777 m to 20+807 m.

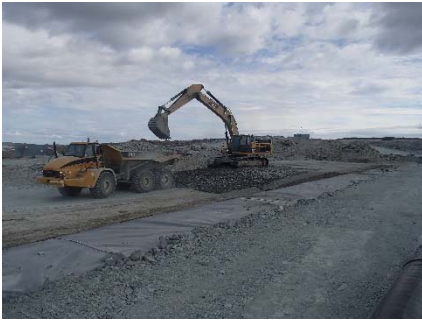
**SD3-350 (2018-07-18), looking SE from Sta. 20+740/-24 m. Placement of a 0.5 m thick lift of coarse filter on the top of 0.5 m lift of low quality till (0-150 mm) the fine filter on the upstream toe liner with an excavator from Sta. 20+777 m to 20+807 m.**

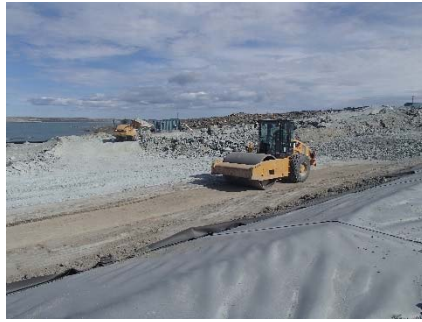
**SD3-351 (2018-07-18), looking SE from Sta. 20+740/-24 m. Compaction of the layer of compacted sieved till placed against the upstream slope from Sta. 20+599 m to 20+613 m.**

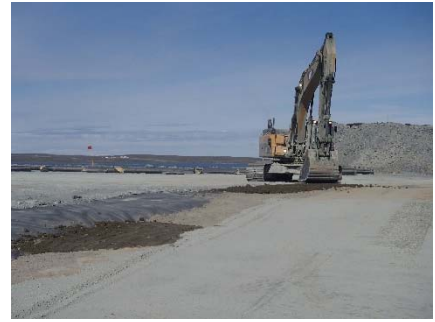
**SD3-352 (2018-07-19), looking SW from Sta. 20+580/-49 m. View of SD3 at the end of the 2018 construction phase.**

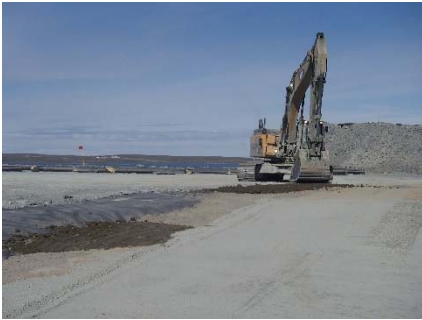
**SD3-353 (2018-07-22), looking SW from Sta. 20+580/-49 m. View of SD3 at the end of the 2018 construction phase.**

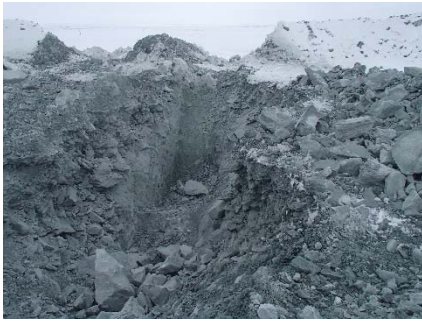
**NCIS-001 (2018-05-19).** View of a test pit in the UM rockfill lift at El. 152 m: a thick layer of snow (2 m) underlies the rockfill.

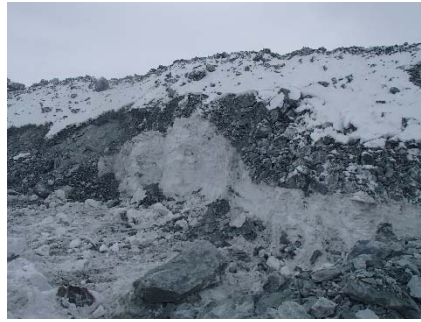
**NCIS-002 (2018-05-19).** View of the scraped upstream side of the UM rockfill lift at El. 152 m: a thick layer of snow (1.5 m) underlies the rockfill.

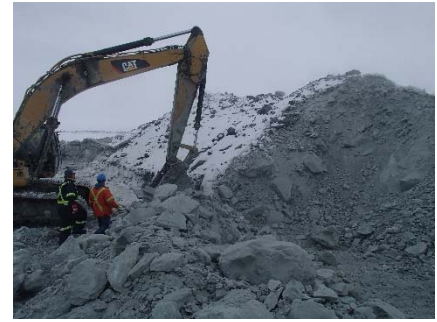
**NCIS-003 (2018-05-19).** Excavation of the snow-rich upstream toe material on an average width of 2 to 3 m with an excavator.

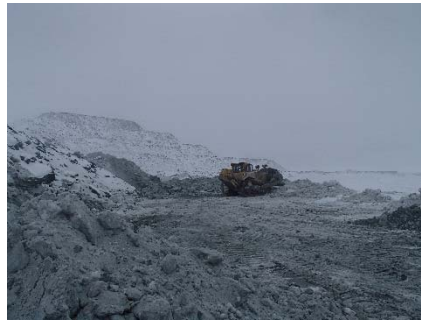
**NCIS-004 (2018-05-19).** View of the scraped upstream side of the UM rockfill lift at El. 152 m further to the north: the snow layer is only observed at the toe and is approximately 0.5 m thick.

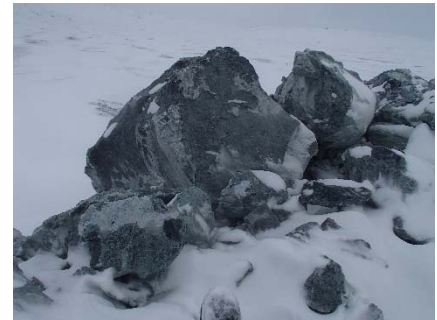
**NCIS-005 (2018-05-19).** Removal of the excavated material, pushed with a dozer towards the center of the North Cell to clear the upstream toe.

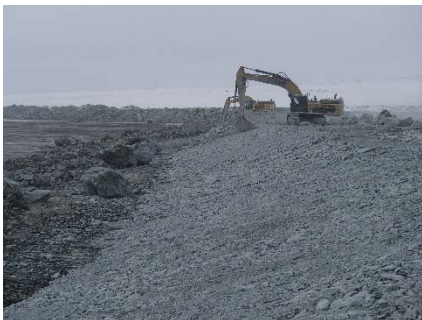
**NCIS-006 (2018-05-19).** View of oversized boulders on the UM rockfill lift at El. 152 m.

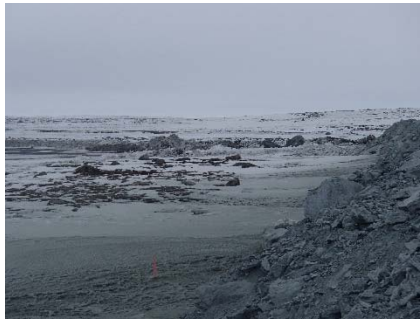
**NCIS-013 (2018-05-22),** looking NE from Sta. 2+600 m. Correction of the crest elevation with an excavator to achieve a closer elevation to 152 m around Sta. 2+650 m.

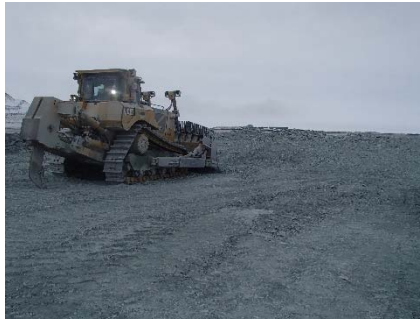
NCIS-019 (2018-05-26), looking SW from Sta. 2+100 m. Profiling of the upstream slope (3H:1V) from El. 150 to 152 m with an excavator from Sta. 1+860 m to 1+678 m. The portion between Sta. 1+900 m and 1+800 m, where the structure is built on the natural ground, was not profiled.

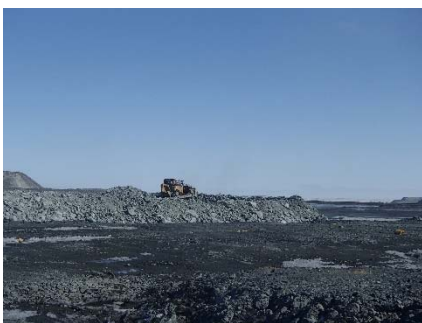
NCIS-024 (2018-05-31), looking SW from Sta. 2+570 m. Removal of the snow bank in the footprint with an excavator from Sta. 1+160 m to 1+120 m (approx.).

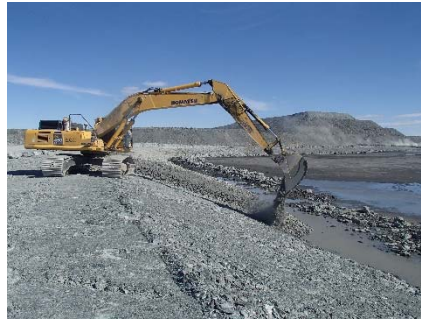
**NCIS-028 (2018-06-09), looking E from Sta. 1+340/+3 m. View of the UM rockfill lift approximately 3.2 m thick.**

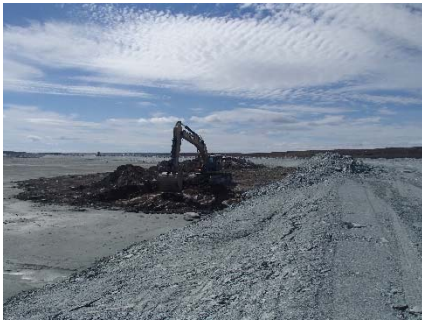
**NCIS-030 (2018-06-20), looking W from Sta. 2+140/-29 m. Placement of a 0.5 m thick lift of coarse filter in the upstream slope from El. 150 m to 152 m with an excavator from Sta. 2+105 m to 1+930 m. Notice the presence of water ponding at the bottom of the slope.**

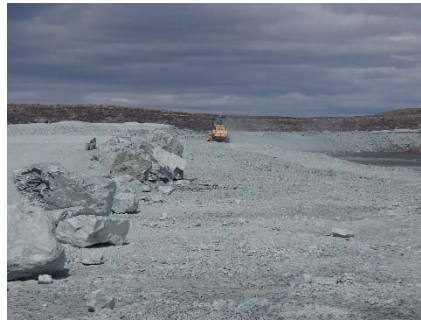
**NCIS-031 (2018-06-20), looking SW from Sta. 1+880/-21 m. Final clean-up of the dike footprint with an excavator to reach a good quality bedrock from Sta. 1+800 to 1+850 m (o.s. -42 to -33 m).**

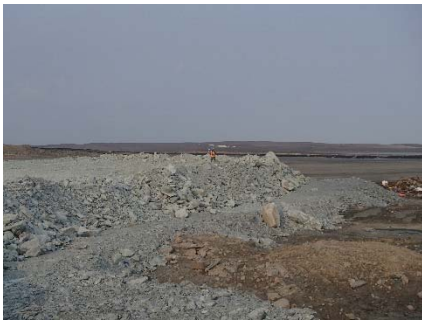
NCIS-084 (2018-07-08), looking E from Sta. 1+080/+47 m (approx.). Placement of a 2 m thick (approx.) lift of UM rockfill from El. 150 m to El. 152 m (approx.) with a dozer from Sta. 1+160 m to 1+130 m (-55 m to -102 m).

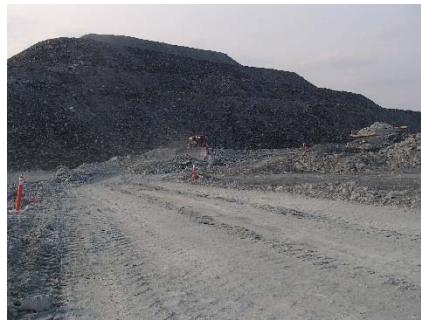
NCIS-085 (2018-07-09), looking SW from Sta. 1+150/-67 m (approx.). Placement of a 2 m thick (approx.) lift of UM rockfill from El. 150 m to El. 152 m (approx.) with a dozer from Sta. 1+130 m to 1+100 m (-55 m to -78 m).

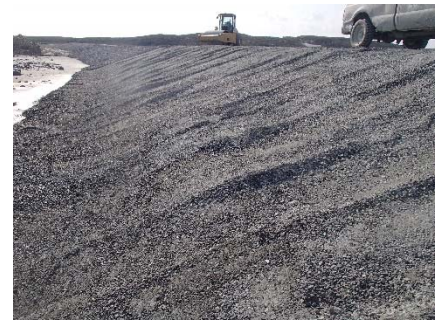
NCIS-086 (2018-07-10), looking E from Sta. 2+750/+14 m (approx.). Placement of a 2 m thick (approx.) lift of UM rockfill from El. 152 m to El. 154 m (approx.) with a dozer from Sta. 2+780 m to 2+760 m (-60 m to -44 m).

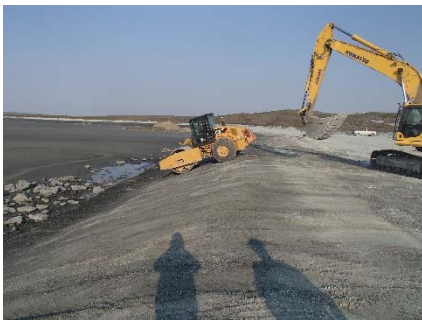
NCIS-087 (2018-07-11), looking W from Sta. 1+950/-34 m (approx.). Compaction of the 0.5 m lift (approx.) of fine filter between El. 150 and 152 m with a 10-tonne smooth-drum compactor (4 passes) in the upstream slope from Sta. 2+000 m to 1+930 m.

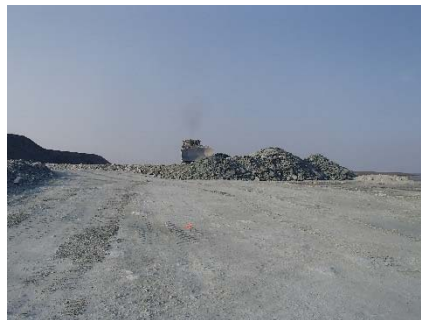
NCIS-088 (2018-07-12), looking W from Sta. 2+000/-35 m (approx.). Compaction of the 0.5 m lift (approx.) of fine filter between El. 150 m and 152 m with a 10-tonne smooth-drum compactor (4 passes) in the upstream slope from Sta. 2+028 m to 1+650 m.

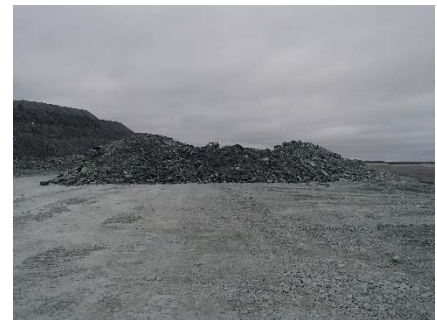
NCIS-089 (2018-07-12), looking S from Sta. 2+525/+4 m (approx.). Placement of a 2 m thick (approx.) lift of UM rockfill from El. 152 m to El. 154 m (approx.) with a dozer from Sta. 2+605 m to 2+455 m (+3 m to -23 m).

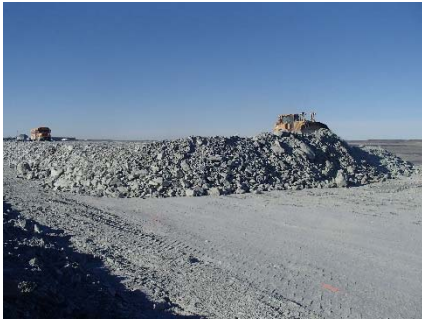
NCIS-090 (2018-07-13), looking SE from Sta. 2+440/-1 m (approx.). Placement of a 2 m thick (approx.) lift of UM rockfill from El. 152 m to El. 154 m (approx.) with a dozer from Sta. 2+455 m to 2+370 m (+4 m to -24 m).

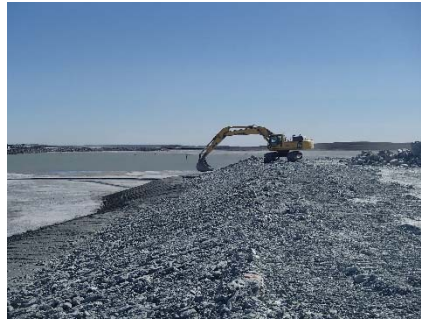
**NCIS-091 (2018-07-14), looking S from Sta. 2+330/+13 m (approx.). Placement of a 2 m thick (approx.) lift of UM rockfill from El. 152 m to El. 154 m (approx.) with a dozer from Sta. 2+370 m to 2+290 m (+9 m to -22 m).**

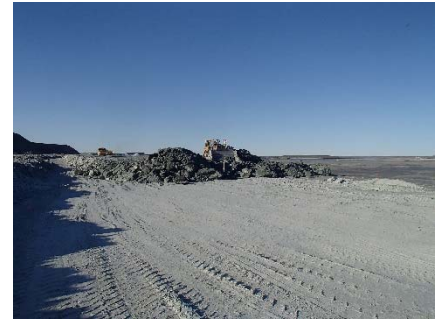
**NCIS-092 (2018-07-14), looking S from Sta. 1+160/-77 m (approx.). Profiling of the upstream slope (3H:1V) from El. 150 to 152 m with an excavator from Sta. 1+185 m to 1+135 m.**

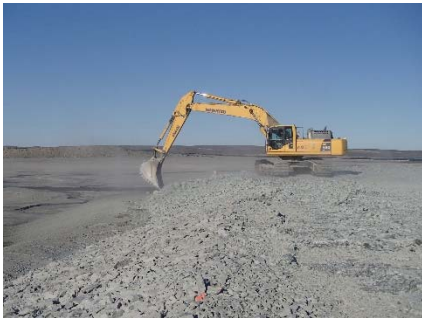
**NCIS-093 (2018-07-15), looking S from Sta. 2+260/+12 m (approx.). Placement of a 2 m thick (approx.) lift of UM rockfill from El. 152 m to El. 154 m (approx.) with a dozer from Sta. 2+290 m to 2+280 m (+9 m to -22 m).**

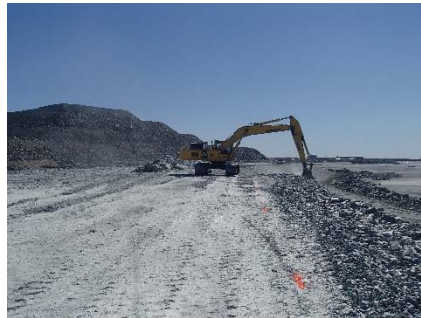
**NCIS-094 (2018-07-15), looking SW from Sta. 1+125/-109 m (approx.). Profiling of the upstream slope (3H:1V) from El. 150 to 152 m with an excavator from Sta. 1+135 m to 1+115 m.**

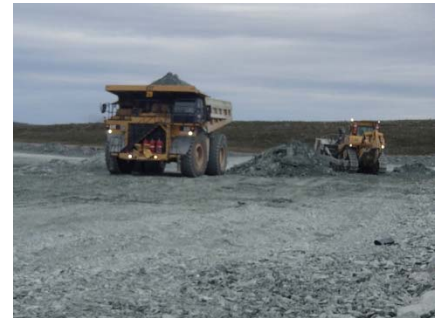
**NCIS-095 (2018-07-16), looking S from Sta. 2+375/-18 m (approx.). Profiling of the upstream slope (3H:1V) from El. 152 to 154 m with an excavator from Sta. 2+545 m to 2+410 m.**

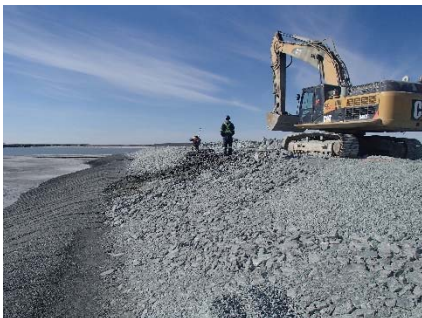
**NCIS-096 (2018-07-18), looking N from Sta. 2+355/+9 m (approx.). Placement of a 2 m thick (approx.) lift of UM rockfill from El. 152 m to El. 154 m (approx.) with a dozer from Sta. 2+190 m to 2+103 m (+7 m to -22 m).**

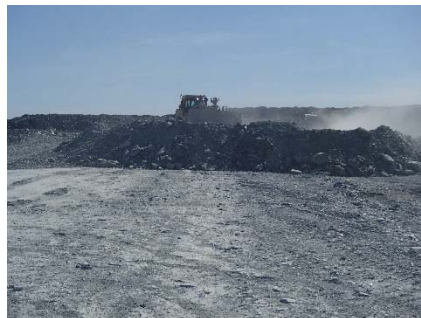
**NCIS-097 (2018-07-19), looking SW from Sta. 1+180/-75 m (approx.). Placement of a 0.5 m thick lift of coarse filter in the upstream slope from El. 150 m to 152 m with an excavator from Sta. 1+200 m to 1+113 m.**

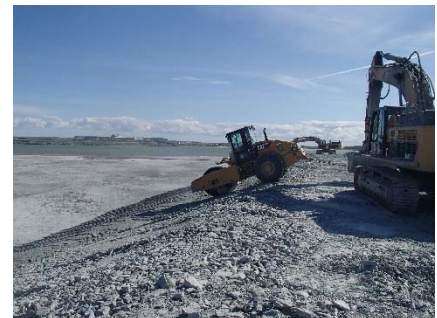
**NCIS-098 (2018-07-19), looking E from Sta. 2+040/-9 m (approx.). Placement of a 2 m thick (approx.) lift of UM rockfill from El. 152 m to El. 154 m (approx.) with a dozer from Sta. 2+103 m to 1+984 m (+7 m to -22 m). The material is of good quality and is well graded.**

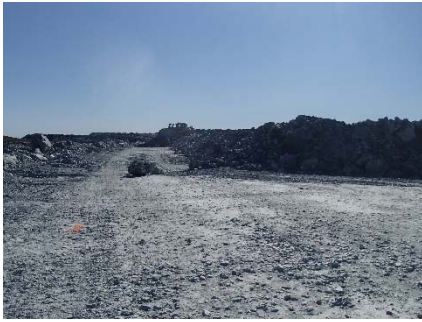
**NCIS-099 (2018-07-19), looking SE from Sta. 1+180/-76 m (approx.). Compaction of the 0.5 m lift (approx.) of coarse filter between El. 150 m and 152 m with a 10-tonne smooth-drum compactor with vibration (4 passes) in the upstream slope from Sta. 1+200 m to 1+170 m.**

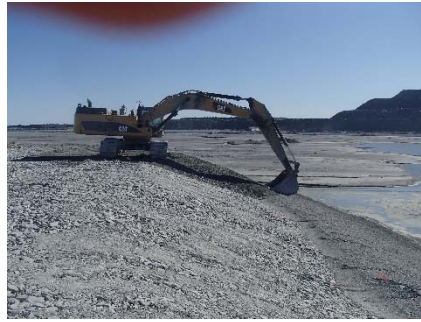
NCIS-100 (2018-07-20), looking E from Sta. 1+960/+10 m (approx.). Placement of a 2 m thick (approx.) lift of UM rockfill from El. 152 m to El. 154 m (approx.) with a dozer from Sta. 1+984 m to 1+947 m (+14 m to -26 m). The material is of good quality and is well graded.

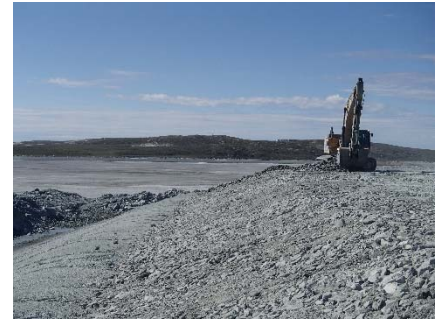
NCIS-101 (2018-07-20), looking N from Sta. 1+120/-89 m (approx.). Placement of a 0.5 m thick lift of fine filter in the upstream slope from El. 150 m to 152 m with an excavator from Sta. 1+113 m to 1+205 m.

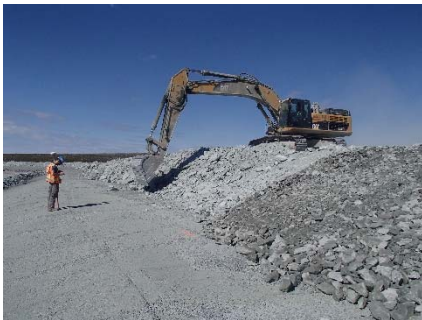
NCIS-102 (2018-07-20), looking W from Sta. 2+680/-21 m (approx.). Placement of a 0.5 m thick lift of coarse filter in the upstream slope from El. 152 m to 154 m with an excavator from Sta. 2+575 m to 2+710 m and from Sta. 2+411 m to 2+460 m.

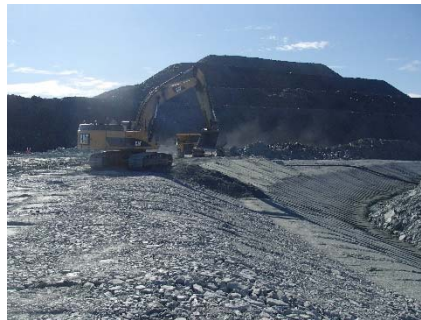
NCIS-103 (2018-07-20), looking NE from Sta. 2+420/-27 m (approx.). Profiling of the upstream slope (3H:1V) from El. 152 to 154 m with an excavator from Sta. 2+400 m to 2+410 m. Oversize boulders were removed.

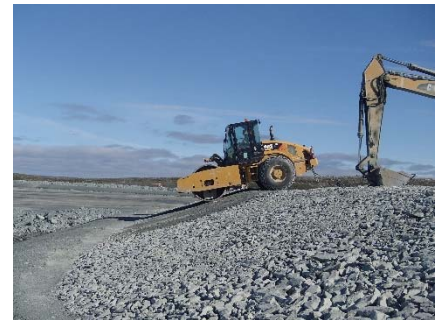
NCIS-104 (2018-07-21), looking SE from Sta. 2+650/-23 m (approx.). Placement of a 0.5 m thick lift of fine filter in the upstream slope from El. 152 m to 154 m with an excavator from Sta. 2+710 m to 2+445 m.

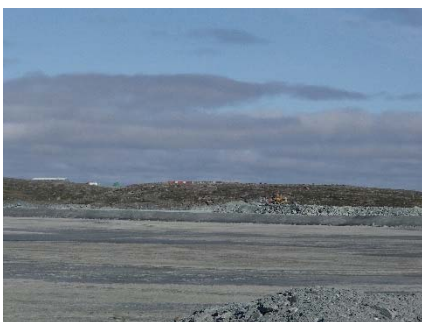
NCIS-105 (2018-07-21), looking NW from Sta. 2+630/-34 m (approx.). Compaction of the 0.5 m lift (approx.) of coarse filter between El. 152 m and 154 m with a 10-tonne smooth-drum compactor with vibration (4 passes) in the upstream slope from Sta. 2+710 m to 2+411 m.

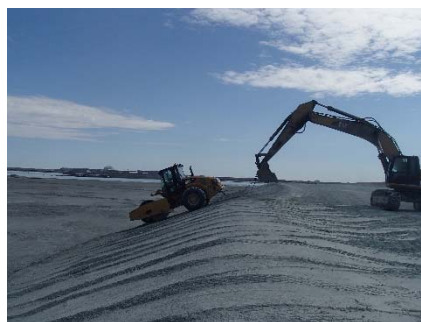
NCIS-106 (2018-07-21), looking NW from Sta. 2+620/-35 m (approx.). Placement of a 2 m thick (approx.) lift of UM rockfill from El. 152 m to El. 154 m (approx.) with a dozer from Sta. 1+947 m to 1+863 m (+14 m to -26 m).

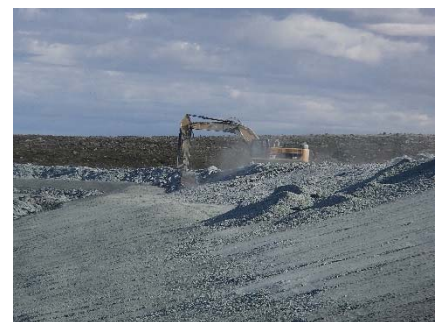
NCIS-107 (2018-07-21), looking S from Sta. 1+380/-38 m (approx.). Compaction of the 0.5 m lift (approx.) of fine filter between El. 150 m and 152 m with a 10-tonne smooth-drum compactor with vibration (4 passes) in the upstream slope from Sta. 1+251 m to 1+660 m.

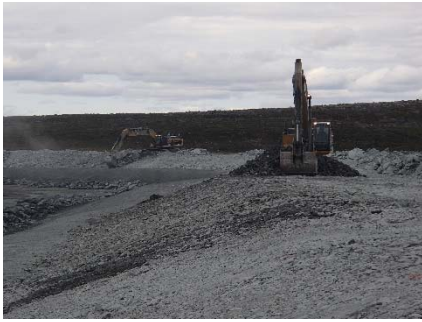
NCIS-108 (2018-07-22), looking N from Sta. 2+490/-32 m (approx.). Profiling of the upstream slope (3H:1V) from El. 152 to 154 m with an excavator from Sta. 2+159 m to 2+409 m.

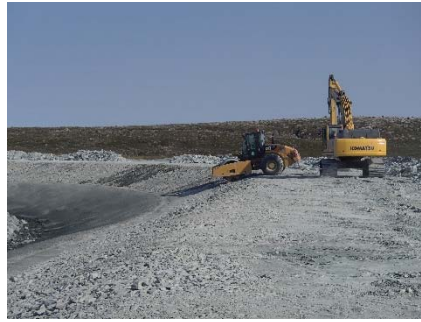
**NCIS-109 (2018-07-22), looking N from Sta. 2+450/-21 m (approx.).** Placement of a 0.5 m thick lift of coarse filter in the upstream slope from El. 152 m to 154 m with an excavator from Sta. 2+293 m to 2+411 m.

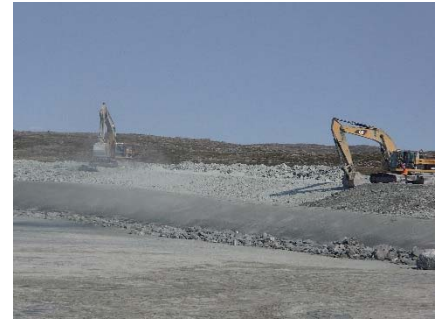
**NCIS-110 (2018-07-23), looking N from Sta. 2+320/-22 m (approx.).** Compaction of the 0.5 m lift (approx.) of coarse filter between El. 152 m and 154 m with a 10-tonne smooth-drum compactor with vibration (4 passes) in the upstream slope from Sta. 2+293 m to 2+080 m.

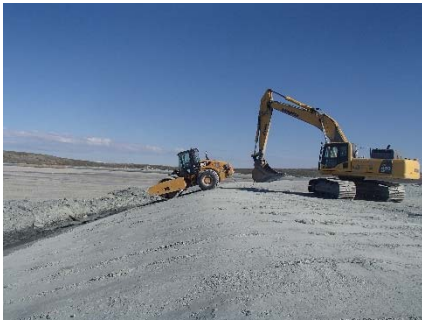
**NCIS-111 (2018-07-23), looking NW from Sta. 2+320/-22 m (approx.).** Profiling of the upstream slope (3H:1V) from El. 152 to 154 m with an excavator from Sta. 2+159 m to 2+000 m and placement of a 0.5 m thick lift of coarse filter in the upstream slope from El. 152 m to 154 m with an excavator from Sta. 2+293 m to 2+080 m.

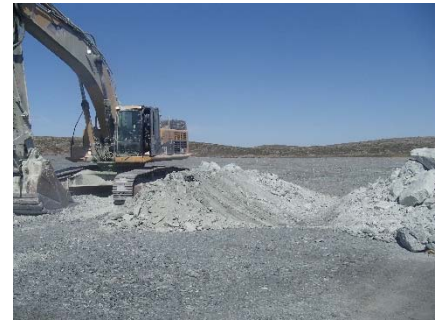
**NCIS-113 (2018-07-24), looking SW from Sta. 2+220/-26 m (approx.).** Profiling of the upstream slope (3H:1V) from El. 152 to 154 m with an excavator from Sta. 2+000 m to 1+185 m and placement of a 0.5 m thick lift of fine filter in the upstream slope from El. 152 m to 154 m with an excavator from Sta. 2+300 m to 2+090 m.

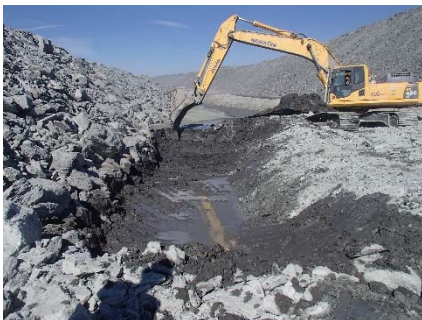
The decision was made to excavate a shallow unlined ditch (at least 1 m wide and 0.5 m deep) in the rockfill cover and tailings on the downstream side of the dike, in order to collect and redirect possible seepage which could occur through the dike toward the North Cell (see Figure 3). The ditch will start from the northwestern extremity of the North Cell Internal Structure, cross the Cyanide Burning Pad area (the pad will ultimately be relocated) and extend beyond the southwestern extremity of the dike to ensure that water is redirected toward the North Cell pond. A layer of rockfill was placed on the surfaces of the ditch excavated within the tailings to prevent erosion of the tailings. A temporary sump was excavated at the south extremity of the ditch.

**NCIS-114 (2018-07-24), looking N from Sta. 1+700/-34 m (approx.).** Excavation of a 0.8 m (approx.) deep, 1 m wide shallow ditch in the rockfill capping with an excavator from Sta. 1+500 m to 1+650 m.

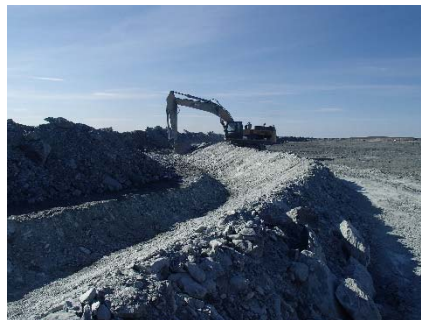
**NCIS-115 (2018-07-24), looking NE from Sta. 3+040/-33 m (approx.).** Excavation of a 1 m (approx.) sump in the tailings with an excavator from Sta. 3+010 m to 3+030 m (o.s. +27 to +30 m).

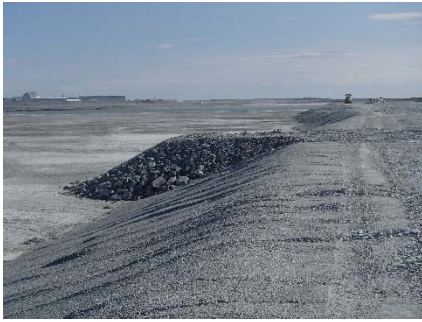
**NCIS-117 (2018-07-25), looking SW from Sta. 2+050/-25 m (approx.).** Placement of a 0.5 m thick lift of fine filter in the upstream slope from El. 152 m to 154 m with an excavator from Sta. 2+090 m to 1+890 m.

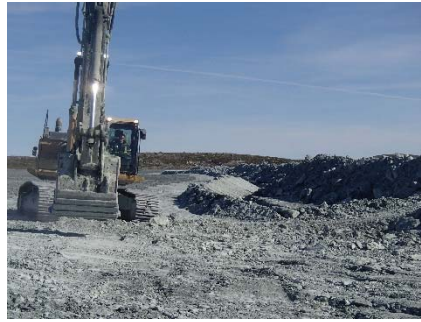
**NCIS-118 (2018-07-25), looking S from Sta. 1+500/-37 m (approx.). View of a deposition point.**

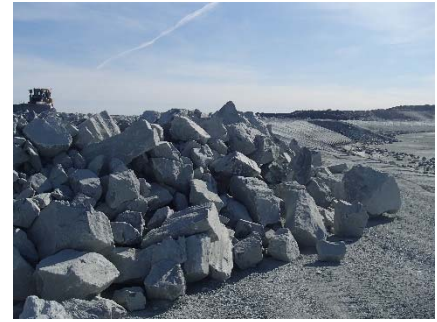
**NCIS-119 (2018-07-26), looking N from Sta. 1+430/-22 m (approx.). Excavation of a 0.8 m (approx.) deep, 1 m wide shallow ditch in the rockfill capping with an excavator from Sta. 1+455 m to 1+400 m.**

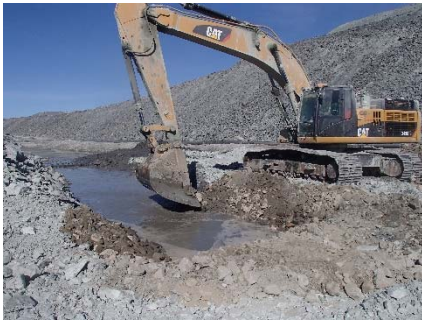
**NCIS-120 (2018-07-26), looking NE from Sta. 1+830/-27 m (approx.). View of an accumulation of boulders on the upstream slope of the NCIS.**

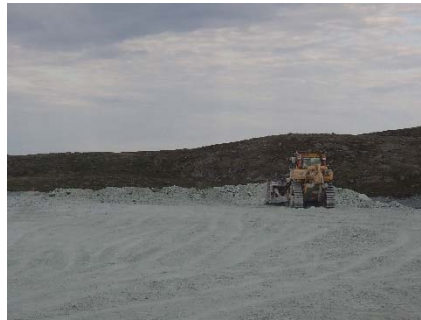
**NCIS-121 (2018-07-26), looking NE from Sta. 3+050/+26 m (approx.). Placement of a 0.3 m thick (approx.) layer of till sieving reject material on the bottom and on the slopes of the sump.**

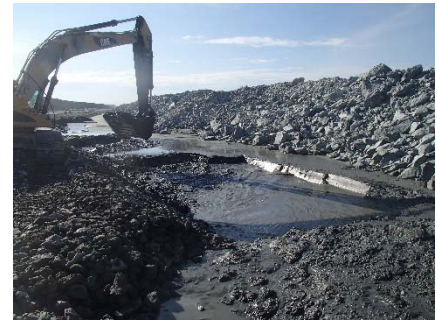
**NCIS-122 (2018-07-27), looking W from Sta. 1+960/-6 m (approx.). Placement of a 2 m thick (approx.) lift of UM rockfill from El. 152 m to El. 154 m (approx.) with a dozer from Sta. 1+830 m to 1+860 m (+8 m to -23 m).**

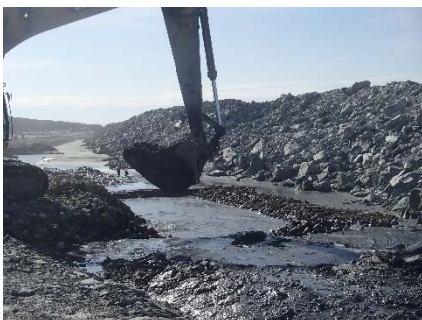
**NCIS-123 (2018-07-27), looking S from Sta. 3+340/+33 m (approx.). Excavation of a 1 m (approx.) deep sump (south sump) in the tailings with an excavator from Sta. 3+345 m to 3+365 m (o.s. +24 to +32 m).**

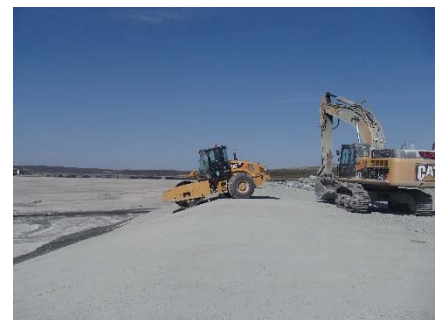
**NCIS-125 (2018-07-27), looking NE from Sta. 3+050/+26 m (approx.). Corrections to the north sump: removal of approx. 0.5 m of tailing and till sieving reject material on the bottom of the excavation. The erosion protection material was replaced.**

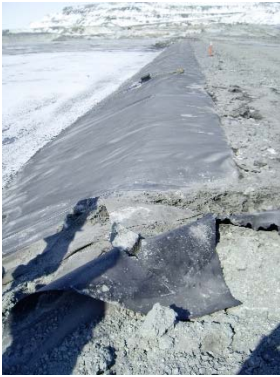
CD-1796 (2018-04-23), looking N from Sta. 0+650/-28 m. Damaged geomembrane near a deposition finger on Central Dike.

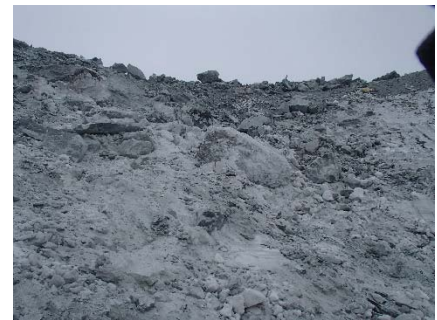
CD-1804 (2018-04-28), looking S from Sta. 40+790/-2 m. Presence of oversize boulders on the existing slope at the junction between SD5 and Central Dike.

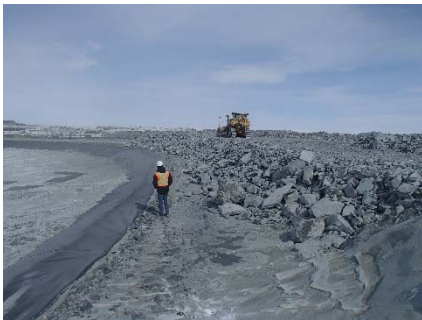
CD-1817 (2018-05-02), looking NE from Sta. 40+700/-10 m. View of the rockfill lift thickness at the junction of Saddle Dam 5 and Central Dike, approx. 2.5 m thick..

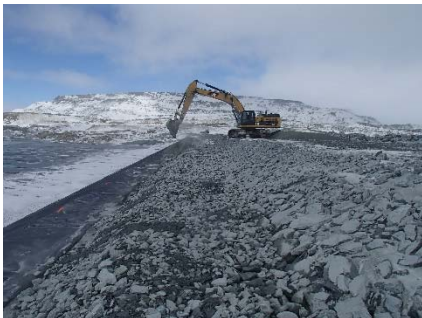
CD-1828 (2018-05-06), looking N from Sta. 0+410/-22 m. Defrosting of the deposition point finger materials with two Frost Fighters at Sta. 0+390 m.

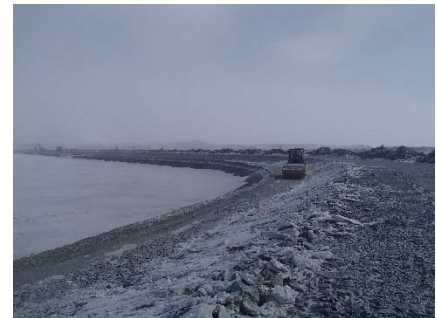
CD-1830 (2018-05-07), looking N from Sta. 0+420/-26 m. Removal of the deposition finger materials with an excavator at Sta. 0+390 m.

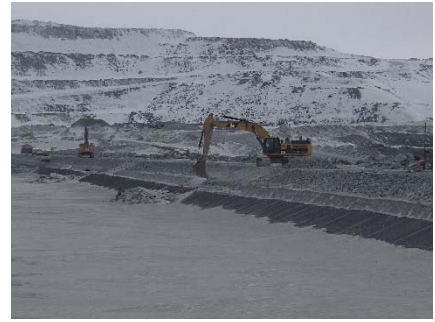
CD-1833 (2018-05-07), looking S from Sta. 0+390/-25 m. Damaged geomembrane near a deposition finger on Central Dike at Sta. 0+390 m.

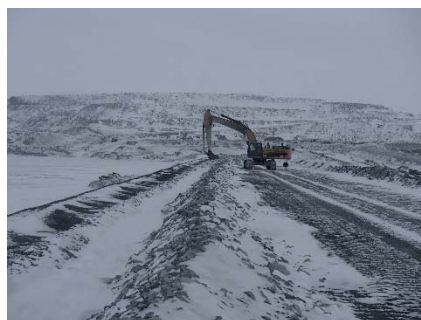
CD-1856 (2018-05-18), looking N from Sta. 0+670/-24 m. Clean-up of the fine filter placed against the slope at the deposition finger at approx. Sta. 0+670 m with pressurized air stream to expose 1 m of LLDPE liner, in preparation for the new liner installation.

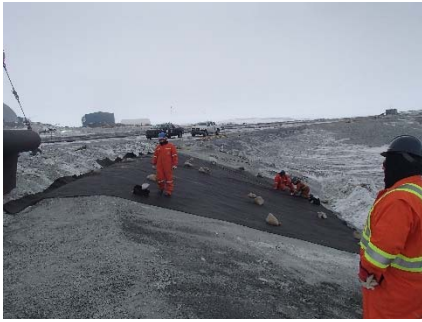
CD-1858 (2018-05-21), looking S from Sta. 0+970/-45 m. View of the bottom of the fine filter upstream slope. Some material is missing to achieve a smooth slope.

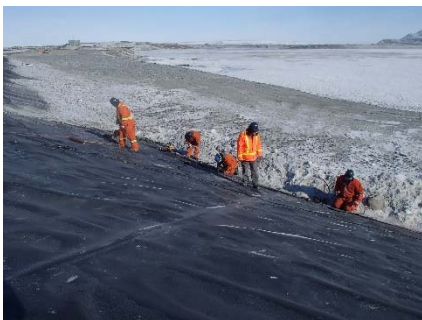
CD-1864 (2018-05-25), looking from Sta. 40+700/-38 m. View of bubbles formed in the extrusion weld because of humidity.

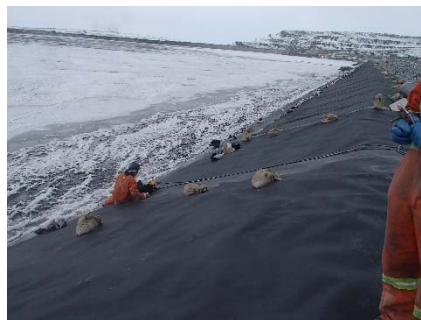
CD-1865 (2018-05-25), looking NW from Sta. 40+740/-35 m. Repairs on the extrusion fillet seam at the bottom of the LLDPE liner panels between Sta. 40+680 m and 0+950 m, on panels 802 to 807, and 811 to 813.

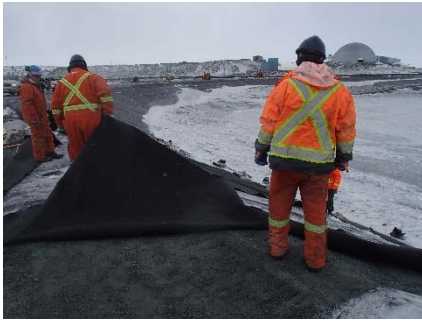
CD-1867 (2018-05-25), looking E from Sta. 40+680/-37 m. View of repair patches on the extrusion weld at the bottom of the panels.

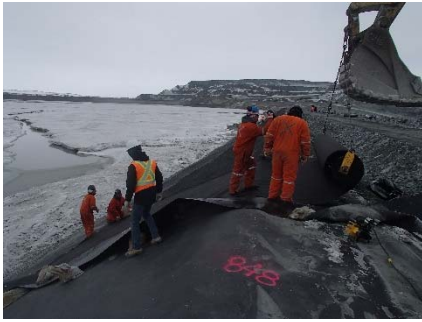
CD-1876 (2018-05-30), looking N from Sta. 0+820/-26 m. View of repair patches on the extrusion weld at the bottom of the panel 838.

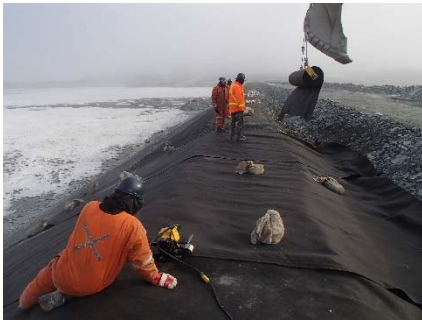
CD-1879 (2018-06-01), looking N from Sta. 0+735/-28 m. View of the repaired holes on panel 850.

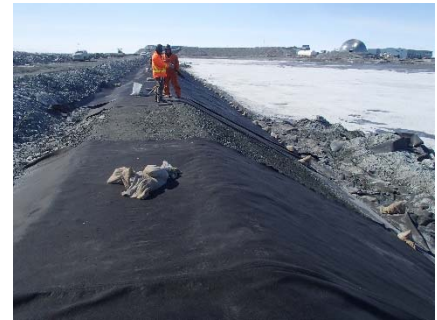
CD-1881 (2018-06-02), looking N from Sta. 0+530/-27 m. View of a geotextile panel with a horizontal weld in the slope at Sta. 0+520 m before its removal.

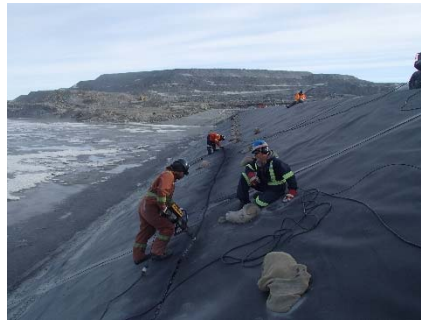
CD-1889 (2018-06-04), looking N from Sta. 0+150/-28 m. View of the underlying liner that has been cut at around Sta. 0+160 m to drain the water.

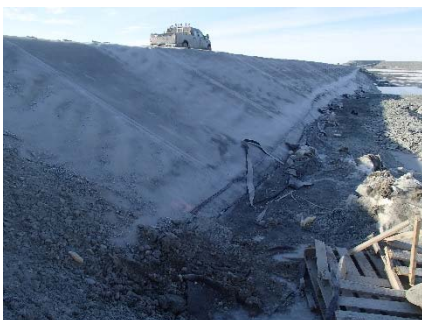
CD-1891 (2018-06-05), looking NE from Sta. 0+960/-28 m. View of leaking extrusion fillet seams before their repair on panel 816 and 818.

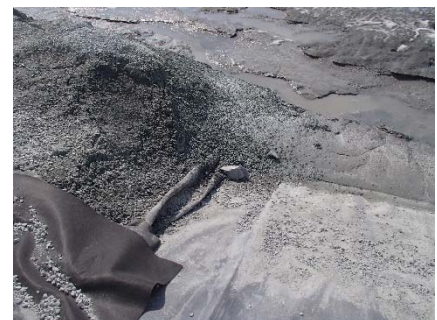
CD-1893 (2018-06-06), looking SW from Sta. 0+950/-27 m. View of repair patches on the extrusion weld at the bottom of the panels 803, 807, 808, 810, 814, 815, 816 and 818.

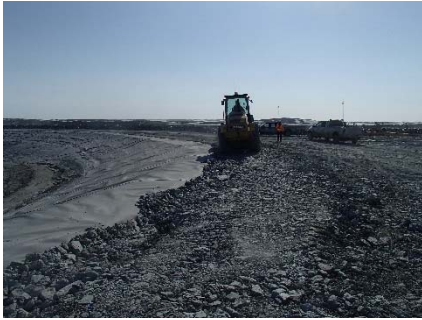
CD-1894 (2018-06-10), looking W from Sta. 0+800/-28 m. View of a block in direct contact with the LLDPE liner following the construction of the deposition fingers on Central Dike.
