### **Meadowbank 2018 TSF As-built report**

**2018 CONSTRUCTION SEASON AS-BUILT REPORT  
TAILINGS STORAGE FACILITY  
MEADOWBANK GOLD PROJECT, NUNAVUT**

1897439-1578-R-Rev0

November 2018

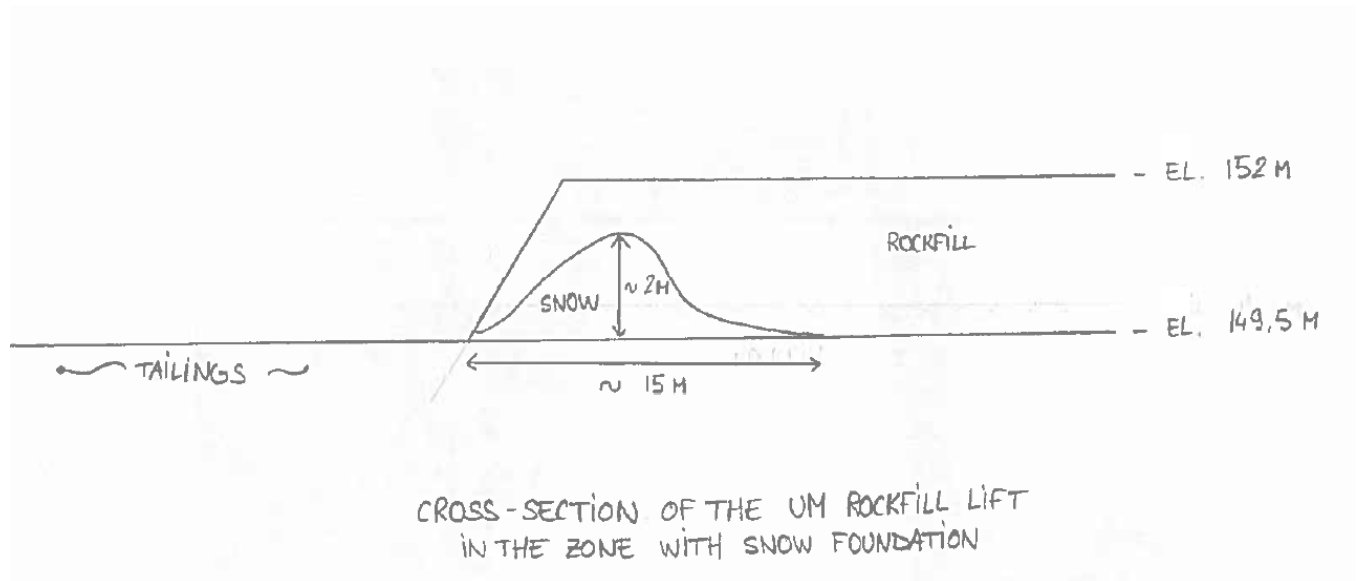
- It was noticed that the 2-m thick UM rockfill at El. 152 m (approx.) was placed on an important layer of hard snow (up to 2 m thick) without QA/QC supervision earlier in the season (see photographs and sketch below), over a distance of approx. 100 m along the dike. It is required to remove this rockfill and clear the snow before placing rockfill again, as the presence of an underlying snow layer will cause excessive settlement in the structure. It was reiterated that per the design, the foundation of the structure must be snow-free, compacted rockfill material constituting the capping of the North Cell.

- Test pits were excavated to identify the extent of the snow layer. Since snow was not observed in the northern part of the UM rockfill lift, which appears to be built directly on the North Cell capping, it was decided to move the operations there and progress towards the north. The excavator removes the snow-rich toe of the UM rockfill lift until snow is no longer observed (a 2-3 m wide zone in average), and a dozer pushes the excavated material (UM rockfill mixed with snow) toward the center of the North Cell to clear the upstream toe.

- Ensure that the layer of hard snow (up to 2 m thick) under the 2 m thick UM rockfill at El. 152 m (approx.) is not within the footprint of the dike, or that it is removed during the profiling of the slope. The foundation of the structure must be snow-free, compacted rockfill material constituting the capping of the North Cell.

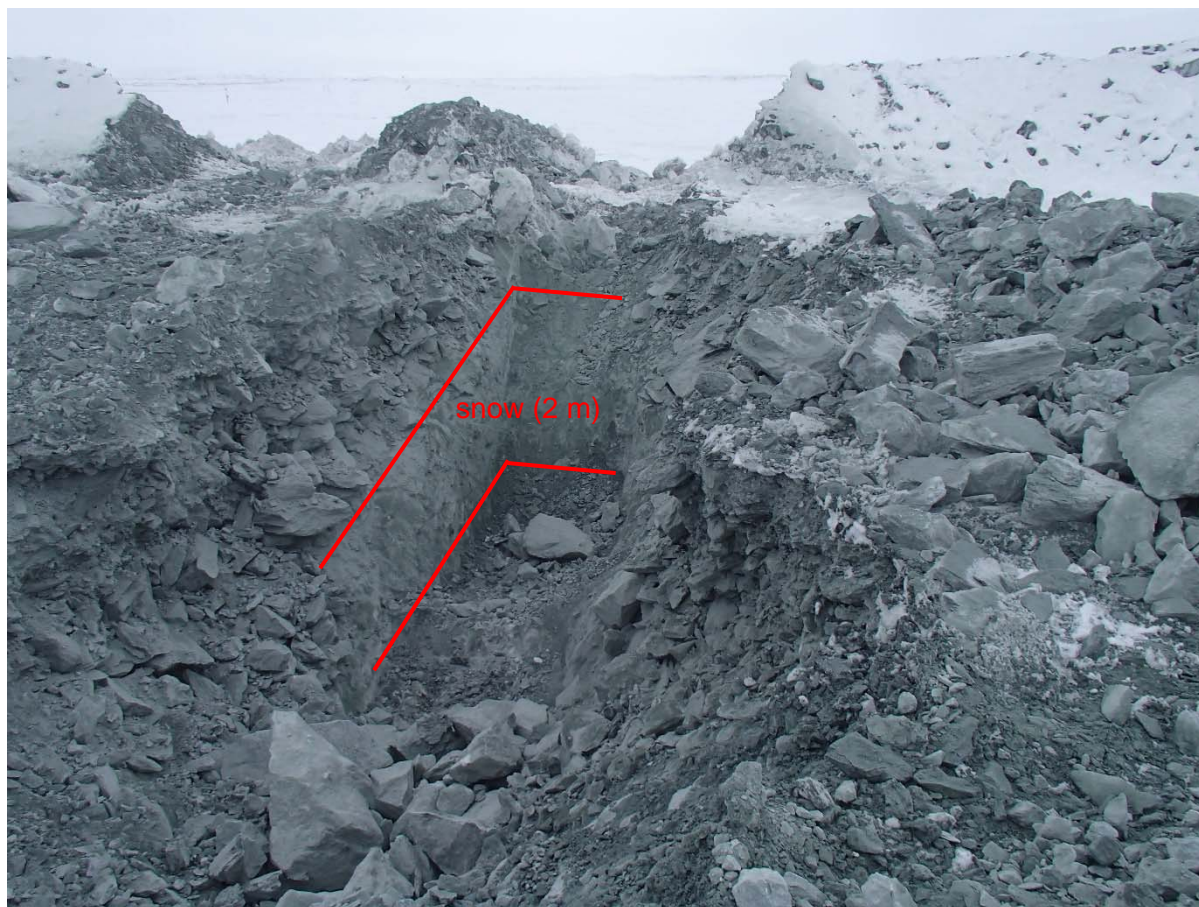
Photograph NCIS-001: View of a test pit in the UM rockfill lift at El. 152 m: a thick layer (2 m) of snow underlies the rockfill.

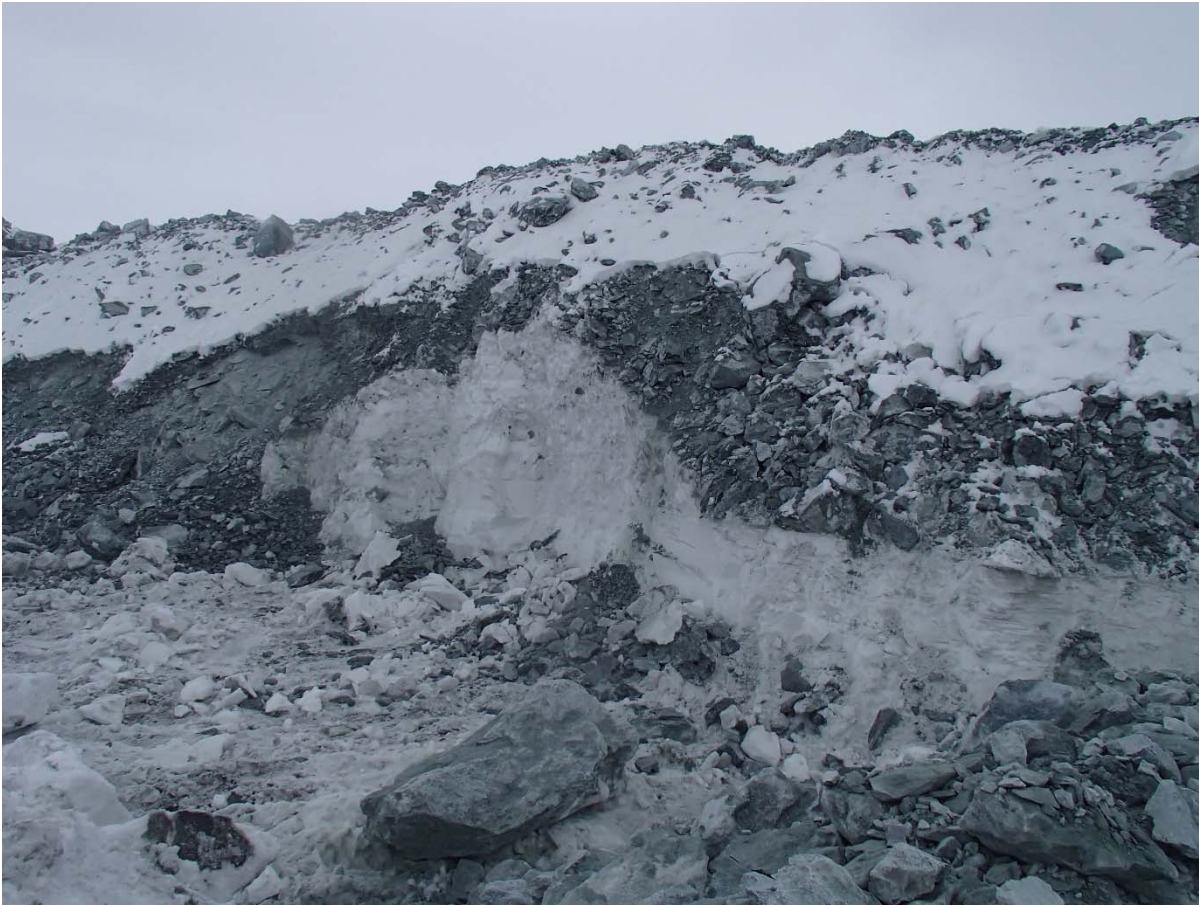
**Photograph NCIS-002: View of the scraped upstream side of the UM rockfill lift at El. 152 m: a thick layer of snow (1.5 m) underlies the rockfill.**

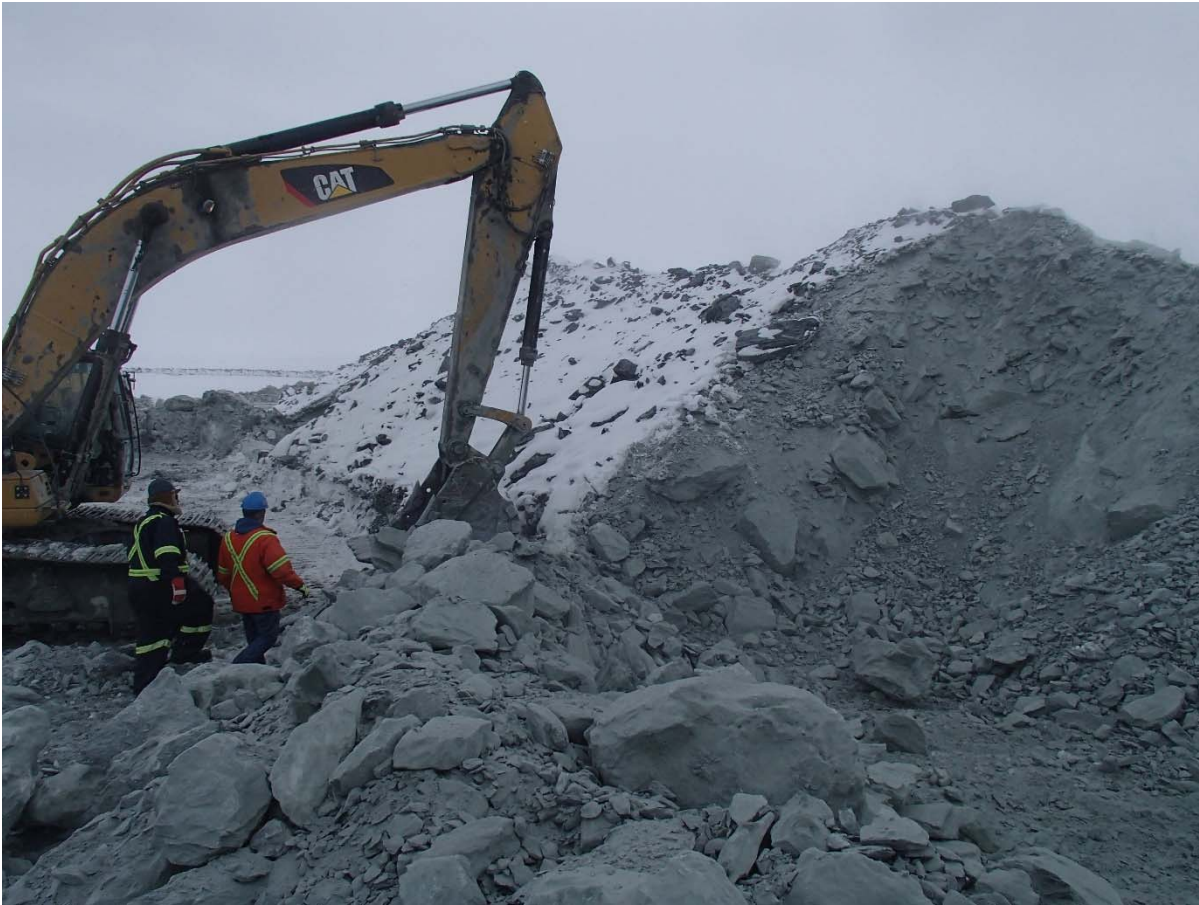
**Photograph NCIS-003: Excavation of the snow-rich upstream toe material on an average width of 2 to 3 m with an excavator.**

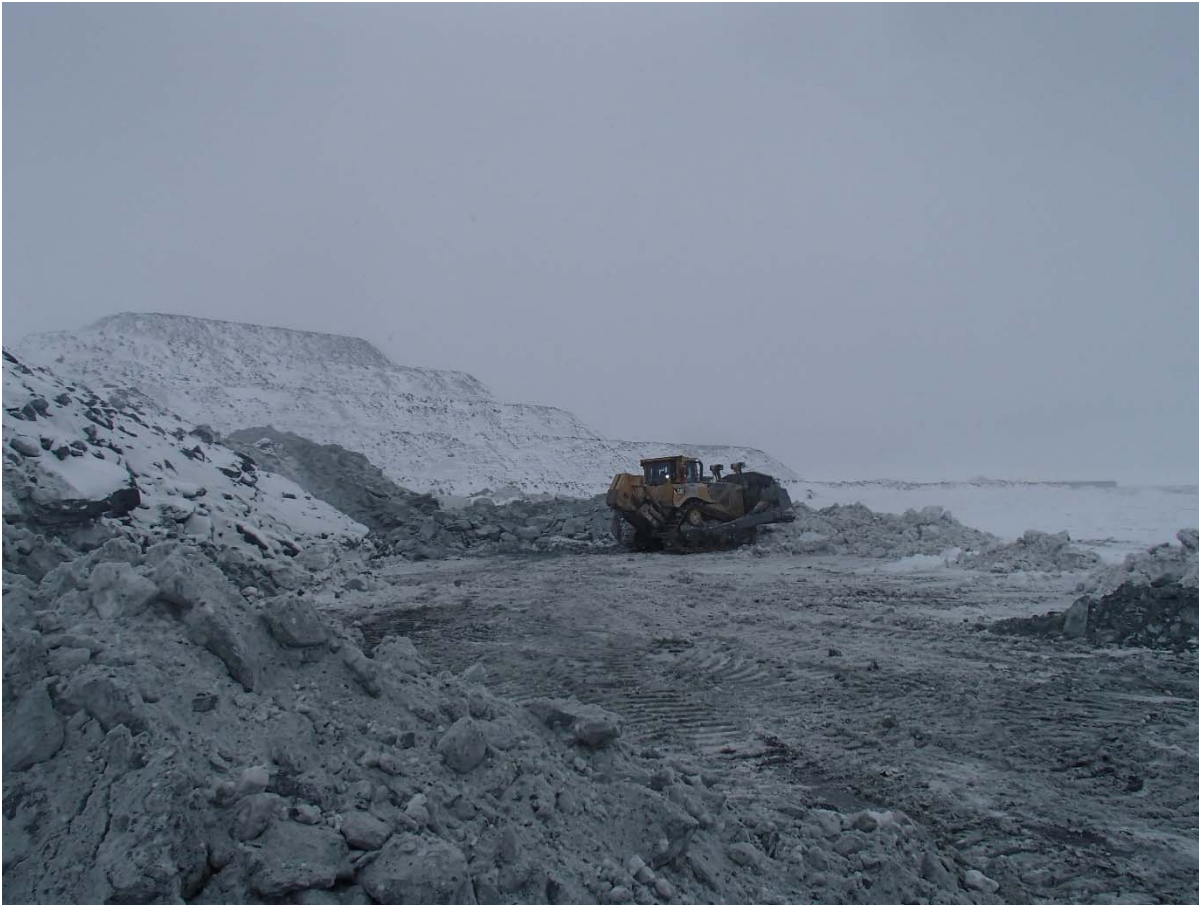
**Photograph NCIS-005: Removal of the excavated material, pushed with a dozer towards the center of the North Cell to clear the upstream toe.**

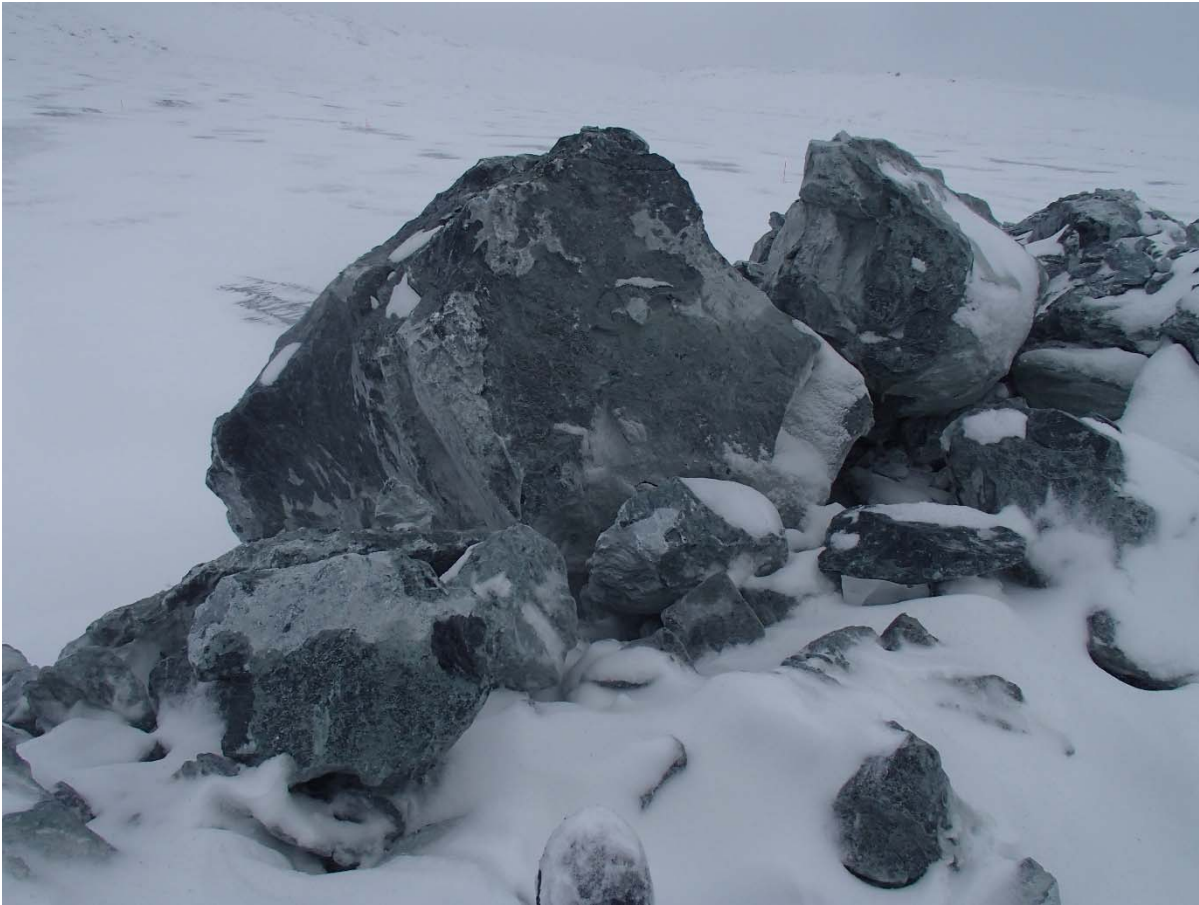
**Photograph NCIS-006: View of oversize boulders on the UM rockfill lift at El. 152 m.**

- The QC representative marked some oversize boulders on the upstream slope with paint. The boulders need to be removed during sloping operations.
- The UM rockfill lift at El. 152 m included a portion where the 2015 North Cell rockfill capping is built on the natural soil (thin layer of organic soil overlying till), between Sta. 1+800 m and 1+900 m approximately. The toe of the UM rockfill lift reaches beyond the toe of the capping, meaning the dike is partially founded on unprepared natural soil. The filter zone is also expected to extend on the natural soil. A test pit has been excavated to estimate the thickness of the soil layer; however, the frozen conditions prevented the excavator from reaching deeper than about 200 mm (see photograph below). The QA Manager asked that the surveyor estimate the width of the lift that lies beyond the capping. The upstream slope in this section was not profiled and further discussions will follow regarding actions to take.

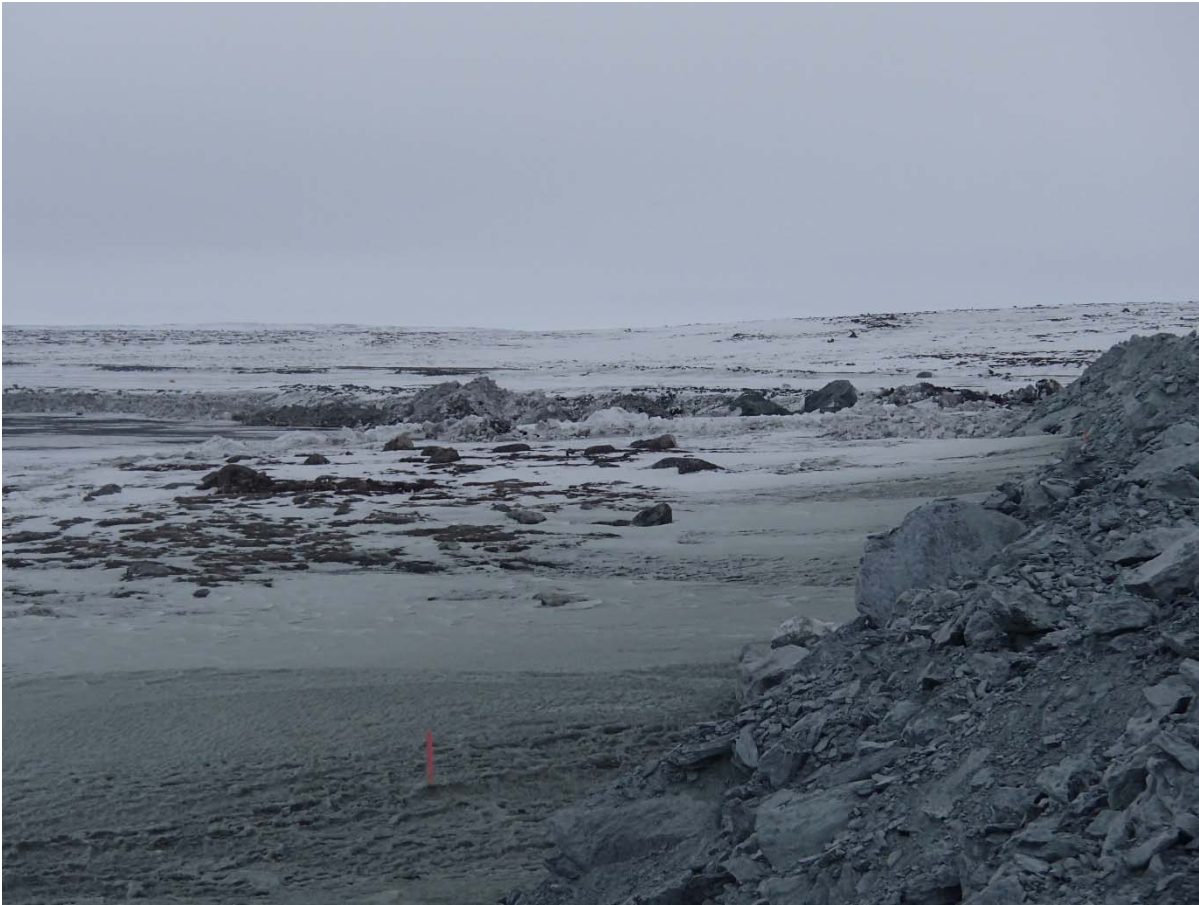
- The quality and gradation of the UM rockfill placed on the structure is now satisfactory.
- The alignment of the Internal Structure has been reviewed (see plan enclosed).
- Centerline to be obtained from SANA for QA follow-up of activities using the portable GPS.
- Decision to make with AEM about the foundation of the section of the structure between Sta. 1+800 m and 1+900 m, built on unprepared natural soil.

**Photograph NCIS-014: From Sta. 1+900 m (approx.), looking SE. View of the natural soil on which the 2015 capping is built.**

- Updated material quantities were issued with the new alignment of the North Cell Internal Structure.
- Regarding the rockfill lift founded on unprepared natural soil (Sta. 1+800 m to 1+900 m, approx.), AEM decided that the rockfill will be removed and the natural soils excavated within the footprint to reach a good quality bedrock. The frozen natural soil material will need to be exposed and excavated as it thaws.

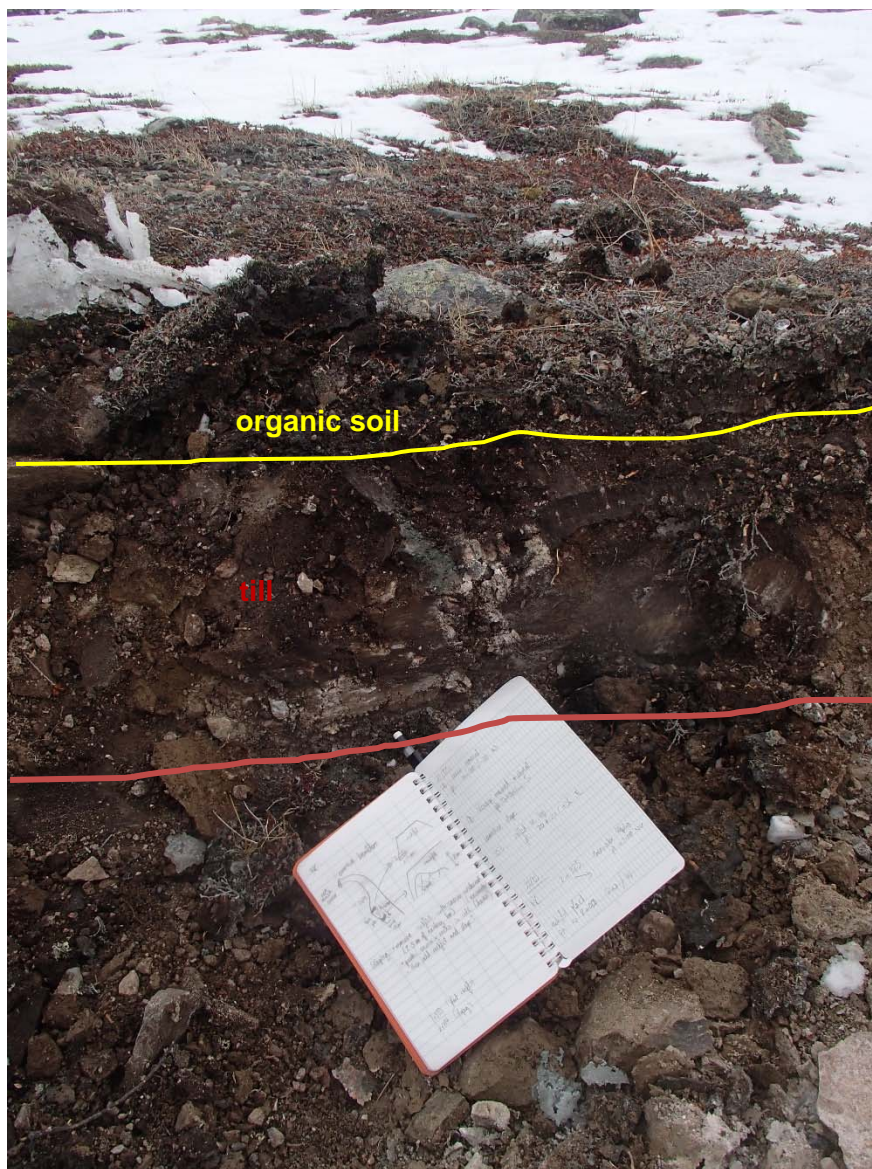
Photograph NCIS-015: From Sta. 1+850 m (approx.), looking S. View of the 200 mm deep test pit excavated into the natural soil. A thin layer or organic soil overlies frozen till.

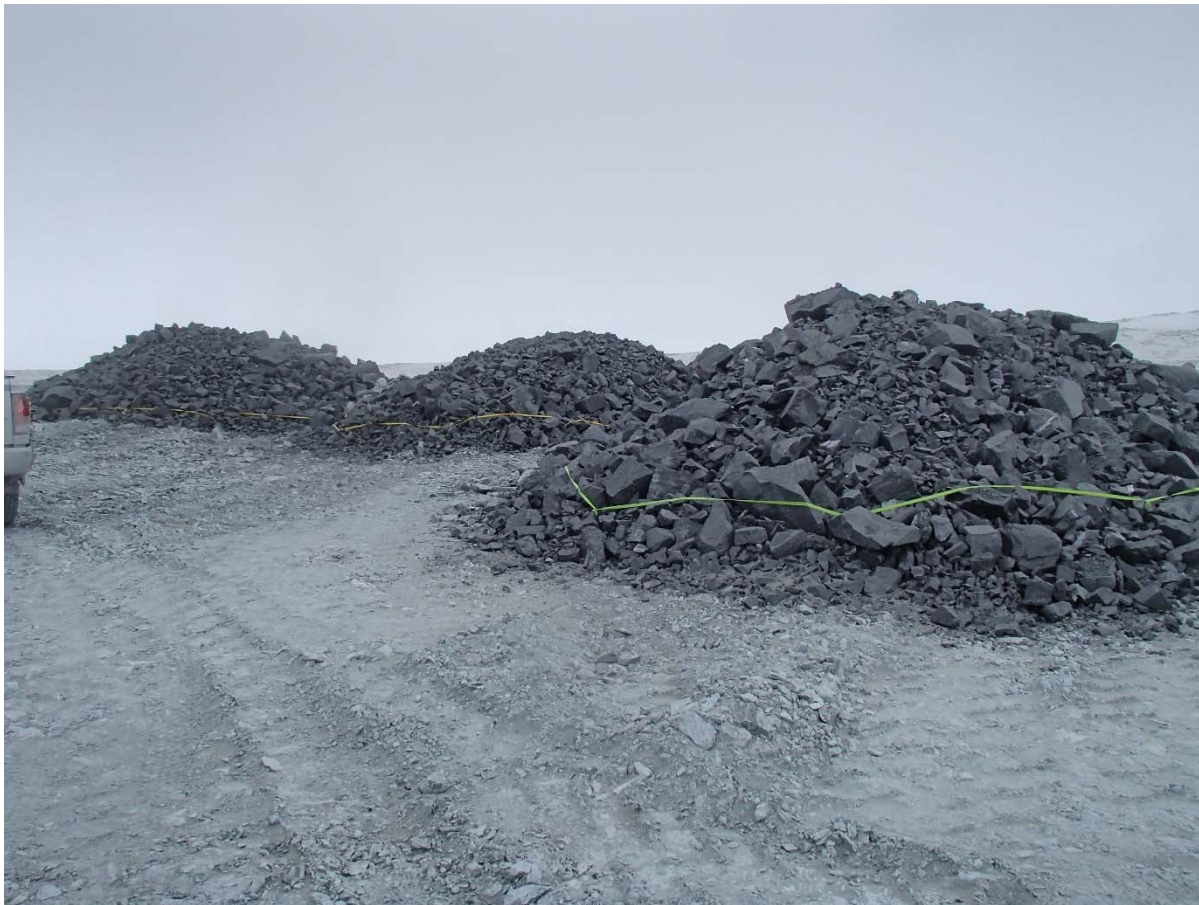
**Photograph NCIS-016: From Sta. 1+750 m (approx.), looking SE. View of the Iron Formation rockfill (PAG material) piles on the North Cell Internal Structure to be cleaned from the structure embankment.**

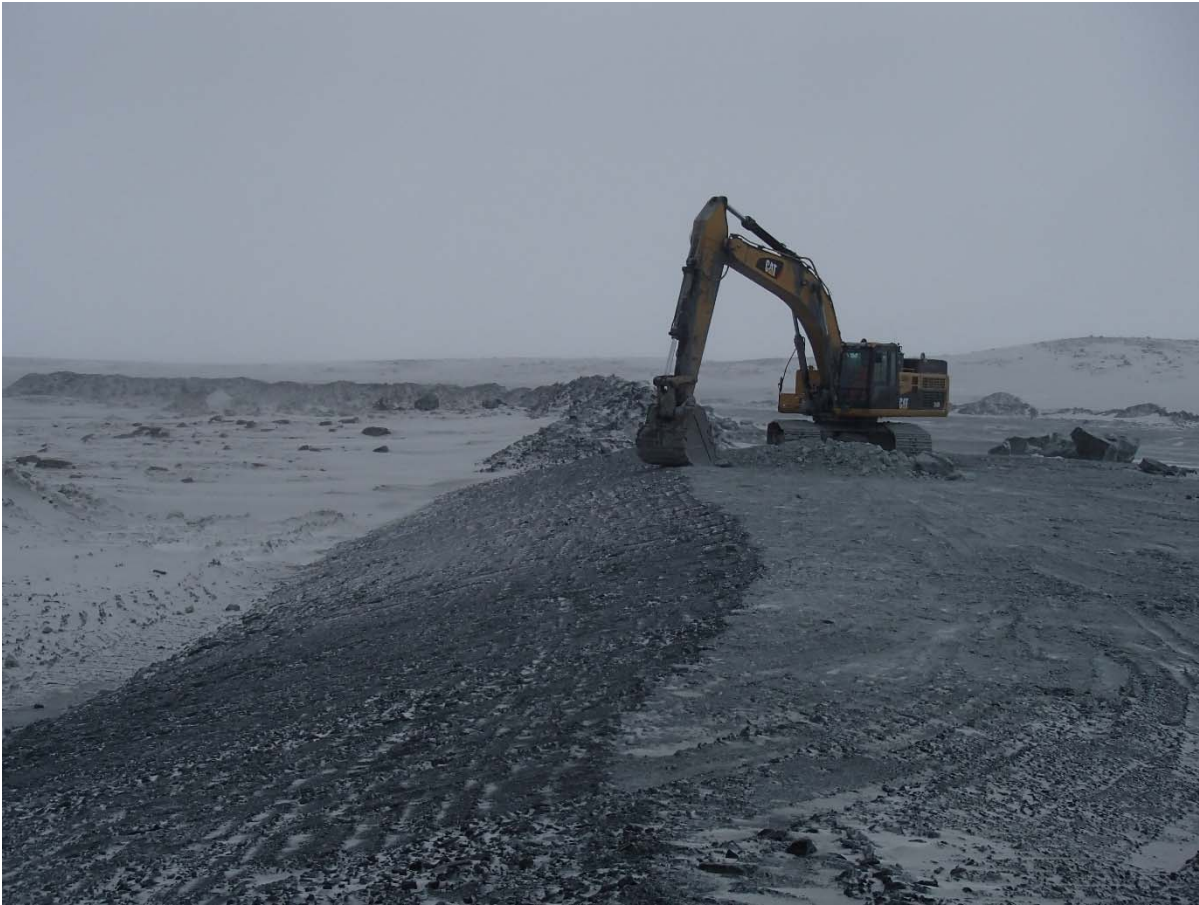
**Photograph NCIS-019: From Sta. 2+100 m (approx.), looking SW. Profiling of the upstream slope (3H:1V) from El. 150 to 152 m with an excavator from Sta. 1+860 m to 1+678 m. The portion between Sta. 1+900 m and 1+800 m, where the structure is built on the natural ground, was not profiled.**

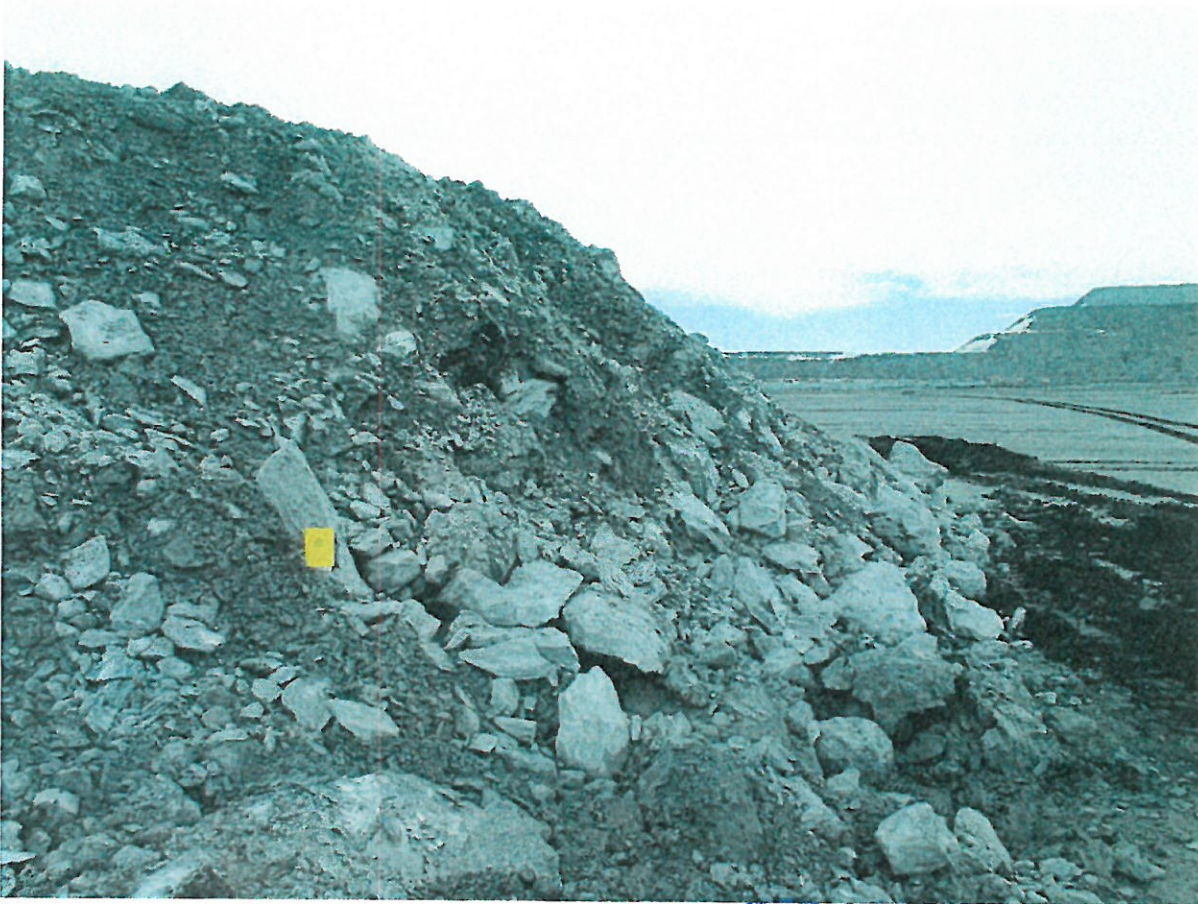
- The QA Manager observed that the UM rockfill lift was about 3.2 m thick around Sta. 1+340 m and asked for the elevation of the tailings ahead of the UM rockfill lift advancement front. AEM consulted the LIDAR survey and reported a 148.8 m elevation (approx.) that is declining towards the direction of the rockfill lift advancement and reaches 148 m around Sta. 1+200 m. Based on the 152 m elevation of the rockfill lift, the lift thickness is of 3.2 m around Sta. 1+340 m and would increase to 4 m around Sta. 1+200 m. Furthermore, as the tailings are thawing at the surface, the expected settling of soft tailings below the rockfill will increase the lift thickness. Considering that the lift maximum thickness was 2 m per design, it is not recommended to continue placement of UM rockfill in a single lift thicker than 2 m, as the compaction quality will be compromised. A maximum lift thickness of 2.8 m had previously been agreed by the Designer. AEM will have a meeting regarding this situation.

Photograph NCIS-028: From Sta. 1+340/+3 m, looking E. View of the LM rockfill lift approximately 3.2 m thick.

- Ensure that the layer of hard snow (up to 2 m thick) under the 2 m thick UM rockfill at El. 152 m (approx.) is not in the footprint of the dike, or that it is removed during the profiling of the slope. The foundation of the structure must be snow-free, compacted rockfill material constituting the capping of the North Cell.
- Thickness of the UM rockfill lift to be limited to 2.8 m.

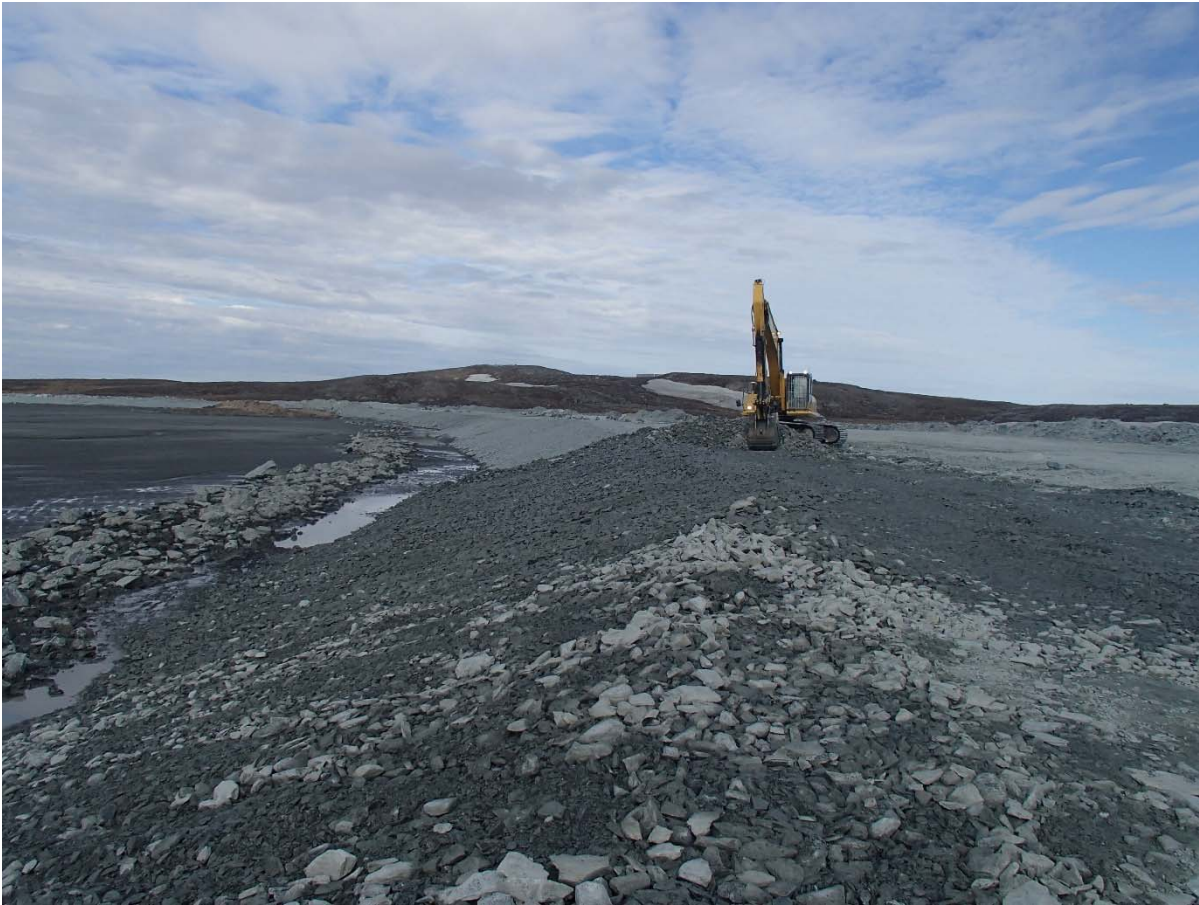
**Photograph NCIS-030: From Sta. 2+140/-29 m (approx.), looking W. Placement of a 0.5 m thick lift of coarse filter in the upstream slope from El. 150 m to 152 m with an excavator from Sta. 2+105 m to 1+930 m. Notice the presence of water ponding at the bottom of the slope.**

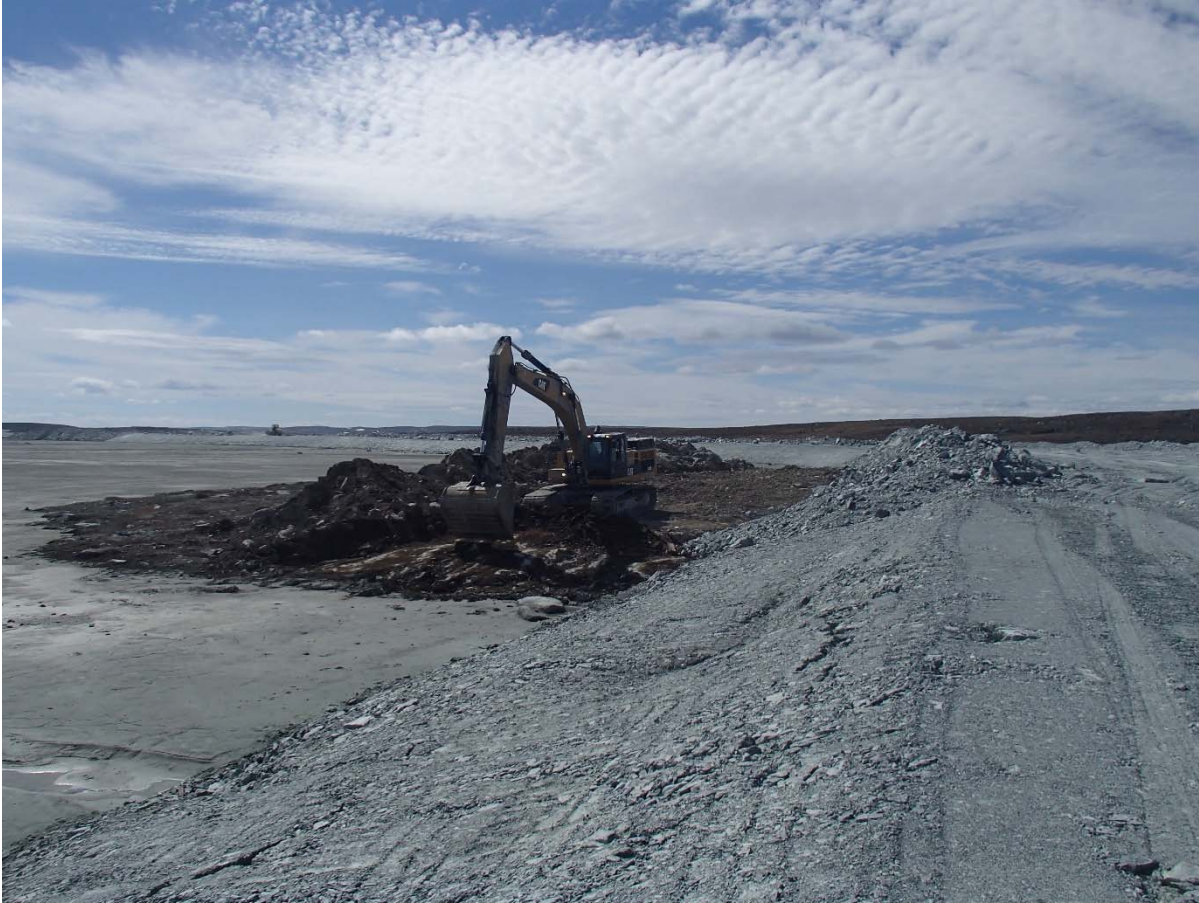
- The foundation has been exposed in the section where the structure is built on natural ground (approx. Sta. 1+800 to 1+900 m). The natural soil was constituted of a shallow layer of till and organic soil overlying bedrock. Till removal down to the bedrock with an excavator was done to ensure a sound foundation for the filters and reduce the risk of settlement. The foundation was approved by the QA Manager. No foundation approval forms are required for the North Cell Internal Structure.

**Photograph NCIS-031: From Sta. 1+880/-21 m (approx.), looking SW. Final clean-up of the dike footprint with an excavator to reach a good quality bedrock from Sta. 1+800 to 1+850 m (offset -42 to -33 m).**

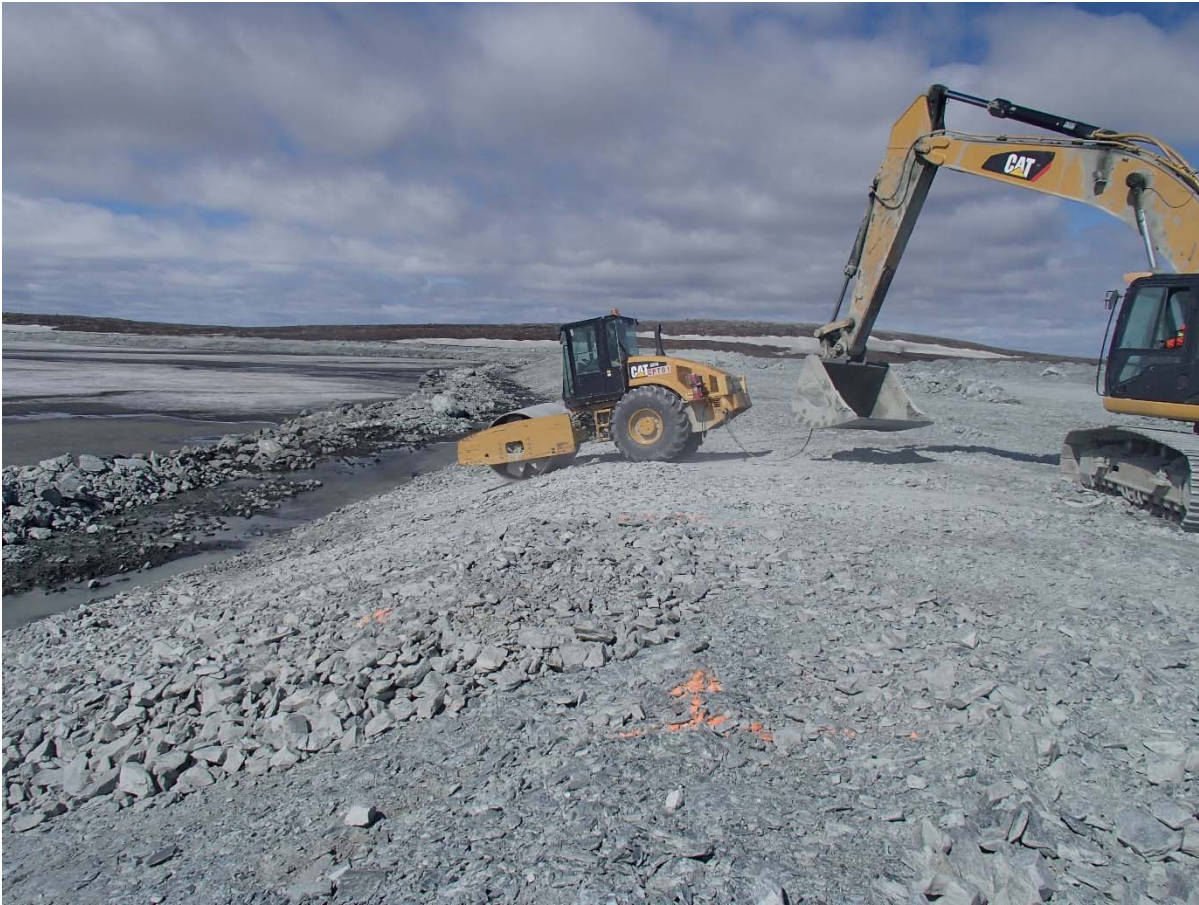
**Photograph NCIS-035: From Sta. 2+550/-25 m (approx.), looking N. Compaction of the 0.5 m lift (approx.) of coarse filter between El. 150 and 152 m with a 10-tonne smooth-drum compactor (4 passes) in the upstream slope from Sta. 2+524 m to 2+450 m.**

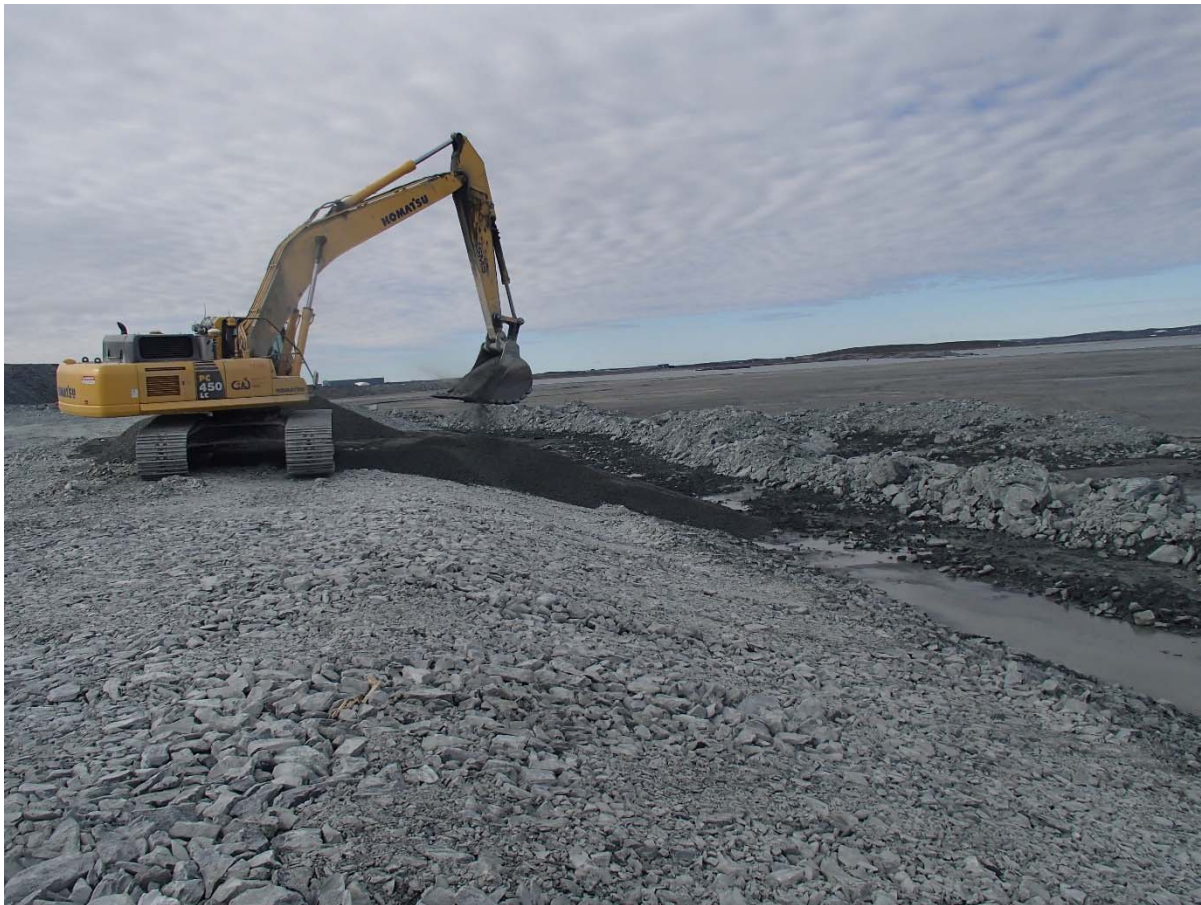
**Photograph NCIS-036: From Sta. 1+900/-21 m (approx.), looking SE. Placement of a 0.5 m thick lift of fine filter over the coarse filter in the upstream slope from El. 150 m to 152 m with an excavator from Sta. 2+542 m to 2+475 m.**

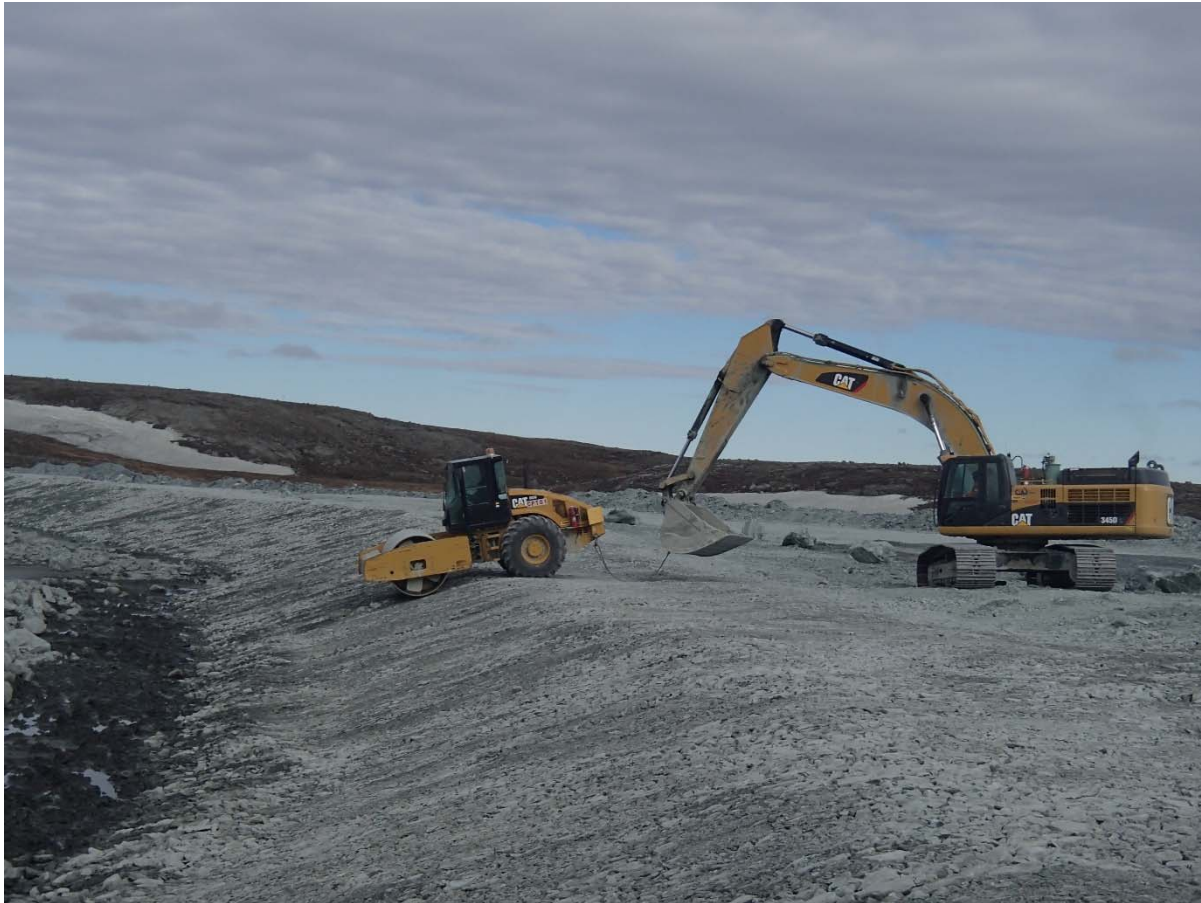
**Photograph NCIS-037: From Sta. 1+550/-25 m (approx.), looking NW. Compaction of the 0.5 m lift (approx.) of coarse filter between El. 150 and 152 m with a 10-tonne smooth-drum compactor (4 passes) in the upstream slope from Sta. 2+450 to 1+805 m.**

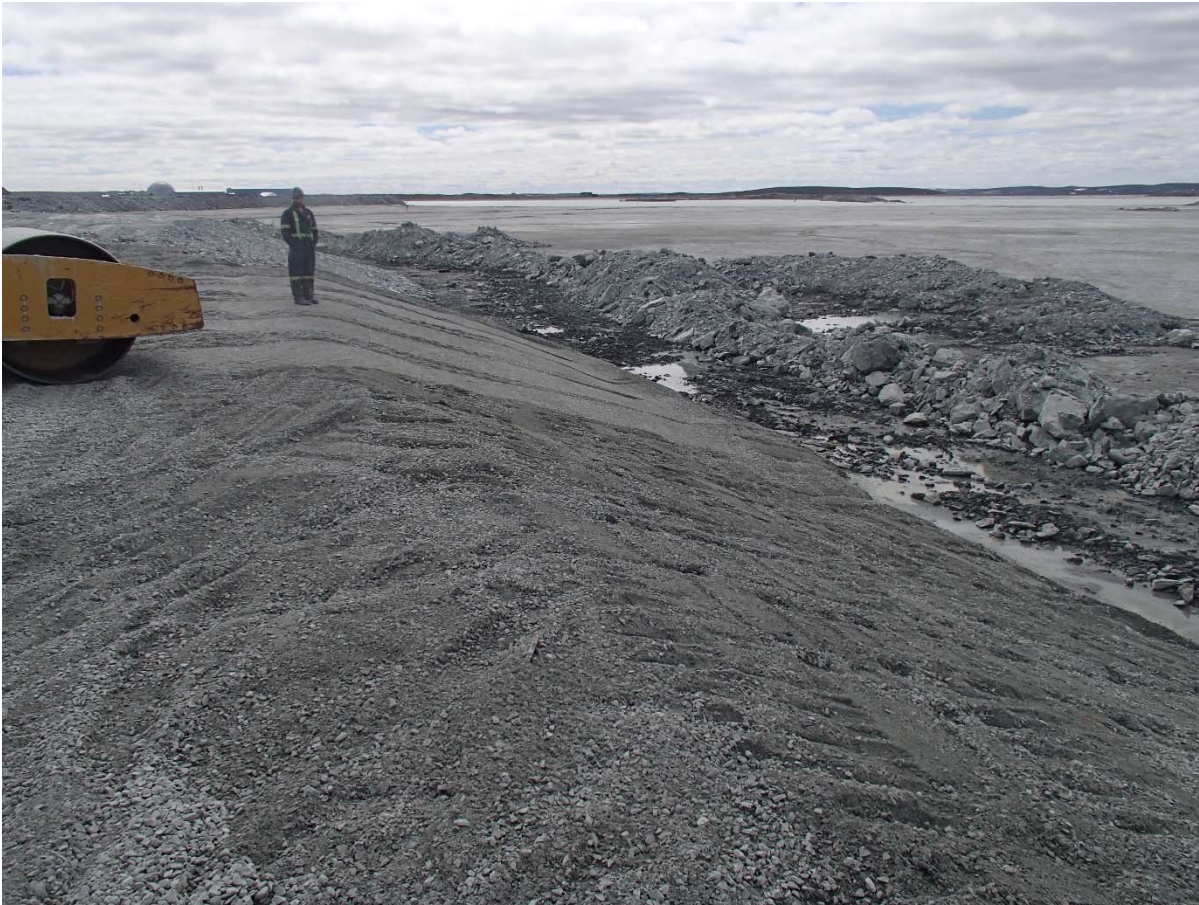
**Photograph NCIS-038: From Sta. 2+510/-28 m (approx.), looking SE. Compaction of the 0.5 m lift (approx.) of fine filter between El. 150 and 152 m with a 10-tonne smooth-drum compactor (4 passes) in the upstream slope from Sta. 2+542 m to 2+475 m.**

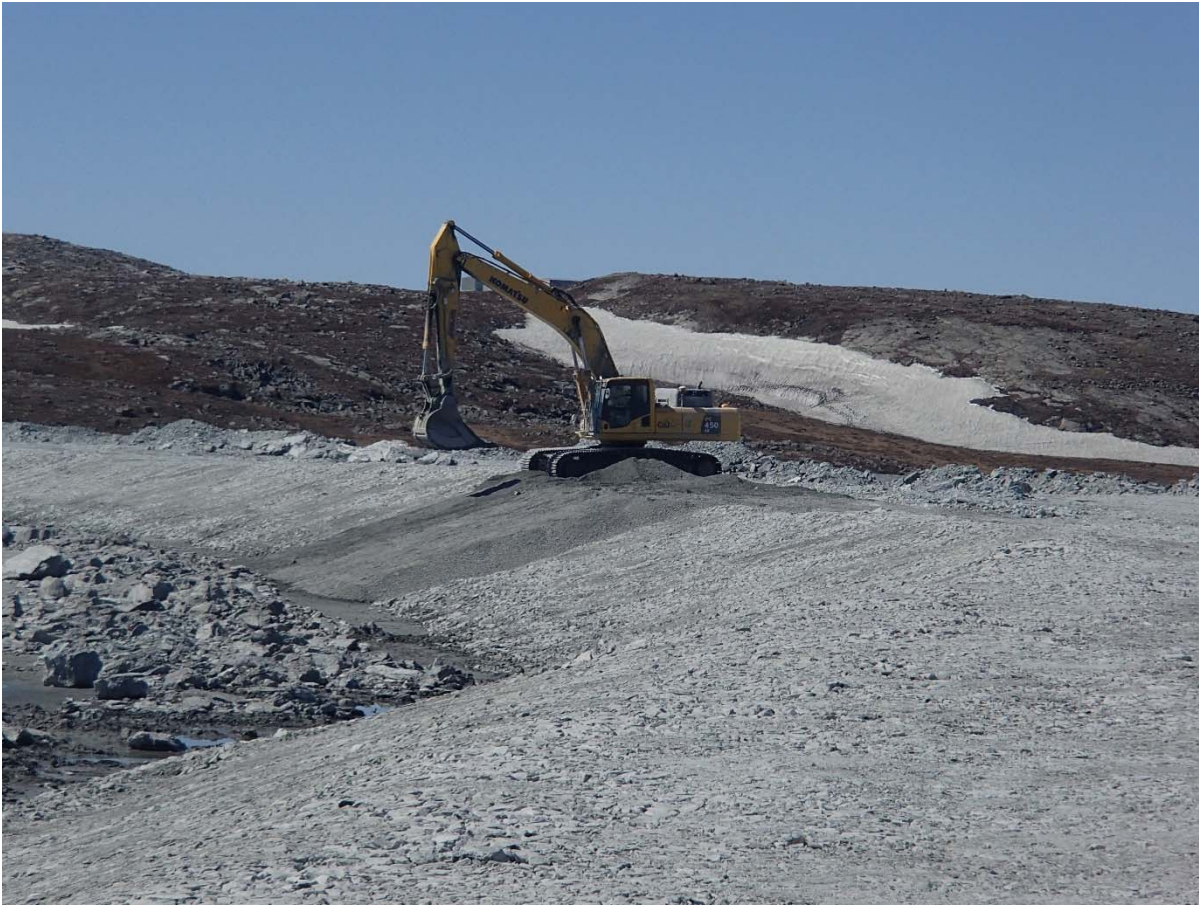
**Photograph NCIS-039: From Sta. 2+200/24 m (approx.), looking W. Placement of a 0.5 m thick lift of fine filter over the coarse filter in the upstream slope from El. 150 m to 152 m with an excavator from Sta. 2+460 m to 2+475 m and from Sta. 2+065 m to 1+980 m.**

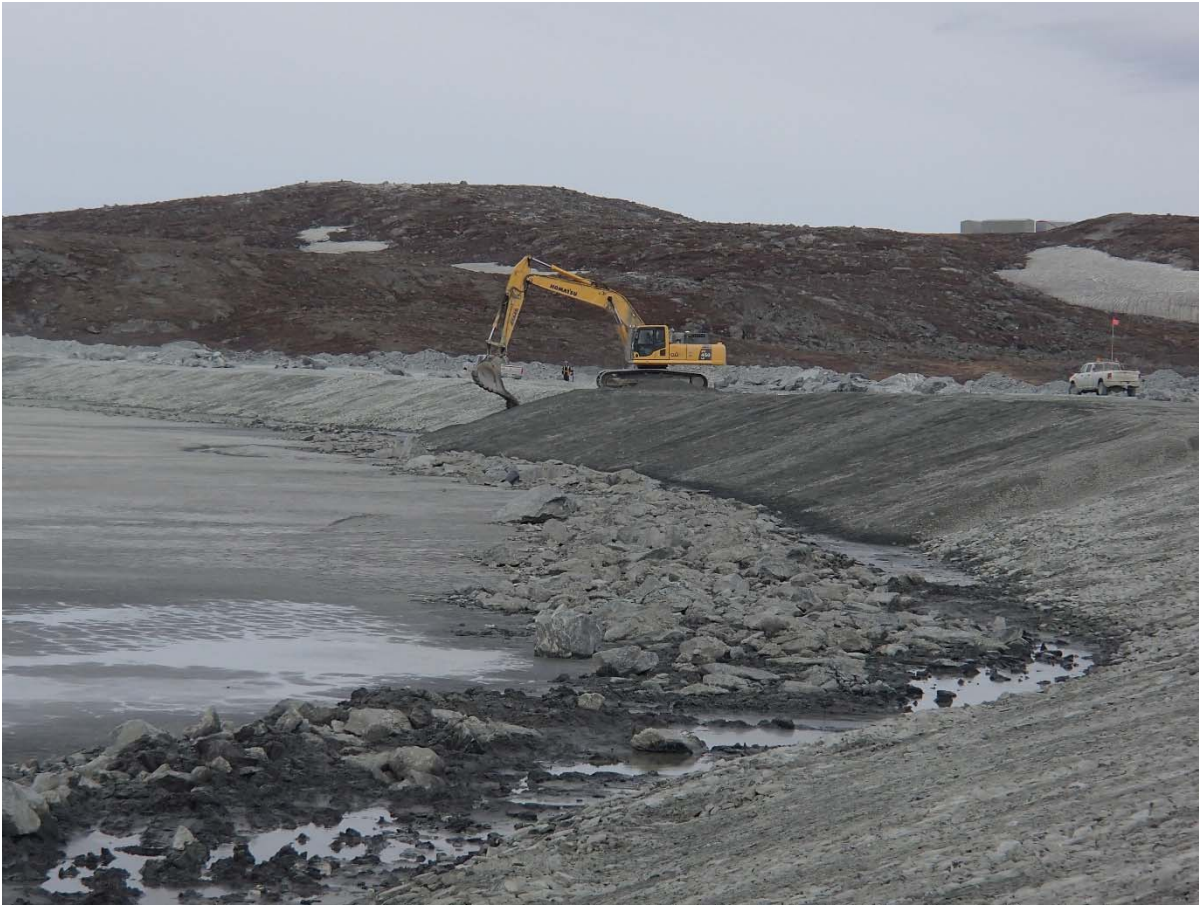
**Photograph NCIS-040: From Sta. 2+185/-25 m (approx.), looking W. Placement of a 0.5 m thick lift of fine filter over the coarse filter in the upstream slope from El. 150 m to 152 m with an excavator from Sta. 2+305 m to 2+460 m and from Sta. 1+980 m to 1+835 m.**
