### **Meadowbank 2018 TSF As-built report**

**2018 CONSTRUCTION SEASON AS-BUILT REPORT  
TAILINGS STORAGE FACILITY  
MEADOWBANK GOLD PROJECT, NUNAVUT**

1897439-1578-R-Rev0

November 2018

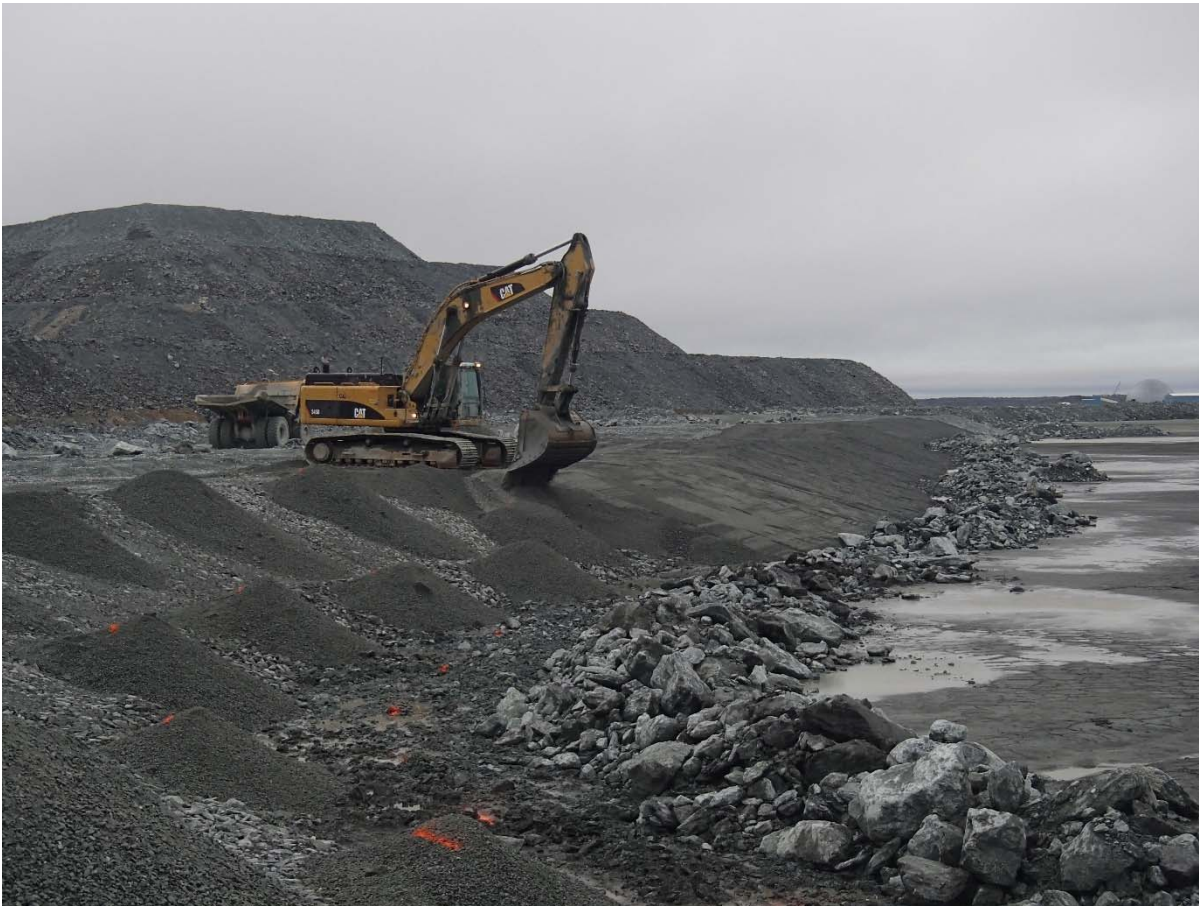
**Photograph NCIS-042: From Sta. 2+210/-27 m (approx.), looking SE. Placement of a 0.5 m thick lift of fine filter over the coarse filter in the upstream slope from El. 150 m to 152 m with an excavator from Sta. 2+305 m to 2+040 m.**

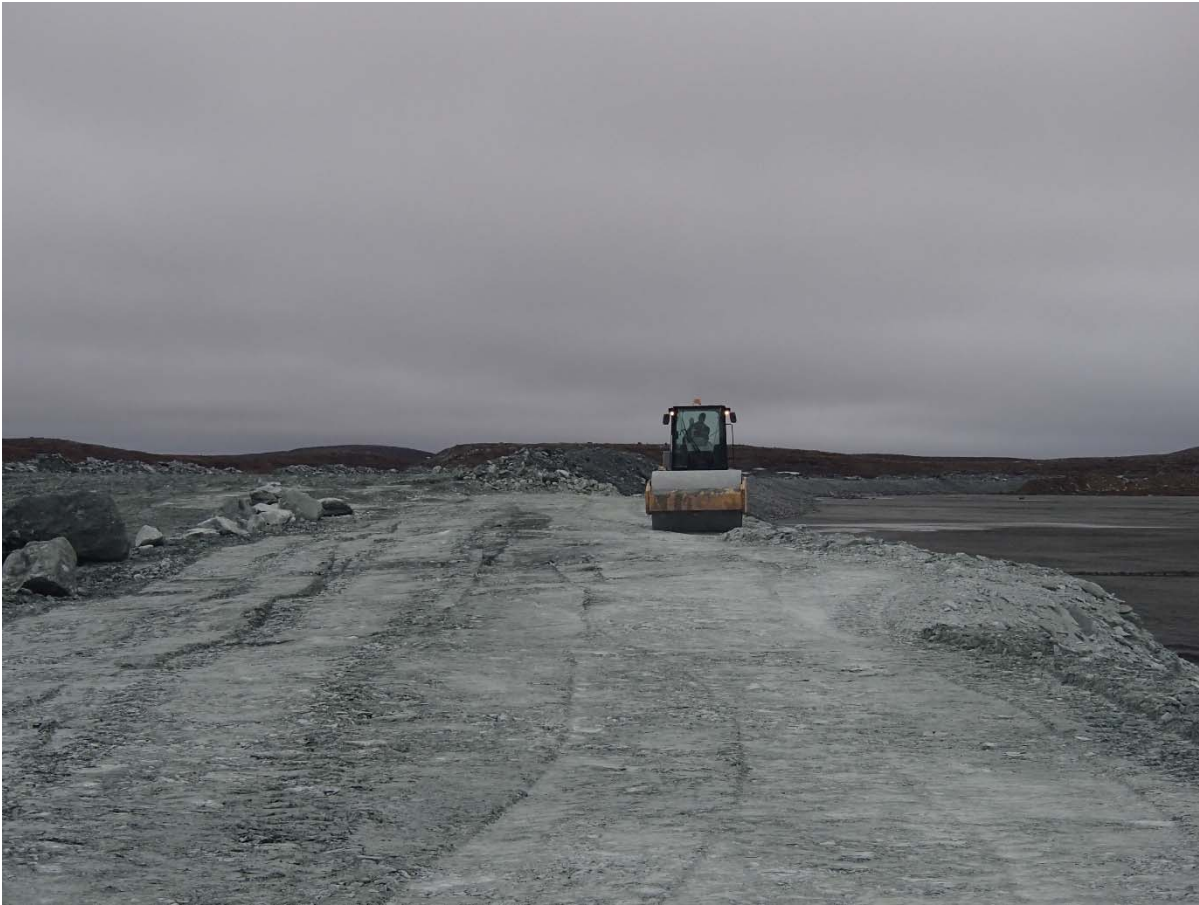
**Photograph NCIS-043: From Sta. 1+250/-38 m (approx.), looking N. Compaction of the 1.5 to 2 m lift (approx.) of ultramafic (UM) rockfill at El. 150 m with a 10-tonne smooth-drum compactor with vibration (6 passes) between the haul truck traffic lane and the upstream slope from Sta. 1+330 to 1+200 m (offset -53 to -24 m).**

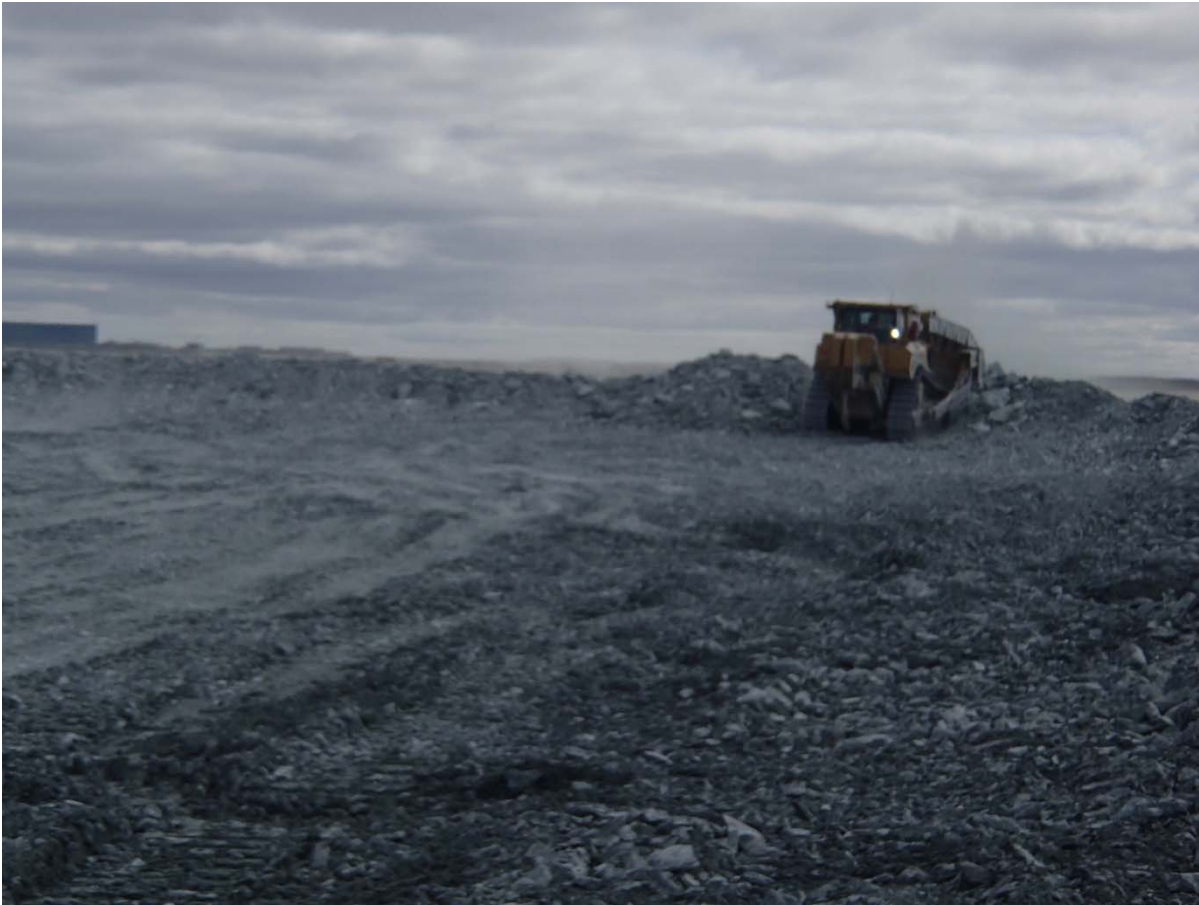
**Photograph NCIS-044: From Sta. 1+200/-19 m (approx.), looking S. Placement of a 1.5 to 2 m thick (approx.) lift of UM rockfill from El. 148 m to El. 150 m (approx.) with a dozer from Sta. 1+150 m to 1+120 m (-92 m to +10 m). The material is of good quality and is well graded.**

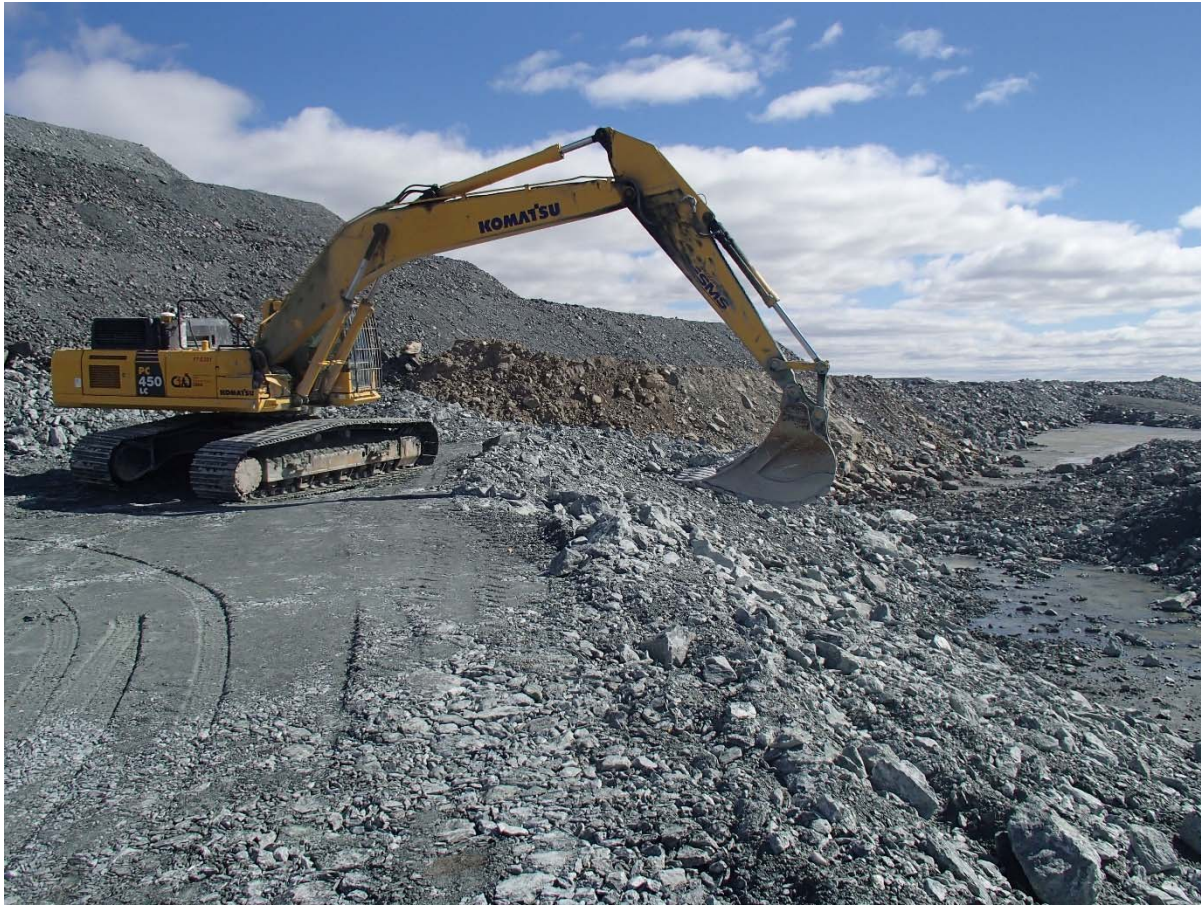
**Photograph NCIS-045: From Sta. 2+760/-40 m (approx.), looking S. Profiling of the upstream slope (3H:1V) from El. 150 to 152 m with an excavator from Sta. 2+715 m to 2+825 m.**

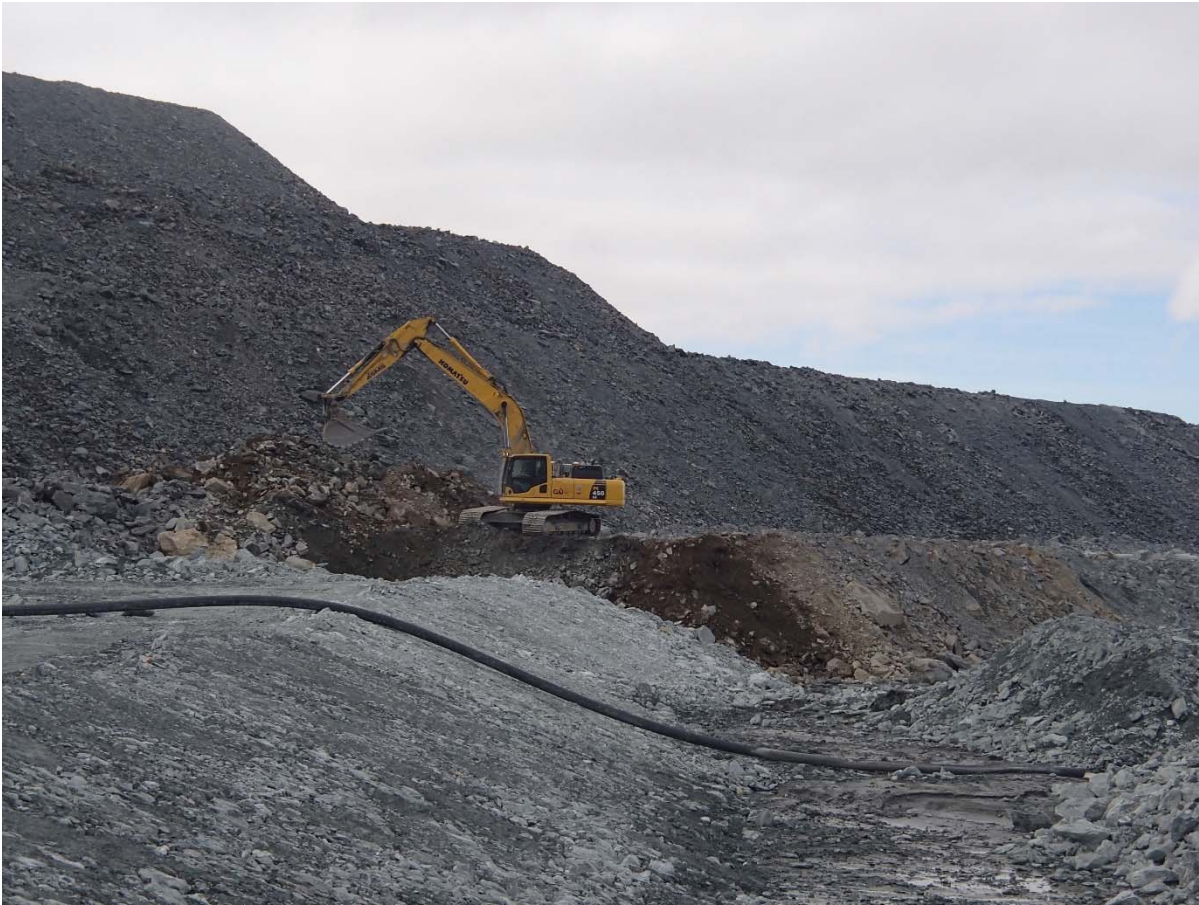
**Photograph NCIS-046: From Sta. 2+680/-18 m (approx.), looking SE. Removal of till material mixed with the UM rockfill of the capping (about 1 to 2 m thick along the slope) with an excavator from Sta. 2+760 m to 2+850 m (offset -35 to -17 m).**

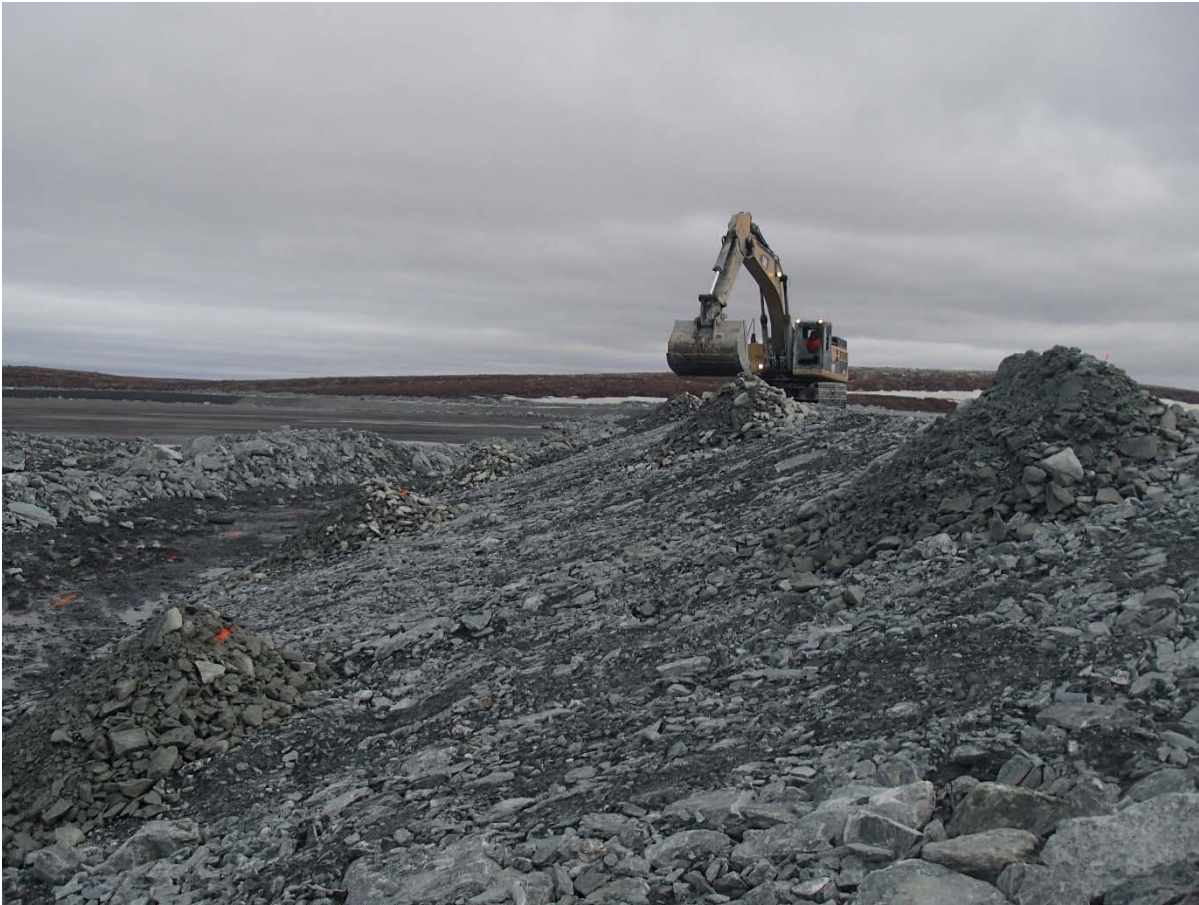
**Photograph NCIS-047: From Sta. 2+580/-35 m (approx.), looking N. Placement of a 0.5 m thick lift of coarse filter in the upstream slope from El. 150 m to 152 m with an excavator from Sta. 2+560 m to 2+640 m.**

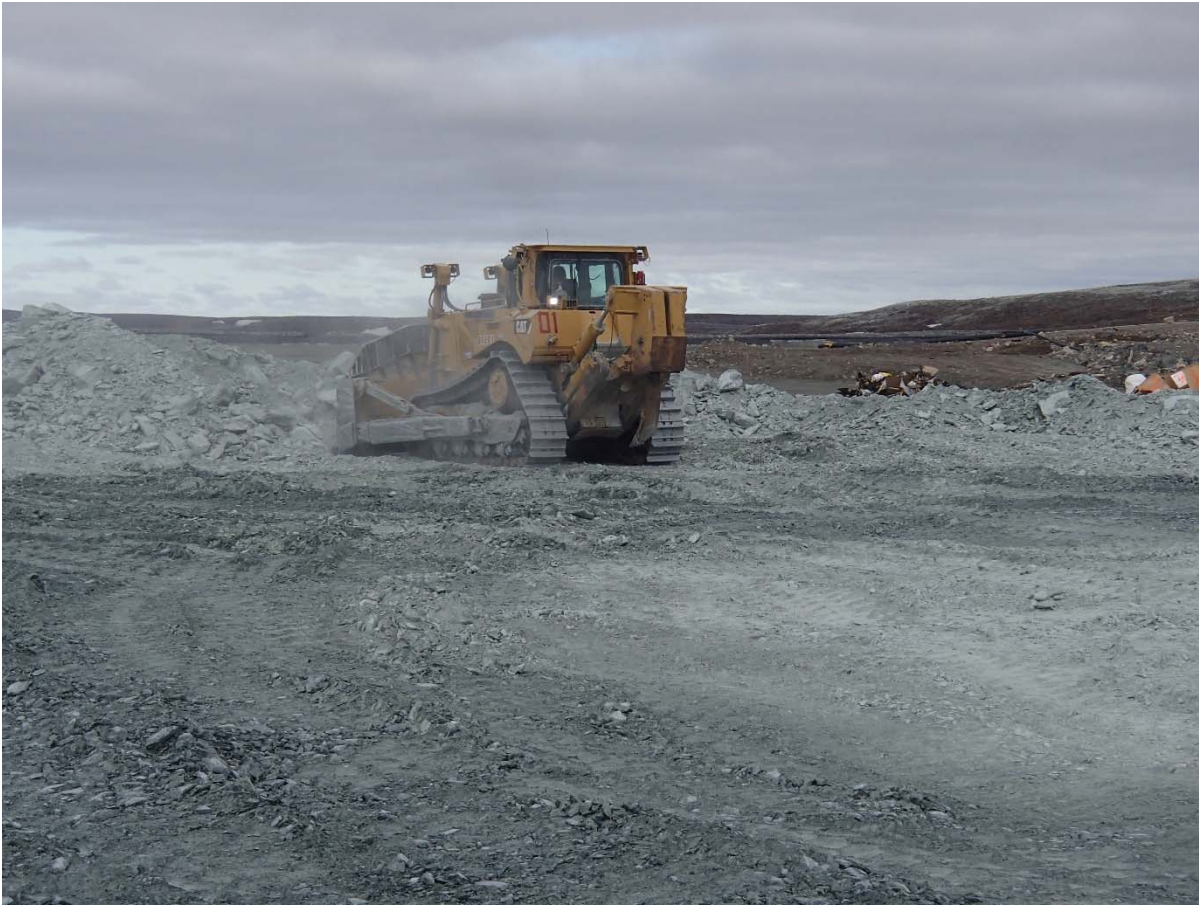
**Photograph NCIS-048: From Sta. 1+120/-92 m (approx.), looking SW. Placement of a 1.5 to 2 m thick (approx.) lift of UM rockfill from El. 148 m to El. 150 m (approx.) with a dozer from Sta. 1+125 m to 1+115 m (-92 m to -47 m). The material is of good quality and is well graded.**

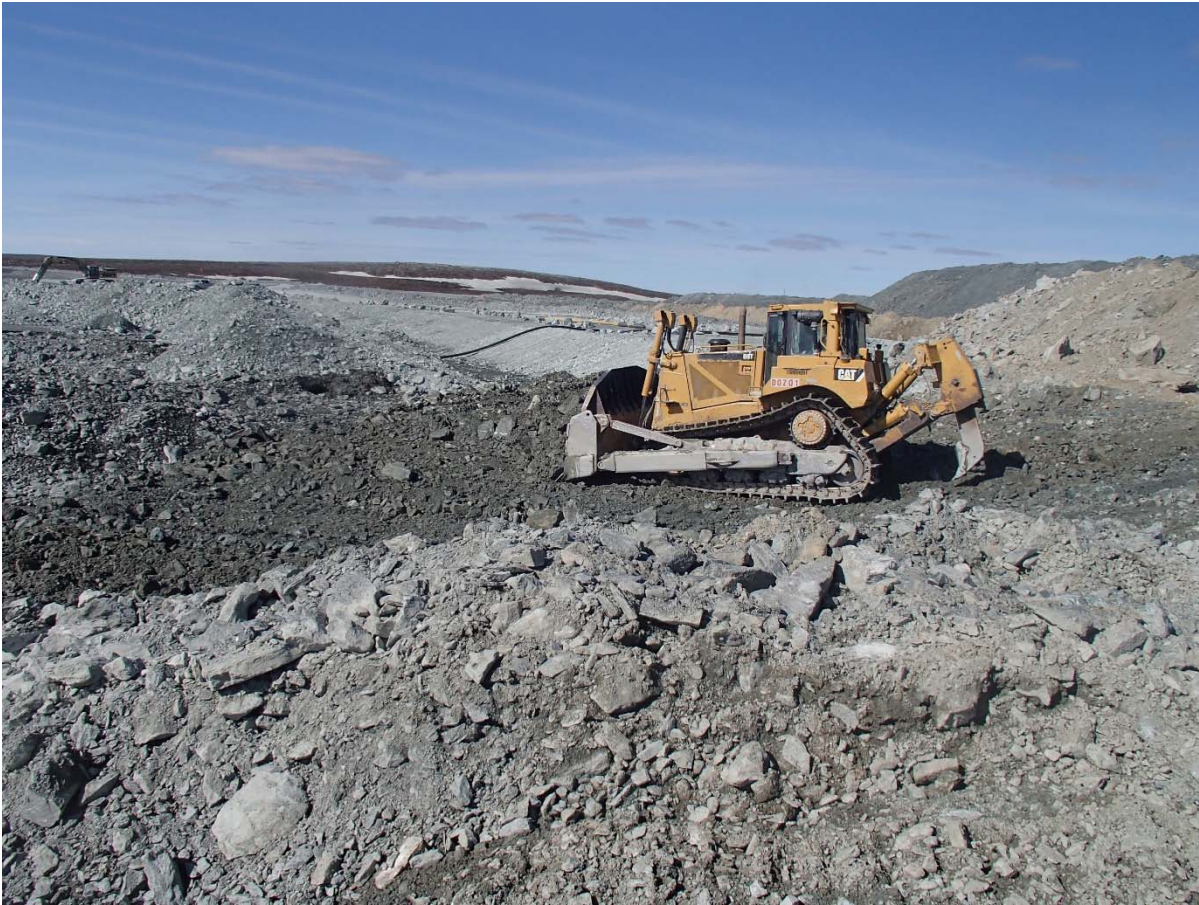
**Photograph NCIS-049: From Sta. 2+870/-28 m (approx.), looking N. Removing of UM rockfill material from the capping with a dozer to level the surface to El. 150 m from Sta. 2+760 m to 2+850 m (offset -29 to -17 m).**

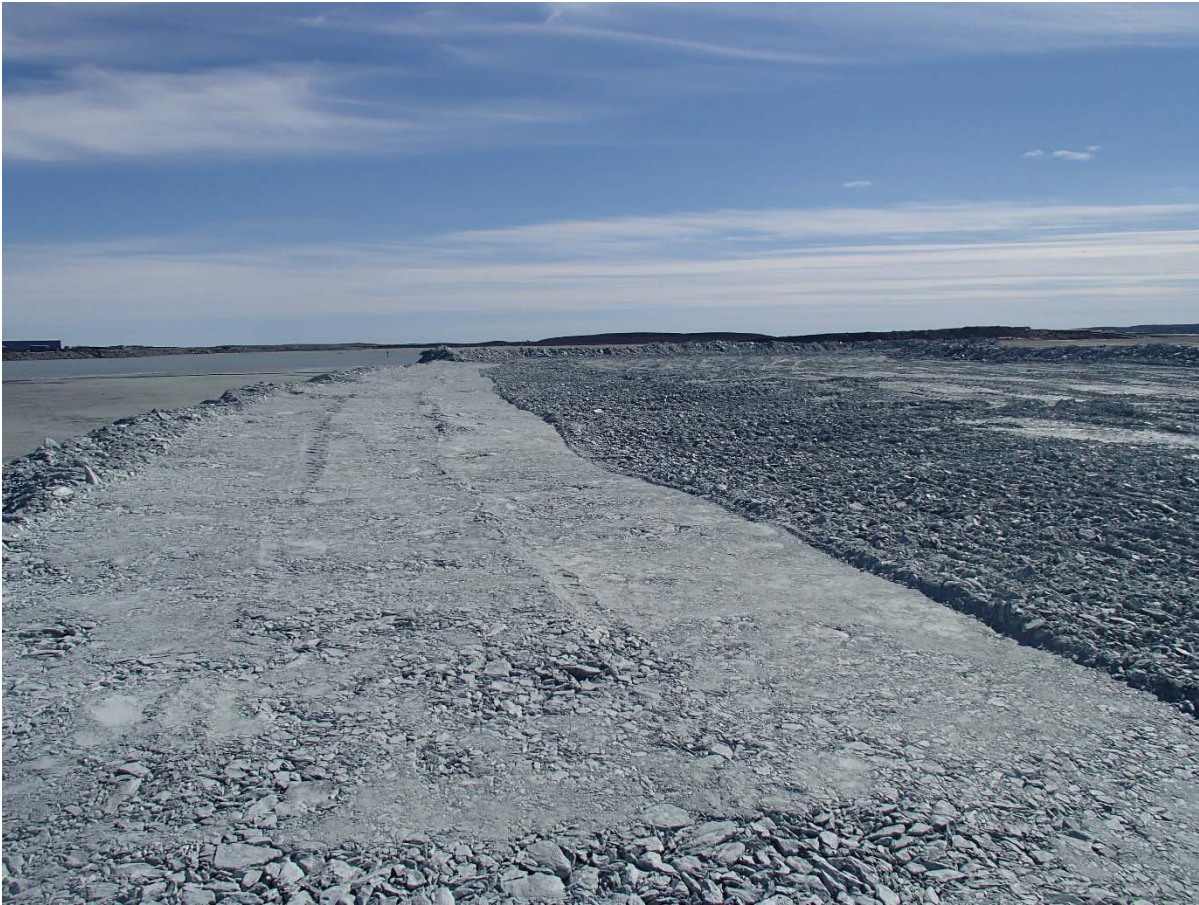
**Photograph NCIS-050: From Sta. 1+230/-55 m (approx.), looking S. Compaction of the 1.5 to 2 m lift (approx.) of ultramafic (UM) rockfill at El. 150 m with a 10-tonne smooth-drum compactor with vibration (6 passes) between the haul truck traffic lane and the upstream slope from Sta. 1+220 to 1+130 m (offset -91 to -44 m).**

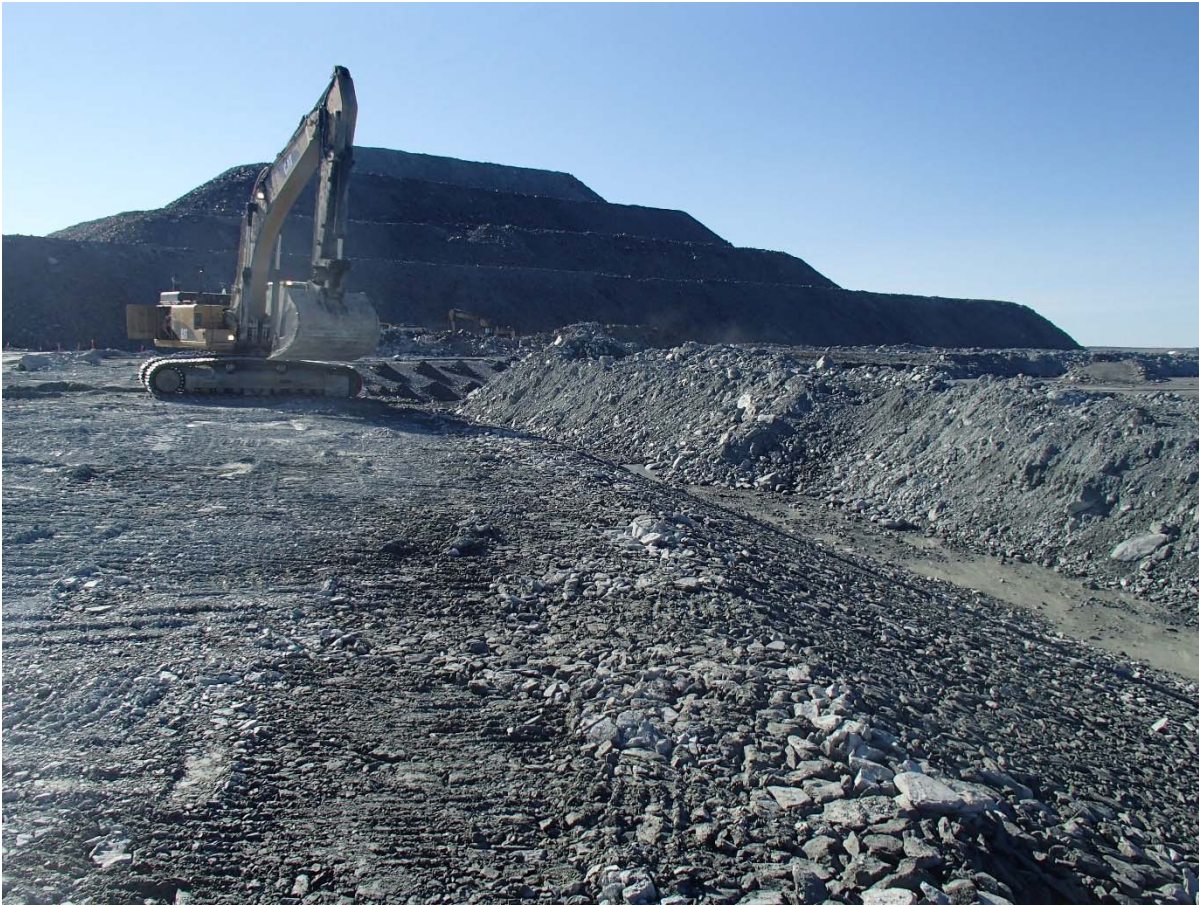
**Photograph NCIS-051: From Sta. 2+630/-34 m (approx.), looking SE. Placement of a 0.5 m thick lift of coarse filter in the upstream slope from El. 150 m to 152 m with an excavator from Sta. 2+640 m to 2+815 m.**

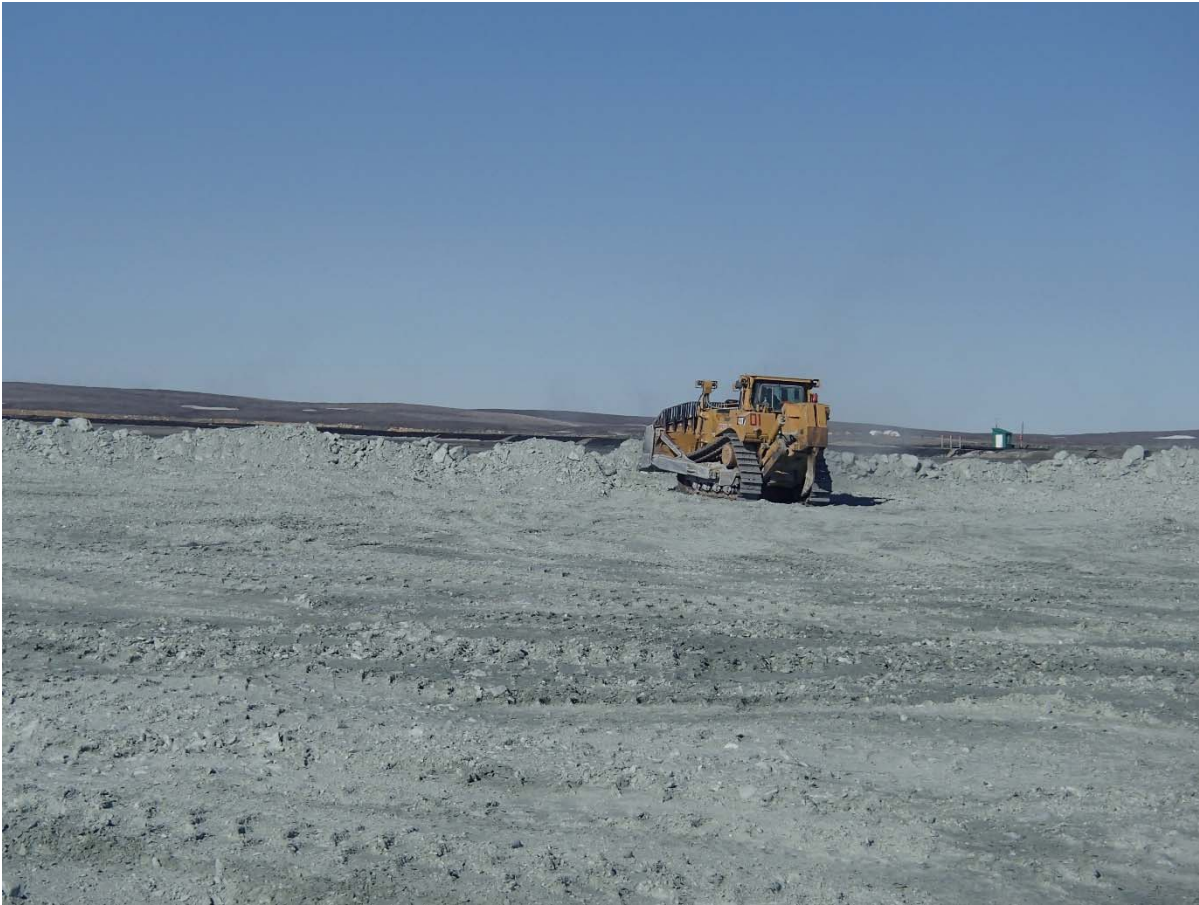
**Photograph NCIS-052: From Sta. 1+120/-87 m (approx.), looking SW. Placement of a 1.5 to 2 m thick (approx.) lift of UM rockfill from El. 148 m to El. 150 m (approx.) with a dozer from Sta. 1+115 m to 1+100 m (-107 m to -45 m). The material is of good quality and is well graded.**

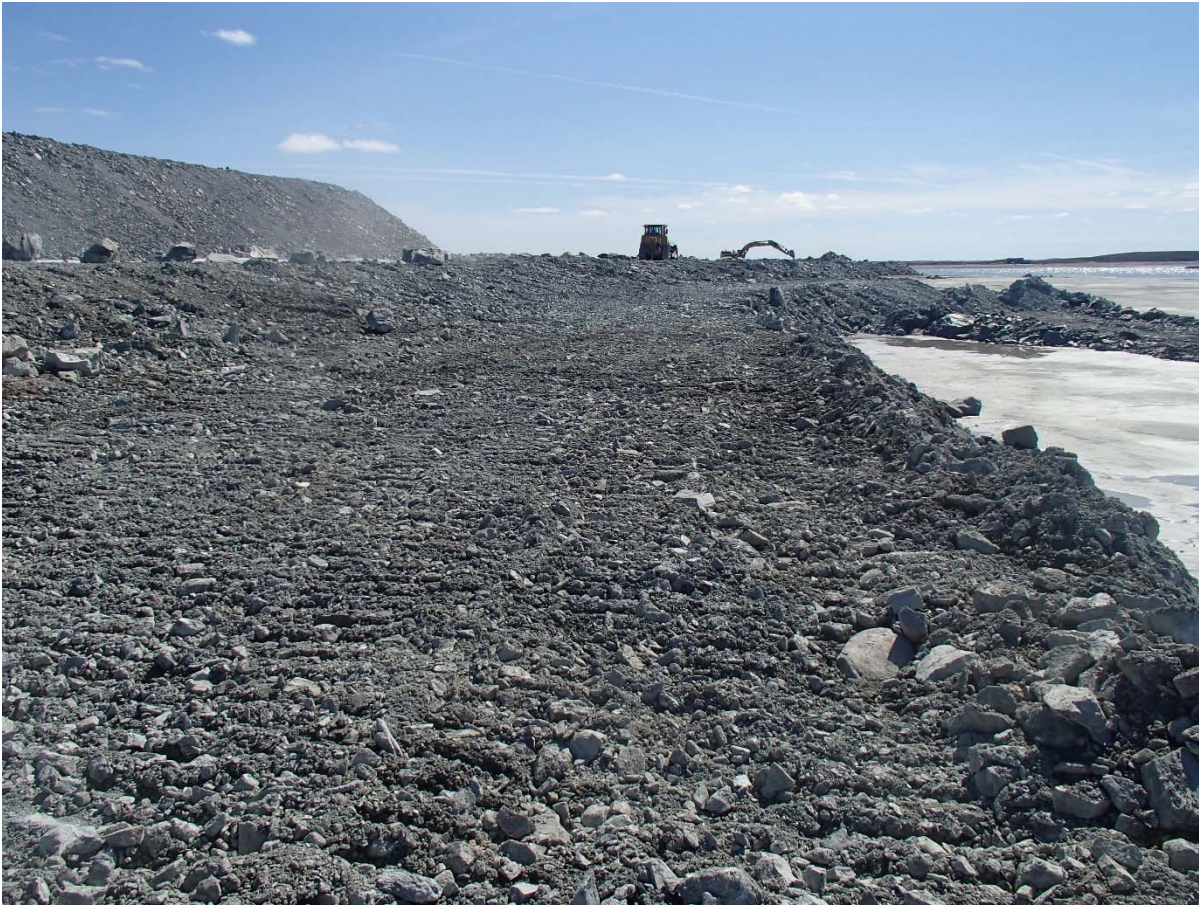
**Photograph NCIS-053: From Sta. 2+840/-37 m (approx.), looking S. Removing of UM rockfill material from the capping with a dozer to level the surface to El. 152 m from Sta. 2+850 m to 2+980 m (offset -38 to -24 m).**

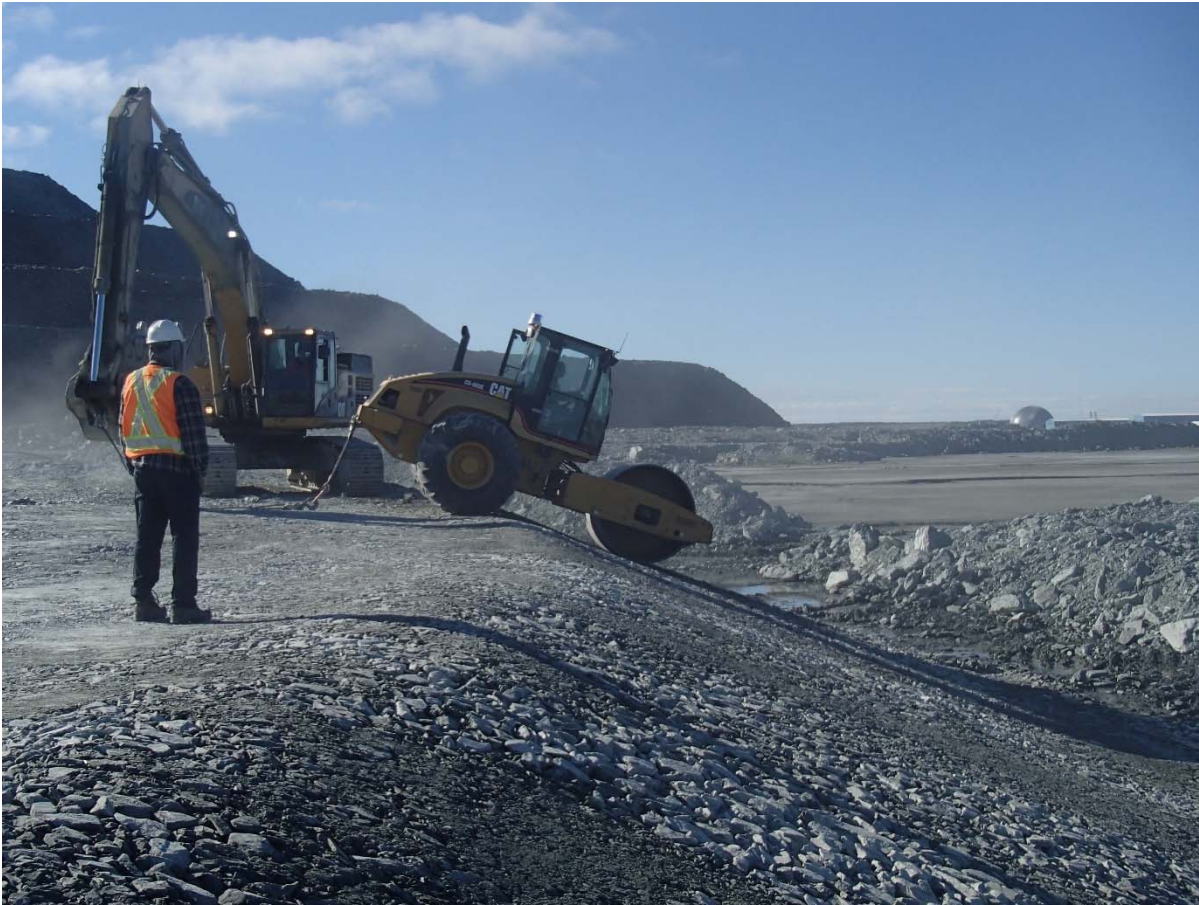
**Photograph NCIS-054: From Sta. 2+580/-31 m (approx.), looking SE. Compaction of the 0.5 m lift (approx.) of coarse filter between El. 150 and 152 m with a 10-tonne smooth-drum compactor with vibration (4 passes) in the upstream slope from Sta. 2+560 m to 2+815 m.**

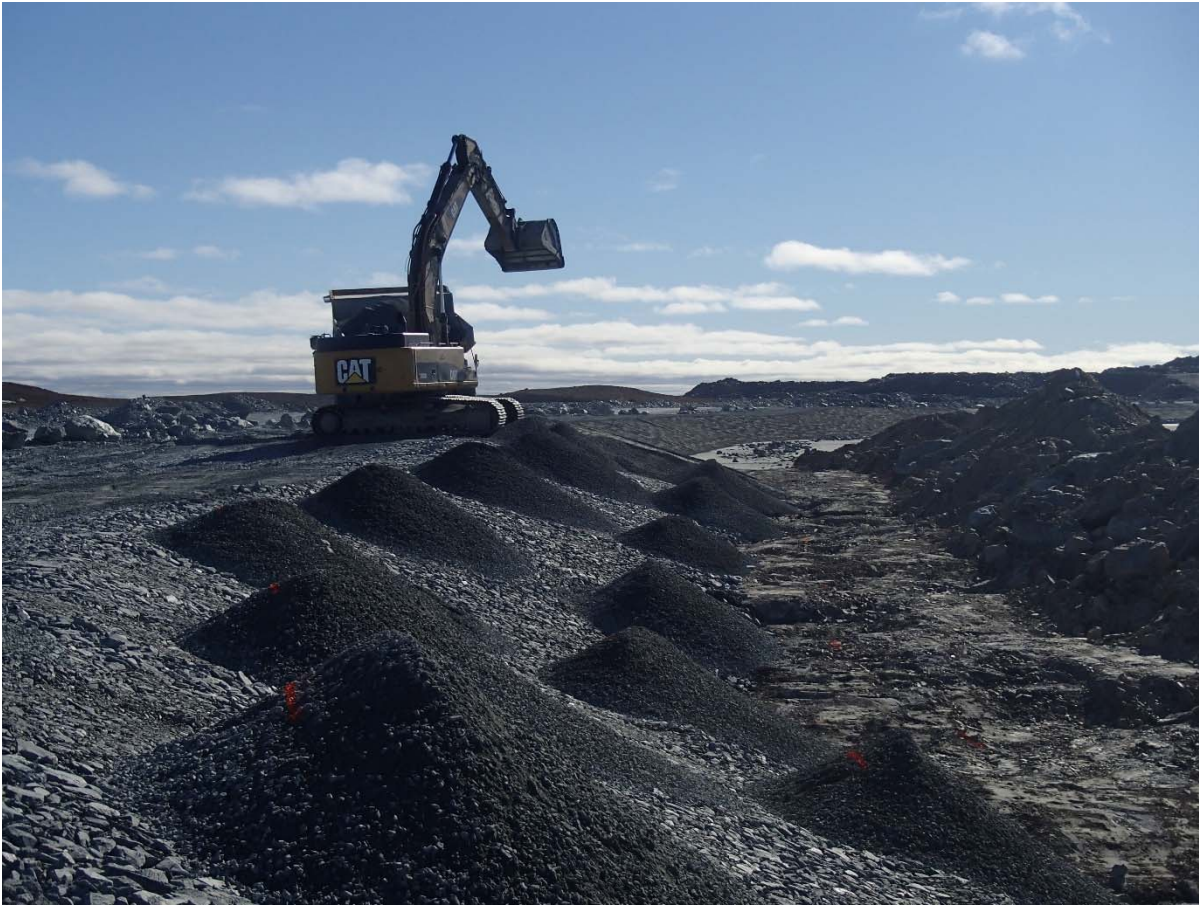
**Photograph NCIS-055: From Sta. 1+730/-42 m (approx.), looking NE. Placement of a 0.5 m thick lift of fine filter over the coarse filter in the upstream slope from El. 150 m to 152 m with an excavator from Sta. 1+820 m to 1+595 m.**

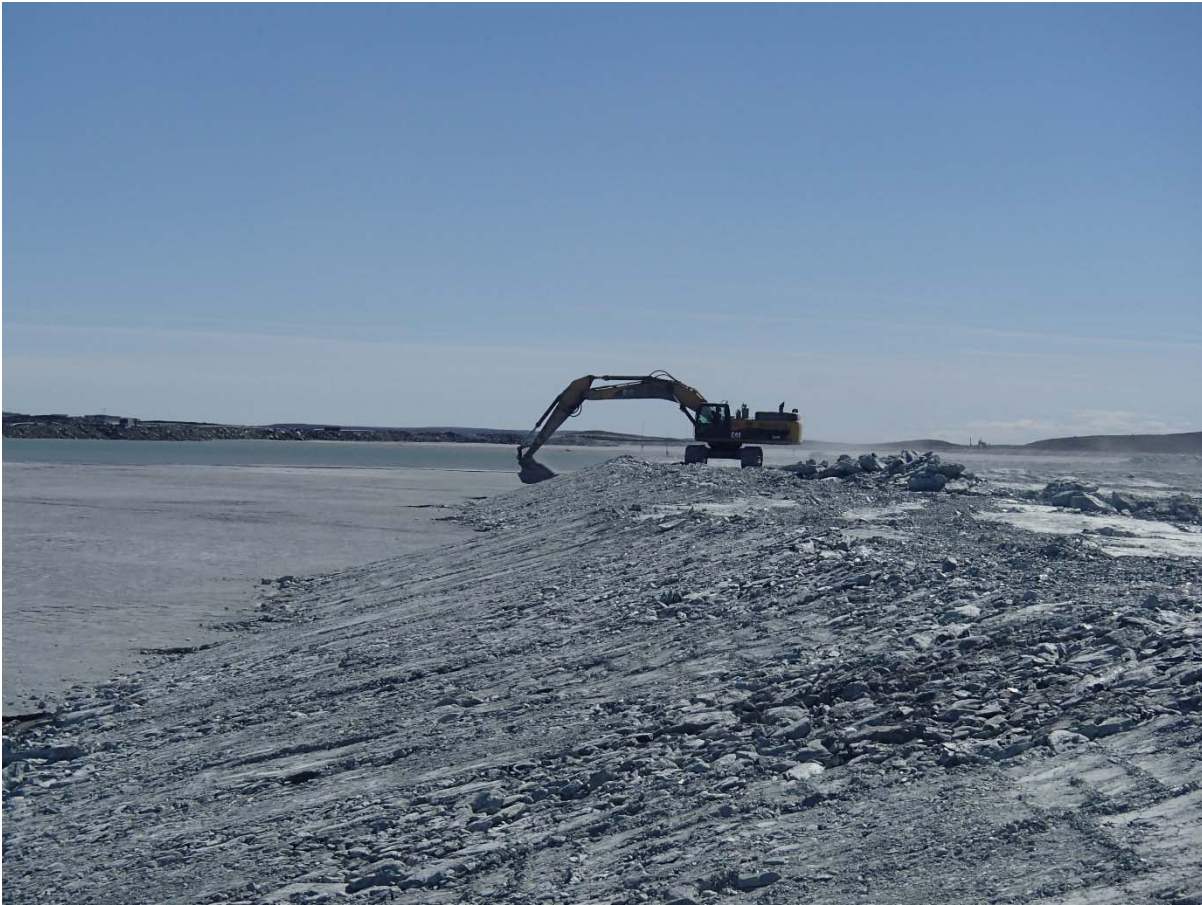
**Photograph NCIS-056: From Sta. 1+290/-39 m (approx.), looking S. Profiling of the upstream slope (3H:1V) from El. 148 to 150 m with an excavator from Sta. 1+340 m to 1+130 m.**

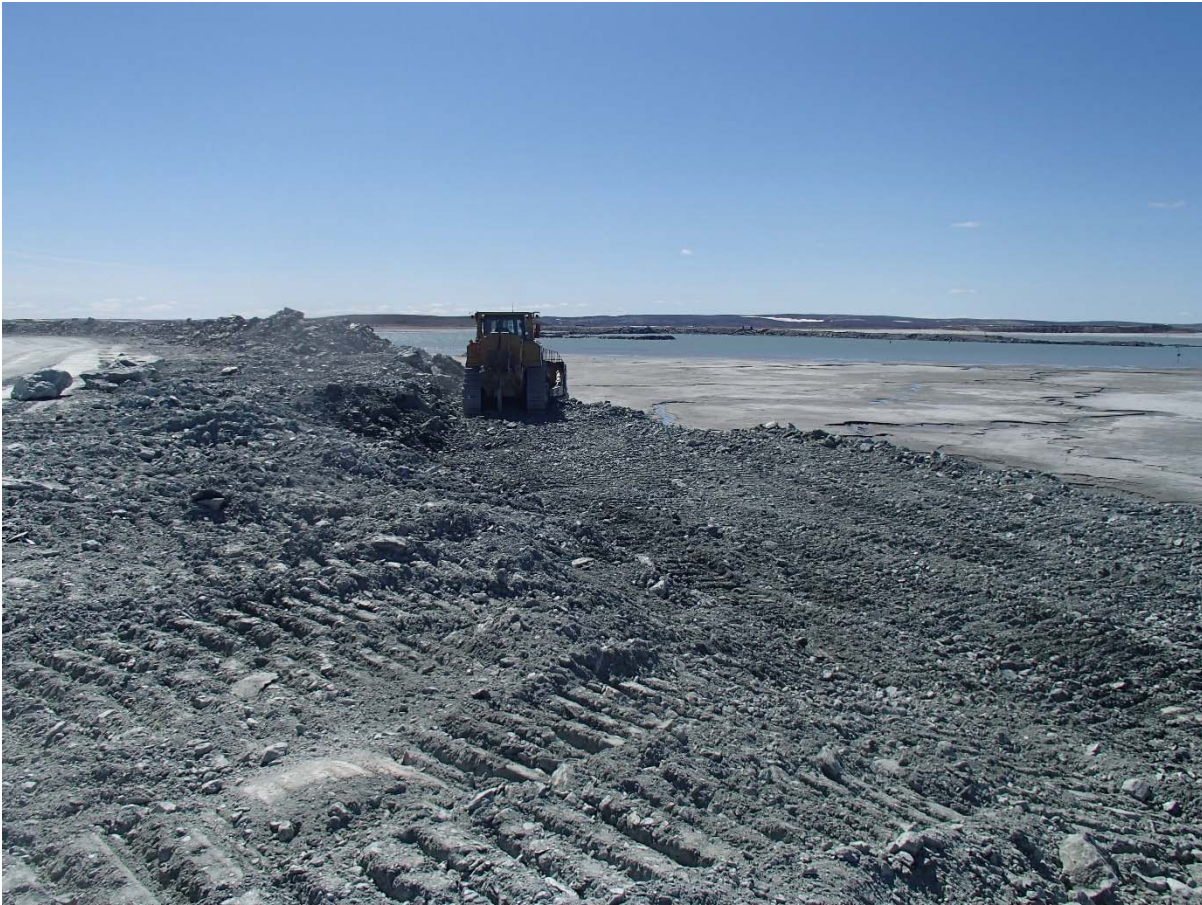
**Photograph NCIS-057: From Sta. 3+010/-15 m (approx.), looking SW. Removing of UM rockfill material from the capping with a dozer to level the surface to El. 152 m from Sta. 2+980 m to 3+050 m (offset -30 to -20 m).**

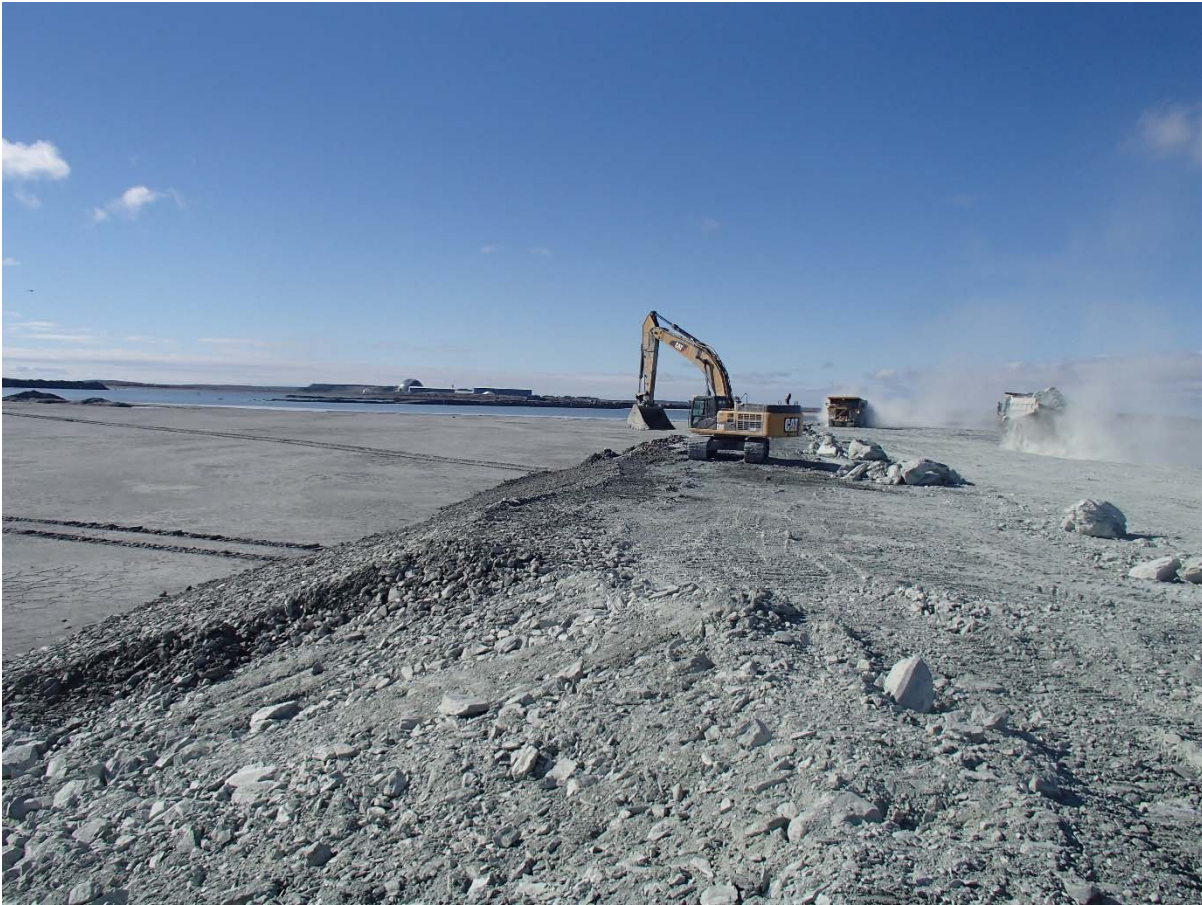
**Photograph NCIS-058: From Sta. 1+340/-34 m (approx.), looking S. Placement of a 0.5 m thick lift of coarse filter in the upstream slope from El. 148 m to 152 m with an excavator from Sta. 1+340 m to 1+270 m.**

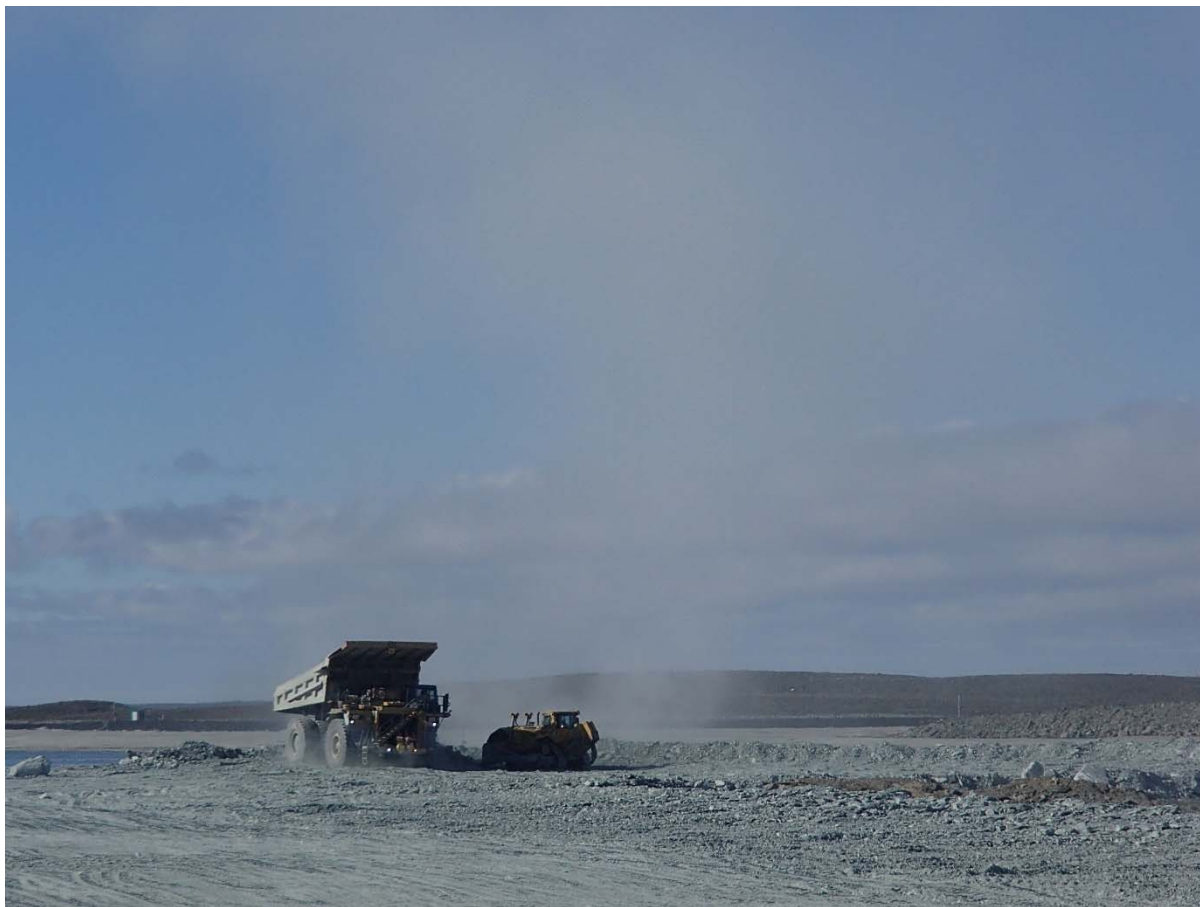
**Photograph NCIS-059: From Sta. 1+330/-34 m (approx.), looking S. Placement of a 1.5 to 2 m thick (approx.) lift of UM rockfill from El. 148 m to El. 150 m (approx.) with a dozer from Sta. 1+120 m to 1+100 m (-96 m to -60 m). The material is of good quality and is well graded.**

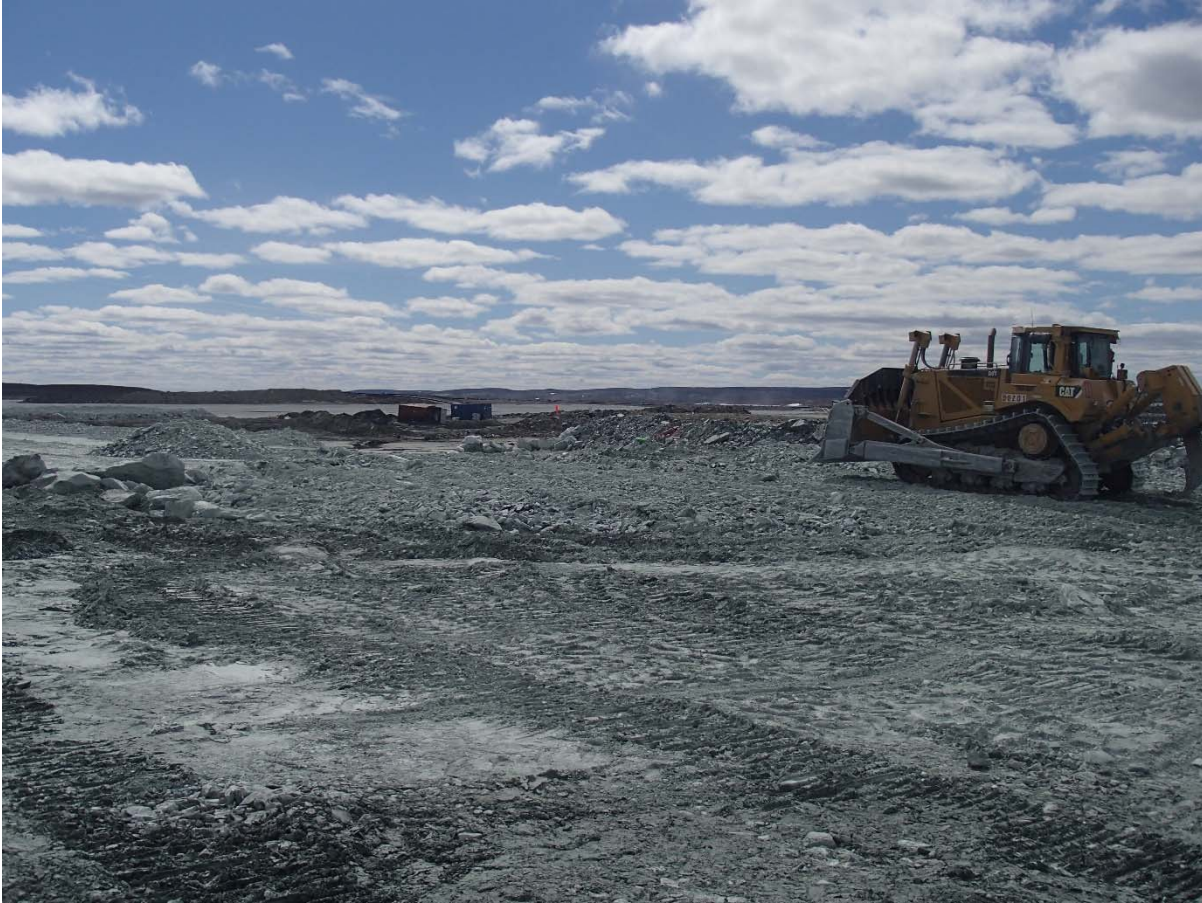
**Photograph NCIS-060: From Sta. 1+365/-35 m (approx.), looking SW. Placement of a 2 m thick (approx.) lift of UM rockfill from El. 150 m to El. 152 m (approx.) with a dozer from Sta. 1+340 m to 1+320 m (-19 m to +16 m). The material is of good quality and is well graded.**

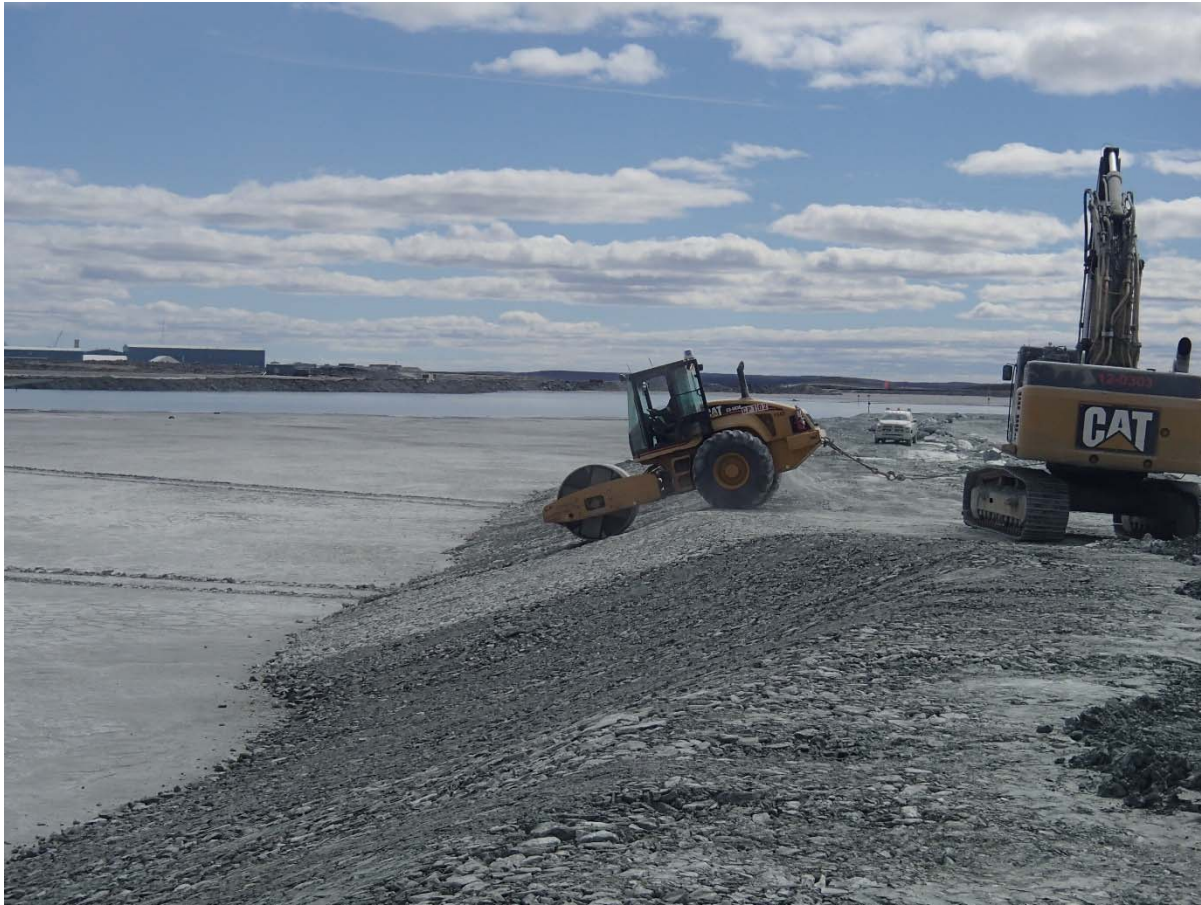
**Photograph NCIS-061: From Sta. 1+365/-35 m (approx.), looking S. Compaction of the 0.5 m lift of coarse filter between El. 148 and 152 m with a 10-tonne smooth-drum compactor with vibration (4 passes) in the upstream slope from Sta. 1+340 m to 1+270 m.**
