### **Meadowbank 2018 TSF As-built report**

**2018 CONSTRUCTION SEASON AS-BUILT REPORT  
TAILINGS STORAGE FACILITY  
MEADOWBANK GOLD PROJECT, NUNAVUT**

1897439-1578-R-Rev0

November 2018

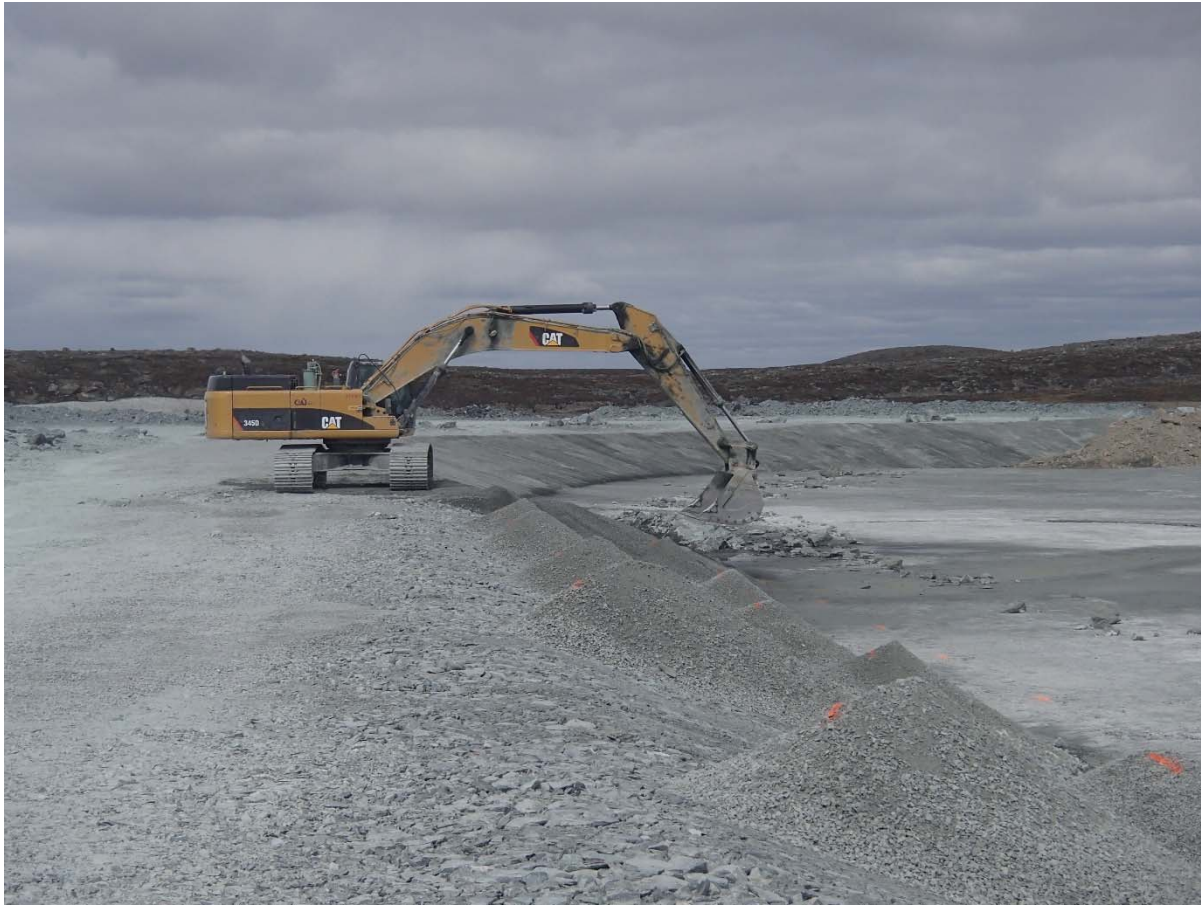
**Photograph NCIS-062: From Sta. 1+525/-33 m (approx.), looking N. Placement of a 0.5 m thick lift of fine filter over the coarse filter in the upstream slope from El. 150 m to 152 m with an excavator from Sta. 1+330 m to 1+260 m and from Sta. 1+595 m to 1+550 m.**

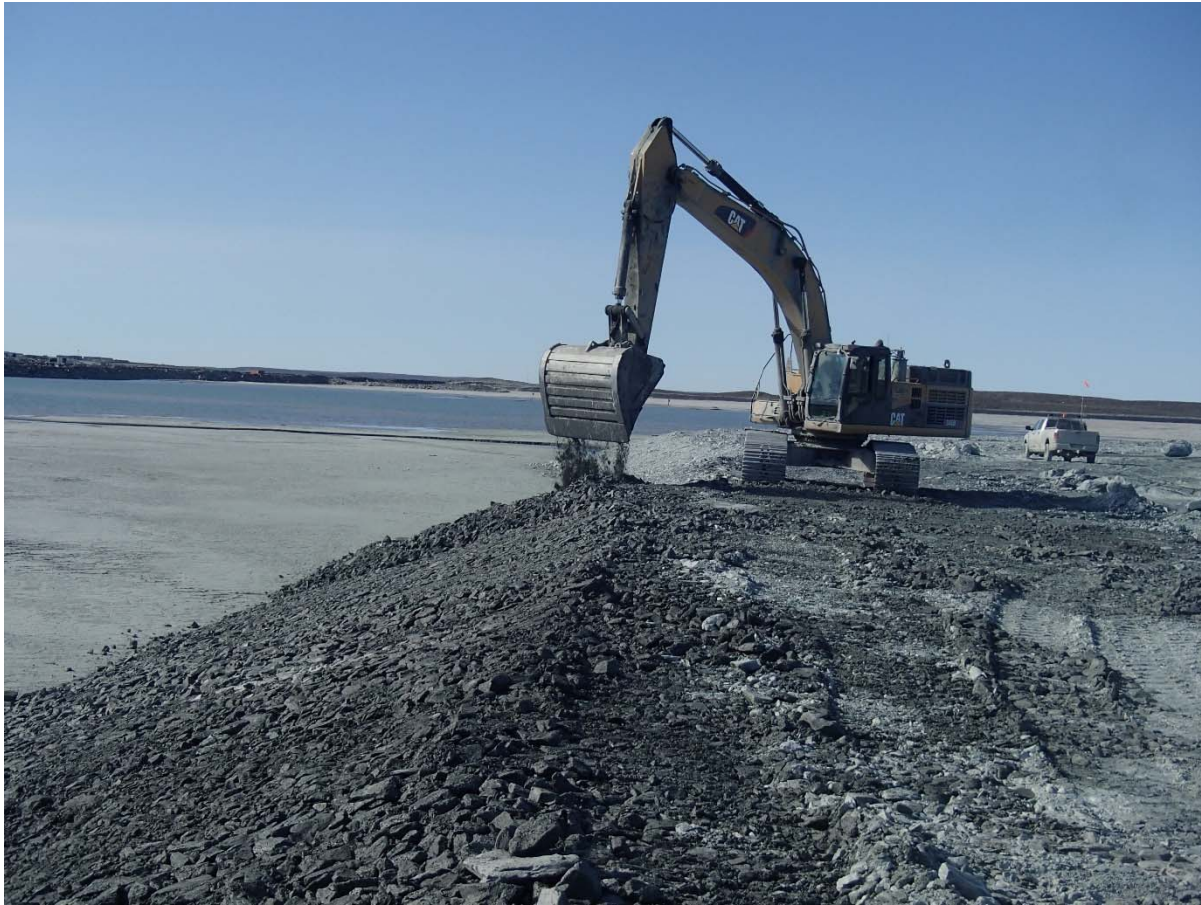
**Photograph NCIS-063: From Sta. 1+200/-65 m (approx.), looking SW. Placement of a 0.5 m thick lift of coarse filter in the upstream slope from El. 148 m to 152 m with an excavator from Sta. 1+270 m to 1+100 m.**

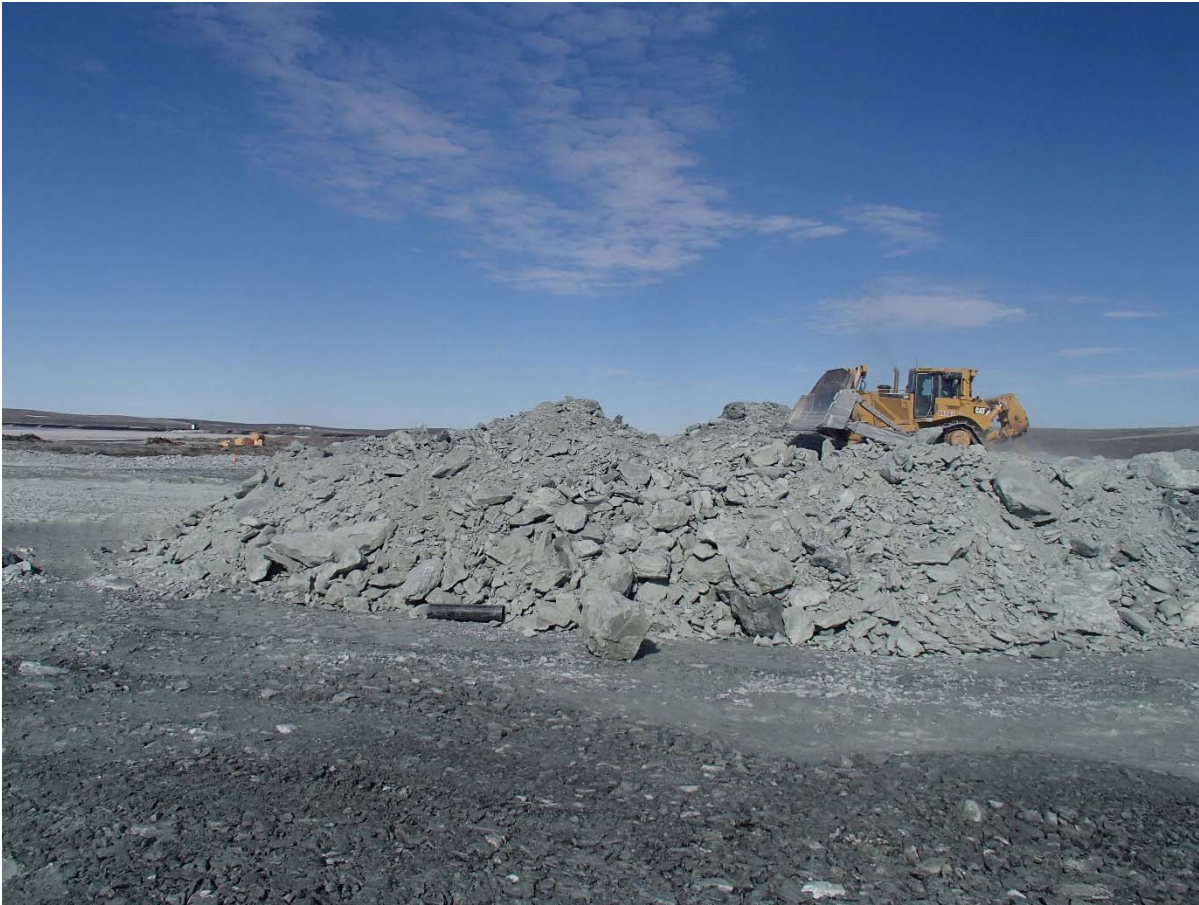
**Photograph NCIS-064: From Sta. 1+200/-65 m (approx.), looking W. Placement of a 2 m thick (approx.) lift of UM rockfill from El. 150 m to El. 152 m (approx.) with a dozer from Sta. 1+320 m to 1+235 m (-65 m to -45 m). The material is of good quality and is well graded.**

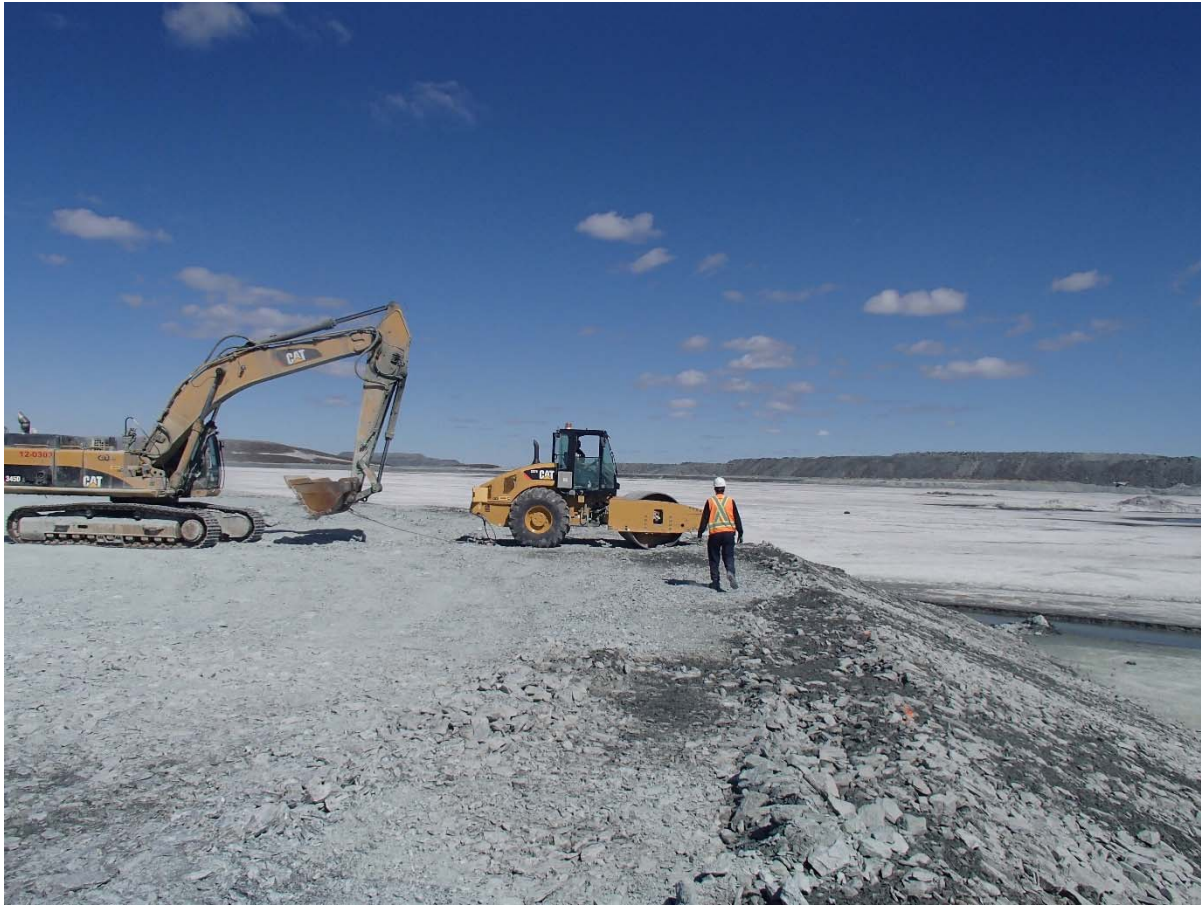
**Photograph NCIS-065: From Sta. 1+140/96 m (approx.), looking NE. Compaction of the 0.5 m lift of coarse filter between El. 148 and 152 m with a 10-tonne smooth-drum compactor with vibration (4 passes) in the upstream slope from Sta. 1+270 m to 1+100 m.**

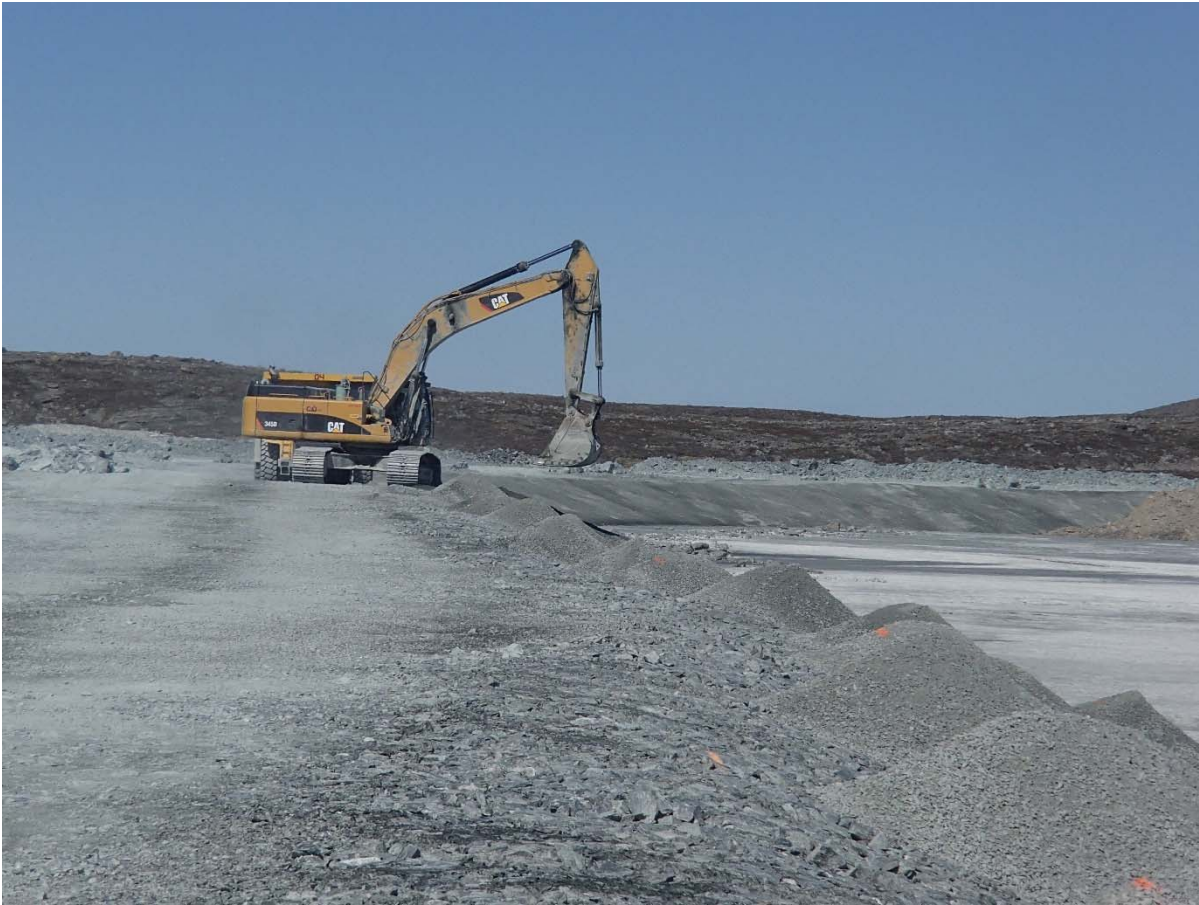
**Photograph NCIS-066: From Sta. 1+400/-34 m (approx.), looking N. Placement of a 0.5 m thick lift of fine filter over the coarse filter in the upstream slope from El. 150 m to 152 m with an excavator from Sta. 1+595 m to 1+550 m.**

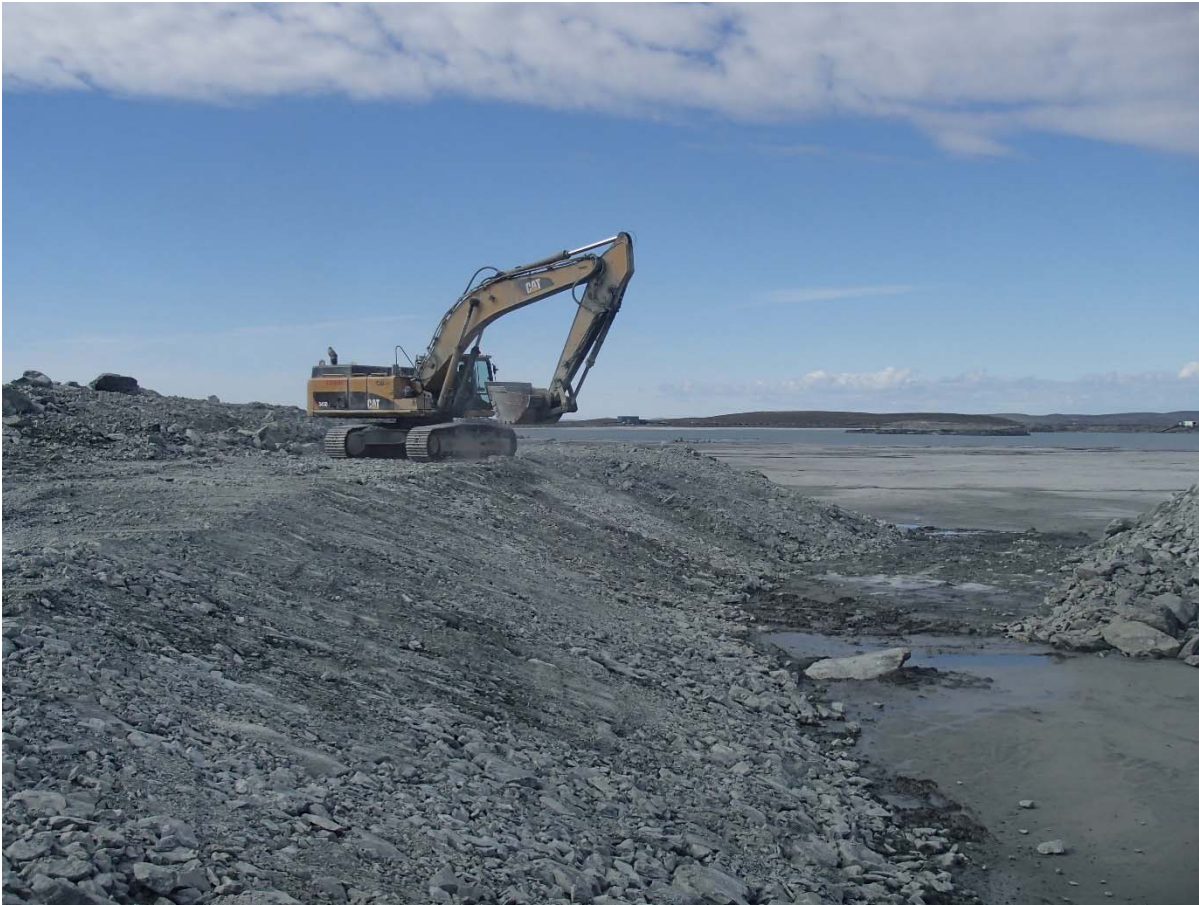
**Photograph NCIS-067: From Sta. 2+880/-26 m (approx.), looking SW. Profiling of the upstream slope (3H:1V) from El. 150 to 152 m with an excavator from Sta. 2+860 m to 2+975 m.**

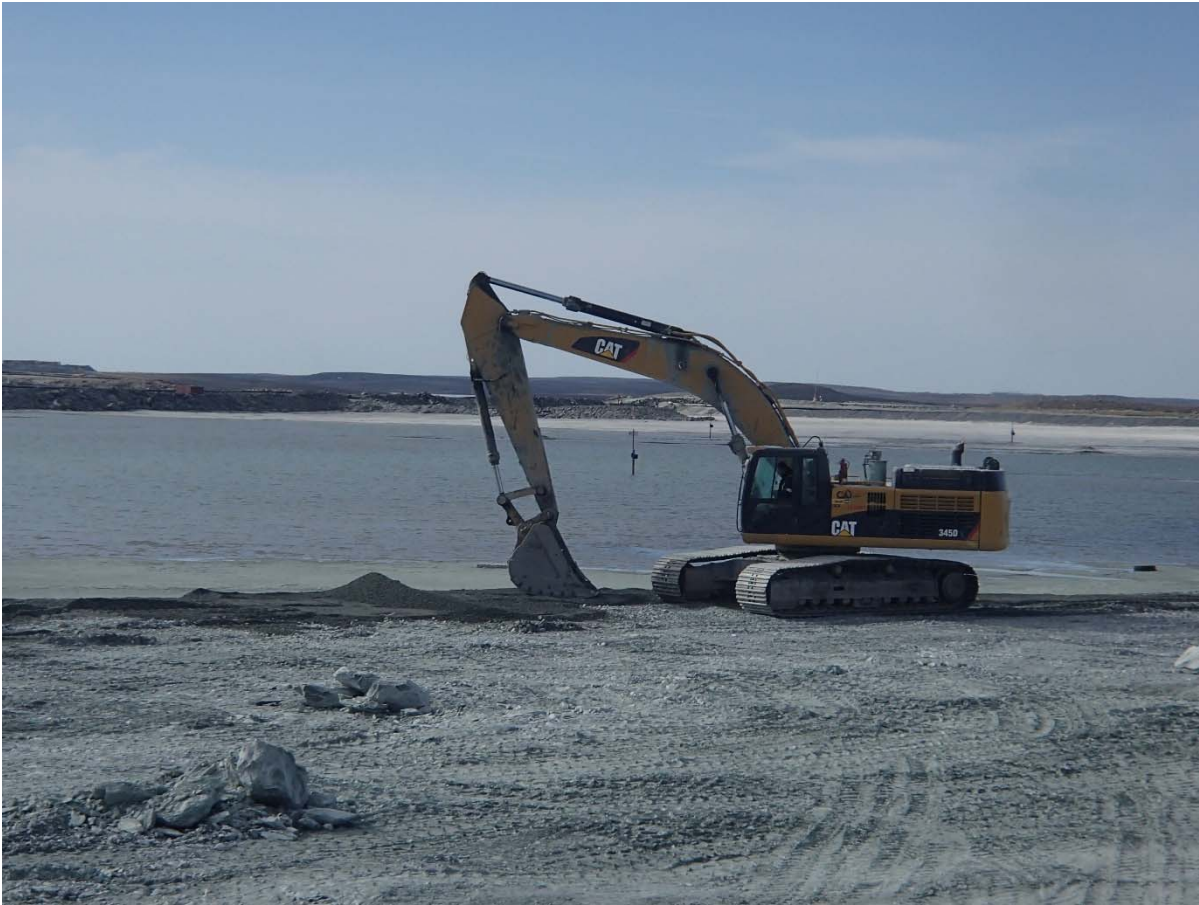
**Photograph NCIS-068: From Sta. 1+150/-62 m (approx.), looking S. Placement of a 0.5 m thick lift of fine filter over the coarse filter in the upstream slope from El. 148 m to 150 m with an excavator from Sta. 1+180 m to 1+100 m.**

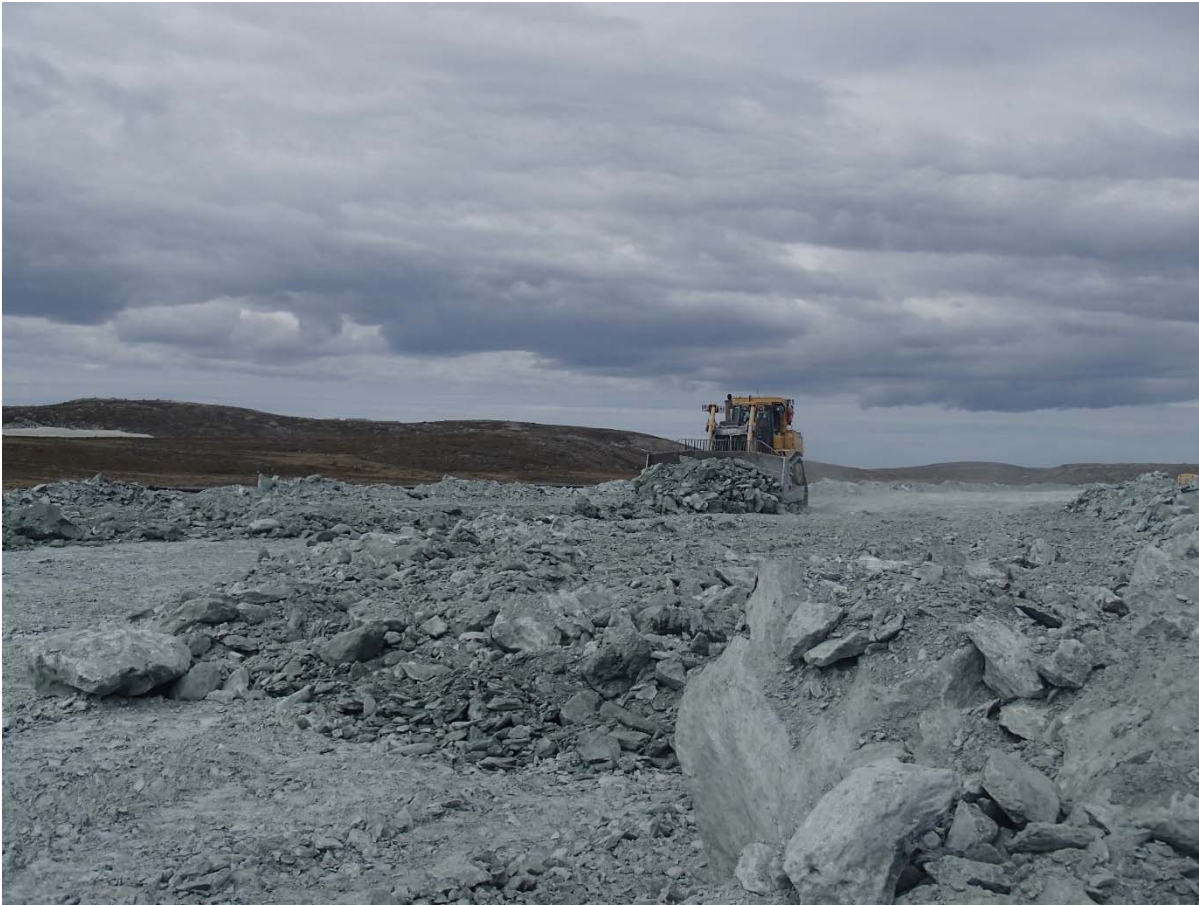
**Photograph NCIS-069: From Sta. 1+180/-56 m (approx.), looking NW. Placement of a 2 m thick (approx.) lift of UM rockfill from El. 150 m to El. 152 m (approx.) with a dozer from Sta. 1+235 m to 1+160 m (-60 m to -44 m). The material is of good quality and is well graded.**

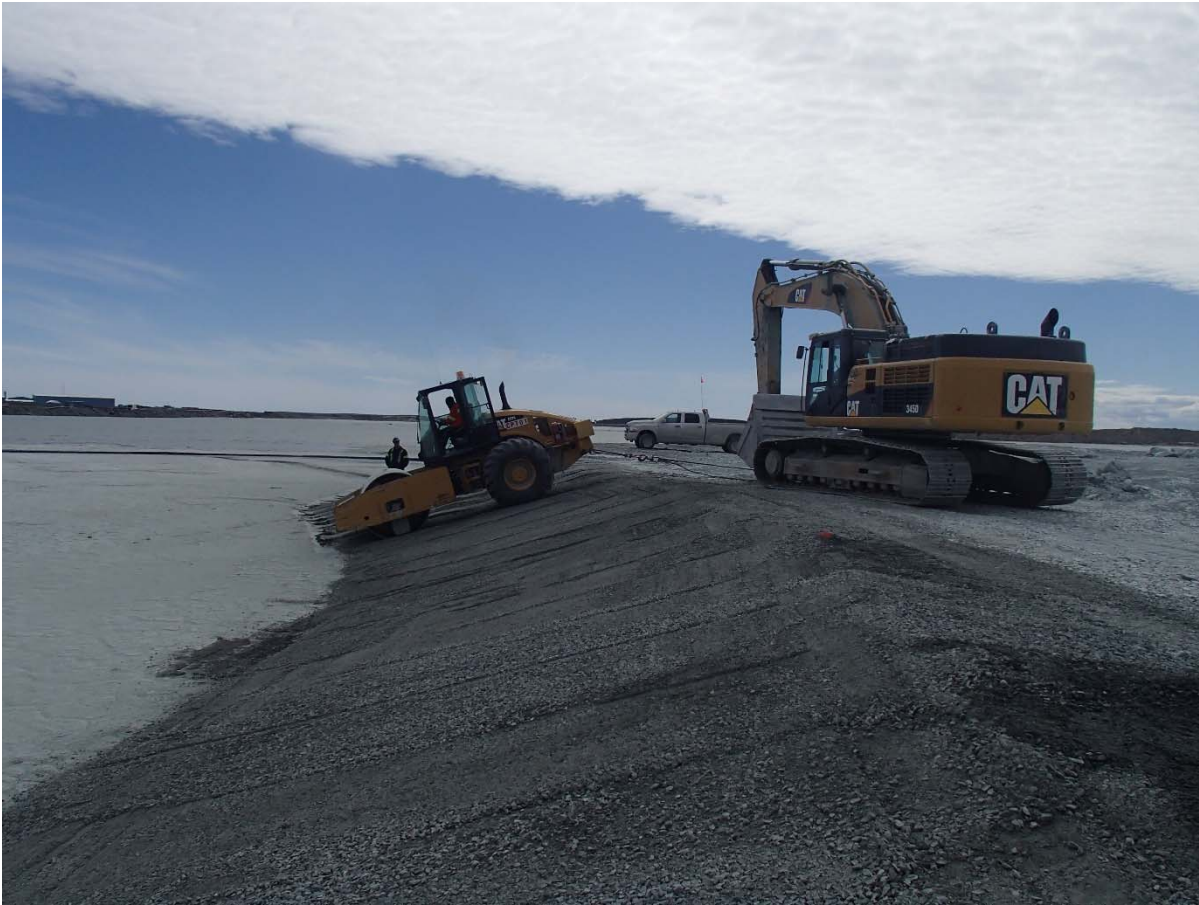
**Photograph NCIS-070: From Sta. 1+160/-89 m (approx.), looking S. Compaction of the 0.5 m lift of fine filter between El. 150 and 152 m with a 10-tonne smooth-drum compactor with vibration (4 passes) in the upstream slope from Sta. 1+335 m to 1+100 m.**

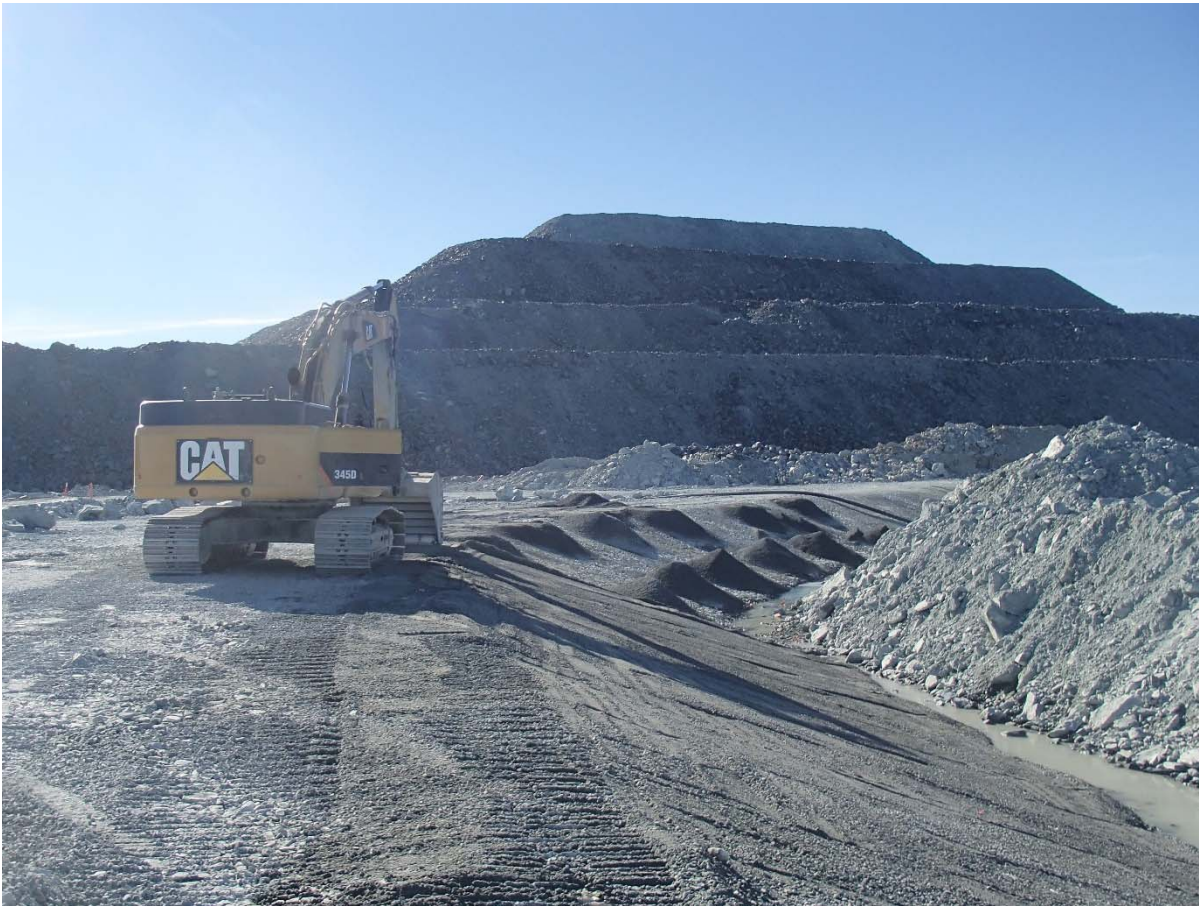
**Photograph NCIS-071: From Sta. 2+670/-28 m (approx.), looking SE. Placement of a 0.5 m thick lift of fine filter over the coarse filter in the upstream slope from El. 150 m to 152 m with an excavator from Sta. 1+550 m to 1+320 m and 1+630 m to 1+610 m.**

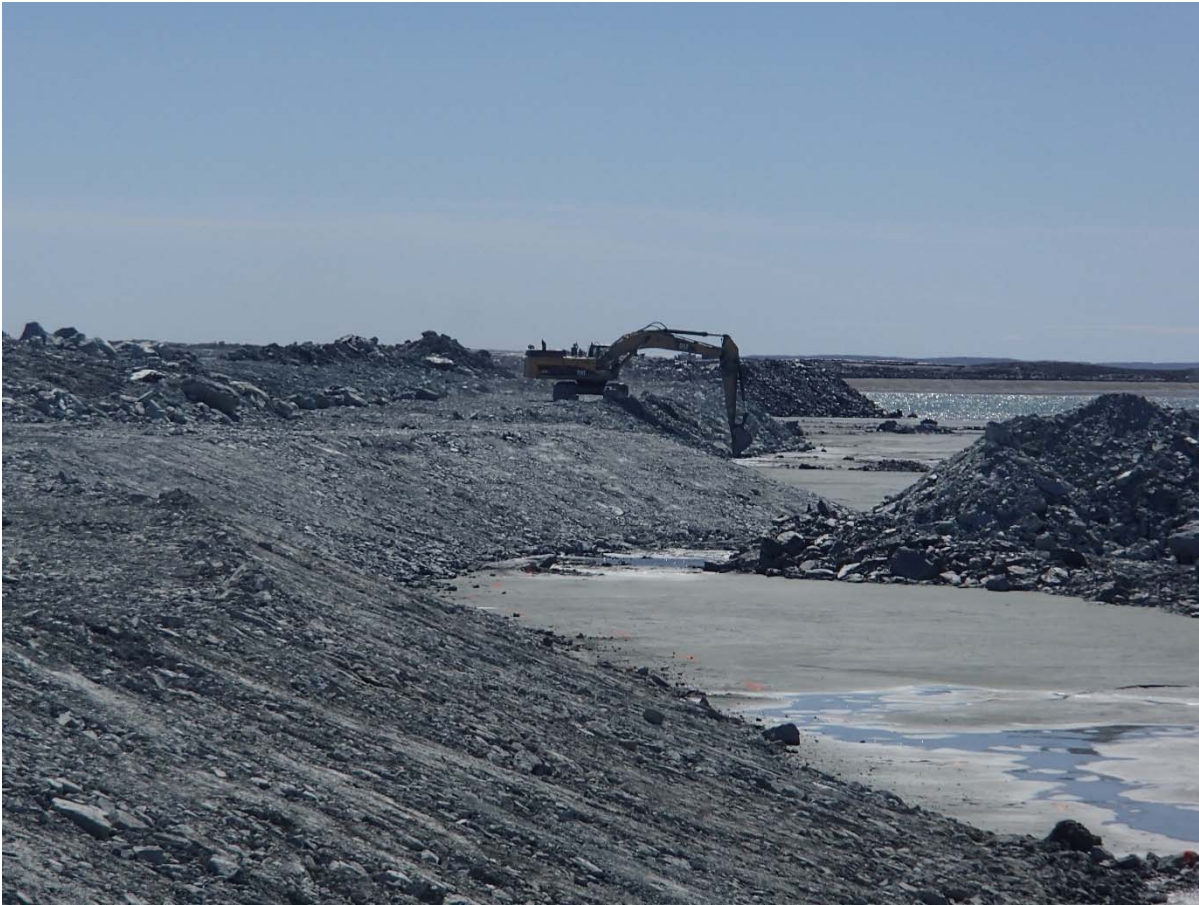
**Photograph NCIS-072: From Sta. 2+790/-38 m (approx.), looking W. Profiling of the upstream slope (3H:1V) from El. 150 to 152 m with an excavator from Sta. 2+975 m to 3+070 m.**

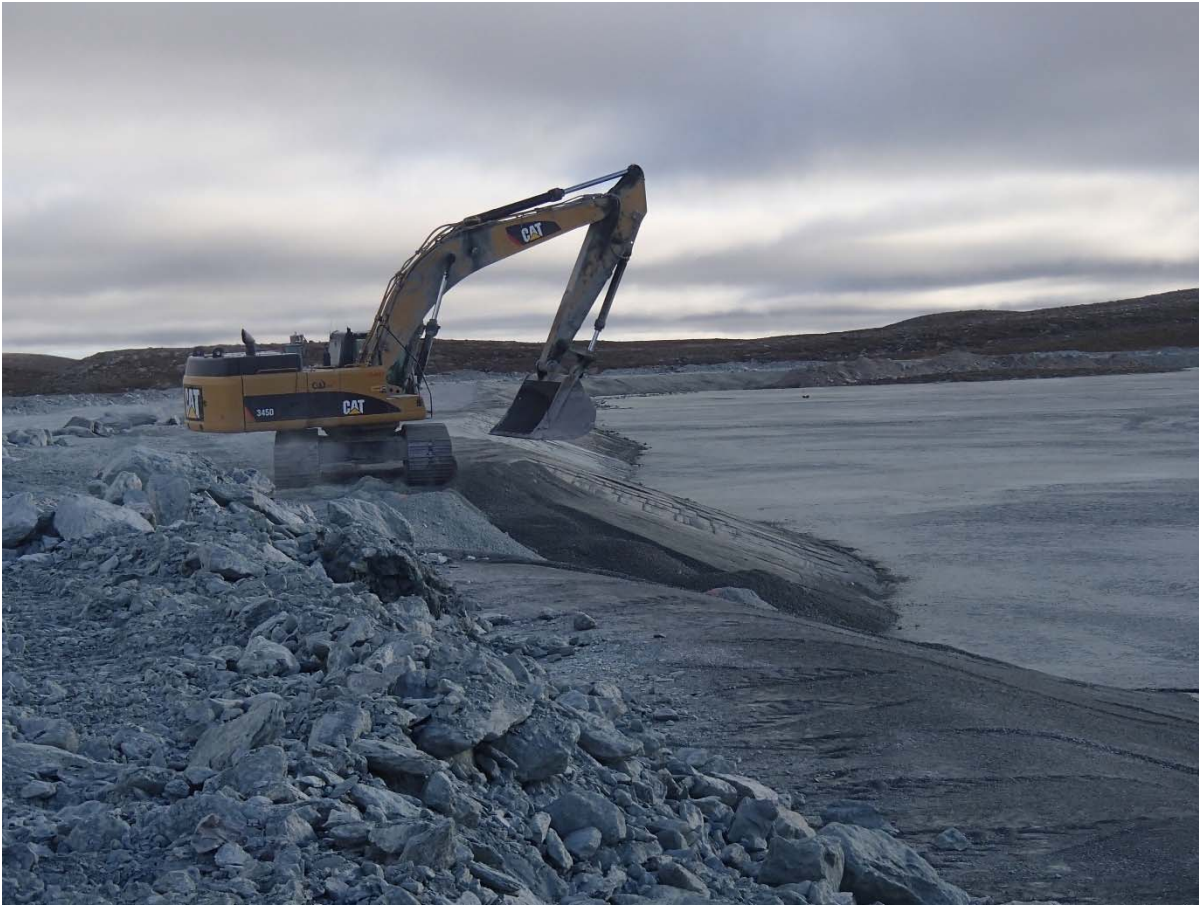
**Photograph NCIS-073: From Sta. 1+300/-33 m (approx.), looking N. Placement of a 0.5 m thick lift of fine filter over the coarse filter in the upstream slope from El. 150 m to 152 m with an excavator from Sta. 1+320 m to 1+300 m.**

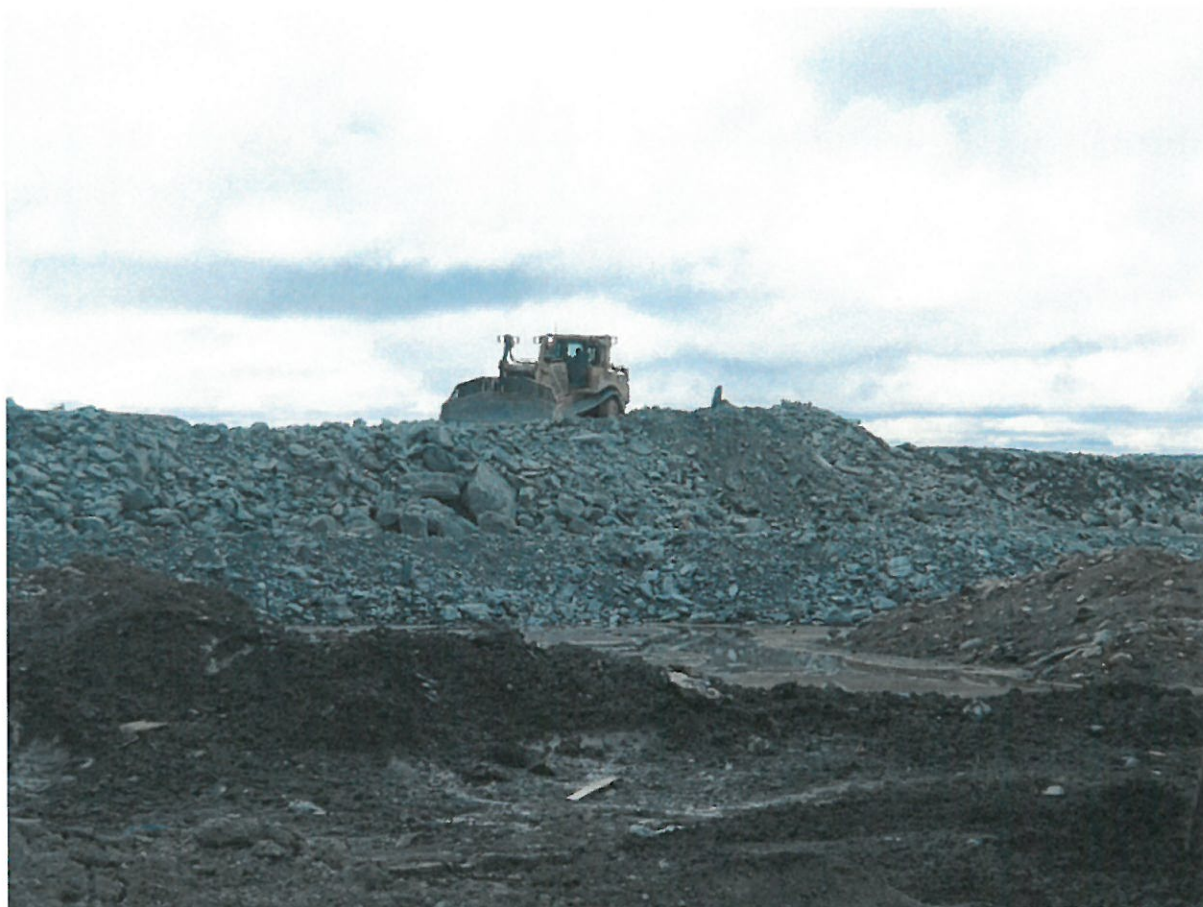
**Photograph NCIS-083: From Sta 1+140/-52 m (approx.), looking SW. Placement of a 2 m thick (approx.) lift of IV rockfill from El. 150 m to El. 152 m (approx.) with a dozer from Sta. 1+160 m to 1+170 m (-64 m to -111 m). The material is of good quality and is well graded.**

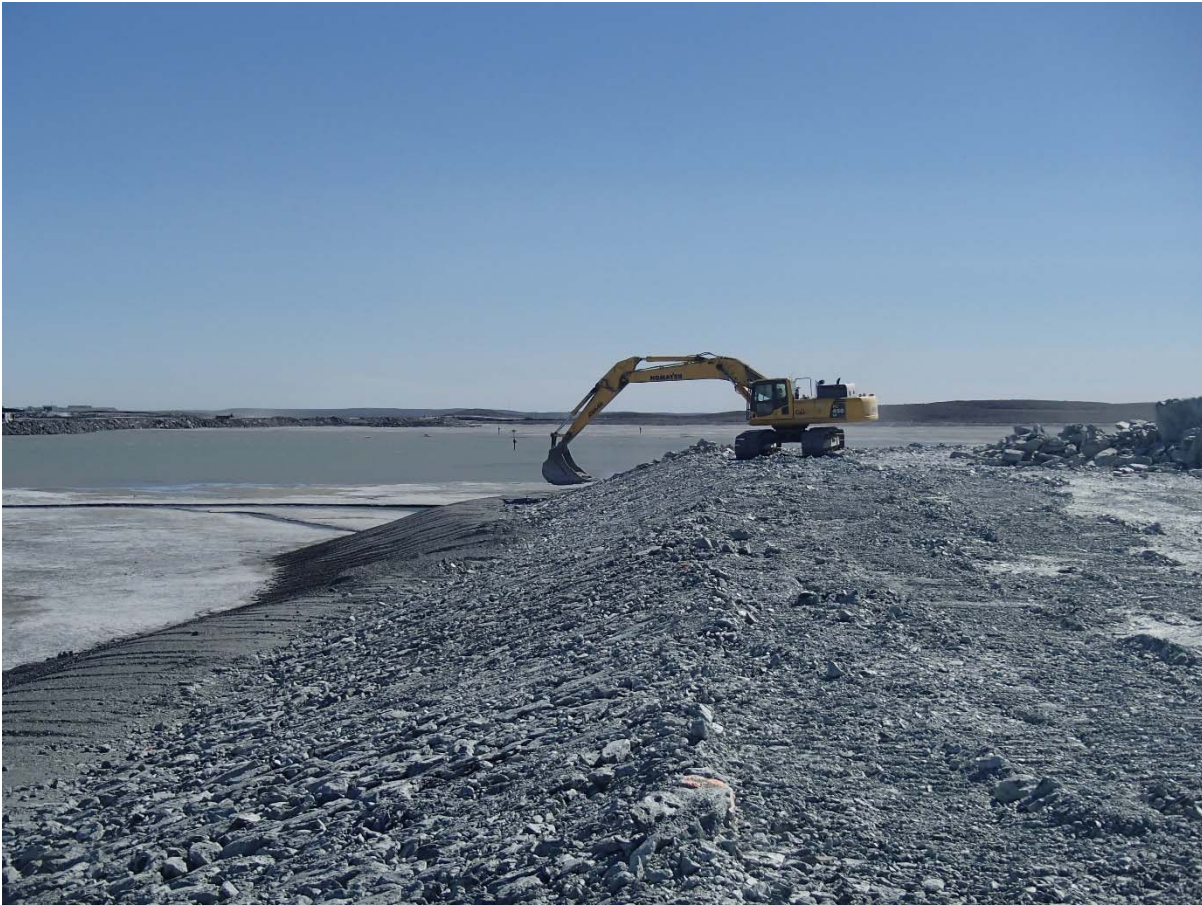
**Photograph NCIS-091: From Sta 2+330/+13 m (approx.), looking S. Placement of a 2 m thick (approx.) lift of UM rockfill from El. 152 m to El. 154 m (approx.) with a dozer from Sta. 2+370 m to 2+290 m (+9 m to -22 m). The material is of good quality and is well graded.**

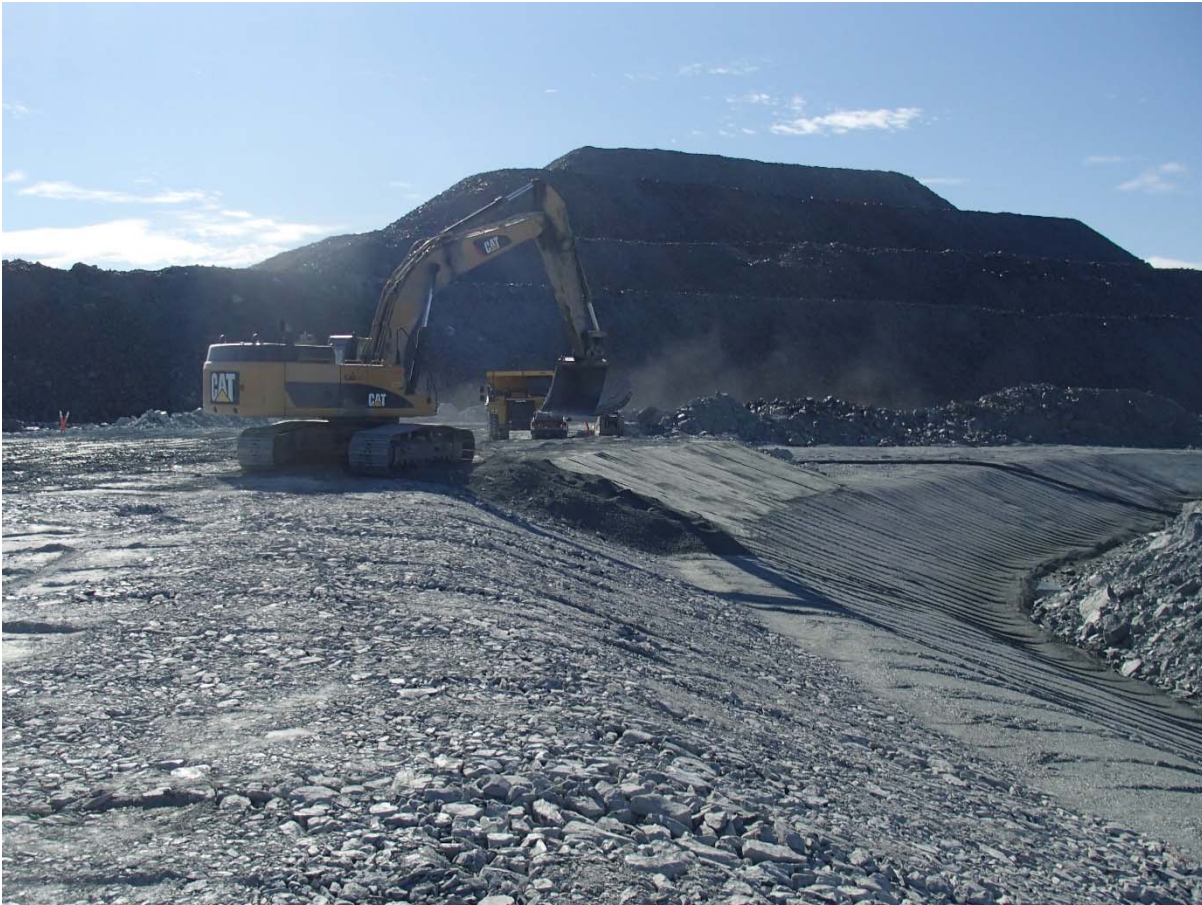
**Photograph NCIS-103: From Sta. 2+420/-27 m (approx.), looking NE. Profiling of the upstream slope (3H:1V) from El. 152 to 154 m with an excavator from Sta. 2+400 m to 2+410 m. Oversize boulders were removed.**

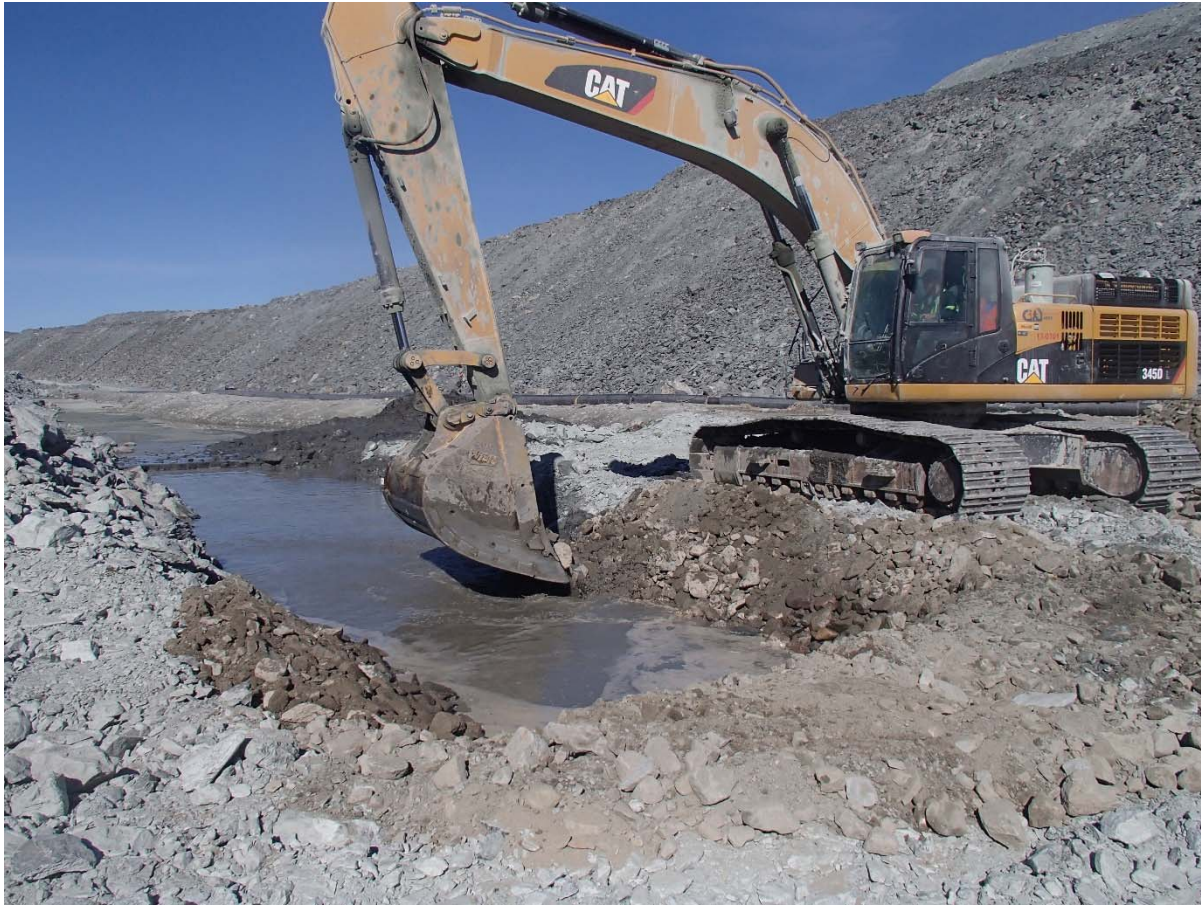
- The QA Manager observed oversized boulders at the North Cell Internal Structure in the lift close to the upstream slope. AEM mine supervisor was informed of the situation. The loader operator in the pit will hence informed the haul truck if a boulder is present in its load and transfer this information to the bulldozer operator. The haul truck will drop its load on the downstream side of the pad and the bulldozer operator shall push the oversized boulders downstream.

**Photograph NCIS-120: From Sta. 1+830/-27 m (approx.), looking NE. View of an accumulation of boulders on the upstream slope of the NCIS.**

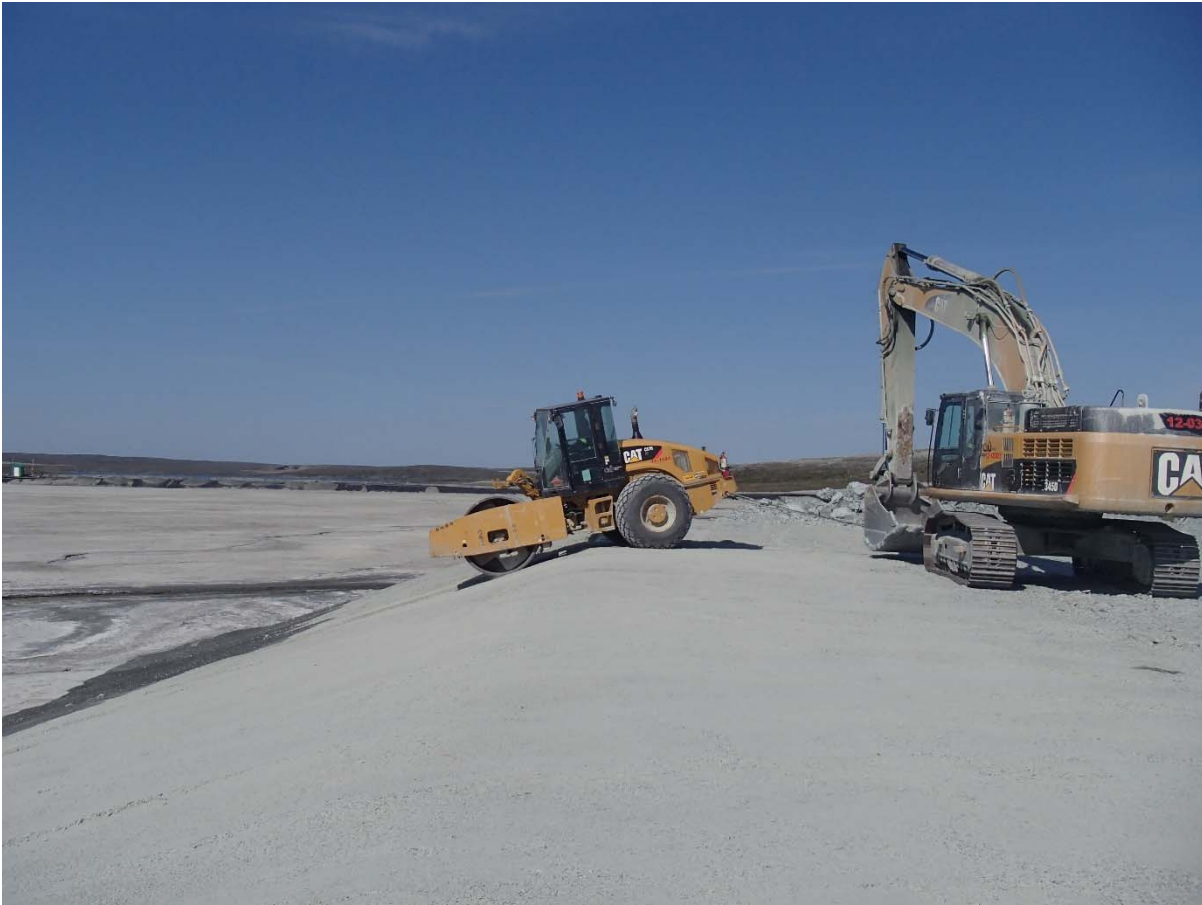
**Photograph NCIS-125: From Sta. 3+050/+26 m (approx.), looking NE. Corrections to the north sump: removal of approx. 0.5 m of tailing and till sieving reject material on the bottom of the excavation. The erosion protection material was replaced.**

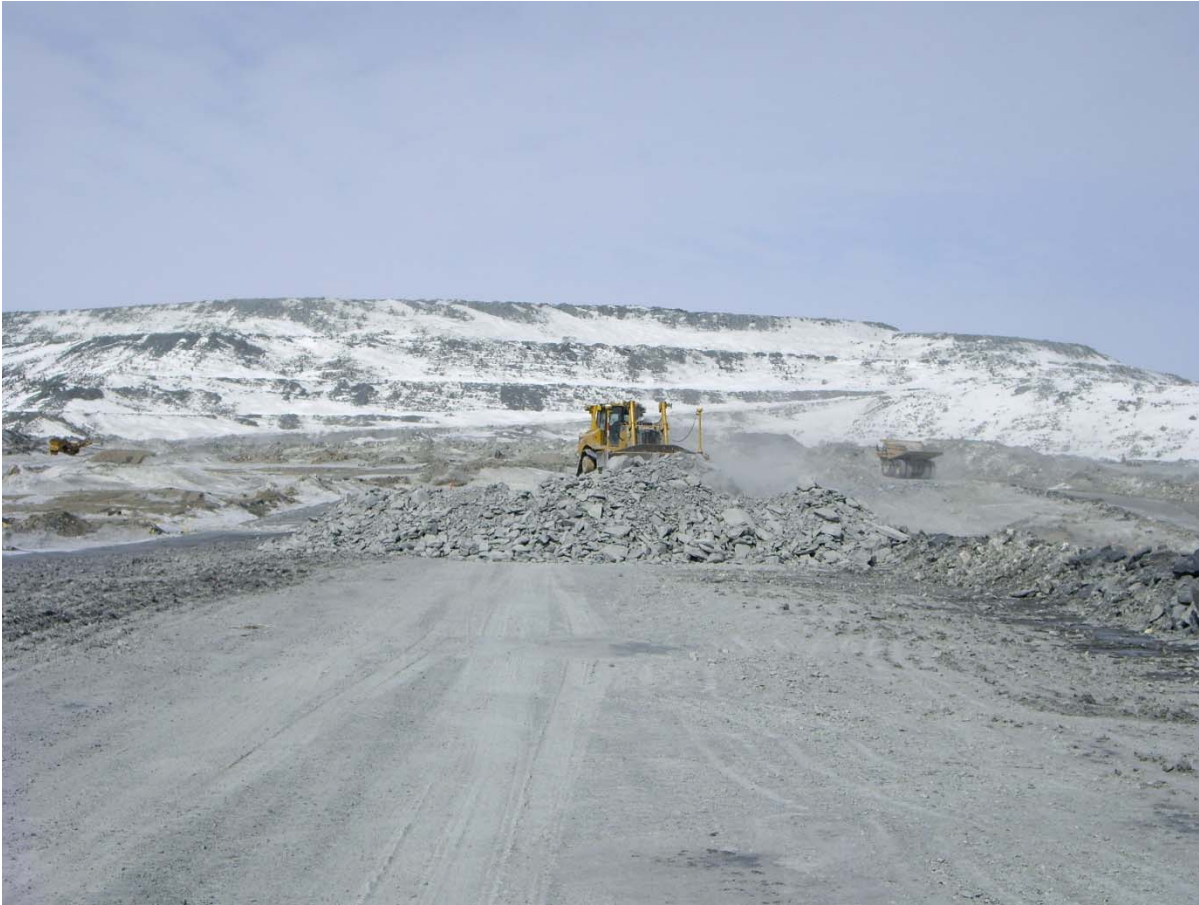
- The LLDPE liner installed on the upstream slope of Central Dike has been damaged near the deposition finger at approx. Sta. 0+650 m during snow removal operations. The amount of repairs required will be estimated when the deposition finger is removed entirely before installation of the new liner at El. 145 m.

Photograph CD-1796: From Sta. 0+650/-28 m, looking N. Damaged geomembrane near a deposition finger on Central Dike.

- Evaluate the LLDPE liner damages on the upstream slope of Central Dike.
- Inspect the LLDPE rolls stored on trailers outside once the snow has melted.

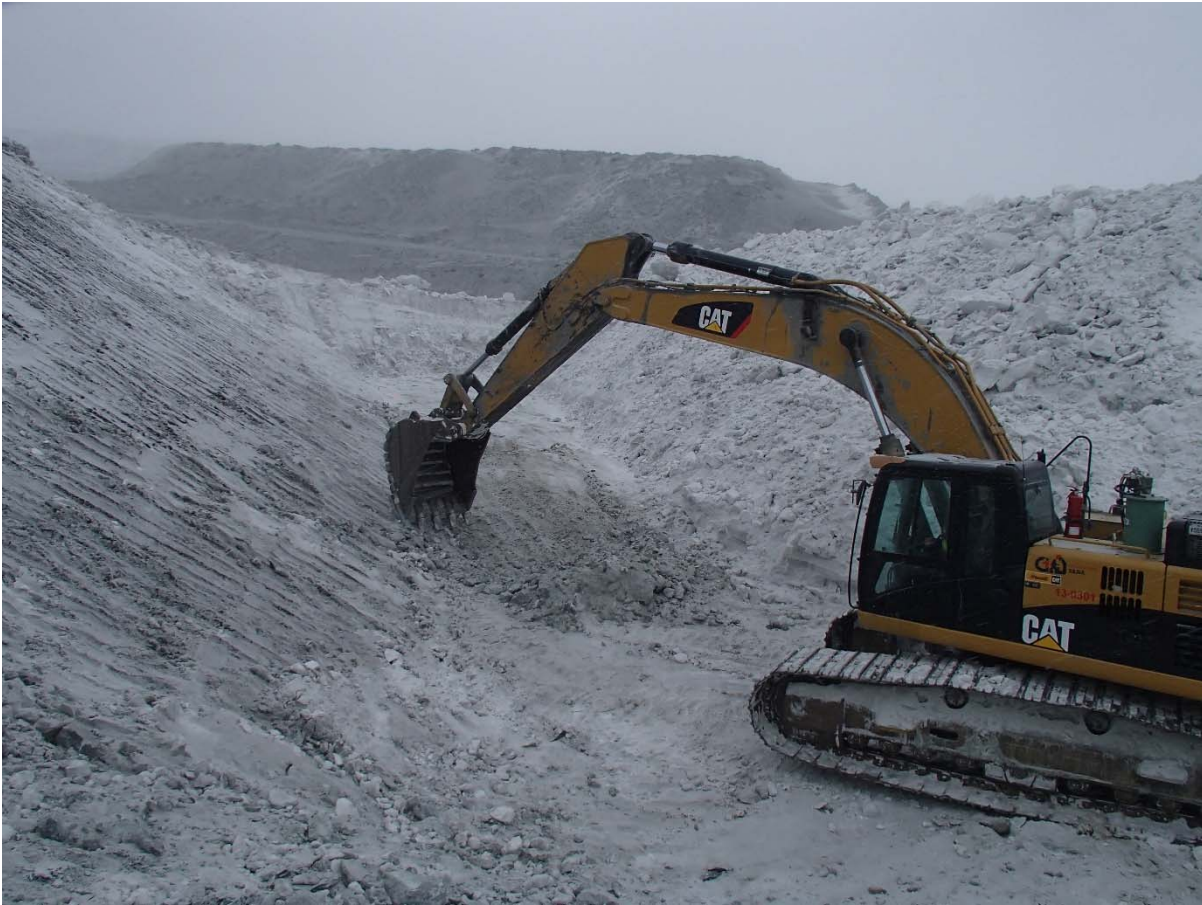
**Photograph CD-1804: From Sta. 40+790/-2 m looking S. Presence of oversize boulders on the existing slope at the junction between SD5 and Central Dike.**

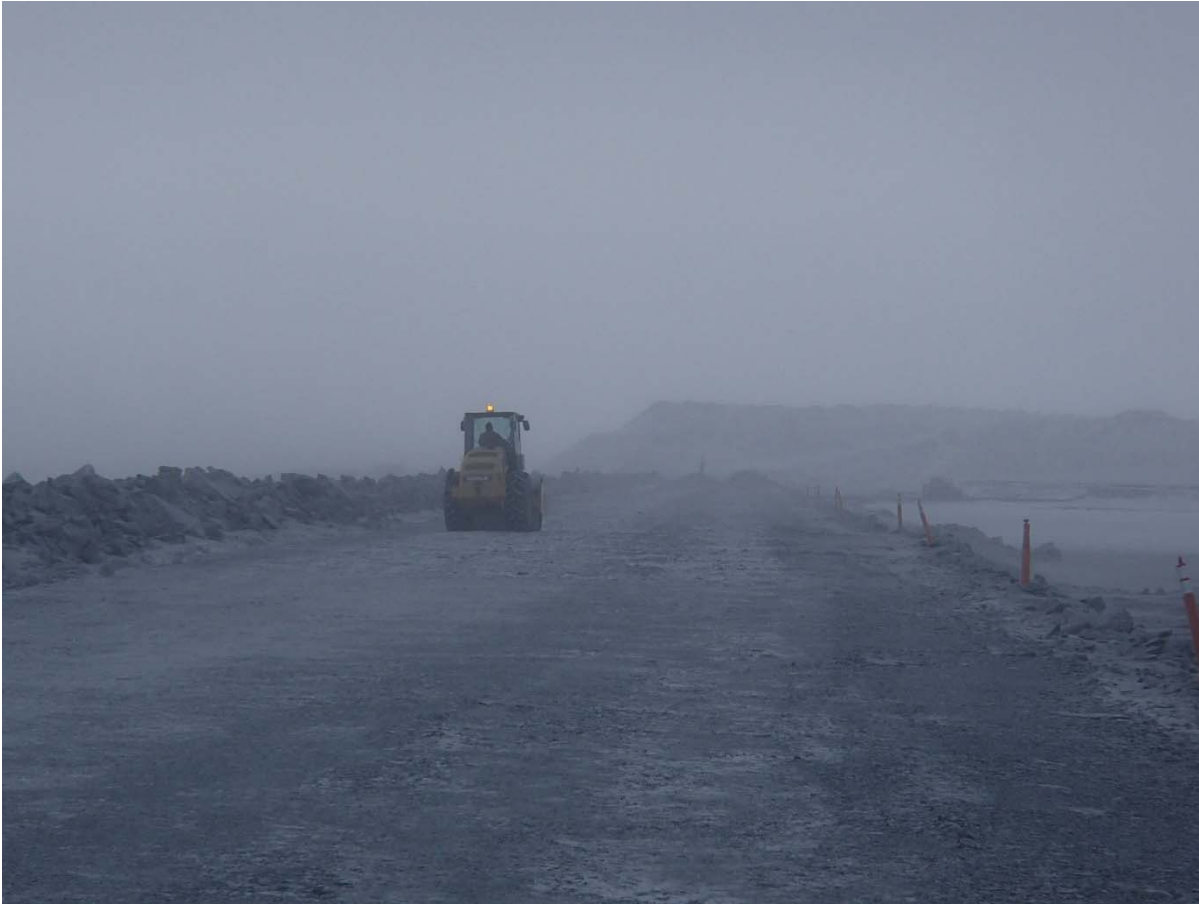
**Photograph CD-1810: From Sta. 0+335/-15 m looking S. Compaction of the 2 m lift (approx.) of IV rockfill at El. 145 m with a 10-tonne smooth-drum compactor with vibration (6 passes) from Sta. 0+350 to 0+540 m (o.s. -19 to -7 m).**
