### **Meadowbank 2018 TSF As-built report**

**2018 CONSTRUCTION SEASON AS-BUILT REPORT  
TAILINGS STORAGE FACILITY  
MEADOWBANK GOLD PROJECT, NUNAVUT**

1897439-1578-R-Rev0

November 2018

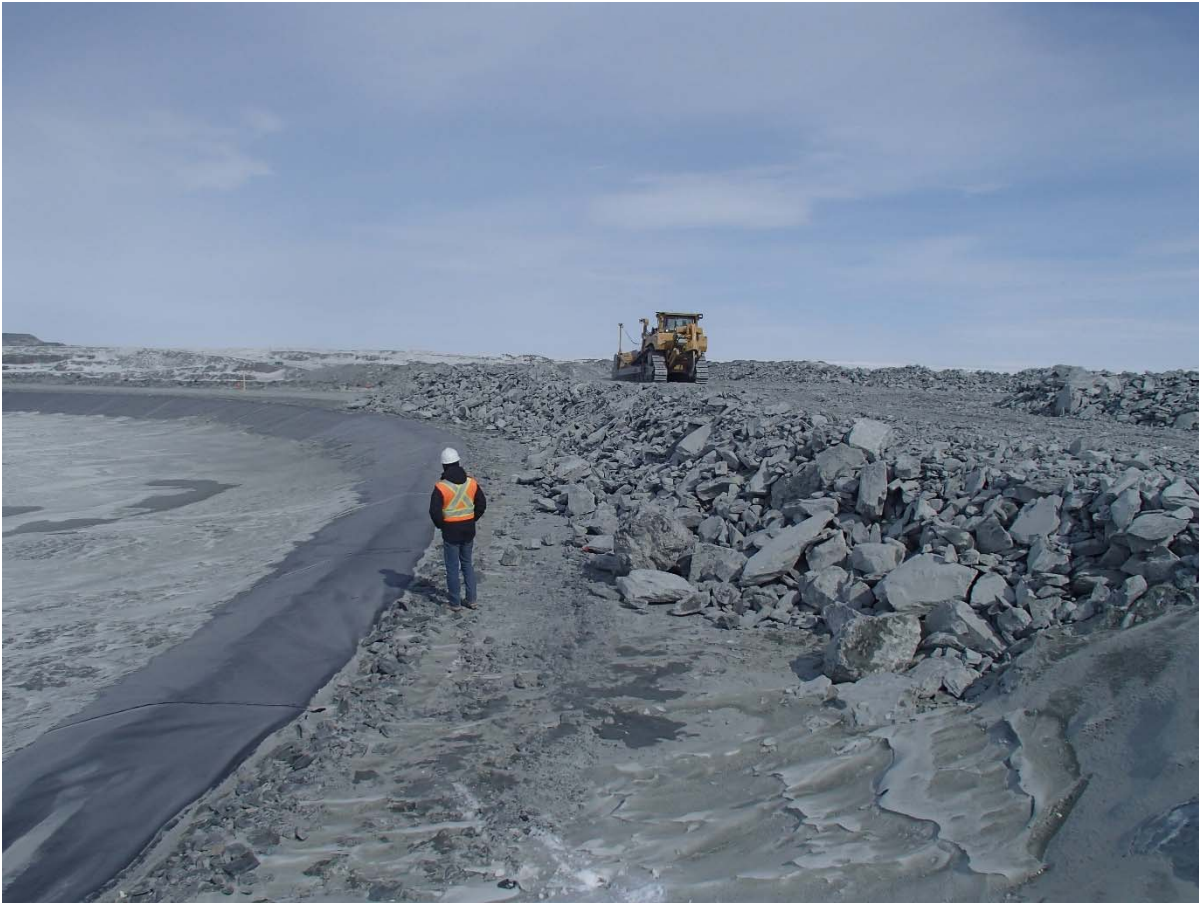
- It was observed that when using the D9 bulldozer, which does not have a GPS to monitor elevation, the intermediate volcanic (IV) rockfill lift thickness was slightly in excess of 2 m (approx. 2.5 m) on Central Dike, at the junction with Saddle Dam 5. The bulldozer was replaced with the GPS-equipped D8 bulldozer used in the previous days, which ensured that the elevation of the lift was at 145m.

**Photograph CD-1817: From Sta. 40+700/-10, looking NE. View of the rockfill lift thickness at the junction of Saddle Dam 5 and Central Dike, approx. 2.5 m thick.**

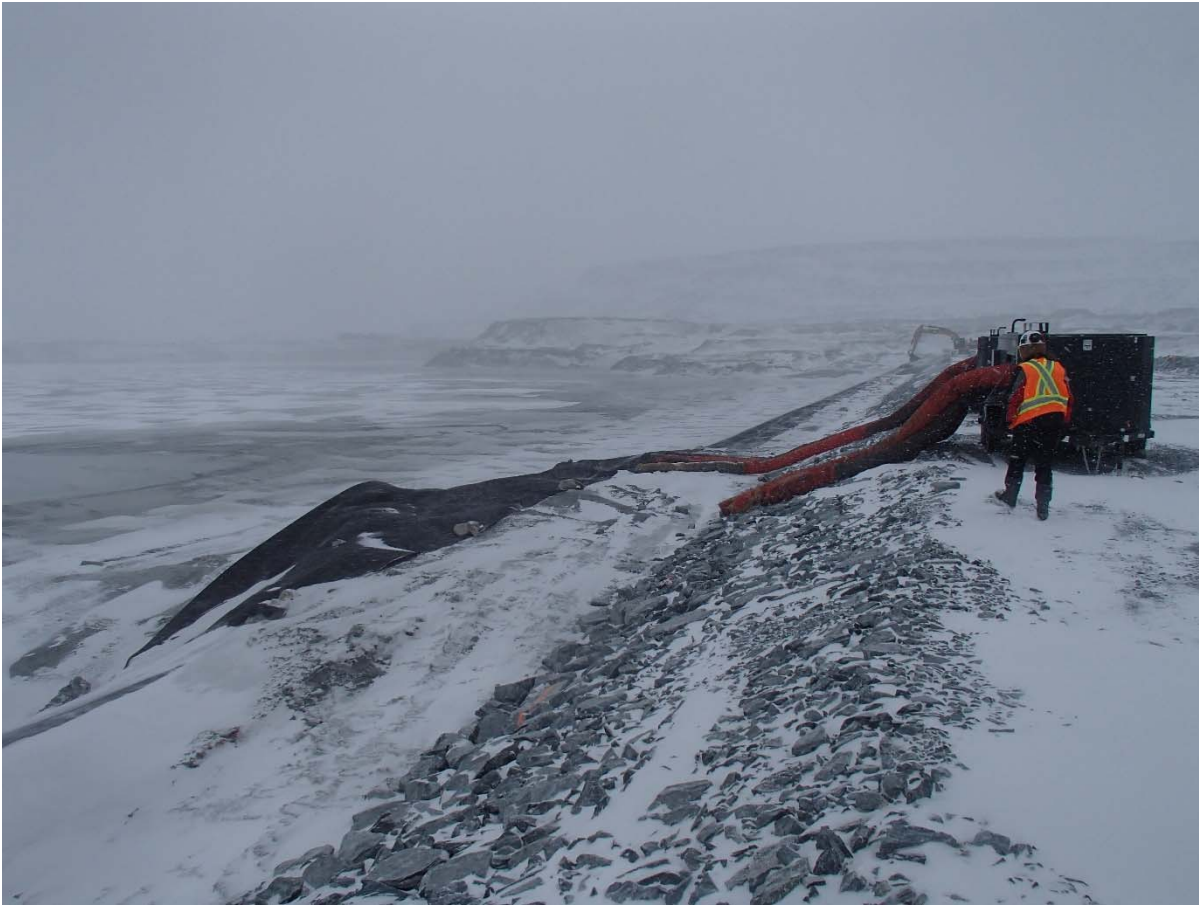
- The intermediate volcanic (IV) rockfill placement on Central Dike is complete.
- The QA Manager reiterated that the A.B. Gensets (model #1D008K4NACU) frost fighters used to defrost the 0,4 m (approx.) thick deposition fingers materials on the LLDPE liner must not be applied directly on the LLDPE as intense heat may damage it.

**Photograph CD-1828: From Sta 0+410/-22 m, looking N. Defrosting of the deposition finger materials with two Frost Fighters at Sta. 0+390 m.**

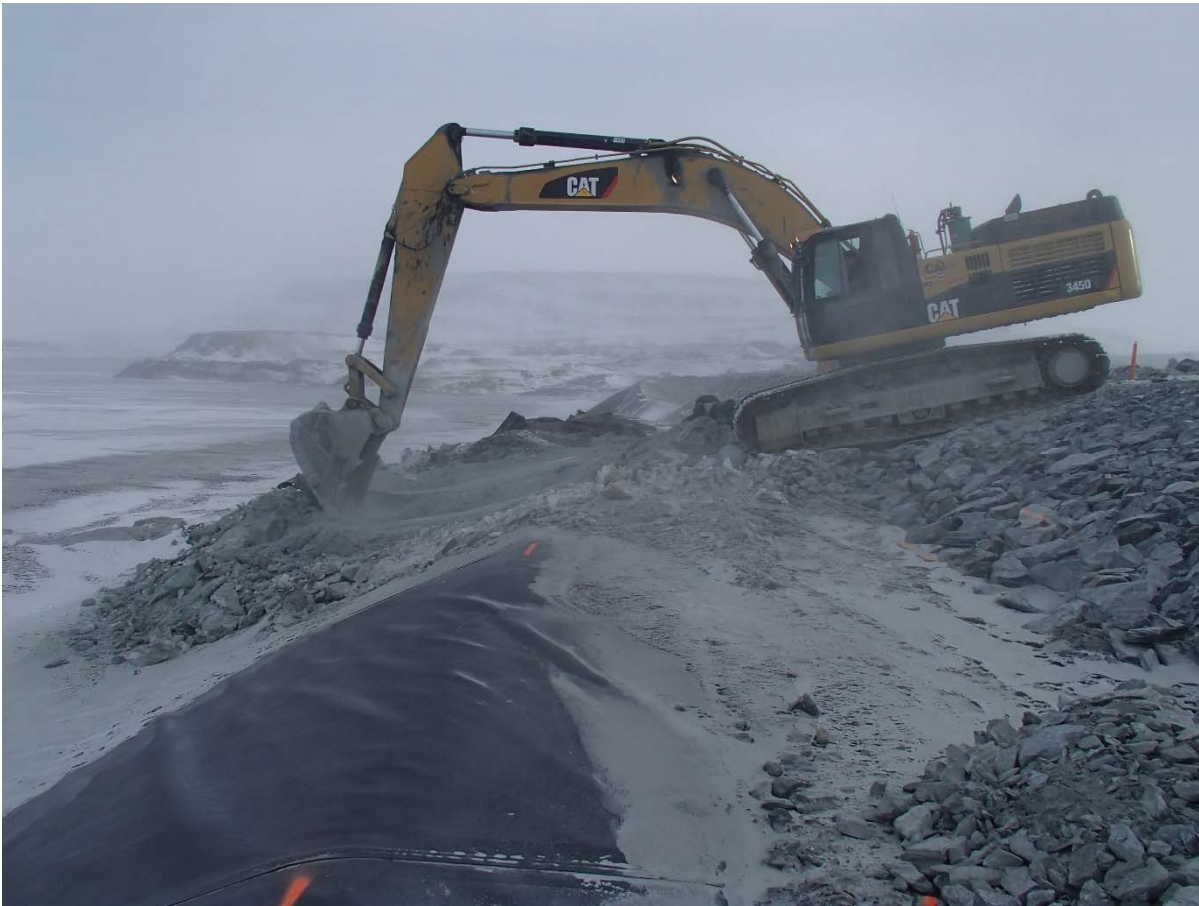
- Punctures were noticed on the top of the LLDPE liner around the four deposition fingers which were removed with the excavator. The holes all seem to be located above El. 142 m, where the horizontal extrusion weld for the raise of the liner is planned to be done. An inspection to assess the damages to the LLDPE liner on the upstream slope of Central Dike will be performed by the QA Manager.

Photograph CD-1830: From Sta. 0+420/-26 m, looking N. Removal of the deposition point finger materials with an excavator at Sta. 0+390 m.

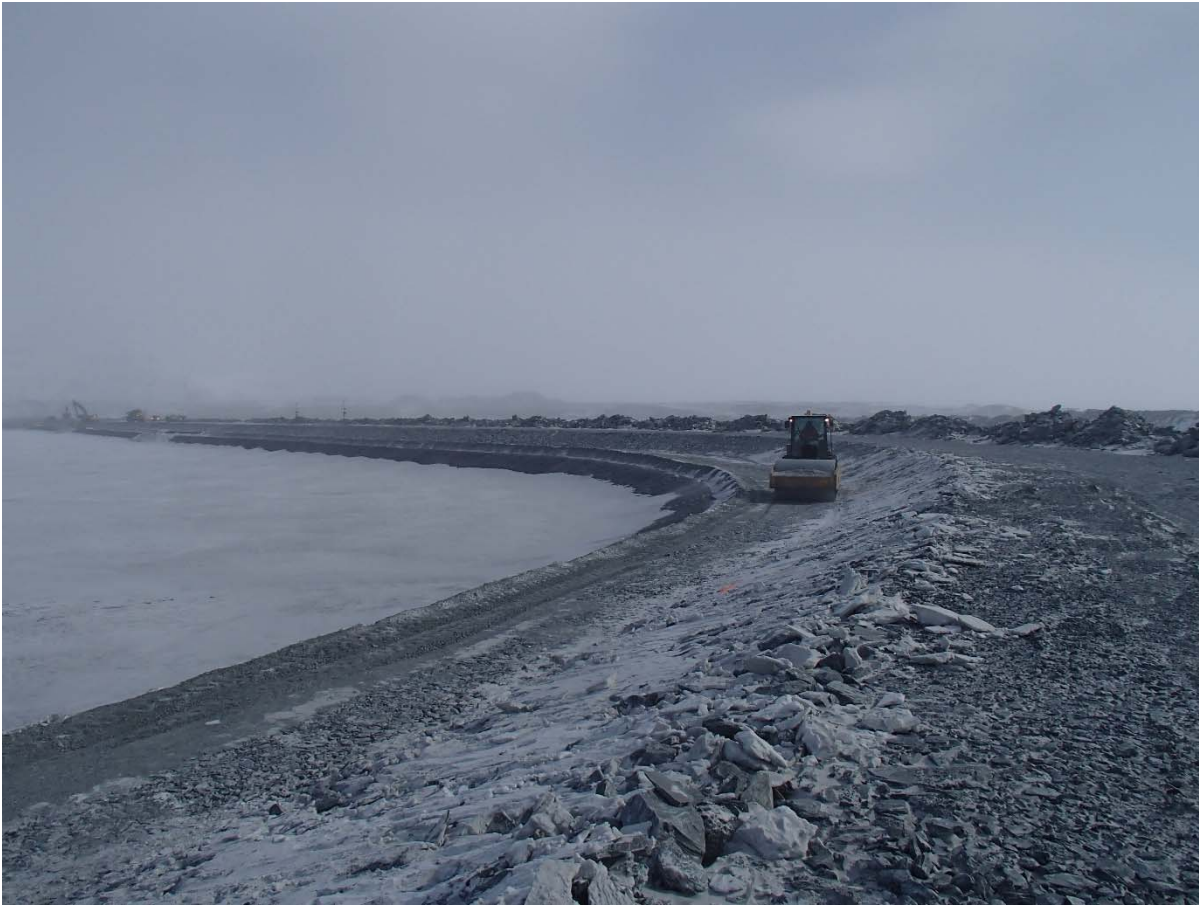
- Six passes of compactor were needed for the compaction of the first lift of coarse and fine filters at El. 143.5 m on Central Dike to achieve the maximum compaction (assessed visually). No watering of the filter materials was possible as water would have frozen inside the lift. The compaction was followed closely by the QC and QA personnel. Compaction of the filters is not optimal. However, the placed filter materials are not expected to settle significantly and will provide a good foundation for the geosynthetics.

**Photograph CD-1831: From Sta. 40+730/-24 m, looking NE. Compaction of the first 0.5 m lift (approx.) of fine and coarse filters material at El. 143.5 m with a 10-tonne smooth-drum compactor with vibration (6 passes) from Sta. 40+730 m to 0+830 m and from Sta. 0+175 m to 0+490 m.**

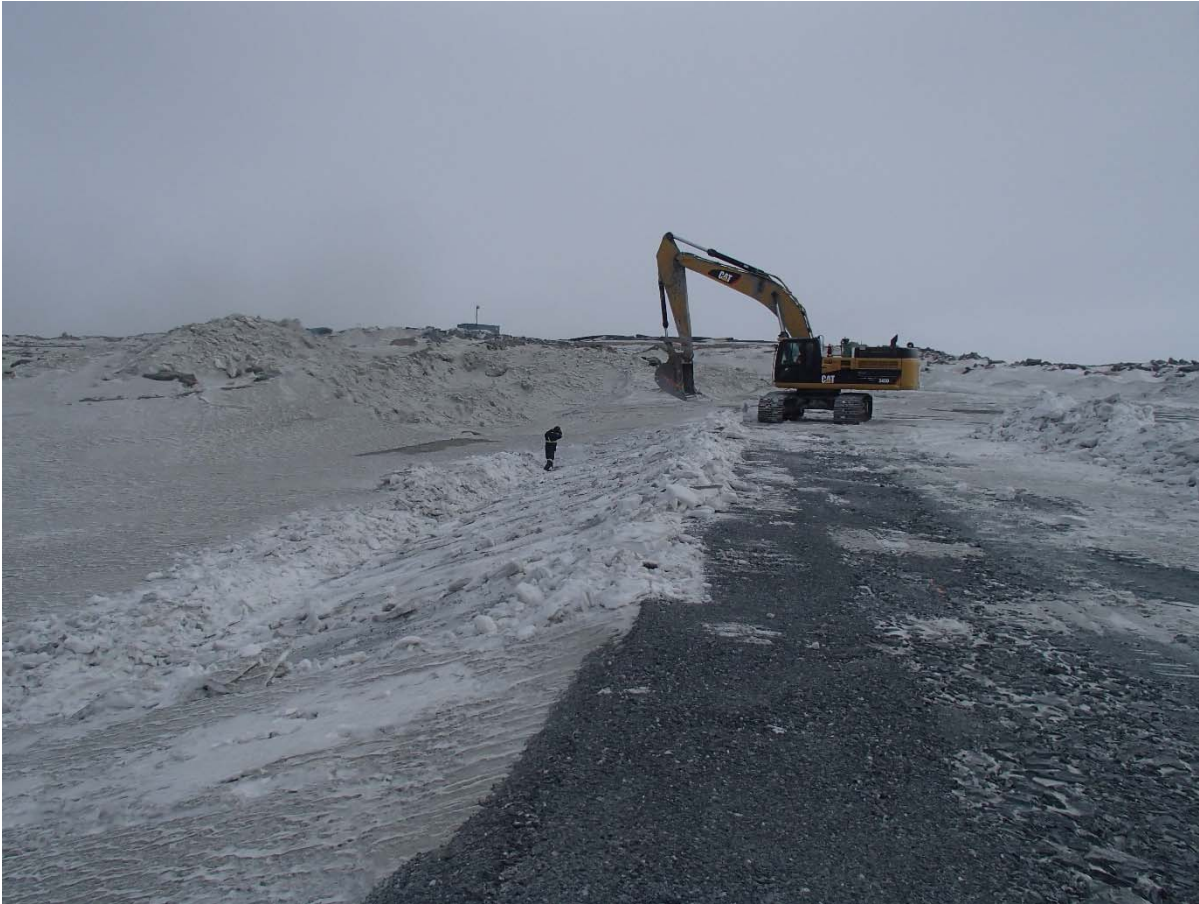
- Snow and ice are beginning to melt. As a result, some water is ponding on the upstream toe line tie-in on the east extremity of SD3 and will need to be pumped out before installation of the LLDPE liner next week. The QA Manager noticed that a horizontal portion of existing LLDPE liner in the upstream toe liner tie-in had been exposed and damaged during snow removal operations at approx. Sta. 20+595 m.

Photograph SD3-297: From Sta. 20+730/-10 m, looking SE. Removal of snow on the upstream slope of SD3 with an excavator, from Sta. 20+640 to 20+760 m.

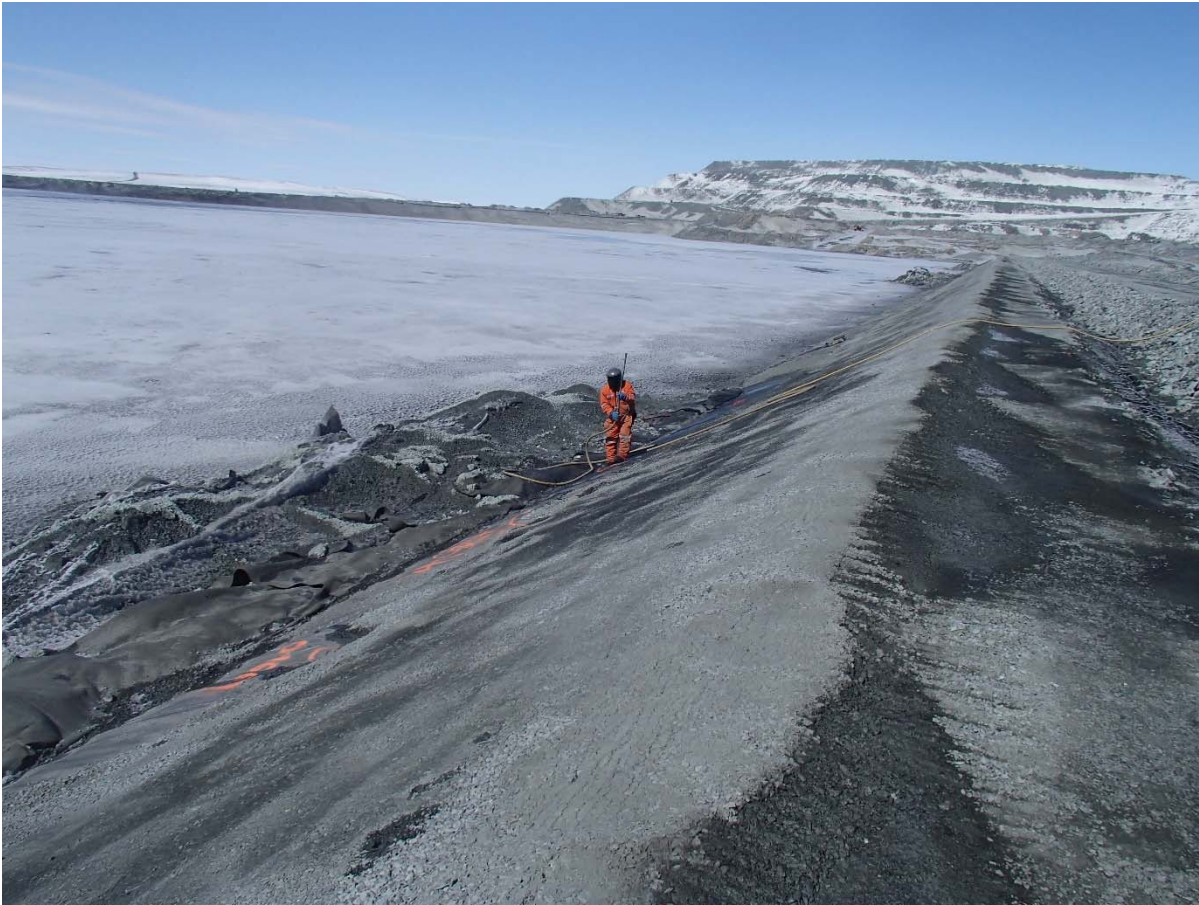
**Photograph CD-1586: From Sta. 0+670/-24 m, looking N. Clean-up of the fine filter placed against the slope at the deposition finger at approx. Sta. 0+670 m with pressurized air stream to expose 1 m of LLDPE liner, in preparation for the new liner installation.**

- The last panel of existing liner on the upstream slope at approx. Sta. 20+595 m is covered in finer filter. This fine filter will need to be removed to expose the liner for seaming of the next panel and prevent any contamination of the tie-in compacted sieved till;
- The portion of damaged liner needs to be exposed on at least 0.5 m on each side of the tear to allow for repairs and to ensure no further damage is encountered;
- The upstream slope of fine filter will need additional compaction with the roller attachment around the new upstream toe liner tie-ins at the extremities of the dike to ensure a smooth slope.

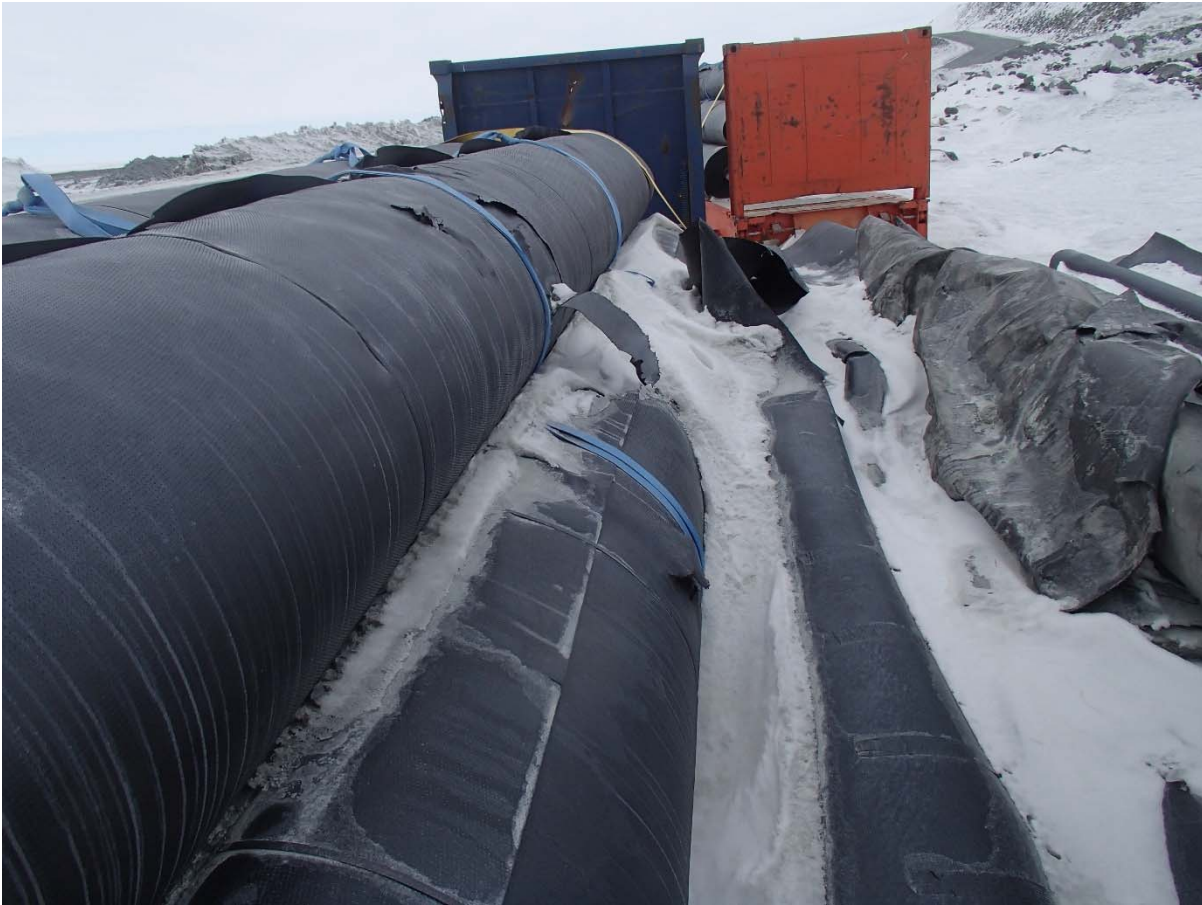
- The QA Manager inspected visually the LLDPE rolls stored between Central Dike and the Rock Storage Facility. The new rolls are stored outside on 2 trailers, while old rolls are stored on the ground and are covered in snow. Those seem to be leftovers from last year's construction season and should not be used on the dikes this year. Most new rolls are in good condition, with some rolls on the blue trailer showing tears on their outer layers. It will be important before the LLDPE liner placement to discard the first few meters of the rolls to ensure that only intact, good quality material is used.

Photograph from the LLDPE storage site: View of new rolls stored on a trailer, showing tears.

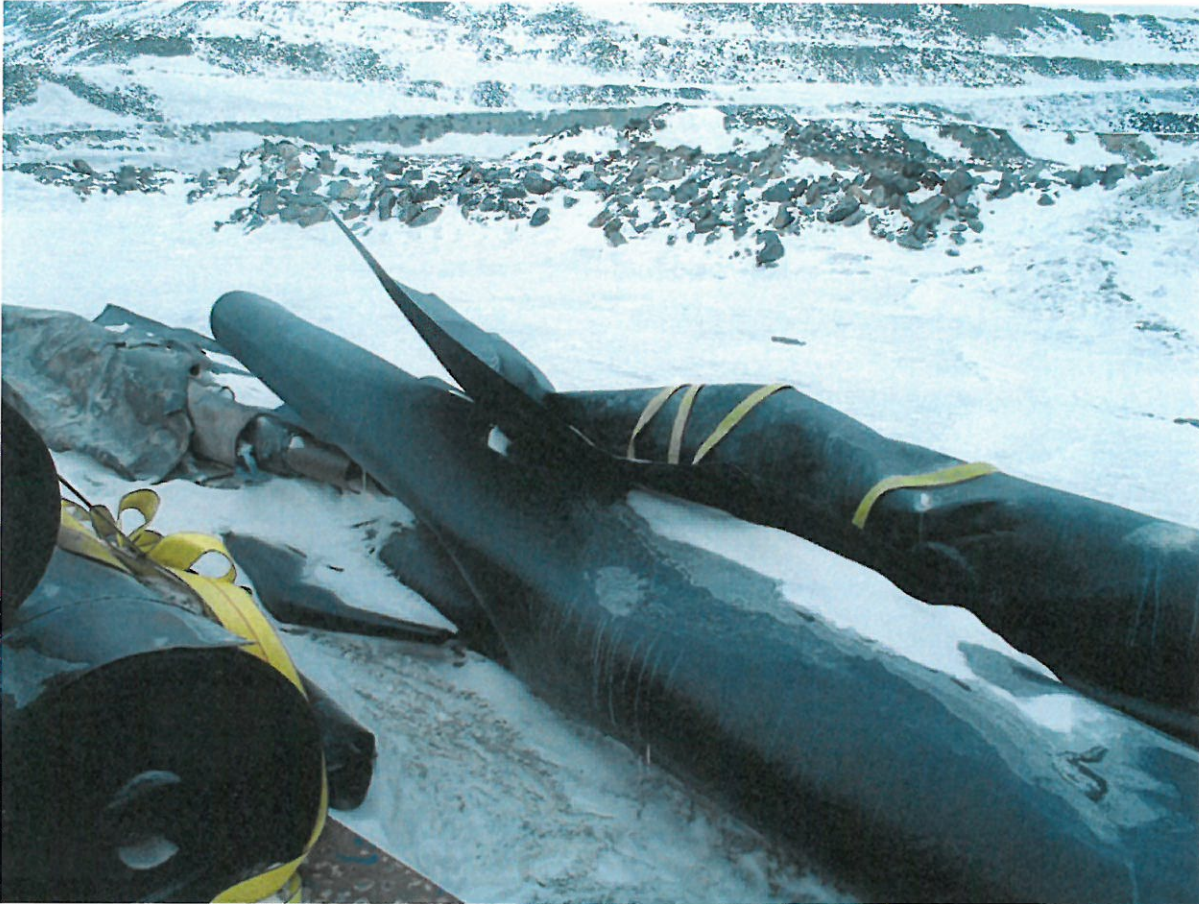
Photograph from the LLDPE storage site: View of old rolls stored on the ground.

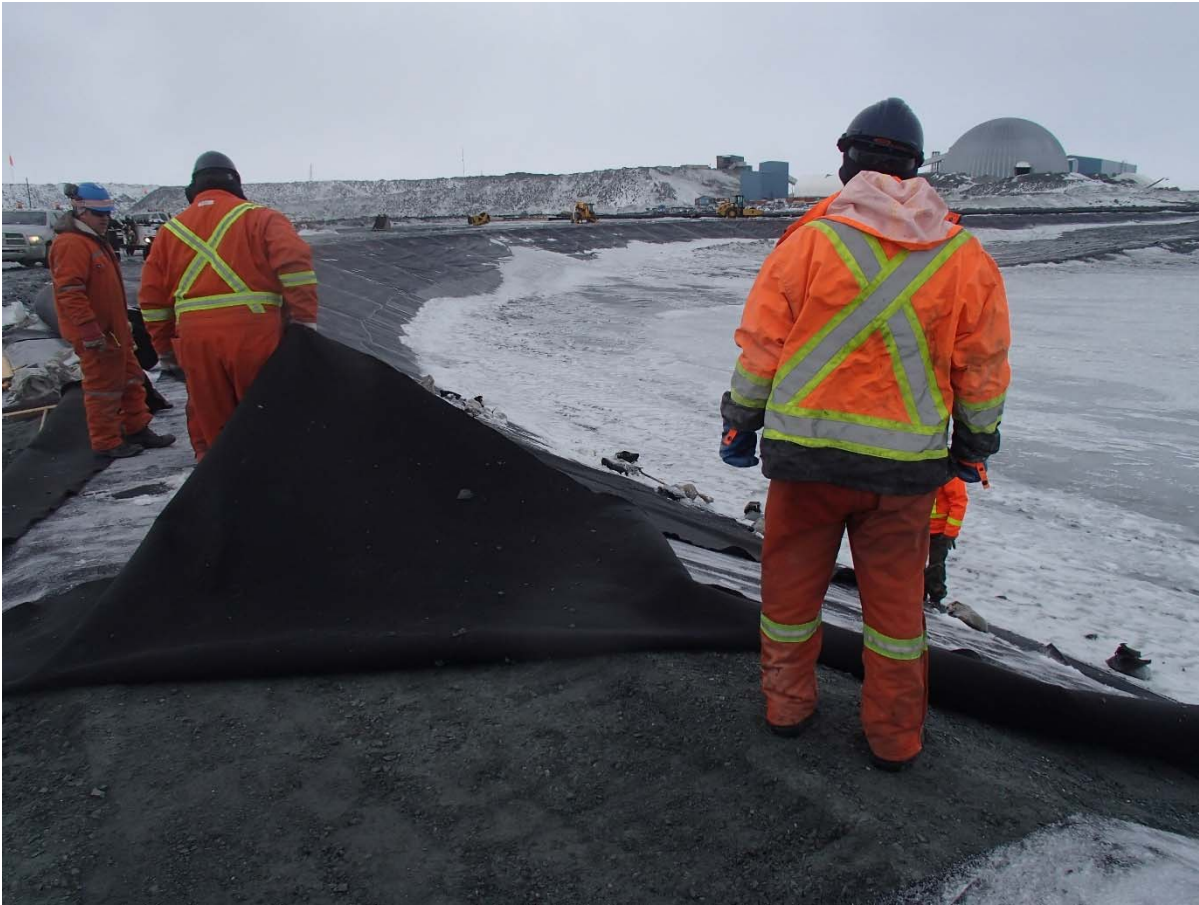
**Photograph CD-1868: From Sta. 0+915/-24 m, looking S. Removal of the wet geotextile in place from Sta. 0+935 m to 0+900 m.**

- The uncovered geotextile in place is wet and frozen in the morning. In order to avoid welding issues due to humidity, uncovered geotextile panels are inspected and if deemed too wet, they are removed and replaced with new geotextile before LLDPE liner installation.

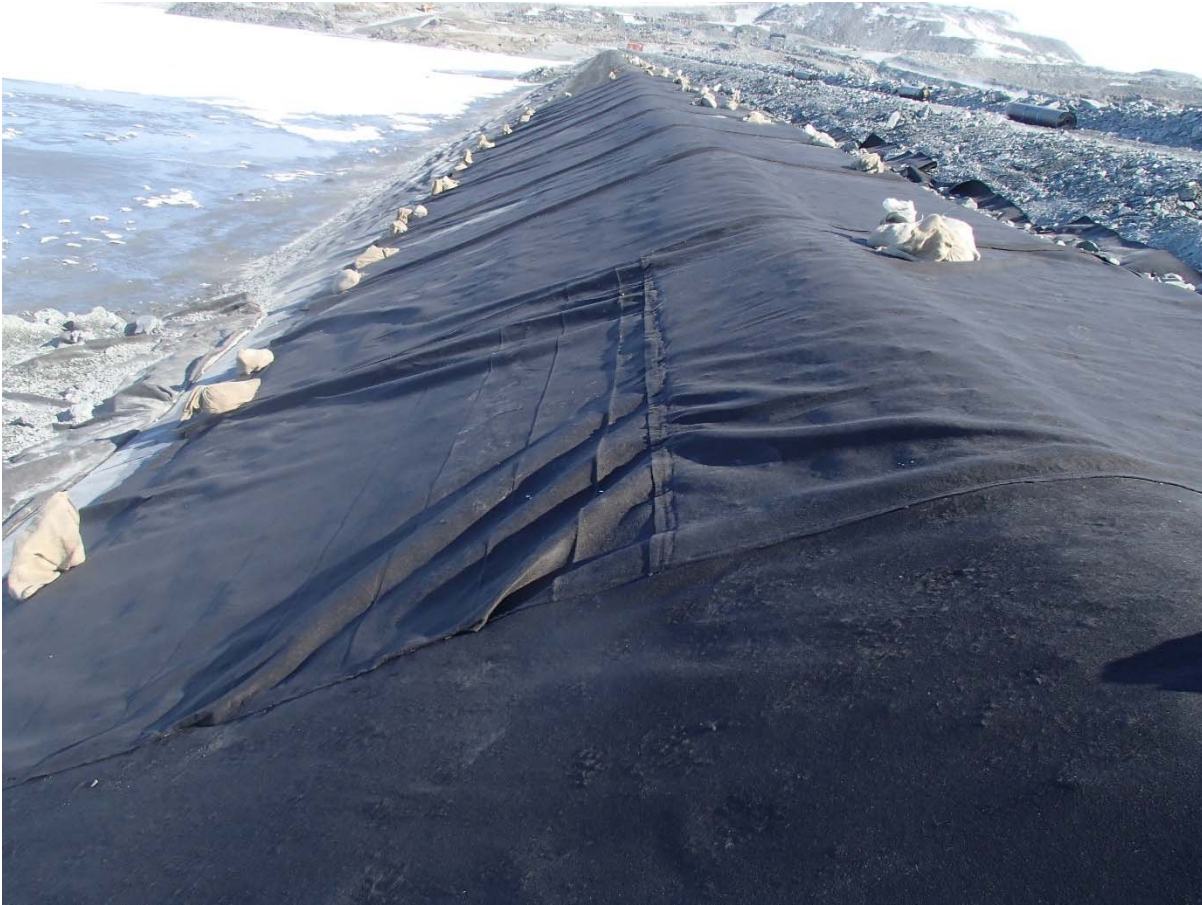
- The QA Manager observed a geotextile panel with a horizontal weld in the slope at Sta. 0+520 m following its installation. The panel was removed and replaced by a new geotextile panel before installing the LLDPE liner panels.

**Photograph CD-1881: From Sta. 0+530/-27 m, looking N. View of a geotextile panel with a horizontal weld in the slope at Sta. 0+520 m before its removal.**

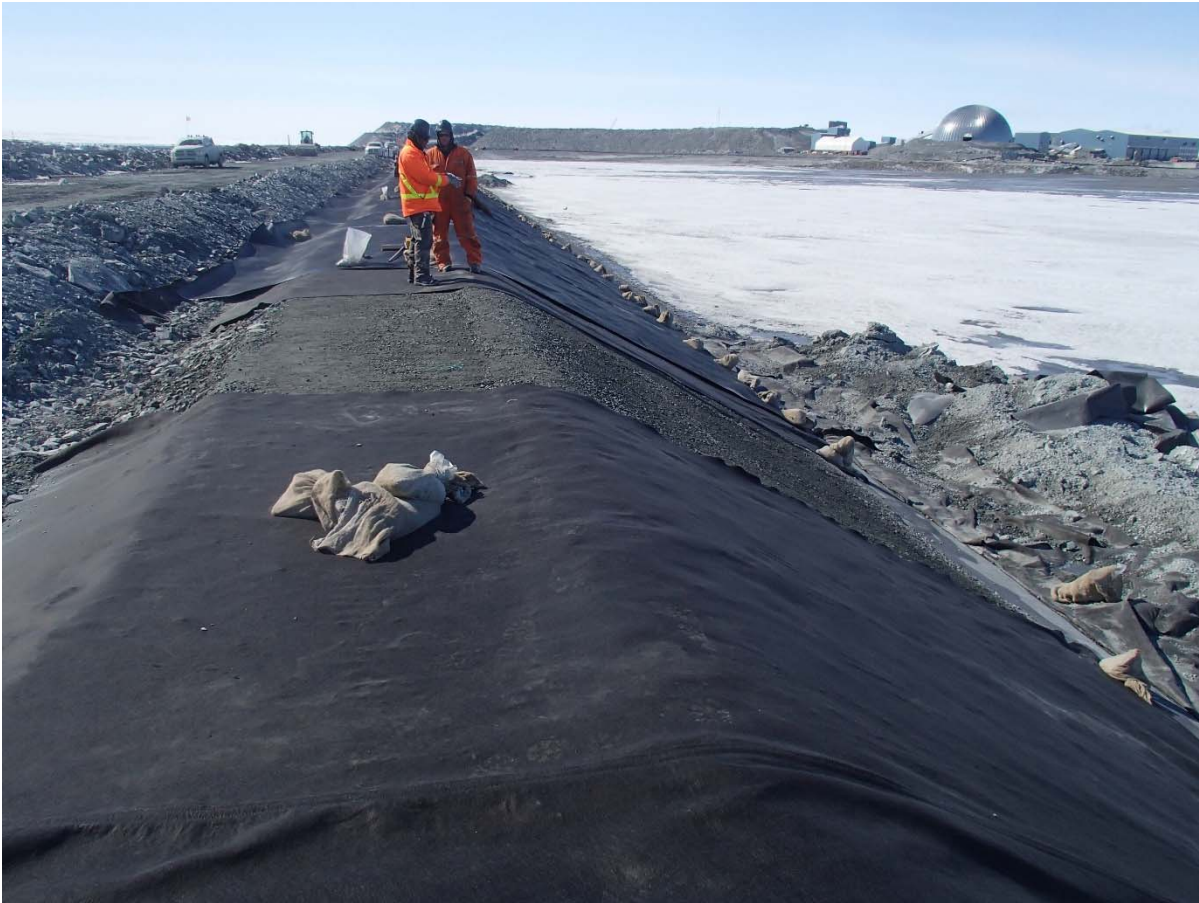
**Photograph CD-1882: From Sta. 0+510/-25 m, looking S. View of the emplacement of the geotextile panel with a horizontal weld in the slope at Sta. 0+520 following its removal.**

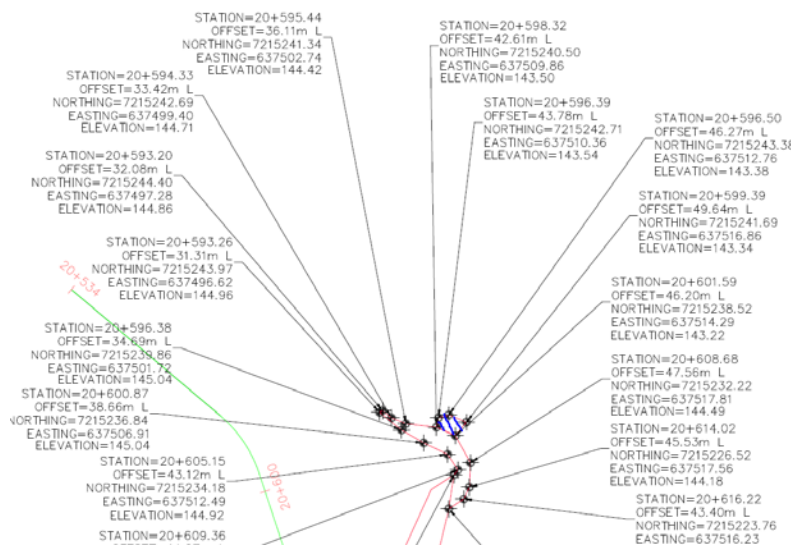
**Figure 1: Sketch of the area to test with the portable nuclear gauge**

- The QA Manager observed a depression on the compacted sieved till layer of the upstream toe liner tie-in at approx. Sta. 20+595 m where the pump evacuated the water for three days. The depression is approximately 3 m wide by 5 m long and 0.15 m deep. It was filled with compacted sieved till. As no portable nuclear gauge was present on site, a sample was taken for water content analysis and gradation, and no compaction test could be done. Compaction tests will be required on the compacted sieved till before the next phase of construction for the installation of the LLDPE liner protection cover on SD3.

- Calibration certificate of the tensiometer to be provided by ZTG.
- An alternative solution needs to be found for the TenCate Mirafi S1600 geotextile that is not equivalent to Texel 34.
- Portable nuclear gauge compaction tests will be required on the compacted sieved till around Sta. 20+595 m, El. 143.3 m, identified on the blue hatched area in Figure 1, before the next phase of construction for the installation of the LLDPE liner protection cover on SD3.

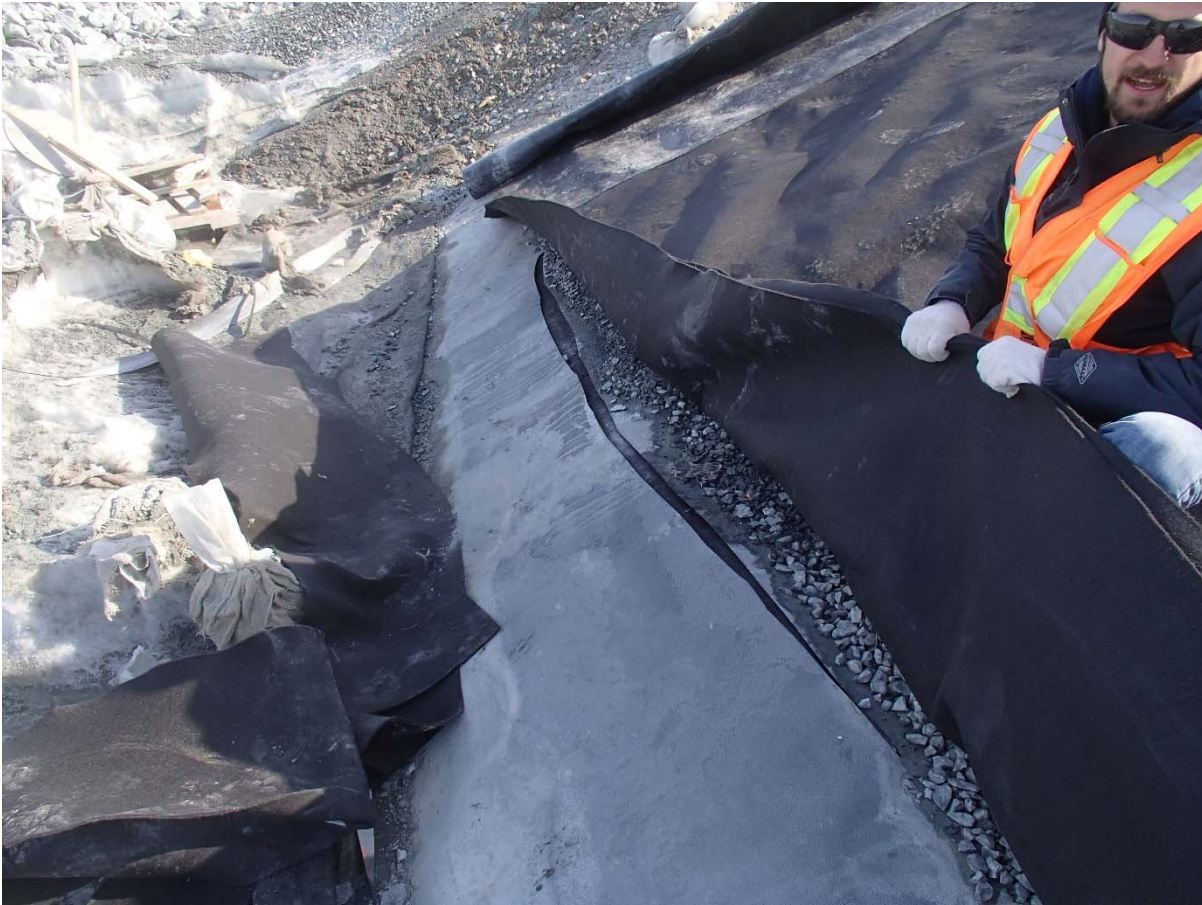
- An underlying liner has been cut at around Sta. 0+160 to drain the water (see photograph below) and is overlapped by the new panel 933.
- The QA Manager observed holes on the LLDPE liner panels 832, 833, 834, 879, 883 and 922. All holes were marked in paint, repaired and vacuum tested.
- Water leaking from extrusion fillet seams were noticed by the QA Manager at the bottom of panels 803, 807, 808, 810, 814, 815, 816 and 818. All leaks were marked with paint, repaired and vacuum tested.
- The installation of geosynthetics at Central Dike was completed on June 9<sup>th</sup>.

**Photograph CD-1889: From Sta. 0+150/-28 m, looking N. View of the underlying liner that has been cut at around Sta. 0+160 m to drain the water.**

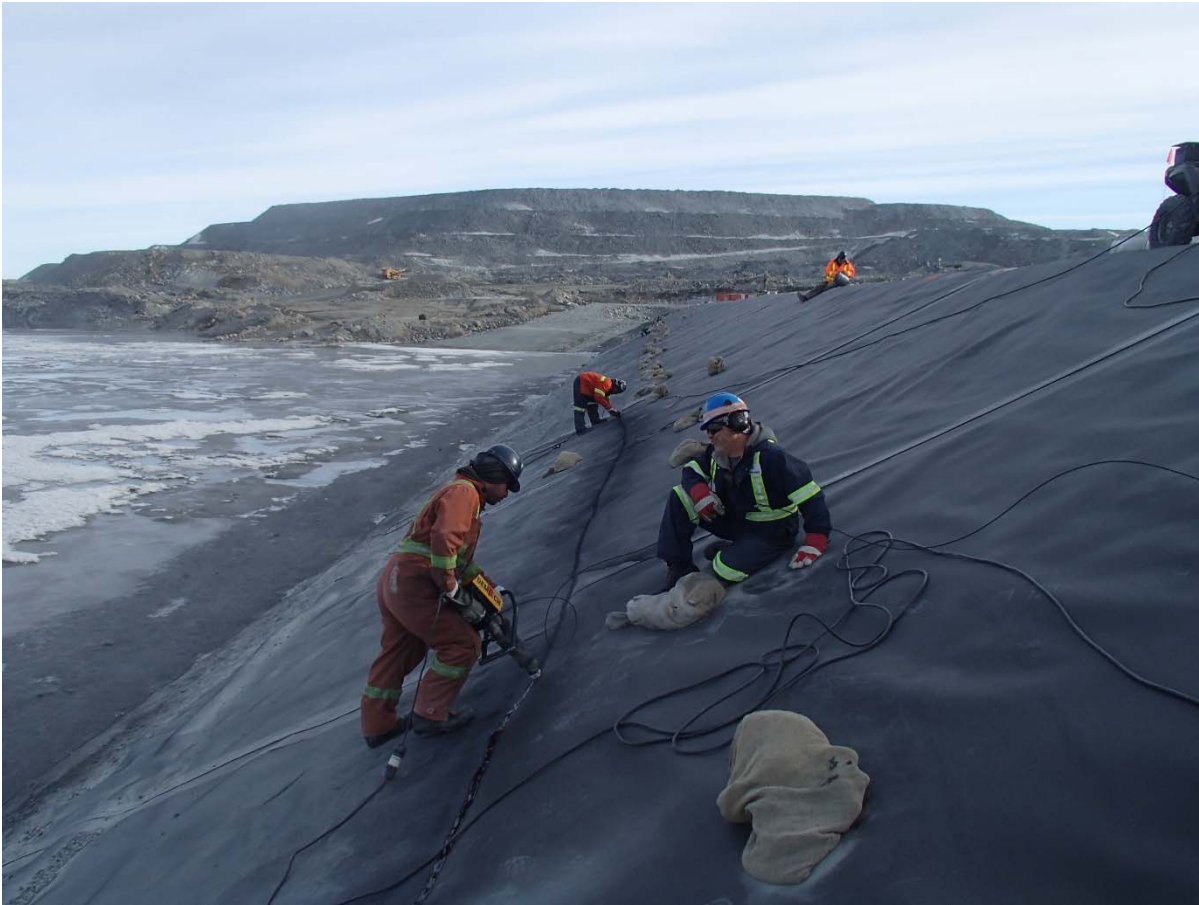
Photograph CD-1890: From Sta. 0+310/-26 m, looking N. View of the extrusion welding.

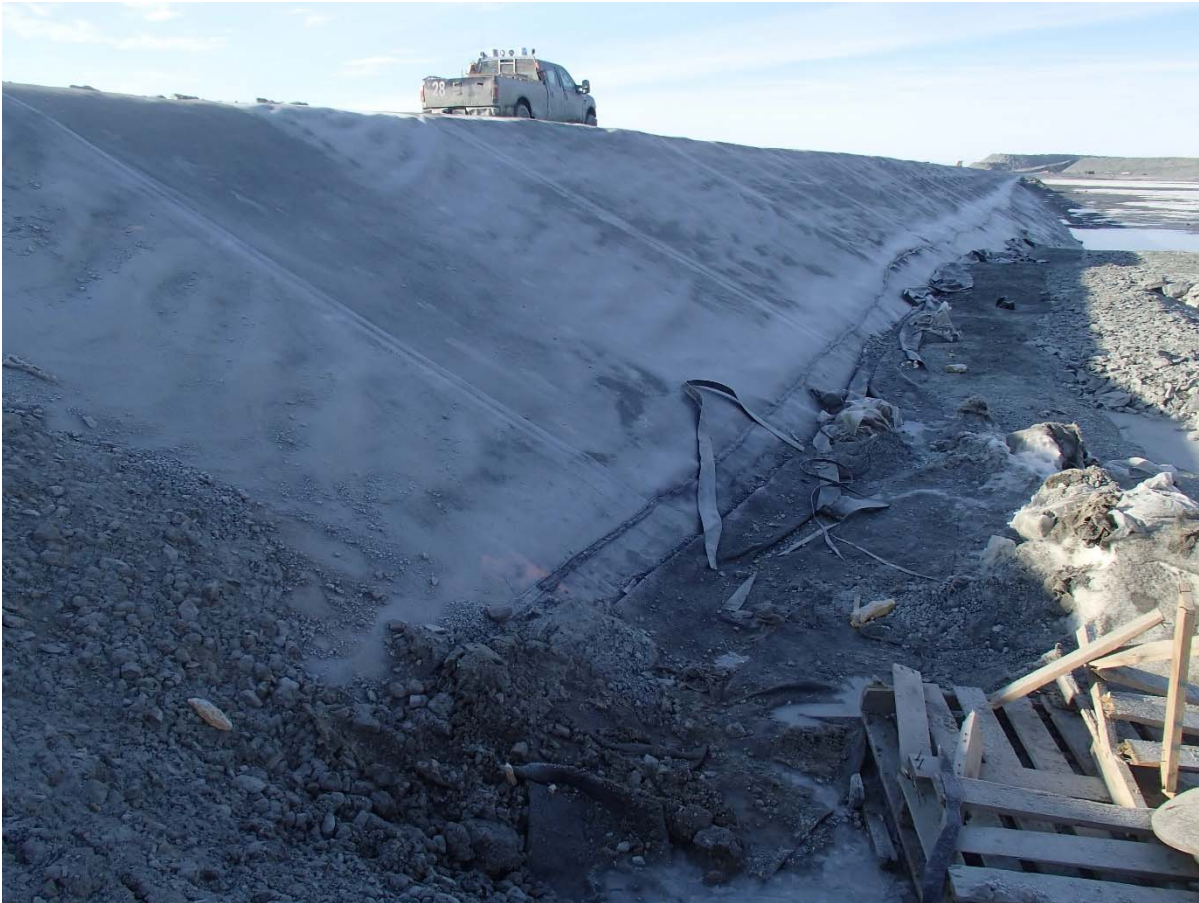
**Photograph CD-1892: From Sta. 0+155/-32 m, looking S. View of the liner panel 933 overlapping the underlying liner that has been cut at around Sta. 0+160 m to drain the water.**

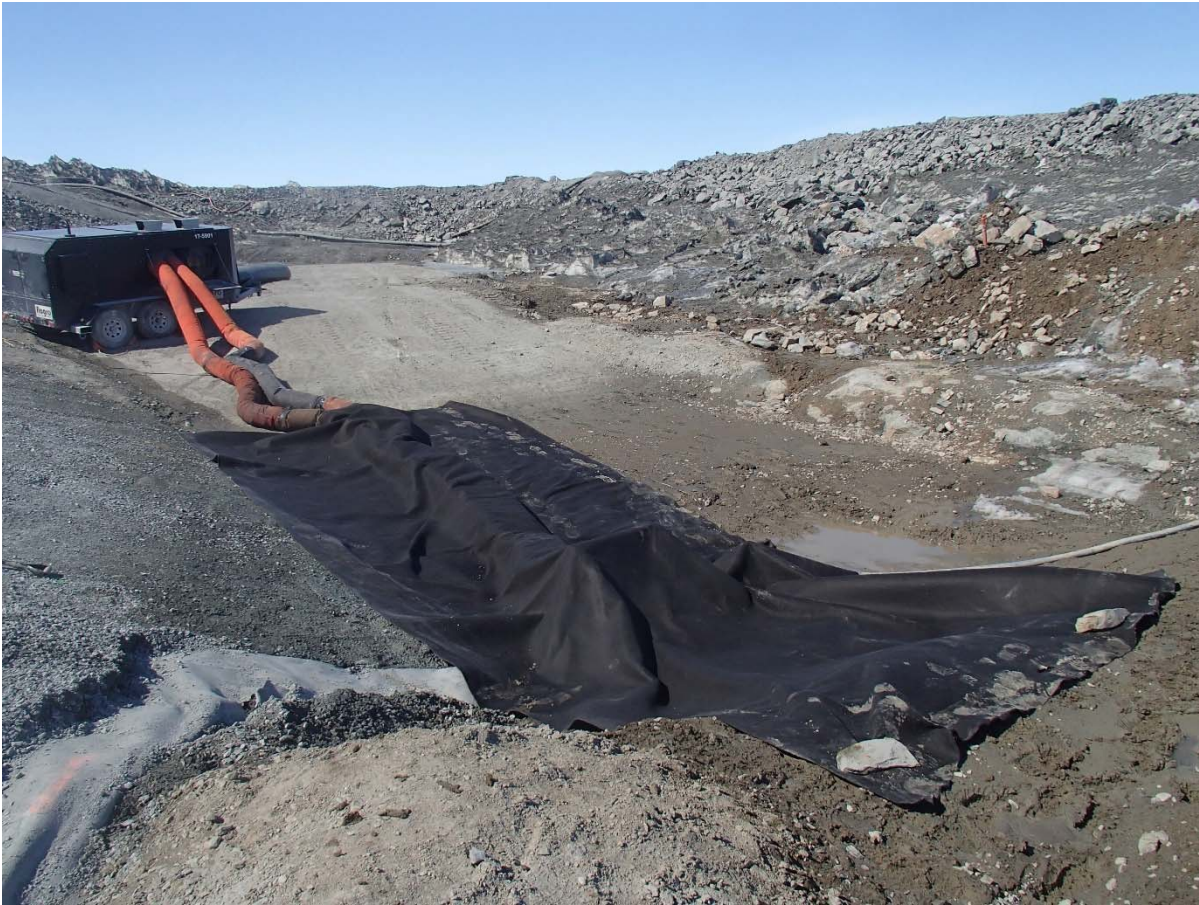
- The water runoff from a melting snow berm north of SD3 was flowing into the small pond on the first compacted sieved till layer of the upstream toe liner tie-in at approx. Sta. 20+595 m. A temporary trench was dug to deviate the water flow to allow for the dewatering of the pond before the installation of the LLDPE. The water ponding was then pumped out. A Genset Frost-fighter heated the sieved till layer and a pump evacuated the water.

**Photograph SD3-305: From Sta. 20+610/-48 m, looking NW. Dewatering of the water ponding on the first compacted sieved till layer of upstream toe liner tie-in. A Genset Frost-fighter is heating the sieved till layer and a pump is evacuating the water.**

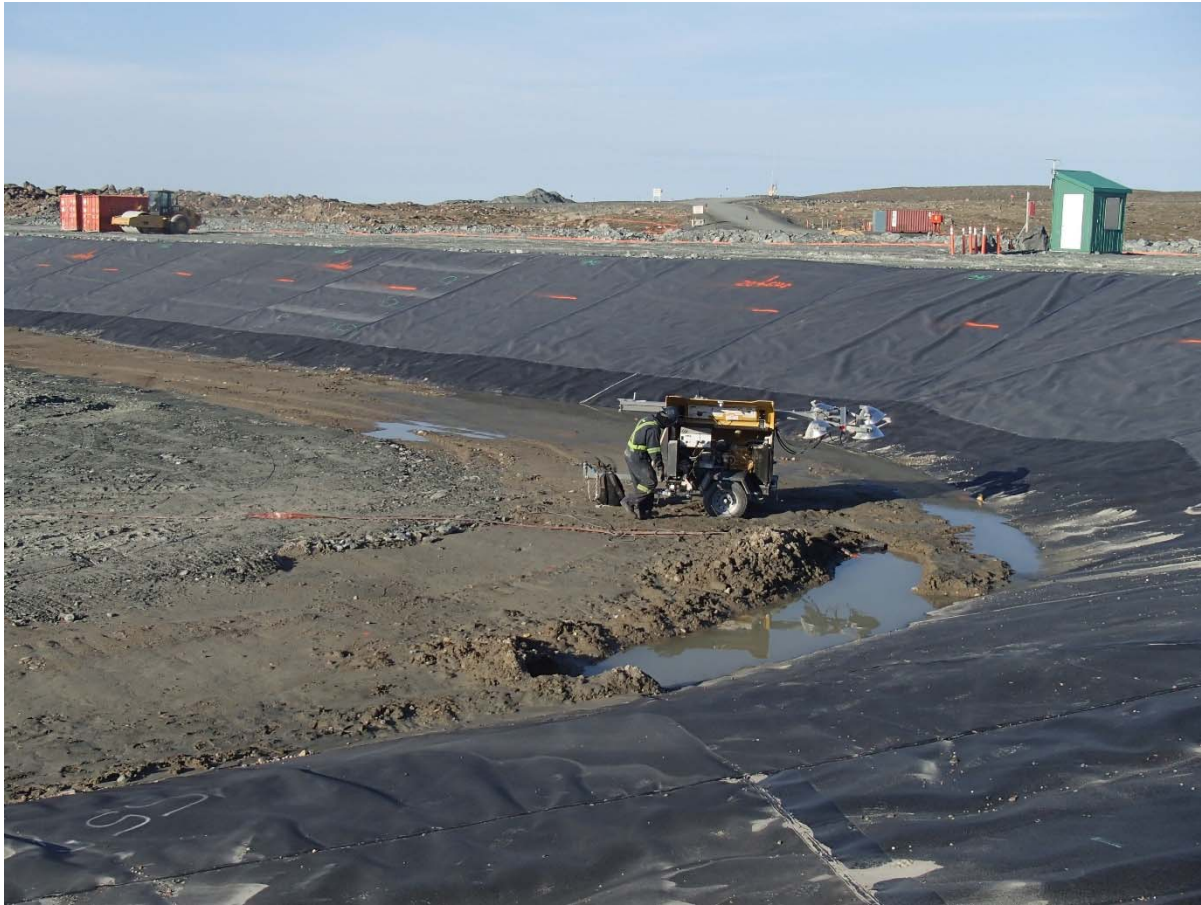
**Photograph SD3-321: From Sta. 20+610/-56 m, looking SW. Water ponding at El. 142m on the compacted sieved till layer of the upstream toe liner tie-in at approx. Sta. 20+620 m to 20+630 m was pumped.**

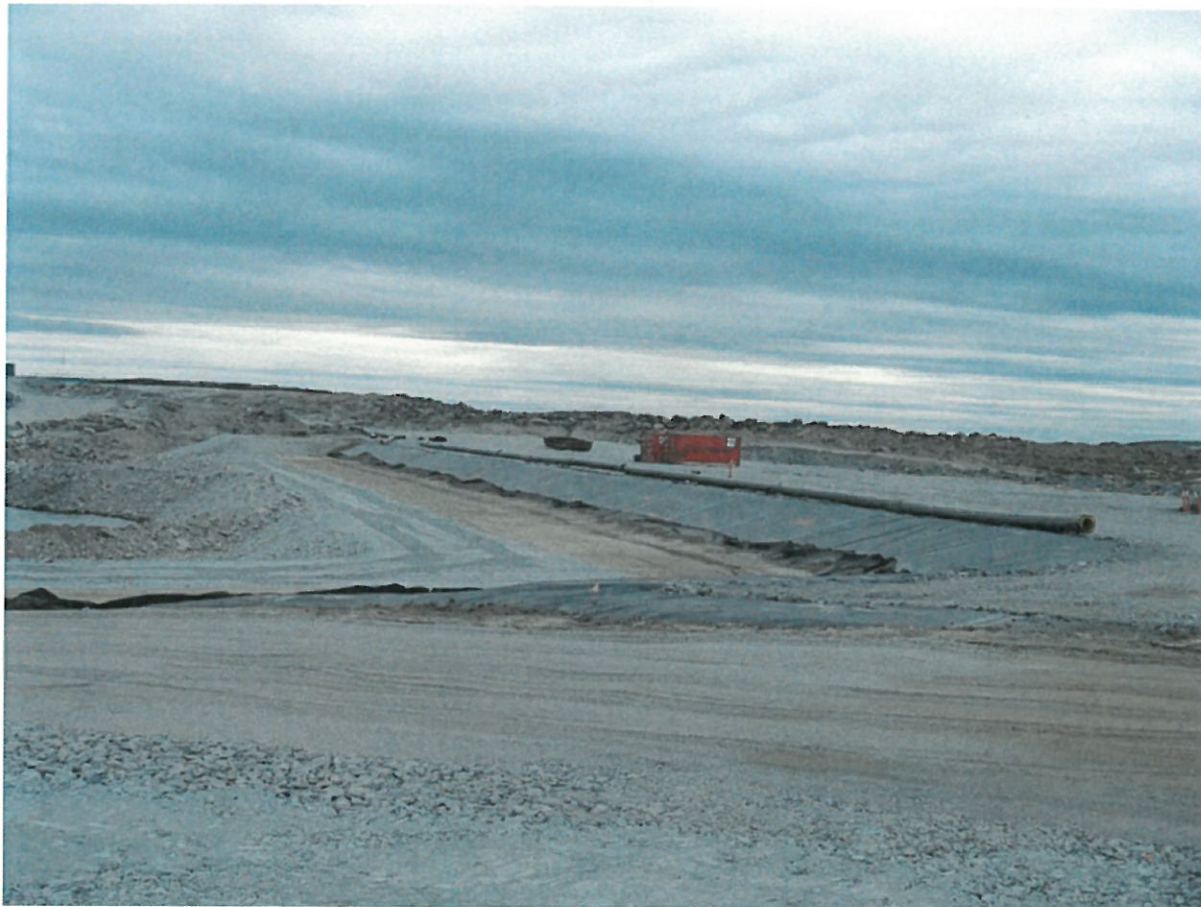
**Photograph SD3-352: From Sta. 20+600/-59 m, looking SW. Corrections to the layer of compacted sieved till placed against the upstream slope from Sta. 20+599 m to 20+613 m.**

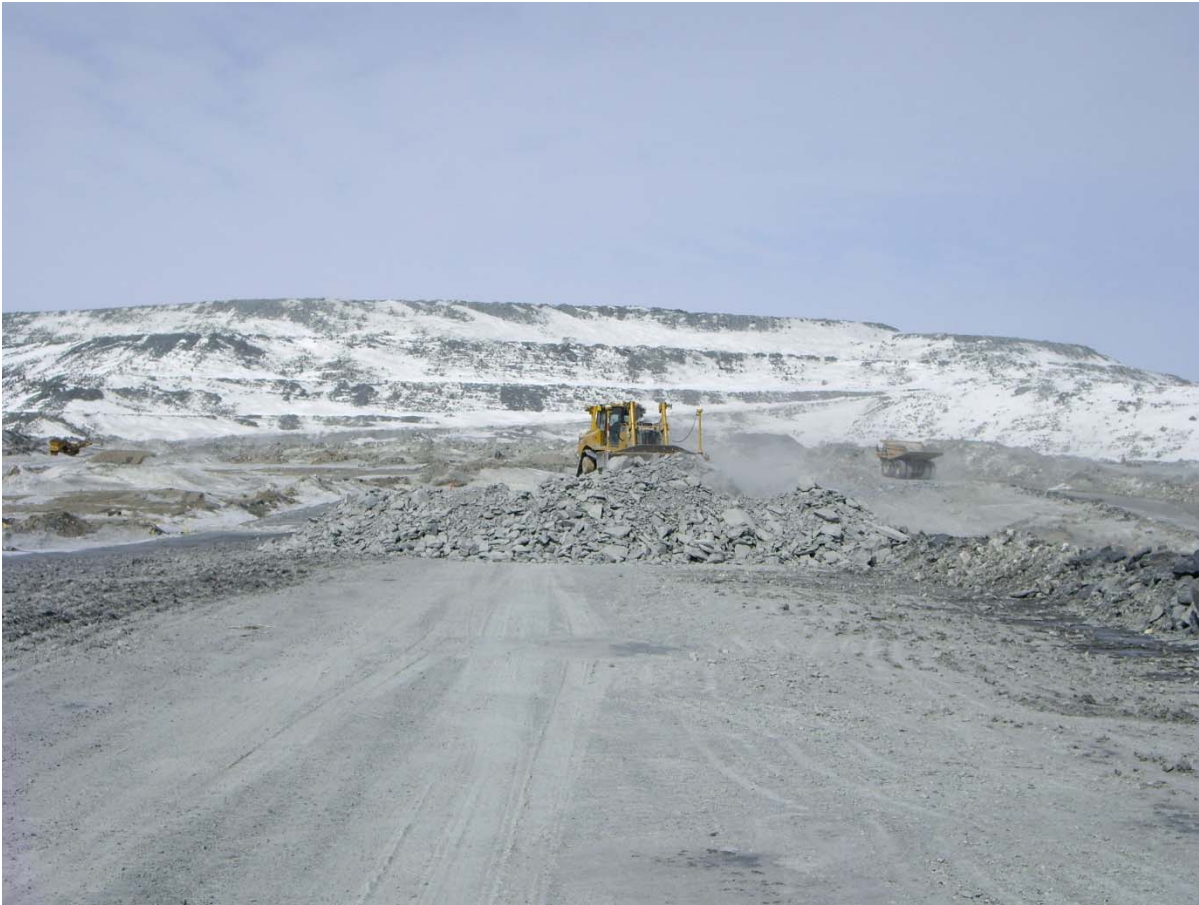
- The LLDPE liner installed on the upstream slope of Central Dike was damaged near the deposition finger at approx. Sta. 0+650 m during snow removal operations. The amount of repairs needed will be estimated when the deposition finger is removed entirely before installation of the new liner at El. 145 m.

*Photograph CD-1796: From Sta. 0+650/-28 m looking N. Damaged geomembrane near a deposition finger on Central Dike.*
