### **Meadowbank 2018 TSF As-built report**

**2018 CONSTRUCTION SEASON AS-BUILT REPORT  
TAILINGS STORAGE FACILITY  
MEADOWBANK GOLD PROJECT, NUNAVUT**

1897439-1578-R-Rev0

November 2018

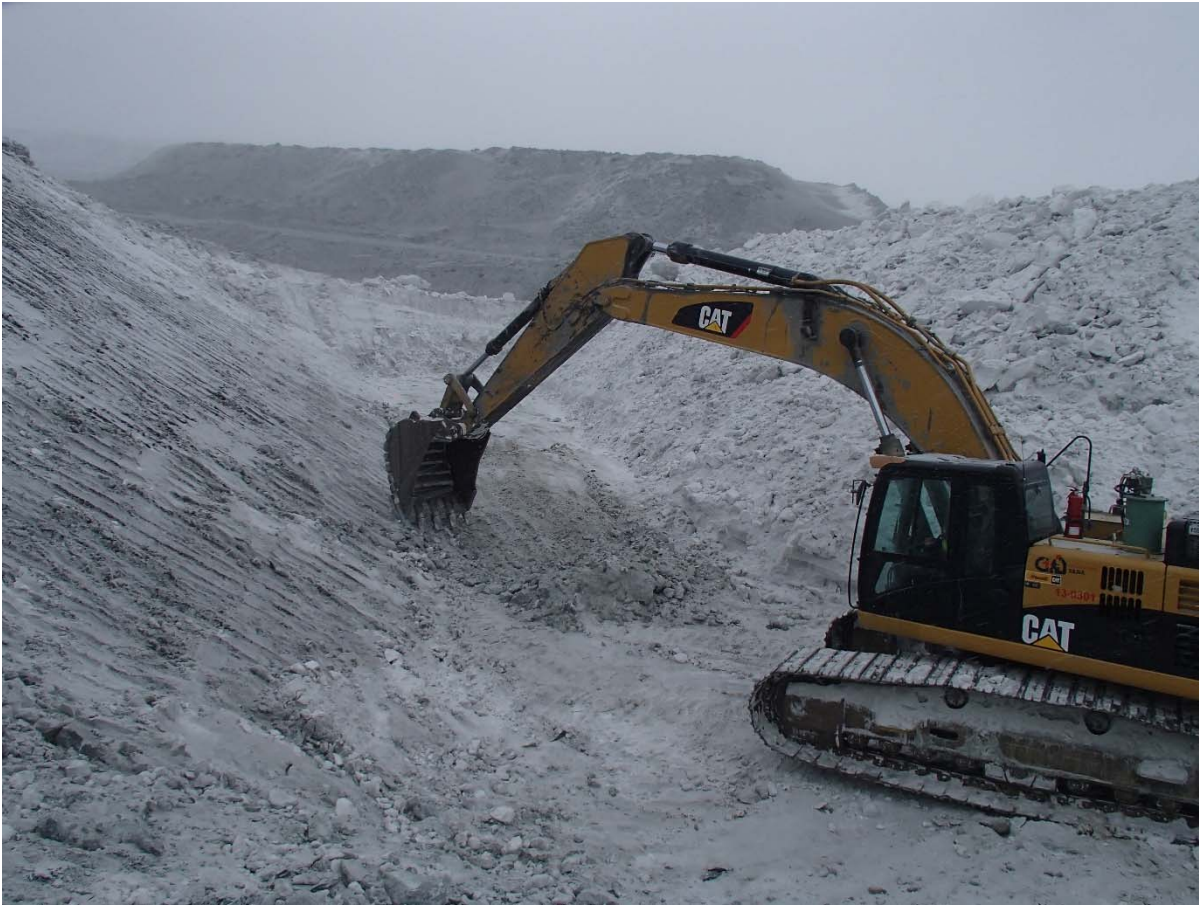
*Photograph CD-1804: From Sta. 40+790/-2 m looking S. Presence of oversize boulders on the existing slope at the junction between SD5 and Central Dike.*

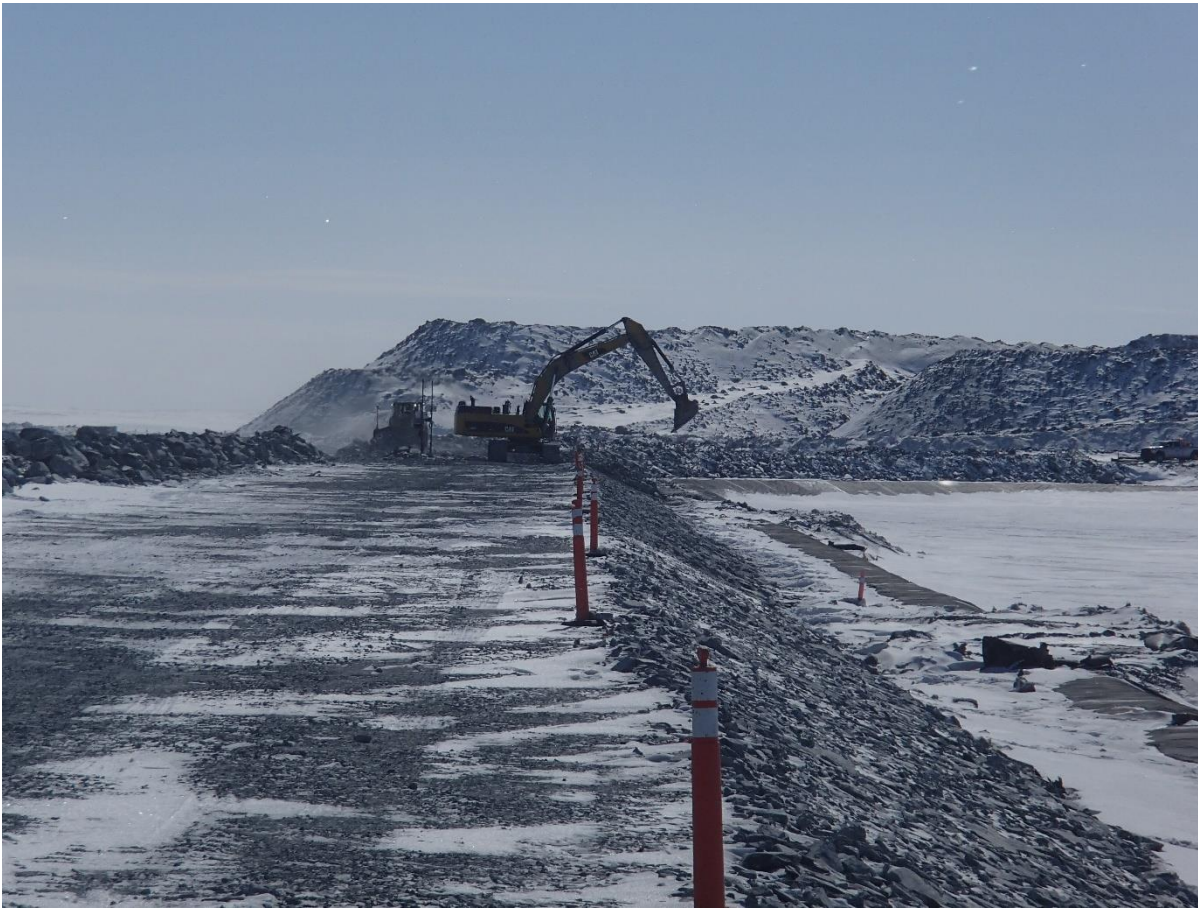
**Photograph CD-1819: From Sta. 0+560/-21, looking S. Profiling of the upstream slope (2H:1V) from El. 143 to 145 m with an excavator between Sta. 0+560 m and 0+830 m.**

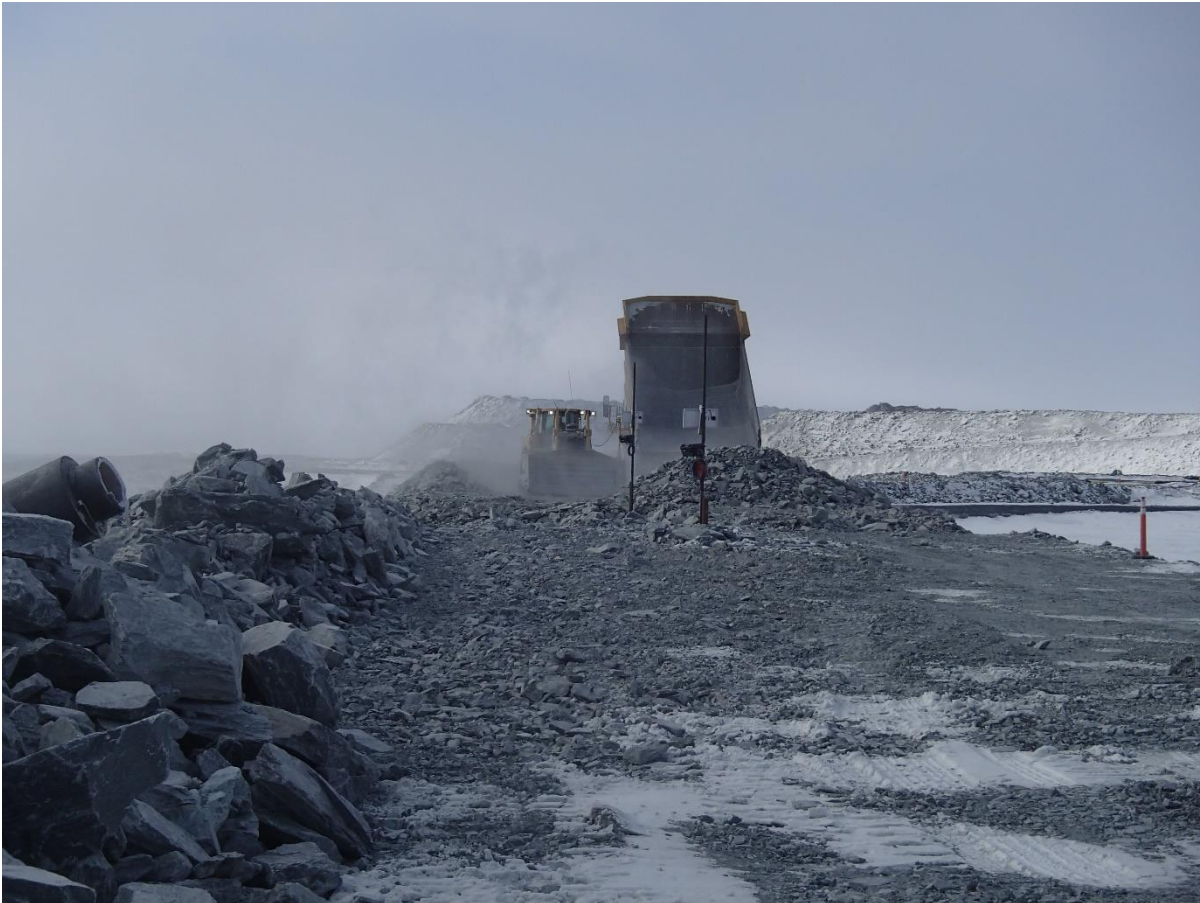
Photograph CD-1820: From Sta. 0+790/-7, looking S. Placement of a 2 m thick (approx.) lift of intermediate volcanic (IV) rockfill from El. 143 m to El. 145 m from approx. Sta. 0+880 m to 0+830 m (o.s. -28 to -11 m).

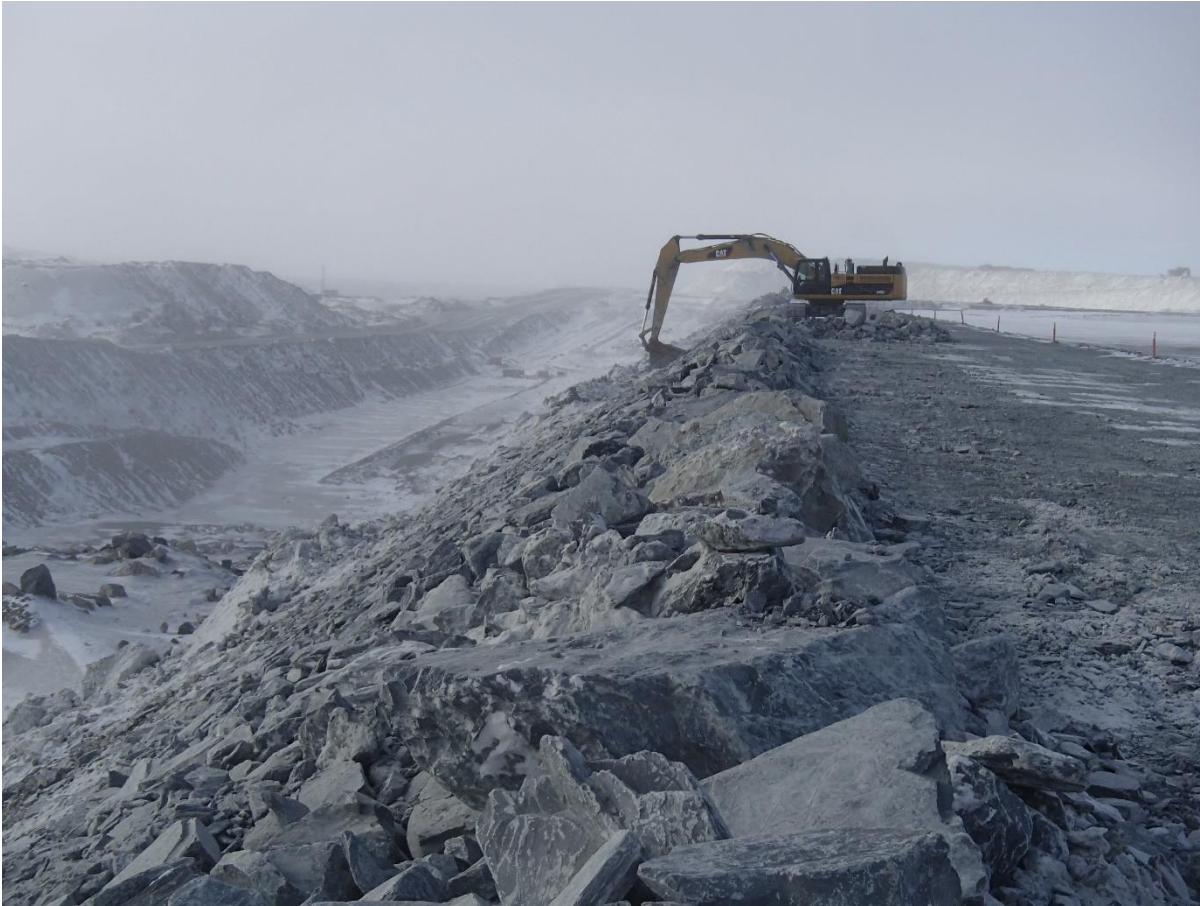
**Photograph CD-1821: From Sta. 0+175/+3, looking S. Profiling of the downstream slope (1.5H:1V) from El. 143 to 145 m with an excavator between Sta. 0+250 m and 0+330 m.**

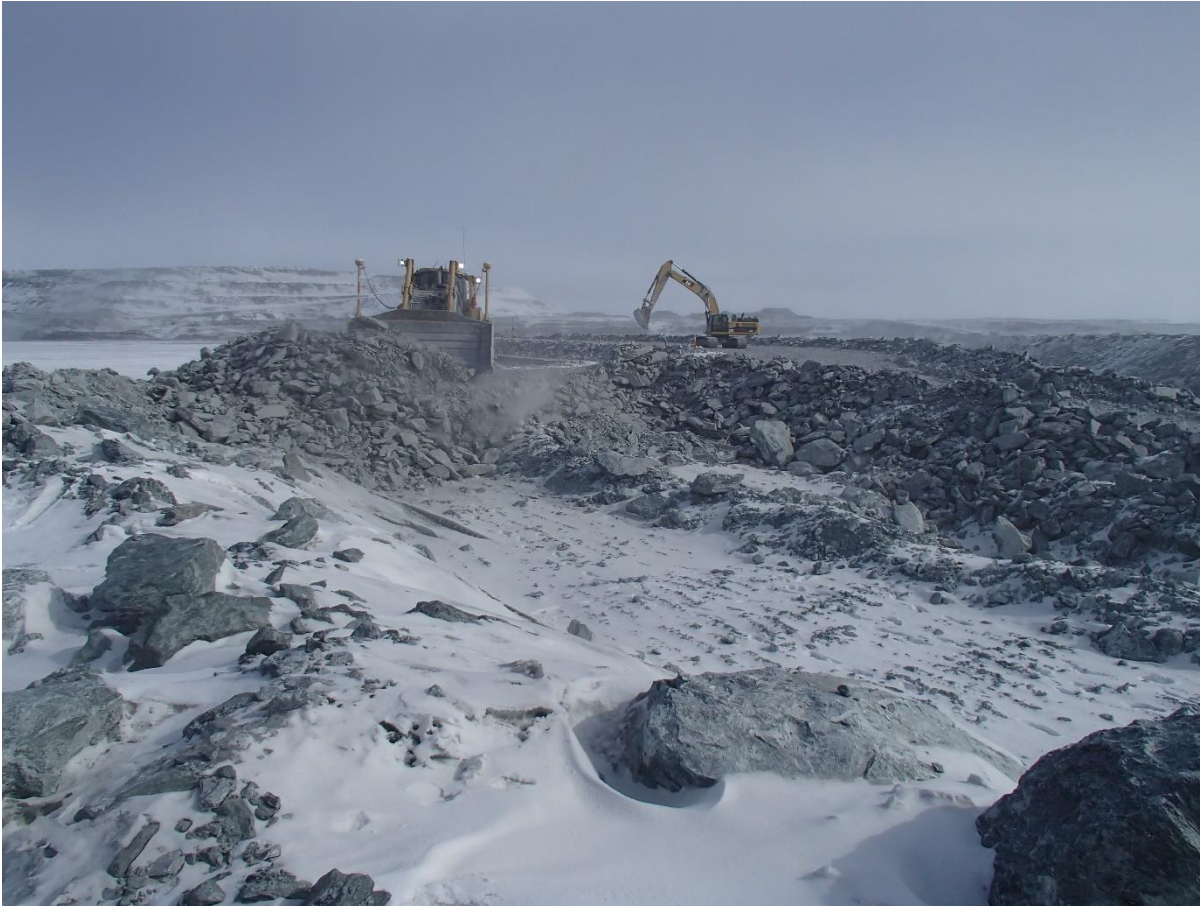
**Photograph CD-1822: From Sta. 40+725/+7, looking N. Placement of two 2 m thick (approx.) lifts of intermediate volcanic (IV) rockfill from El. 141 m to El. 145 m from approx. Sta. 40+720 m to 40+750 m (o.s. -10 to +10 m) and profiling of the upstream slope (2H:1V) from El. 143 to 145 m with an excavator between Sta. 0+830 m and 0+980 m.**

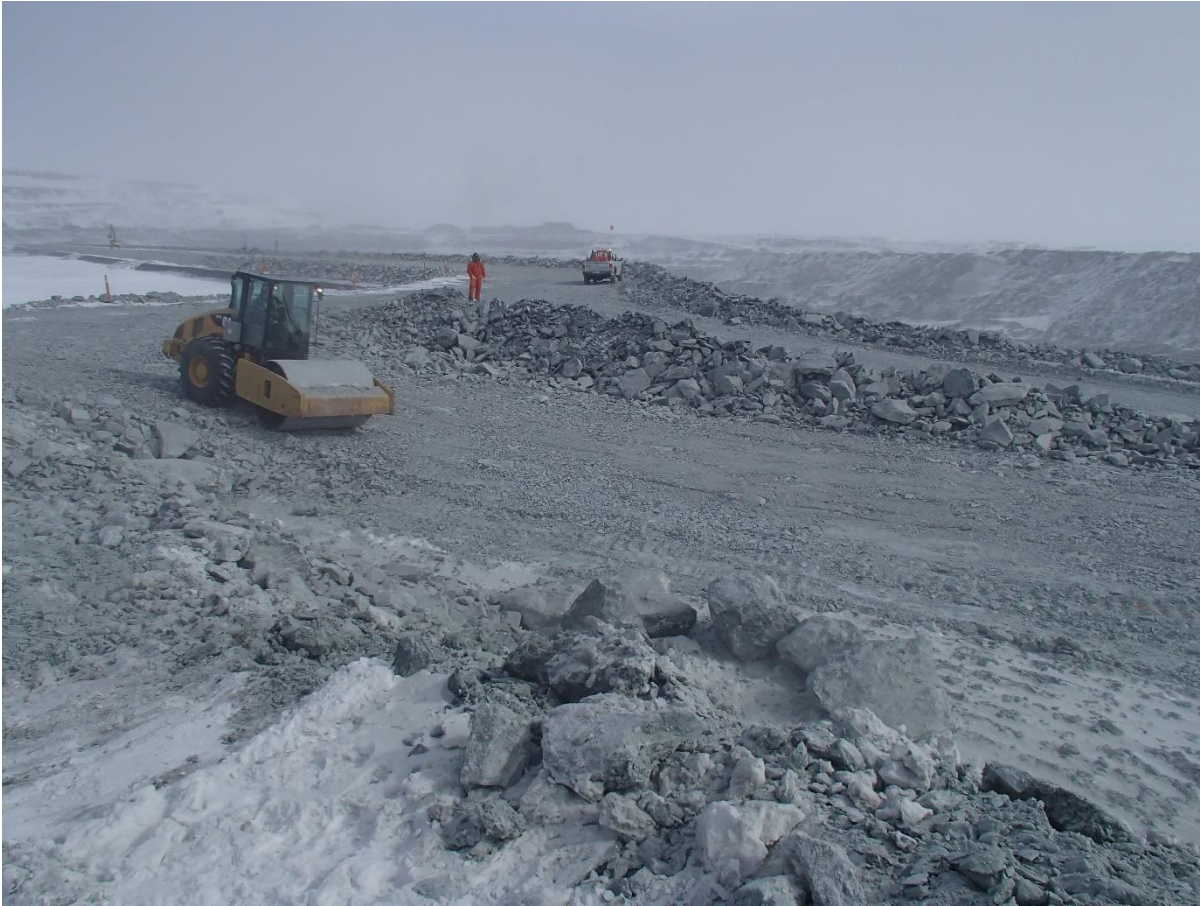
**Photograph CD-1823: From Sta. 0+175/+8, looking NE. Compaction of the two 2 m lifts (approx.) of intermediate volcanic (IV) rockfill at El. 143 and at El. 145 m with a 10-tonne smooth-drum compactor with vibration (6 passes) from Sta. 40+720 m to 40+750 m (o.s. -10 to +10 m).**

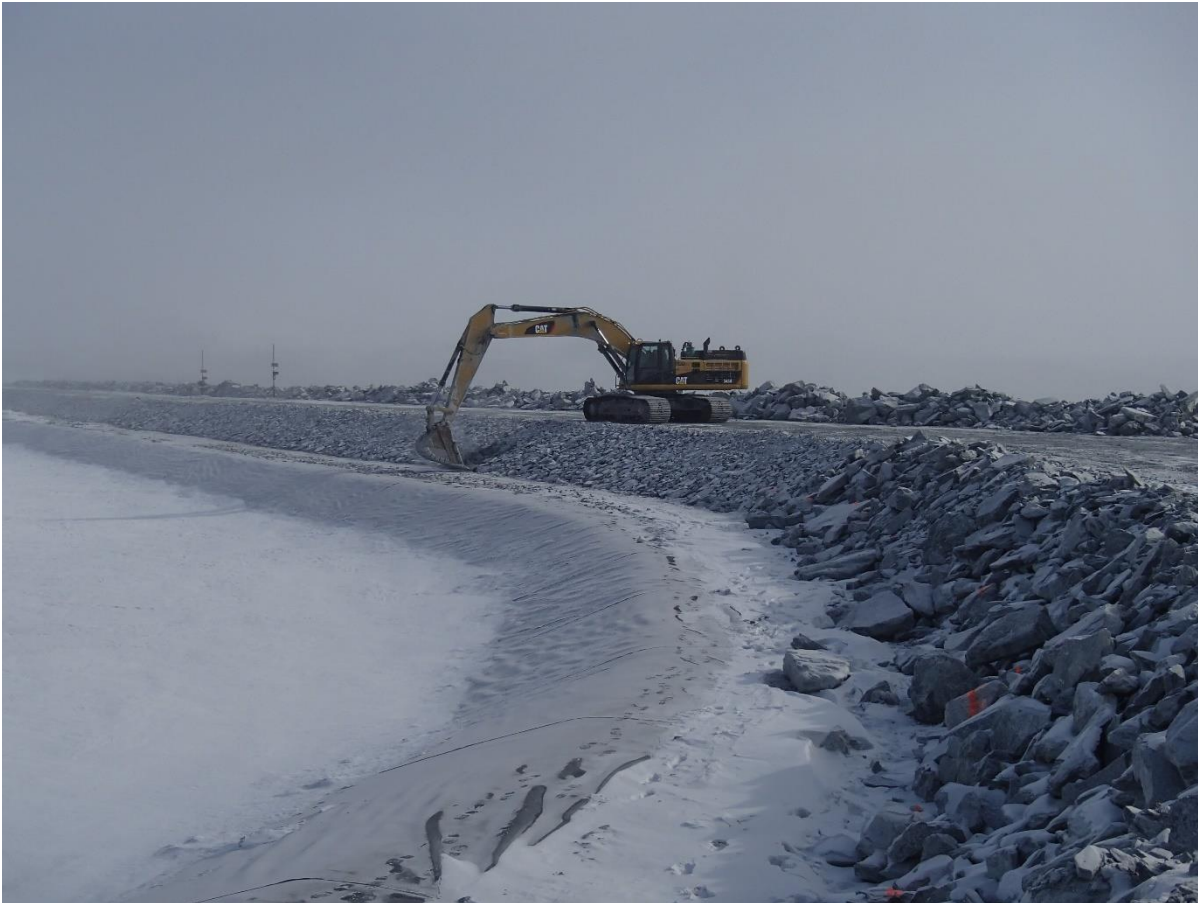
Photograph CD-1824: From Sta 40+760/-25 m, looking NE. Profiling of the upstream slope (2H:1V) from El. 143 to 145 m with an excavator between Sta. 0+830 m and 40+730 m.

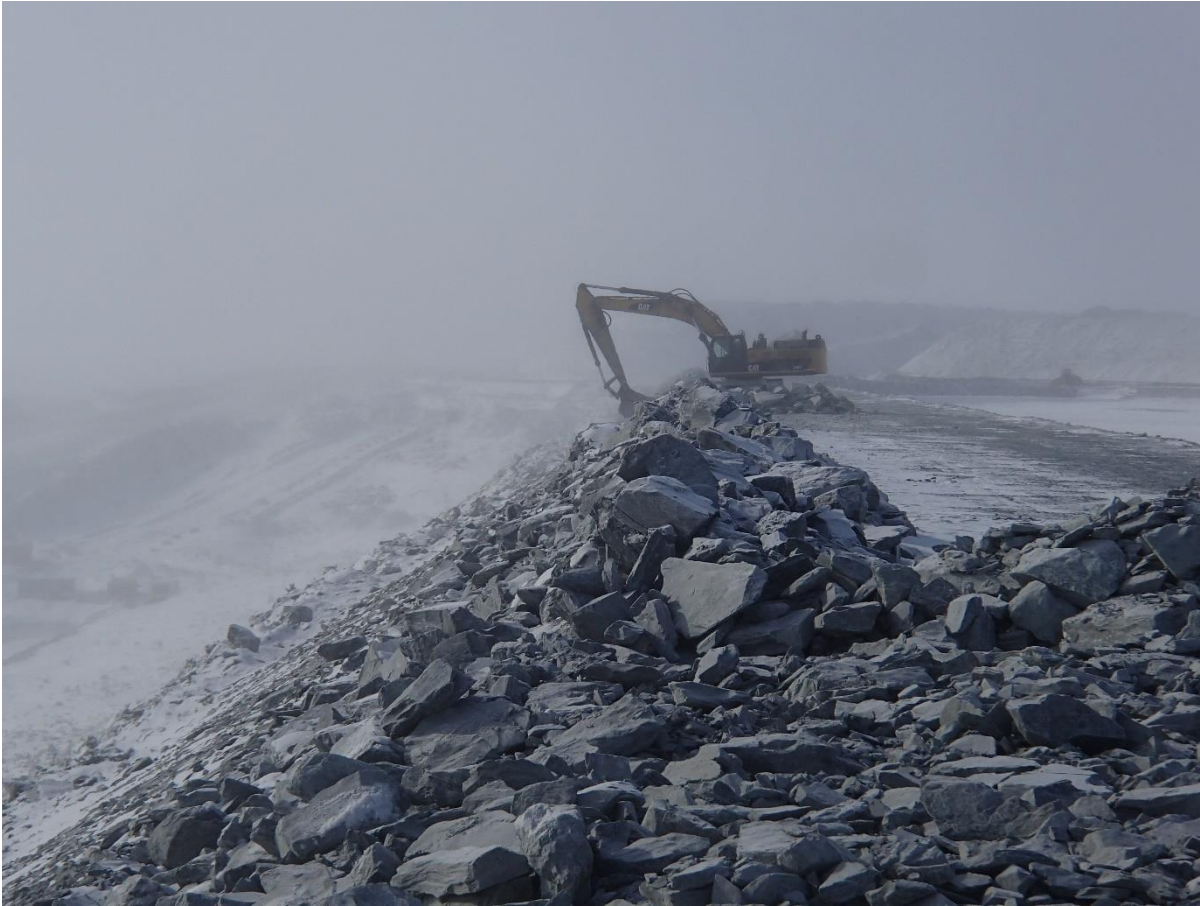
**Photograph CD-1825: From Sta 0+430/+9 m, looking S. Profiling of the downstream slope (1.5H:1V) from El. 143 to 145 m with an excavator between Sta. 0+330 m and 0+440 m and between Sta. 0+530 m and 0+745 m.**

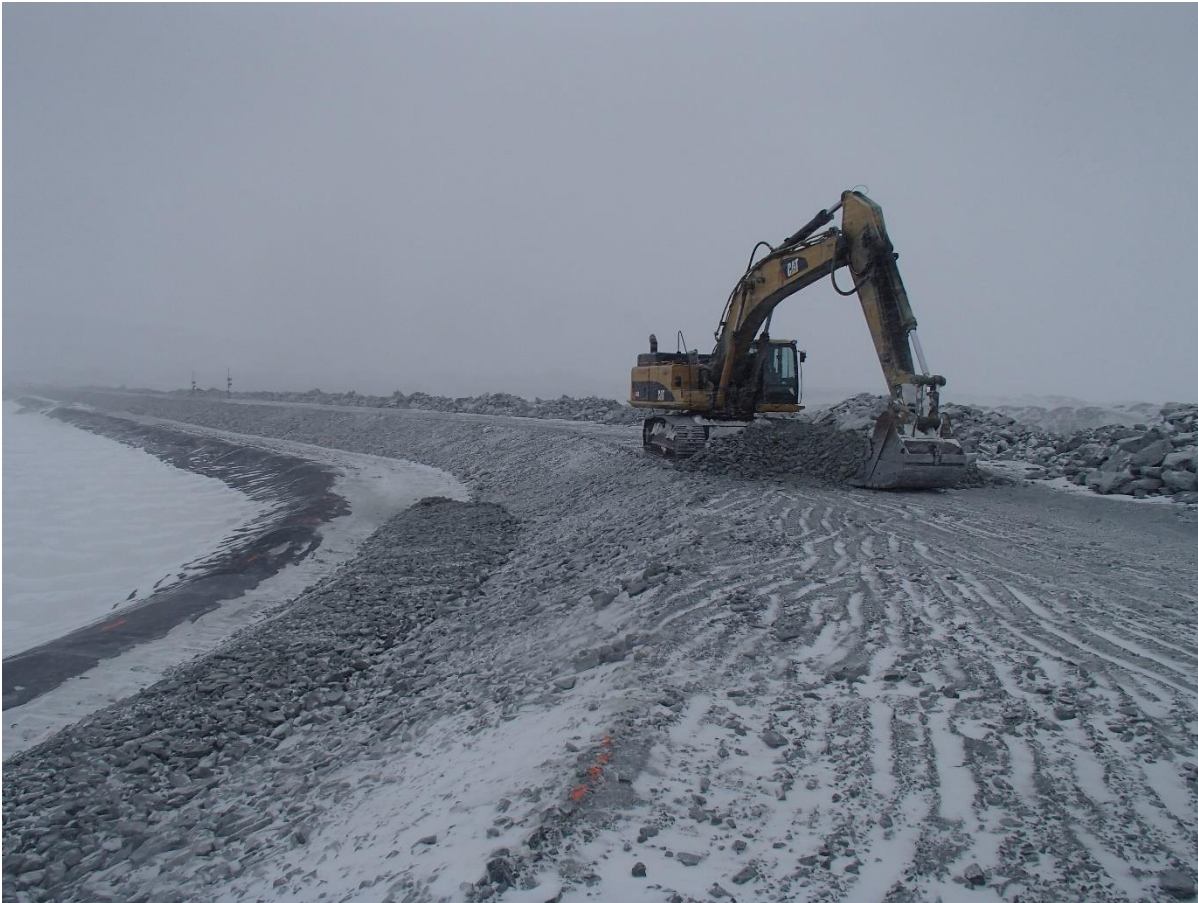
Photograph CD-1826: From Sta 40+770/-27 m, looking NE. Placement of a 0.5 m thick lift of coarse filter from El. 143 m to 143.5 m with an excavator from Sta. 40+730 m to 0+ 775 m.

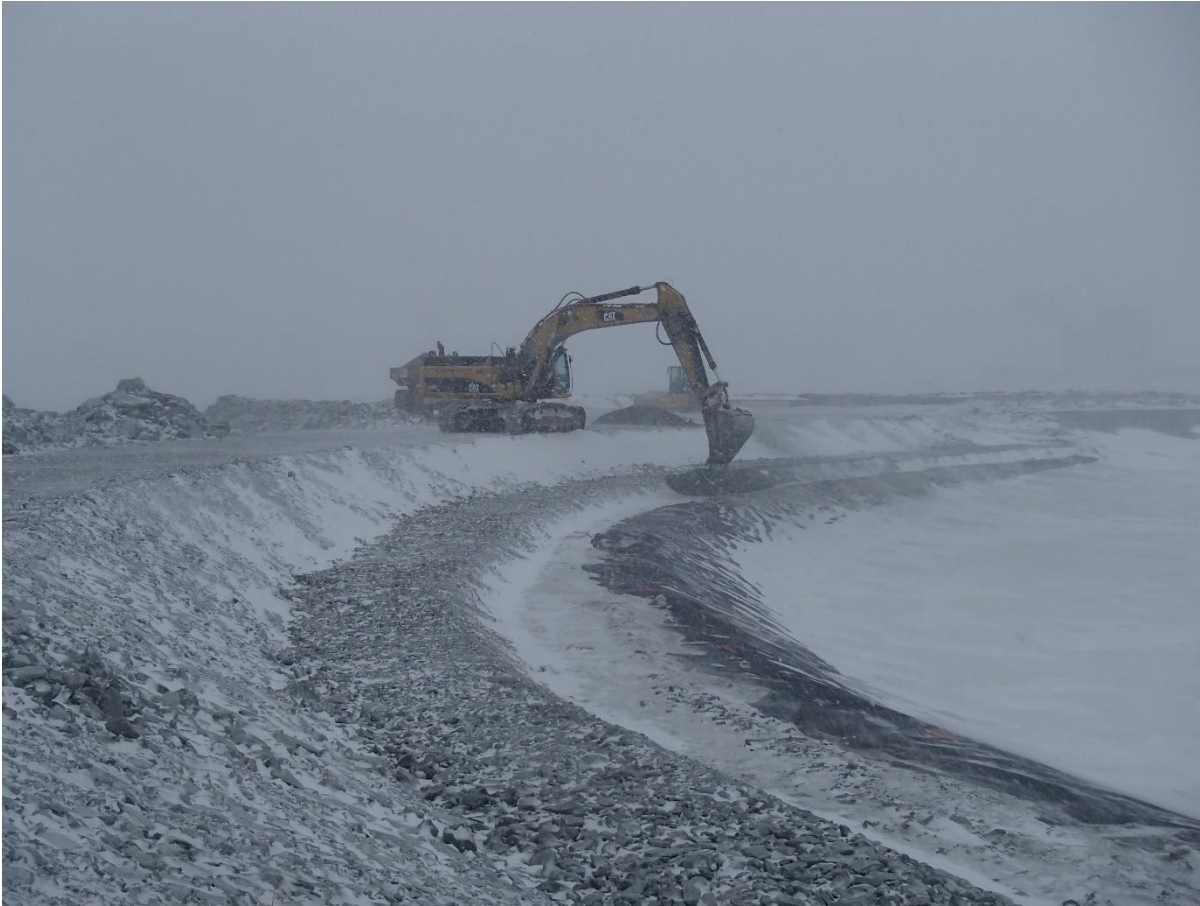
**Photograph CD-1827: From Sta 0+940/-16 m, looking SW. Placement of a 0.5 m thick lift of fine filter from El. 143 m to 143.5 m with an excavator from Sta. 40+730 m to 0+ 835 m.**

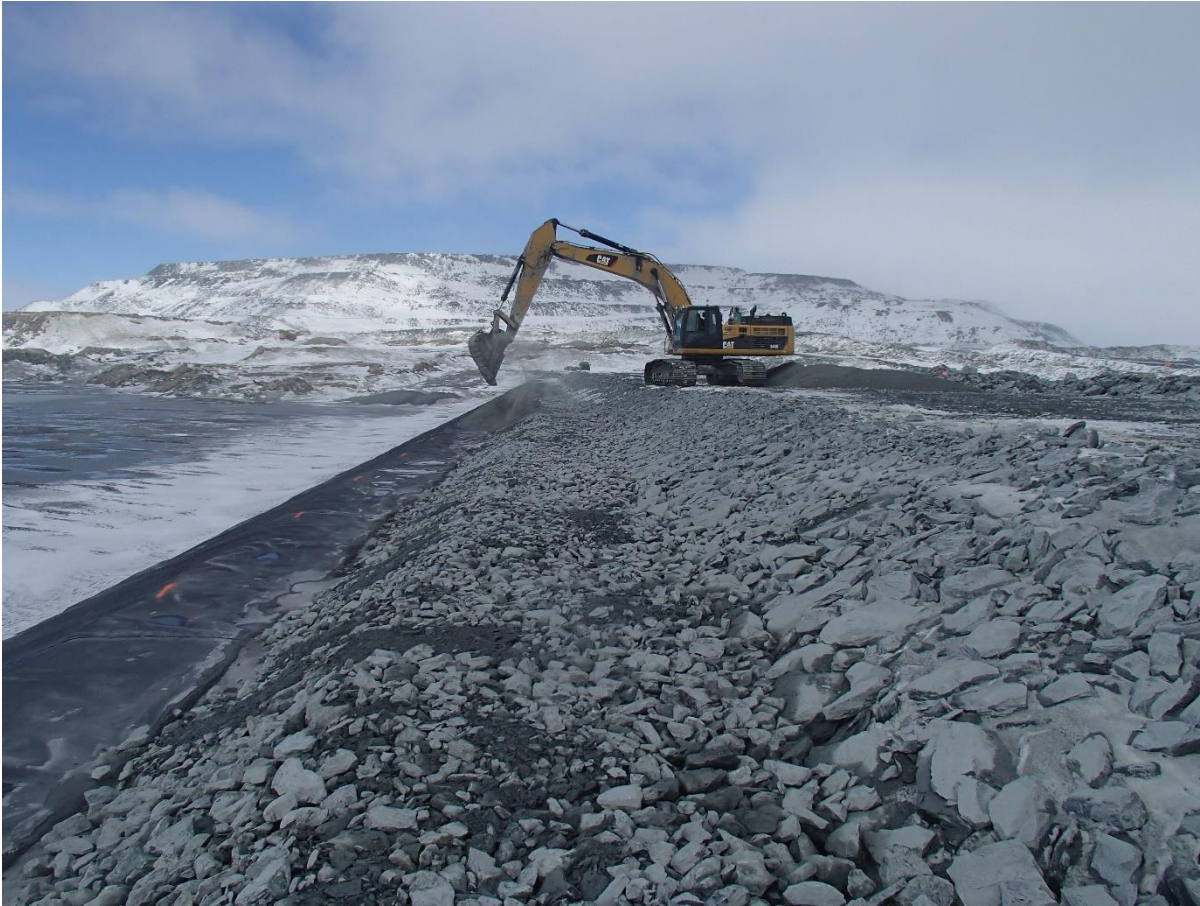
**Photograph CD-1829: From Sta 0+410/-22 m, looking N. Placement of a 0.5 m thick lift of coarse filter from El. 143 m to 143.5 m with an excavator from Sta. 0+170 m to 0+460 m and placement of a 0.5 m thick lift of fine filter from Sta. 0+170 m to 0+380 m.**

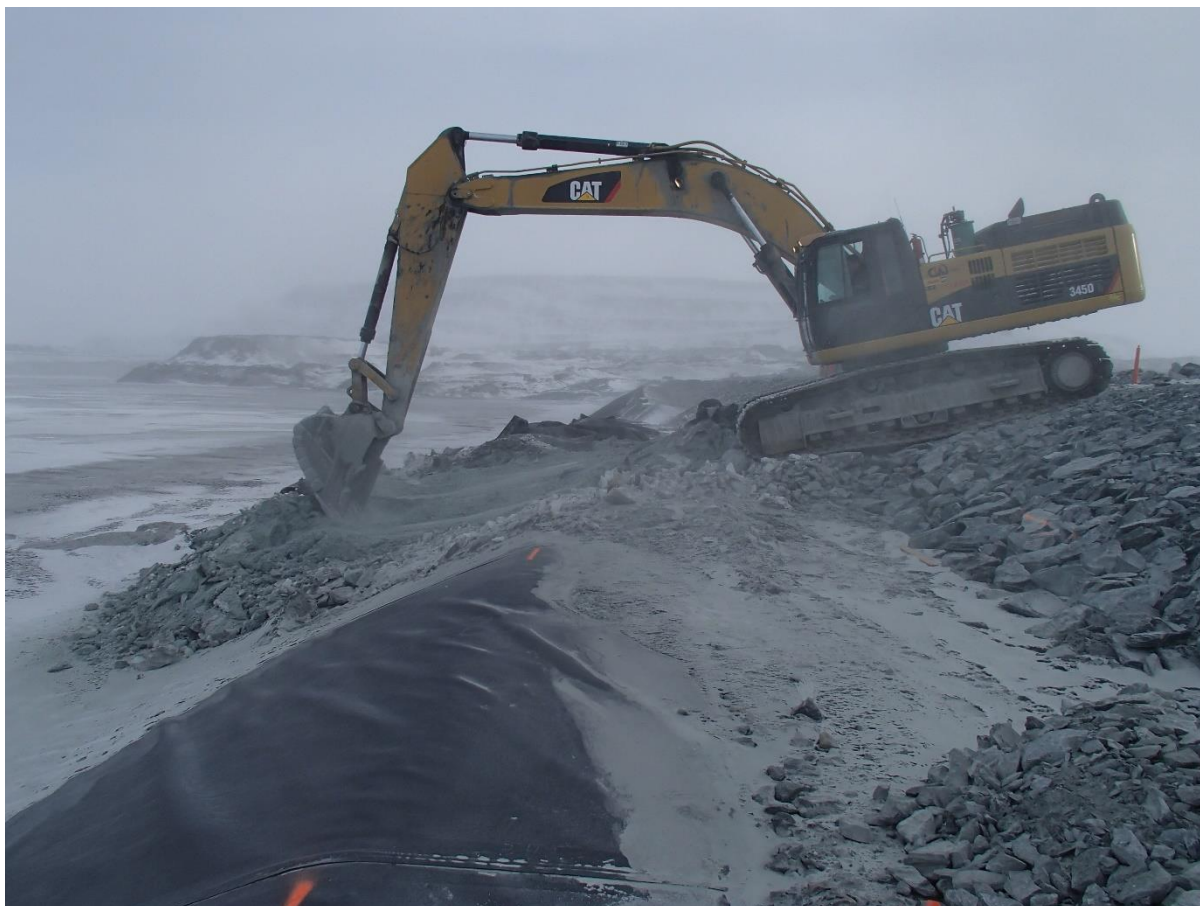
Photograph CD-1830: From Sta 0+420/-26 m, looking N. Removal of the deposition point finger materials with an excavator at Sta. 0+390 m.

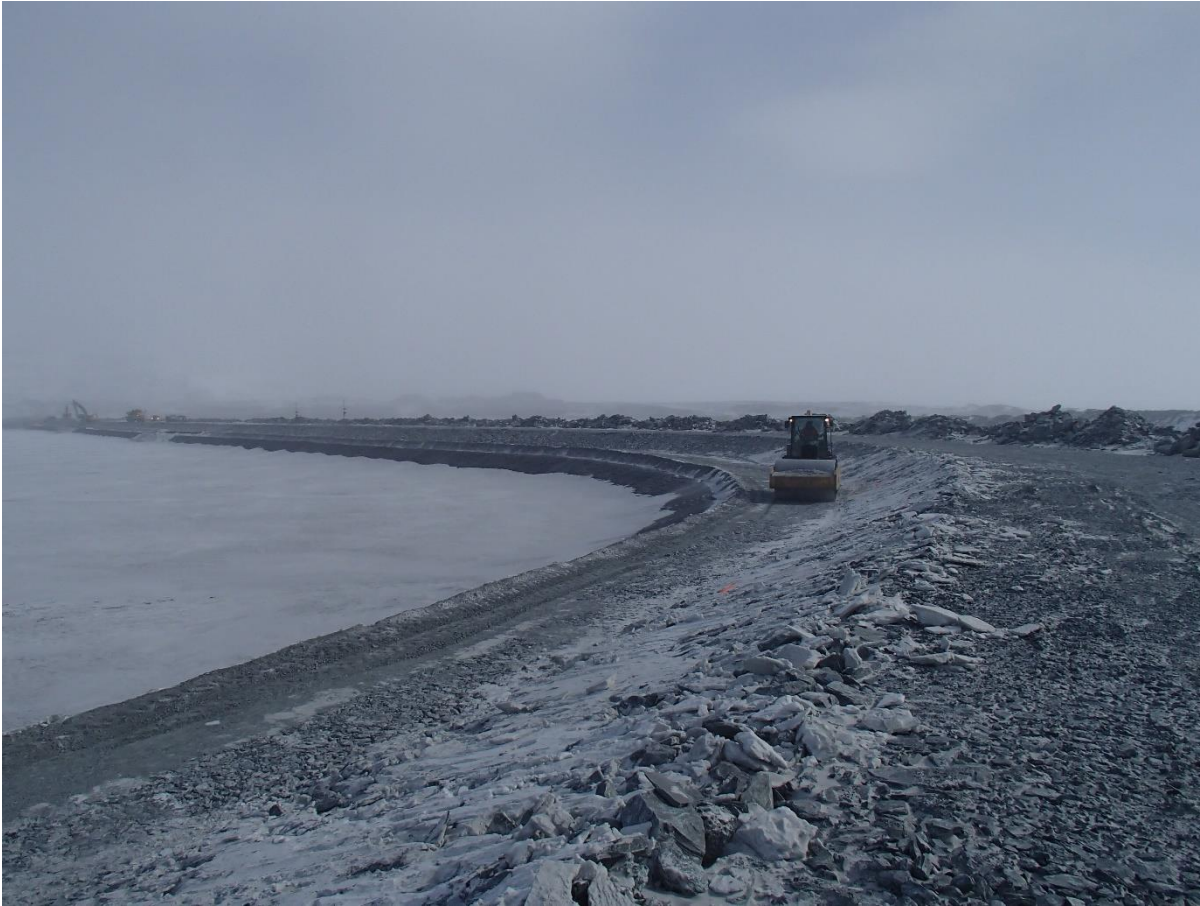
**Photograph CD-1831: From Sta 40+730/-24 m, looking NE. Compaction of the first 0.5 m lift (approx.) of fine and coarse filters material at El. 143.5 m with a 10-tonne smooth-drum compactor with vibration (6 passes) from Sta. 40+730 m to 0+830 m and from Sta. 0+175 m to 0+490 m.**

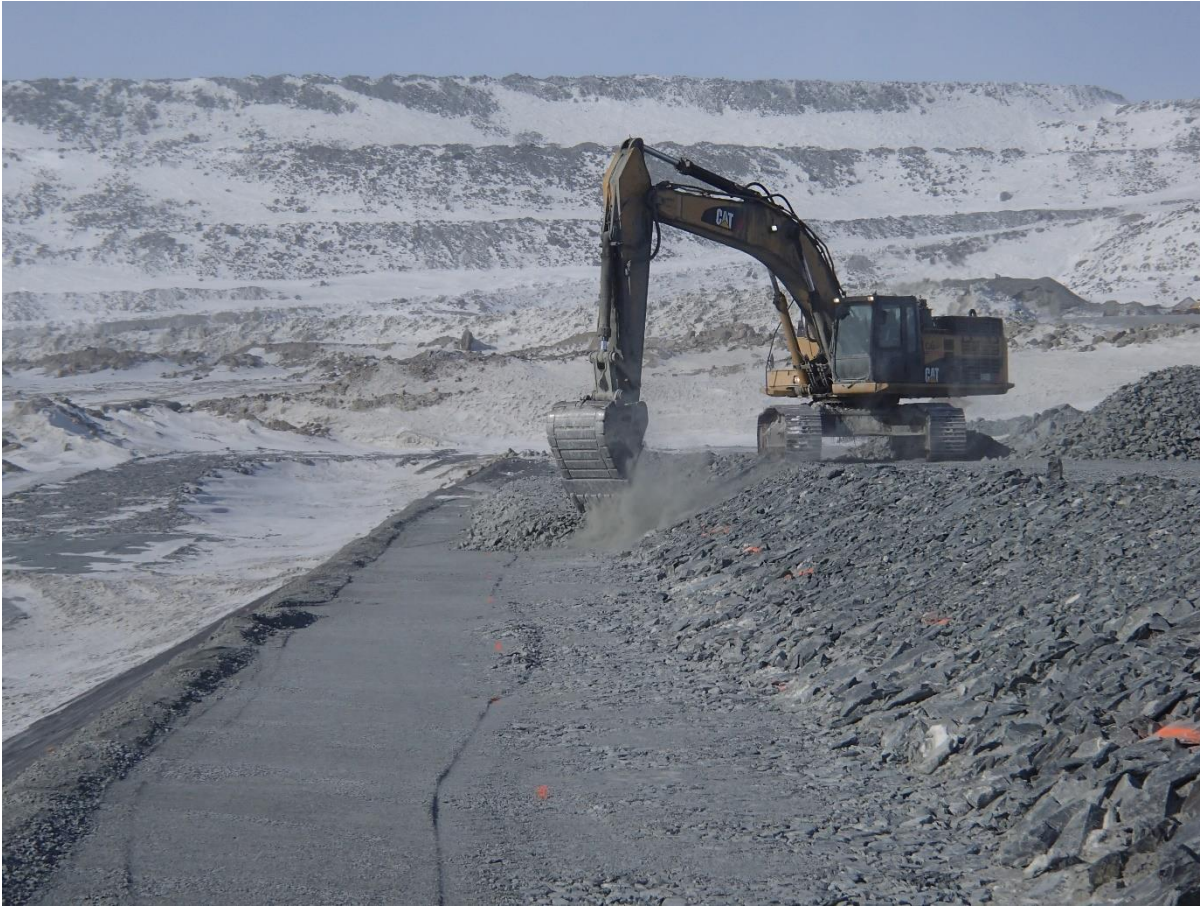
**Photograph CD-1832: From Sta 0+280/-25 m, looking N. Placement of a second 0.5 m thick lift of coarse filter from El. 143.5 m to 144 m with an excavator from Sta. 0+175 m to 0+280 m.**

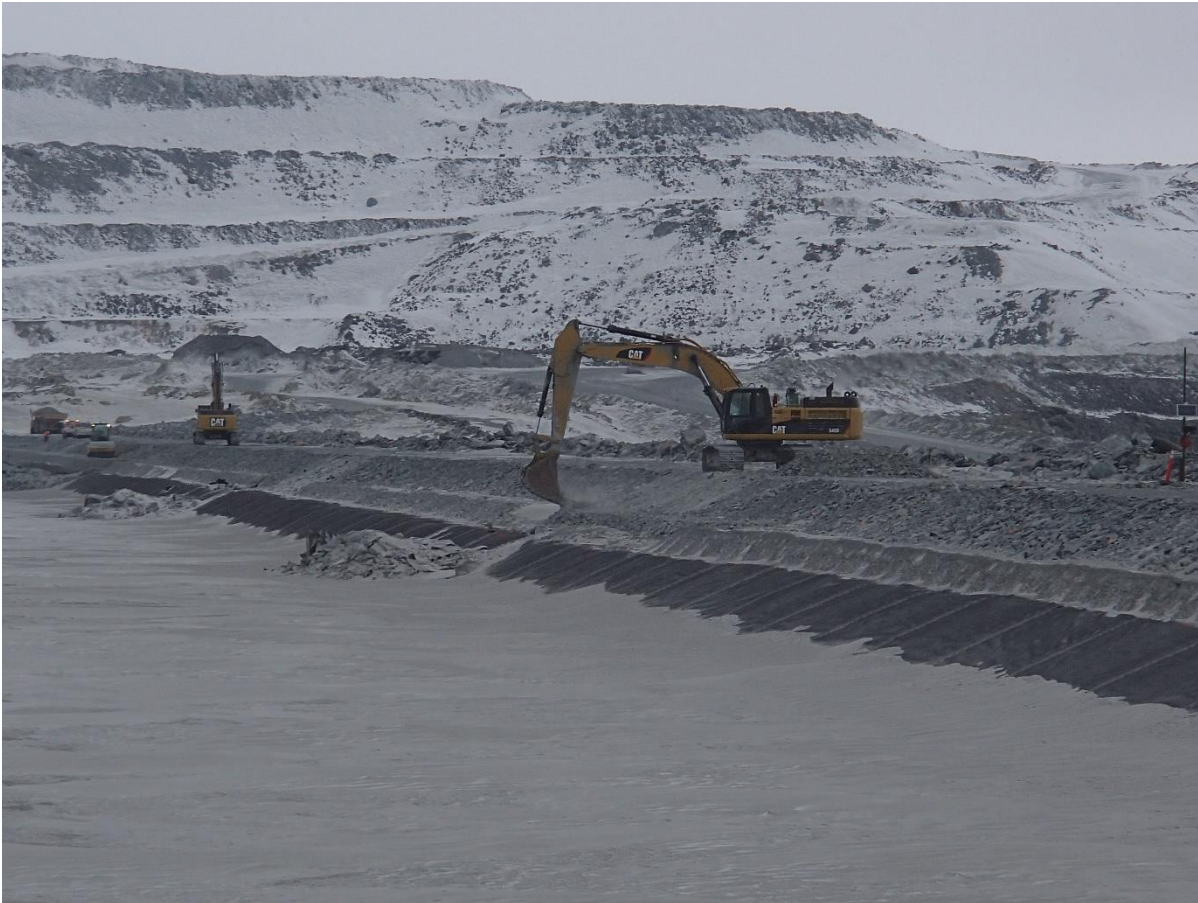
**Photograph CD-1834: From Sta 40+760/-23 m, looking NE. Placement of a first 0.5 m thick lift of coarse filter from El. 143 m to 143.5 m on length of approx. 5 m with an excavator at the location of the deposition finger at Sta 0+520 m and 0+660 m.**

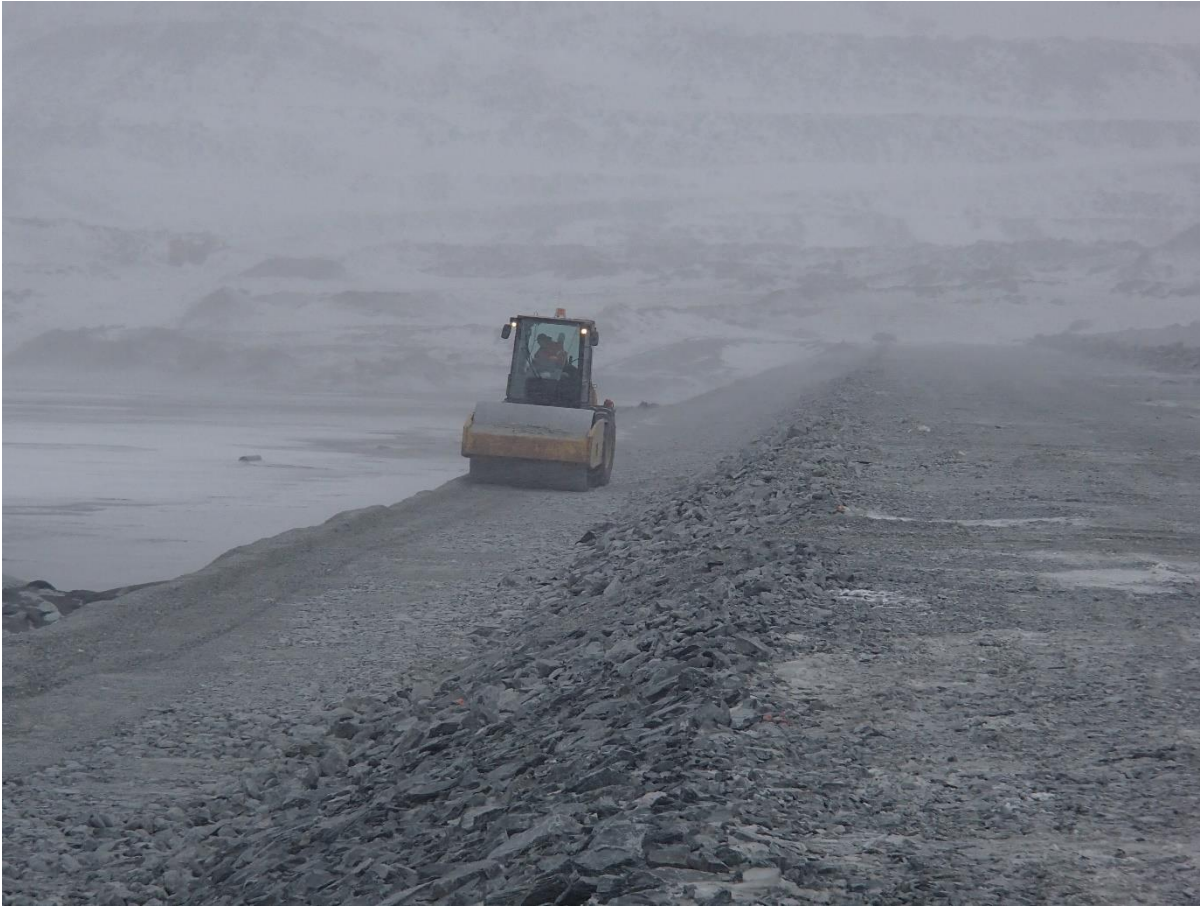
**Photograph CD-1835: From Sta 0+830/-20m, looking N. Compaction of the first 0.5 m lift (approx.) of fine and coarse filters material at El. 143.5 m with a 10-tonne smooth-drum compactor with vibration (6 passes) from Sta 0+490 to 0+835 m.**

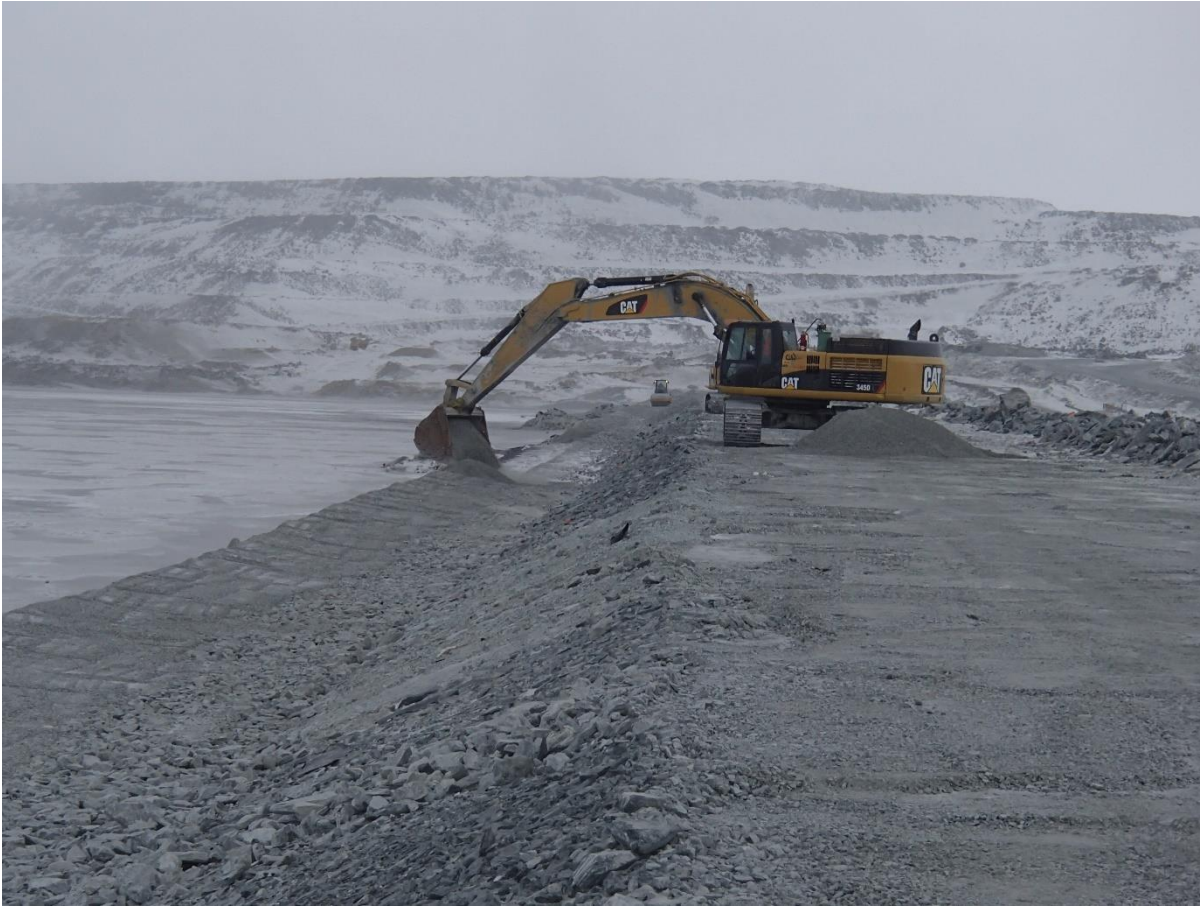
**Photograph CD-1836: From Sta 0+830/-20m, looking N. Placement of a first 0.5 m thick lift of fine filter from El. 143 m to 143.5 m upstream of the coarse filter with an excavator from Sta. 0+490 to 0+835 m.**

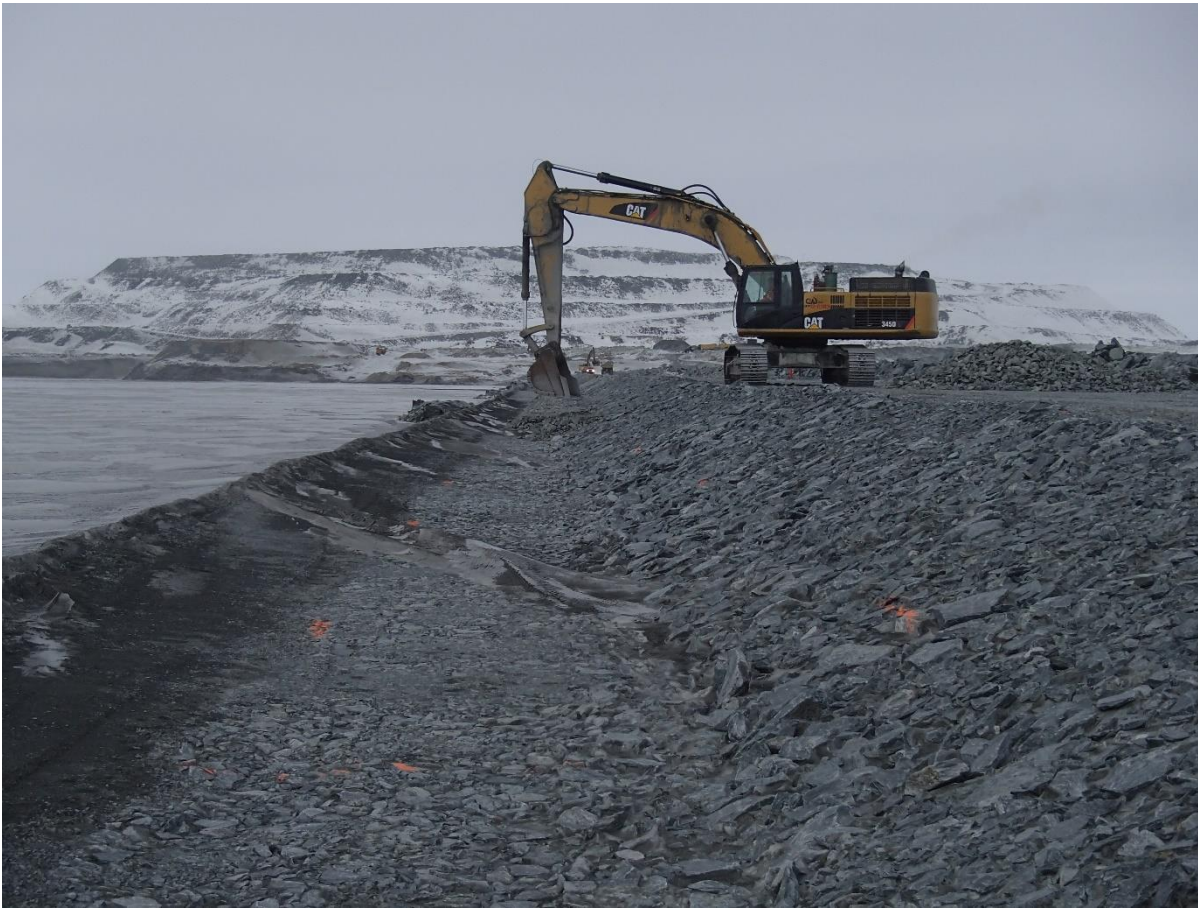
**Photograph CD-1837: From Sta 0+940/-25m, looking N. Placement of a second 0.5 m thick lift of coarse filter from El. 143.5 m to 144 m with an excavator from Sta. 0+290 to 0+500 m and from Sta. 0+835 to 0+930 m.**

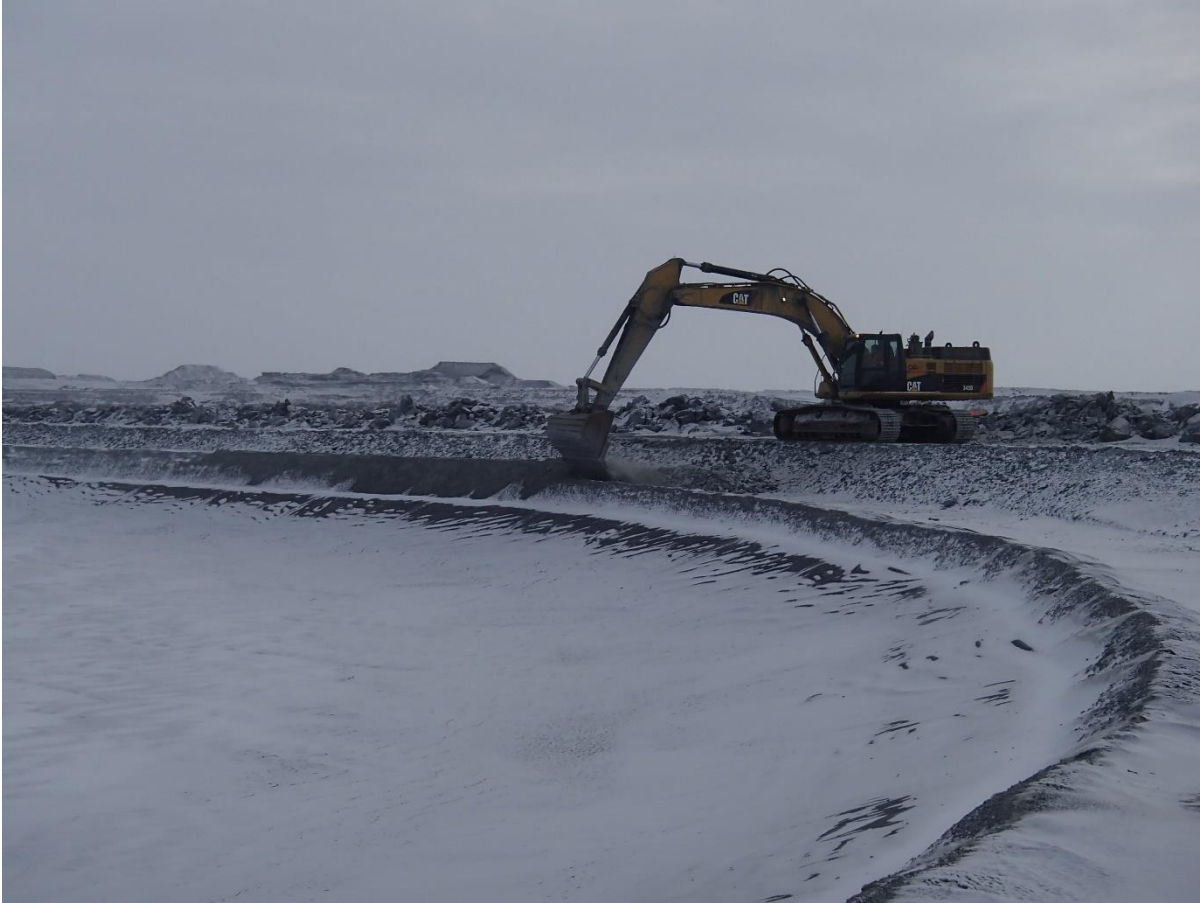
**Photograph CD-1838: From Sta 40+750/-31 m, looking NE. Placement of a second 0.5 m thick lift of fine filter from El. 143.5 m to 144 m upstream of the coarse filter with an excavator from Sta. 0+500 m to 0+835 m and from 0+930 to 40+730 m.**

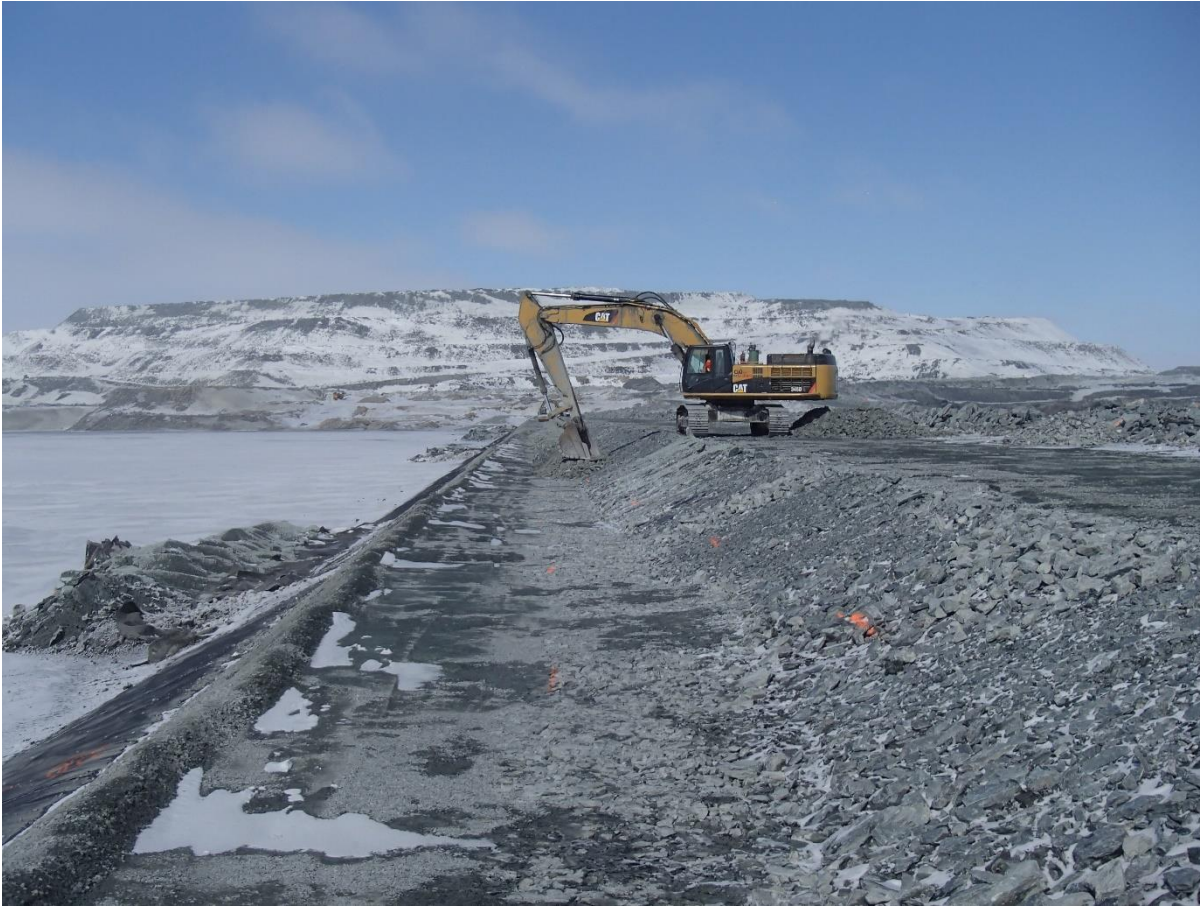
**Photograph CD-1838: From Sta 0+835/-20 m, looking N. Placement of a second 0.5 m thick lift of coarse filter from El. 143.5 m to 144 m with an excavator from Sta. 0+500 m to 0+835 m and from 0+930 to 40+730 m.**
