### **Meadowbank 2018 TSF As-built report**

**2018 CONSTRUCTION SEASON AS-BUILT REPORT  
TAILINGS STORAGE FACILITY  
MEADOWBANK GOLD PROJECT, NUNAVUT**

1897439-1578-R-Rev0

November 2018

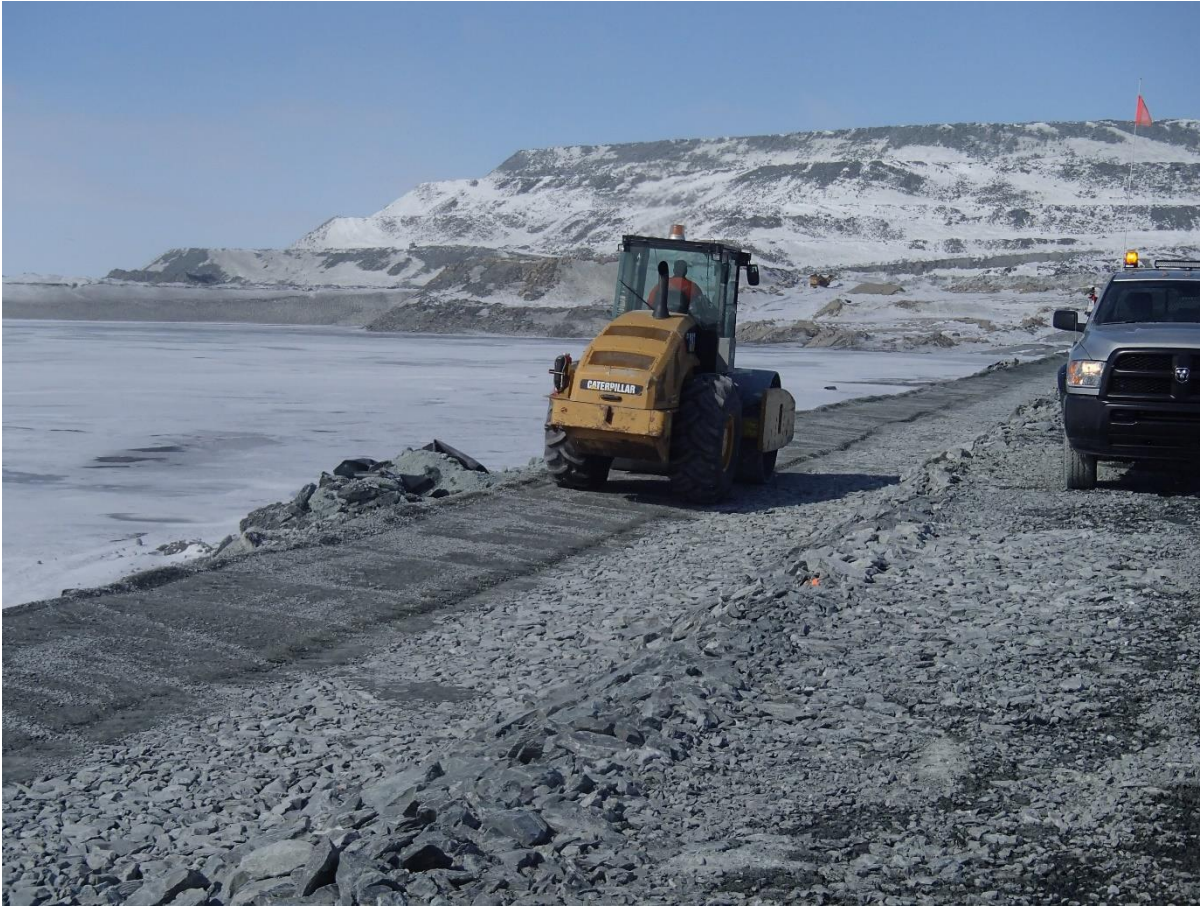
**Photograph CD-1840: From Sta 0+575/-15 m, looking NW. Compaction of the second 0.5 m lift (approx.) of fine and coarse filters material at El. 144 m with a 10-tonne smooth-drum compactor with vibration (4 passes) from Sta 0+500 m to 40+730 m.**

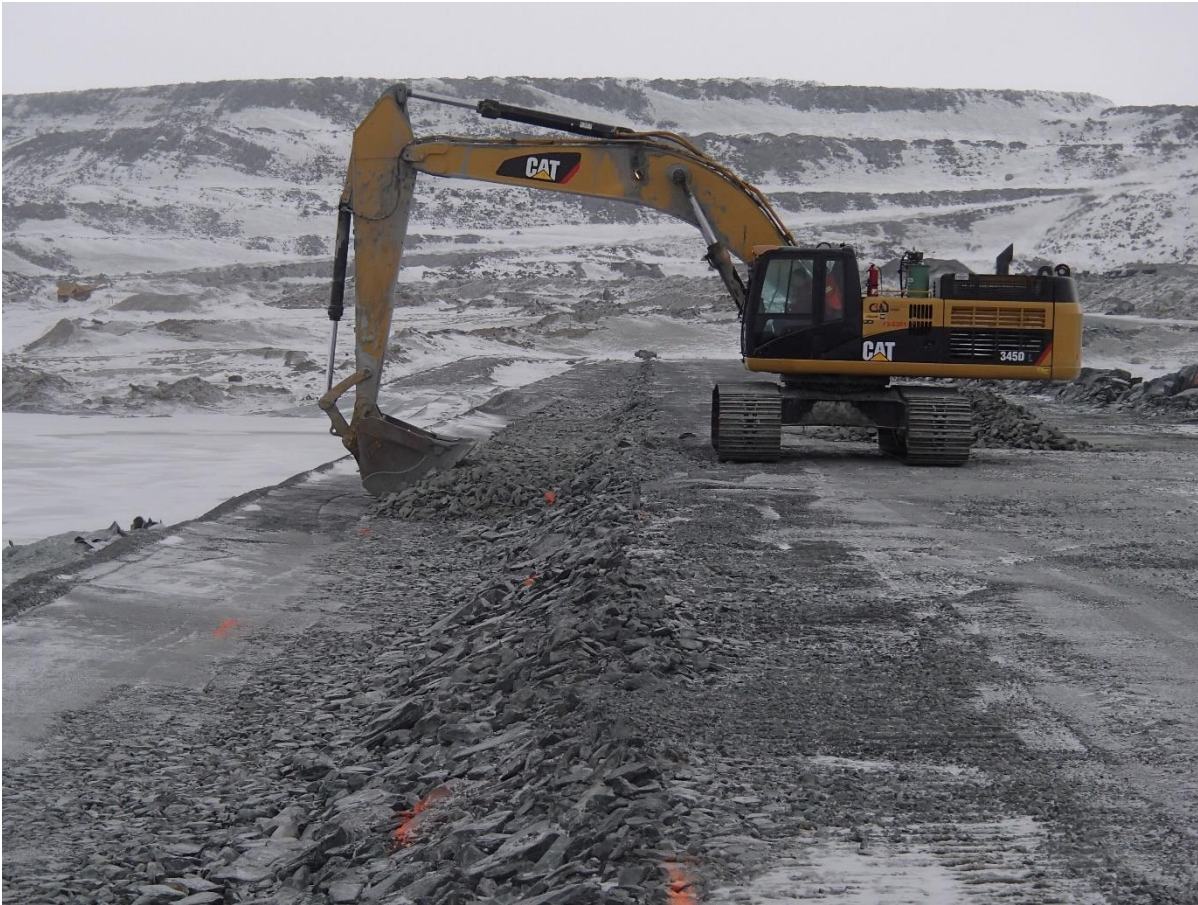
Photograph CD-1841: From Sta 0+475/-14 m, looking N. Placement of a third 0.5 m thick lift of coarse filter from El. 144 m to 144.5 m with an excavator from Sta. 0+335 m to 40+730 m.

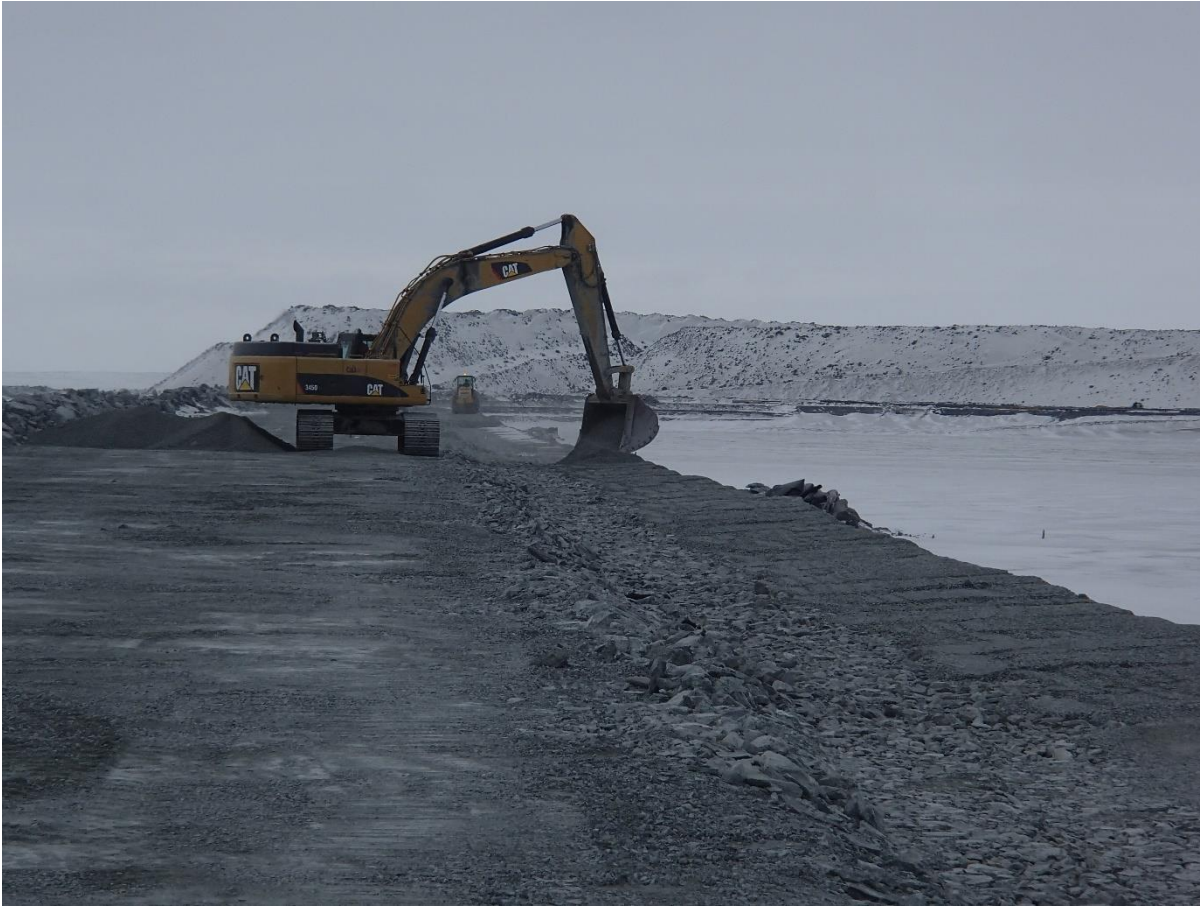
**Photograph CD-1842: From Sta 0+380/-16 m, looking S. Placement of a third 0.5 m thick lift of fine filter from El. 143.5 m to 144 m upstream of the coarse filter with an excavator from Sta. 0+335 m to 0+940 m.**

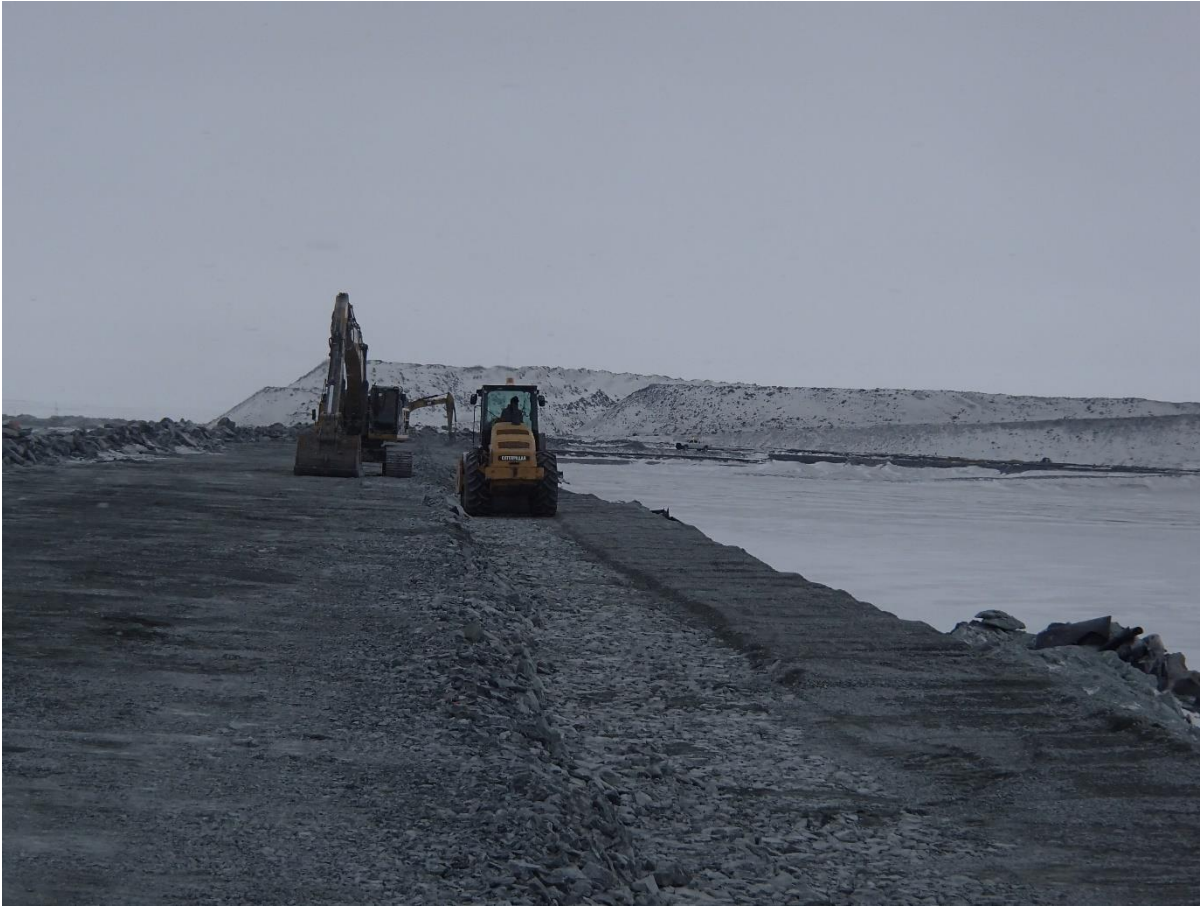
**Photograph CD-1843: From Sta 0+460/-23 m, looking S. Compaction of the third 0.5 m lift (approx.) of fine and coarse filters material at El. 144.5 m with a 10-tonne smooth-drum compactor with vibration (4 passes) from Sta 0+335m to 0+900 m.**

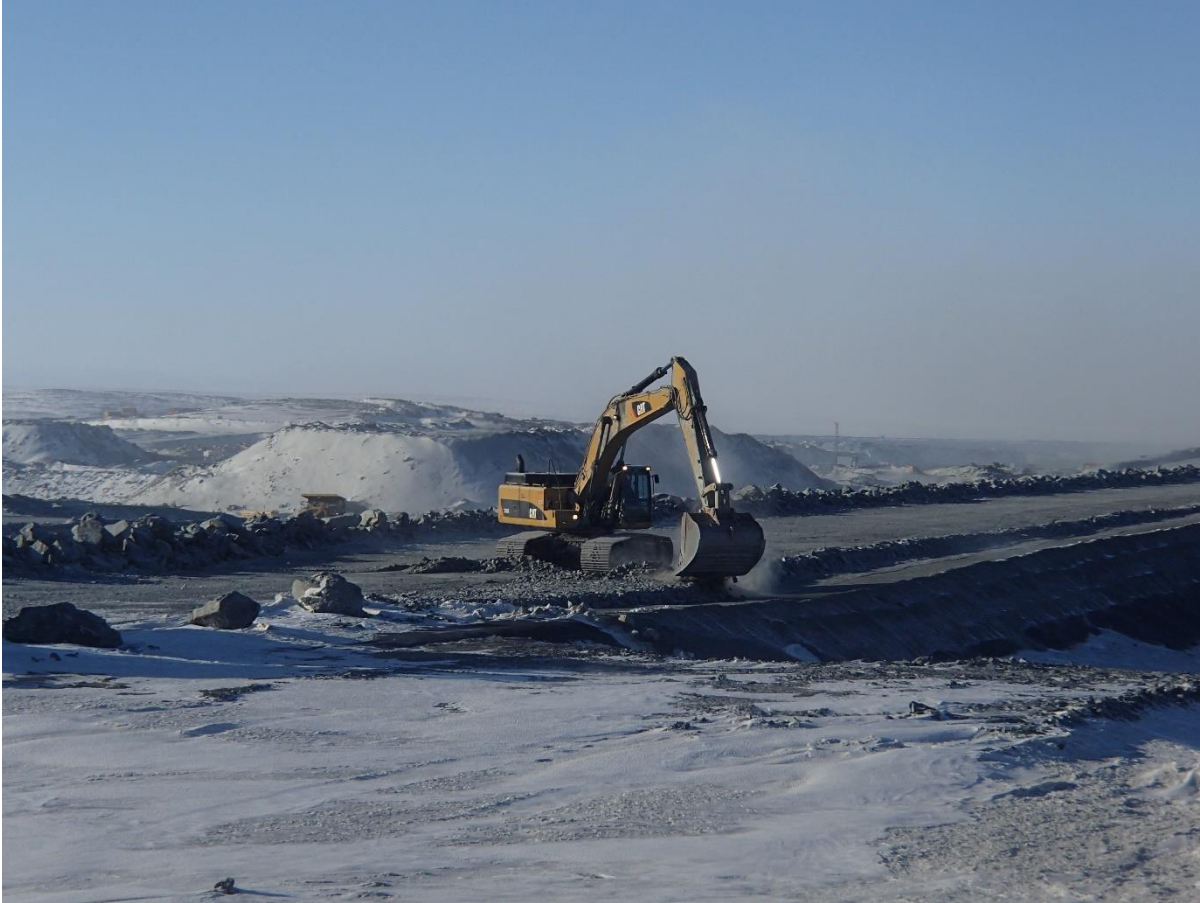
Photograph CD-1844: From Sta 0+080/-49 m, looking SW. Placement of a fourth 0.5 m thick lift of coarse filter from El. 144.5 m to 145 m with an excavator from Sta. 0+170 m to 40+730 m.

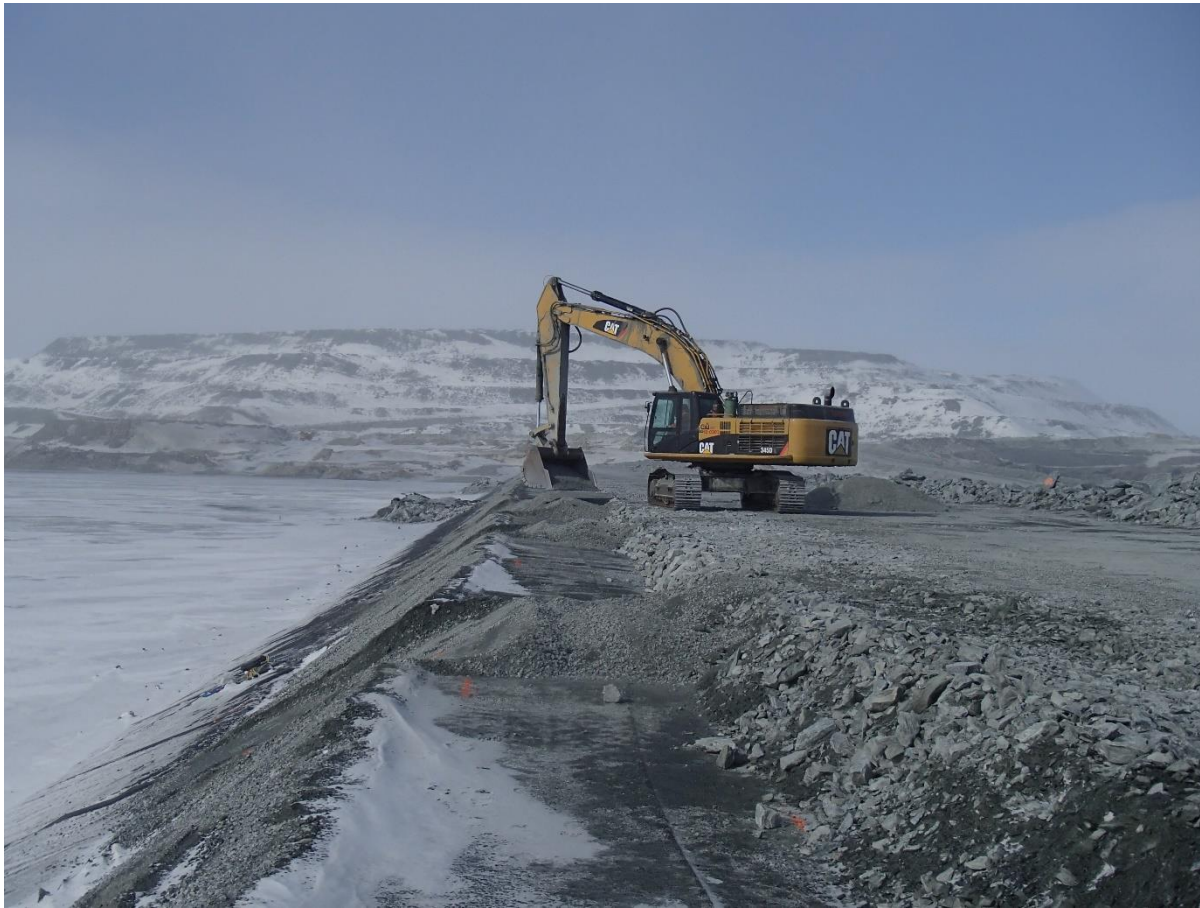
**Photograph CD-1845: From Sta 0+660/-20 m, looking N. Profiling of the upstream slope (2H:1V) from El. 143 to 145 m with an excavator between Sta. 0+175 and 0+330 m and between Sta. 0+600 m and 0+715 m. The removed material is placed on the fourth 0.5 m thick lift of fine filter from El. 144.5 m to 145 m upstream of the coarse filter with an excavator from Sta. 0+170 m to 0+330 m and between Sta. 0+600 m and 0+715 m.**

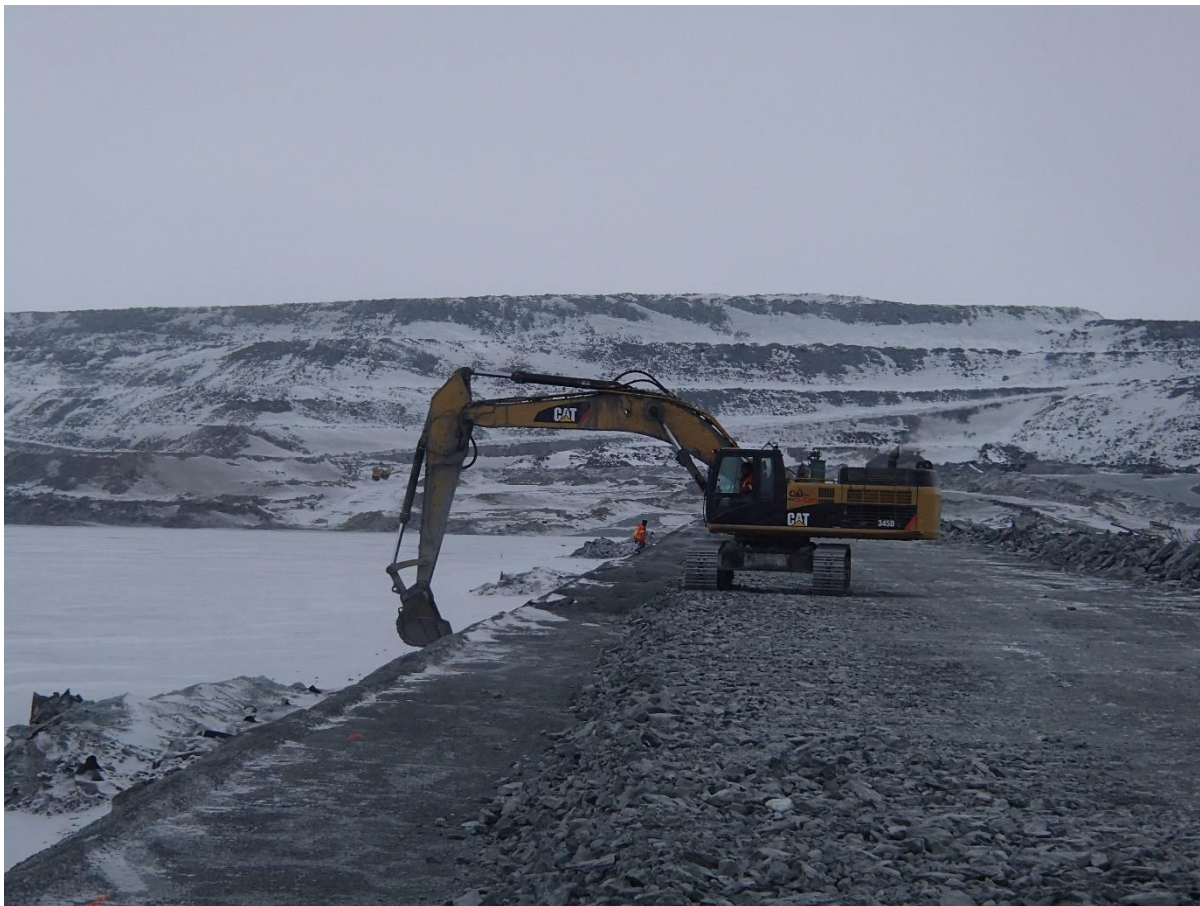
**Photograph CD-1846: From Sta 0+835/-25 m, looking N. Profiling of the upstream slope (2H:1V) from El. 143 to 145 m with an excavator between Sta. 0+330 and 0+600 m and between Sta. 0+715 m and 40+730 m. The removed material was placed with material from the fine filter stockpile on the fourth 0.5 m thick lift of fine filter from El. 144.5 m to 145 m upstream of the coarse filter with an excavator from Sta. 0+330 m to 0+600 m and between Sta. 0+715 m and 40+730 m.**

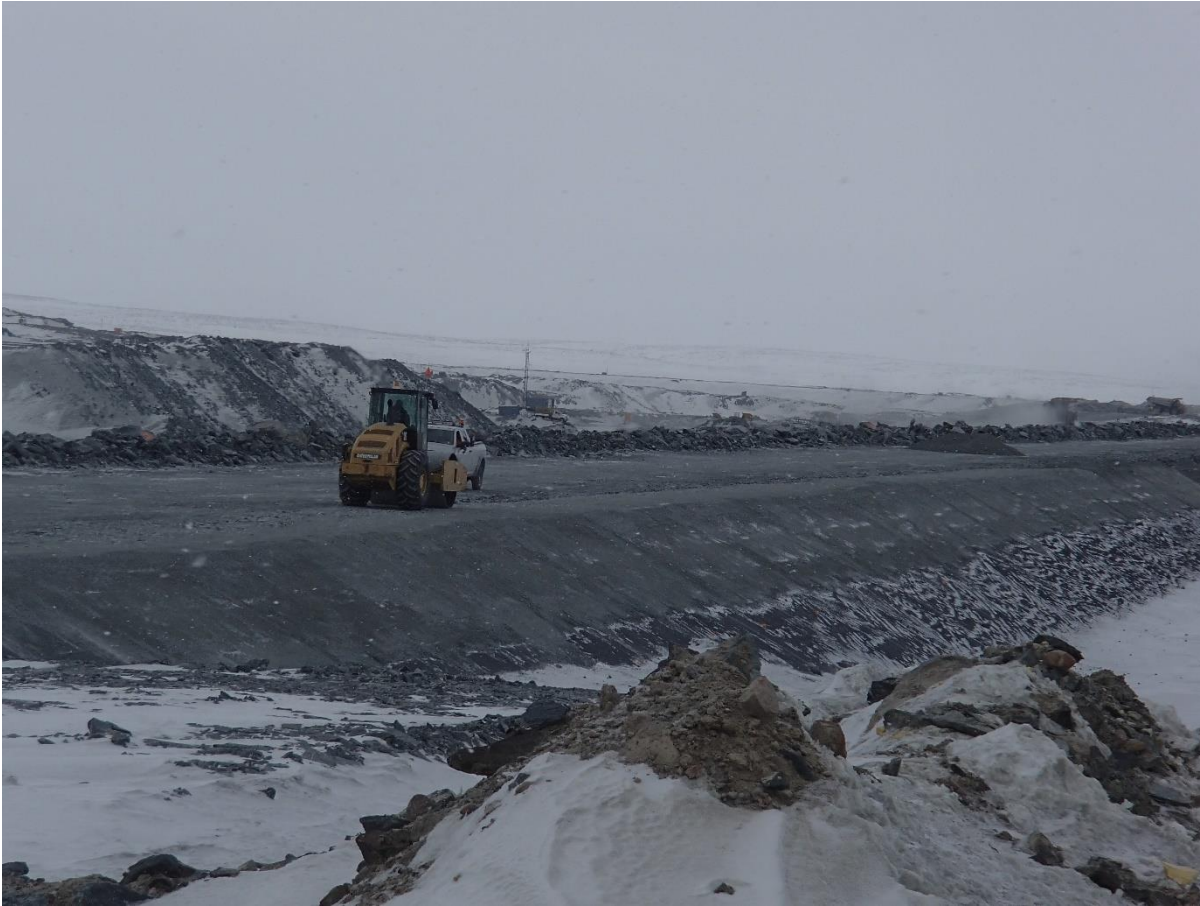
**Photograph CD-1847: From Sta 0+085/-48 m, looking SE. Compaction of the fourth 0.5 m lift (approx.) of fine and coarse filters material at El. 145 m with a 10-tonne smooth-drum compactor with vibration (4 passes) from Sta 0+170 m to 0+930 m.**

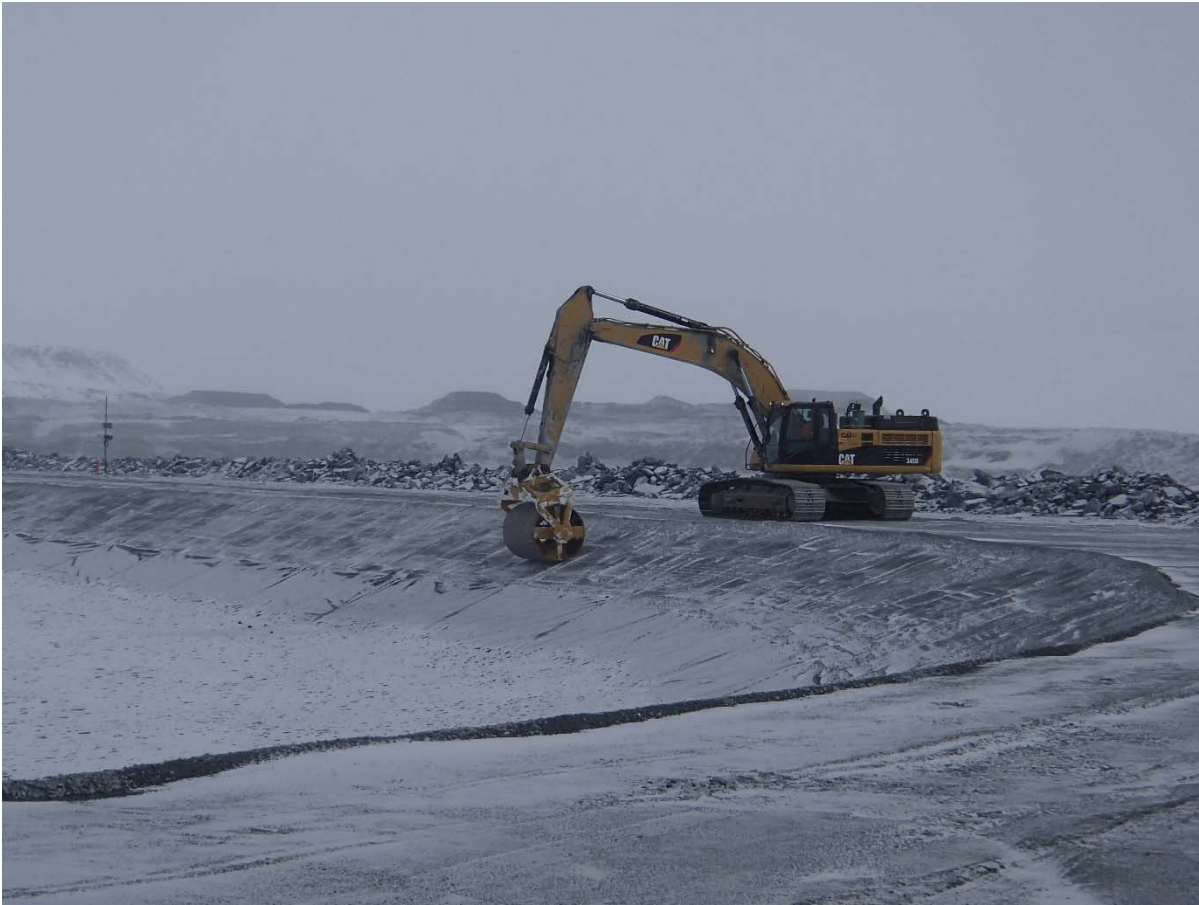
**Photograph CD-1849: From Sta. 40+750/-17 m, looking NE. Final rolling of the upstream slope in view of the LLDPE geomembrane installation from Sta. 0+170 m to 40+730 m.**

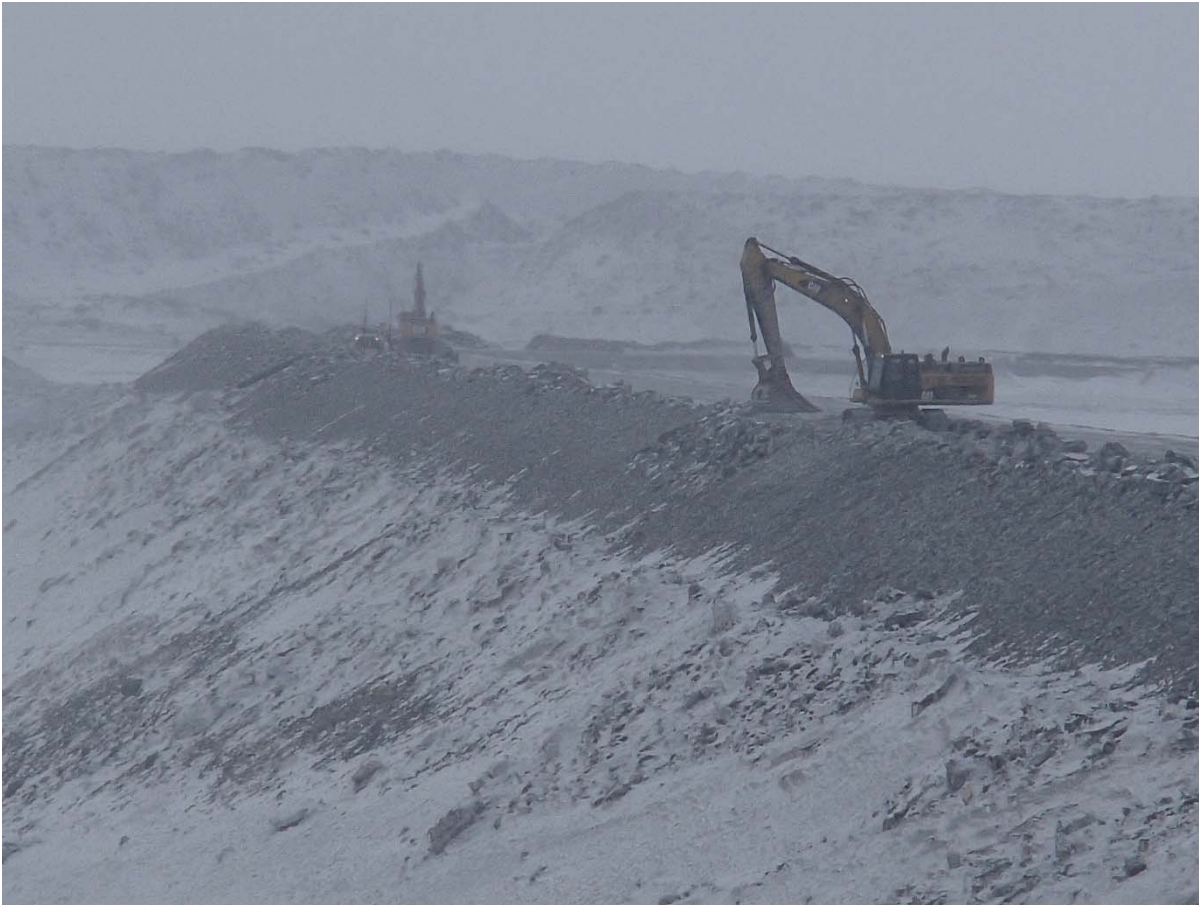
**Photograph CD-1850: From Sta. 0+160/+20 m, looking SW. Profiling of the downstream slope (1.5H:1V) from El. 143 to 145 m with an excavator between Sta. 0+440 m and 0+530 m and between Sta. 0+745 m and 0+835 m.**

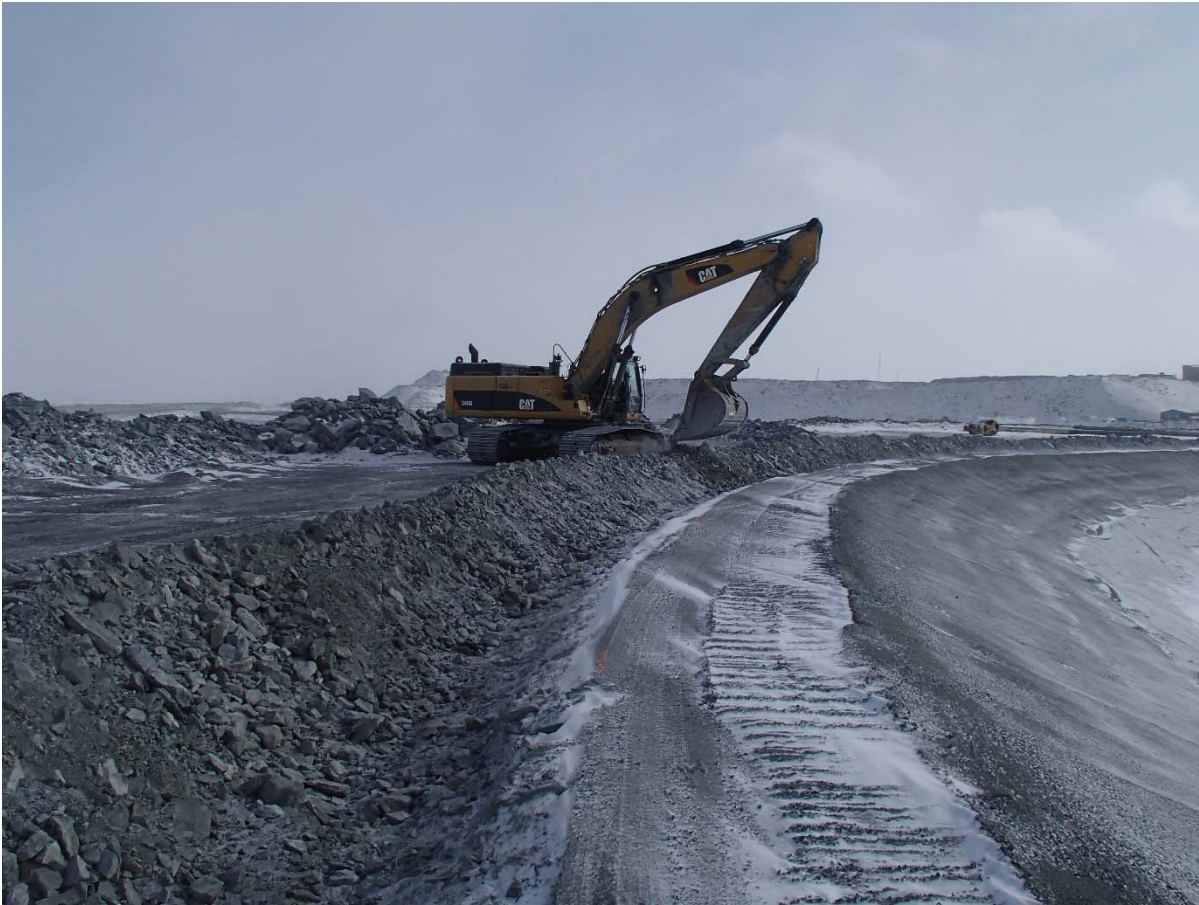
**Photograph CD-1851: From Sta. 0+910/-18 m, looking S. Excavation of the LLDPE geomembrane crest anchoring trench from Sta. 40+730 m to 0+830 m.**

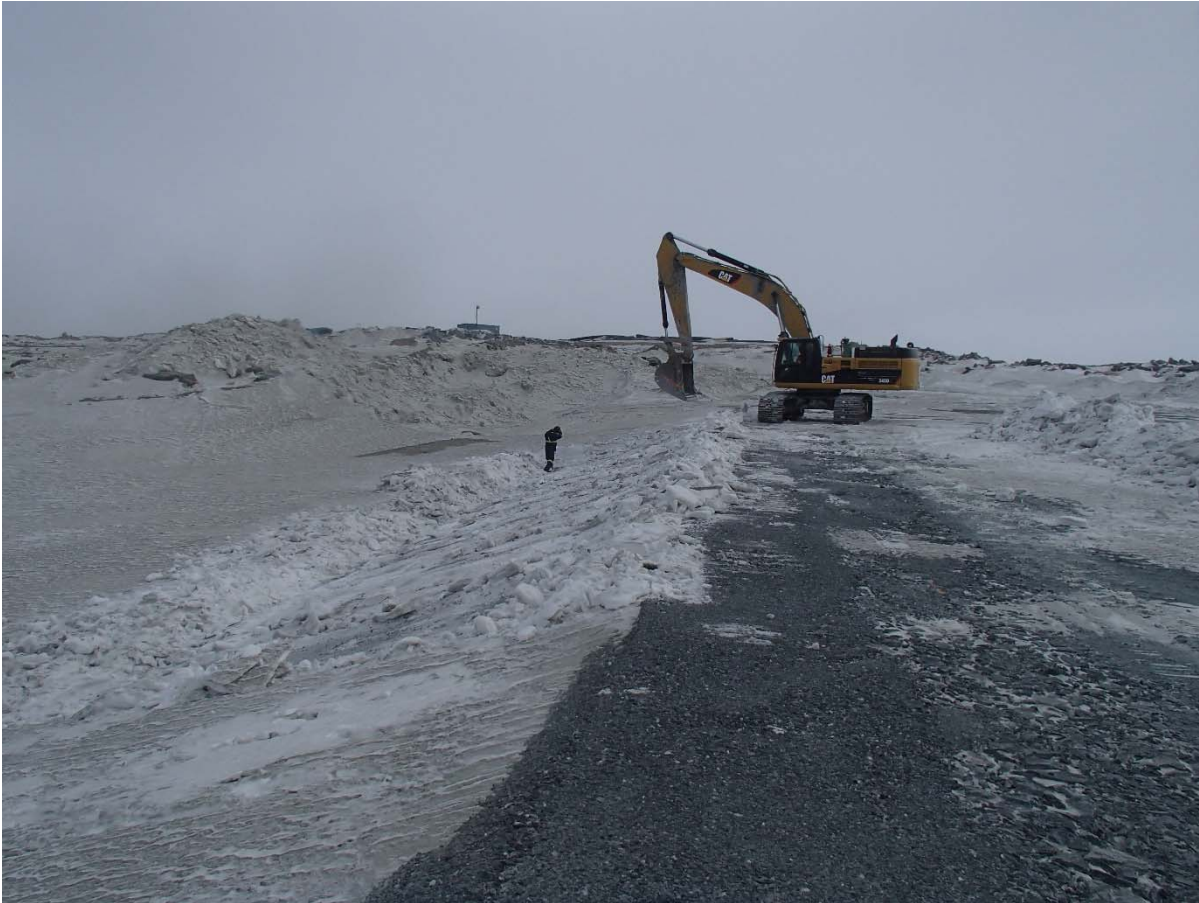
Photograph SD-297: From Sta. 20+730/-10 m, looking SE. Removal of snow on the upstream slope of SD3 with an excavator, from Sta. 20+640 to 20+760 m.

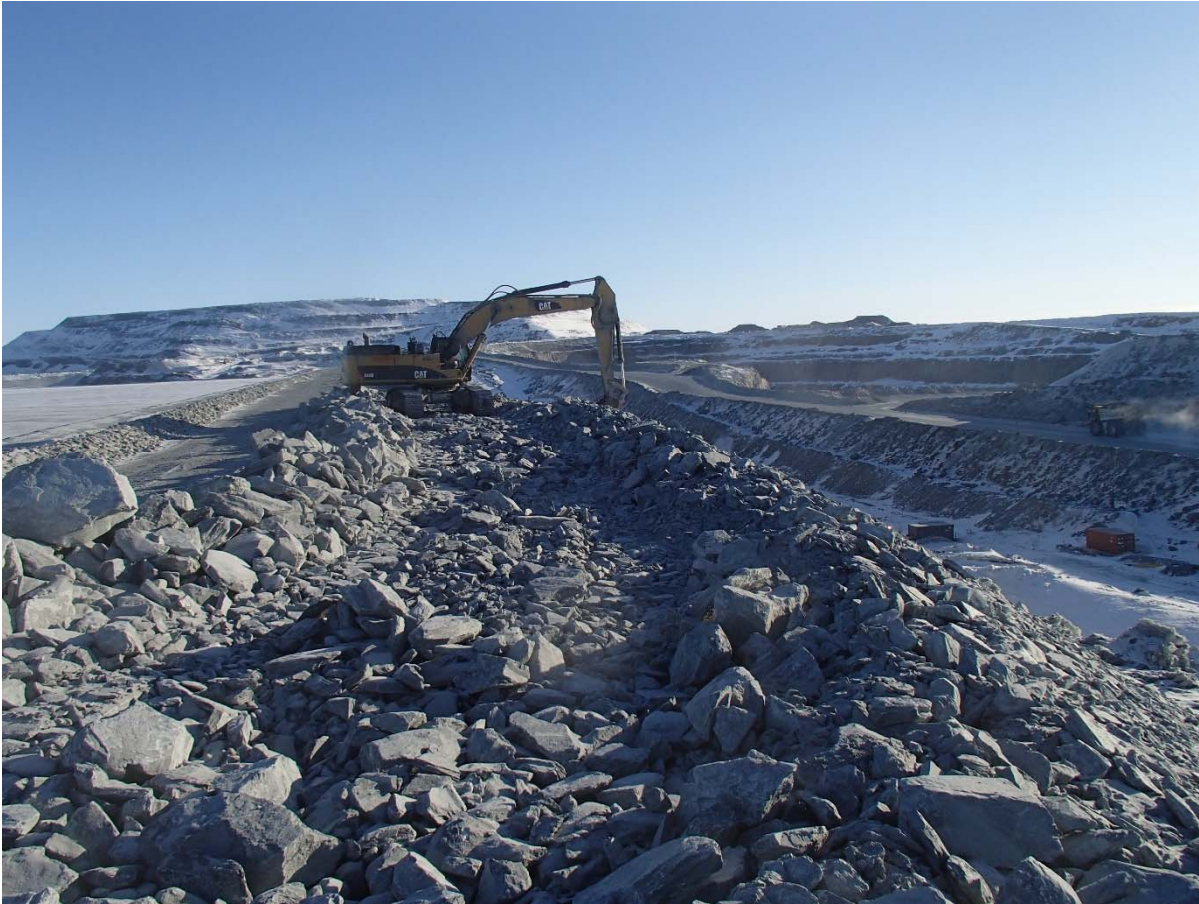
**Photograph CD-1854: From Sta. 0+960/-13 m, looking N. Profiling of the downstream slope (1.5H:1V) from El. 143 to 145 m with an excavator between Sta. 0+940 m and 0+990 m.**

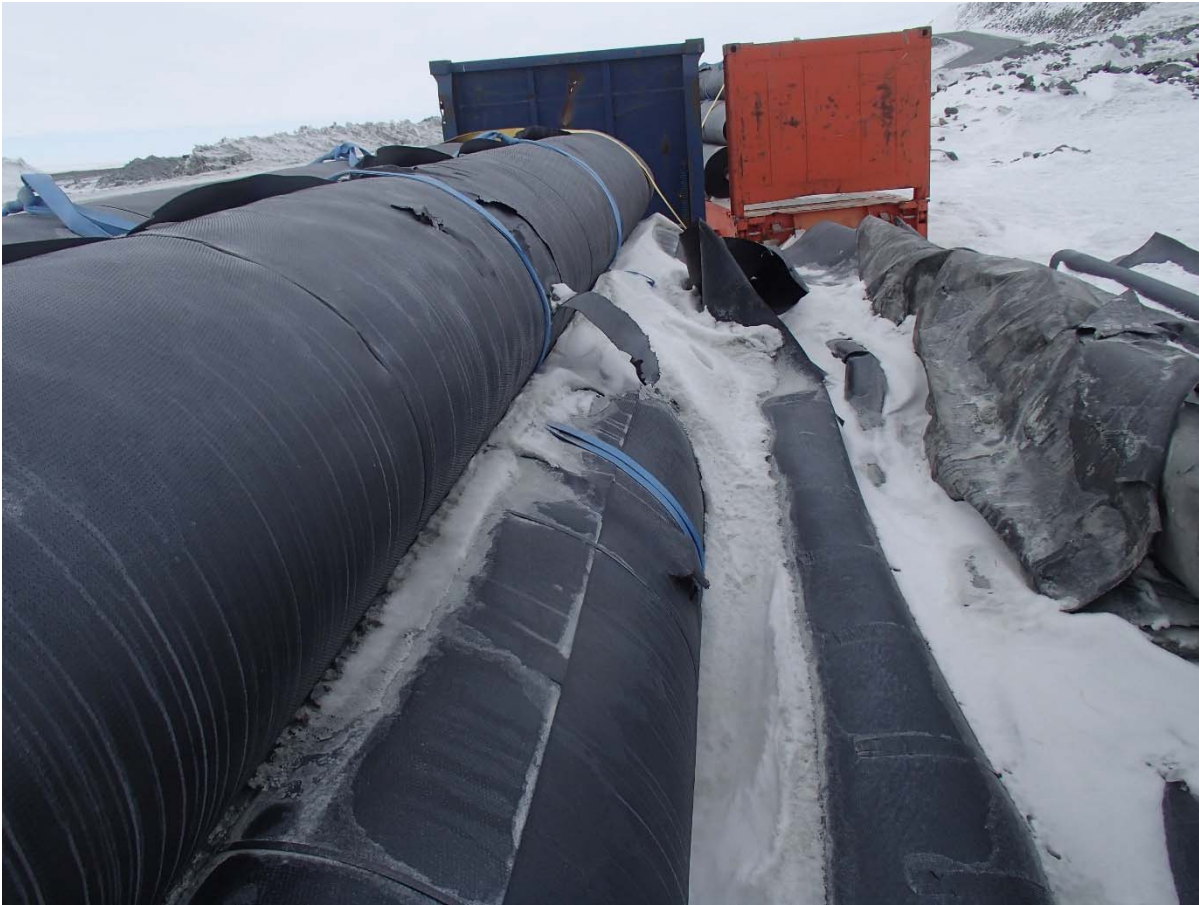
Photograph from the LLDPE storage site: View of new rolls stored on a trailer, showing tears.

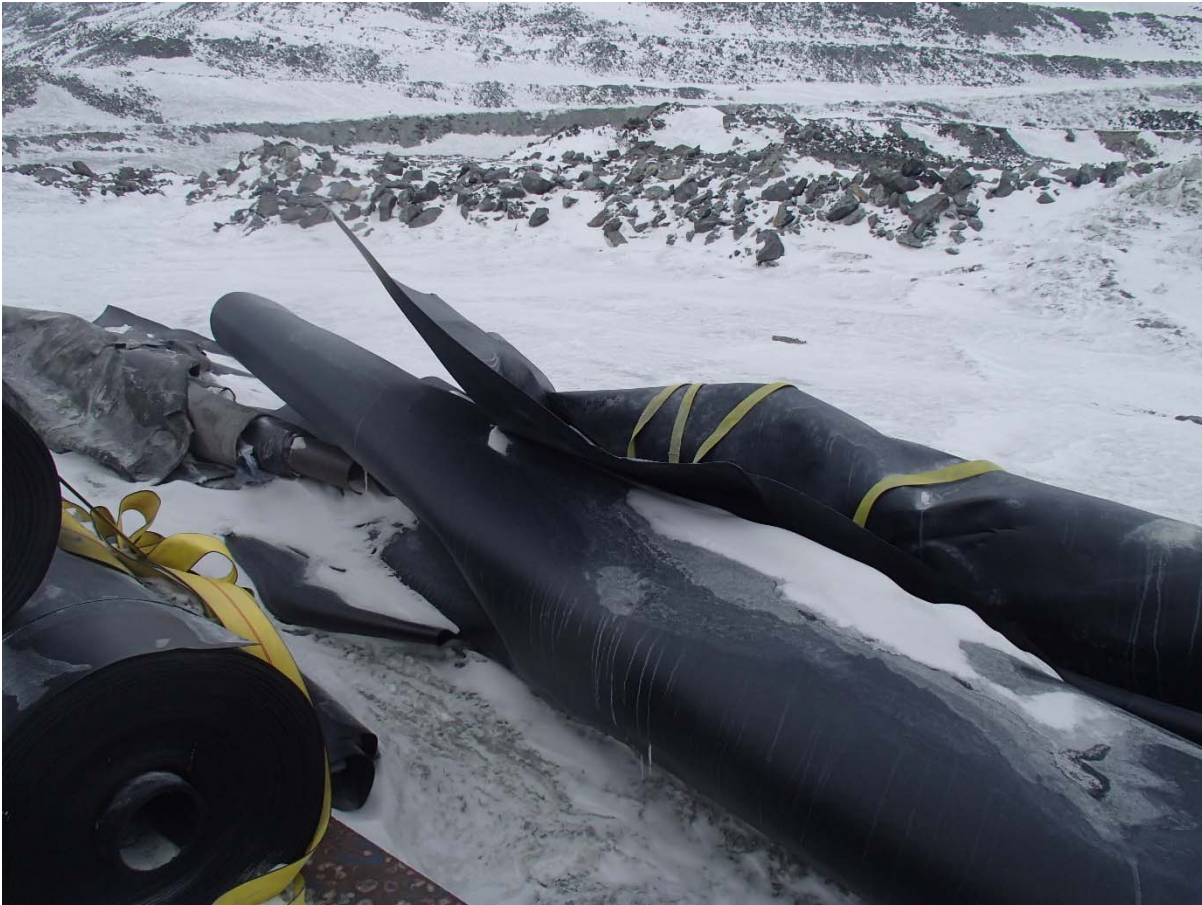
**Photograph from the LLDPE storage site: View of old rolls stored on the ground.**

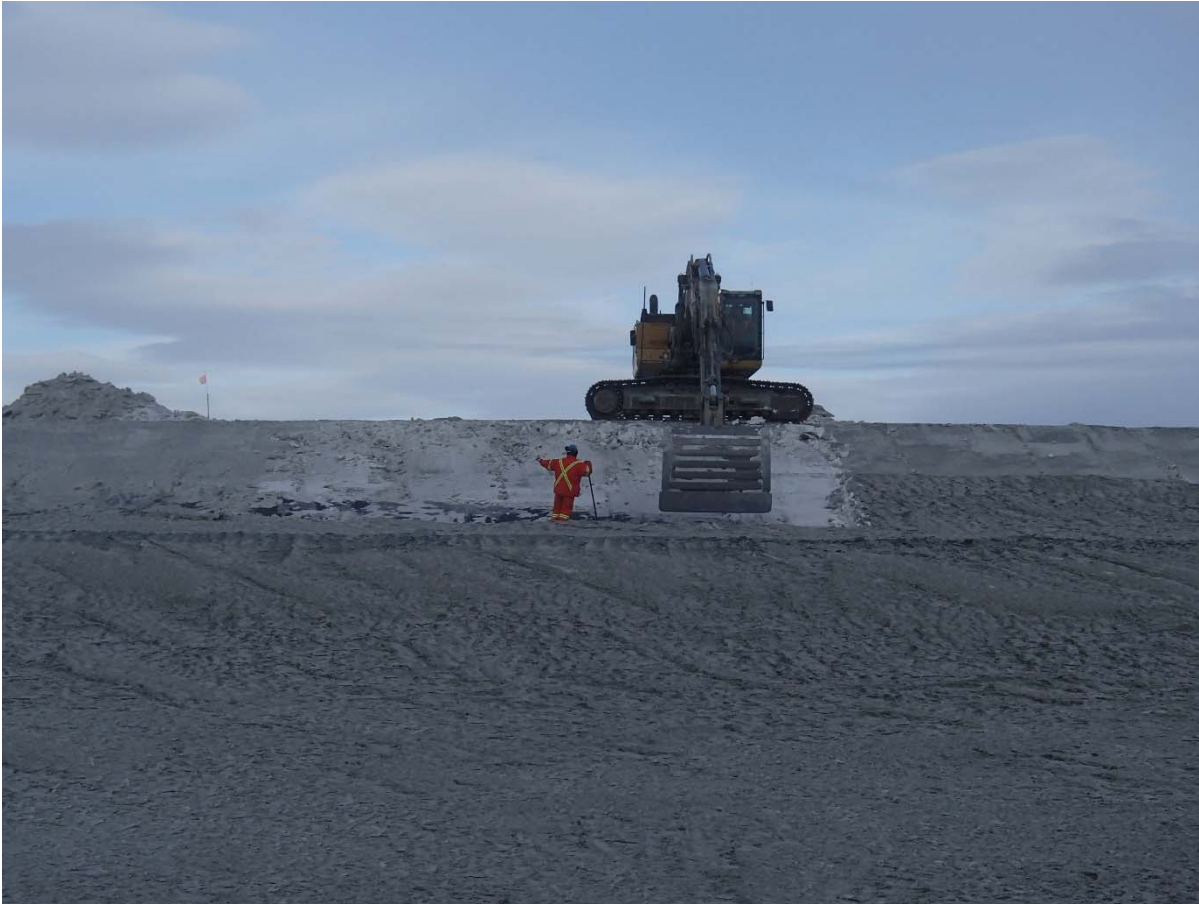
Photograph SD3-298: From Sta. 20+680/-88 m, looking S. Removal of snow on the upstream slope of SD3 above El. 142 m, from Sta. 20+620 m to 20+780 m.

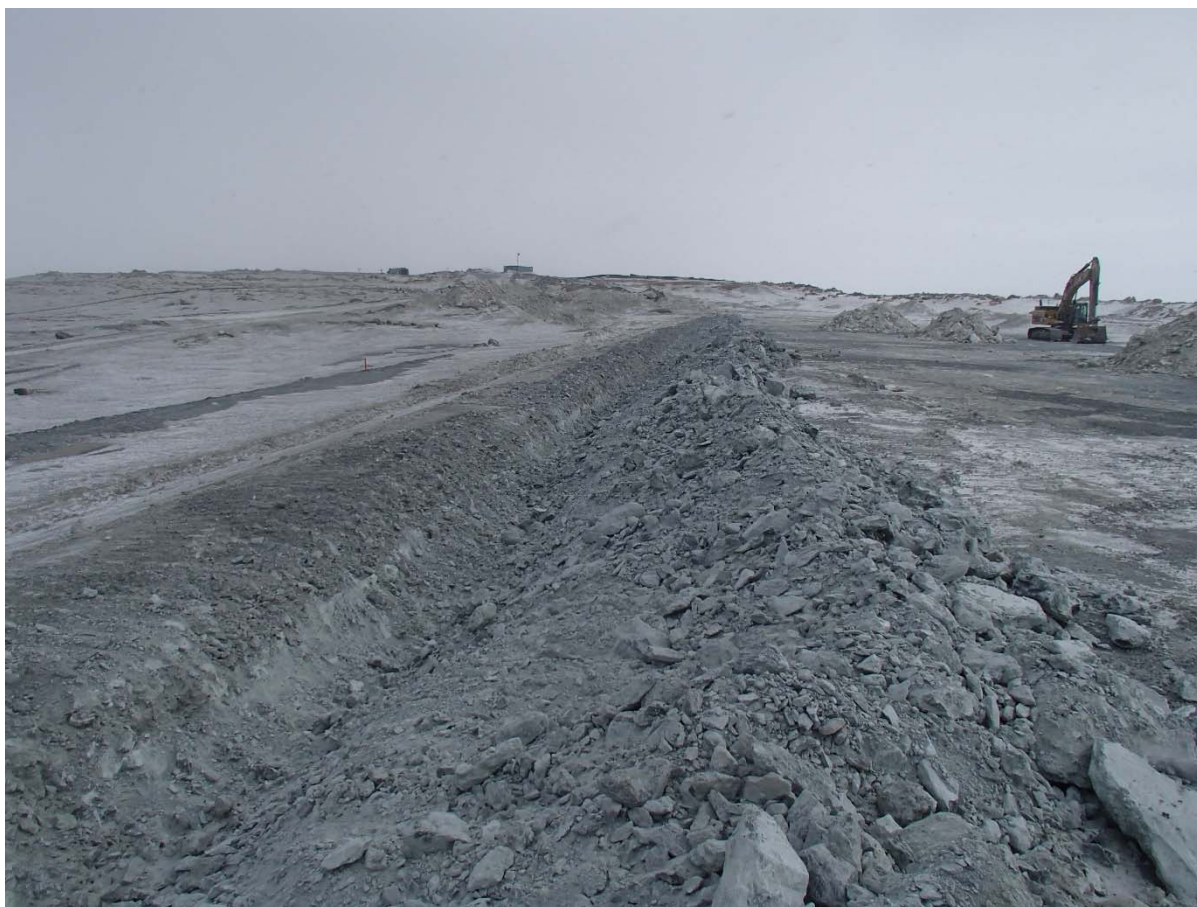
**Photograph SD3-301: From Sta. 20+660/-22 m, looking SE. Excavation of the LLDPE geomembrane crest anchoring trench with an excavator from Sta. 20+655 m to 20+675 m.**

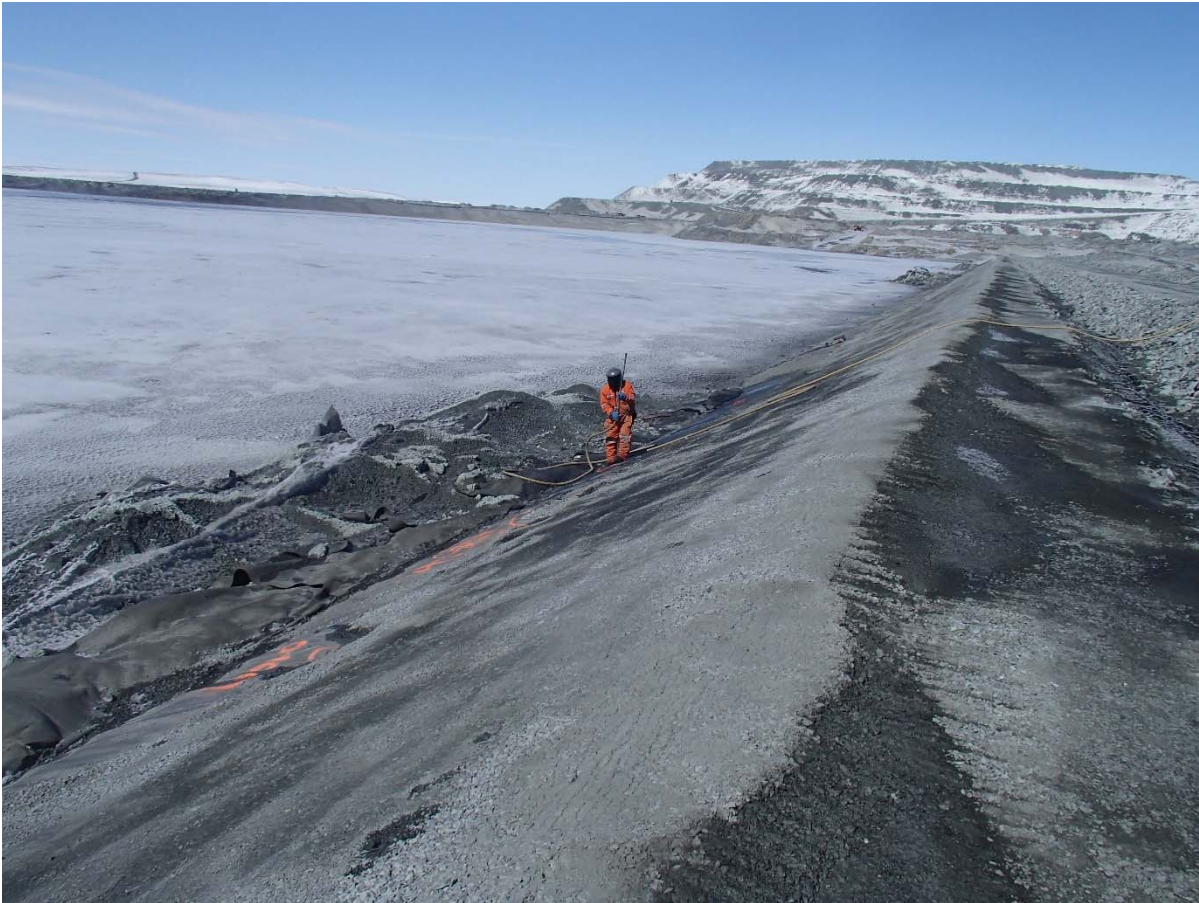
**Photograph CD-1586: From Sta. 0+670/-24 m, looking N. Clean-up of the fine filter placed against the slope at the deposition finger at approx. Sta. 0+670 m with pressurized air stream to expose 1 m of LLDPE liner, in preparation for the new liner installation.**

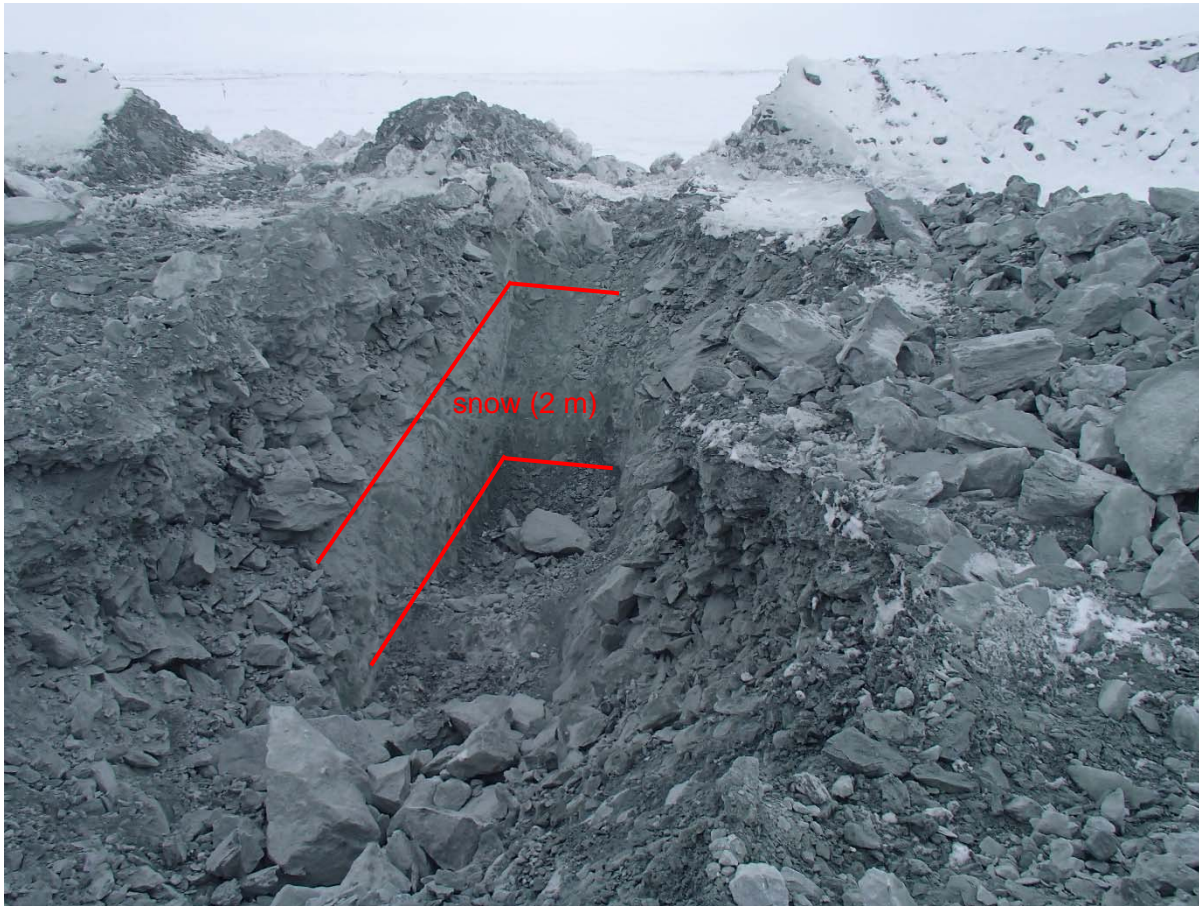
Photograph NCIS-001: View of a test pit in the UM rockfill lift at El. 152 m: a thick layer (2 m) of snow underlies the rockfill.

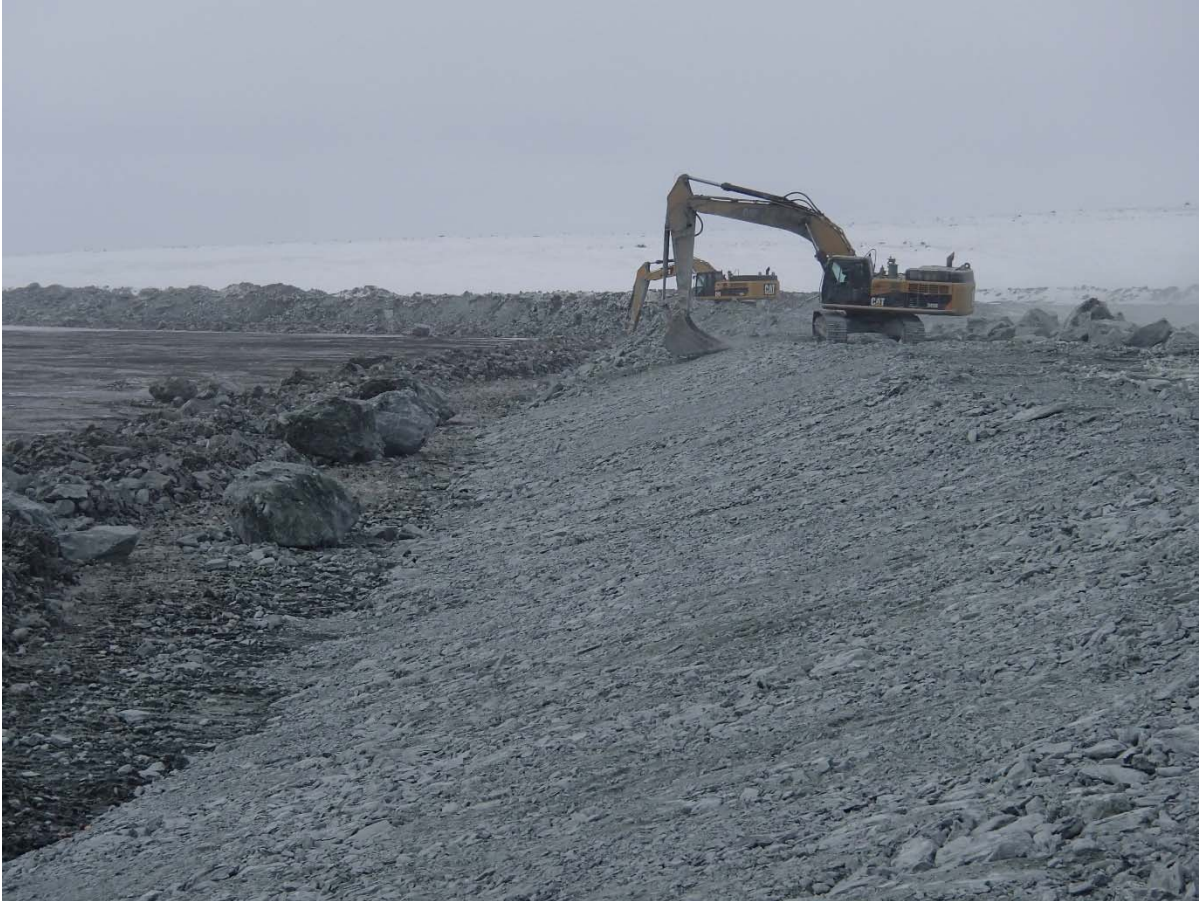
Photograph NCIS-007: Profiling of the upstream slope (3H:1V) from El. 150 to 152 m with an excavator.
