### **Meadowbank 2018 TSF As-built report**

**2018 CONSTRUCTION SEASON AS-BUILT REPORT  
TAILINGS STORAGE FACILITY  
MEADOWBANK GOLD PROJECT, NUNAVUT**

1897439-1578-R-Rev0

November 2018

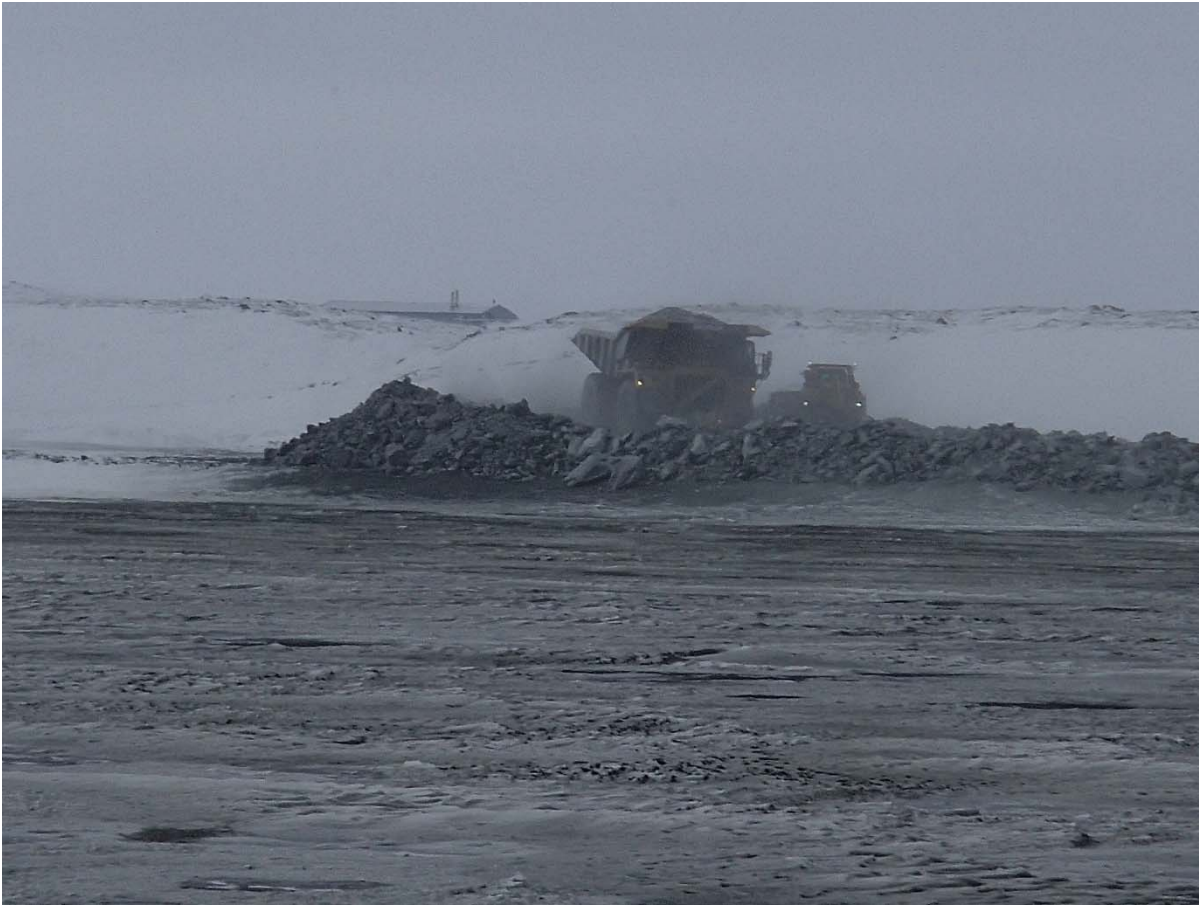
**Photograph NCIS-008: Placement a 2 m thick (approx.) lift of UM rockfill from El. 150 m to El. 152 m (approx.) with a dozer. The material is of good quality and is well graded.**

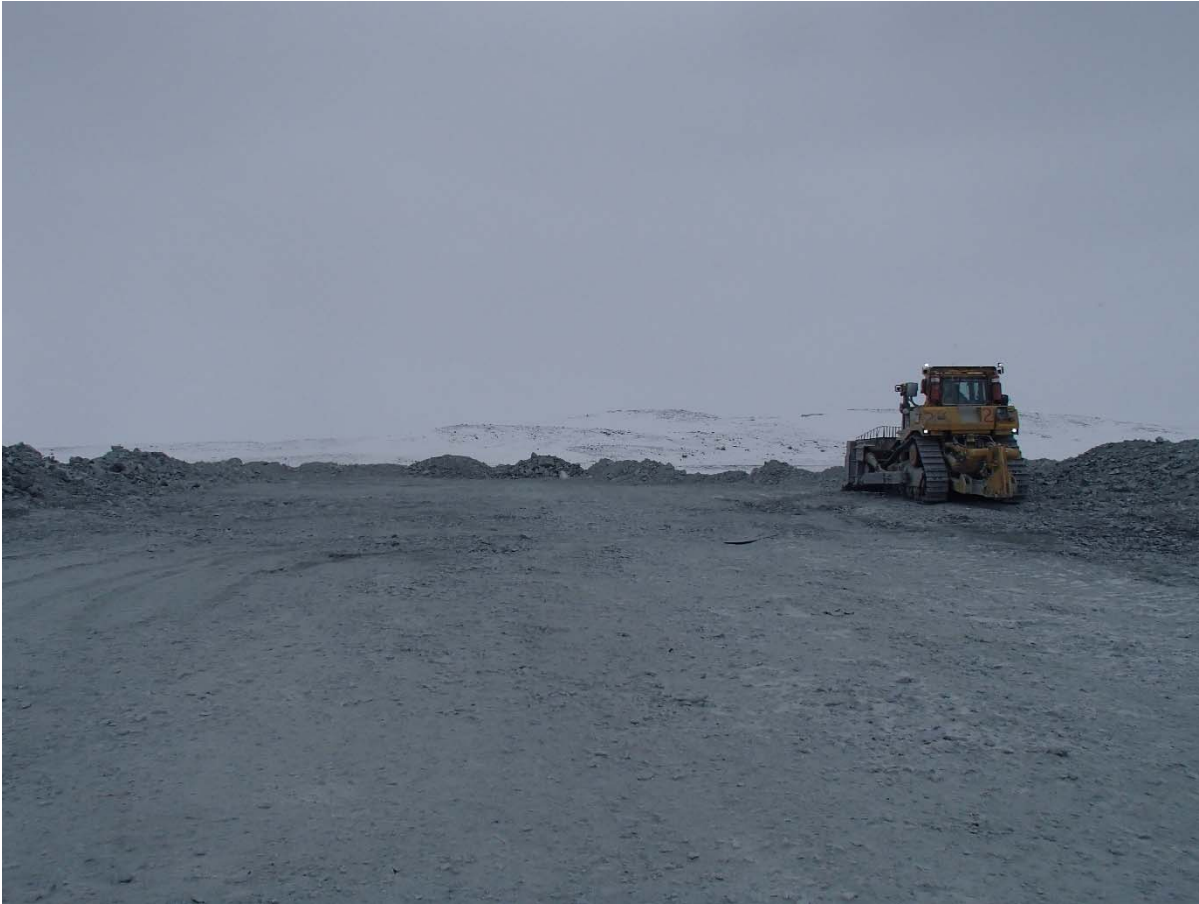
Photograph NCIS-009: Placement a 2 m thick (approx.) lift of UM rockfill from El. 150 m to El. 152 m (approx.) with a dozer from Sta. 1+880 m to 1+825 m (o.s. unavailable).

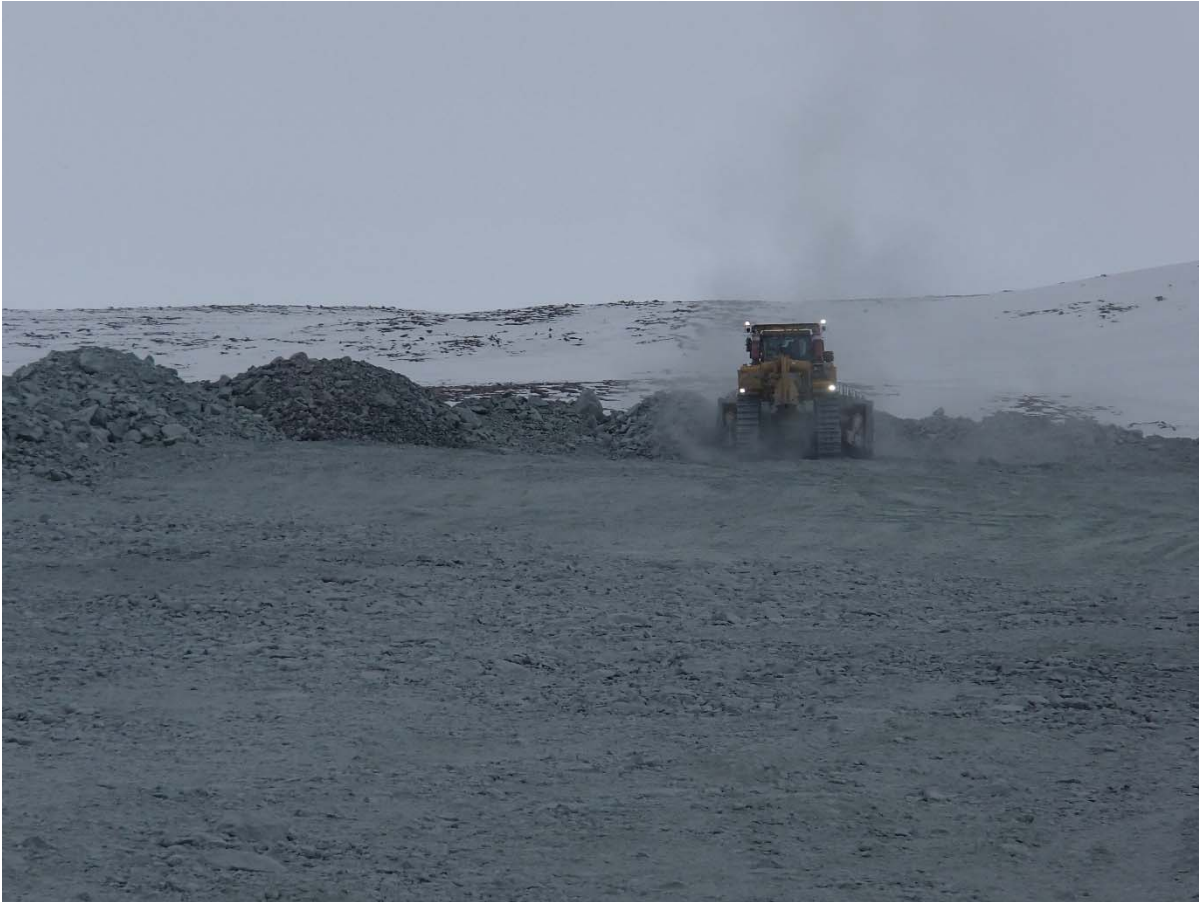
Photograph NCIS-011: From Sta. 2+000 m (approx.), looking SW. Placement a 2 m thick (approx.) lift of UM rockfill from El. 150 m to El. 152 m (approx.) with a dozer from Sta. 1+880 m to 1+767 m (o.s. unavailable).

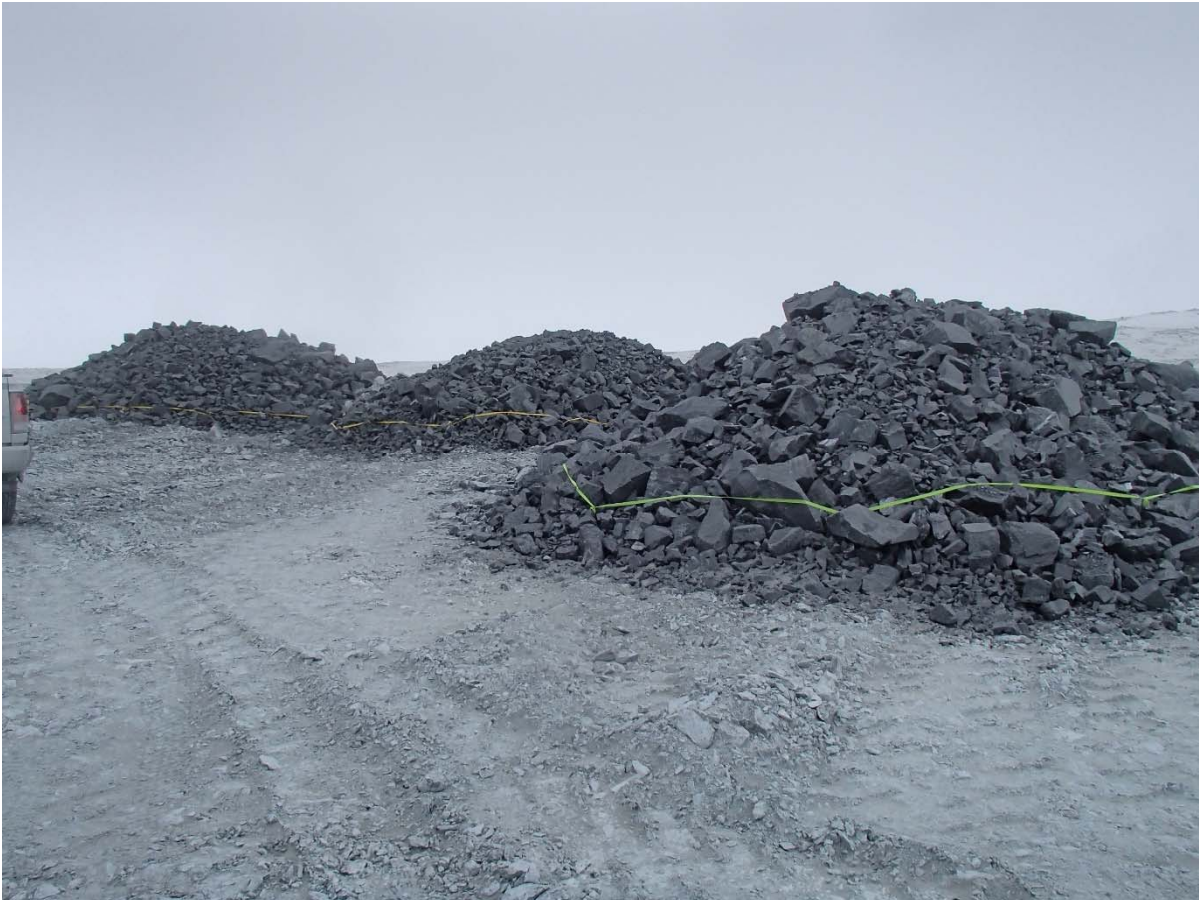
**Photograph NCIS-016: From Sta. 1+750 m (approx.), looking SE. View of the Iron Formation rockfill (PAG material) piles on the North Cell Internal Structure.**

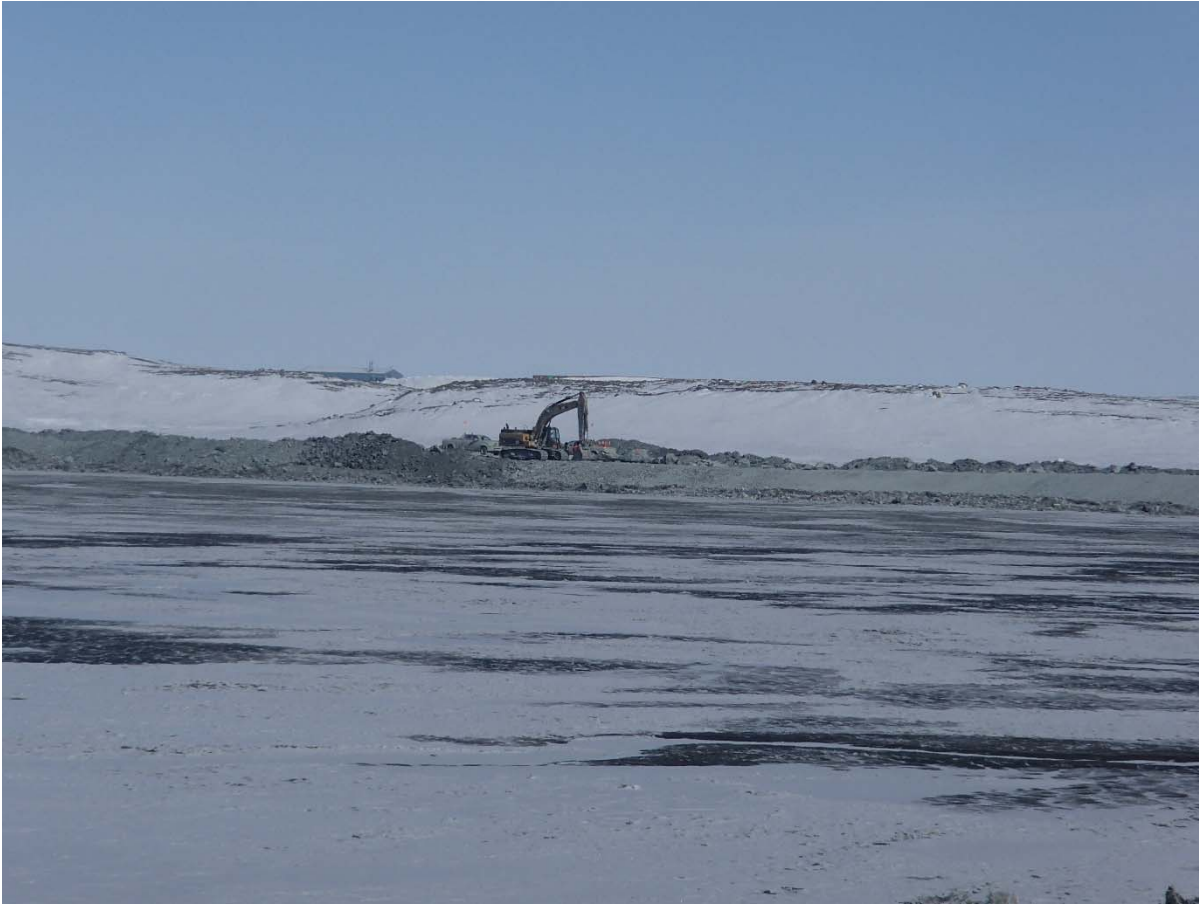
**Photograph NCIS-018: From Sta. 2+310 m (approx.), looking NW. Profiling of the upstream slope (3H:1V) from El. 150 to 152 m with an excavator from Sta. 1+989 m to 1+860 m.**

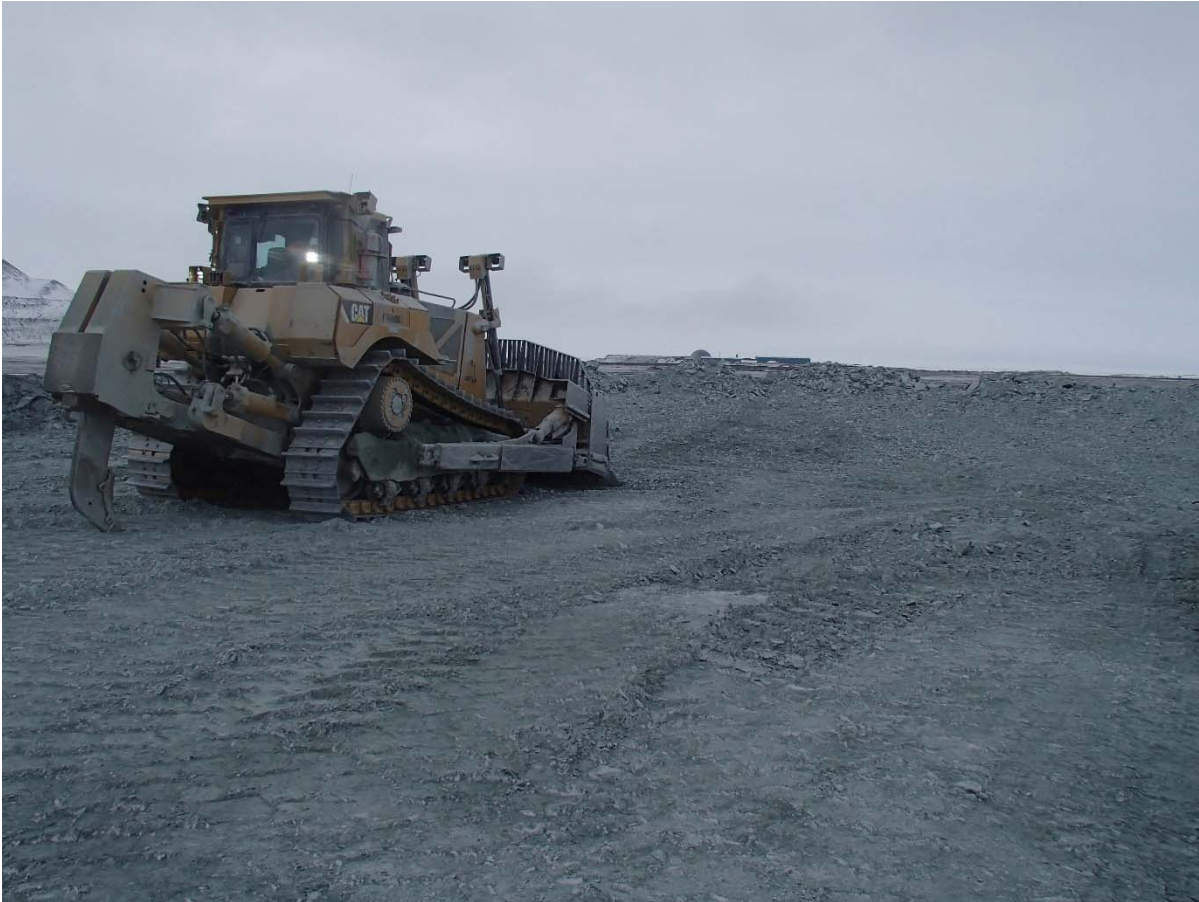
**Photograph NCIS-020: From Sta. 1+570 m (approx.), looking S. Placement a 2 m thick (approx.) lift of UM rockfill from El. 150 m to El. 152 m (approx.) with a dozer from Sta. 1+564 m to 1+535 m (o.s. unavailable).**

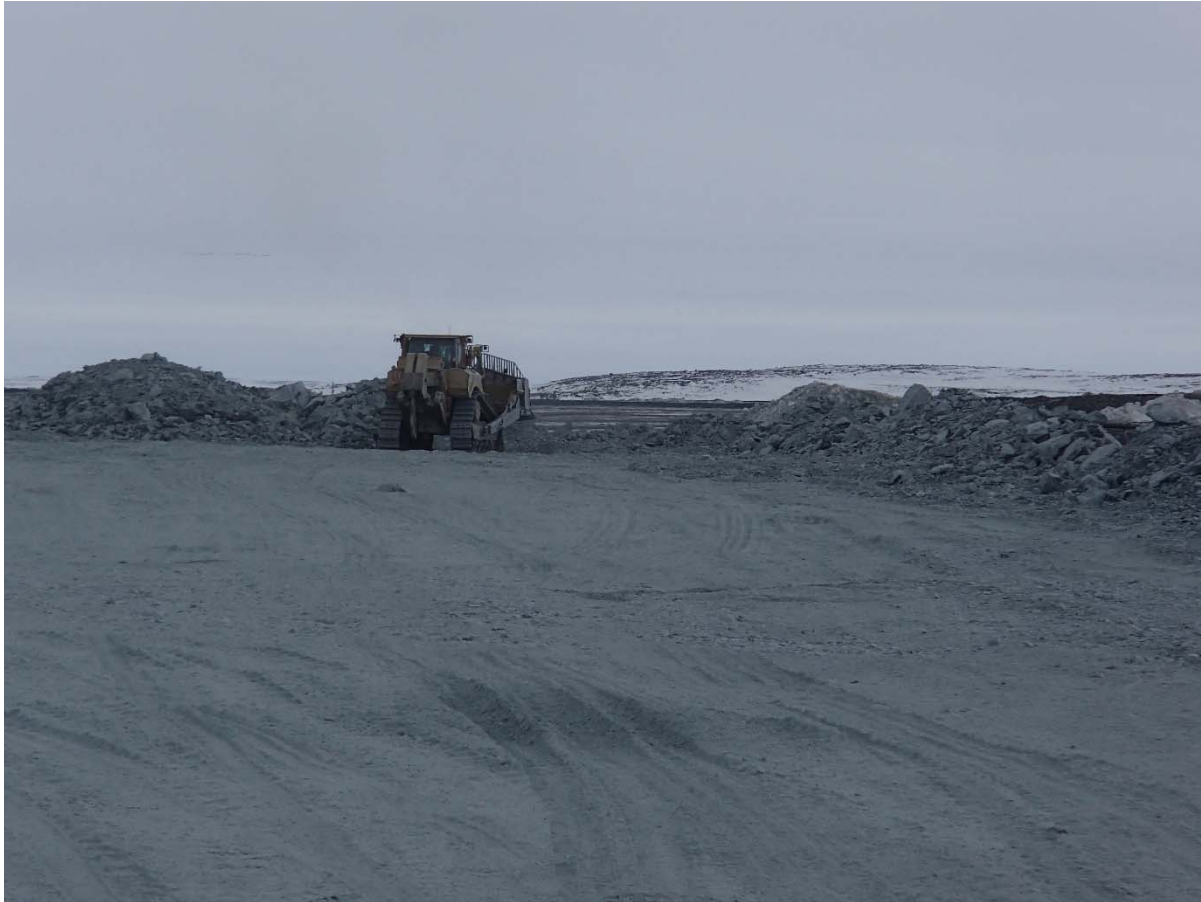
**Photograph NCIS-021: From Sta. 1+550 m (approx.), looking S. Placement a 2 m thick (approx.) lift of UM rockfill from El. 150 m to El. 152 m (approx.) with a dozer from Sta. 1+535 m to 1+500 m (o.s. unavailable).**

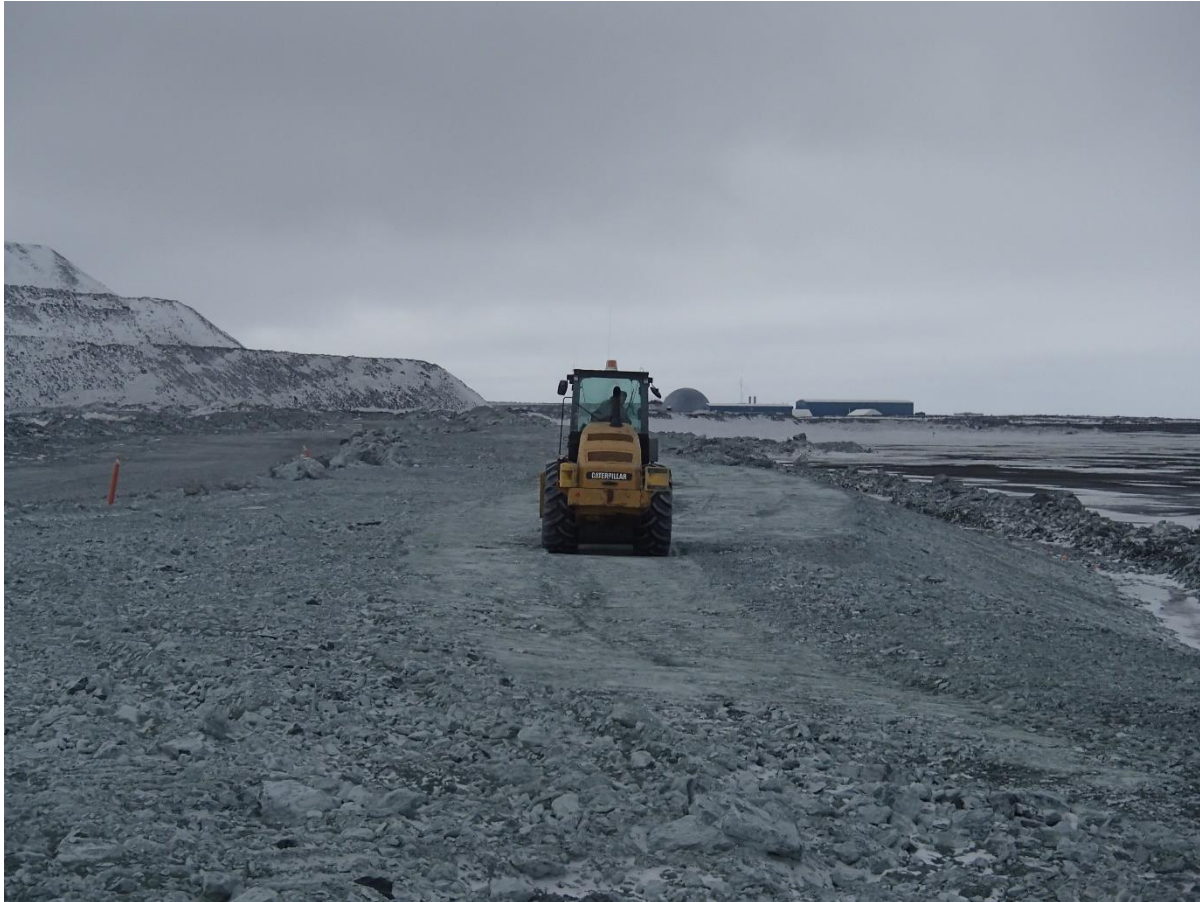
**Photograph NCIS-022: From Sta. 2+245 m (approx.), looking SE. Compaction of the 2 m lift (approx.) of ultramafic (UM) rockfill at El. 152 m with a 10-tonne smooth-drum compactor with vibration (6 passes) between the haul truck traffic lane and the upstream slope from Sta. 2+625 to 1+625 m (o.s. unavailable).**

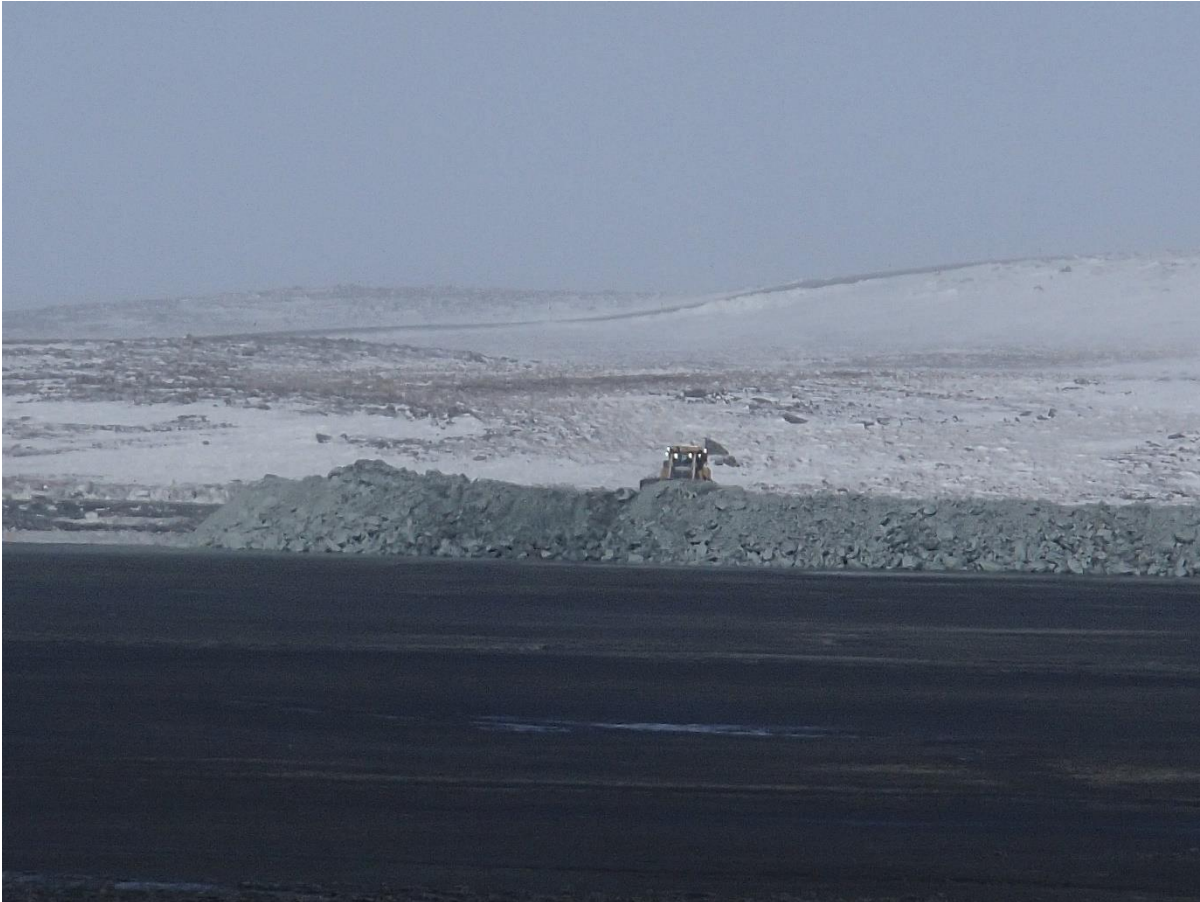
Photograph NCIS-023: From Sta. 2+570 m (approx.), looking W. Placement of a 2 m thick (approx.) lift of UM rockfill from El. 150 m to El. 152 m (approx.) with a dozer from Sta. 1+500 m to 1+450 m (o.s. unavailable). The material is of good quality and is well graded.

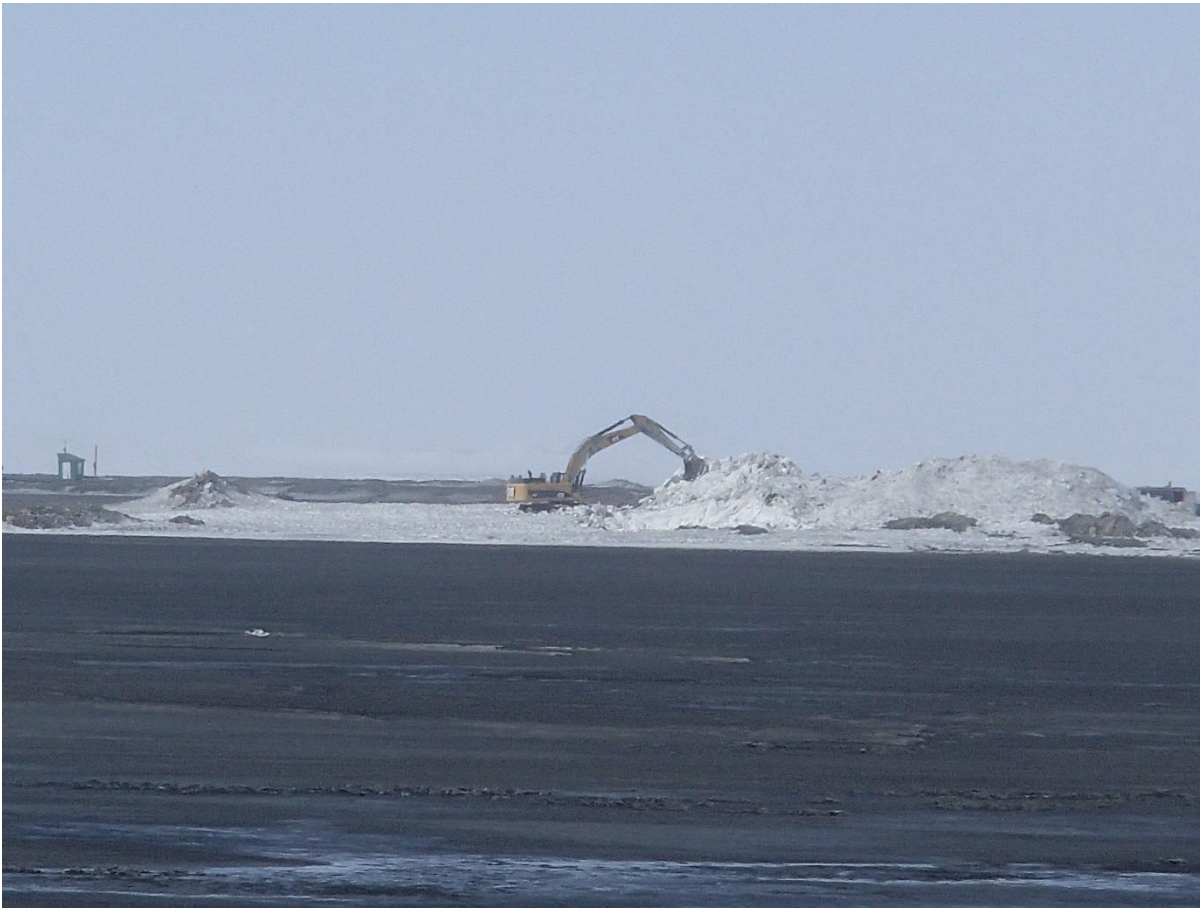
**Photograph NCIS-024: From Sta. 2+570 m (approx.), looking SW. Removal of the snow bank in the footprint with an excavator from Sta. 1+160 m to 1+120 m (approx.).**

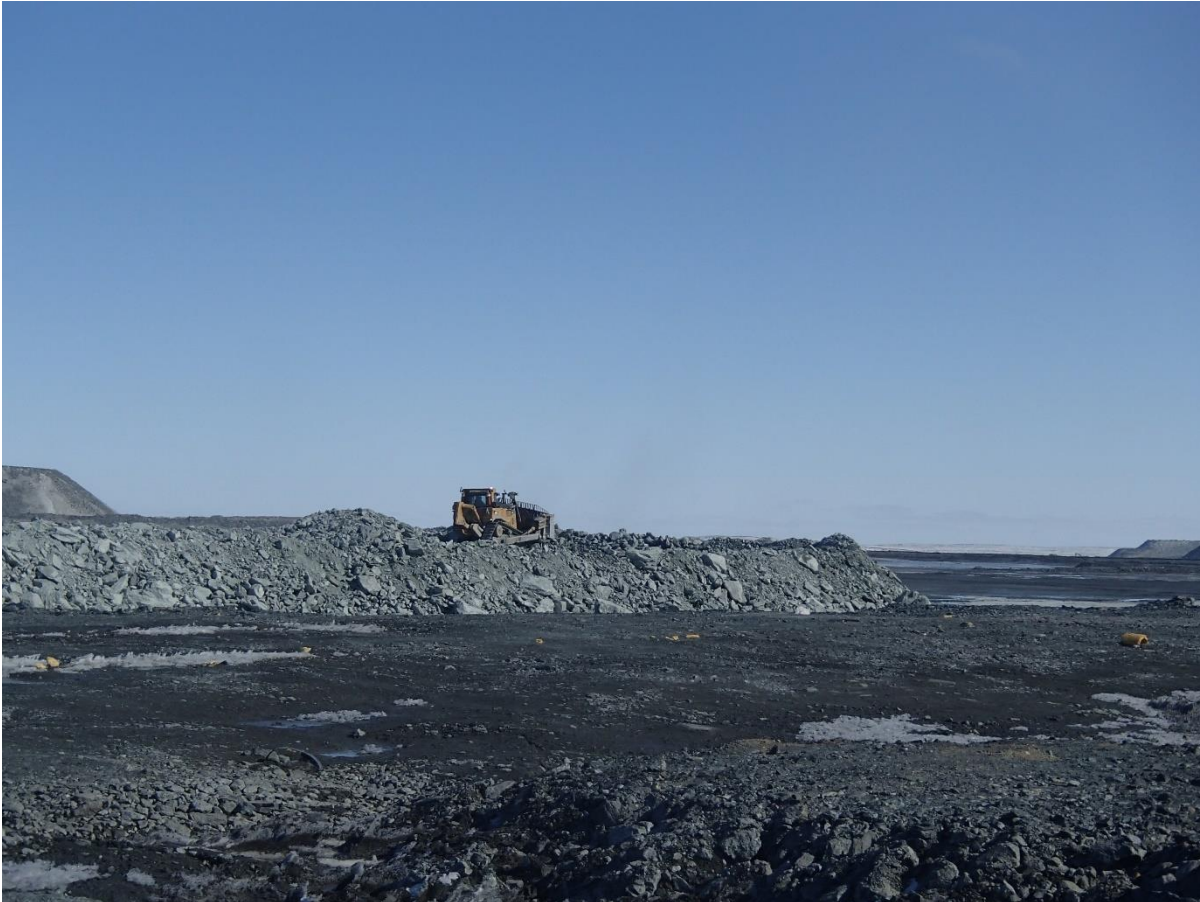
**Photograph NCIS-025: From Sta. 1+475 m (approx.), looking SE. Placement of a 2 m thick (approx.) lift of UM rockfill from El. 150 m to El. 152 m (approx.) with a dozer from Sta. 1+450 m to 1+390 m (o.s. unavailable). The material is of good quality and is well graded.**

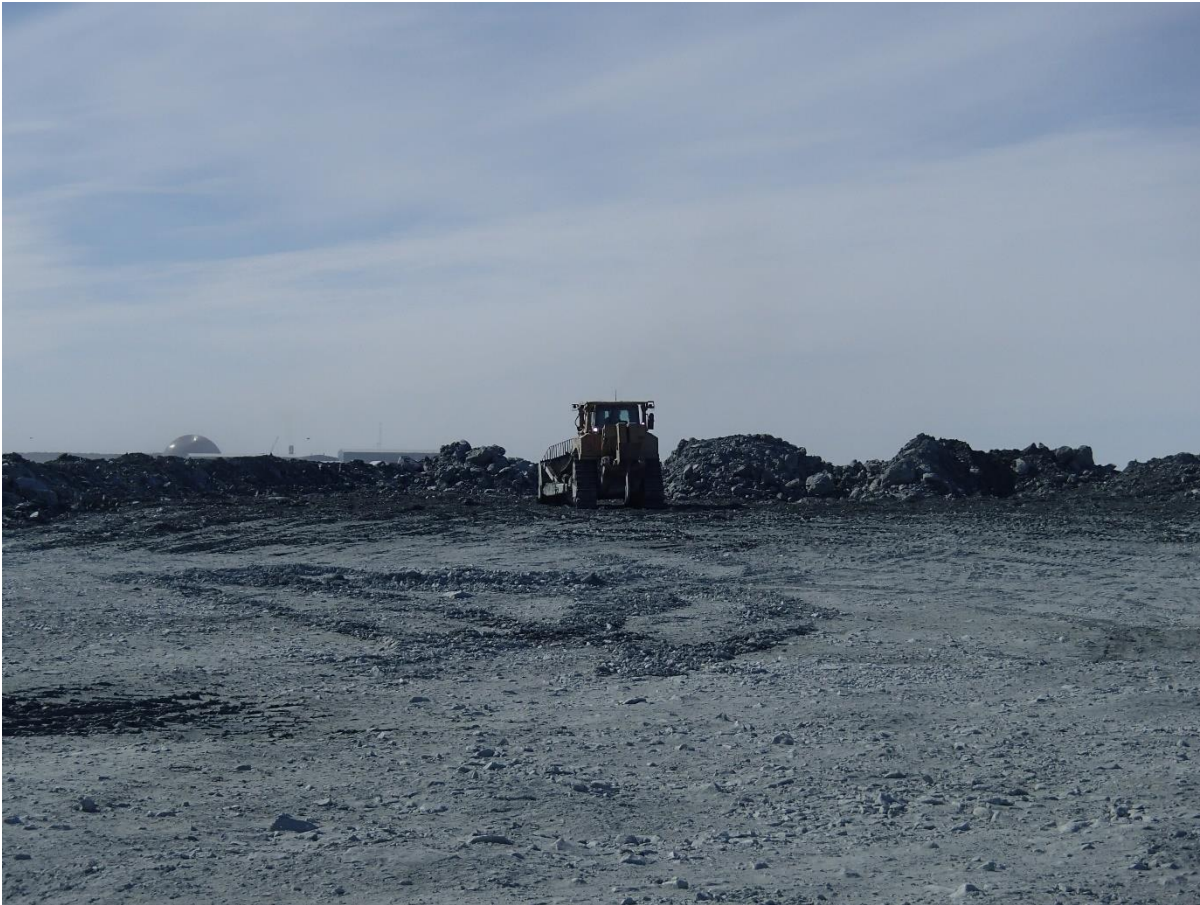
**Photograph NCIS-026: From Sta. 1+440/+2 m, looking S. Placement of a 2 m thick (approx.) lift of UM rockfill from El. 150 m to El. 152 m (approx.) with a dozer from Sta. 1+390 m to 1+365 m (o.s. +10 m to -29 m).**

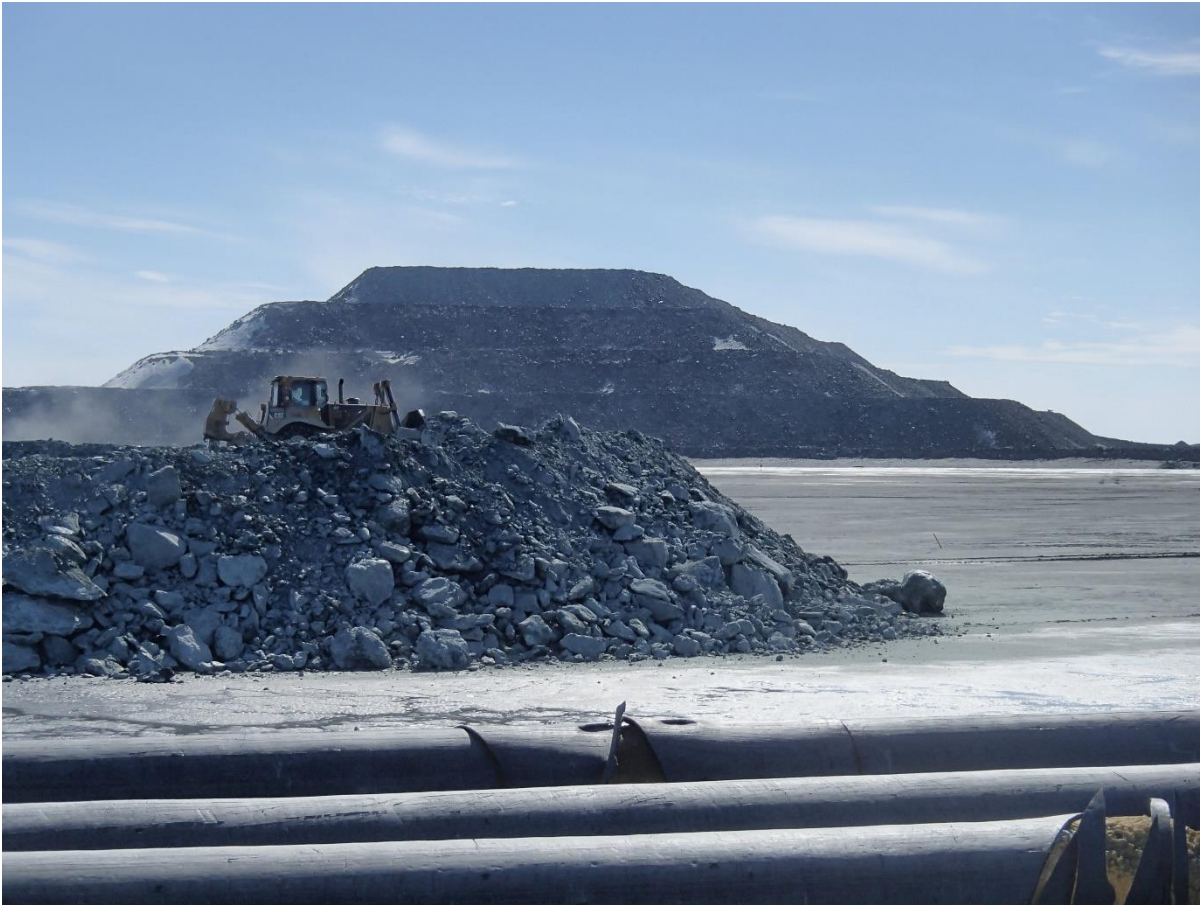
**Photograph NCIS-027: From Sta. 1+360/+67 m, looking S. Placement of a 2 m thick (approx.) lift of UM rockfill from El. 150 m to El. 152 m (approx.) with a dozer from Sta. 1+365 m to 1+360 m (o.s. +9 m to -28 m).**

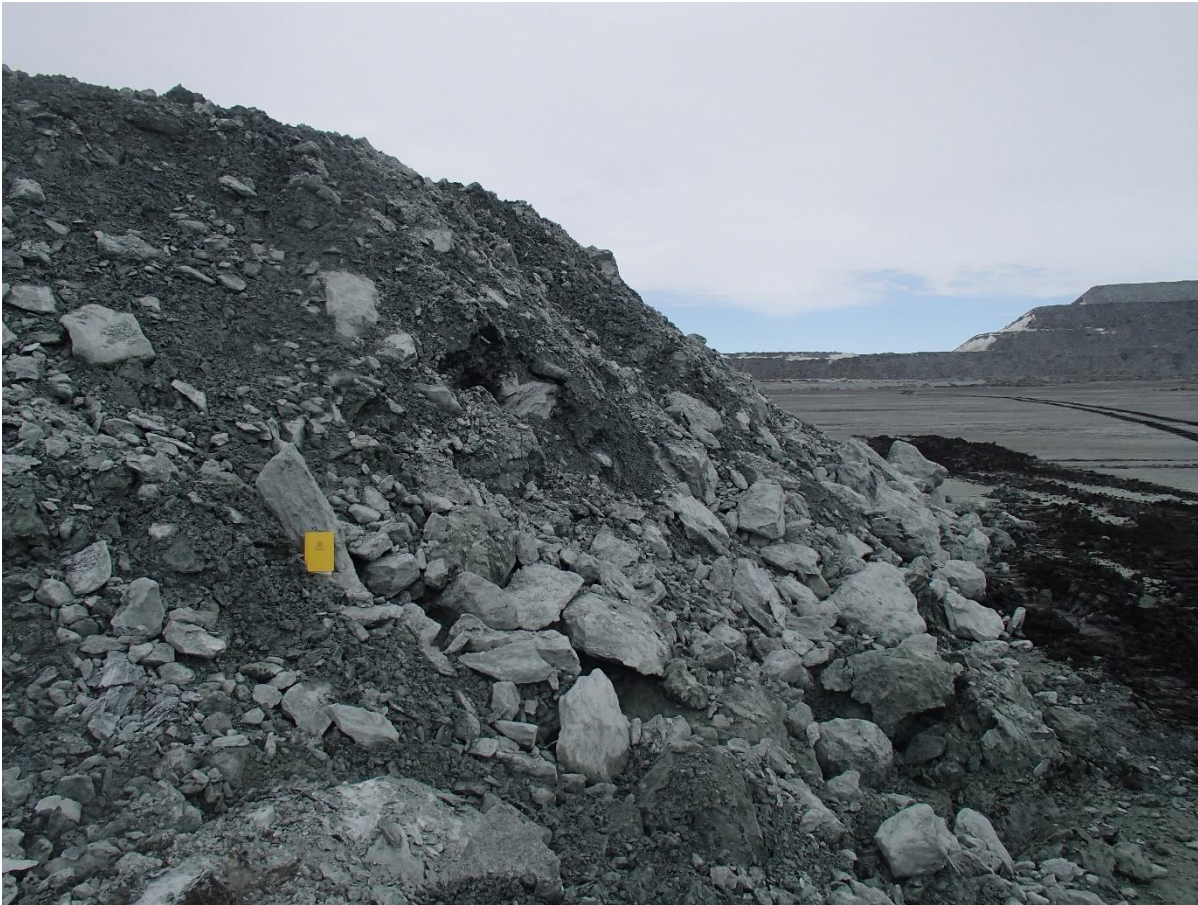
Photograph NCIS-028: From Sta. 1+340/+3 m, looking E. View of the UM rockfill lift approximately 3.2 m thick.

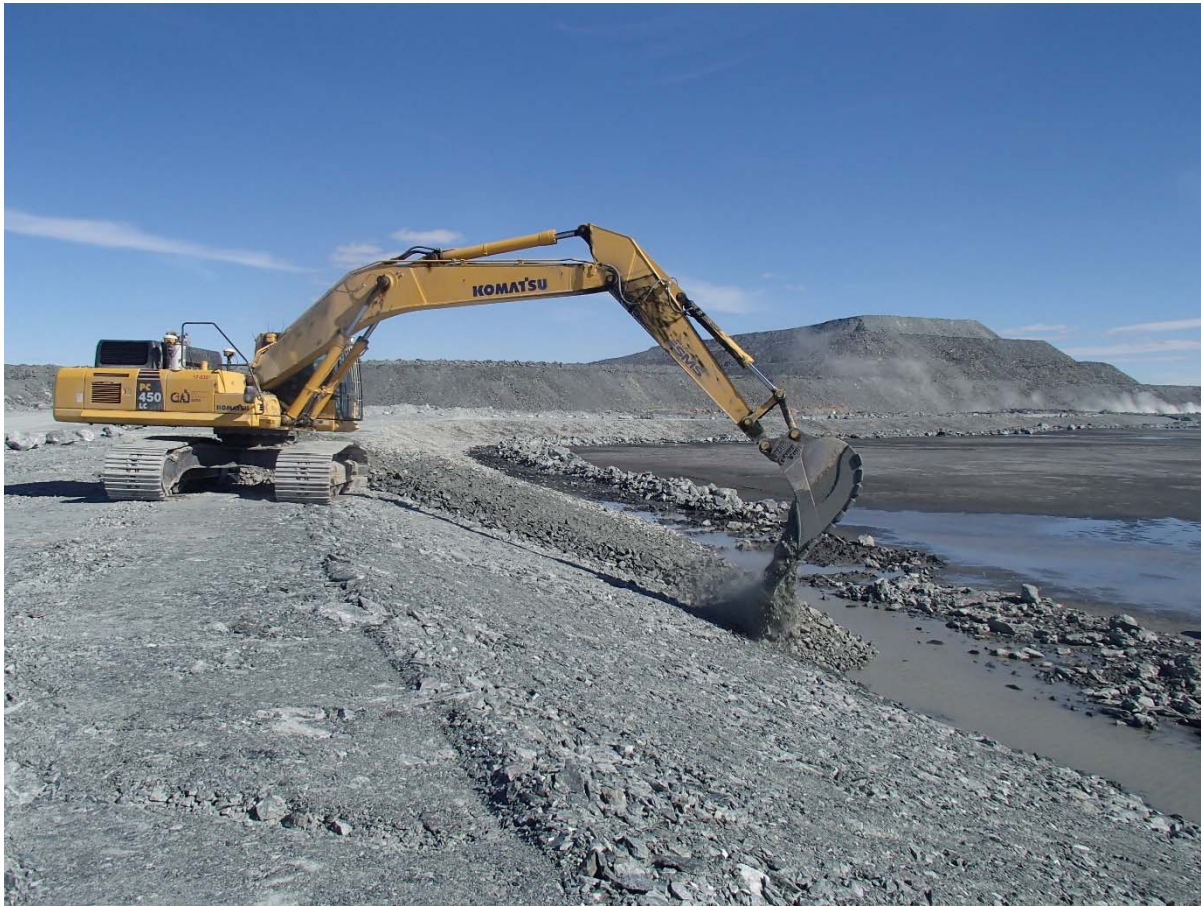
**Photograph NCIS-029: From Sta. 2+120/-27 m (approx.), looking SE. Placement of a 0.5 m thick lift of coarse filter in the upstream slope from El. 150 m to 152 m with an excavator from Sta. 2+280 m to 2+105 m.**

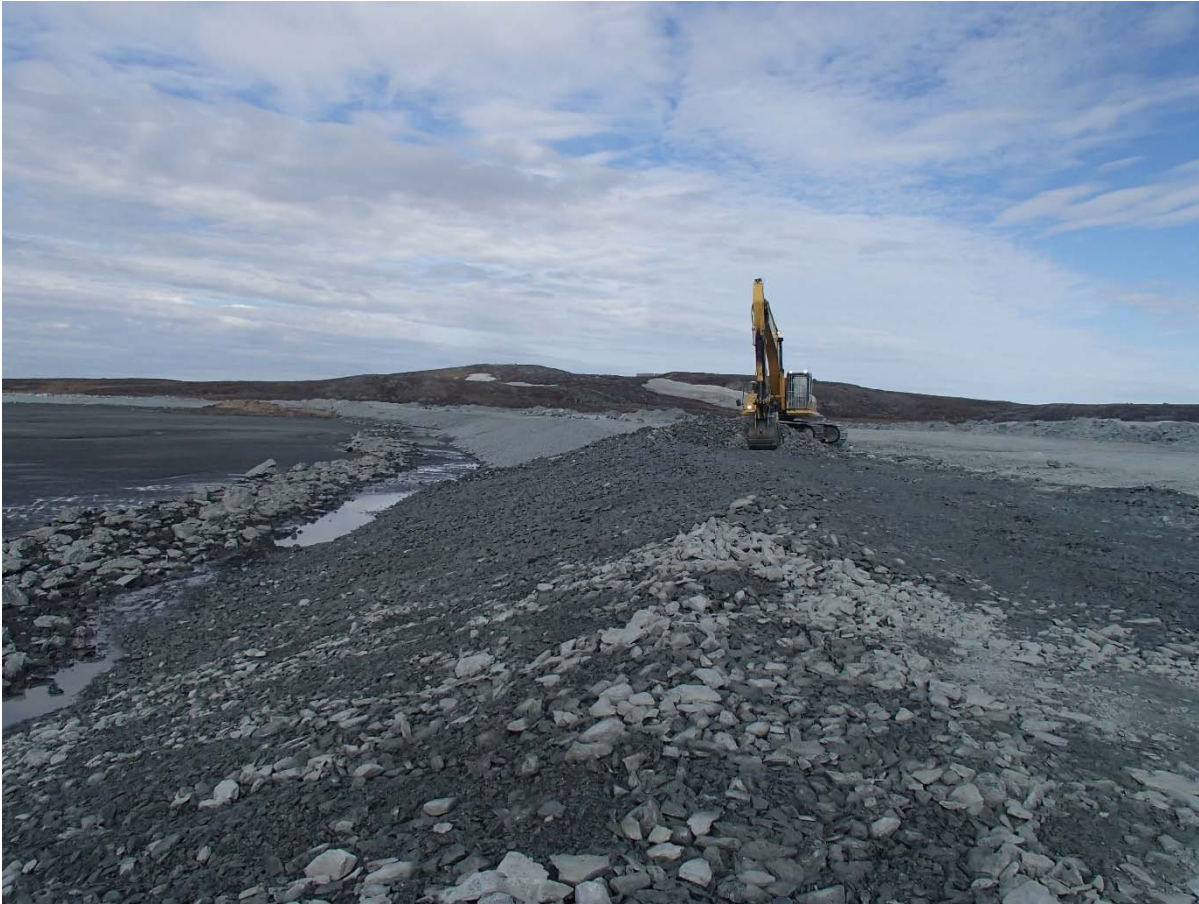
**Photograph NCIS-030: From Sta. 2+140/-29 m (approx.), looking W. Placement of a 0.5 m thick lift of coarse filter in the upstream slope from El. 150 m to 152 m with an excavator from Sta. 2+105 m to 1+930 m. Notice the presence of water ponding at the bottom of the slope.**

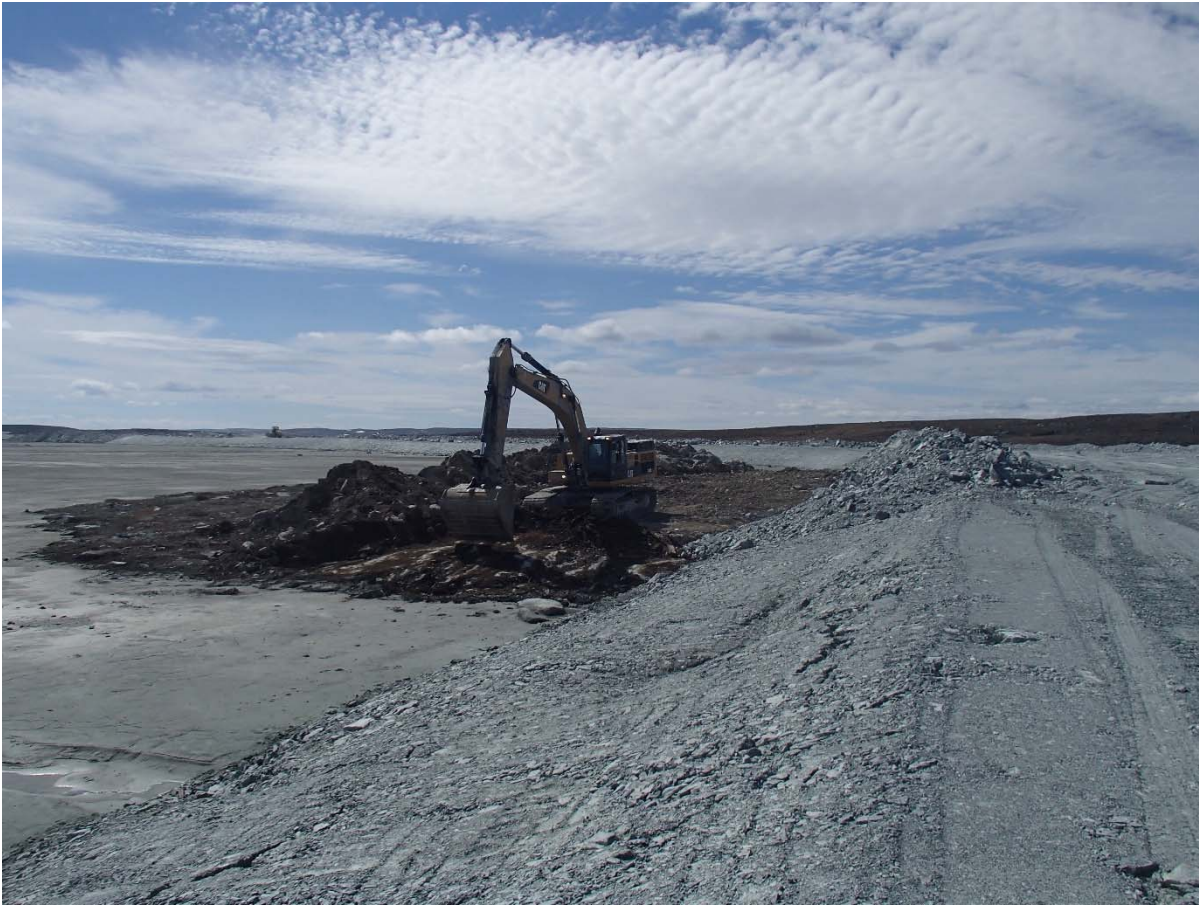
**Photograph NCIS-031: From Sta. 1+880/-21 m (approx.), looking SW. Final clean-up of the dike footprint with an excavator to reach a good quality bedrock from Sta. 1+800 to 1+850 m (o.s. -42 to -33 m).**

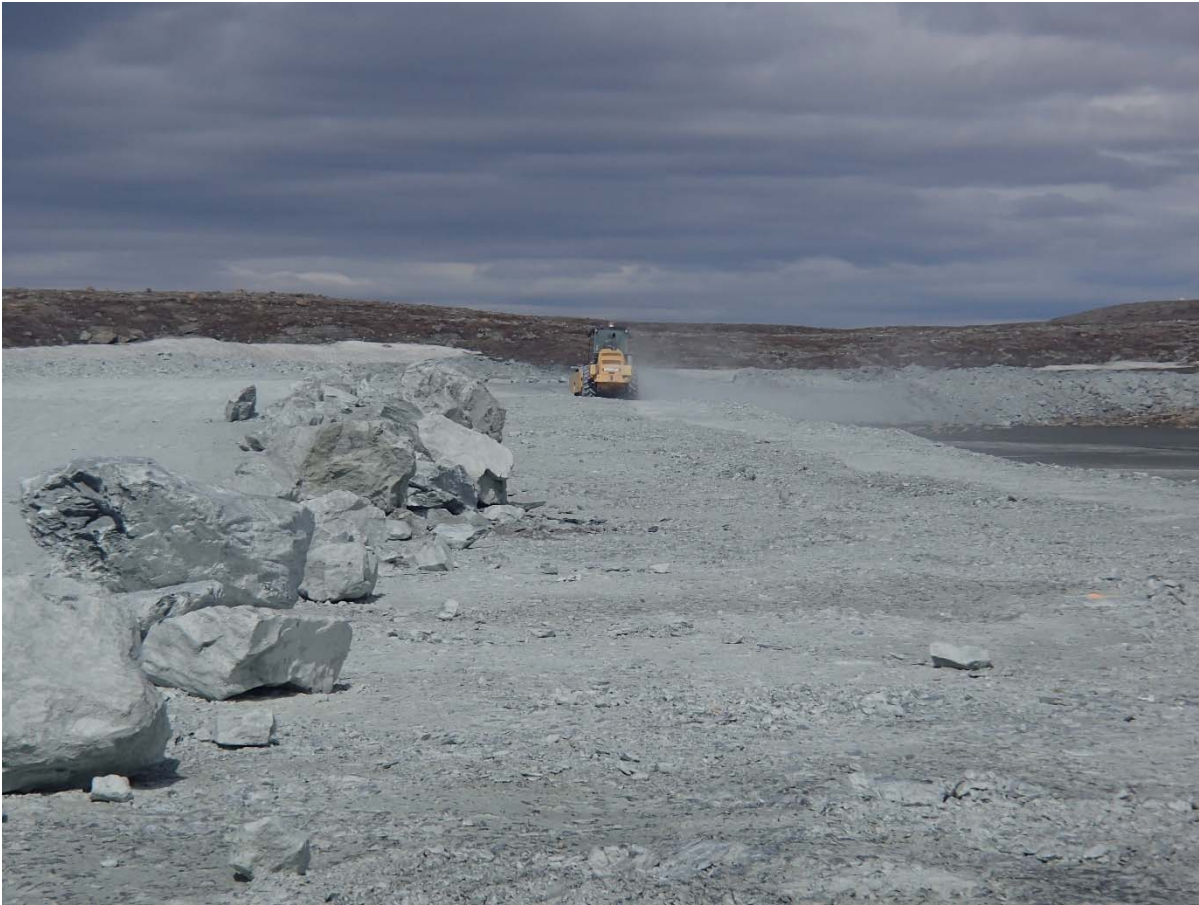
**Photograph NCIS-032: From Sta. 1+400/-24 m (approx.), looking N. Compaction of the 2 m lift (approx.) of ultramafic (UM) rockfill at El. 152 m with a 10-tonne smooth-drum compactor with vibration (6 passes) between the haul truck traffic lane and the upstream slope from Sta. 1+660 to 1+380 m (o.s. -45 to -24 m).**

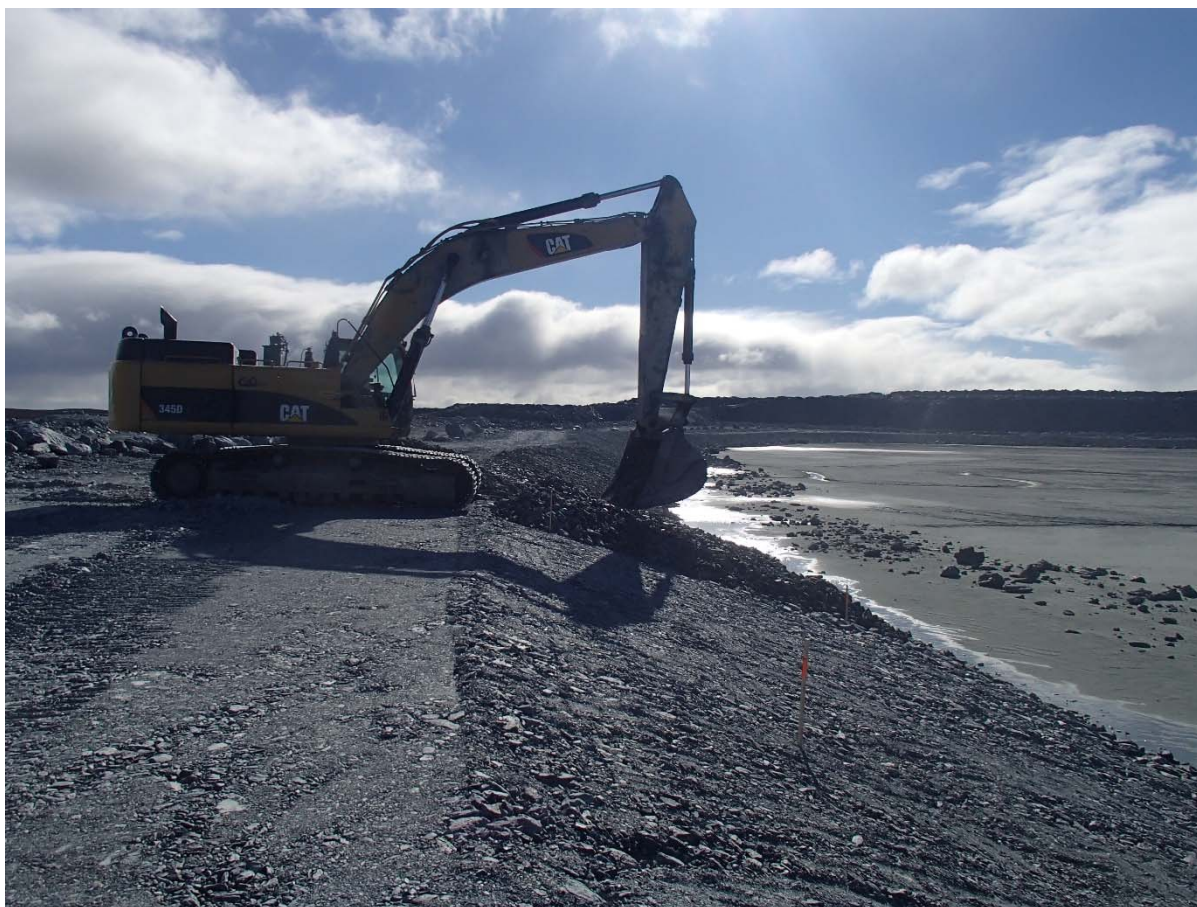
Photograph NCIS-033: From Sta. 1+900/-21 m (approx.), looking E. Placement of a 0.5 m thick lift of coarse filter in the upstream slope from El. 150 m to 152 m with an excavator from Sta. 1+930 m to 1+715 m.

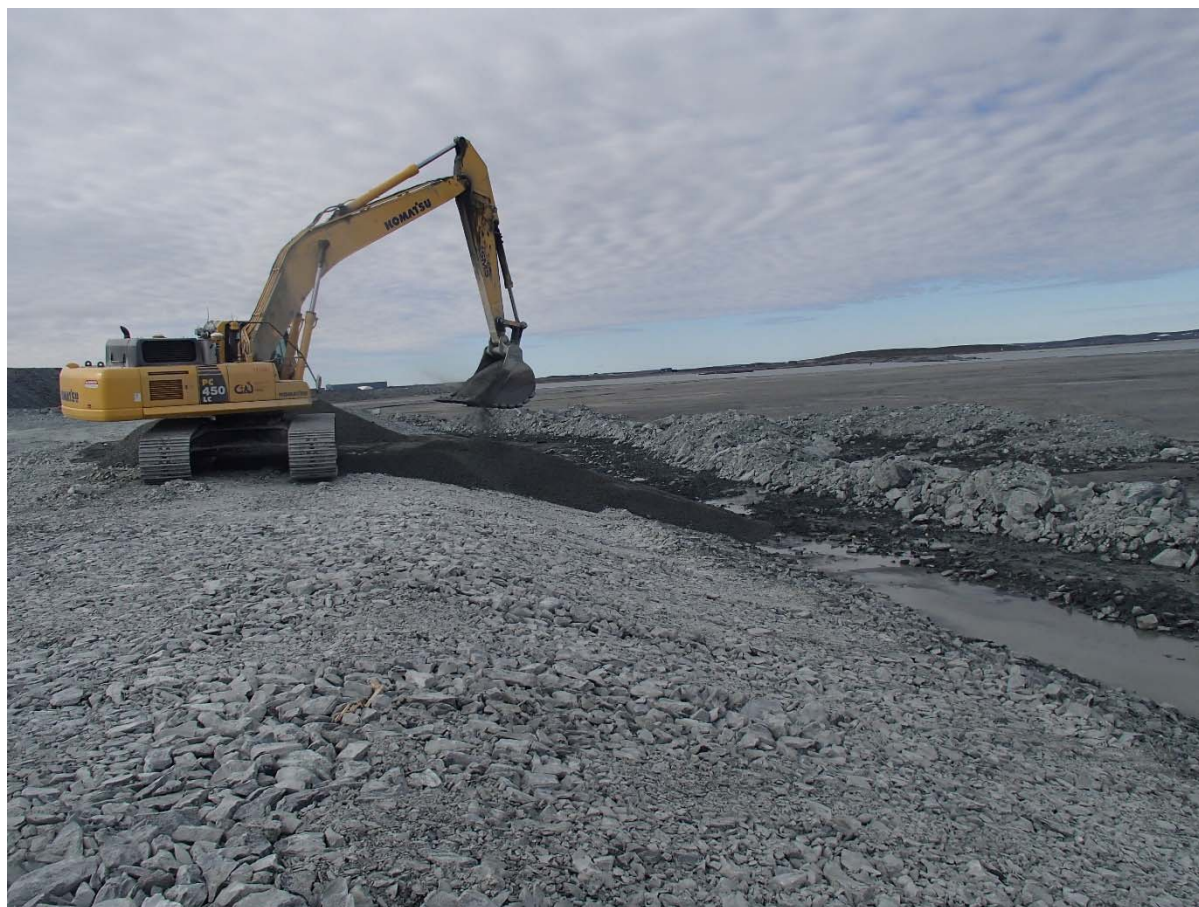
**Photograph NCIS-036: From Sta. 1+900/-21 m (approx.), looking SE. Placement of a 0.5 m thick lift of fine filter over the coarse filter in the upstream slope from El. 150 m to 152 m with an excavator from Sta. 2+542 m to 2+475 m.**
