### **Meadowbank 2018 TSF As-built report**

**2018 CONSTRUCTION SEASON AS-BUILT REPORT  
TAILINGS STORAGE FACILITY  
MEADOWBANK GOLD PROJECT, NUNAVUT**

1897439-1578-R-Rev0

November 2018

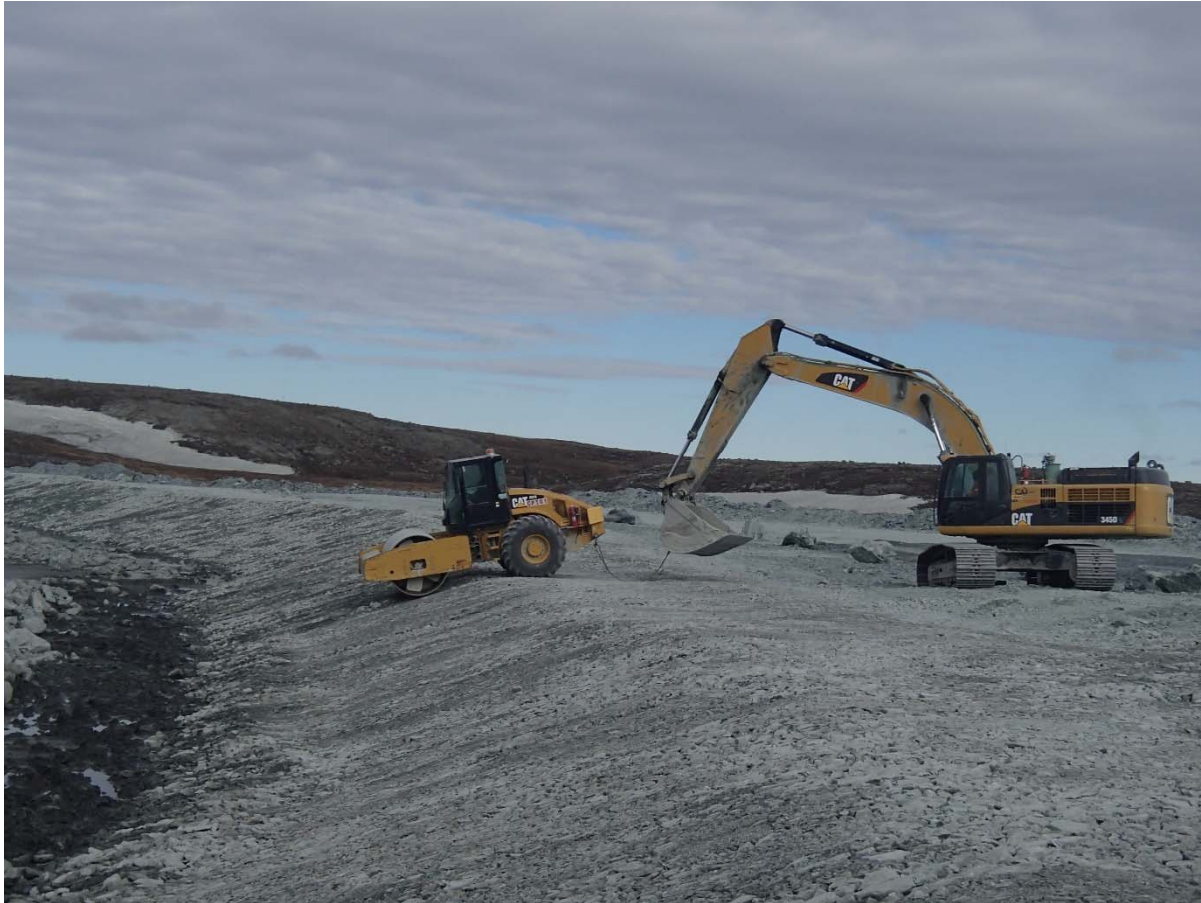
**Photograph NCIS-037: From Sta. 1+550/-25 m (approx.), looking NW. Compaction of the 0.5 m lift (approx.) of coarse filter between El. 150 and 152 m with a 10-tonne smooth-drum compactor (4 passes) in the upstream slope from Sta. 2+450 to 1+805 m.**

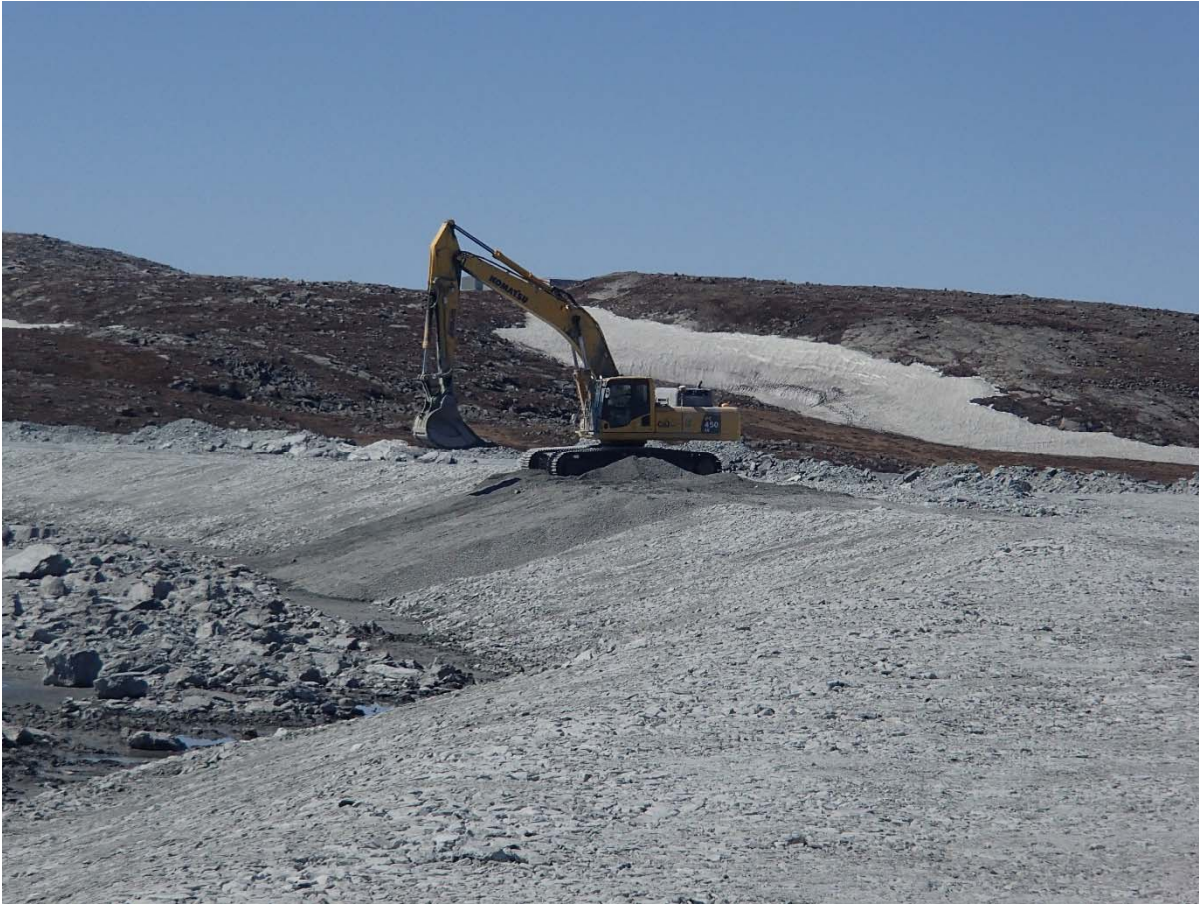
**Photograph NCIS-039: From Sta. 2+200/-24 m (approx.), looking W. Placement of a 0.5 m thick lift of fine filter over the coarse filter in the upstream slope from El. 150 m to 152 m with an excavator from Sta. 2+460 m to 2+475 m and from Sta. 2+065 m to 1+980 m.**

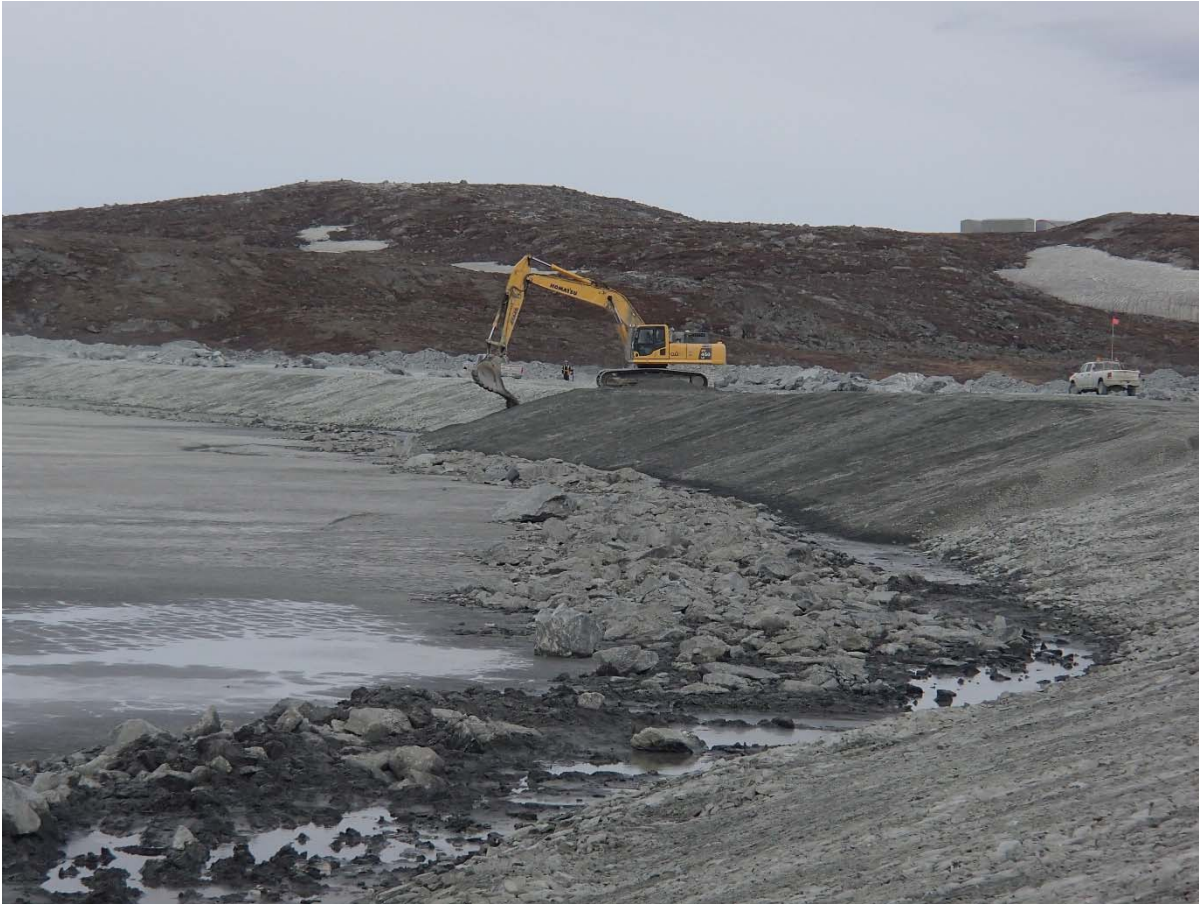
**Photograph NCIS-040: From Sta. 2+185/-25 m (approx.), looking W. Placement of a 0.5 m thick lift of fine filter over the coarse filter in the upstream slope from El. 150 m to 152 m with an excavator from Sta. 2+305 m to 2+460 m and from Sta. 1+980 m to 1+835 m.**

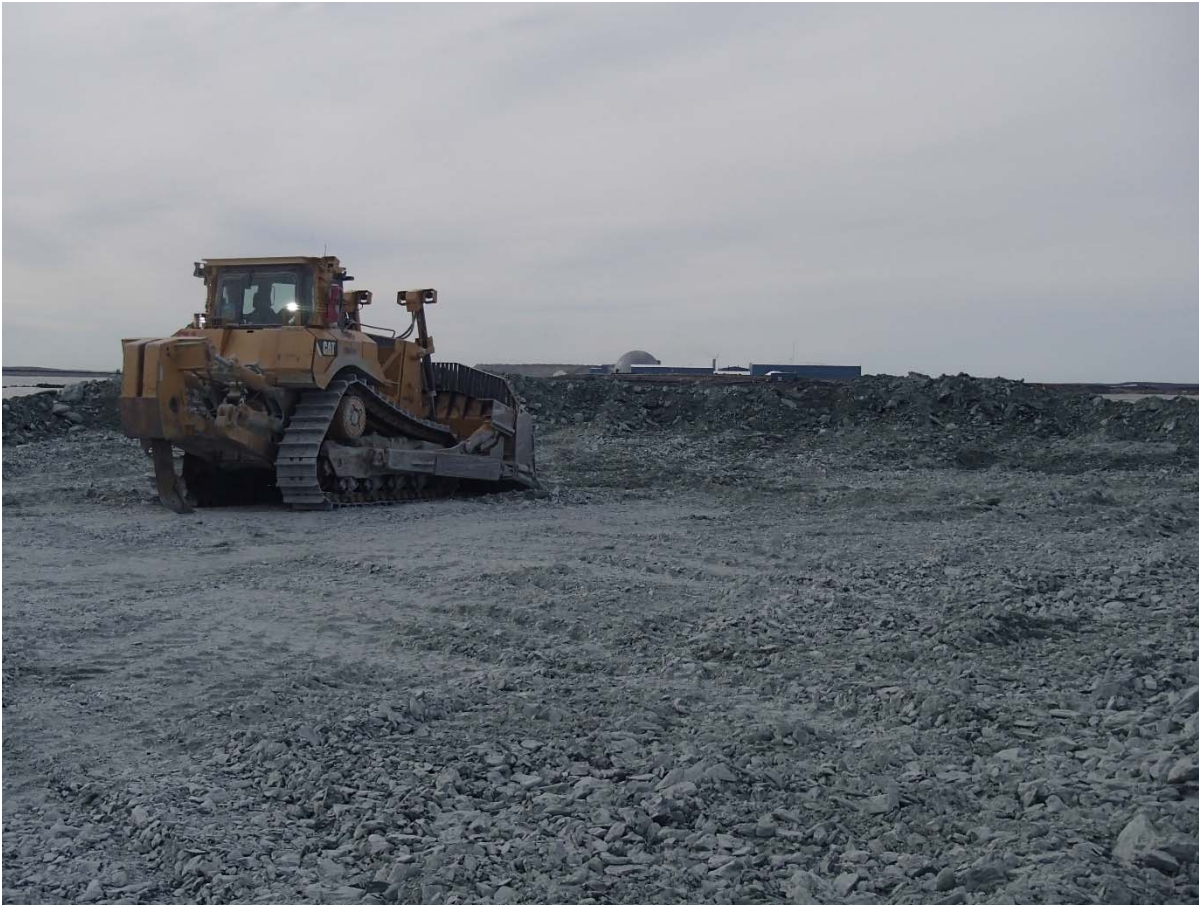
**Photograph NCIS-041: From Sta. 1+220/-7 m (approx.), looking S. Placement of a 1.5 to 2 m thick (approx.) lift of UM rockfill from El. 148 m to El. 150 m (approx.) with a dozer from Sta. 1+197 m to 1+150 m (-7 m to -41 m).**

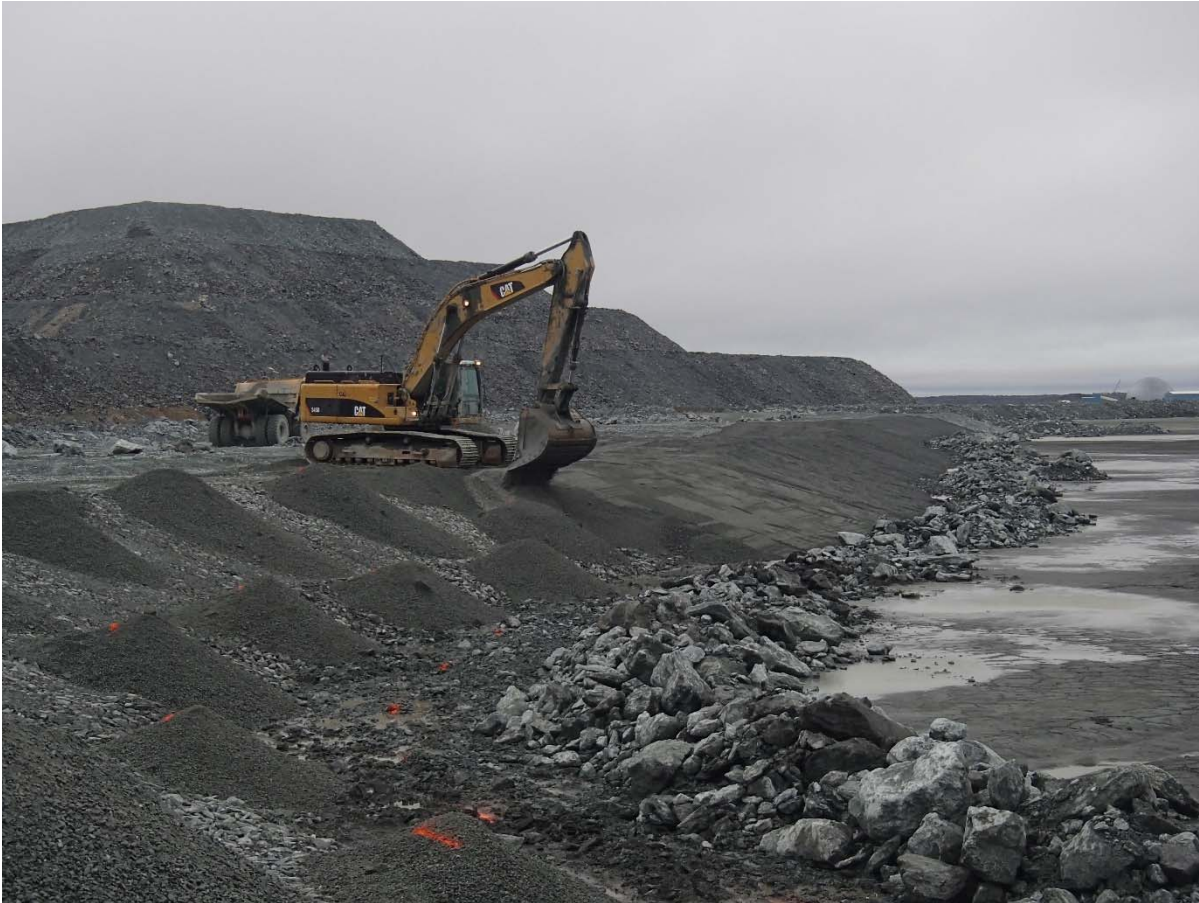
**Photograph NCIS-042: From Sta. 2+210/-27 m (approx.), looking SE. Placement of a 0.5 m thick lift of fine filter over the coarse filter in the upstream slope from El. 150 m to 152 m with an excavator from Sta. 2+305 m to 2+040 m.**

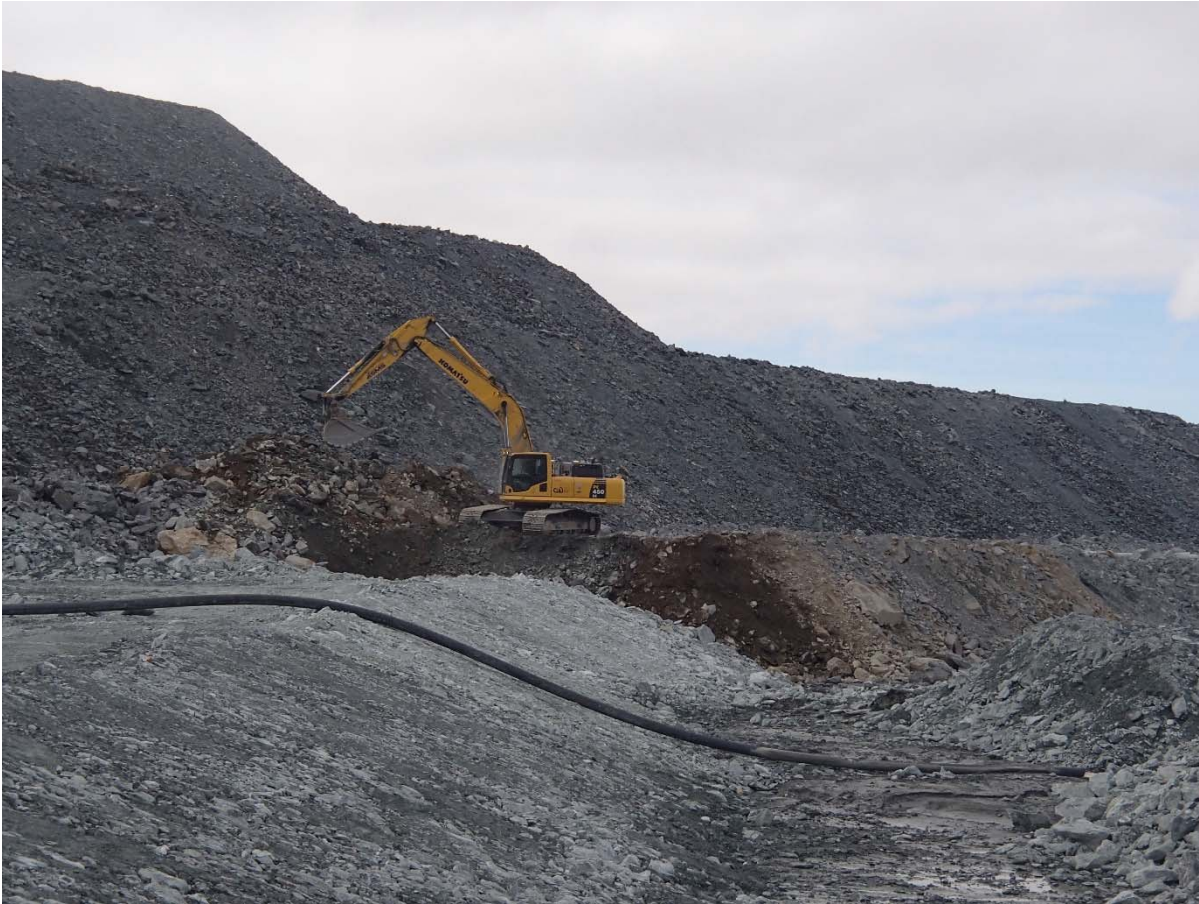
Photograph NCIS-046: From Sta. 2+680/-18 m (approx.), looking SE. Removal of till material mixed with the UM rockfill of the capping (about 1 to 2 m thick along the slope) with an excavator from Sta. 2+760 m to 2+850 m (o.s. -35 to -17 m).

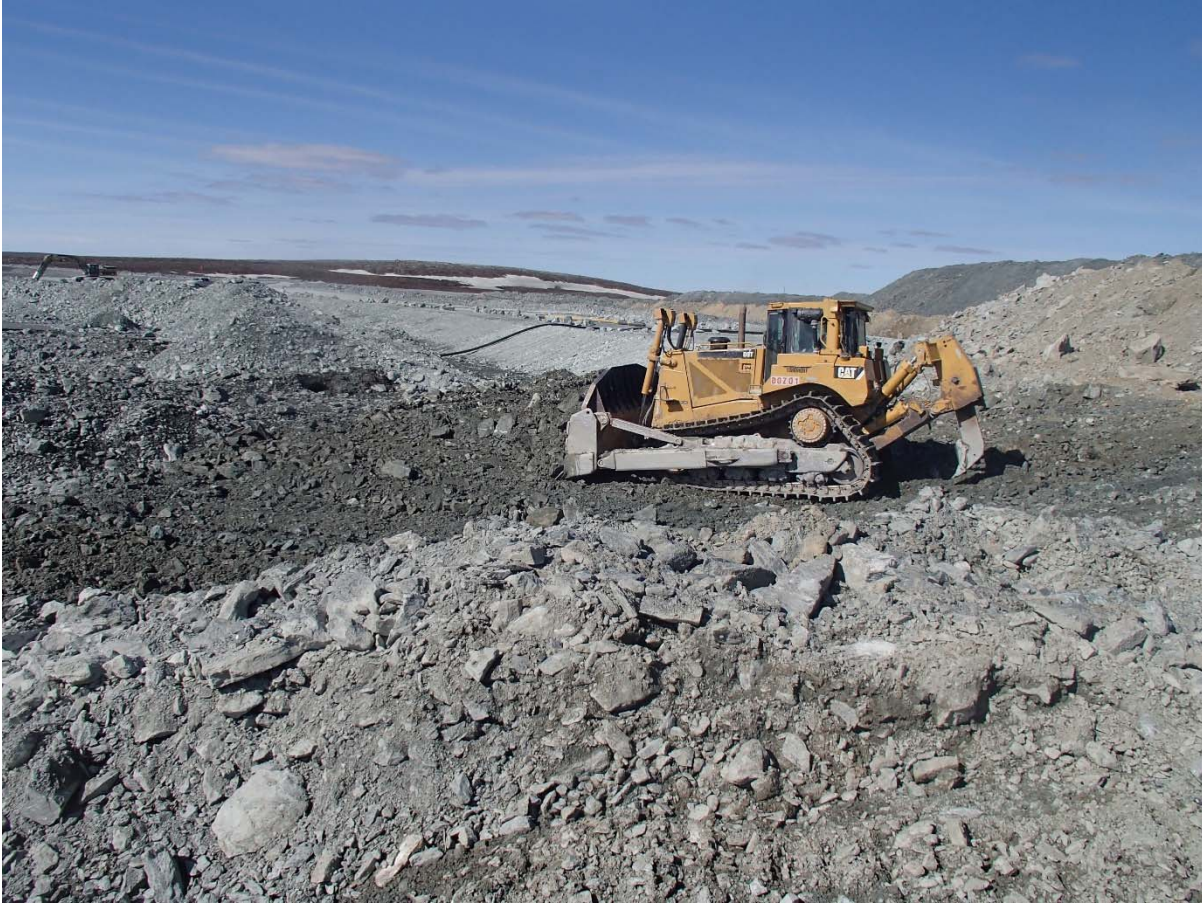
**Photograph NCIS-049: From Sta. 2+870/-28 m (approx.), looking N. Removing of UM rockfill material from the capping with a dozer to level the surface to El. 150 m from Sta. 2+760 m to 2+850 m (o.s. -29 to -17 m).**

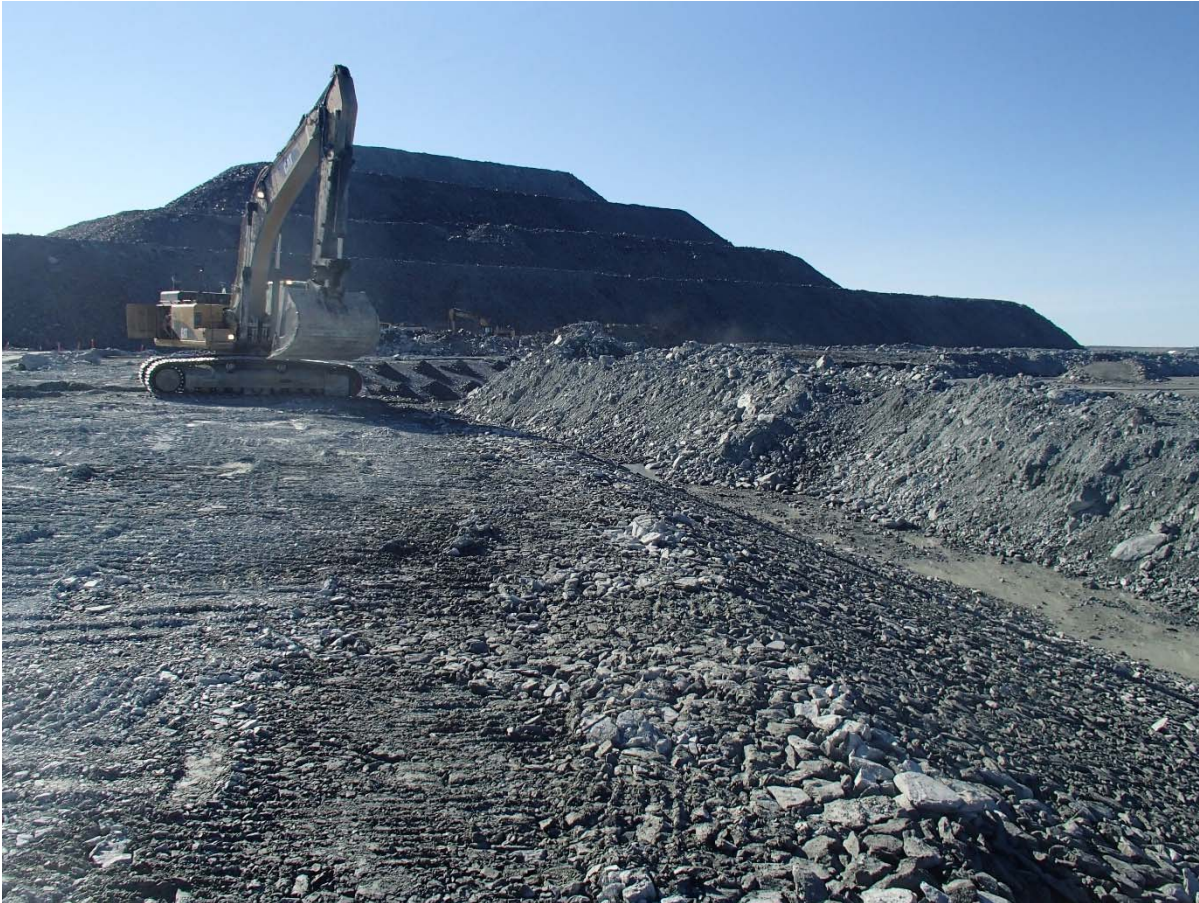
**Photograph NCIS-051: From Sta. 2+630/-34 m (approx.), looking SE. Placement of a 0.5 m thick lift of coarse filter in the upstream slope from El. 150 m to 152 m with an excavator from Sta. 2+640 m to 2+815 m.**

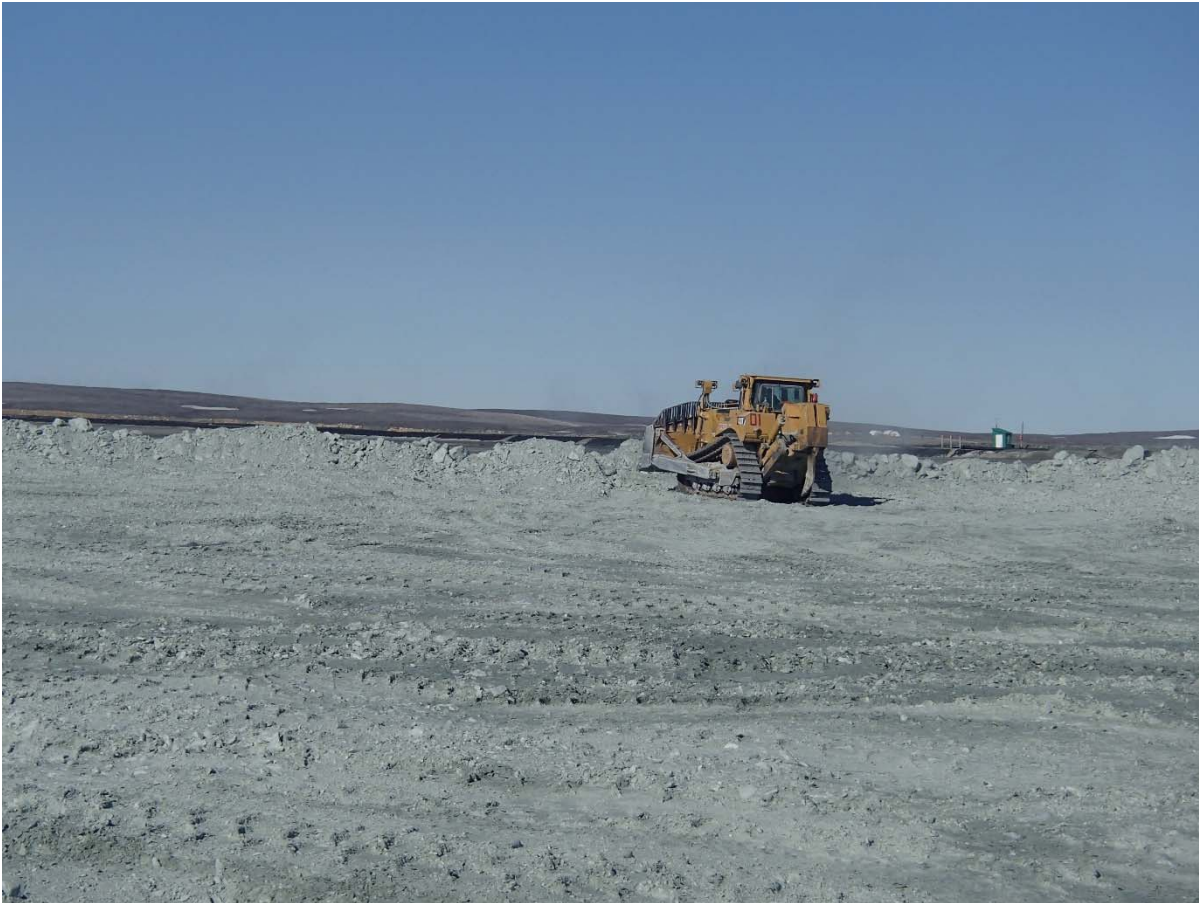
**Photograph NCIS-052: From Sta. 1+120/-87 m (approx.), looking SW. Placement of a 1.5 to 2 m thick (approx.) lift of UM rockfill from El. 148 m to El. 150 m (approx.) with a dozer from Sta. 1+115 m to 1+100 m (-107 m to -45 m). The material is of good quality and is well graded.**

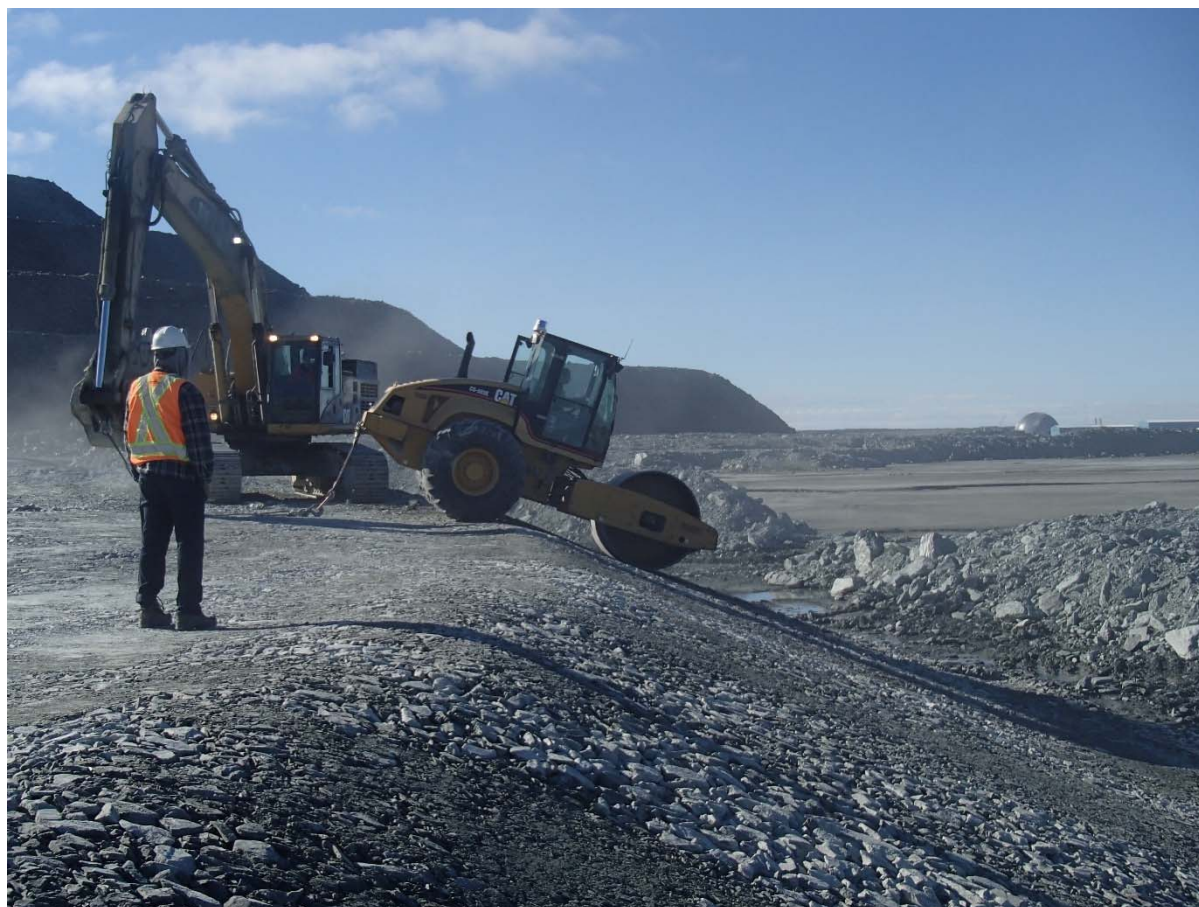
**Photograph NCIS-054: From Sta. 2+580/-31 m (approx.), looking SE. Compaction of the 0.5 m lift (approx.) of coarse filter between El. 150 and 152 m with a 10-tonne smooth-drum compactor with vibration (4 passes) in the upstream slope from Sta. 2+560 m to 2+815 m.**

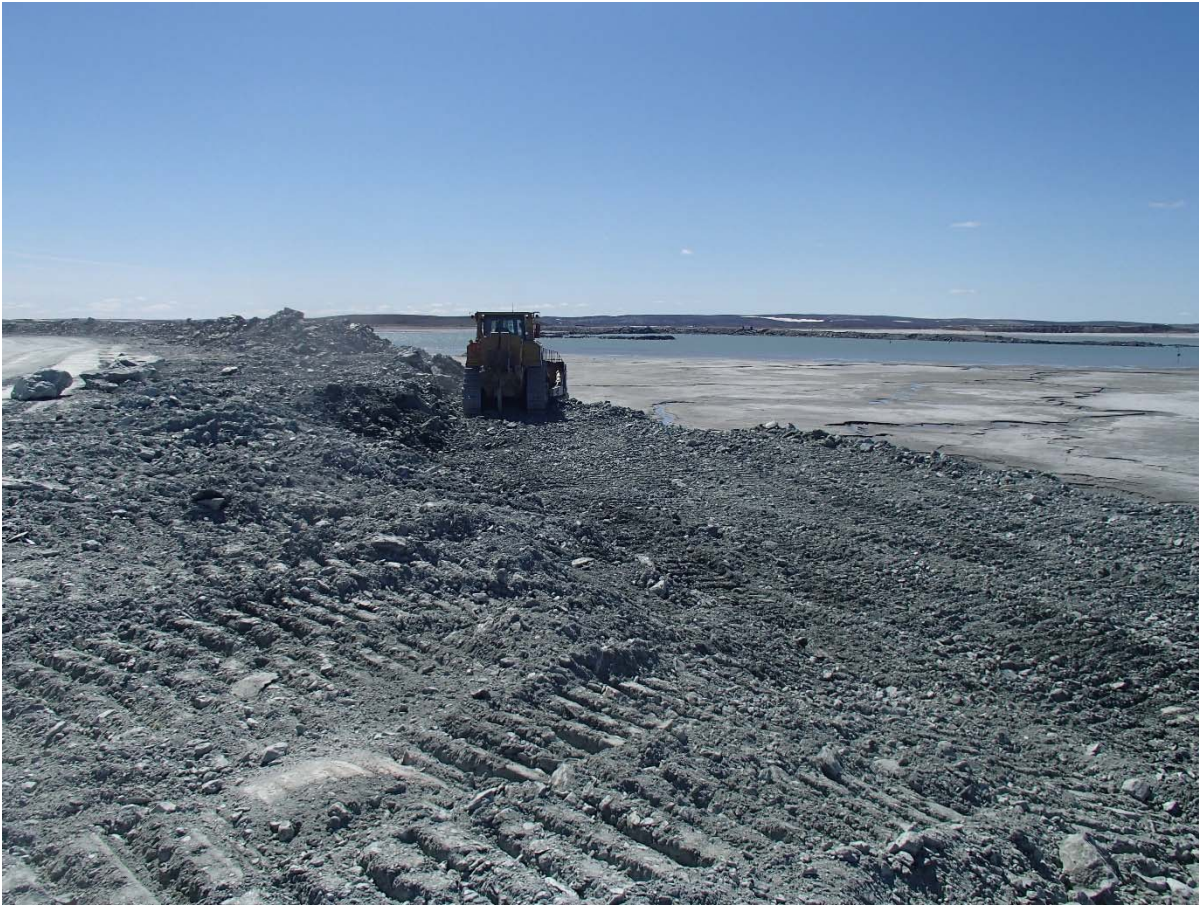
**Photograph NCIS-057: From Sta. 3+010/-15 m (approx.), looking SW. Removing of UM rockfill material from the capping with a dozer to level the surface to El. 152 m from Sta. 2+980 m to 3+050 m (o.s. -30 to -20 m).**

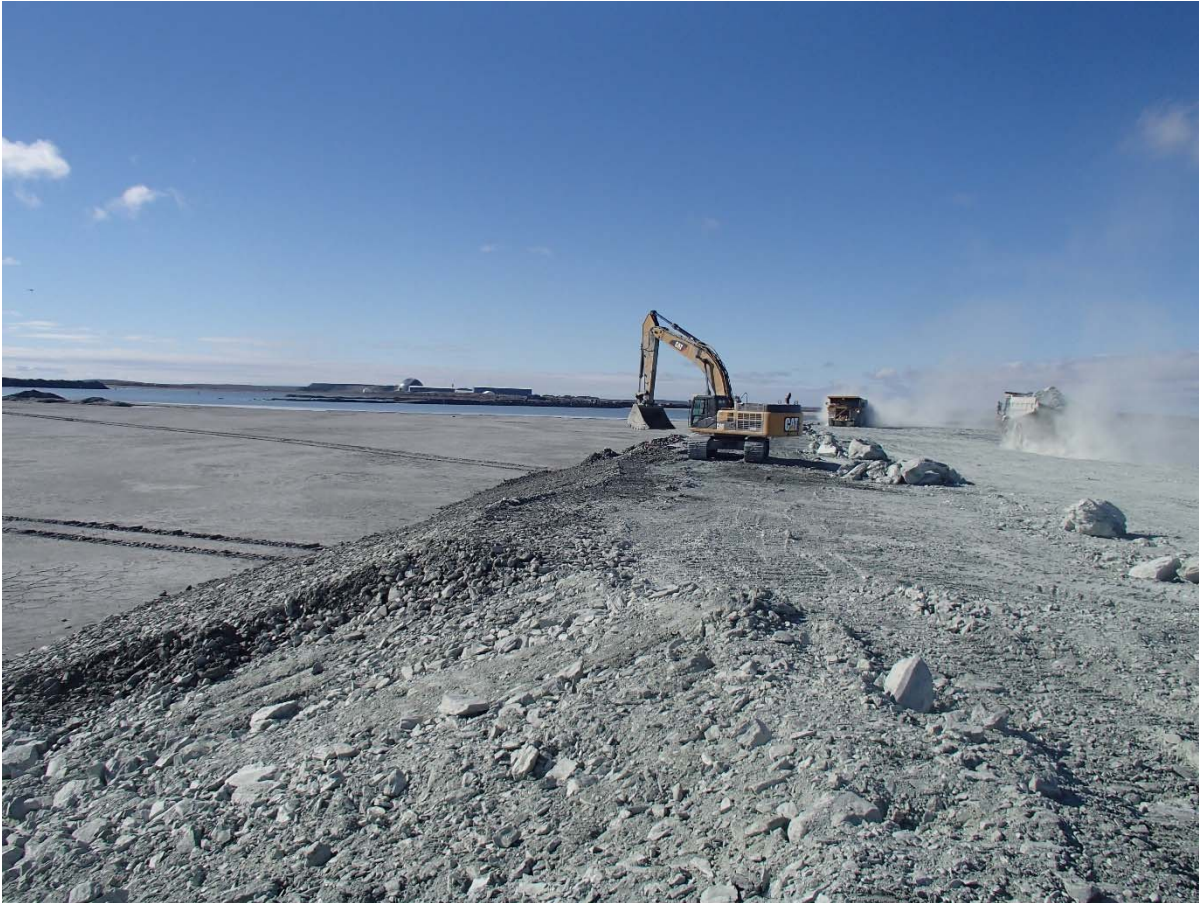
**Photograph NCIS-058: From Sta. 1+340/-34 m (approx.), looking S. Placement of a 0.5 m thick lift of coarse filter in the upstream slope from El. 148 m to 152 m with an excavator from Sta. 1+340 m to 1+270 m.**

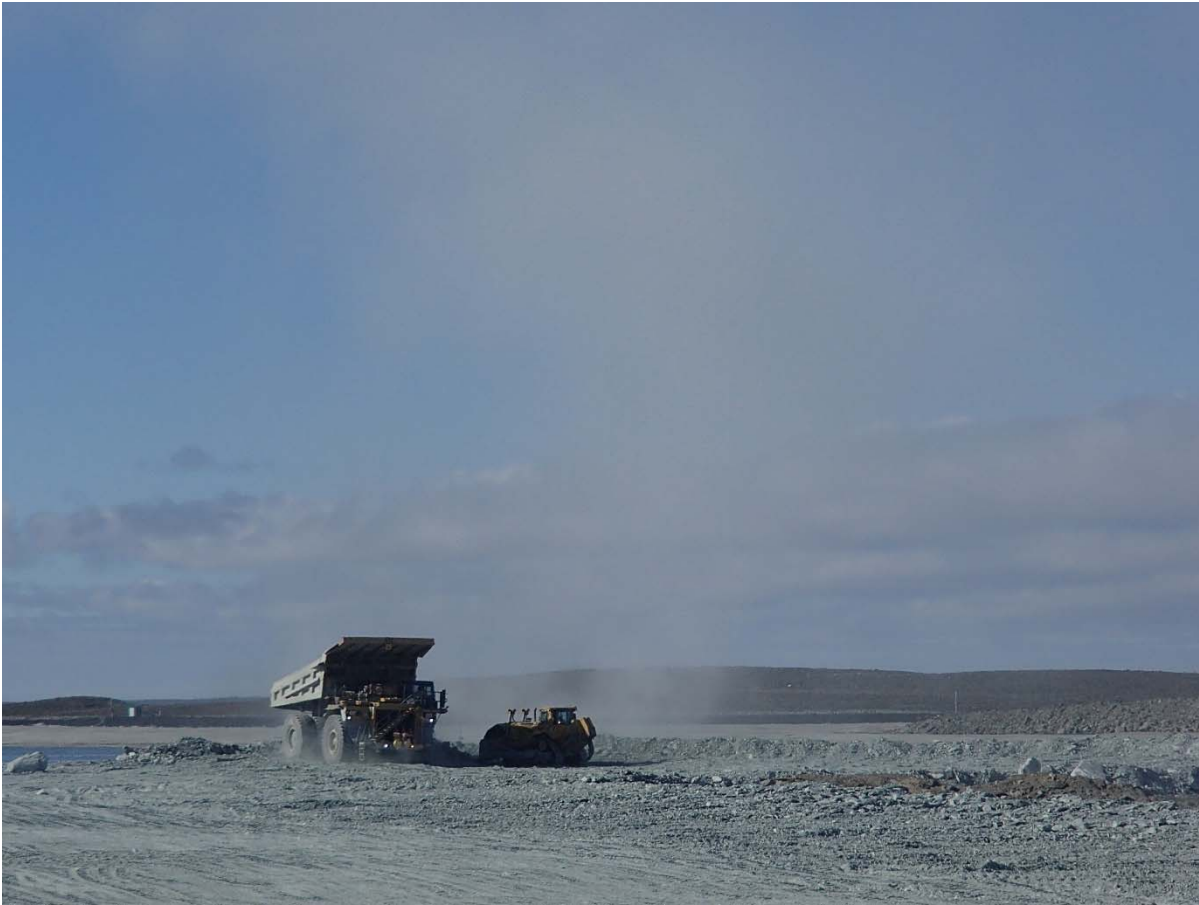
**Photograph NCIS-059: From Sta. 1+330/-34 m (approx.), looking S. Placement of a 1.5 to 2 m thick (approx.) lift of UM rockfill from El. 148 m to El. 150 m (approx.) with a dozer from Sta. 1+120 m to 1+100 m (-96 m to -60 m). The material is of good quality and is well graded.**

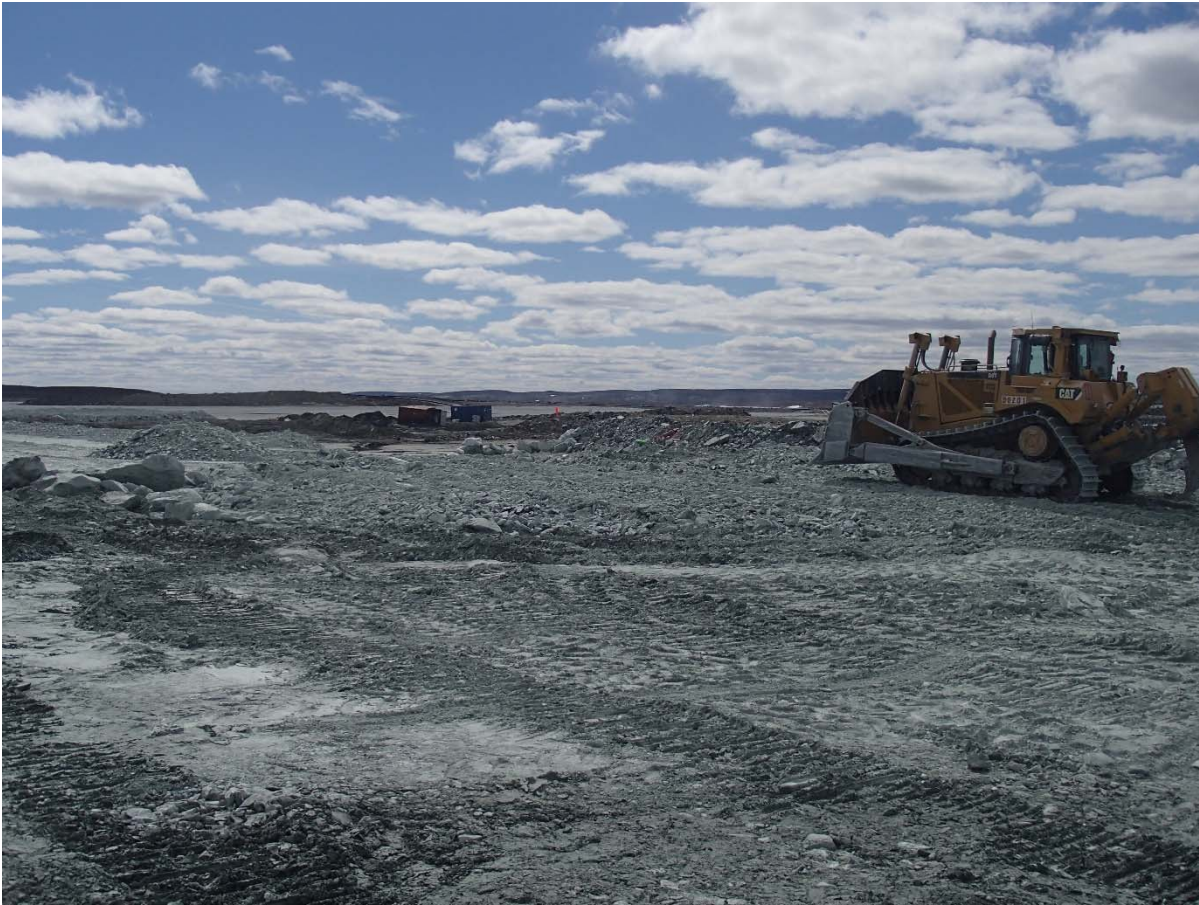
**Photograph NCIS-060: From Sta. 1+365/-35 m (approx.), looking SW. Placement of a 2 m thick (approx.) lift of UM rockfill from El. 150 m to El. 152 m (approx.) with a dozer from Sta. 1+340 m to 1+320 m (-19 m to +16 m). The material is of good quality and is well graded.**

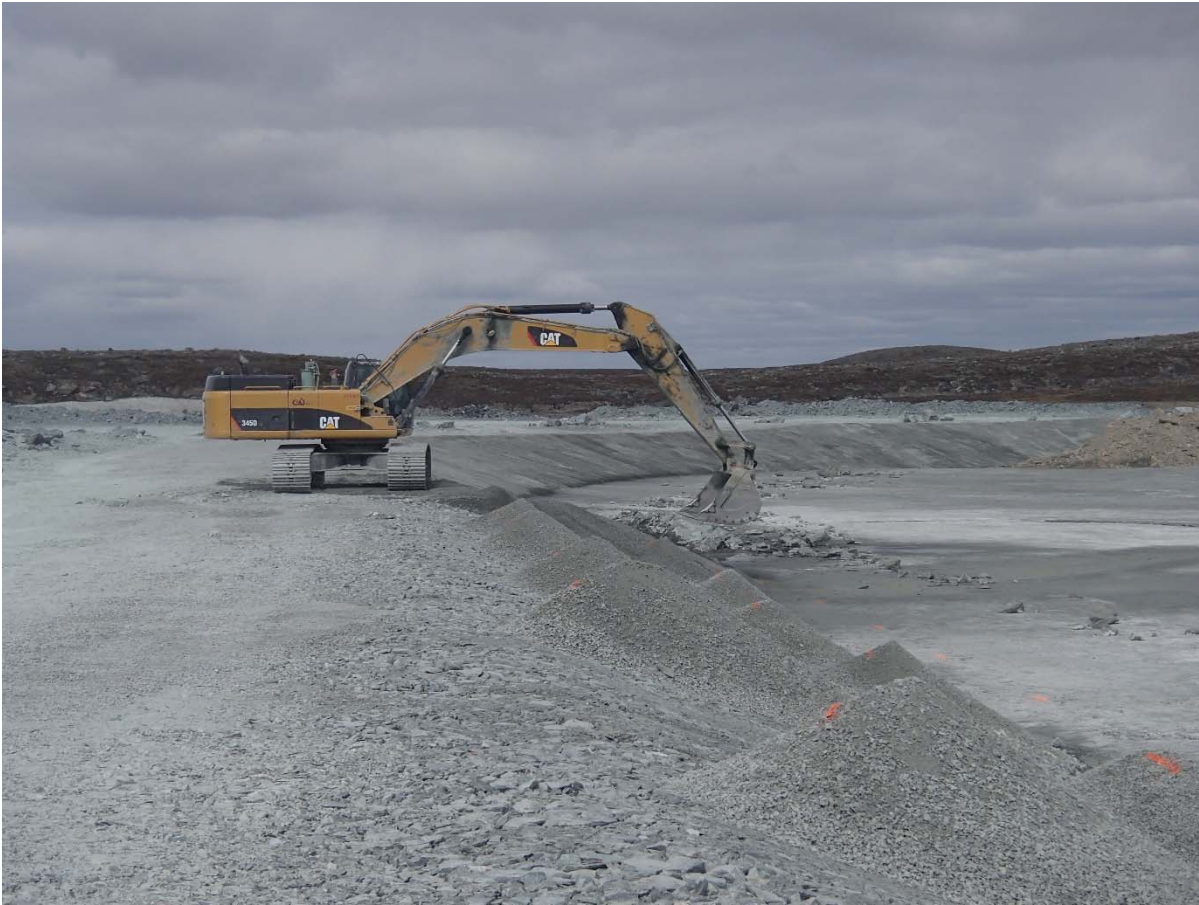
**Photograph NCIS-062: From Sta. 1+525/-33 m (approx.), looking N. Placement of a 0.5 m thick lift of fine filter over the coarse filter in the upstream slope from El. 150 m to 152 m with an excavator from Sta. 1+330 m to 1+260 m and from Sta. 1+595 m to 1+550 m.**

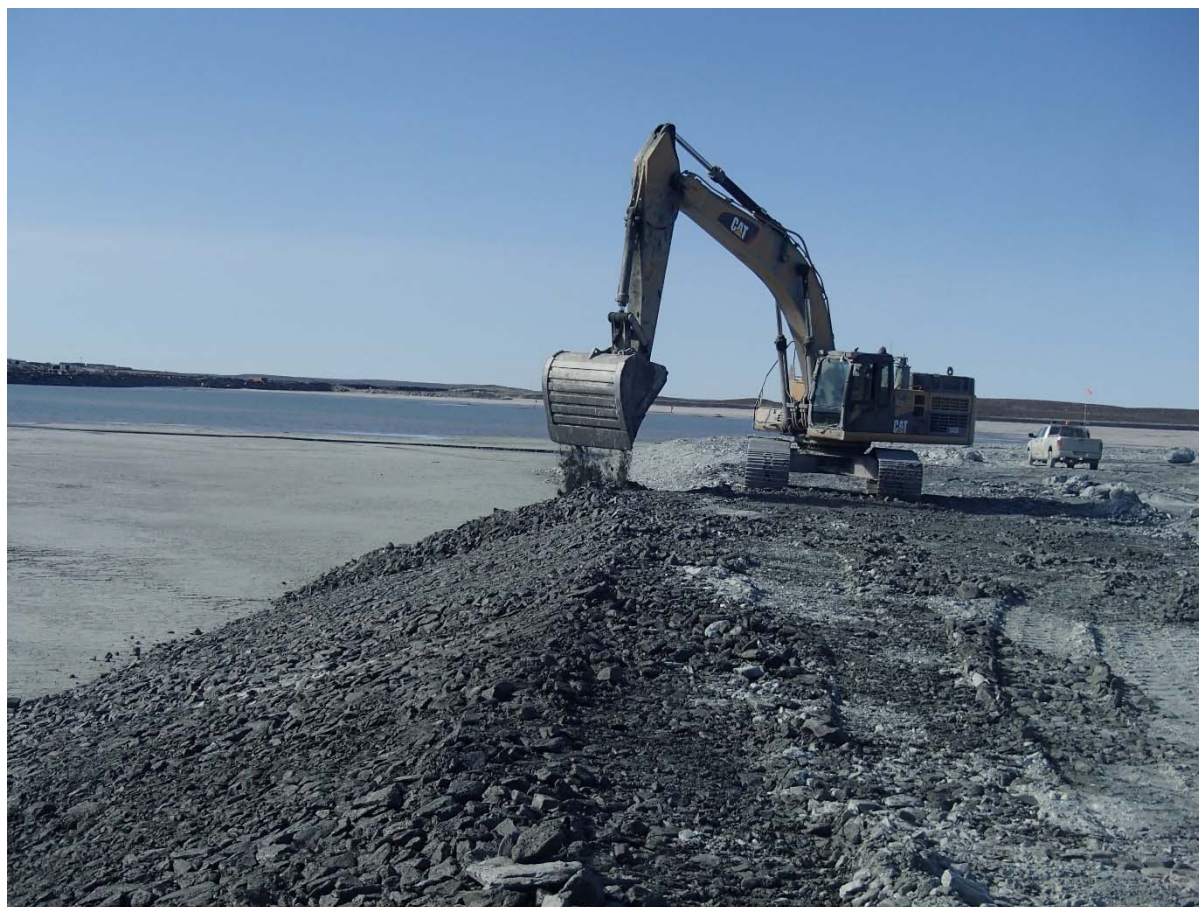
**Photograph NCIS-063: From Sta. 1+200/-65 m (approx.), looking SW. Placement of a 0.5 m thick lift of coarse filter in the upstream slope from El. 148 m to 150 m with an excavator from Sta. 1+270 m to 1+100 m.**

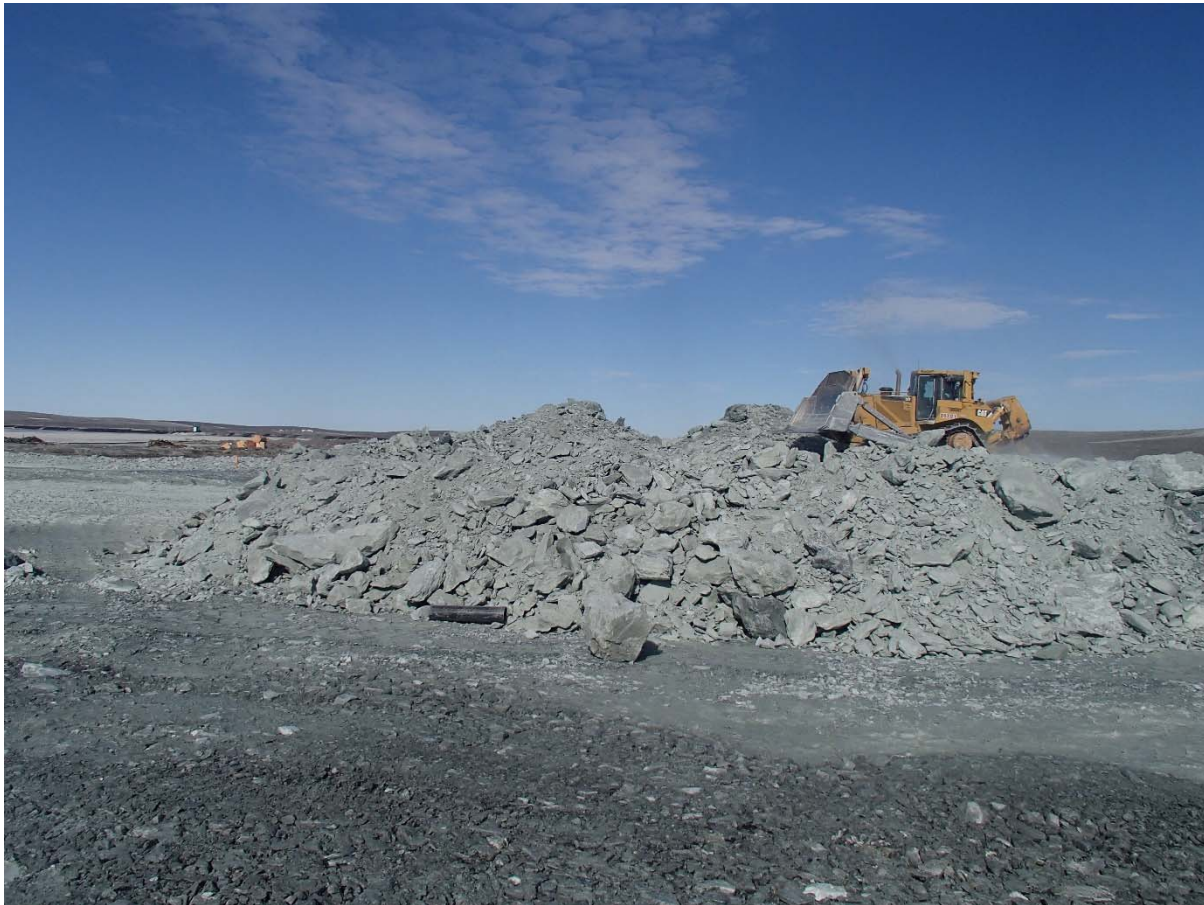
**Photograph NCIS-064: From Sta. 1+200/-65 m (approx.), looking W. Placement of a 2 m thick (approx.) lift of UM rockfill from El. 150 m to El. 152 m (approx.) with a dozer from Sta. 1+320 m to 1+235 m (-65 m to -45 m). The material is of good quality and is well graded.**

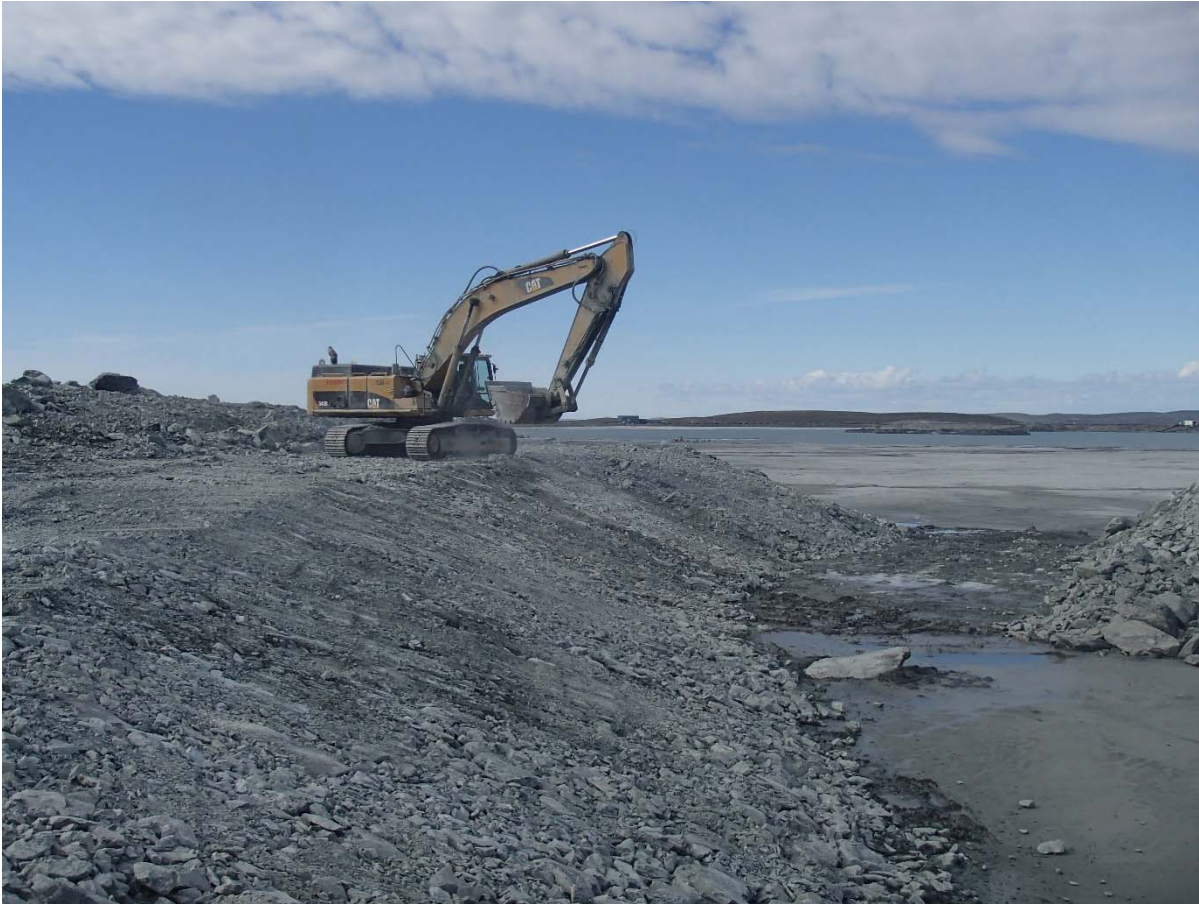
**Photograph NCIS-067: From Sta. 2+880/-26 m (approx.), looking SW. Profiling of the upstream slope (3H:1V) from El. 150 to 152 m with an excavator from Sta. 2+860 m to 2+975 m.**

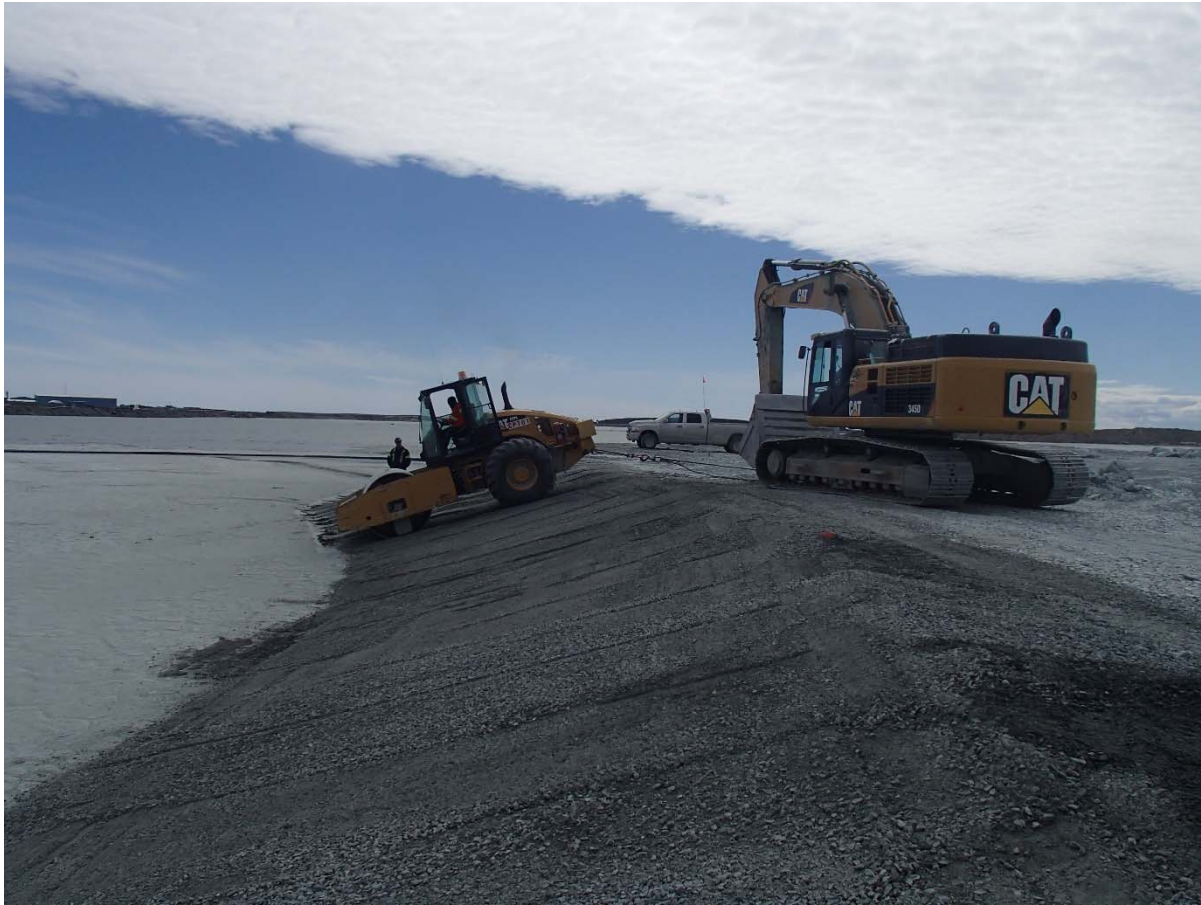
**Photograph NCIS-070: From Sta. 1+160/-89 m (approx.), looking S. Compaction of the 0.5 m lift of fine filter between El. 150 and 152 m with a 10-tonne smooth-drum compactor with vibration (4 passes) in the upstream slope from Sta. 1+335 m to 1+100 m.**

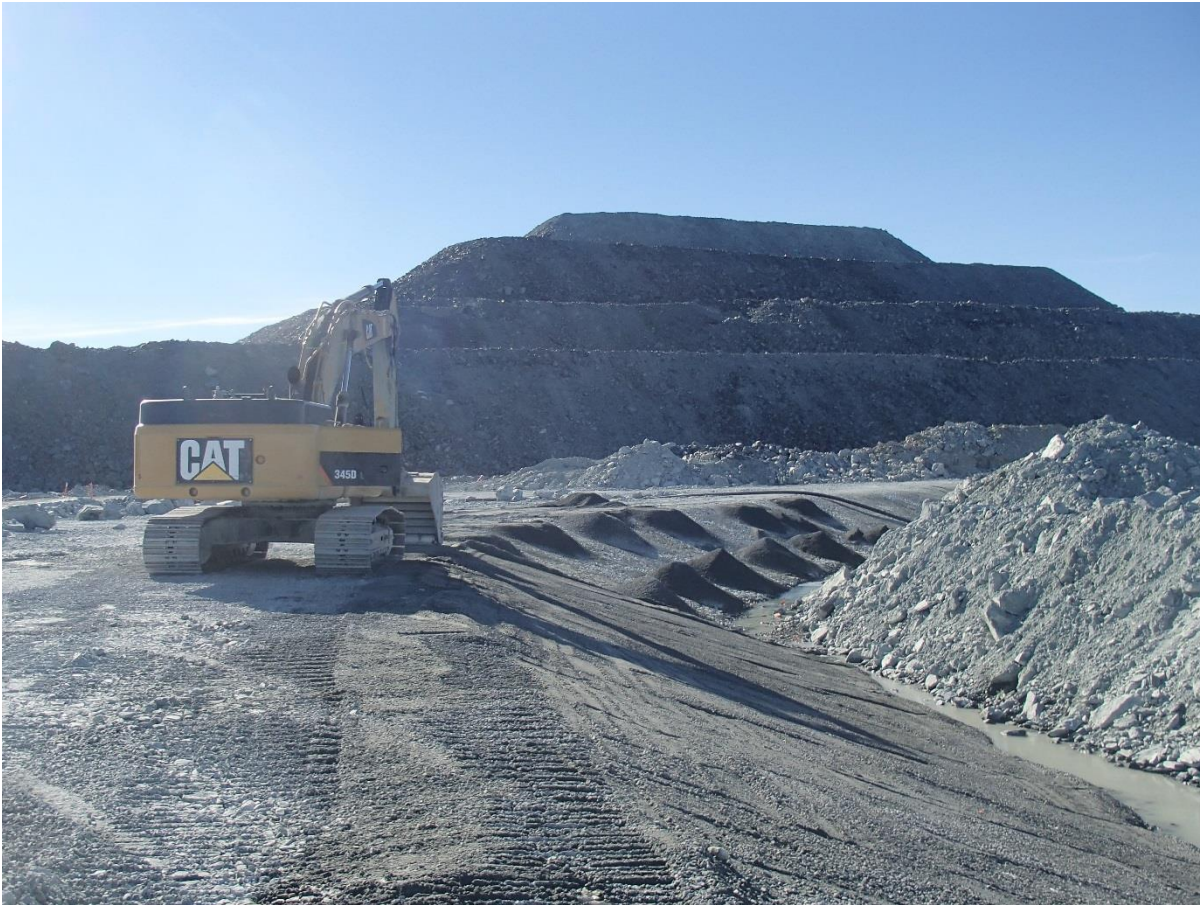
**Photograph NCIS-071: From Sta. 2+670/-28 m (approx.), looking SE. Placement of a 0.5 m thick lift of fine filter over the coarse filter in the upstream slope from El. 150 m to 152 m with an excavator from Sta. 1+550 m to 1+320 m and 1+630 m to 1+610 m.**
