### **Meadowbank 2018 TSF As-built report**

**2018 CONSTRUCTION SEASON AS-BUILT REPORT  
TAILINGS STORAGE FACILITY  
MEADOWBANK GOLD PROJECT, NUNAVUT**

1897439-1578-R-Rev0

November 2018

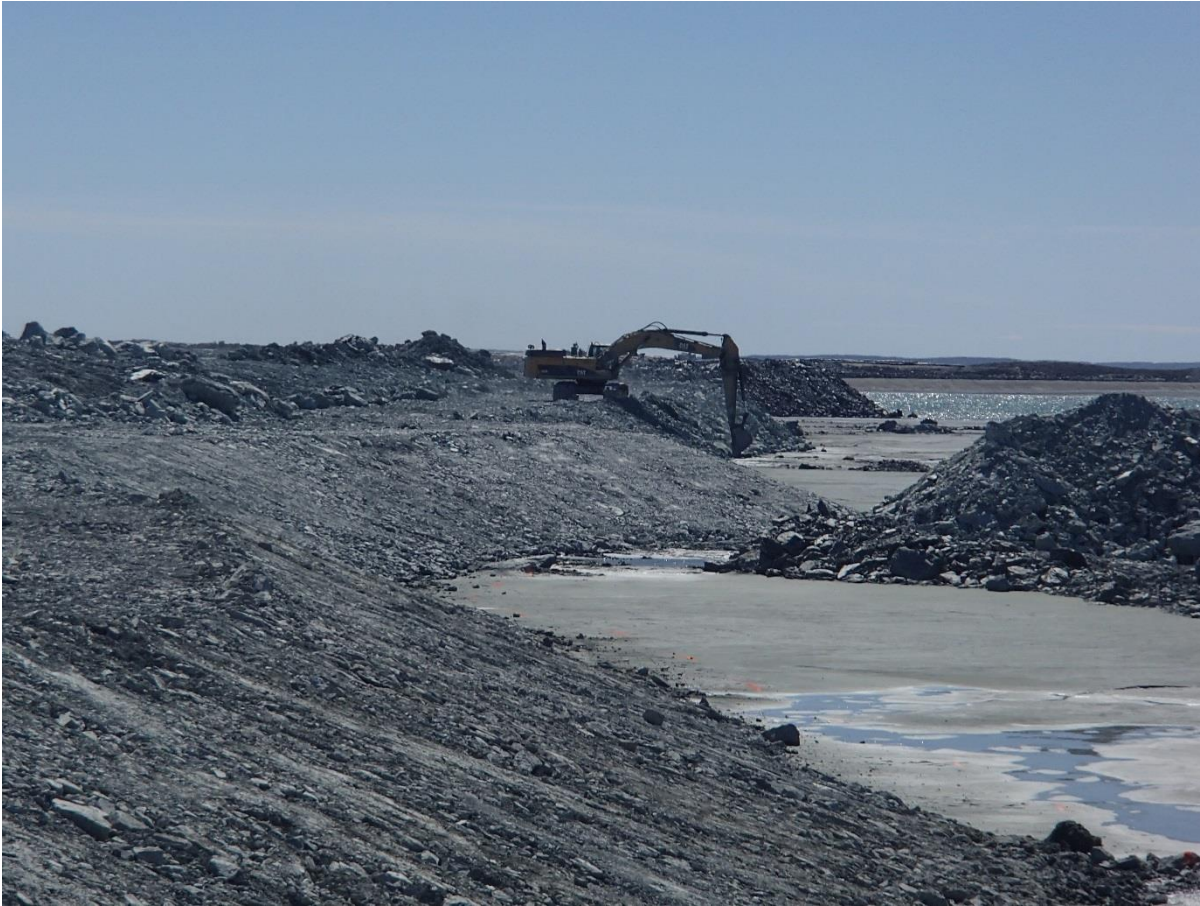
**Photograph NCIS-072: From Sta. 2+790/-38 m (approx.), looking W. Profiling of the upstream slope (3H:1V) from El. 150 to 152 m with an excavator from Sta. 2+975 m to 3+070 m.**

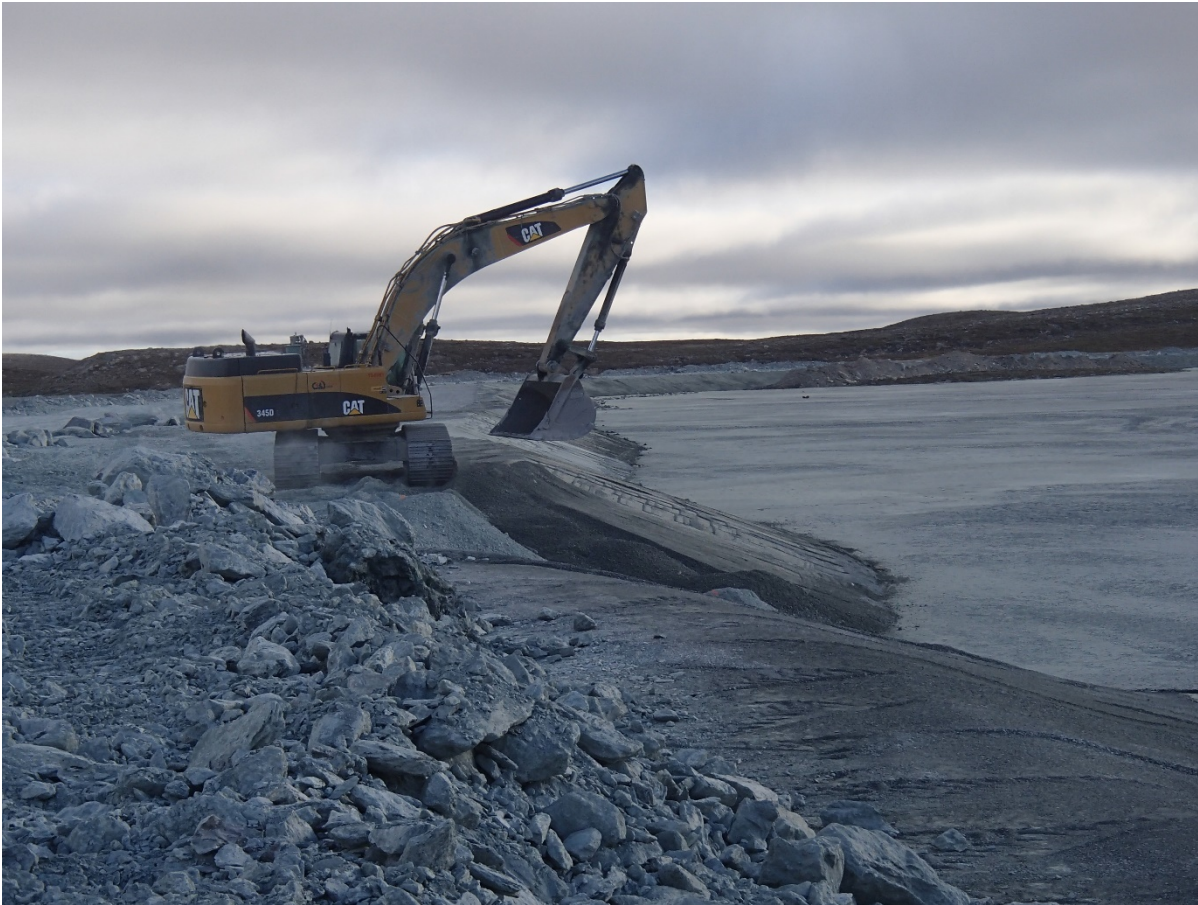
**Photograph NCIS-073: From Sta. 1+300/-33 m (approx.), looking N. Placement of a 0.5 m thick lift of fine filter over the coarse filter in the upstream slope from El. 150 m to 152 m with an excavator from Sta. 1+320 m to 1+300 m.**

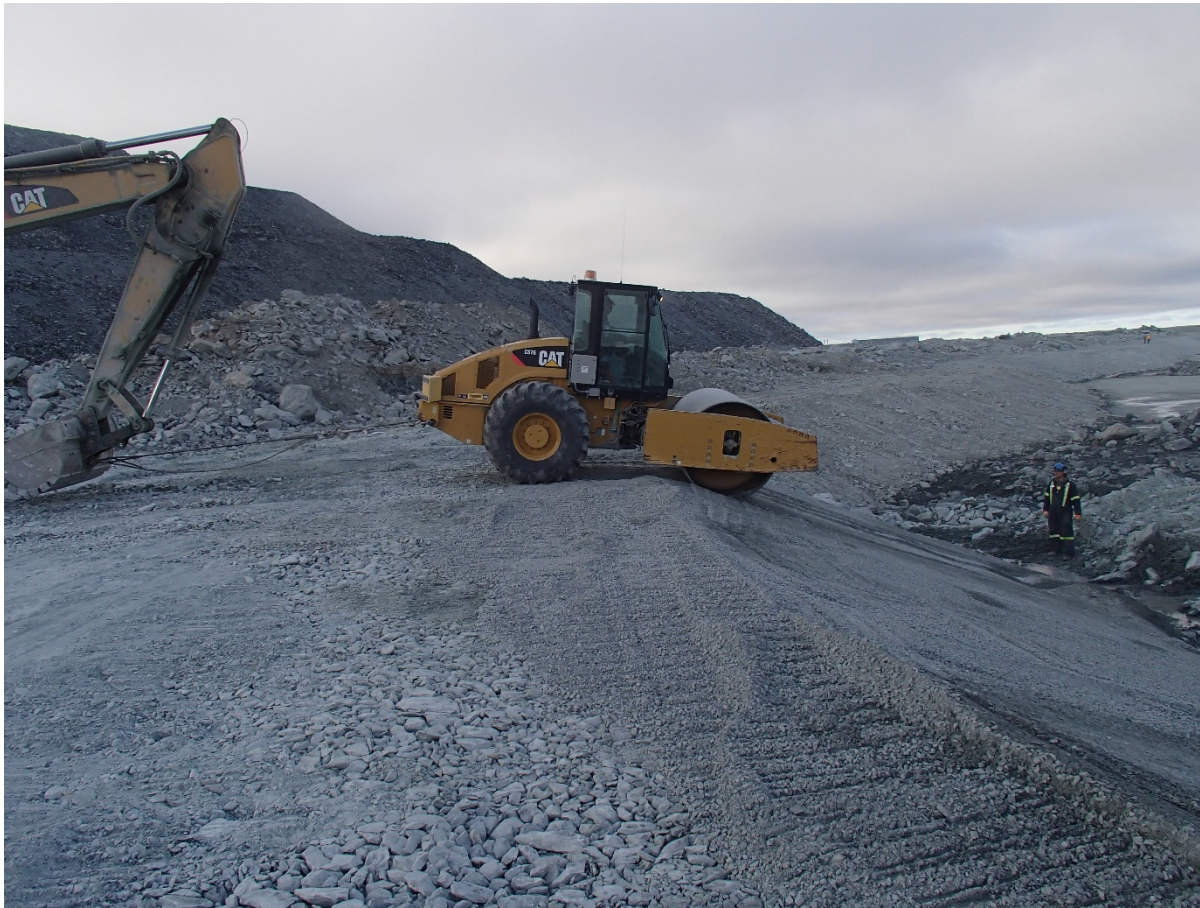
**Photograph NCIS-074: From Sta. 2+750/-37 m (approx.), looking SE. Compaction of the 0.5 m lift (approx.) of fine filter between El. 150 and 152 m with a 10-tonne smooth-drum compactor (4 passes) in the upstream slope from Sta. 2+810 m to 2+095 m. Vibration is used except for the first pass down the slope in order to stabilize the material and limit deformation of the lift.**

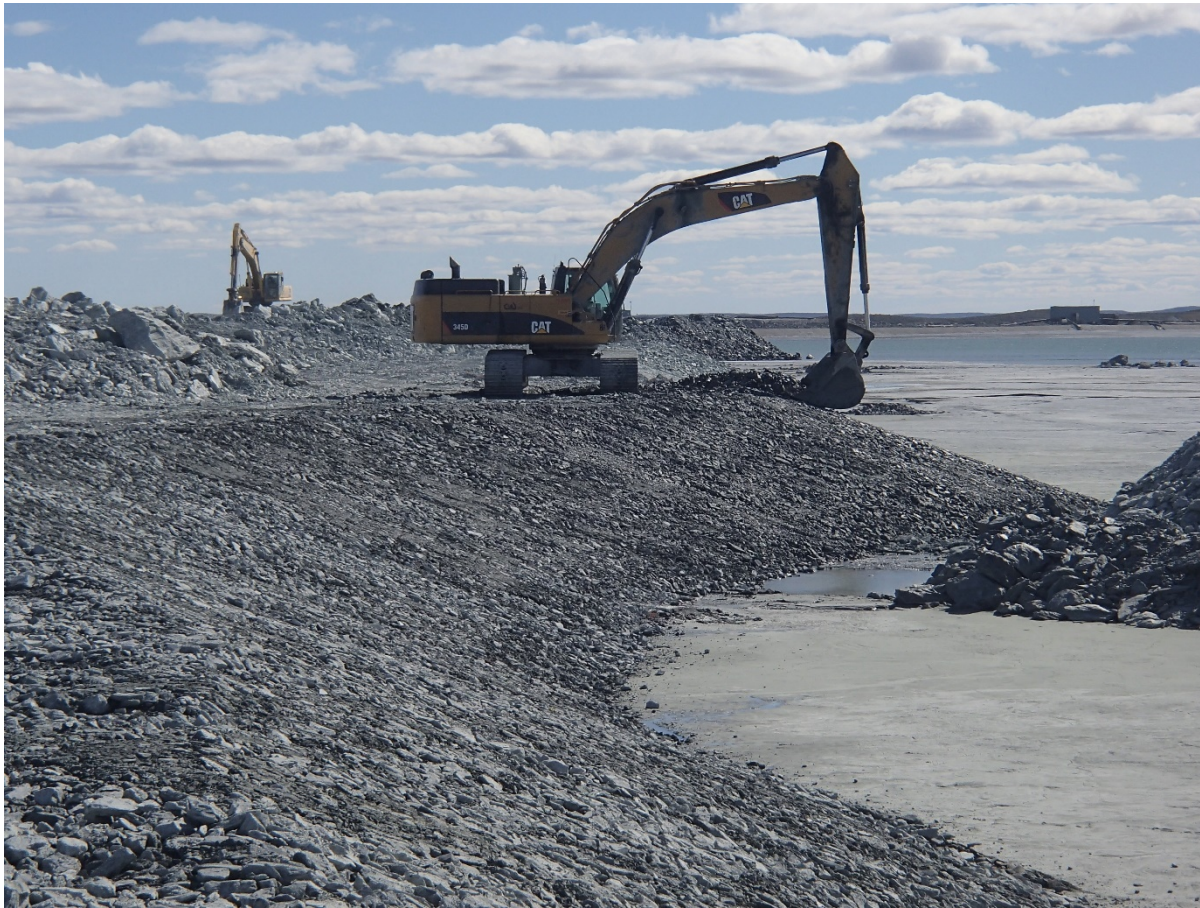
**Photograph NCIS-075: From Sta. 2+860/-36 m (approx.), looking S. Placement of a 0.5 m thick lift of coarse filter in the upstream slope from El. 150 m to 152 m with an excavator from Sta. 2+815 m to 2+980 m.**

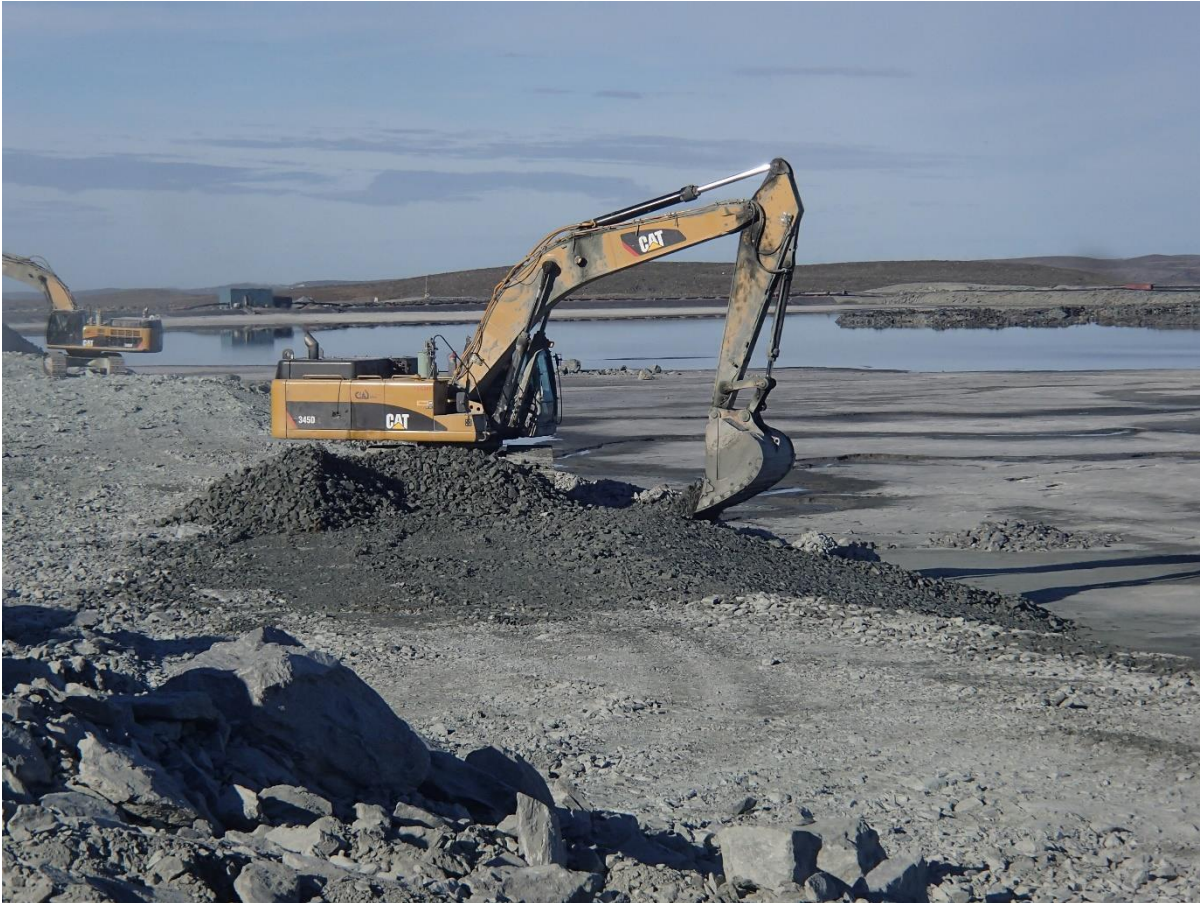
**Photograph NCIS-076: From Sta. 2+940/-15 m (approx.), looking SW. Placement of a 0.5 m thick lift of coarse filter in the upstream slope from El. 150 m to 152 m with an excavator from Sta. 2+980 m to 3+160 m.**

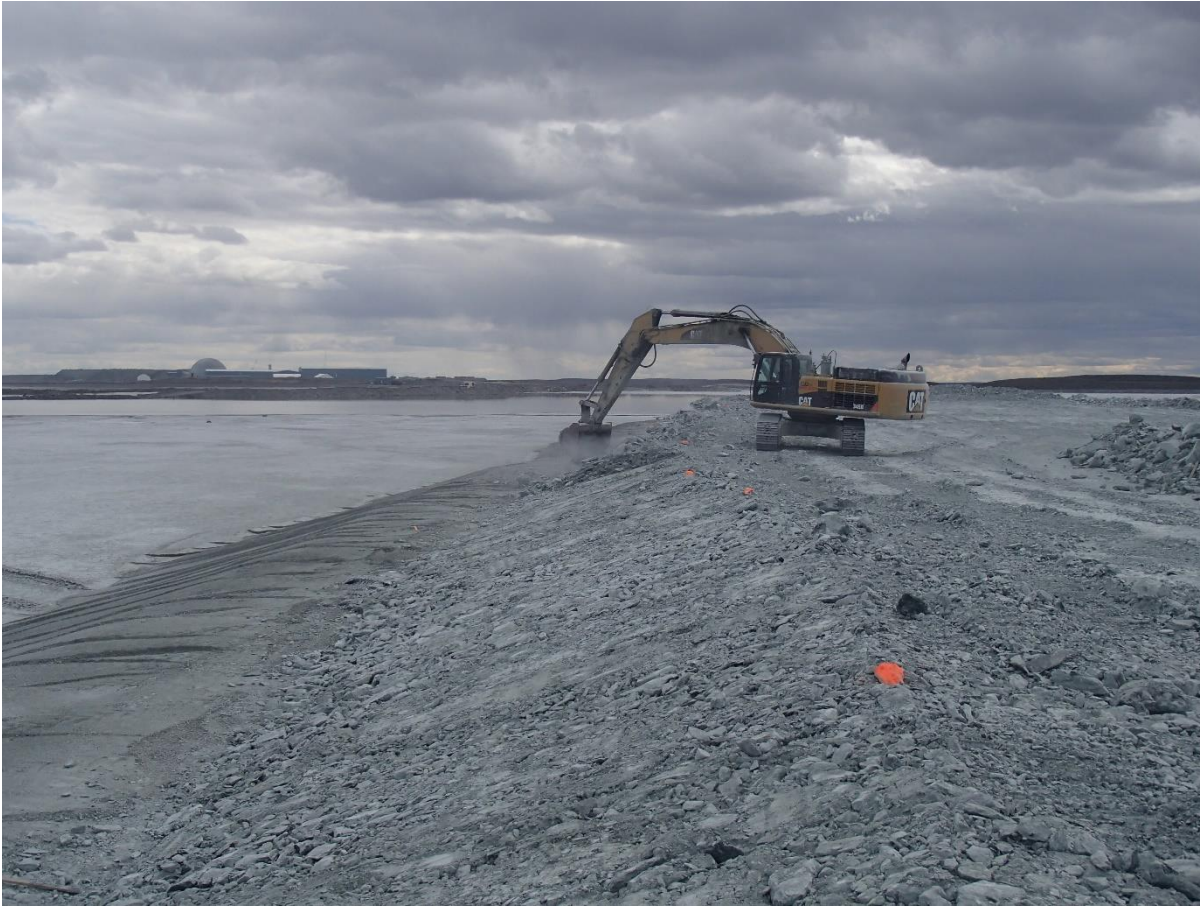
**Photograph NCIS-077: From Sta. 1+310/-32 m (approx.), looking S. Profiling of the upstream slope (3H:1V) from El. 150 to 152 m with an excavator from Sta. 1+300 m to 1+175 m and from 3+070 m to 3+160 m.**

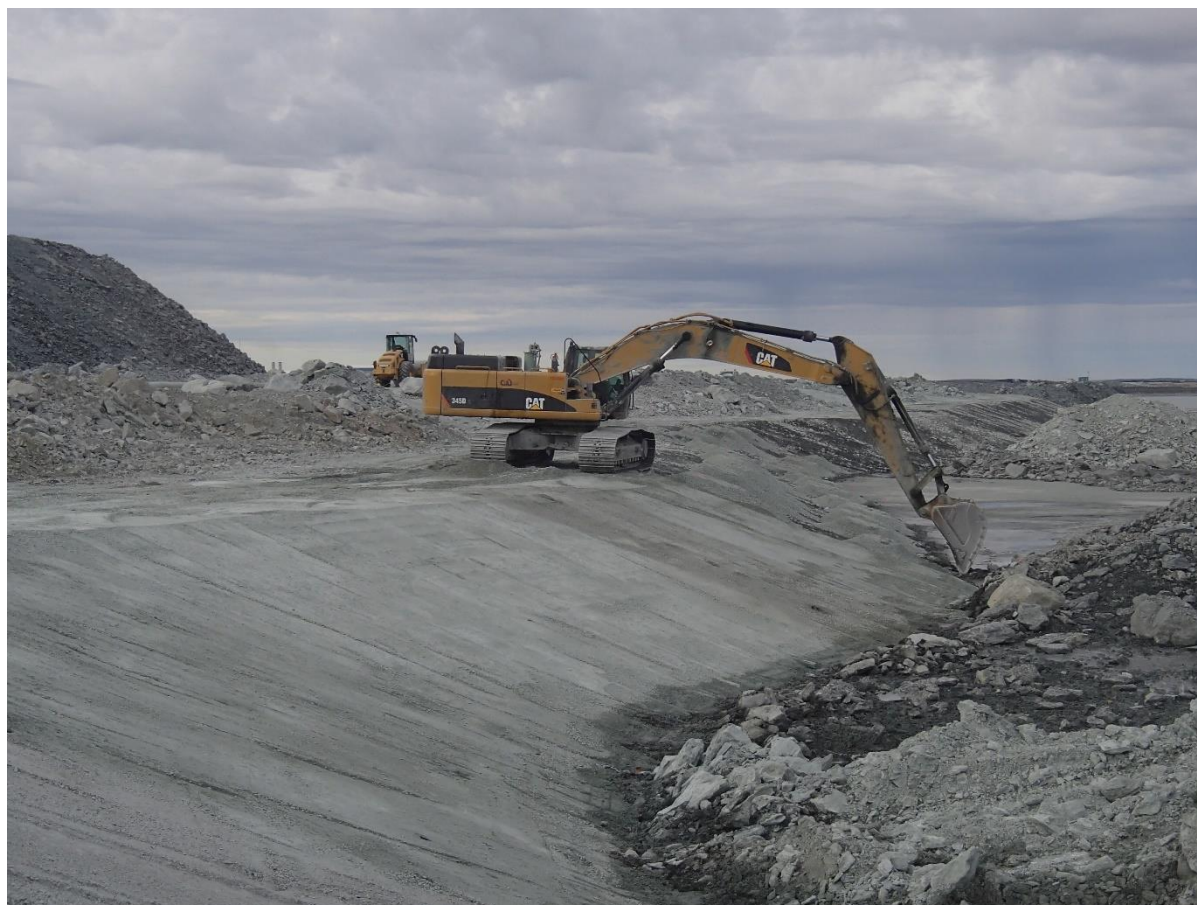
**Photograph NCIS-078:** From Sta. 2+760/-39 m (approx.), looking S. Placement of a 0.5 m thick lift of fine filter over the coarse filter in the upstream slope from El. 150 m to 152 m with an excavator from Sta. 2+800 m to 2+980 m.

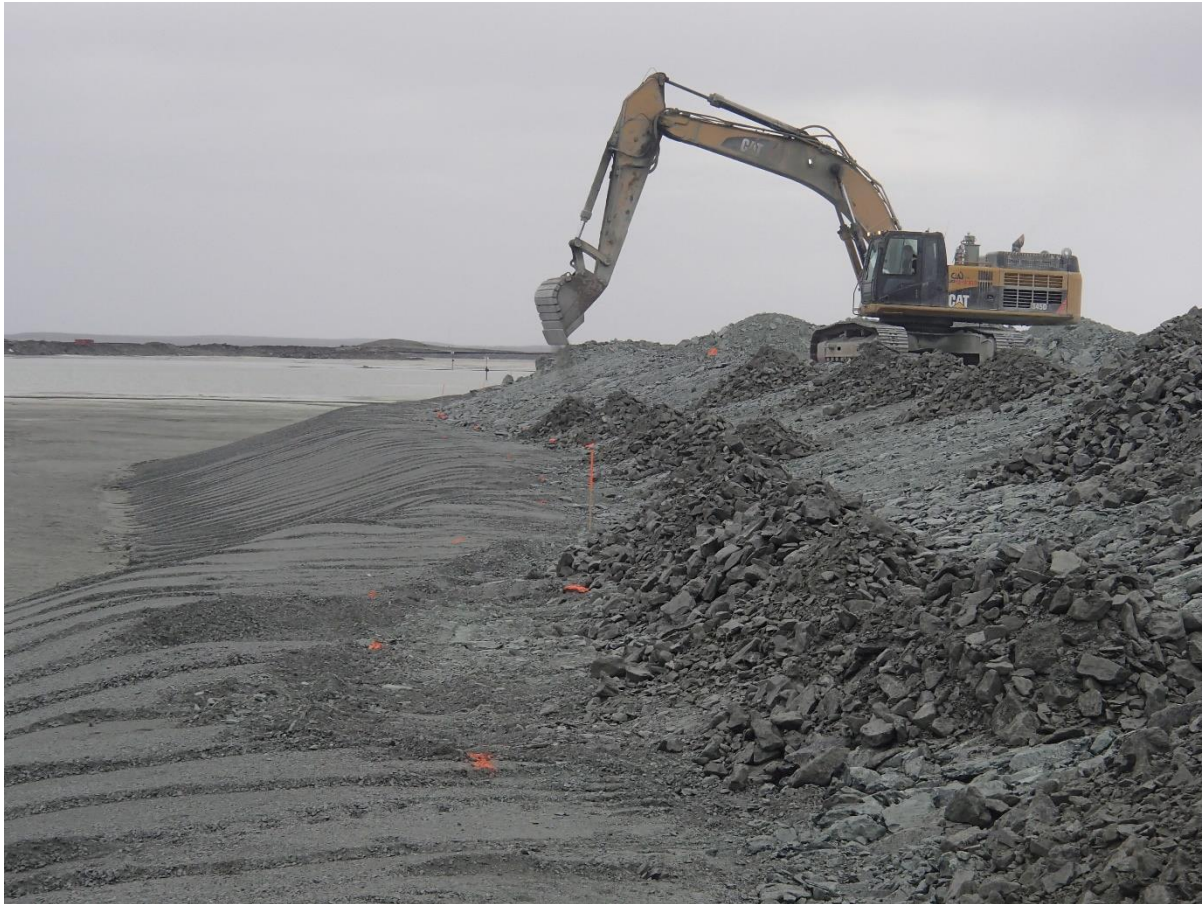
**Photograph NCIS-079: From Sta. 1+280/-39 m (approx.), looking SW. Placement of a 0.5 m thick lift of coarse filter in the upstream slope from El. 150 m to 152 m with an excavator from Sta. 1+300 m to 1+200 m.**

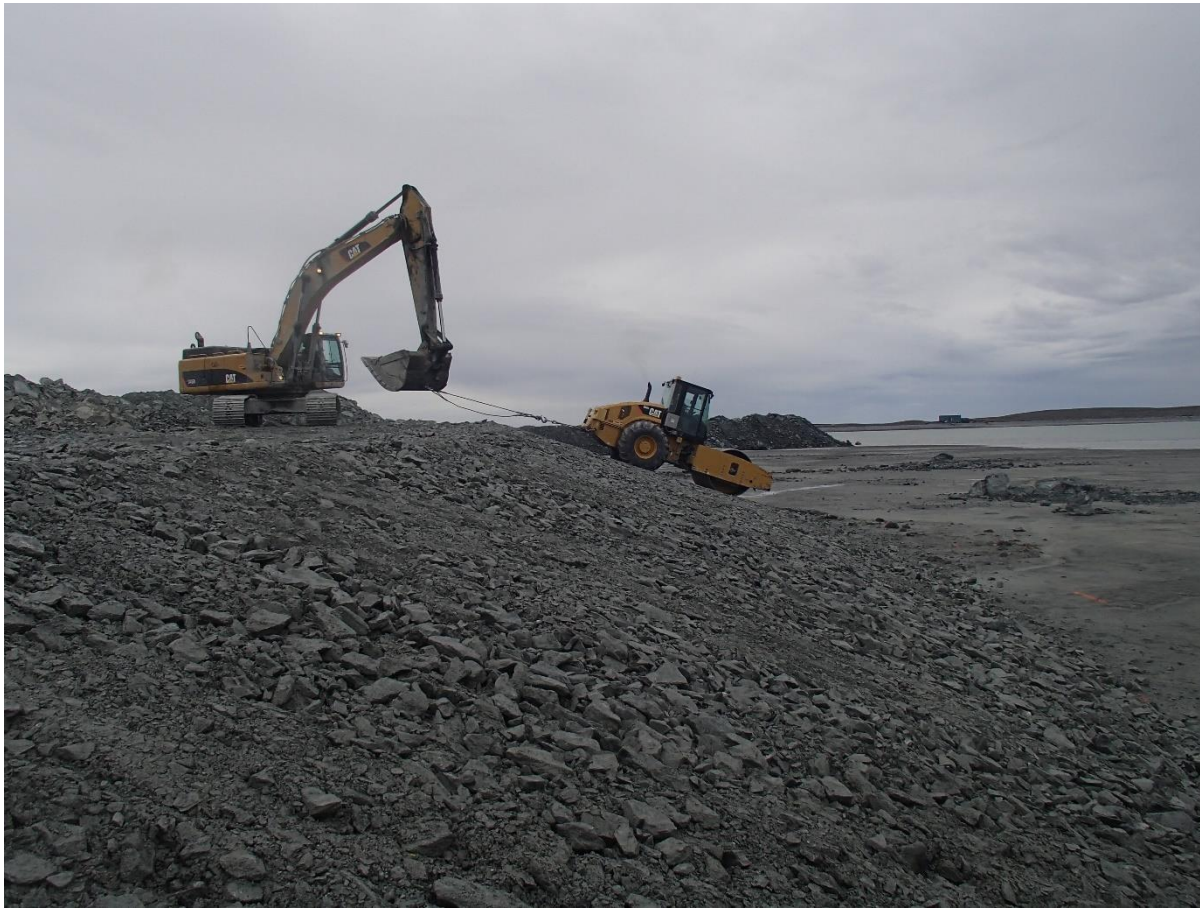
**Photograph NCIS-080: From Sta. 2+800/-38 m (approx.), looking S. Compaction of the 0.5 m lift (approx.) of coarse filter between El. 150 and 152 m with a 10-tonne smooth-drum compactor (4 passes) in the upstream slope from Sta. 2+925 m to 3+160 m and from Sta. 1+300 m to 1+200 m.**

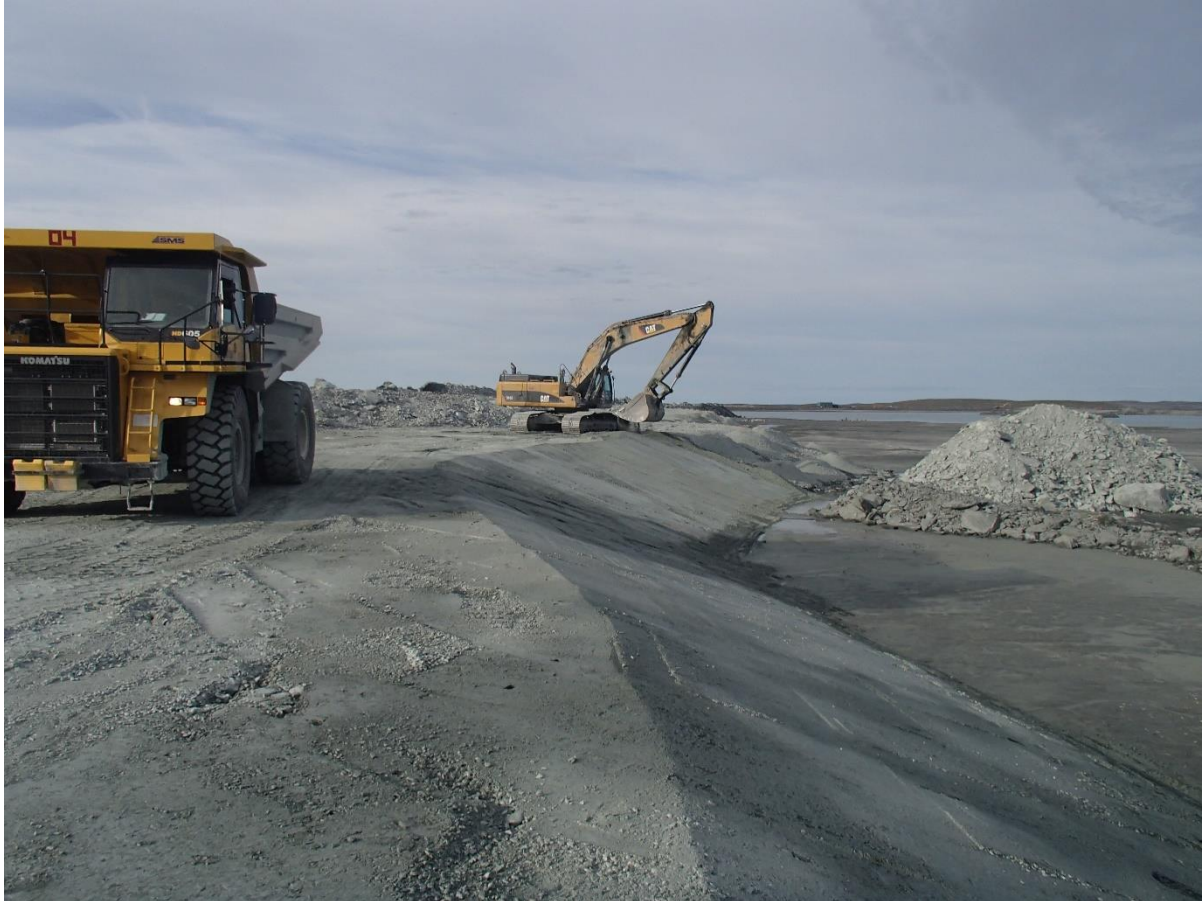
**Photograph NCIS-081: From Sta2+975/-37 m (approx.), looking SE. Placement of a 0.5 m thick lift of fine filter over the coarse filter in the upstream slope from El. 150 m to 152 m with an excavator from Sta. 1+300 m to 1+210 m and from Sta. 2+940 m to 3+120 m.**

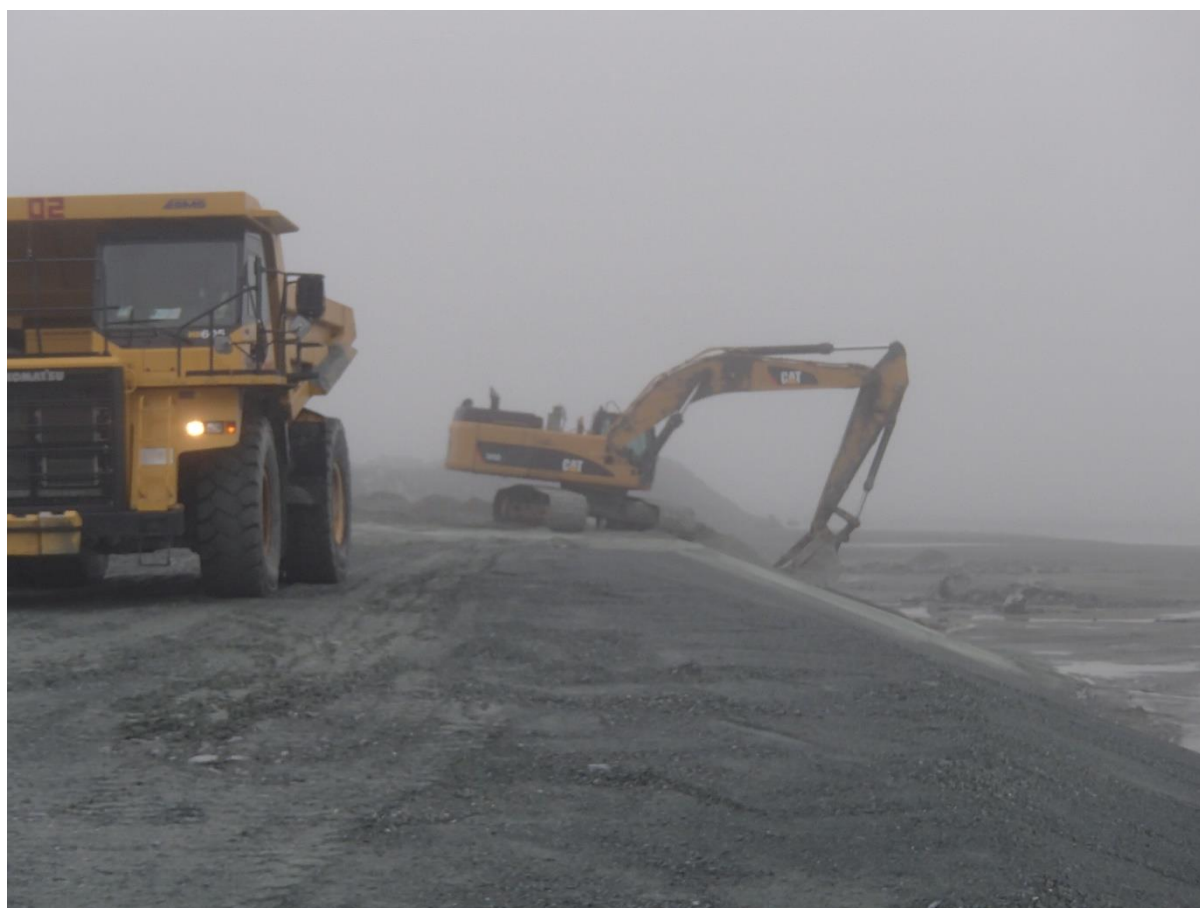
**Photograph NCIS-082: From Sta 3+060/-33 m (approx.), looking S. Placement of a 0.5 m thick lift of fine filter over the coarse filter in the upstream slope from El. 150 m to 152 m with an excavator from Sta. 3+120 m to 3+160 m.**

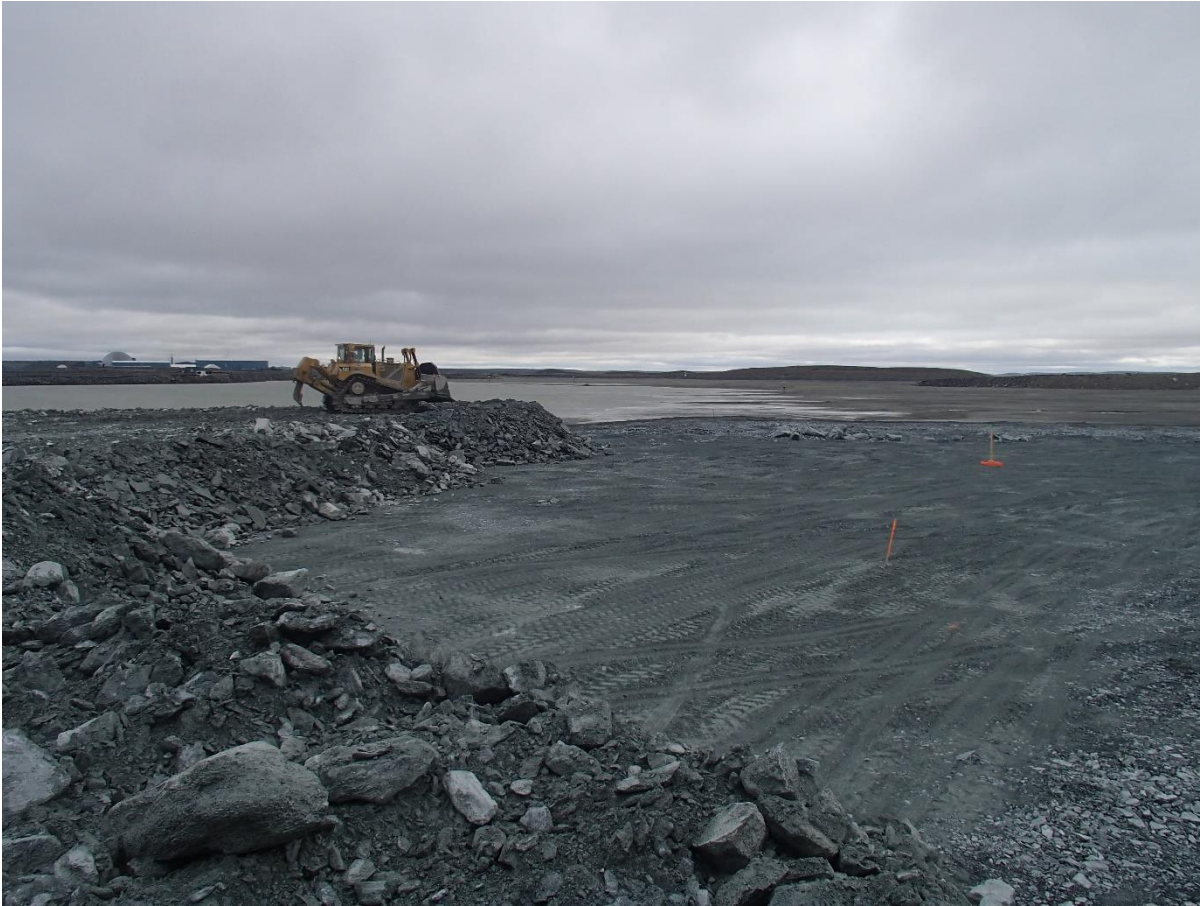
**Photograph NCIS-082: From Sta 1+140/-52 m (approx.), looking SW. Placement of a 2 m thick (approx.) lift of IV rockfill from El. 150 m to El. 152 m (approx.) with a dozer from Sta. 1+160 m to 1+170 m (-64 m to -111 m). The material is of good quality and is well graded.**

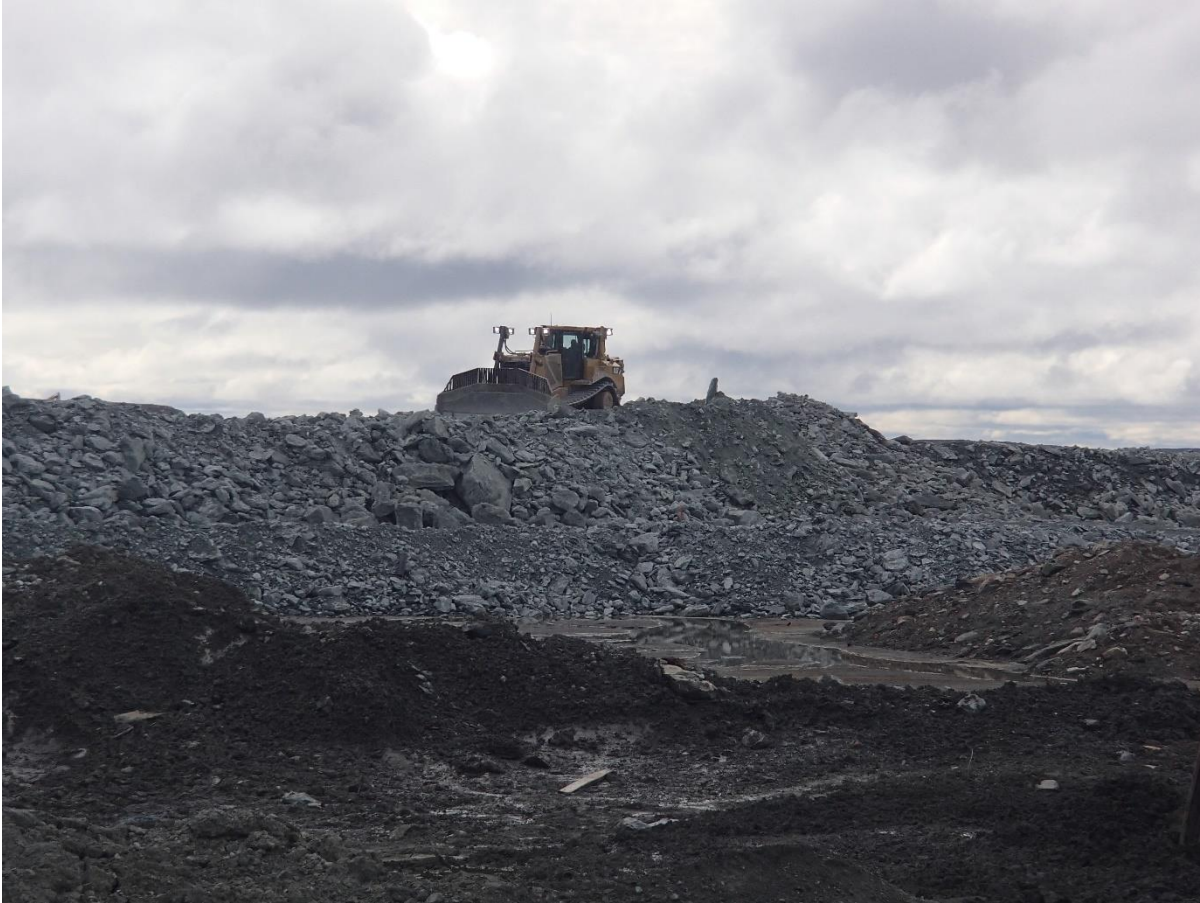
**Photograph NCIS-084: From Sta 1+080/+47 m (approx.), looking E. Placement of a 2 m thick (approx.) lift of UM rockfill from El. 150 m to El. 152 m (approx.) with a dozer from Sta. 1+160 m to 1+130 m (-55 m to -102 m).**

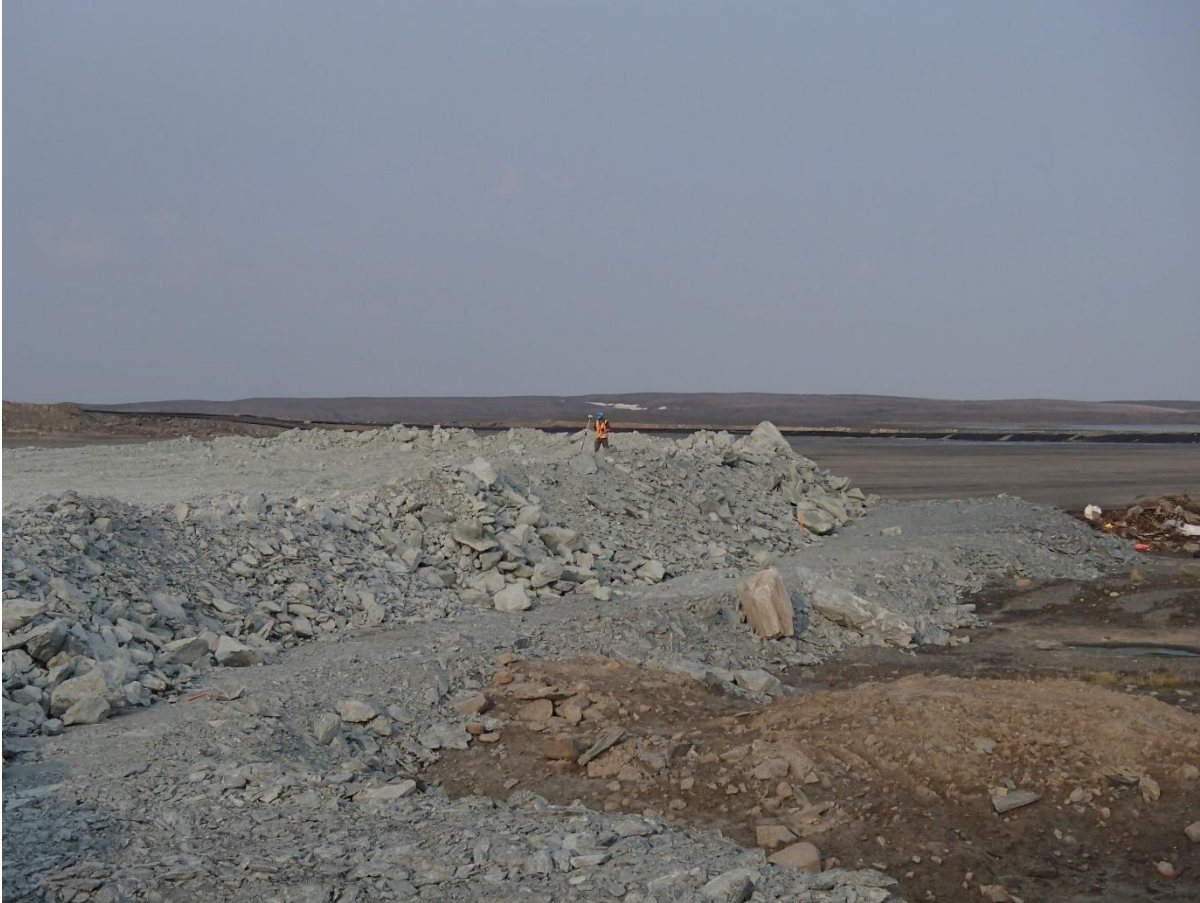
**Photograph NCIS-085: From Sta 1+150/-67m (approx.), looking SW. Placement of a 2 m thick (approx.) lift of UM rockfill from El. 150 m to El. 152 m (approx.) with a dozer from Sta. 1+130 m to 1+100 m (-55 m to -78 m).**

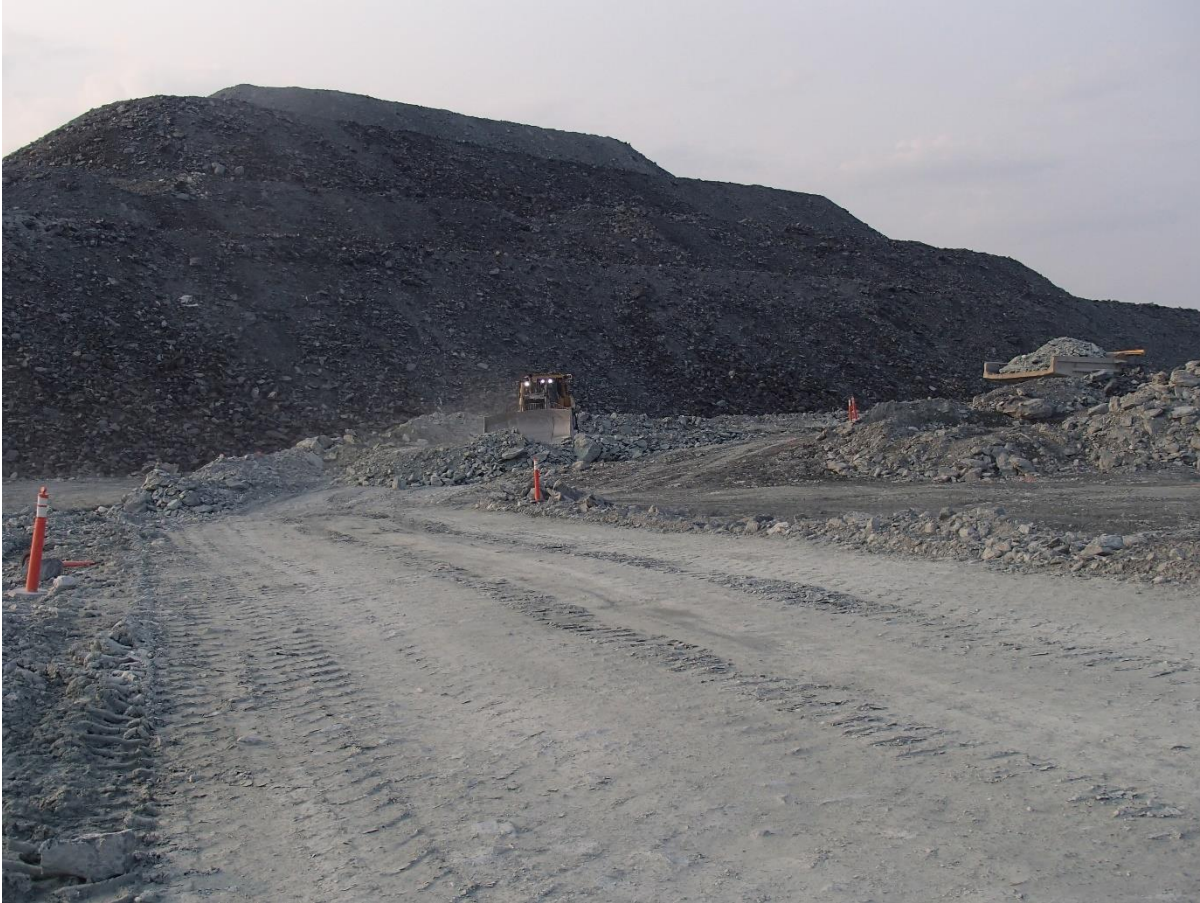
**Photograph NCIS-086: From Sta 2+750/+14 m (approx.), looking E. Placement of a 2 m thick (approx.) lift of UM rockfill from El. 152 m to El. 154 m (approx.) with a dozer from Sta. 2+780 m to 2+760 m (-60 m to -44 m).**

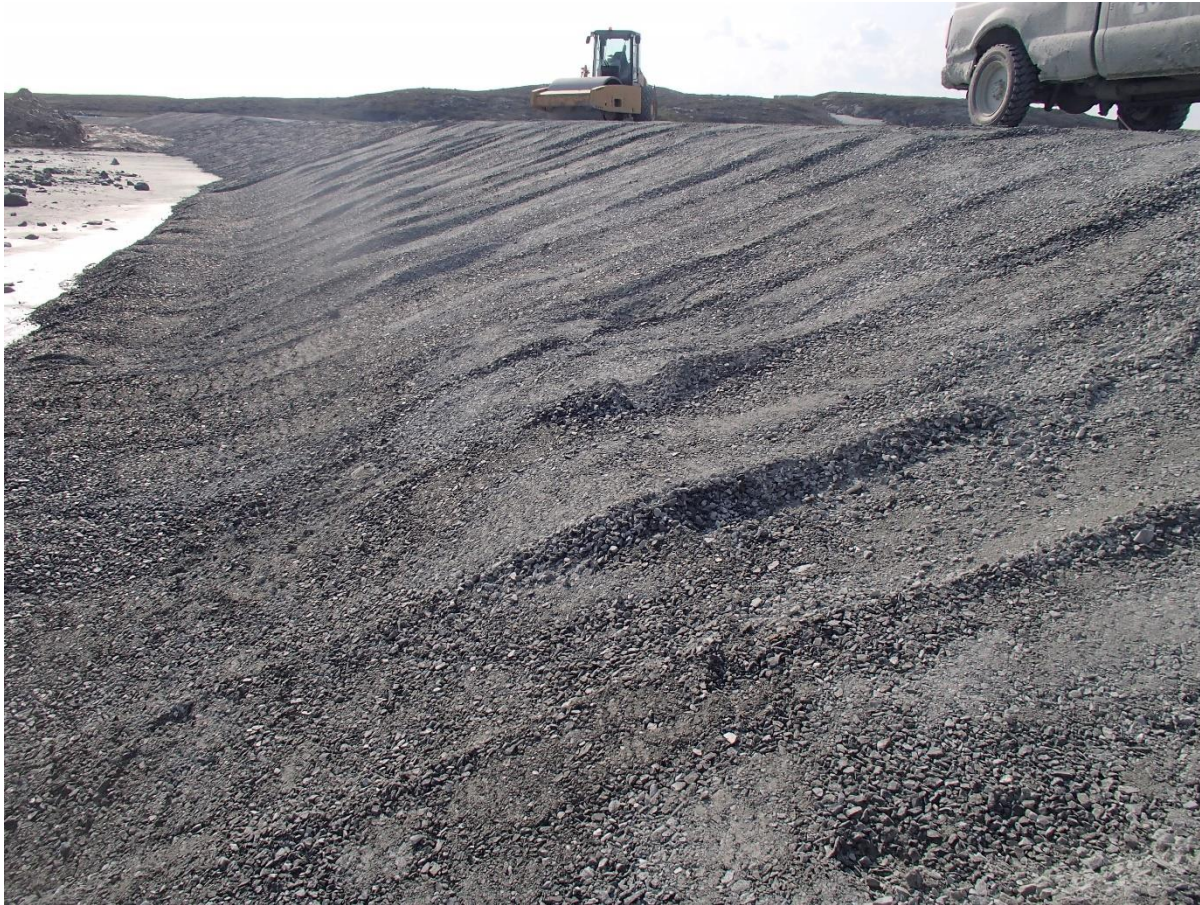
- The QA Manager observed large deformations in the fine filter surface on the North Cell Internal Structure around Sta. 1+940 m following the compaction. According to SANA foreman, the deformations are due to a new operator on the excavator towing the compactor. The surface will be corrected tomorrow.

**Photograph NCIS-087: From Sta 1+950/-34 m (approx.), looking W. Compaction of the 0.5 m lift (approx.) of fine filter between El. 150 and 152 m with a 10-tonne smooth-drum compactor (4 passes) in the upstream slope from Sta. 2+000 m to 1+930 m. Vibration is used except for the first pass down the slope in order to stabilize the material and limit deformation of the lift.**

- The deformations observed yesterday in the fine filter surface on the North Cell Internal Structure around Sta. 1+940 m were corrected with the compactor.
- SANA Surveyor reports that the lift is 0.3 m to 0.5 m to thick around Sta. 2+610 m (approx.) as it was placed during the night shift. SANA surveyor will install picket at the end of the day shift to guide the bulldozer during the night shift.
- An approx. 30 m shift between the Station measured by SANA Surveyor and the QA Manager was noted. A new alignment for the North Cell Internal Structure centerline at El. 154 m had been emitted about 2 weeks ago. The new GPX file was provided to the QA Manager today.

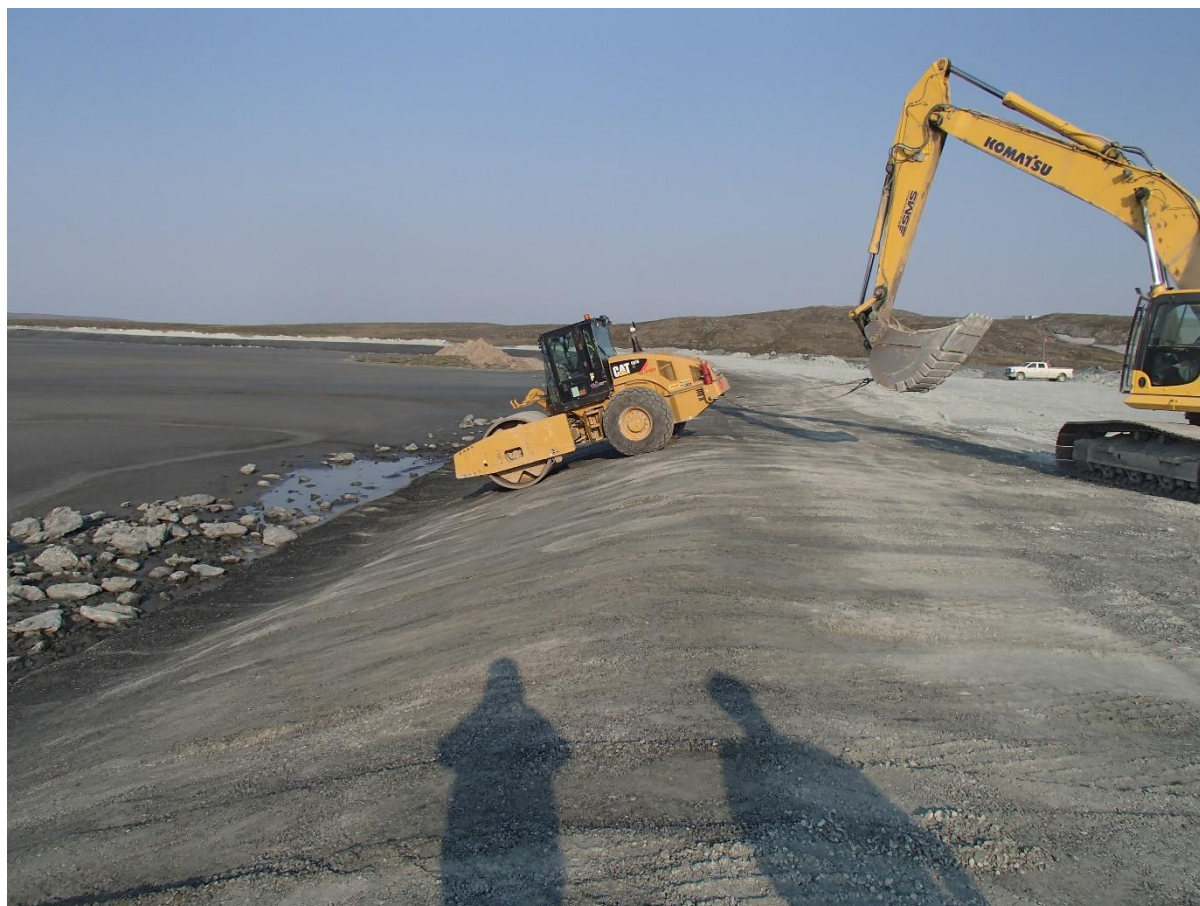
**Photograph NCIS-088: From Sta 2+000/-35 m (approx.), looking W. Compaction of the 0.5 m lift (approx.) of fine filter between El. 150 m and 152 m with a 10-tonne smooth-drum compactor (4 passes) in the upstream slope from Sta. 2+028 m to 1+650 m.**

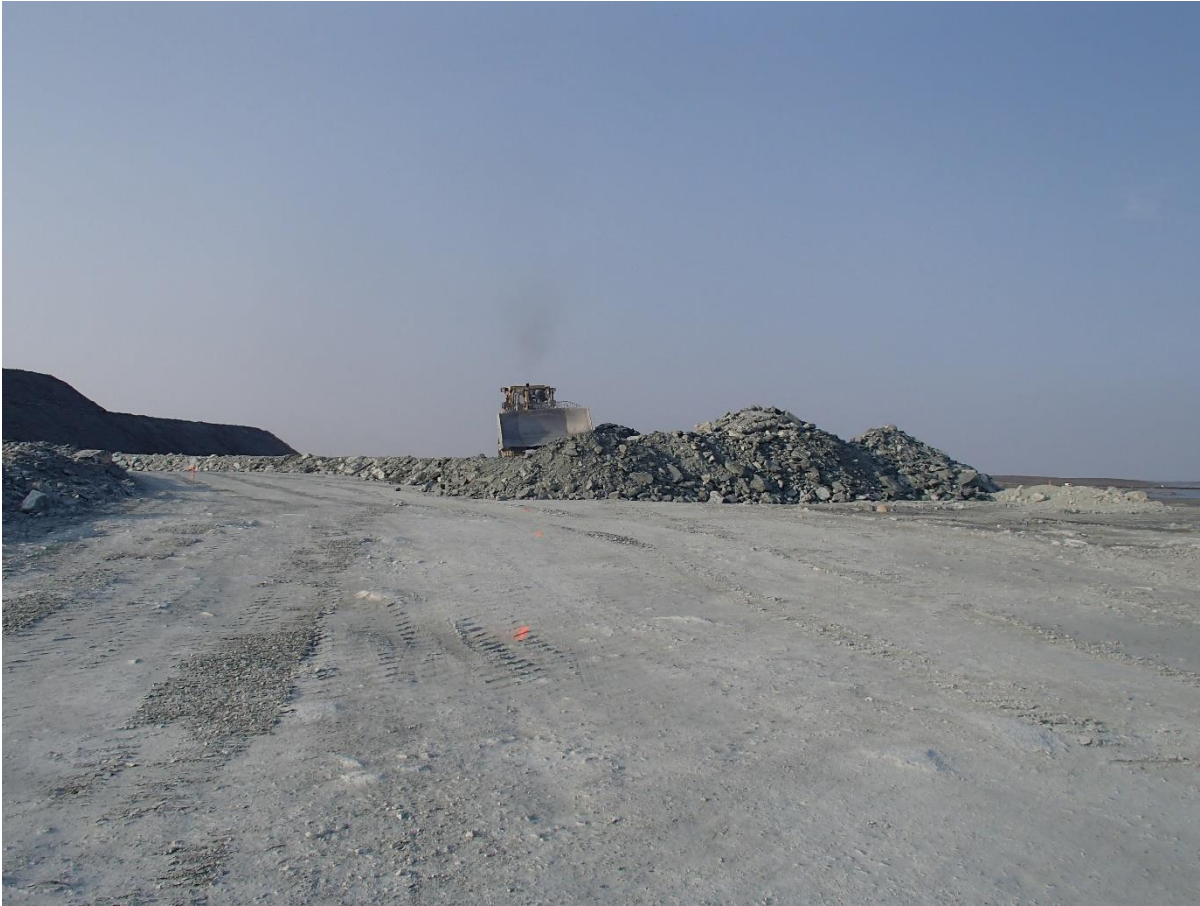
**Photograph NCIS-089: From Sta 2+525/+4 m (approx.), looking S. Placement of a 2 m thick (approx.) lift of UM rockfill from El. 152 m to El. 154 m (approx.) with a dozer from Sta. 2+605 m to 2+455 m (+3 m to -23 m).**

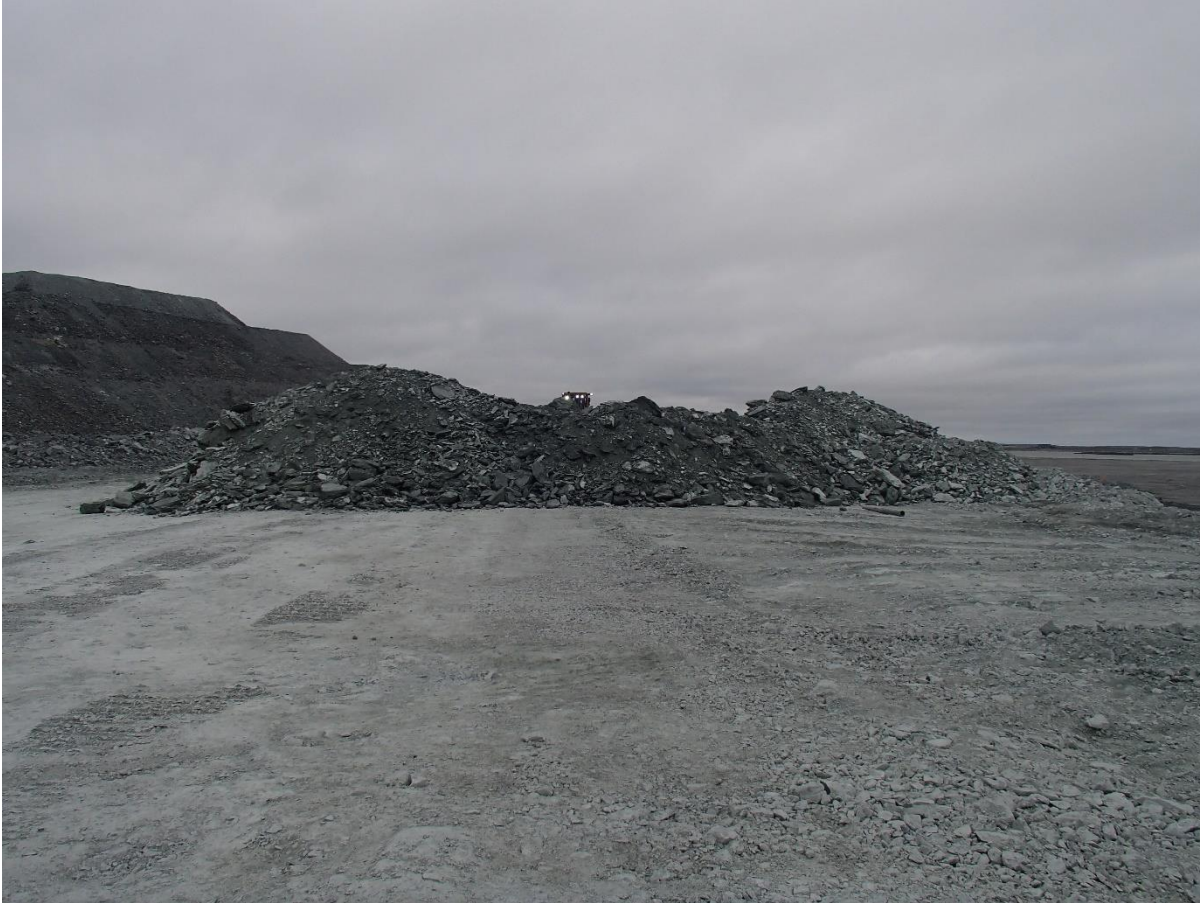
**Photograph NCIS-090: From Sta 2+440/-1 m (approx.), looking SE. Placement of a 2 m thick (approx.) lift of UM rockfill from El. 152 m to El. 154 m (approx.) with a dozer from Sta. 2+455 m to 2+370 m (+4 m to -24 m).**
