### **Meadowbank 2018 TSF As-built report**

**2018 CONSTRUCTION SEASON AS-BUILT REPORT  
TAILINGS STORAGE FACILITY  
MEADOWBANK GOLD PROJECT, NUNAVUT**

1897439-1578-R-Rev0

November 2018

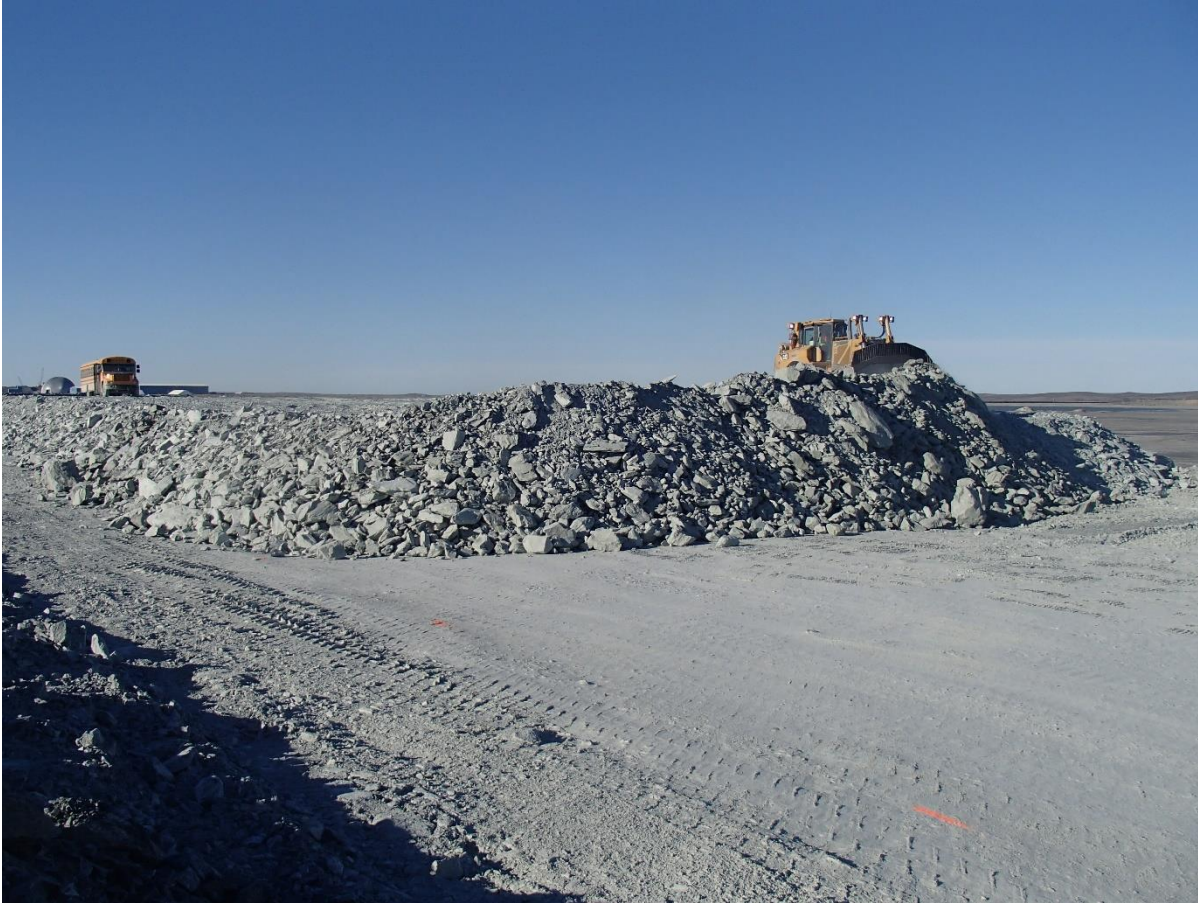
**Photograph NCIS-091: From Sta 2+330/+13 m (approx.), looking S. Placement of a 2 m thick (approx.) lift of UM rockfill from El. 152 m to El. 154 m (approx.) with a dozer from Sta. 2+370 m to 2+290 m (+9 m to -22 m). The material is of good quality and is well graded.**

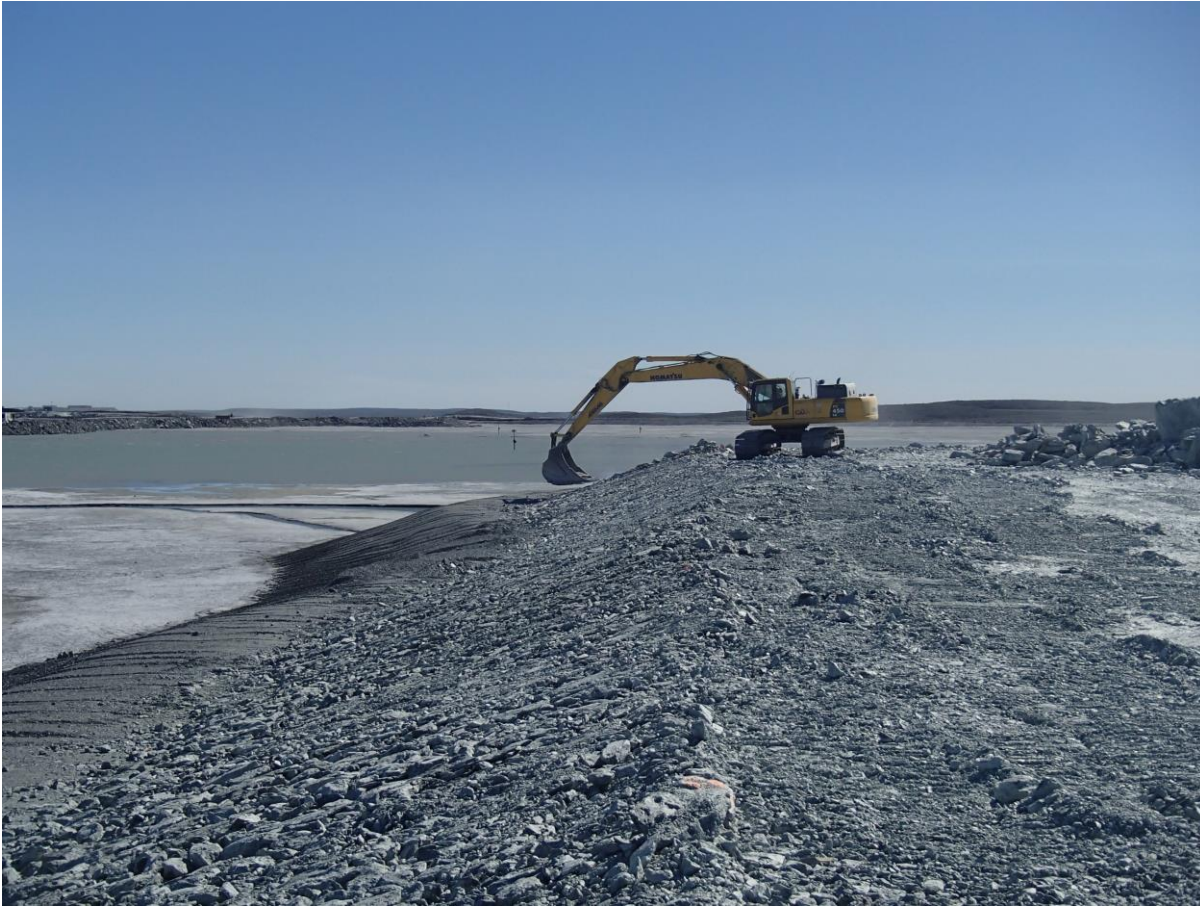
**Photograph NCIS-092: From Sta 1+160/-77 m (approx.), looking S. Profiling of the upstream slope (3H:1V) from El. 150 to 152 m with an excavator from Sta. 1+185 m to 1+135 m.**

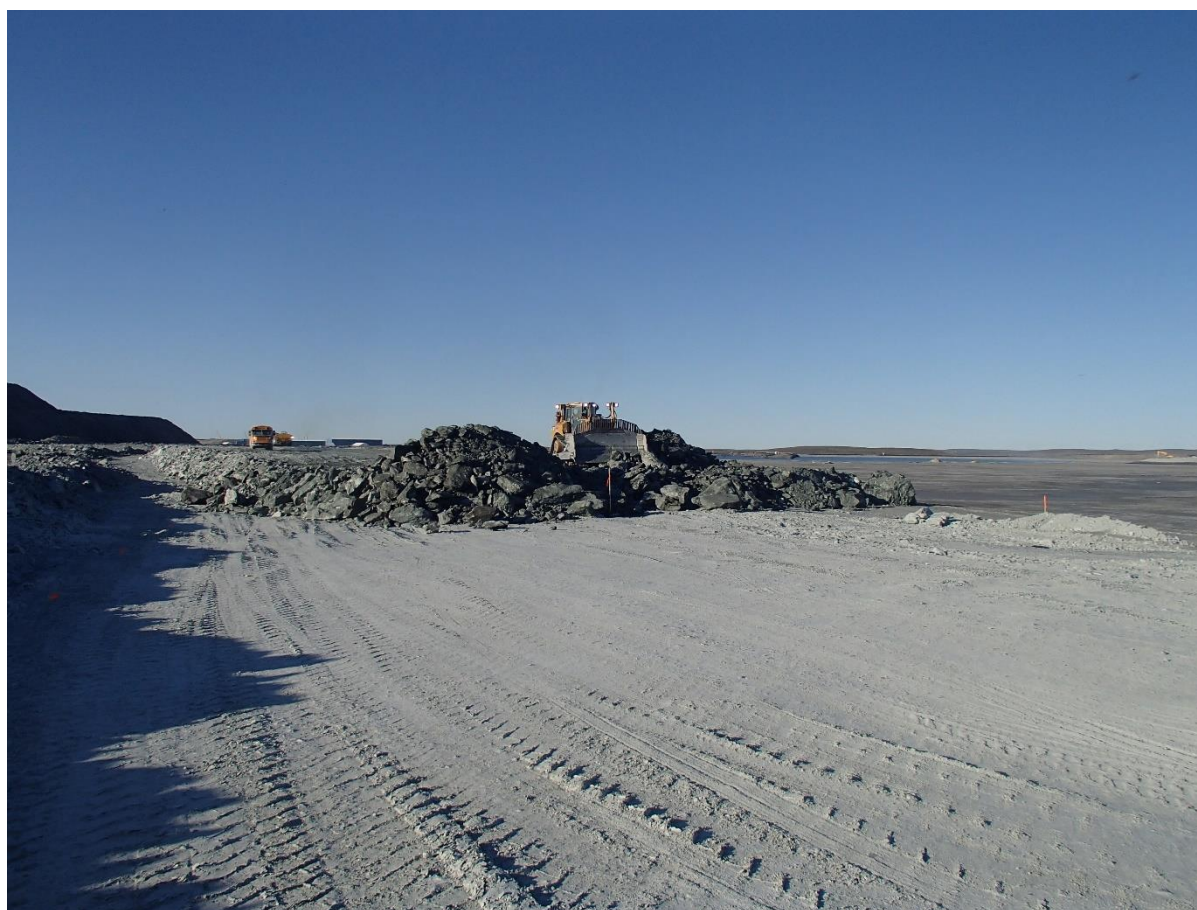
**Photograph NCIS-093: From Sta 2+260/+12 m (approx.), looking S. Placement of a 2 m thick (approx.) lift of UM rockfill from El. 152 m to El. 154 m (approx.) with a dozer from Sta. 2+290 m to 2+280 m (+9 m to -22 m).**

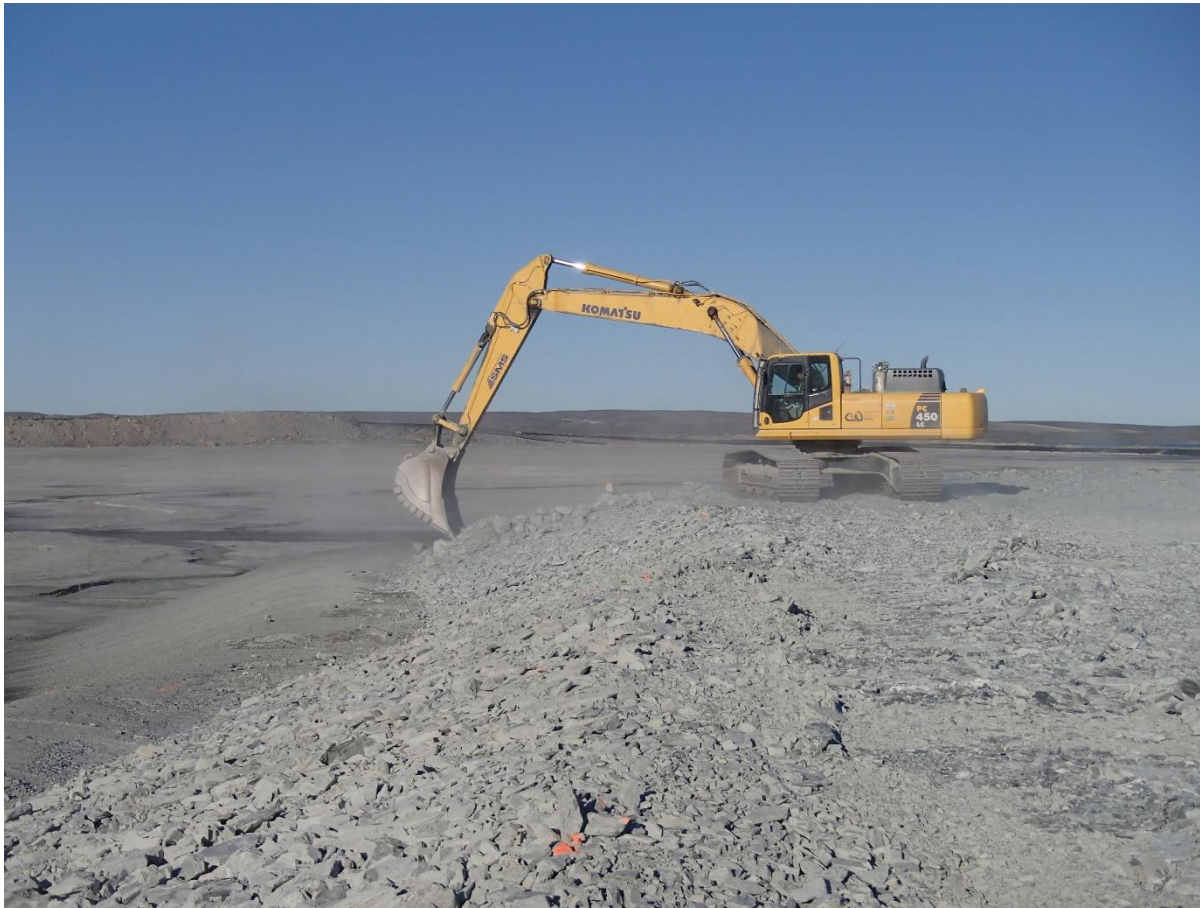
**Photograph NCIS-094: From Sta 1+125/-109 m (approx.), looking SW. Profiling of the upstream slope (3H:1V) from El. 150 to 152 m with an excavator from Sta. 1+135 m to 1+100 m.**

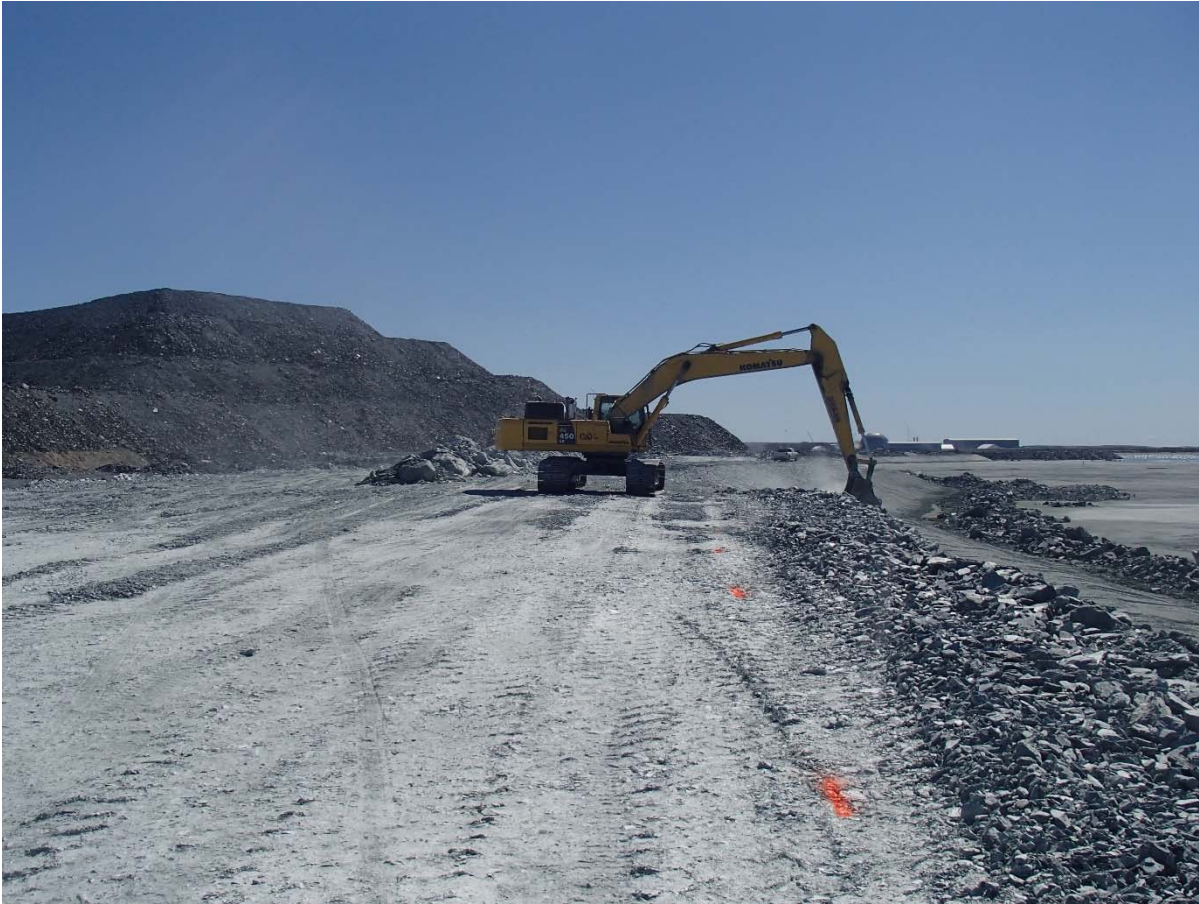
**Photograph NCIS-095: From Sta 2+375/-18 m (approx.), looking S. Profiling of the upstream slope (3H:1V) from El. 152 to 154 m with an excavator from Sta. 2+545 m to 2+410 m.**

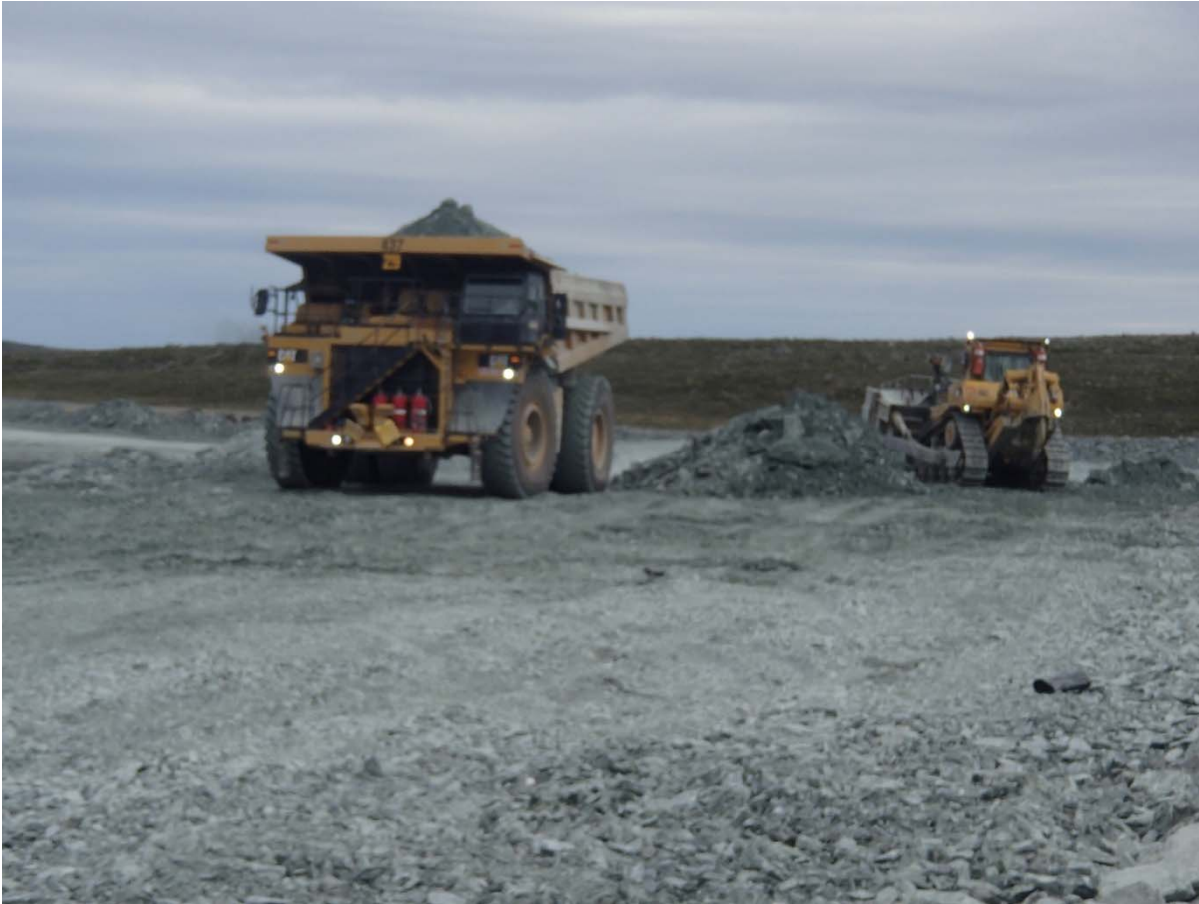
**Photograph NCIS-096: From Sta 2+355/+9 m (approx.), looking N. Placement of a 2 m thick (approx.) lift of UM rockfill from El. 152 m to El. 154 m (approx.) with a dozer from Sta. 2+190 m to 2+103 m (+7 m to -22 m). The material is of good quality and is well graded.**

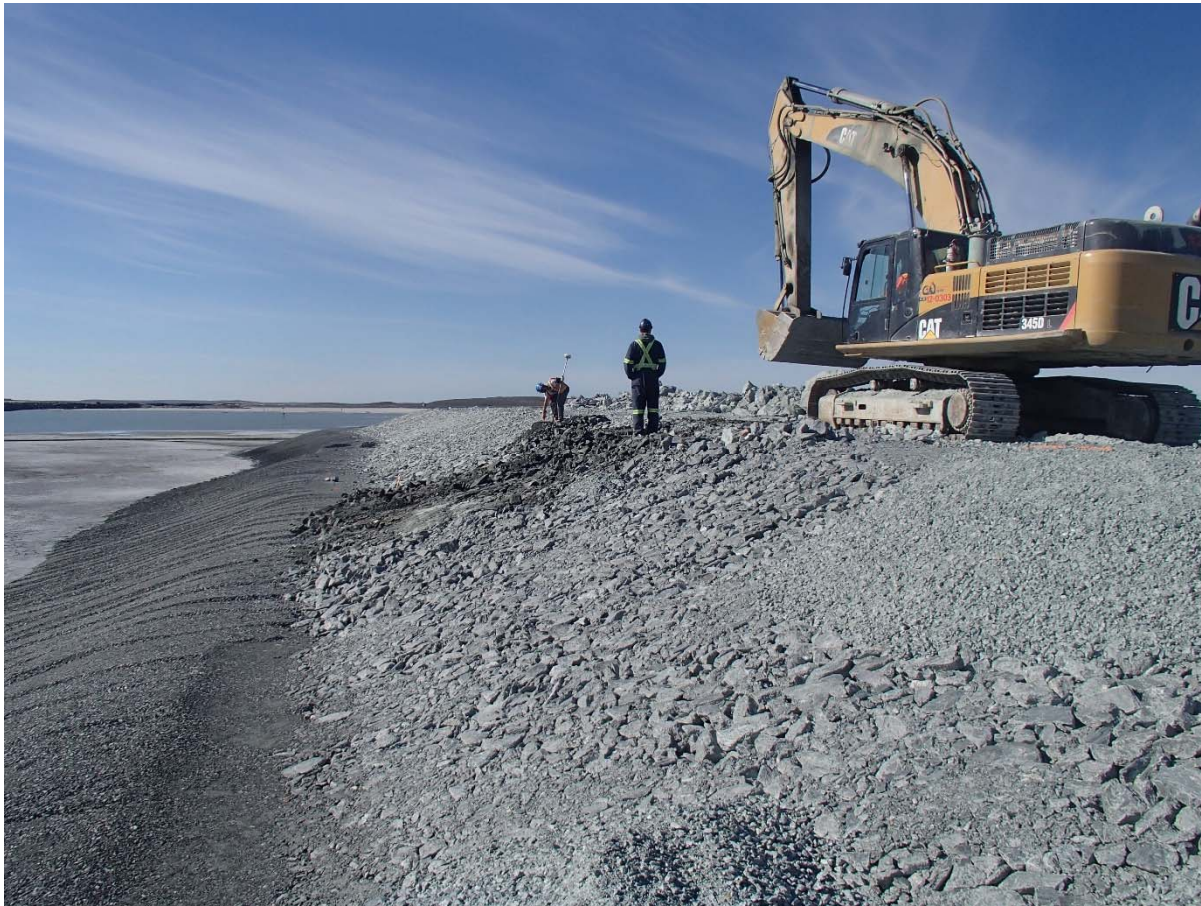
**Photograph NCIS-097: From Sta. 1+180/-75 m (approx.), looking SW. Placement of a 0.5 m thick lift of coarse filter in the upstream slope from El. 150 m to 152 m with an excavator from Sta. 1+200 m to 1+113 m.**

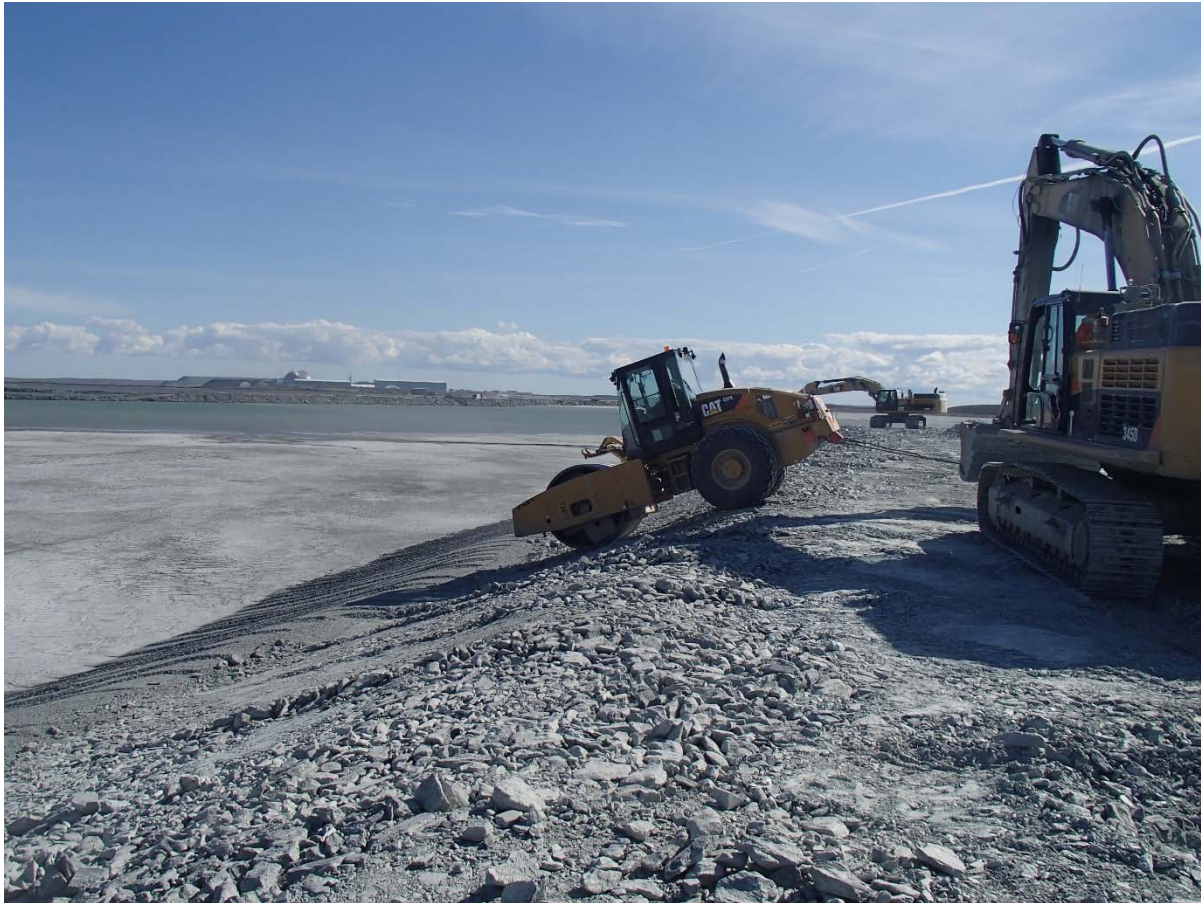
**Photograph NCIS-099: From Sta. 1+180/-76 m (approx.), looking SE. Compaction of the 0.5 m lift (approx.) of coarse filter between El. 150 m and 152 m with a 10-tonne smooth-drum compactor with vibration (4 passes) in the upstream slope from Sta. 1+200 m to 1+170 m.**

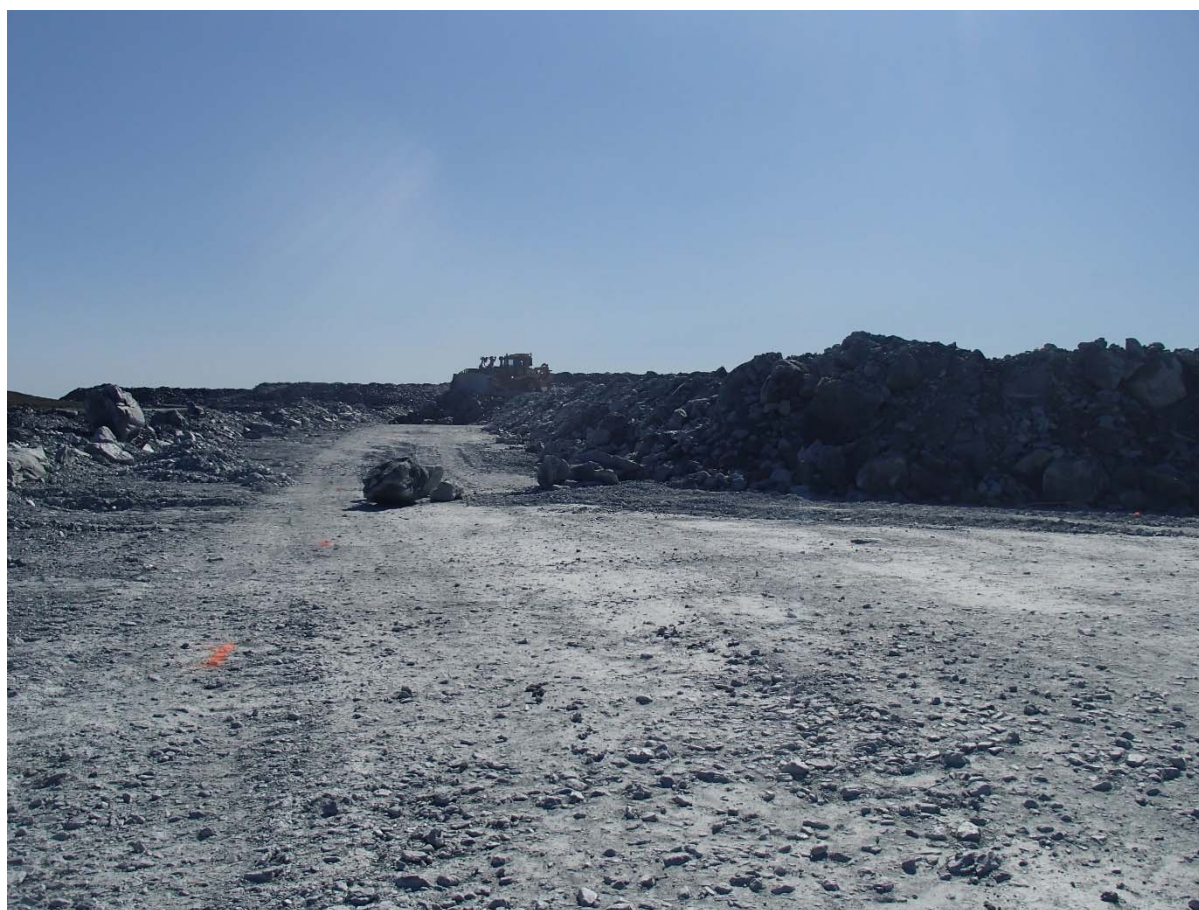
Photograph NCIS-100: From Sta. 1+960/+10 m (approx.), looking E. Placement of a 2 m thick (approx.) lift of UM rockfill from El. 152 m to El. 154 m (approx.) with a dozer from Sta. 1+984 m to 1+947 m (+14 m to -26 m). The material is of good quality and is well graded.

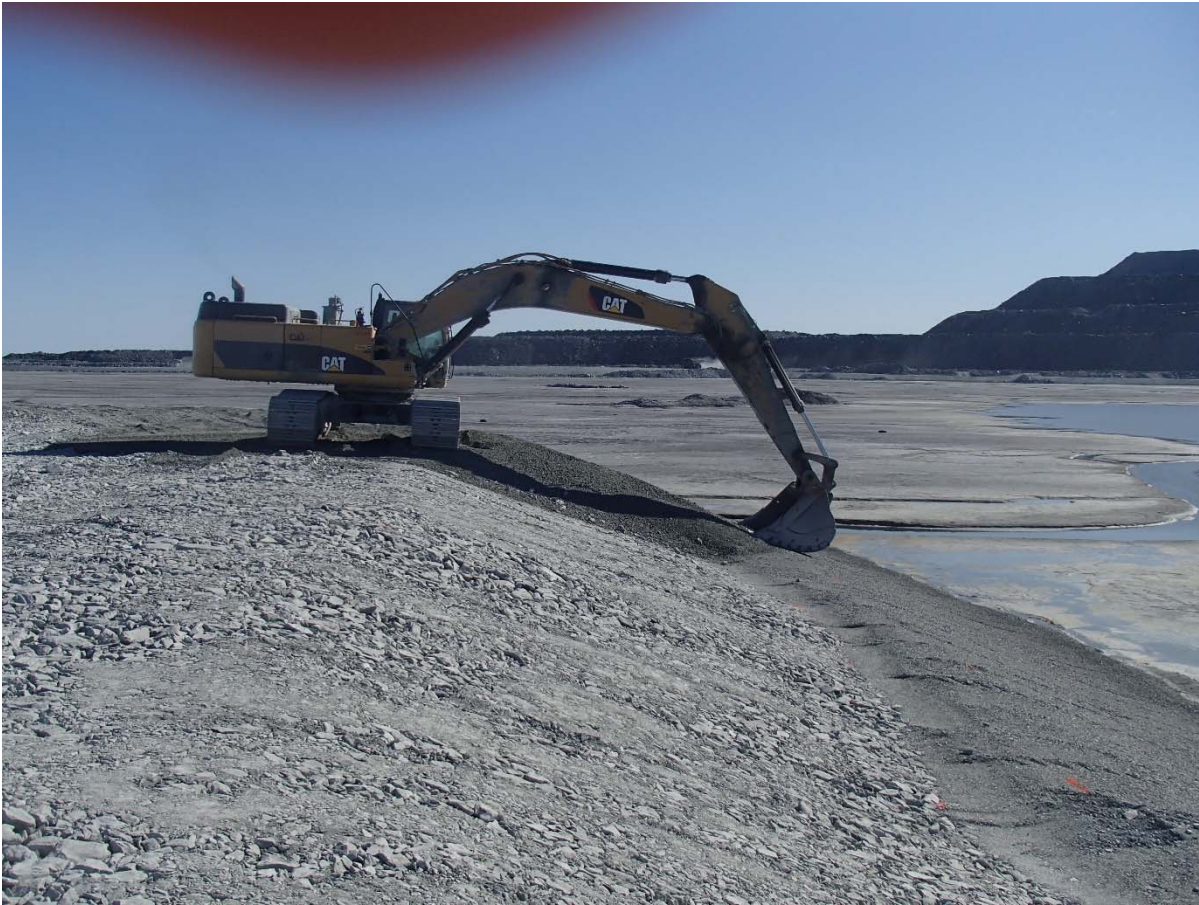
**Photograph NCIS-101: From Sta. 1+120/-89 m (approx.), looking N. Placement of a 0.5 m thick lift of fine filter in the upstream slope from El. 150 m to 152 m with an excavator from Sta. 1+113 m to 1+205 m.**

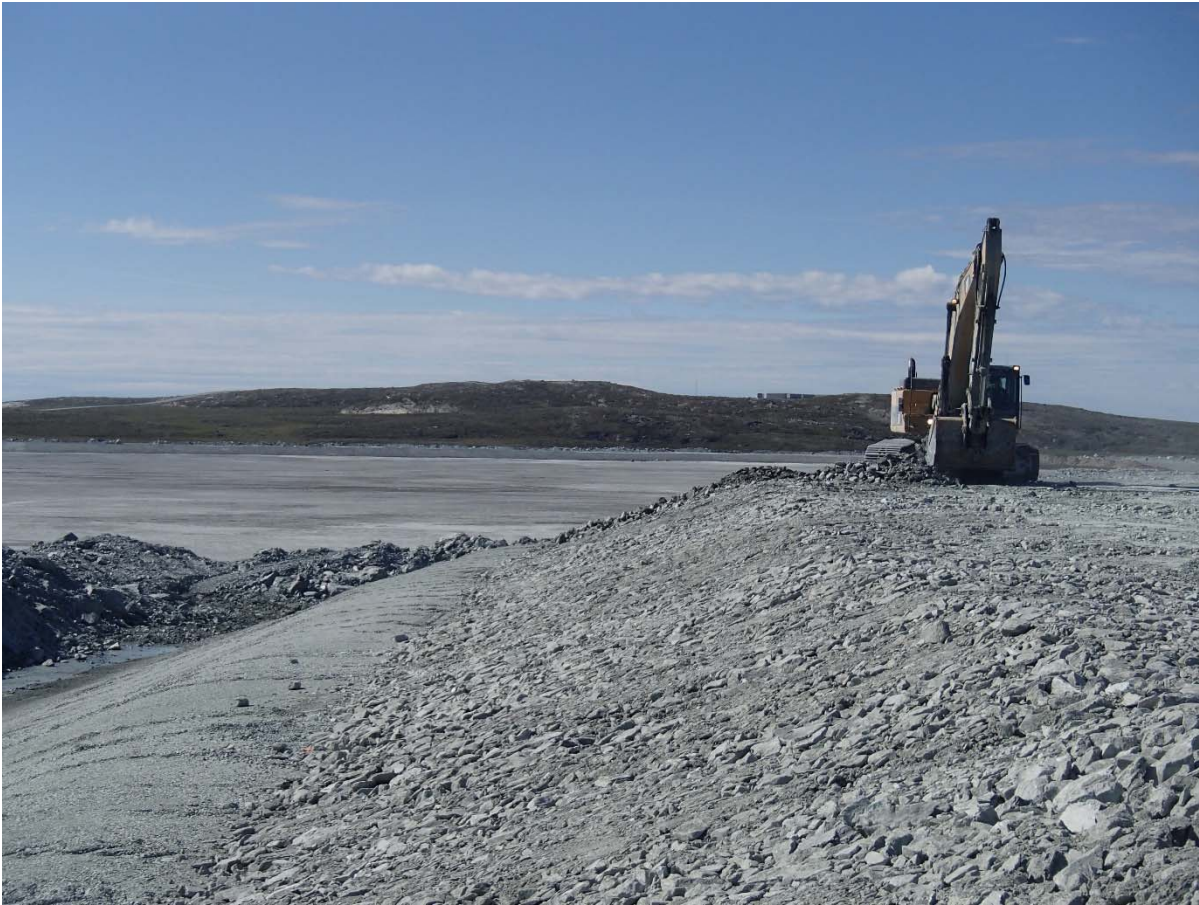
**Photograph NCIS-102: From Sta. 2+680/-21 m (approx.), looking W. Placement of a 0.5 m thick lift of coarse filter in the upstream slope from El. 152 m to 154 m with an excavator from Sta. 2+575 m to 2+710 m and from Sta. 2+411 m to 2+460 m.**

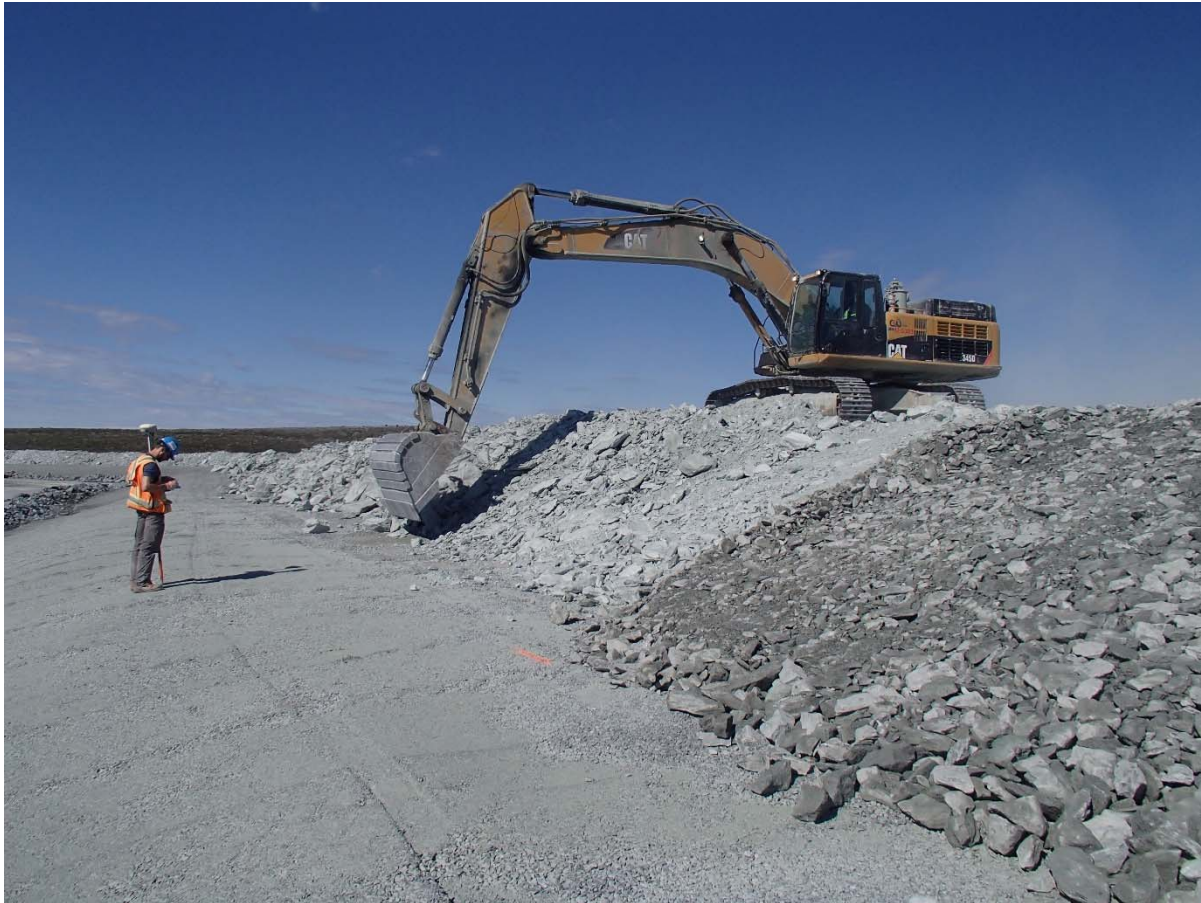
**Photograph NCIS-103: From Sta. 2+420/-27 m (approx.), looking NE. Profiling of the upstream slope (3H:1V) from El. 152 to 154 m with an excavator from Sta. 2+400 m to 2+410 m. Oversize boulders were removed.**

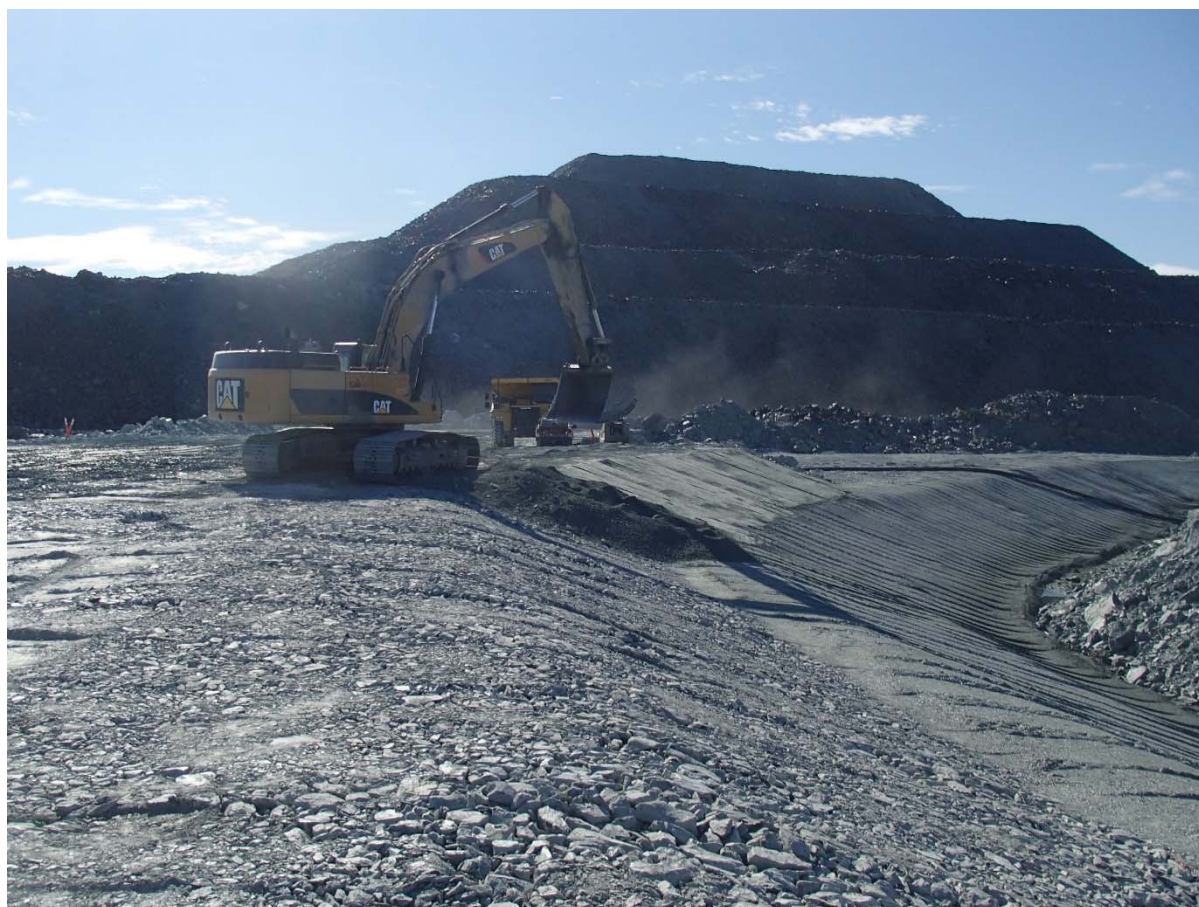
**Photograph NCIS-104:** From Sta. 2+650/-23 m (approx.), looking SE. Placement of a 0.5 m thick lift of fine filter in the upstream slope from El. 152 m to 154 m with an excavator from Sta. 2+710 m to 2+445 m.

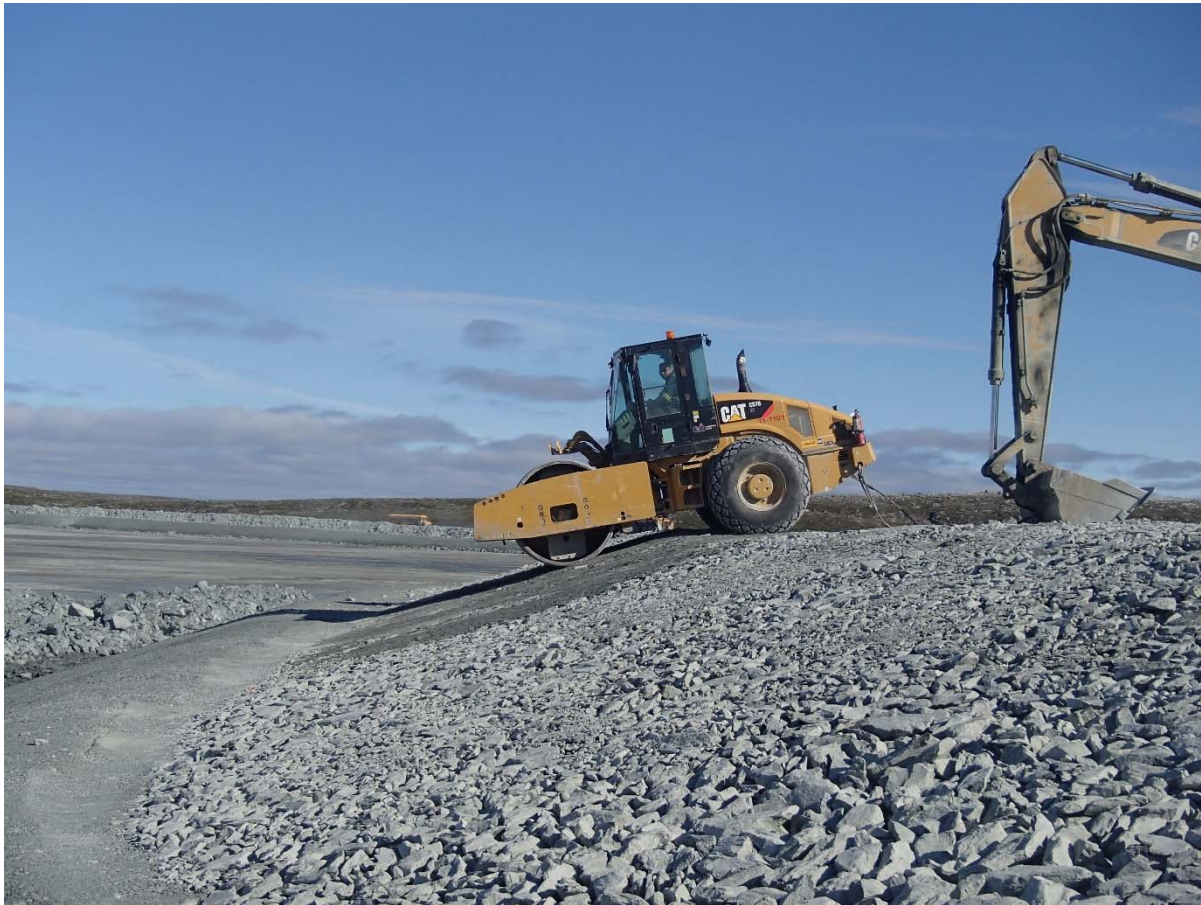
**Photograph NCIS-105: From Sta. 2+630/-34 m (approx.), looking NW. Compaction of the 0.5 m lift (approx.) of coarse filter between El. 152 m and 154 m with a 10-tonne smooth-drum compactor with vibration (4 passes) in the upstream slope from Sta. 2+710 m to 2+411 m.**

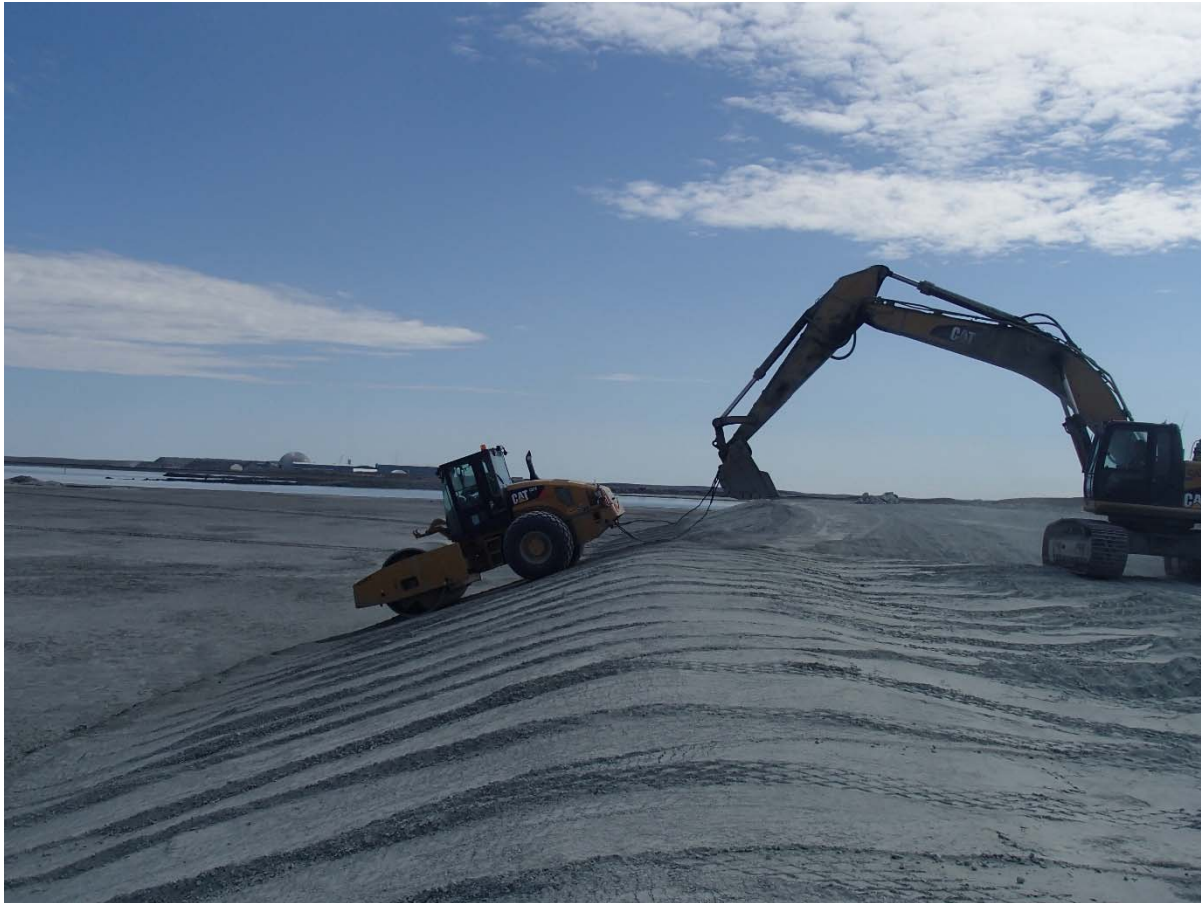
**Photograph NCIS-107: From Sta. 1+380/-38 m (approx.), looking S. Compaction of the 0.5 m lift (approx.) of fine filter between El. 150 m and 152 m with a 10-tonne smooth-drum compactor with vibration (4 passes) in the upstream slope from Sta. 1+251 m to 1+660 m.**

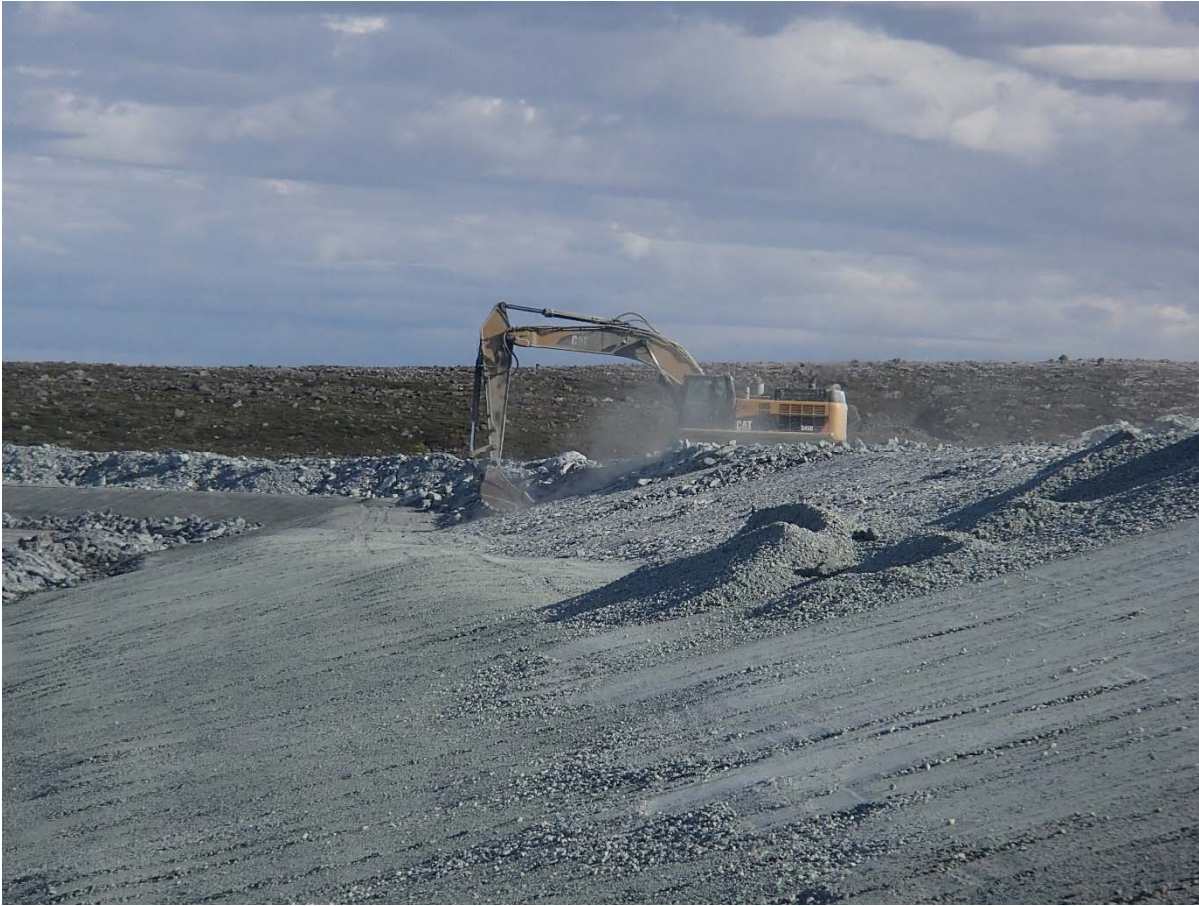
**Photograph NCIS-108: From Sta. 2+490/-32 m (approx.), looking N. Profiling of the upstream slope (3H:1V) from El. 152 to 154 m with an excavator from Sta. 2+159 m to 2+409 m.**

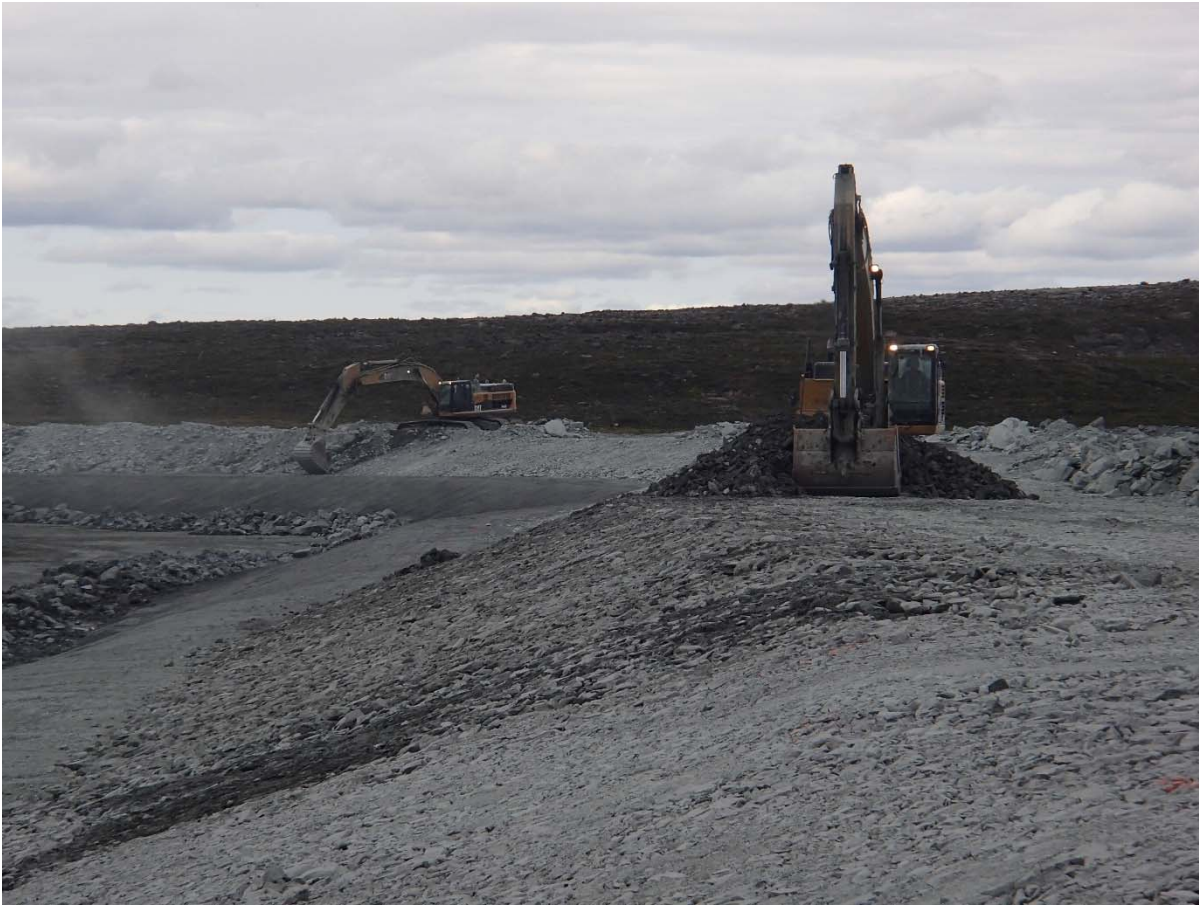
**Photograph NCIS-109: From Sta. 2+450/-21 m (approx.), looking N. Placement of a 0.5 m thick lift of coarse filter in the upstream slope from El. 152 m to 154 m with an excavator from Sta. 2+293 m to 2+411 m.**

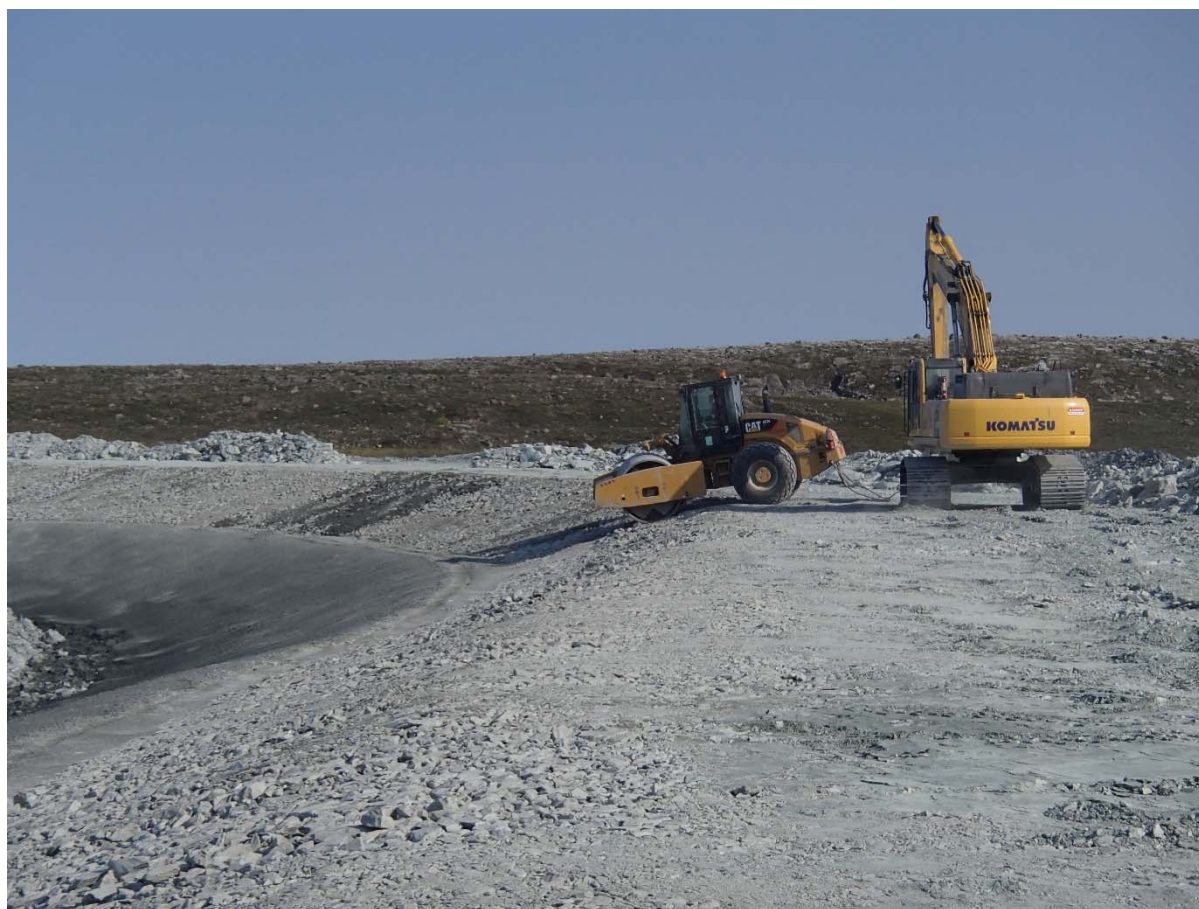
**Photograph NCIS-110: From Sta. 2+320/-22 m (approx.), looking N. Compaction of the 0.5 m lift (approx.) of coarse filter between El. 152 m and 154 m with a 10-tonne smooth-drum compactor with vibration (4 passes) in the upstream slope from Sta. 2+293 m to 2+080 m.**

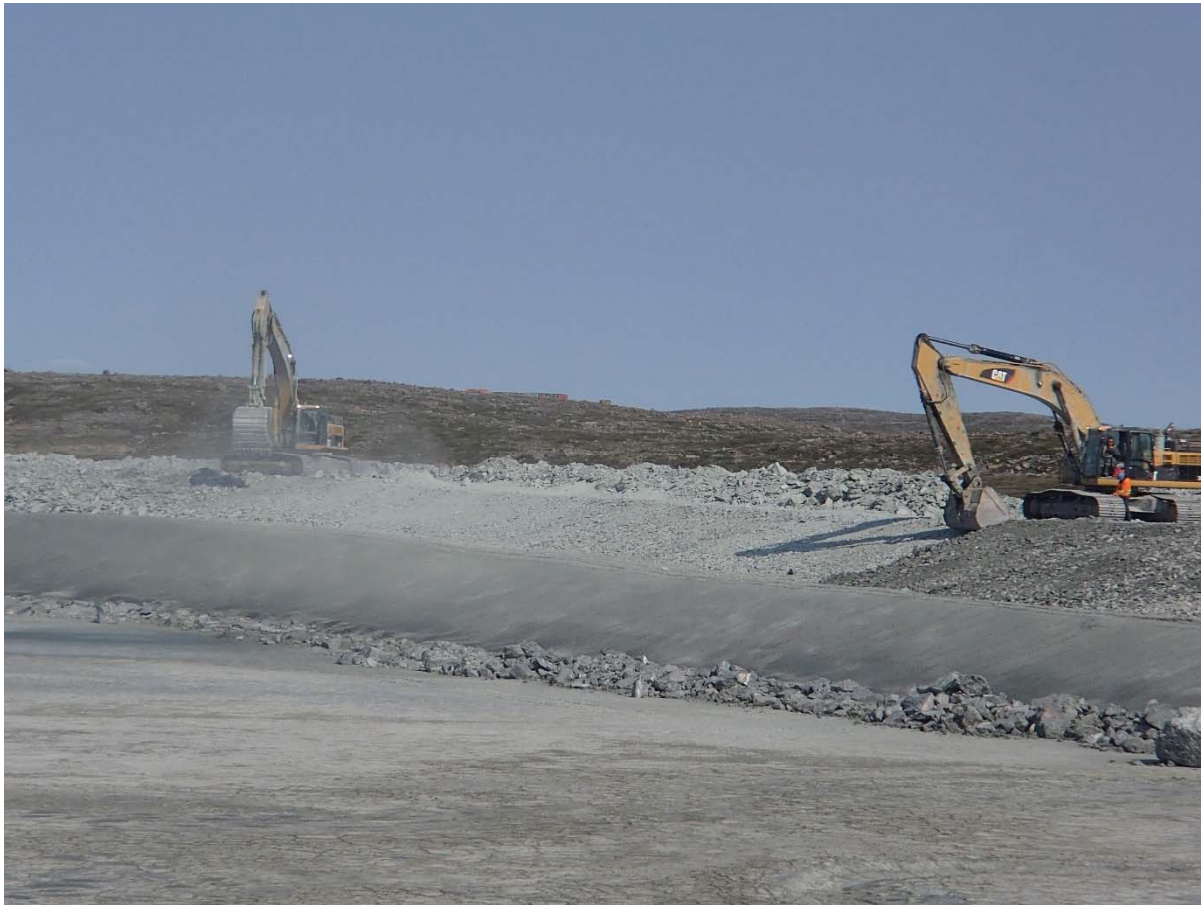
**Photograph NCIS-111: From Sta. 2+320/-22 m (approx.), looking NW. Profiling of the upstream slope (3H:1V) from El. 152 to 154 m with an excavator from Sta. 2+159 m to 2+000 m and placement of a 0.5 m thick lift of coarse filter in the upstream slope from El. 152 m to 154 m with an excavator from Sta. 2+293 m to 2+080 m.**

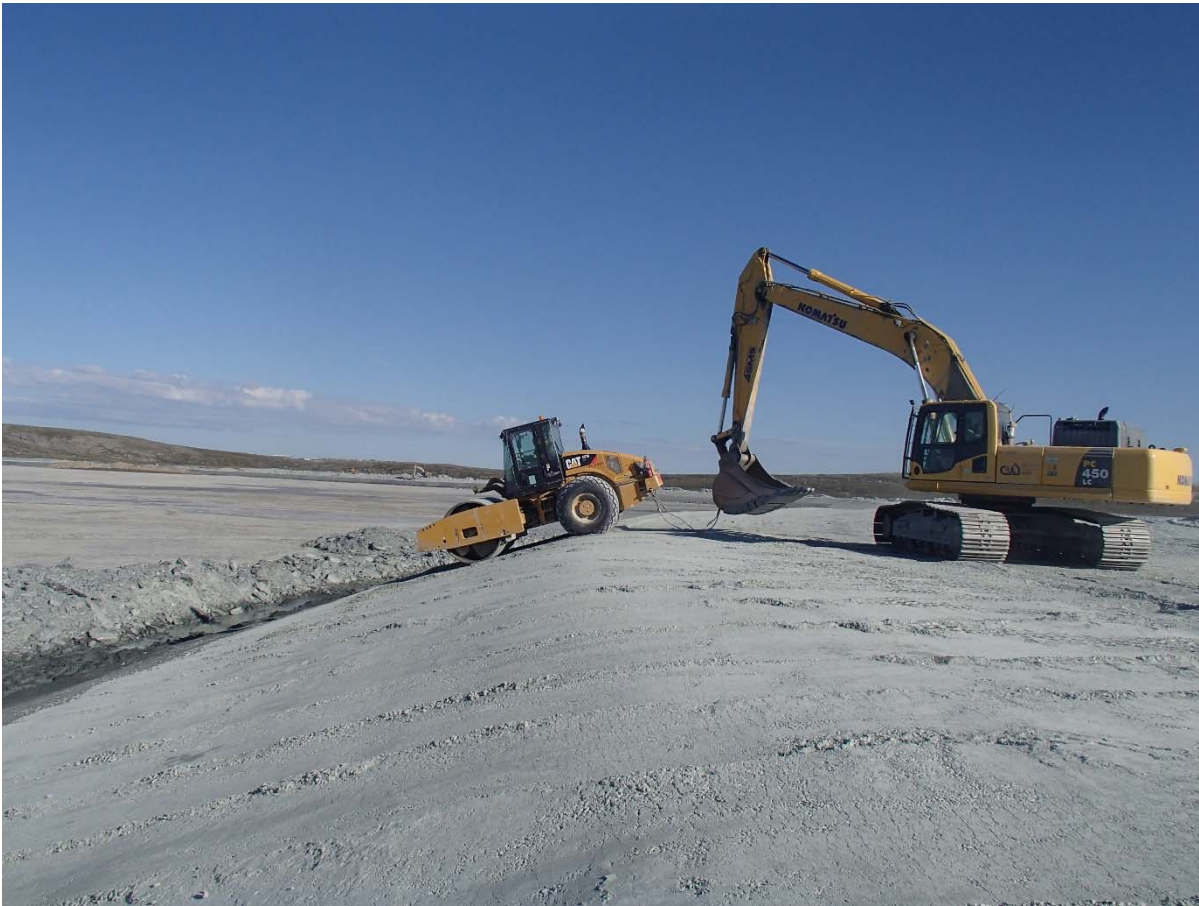
**Photograph NCIS-112: From Sta. 2+610/-29 m (approx.), looking N. Compaction of the 0.5 m lift (approx.) of coarse filter between El. 152 m and 154 m with a 10-tonne smooth-drum compactor with vibration (4 passes) in the upstream slope from Sta. 2+080 m to 2+000 m.**
