### **Meadowbank 2018 TSF As-built report**

**2018 CONSTRUCTION SEASON AS-BUILT REPORT  
TAILINGS STORAGE FACILITY  
MEADOWBANK GOLD PROJECT, NUNAVUT**

1897439-1578-R-Rev0

November 2018

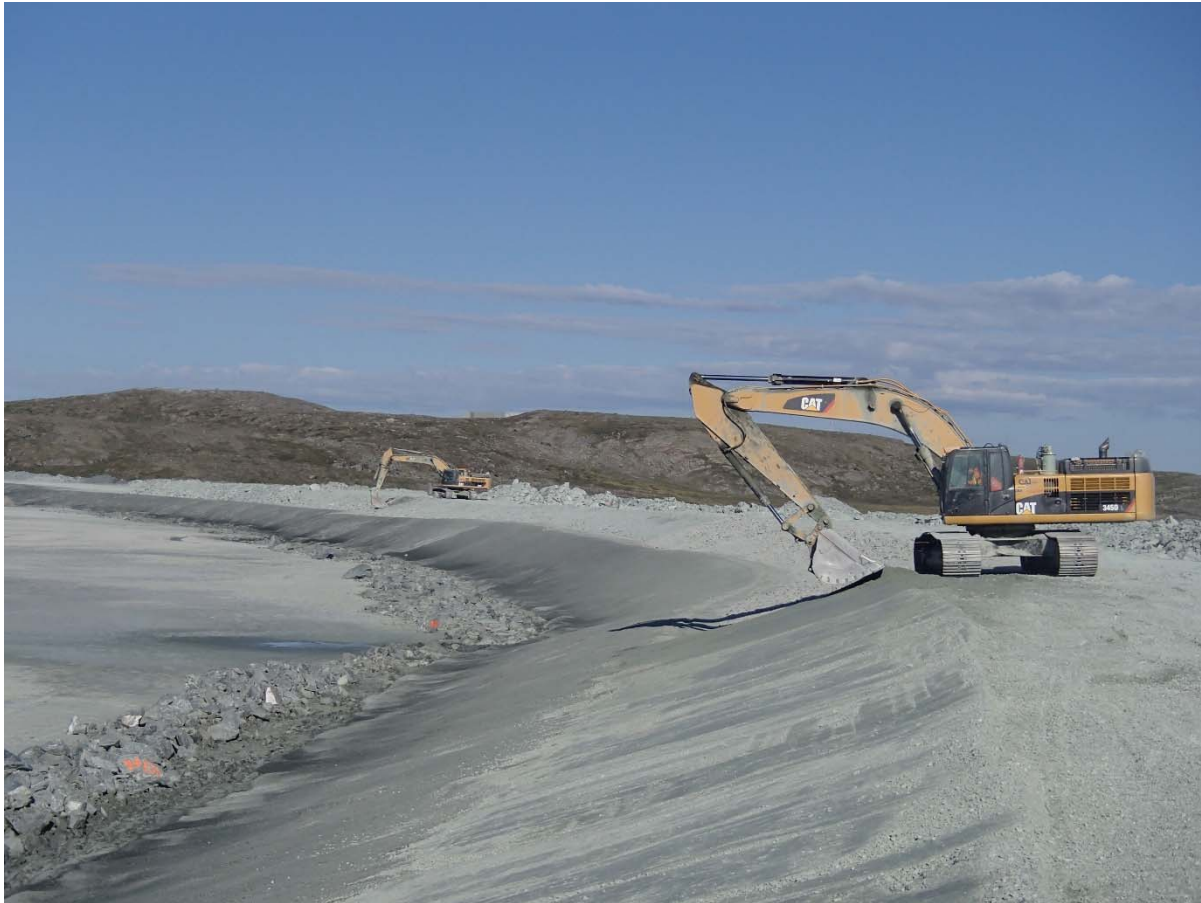
**Photograph NCIS-113: From Sta. 2+220/-26 m (approx.), looking SW. Profiling of the upstream slope (3H:1V) from El. 152 to 154 m with an excavator from Sta. 2+000 m to 1+185 m and placement of a 0.5 m thick lift of fine filter in the upstream slope from El. 152 m to 154 m with an excavator from Sta. 2+300 m to 2+090 m.**

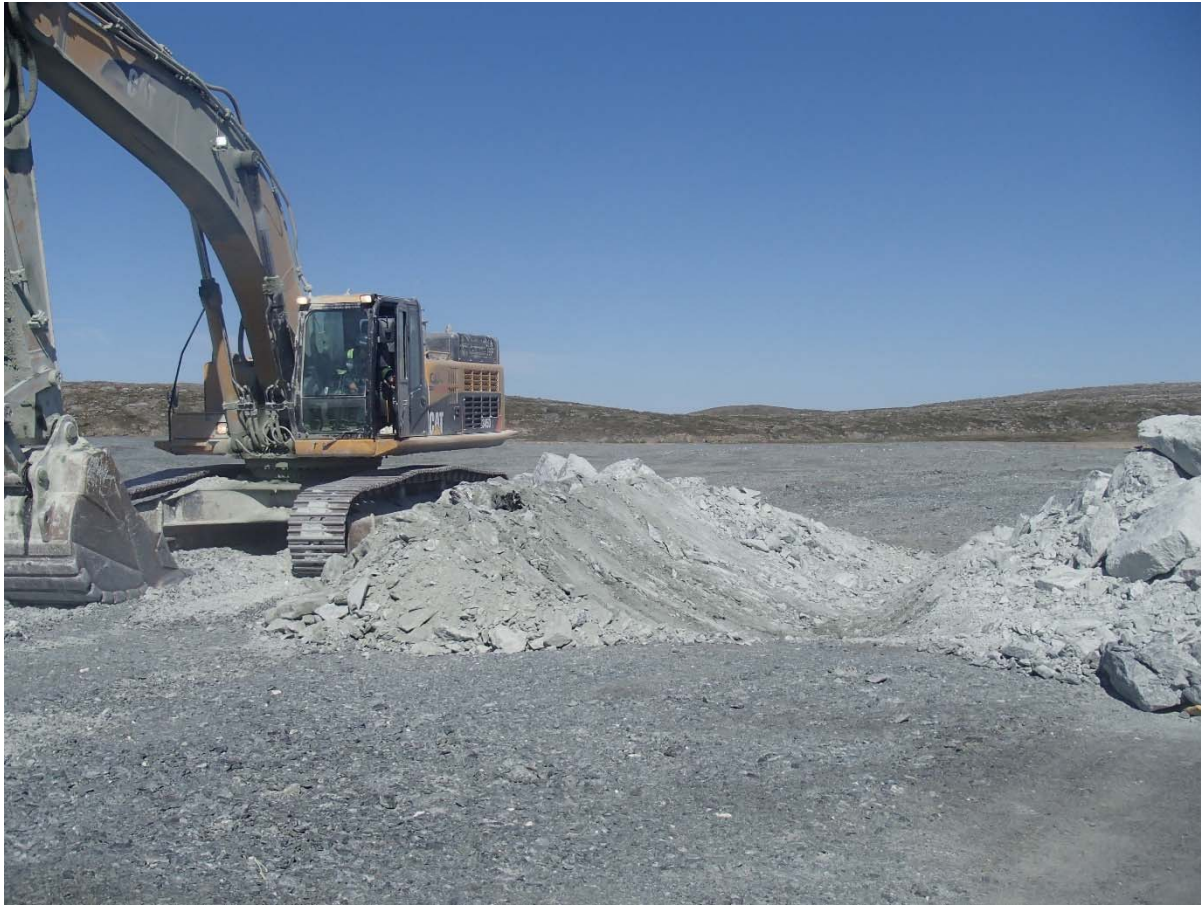
**Photograph NCIS-114: From Sta. 1+700/-34 m (approx.), looking N. Excavation of a 0.8 m (approx.) deep, 1 m wide shallow ditch in the rockfill capping with an excavator from Sta. 1+500 m to 1+650 m.**

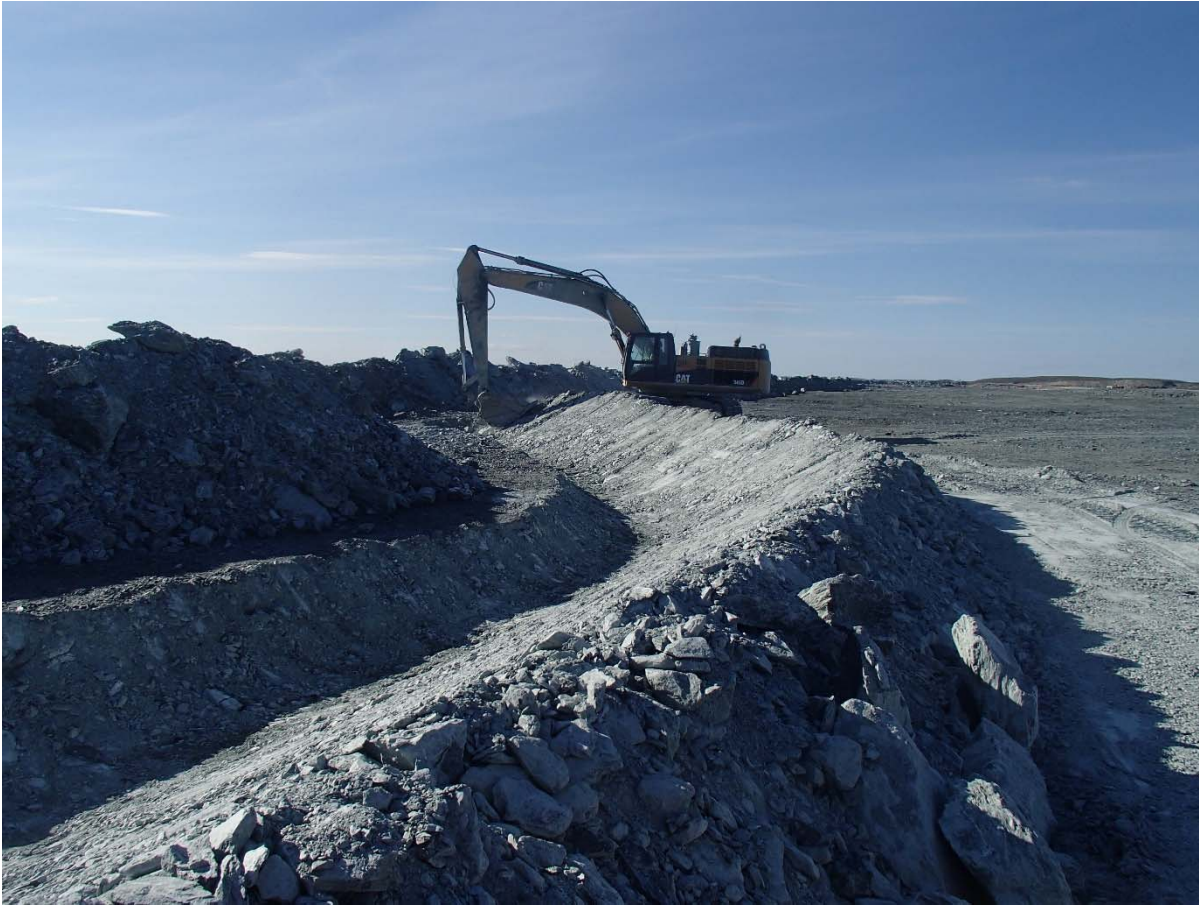
**Photograph NCIS-116: From Sta. 1+700/+37 m (approx.), looking SE. Excavation of a 0.8 m (approx.) deep, 1 m wide shallow ditch in the rockfill capping with an excavator from Sta. 1+500 m to 1+455 m.**

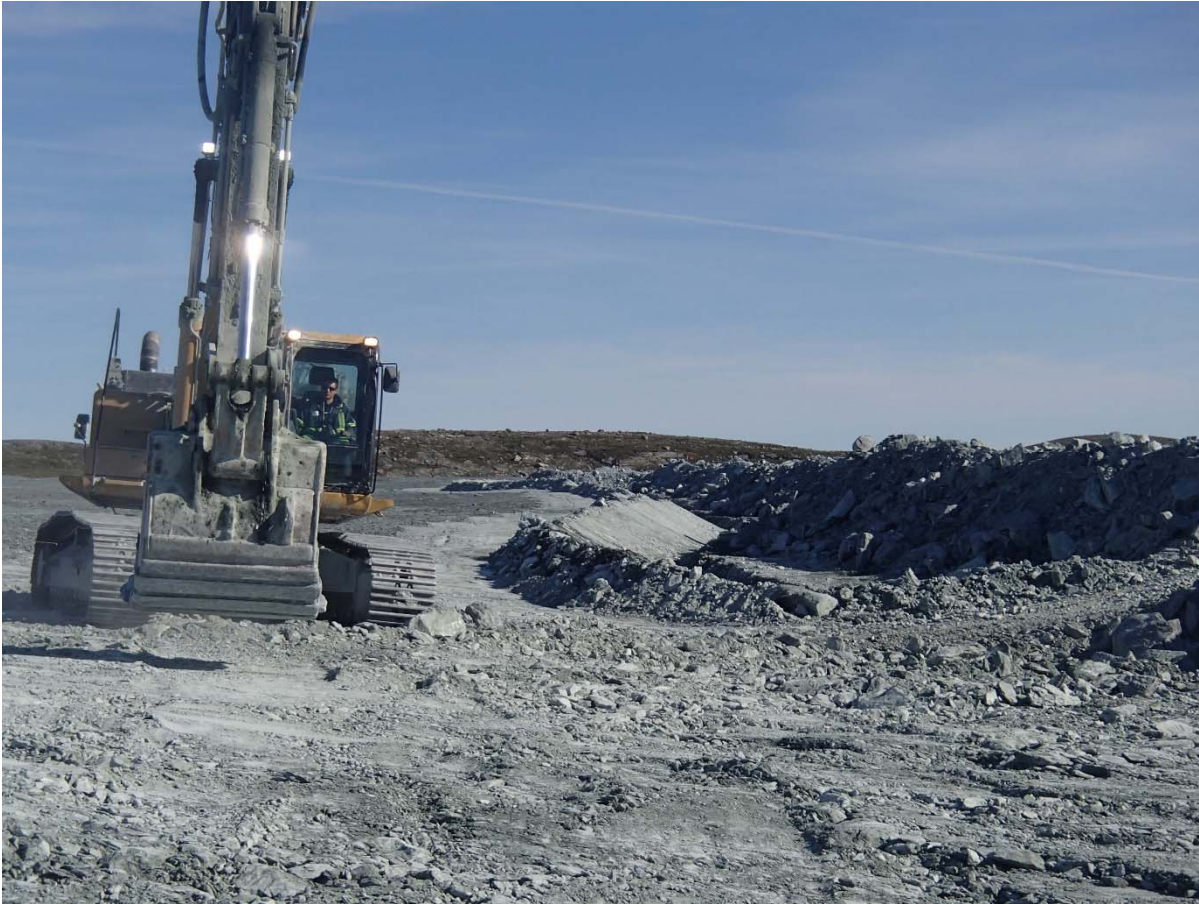
**Photograph NCIS-119: From Sta. 1+430/-22 m (approx.), looking N. Excavation of a 0.8 m (approx.) deep, 1 m wide shallow ditch in the rockfill capping with an excavator from Sta. 1+455 m to 1+400 m.**

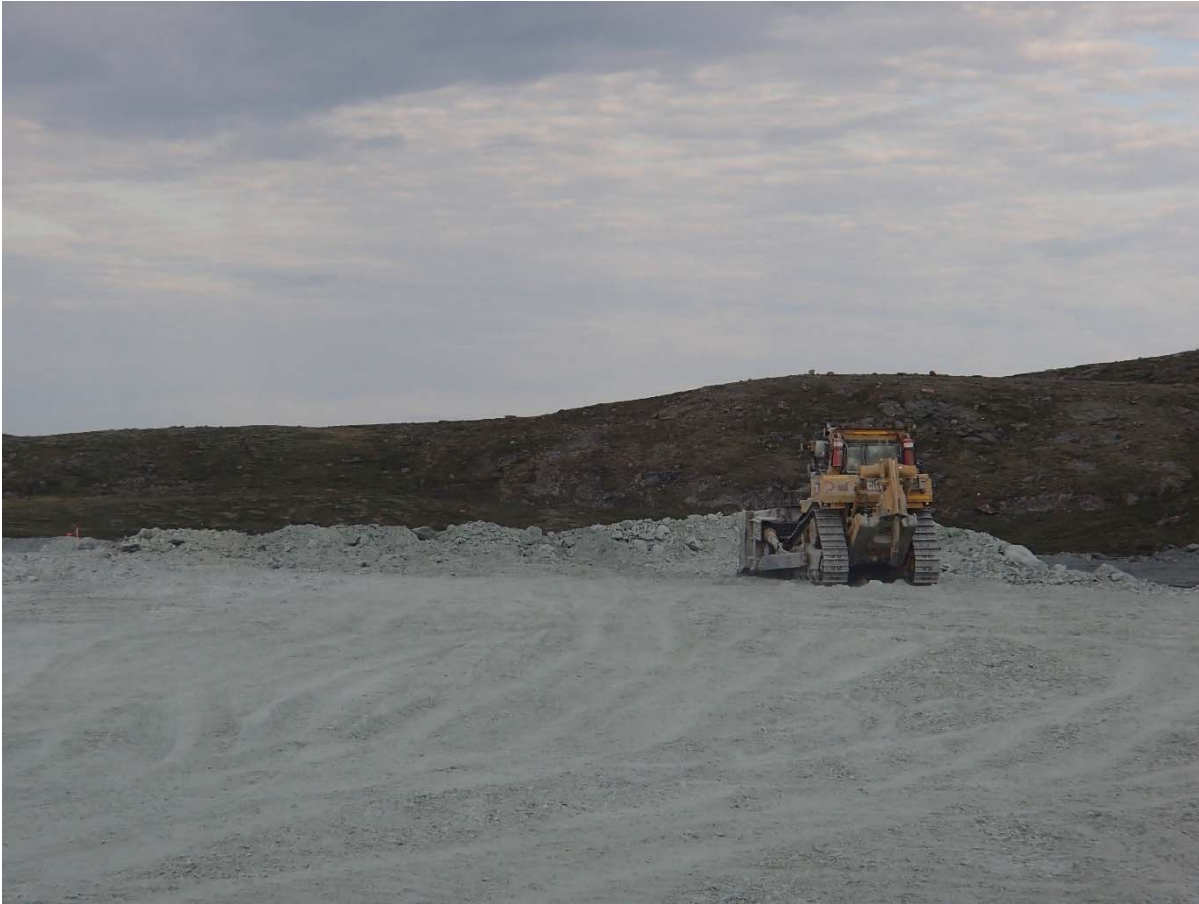
**Photograph NCIS-122: From Sta. 1+960/-6 m (approx.), looking W. Placement of a 2 m thick (approx.) lift of UM rockfill from El. 152 m to El. 154 m (approx.) with a dozer from Sta. 1+830 m to 1+860 m (+8 m to -23 m).**

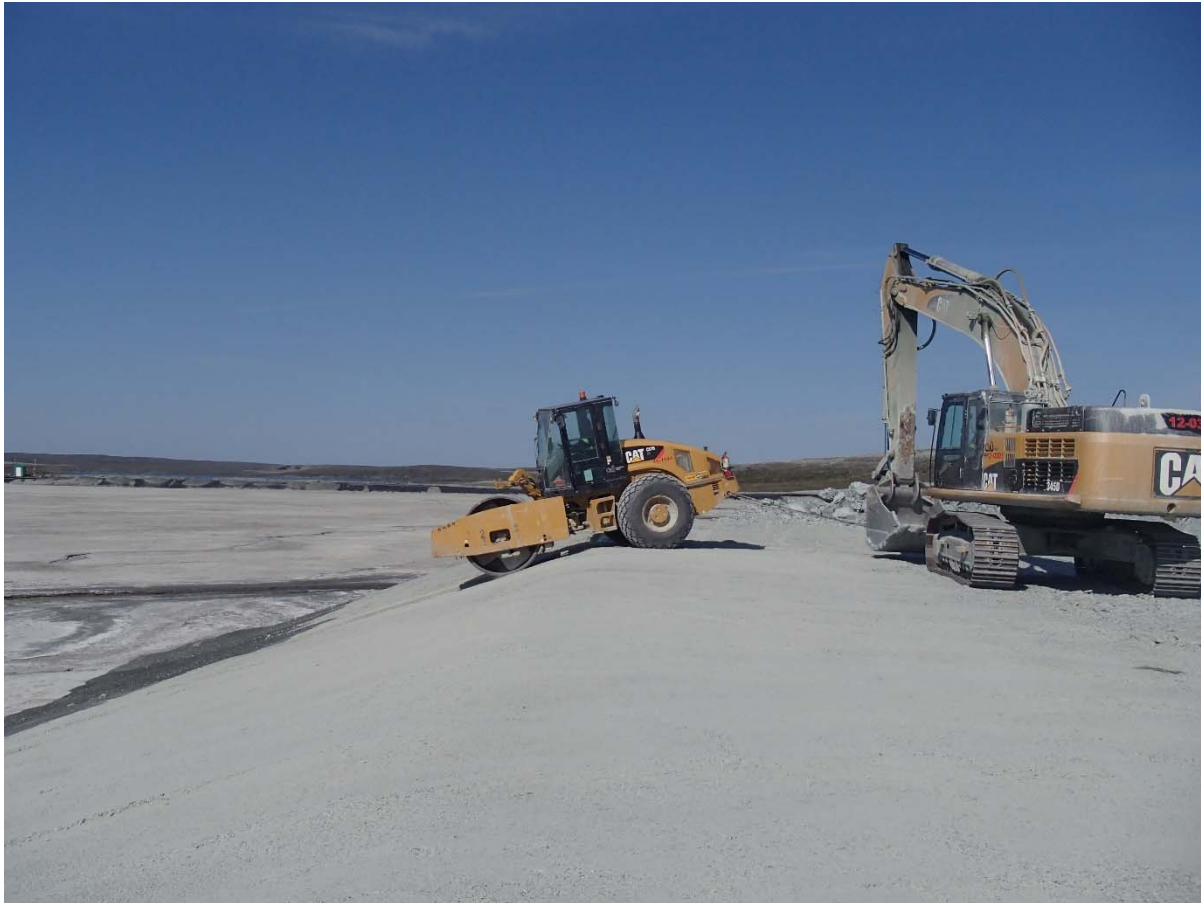
**Photograph NCIS-126: From Sta. 1+140/-98 m (approx.), looking W. Compaction of the 0.5 m lift (approx.) of fine filter between El. 150 m and 152 m with a 10-tonne smooth-drum compactor with vibration (4 passes) in the upstream slope from Sta. 1+240 m to 1+100 m.**

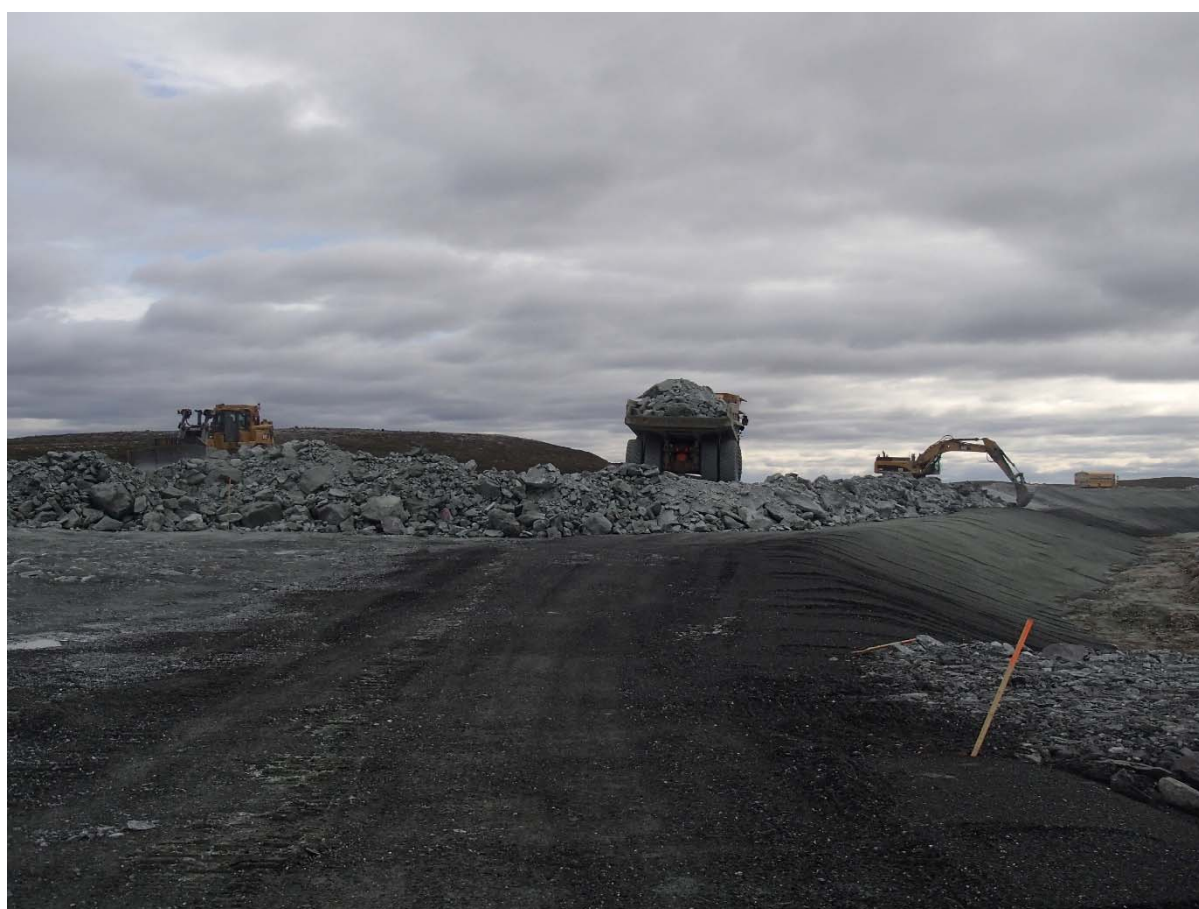
Photograph NCIS-128: From Sta. 1+680/-42 m (approx.), looking NE. Placement of a 2 m thick (approx.) lift of UM rockfill from El. 152 m to El. 154 m (approx.) with a dozer from Sta. 1+830 m to 1+660 m (+8 m to -31 m) and profiling of the upstream slope (3H:1V) from El. 152 to 154 m with an excavator from Sta. 1+880 m to 1+780 m.

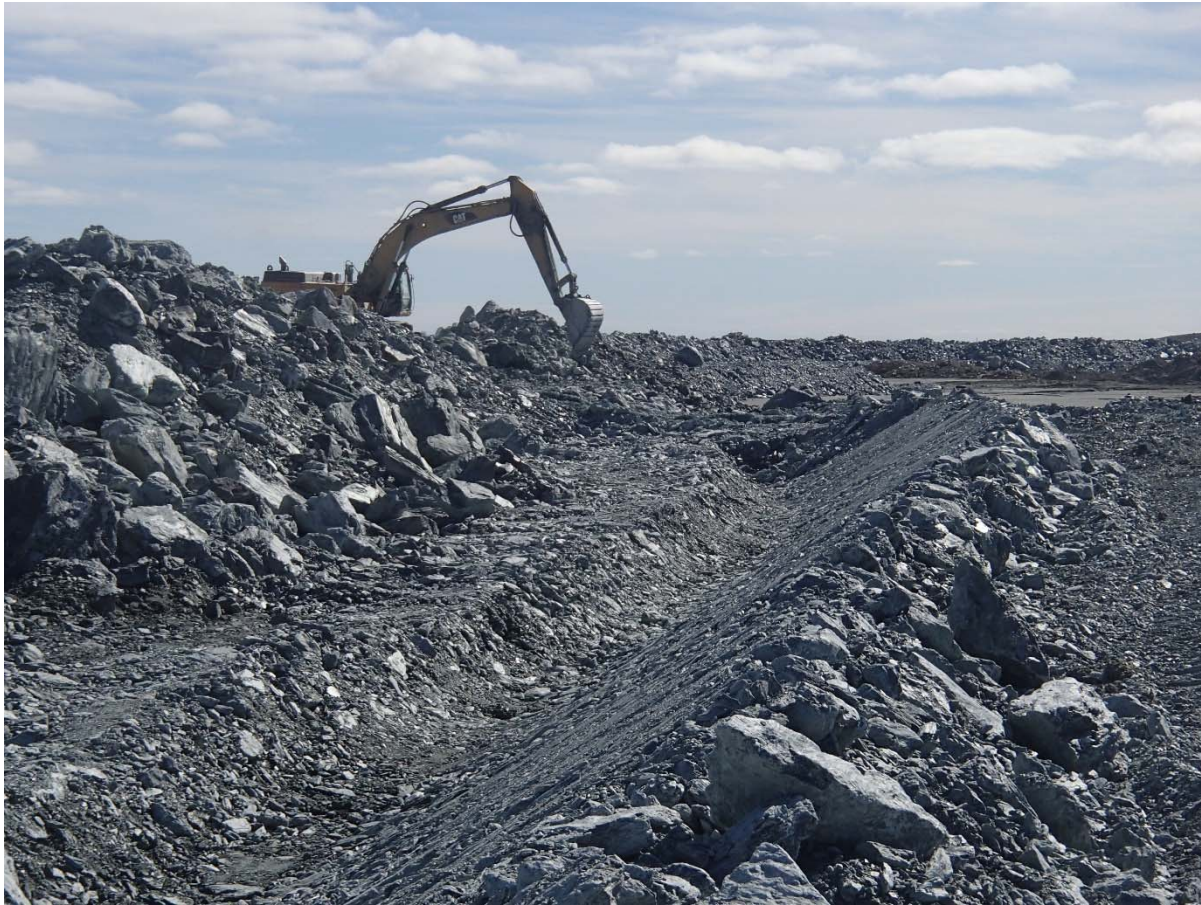
**Photograph NCIS-130: From Sta. 1+446/+16 m (approx.), looking S. Excavation of a 0.8 m (approx.) deep, 1 m wide shallow ditch in the rockfill capping with an excavator from Sta. 1+380 m to 1+300 m.**

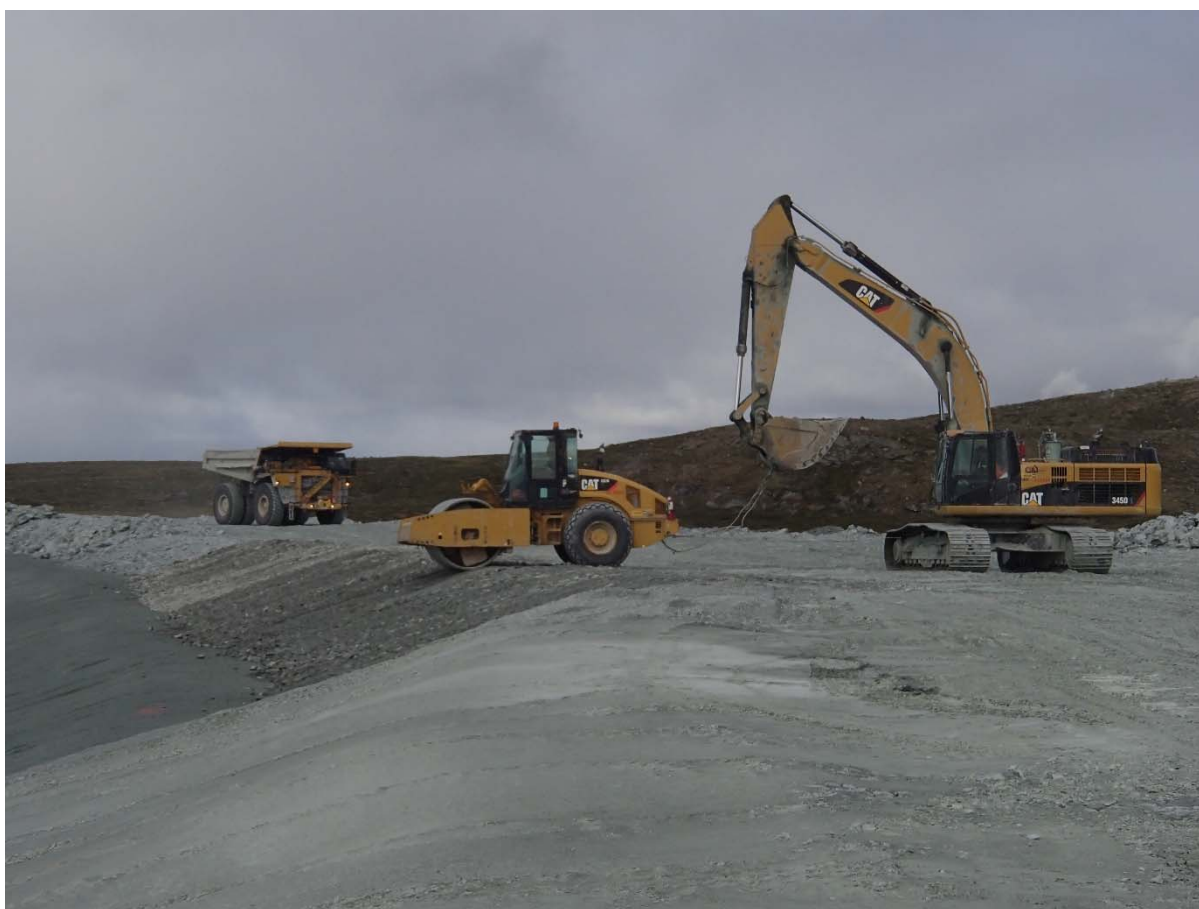
**Photograph NCIS-131: From Sta. 1+940/-20 m (approx.), looking W. Compaction of the 0.5 m lift (approx.) of coarse filter between El. 152 m and 154 m with a 10-tonne smooth-drum compactor with vibration (4 passes) in the upstream slope from Sta. 1+890 m to 1+826 m.**

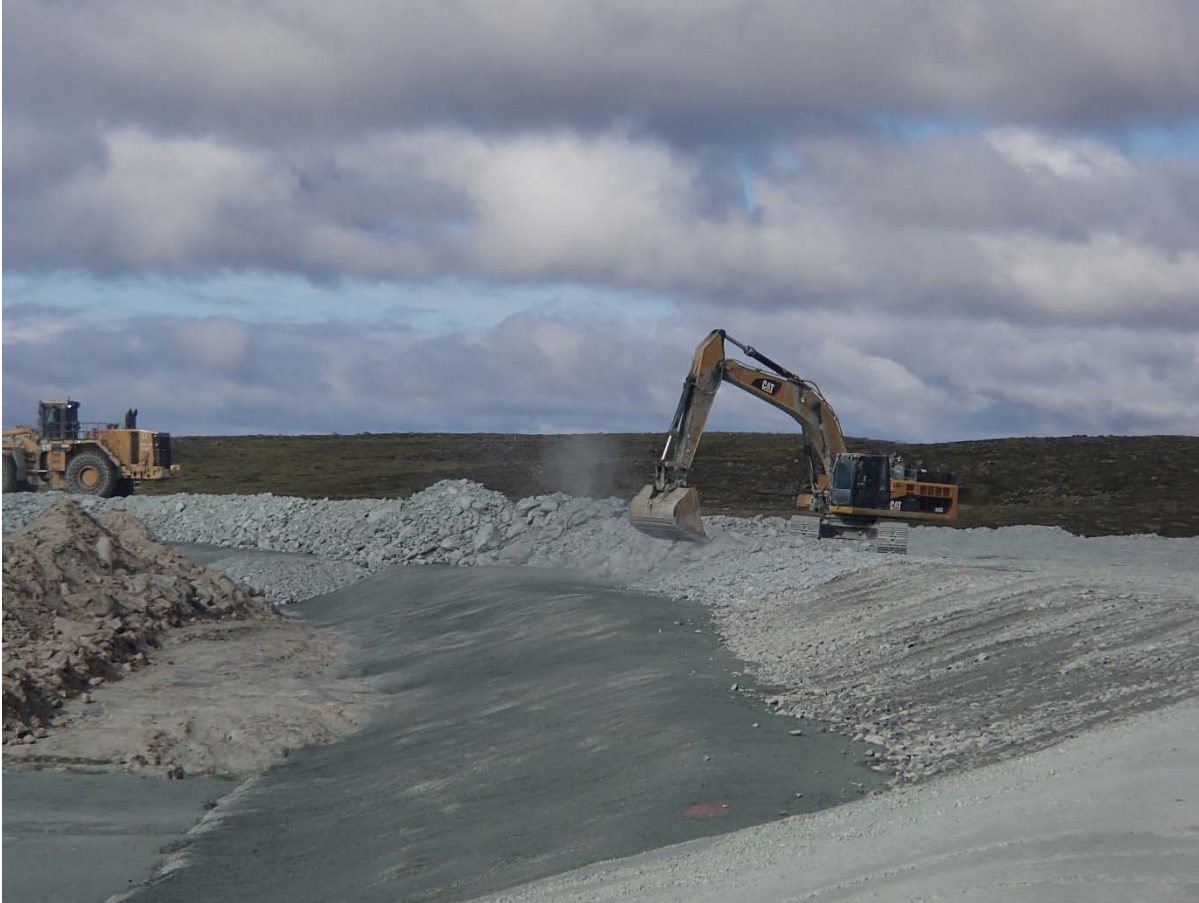
**Photograph NCIS-132: From Sta. 1+940/-20 m (approx.), looking W. Profiling of the upstream slope (3H:1V) from El. 152 to 154 m with an excavator from Sta. 1+780 m to 1+660 m.**

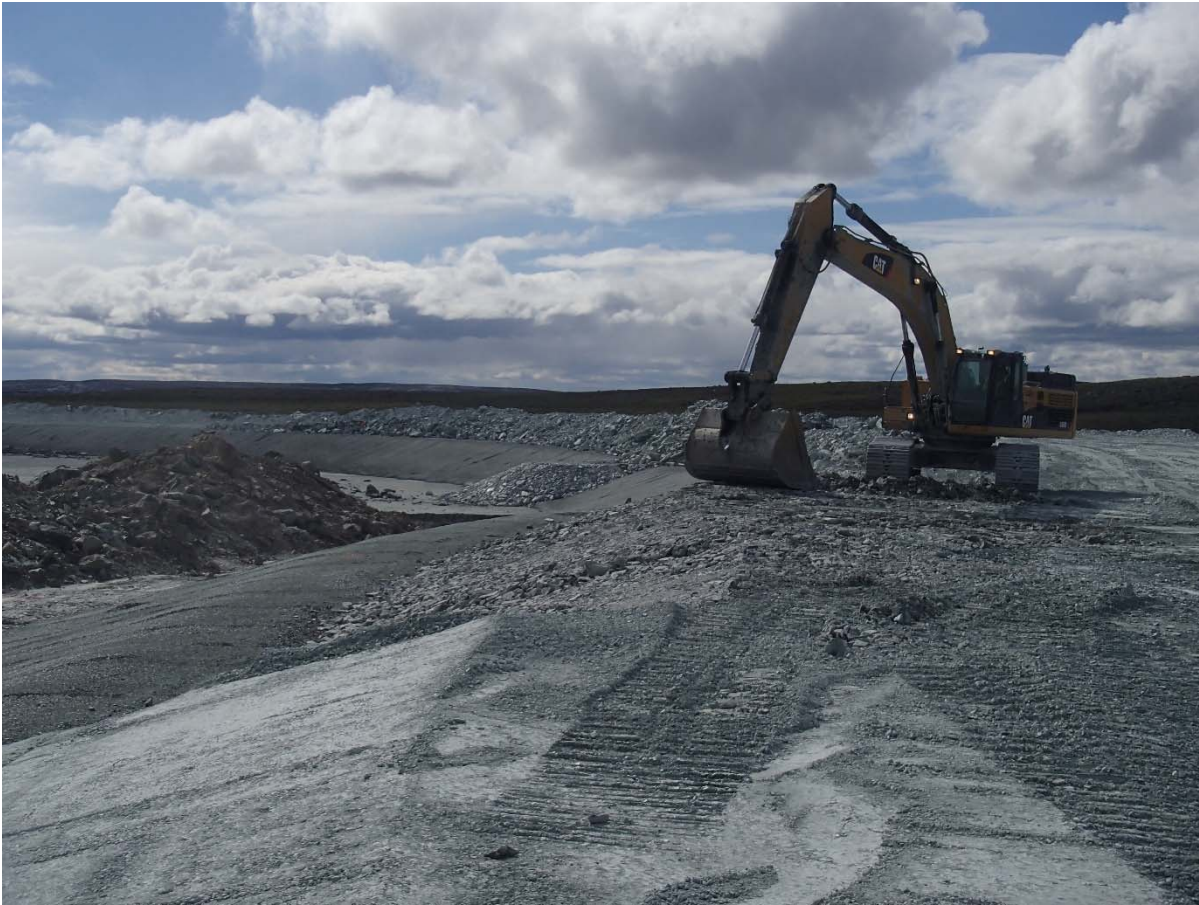
**Photograph NCIS-133: From Sta. 1+820/-28 m (approx.), looking W. Placement of a 0.5 m thick lift of coarse filter in the upstream slope from El. 152 m to 154 m with an excavator from Sta. 1+890 m to 1+826 m.**

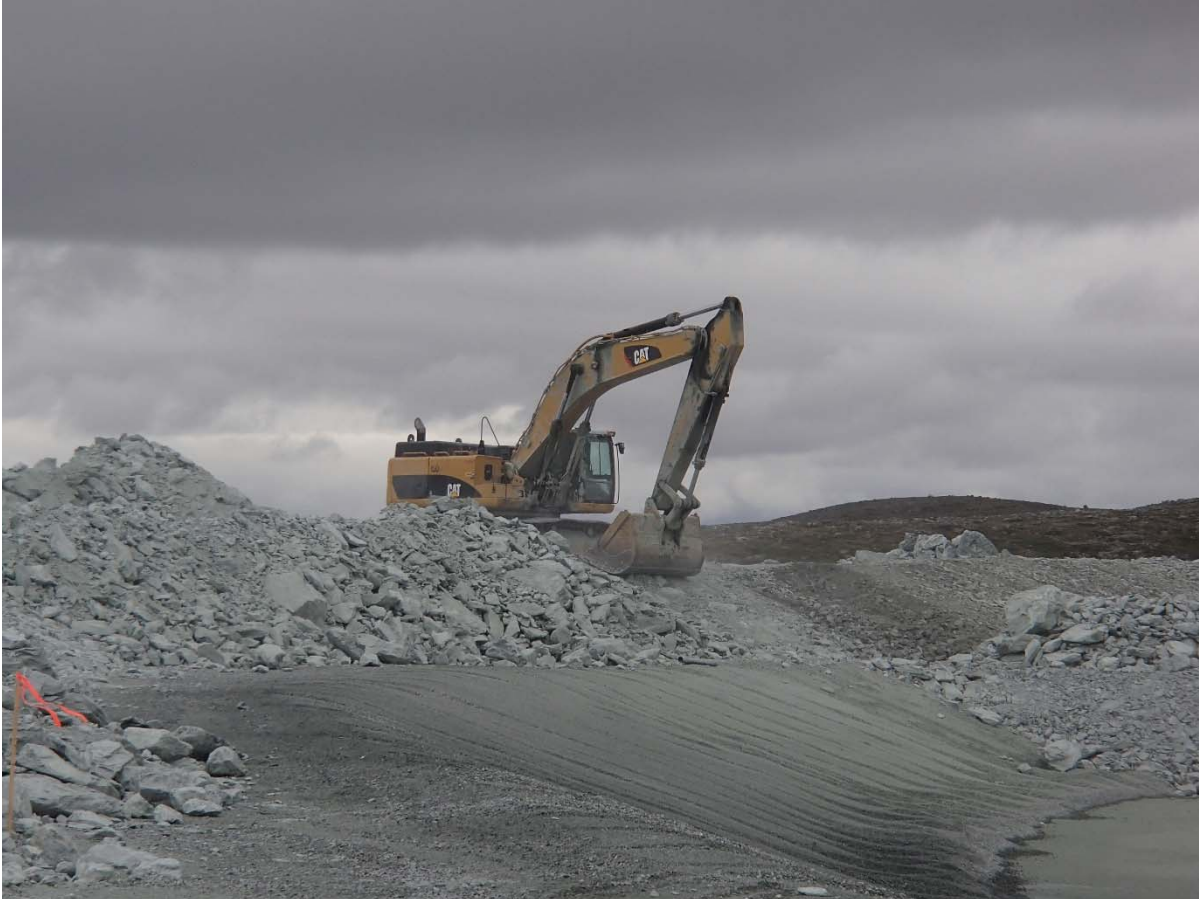
**Photograph NCIS-134: From Sta. 1+630/-32 m (approx.), looking NE. Completion of the profiling of the upstream slope (3H:1V) from El. 152 to 154 m with an excavator from Sta. 1+700 m to 1+660 m.**

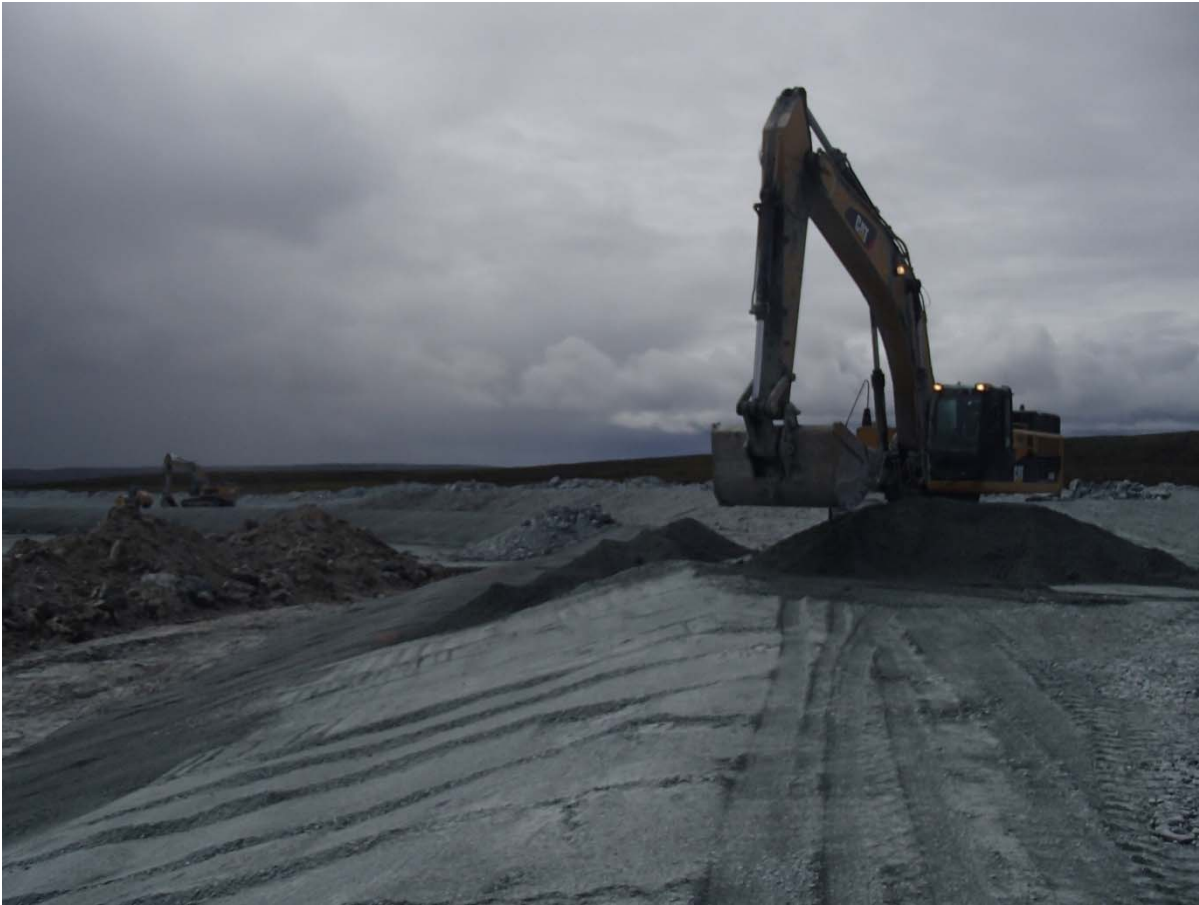
**Photograph NCIS-135: From Sta. 1+860/-12 m (approx.), looking SW. Placement of a 0.5 m thick lift of fine filter in the upstream slope from El. 152 m to 154 m with an excavator from Sta. 1+830 m to 1+700 m.**

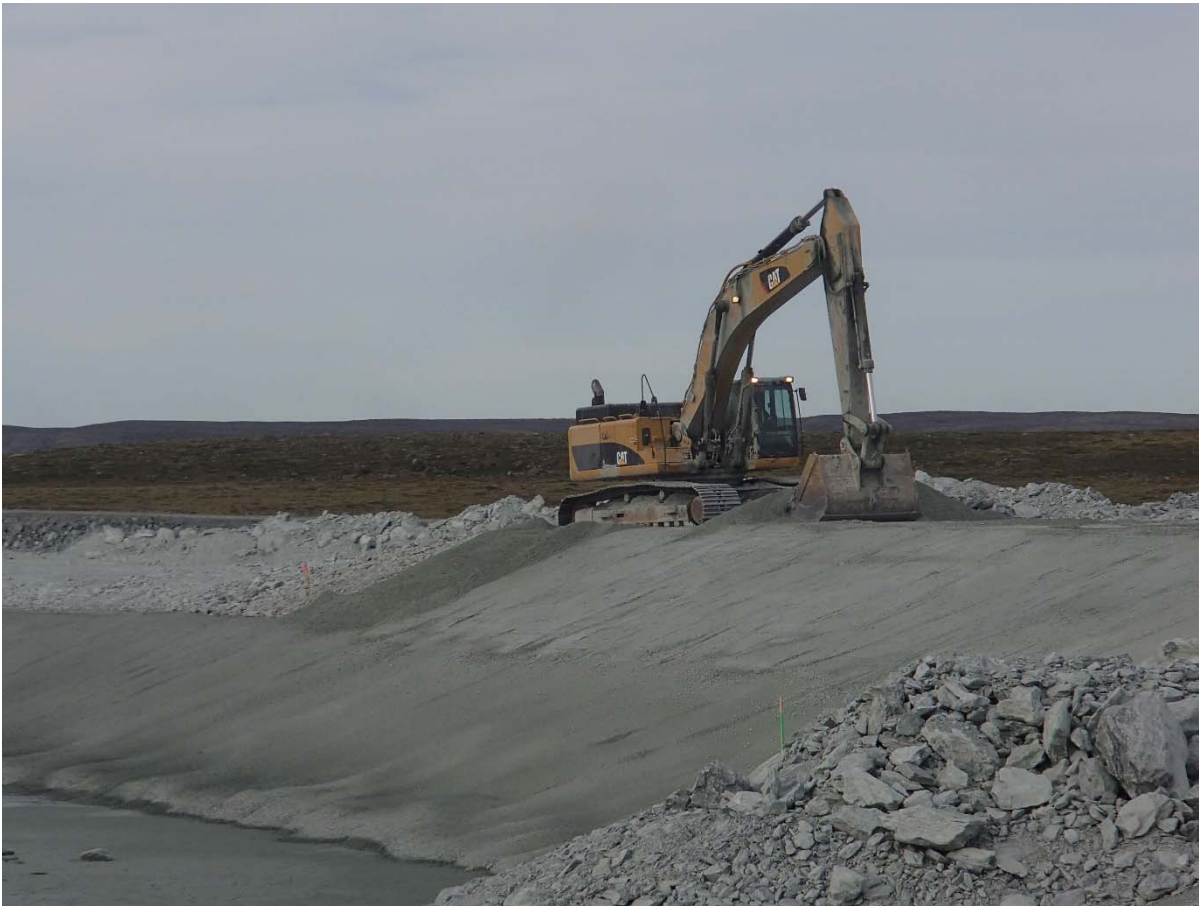
**Photograph NCIS-136: From Sta. 1+800/-33 m (approx.), looking SW. Placement of a 0.5 m thick lift of fine filter in the upstream slope from El. 152 m to 154 m with an excavator from Sta. 1+700 m to 1+660 m.**

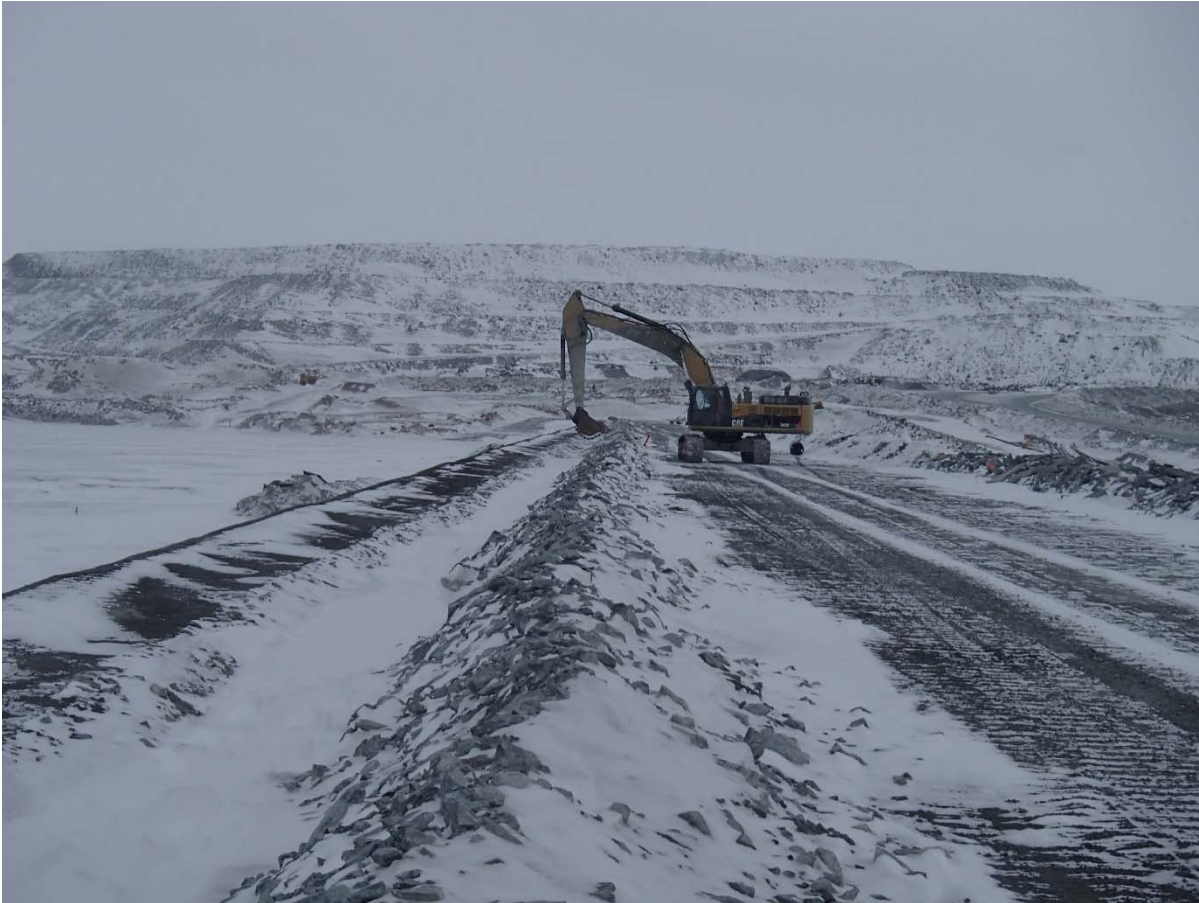
**Photograph CD-1857: From Sta. 0+700/-20 m, looking N. Snow removal in the anchoring trench with an excavator between Sta. 0+170 m and 40+780 m.**

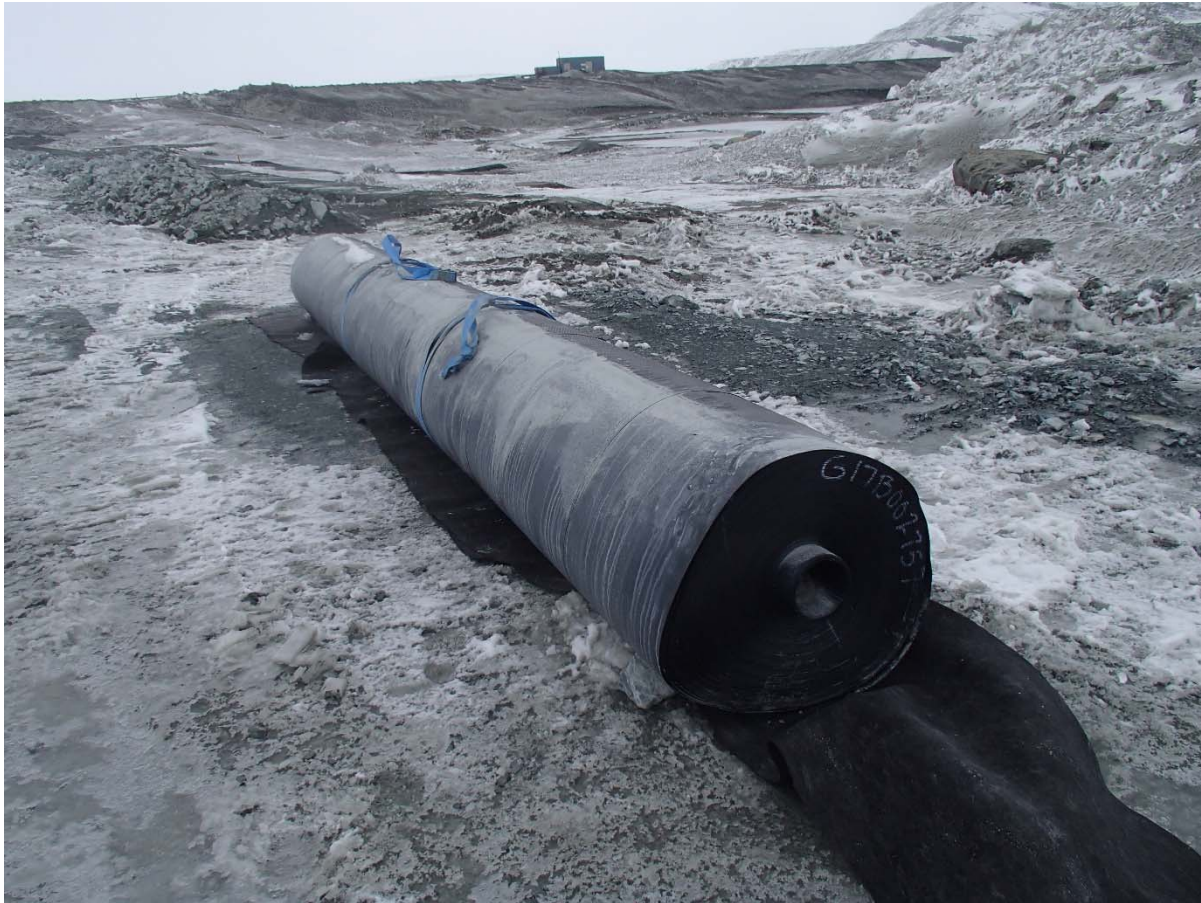
Photograph SD3-303: From Sta. 20+780/-15 m, looking N. View of a LLDPE liner roll stored on geotextile.

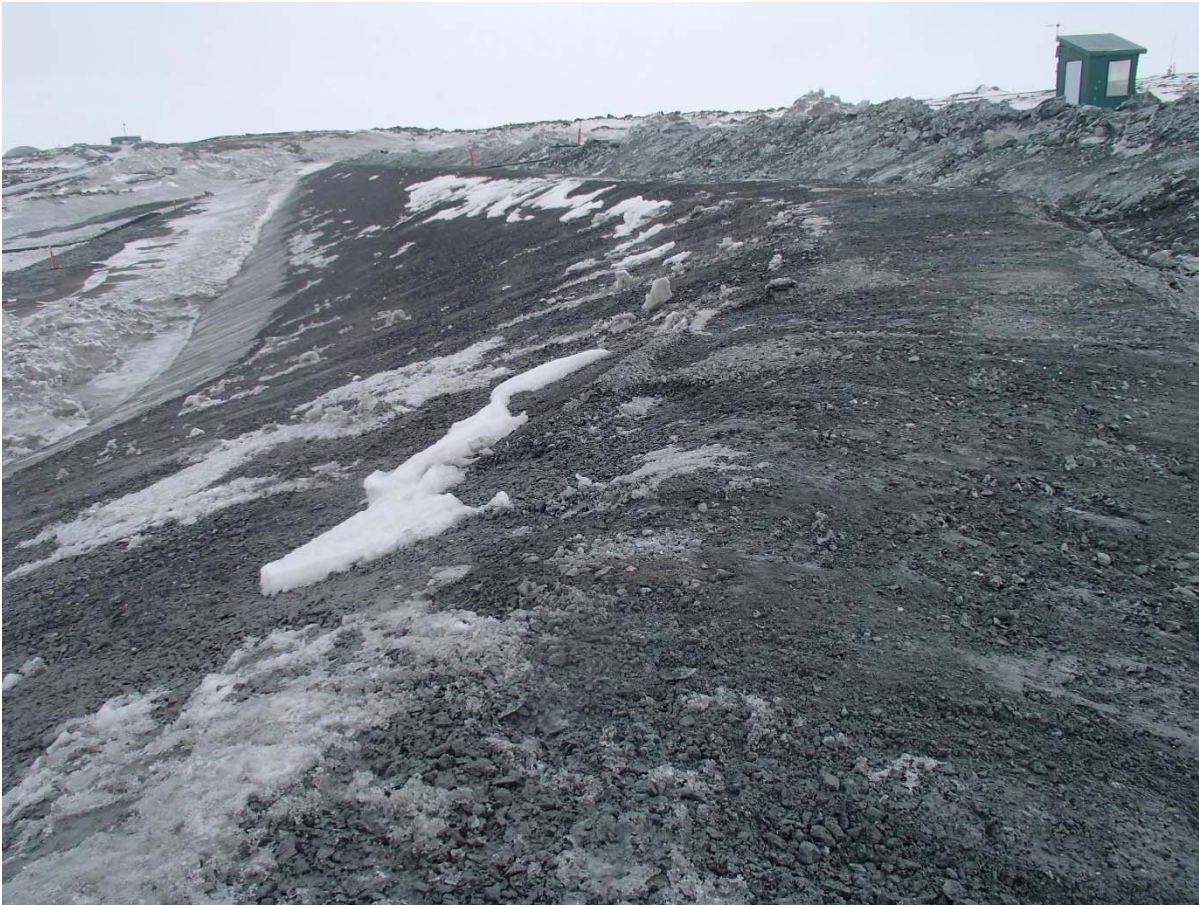
**Photograph SD3-304: From Sta. 20+620/-36 m, looking SE. Smoothing of the surface of the fine filter with an excavator on top of the upstream slope from Sta. 20+600 m to 20+780 m.**

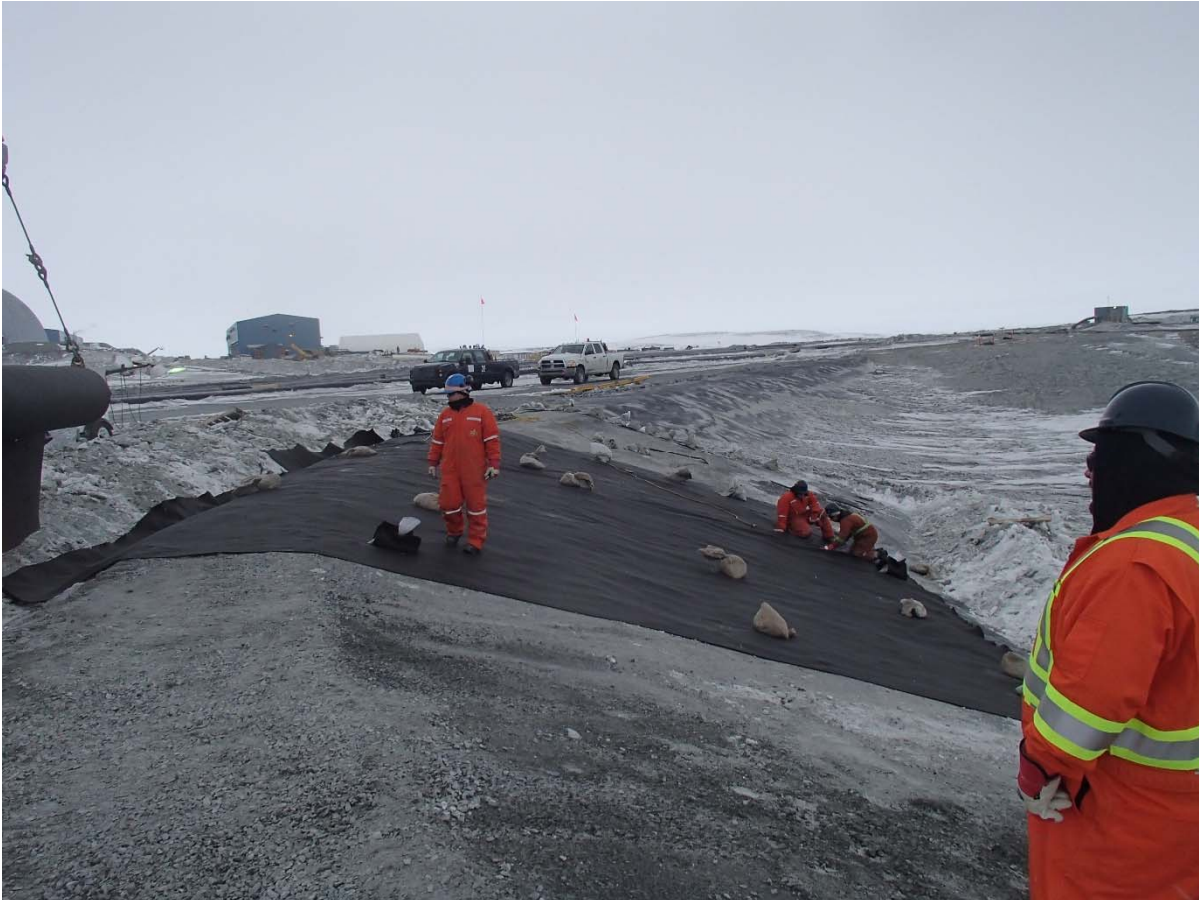
**Photograph CD-1859: From Sta. 40+780/-38 m, looking SW. Installation of the geotextile on the upstream slope 3H:1V (SD5 side) to 2H:1V (Central Dike side) between El. 143 m and 145 m from Sta. 40+640 m to 0+830 m.**

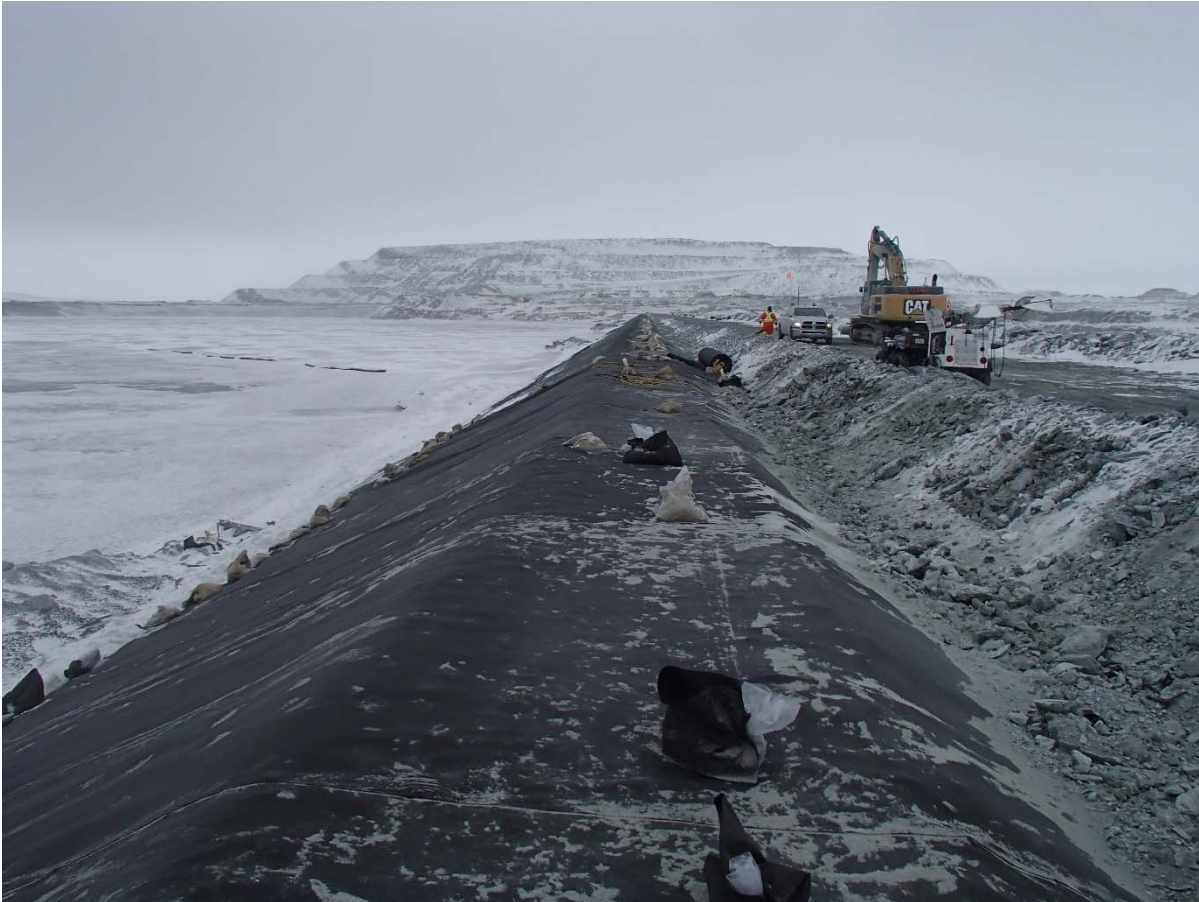
**Photograph CD-1860: From Sta. 0+790/-26 m, looking N. Installation of the geotextile on the upstream slope 2H:1V between El. 143 m and 145 m from Sta. 0+830 m to 0+750 m.**

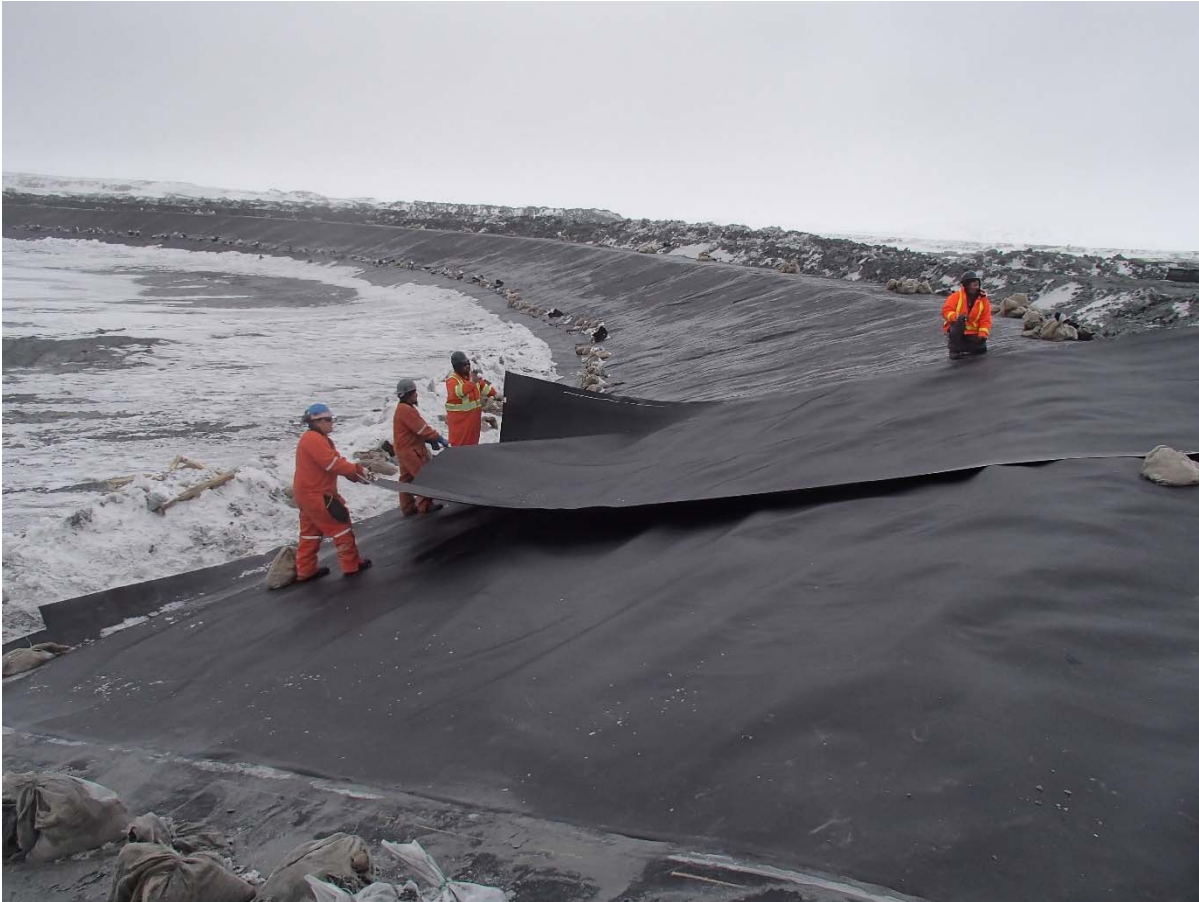
**Photograph CD-1861: From Sta. 40+680/-28 m, looking NE. Installation of the LLDPE liner on the upstream slope 3H:1V (SD5 side) to 2H:1V (Central Dike side) between El. 143 m and 145 m from Sta. 40+680 m to 0+950 m (panel numbers 802 to 817).**
