### **Meadowbank 2018 TSF As-built report**

**2018 CONSTRUCTION SEASON AS-BUILT REPORT  
TAILINGS STORAGE FACILITY  
MEADOWBANK GOLD PROJECT, NUNAVUT**

1897439-1578-R-Rev0

November 2018

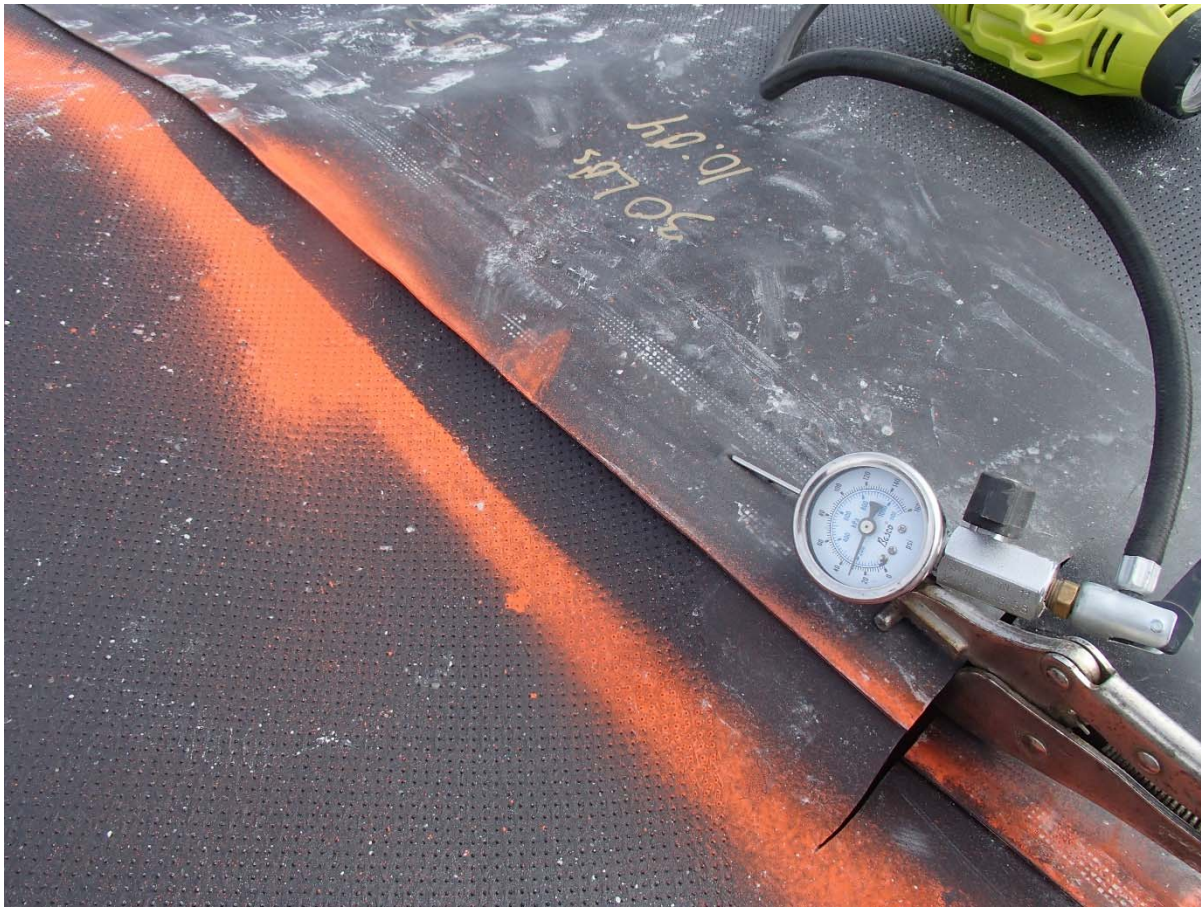
Photograph CD-1862: From Sta. 40+960/-24 m. View of an air channel test.

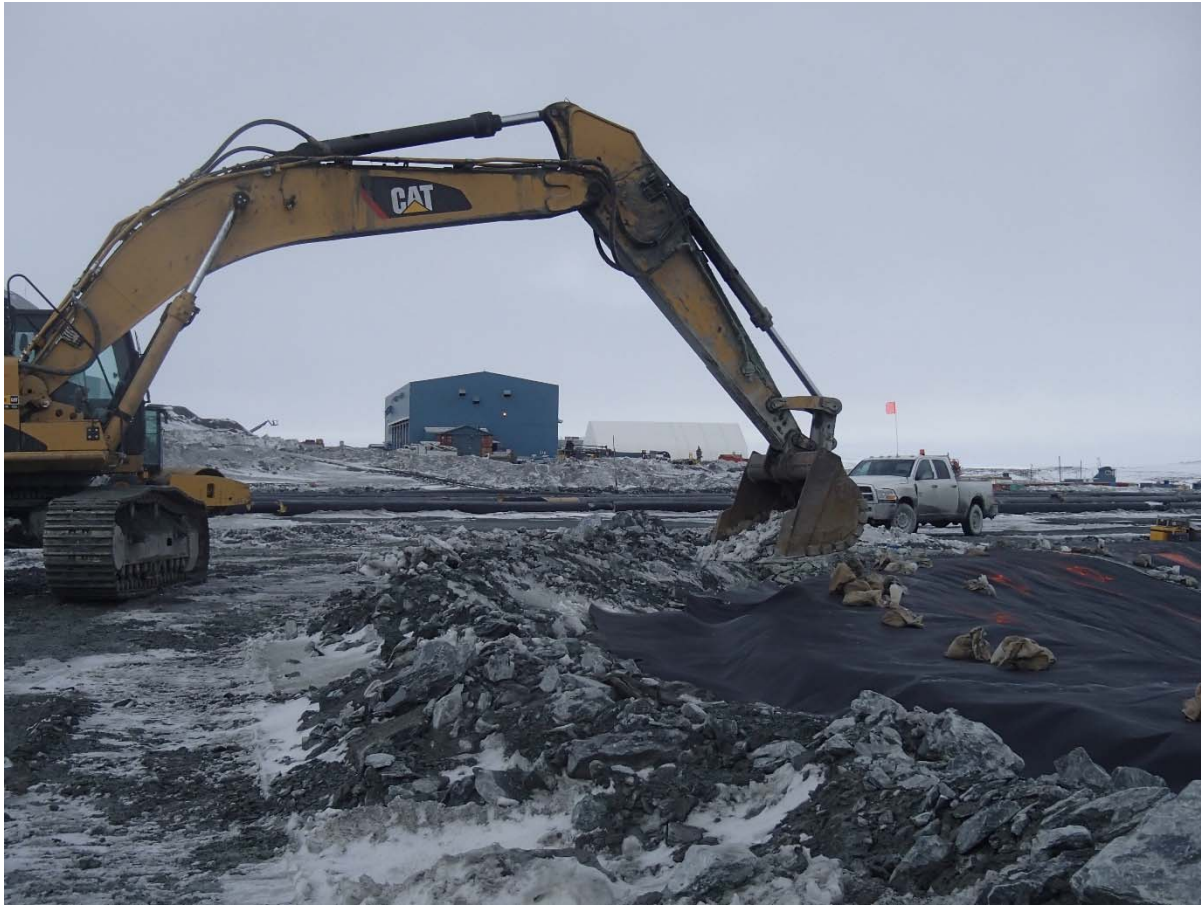
**Photograph CD-1863: From Sta. 40+750/-18 m, looking SW. Backfilling of the geosynthetics tie-in from Sta. 40+680 m to 0+950 m.**

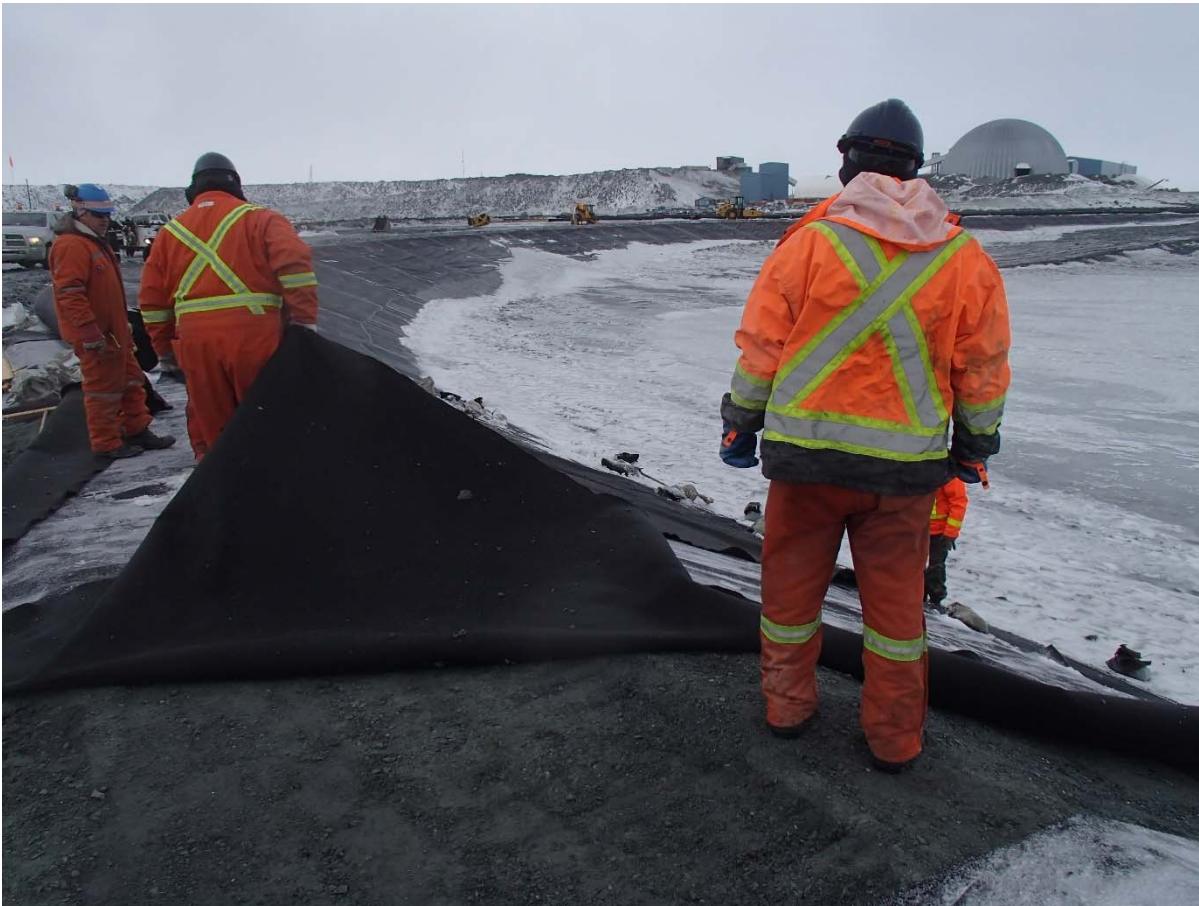
- The uncovered geotextile in place is wet and frozen. In order to avoid welding issues, geotextile panels from Sta. 0+935 m to 0+900 m were removed and replaced with new geotextile before LLDPE liner installation.
- Starting today, the geotextile panels are welded together with the dual hot wedge instrument. The overlap is about 150 mm. This type of welding yields a more regular and stronger bond than the heat gun.
- Due to strong winds, geosynthetics installation was interrupted at 12:00.

Photograph CD-1868: From Sta. 0+915/-24 m, looking S. Removal of the wet geotextile in place from Sta. 0+935 m to 0+900 m.

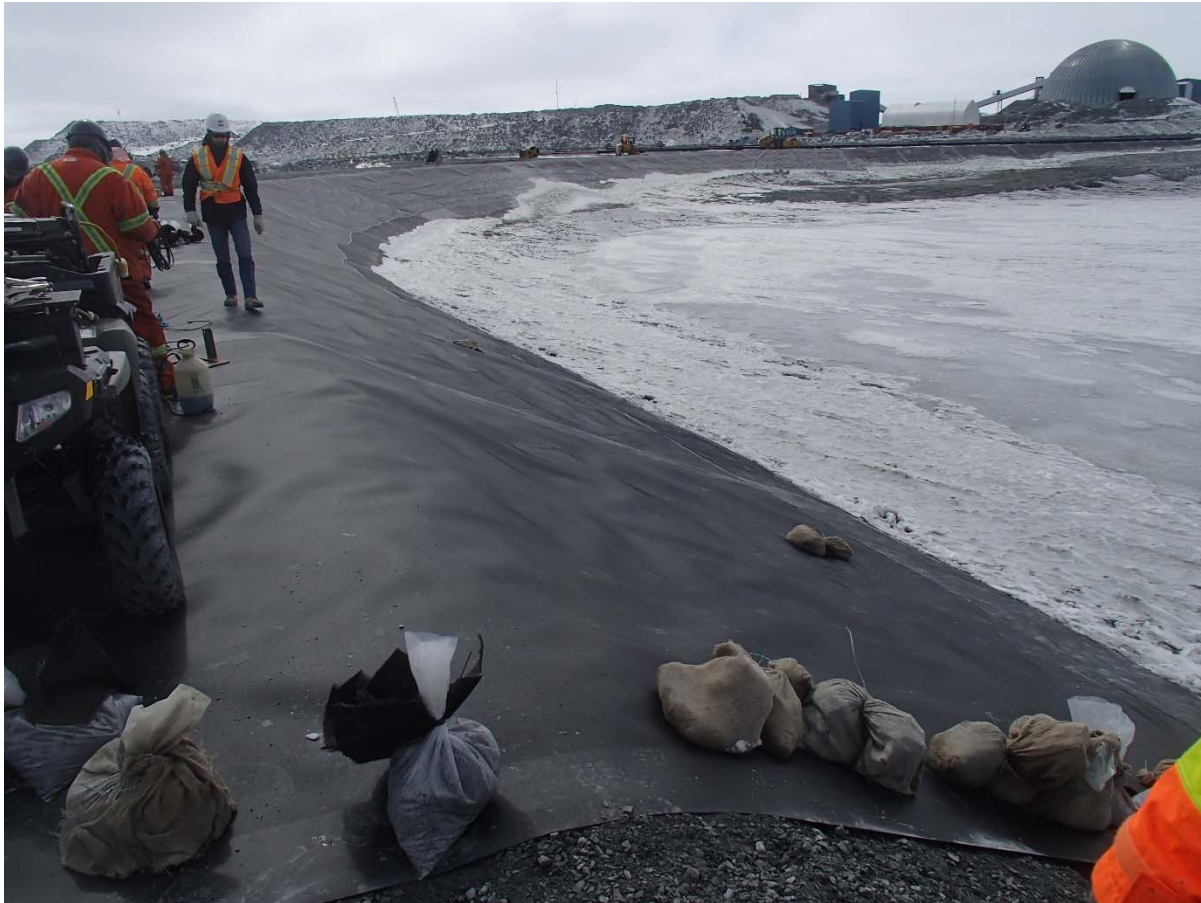
**Photograph CD-1870: From Sta. 0+900/-26 m, looking S. Installation of the LLDPE liner on the upstream slope 2H:1V between El. 143 m and 145 m from Sta. 0+935 m to 0+900 m (panel numbers 820 to 823).**

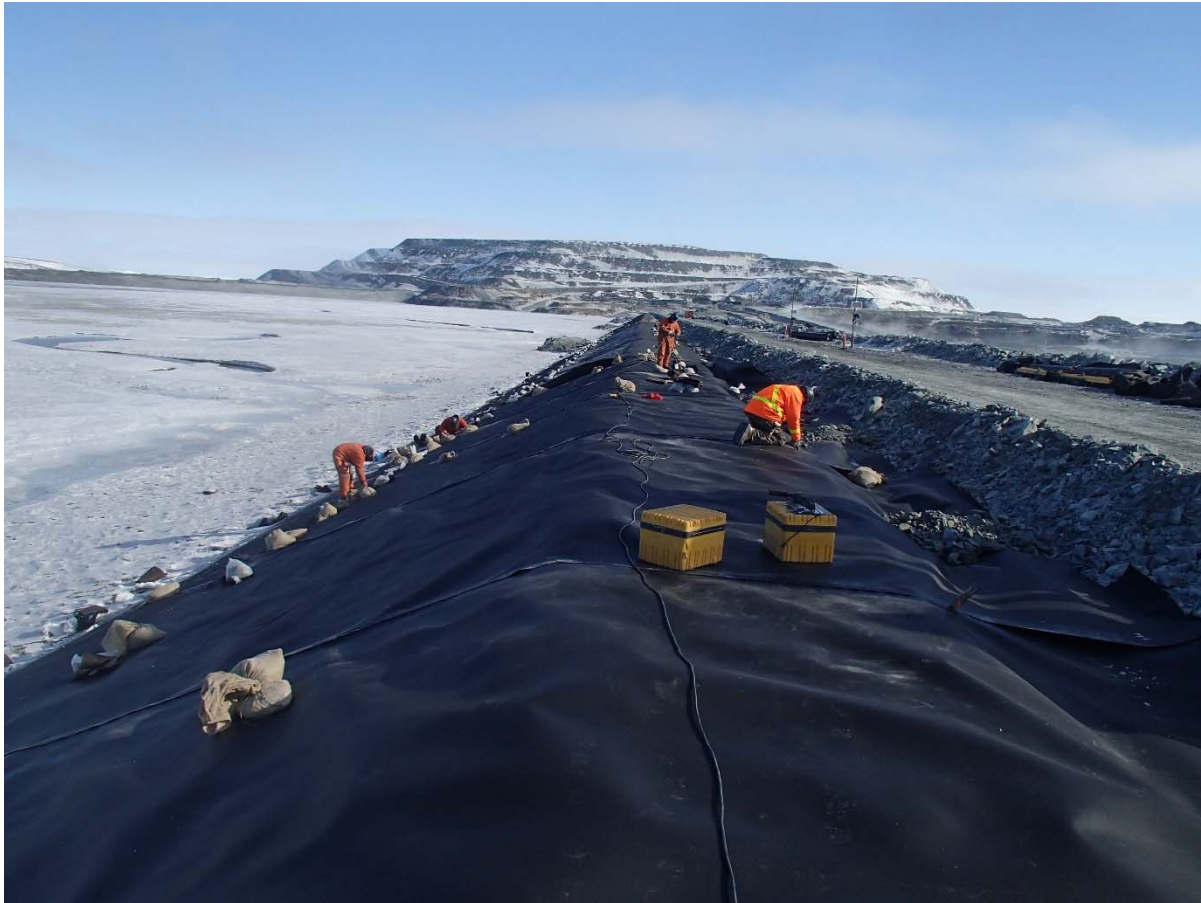
**Photograph CD-1872: From Sta. 0+900/-24 m, looking N. Installation of the LLDPE liner on the upstream slope 2H:1V between El. 143 m and 145 m from Sta. 0+900 m to 0+760 m (panel numbers 824 to 844).**

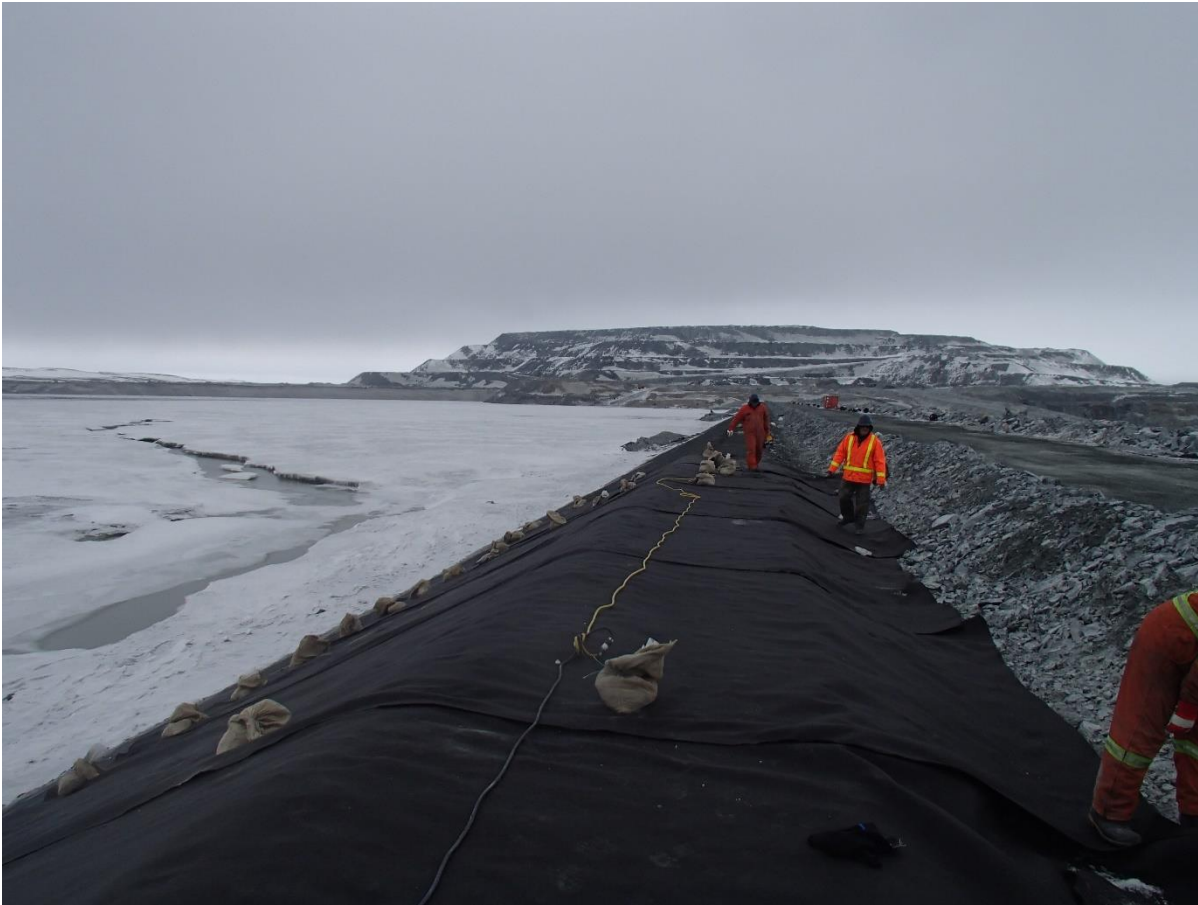
Photograph CD-1873: From Sta. 0+760/-26 m, looking N. Installation of the geotextile on the upstream slope 2H:1V between El. 143 m and 145 m from Sta. 0+760 m to 0+740 m.

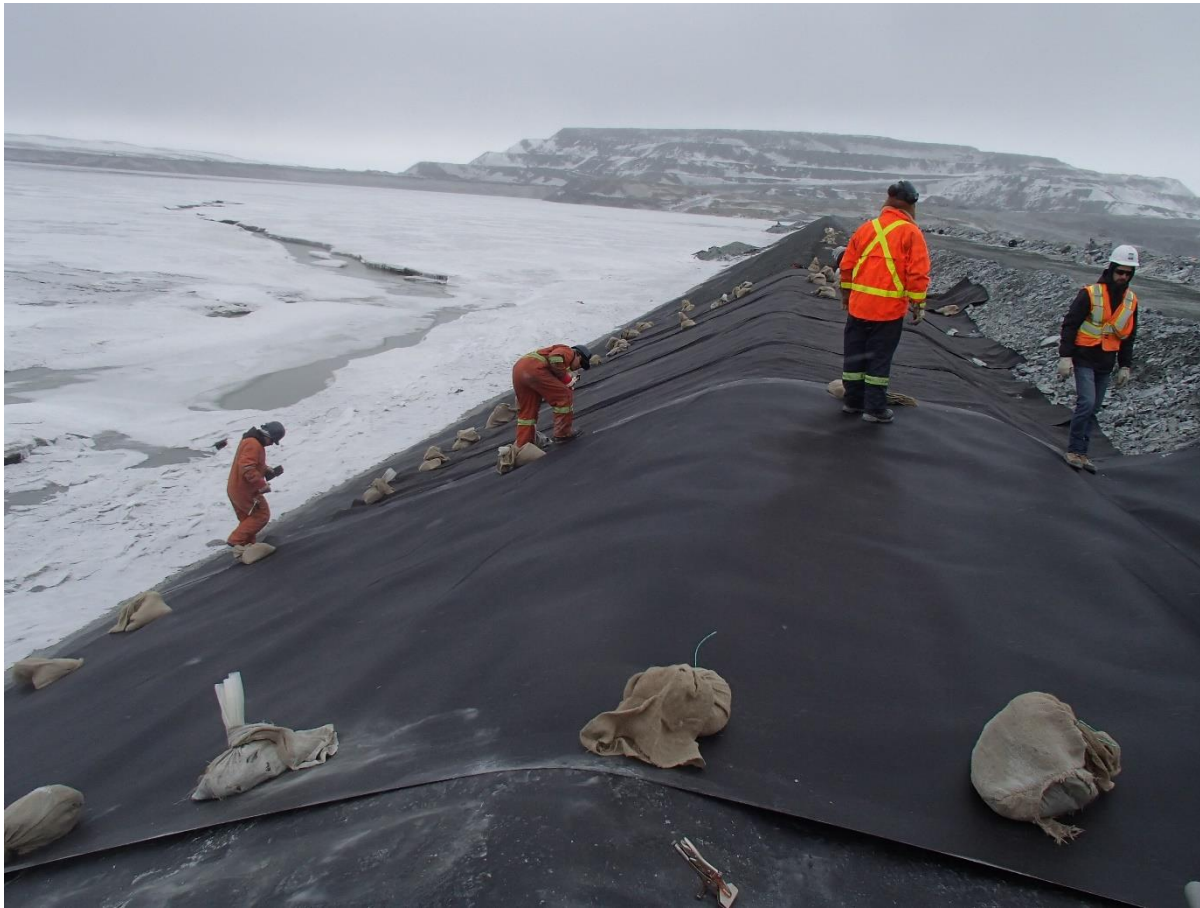
**Photograph CD-1874: From Sta. 0+760/-26 m, looking N. Installation of the geotextile on the upstream slope 2H:1V between El. 143 m and 145 m from Sta. 0+760 m to 0+740 m.**

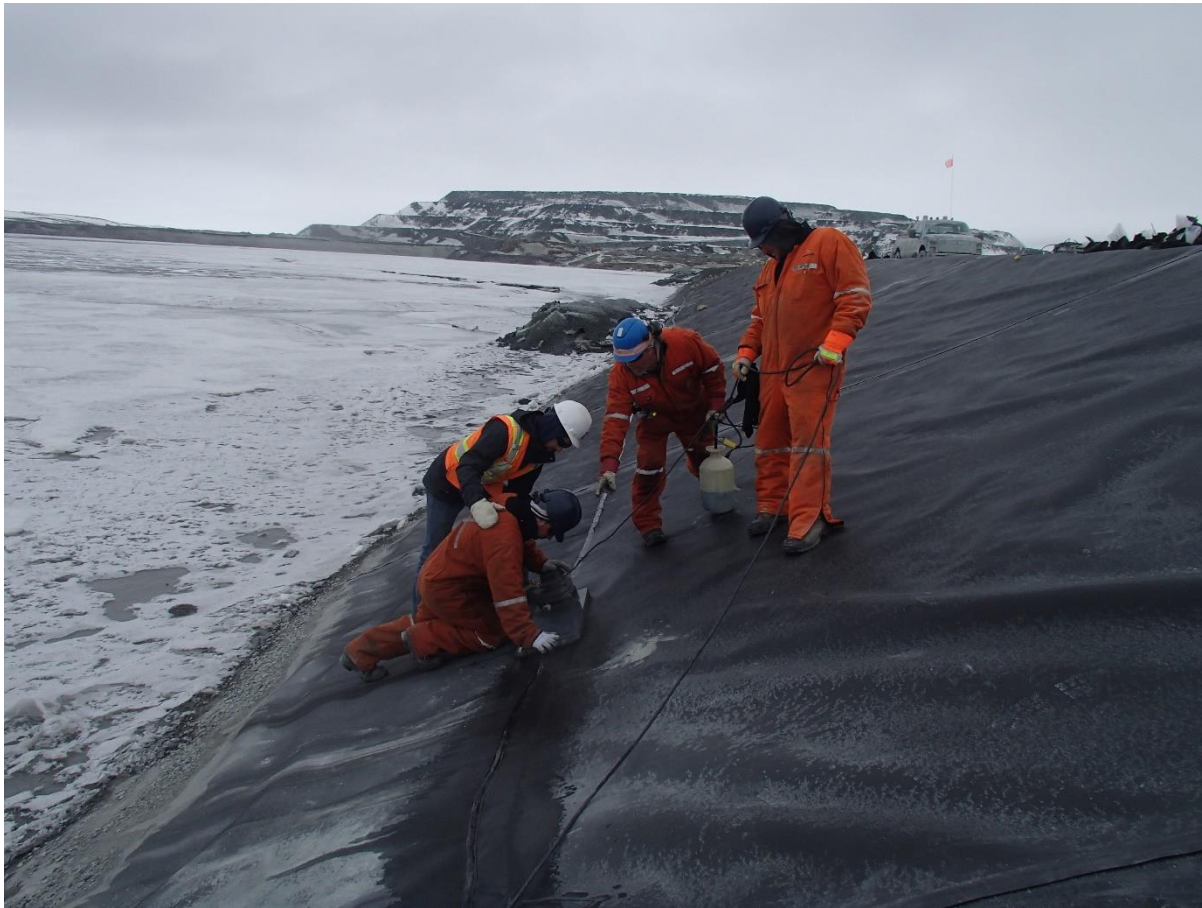
Photograph CD-1875: From Sta. 0+835/-26 m, looking N. View of a vacuum box testing.

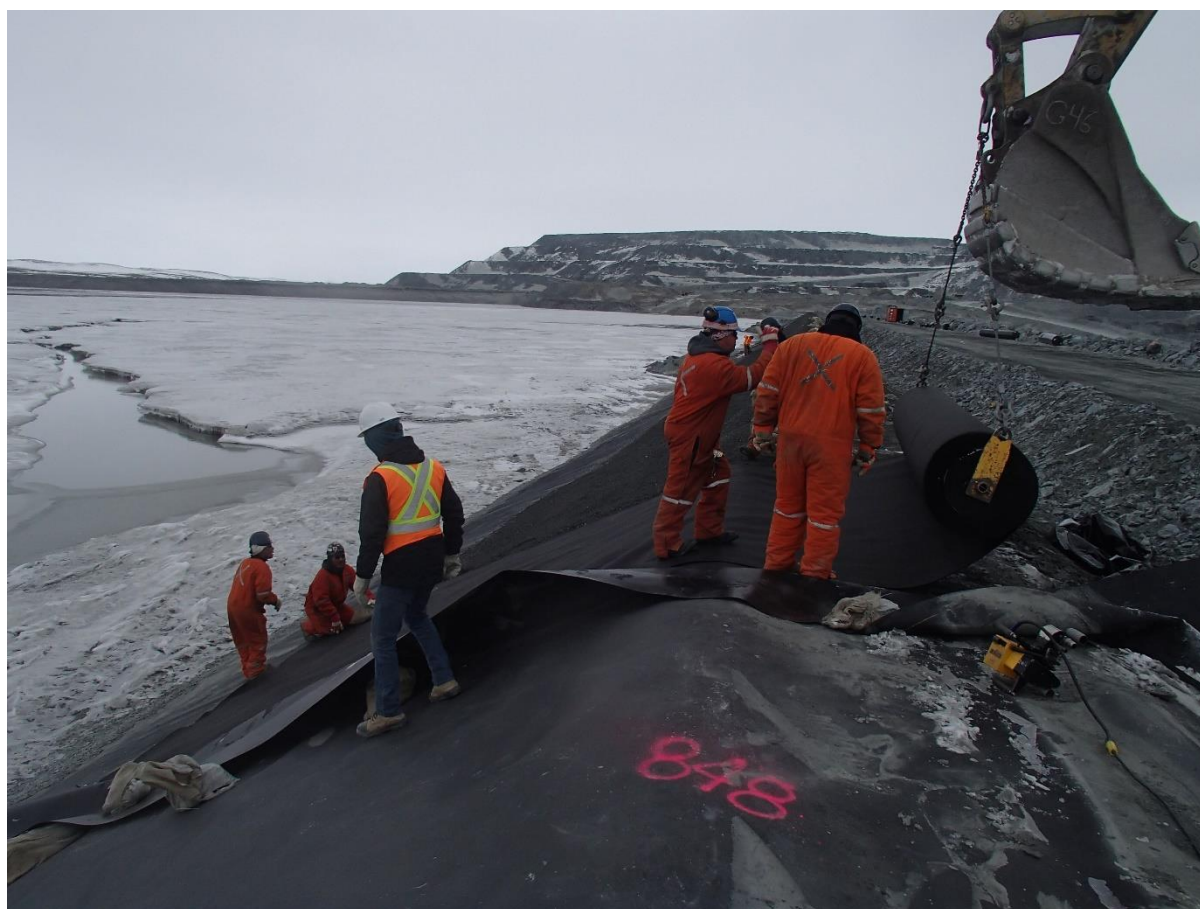
Photograph CD-1877: From Sta. 0+745/-26 m, looking N. Installation of the geotextile on the upstream slope 2H:1V between El. 143 m and 145 m from Sta. 0+740 m to 0+610 m.

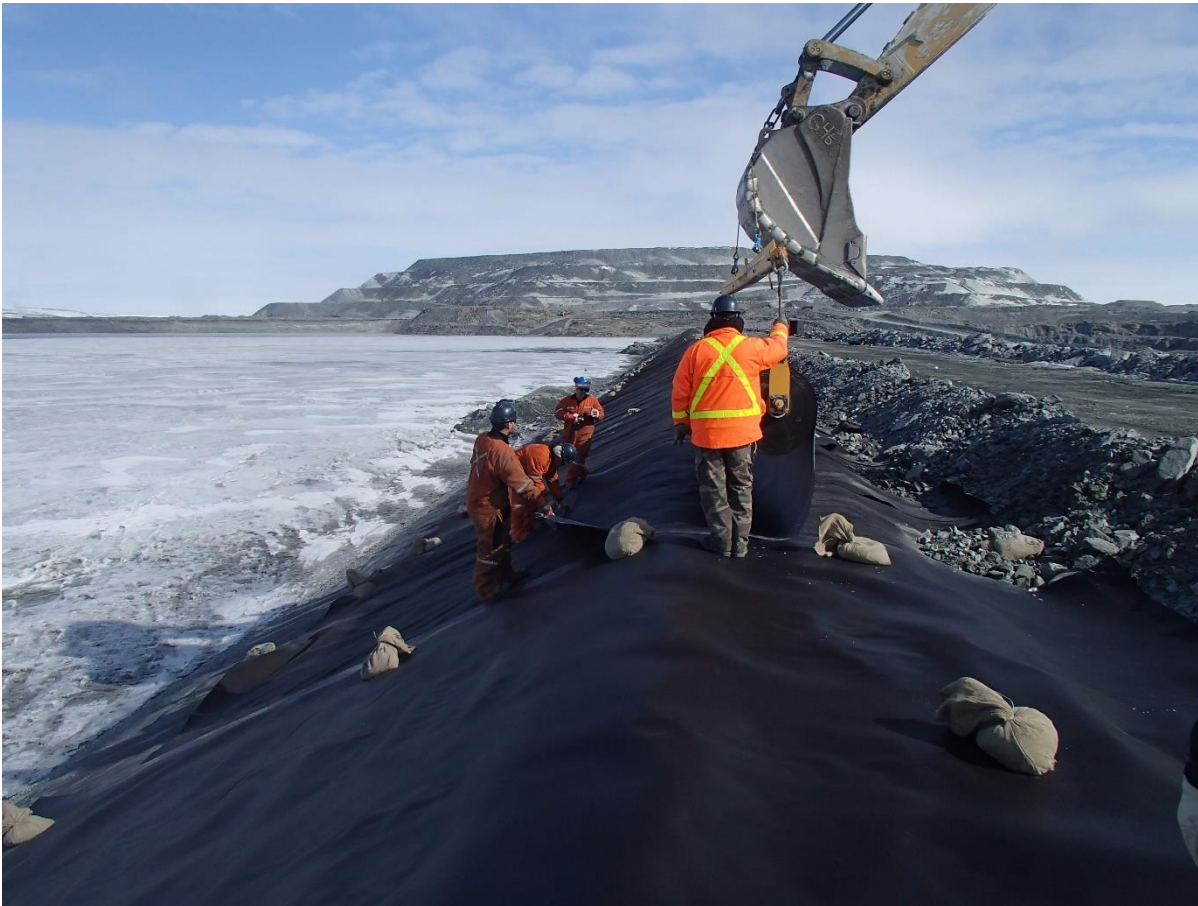
**Photograph CD-1878: From Sta. 0+720/-24 m, looking N. Installation of the LLDPE liner on the upstream slope 2H:1V between El. 143 m and 145 m from Sta. 0+740 m to 0+610 m (panel numbers 849 to 867).**

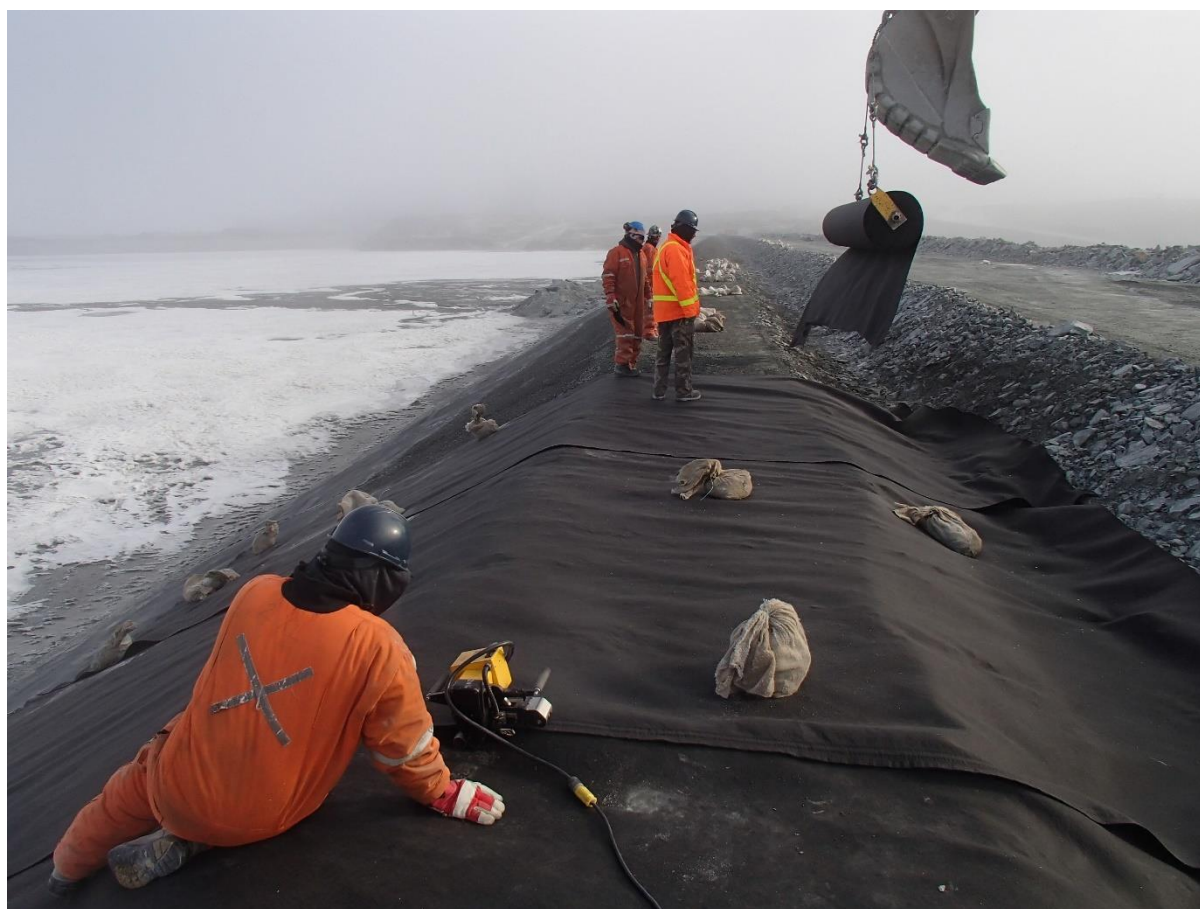
Photograph CD-1880: From Sta. 0+600/-25 m, looking N. Installation of the geotextile on the upstream slope 2H:1V between El. 143 m and 145 m from Sta. 0+610 m to 0+480 m.

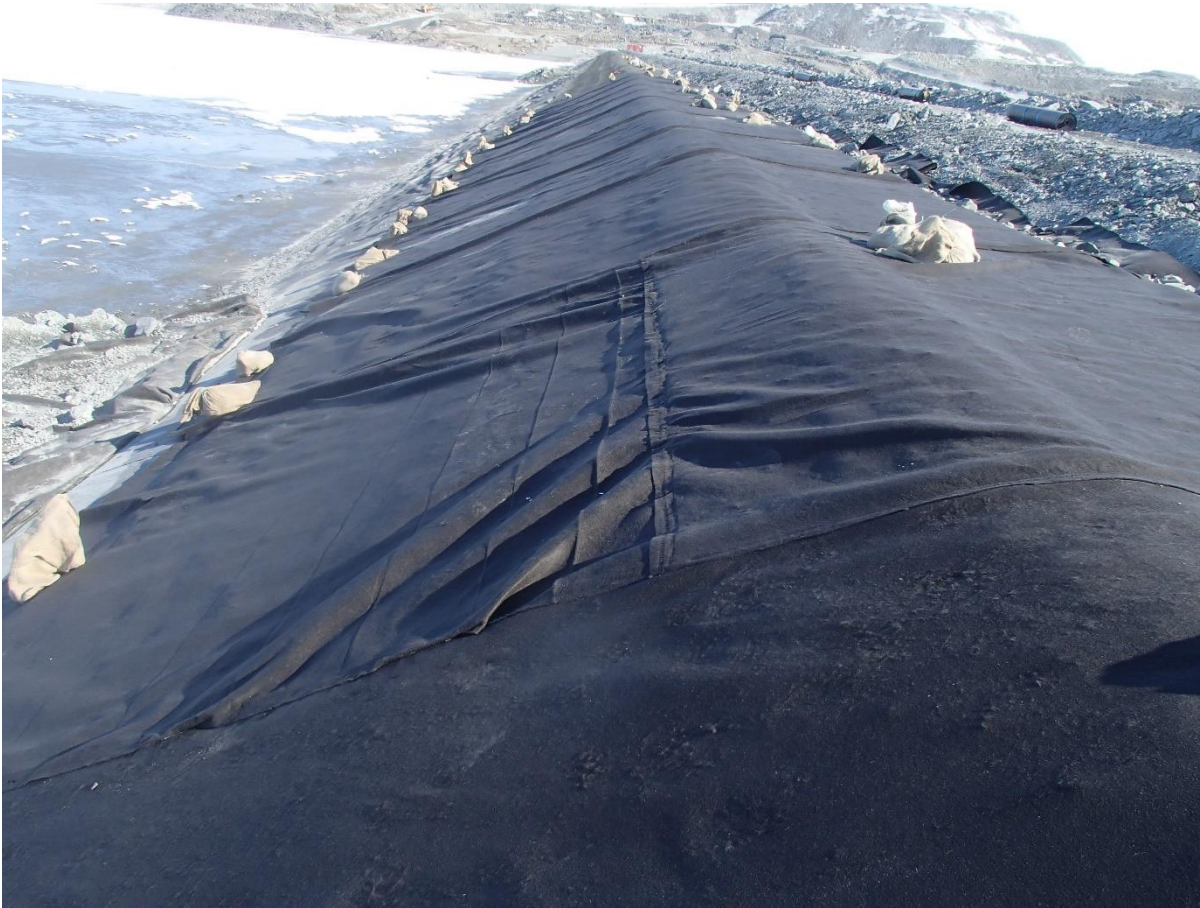
**Photograph CD-1881: From Sta. 0+530/-27 m, looking N. View of a geotextile panel with a horizontal weld in the slope at Sta. 0+520 m before its removal.**

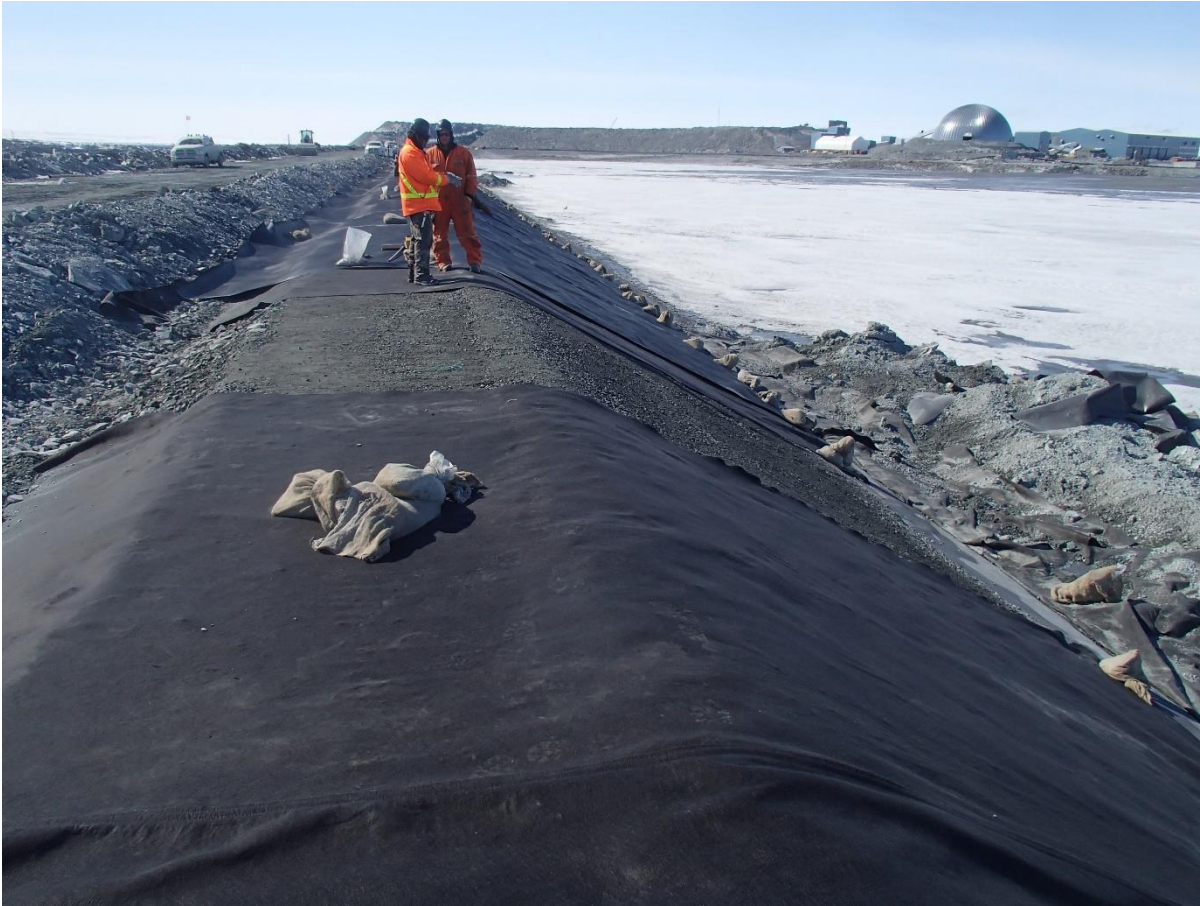
**Photograph CD-1882: From Sta. 0+510/-25 m, looking S. View of the emplacement of the geotextile panel with a horizontal weld in the slope at Sta. 0+520 following its removal.**

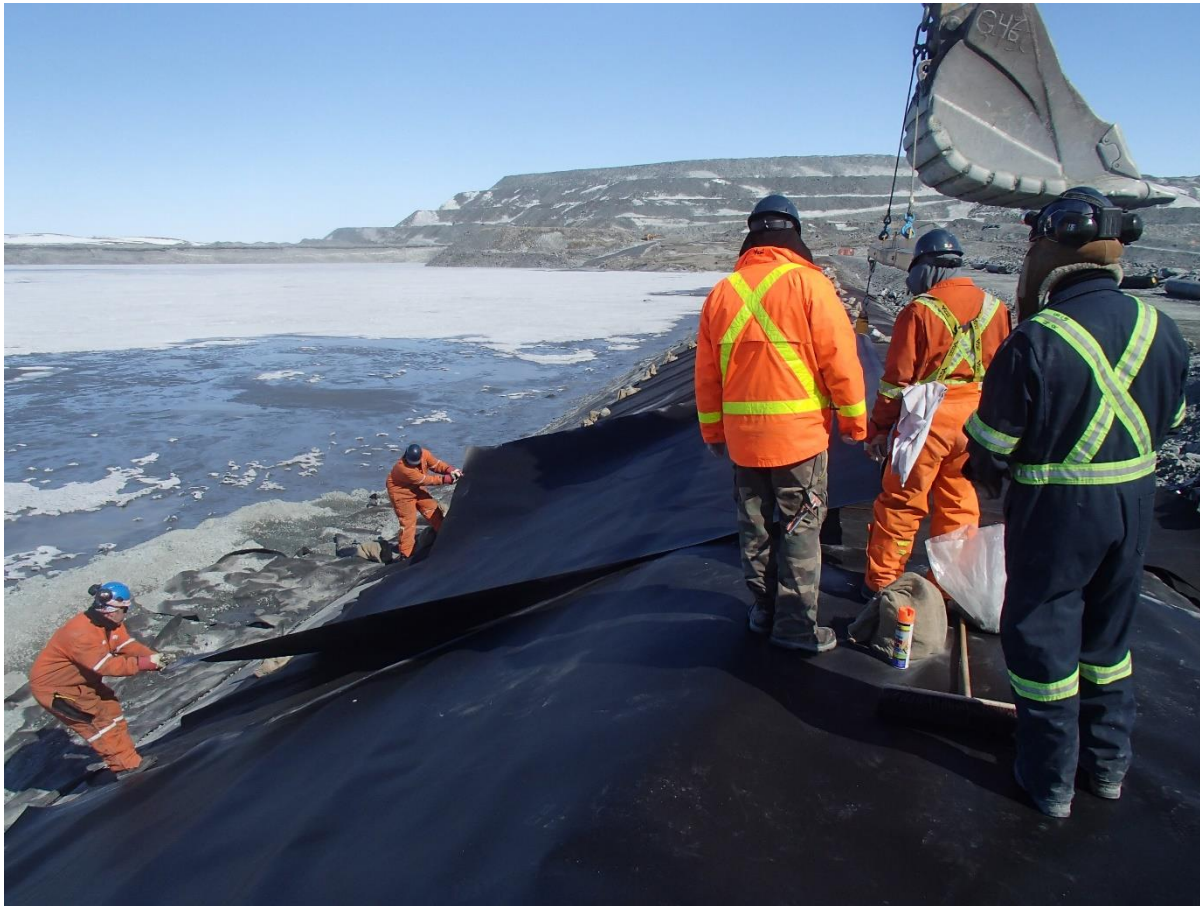
**Photograph CD-1883: From Sta. 0+525/-26 m, looking N. Installation of the LLDPE liner on the upstream slope 2H:1V between El. 143 m and 145 m from Sta. 0+610 m to 0+480 m (panel numbers 868 to 886).**

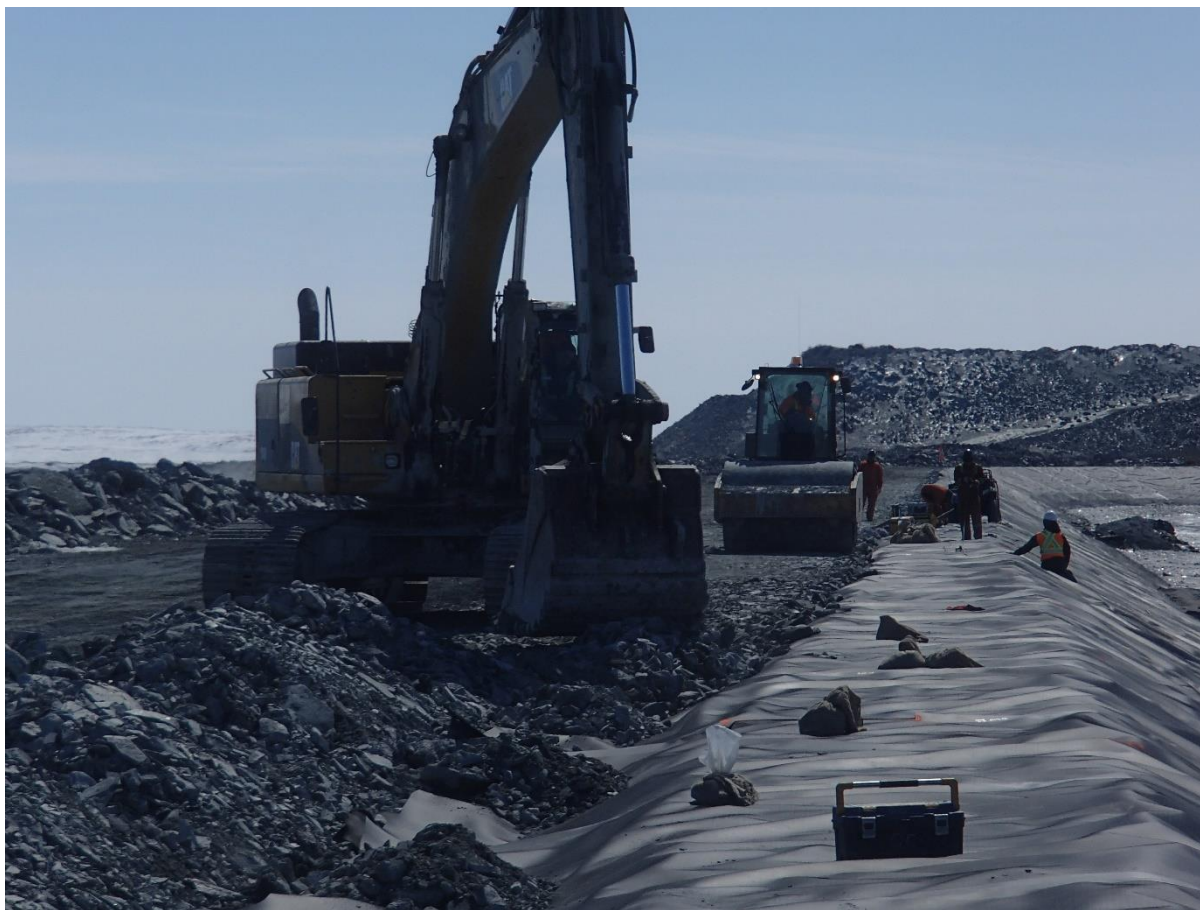
**Photograph CD-1884: From Sta. 0+530/-25 m, looking S. Backfilling of the geosynthetics tie-in from Sta. 0+610 m to 0+480 m and compaction of the tie-in material with a 10-tonne smooth-drum compactor with vibration (4 passes) from Sta.0+610 to 0+480 m.**

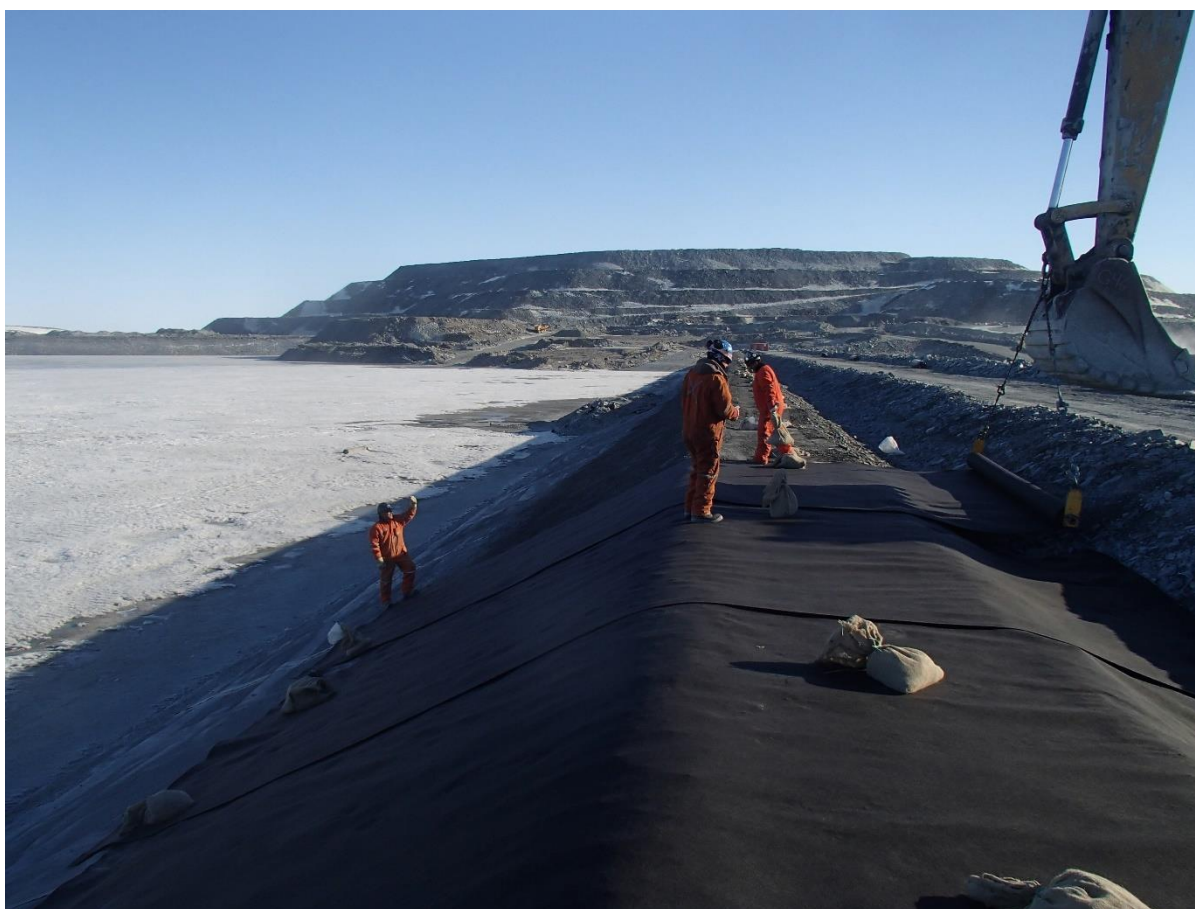
Photograph CD-1885: From Sta. 0+460/-26 m, looking N. Installation of the geotextile on the upstream slope 2H:1V between El. 143 m and 145 m from Sta. 0+480 m to 0+320 m.

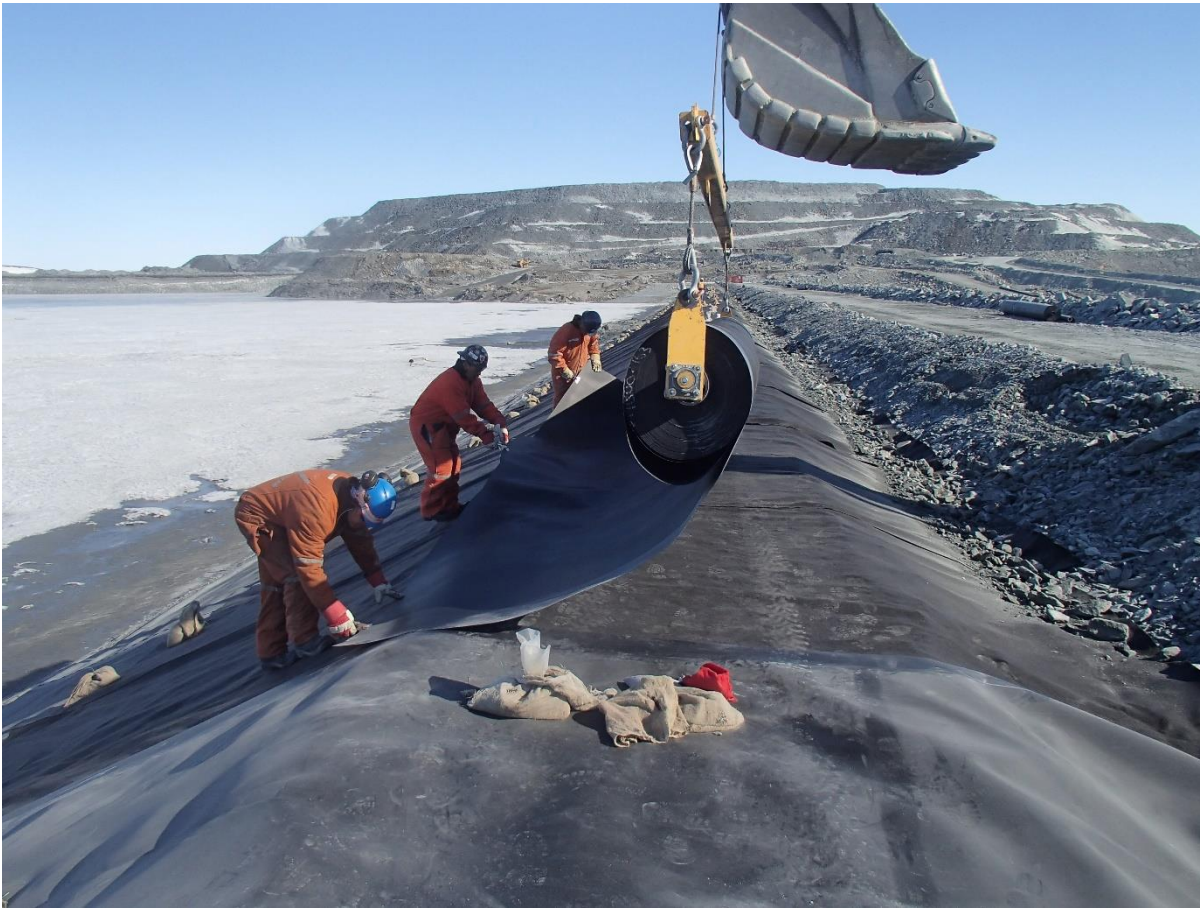
**Photograph CD-1886: From Sta. 0+525/-26 m, looking N. Installation of the LLDPE liner on the upstream slope 2H:1V between El. 143 m and 145 m from Sta. 0+480 m to 0+320 m (panel numbers 887 to 910).**

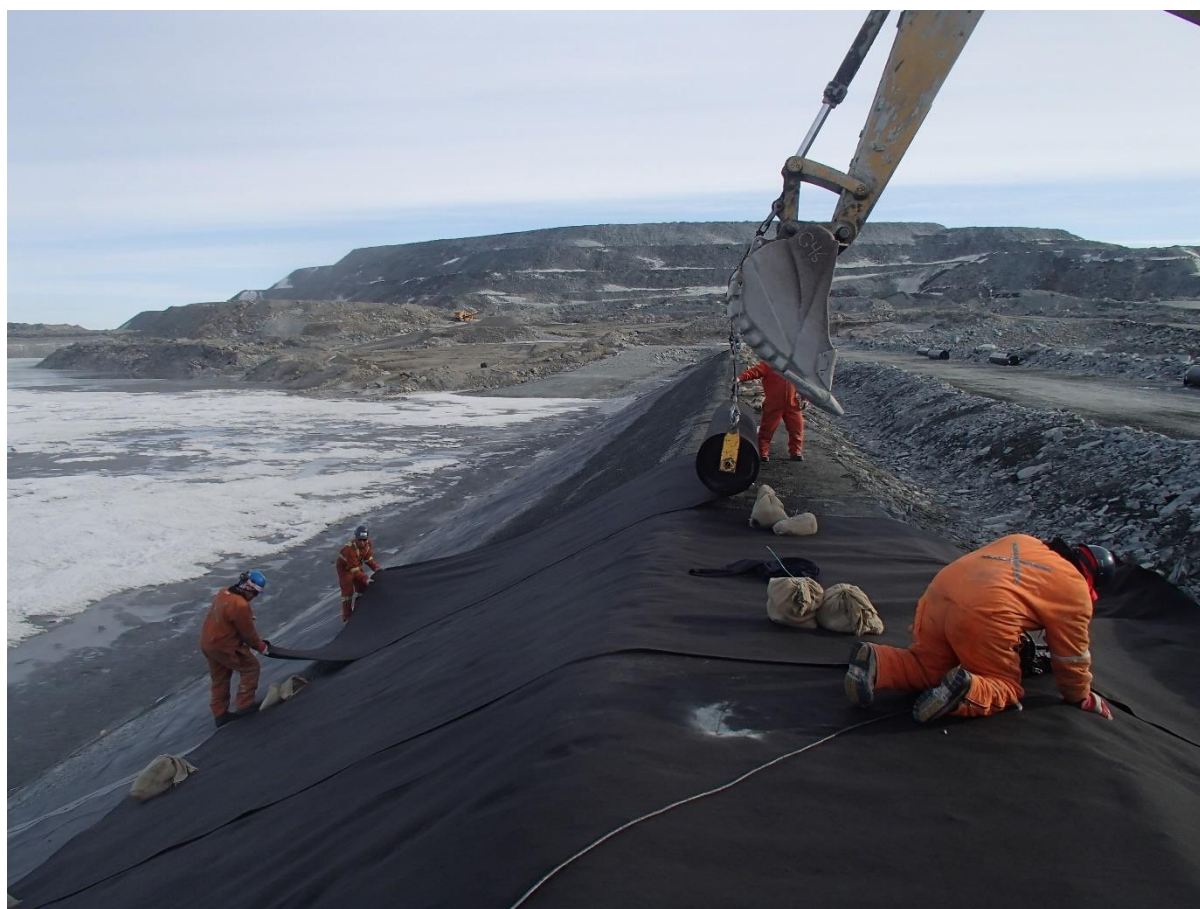
Photograph CD-1887: From Sta. 0+310/-26 m, looking N. Installation of the geotextile on the upstream slope 2H:1V between El. 143 m and 145 m from Sta. 0+320 m to 0+150 m.

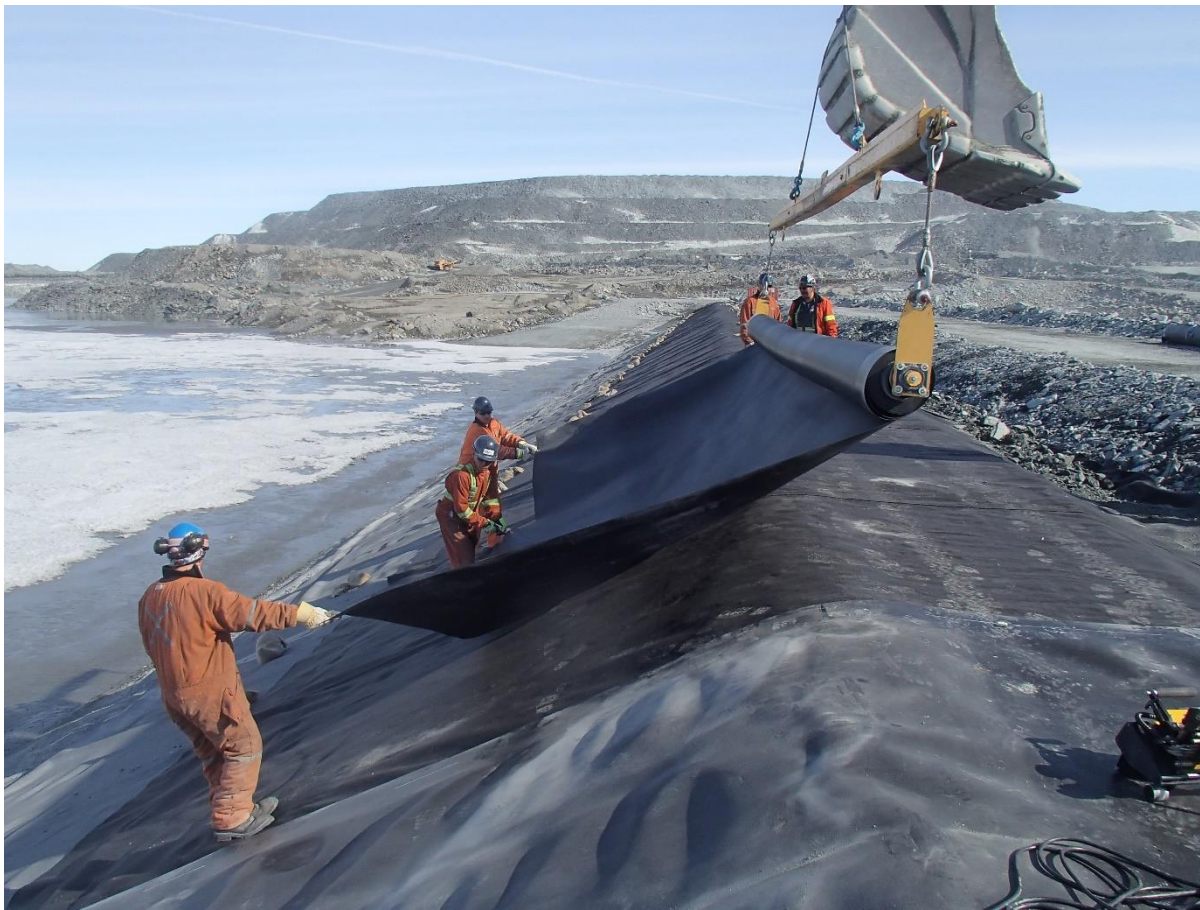
**Photograph CD-1888: From Sta. 0+525/-26 m, looking N. Installation of the LLDPE liner on the upstream slope 2H:1V between El. 143 m and 145 m from Sta. 0+320 m to 0+150 m (panel numbers 911 to 933).**

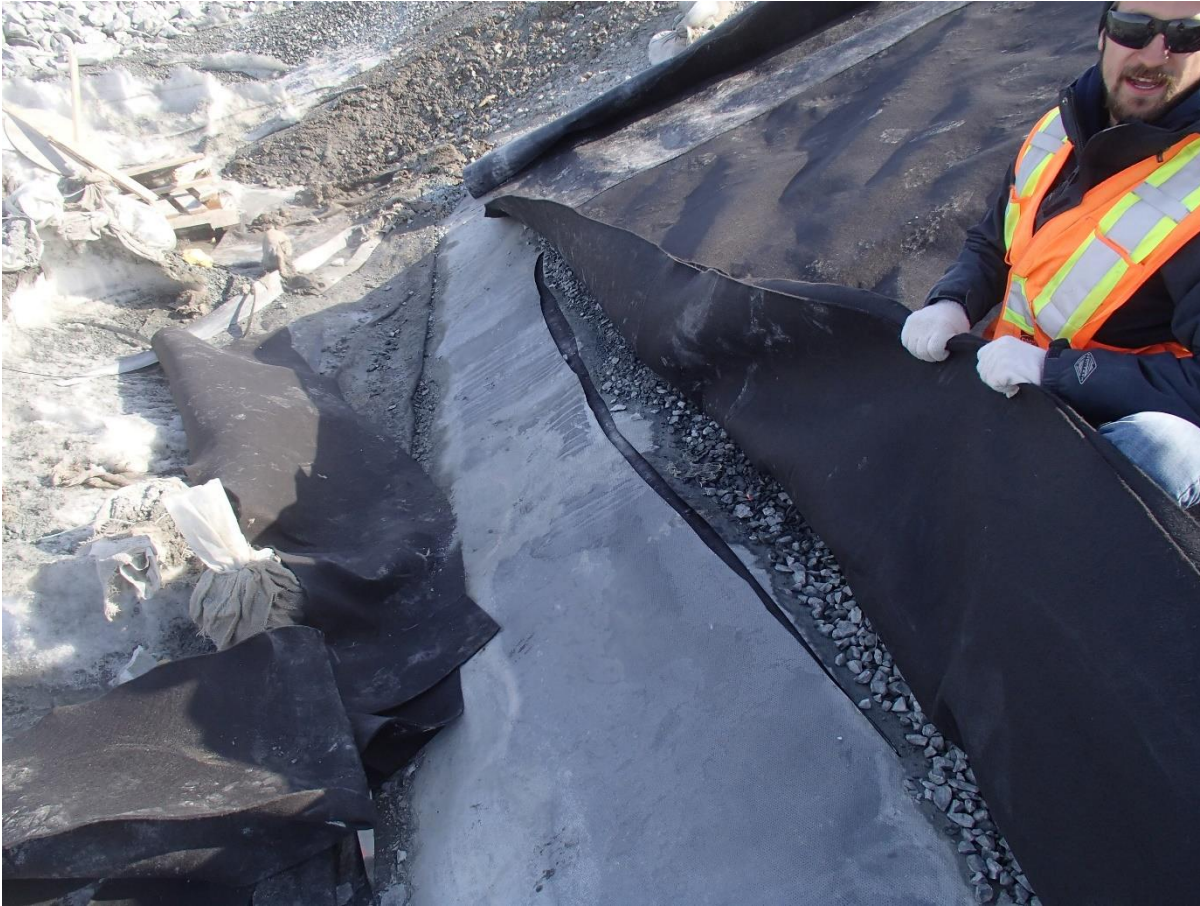
**Photograph CD-1889: From Sta. 0+150/-28 m, looking N. View of the underlying liner that has been cut at around Sta. 0+160 m to drain the water.**
